Hydraulic, Water-Quality, and Temperature Performance of Three Types of Permeable Pavement under High Sediment Loading Conditions

Scientific Investigations Report 2018–5037

By William R. Selbig and Nicolas Buer

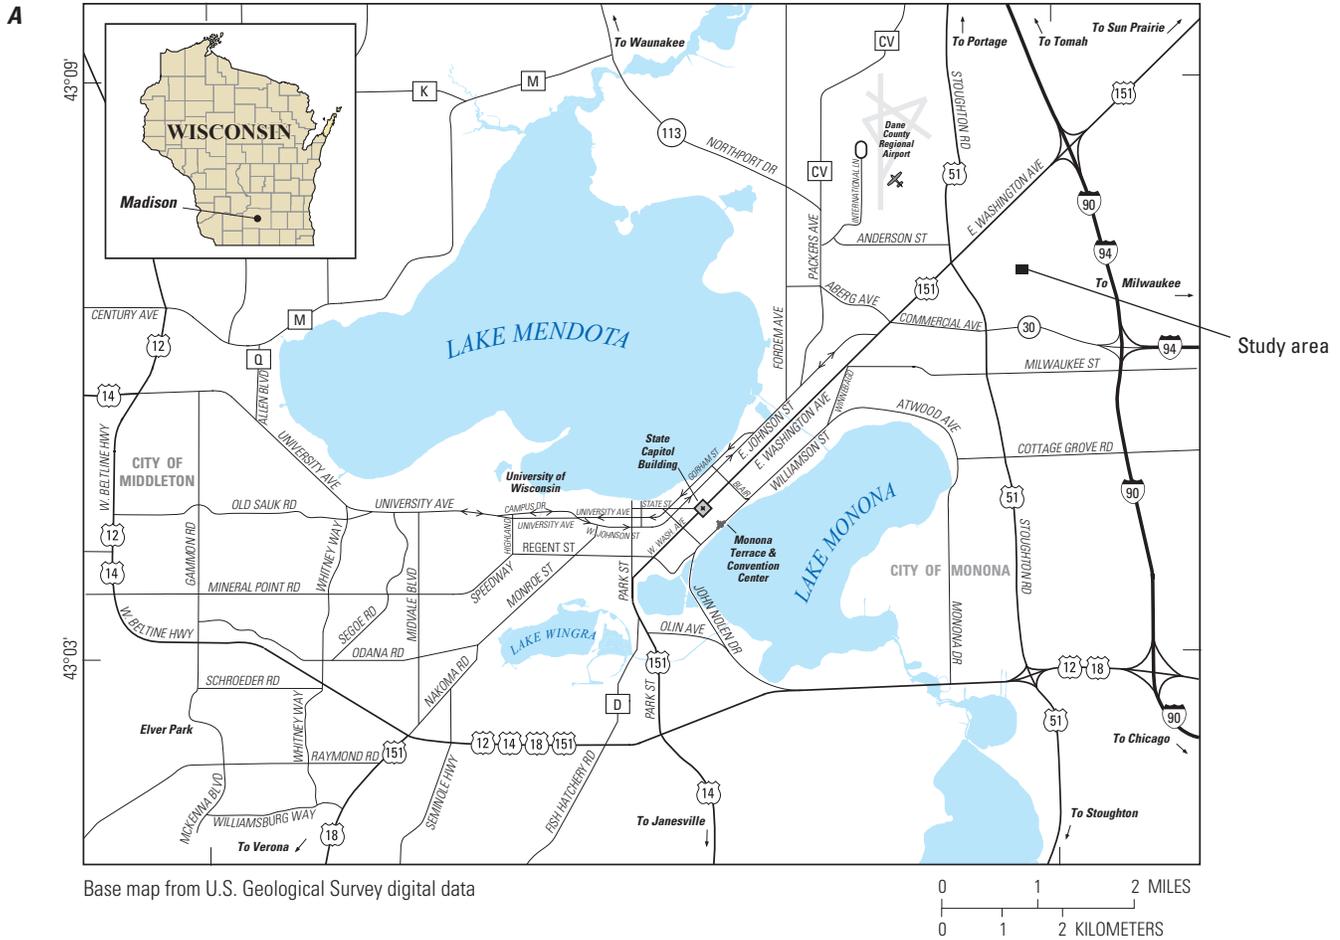
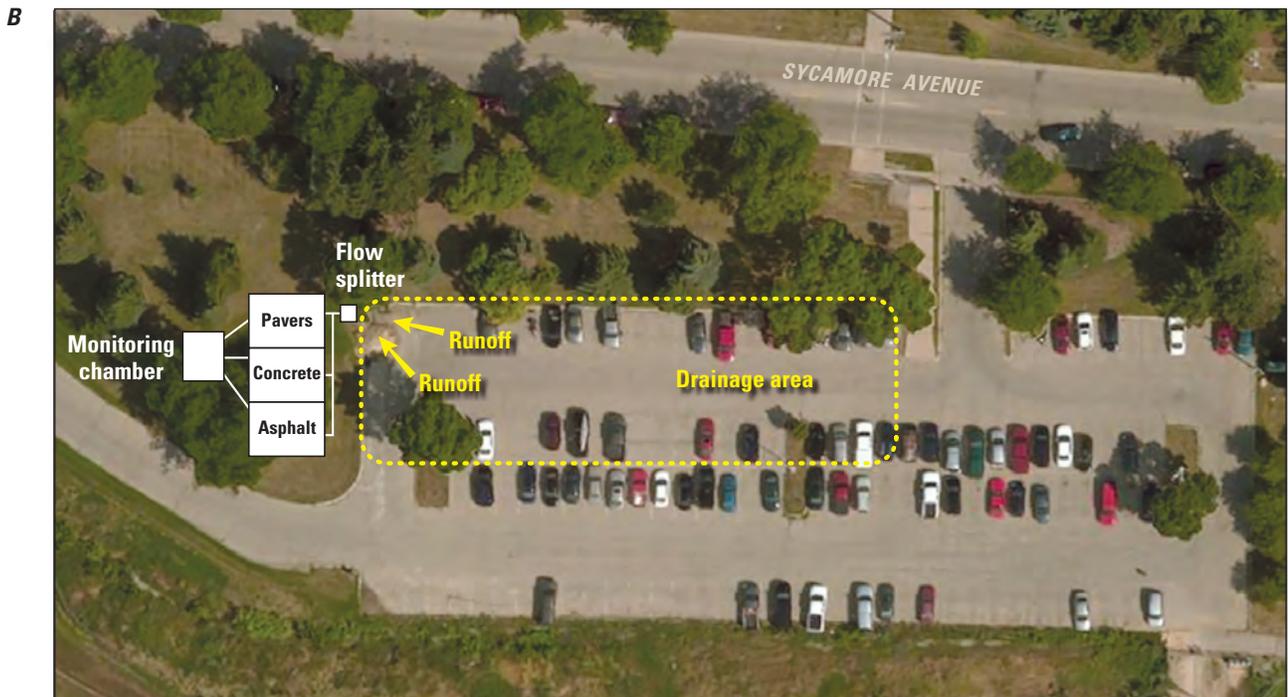
Schematic not drawn to scale.

Figure 1. Map and corresponding aerial photograph showing *A*, location of permeable pavement research facility in Madison, Wisconsin, and *B*, schematic of drainage area and orientation of permeable pavements.

In the summer of 2014, a permeable pavement test site was constructed adjacent to a public parking lot on the north-east side of Madison, Wisconsin, (fig. 1). The curbed asphalt lot provides parking for city of Madison employees as well as users of a nearby dog park. Asphalt berms were used to create an impermeable surface area (0.32 acre) with approximately 45 parking spaces and associated driving lanes that naturally drain towards the test site. The parking lot was approximately 25 years old at the time of the study and in poor condition. Maintenance of the parking lot was limited to a one-time repair of large potholes in May 2015. During the winter, snow and ice were removed from the parking lot by use of plows and a mixture of sand and salt when needed. Vehicles were restricted to the parking lot only and prohibited from accessing the permeable surfaces.

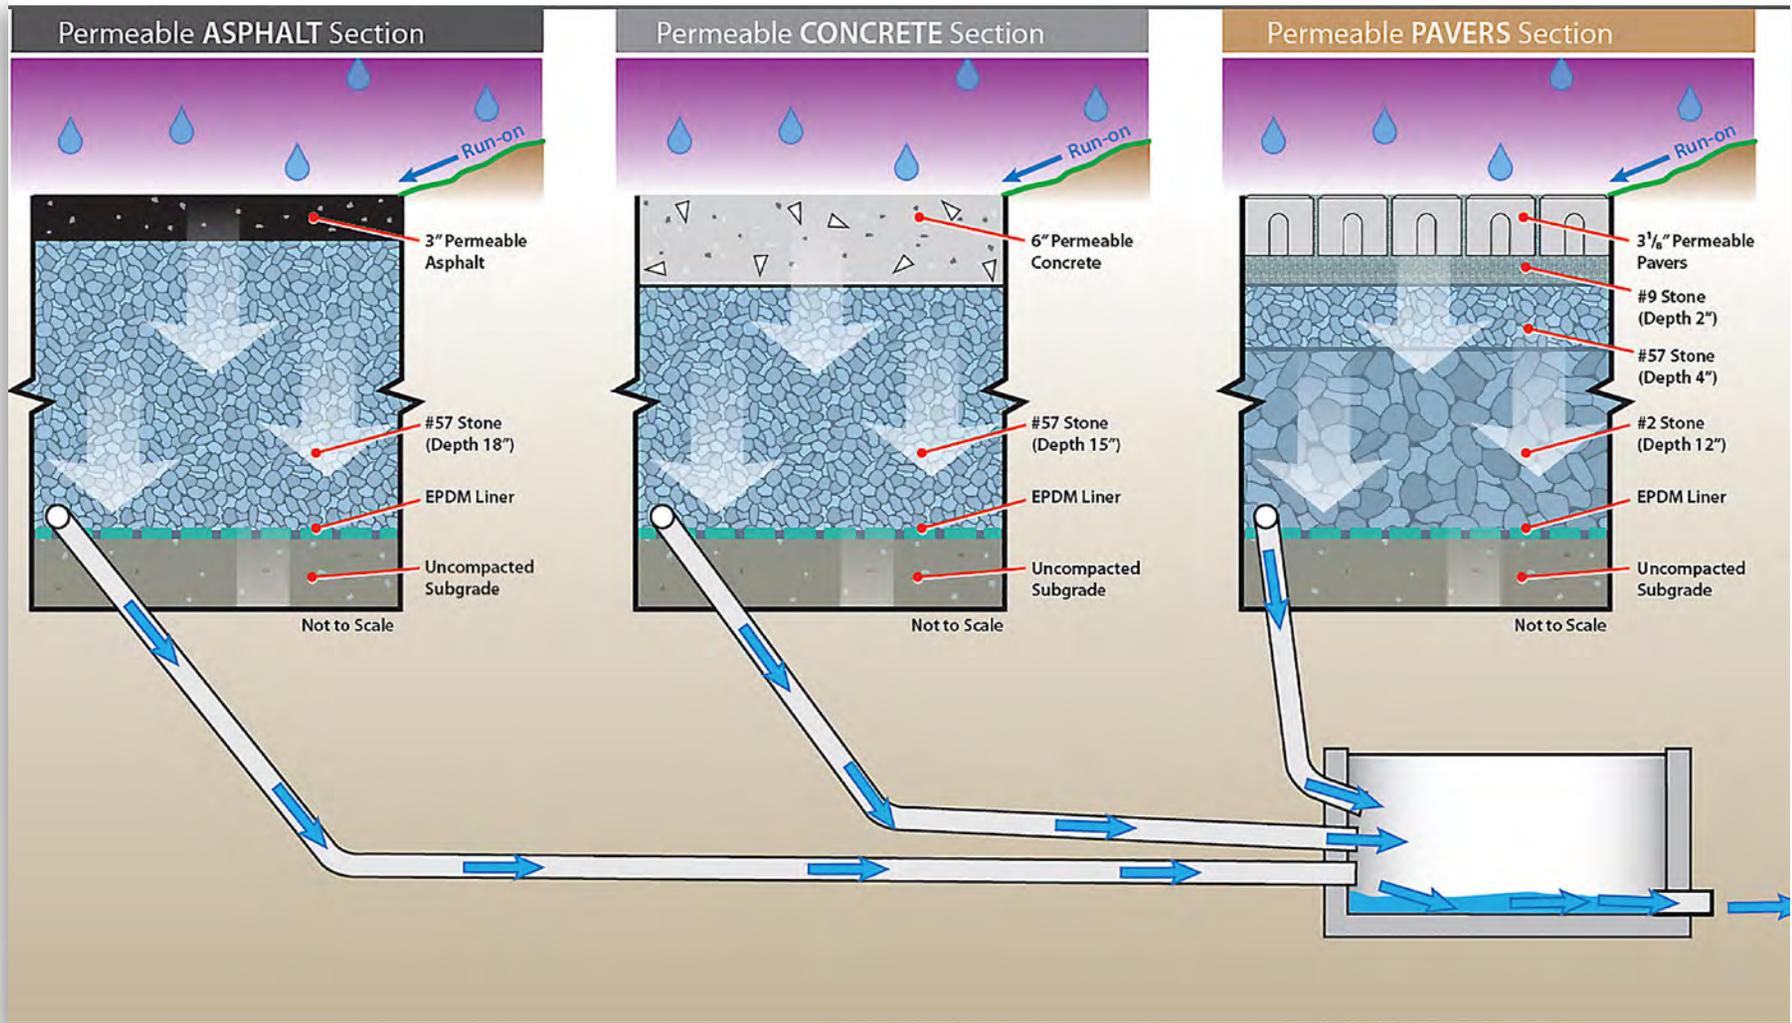
Figure 2. Conceptual diagram showing cross-sectional profile of porous asphalt, pervious concrete, and permeable interlocking pavers test surfaces and aggregate base. Blue arrows indicate flow of infiltrated runoff from the underdrain towards the monitoring chamber. (Courtesy of County Materials Corporation).

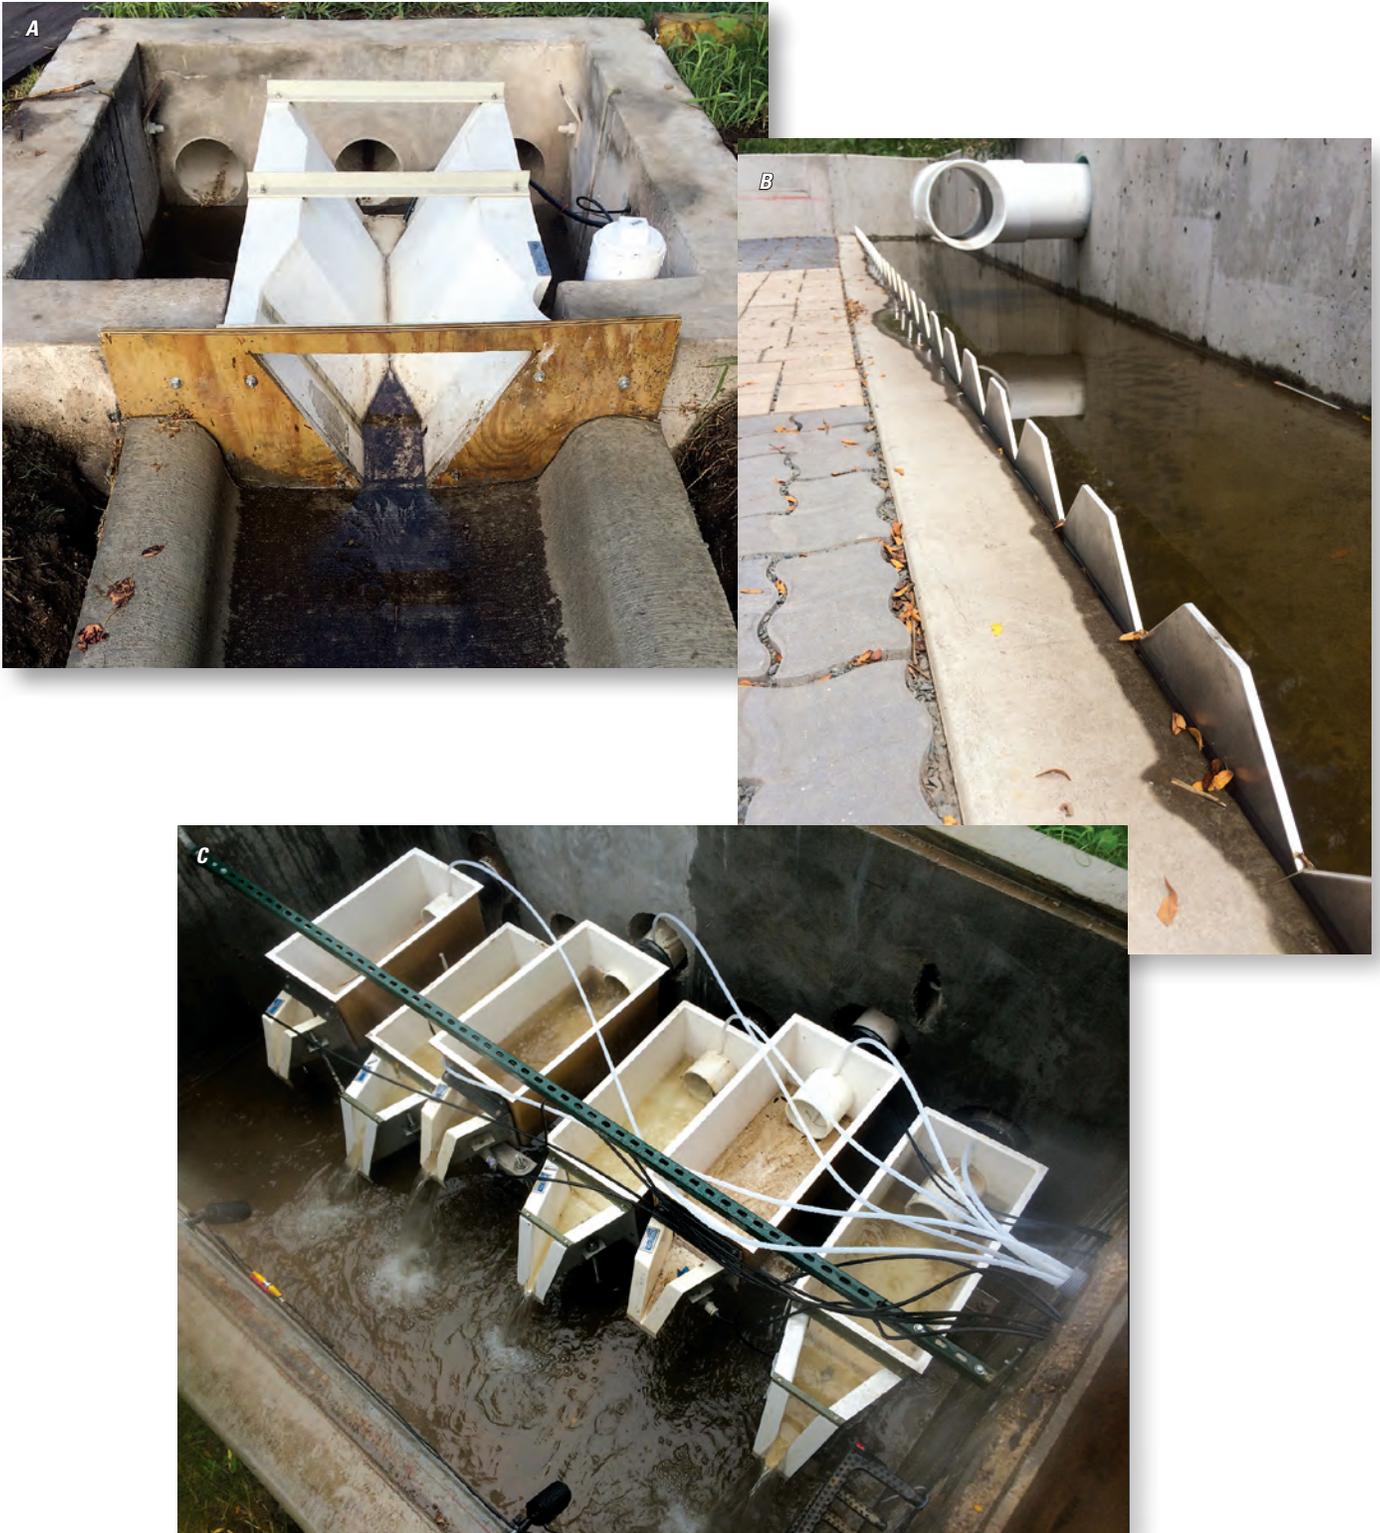
Figure 3. Hydraulic structures used to *A*, measure and distribute the flow of runoff from the parking lot; *B*, uniformly spread runoff across the test surface; and *C*, measure runoff that either passes through the underdrain of each permeable surface or bypasses as overflow.

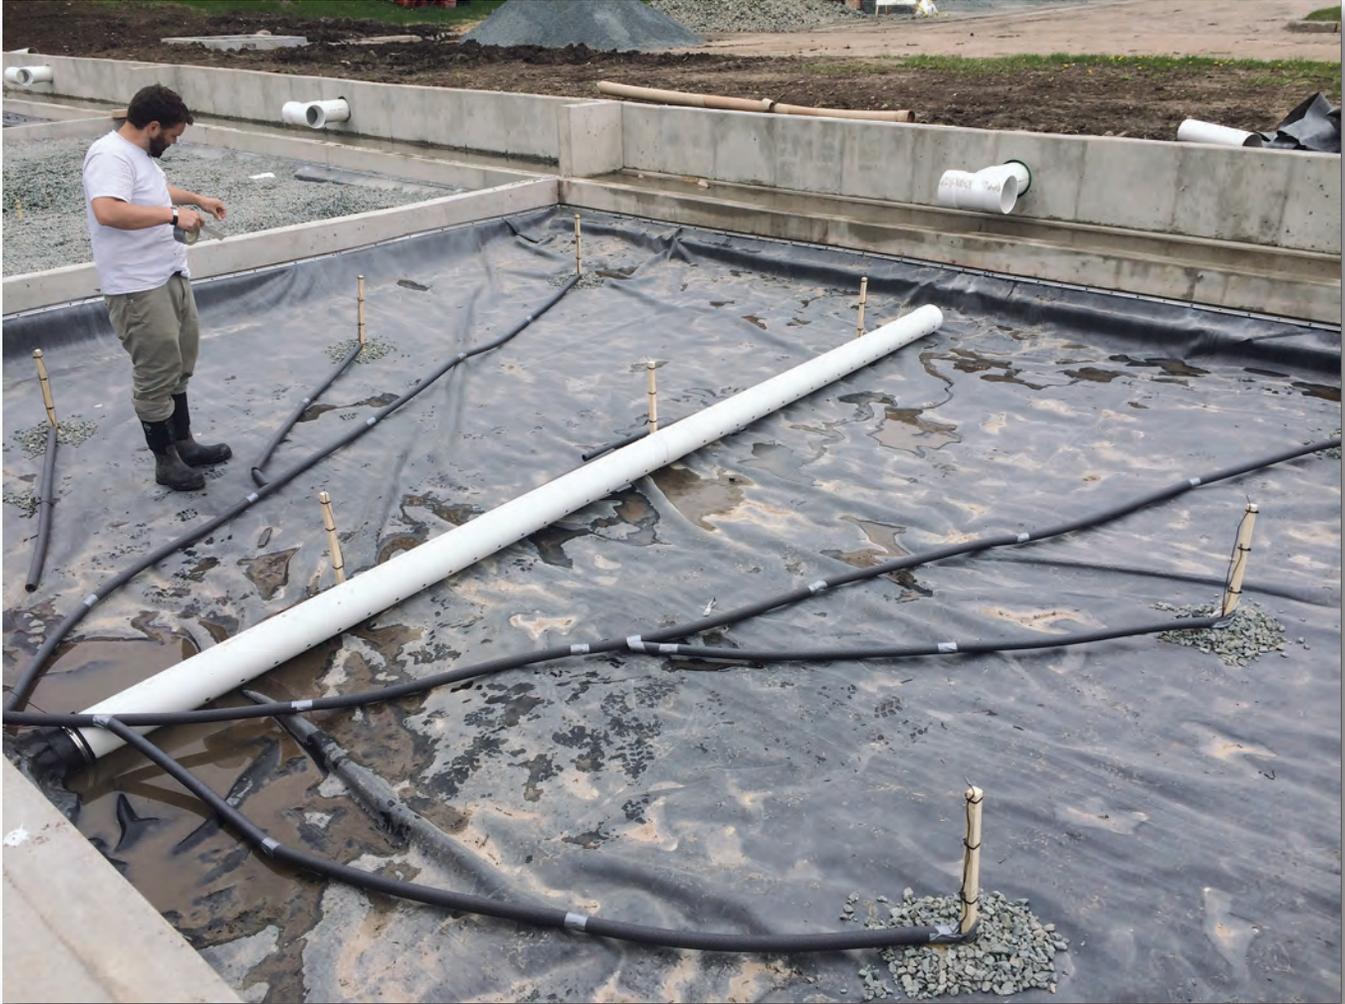
Figure 4. A network of temperature sensors placed in the porous asphalt test plot prior to installation of the aggregate base and asphalt surface. Attached to each wooden dowel placed in the three by three matrix were sensors spaced at about 0 (top), 6 (middle), and 12 (bottom) inches below the permeable surface. The pervious concrete and permeable interlocking pavers test plots had a similar configuration.

Continuous water temperature was measured with an insulated thermocouple wire during periods of runoff. Thermocouples were placed at the flume approach and exit for runoff influent and underdrain effluent, respectively. The temperature of runoff that bypassed as overflow was not measured. Additionally, a matrix of 27 thermocouples was installed below each permeable surface to measure both ambient air and water temperature as runoff percolated across and through each system. The thermocouples were in a three by three matrix with measurements made at approximately 0, 6, and 12 inches below the permeable layer into the aggregate base (fig. 4). Additional thermocouples were used to measure the surface temperature of each permeable system.

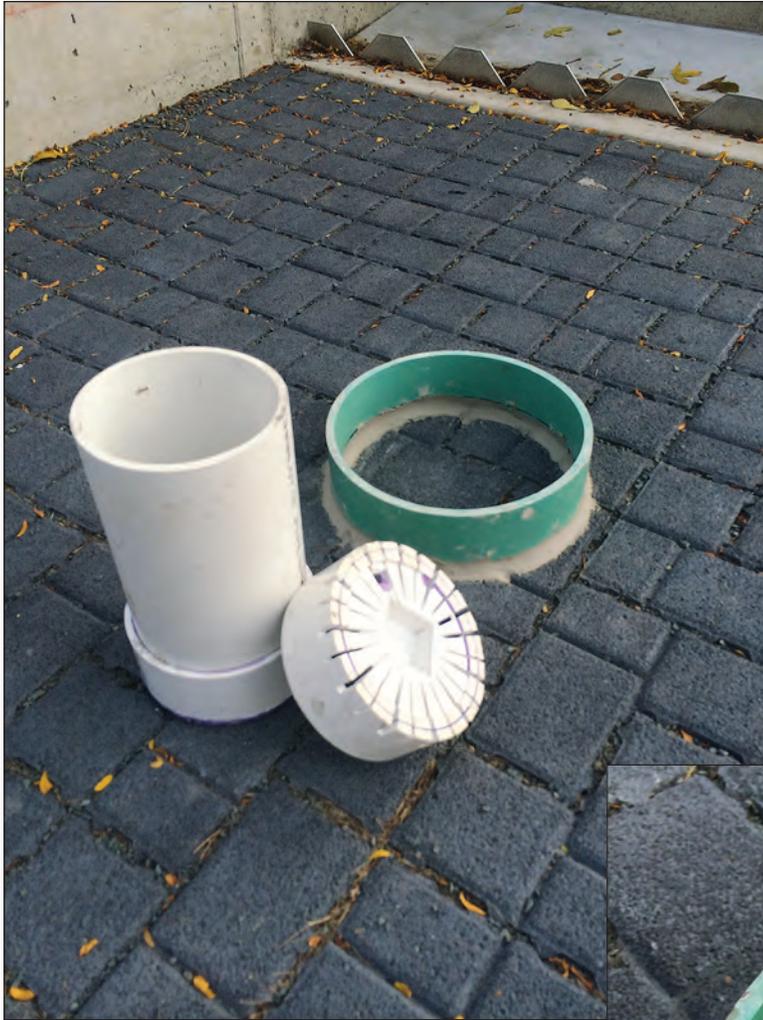
Figure 5. Illustration of device used to measure infiltration rates of porous asphalt, pervious concrete, and permeable interlocking pavers based on a modified version of ASTM C1701 (American Society of Testing and Materials, 2009).

Infiltration rates were measured using a modified version of the ASTM standard test method C1701/1701M (American Society of Testing and Materials, 2009). Although designed for PC, the method was applied to all three permeable surfaces in this study. This method measures the time required to infiltrate a known volume of water through a ring of known area sealed to the permeable surface. The device used to measure infiltration rates of each permeable surface is shown in figure 5. The ring consisted of a 12-inch diameter PVC pipe cut to 3.5 inches. The ring was sealed to the pavement by use of rolled coils of pottery clay. Water in the ring maintained a constant head of 0.4–0.6 inch by use of an automatic water feeder consisting of a 6-inch diameter PVC pipe with a tight-fitting cap capable of holding 1 gallon of water. A total of 12 evenly spaced 0.25-inch slits were cut into the cap at a depth of 0.6 inch. When inverted, the automatic water feeder filled the area inside the test ring with water to the height of the slits (0.6 inch). Once water in the ring reached this height, a vacuum inside the automatic water feeder prevented more water from escaping until the water level in the ring dropped again. This auto-regulation through water level manipulation, a commonly used principle in water tanks for livestock, was able to produce the constant head needed for this test.

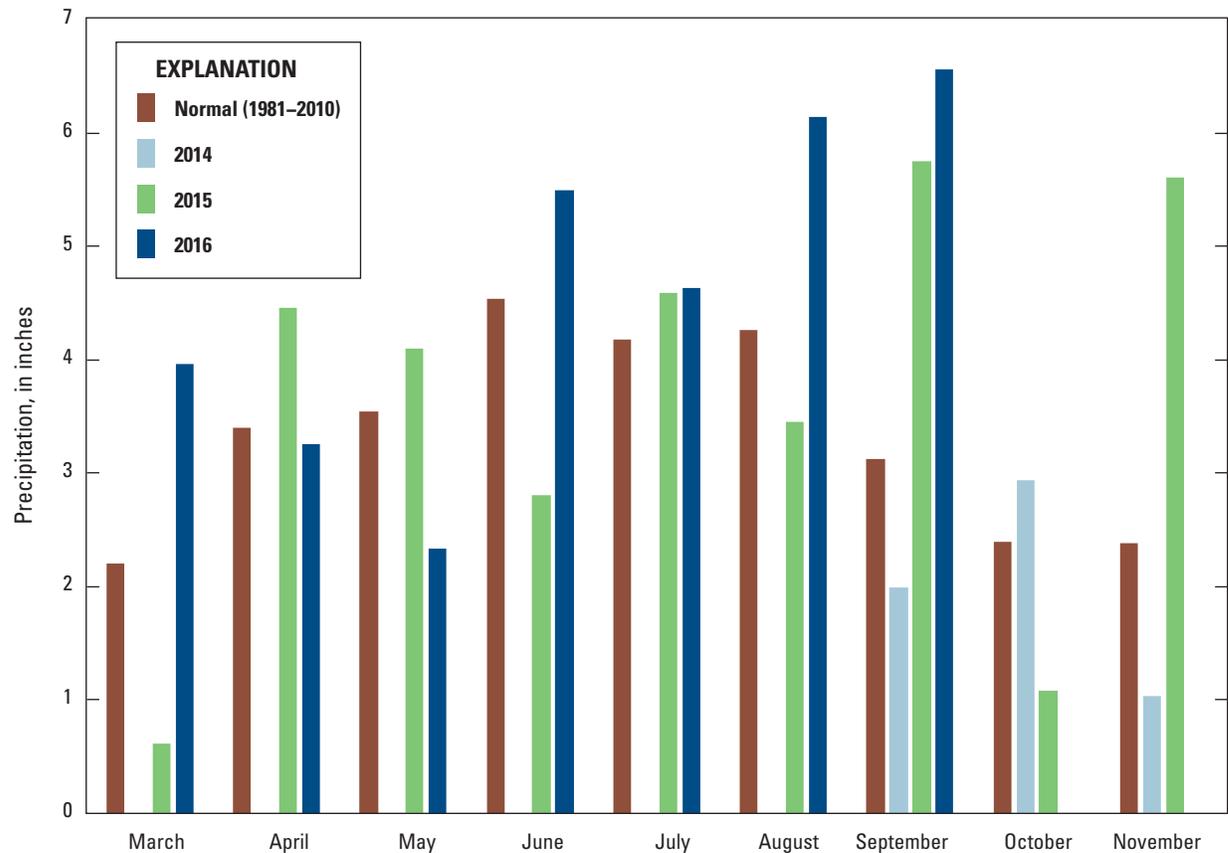
Figure 6. Monthly precipitation depth measured at the permeable pavement research facility from September 2014 through September 2016 compared to the 30-year normal (1981–2010).

depth during the monitored period are shown in figure 6. Winter months from December through February were excluded because the precipitation gage was not equipped to measure the water equivalency of snow. Monthly precipitation generally was below normal during the 2014 monitoring year. Monthly precipitation generally was within 1 inch of normal in 2015 except September and November, which were above normal. Monthly precipitation was similar in 2016, with August and September recording more than 6 inches.

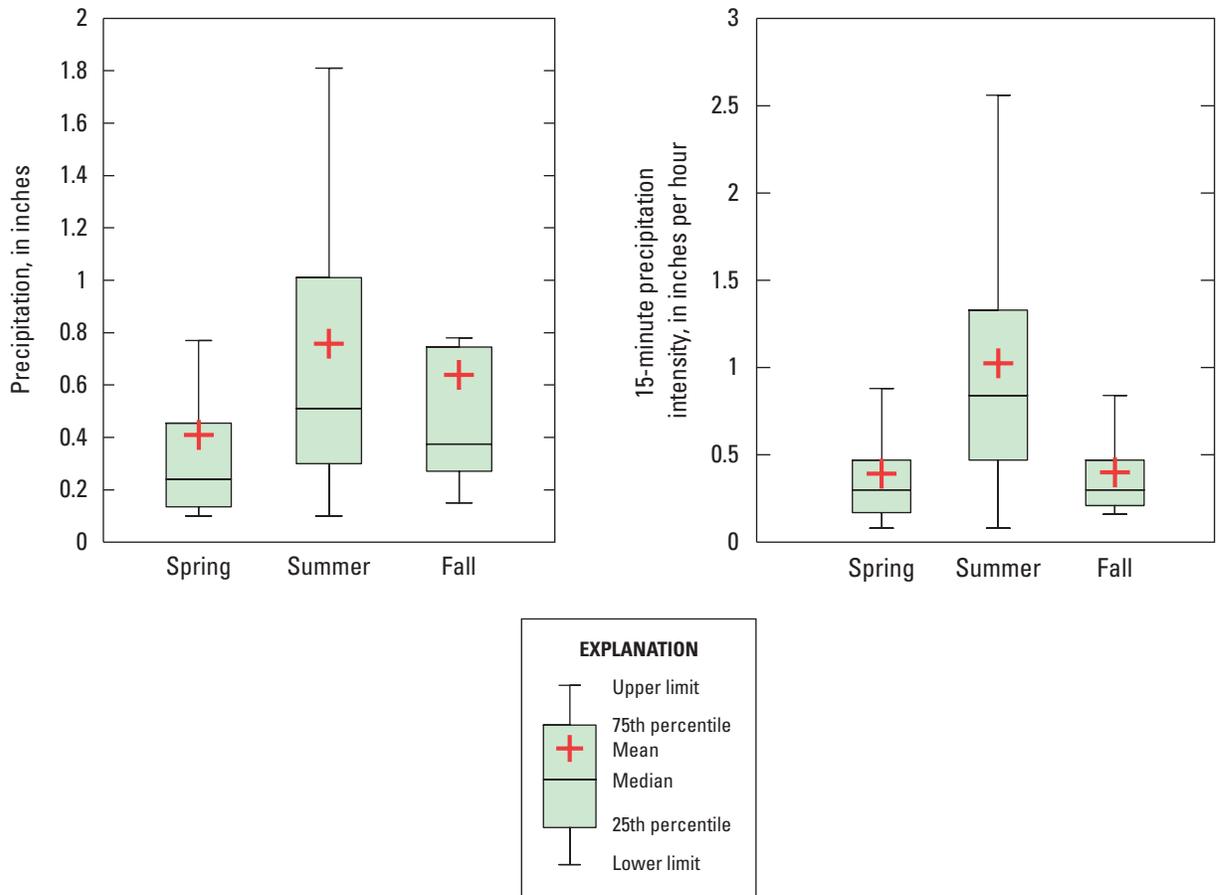
Figure 7. Box plots showing seasonal precipitation depth and intensity for monitored events at the permeable pavement research facility.

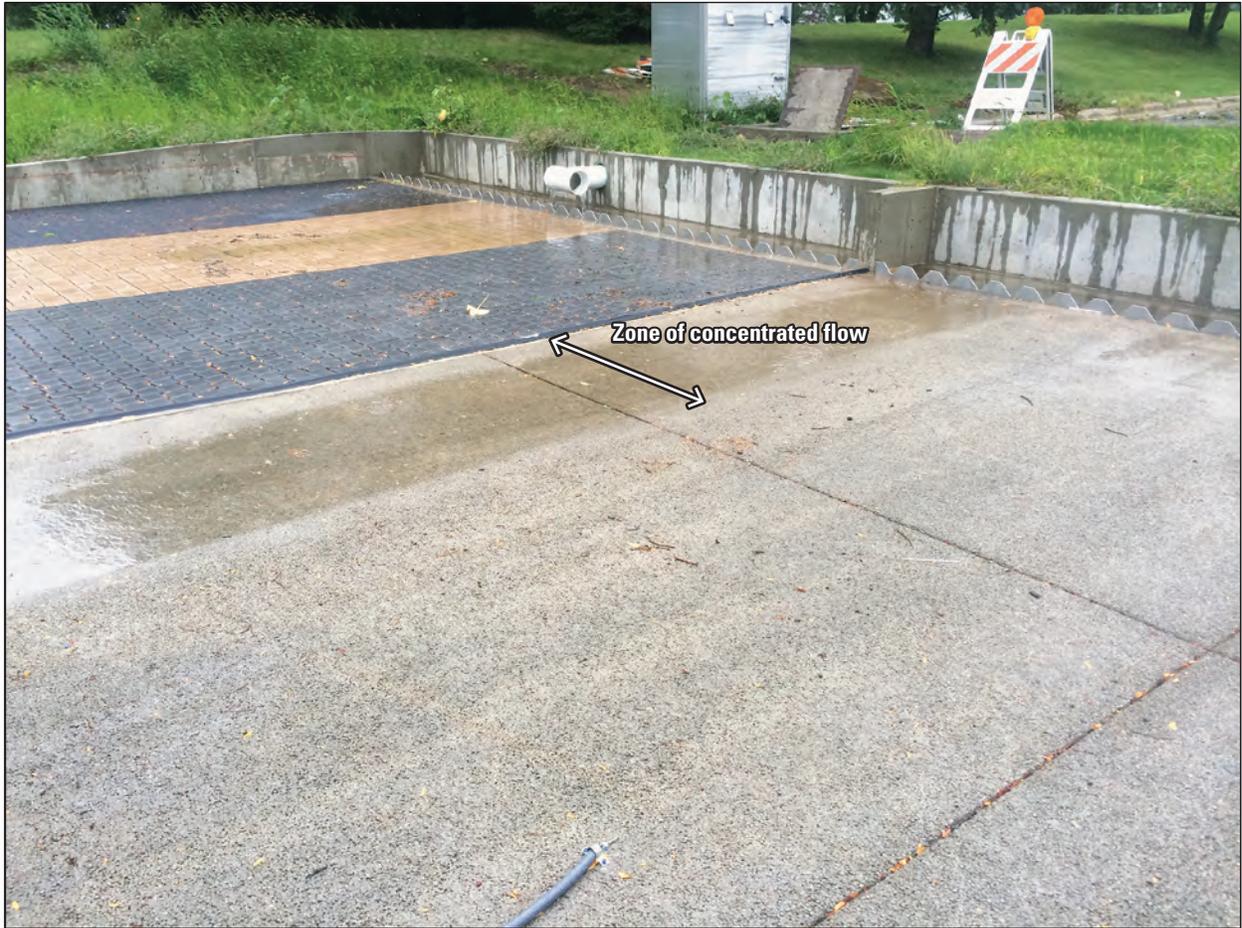
Figure 8. Photograph showing zone of concentrated flow for runoff in the pervious concrete test plot.

Irregularities such as the settling of inadequately compacted aggregate may also have created opportunities to promote preferential pathways for runoff. The pathways identified for PC were the most obvious. However, pathways were later observed in PIP and were observed to a lesser degree in PA. Collins and others (2008) made similar conclusions when evaluating two variations of PIP. One of the PIP surfaces produced a higher amount of runoff despite having a higher void area and surface infiltration rate; therefore, differences in configurations and geometries may have influenced the way water flowed across each surface (Collins and others, 2008). Other than through visual observation, predicting where and when these pathways would emerge is difficult.

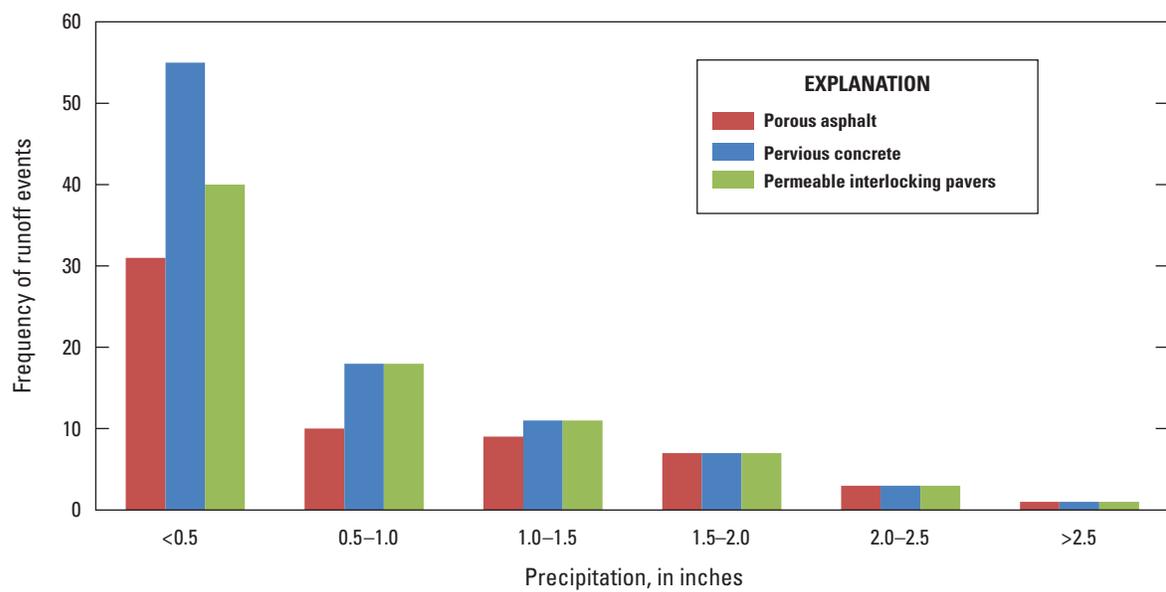
Figure 9. Histogram showing the frequency of measurable runoff bypassing as overflow in the porous asphalt, pervious concrete, and permeable interlocking pavers test plots with increasing event precipitation depth.

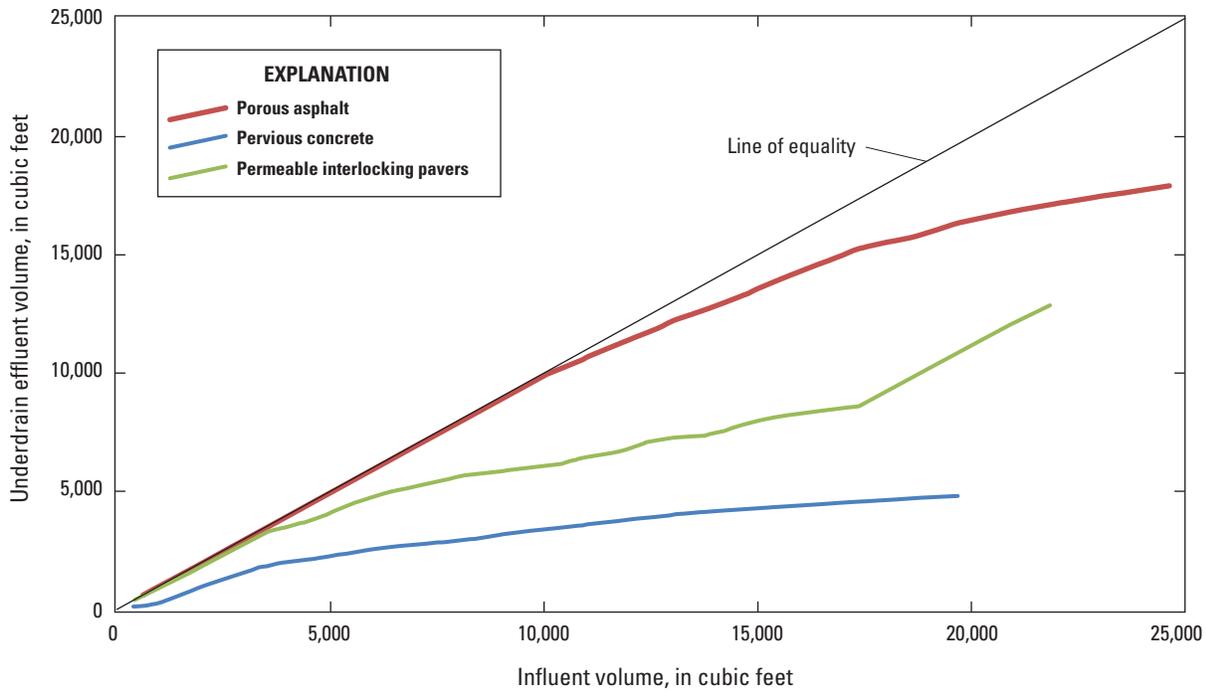
Figure 10. Cumulative influent runoff volume measured from the parking lot compared to the cumulative effluent volume measured in the underdrains of the porous asphalt, pervious concrete, and permeable interlocking pavers test plots.

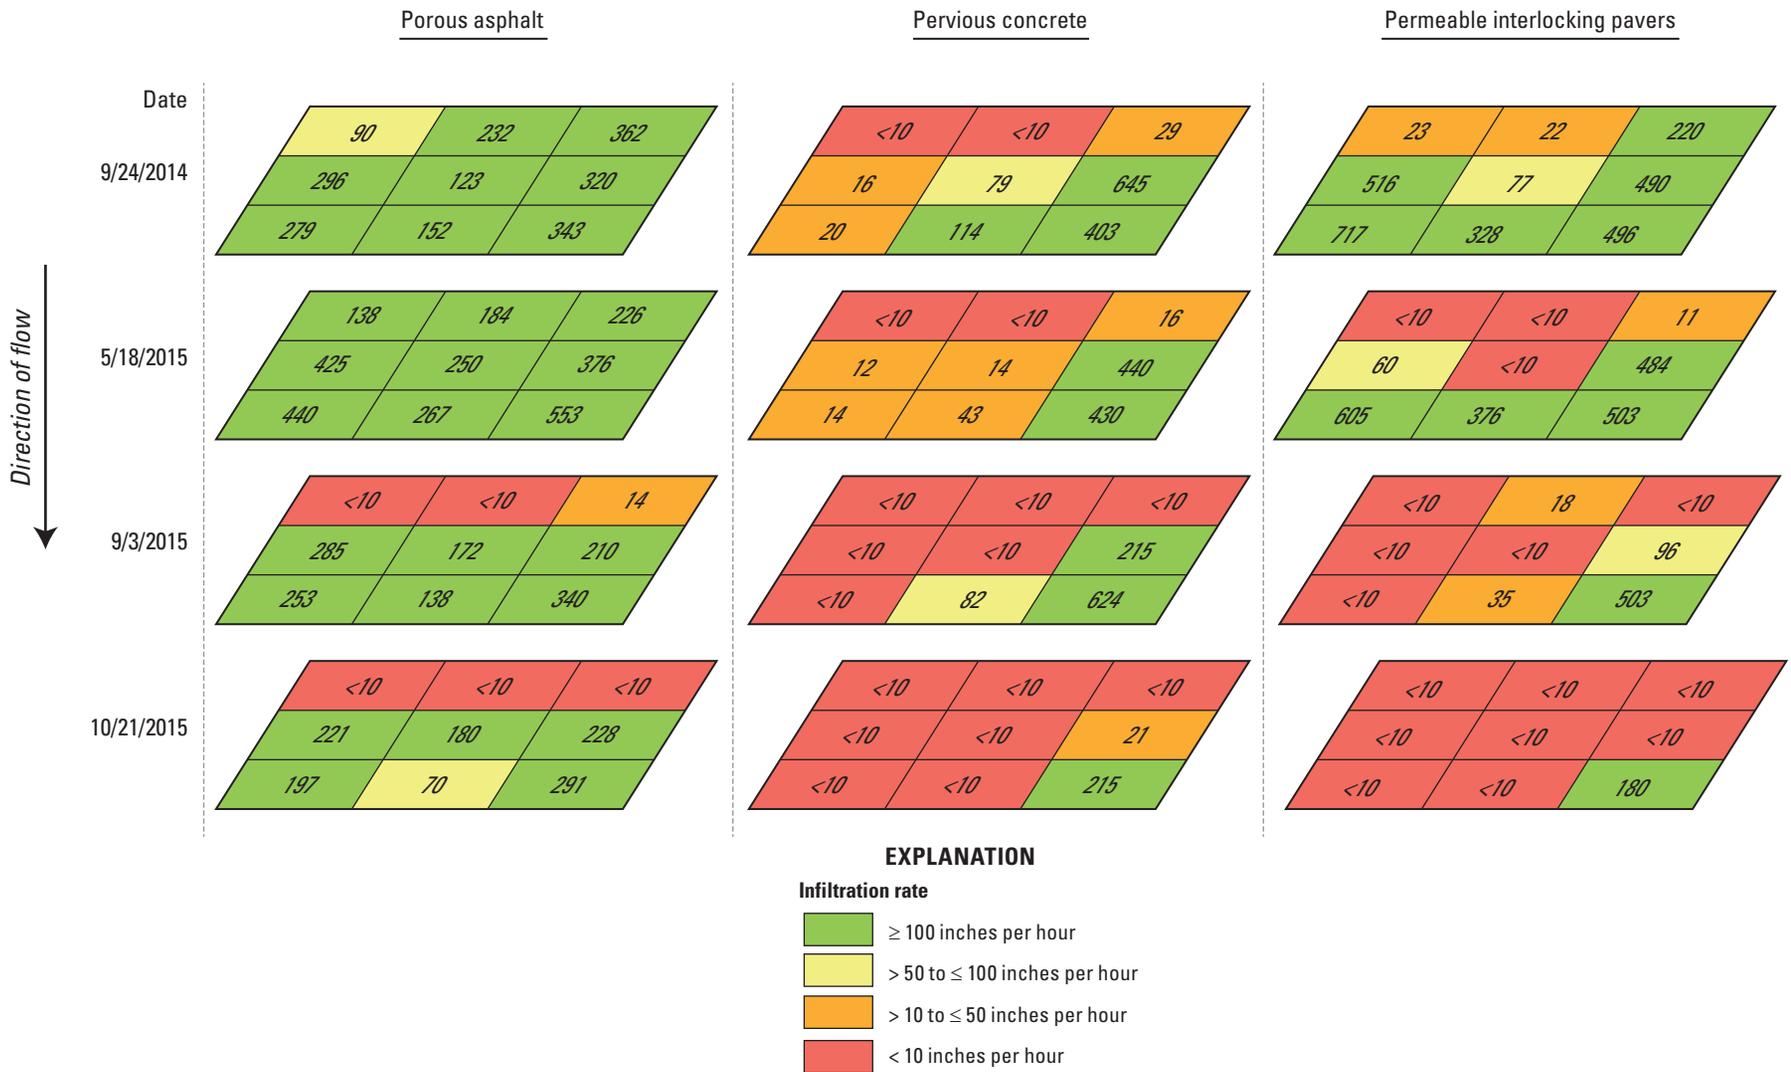
Figure 11. Heat map illustrating spatial distribution of infiltration rates in the porous asphalt, pervious concrete, and permeable interlocking pavers test plots, in plan view, from 1 month to about 1 year after construction.

As expected, areas that received runoff first from the level spreader were also first to clog, the exception was PC, which failed along the aforementioned lateral portion of the test plot soon after construction. The decline in infiltrative capacity was less predictable as distance increased from the level spreader. Despite best efforts to create a level surface, a lack of uniform degradation in surface infiltration rates across the PC and PIP surface indicated that preferential flow left some sections subjected to only direct precipitation. The PA surface did not exhibit the same variability as PC and PIP. Although preferential pathways may have existed in the PA test plot, most of the runoff filtered through the surface within the first few feet of the level spreader (fig. 11).

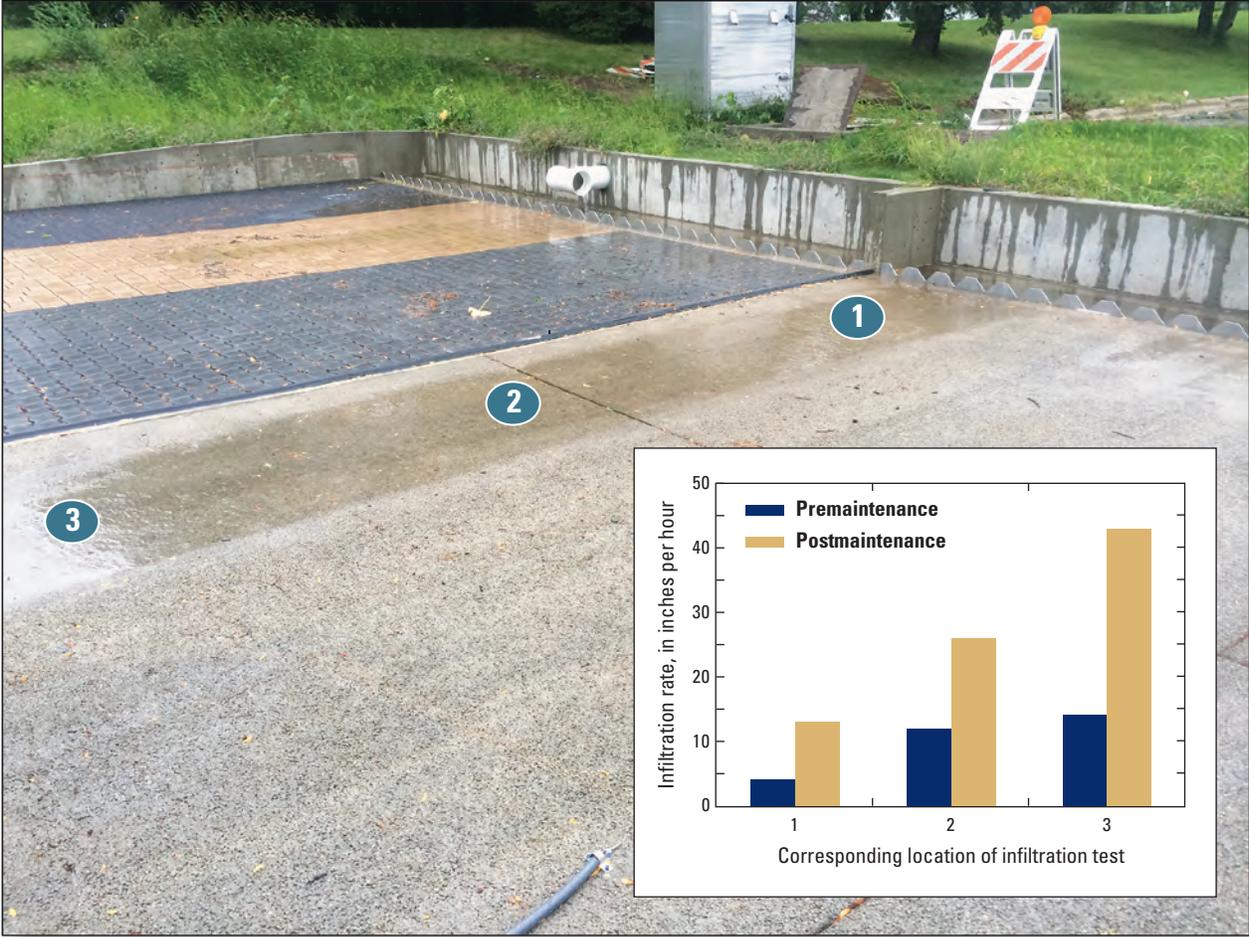
Figure 12. Response in infiltration rates at select locations pre-maintenance and post-maintenance of the pervious concrete surface.

Maintenance of the PC surface was done in May 2015 as an attempt to restore the permeability of the surface caused by construction deformation. A high-powered, hand-held pressure washer was applied to the affected area followed by a high-powered vacuum suction to remove any dislodged material. The response in infiltration rates at select locations pre-maintenance and post-maintenance of the PC surface is shown in figure 12. Appreciable gains in infiltration rates were achieved at each location. Clogging was most pronounced near the influent level spreader, which, despite improvement from maintenance efforts, was still enough to limit infiltration rates to less than 15 in/hr. Although post-maintenance infiltration rates in the affected area increased by more than 100 percent, the rates were still far lower than those measured at other locations within the PC surface. Although this level of maintenance effort might exceed normal industry recommendations, results indicate the potential outcome in extreme circumstances.

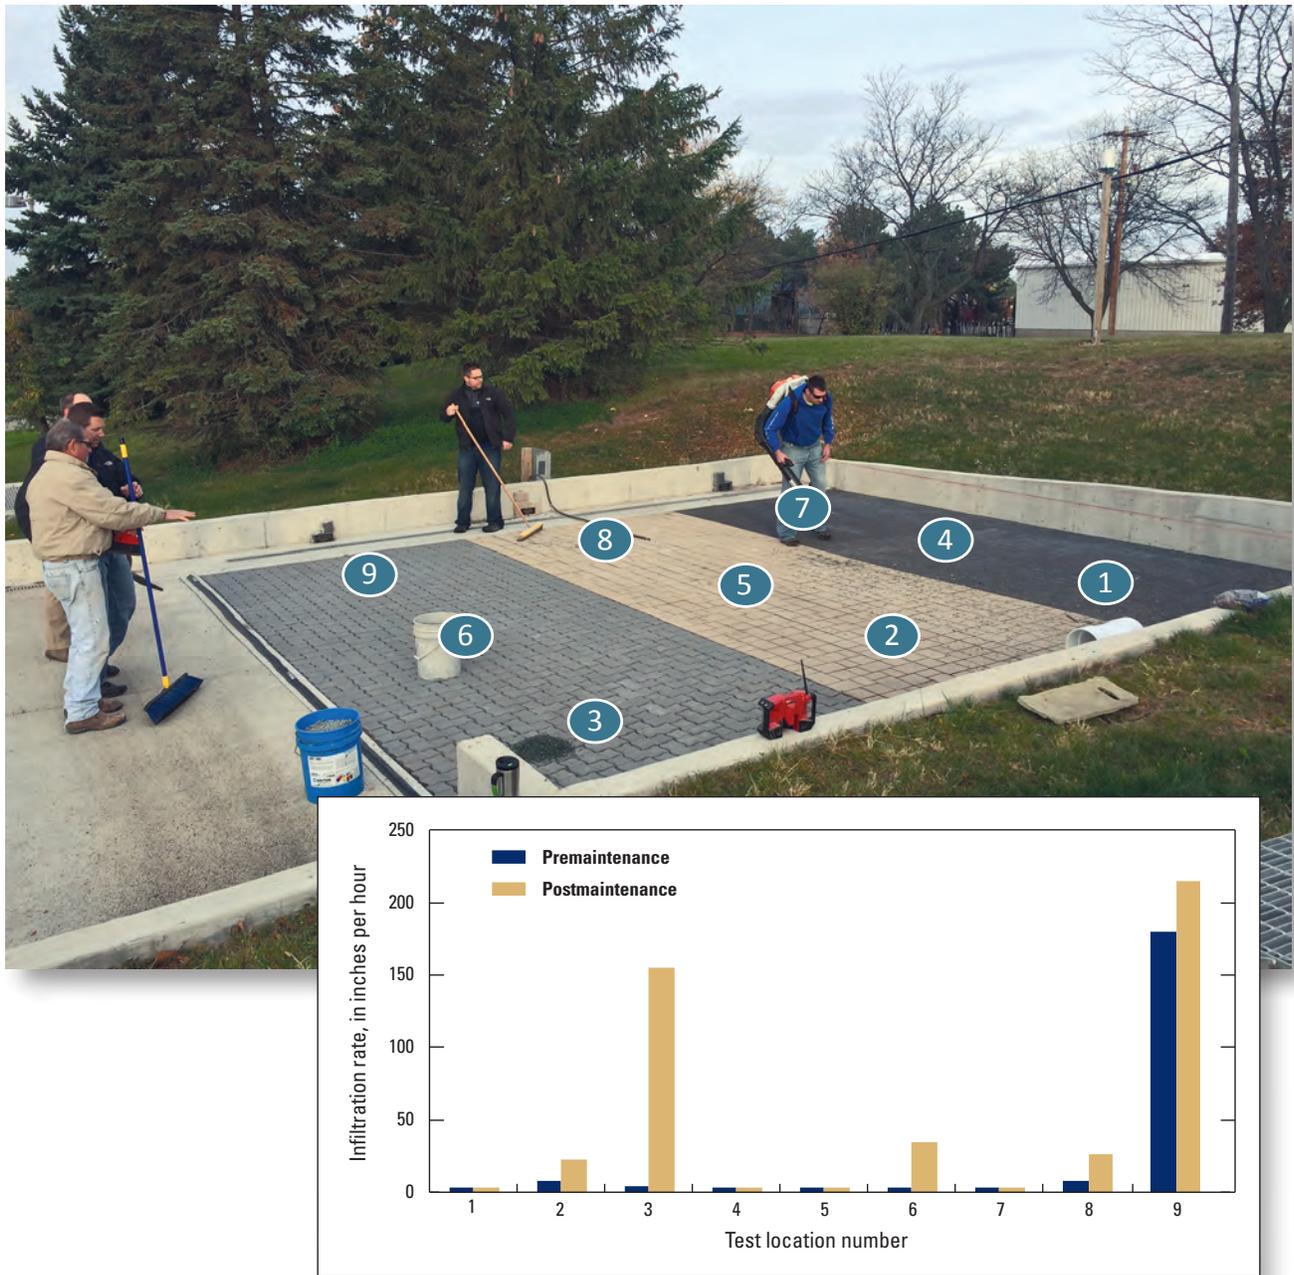
Figure 13. Spatial variation in infiltration rates before and after surface cleaning in the permeable interlocking pavers test plot.

Based on the low average infiltration rate measured in October 2015, maintenance was done on the PIP surface by industry representatives. A cleaning approach similar to what might be done by a typical homeowner was used as a first attempt to restore surface infiltration rates. This process involved an initial clearing of debris using a high-powered leaf blower followed by sweeping using a bristled push broom. Any aggregate that was dislodged from the surface was removed and replaced with new aggregate. The variability in response to this activity based on pre-maintenance and post-maintenance infiltration measurements is shown in figure 13. The PIP configuration representing locations 1, 4,

and 7 showed no improvement, a second paver configuration represented by locations 2, 5, and 8 had mixed results, and a third paver configuration represented by locations 3, 6, and 9 showed appreciable gains in post-maintenance infiltration rates. Despite little to no improvement in some areas of the PIP test plot, the overall average infiltration rate increased 114 percent from 24 in/hr pre-maintenance to 52 in/hr post-maintenance. Why each configuration of PIP produced varying improvement to surface infiltration rates is unclear. A clue may be in the geometry of the paver itself. Depending on the orientation of the channels between paver blocks, the bristles of the push broom may have been effective at penetrating and loosening the aggregate in one direction but not the other. The orientation of permeable channels between pavers may also have some bearing on how water is directed over a PIP surface. Collins and others (2008) reported certain geometric patterns of PIP produced less runoff than others and determined that some paver configurations were better at forcing water to fill permeable channels before moving downslope. Additional research is needed to better characterize the role geometry may have on the hydraulic and water-quality performance of PIP.

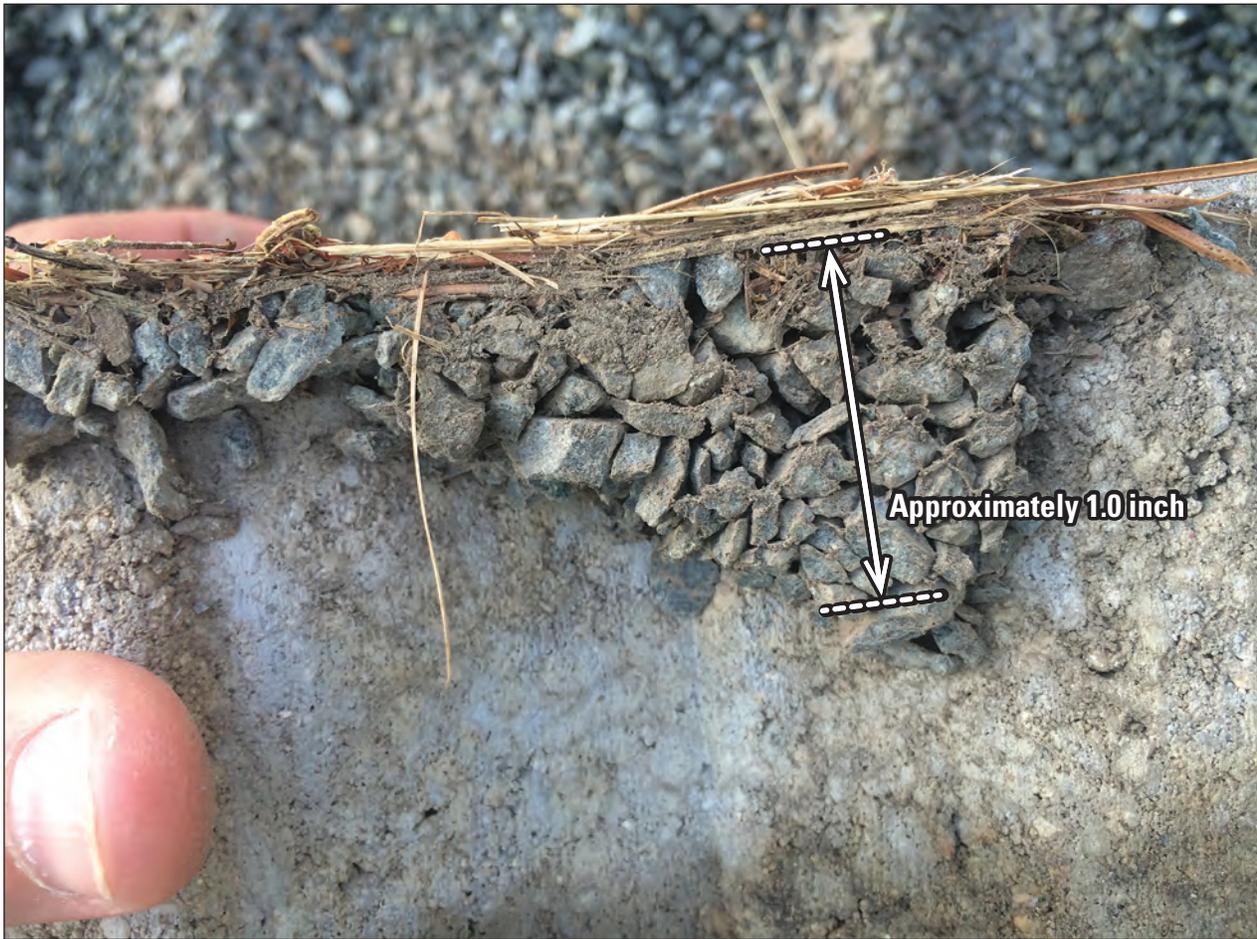
Figure 14. Profile of sediment captured into the aggregate used between the joints of the permeable interlocking pavers test surface.

On April 6, 2016, maintenance was done by use of a vacuum-assisted street cleaner. The sweeper operator passed across each surface twice using only the vacuum feature of the street cleaner. Post-maintenance measurements determined the average infiltration rate in the PIP to be 192 in/hr, more than seven times greater than the pre-maintenance average of 27 in/hr (table 5). The street cleaner was unable to reach one-third of the PIP because of restrictions imposed by the concrete wall of the test site and wide wheelbase of the machine; therefore, results would have been greater had these restrictions not existed. Responses to maintenance in PC and PA were negligible with only slight changes from pre-maintenance levels (table 5). An appreciable increase in the infiltration rate of PIP but not PA or PC may have been related to the depth at which sediment becomes trapped in the permeable surface. The smaller void space of aggregate used in joints between PIP was able to retain more sediment at shallower depth than PA or PC. Visual inspection of the joint aggregate during replacement of the PIP in July 2016 indicated that most of the sediment seemed to be retained within approximately the first 0.5–1.0 inch (fig. 14). Lucke and Beecham (2011) similarly observed that most of sediment retained in PIP was in the upper 0.25 inch of aggregate bedding layer. Dierkes and others (2002) also determined that most pollutants were captured in the top 0.75-inch layer of aggregates in the joints of PC blocks. The shallow penetration of sediment in PIP aggregate was, therefore, more easily removed by the vacuum suction of the street cleaner. Sediment in the PA and PC test plots may have penetrated deeper, outside the effect of the vacuum. However, Winston and others (2016b) suggested that most of the sediment captured by PA (and presumable PC) similarly resides within the top 1 inch. This idea was based on a significantly increased infiltration rate in PA after milling the top layer. Additional research is needed to determine the depth to which sediment penetrates into PA and PC.
