Hydraulic, Water-Quality, and Temperature Performance of Three Types of Permeable Pavement under High Sediment Loading Conditions

Scientific Investigations Report 2018–5037

By William R. Selbig and Nicolas Buer

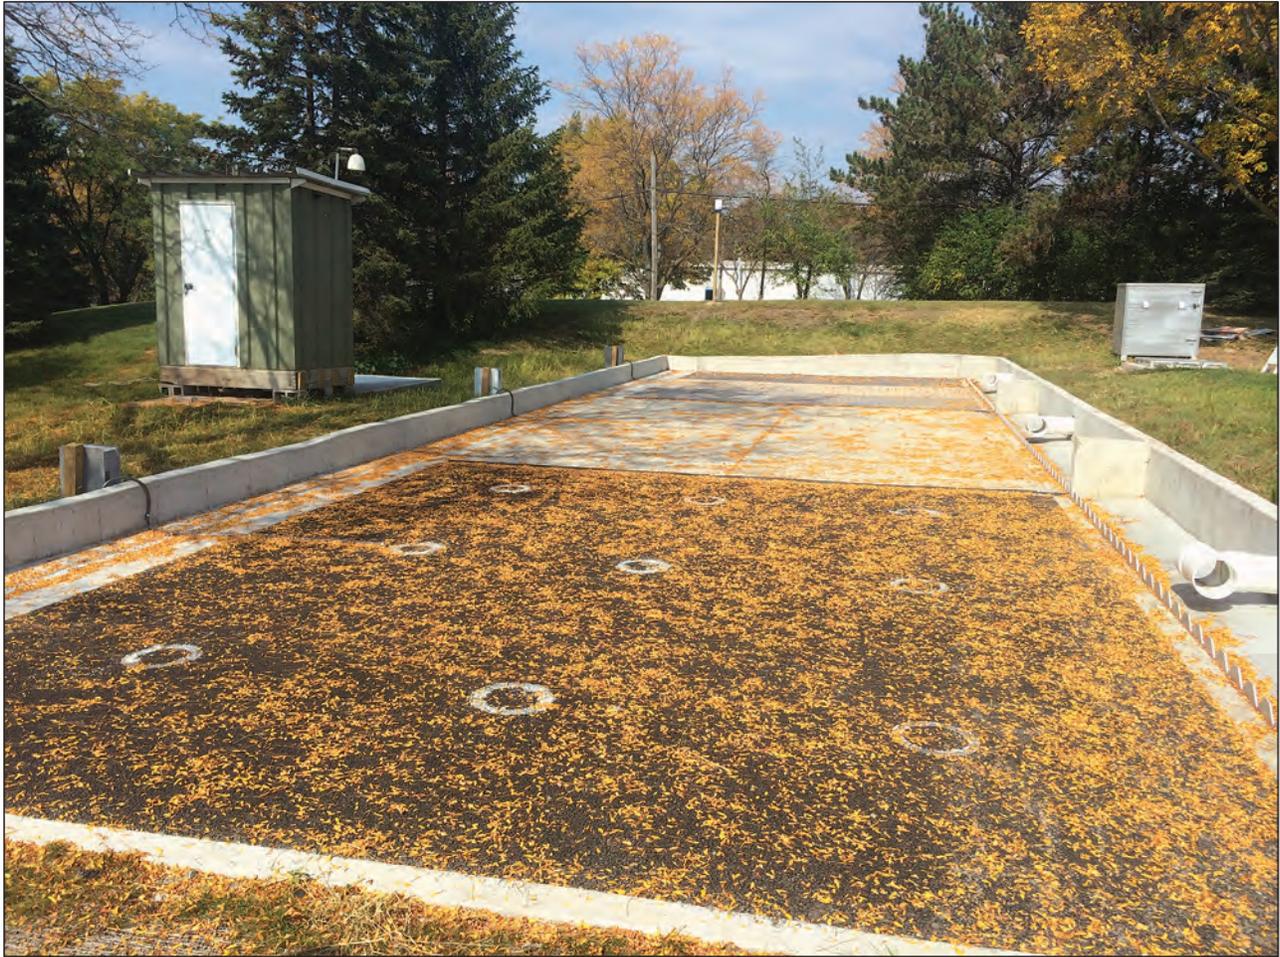
Figure 15. Unmonitored sources of nutrients, seen here as the deposition of leaves from nearby trees, could potentially lead to effluent concentrations of dissolved phosphorus that are higher than the influent.

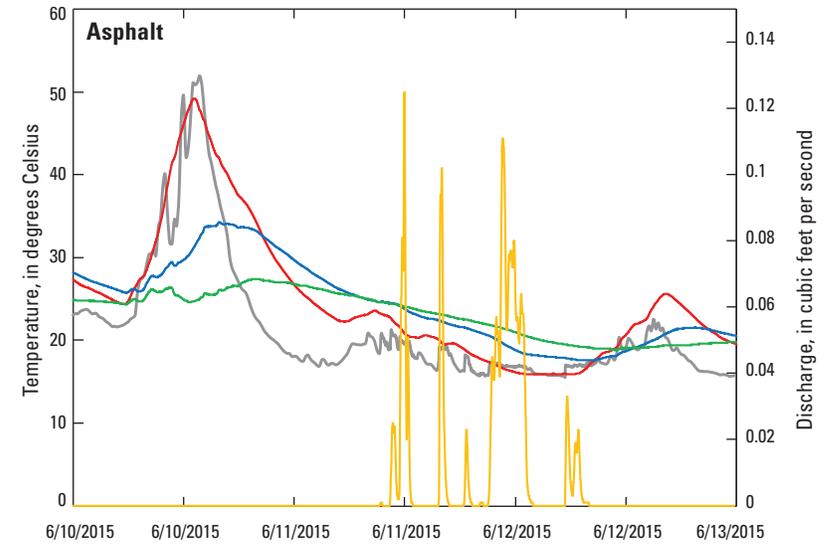
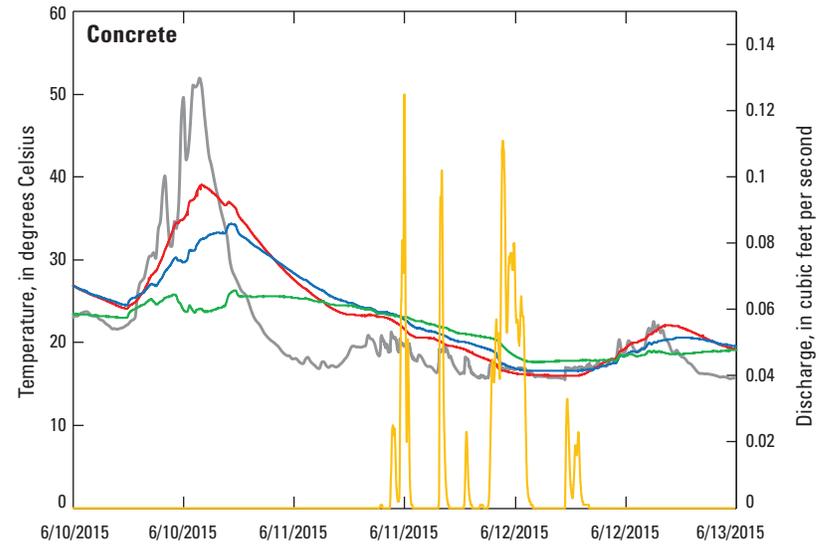
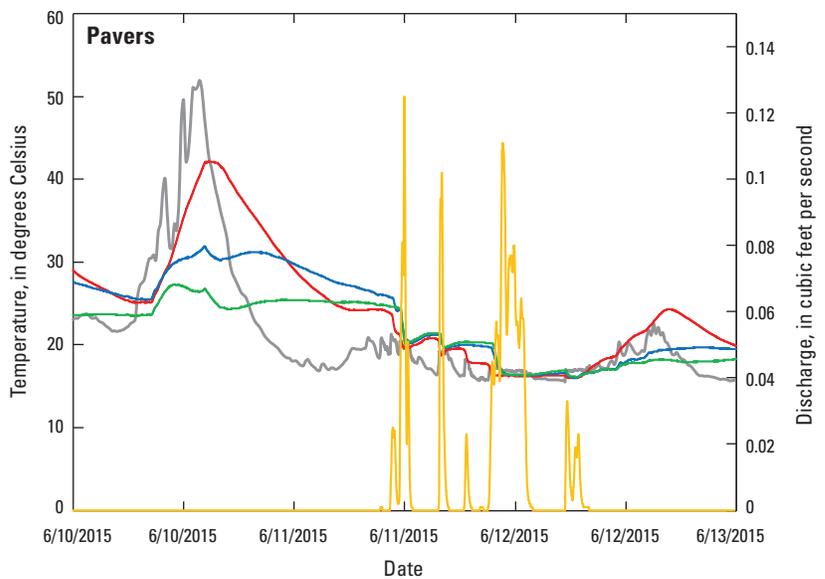
Figure 16. Typical response to changing air temperatures at 0 (top), 6 (middle), and 12 (bottom) inches below the porous asphalt, pervious concrete, and permeable interlocking pavers surfaces during summer. Air temperature becomes parking lot runoff temperature during periods of influent discharge.

Runoff filtering through permeable pavement may not be appreciably cooled during summer (figs. 16–17). The temperature of runoff from the parking lot seems to be mostly controlled by ambient air temperature with only slight increases in temperature after daytime heating. The absorption of heat at depth by each permeable pavement, although initially reduced by the onset of runoff, was enough to sustain temperatures above what were measured from the parking lot. Circumstances, however, could cause permeable pavement to provide cooling below ambient air temperature, such as runoff events that occur during midday, when air temperature is much warmer than the bottom layer of permeable pavement.

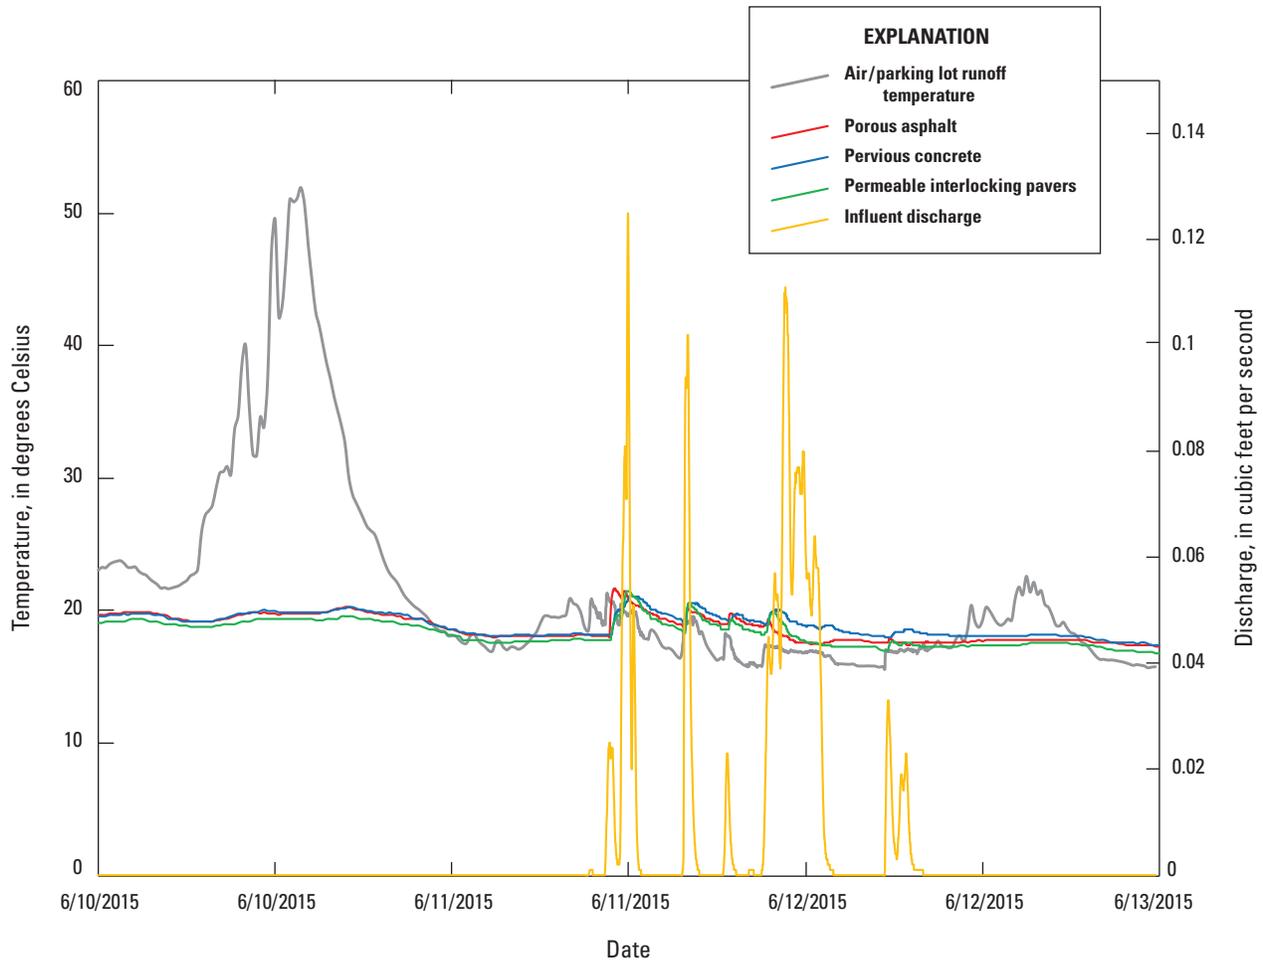
Figure 17. Influence of permeable pavement type on water temperature measured in the underdrains of the porous asphalt, pervious concrete, and permeable interlocking pavers test plots during a typical summer storm in June 2015. Air temperature becomes parking lot runoff temperature during periods of influent discharge.

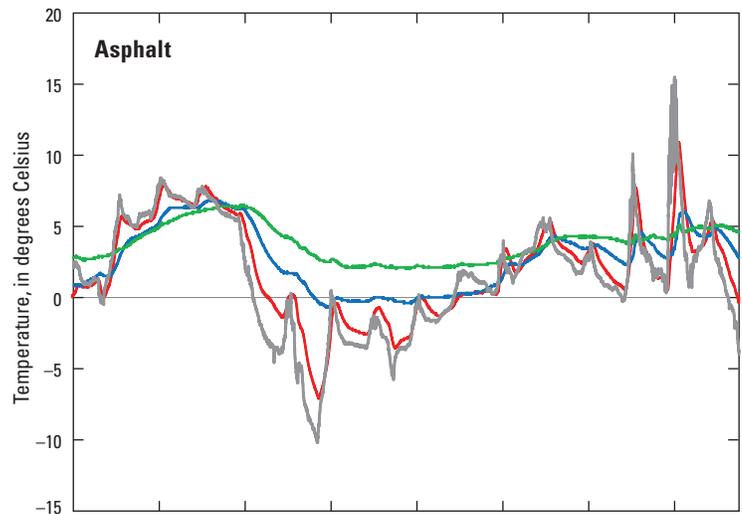
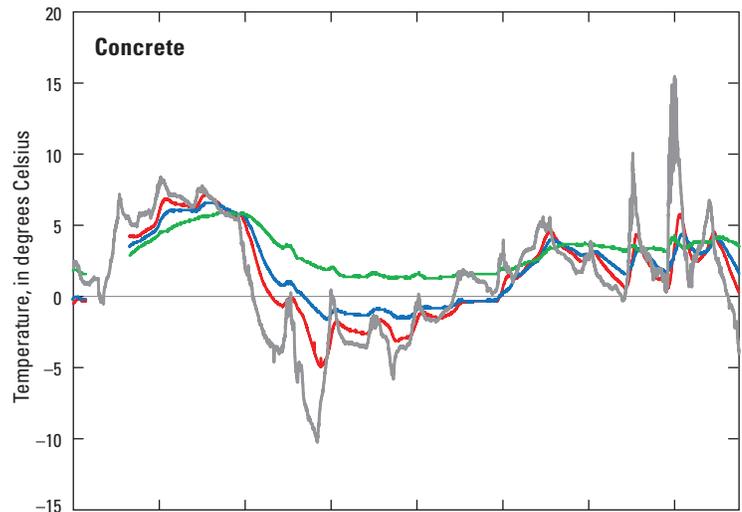
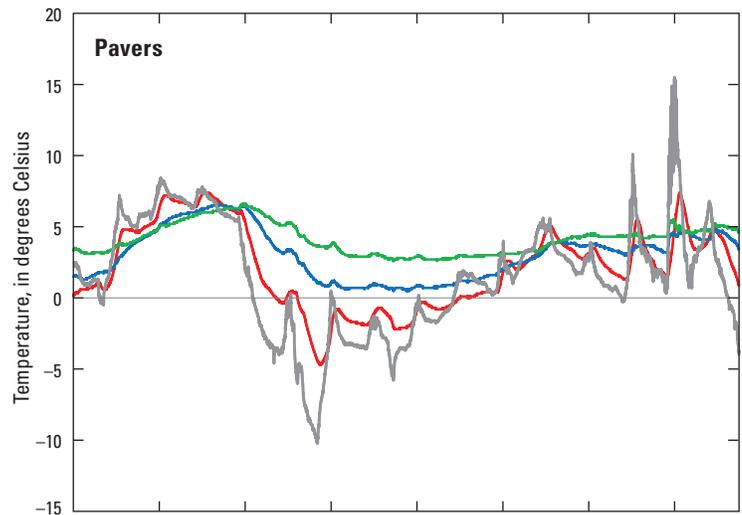
Similar to summer, temperatures just below each permeable surface closely followed diurnal changes in air temperature during winter, with rate and magnitude responding much faster in PA than in PC or PIP (fig. 18). The lag to peak behind air temperature for PA was approximately 45 minutes compared to 60 and 90 minutes for PIP and PC, respectively. Despite the rapid changes in temperature observed in the top layers, winter lag for all test plots was much slower than in summer. This result, in part, may be due to frozen pore openings in the permeable surface, thereby reducing exposure to atmospheric conditions. Temperatures at increasing depth below each surface were slower to respond. Even after several days with air temperature remaining below 0 °C, temperature in the bottom layers declined but remained above freezing (fig. 18).

The patterns in temperature illustrated in figure 18 indicate that in the winter, permeable pavement may have certain advantages over impermeable asphalt pavement. Meltwater infiltrates into deeper layers of a permeable pavement system once air temperature goes above freezing, thereby preventing formation of ice on the pavement surface. This conclusion could potentially influence the way snow and ice are managed in areas where deicing salt application is the primary form of treatment for paved surfaces. This same conclusion was reached by Houle and others (2009), who suggested up to 75 percent less road salt was needed for PA to maintain equivalent or better traction as a reference impermeable asphalt lot. The reduced need of road salt was attributed to the well-drained nature of the reservoir base (Houle and others, 2009). More research is needed to better quantify the reduced need for road salt and other deicing agents on permeable pavements.
