Shoreline Erosion at Selected Areas Along Lake Sharpe on the Lower Brule Reservation in South Dakota, 1966–2015

Scientific Investigations Report 2018–5058

U.S. Department of the Interior
U.S. Geological Survey

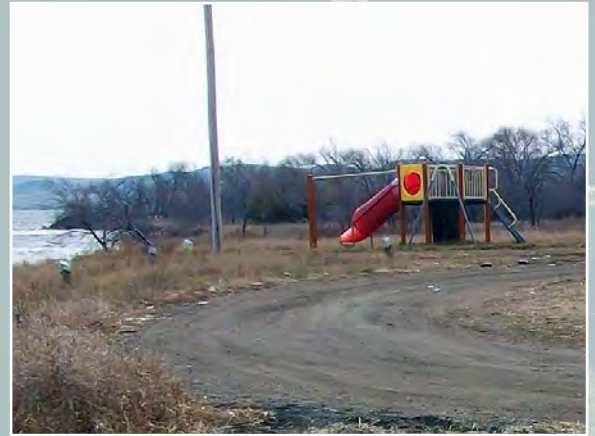
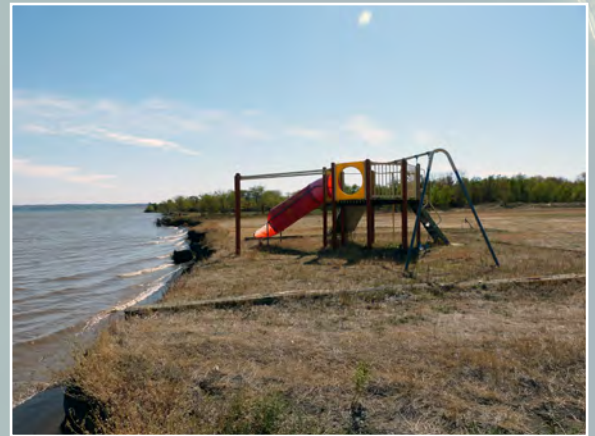
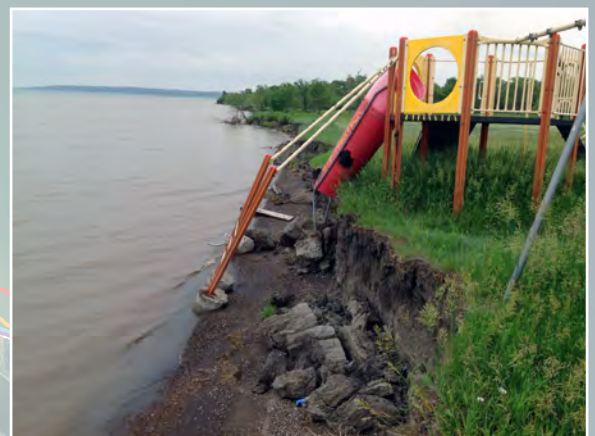
Top photo: Shoreline adjacent to playground equipment at Lower Brule, South Dakota, November 9, 2010. Photograph by Kathleen Neitzert.

Middle photo: Shoreline near playground equipment at Lower Brule, South Dakota, October 3, 2012. Photograph by Kathleen Neitzert.

Bottom photo: Shoreline undercutting playground equipment at Lower Brule, South Dakota, June 20, 2013. Photograph by Kathleen Neitzert.

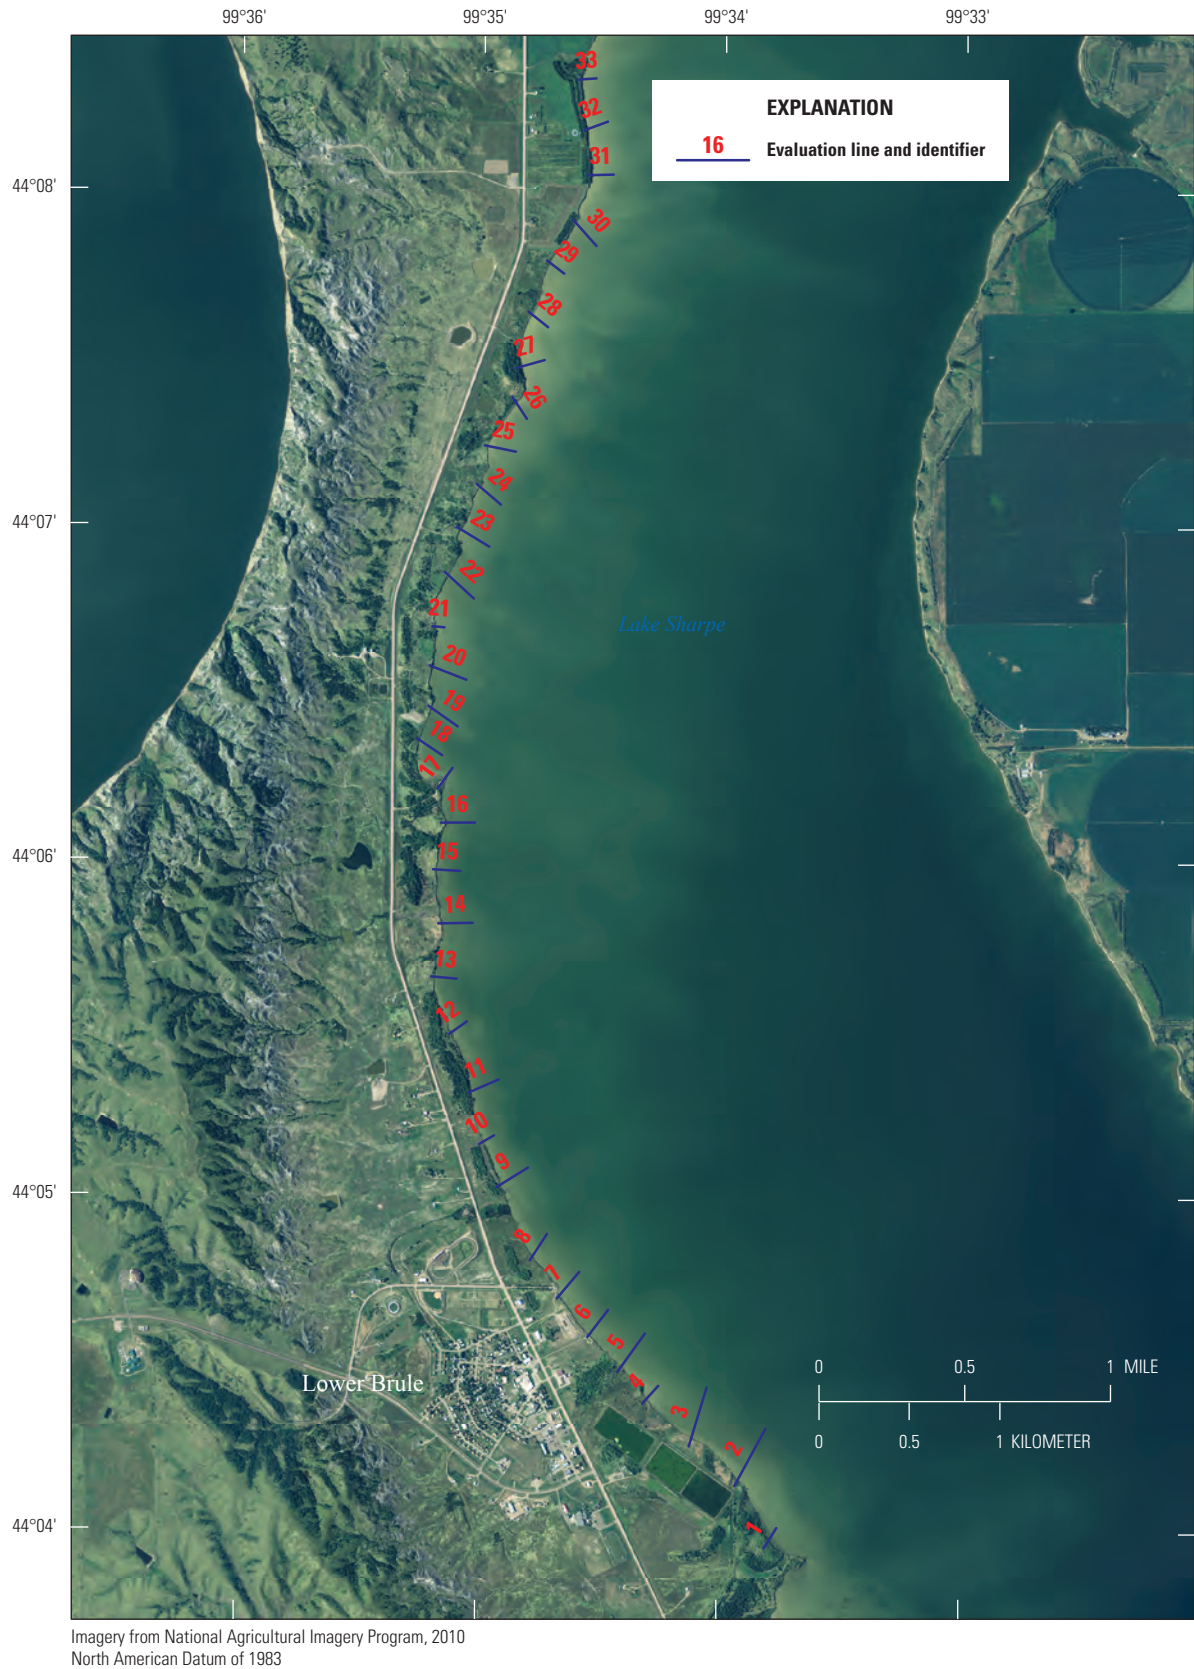
Figure 3. Locations of evaluation lines used in map and imagery analysis for the 7-mile reach on Lake Sharpe near Lower Brule, South Dakota.

To evaluate shoreline erosion between imagery dates, 33 evaluation lines on the 7-mile reach of the Lake Sharpe shoreline near Lower Brule, S. Dak., were set up generally perpendicular to the shoreline at intervals of about 0.16 to 0.21 miles (fig. 3). Evaluation lines were placed intentionally at locations that were not within a cove of the 1966 shoreline because these locations tended to silt in rather than erode. Measurements were made along the evaluation lines between the trace of the 1966 shoreline and each of the shoreline traces from other imagery dates.

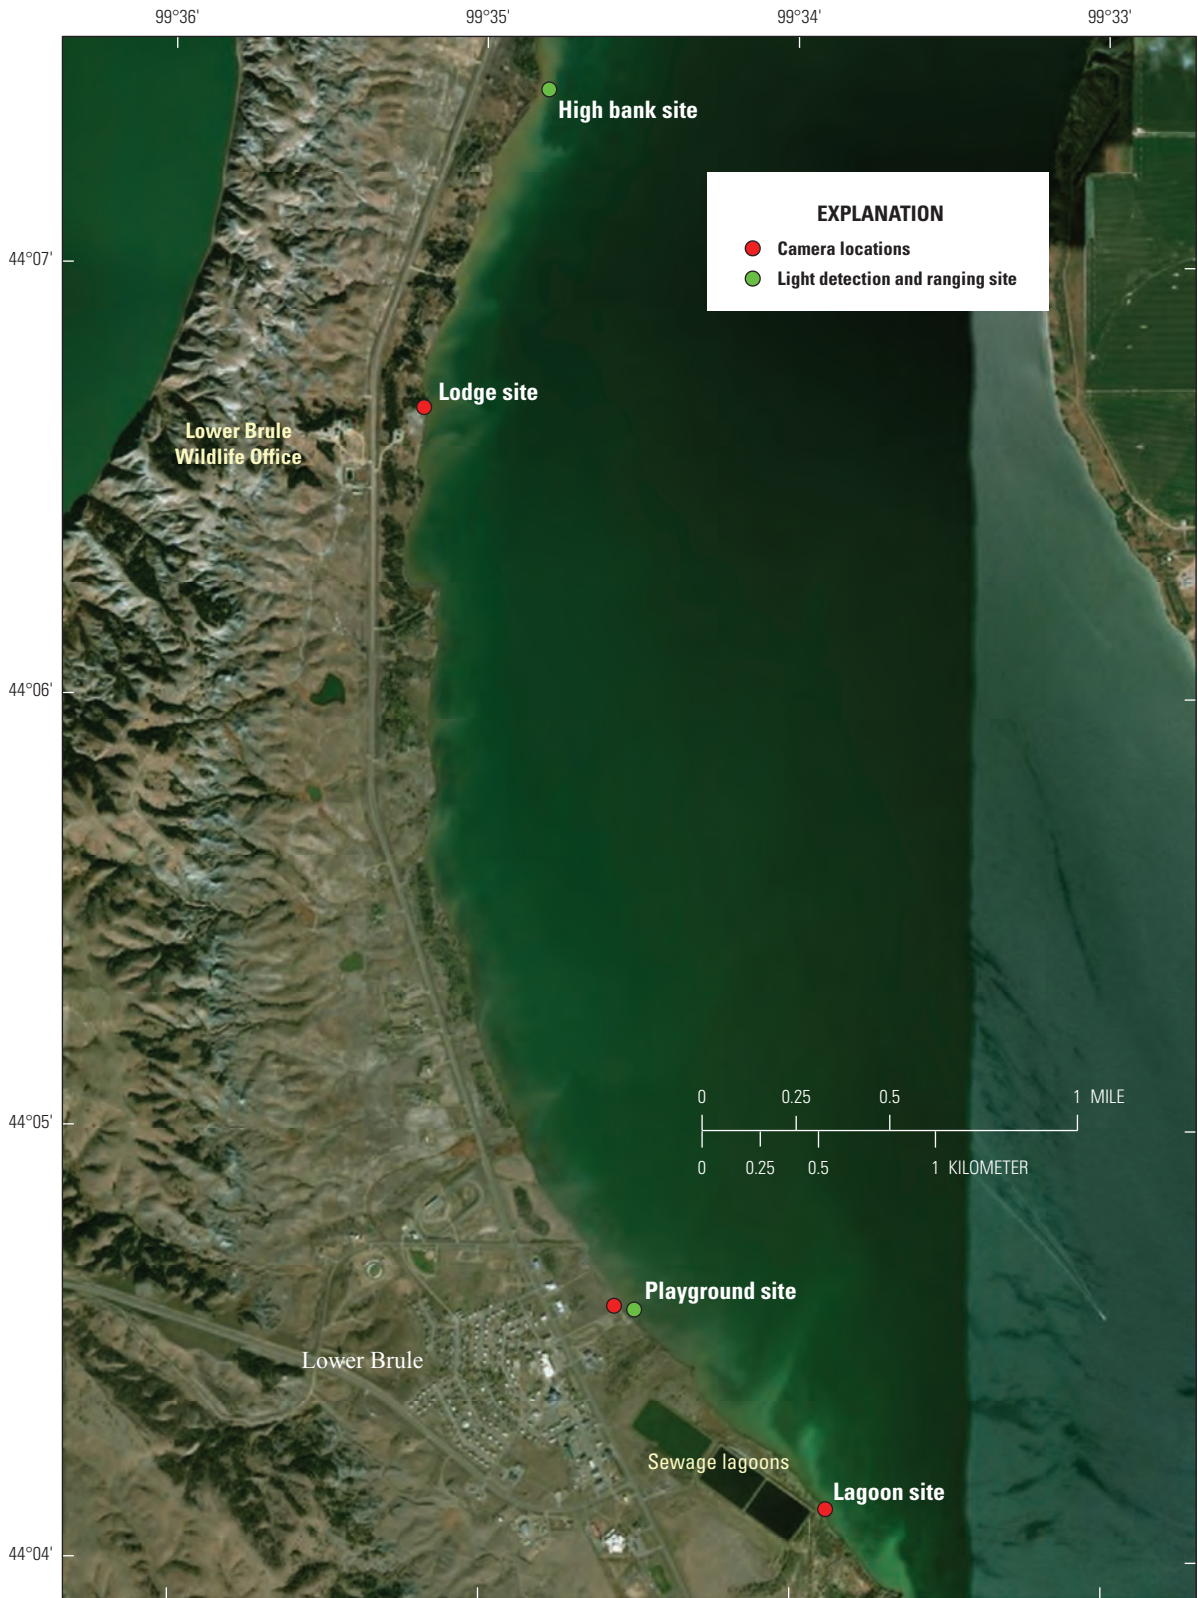
Figure 4. Locations of time-lapse cameras and light detection and ranging sites on the 7-mile reach of Lake Sharpe near Lower Brule, South Dakota.

At two of the sites (lagoon and lodge; fig. 4), the cameras needed to be moved because the trees they were mounted on became in danger of toppling into Lake Sharpe. Some days of photos were missed until the cameras could be remounted in a new location and begin capturing shoreline images again. Because a somewhat different field of view was framed after the cameras were moved, two videos (one before and one after the move) were used to display the images at each of these two sites.

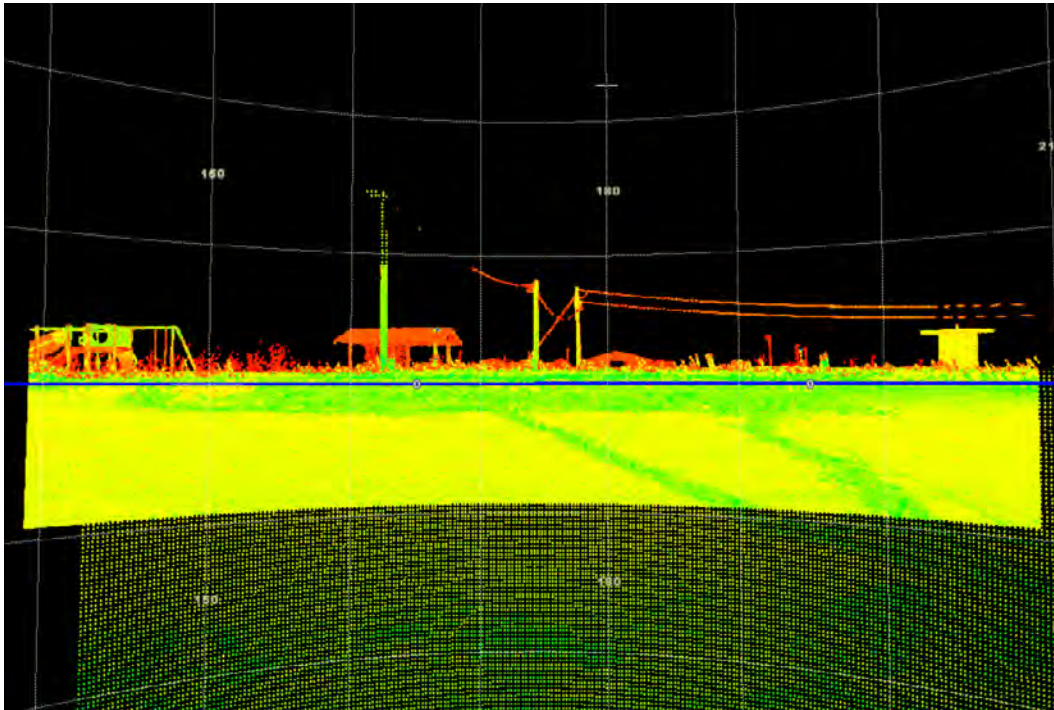
Figure 5. Multiresolution light detection and ranging scan near the playground site near Lower Brule, South Dakota, February 28, 2011.

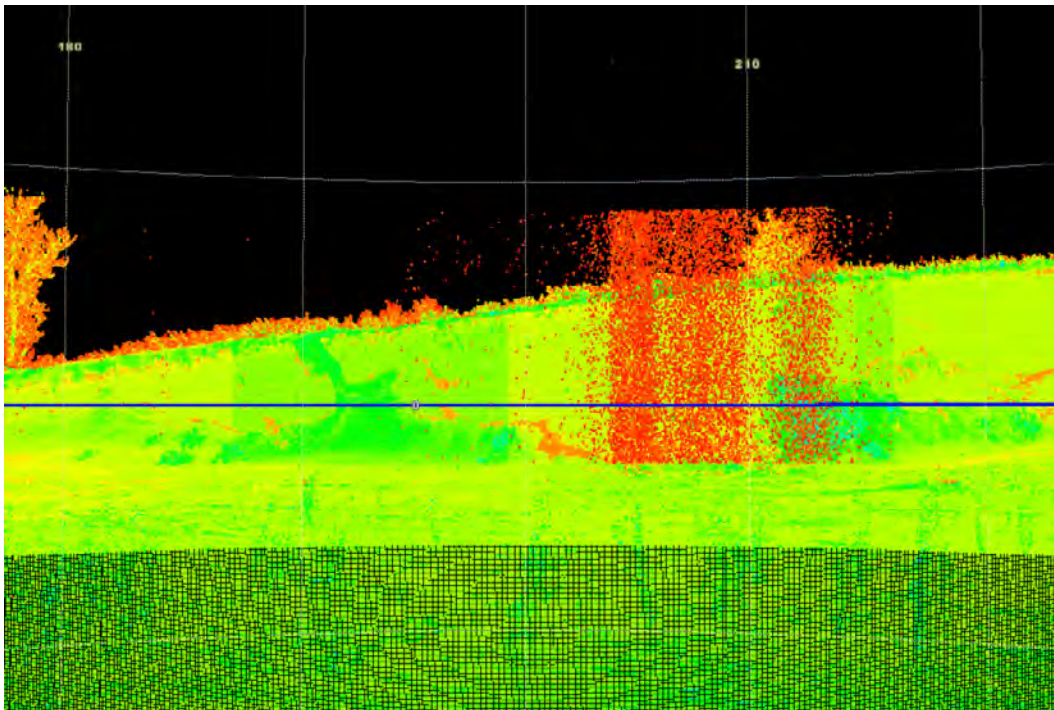
Figure 6. Light detection and ranging scan of a high-bank area near Lower Brule, South Dakota, March 1, 2011.

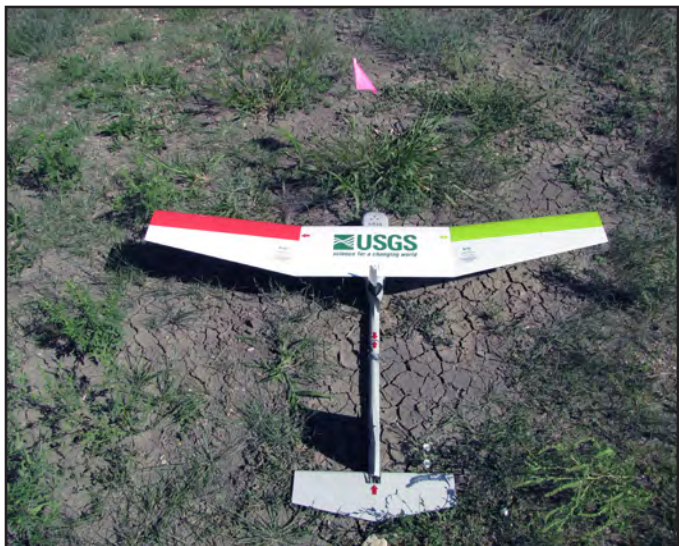
Figure 7. A small, unmanned aerial system (drone) used to collect imagery data of the shoreline near Lower Brule, South Dakota. Photograph by Kathleen Neitzert.

A small, unmanned aerial system, or drone (fig. 7), with an onboard natural-color camera, was used to capture digital video imagery along the shoreline of the 7-mile reach. The initial flights were completed in August 2011, and a similar effort was repeated in August 2012. The imagery captured from the drone was collected and postprocessed by the USGS National Unmanned Aircraft Systems Project Office (<https://uas.usgs.gov/index.shtml>). The nose cone housing the camera was available in two configurations (vertically downward

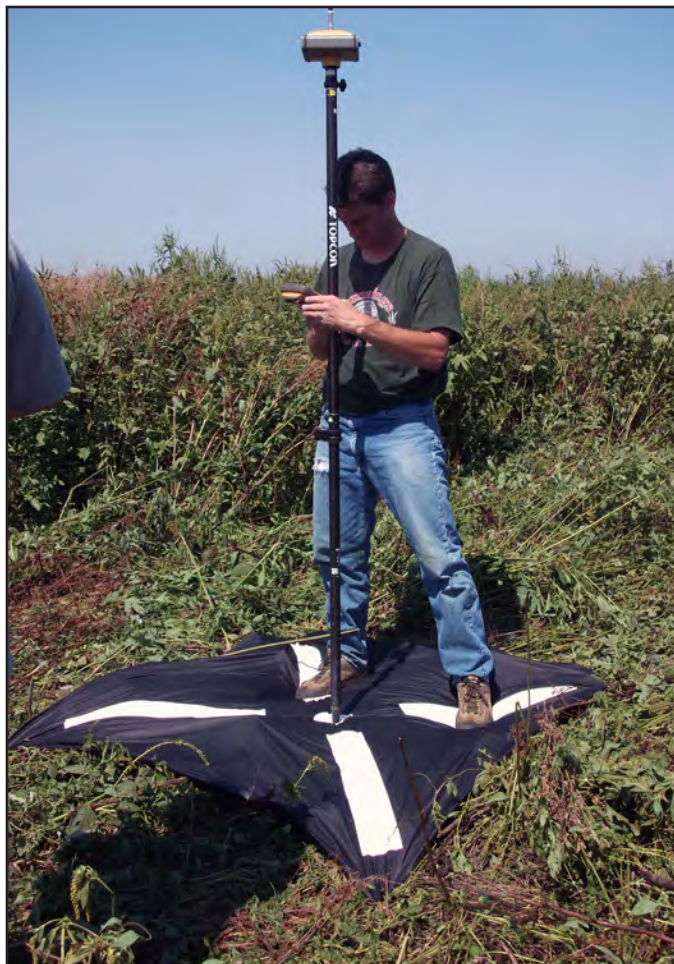
Figure 8. Surveying a target used to georeference images from the drone. Photograph by Kathleen Neitzert.

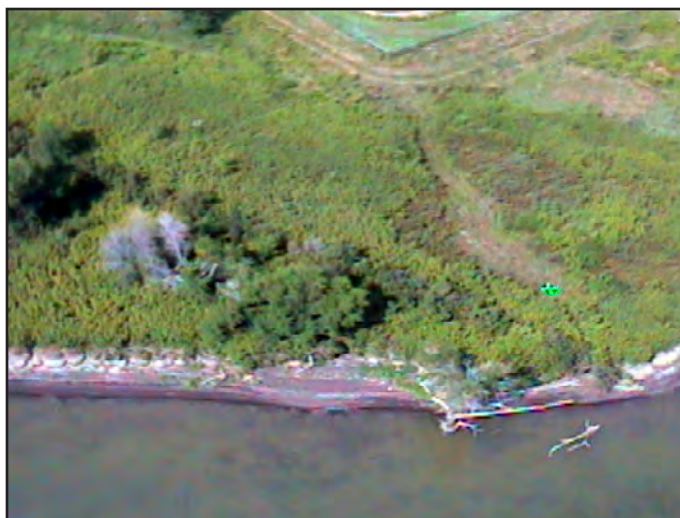
Figure 9. A still capture from the drone video showing the shoreline near Lower Brule, South Dakota, and a target used in georeferencing (green cross in lower-right of image).

and side-looking), which allowed the video to be captured from differing perspectives. Still images could be generated from the video and used to compare shoreline conditions between dates. A set of information from the drone, including time, date, heading, approximate horizontal coordinates, and altitude are superimposed on the video. Before the drone flights, a series of targets were staked to the ground along the shoreline. The horizontal locations of the targets were determined using RTK GNSS surveying equipment (fig. 8), which allowed the images to be more accurately georeferenced (fig. 9).

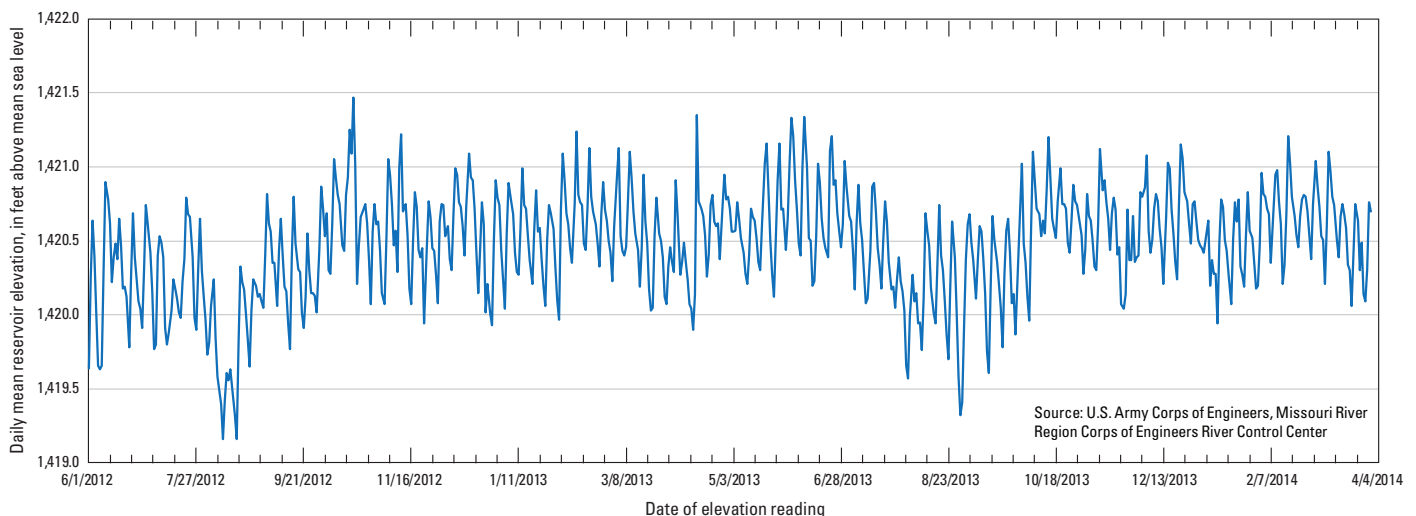
Figure 10. Daily mean reservoir elevation data for June 1, 2012, through April 4, 2014, on Lake Sharpe, South Dakota.

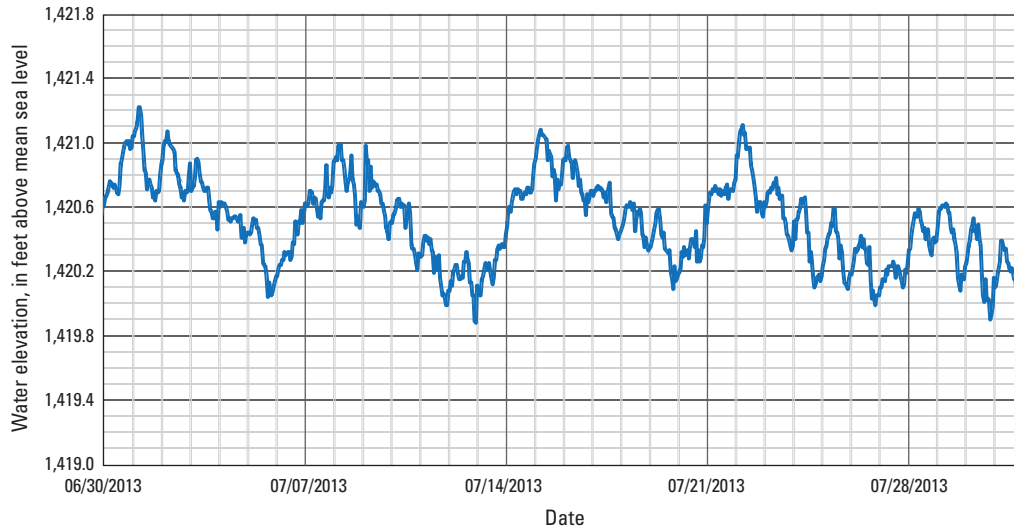
Figure 11. Hourly reservoir water elevation data for July 2013 on Lake Sharpe, South Dakota.

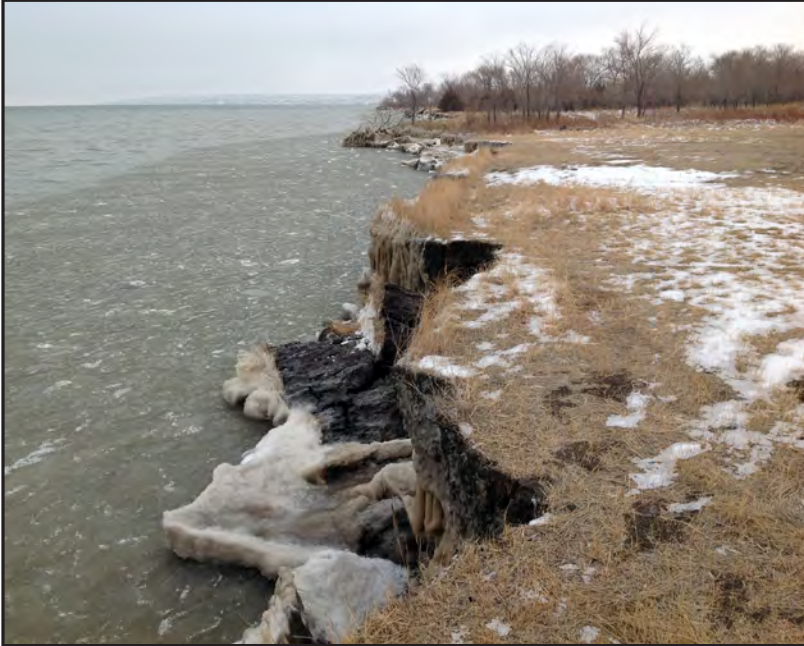
Figure 13. Ice build-up caused by wave action on Lake Sharpe near Lower Brule, South Dakota. Photograph by Kathleen Neitzert.

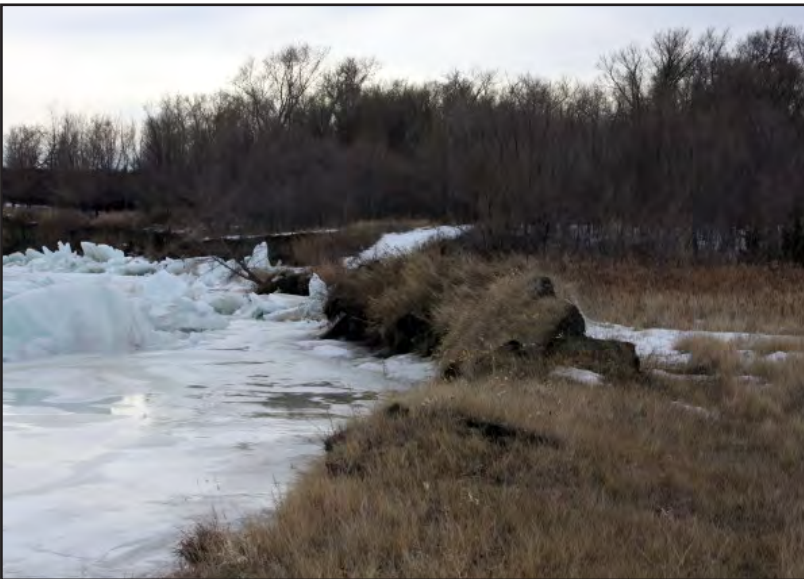
Figure 14. Mounded soils caused by ice heave at Lake Sharpe near Lower Brule, South Dakota. Photograph by George Honeywell, Environmental Protection Office, Lower Brule Sioux Tribe.

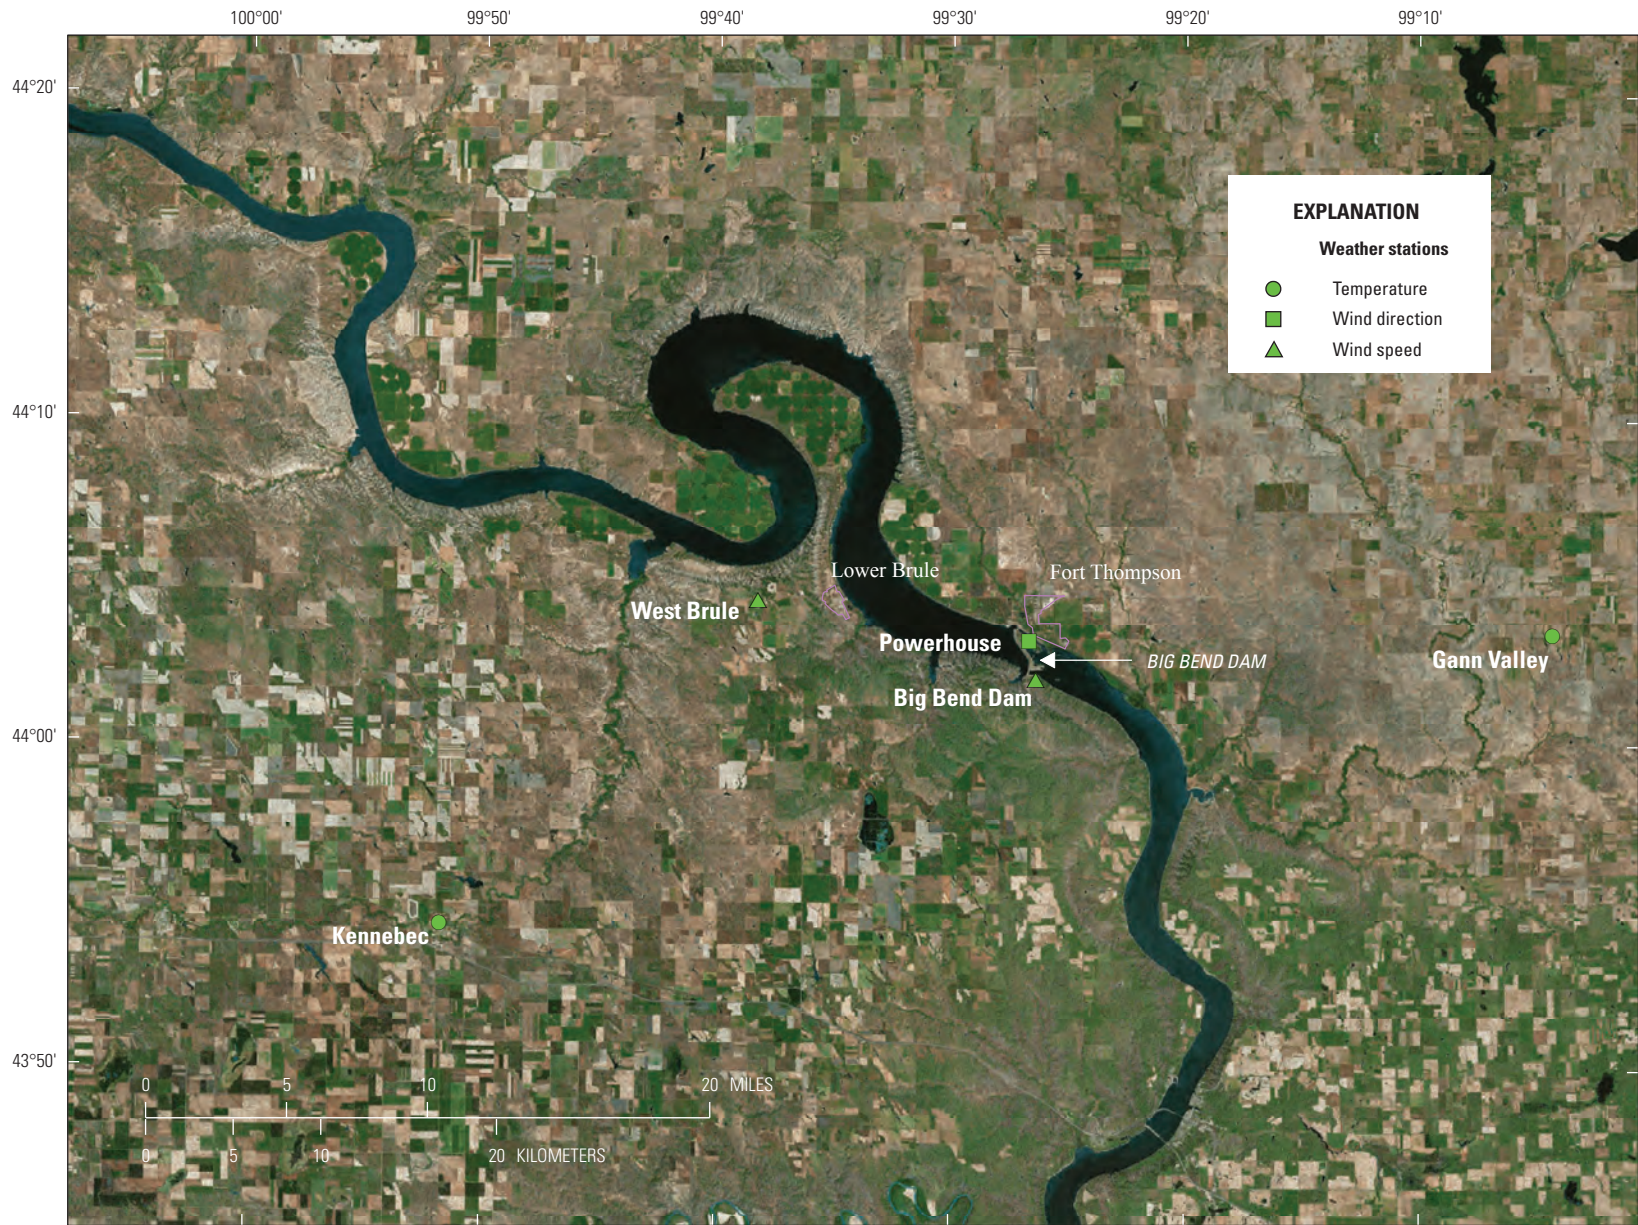
Figure 15. Locations of weather stations near Lower Brule, South Dakota.

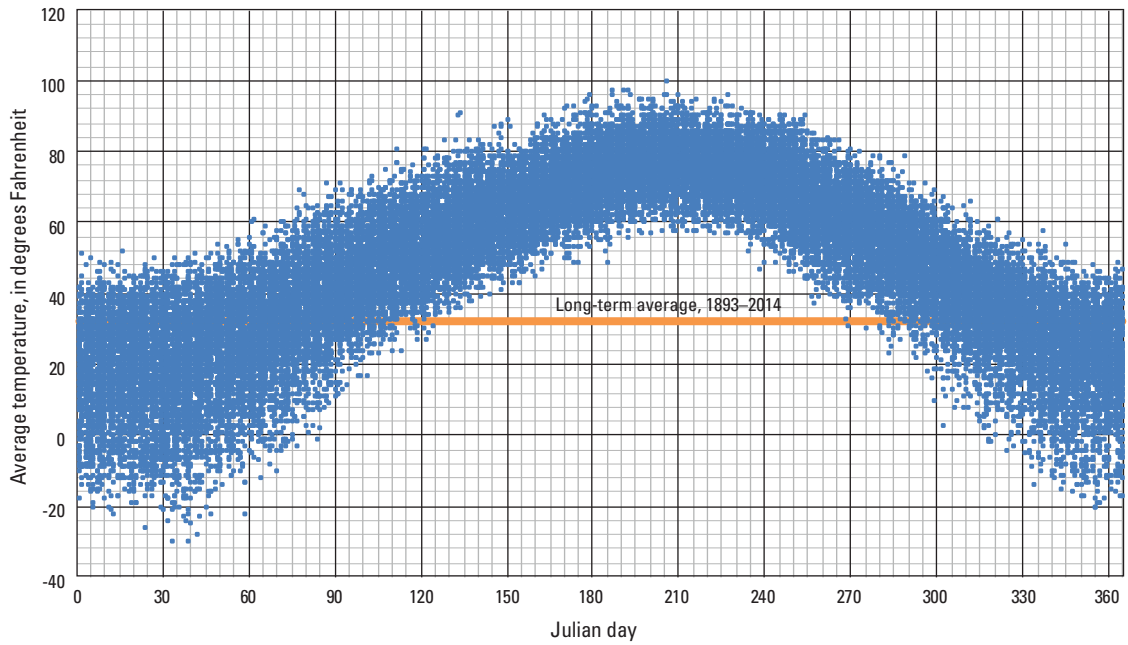
Figure 16. Average daily temperature from the Kennebec, South Dakota, weather station by Julian day of the year, 1893 to 2014.

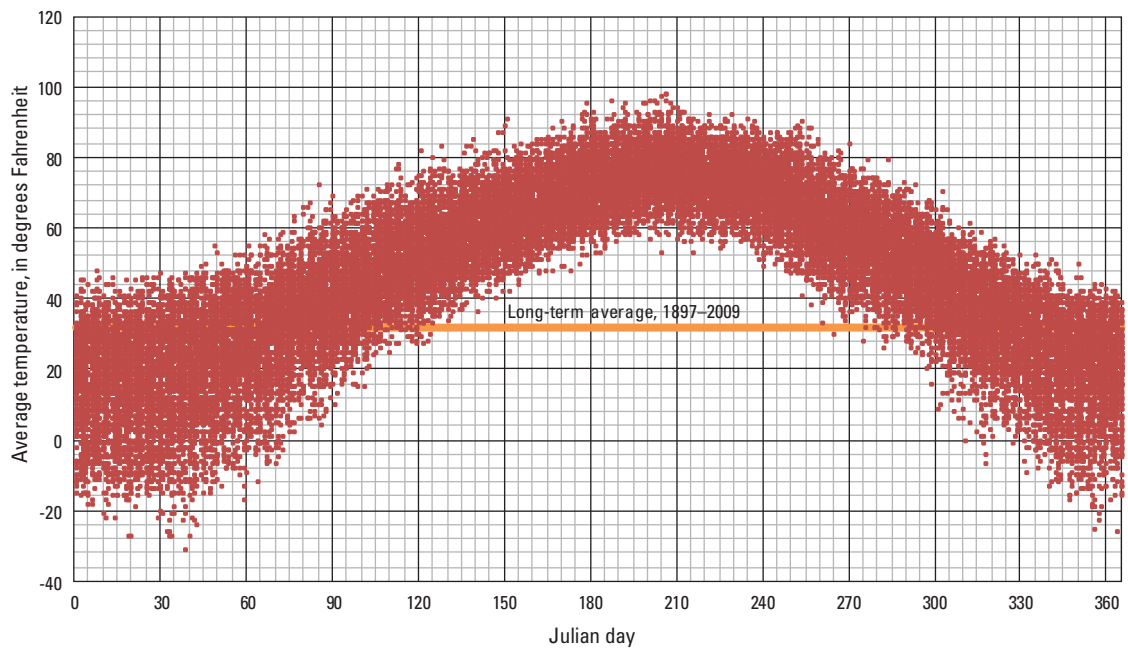
Figure 17. Average daily temperature from the Gann Valley, South Dakota, weather station by Julian day of the year, 1897 to 2009.

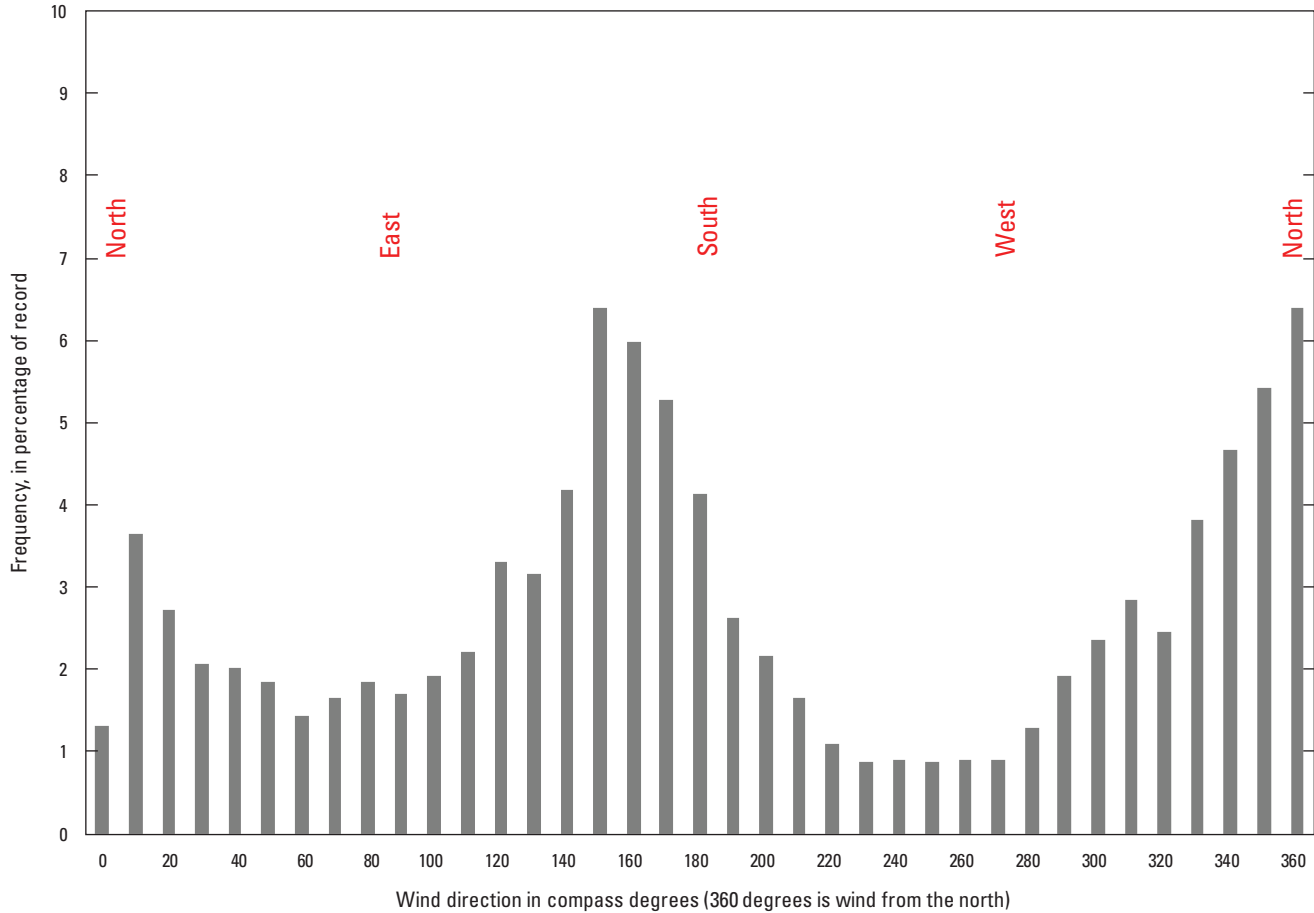
Figure 18. Wind direction at Big Bend Dam, South Dakota, January 1 through December 31, 2013, based on hourly record.

commun., 2014) downstream from Lower Brule (fig. 15). Hourly wind direction data from 2013 (fig. 18) shows wind direction is most frequently from north-northwest (320 to 360 degrees) and south-southeast (120 to 180 degrees).

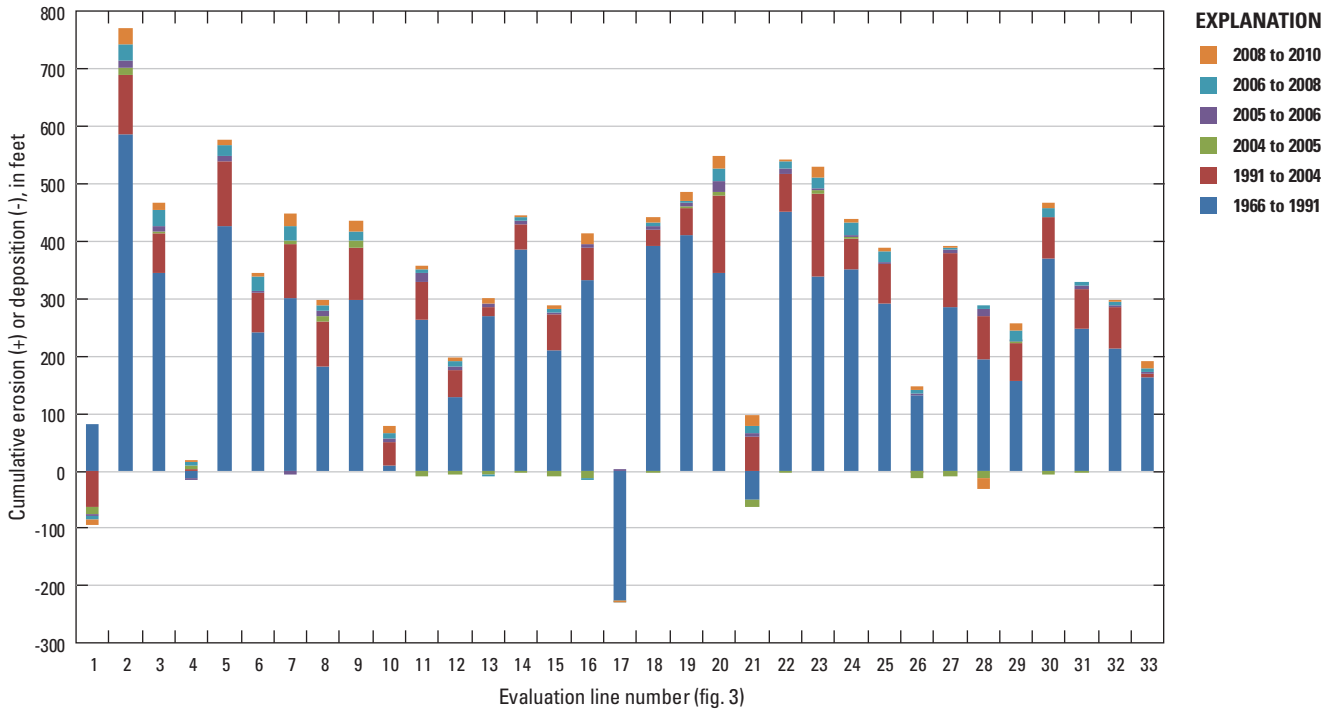
Figure 19. Cumulative erosion by time step by evaluation line from map and imagery analysis for Lake Sharpe near Lower Brule, South Dakota.
