Geomorphic Characteristics of Tenmile Creek, Montgomery County, Maryland, 2014–16

Scientific Investigations Report 2018–5098

By Edward J. Doheny and S. Matthew Baker

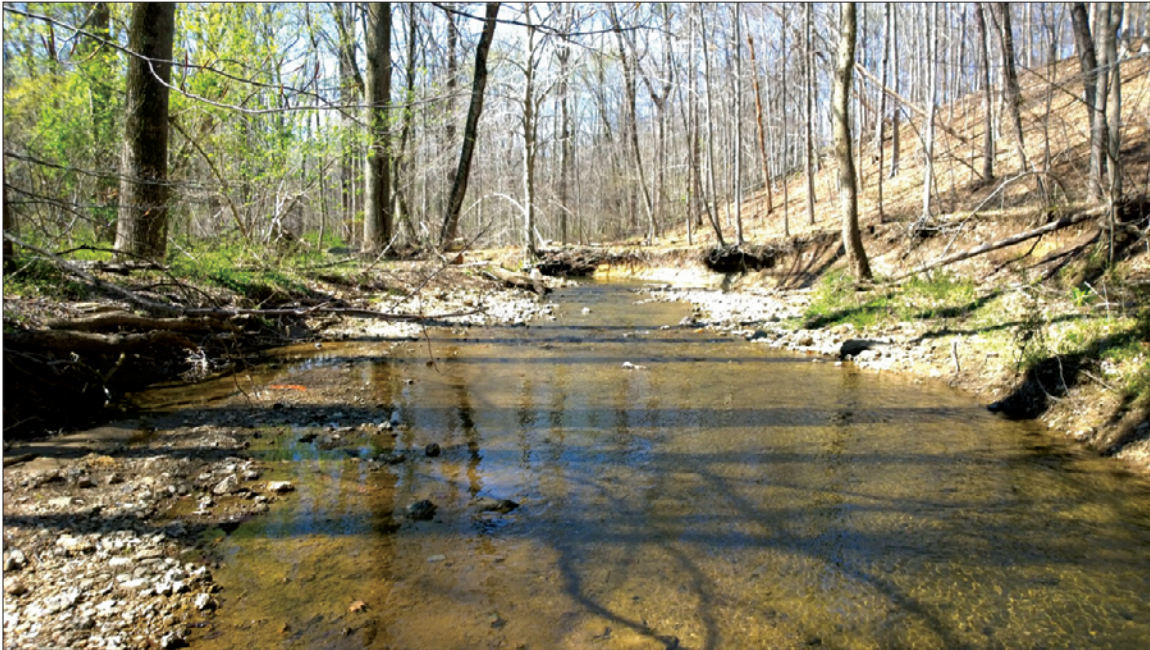
Figure 3. View looking downstream at lower section of Tenmile Creek study reach. Photograph by Edward Doheny, U.S. Geological Survey, April 24, 2014.

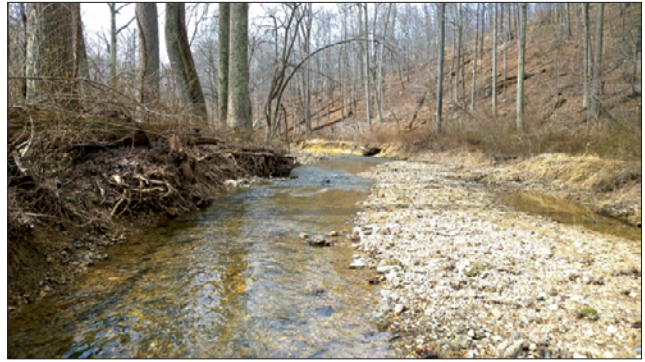
View looking downstream from cross section Aa. Photograph by Edward Doheny, U.S. Geological Survey, March 30, 2015.

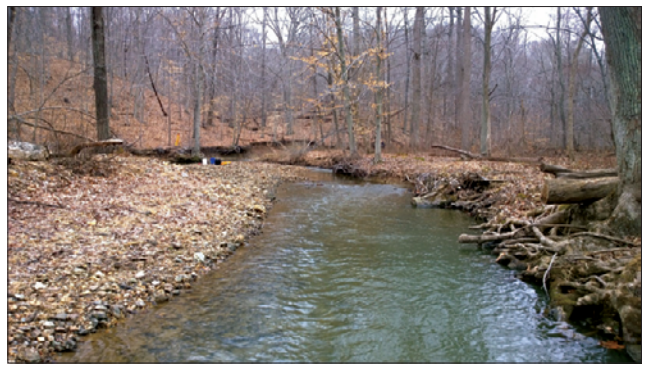
View looking upstream from cross section Gg. Photograph by Edward Doheny, U.S. Geological Survey, March 30, 2015.

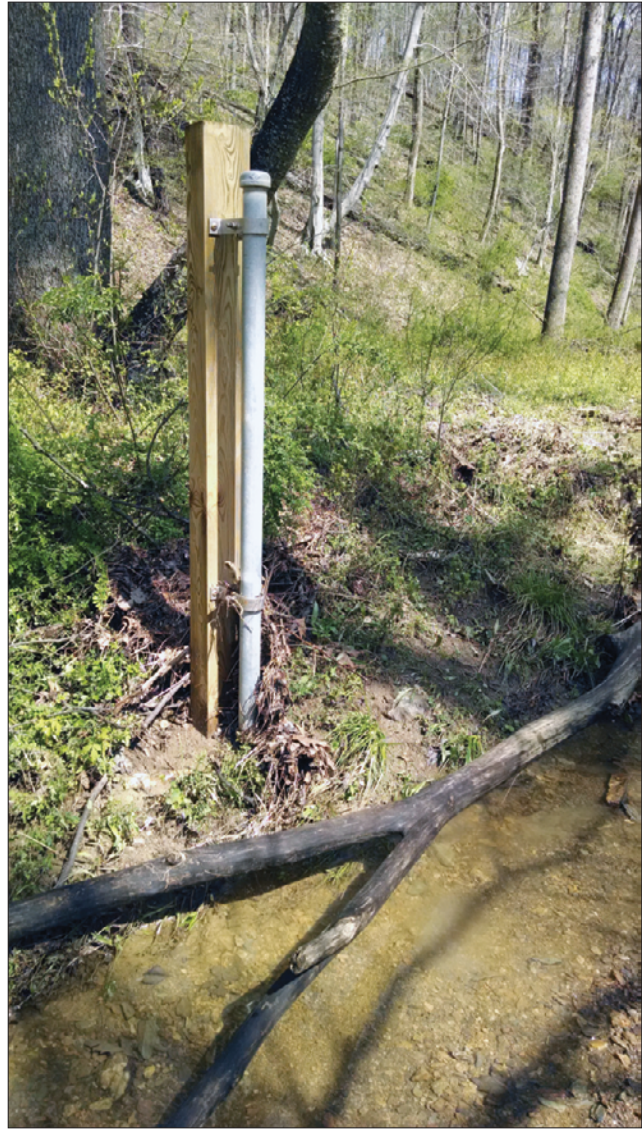
Figure 7. Crest-stage gage for obtaining high-water marks in the Tenmile Creek study reach. Photograph by Michael A. Clark, U.S. Geological Survey, May 1, 2014.

The distance between crest-stage gages along the thalweg of the stream channel was measured so that water-surface slopes could be determined at a range of stages and discharges by use of the high-water marks. A crest-stage gage that was used for obtaining high-water marks in the Tenmile Creek study reach is shown in figure 7.

In May 2016, non-vented, internally logging pressure transducers, HOBO U-20L-01 water-level data loggers, were installed at the three crest-stage gage locations to supplement high-water mark data collected from the crest-stage gages. These loggers were used to generate additional time-series stage data that could be used to compute water-surface slope

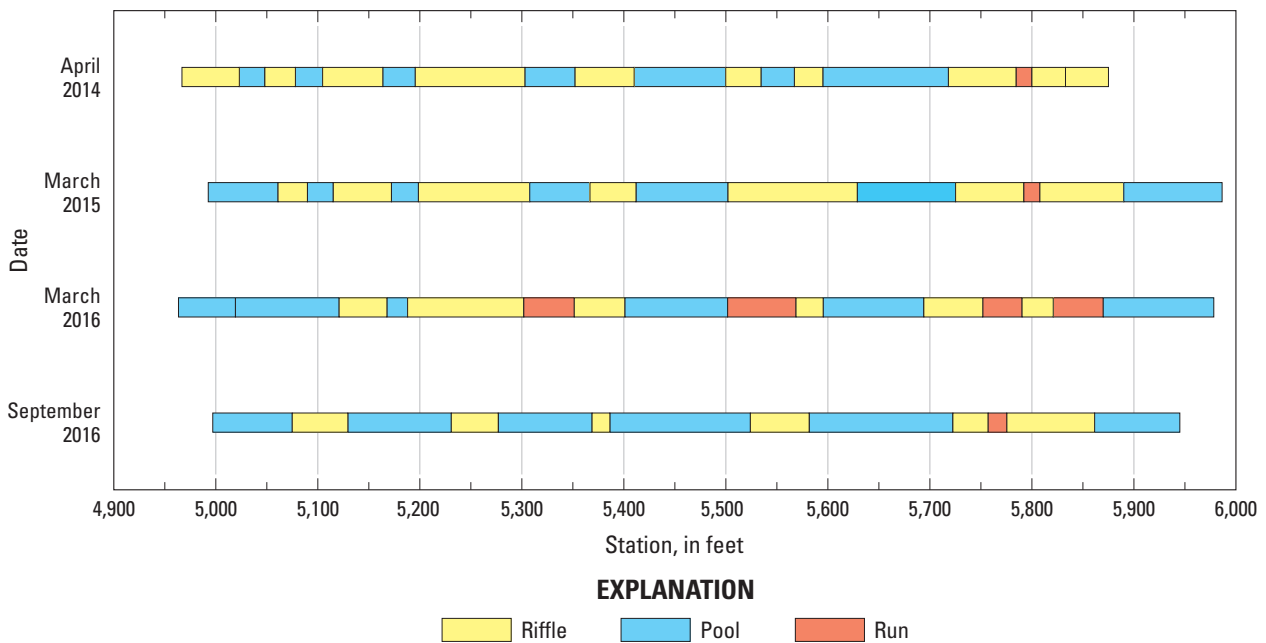
Figure 9. Comparison of riffle, pool, and run distribution in the Tenmile Creek study reach, April 2014 through September 2016.

A slight decrease in riffle percentages with a corresponding increase in pool percentages was observed between April 2014 and March 2015. In March 2016, a large drop in riffle percentages was observed with a corresponding increase in run percentages. Pool percentages also increased slightly. In September 2016, pool percentages increased considerably with a corresponding decrease in run percentages. Riffle percentages increased very slightly.

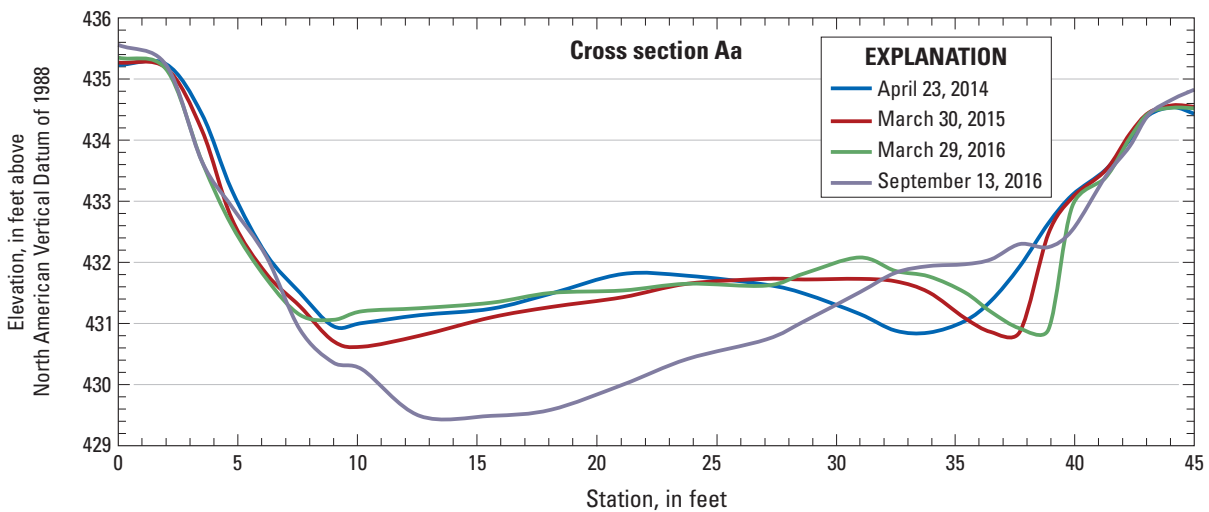
Figure 10. Cross-section geometry at permanent cross section Aa, April 2014 through September 2016.

A net increase in cross-sectional area (24.0 percent), mean depth (25.2 percent), and hydraulic radius (24.4 percent) was observed at cross section Aa, with much of the difference occurring between March 2016 and September 2016 (table 9). The maximum depth in the stream channel showed alternating increases and decreases over time, with the largest change occurring between March 2016 and September 2016. Channel width and wetted perimeter showed some alternating decreases and increases over time, but only within a small range. The width/depth ratio showed a net decrease of 20.6 percent over time, with much of the change occurring between March 2016 and September 2016, due mainly to a 24.7-percent increase in mean depth in the aftermath of the storm and flood of July 30, 2016.

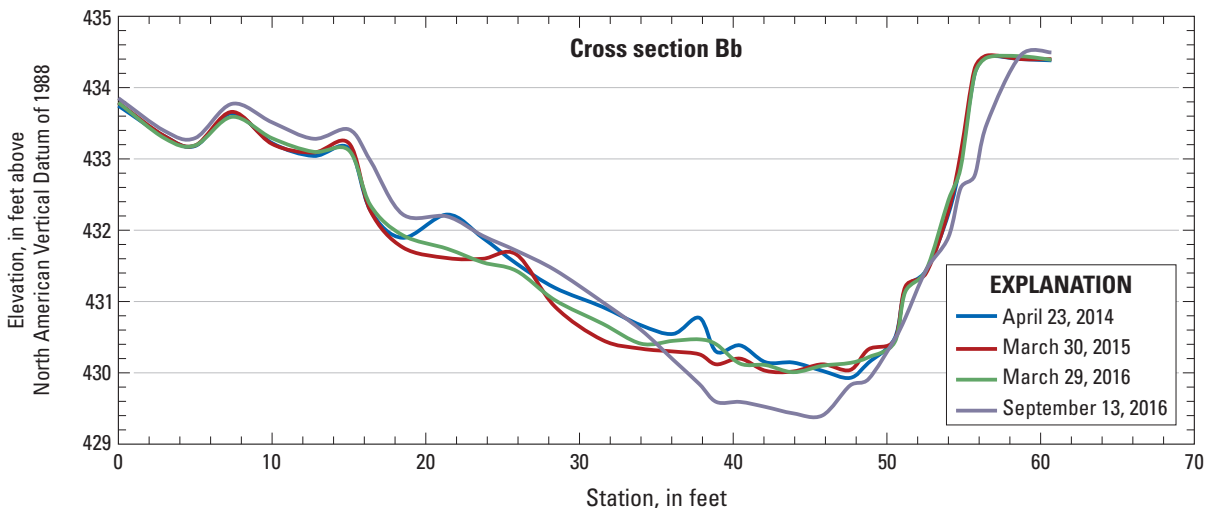
Figure 11. Cross-section geometry at permanent cross section Bb, April 2014 through September 2016.

A net increase of 7.9 percent in cross-sectional area was observed at cross section Bb, with much of the difference occurring between April 2014 and March 2015 (table 9). Smaller increases also were observed over time in channel width, mean depth, wetted perimeter, and hydraulic radius. Maximum depth decreased by 2.5 percent between April 2014 and March 2016, and then increased by 19.6 percent in September 2016. Width/depth ratio showed a net decrease of 6.1 percent over time, with some alternating decreases and increases over time. Other than maximum depth, all other hydraulic variables showed only relatively small changes (plus or minus 2.3 percent or less) in the aftermath of the storm and flood of July 30, 2016.

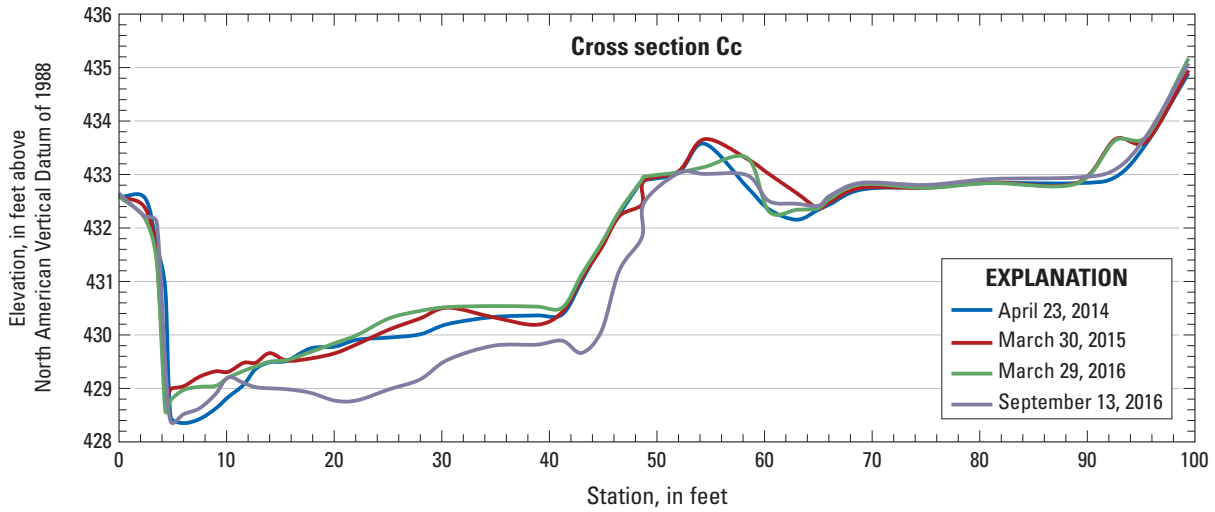
Figure 12. Cross-section geometry at permanent cross section Cc, April 2014 through September 2016.

A net increase in cross-sectional area (14.5 percent), mean depth (13.9 percent), and hydraulic radius (11.7 percent) was observed at cross section Cc, with much of the difference occurring between March 2016 and September 2016 (table 9). The maximum depth in the stream channel showed an 11.1-percent decrease between April 2014 and March 2015, then increases of 6.4 percent in March 2016 and 7.5 percent in September 2016. Channel width and wetted perimeter showed relatively small changes over time. The width/depth ratio showed a 9.5-percent increase between April 2014 and March 2015, a small increase of 1.0 percent between March 2015 and March 2016, and a 20.1-percent decrease between March 2016

and September 2016 caused by runoff from the storm and flood of July 30, 2016.

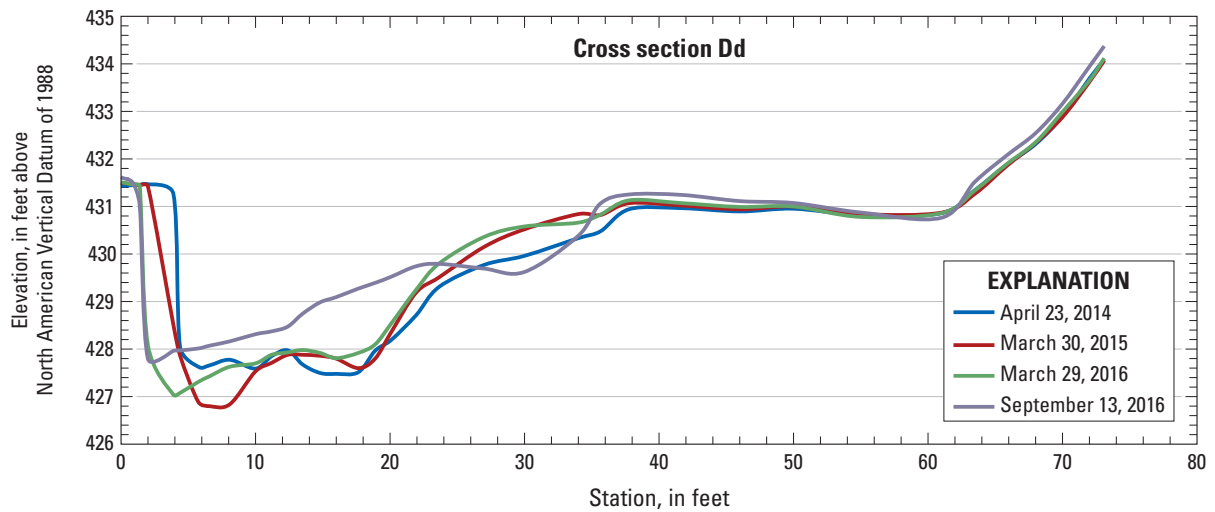
Figure 13. Cross-section geometry at permanent cross section Dd, April 2014 through September 2016.

A net decrease in cross-sectional area (-15.0 percent), mean depth (-12.2 percent), wetted perimeter (-3.1 percent), and hydraulic radius (-12.2 percent) was evident at cross section Dd, with much of the difference occurring between March 2016 and September 2016 (table 8). The maximum depth in the stream channel showed a 19.6-percent increase between April 2014 and March 2015, then a 5.8-percent decrease in March 2016, and another 19.4-percent decrease in September 2016. Lateral erosion along the left bank in this cross section is the likely cause of some of the variability in maximum depth over time. Channel width showed a net decrease of 2.9 percent over time. The width/depth ratio showed a net increase

of 10.5 percent over time, with much of the change occurring between March 2016 and September 2016. Runoff from the storm and flood of July 30, 2016 likely caused the changes in hydraulic variables observed between March 2016 and September 2016.

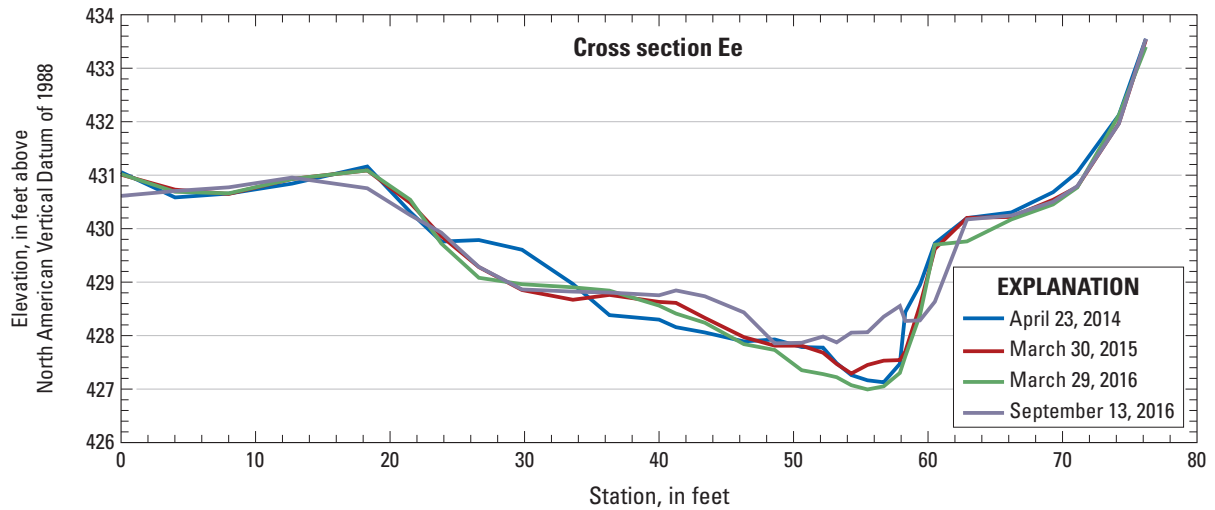
Figure 14. Cross-section geometry at permanent cross section Ee, April 2014 through September 2016.

An increase in cross-sectional area of 29.2 percent was observed in cross section Ee between April 2014 and March 2016, then a decrease of 16.4 percent in September 2016, with an overall net increase of 8.1 percent over time (table 9). Mean depth and hydraulic radius showed respective increases of 5.8 percent and 6.7 percent between April 2014 and March 2016, then respective decreases of 12.2 percent and 11.3 percent in September 2016, with overall net decreases over time of 7.1 percent for mean depth, and 5.3 percent for hydraulic radius. The maximum depth showed some alternating decreases and increases over time, with a 26.9-percent decrease between March 2016 and September 2016 due primarily to runoff from the storm and flood of July 30, 2016. Channel width and wetted perimeter showed increases of 22.3 percent and 21.2 percent, respectively, between April 2014 and March 2016, then decreases of 4.8 percent and 5.8 percent, respectively, between March 2016 and September 2016. The width/depth ratio showed a gradual increase of 25.5 percent over time.

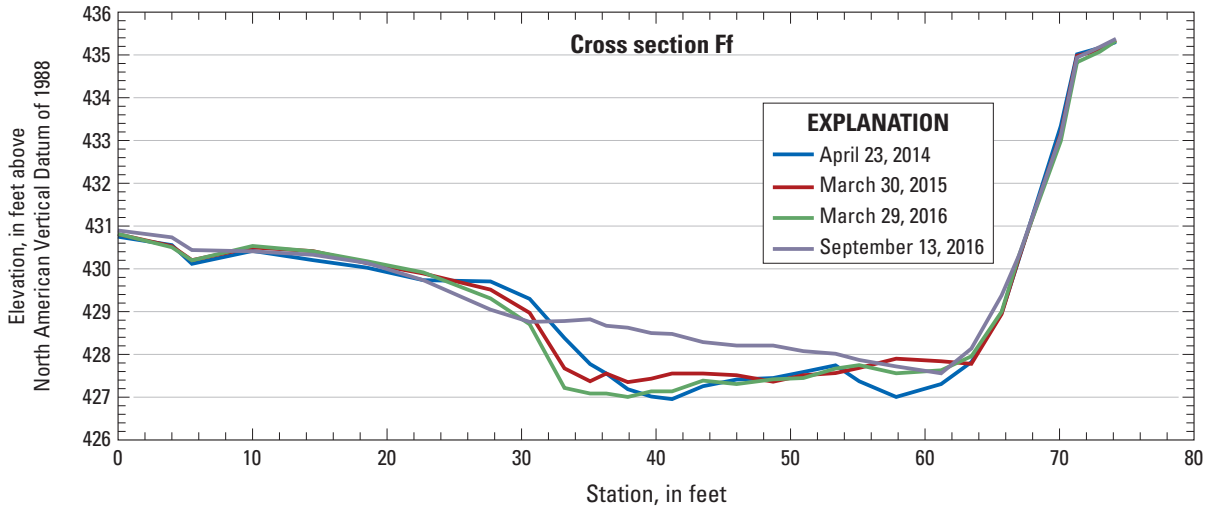
Figure 15. Cross-section geometry at permanent cross section Ff, April 2014 through September 2016.

A net decrease in cross-sectional area (-28.2 percent), mean depth (-35.7 percent), and hydraulic radius (-35.1 percent) was observed at cross section Ff, with much of the difference occurring between March 2016 and September 2016 (table 9). The maximum depth in the stream channel showed alternating decreases and increases over time, with a 20.7-percent decrease occurring between March 2016 and September 2016. The channel width and wetted perimeter showed gradual increases of 11.6 percent and 10.1 percent, respectively, over time. The width/depth ratio showed an increase of 18.7 percent between April 2014 and March 2015, a decrease of 6.0 percent between March 2015 and March 2016, and an increase of 55.2 percent between March 2016 and September 2016, mainly caused by runoff from the storm and flood of July 30, 2016.

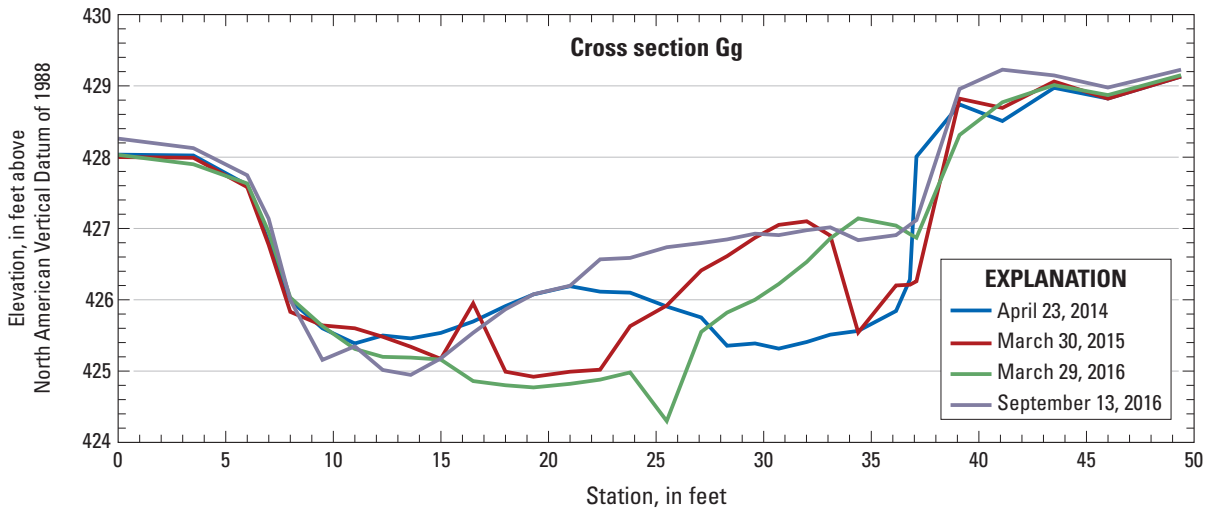
Figure 16. Cross-section geometry at permanent cross section Gg, April 2014 through September 2016.

Respective increases in cross-sectional area of 9.0 percent and 11.5 percent were observed in cross section Gg between April 2014, March 2015, and March 2016. A decrease of 28.2 percent was observed in September 2016, with an overall net decrease of 12.6 percent over time (table 9). Channel width showed a net increase of 6.9 percent with considerable fluctuations over time, but this was caused by large volumes of sand aggrading and degrading in the cross section over time, not by bank erosion and retreat. The mean depth and hydraulic radius in the stream channel showed alternating decreases and increases over time, with net decreases of 18.3 percent and 14.9 percent, respectively. Maximum depth showed a gradual increase of 38.1 percent between April 2014 and March 2016, then a decrease of 17.6 percent between March 2016 and September 2016. Wetted perimeter showed a net increase of 2.7 percent over time, with an increase of 22.4 percent between April 2014 and March 2015, a decrease of 1.7 percent between March 2015 and March 2016, and a decrease of 14.6 percent between March 2016 and September 2016. The width/depth ratio showed a net increase of 31.1 percent over

time, with an increase of 45.0 percent between April 2014 and March 2015, a decrease of 13.2 percent between March 2015 and March 2016, and an increase of 4.2 percent between March 2016 and September 2016.

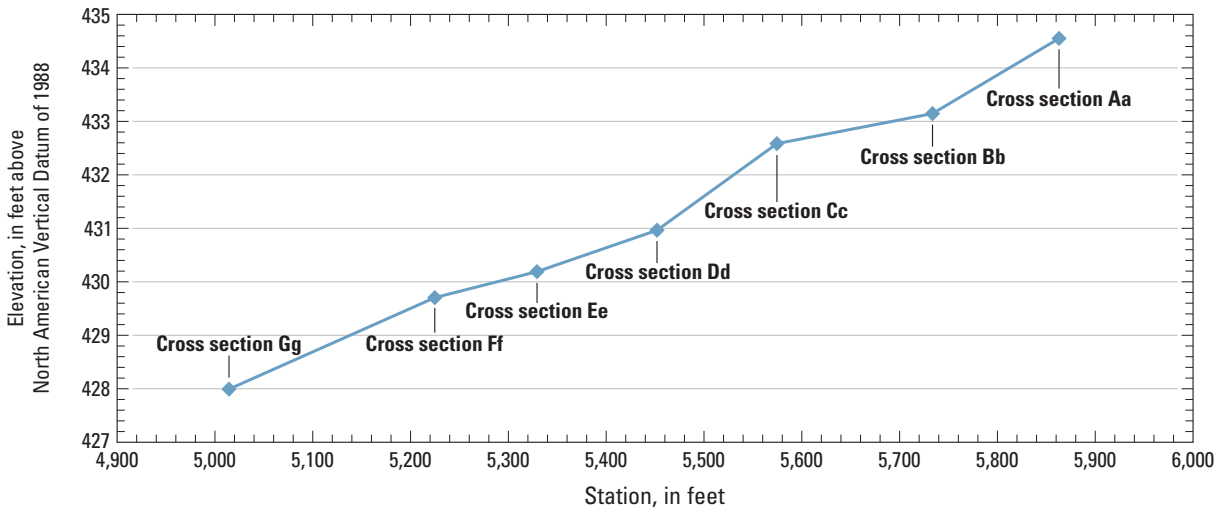
Figure 17. Bankfull water-surface profile, Tenmile Creek study reach, April 2014 through September 2016.

A reasonable profile of bankfull elevation in the Tenmile Creek study reach is shown in figure 17. The bankfull elevation at cross section Cc appeared to be slightly higher than expected compared to other cross sections in the study reach, but was based on a distinct **bankfull indicator** where streamflow begins to break out of the stream channel and into the flood plain. However, cross section Cc is located just downstream from a meander bend, with some cut-bank activity and vertical instability of the channel bed over time. These factors could be contributing to some variability in the bankfull elevation in this section of the stream channel.

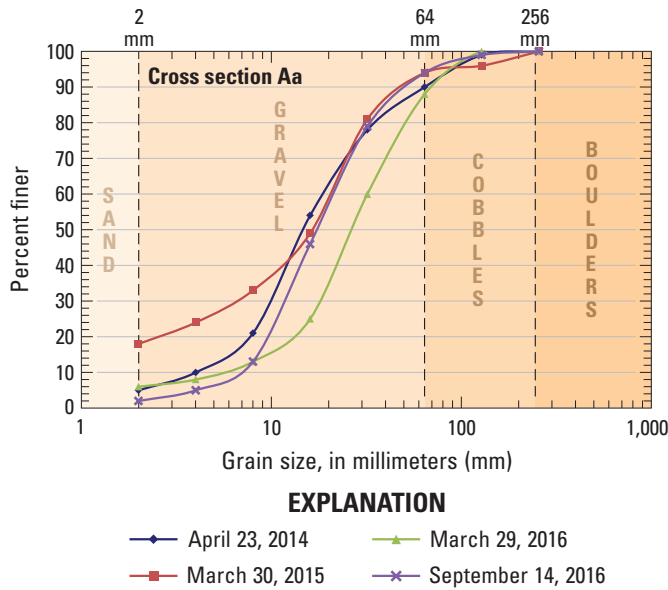
Figure 19. Comparison of grain-size distributions at cross section Aa, April 2014 through September 2016.

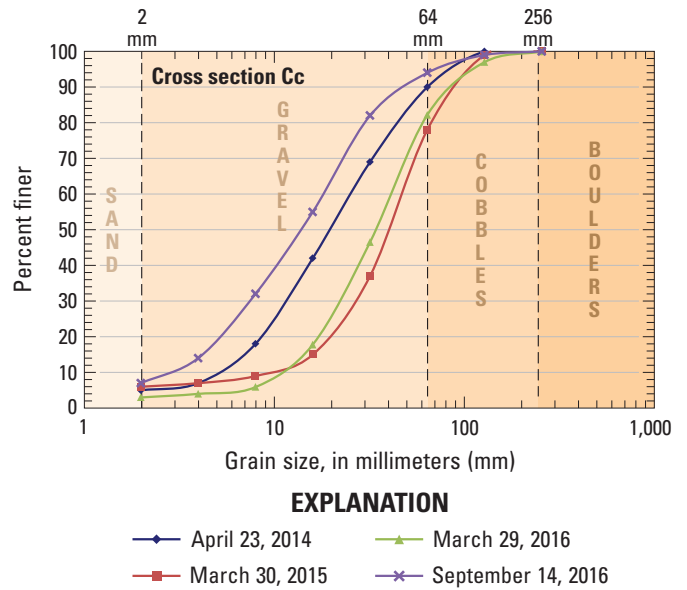
Figure 21. Comparison of grain-size distributions at cross section Cc, April 2014 through September 2016.

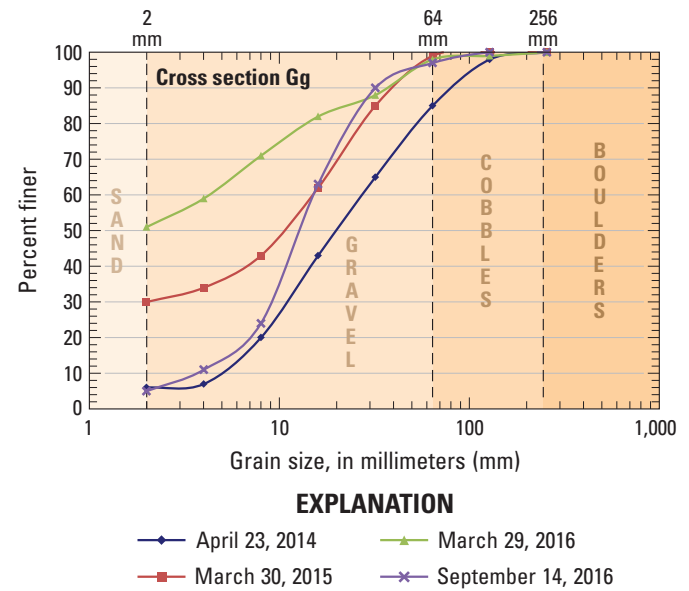
Figure 25. Comparison of grain-size distributions at cross section Gg, April 2014 through September 2016.

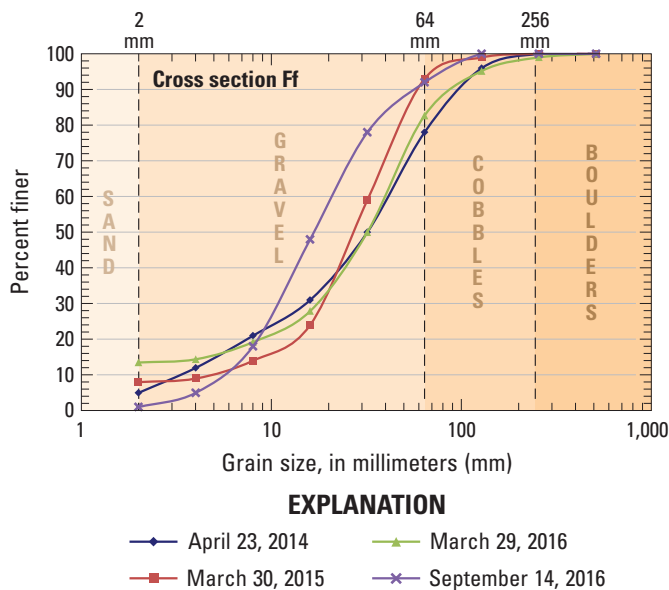
Figure 24. Comparison of grain-size distributions at cross section Ff, April 2014 through September 2016.

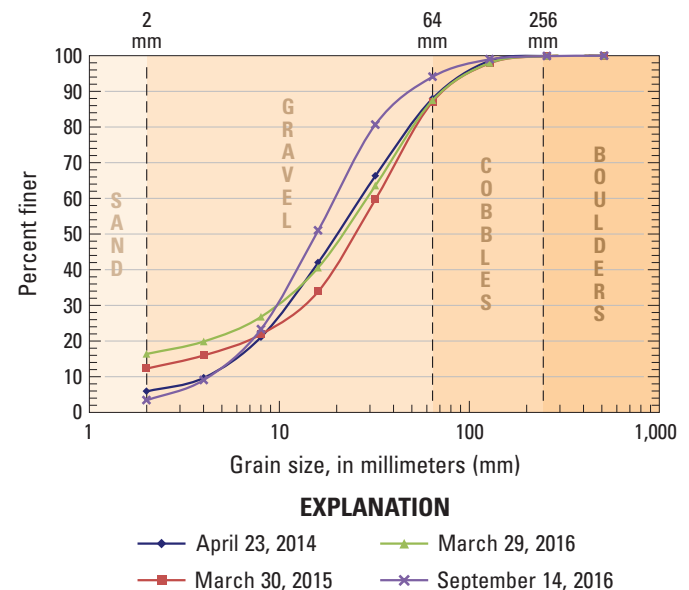
Figure 26. Comparison of composite pebble counts for Tenmile Creek study reach, April 2014 through September 2016.

Data from the pebble counts at each of the seven cross sections also were combined to develop a composite grain-size distribution of the surficial bed material for the entire study reach. The distribution was developed using a sample of 700 or more pebbles that were collected in the cross sections in April 2014, March 2015, March 2016, and September 2016. The grain-size distributions and computations of percent finer for the composite pebble counts are shown in table 14 and figure 26.

The data in table 14 and figure 26 show that most of the particle sizes in the Tenmile Creek study reach were between fine gravel and very coarse gravel. The analysis also indicated increasing percentages of sand in the study reach, from 5.9 percent in April 2014 to 16.4 percent in March 2016. In September 2016, the composite pebble count only indicated 3.4 percent of the particles being sand in the study reach. This indicated that the stormflows from the storm and flood of

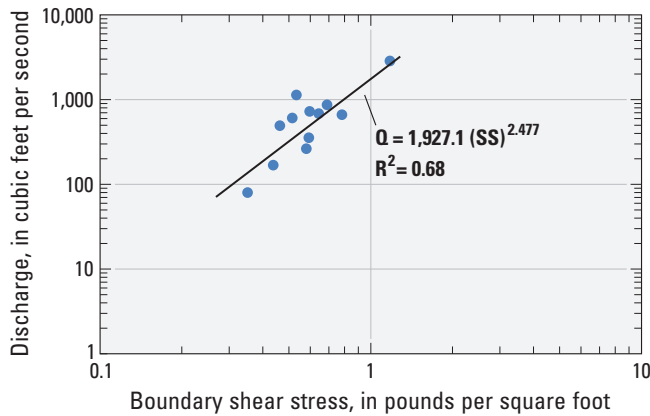
Figure 28. Boundary shear stress and discharge relations in the Tenmile Creek study reach, April 2014 through July 2016.

(Q, discharge estimated by least-squares regression; SS, boundary shear stress; R², coefficient of determination)
