Real-Time Streambed Scour Monitoring at Two Bridges over the Gunnison River in Western Colorado, 2016–17

Scientific Investigations Report 2018–5123

By Mark F. Henneberg

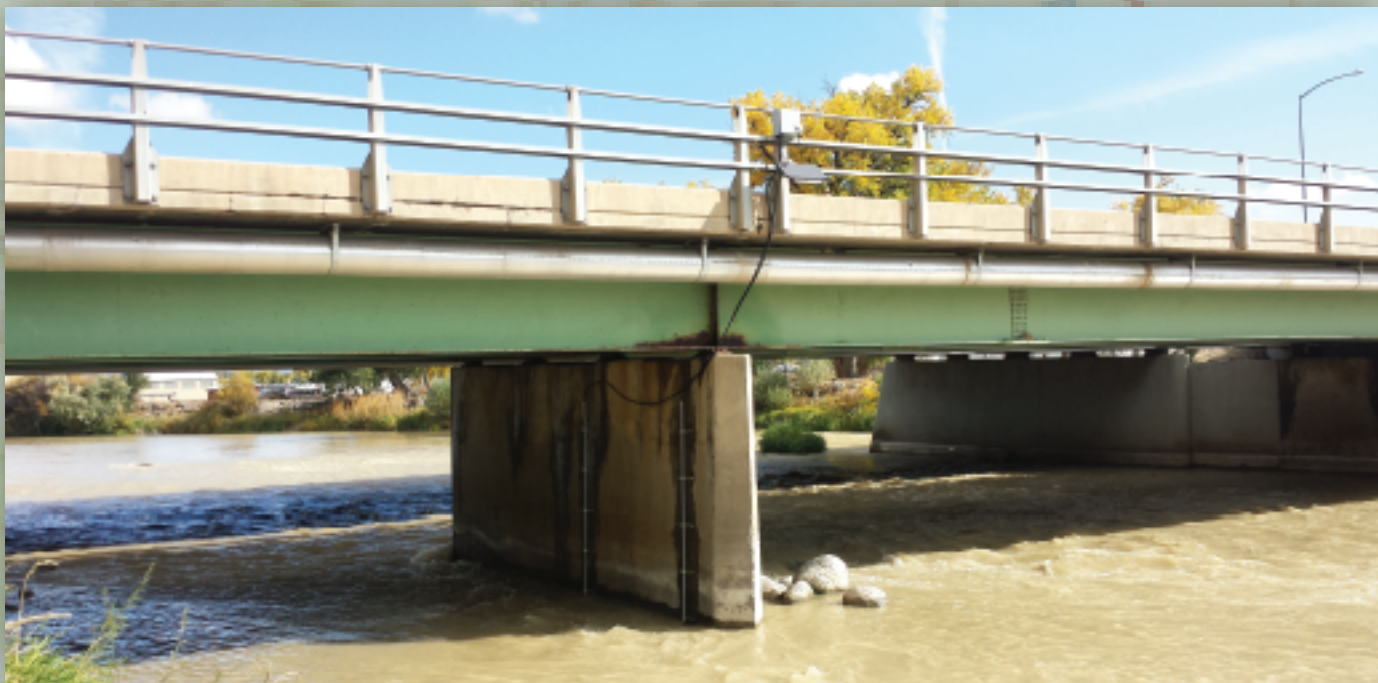
Cover photograph. Sensor installation on bridge I-04-K, from the north side of pier 3, looking upstream, western Colorado. Photograph by the U.S. Geological Survey.

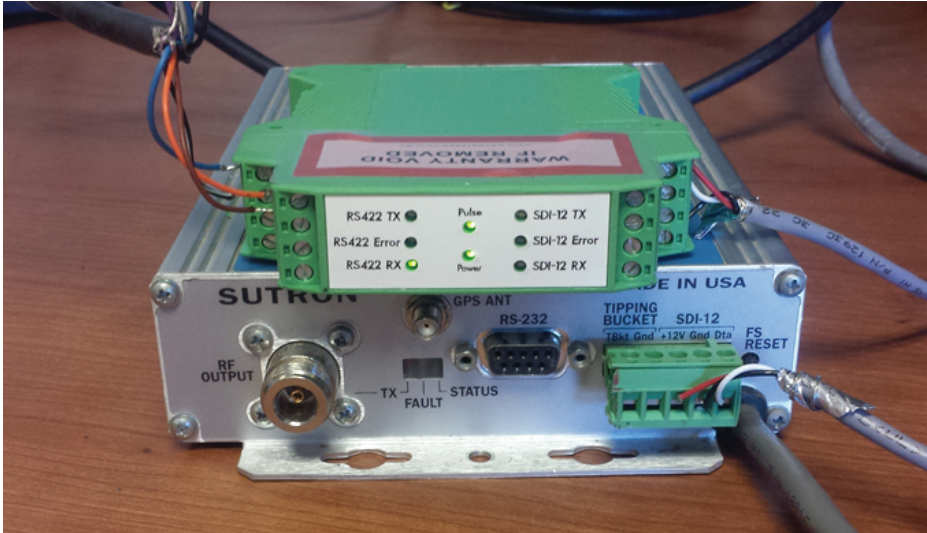
Figure 2. Example of a National Marine Electronics Association 0183 to Serial Digital Interface at 1,200-Baud protocol converter dialog and equipment; photograph by the U.S. Geological Survey.

To interface acoustic echosounders used for marine applications with DCPs in widespread use by the USGS, a protocol converter was developed by Pacific Data Systems, Proprietary Limited of Australia, and the USGS (Pacific Data Systems, 2017). The echosounders used for the study produce NMEA 0183 data sentences at 1 hertz. The protocol converter receives the serial data sentence from the echosounder, parses the sentence for the pertinent data values, stores those values in a register, and makes the registered values available using the SDI–12 protocol (fig. 2). The values in the register update at 1 hertz as new data are acquired from the echosounder. Each protocol converter is addressable as an individual SDI–12 sensor, so multiple echosounders can be connected to any SDI–12-compliant DCP. The converter and the echosounder are powered by the SDI–12 power supply from the DCP. Error checking was incorporated in the protocol conversion, such that any data missing from the echosounder result in “–1” values in the SDI–12 data register. Connecting an echosounder to any SDI–12-compliant DCP with the protocol converter requires no custom programming because the protocol converter responds to standard SDI–12 commands.

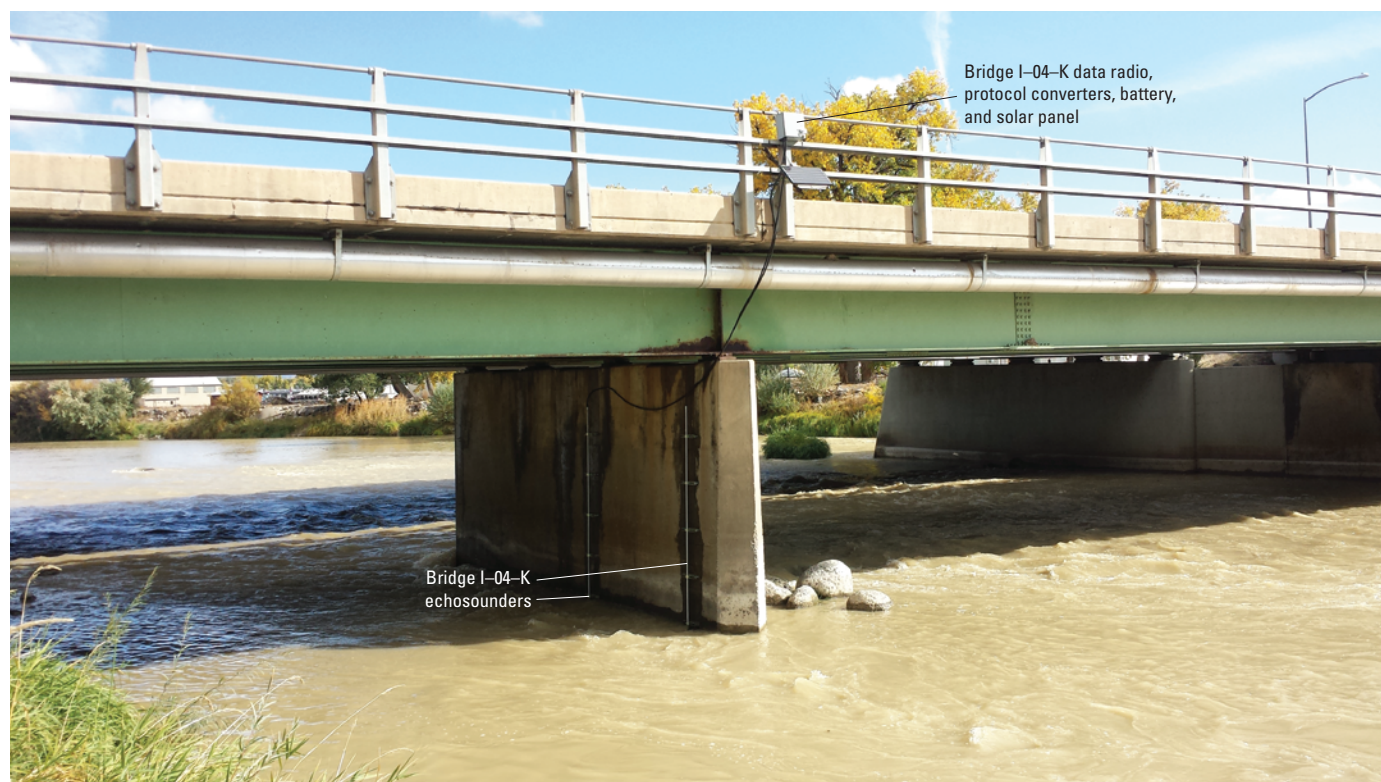
Figure 3. Sensor installation on bridge I-04-K, from the north side of pier 3, looking upstream, western Colorado; photograph by the U.S. Geological Survey.

Bridge I-04-K was configured with two Airmar Echo-Range™ Smart™ Sensor echosounders (Airmar Technology Corporation, 2017), each mounted on the north side of pier 3 (fig. 3). Each sensor was connected to a protocol converter. The protocol converters were connected to a SDI-12 data radio mounted in an enclosure on the bridge railing. A second data radio was installed at the existing, streamflow-gaging station enclosure, about 1,500 feet (ft) downstream, and connected to a DCP in the enclosure for data logging and transmission. Relaying data using SDI-12 data radio minimized the installation footprint on the bridge and reduced the amount of time field staff were required to work on the roadway. The upstream and downstream echosounders were mounted at elevations of 4,924.73 and 4,924.76 ft, respectively, above the North American Vertical Datum of 1988 (NAVD 88). Because of water depths and velocities, most of the instrumentation was installed by motor boat; however, probing and inspecting the streambed and pier wall interface was possible

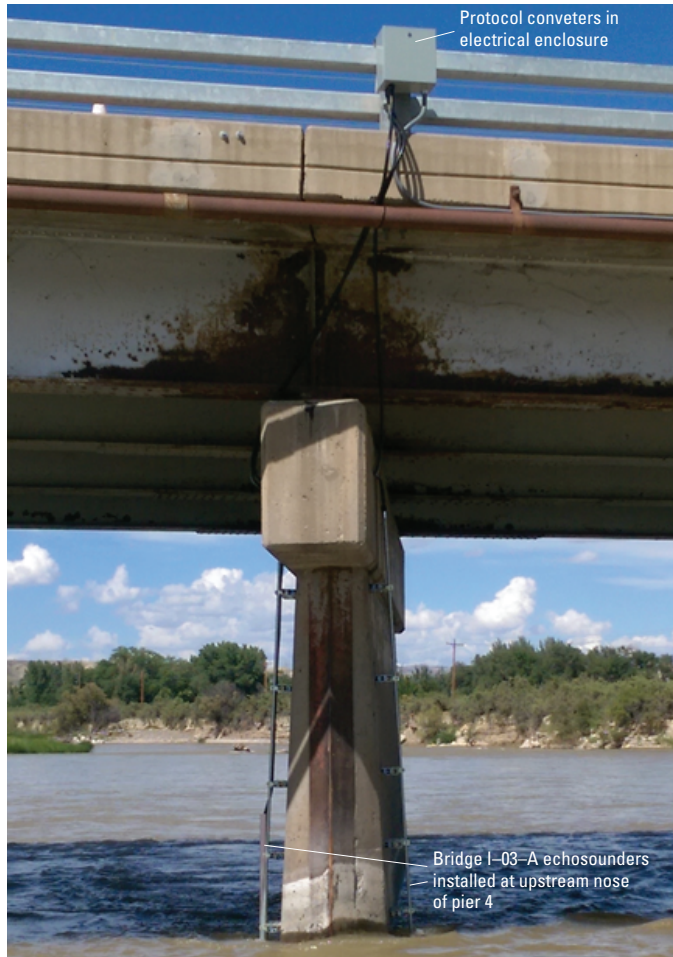
Figure 4. Sensor installation on bridge I-03-A, from the south side of pier 4, looking downstream, western Colorado; photograph by the U.S. Geological Survey.

Bridge I-03-A was configured with two Airmar Echo-Range™ Smart™ Sensor echosounders (Airmar Technology Corporation, 2017), each mounted on opposite sides of pier 4 at the transition of the upstream nose to the straight section of the pier wall (fig. 4). The sensors were located to measure streambed elevations on both sides of the upstream nose of the pier. The east and west echosounders were mounted at elevations of 4,632.83 and 4,632.55 ft, respectively, above the NAVD 88. Each echosounder has a beam width of 9 degrees,

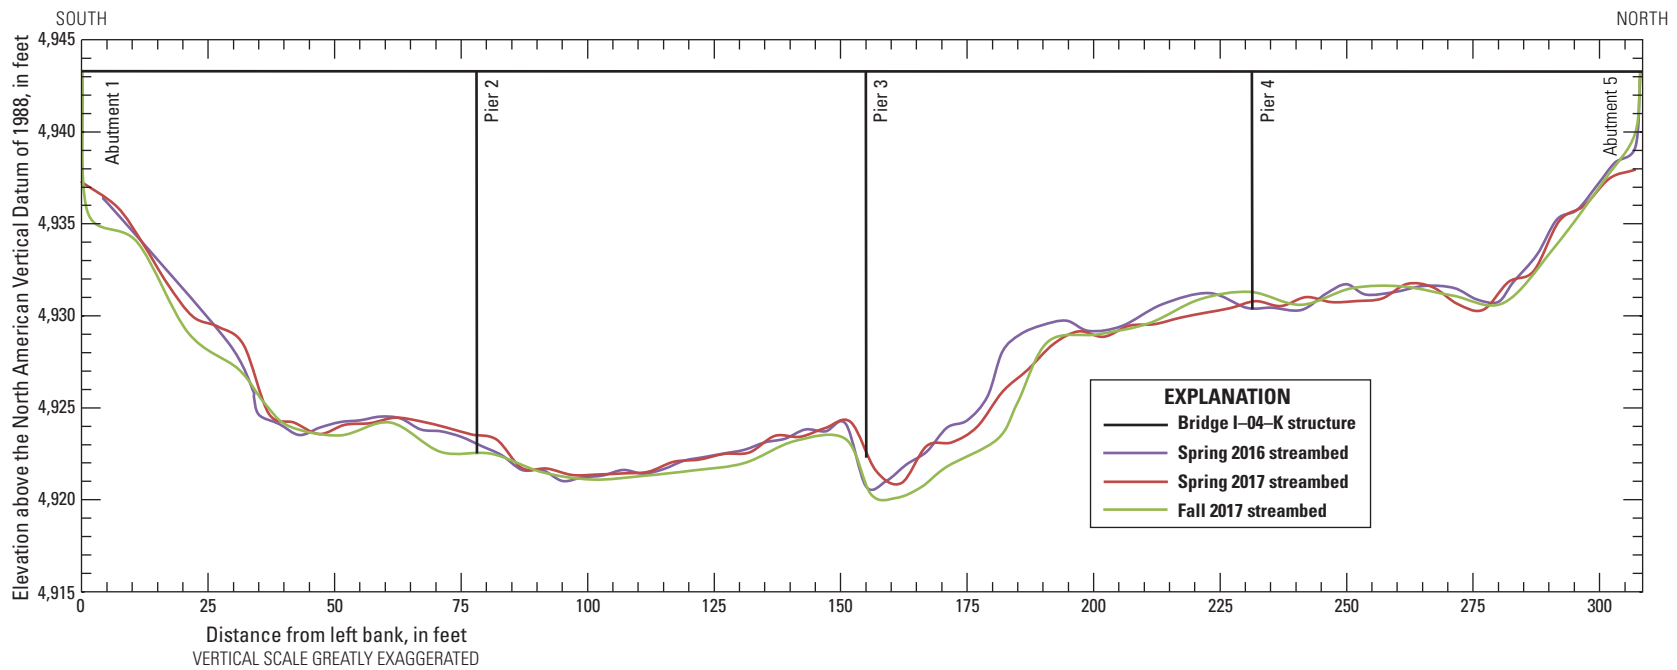
Figure 5. Cross section of streambed elevation surveys of the Gunnison River at bridge I-04-K with the location of the bridge structure, western Colorado, 2016 and 2017.

The echosounders for this study were mounted on the north side of pier 3 (fig. 5). Field inspections by USGS staff identified local scour along the downstream one-half of the pier wall on the north side. The echosounders were located to measure streambed elevations within the scour hole, at the upstream and downstream extents. The scour hole also exhibited undermining of the pier wall, about 1 ft deep and extending 1 ft under the pier wall. Water depths adjacent to the pier wall ranged from 3 to 4 ft during lower streamflow with the greatest depths at the downstream end of the pier. Estimated water velocity was about 2.5 to 3.5 feet per second (ft/s), based on direct observation.

All mean streambed elevations decreased during periods with *p*-values less than 0.05, indicating section-wide degradation and localized scour processes had occurred when changes in mean streambed elevations were statistically significant (table 1). The mean streambed elevation for the cross section decreased by 0.39 ft, whereas mean streambed elevations for the pier section decreased by 0.81 and 0.86 ft for the statistically significant periods. The median sediment-particle size (*d*₅₀) of the streambed sediment, determined for a previous study, was 79 millimeters (mm; 0.26 ft; Williams and others, 2013). Deducting the *d*₅₀ (0.26 ft) from the 0.81 and 0.86 ft decrease indicated around the pier, a decrease in mean streambed elevations of 0.55 to 0.60 ft approximates the 0.70 ft streambed elevation change measured by the downstream echosounder. The *d*₅₀ values were deducted from changes in streambed elevation to reduce noise that could result from sediment transport without degradation. The magnitude of the detected scour is about 2–3 particle diameters in extent and, as such, may represent limited movement of the streambed. It is important to note that the surveyed cross sections were at the downstream bridge opening, about 5 ft downstream from the echosounder, so direct comparisons of elevations from the cross sections versus the echosounder would not be appropriate. Indications of significance from the paired t-tests and Wilcoxon rank sum tests support changes between surveys illustrated in the graphical representation of surveyed cross-section data presented in figure 5.

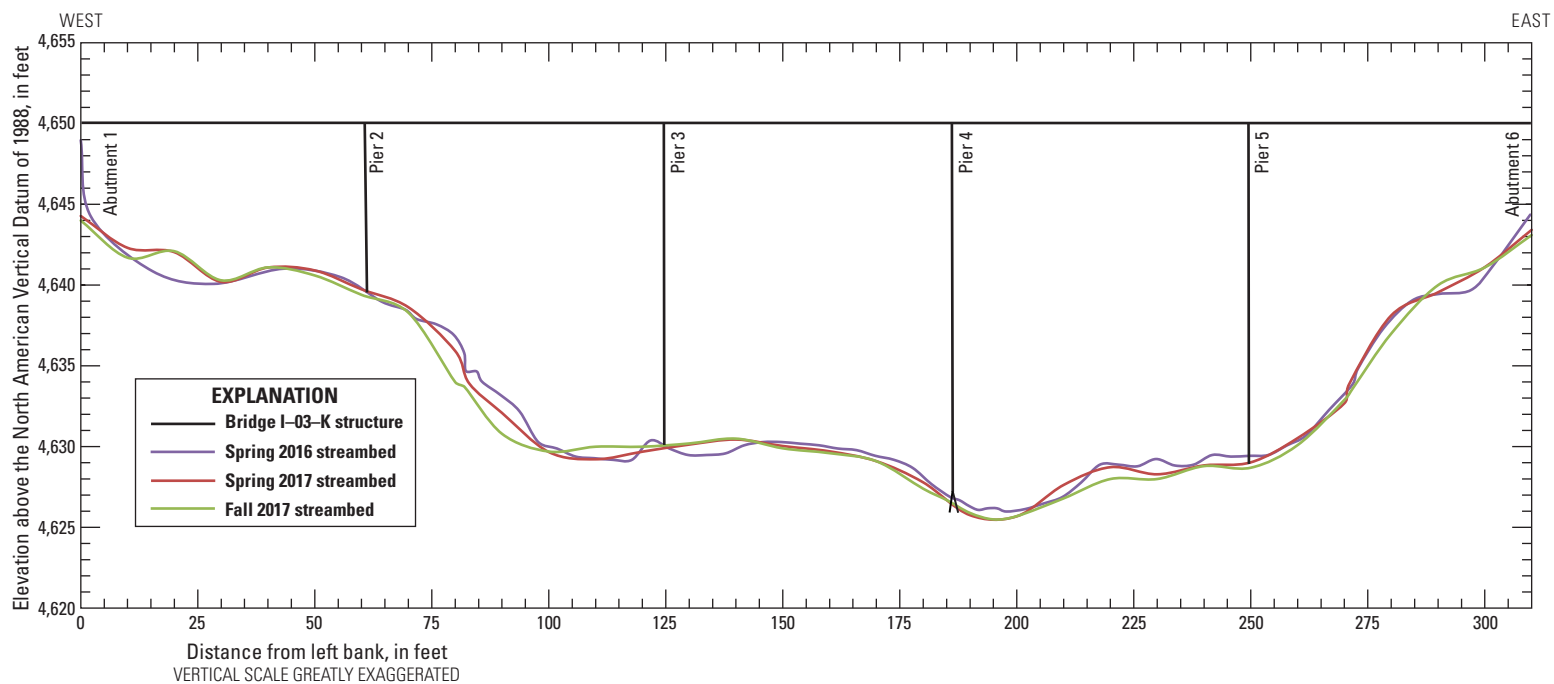
Figure 6. Cross section of streambed elevation surveys of the Gunnison River at bridge I-03-A with the location of the bridge structure, western Colorado, 2016 and 2017.

mean streambed elevations occurred primarily during the first year of the study at this site (fig. 6).

Changes in mean streambed elevations indicated by the statistical tests for the pier section and the cross section ranged from 0.11 to 0.56 ft. The median sediment-particle size (d₅₀) of the streambed sediment, determined for a previous study, ranged from 71 to 77 mm (0.23 to 0.25 ft) with a mean of 74 mm (0.24 ft; Williams and others, 2013). Mean streambed elevations decreased for all statistically significant periods, which may suggest streambed scour or reach-wide channel degradation. Deducting the d₅₀ (0.24 ft) from the 0.56-ft maximum change in mean streambed elevations indicated by the statistical tests results in scour at the pier section of 0.32 ft during the first year of the study. The d₅₀ values were deducted from changes in streambed elevation to reduce noise that could result from sediment transport without degradation. The magnitude of the detected scour is about 1–2 particle diameters in extent and, as such, may represent limited movement of the streambed. It is important to note again that the surveyed cross sections were at the upstream bridge opening about 10 ft upstream from the echosounders, so direct comparisons of elevations from the cross sections versus the echosounders would not be appropriate. Indications of significance from the paired t-tests and Wilcoxon rank sum tests support changes between surveys illustrated in the graphical representation of surveyed cross-section data presented in figure 6.

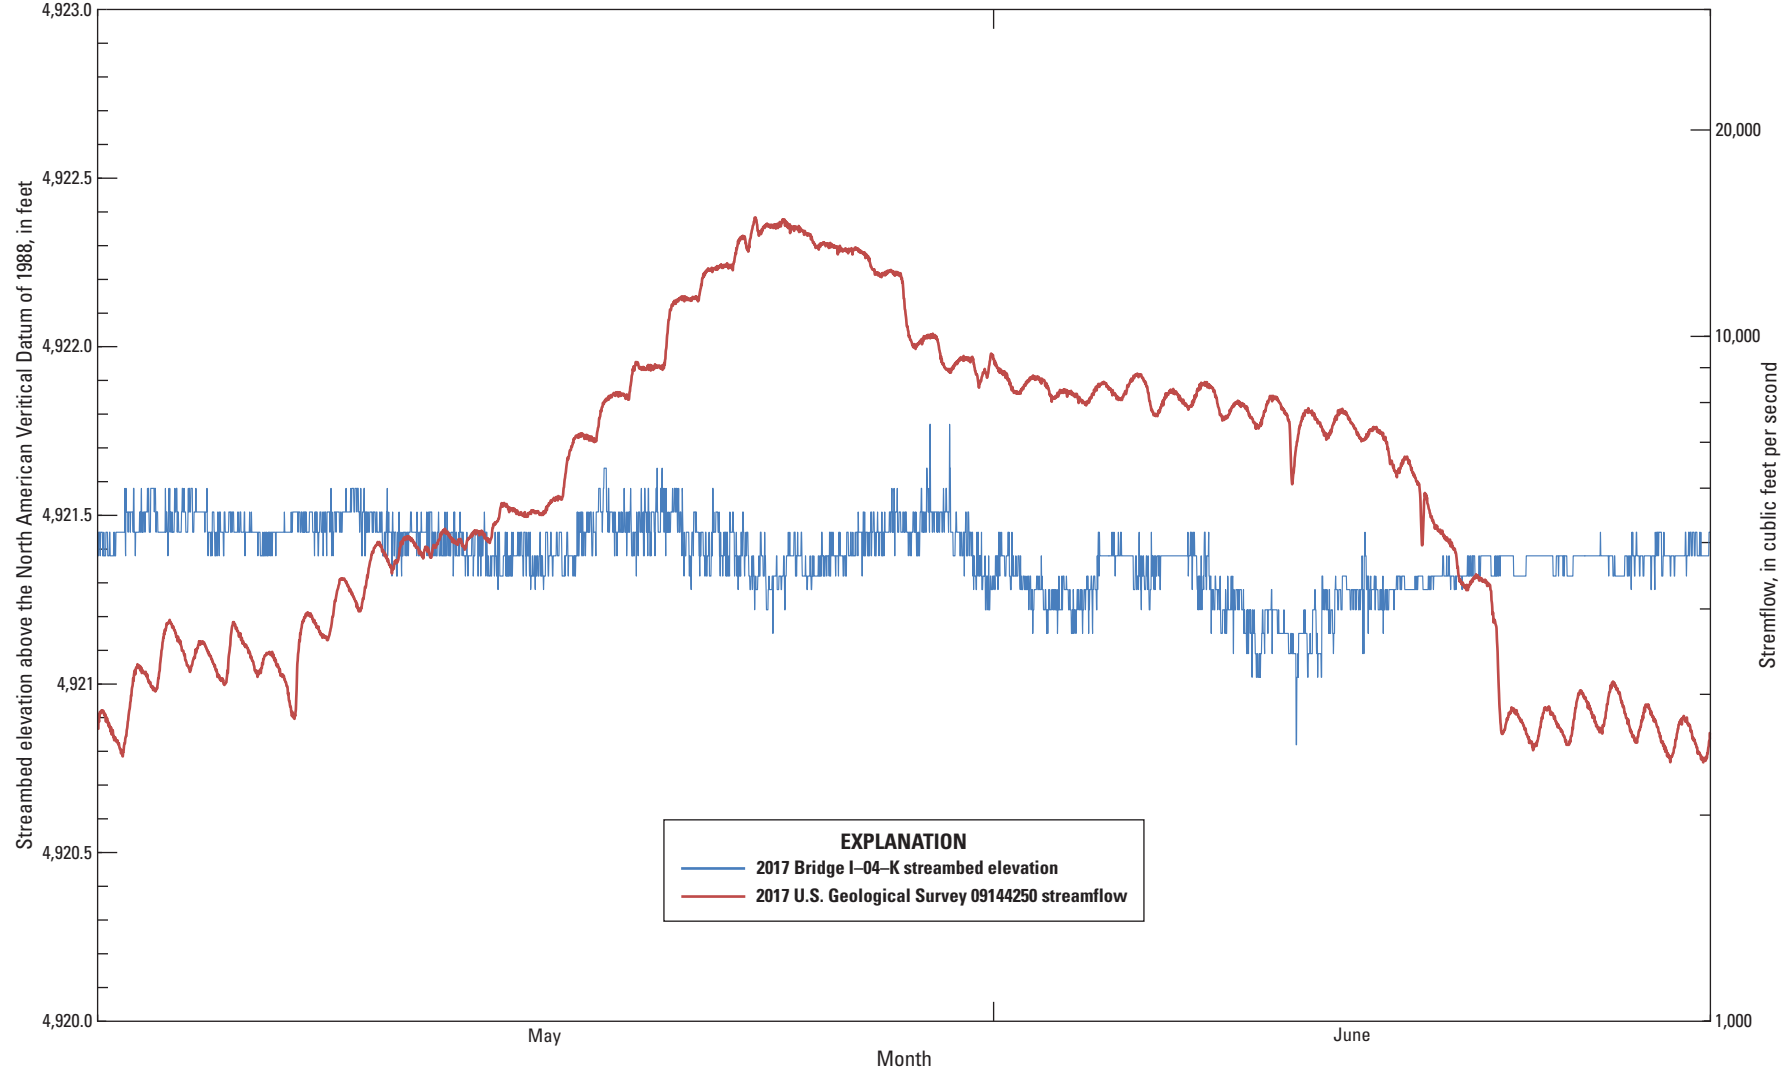
Figure 7. Streambed elevation at bridge I-04-K and streamflow from U.S. Geological Survey streamflow-gaging station 09144250 during snowmelt runoff in 2017, western Colorado.

Data collected during 2017 snowmelt runoff seems to exhibit minor scour and fill under the downstream sensor (fig. 7). The measured streambed elevation was about 4,921.5 ft as streamflow began to increase during May. This elevation remained nearly constant until the streamflow rose above 10,000 ft³/s. Elevations slowly decreased through the streamflow peak to an elevation of 4,921.2 ft during the peak, then rose slightly back to 4,921.5 ft (fig. 7). As runoff progressed, the elevation decreased and subsequently rose on two more occasions during June, both coinciding with the higher-streamflow period of the snowmelt-runoff hydrograph. The first occurrence had a low elevation of 4,921.2 ft, and the second had a low elevation of 4,920.8 ft. As streamflow continued to recede, the measured streambed elevation slowly increased to 4,921.5 ft and remained nearly constant for the duration of the period (fig. 7).

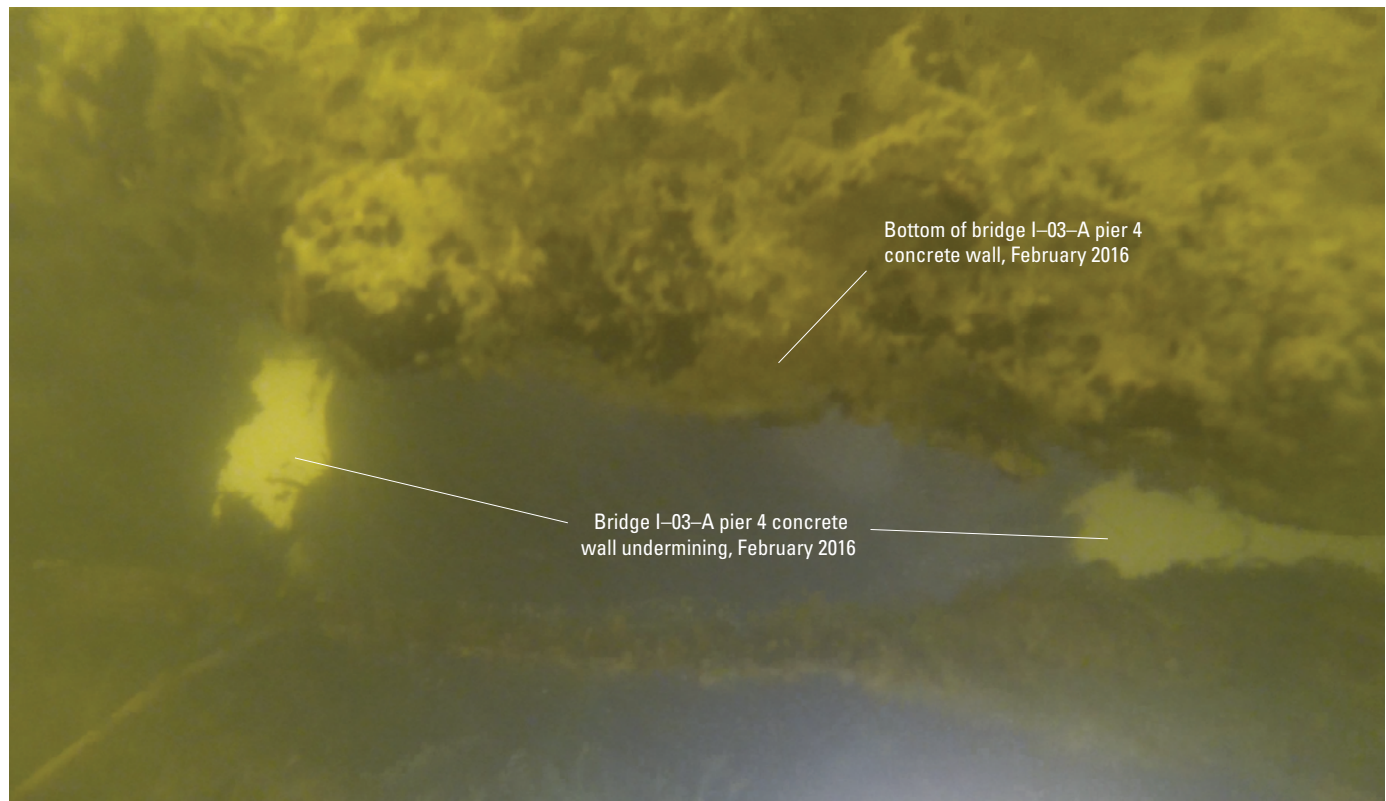
The echosounders and all associated instrumentation were installed in September 2015 in advance of the 2016 snowmelt-runoff season. A cross-section survey and site inspection were performed in spring 2016 to verify proper sensor operation before runoff. Probing of the pier wall and streambed interface from a boat revealed undermining along the length of the pier wall. The undermining extended from side-to-side to a depth of about 2 ft. Underwater photographs were obtained by submerging a waterproof camera on an extended wading rod to document the location and extent (fig. 8). Undermining along the entire length of the pier

suggests reach-length channel degradation, as opposed to localized scour. Minor to moderate debris was noted at the upstream nose of the pier during this inspection.

Figure 8. Underwater photograph of undermining of bridge I-03-A at pier 4, western Colorado, February 2016; photograph by the U.S. Geological Survey.
