# Evaluation of Land Subsidence and Ground Failures at Bicycle Basin, Fort Irwin National Training Center, California, 1992–2017

Scientific Investigations Report 2019–5015

By Jill N. Densmore, Kevin M. Ellett, Michelle Sneed, Justin T. Brandt,  
James F. Howle, Andrew Y. Morita, Rodrigo Borela, Antonio Bobet, and  
Drew C. Thayer

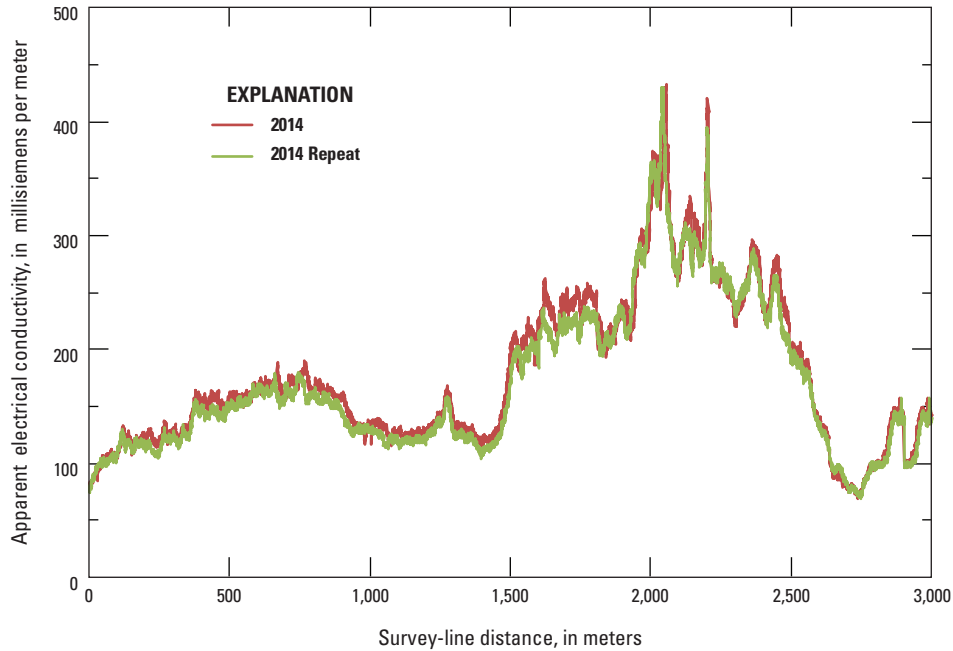
**Figure 9.** Results from the test of repeatability along a 3-kilometer survey line of the main runway, December 2014, Fort Irwin National Training Center, California, indicating average variability for repeat survey lines is around 7 millisiemens per meter.

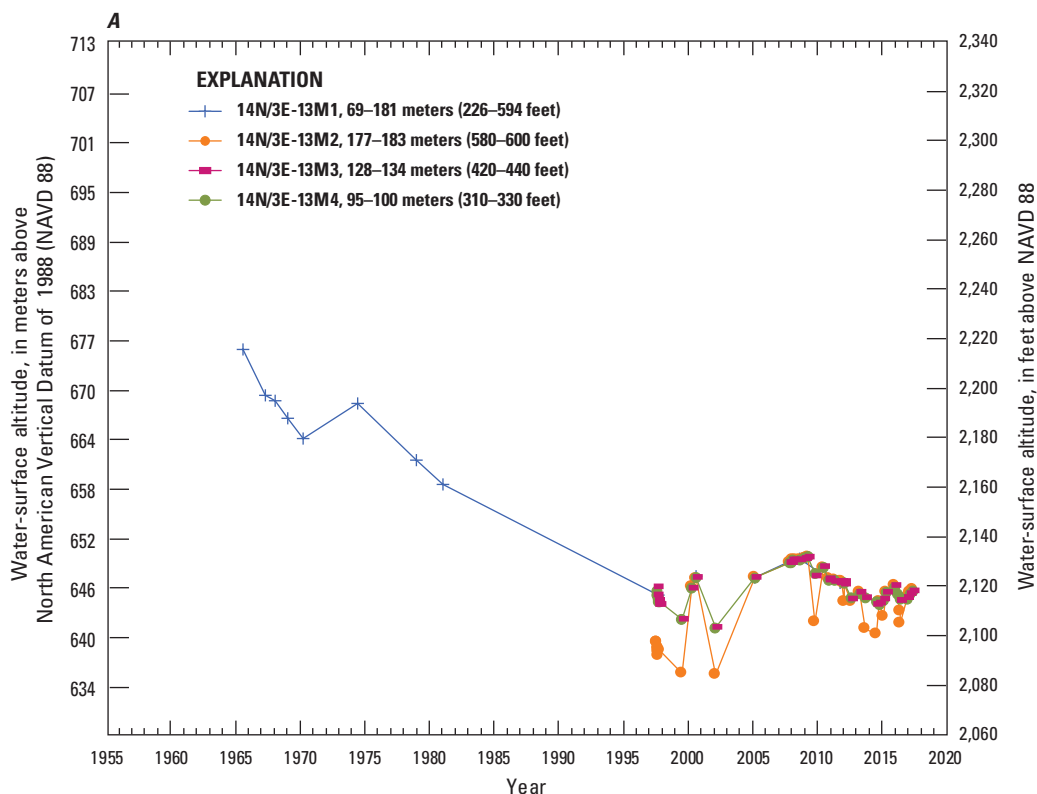
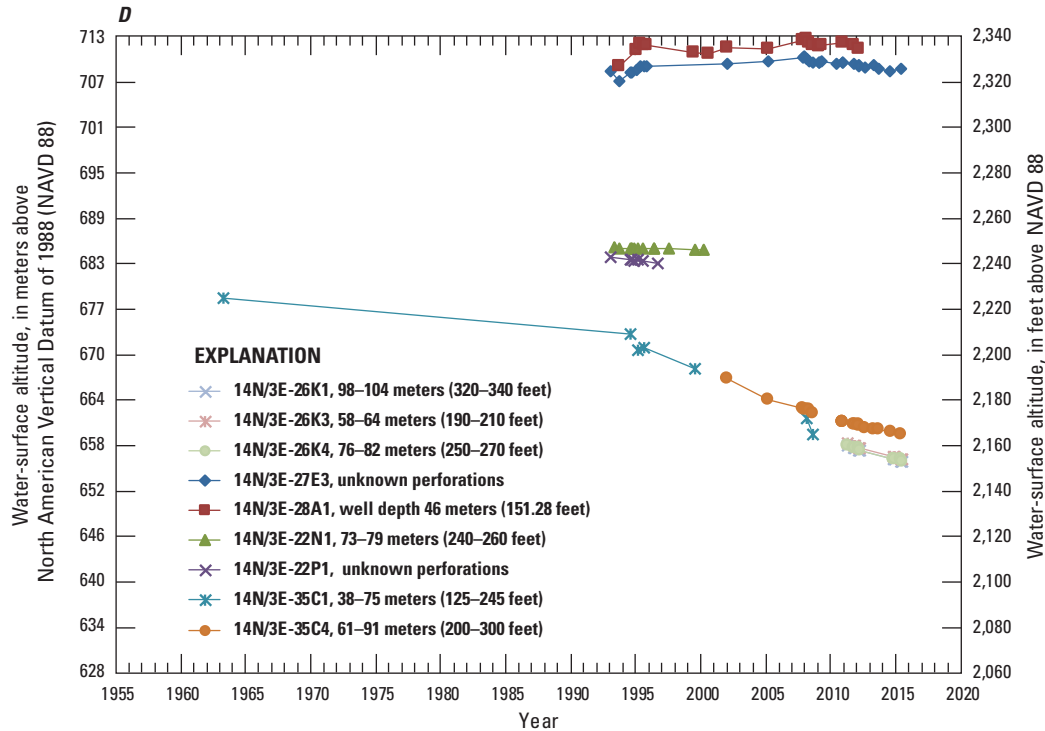
**Figure 13.** Water-level changes in selected wells during 1955–2017 in Bicycle Basin, Fort Irwin National Training Center, California, for the following areas: A, northern; B, central (west); C, central (east); and D, southern.

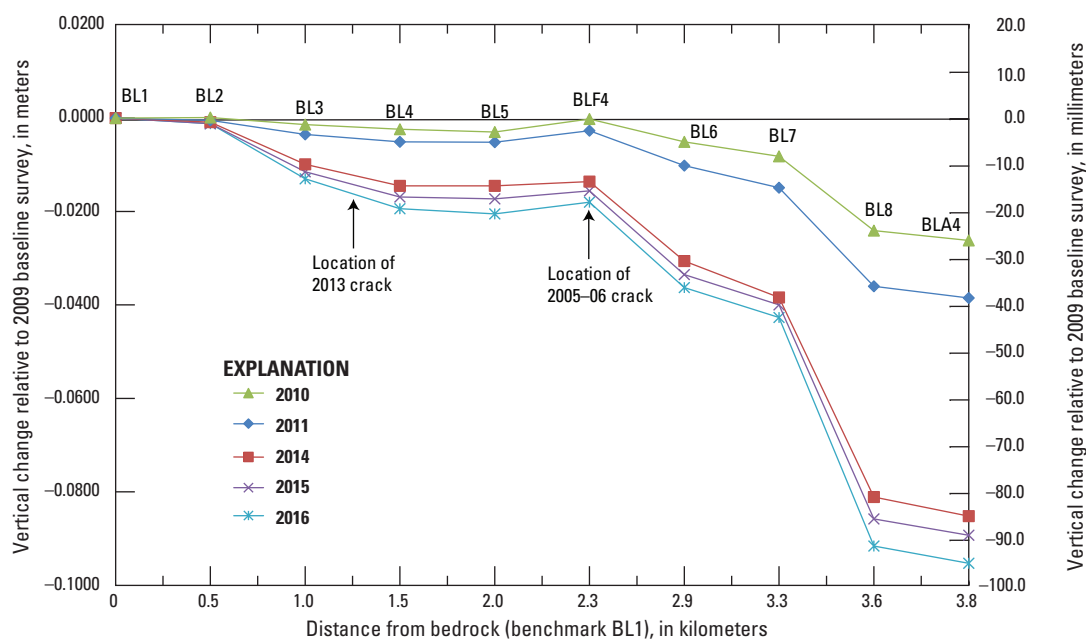
**Figure 16.** Vertical change along transect for repeat leveling surveys relative to 2009 baseline survey in Bicycle Basin, Fort Irwin National Training Center, California (location of transect is shown on [fig. 7](#)).

Land-surface changes were calculated along the transect for five periods (January 2009 to October 2010, October 2010 to April 2011, April 2011 to October 2014, October 2014 to November 2015, and November 2015 to December 2016). To determine the change relative to stable bedrock (benchmark BL1), the elevation difference was calculated by subtracting the 2009 baseline elevation at each benchmark from the elevation at each benchmark for each survey year. To determine the vertical land-surface change for any given year, the elevation difference between benchmark pairs along the transect was summed and are relative to the stable bedrock benchmark (BL1).

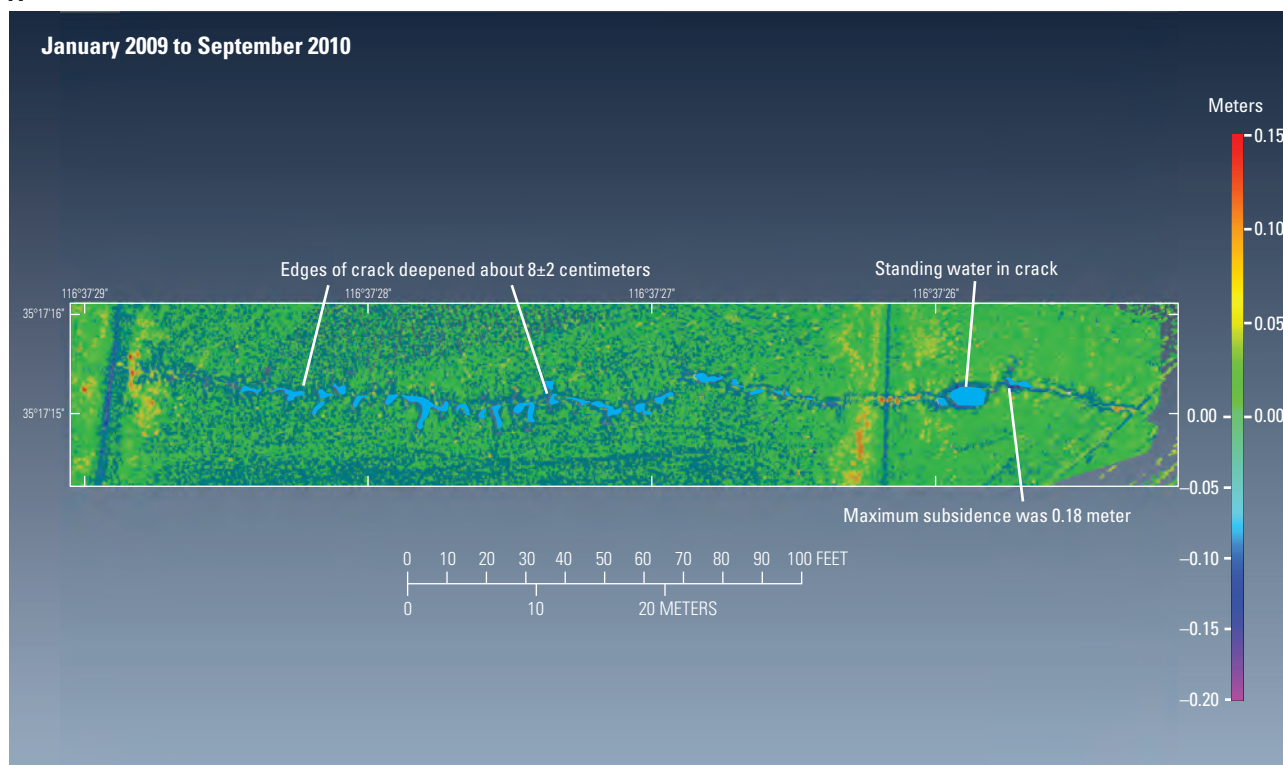
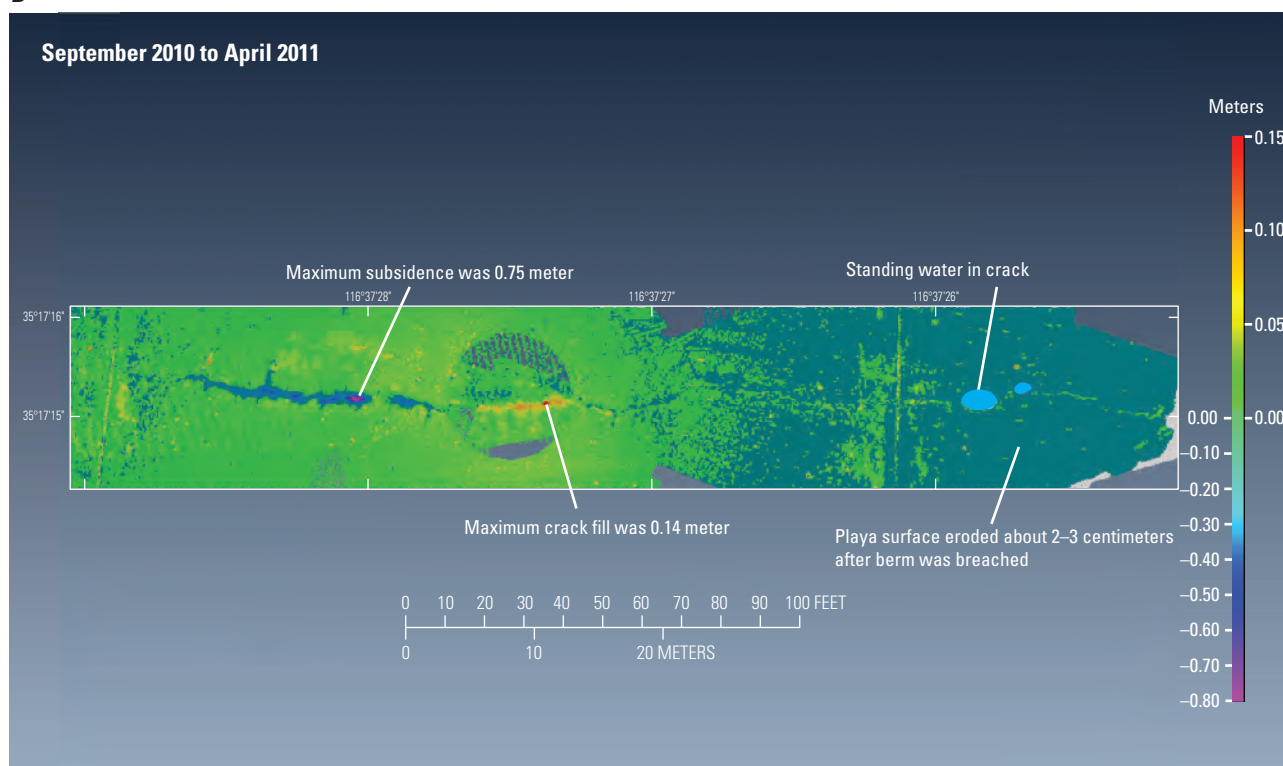
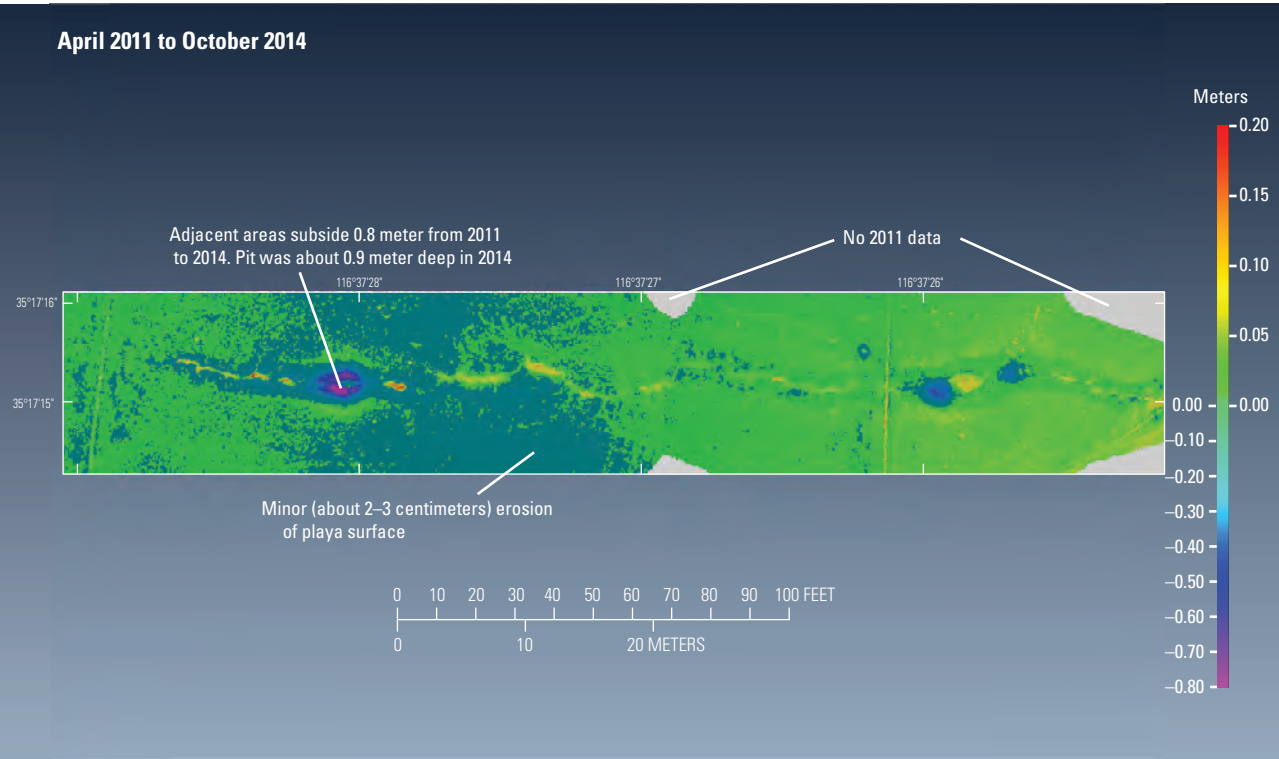
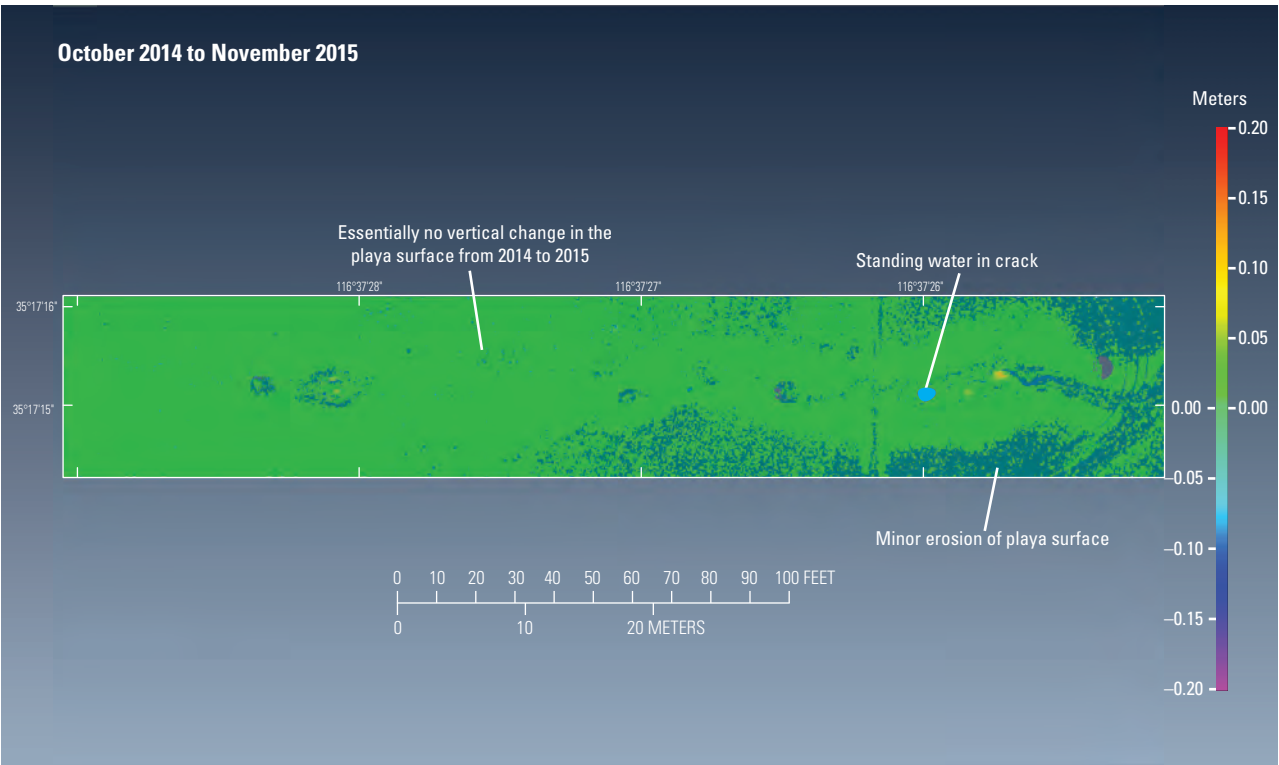
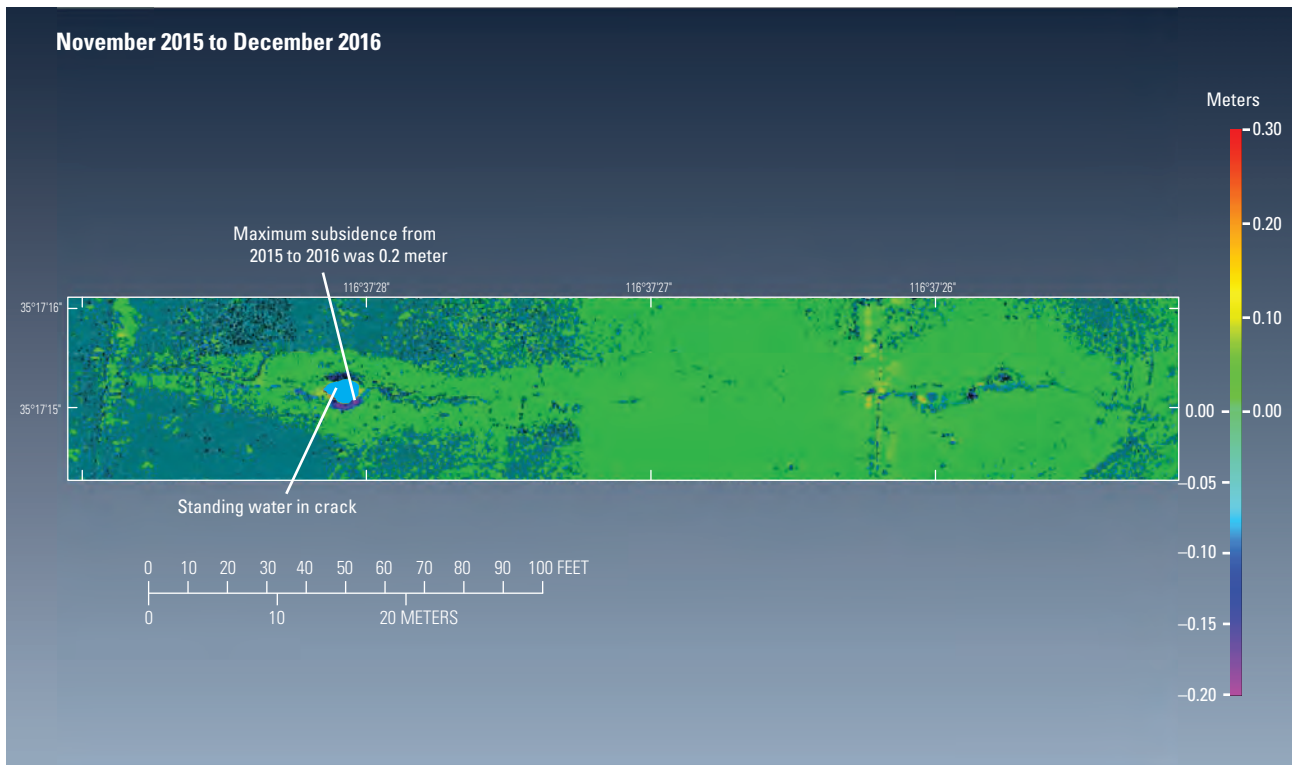
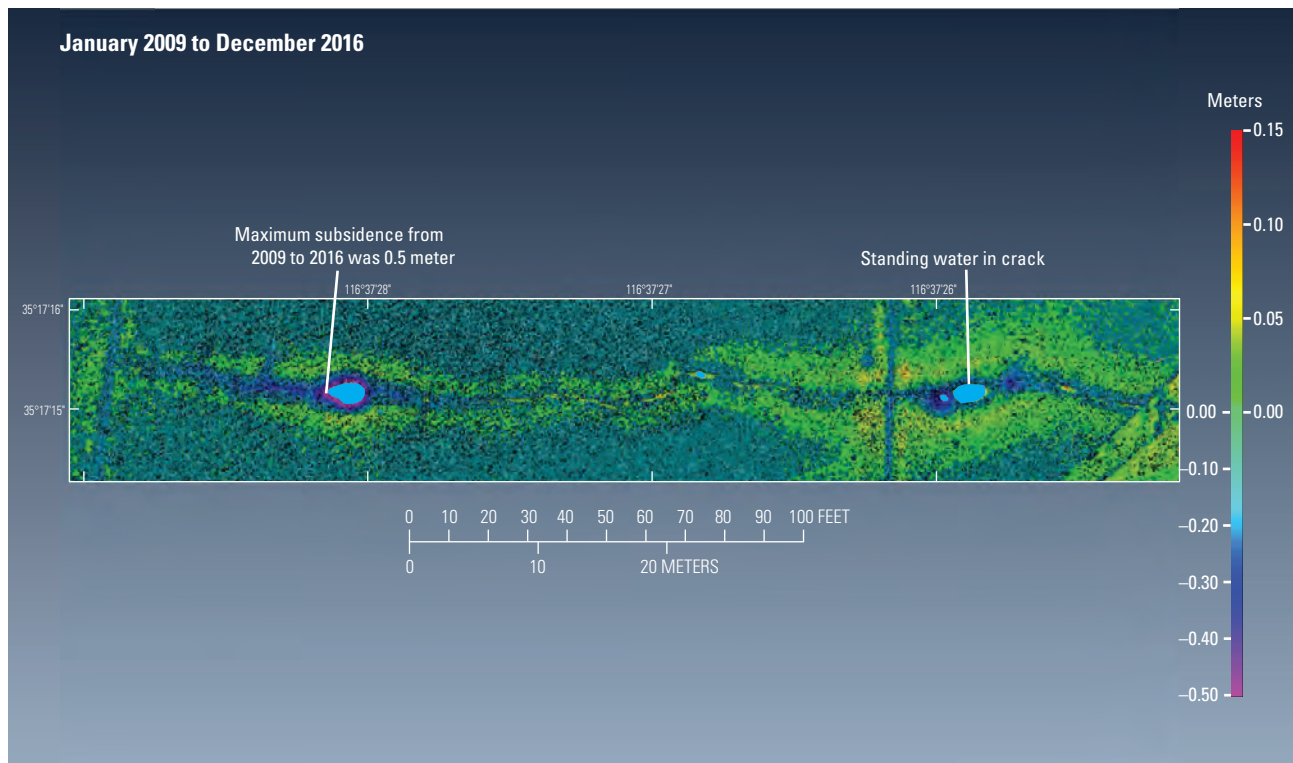
**Figure 18.** Vertical land-surface change for 2005–06 main-runway crack, Fort Irwin National Training Center, California, for *A*, January 2009–September 2010; *B*, September 2010–April 2011; *C*, April 2011–October 2014; *D*, October 2014–November 2015; *E*, November 2015–December 2016; and *F*, January 2009–December 2016.

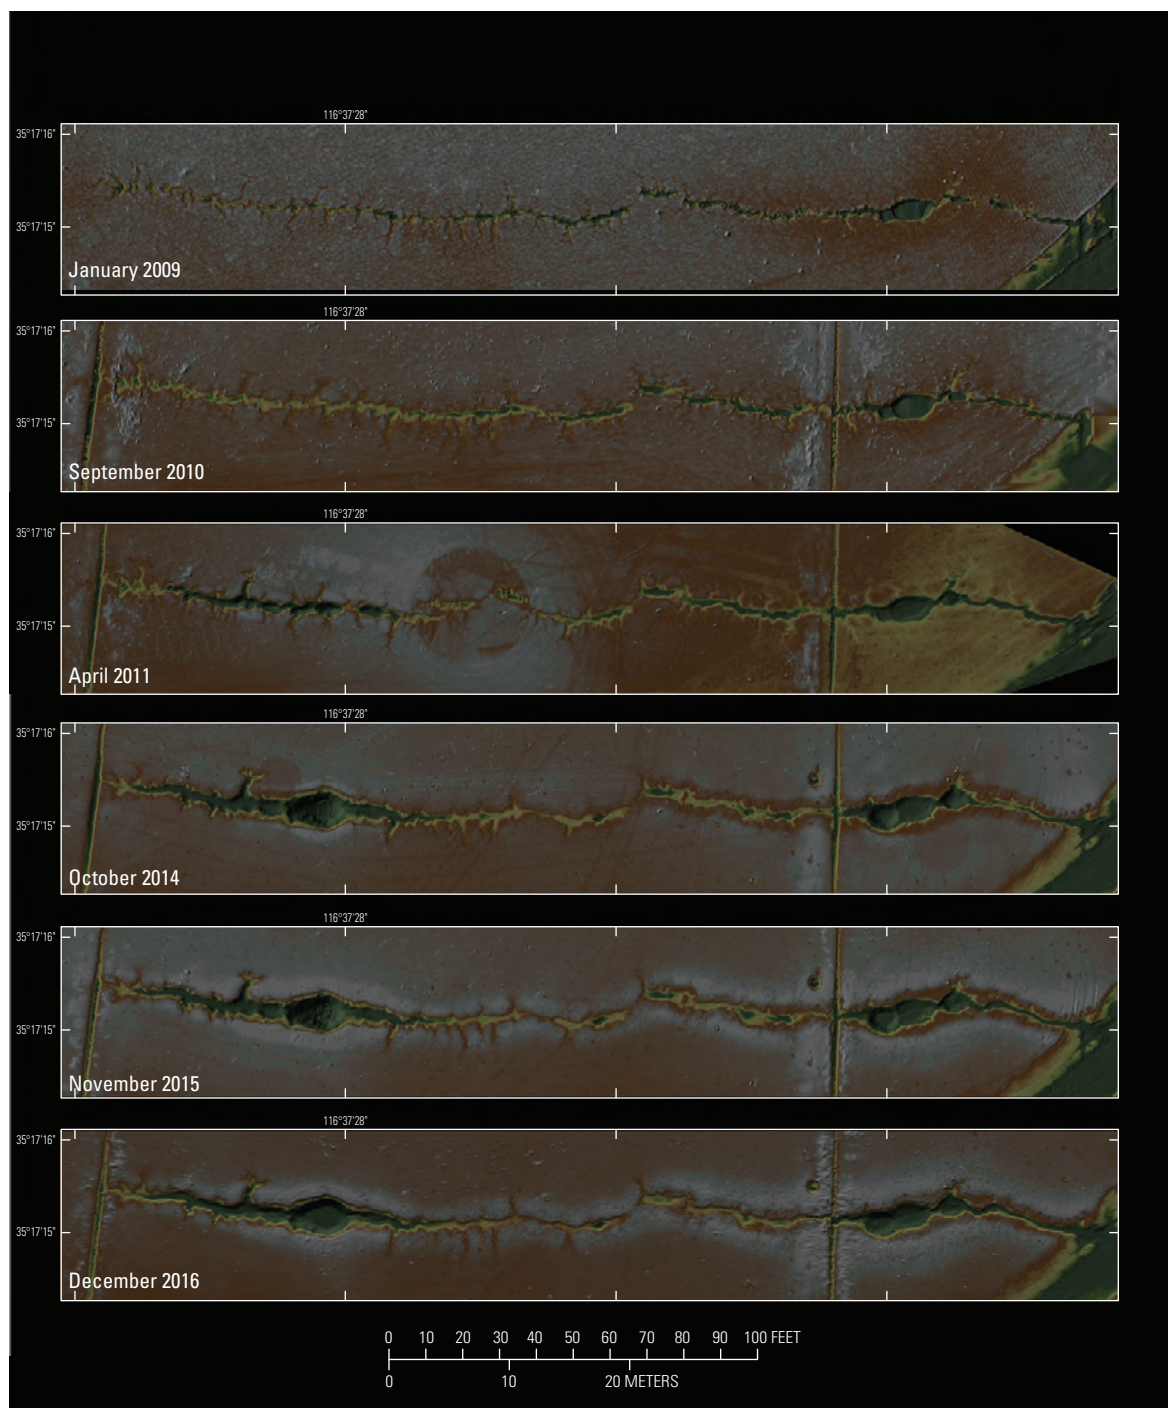
**Figure 19.** Time-series shaded-relief images for 2005–06 main-runway crack from January 2009 through December 2016, Fort Irwin National Training Center, California.

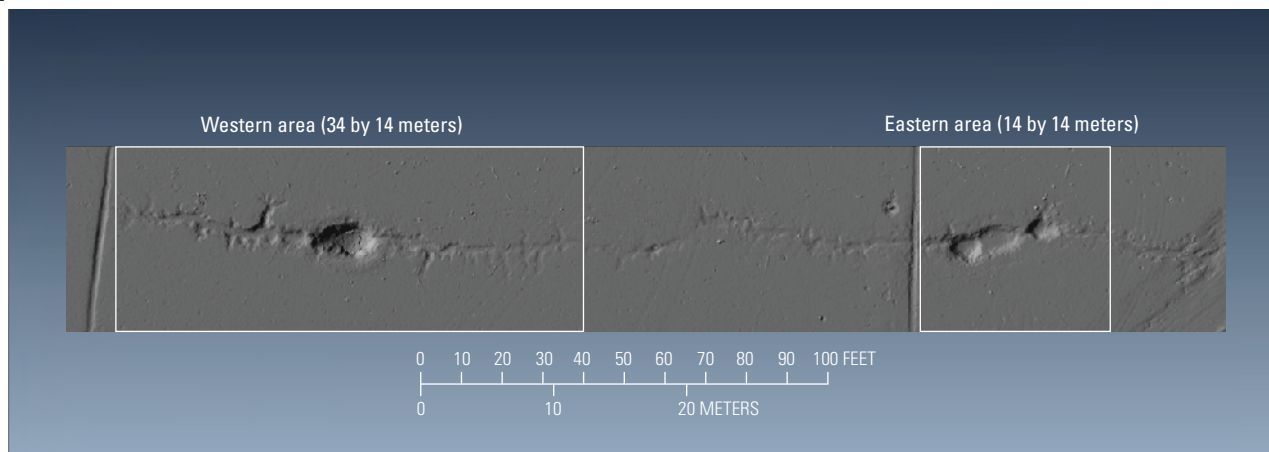
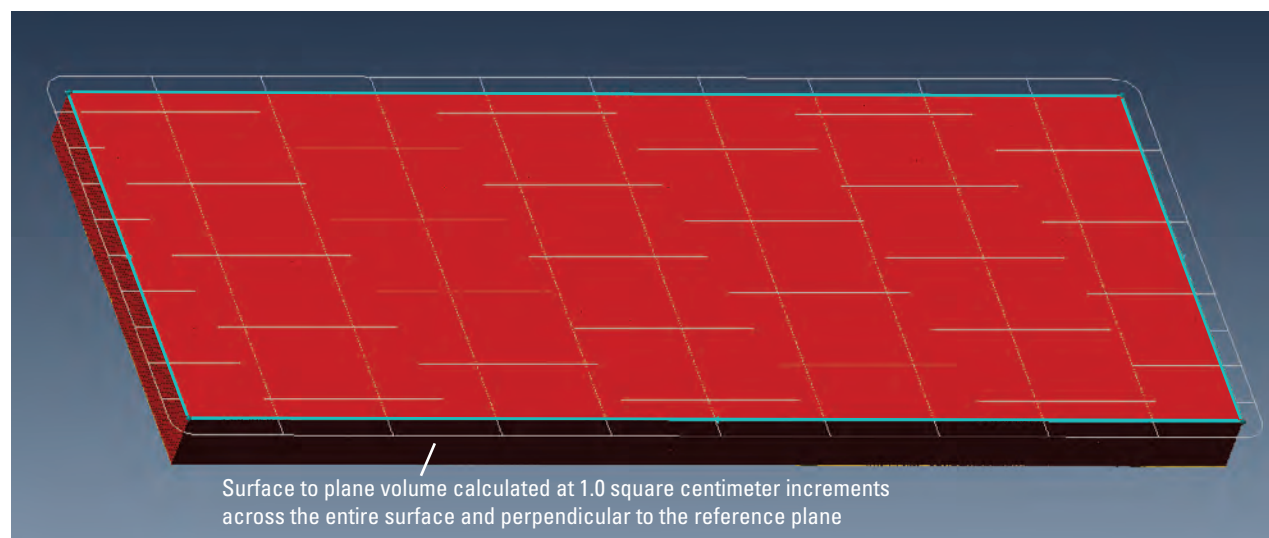
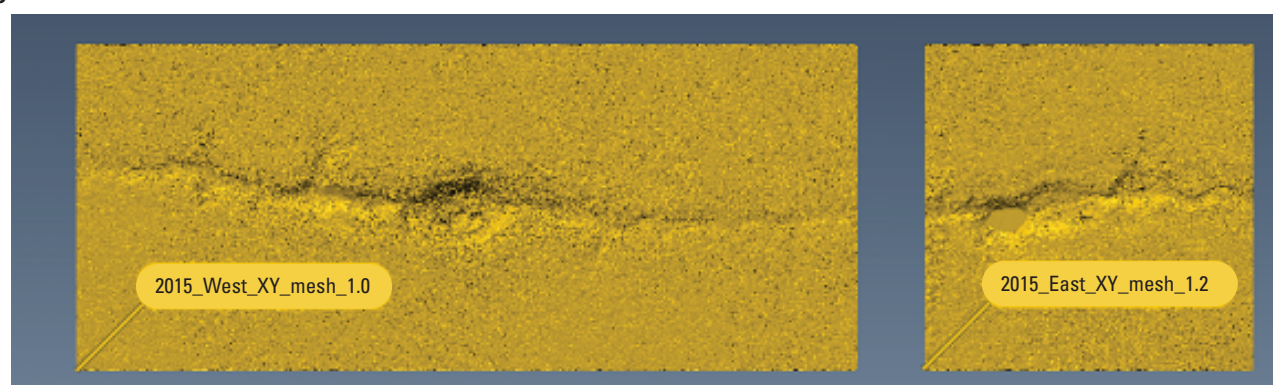
**Figure 20.** Progression of volumetric calculation along the main-runway crack on Bicycle Lake playa, Fort Irwin National Training Center, California: *A.* west and east areas analyzed for change; *B.* surface and reference planes and volume calculations; and *C.* areas of changes in east and west areas.

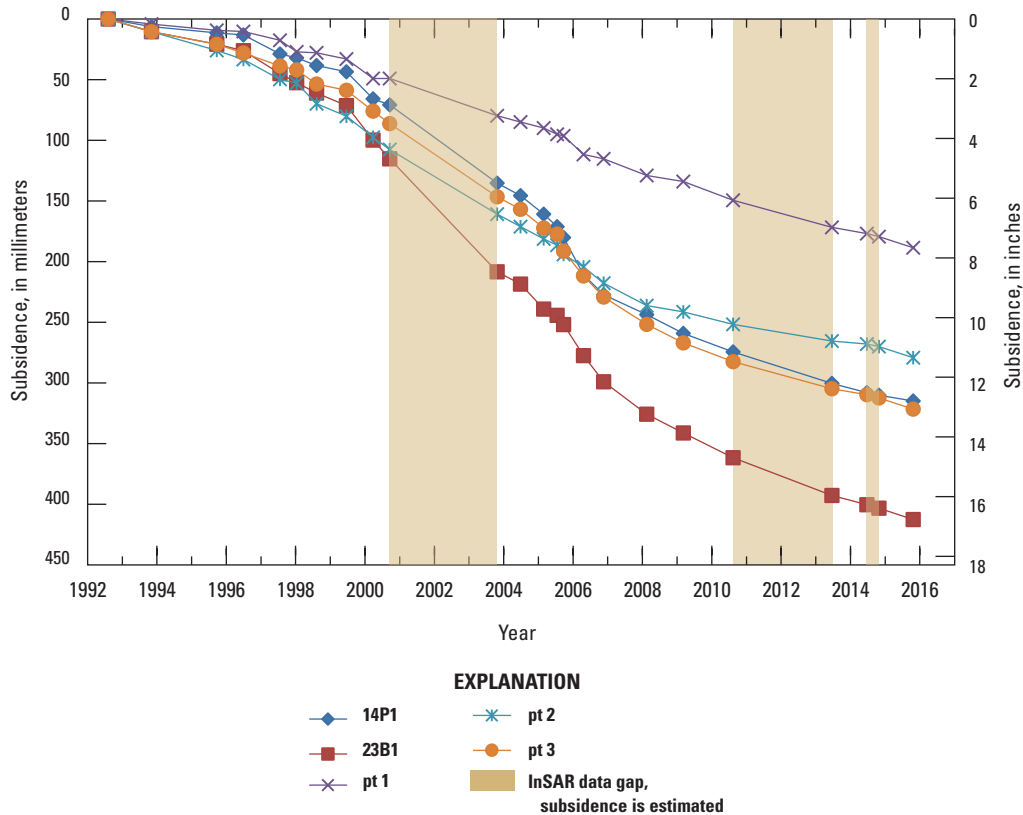
**Figure 23.** Interferogram-derived subsidence time-series data for five selected locations, 1992 to 2014, Bicycle Basin, Fort Irwin National Training Center, California.

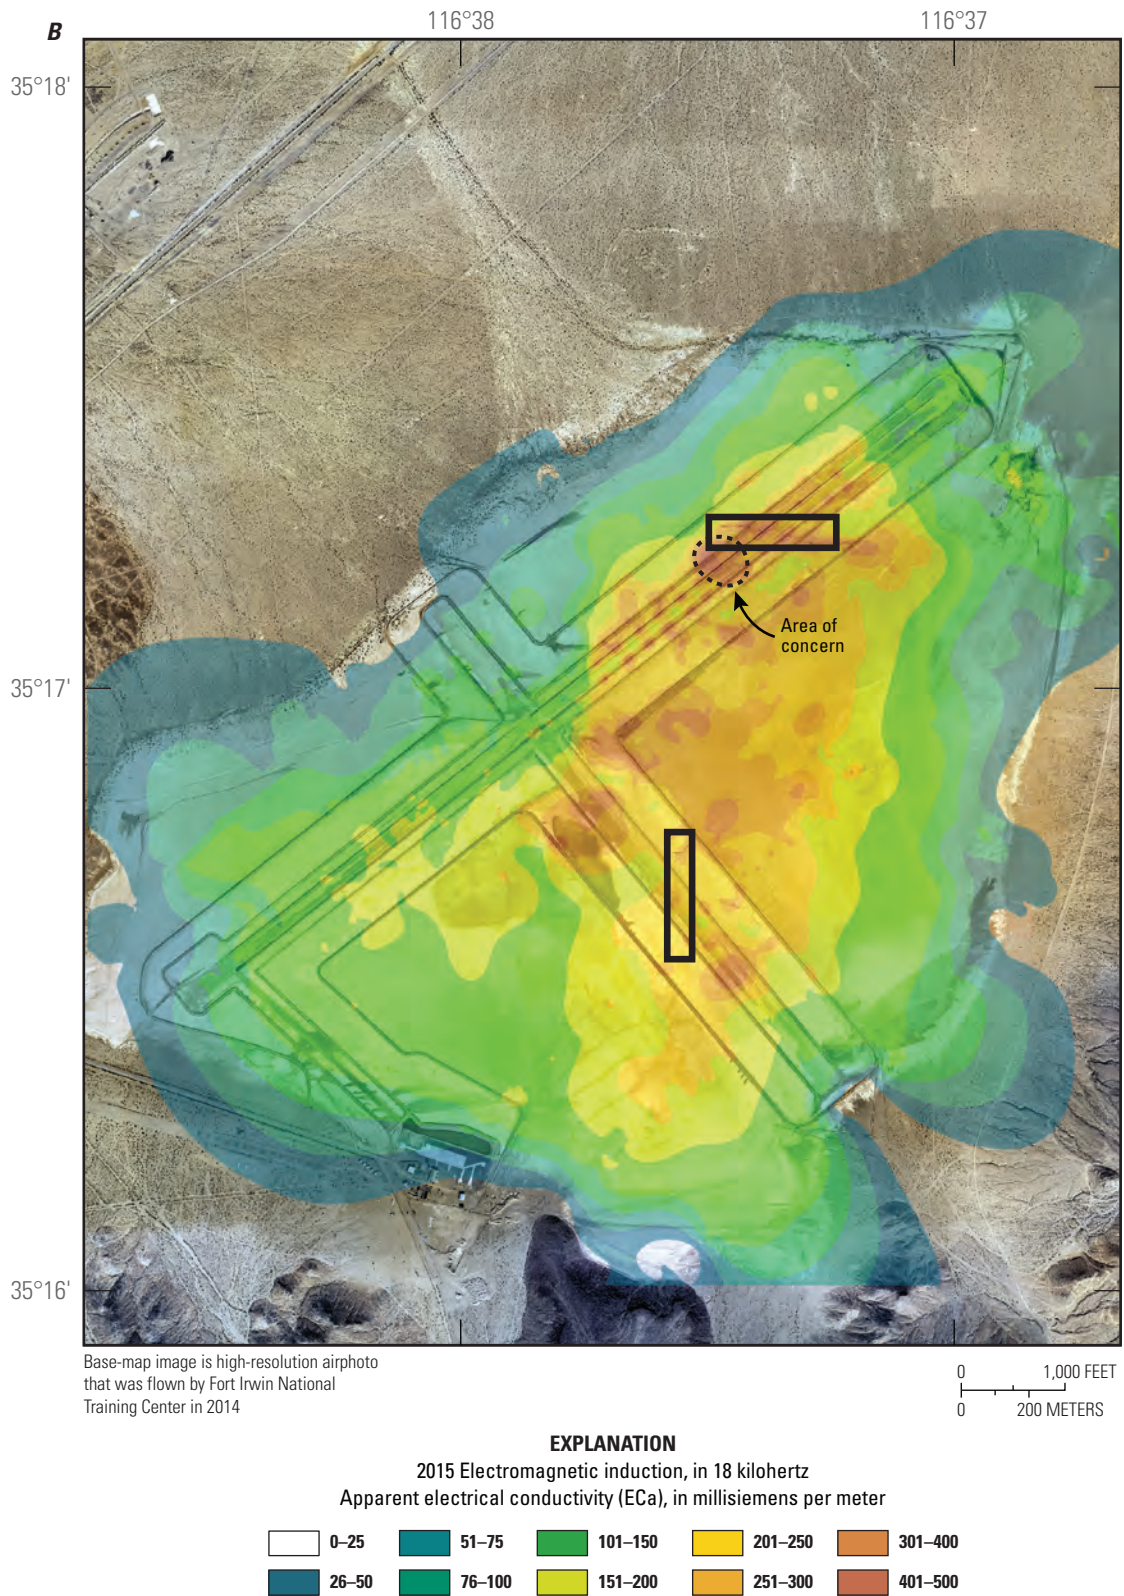
**Figure 25.** Apparent electrical conductivity (ECA, in millisiemens per meter) across the Bicycle Lake airstrip region, with known ground failures of two surface cracks that have formed since 2005 outlined in black, based on results from electromagnetic induction surveys in Bicycle Basin, Fort Irwin National Training Center, California, at 18 kilohertz operating frequency for *A*, December 2014; and *B*, December 2015.

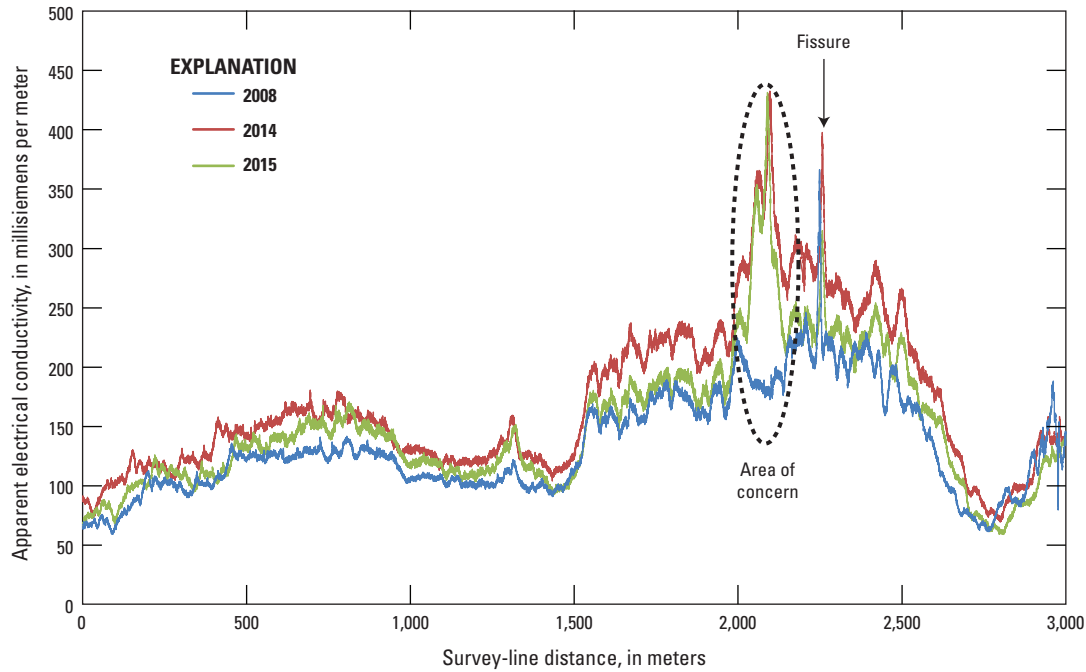
**Figure 26.** Electromagnetic induction surveys for the main runway (location shown on [fig. 8A](#)) from 2008, 2014, and 2015, Bicycle Basin, Fort Irwin National Training Center, California. Notable departure in the later surveys at around a line distance of 2,100 meters indicates an area of concern for potential subsurface voids undetectable by visual inspection of the ground surface.

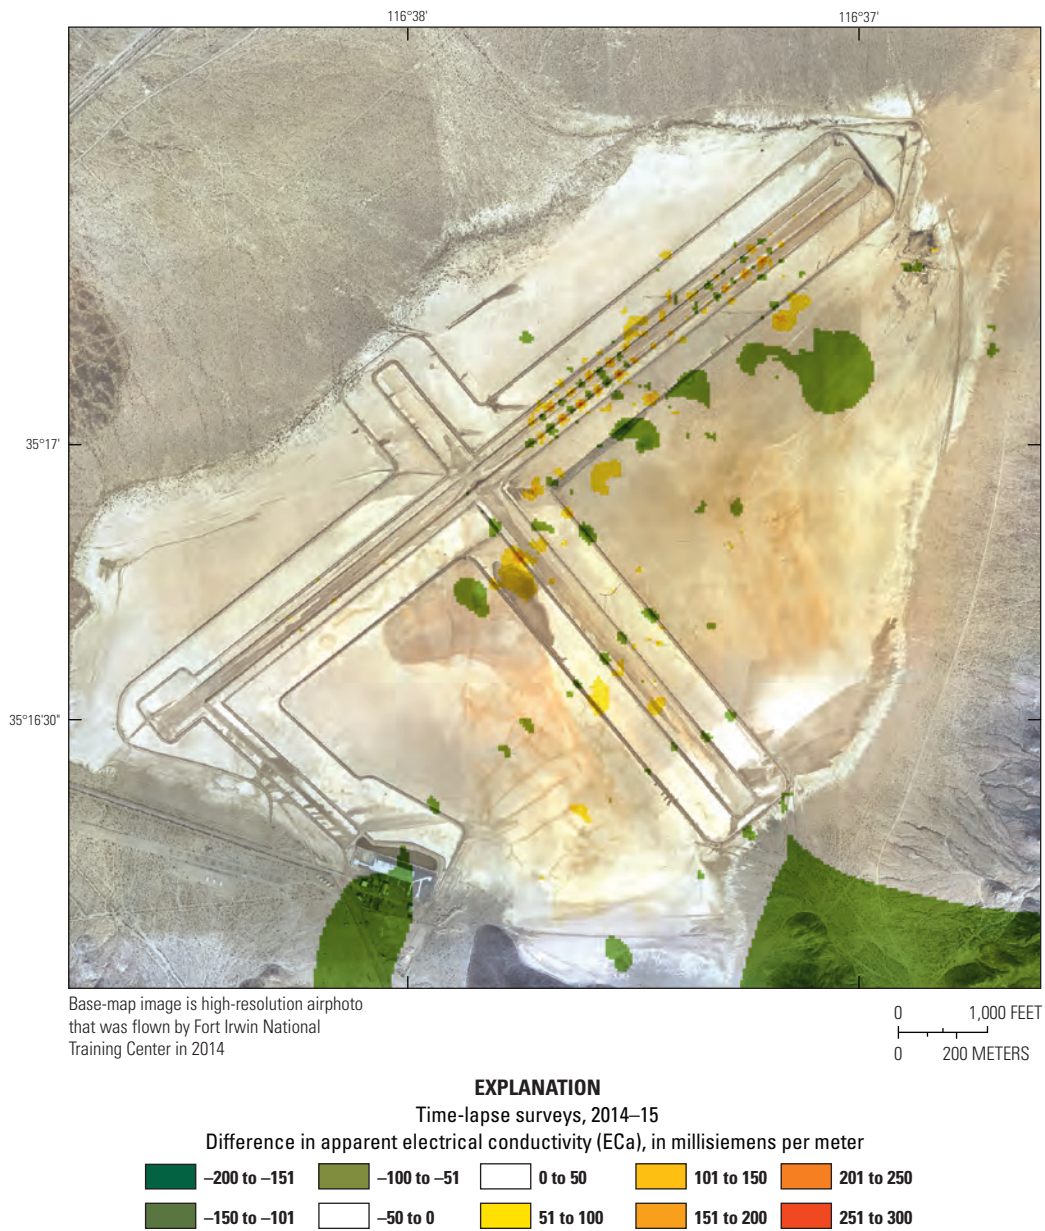
**Figure 27.** Electromagnetic induction time-lapse surveys of Bicycle Basin, Fort Irwin National Training Center, California, for 2014–15.

Difference mapping from the time-lapse surveys indicated that the main-runway crack area was relatively stable during the 2014–15 period (fig. 27). The only notable changes during the 2014–15 period (that is, beyond 50 mS/m) appeared to be in a few areas next to the outer berm of the main runway, but on the southeast side, away from the active runway. Although there were a number of localized, discrete areas of change noted along the main runway in the difference map, the regular cycling of positive and negative changes and the localization of these data at the berm indicated that this result was simply an artifact of interpolation of the discrete survey data. This was clear when comparing the difference map results with the discrete survey-line data in detail around the main-runway crack area (fig. 28A), where the pattern of anomalies in the difference map arose from the inherently spikey response over berms combined with the variability in discrete data sampling between the surveys in 2014 (fig. 28B) and 2015 (fig. 28C). The differences noted earlier, southeast of the main-runway berm, did not appear to be an interpolation artifact and were interpreted as arising from localized changes in the shallow soil moisture in these areas. In particular, the predominantly negative differences observed in the 2014–15 period indicated drying of the soil in these areas and did not have the sharp, positive response that is characteristic of cracking features.

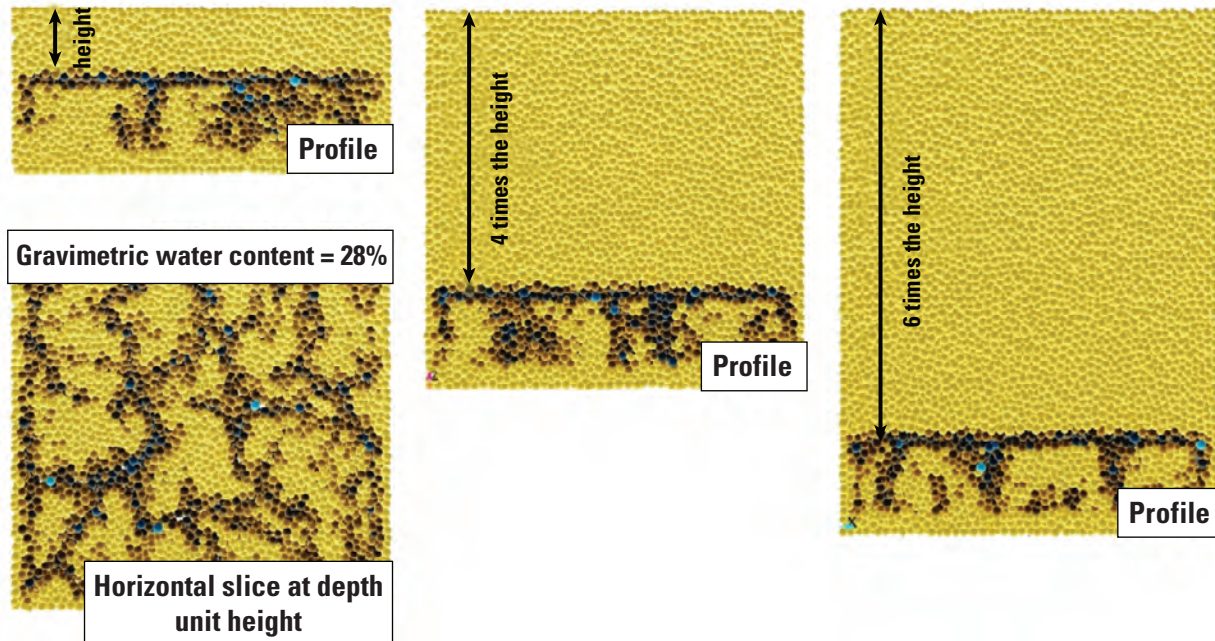
**Figure 31.** Discrete Element Method model results for crack-propagation simulation (particle bond breaking) indicates cracking induced from desiccation volumetric shrinkage in the capillary-fringe zone above a declining water table is unable to propagate upward to the shallow, overlying soil. Darker colors indicate an increase in broken bonds between particles as stress builds from volumetric shrinkage due to desiccation.

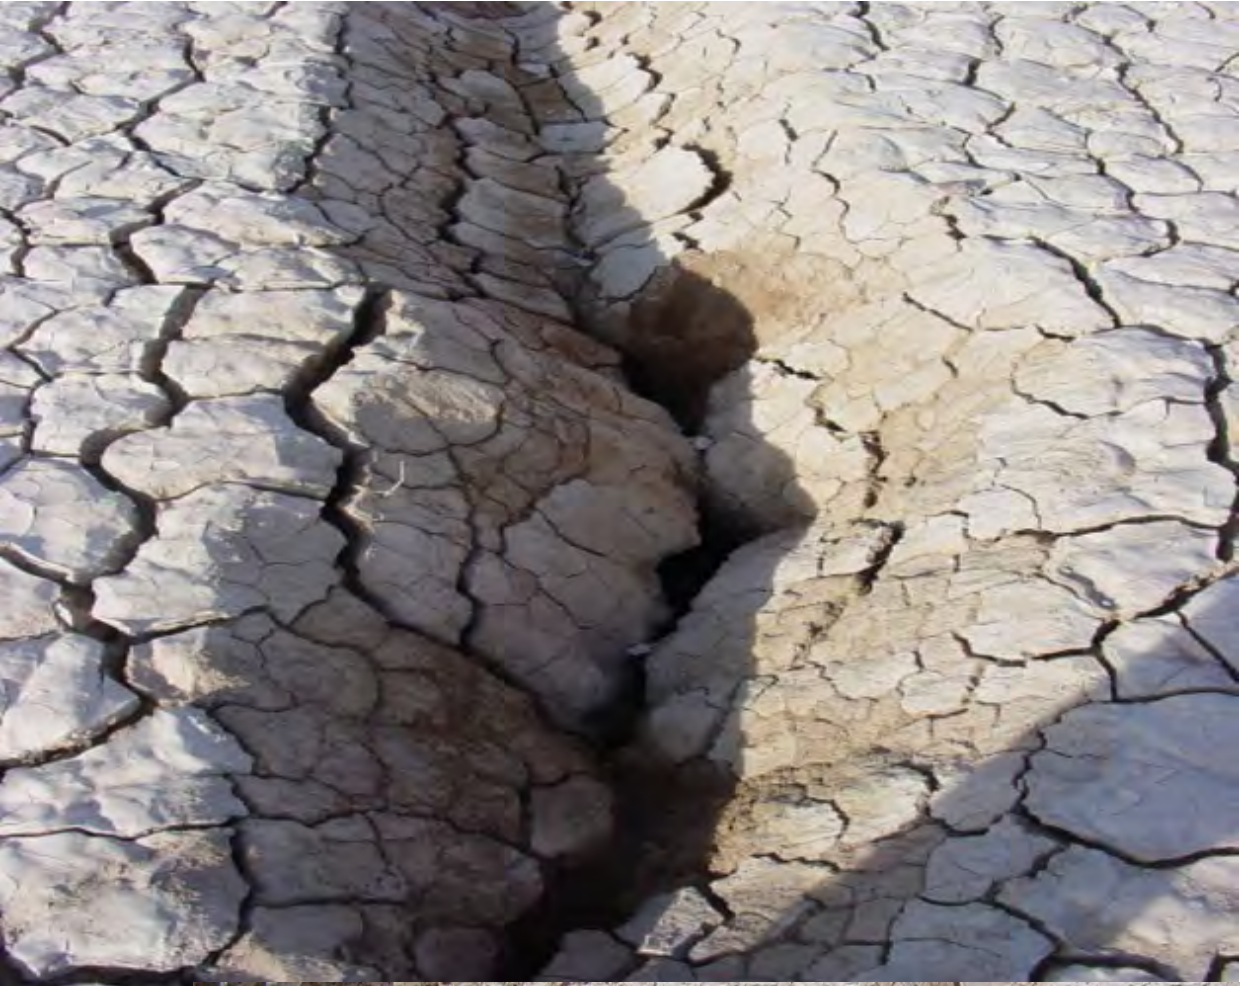
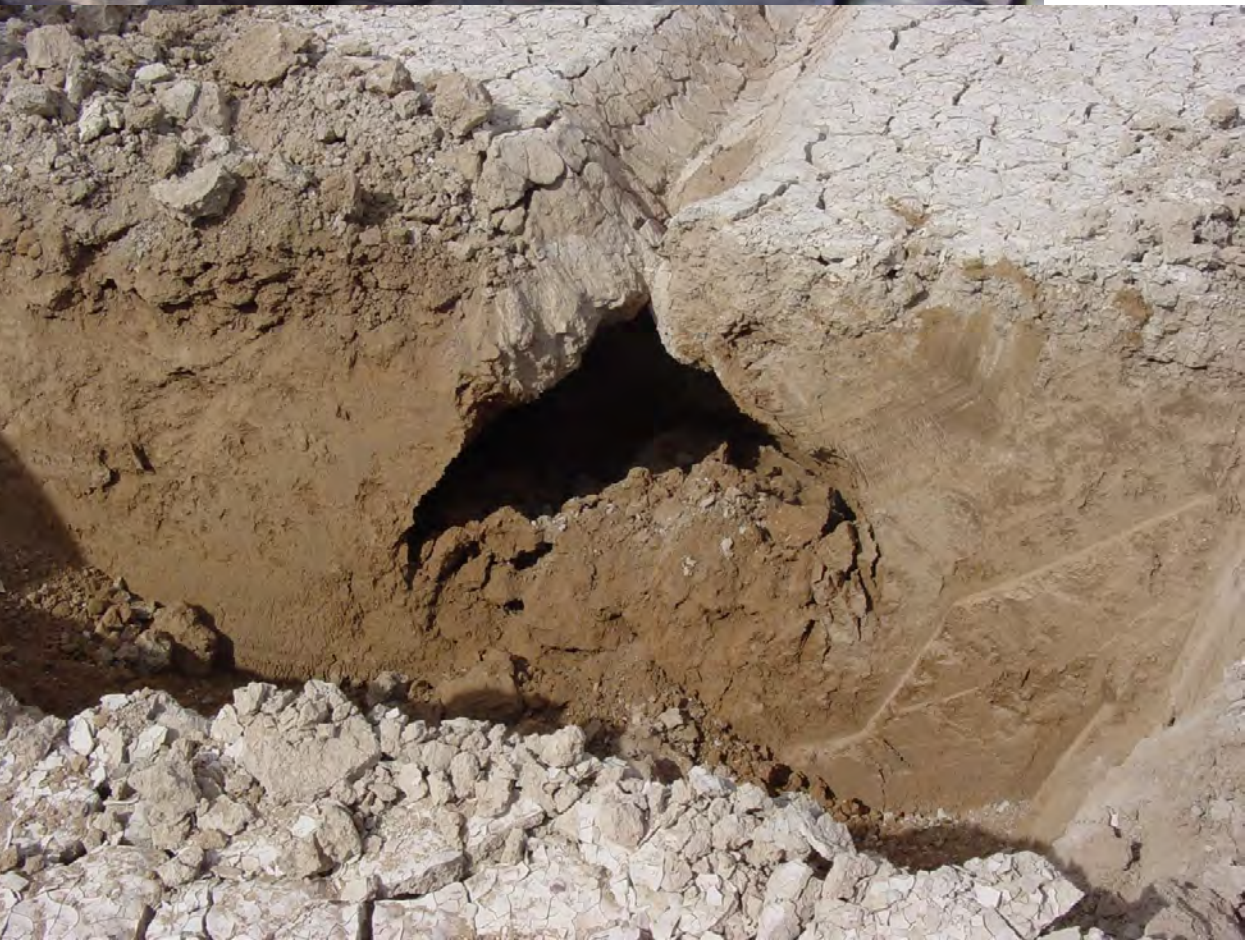
**Back cover:** Photographs of 2005–06 crack at the surface and in trench dug across the crack. Photographs taken during April 2007, provided by Justine Dishart, U.S. Army.
