# **Erosion Monitoring Along Selected Bank Locations of the Coosa River in Alabama Using Terrestrial Light Detection and Ranging (T-Lidar) Technology, 2014–17**

Scientific Investigations Report 2019–5023

By Richard J. Huizinga and Daniel M. Wagner

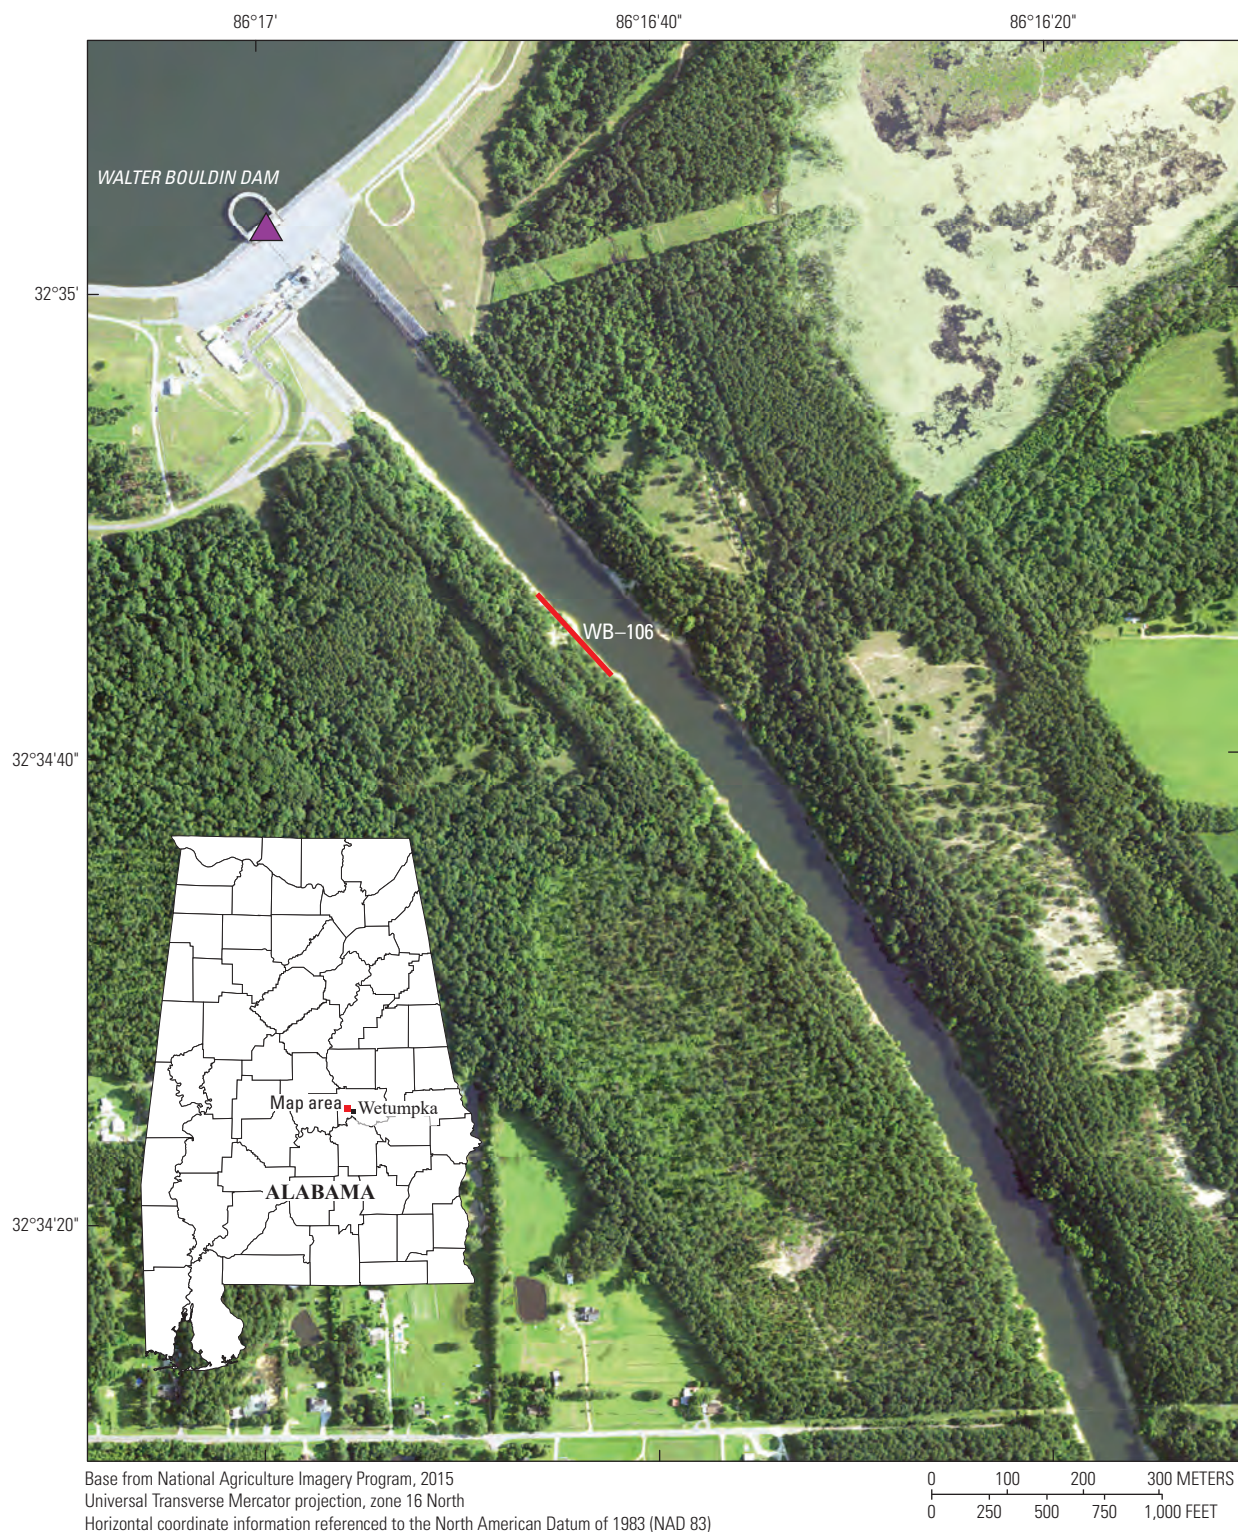
**Figure 4.** Location of survey site WB-106 immediately downstream from Walter Bouldin Dam near Wetumpka, Alabama.

The study area included six survey sites on the Coosa River, consisting of two specific reach locations downstream from three selected dams: H Neely Henry Dam (fig. 2), Logan Martin Dam (fig. 3), and Walter Bouldin Dam (figs. 4–5). The location and length of these reaches was determined by the Alabama Power Company and stakeholders. The naming convention illustrated in figures 2–5 corresponds to Alabama Power Company's existing monitoring program. There are two survey sites downstream from H Neely Henry Dam: NH-104, a long reach on the right bank (fig. 2), and NH-108, a short reach on the left bank farther downstream (fig. 2). Downstream from Logan Martin Dam, site LM-102 on the right bank (fig. 3) was the subject of the previous study (Kimbrow and Lee, 2013); site LM-108 is the upstream end of an island near the right bank (fig. 3). Downstream from Walter Bouldin Dam, site WB-106 is on the right bank near the dam (fig. 4), whereas site WB-101 is on the left bank about 3.8 kilometers downstream from the dam (fig. 5).

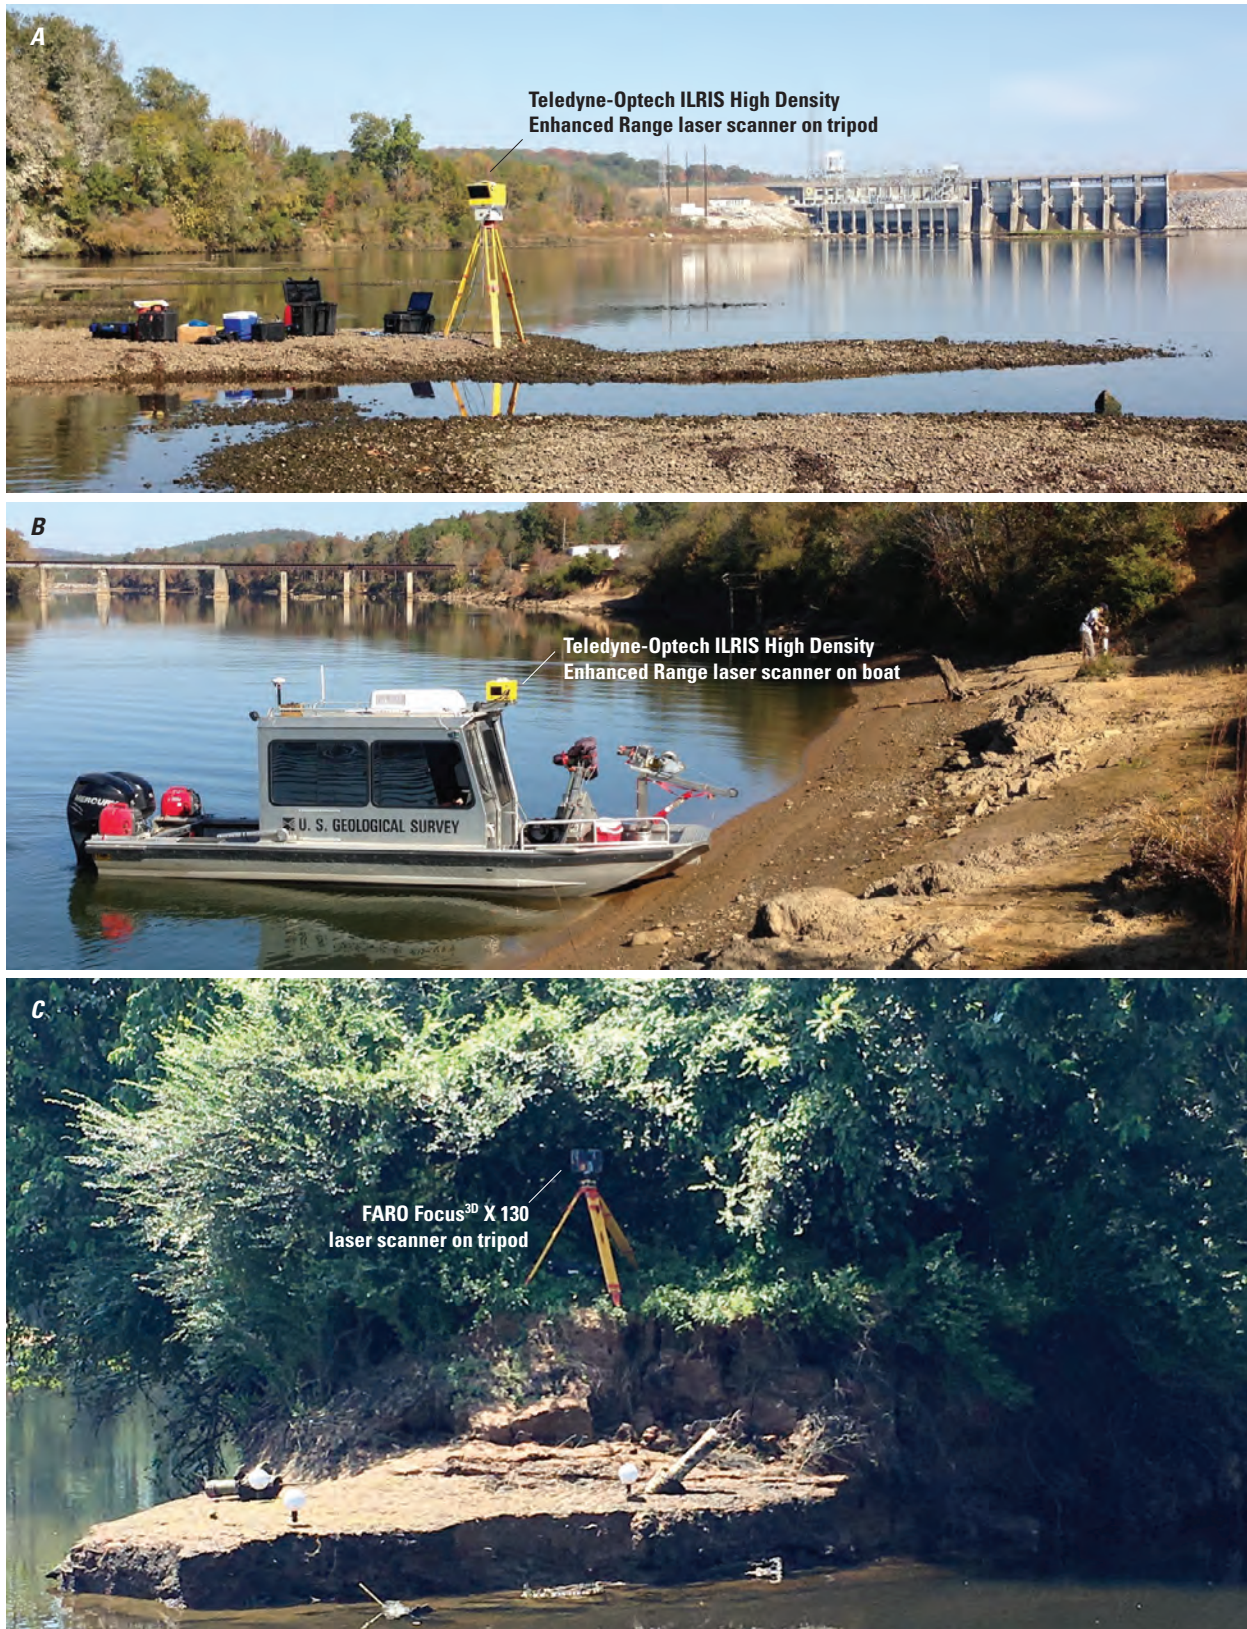
**Figure 7.** The Teledyne-Optech ILRIS High Density Enhanced Range laser scanner mounted on *A*, a tripod with the pan/tilt base; *B*, a survey boat; and *C*, the FARO Focus<sup>3D</sup> X 130 laser scanner used in this study.

Bank condition and stability at each site was determined using either a tripod- or boat-mounted T-lidar system. For all the surveys completed in this investigation, the primary instrument used was a Teledyne-Optech ILRIS High Density (HD) Enhanced Range (ER) laser scanner (Teledyne-Optech, 2012; figs. 7A, 7B); this is the same type of scanner that was used in
