Assessment of Bridge Scour Countermeasures at Selected Bridges in the United States, 2014–18

Scientific Investigations Report 2019–5080

By Thomas P. Suro, Richard J. Huizinga, Ryan L. Fosness, and Taylor J. Dudunake

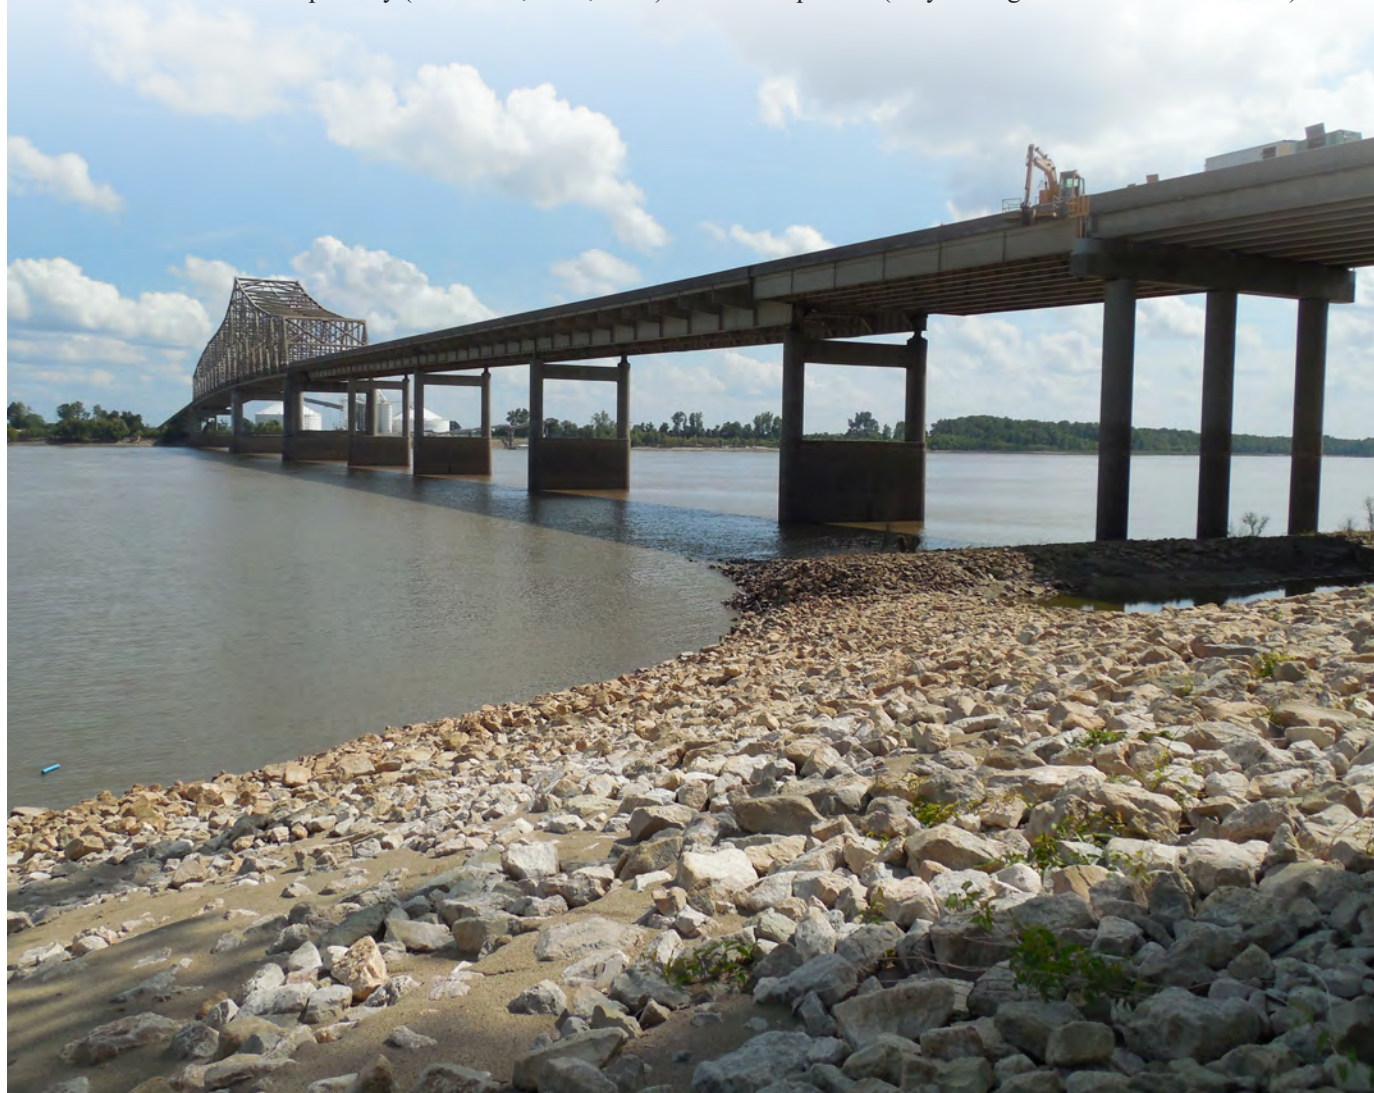
Photograph of scour countermeasures along right bank of the Mississippi River near Caruthersville, Missouri. Photograph by Richard Huizinga, U.S. Geological Survey.

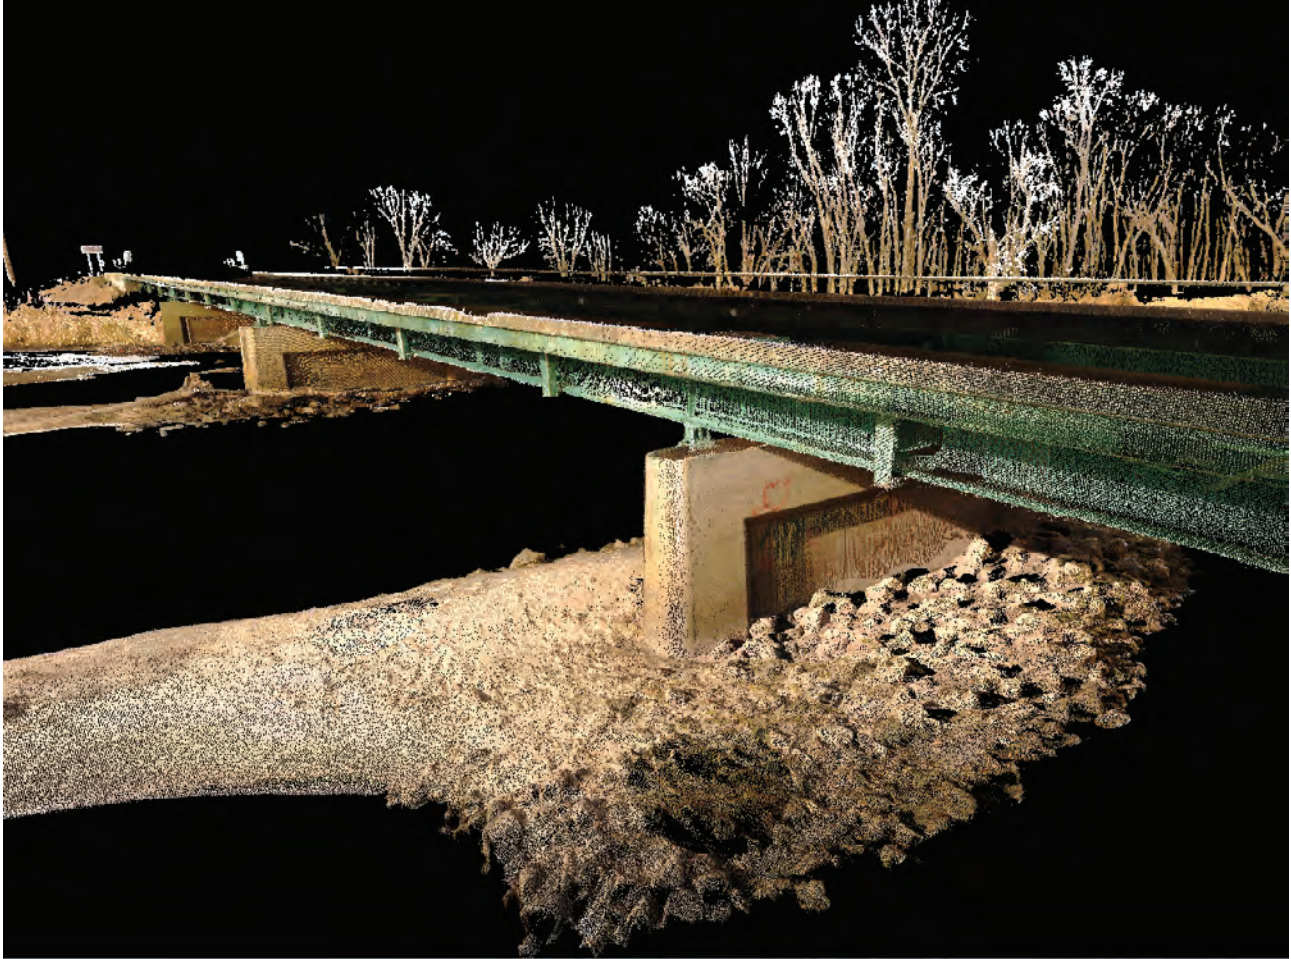
Figure 2. Oblique view (from downstream left [southeast]) showing the topographic point cloud data from the terrestrial lidar survey of site 031, the Wapsipinicon River at structure 20740 on U.S. Highway 30 near Wheatland, Iowa, on December 17, 2017. Topographic points are colored based on concurrent photos taken during the survey.

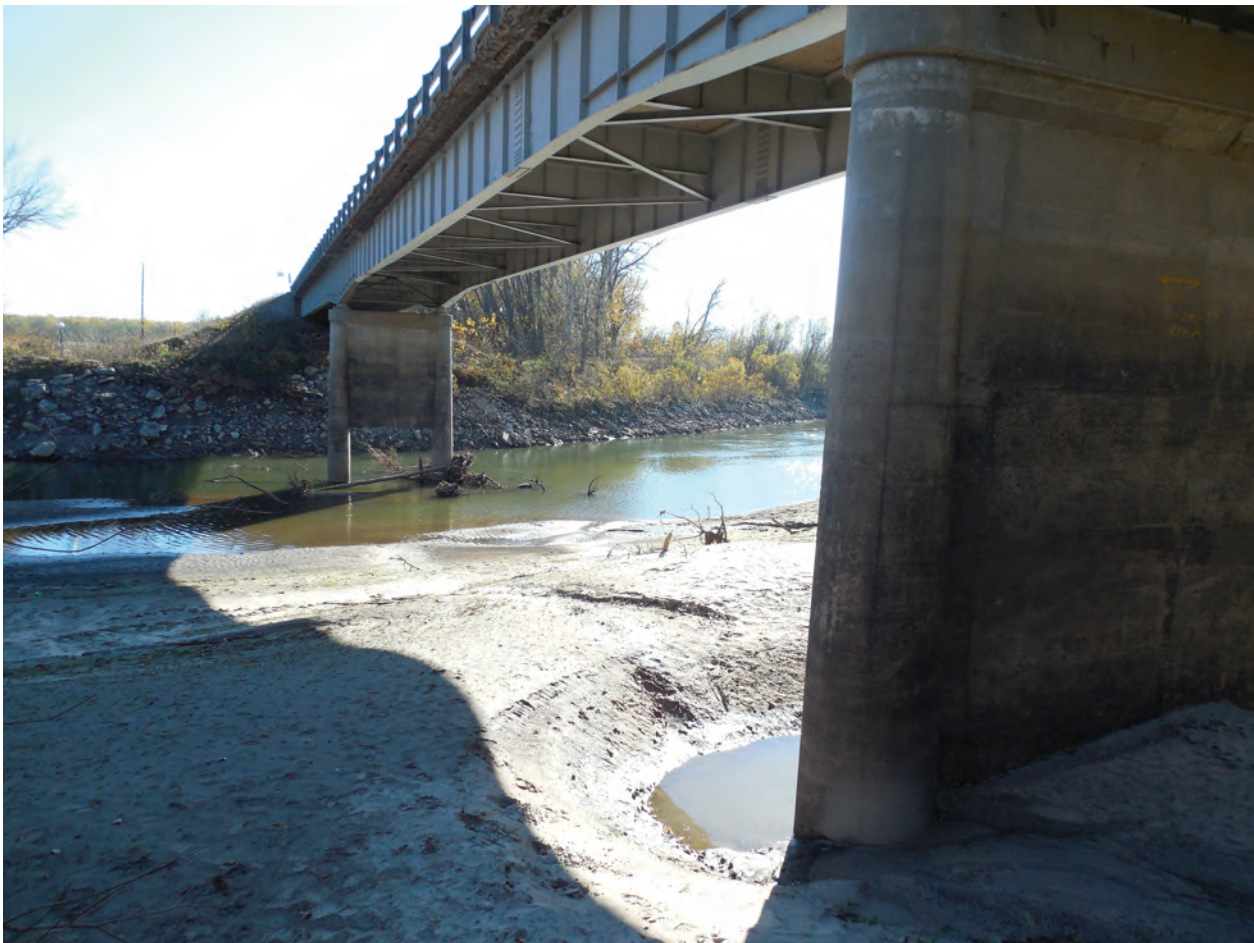
Figure 3. View of downstream side of bridge at site 011 over Grand River at Route A near McFall, Missouri, showing riprap on right bank, debris on right pier, and deposited sand bar with minor scour hole on left bank. Photograph by Richard Huizinga, U.S. Geological Survey.

The assessment of the 17 bridges in this study that utilized riprap as a scour countermeasure indicated that, in most cases, the riprap remained intact even after experiencing peak streamflows of magnitudes exceeding that of the 4-percent AEP (25-year recurrence interval) and, in some cases, streamflows exceeding the 1-percent AEP (100-year recurrence interval). At some locations, bed sediments deposited around the bridge during floods buried the installed countermeasures, making it more difficult to determine the condition of the riprap. Site 11 over the Grand River at Route A near McFall, Missouri, is an example of the challenges of determining the presence and condition of installed riprap countermeasures. The downstream side of the bridge with riprap clearly visible on the right bank, debris caught on the right pier, and a scour hole in the sediments on the downstream side of the left pier are shown in figure 3. At this site, side-scan sonar was used

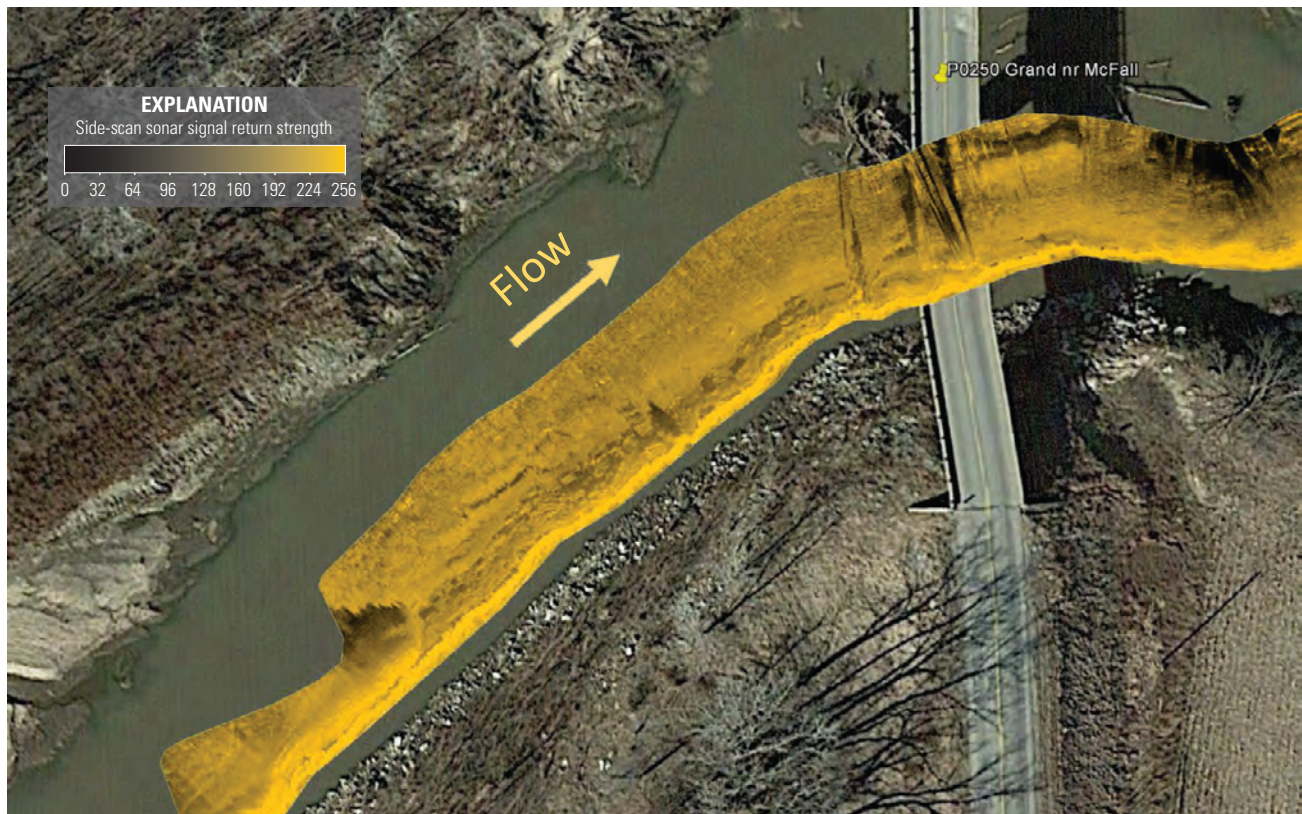
Figure 4. Side-scan sonar image of base of riprap on right bank at site 011, Grand River at Route A near McFall, Missouri.

to inspect the base of the riprap along the right bank (fig. 4). The sand bar on the left bank was assumed to have covered the countermeasures installed along the left bank. In addition to visual inspection of the riprap and sonar imaging to inspect underwater countermeasures, a Wolman particle count (Federal Highway Administration, 2016) also was performed to determine the size distribution based on a random sampling of the in-place riprap. The right bank riprap matrix was found to have a D_{50} median particle size of riprap, of 11.7 inches (fig. 5).

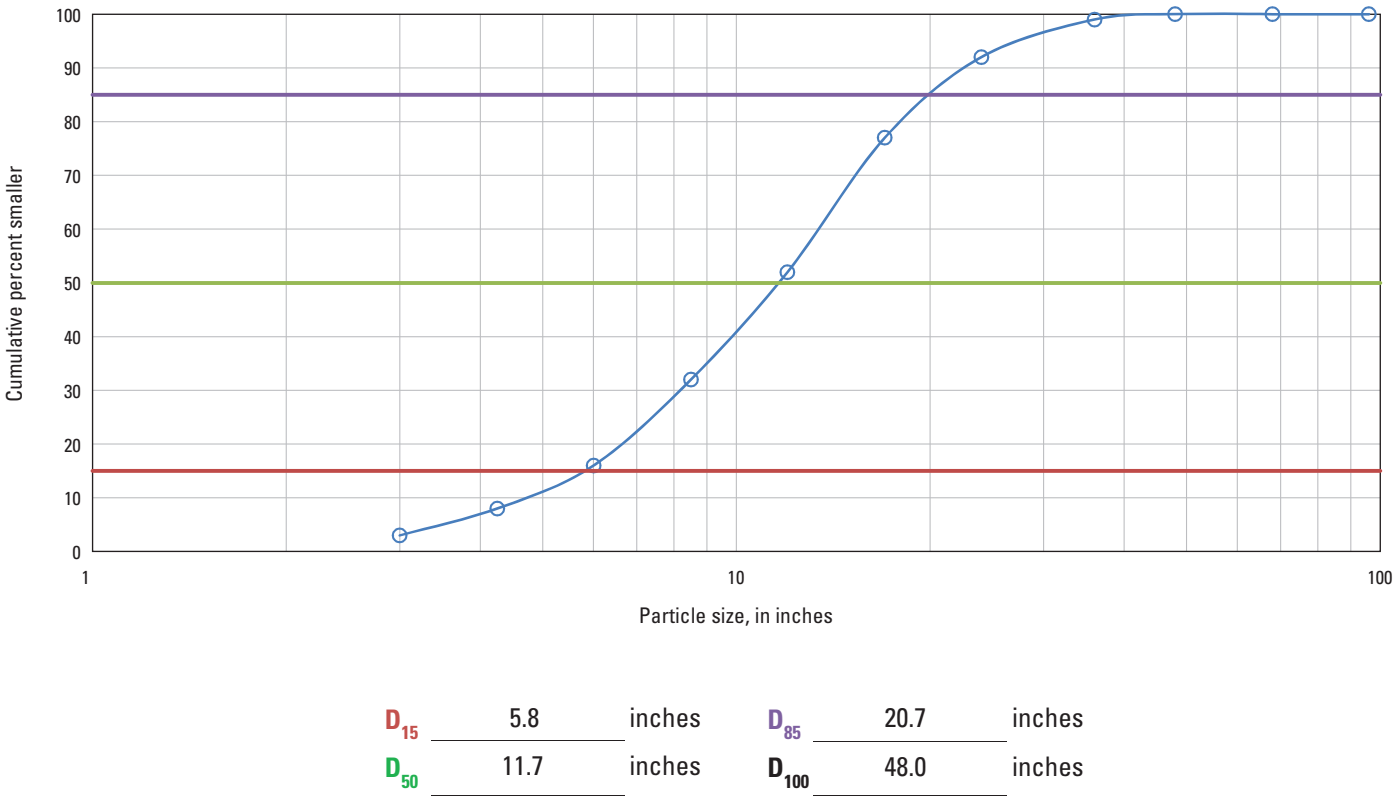
Particle size (inches)	Particle size range (inches)	Particle count	Cumulative particle count	Cumulative percent smaller
3.00	≤ 3	3	3	3.0
4.25	$3 < x \leq 4.25$	5	8	8.0
6.00	$4.25 < x \leq 6$	8	16	16.0
8.50	$6 < x \leq 8.5$	16	32	32.0
12.00	$8.5 < x \leq 12$	20	52	52.0
17.00	$12 < x \leq 17$	25	77	77.0
24.00	$17 < x \leq 24$	15	92	92.0
36.00	$24 < x \leq 36$	7	99	99.0
48.00	$36 < x \leq 48$	1	100	100.0
68.00	$48 < x \leq 68$	0	100	100.0
96.00	$68 < x \leq 96$	0	100	100.0
		Total	100

Figure 5. Wolman Particle Count chart for riprap on right bank at site 011, Grand River at Route A near McFall, Missouri.

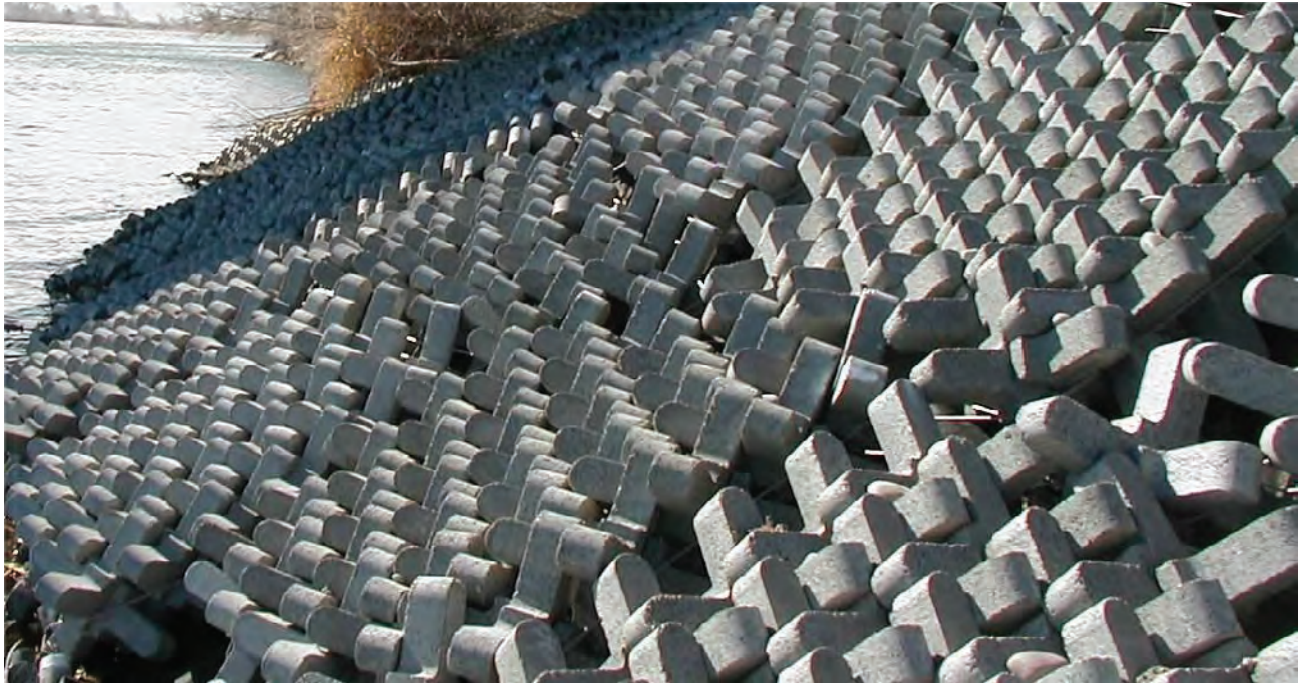
Figure 6. A-Jack countermeasures interlocked along abutment slope at site 006 on the Snake River in Idaho. Photograph by Lotwick Reese, U.S. Geological Survey.

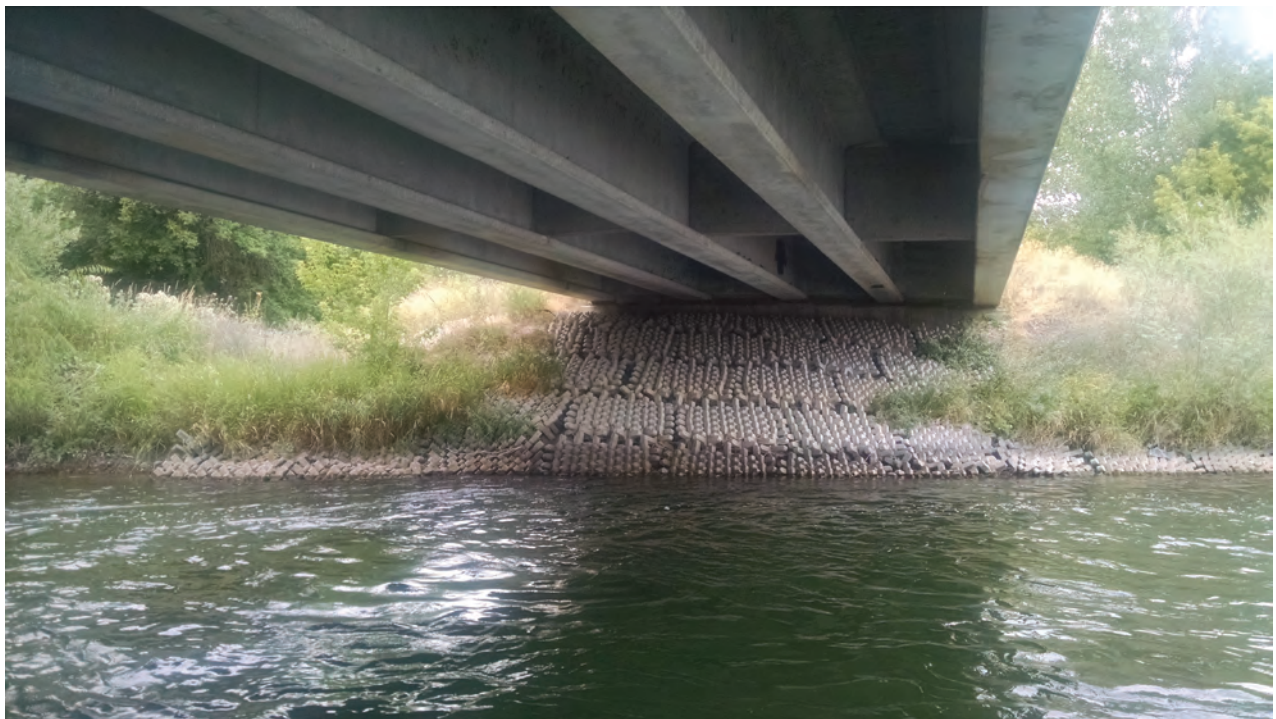
Figure 7. A-Jack countermeasures remain relatively unchanged and effective since installation in 2002 at site 006, Snake River at Shelley West River Road near Shelley, Idaho. Photograph by Daniel Ghre, Federal Highway Administration.

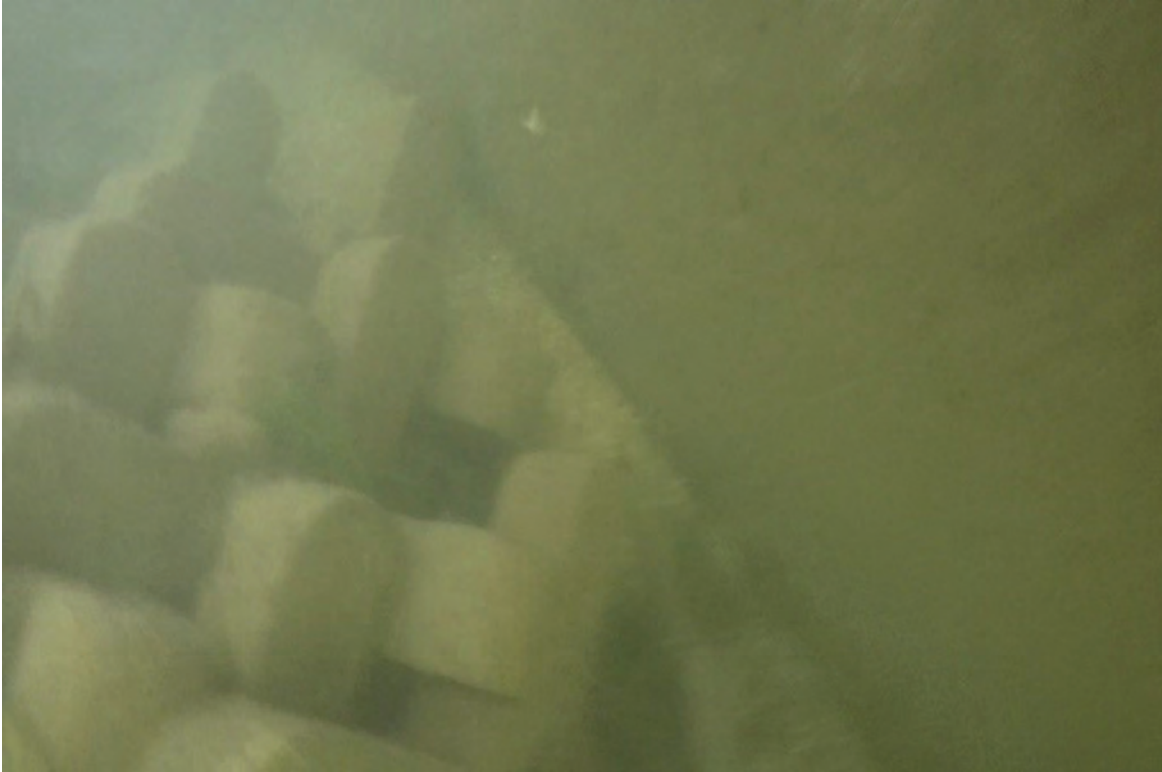
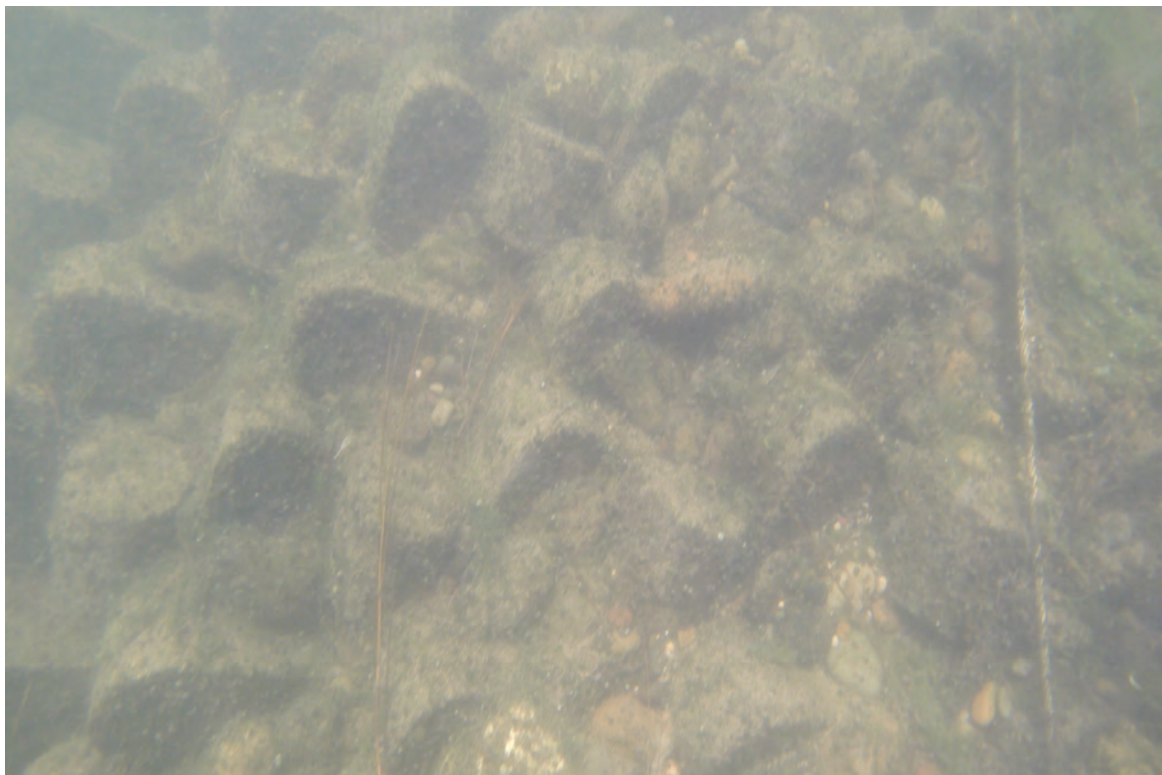
Figure 8. A, A-Jack countermeasures installed around pier 2 (center pier) at site 006 are visible with underwater videography and appear intact and effective; B, A-Jack countermeasures installed on toe of abutment slope and around piers 1 and 3 at site 006 along the Snake River in Idaho are mostly covered or embedded with gravel and sediment. Photographs by Ryan Fosness, U.S. Geological Survey.

13060000, Snake River near Shelley, Idaho, at flows ranging from 26,700 cubic feet per second (ft^3/s) to 40,200 ft^3/s indicated an average channel velocity of 6–7 feet per second (ft/s). The USGS Snake River near Shelley streamgage is located about 5.7 miles (mi) upstream of site 006, and thus the average channel velocity provides some indication about the potential velocities exerted on the countermeasures. The site inspection indicated that the A-Jacks have experienced little damage that would reduce their overall effectiveness (fig. 7). Observations from underwater videography indicate that the A-Jack modules placed along the abutments and around piers have generally remained intact and undamaged. The A-Jacks in the center of the channel (pier 2) remain mostly clear, whereas along the abutments and at piers 1 and 3, they are nearly 100 percent embedded with gravel and sediment (fig. 8).

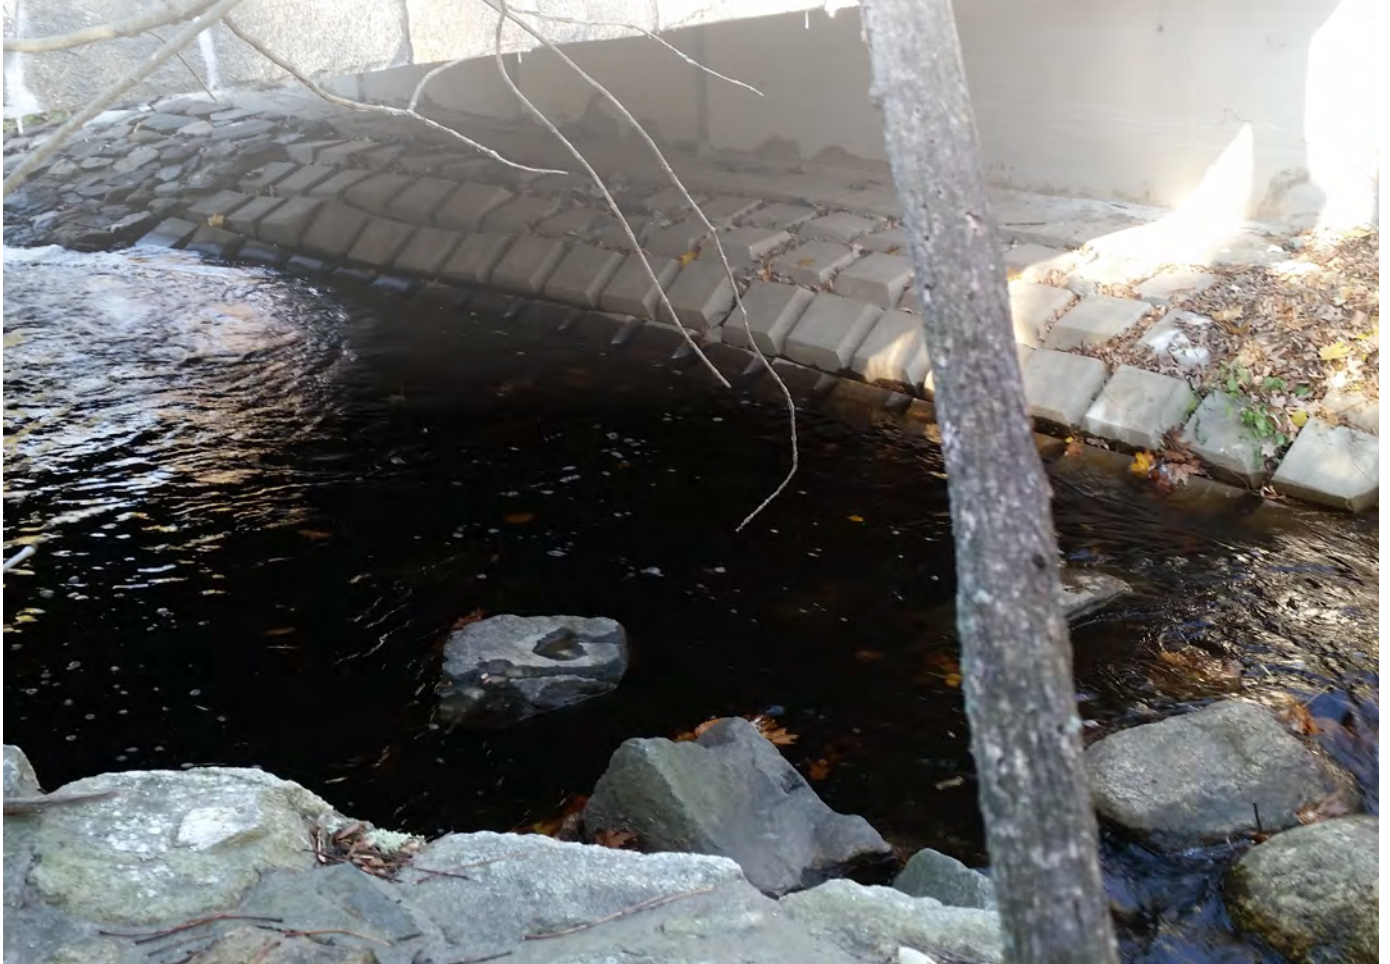
Photograph of articulated concrete block countermeasures along the banks of the Saddle River at Ridgewood, New Jersey. Photograph by Jason Shvanda, U.S. Geological Survey.

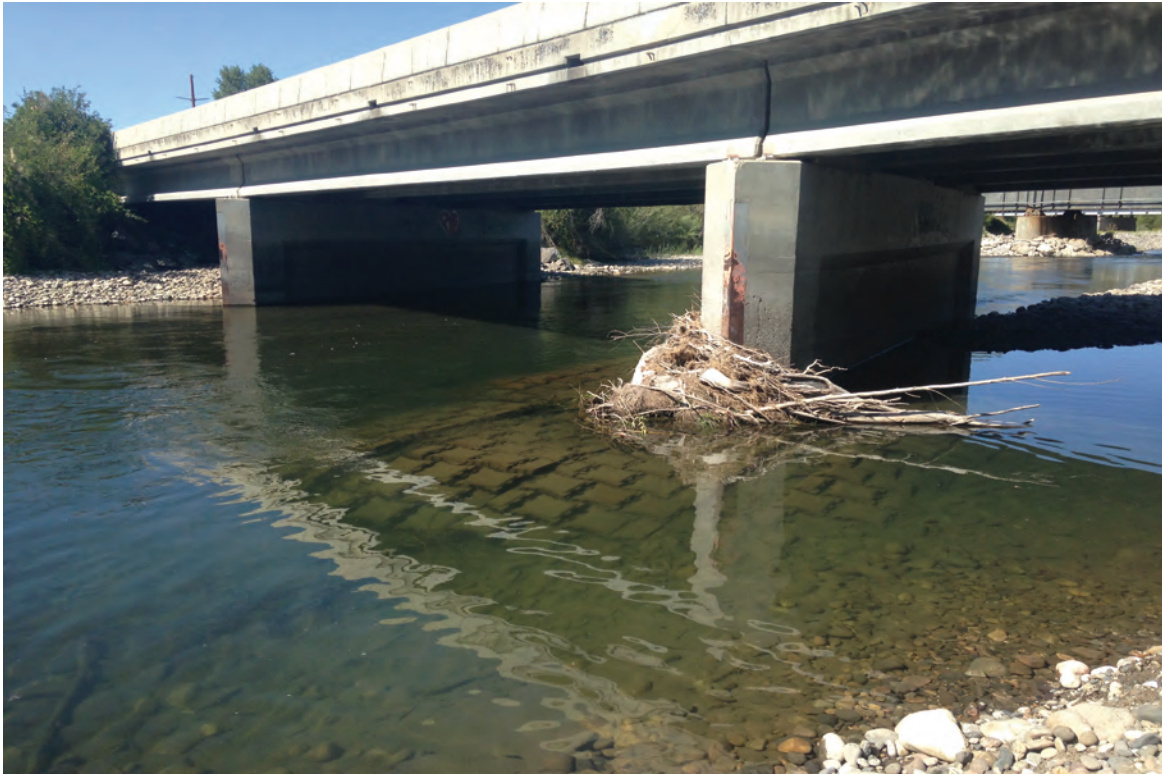
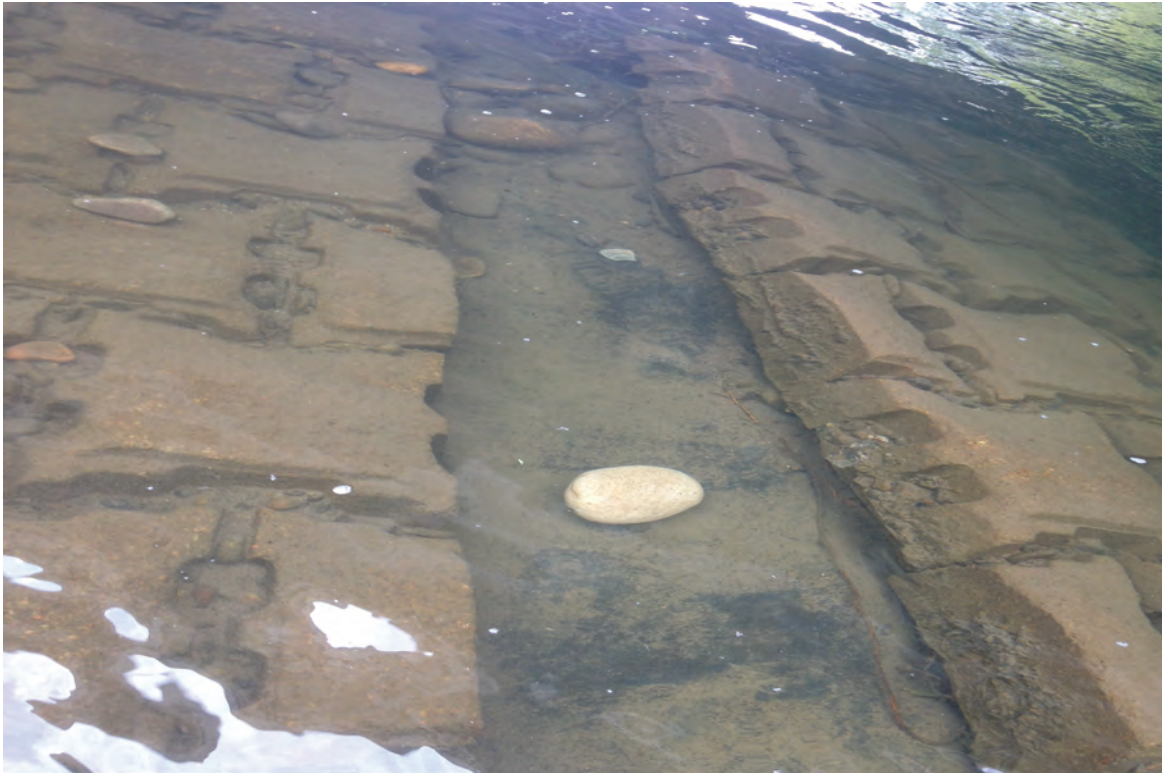
Figure 9. Distressed cabled-concrete mattress countermeasures installed at site 019, Gallatin River at I-90 near Manhattan, Montana. *A*, looking upstream at I-90 bridge towards left bank at distressed countermeasures; *B*, at upstream side of bridge looking down at distressed countermeasure showing large separation to the right towards main channel. Photographs by Stephen Holnbeck, U.S. Geological Survey.

Cabled-concrete mattresses were used as the primary scour countermeasure at seven of the sites in this report. Site 019, Gallatin River at I-90 near Manhattan, Montana, is an example of a cabled-concrete mattress that showed some signs of distress in the form of movement or slumping. The scour countermeasure plans indicated that cabled-concrete mattresses were to be installed at piers 2, 3, and 4 of Interstate 90 (eastbound and westbound) in 2006. Site inspection as part of this study indicated about 1 ft of mattress

separation in the longitudinal direction and some slumping towards the center of the channel (fig. 9).

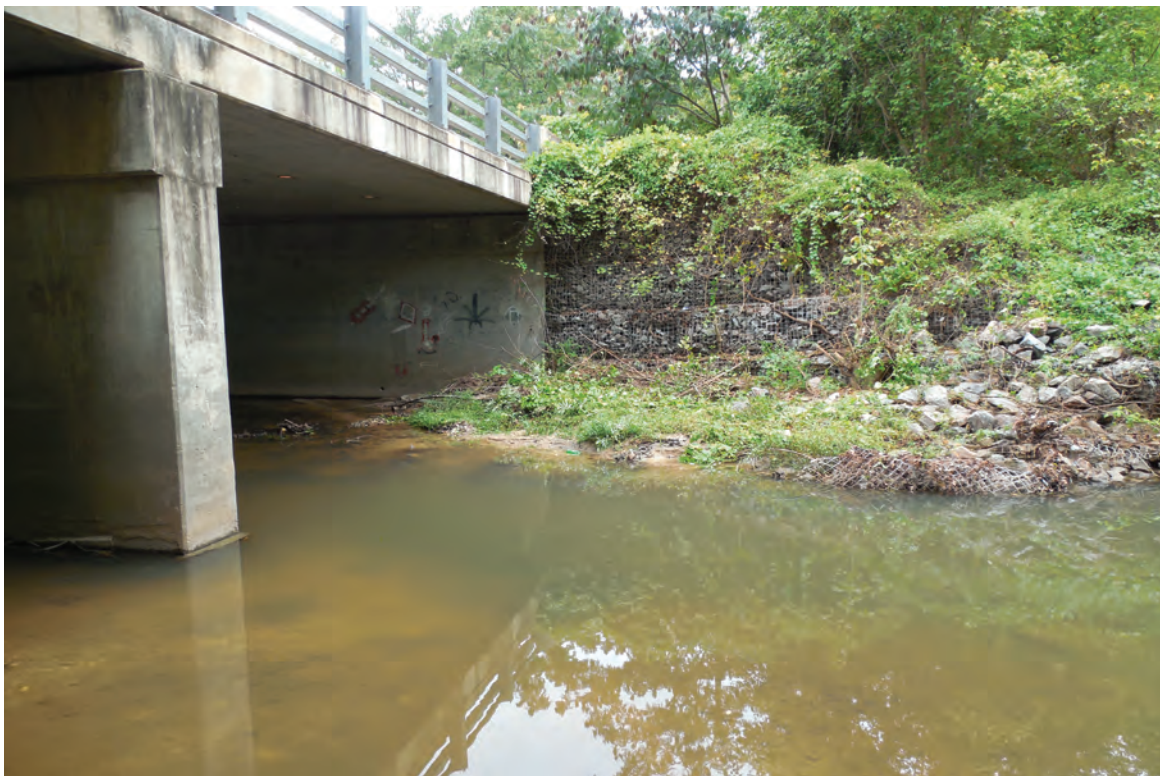
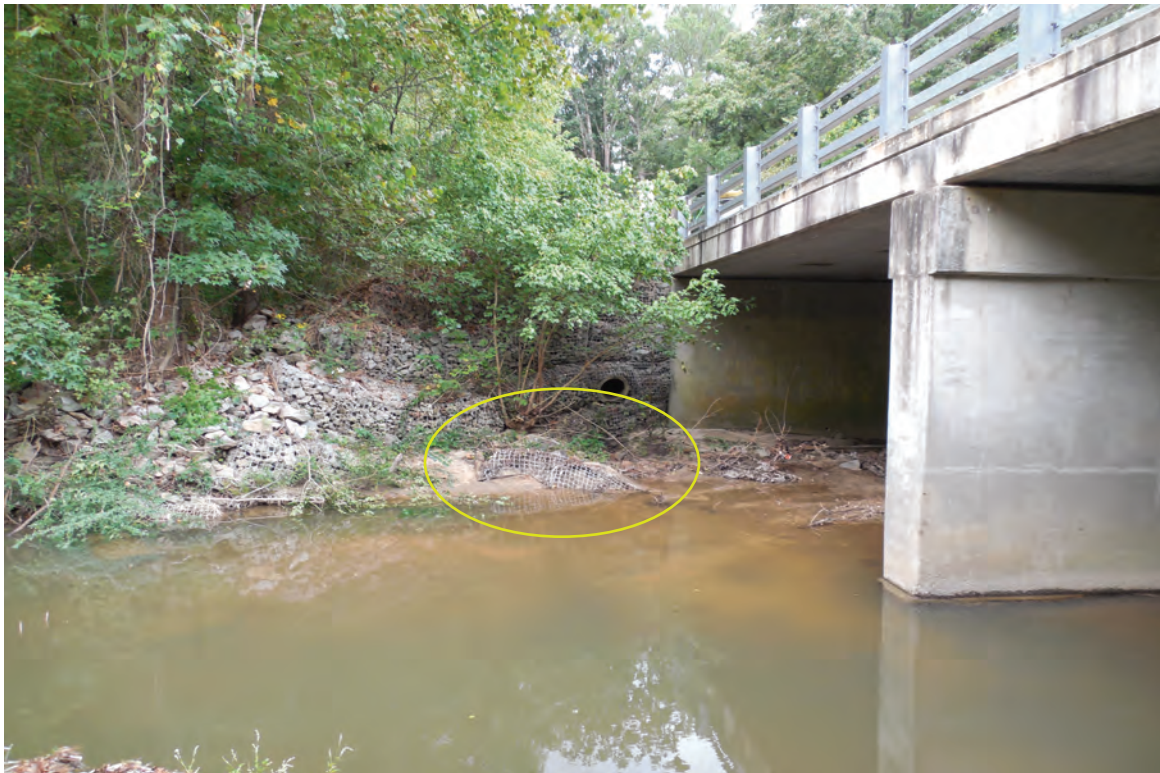
Figure 10. A, Gabion baskets installed around upstream right side of Site 028, a bridge over Smith Branch along Clement Road in Columbia, South Carolina, showing some signs of shifting near toe of embankment; B, Gabion baskets installed around upstream left side of bridge over Smith Branch showing more signs of shifting and the edge of the baskets was scoured, lifted, and folded over itself. Photographs by Richard Huizinga, U.S. Geological Survey.

At four of the study sites, Gabion baskets were installed as the primary scour countermeasure. Two of the sites were in South Carolina, one was in Florida, and one was in New Jersey. Most sites showed minimal, if any, scour, but shifting of the baskets was noted at several sites. Site 028, a bridge over Smith Branch along Clement Road in Columbia, South Carolina, is an example of a site that utilized an extensive layout of Gabion baskets around the bridge and across the channel in the approach to and exit from the bridge (fig. 10). The Gabion baskets at this site were installed in 1998, and major floods that exceeded the 1-percent AEP were documented by the USGS in July 2013, October 2015, and August 2016. Site inspection during this study indicated that the Gabion baskets generally showed shifting and slumping in the vicinity of the bridge, but some areas experienced more extensive damage. Part of the original Gabion baskets were lifted and folded

downstream over themselves during a past flood event, when scour along the edge of the Gabion baskets allowed flood waters to force the baskets downstream resulting in the damaged countermeasures shown in figure 10. A sanitary sewer line is present immediately upstream of the mattress along the stream bottom that may have complicated the flow hydraulics in this area (fig. 11). Articulated concrete block (ACB) countermeasures were installed at site 013, Byram River at Sherwood Ave. at Greenwich, Connecticut; site 015, Bitterroot River at Bell Crossing near Victor, Montana; and site 034, Saddle River at NJ-17 at Ridgewood, New Jersey. The evaluation of sites 013 and 034 showed the countermeasures were generally intact. The ACBs were covered with sediment in some areas but remained generally visible, but some notes indicated that some blocks had begun to separate near the edges. The ACBs at site 015 were submerged and not visible at the time of the site evaluation, but riprap along the banks was noted as being intact without signs of failure. Additional data about this site and others used in this study can be found in two USGS Open-File Reports (Dudunake and others, 2017, 2019) and the companion data releases (Dudunake, 2017, 2019).

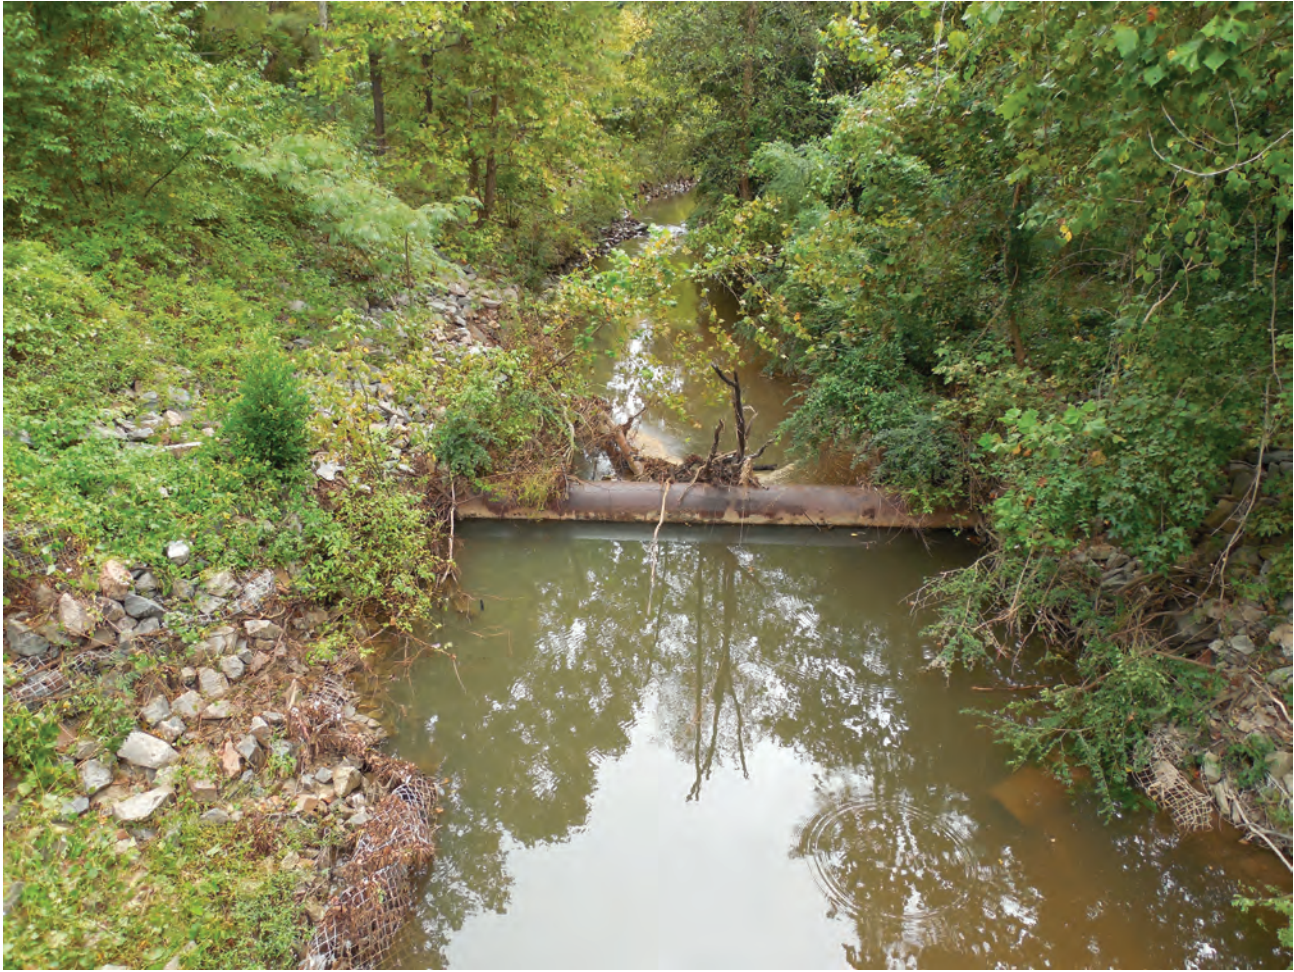
Figure 11. Sanitary sewer pipe line across Smith Branch, site 028, Columbia, South Carolina, just upstream of original upstream extent of Gabion mattress countermeasure installation. Photograph by Richard Huizinga, U.S. Geological Survey.

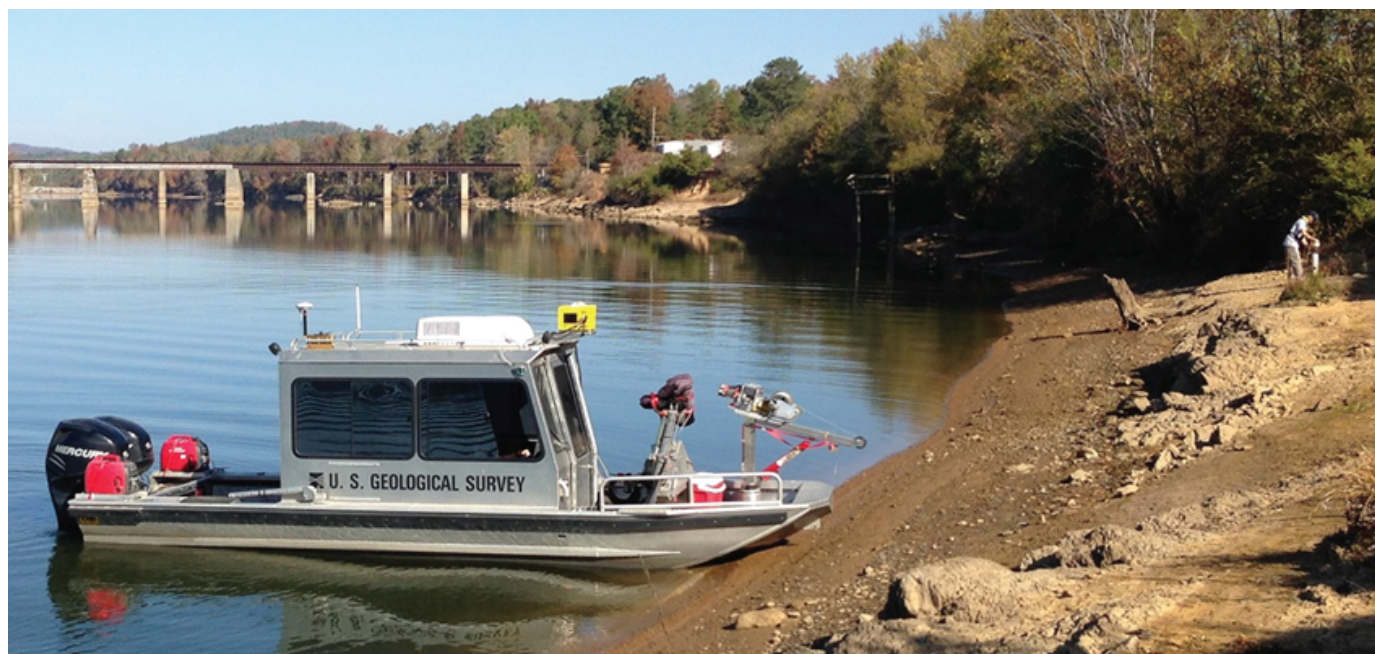
Figure 12. Vessel mounted Teledyne-Optech ILRIS High Density (HD) Enhanced Range (ER) laser scanner. Photograph by Richard Huizinga, U.S. Geological Survey.

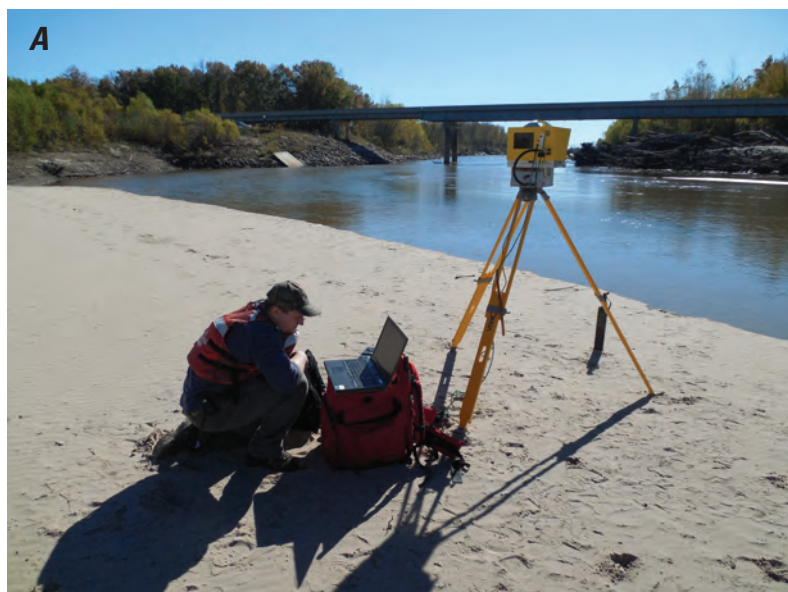
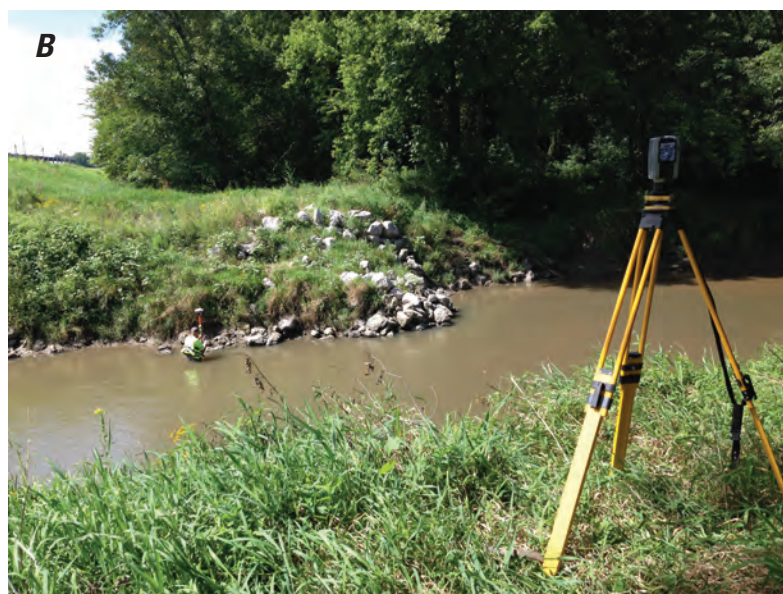
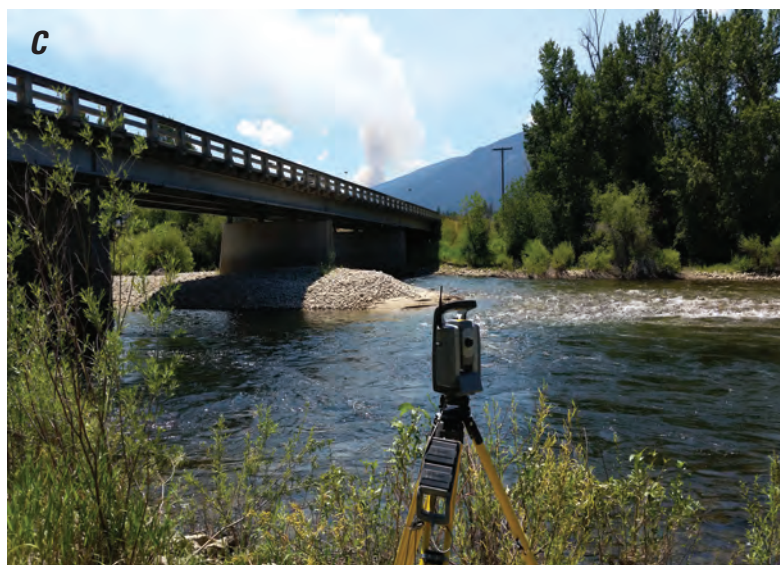
Figure 15. A, Teledyne-Optech ILRIS High Density (HD) Enhanced Range (ER) laser scanner, B, FARO Focus 3D X130 laser scanner setup, and C, Trimble VX Stationary three-dimensional single-laser scanner, all shown mounted on tripods. Photographs 15A and 15B by Richard Huizinga, U.S. Geological Survey. Photograph 15C by Ryan Fosness, U.S. Geological Survey.

At the three Category 3 and 4 sites in Iowa, T-lidar data were collected using a FARO Focus3D X130 laser scanner (fig. 15B). The FARO scanner is substantially smaller than the ILRIS HD ER with a more limited range; however, it

can rapidly collect data in an approximately 130-m sphere around the unit. The smaller size and rapid data-collection ability make the FARO scanner useful for surveying smaller bridge sites. Data were obtained by allowing the FARO unit to rotate 360 degrees at several (up to 12) different tripod setups throughout the surveyed reach, using reference spheres to align the scan from each setup with other scans.

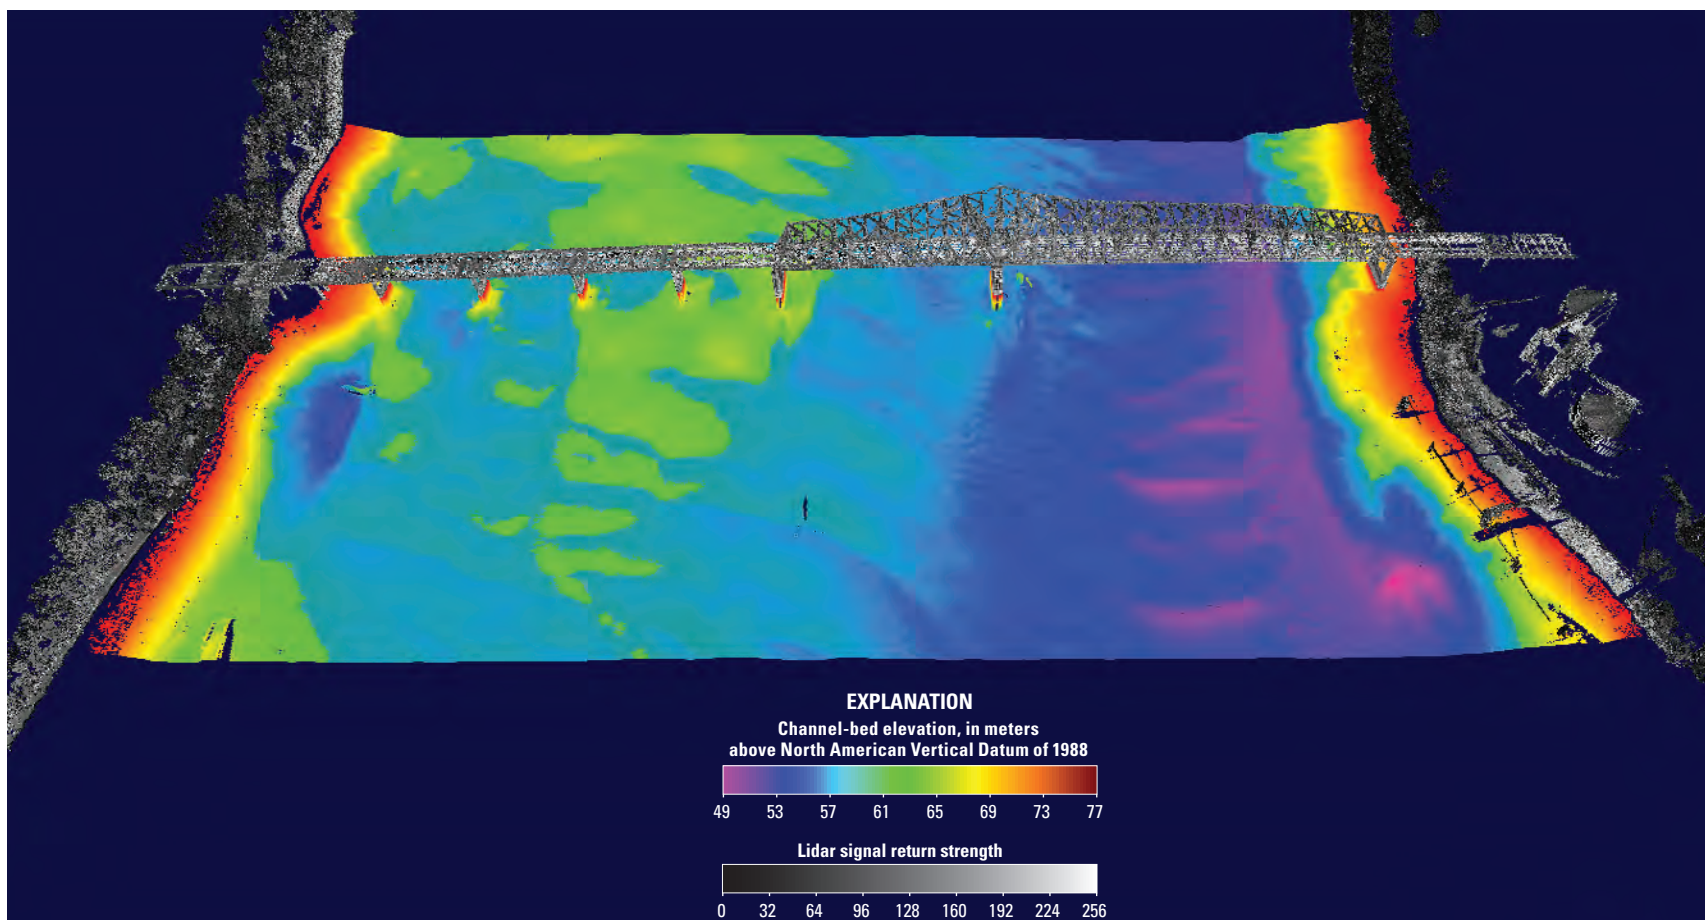
Figure 16. Oblique view (from downstream [southeast]) of the terrestrial lidar scanned data merged with channel bathymetry survey data of the bridge and river channel at site 004, Interstate 155 over the Mississippi River near Caruthersville, Missouri, from May 3, 2016.

The various XYZ files for a given survey were combined into a single topographic dataset and visualized in the PolyWorks IM-Align and IM-Survey software packages. The data were aligned and georeferenced using coordinates for the various reference targets and spheres in the surveyed area. The processed and edited data collected with the ILRIS HD ER unit were output to a space-delimited XYZ dataset with intensity, one file for each survey, and are included with the metadata in data releases by Dudunake (2017, 2019). The processed and cleaned data collected with the FARO unit were output to two space-delimited XYZ datasets, one with intensity and the other with RGB color (one of each per survey), and are also included with the metadata in the two data releases (Dudunake, 2017, 2019). A sample of these colored T-lidar data are shown in figure 2. At sites where available (001, 003, 004, 007, and 030), bathymetric data were combined with the T-lidar data obtained at each site (fig. 16).
