Assessment of Bridge Scour Countermeasures at Selected Bridges in the United States, 2014–18

Scientific Investigations Report 2019–5080

By Thomas P. Suro, Richard J. Huizinga, Ryan L. Fosness, and Taylor J. Dudunake

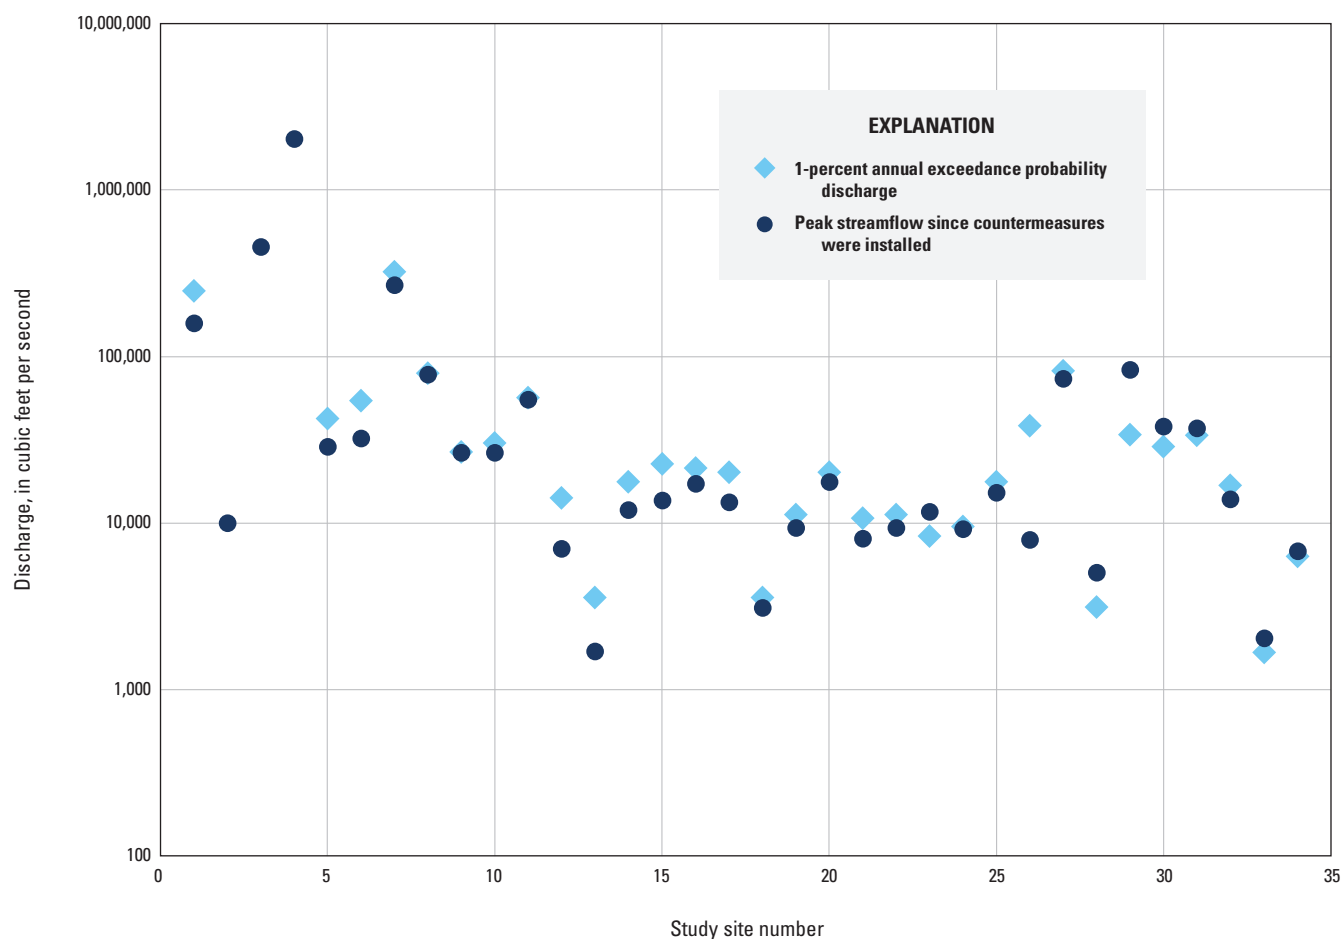
Figure 17. Plot of 1-percent annual exceedance probability discharge and maximum recorded discharge since countermeasures were installed at 34 study sites.
