Streambed Scour Evaluations and Conditions at Selected Bridge Sites, Alaska, 2016–17

Scientific Investigations Report 2019-5110
Version 1.1, April 2023

By Robin A. Beebee, Karenth L. Dworsky, and Schyler J. Knopp

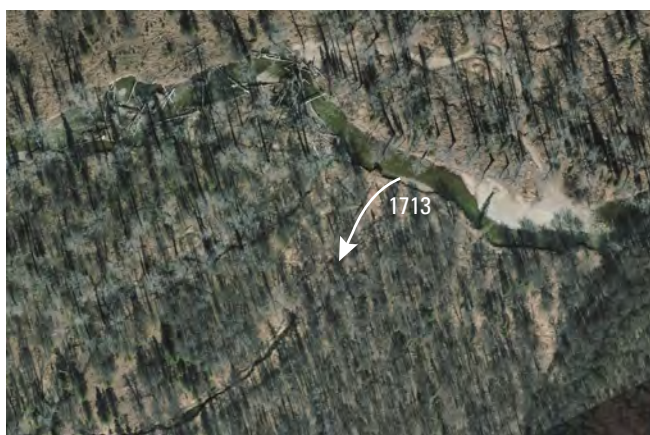
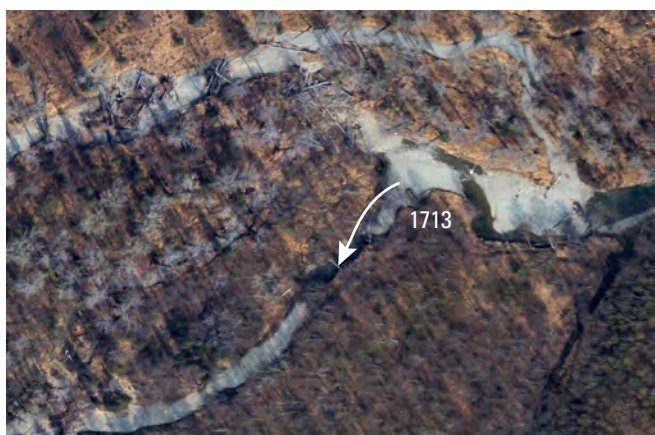
Figure 6. Susitna River and floodplain at the entrance to Bridge 1713, Alaska, 2011 (A) and 2017 (B). [Imagery by Matanuska-Susitna Borough, Alaska]
