Assessment of Soil and Water Resources in the Organ Mountains-Desert Peaks National Monument, New Mexico

Scientific Investigations Report 2019–5142

By Johanna M. Blake, Aurelia C. Mitchell, Zachary Shephard, Grady Ball, Shaleene Chavarria, and
Kyle R. Douglas-Mankin

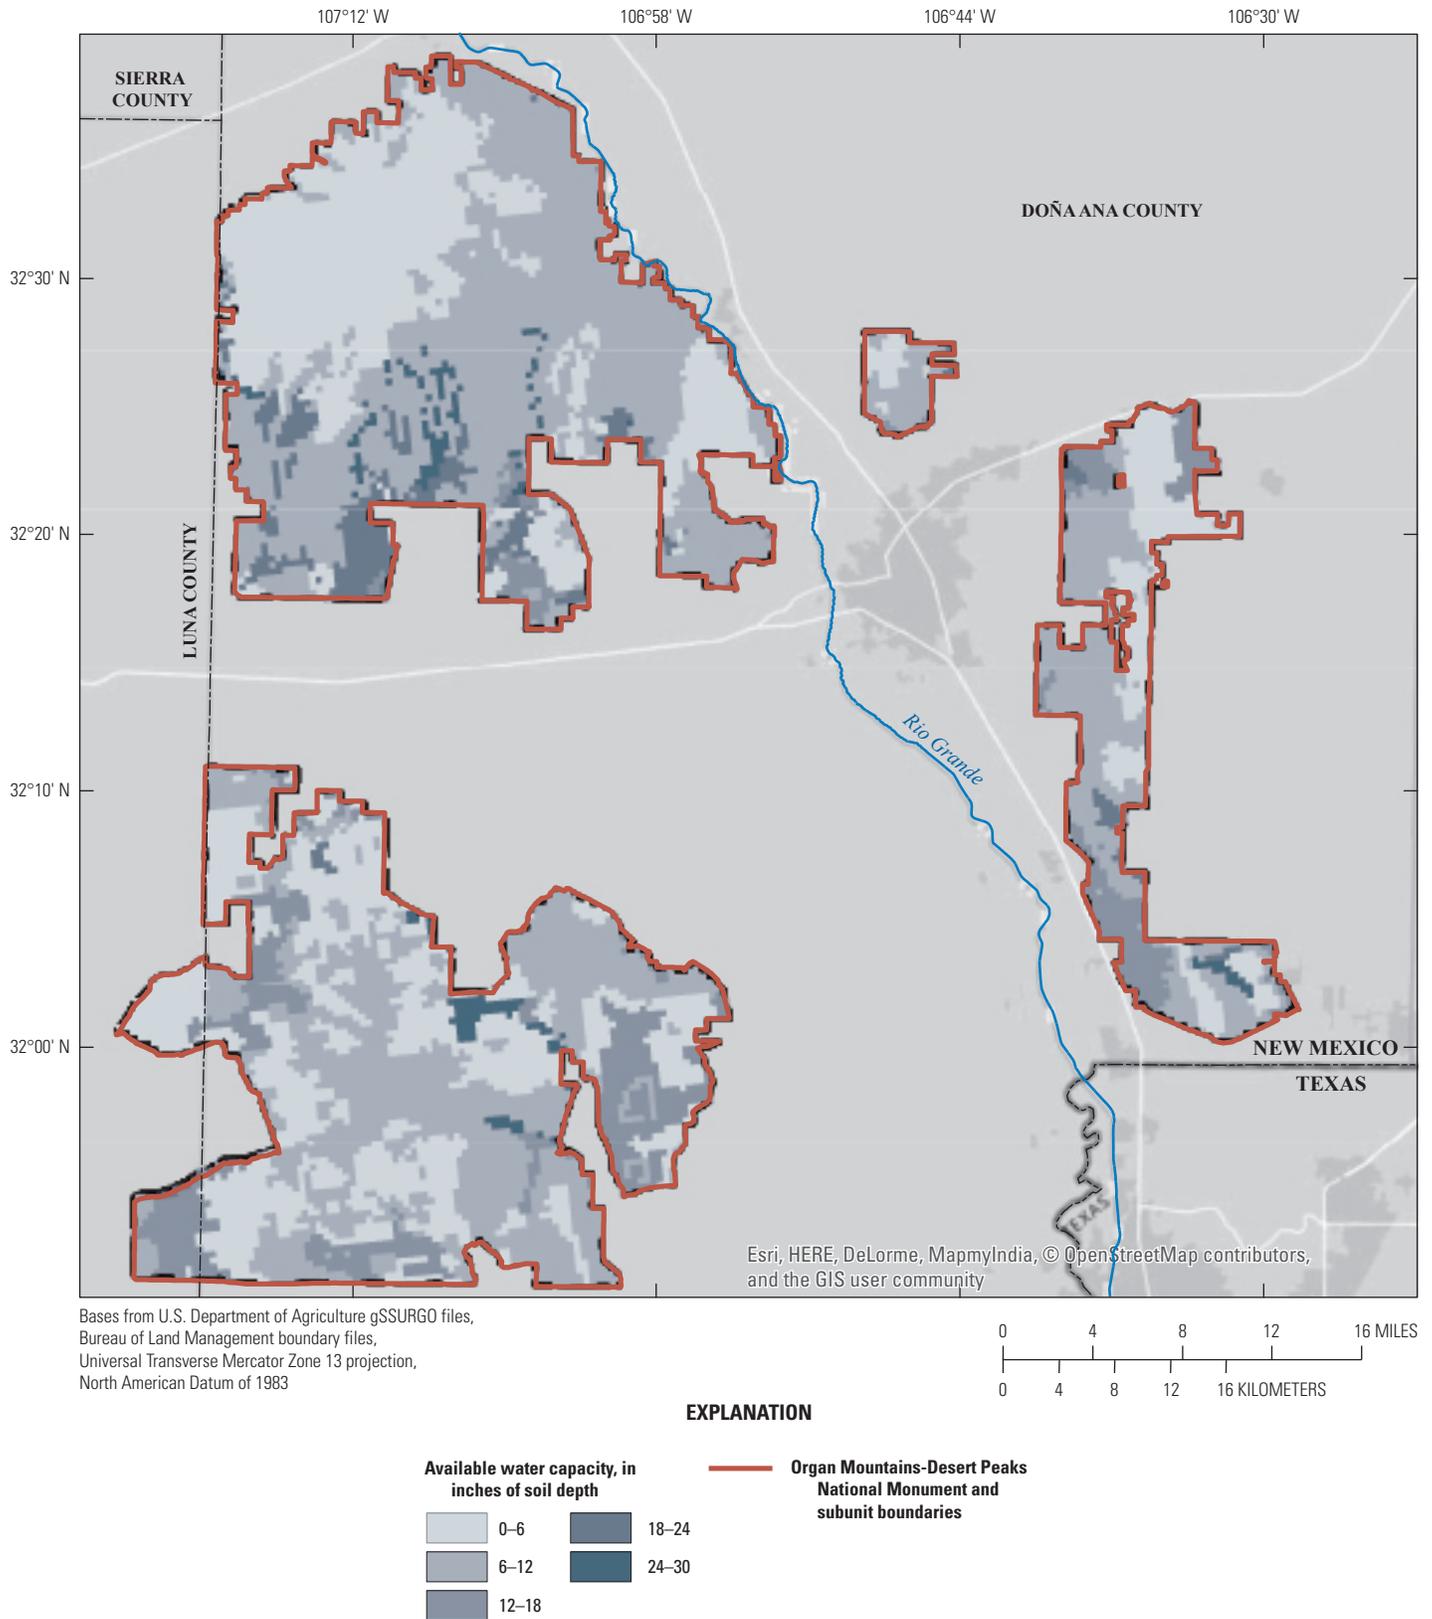
Figure 6. Available water capacity of soils in the Organ Mountains-Desert Peaks National Monument, New Mexico (Natural Resources Conservation Service, 2017a).

Within the Monument boundary, available water capacity ranges from 0 to 30 in. (fig. 6). Available water capacity is critical for sustained plant life in this arid region. The disappearance of plants due to lack of soil moisture may result in erosion in the Monument, which can then be further accelerated by human activities such as building roads. Roads within this Monument generally fall within a moderately low water capacity area of about 2.4–4.7 in. (6–12 cm) except for some roads in the Desert Peaks subunit that fall within a moderate range of 2.4–4.7 in. (12–18 cm) (figs. 6, 34). Erosion may be more likely to occur where roads exist in areas with little to no available water capacity. Available water capacity in the Potrillo subunit is also low to moderate.

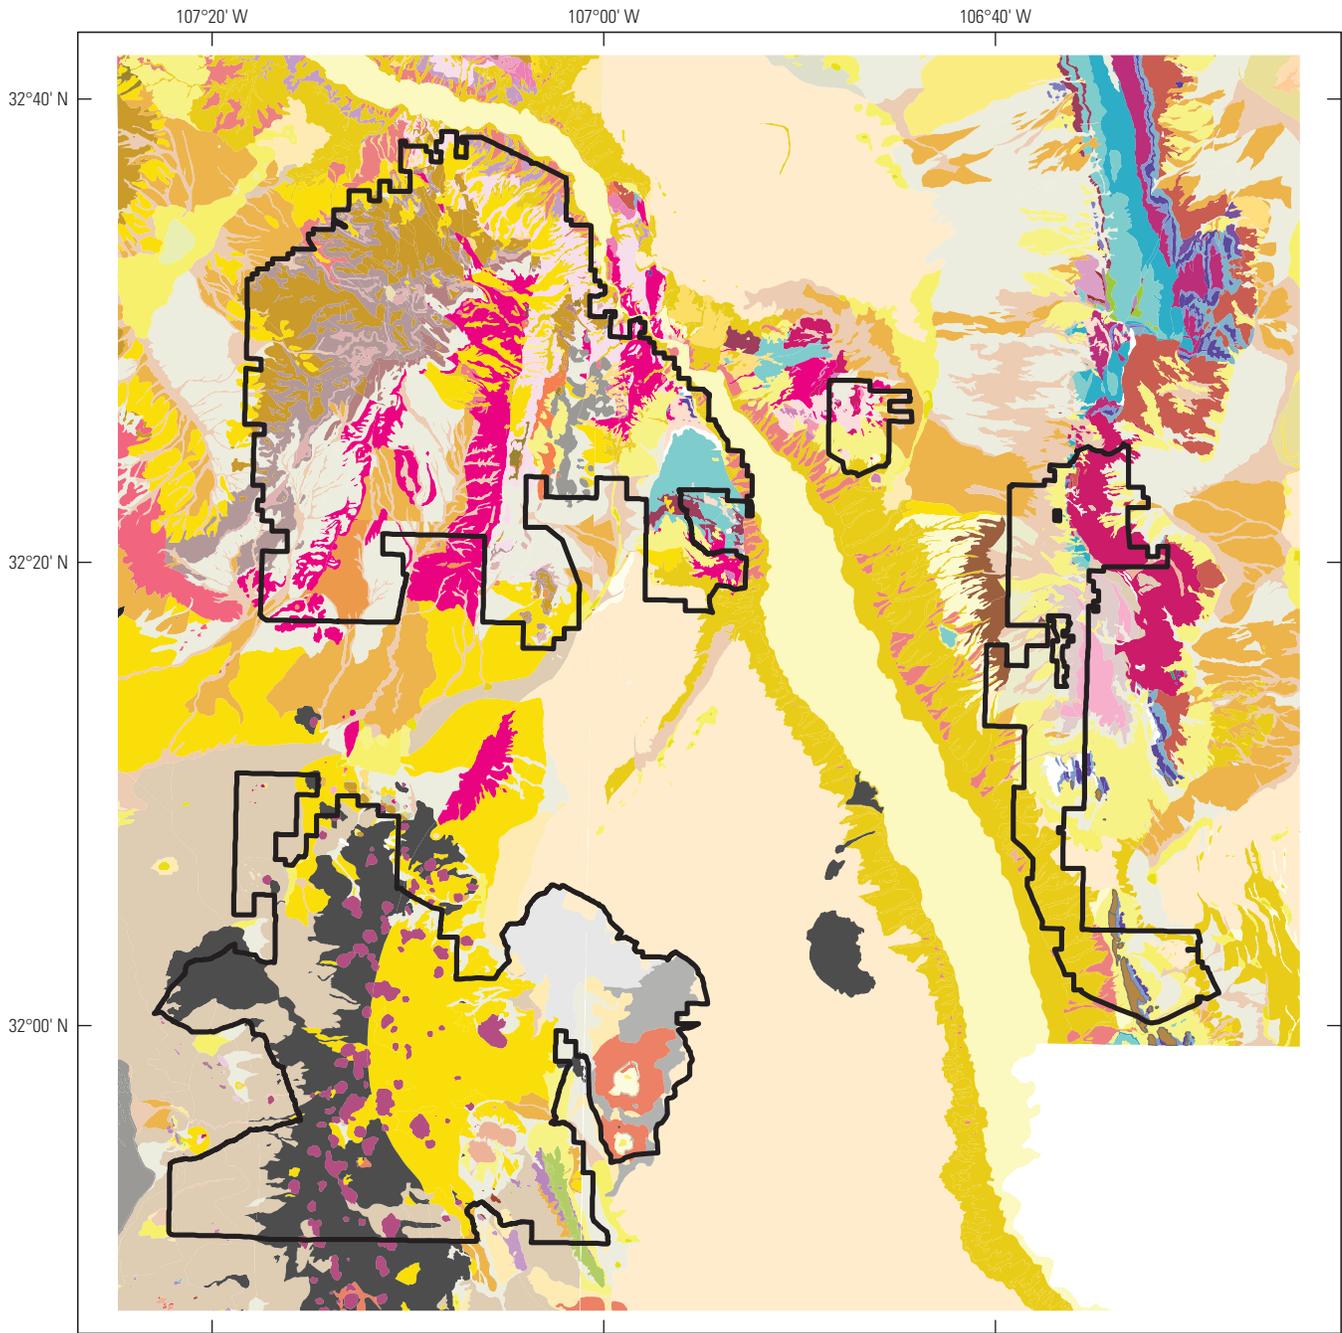
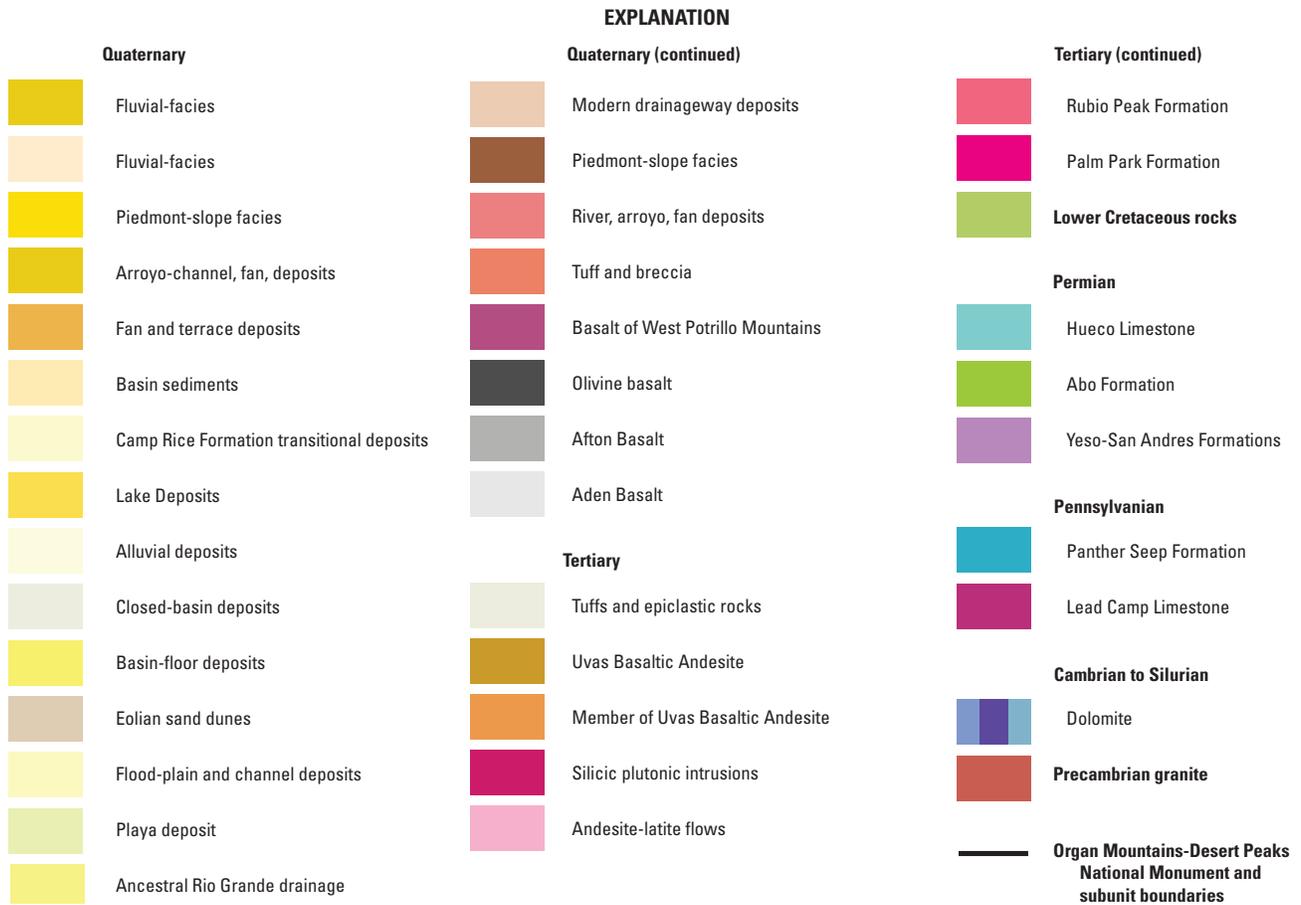
Figure 8. Geology of the area within and surrounding the Organ Mountains-Desert Peaks National Monument, New Mexico (Seager and others, 1982, 1987; Seager, 1995).

The rock types and their structure in the Monument can affect the weathering potential of rocks, infiltration of water to the subsurface, overland flow, and erosion. The Organ Mountains are a steep and jagged mountain range located east of the city of Las Cruces, New Mexico (fig. 1) (Glover, 1975). These mountains are composed of volcanic intrusions of Tertiary age, gravels and alluvium of Tertiary-Quaternary age, sedimentary rocks of Paleozoic age, and granites of Precambrian age. The dominant rock type is quartz-monzonite intrusions, especially on the western slopes (Glover, 1975). Figure 8 shows geologic maps from Seager and others (1982, 1987) and Seager (1995)

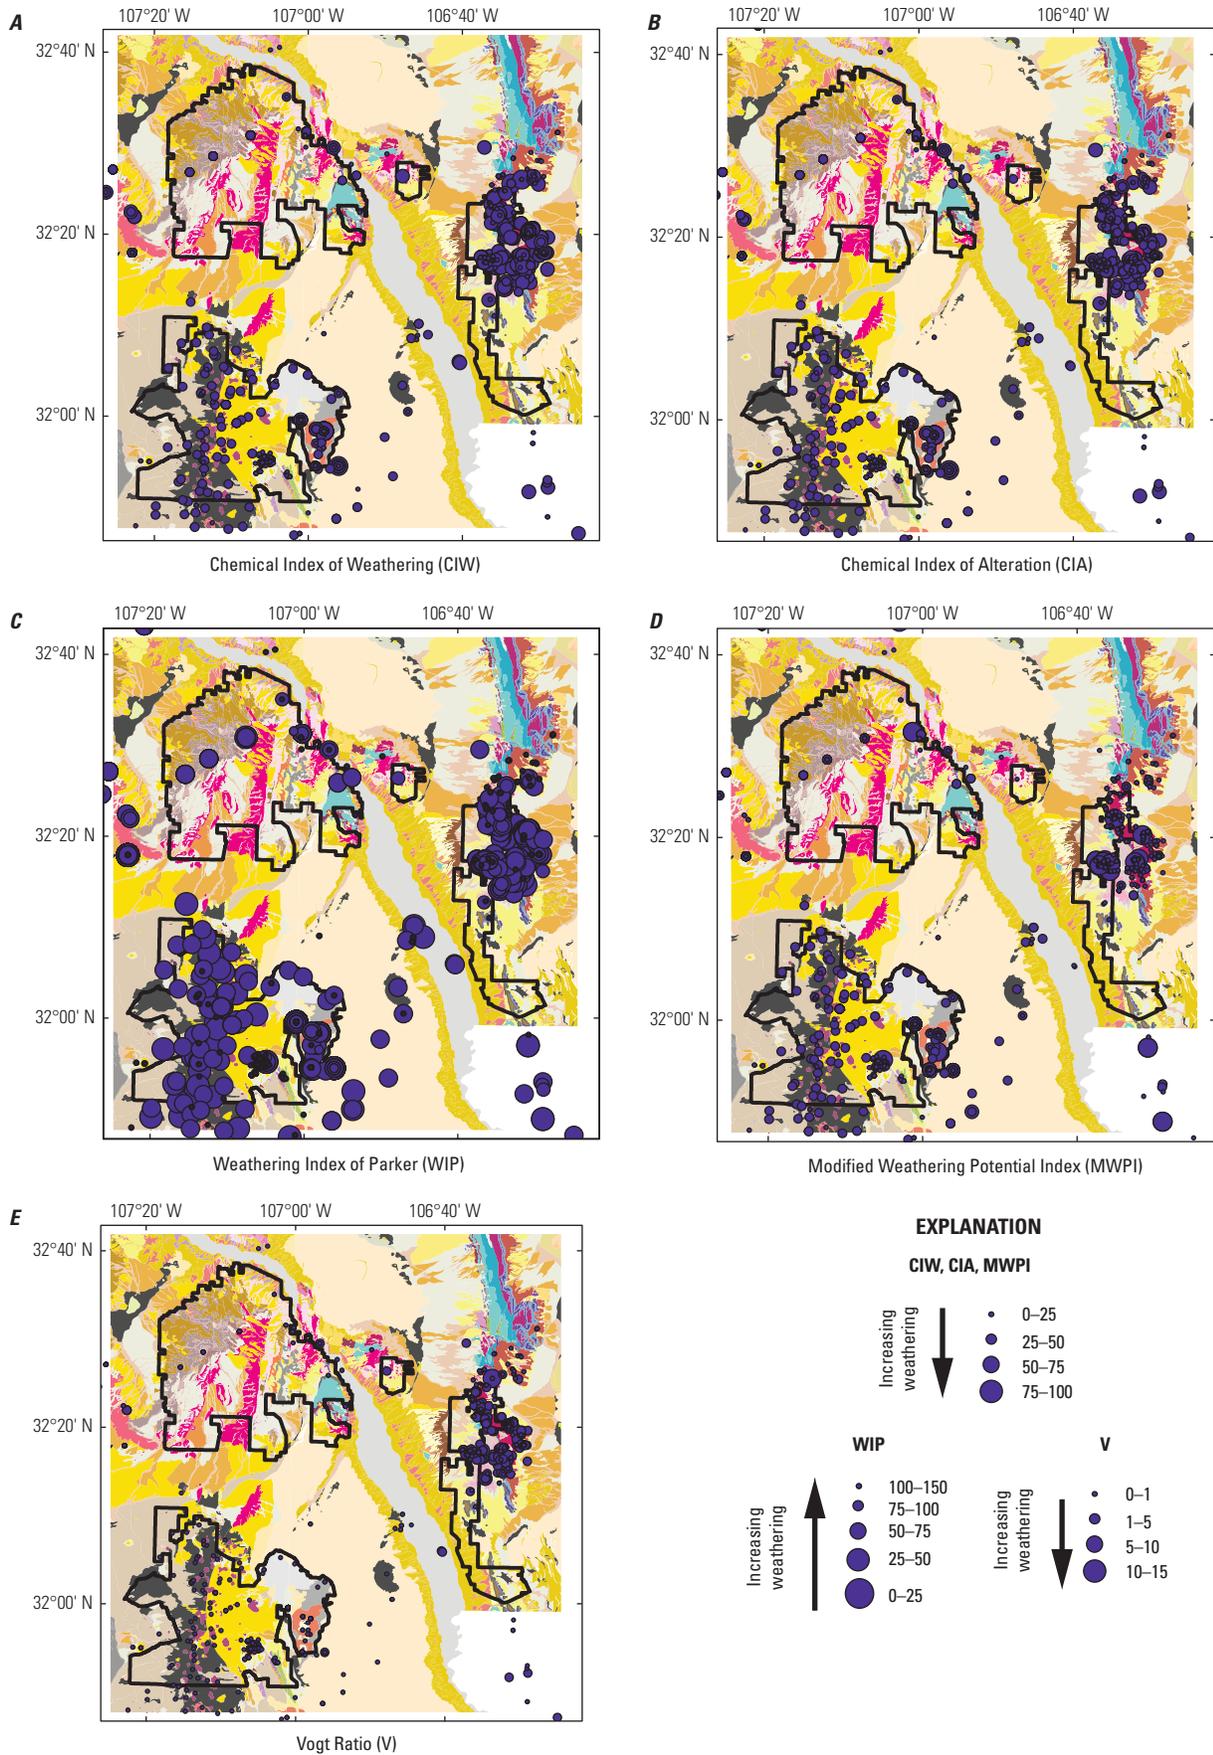
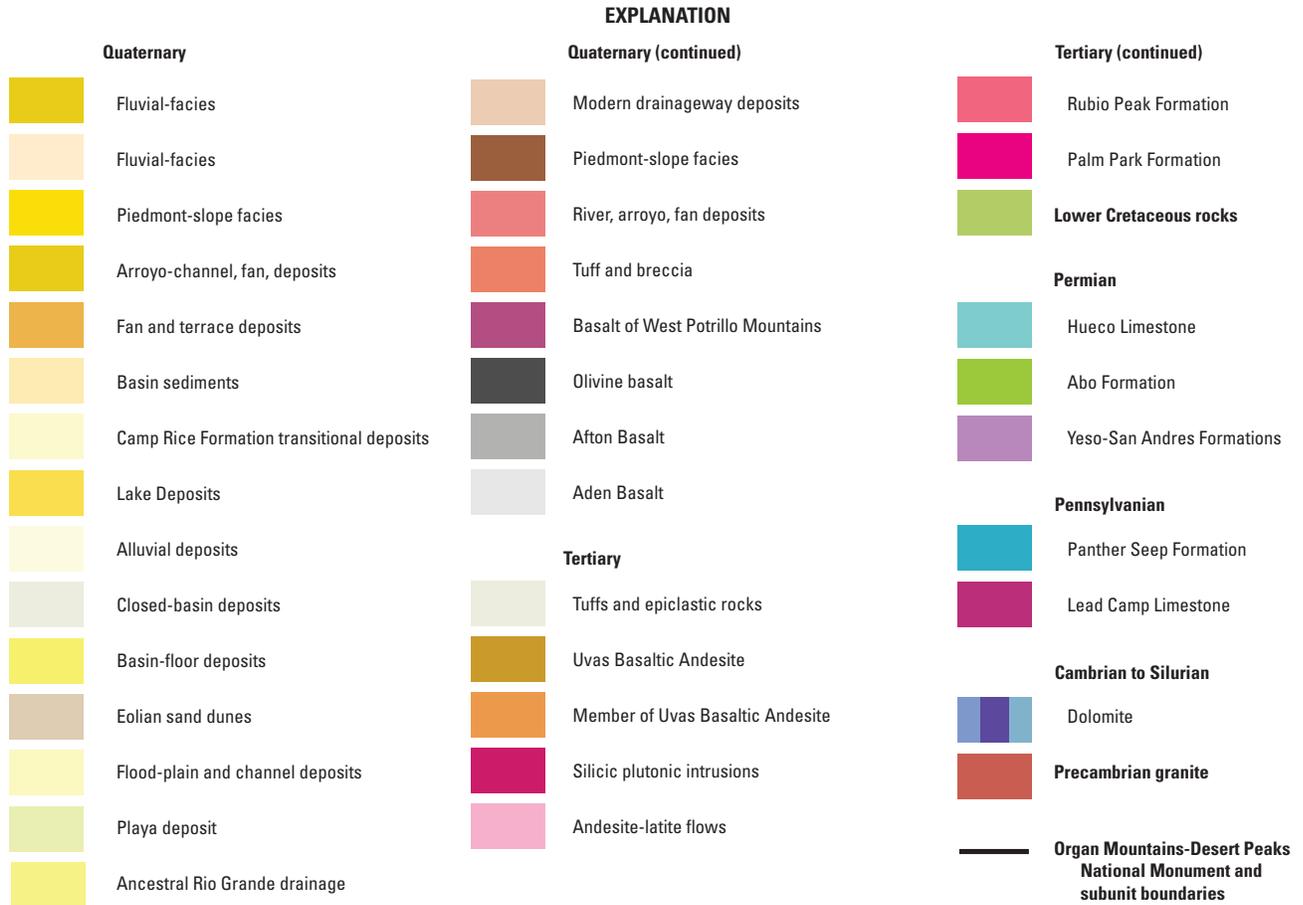
Figure 15. Distribution of potential for rock weathering in the Organ Mountains-Desert Peaks National Monument, New Mexico, based on five chemical weathering indices.

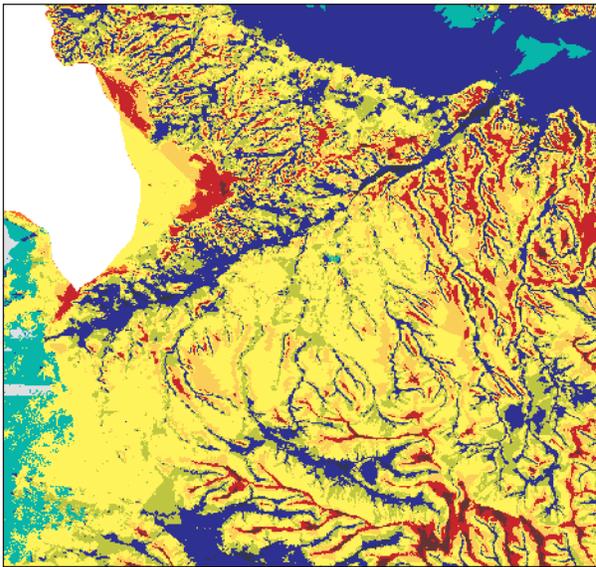
Figure 17. Geomorphon method landforms map, Desert Peaks subunit, Organ Mountains-Desert Peaks National Monument, New Mexico.

The Desert Peaks subunit of the Monument has the most landforms of all the subunits (figs. 16, 17). The landscape is scattered with numerous arroyos, defined in figure 17 as depression/hollow or valley, including smaller arroyos that lead into the Placitas Arroyo. Flooding caused by runoff from the Placitas Arroyo is of major concern for the city of Placitas and Village of Hatch (fig. 1). The north-northwestern portion of the Desert Peaks subunit is dotted with peaks that make up the Sierra de las Uvas Mountains, and the southeastern portion of the subunit contains the Robledo Mountains. Between

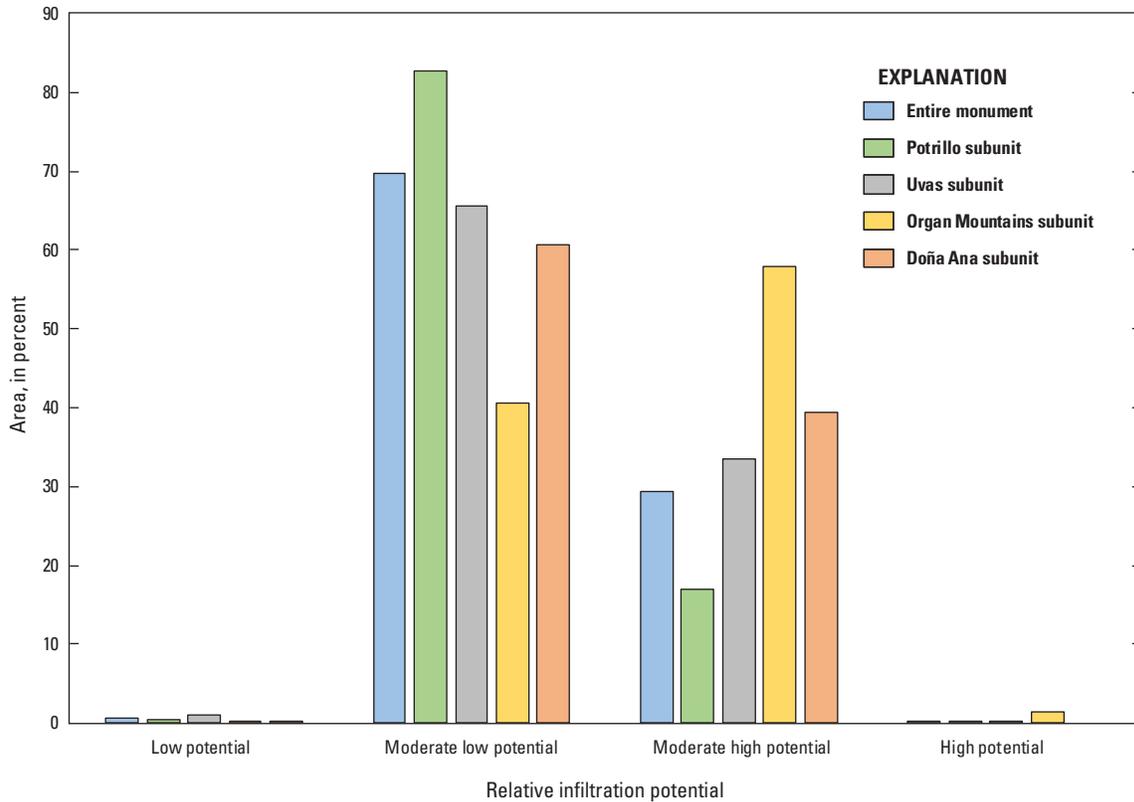
Figure 24. Infiltration potentials for individual subunits and for the entire Organ Mountains-Desert Peaks National Monument, New Mexico.

The IPI results ranged from 10.6 to 91.6 (unitless) and were split into four infiltration potential categories: low (less than 25), moderate low (25–50), moderate high (50–75), and high (greater than 75). These results should be considered qualitative despite having been assigned numeric values and are not a direct measure of infiltration or runoff, meaning that exact infiltration rates (such as inches per hour) were not determined. Less than 1 percent of the Monument area was rated as having a low infiltration potential, 70 percent of the area had a moderate low infiltration potential, 29 percent had a moderate high infiltration potential, and less than 1 percent had a high infiltration potential (fig. 24).

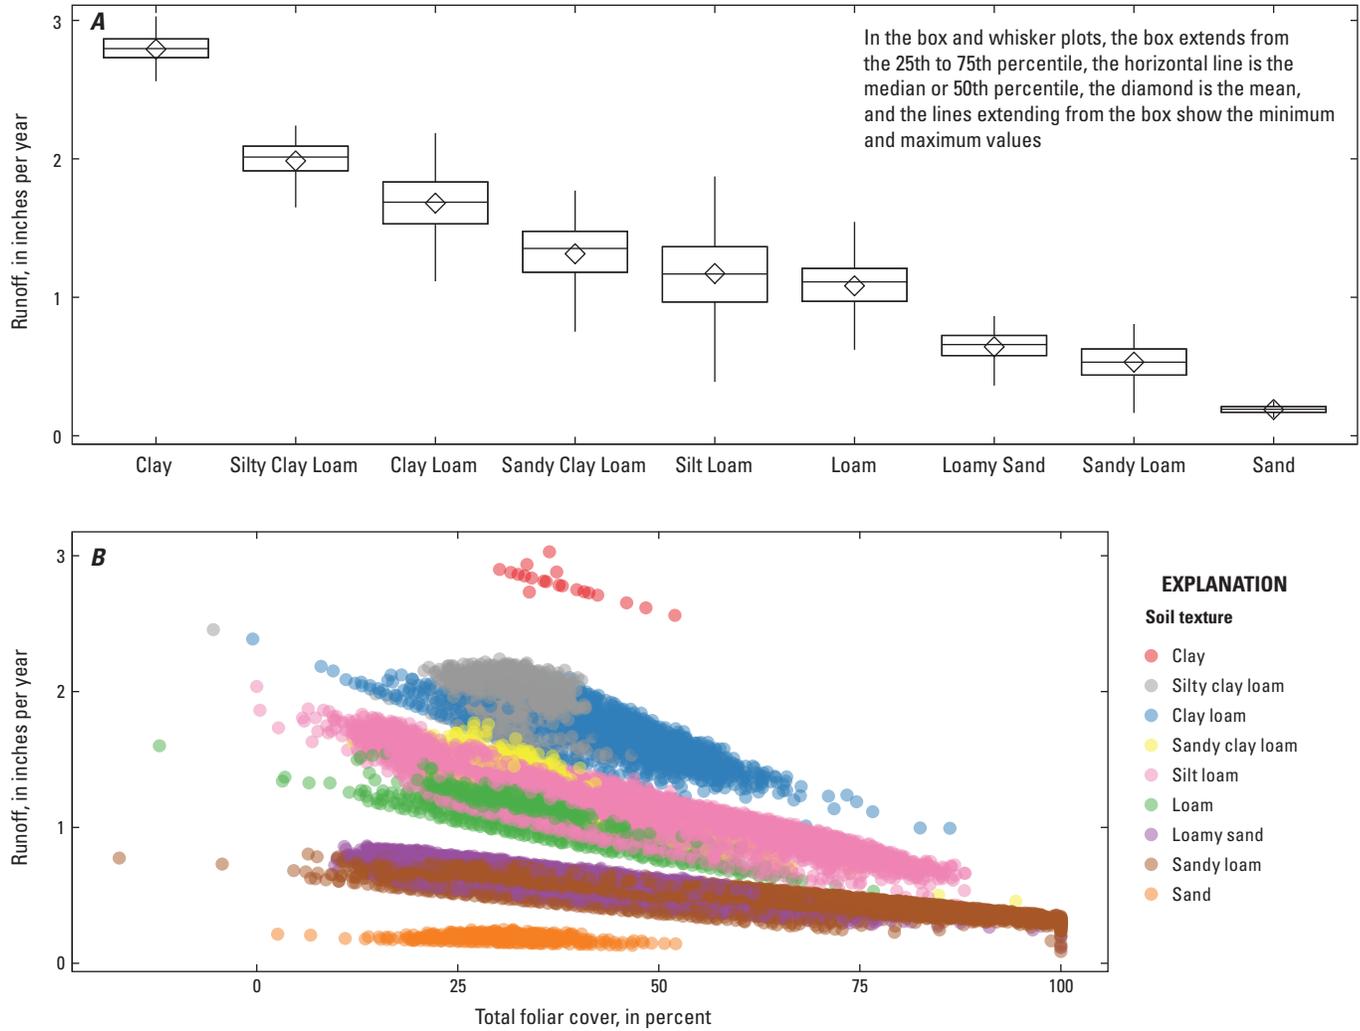
Figure 25. RHEM-simulated annual average runoff response to (A) soil texture and (B) total foliar cover and soil texture for 168,276 cells in the Organ Mountains-Desert Peaks National Monument, New Mexico.

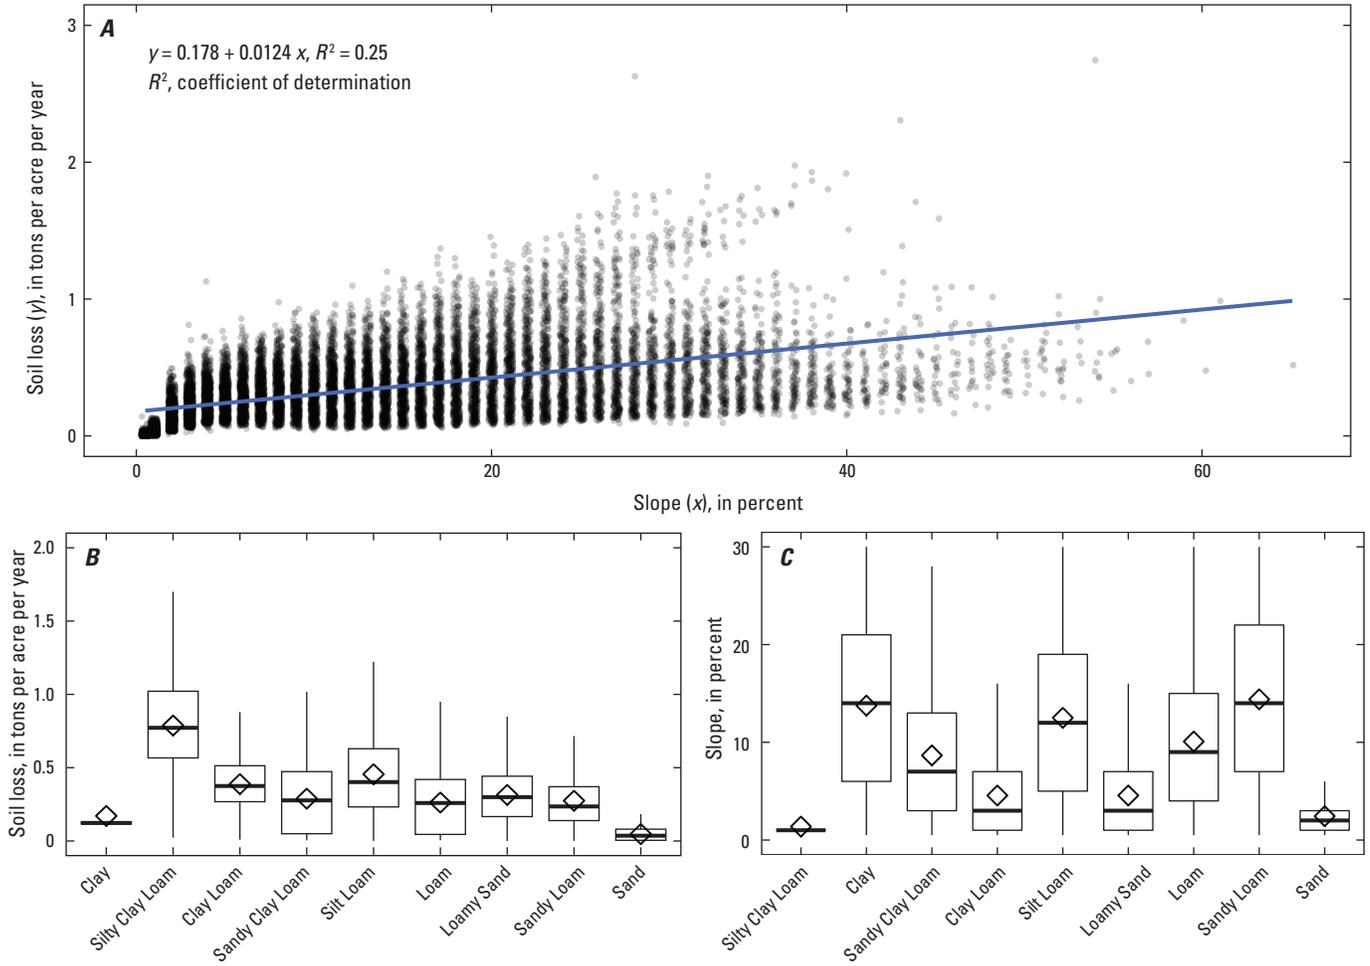
Box and whisker plots are shown in B and C. The box extends from the 25th to 75th percentile, the horizontal line is the median or 50th percentile, the diamond is the mean, and the lines extending from the box show the minimum and maximum values

Figure 26. Rangeland Hydrology and Erosion Model (RHEM)-simulated annual average soil loss response to (A) slope and (B) soil texture and (C) relation between slope and soil texture for 168,276 cells in the Organ Mountains-Desert Peaks National Monument, New Mexico.

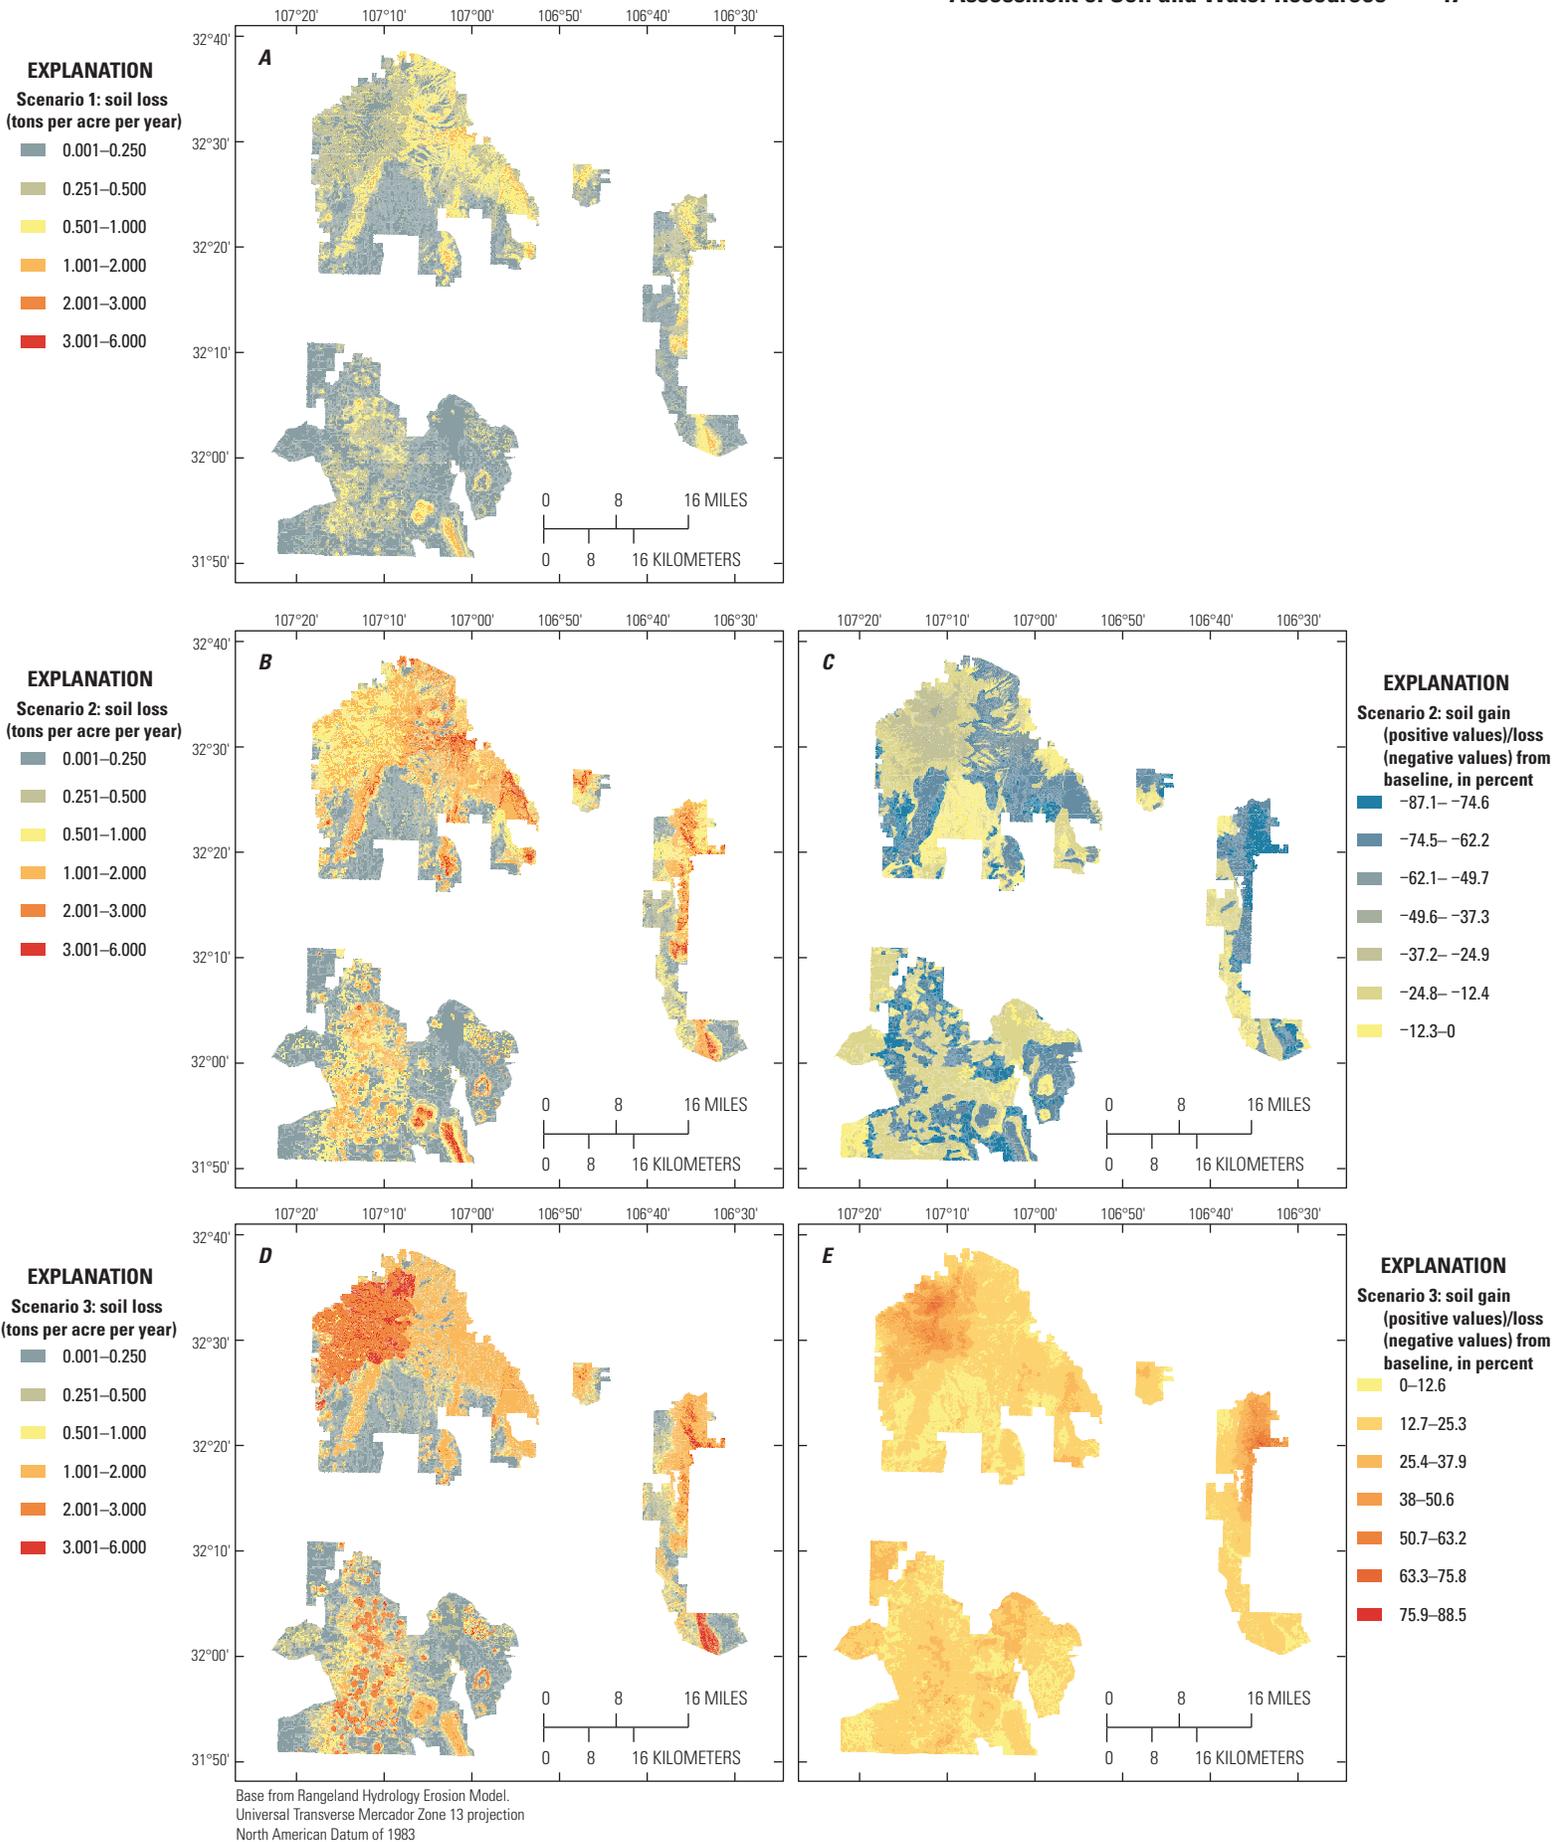
Figure 27. Soil loss and change from baseline scenario, Organ Mountains-Desert Peaks National Monument, New Mexico. *A*, Scenario 1: baseline soil loss. *B*, Scenario 2: soil loss. *C*, Scenario 2: change from baseline. *D*, Scenario 3: soil loss. *E*, Scenario 3: change from baseline.

Annual average soil loss across the Monument for the baseline scenario (Scenario 1) was 0.37 (ton/acre)/yr (figs. 27 and 28, table 14). Among the three simulated vegetation macrogroups, the North American Warm Desert Ruderal Scrub and Grassland (M512) had the lowest rate of annual average soil loss at 0.14 (ton/acre)/yr, followed by the Chihuahuan Semi-Desert Grassland (M087) at 0.38 (ton/acre)/yr. The Chihuahuan Desert Scrub (M086) macrogroup had the highest annual average soil loss at 0.45 (ton/acre)/yr (table 14). This pattern of individual vegetation macrogroup soil-loss rates carries throughout all scenarios but with commensurate increases or decreases in soil loss depending on scenario conditions.

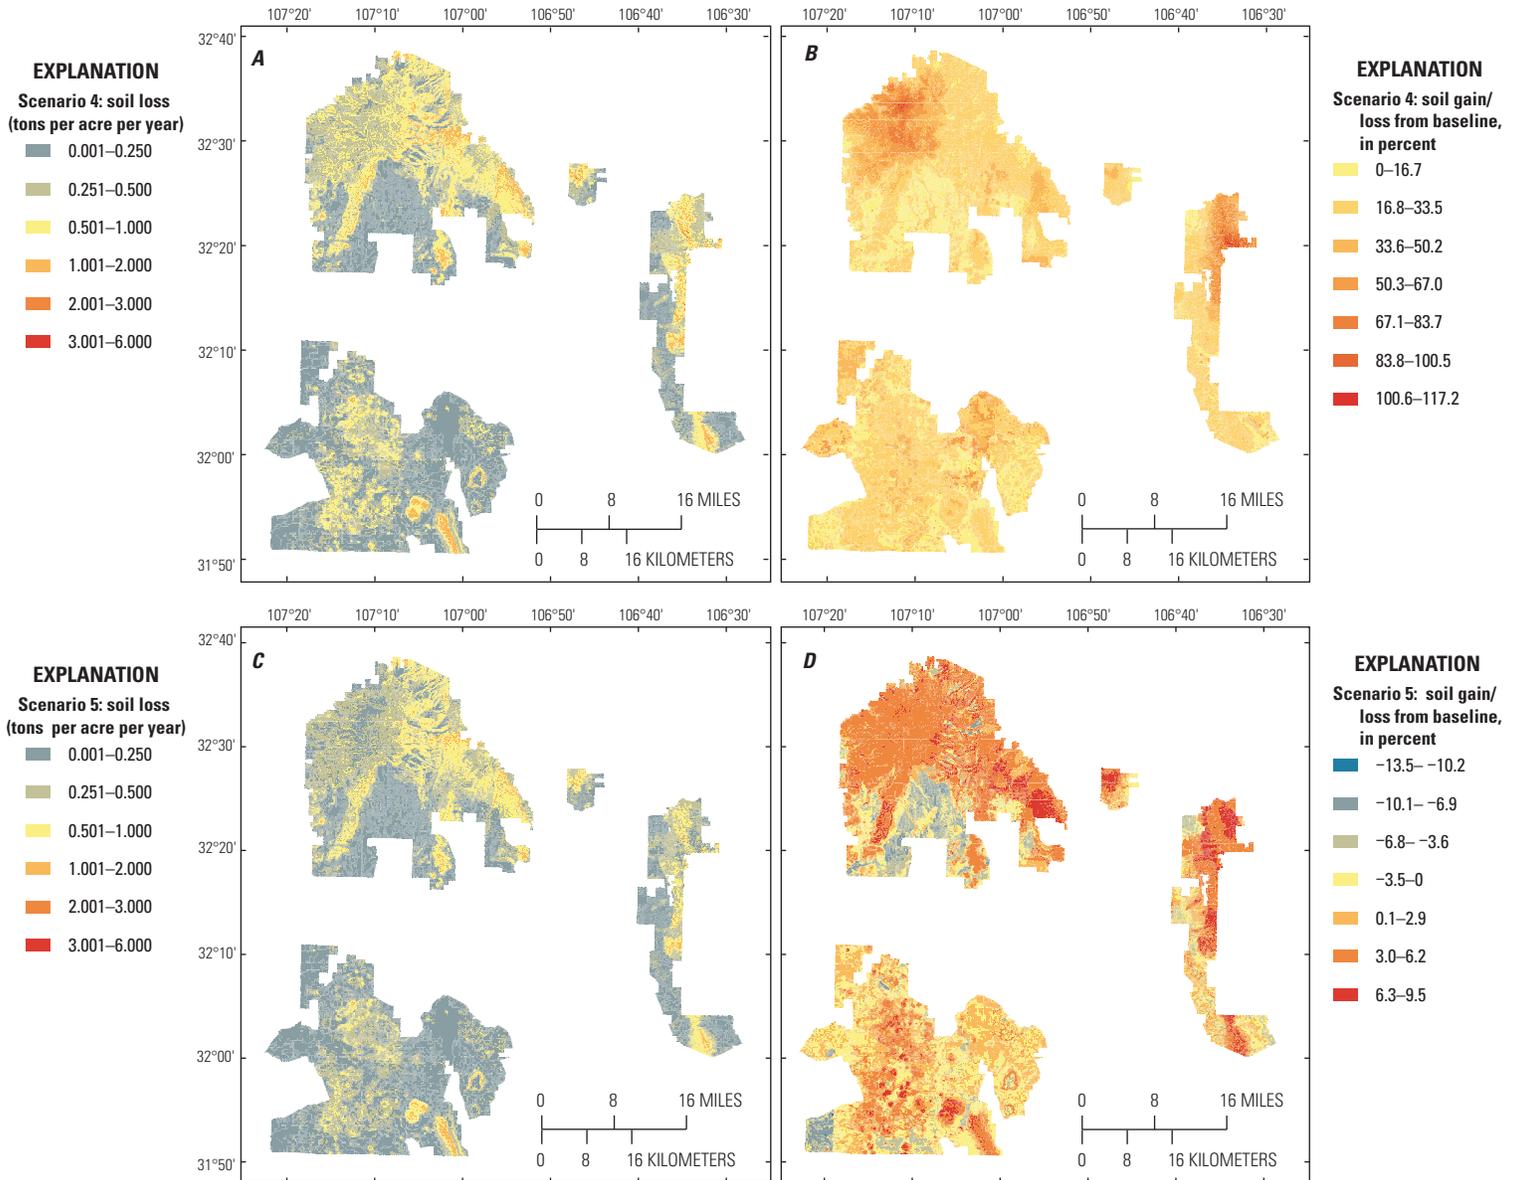
Figure 28. Soil loss and change from baseline scenario, Organ Mountains-Desert Peaks National Monument, New Mexico. *A*, Scenario 4: soil loss. *B*, Scenario 4: change from baseline. *C*, Scenario 5: soil loss. *D*, Scenario 5: change from baseline.

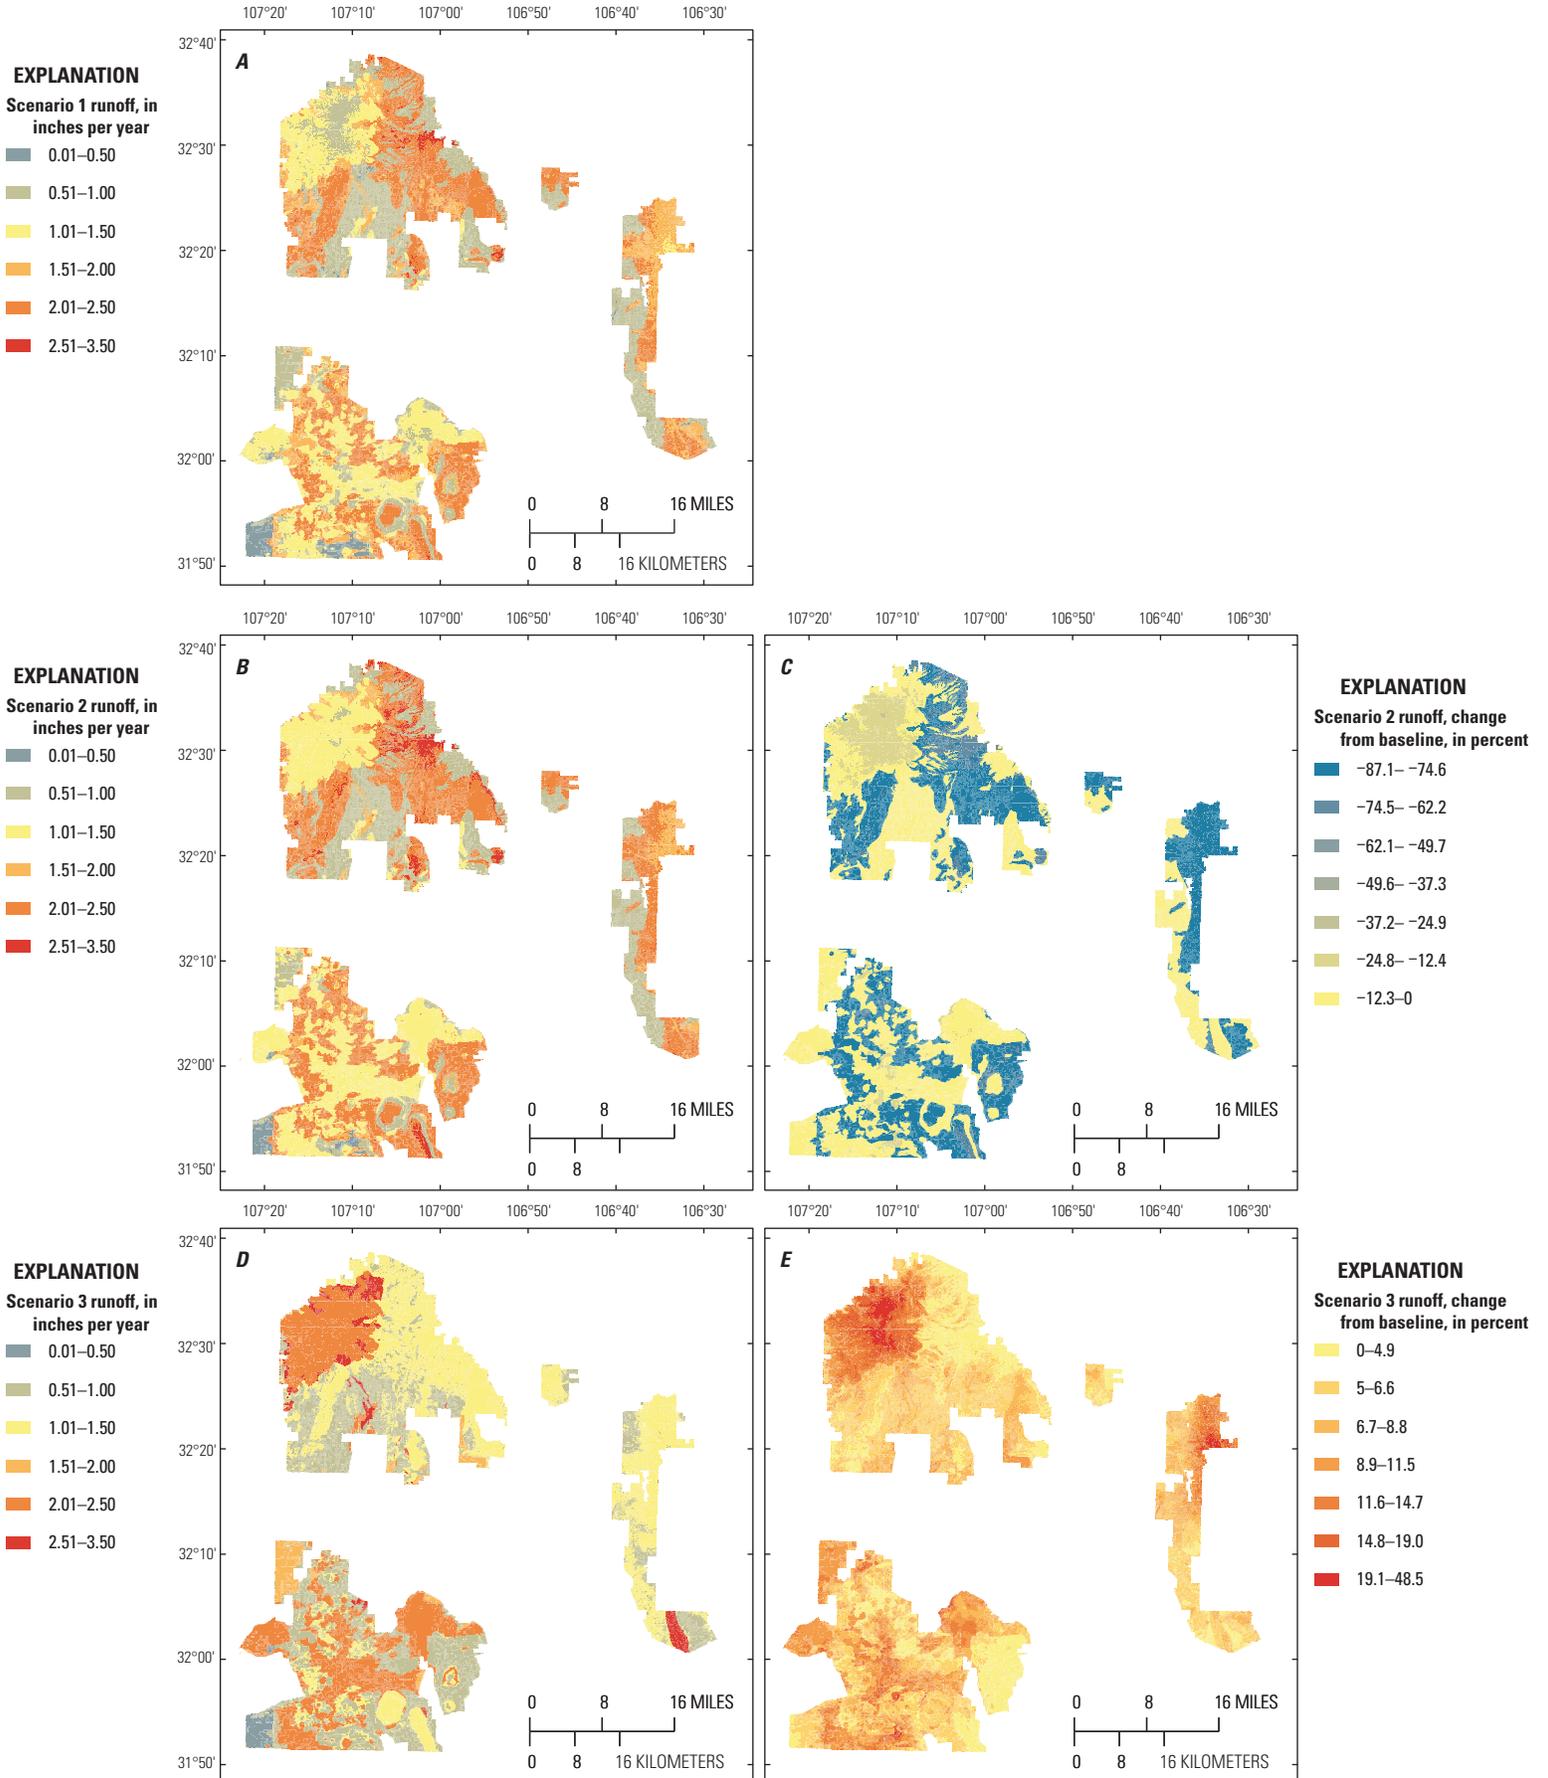
Figure 29. Runoff and change from baseline scenario, Organ Mountains-Desert Peaks National Monument, New Mexico. *A*, Scenario 1: baseline runoff. *B*, Scenario 2: runoff. *C*, Scenario 2: runoff change from baseline. *D*, Scenario 3: runoff. *E*, Scenario 3: runoff change from baseline.
