Assessment of Soil and Water Resources in the Organ Mountains-Desert Peaks National Monument, New Mexico

Scientific Investigations Report 2019–5142

By Johanna M. Blake, Aurelia C. Mitchell, Zachary Shephard, Grady Ball, Shaleene Chavarria, and
Kyle R. Douglas-Mankin

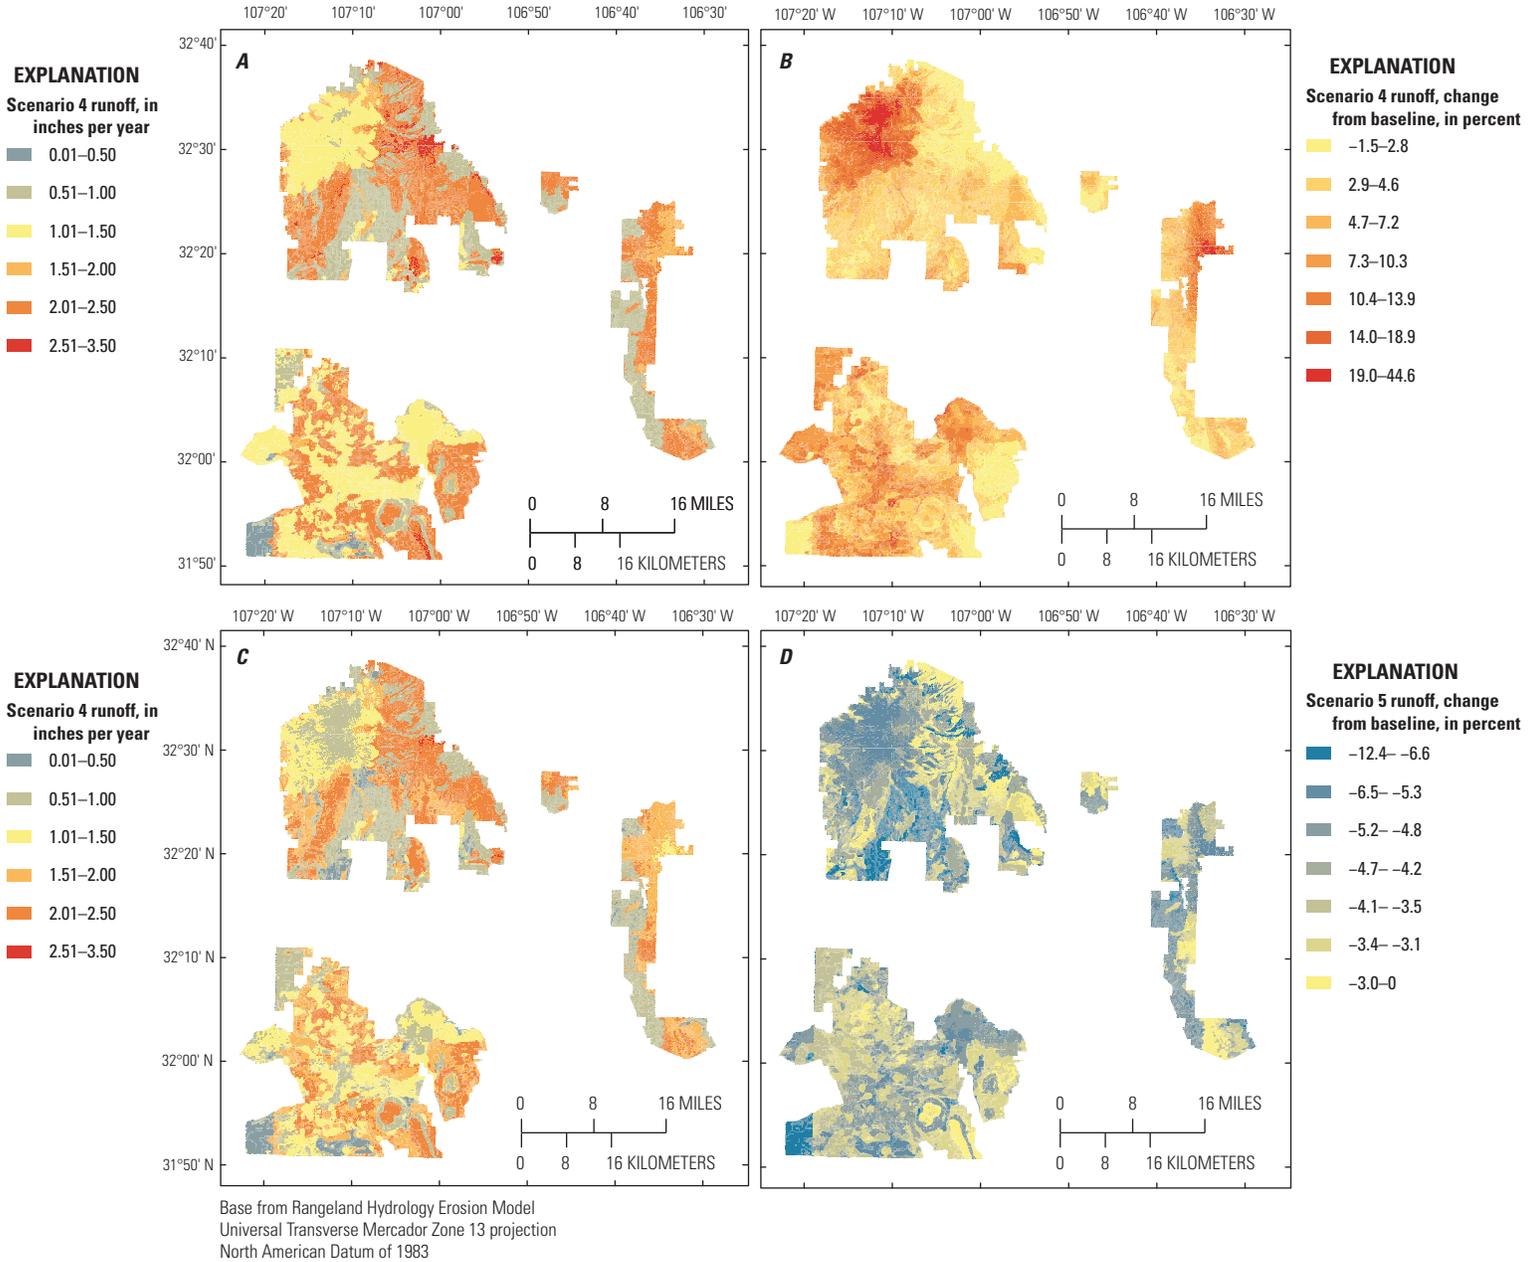
Figure 30. Runoff and percent change from baseline scenario, Organ Mountains-Desert Peaks National Monument, New Mexico. *A*, Scenario 4: baseline runoff. *B*, Scenario 4: percent runoff change from baseline. *C*, Scenario 5: runoff. *D*, Scenario 5: percent runoff change from baseline.

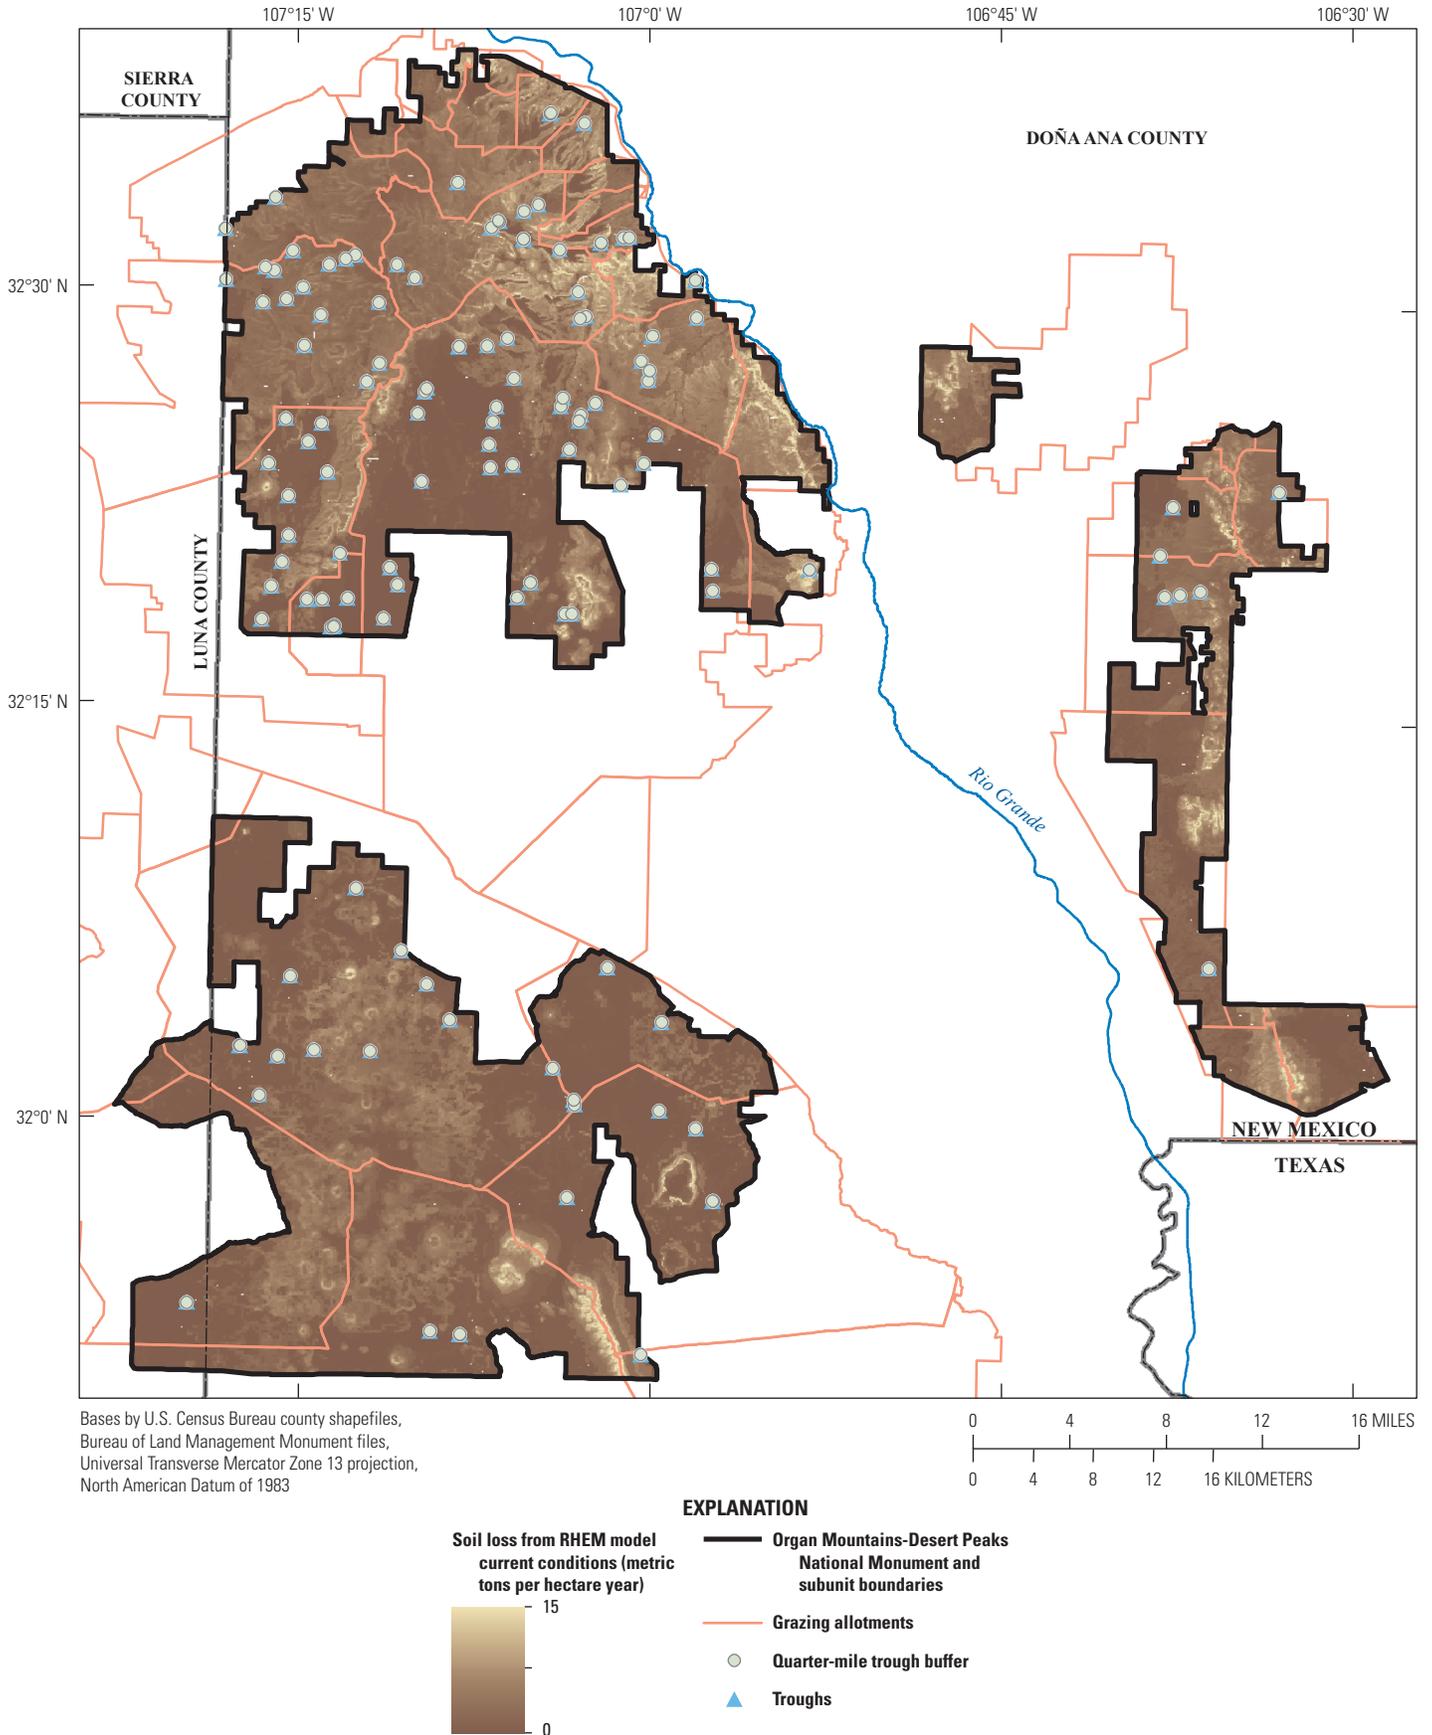
Figure 31. Watering trough locations and baseline soil loss conditions simulated by the Rangeland Hydrology and Erosion Model (RHEM), Organ Mountains-Desert Peaks National Monument, New Mexico.

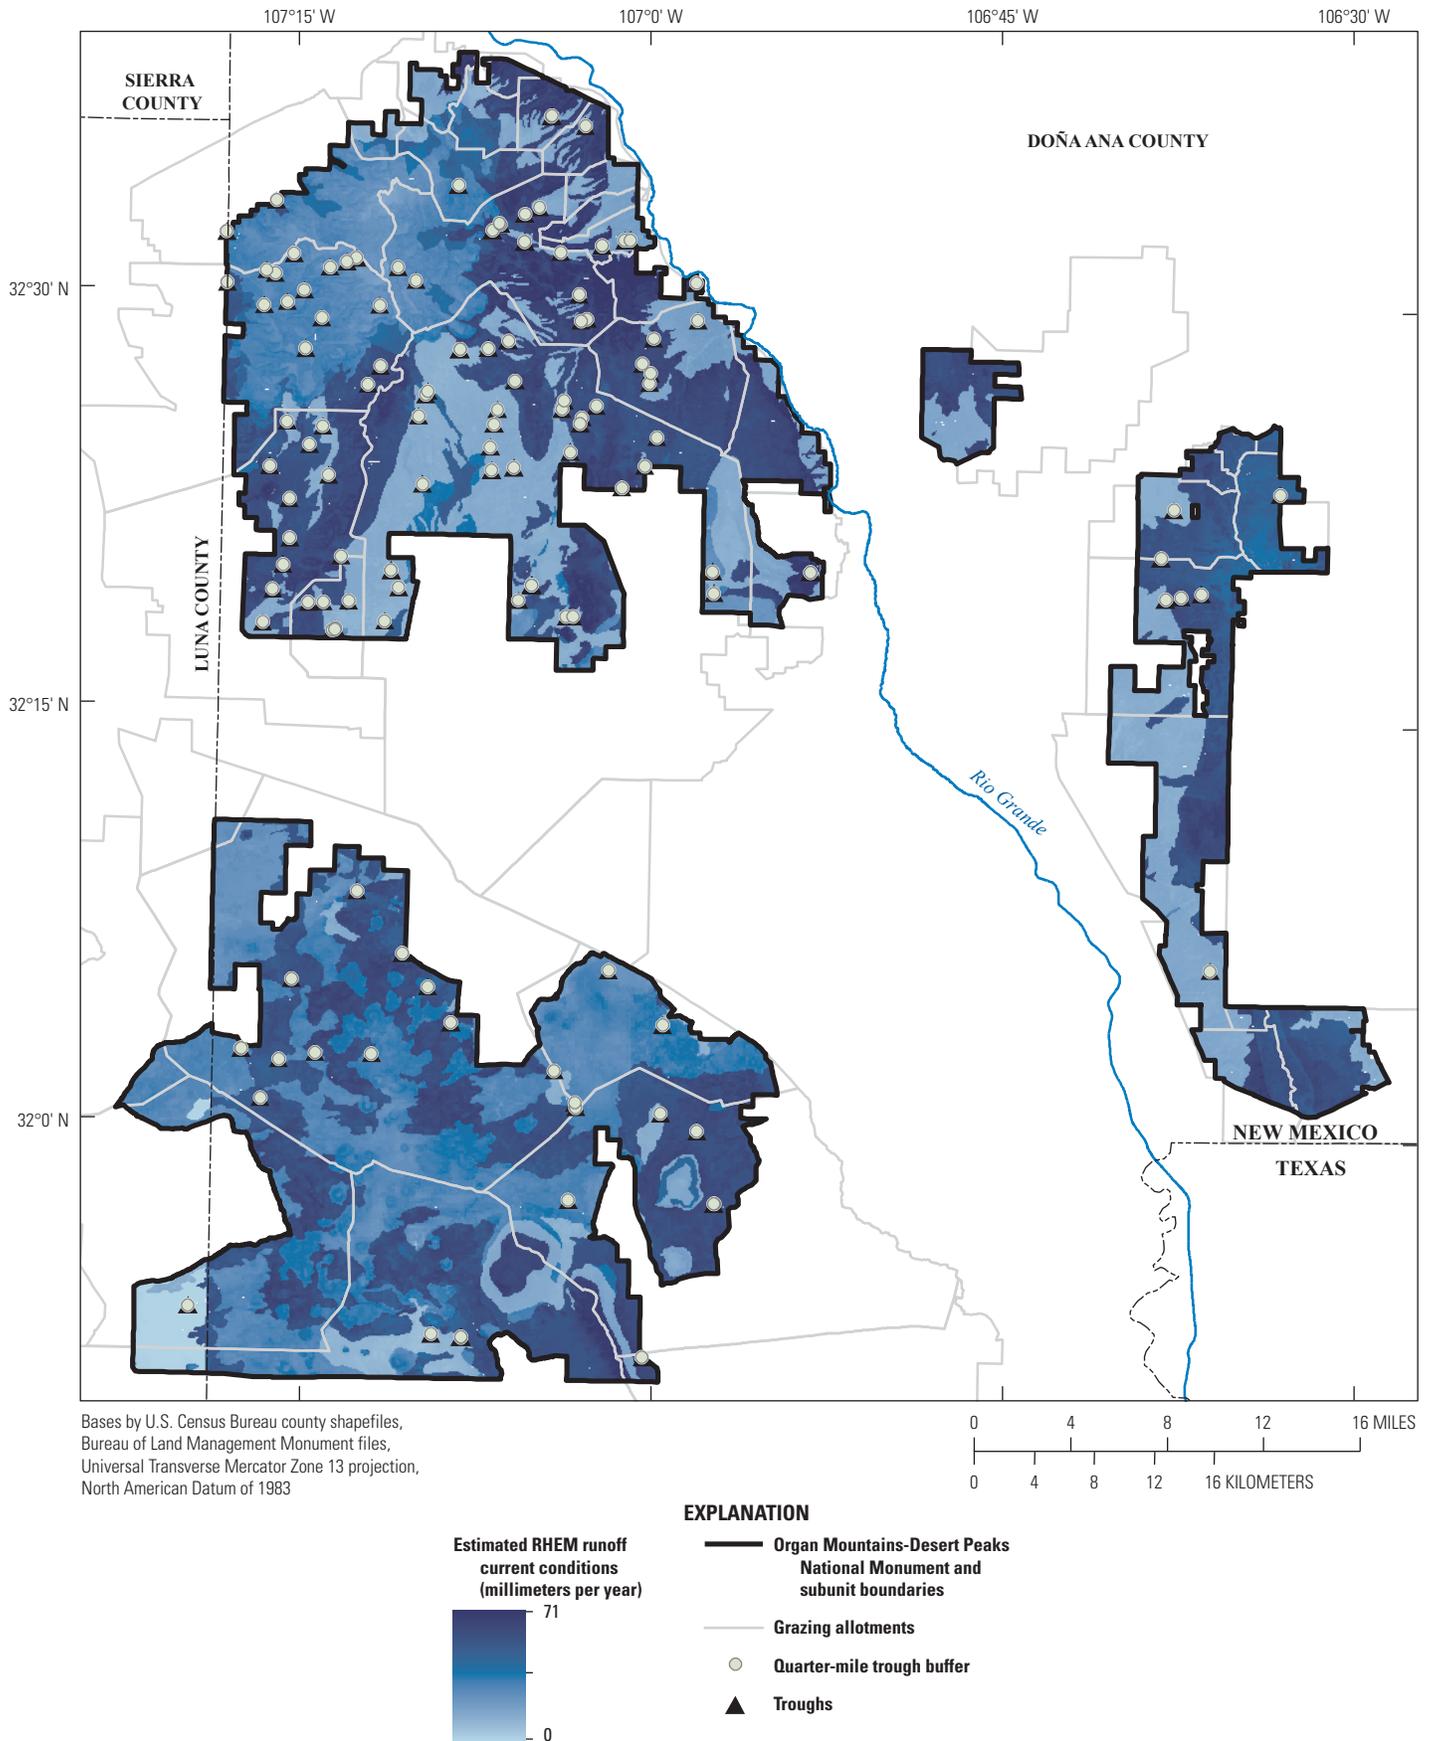
Figure 32. Watering trough locations and baseline runoff conditions simulated by the Rangeland Hydrology and Erosion Model (RHEM), Organ Mountains-Desert Peaks National Monument, New Mexico.

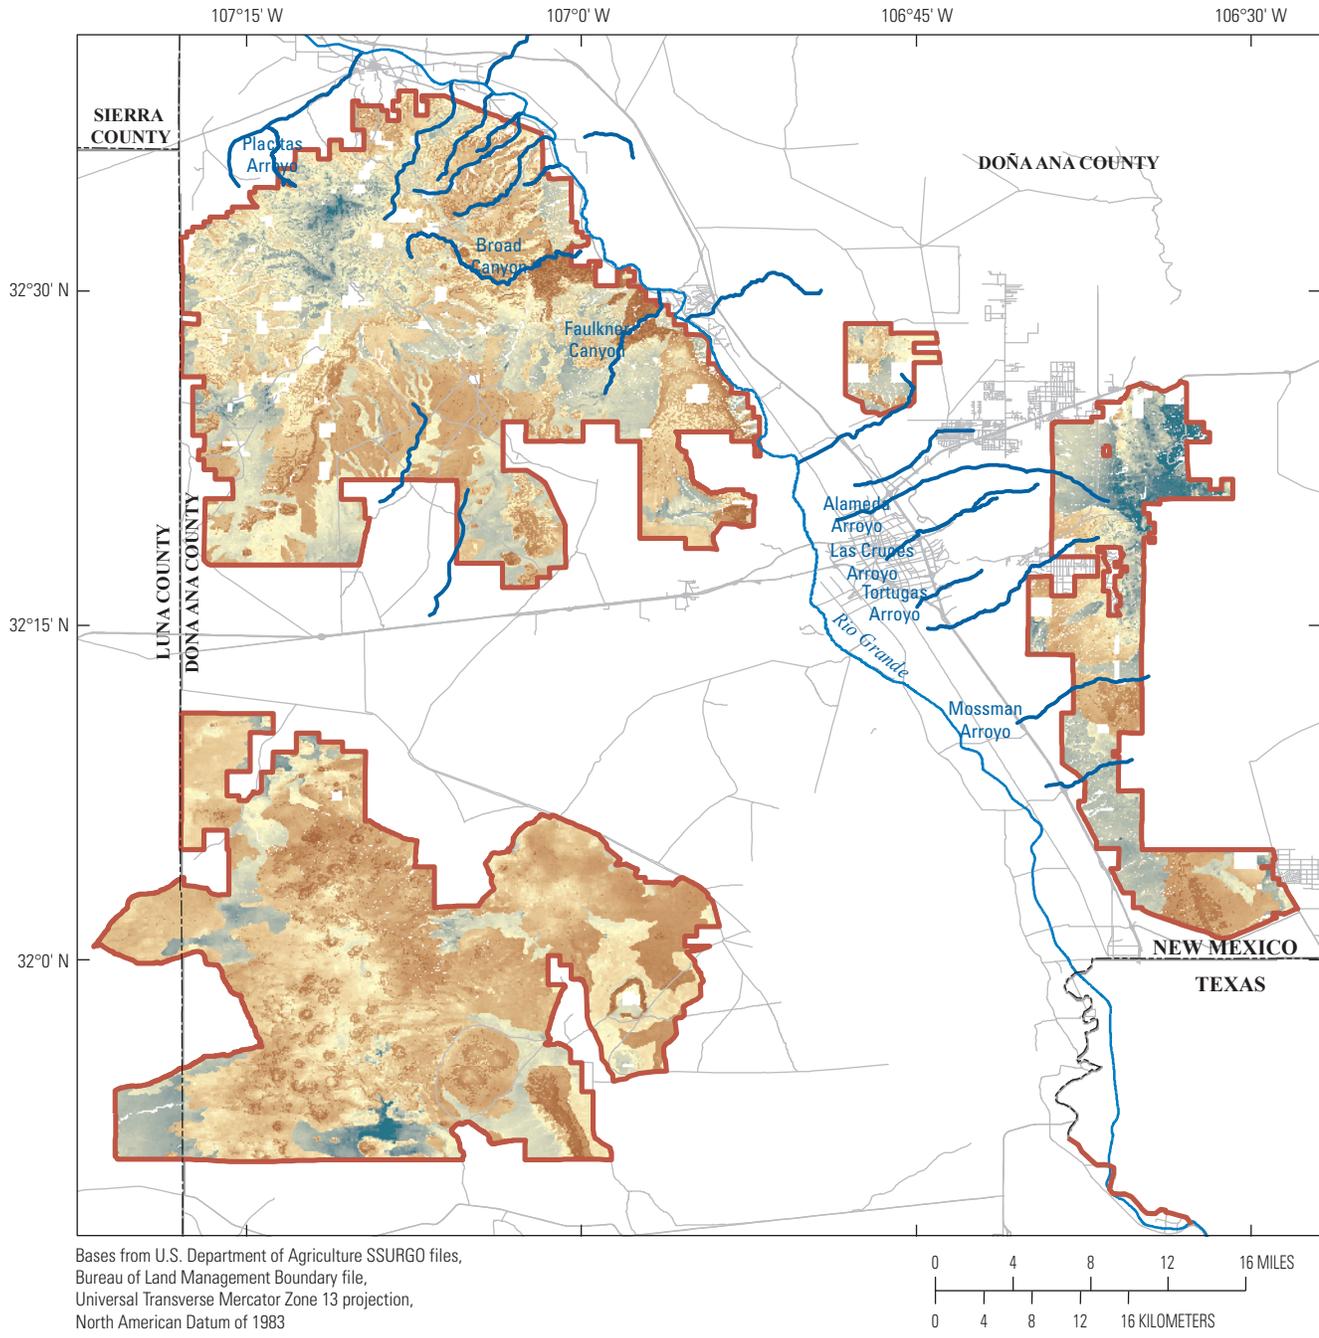
Figure 33. Location of arroyos of concern and infiltration potential in the Organ Mountains-Desert Peaks National Monument, New Mexico.
