Stormwater Quality of Infrastructure Elements in Rapid City, South Dakota, 2016–18

Scientific Investigations Report 2020–5004

By Galen K. Hoogestraat

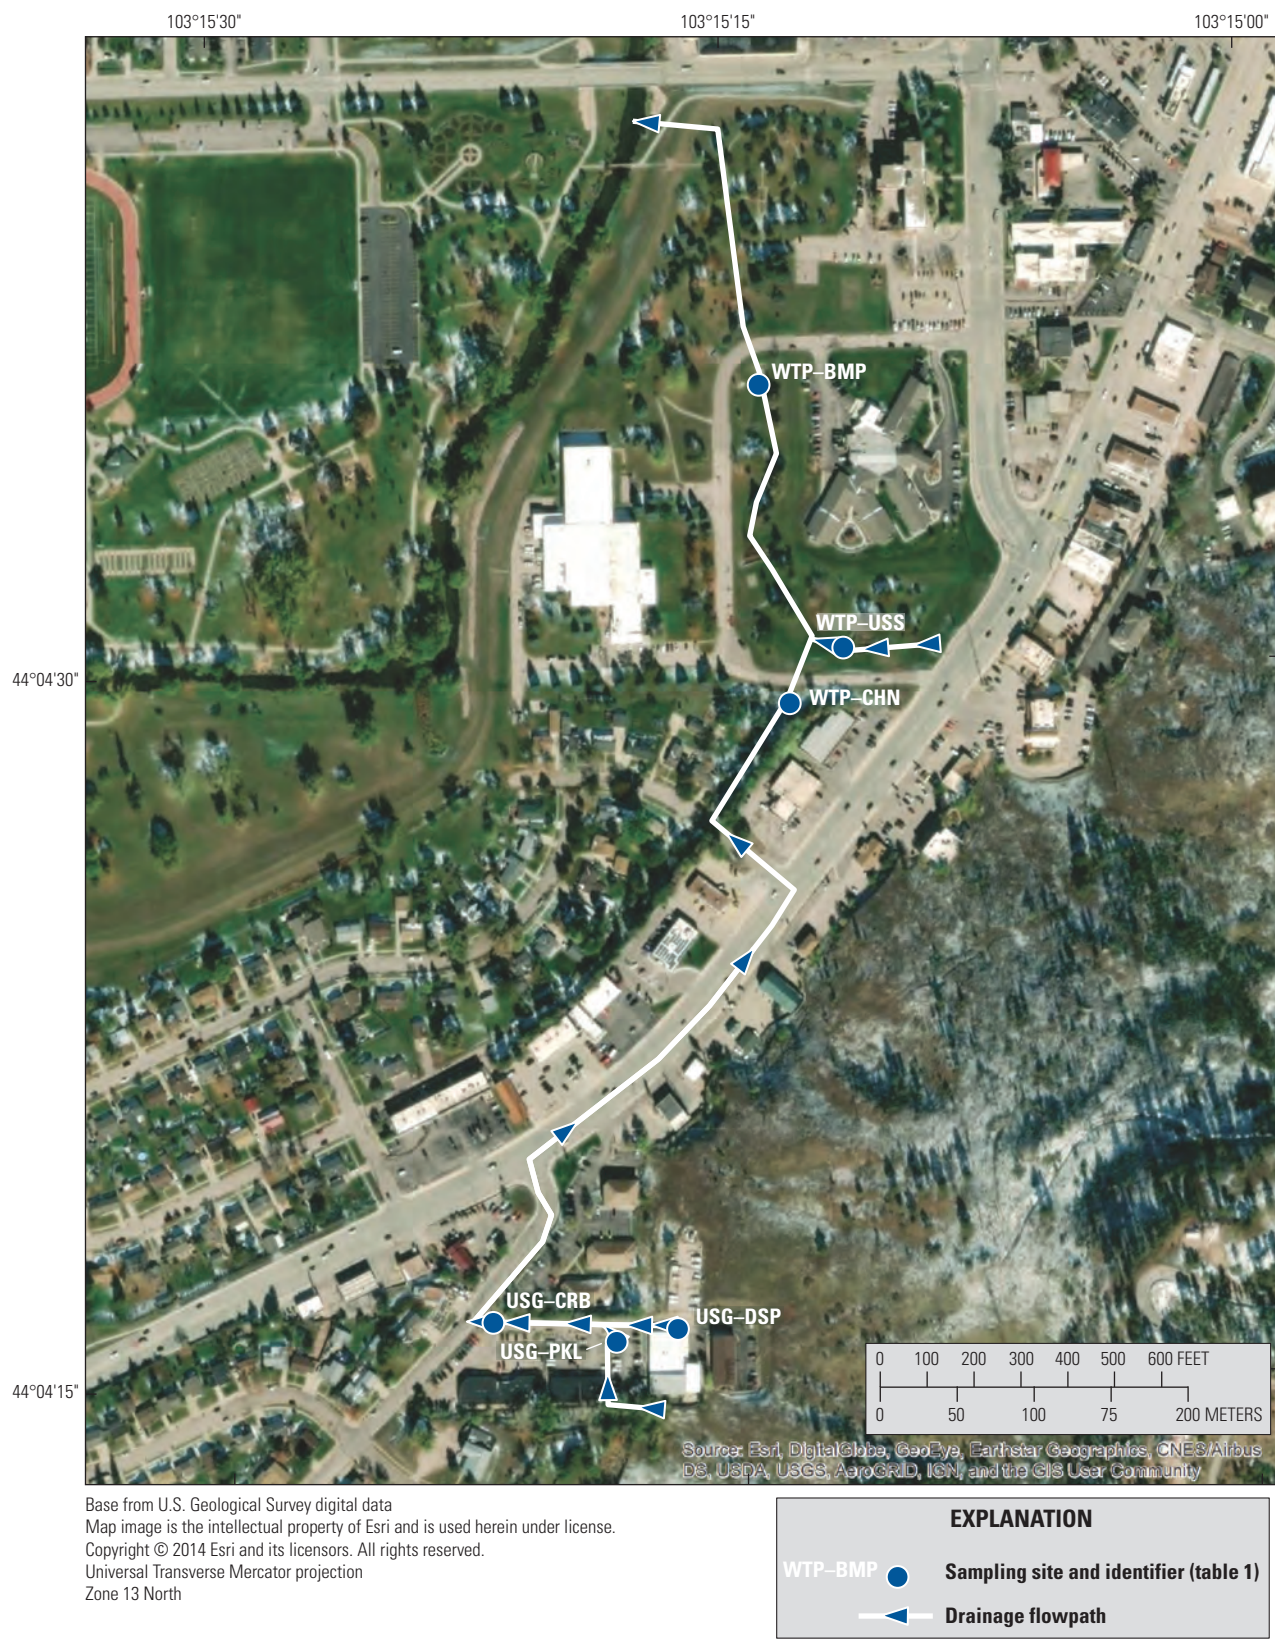
Figure 2. Jackson stormwater-quality flowpath sampling sites and drainage flowpath network in Rapid City, South Dakota.

Each of the three flowpaths represents a unique set of land-use characteristics that affect stormwater quality. The Jackson flowpath (figs. 2–3) originates at a commercial office complex (fig. 3A) and includes a curb (fig. 3B), an underground storm sewer (fig. 3C), and an open concrete-lined channel flow before flowing into an infiltration trench/retention area (fig. 3D). The Jackson flowpath sampling sites represented all infrastructure types targeted in this study, including a roof downspout, parking lot, underground storm sewer, open drainage channel, and BMP channel outlet. Samples were generally collected at the downspout, parking lot, and street curb sites before sample collection at the channel and storm sewer sites farther down the flowpath. The channel and storm sewer sites (table 2) in the Jackson flowpath (WTP–USS, WTP–CHN, and WTP–BMP) included stormwater drainage from a highly developed commercial corridor area (northwest corner of fig. 2) not represented by the upstream flowpath sites (USG–DSP, USG–PKL, and USG–CRB).

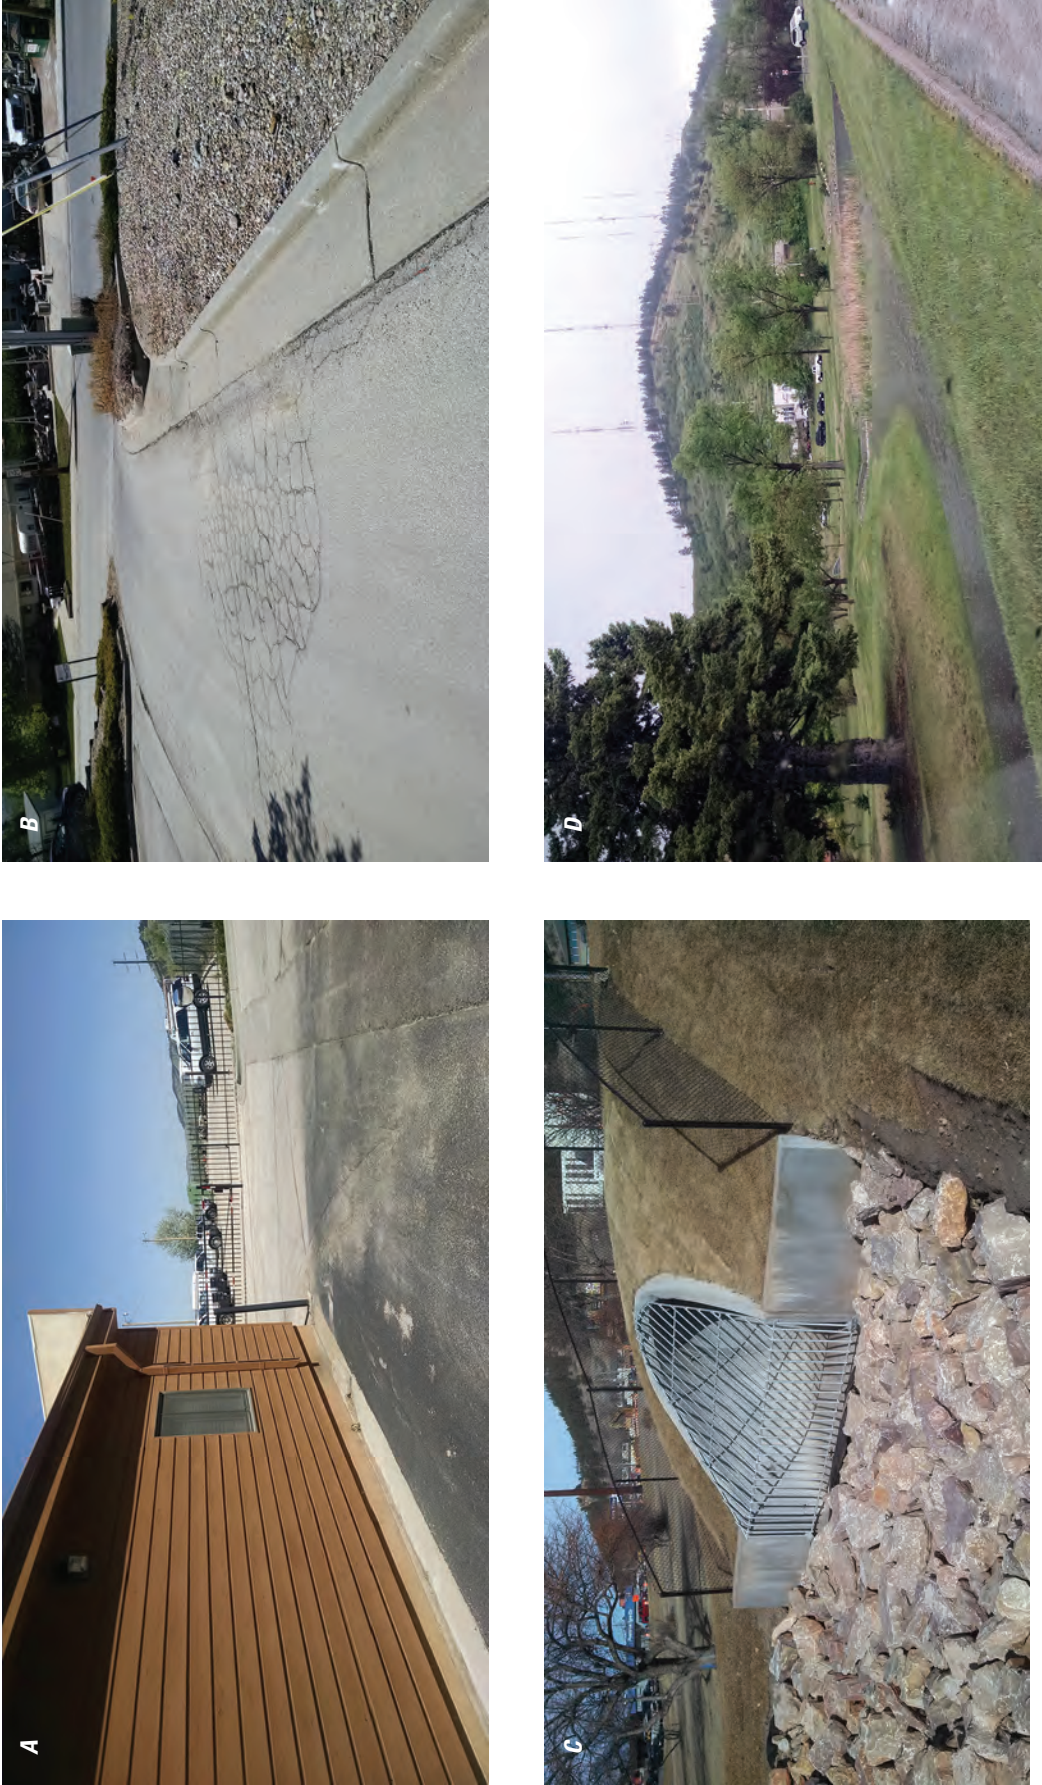
Figure 3. Jackson stormwater-quality flowpath sampling site types in Rapid City, South Dakota. *A*, roof downspout site USG–DSP; *B*, street curb site USG–CRB; *C*, underground storm sewer outfall site WTP–USS; *D*, channel/storm sewer site WTP–BMP.

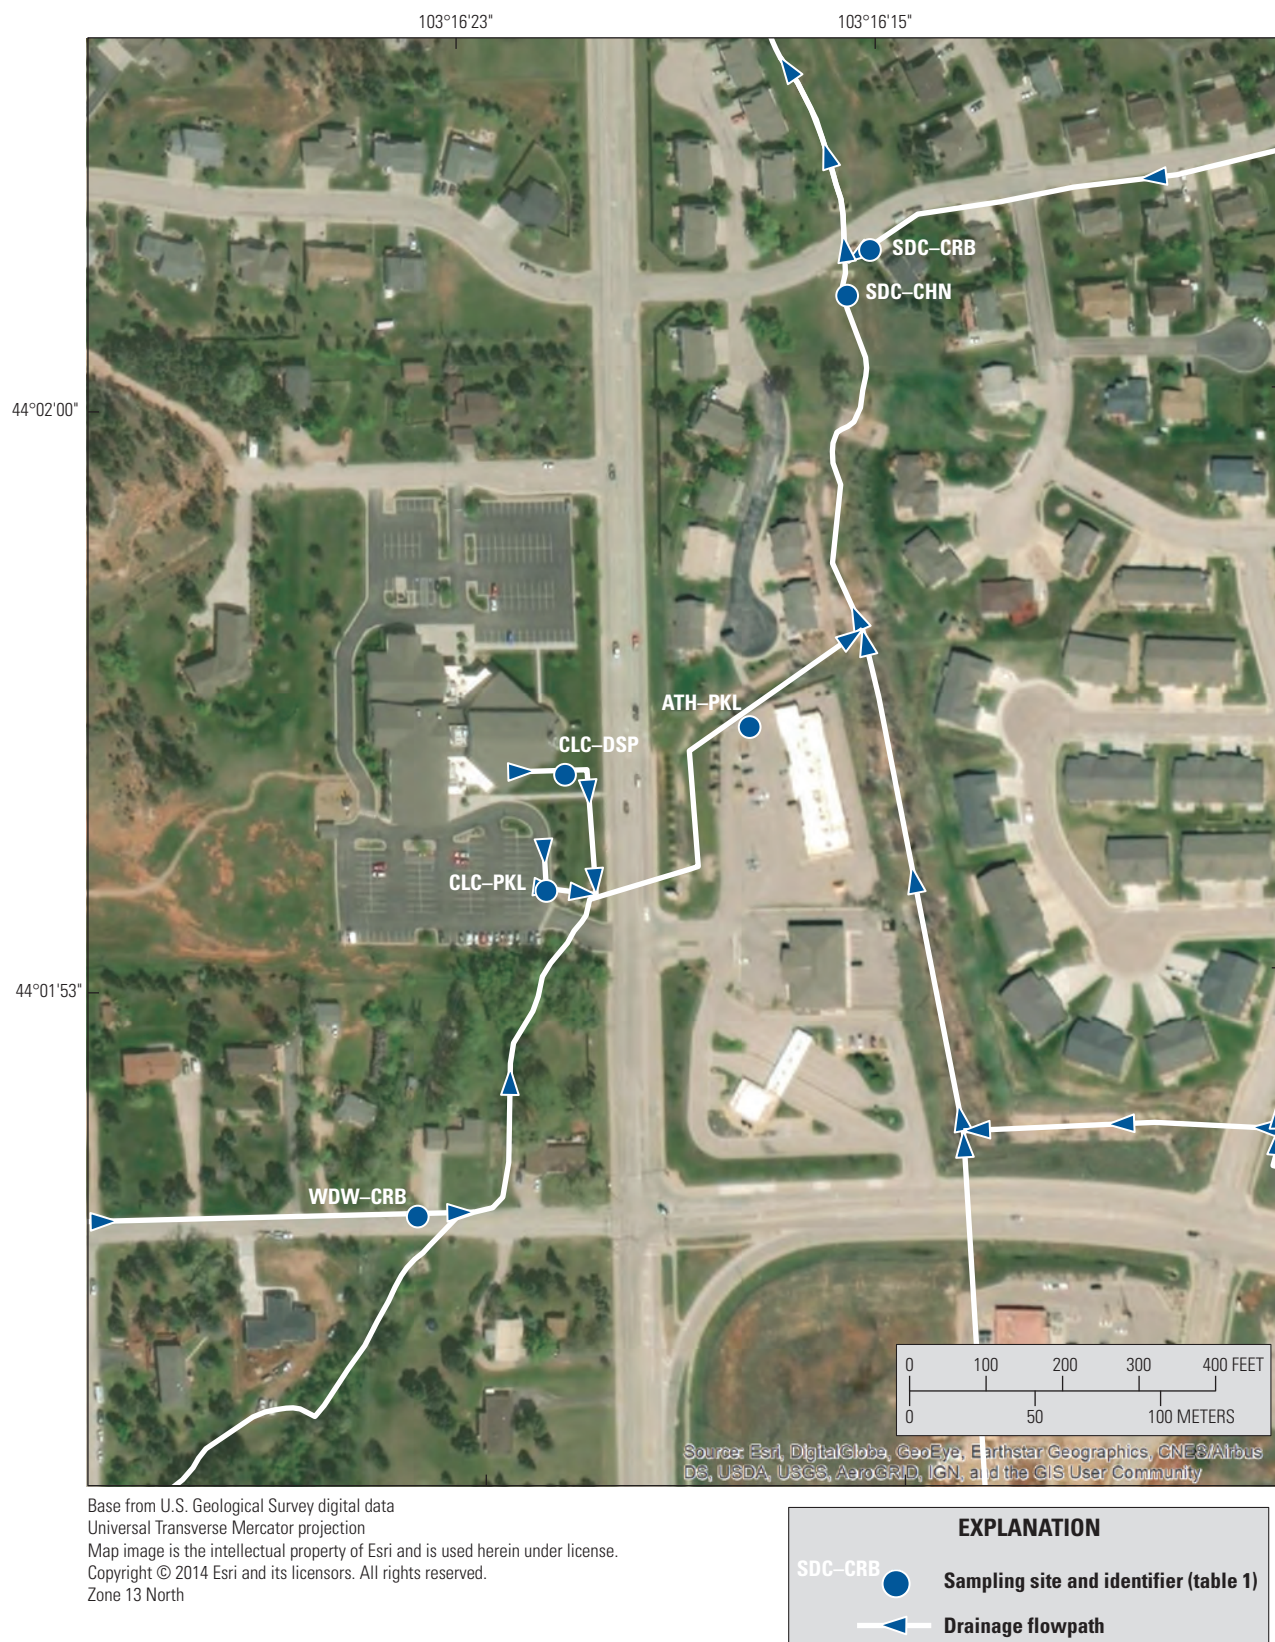
Figure 4. Wildwood stormwater-quality flowpath sampling sites and drainage flowpath network, Rapid City, South Dakota.

The Wildwood flowpath contains a mix of low-density residential and commercial uses in the drainage area. The upper end of the Wildwood flowpath (figs. 4–5) contains primarily low-density residential lots with septic systems. When FIB are detected in surface water that originates from these areas, a common hypothesis has been that septic systems are a likely source; however, past monitoring has indicated that higher bacteria concentrations are often measured in Rapid City urban basins that do not have septic systems (Hoogestraat, 2015). The Wildwood flowpath includes commercial parking lot outfalls, curb discharges, and grass-lined channels in the same general area. The Wildwood flowpath sampling sites (table 2; fig. 4) included 1 roof downspout (CLC–DSP; fig. 5C), 2 parking lots (CLC–PKL and ATH–PKL; figs. 5A and 5D), 2 street curbs (WDW–CRB and SDC–CRB; figs. 5B and 5E), and 1 open grass-lined drainage channel (SDC–CHN; fig. 5E).

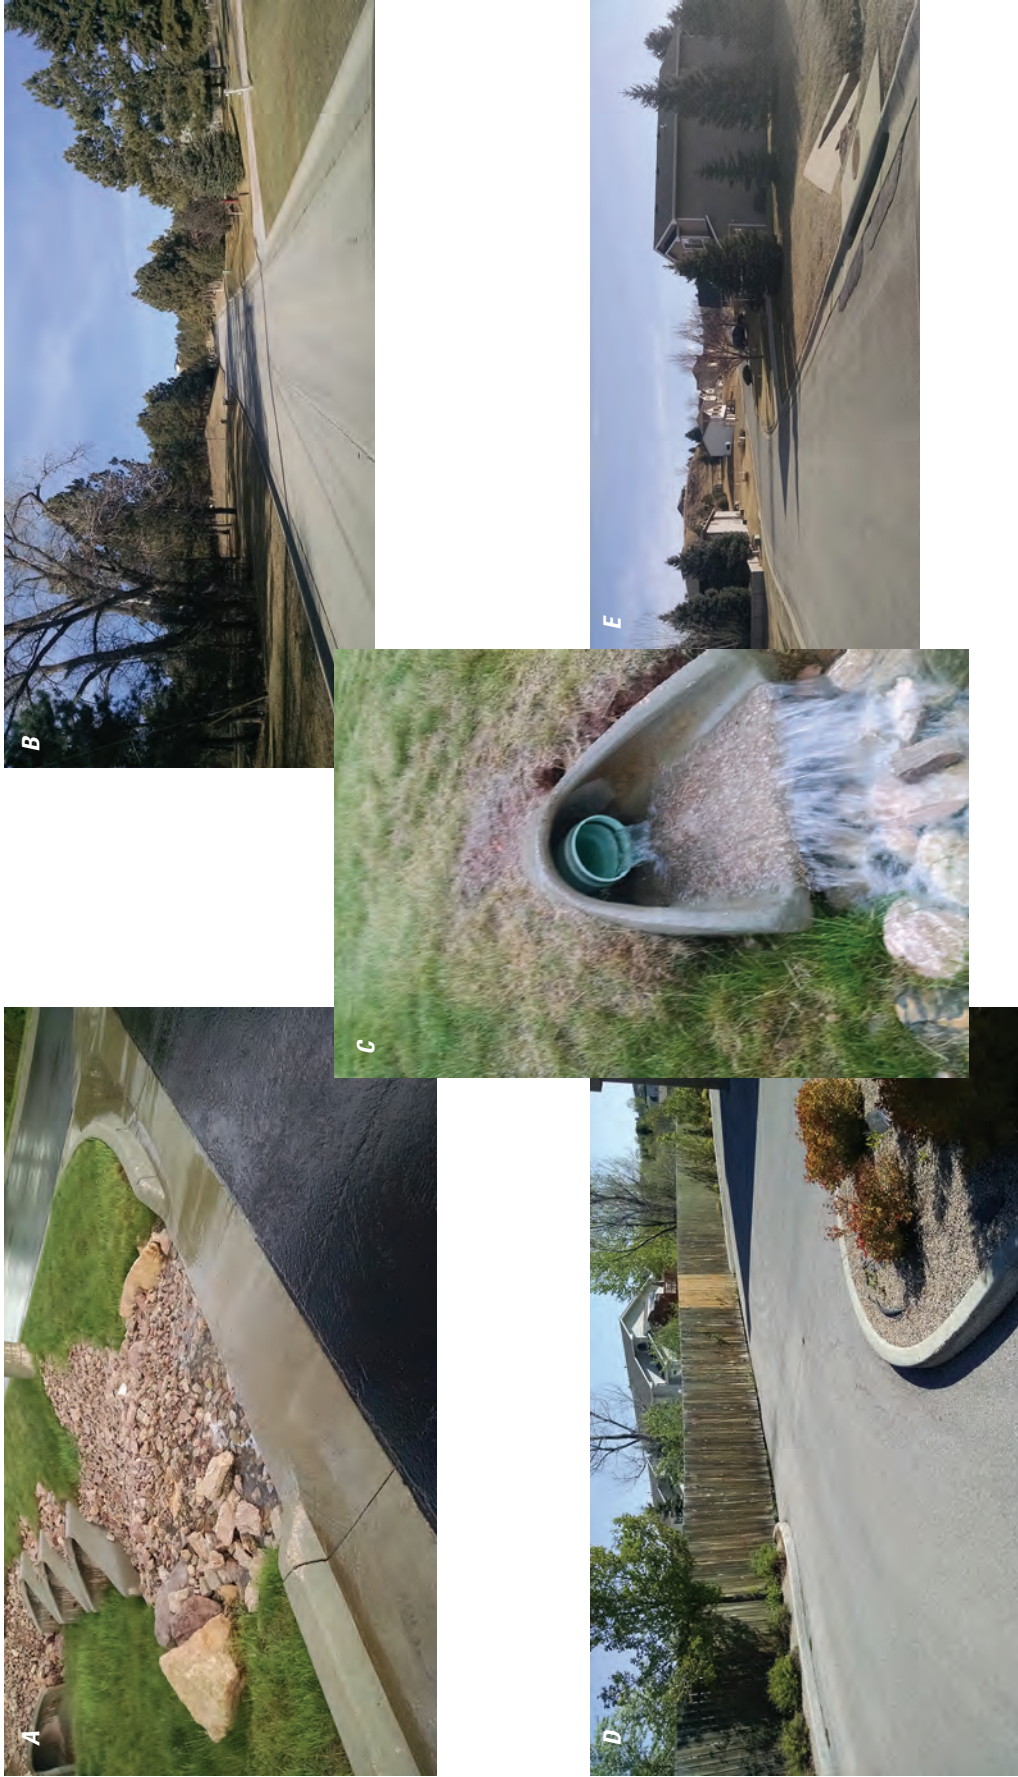
Figure 5. Wildwood stormwater-quality flowpath sampling site types in Rapid City, South Dakota. A, parking lot site CLC-PKL; B, street curb site WDW-CRB; C, outlet pipe from roof downspout site CLC-DSP; D, parking lot site ATH-PKL; E, street curb site SDC-CRB in center of photograph and channel/storm sewer site SDC-CHN at culvert on right side of photograph.

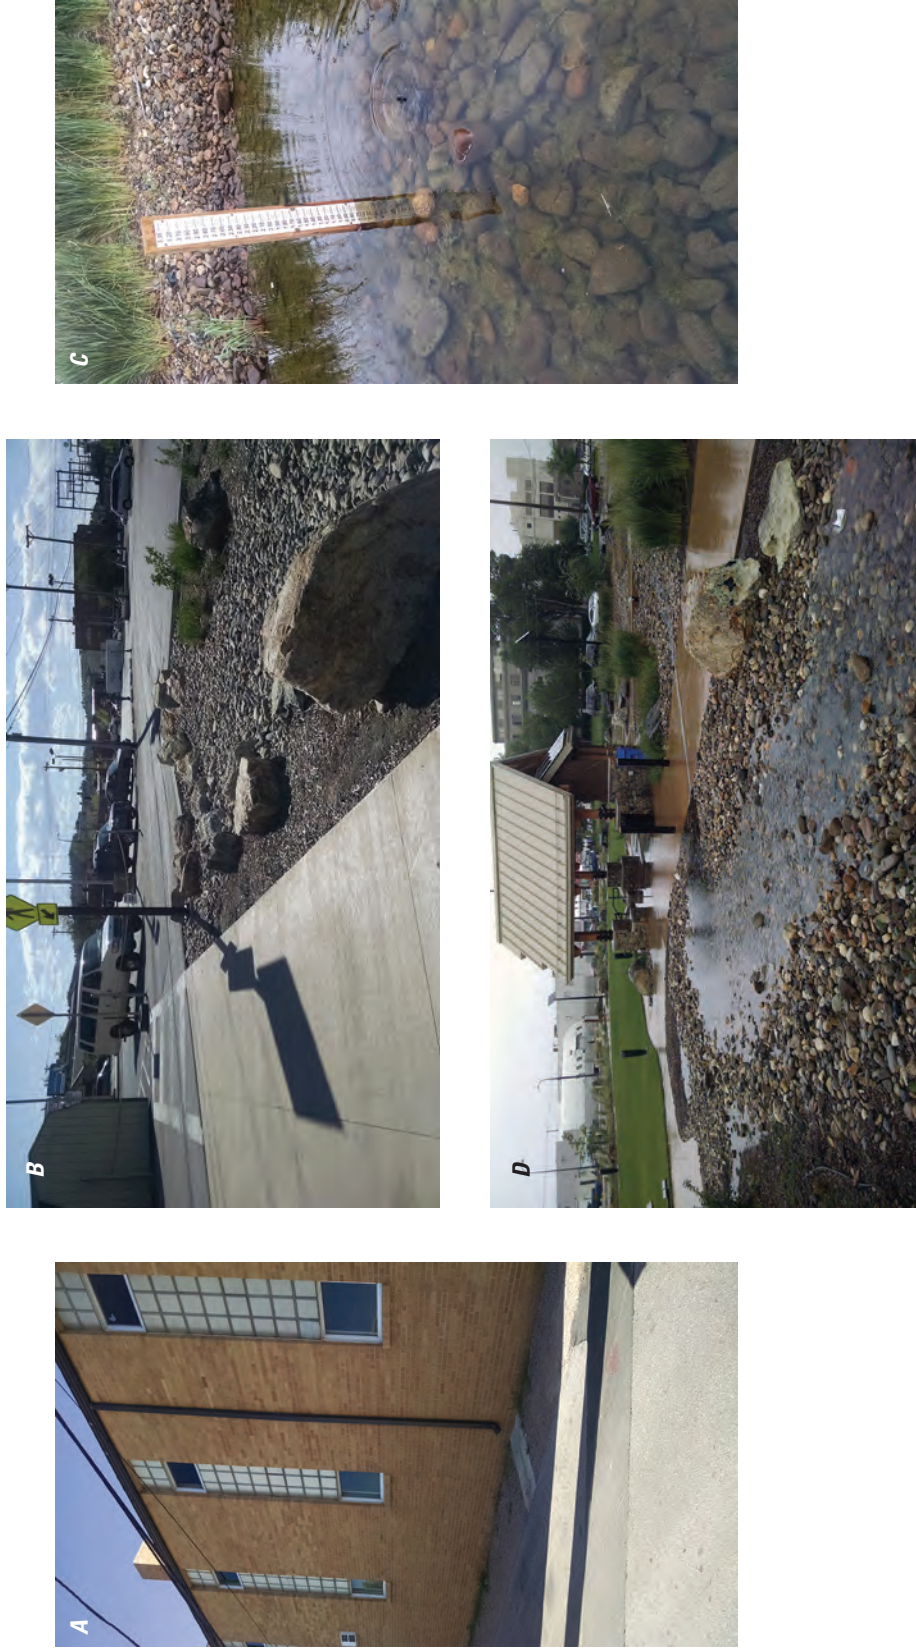
Figure 7. Eco Prayer Park stormwater-quality flowpath sampling site types in Rapid City, South Dakota. *A*, roof downspout site EPP–DSP; *B*, parking lot site EPP–PKL; *C*, retention pond stage plate site EPP–BMP; *D*, rock channel site EPP–CHN.

be attributed entirely to commercial uses and street traffic. The Eco Prayer Park flowpath sites (table 2) included 1 roof downspout (EPP–DSP; fig. 7A), 1 parking lot (EPP–PKL; fig. 7B), 1 rock-lined channel (EPP–CHN; fig. 7C), and 1 outlet from a small retention pond BMP (EPP–BMP; fig. 7D). A stage plate was installed in the retention pond to record changes in the water level during runoff at the EPP–BMP site (fig. 7D). During high inflows to the Eco Prayer Park, the flow splits between the rock channel and an overflow path into a grassed lawn area to the north side (fig. 6). This grassed lawn contains underdrains that flow back into the retention pond.
