Prepared in cooperation with the U.S. Army Corps of Engineers

Biological and Habitat Assessment of the Lower Rouge River, Michigan, 2018

Scientific Investigations Report 2020–5009

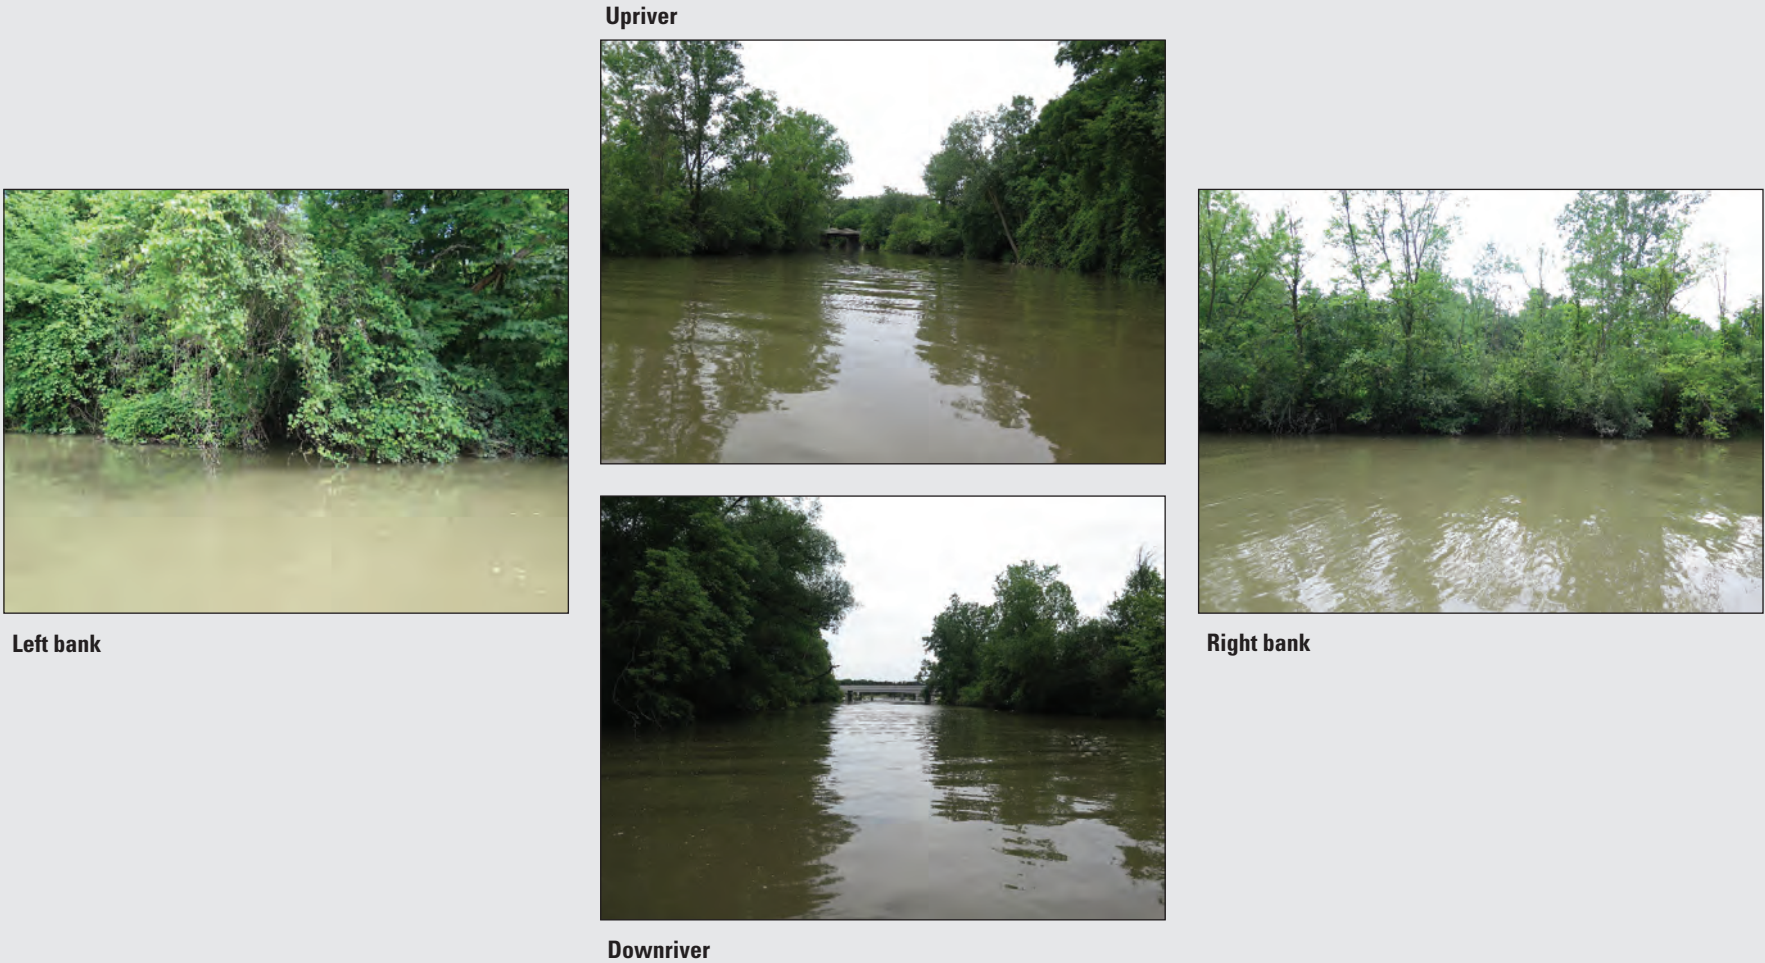
RR-003 June

Figure 4. Photographs of the lowermost assessment site (RR-003) upriver from the concrete channel reach in the lower Rouge River. The Michigan Avenue Bridge that marks the start of the concrete channel is visible in the backdrop of the downriver photograph. Photographs were taken facing upriver, downriver, and the right and left banks. *Vitis* spp. (grape vines) covered much of the foliage along the left bank. Photographs taken June 21, 2018, by U.S. Geological Survey.

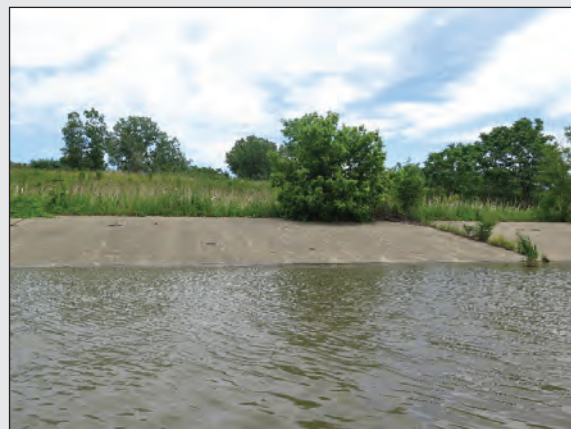
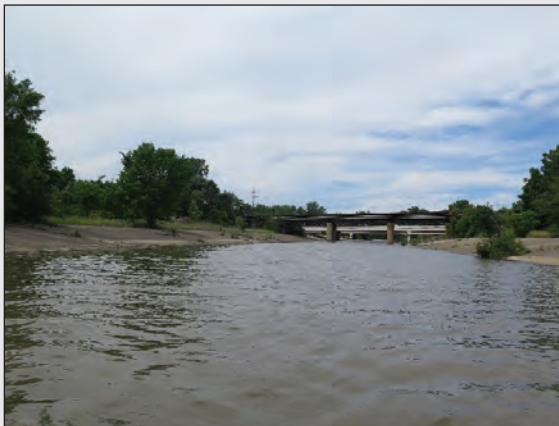
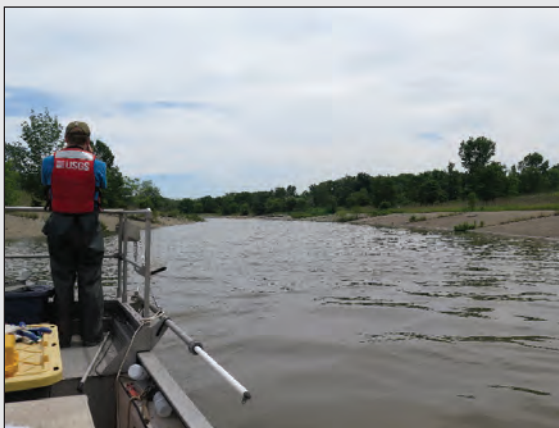
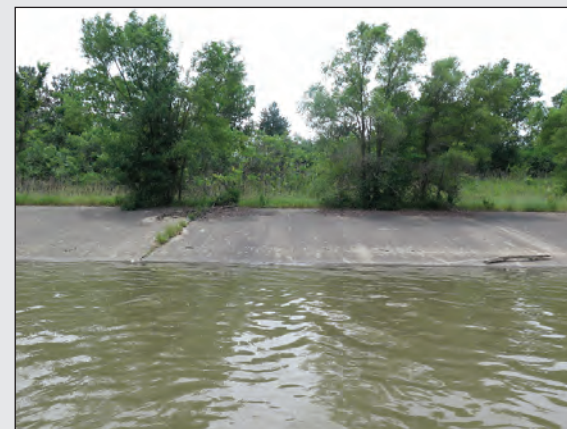
RR-004 June

Figure 5. Photographs of the uppermost assessment site (RR-004) in the concrete channel reach of the lower Rouge River. The Michigan Avenue Bridge that marks the start of the concrete channel is visible in the backdrop of the upriver photograph. Photographs were taken facing upriver, downriver, and the right and left banks. Riparian vegetation was limited to the part of the flood plain above the concrete channel and cracks within the concrete. Photographs taken June 21, 2018, by U.S. Geological Survey.

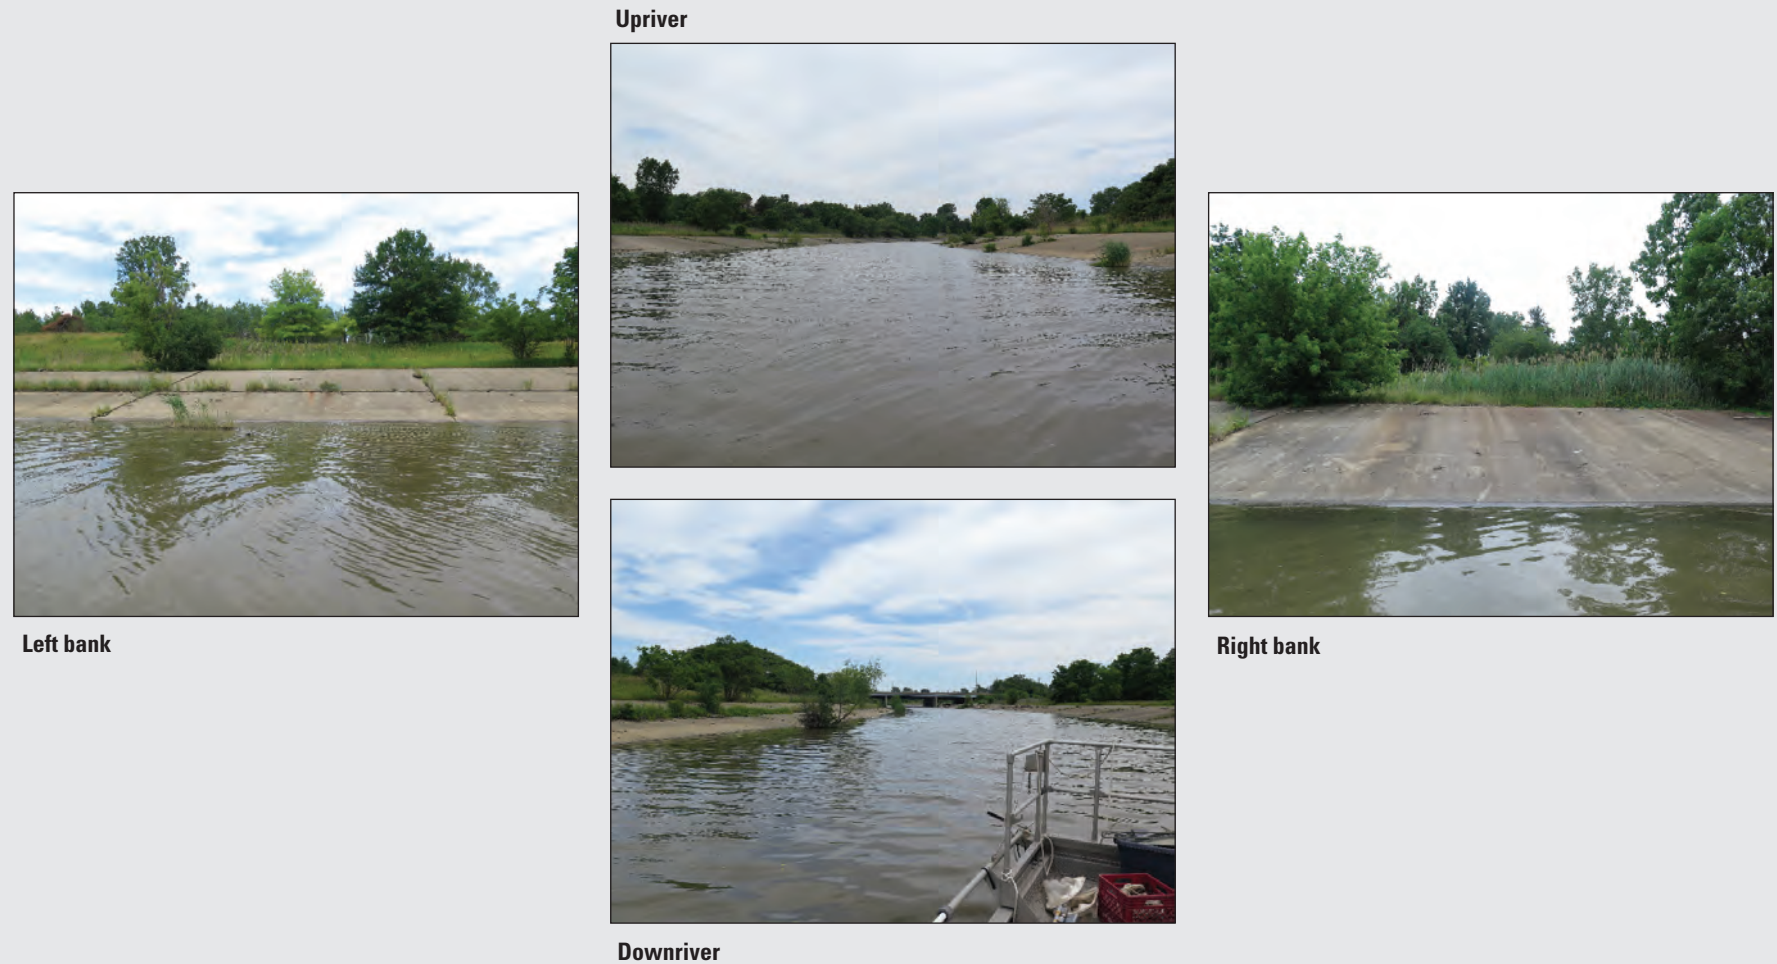
RR-005 June

Figure 6. Photographs of assessment site RR-005 in the concrete channel reach. Photographs were taken facing upriver, downriver, and the right and left banks. The Southfield Freeway Bridge is visible in the backdrop of the downriver photo. Riparian vegetation was limited to the part of the flood plain above the concrete channel and cracks within the concrete. A single *Salix* spp. (willow) growing near the water's edge on the left bank is visible in the middle of the downriver photograph. Photographs taken June 21, 2018, by U.S. Geological Survey.

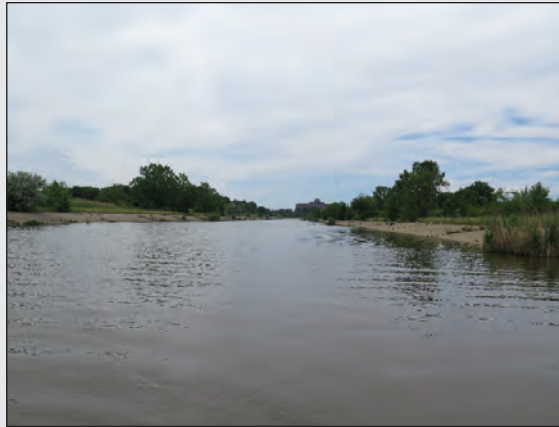
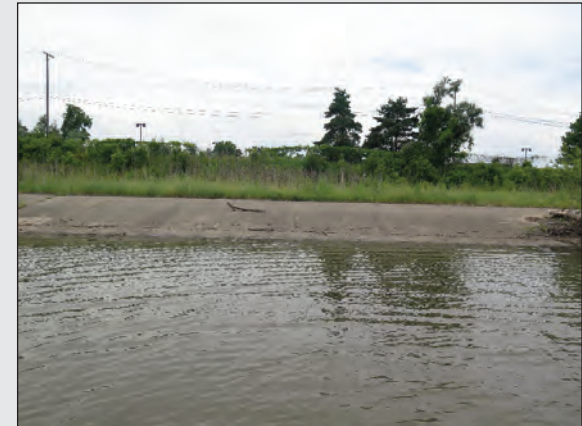
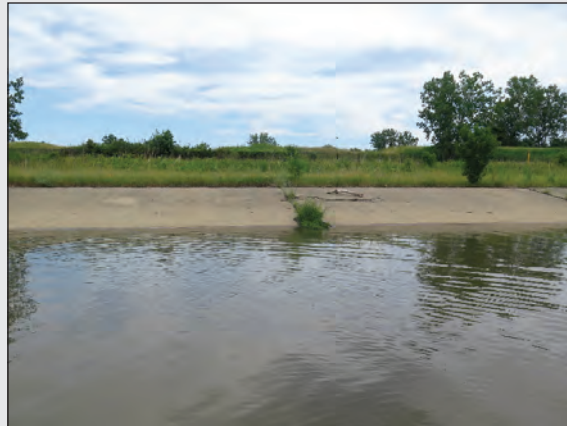
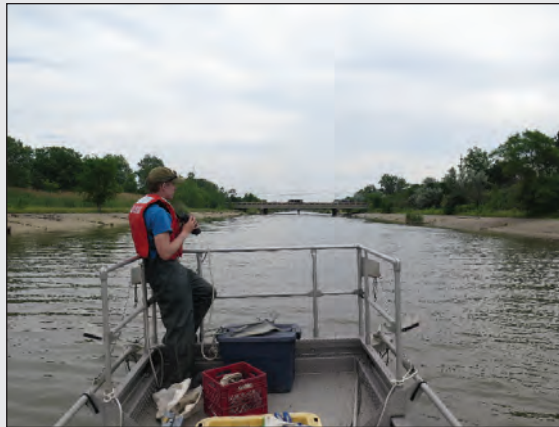
RR-006 June

Figure 7. Photographs of assessment site RR-006 in the concrete channel reach. Photographs were taken facing upriver, downriver, and the right and left banks. The Rotunda Drive bridge is visible in the background of the downriver photograph. Riparian vegetation was limited to the part of the flood plain above the concrete channel and cracks within the concrete. Sparse woody debris can be seen along the banks above the waterline. Photographs taken June 21, 2018, by U.S. Geological Survey.

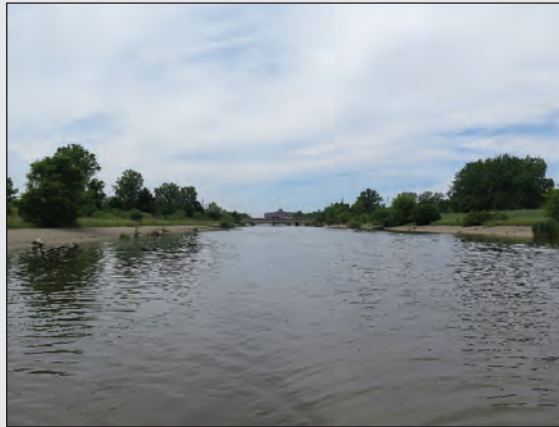
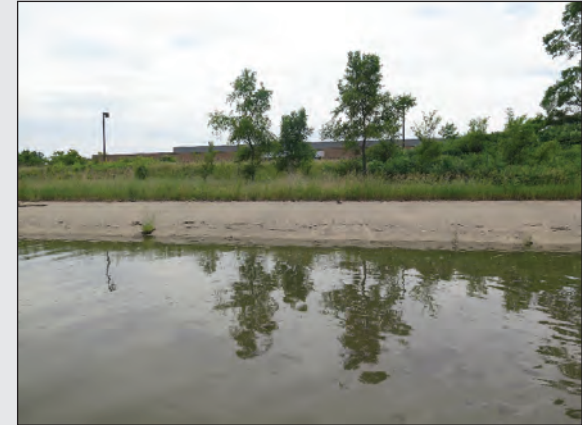
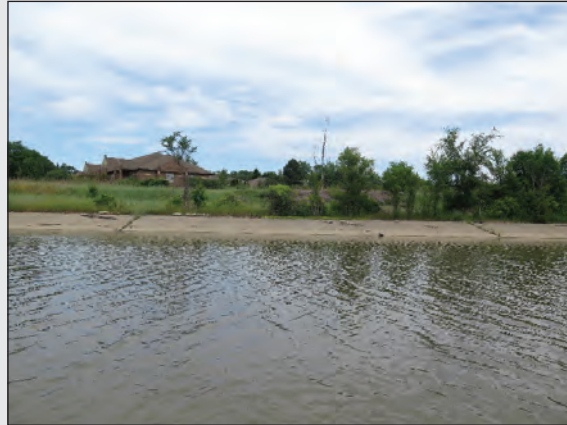
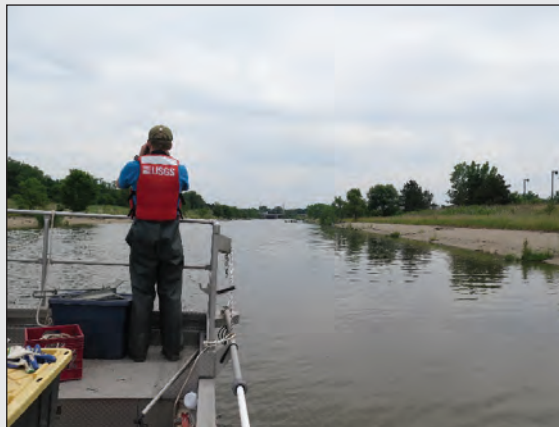
RR-007 June

Figure 8. Photographs of assessment site RR-007 in the concrete channel reach. Photographs were taken facing upriver, downriver, and the right and left banks. Riparian vegetation was limited to the part of the flood plain above the concrete channel and cracks within the concrete. Sparse woody debris can be seen along the banks above the waterline. Photographs taken June 21, 2018, by U.S. Geological Survey.

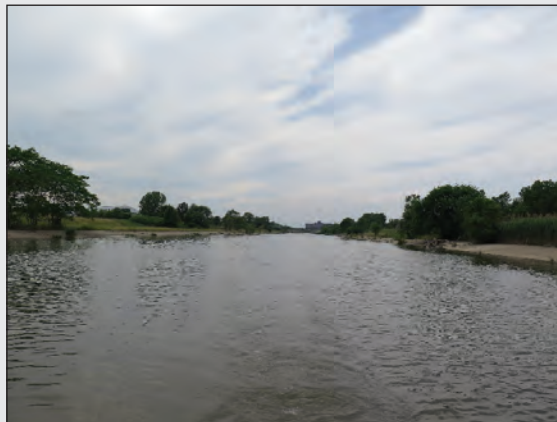
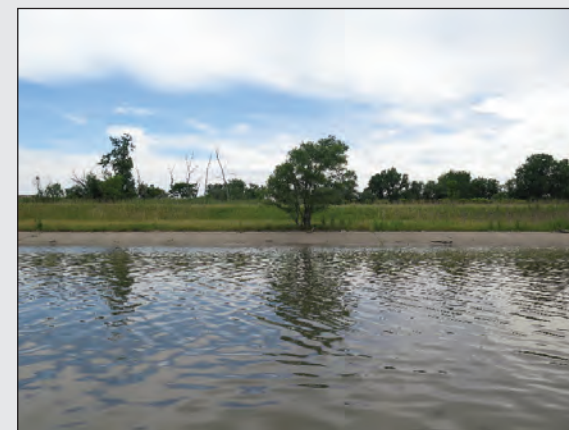
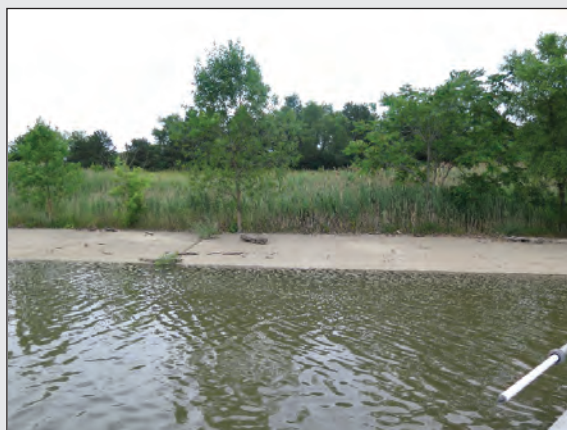
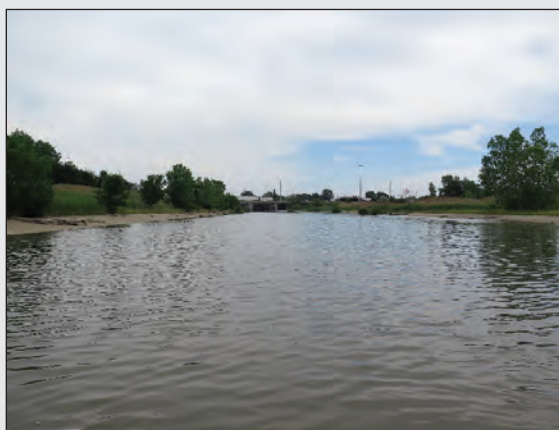
RR-008 June

Figure 9. Photographs of assessment site RR-008 in the concrete channel reach. Photographs were taken facing upriver, downriver, and the right and left banks. The Interstate-94 bridge is visible in the background of the downriver photograph. Riparian vegetation was limited to the part of the flood plain above the concrete channel and cracks within the concrete. Sparse woody debris can be seen along the banks above the waterline. Photographs taken June 21, 2018, by U.S. Geological Survey.

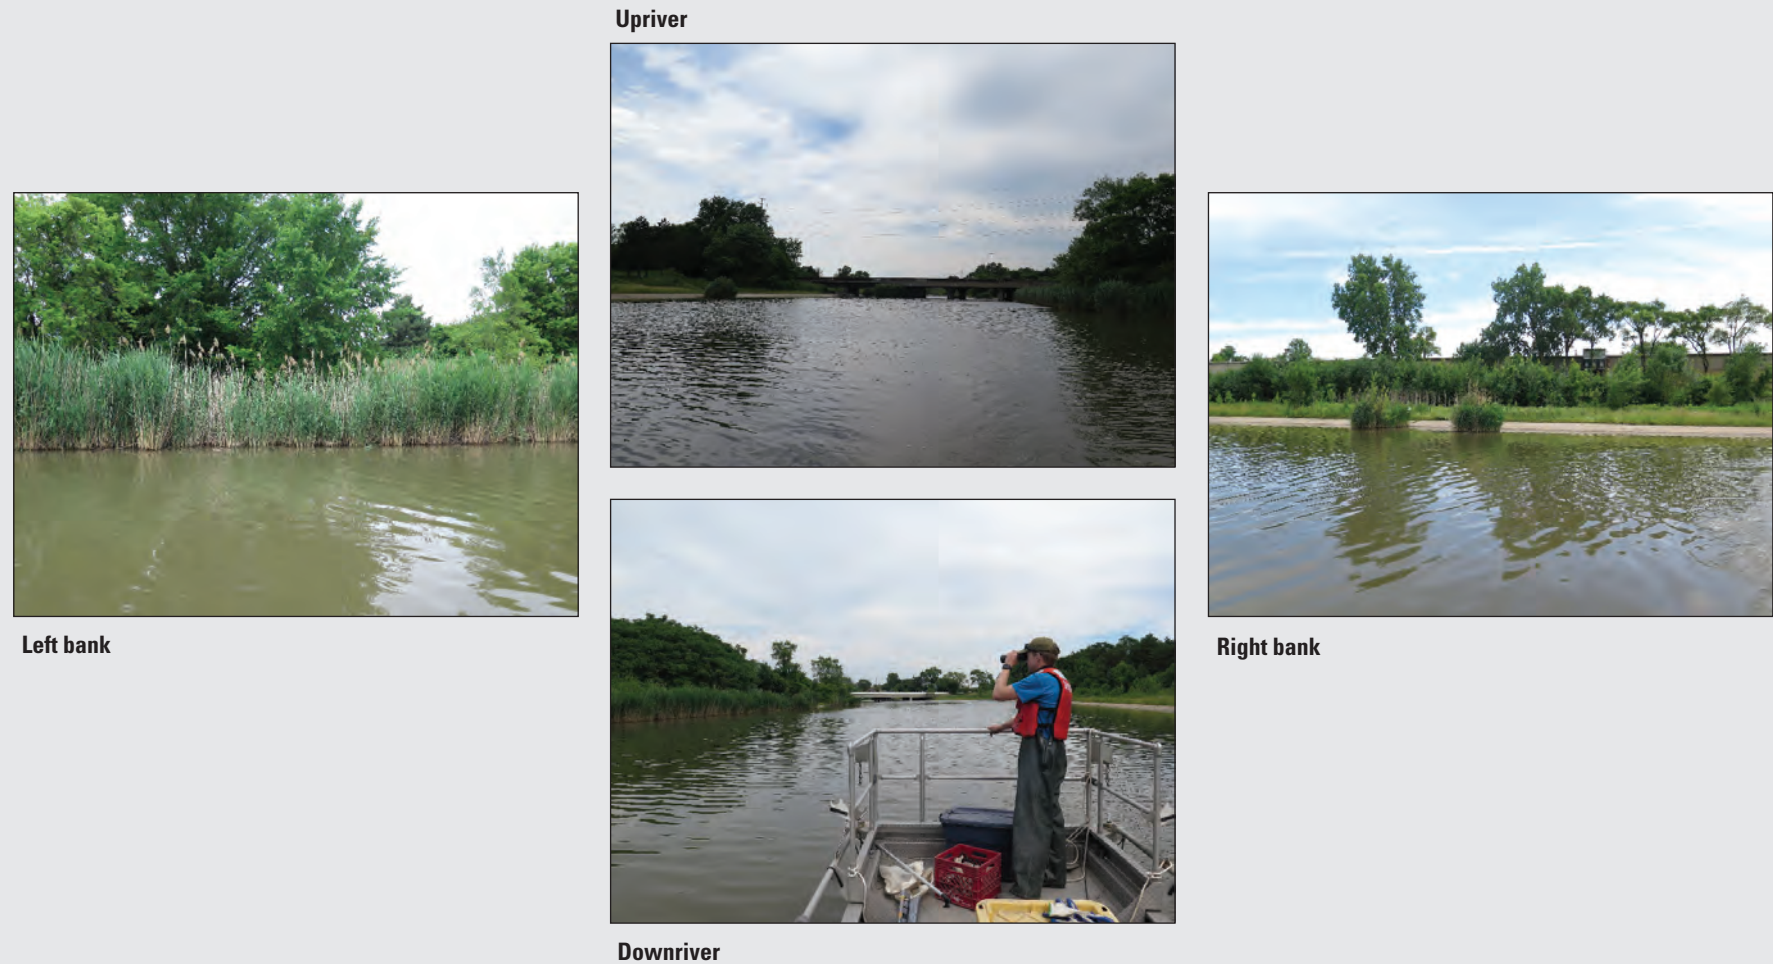
RR-009 June

Figure 10. Photographs of assessment site RR-009 in the concrete channel reach. Photographs were taken facing upriver, downriver, and the right and left banks. The Greenfield Road bridge is visible in the background of the downriver photo and the Melvindale Civic Arena is in the background of the photo facing the right bank. Riparian vegetation along the right bank was limited to the part of the flood plain above the concrete channel and cracks within the concrete. However, a dense patch of *Phragmites* spp. (reed) was growing along the left bank of the site. Photographs taken June 21, 2018, by U.S. Geological Survey.

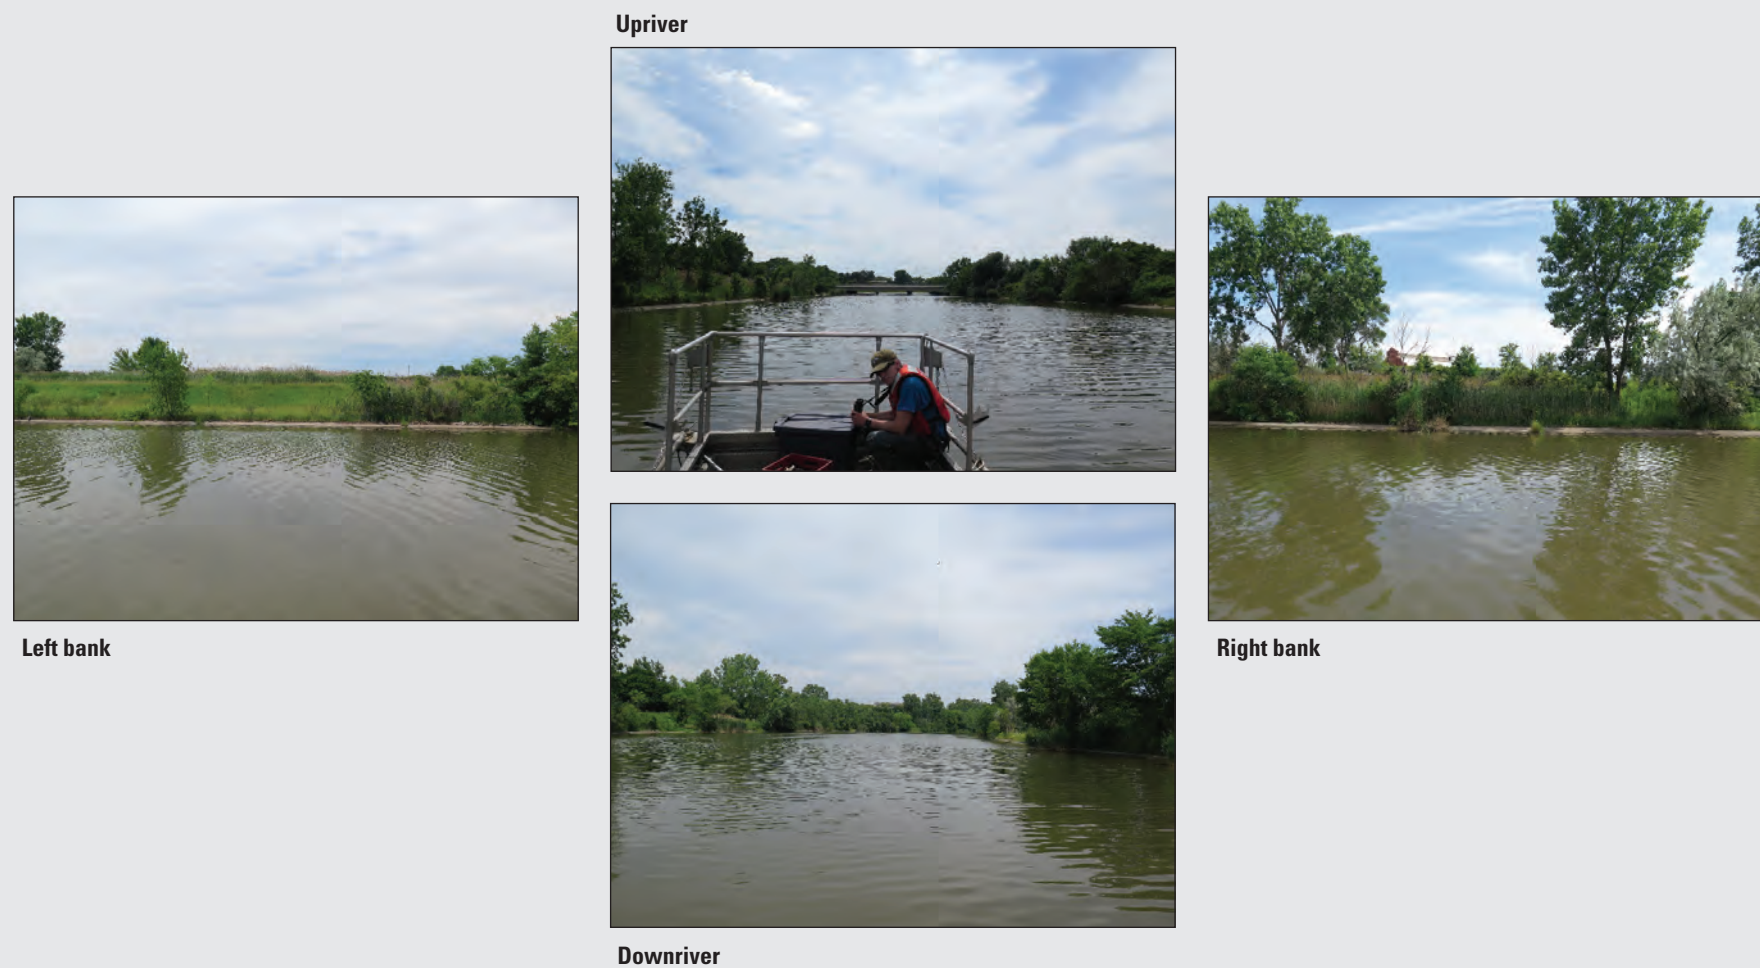
RR-010 June

Figure 11. Photographs of the assessment site RR-010 in the downstream control reach. This is the first site immediately downriver of the part of the lower Rouge River concrete channel reach slated for restoration. Photographs were taken facing upriver, downriver, and the right and left banks. Riparian vegetation along the right bank was limited to the part of the flood plain above the concrete channel and cracks within the concrete. However, the distance between the waterline and upper extent of the concrete channel was less than the upriver sites, and trees and other vegetation overhung the channel. Photographs taken June 21, 2018, by U.S. Geological Survey.

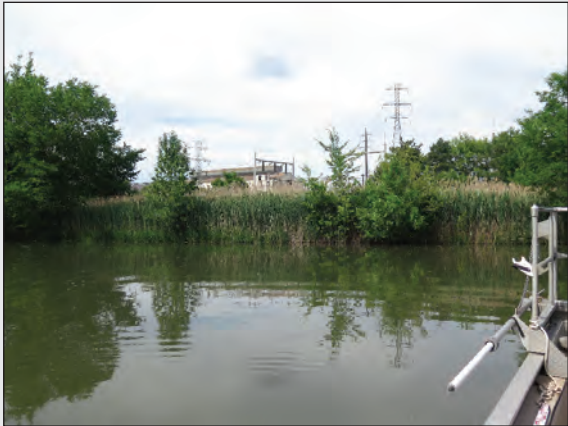
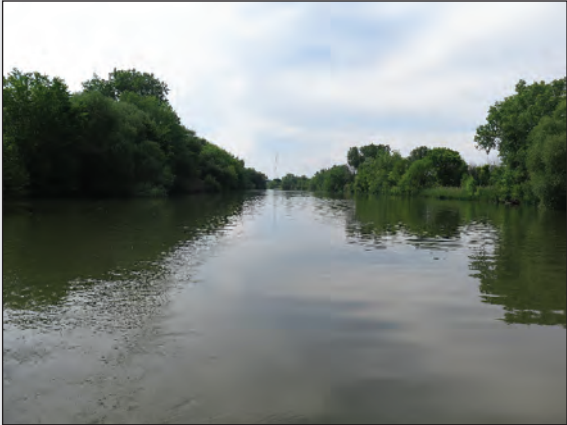
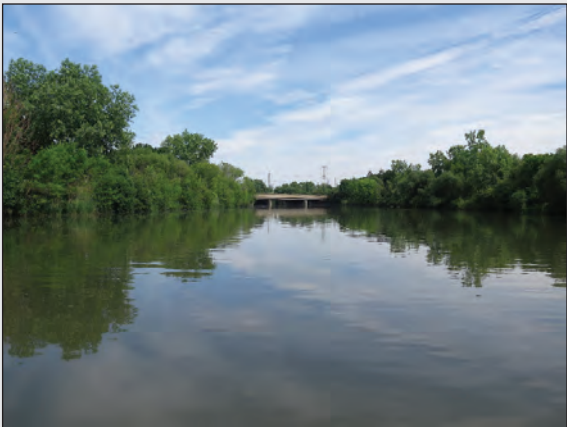
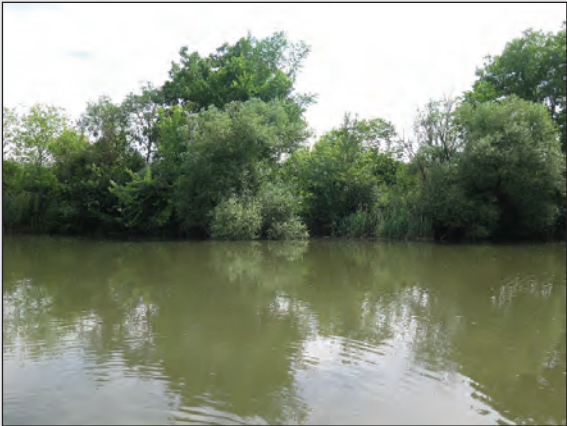
RR-011 June

Figure 12. Photographs of the assessment site RR-011 in the downstream control reach. Photographs were taken facing upriver, downriver, and the right and left banks. The Schaefer Highway bridge is visible in the background of the downriver photograph. Trees, shrubs, and *Phragmites* spp.(reed) were growing at the water's edge and overhung the channel. Photographs taken June 21, 2018, by U.S. Geological Survey.

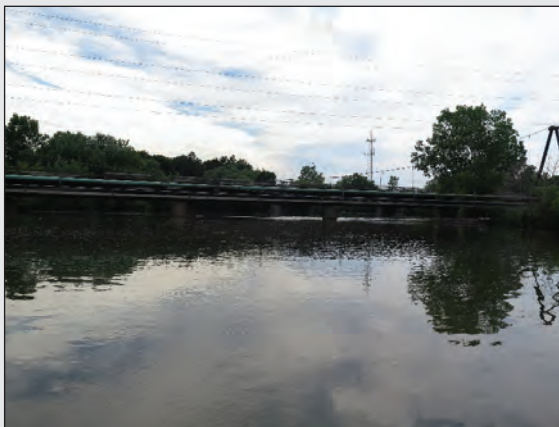
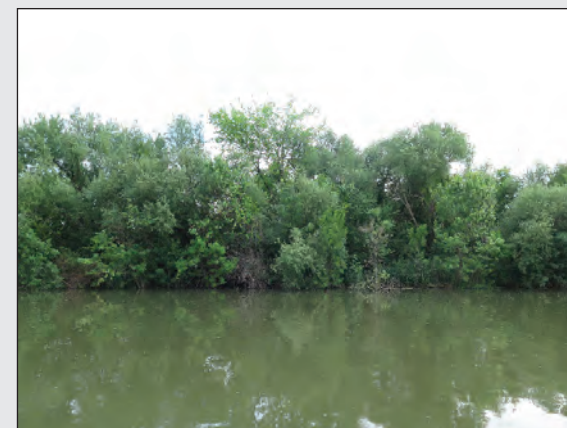
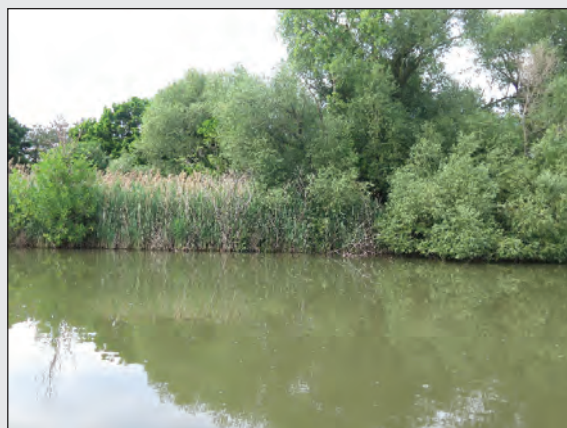
RR-012 June

Figure 13. Photographs of the assessment site RR-012 in the downstream control reach. Photographs were taken facing upriver, downriver, and the right and left banks. A pipeline and railway bridge are visible in the background of the upriver photograph. Trees, shrubs, and *Phragmites* spp. (reed) were growing at the water's edge and overhung the channel. Photographs taken June 21, 2018, by U.S. Geological Survey.

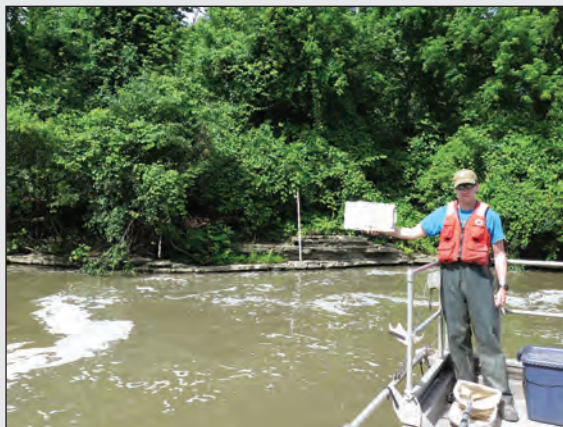
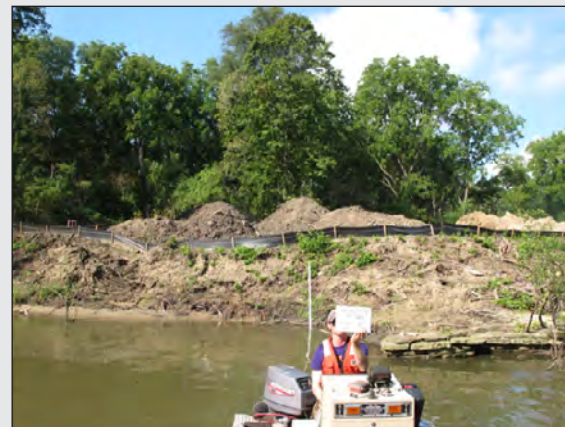
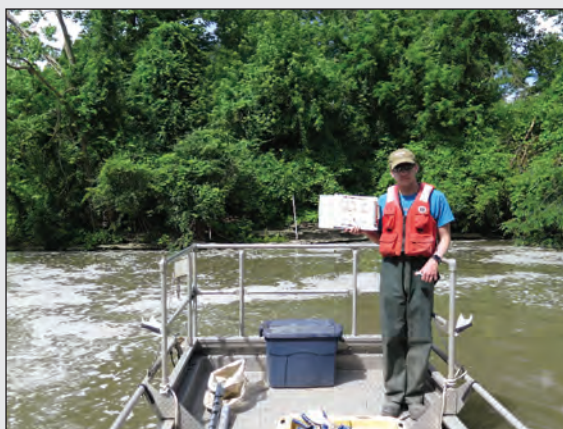
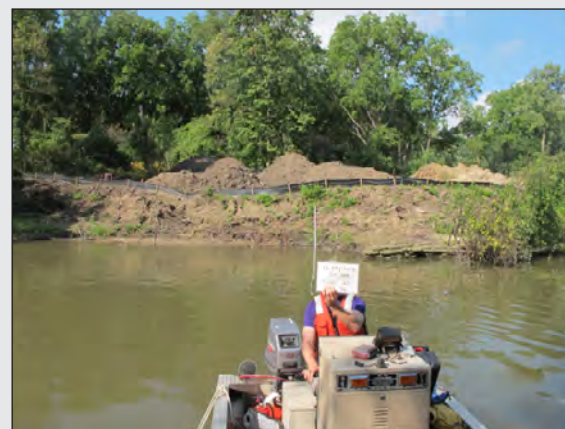
Figure 14. Photographs of the right bank at the upstream end of site RR-001, near the Henry Ford Estate Dam, showing the bank before and after riparian vegetation was removed to build a fish passage construction over the dam. Photographs taken by U.S. Geological Survey.

levels, and bank structure remained similar between June and September at all sites; therefore, the photographs taken in June were representative of conditions in September. The exception was a large amount of riparian vegetation absent from the right (southwest) bank at the upstream end of site RR-001 (fig. 14) as part of construction of a fish passage over the Henry Ford Estate Dam.
