# **A Multidecade Analysis of Fluvial Geomorphic Evolution of the Spirit Lake Blockage, Mount St. Helens, Washington**

Scientific Investigations Report 2020–5027

By Jon J. Major, Gordon E. Grant, Kristin Sweeney, and Adam R. Mosbrucker

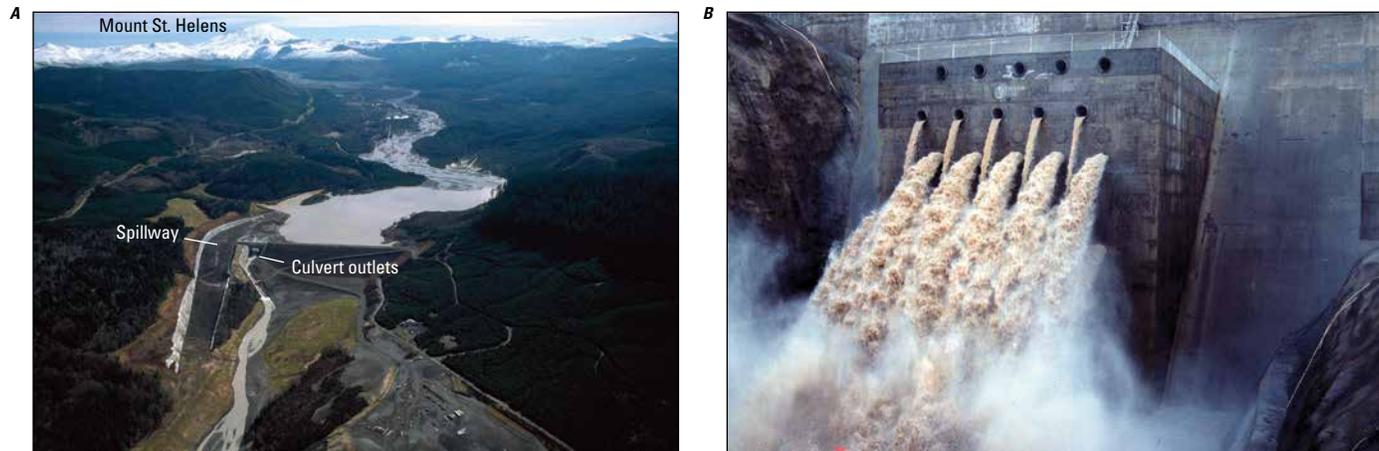
**Figure 8.** Views of sediment retention structure on North Fork Toutle River looking upstream. *A*, Oblique aerial view. *B*, Water passing through rows of culverts embedded in face of structure (see *A* for location). U.S. Army Corps of Engineers photographs from approximately 1990.

<sup>6</sup>Streamflow on North Fork Toutle River below SRS was strongly affected by regulation of flow through culverts in SRS. In other basins within Toutle River watershed (South Fork Toutle River and Green River), this flood was a substantial hydrologic event in the streamflow record.

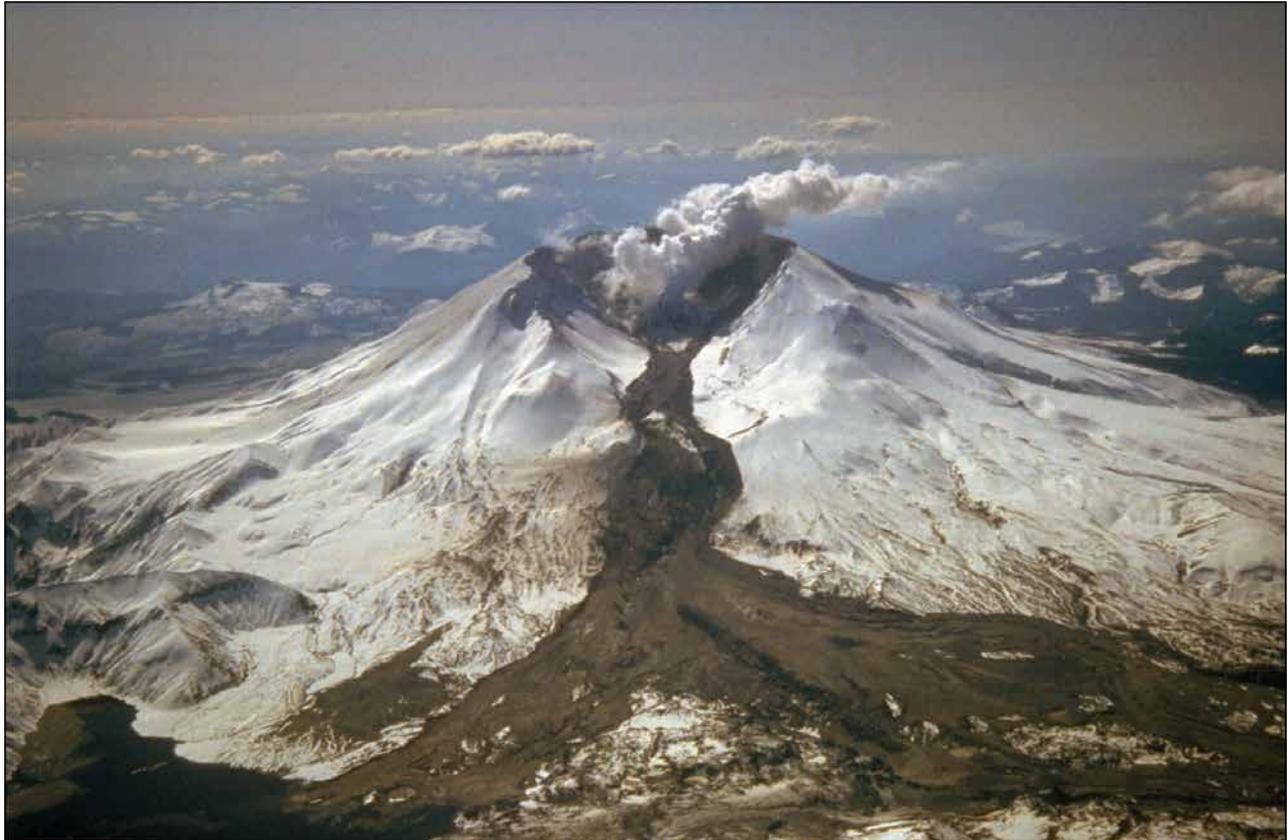
**Figure 17.** Lahar generated by melting of crater snow during a small explosion on March 19, 1982. Spirit Lake is in the lower left corner of the image. U.S. Geological Survey photograph by T. Casadevall.

there (Simon, 1999). Although the March 1982 lahar was a significant hydrologic event (fig. 17), and it left an imprint on the topography as noted above, it generally had little detectable impact, within our threshold limits, other than noted above on the landscape evolution of upper NFTR basin. In general, its deposit is less than 2 m thick (Waite and others, 1983; Pierson, 1999), and thus the depositional imprint of that event, except perhaps in the pumice pond, is below the level of detectable change achieved in this DoD.
