# **Delineation of Flood-Inundation Areas in Grapevine Canyon Near Scotty's Castle, Death Valley National Park, California**

Scientific Investigations Report 2020–5082

By Christopher M. Morris, Toby L. Welborn, and J. Toby Minear

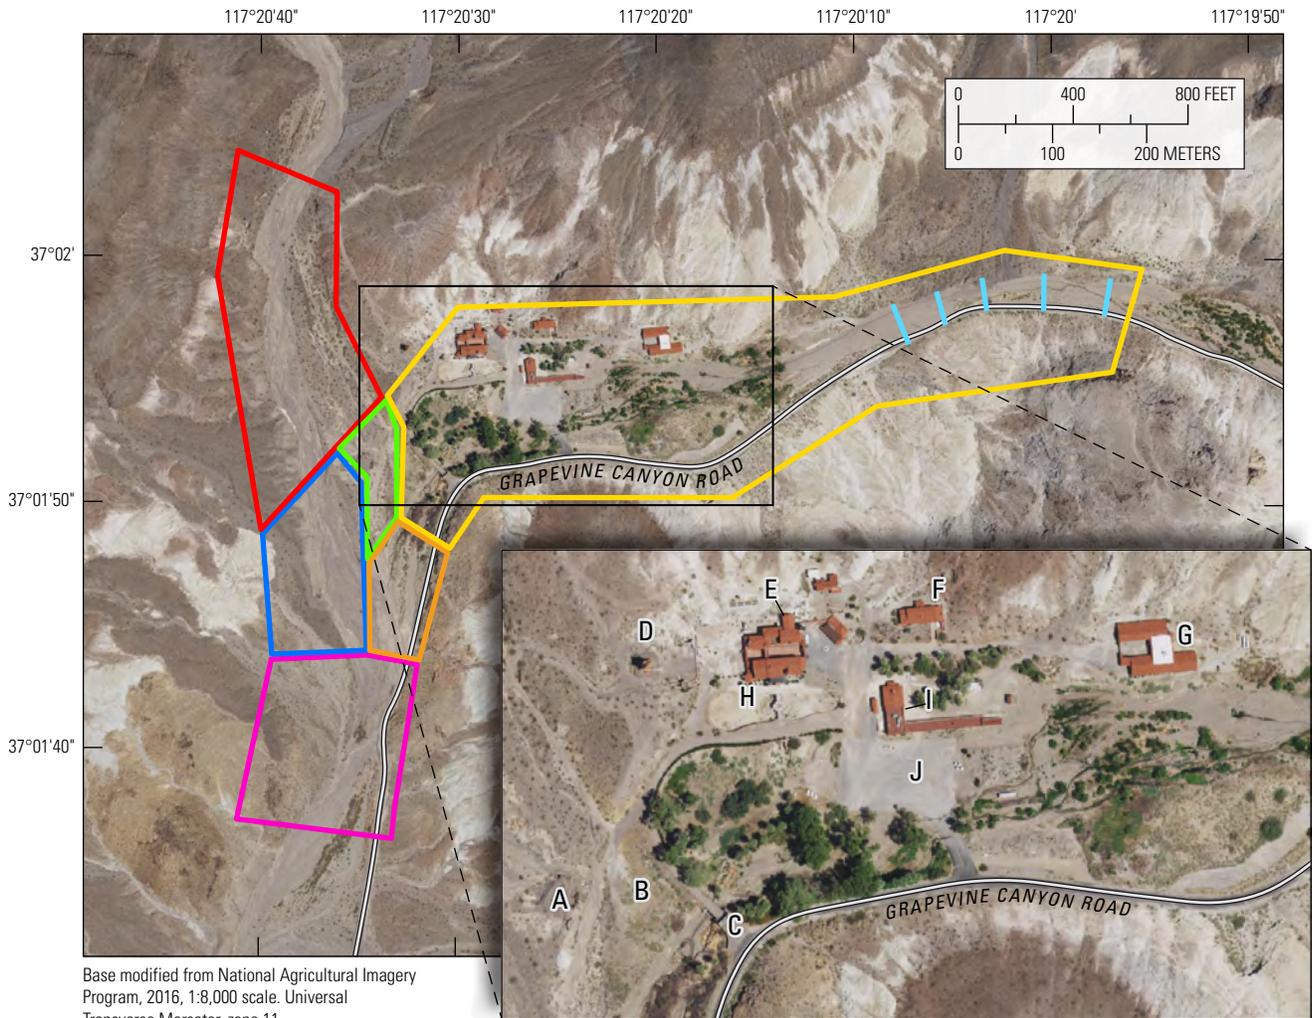
- Cross sections from October 18, 2015, indirect
- Model reaches**
- Upper Grapevine Canyon
- Middle Grapevine Canyon
- Lower Grapevine Canyon
- Upper Tie Canyon
- Lower Tie Canyon
- Side Channel

- Buildings and structures**
- A Gravel separator
- B Overflow parking lot
- C Castle Gate Bridge
- D Chimes Tower
- E Scotty's Castle
- F Hacienda
- G Stable
- H Pools
- I Visitors center and park offices
- J Main parking lot

**Figure 2.** Study area extent and model reaches of Scotty's Castle in Grapevine Canyon, Death Valley National Park, California.

has a drainage area of approximately 20.5 mi<sup>2</sup>. Elevations in the Grapevine Canyon Basin range from 7,008 feet (ft) in the Grapevine Mountains to 2,300 ft at the canyon mouth, with an average slope of 17.6 percent. Both Grapevine and Tie Canyons have very steep channels (0.04 and 0.06, respectively). At its confluence with Grapevine Canyon, the Tie Canyon channel becomes a narrow alluvial fan with two main and several smaller tributary channels (fig. 2).

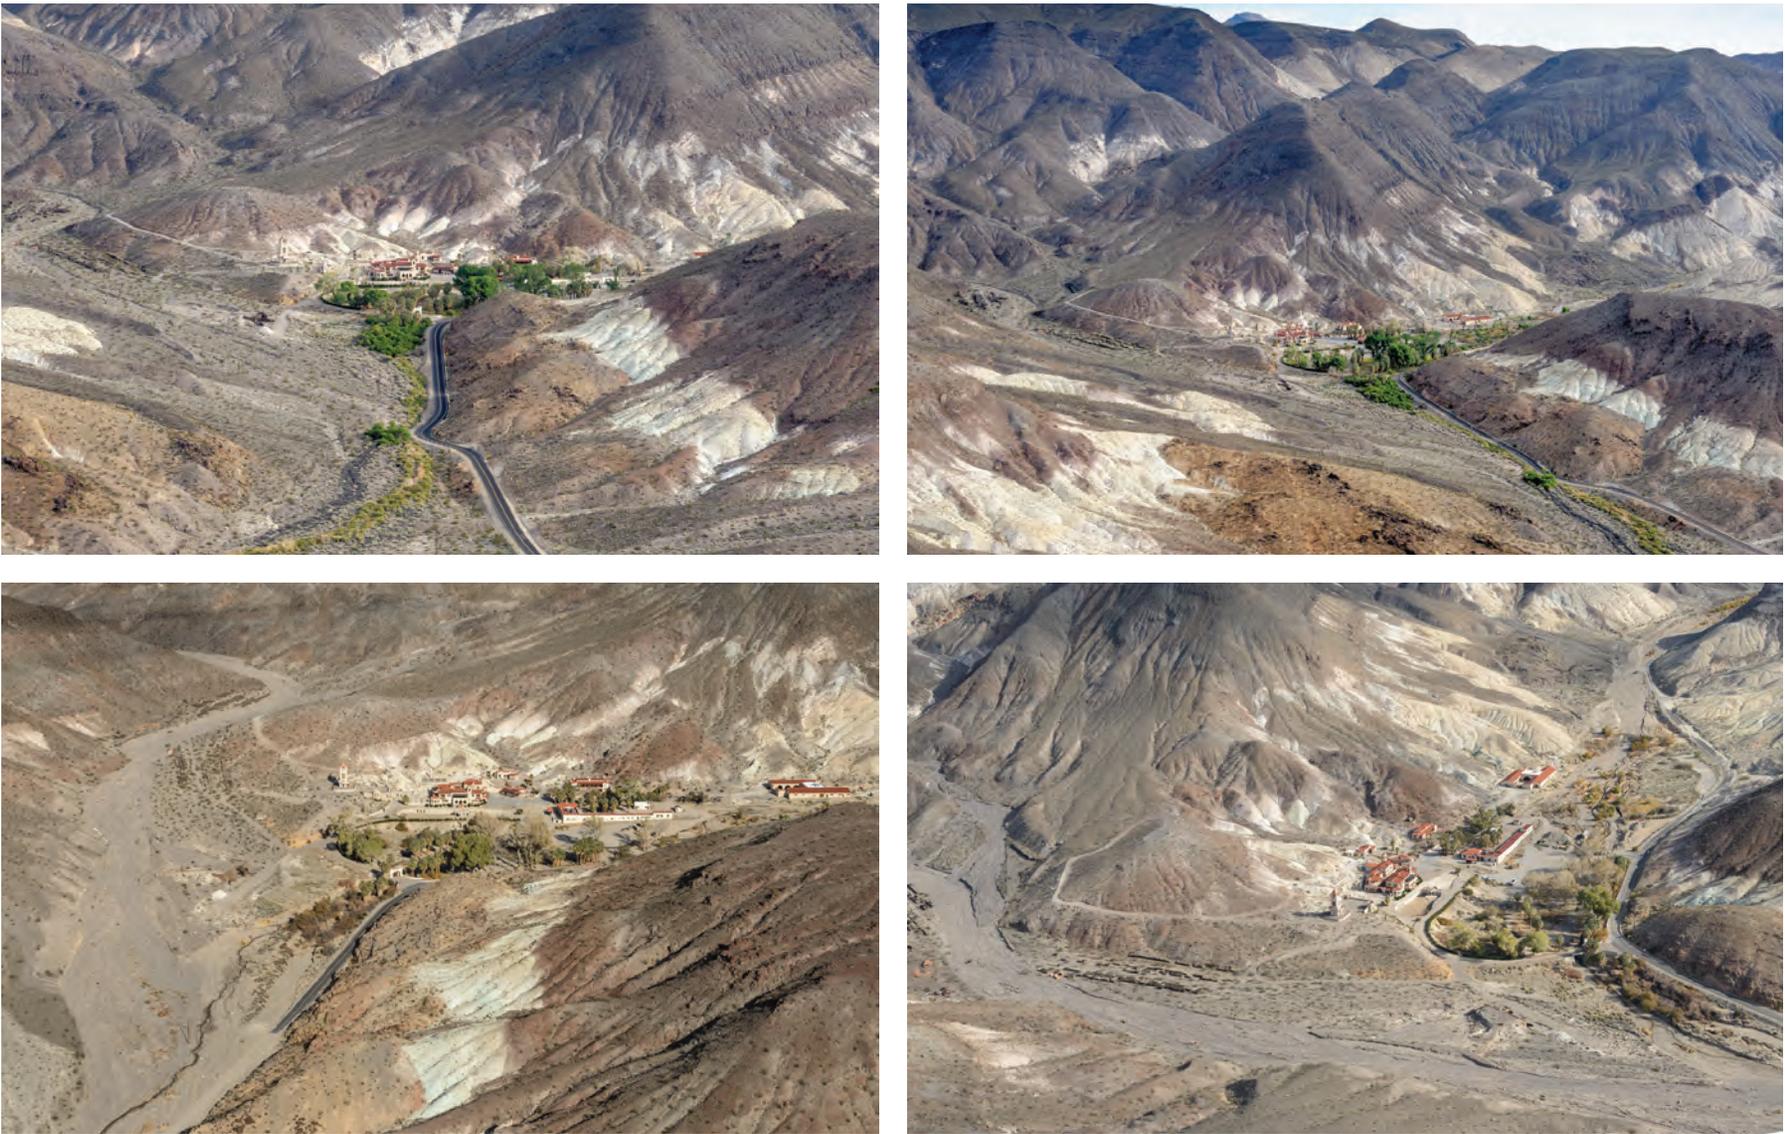
**Figure 3.** Aerial photographs from before and after the October 18, 2015, flood of Scotty's Castle in Grapevine Canyon, Death Valley National Park, California. Photographs (top) taken on March 21, 2015, looking upstream from downstream end of the modeled reach. Photographs by Birgitta Jansen, National Park Service. Photographs (bottom) taken on November 27, 2015, looking upstream from Tie and Grapevine Canyon confluence. Photographs by Neal Nurmi, National Park Service.

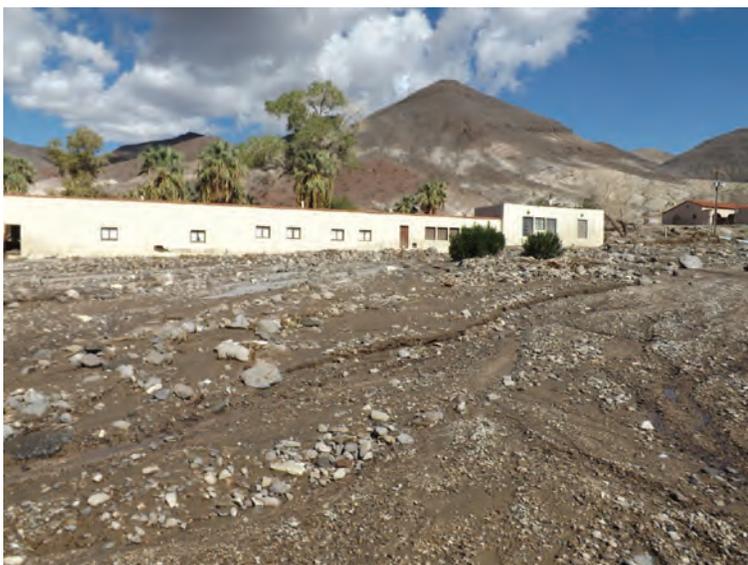
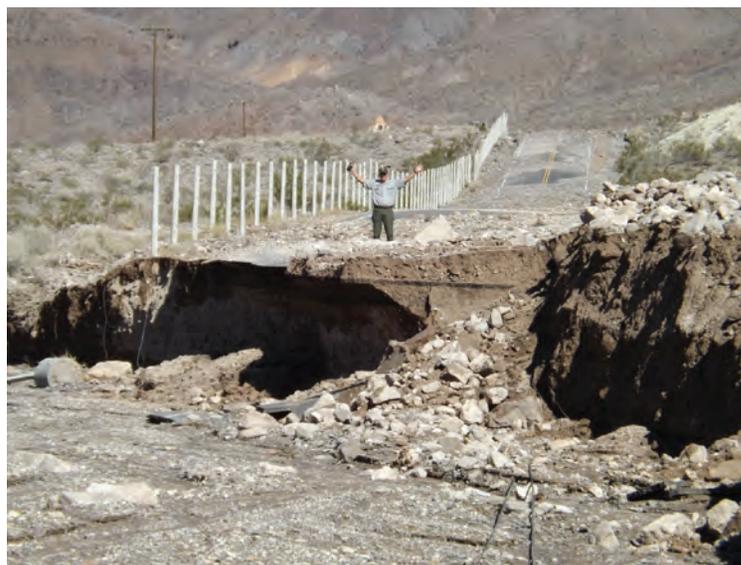
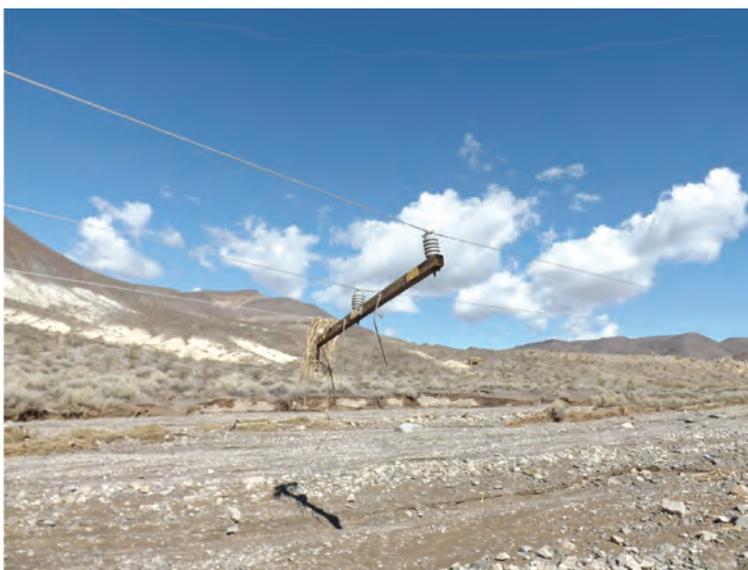
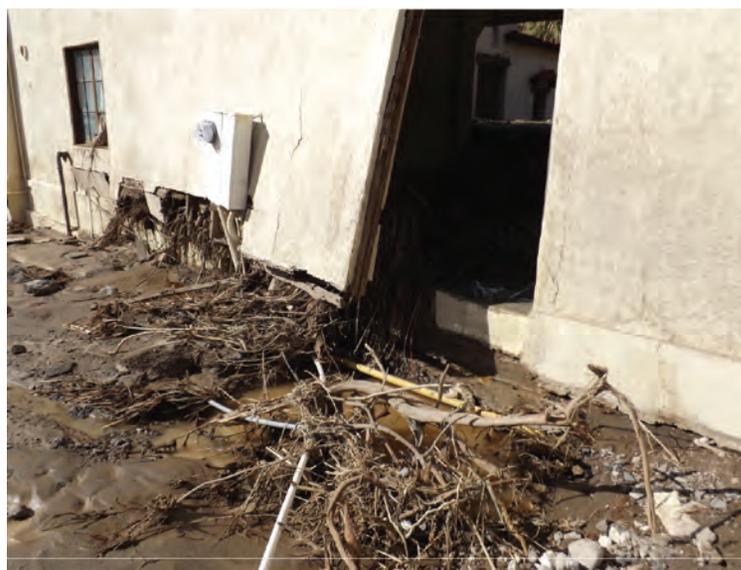
**Figure 4.** Images of flood damage from the October 18, 2015, flood of Scotty's Castle in Grapevine Canyon, Death Valley National Park, California. From upper left clockwise: visitor center and park offices, road damage downstream of modeled reach, visitor center and park offices, damaged power pole. Photographs by National Park Service.

boulders were deposited inside and outside of several historic and park administration buildings, damaging walls and breaking windows and doors. The visitor center parking lot, within the active channel, had sediment deposits several feet deep (fig. 3). The spring house and water pipeline transporting water to Scotty's Castle from a spring upstream were heavily damaged. Twenty power poles and over 1 mile of fencing were destroyed (fig. 4). Five to ten feet of channel incision occurred in Grapevine Canyon from near the confluence with Tie Canyon through Castle Gate Bridge (hereafter referred to as the bridge) to the picnic area next to the parking lot (fig. 2).

A large percentage of vegetation in Grapevine Canyon was removed, leaving bare channels in areas that had previously been dense shrubs. Finally, sections of the Grapevine Canyon Road were either completely removed by the flood waters or heavily damaged (fig. 4; Josh Hoines, National Park Service, oral commun., 2017).

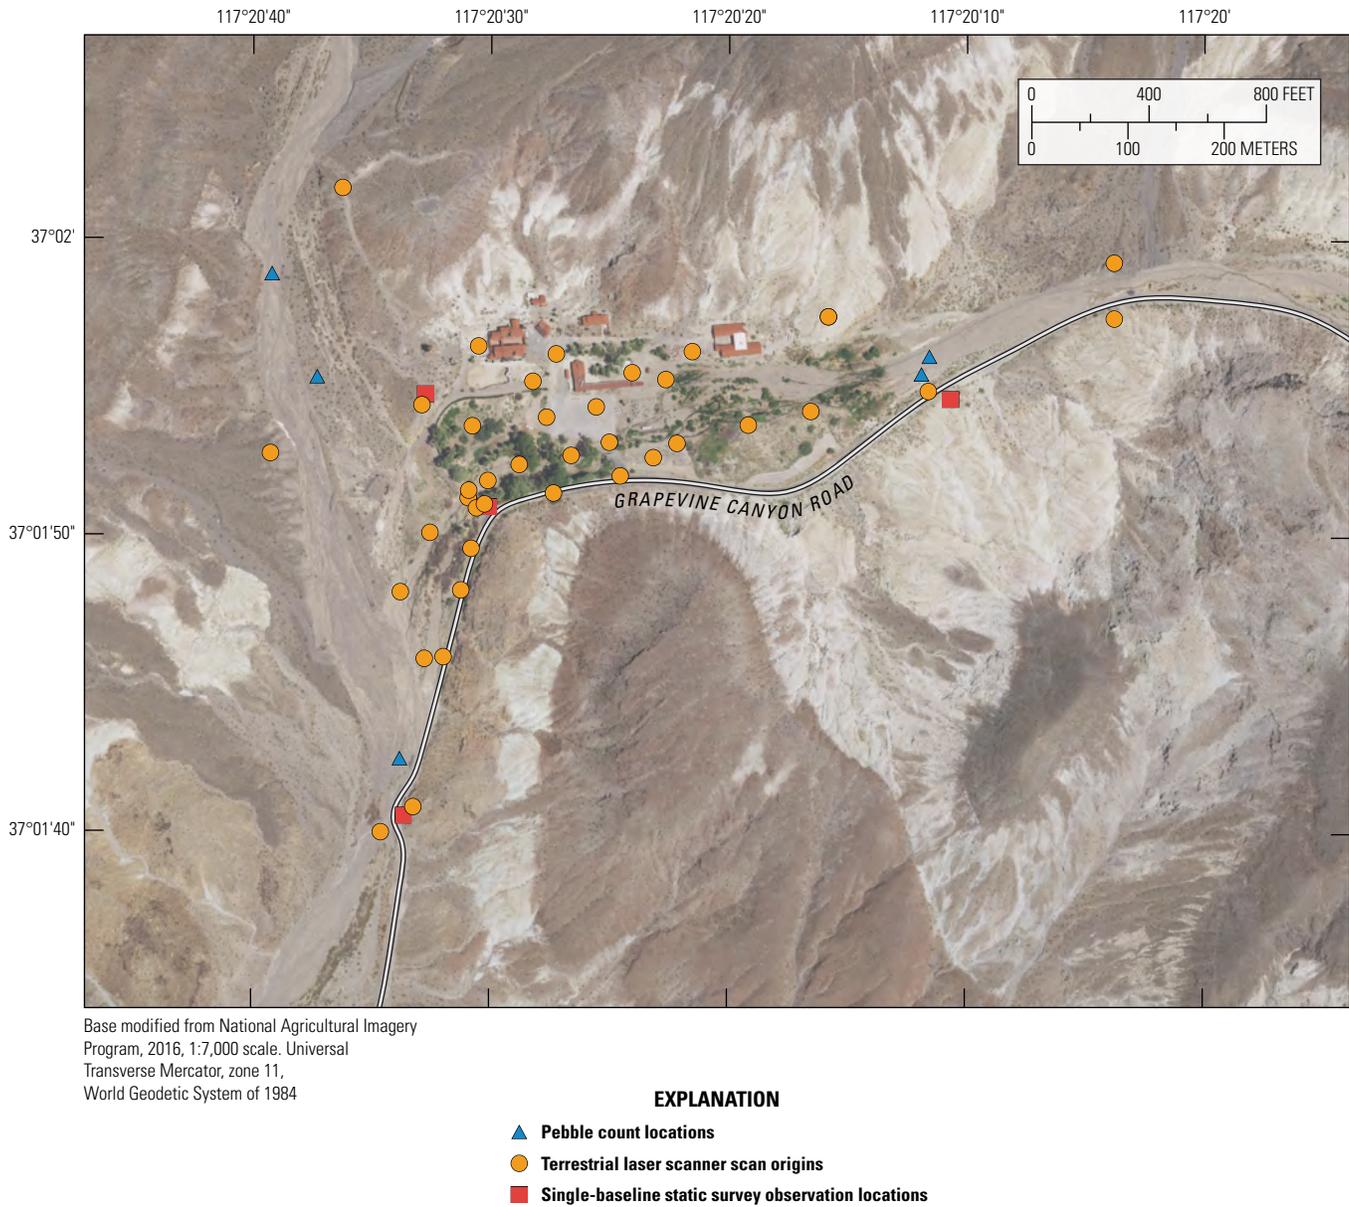
**Figure 5.** Pebble count, terrestrial laser scanner, single-baseline static survey observation locations for Scotty's Castle in Grapevine Canyon, Death Valley National Park, California.

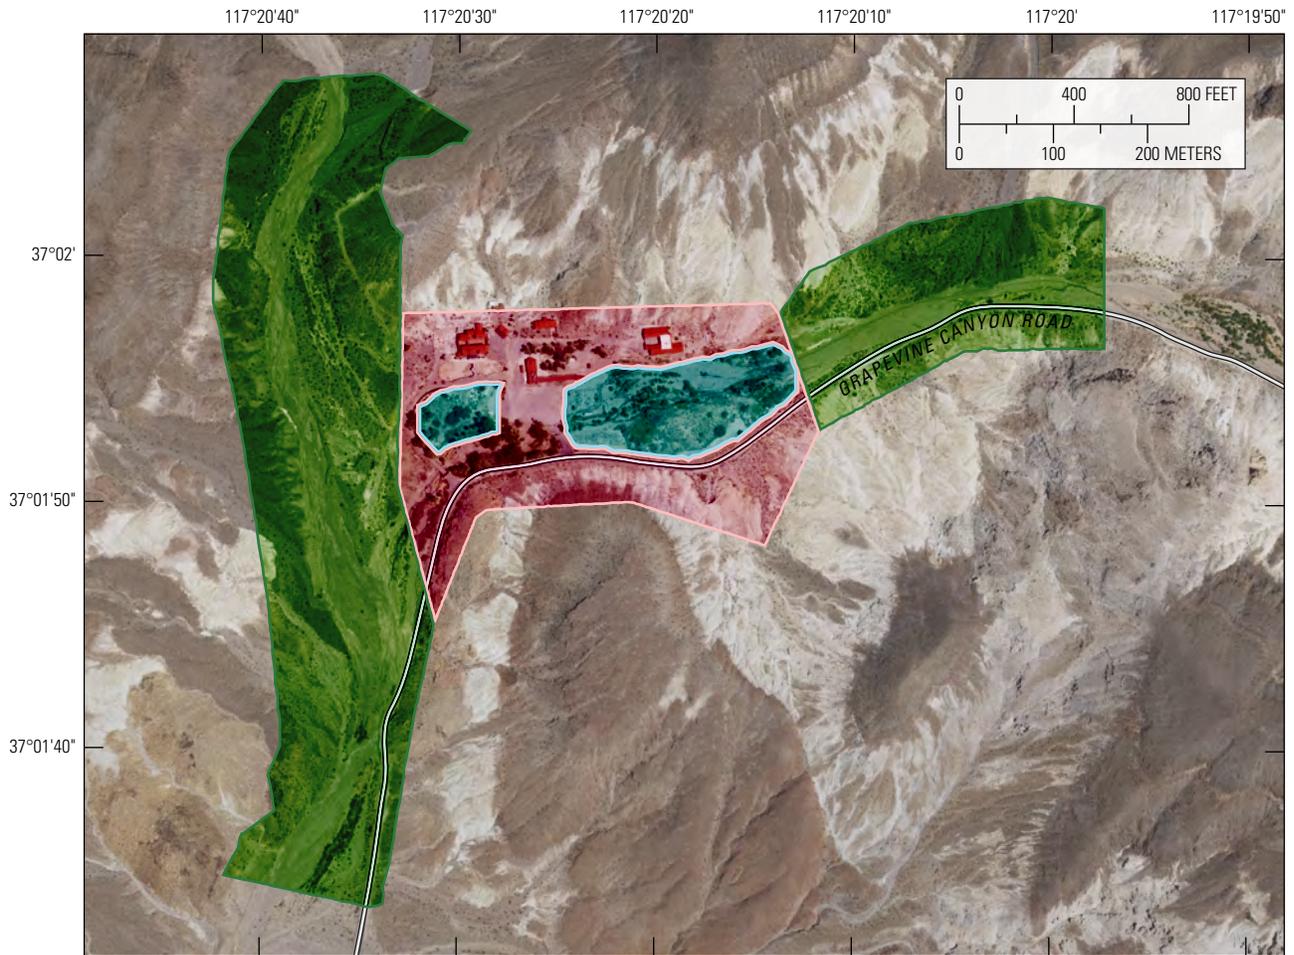
**Figure 6.** Terrestrial laser scanner minimum elevation filtering areas used to create the digital terrain model for Scotty's Castle in Grapevine Canyon, Death Valley National Park, California.

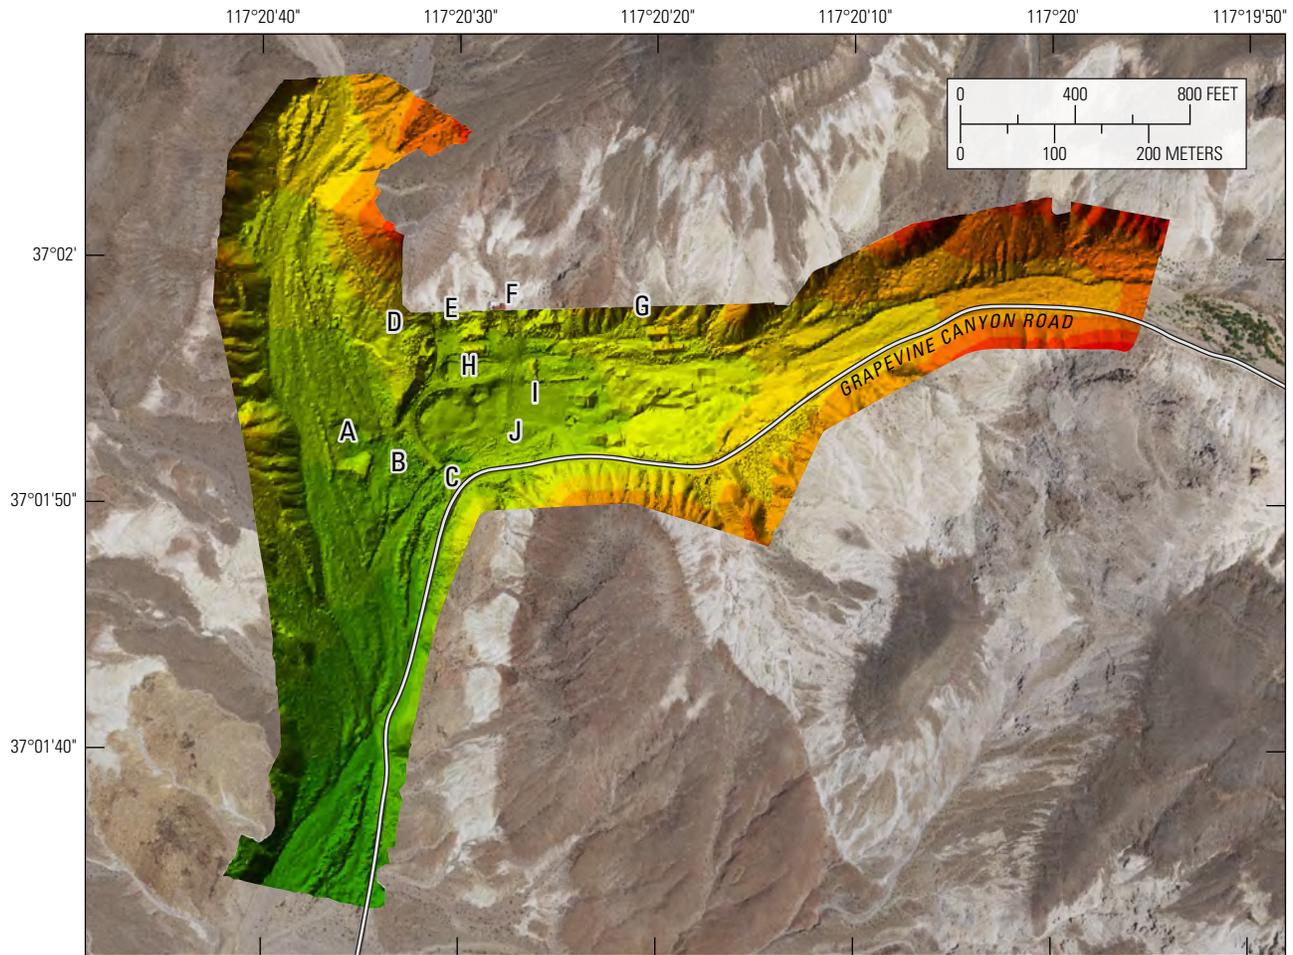
Figure 7. Digital terrain model for Scotty's Castle in Grapevine Canyon, Death Valley National Park, California.

model was created using a triangulated irregular network (TIN) of only the minimum points identified in the filtering process. The extent and spatial distribution of elevations is shown in figure 7.

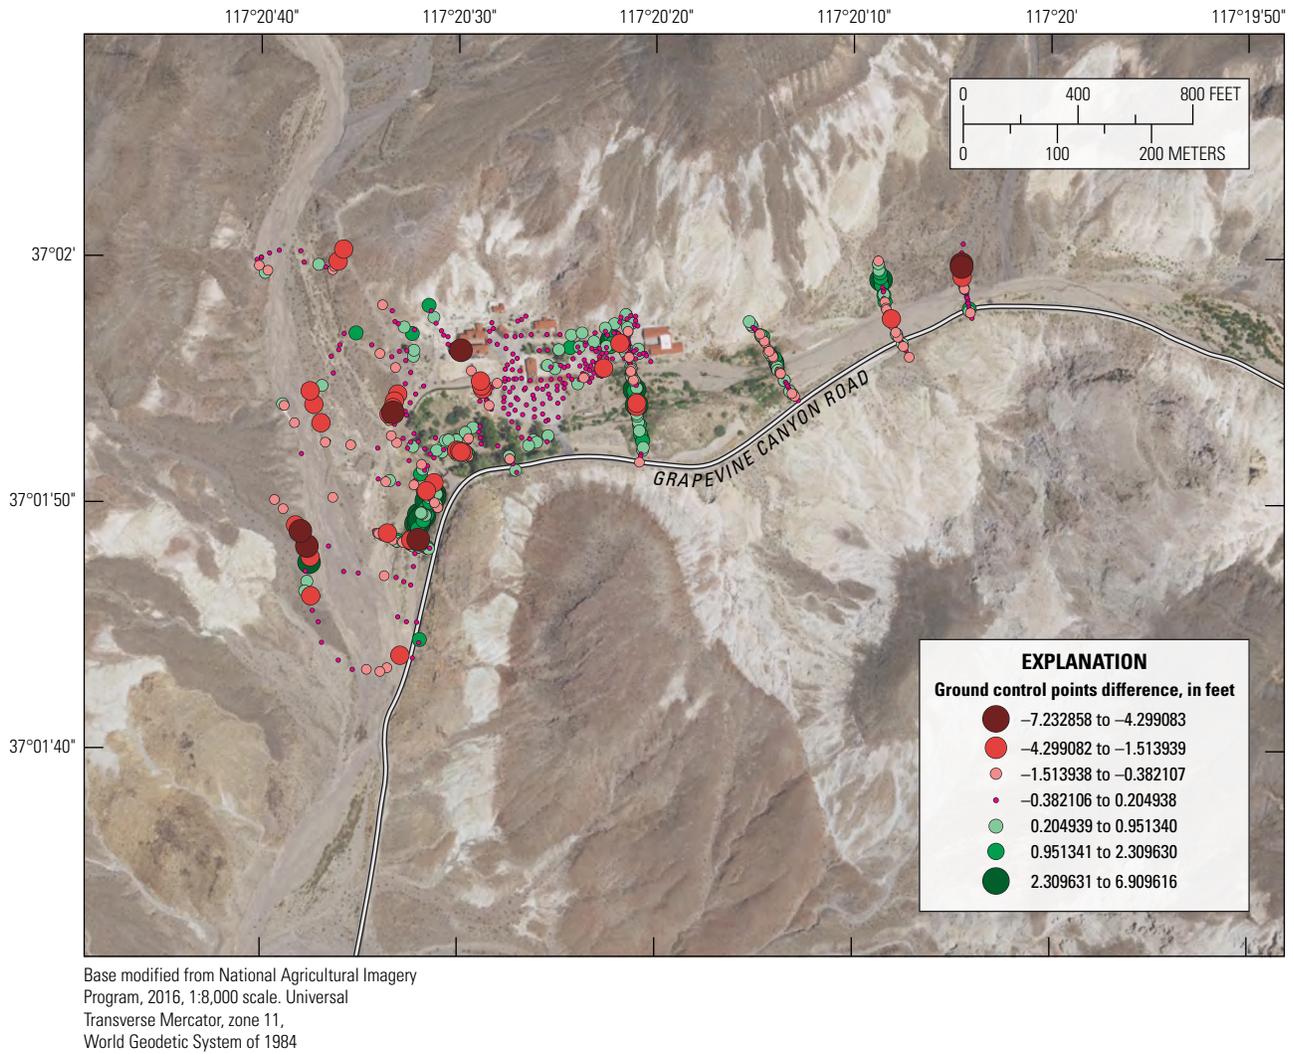
**Figure 8.** Spatial distribution of measured residual error between ground control points and the digital terrain model for Scotty's Castle in Grapevine Canyon, Death Valley National Park, California.

Vertical accuracy was assessed from the 769 GCPs and reported at the 95th confidence level following the standards for reporting the accuracy of digital geospatial data (American Society for Photogrammetry and Remote Sensing, 2014). Vertical accuracy of the DTM at the 95-confidence level is 2 ft, which is within the accuracy guidelines for DTM used in flood inundation mapping for hilly terrain (Federal Emergency Management Agency, 2016). The distribution of GCP residual values are shown in figure 8. The majority of observed error is on steep slopes, incised channels, and in areas with heavy vegetation. These errors can be explained by the range of elevations associated with steep slopes compared to the interpolated single value of the DTM. Incised channels at distance or in heavy vegetation, such as the area immediately downstream of the bridge, may have been influenced by shadowing. Shadowing occurs when a feature such as a tree on a steep slope blocks a laser return from an area or when thick, low-lying vegetation prevents the laser from reflecting off the ground. The histogram and cumulative percentage plot (fig. 9) show that 81 percent of the DTM error is 0.75 ft and that the DTM has a slightly positive skew.

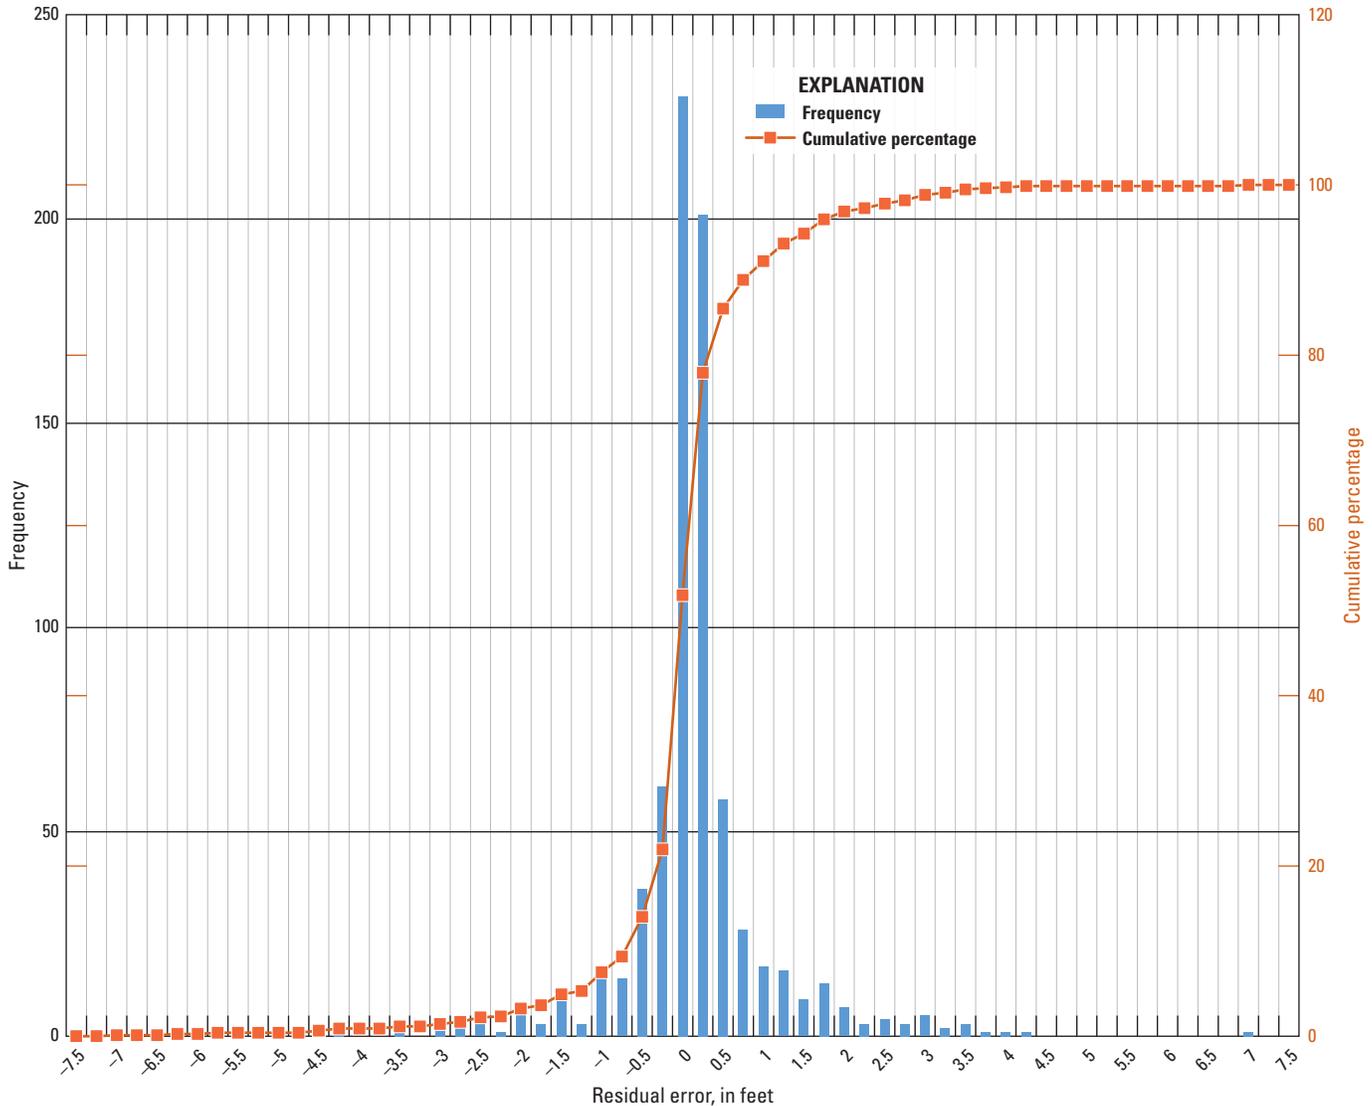
**Figure 9.** Histogram and cumulative percentage of residual error between ground control points and the digital terrain model for Scotty's Castle in Grapevine Canyon, Death Valley National Park, California.

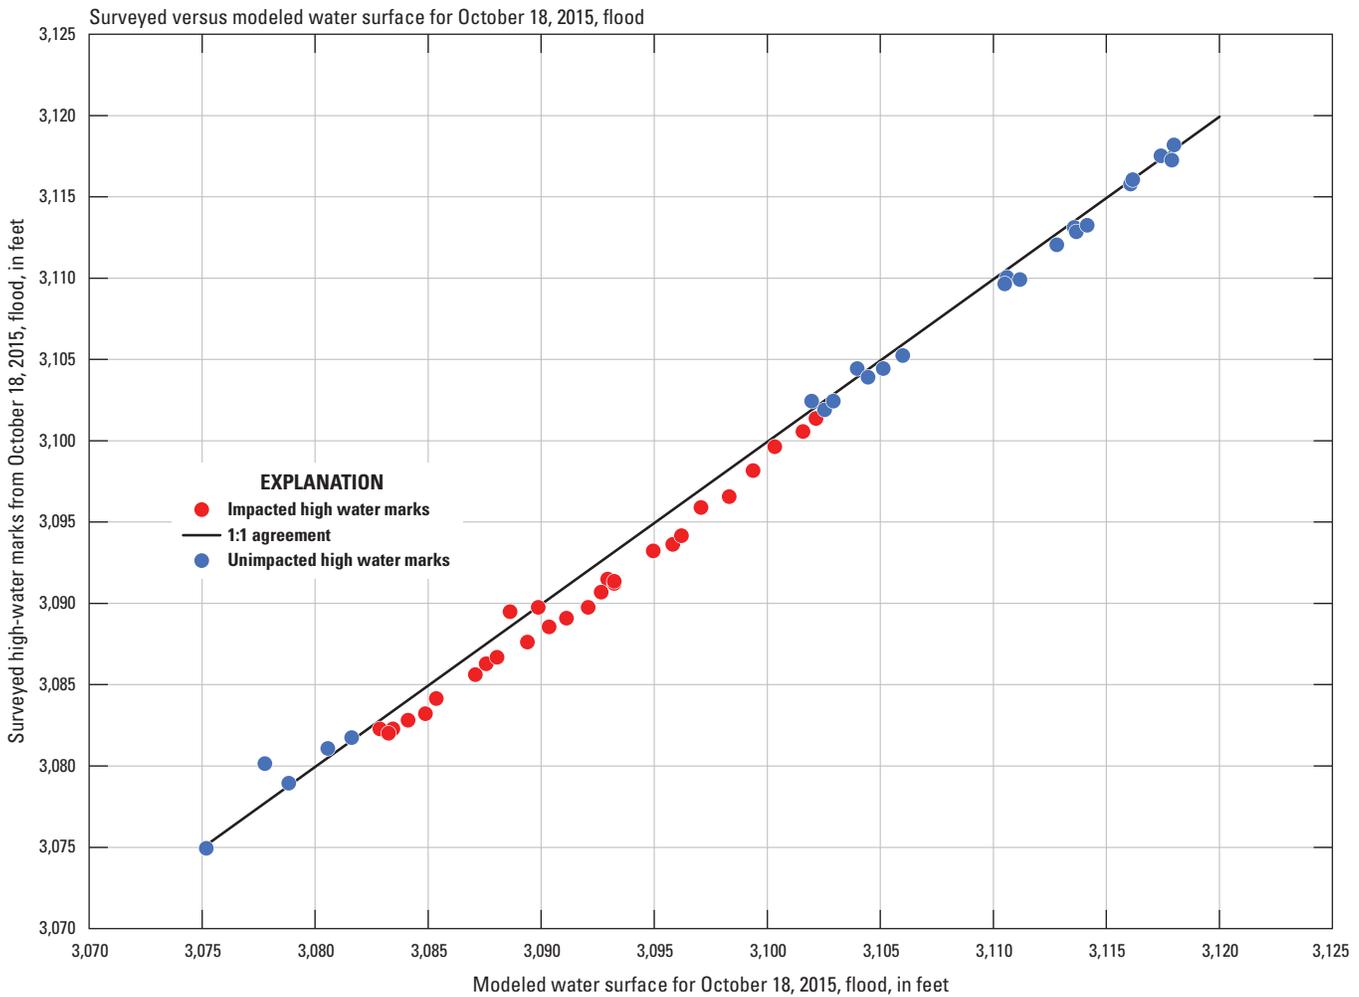
Figure 10. Surveyed versus modeled water surface for October 18, 2015, flood at Scotty's Castle in Grapevine Canyon, Death Valley National Park, California.

Because no gaging stations had been operation in the area before December 2016, model calibration data was limited to the indirect measurement surveyed for the October 18, 2015, flood (at the upstream end of the Upper Grapevine Canyon model reach). The model was run using the indirect streamflow of 3,200 cfs in Grapevine Canyon. The modeled water surface was compared with the surveyed high-water marks (quality good to poor) from the indirect measurement surfaces (fig. 10). When the indirect measurement was computed, it was found that there was a very large decrease in cross-sectional area and increase in velocity in the middle of the reach in contrast to all other parts of the surveyed indirect reach. The significant difference of channel hydraulic properties along with photographic examination of the channel and weather radar data of the movement of the thunderstorm provided ample evidence that an unnamed side canyon had

deposited fill in the middle of the indirect measurement reach after the main flood peak in Grapevine Canyon. Therefore, the high-water marks from the main flood peak would not represent the water surface for the same streamflow in the current channel because fill happened after the peak. Additionally, after the indirect measurement survey, but before the TLS survey, gravel and cobble fill from the road had been moved and placed within the main channel, further complicating the comparison. When impacted high-water marks associated with cross sections that were affected by the greatest fill were removed from consideration, the mean model water surface was found to be on average 0.22 ft. higher than the high-water marks. This is within the accuracy of the surveyed high-water marks (0.20–0.40 ft) from the indirect measurement survey. Because the reach was already computing as critical flow, lowering the n-value would not decrease the water surface further. For these reasons, no additional modifications to the model were made.

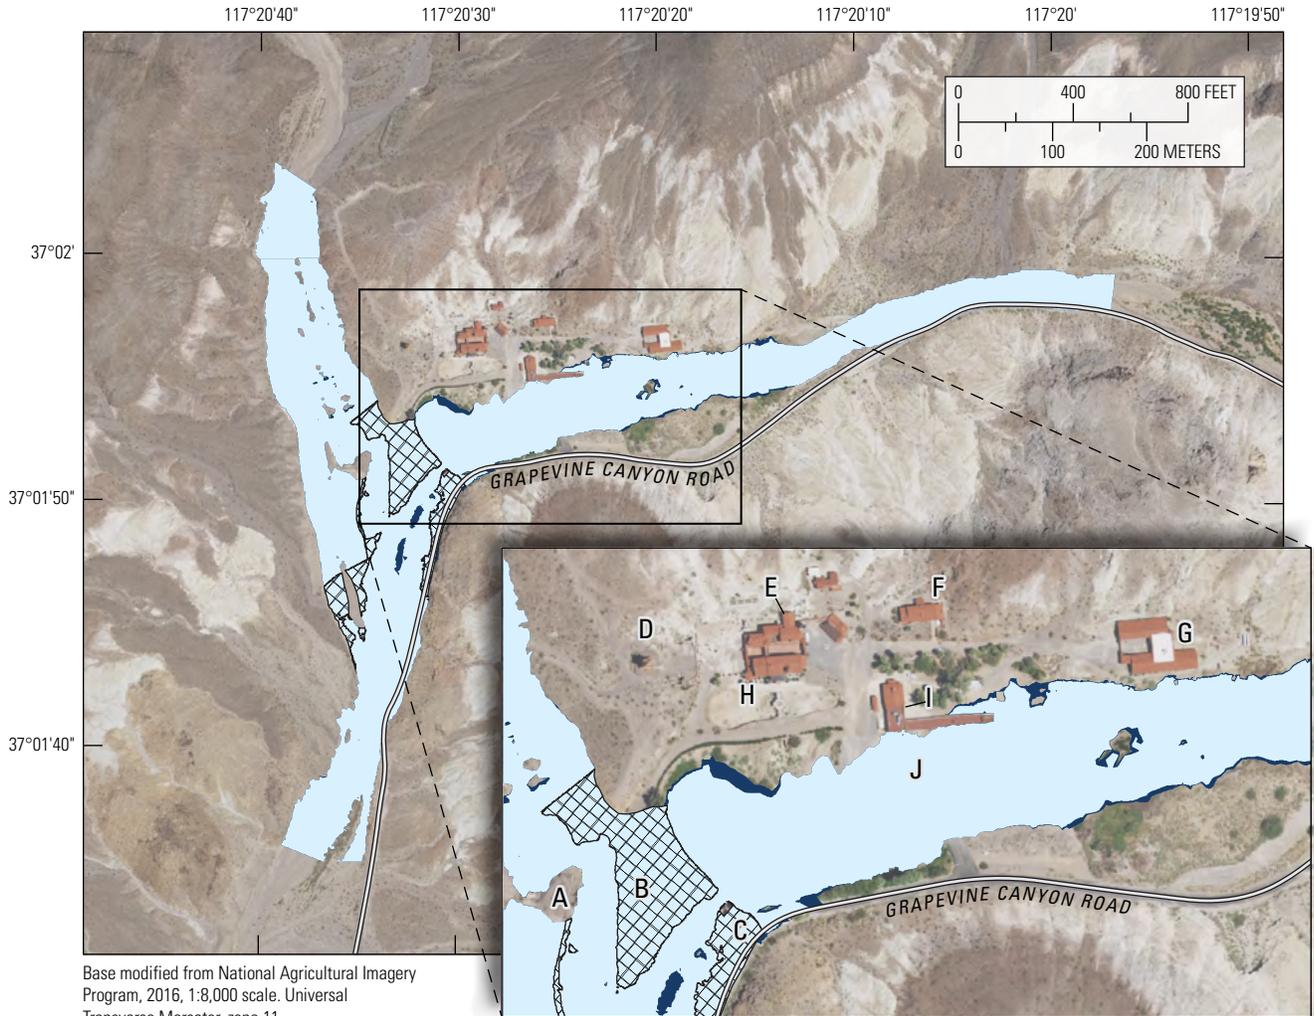
**Figure 12.** Flood-inundation areas for the 2-percent annual exceedance probability flood streamflow for Scotty's Castle in Grapevine Canyon, Death Valley National Park, California.

The flood-inundation maps are presented in figures 11–15. The park offices, visitor center, parts of Grapevine Canyon Road, and the bridge are inundated by the 2-AEP flood; however, none of the computed flows reach Scotty’s Castle proper, the Chimes Tower, or the Hacienda. The model computes steep, fast, critical streamflow for most of the study reaches for all the computed AEP flood streamflows. However, upstream of the bridge and in areas with dense vegetation, high roughness coefficients reduce velocities and cause subcritical streamflow to be computed.

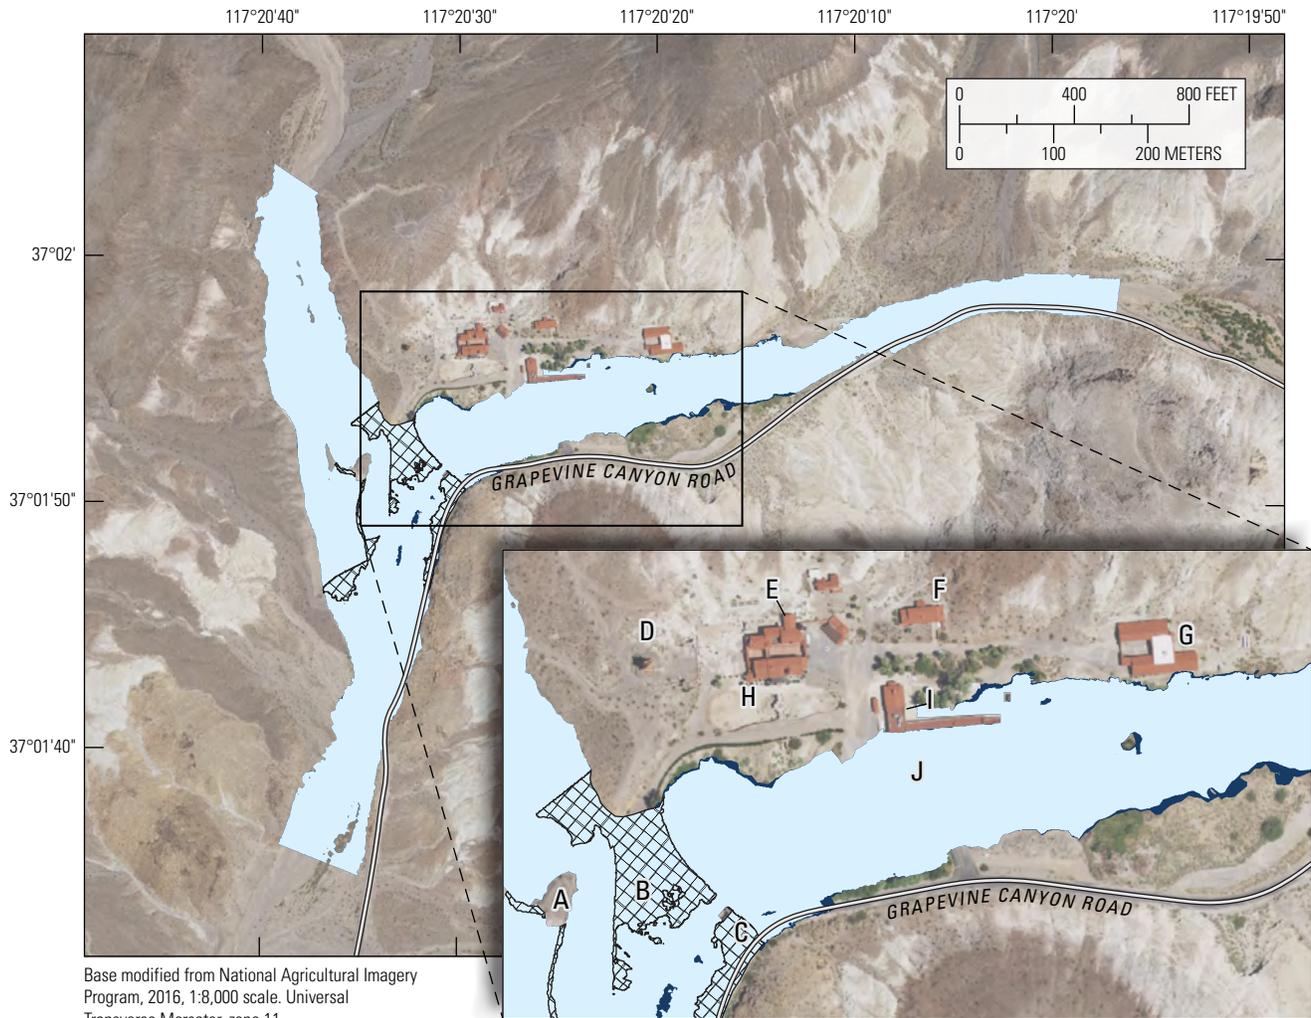
**Figure 13.** Flood-inundation areas for the 1-percent annual exceedance probability flood streamflow for Scotty's Castle in Grapevine Canyon, Death Valley National Park, California.

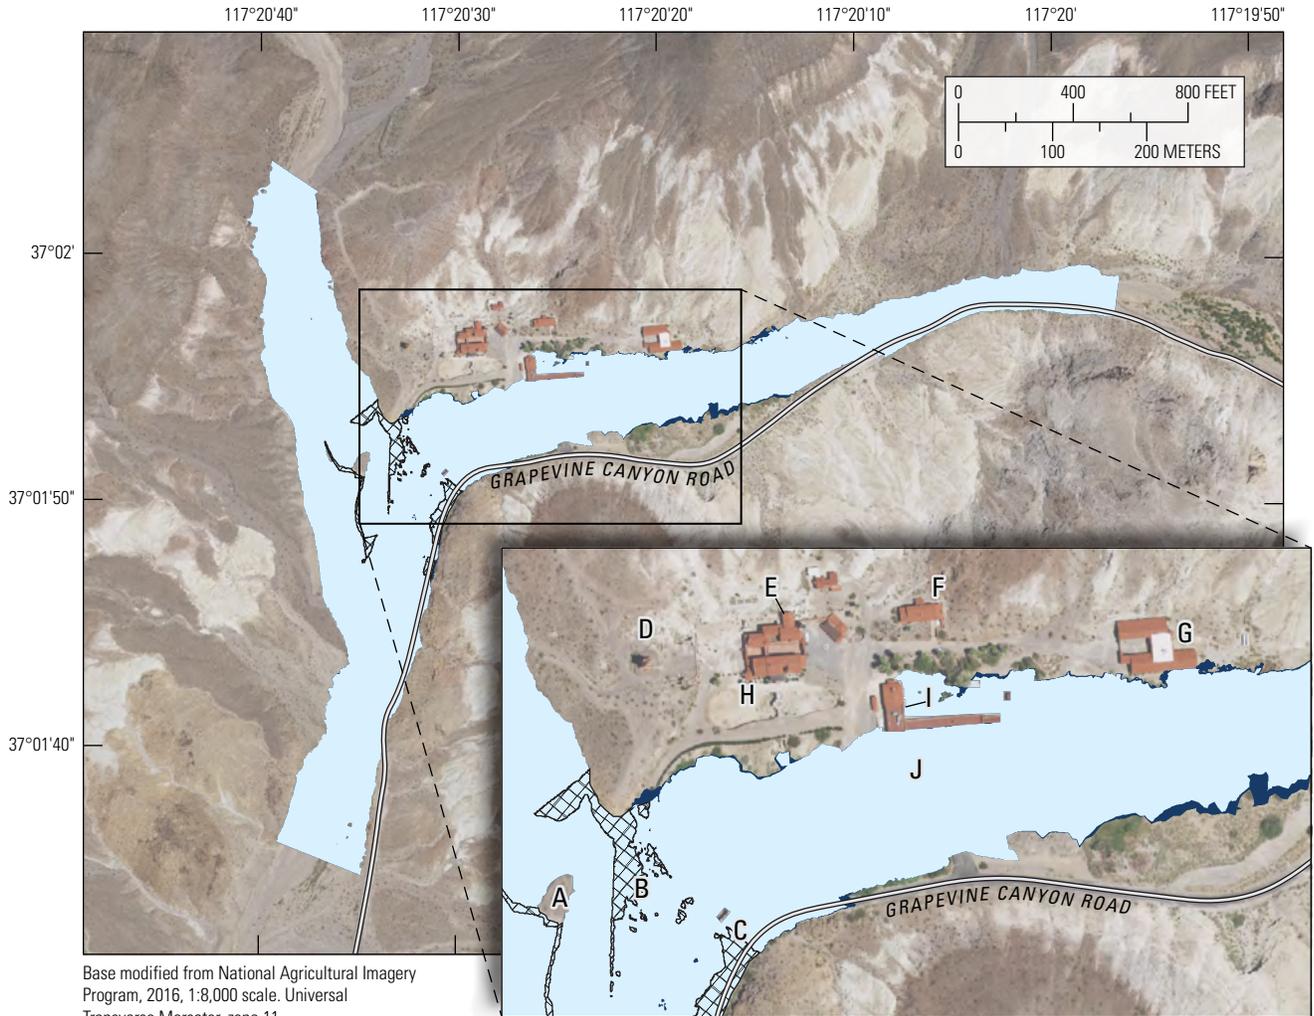
**Figure 14.** Flood-inundation areas for the 0.5-percent annual exceedance probability flood streamflow for Scotty's Castle in Grapevine Canyon, Death Valley National Park, California.

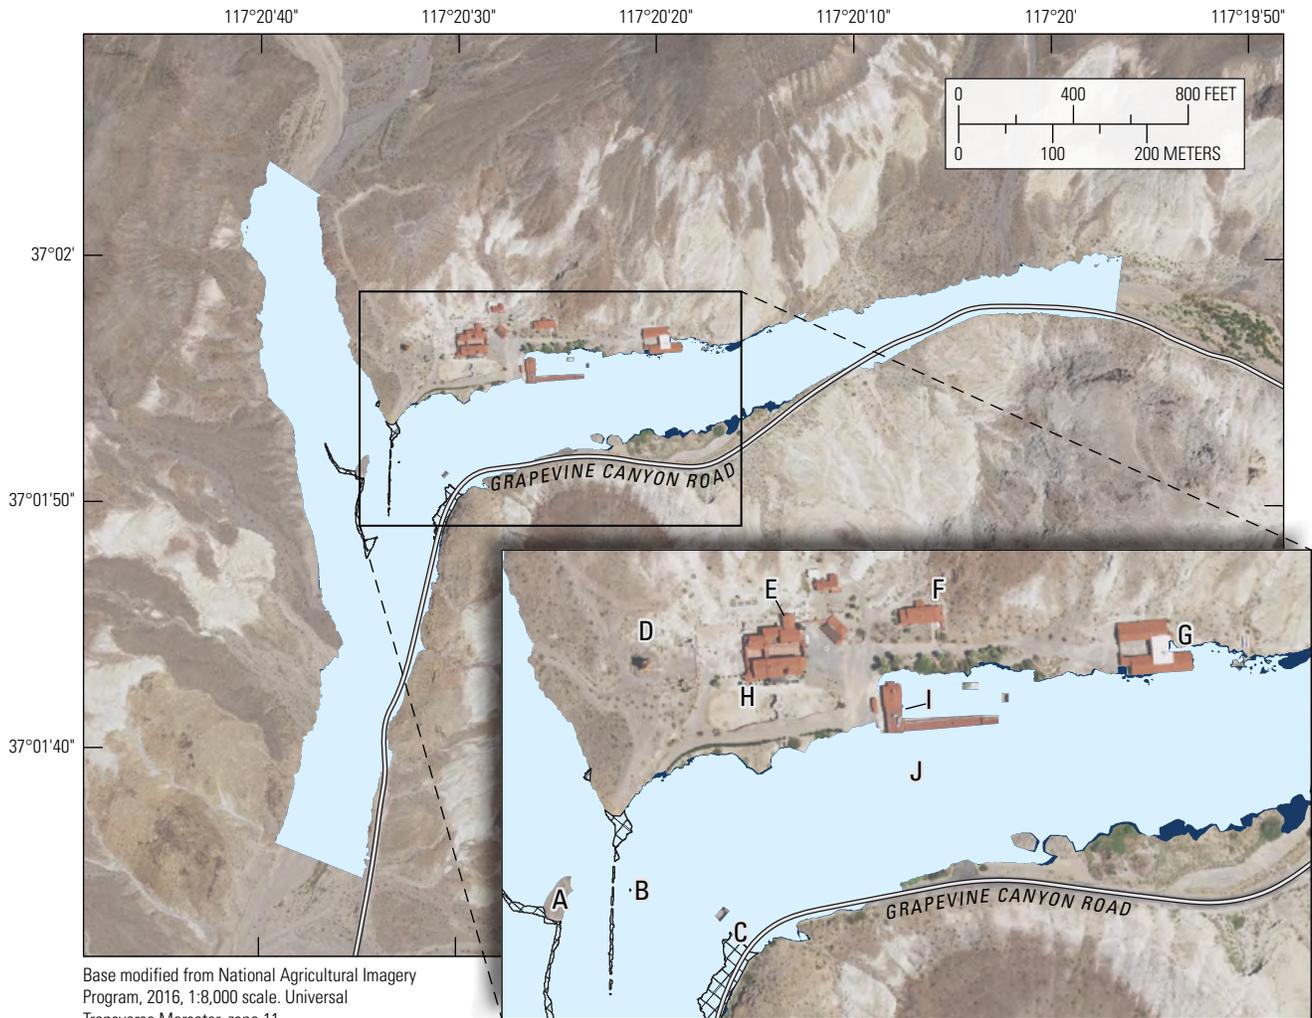
**0.2-percent annual exceedance probability (AEP) streamflow**

The greatest hazard is at the bridge and embankment. In all three streamflow scenarios, the bridge and embankment are overtopped. The 0.2-AEP flood has a depth of nearly 6 ft over the bridge and embankment. Because of the approximately 6 ft drop in the water surface from the upstream to the downstream sides of the bridge, significant amounts of erosion would be possible on the downstream side of the embankment. If a failure of the embankment were to occur<sup>2</sup>, it would cause a drastic drop in the water surface upstream, with a large release of the water, sediment, and entrained debris.
