# **Evaluation of Streamflow Extent and Hydraulic Characteristics of a Restored Channel at Soldier Meadows, Black Rock Desert–High Rock Canyon Emigrant Trails National Conservation Area, Nevada**

Scientific Investigations Report 2020–5143

By Christopher M. Morris

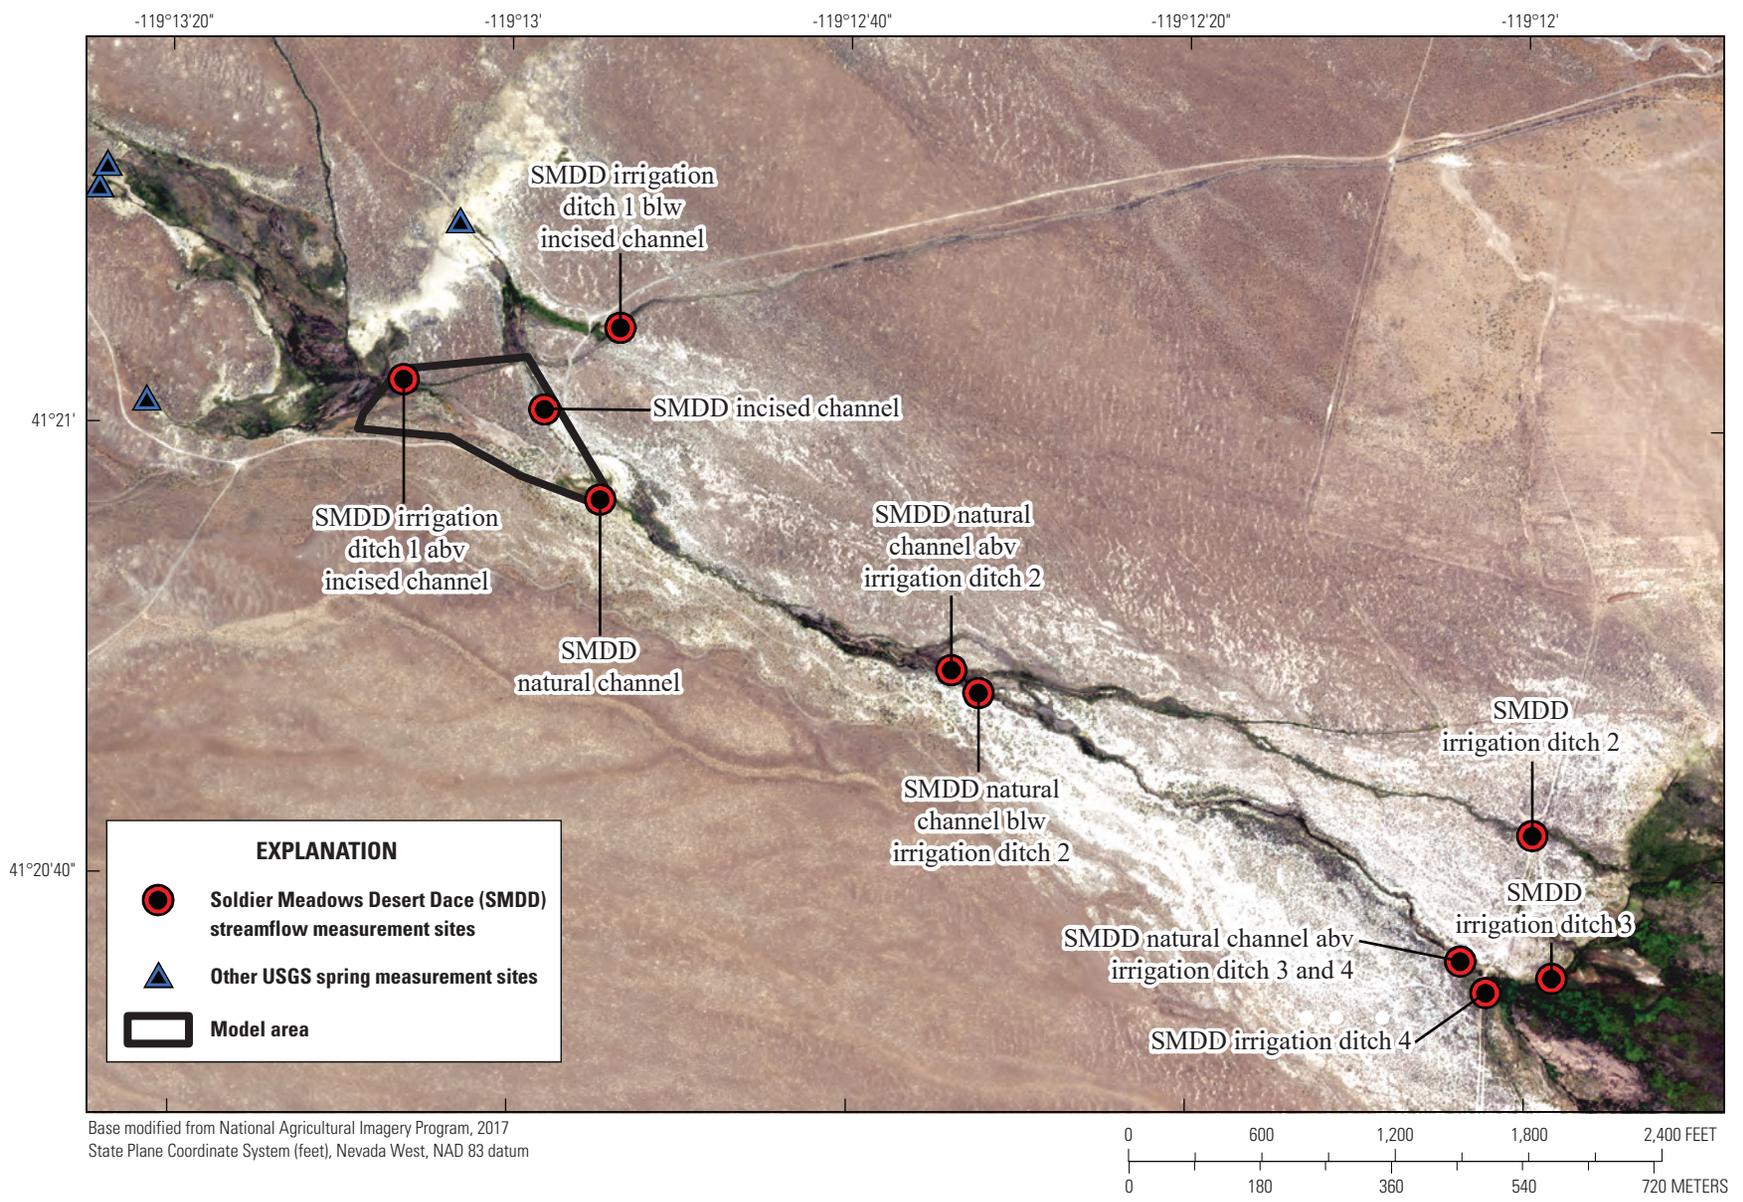
**Figure 2.** Study area, Soldier Meadows, Black Rock Desert–High Rock Canyon Emigrant Trails National Conservation Area, Nevada.

Mud Meadow Reservoir. The study area is a small section of the spring complex (fig. 2) that contains the largest contiguous desert dace habitat and is a subsection of area 4 as defined by Vinyard (1996).

streamflow velocity measurements for irrigation ditch 1 and the incised channel (fig. 2; table 1) were not used for model calibration.

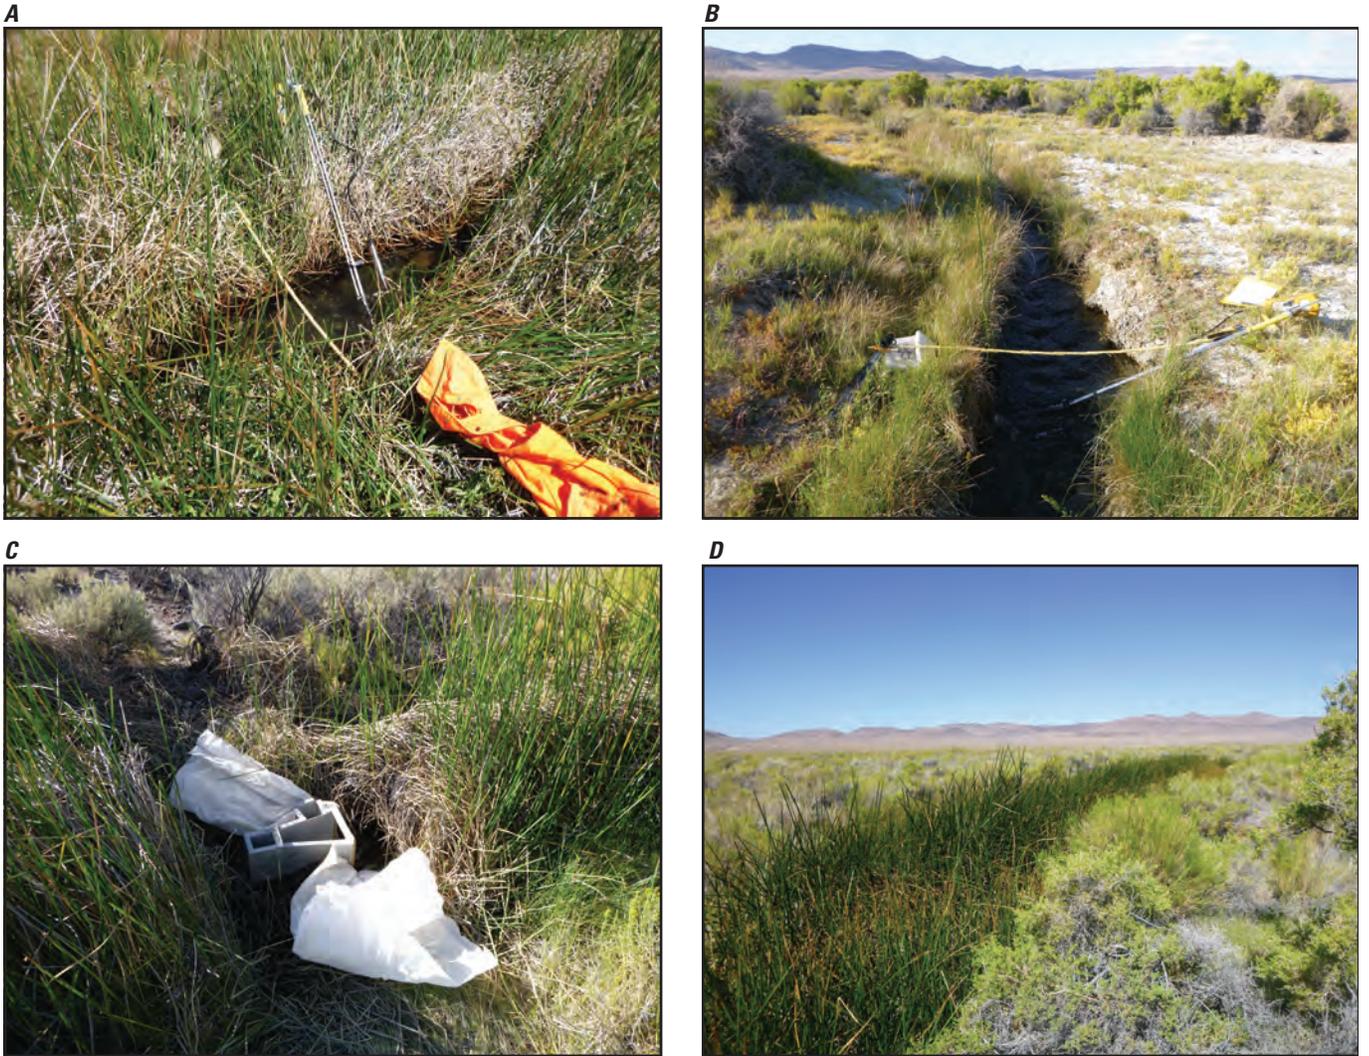
**Figure 3.** Examples of stream channels and irrigation ditches, Soldier Meadows, Black Rock Desert–High Rock Canyon Emigrant Trails National Conservation Area, Nevada.

Stream channels, irrigation ditches, and emergent wetlands occur within the study area. Many locations with water have very dense emergent wetland vegetation dominated by hardstem bulrush (*Schoenoplectus acutus*) and other wetland plants. Heavy thatch from the bulrush means that the true spatial extent of surface water is difficult to discern. Stream channels tend to be more open, especially in areas with gravel or cobble substrate, however, in many locations, vegetation forms a closed canopy over the stream channel water surface (fig. 3). Hubbs and Miller (1948) as well as Nyquist (1963) both provide early descriptions of vegetation and channel shape in the spring complex that are very similar to current conditions.

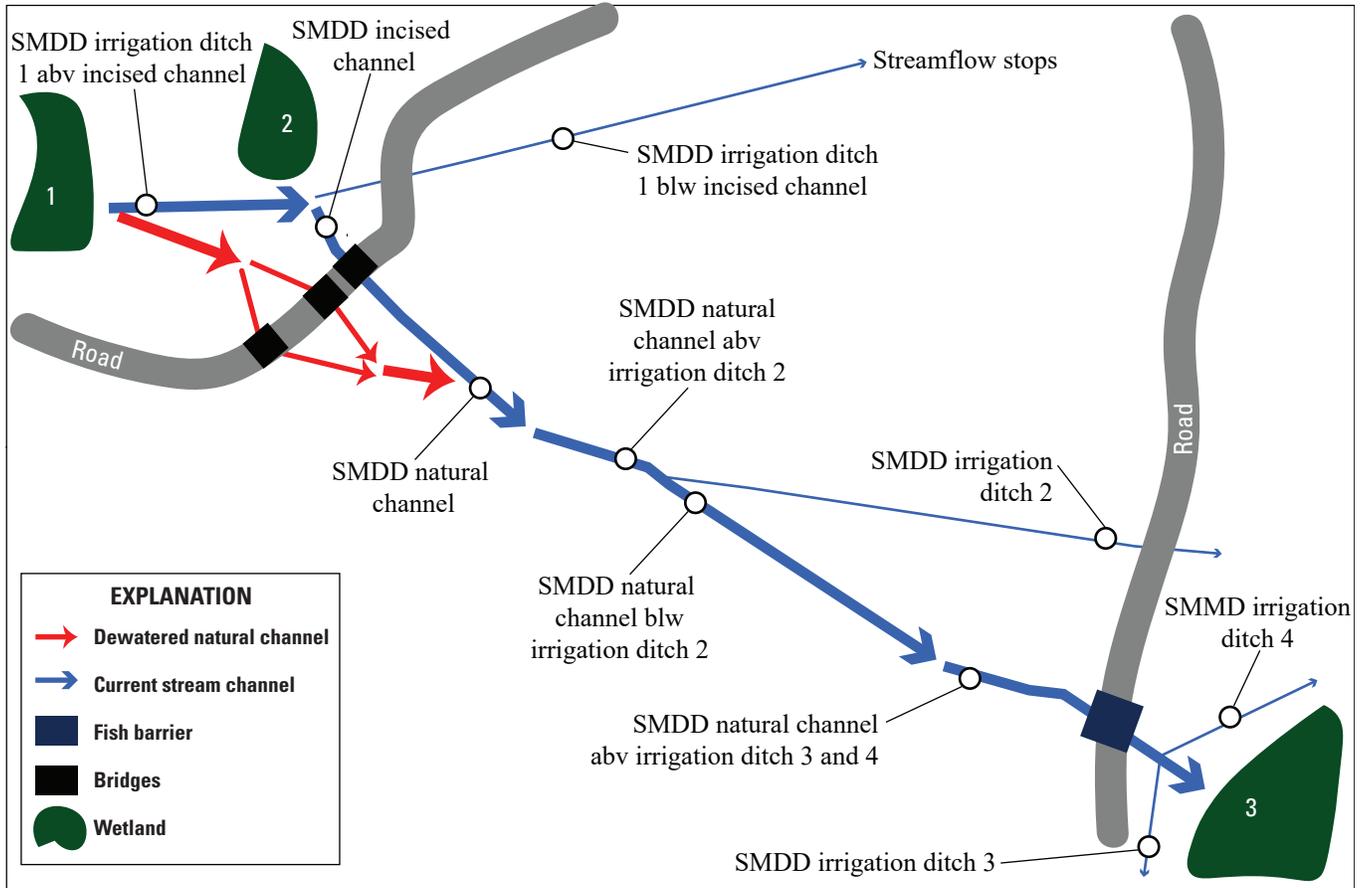
Figure 4. Flow schematic for area 4, Soldier Meadows, Black Rock Desert–High Rock Canyon Emigrant Trails National Conservation Area, Nevada.

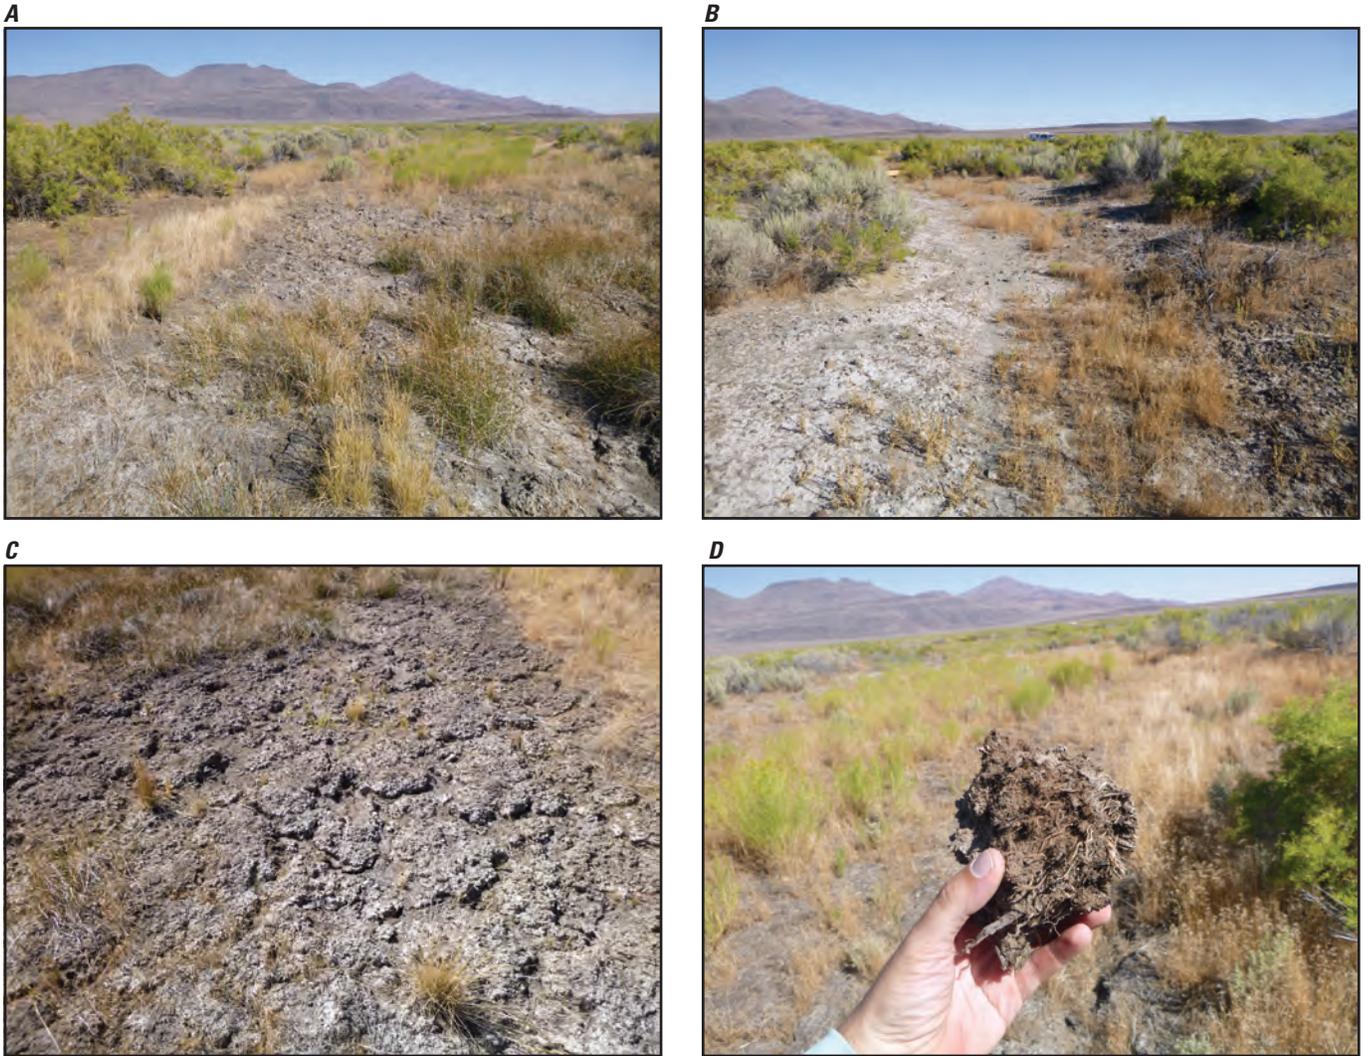
**Figure 5.** Dewatered natural stream channel, Soldier Meadows, Black Rock Desert–High Rock Canyon Emigrant Trails National Conservation Area, Nevada.

During the field survey within the dewatered natural channel, several features were found illustrating the consequences of the dewatering. Parts of the channel had dry, friable root masses (fig. 5). The remaining wetland plants were stunted, and the channel was being colonized by rabbitbrush (*Chrysothamnus* sp.), cheatgrass (*Bromus tectorum*), and sagebrush (*Artemisia* sp.), indicating a transition from wetland to phreatophytic-upland vegetation that has been observed in other Great Basin springs as a result of drying (Patten and others, 2008). The last occurrence of streamflow in the dewatered channel is unknown; however, satellite images from 1981 and 1994 both show much denser vegetation than what is currently present, perhaps indicating some streamflow may have occurred in the dewatered channel during those periods.

In the upstream reaches of the dewatered natural channel (fig. 5), sections of dry, friable root masses and stunted wetland plants were found that may indicate high-water marks and a total of 37 of these points were surveyed. Results of the model calibration indicate that the final simulated water surface had a mean difference from the surveyed possible high-water marks of –0.06 ft. Surveyed elevations of possible high-water marks were not used as a dataset for model calibration because of uncertainty on the magnitude of stream discharge for past flows and on whether the roots were submerged or not; however, the surveyed points may provide a general idea of past water surface elevations.

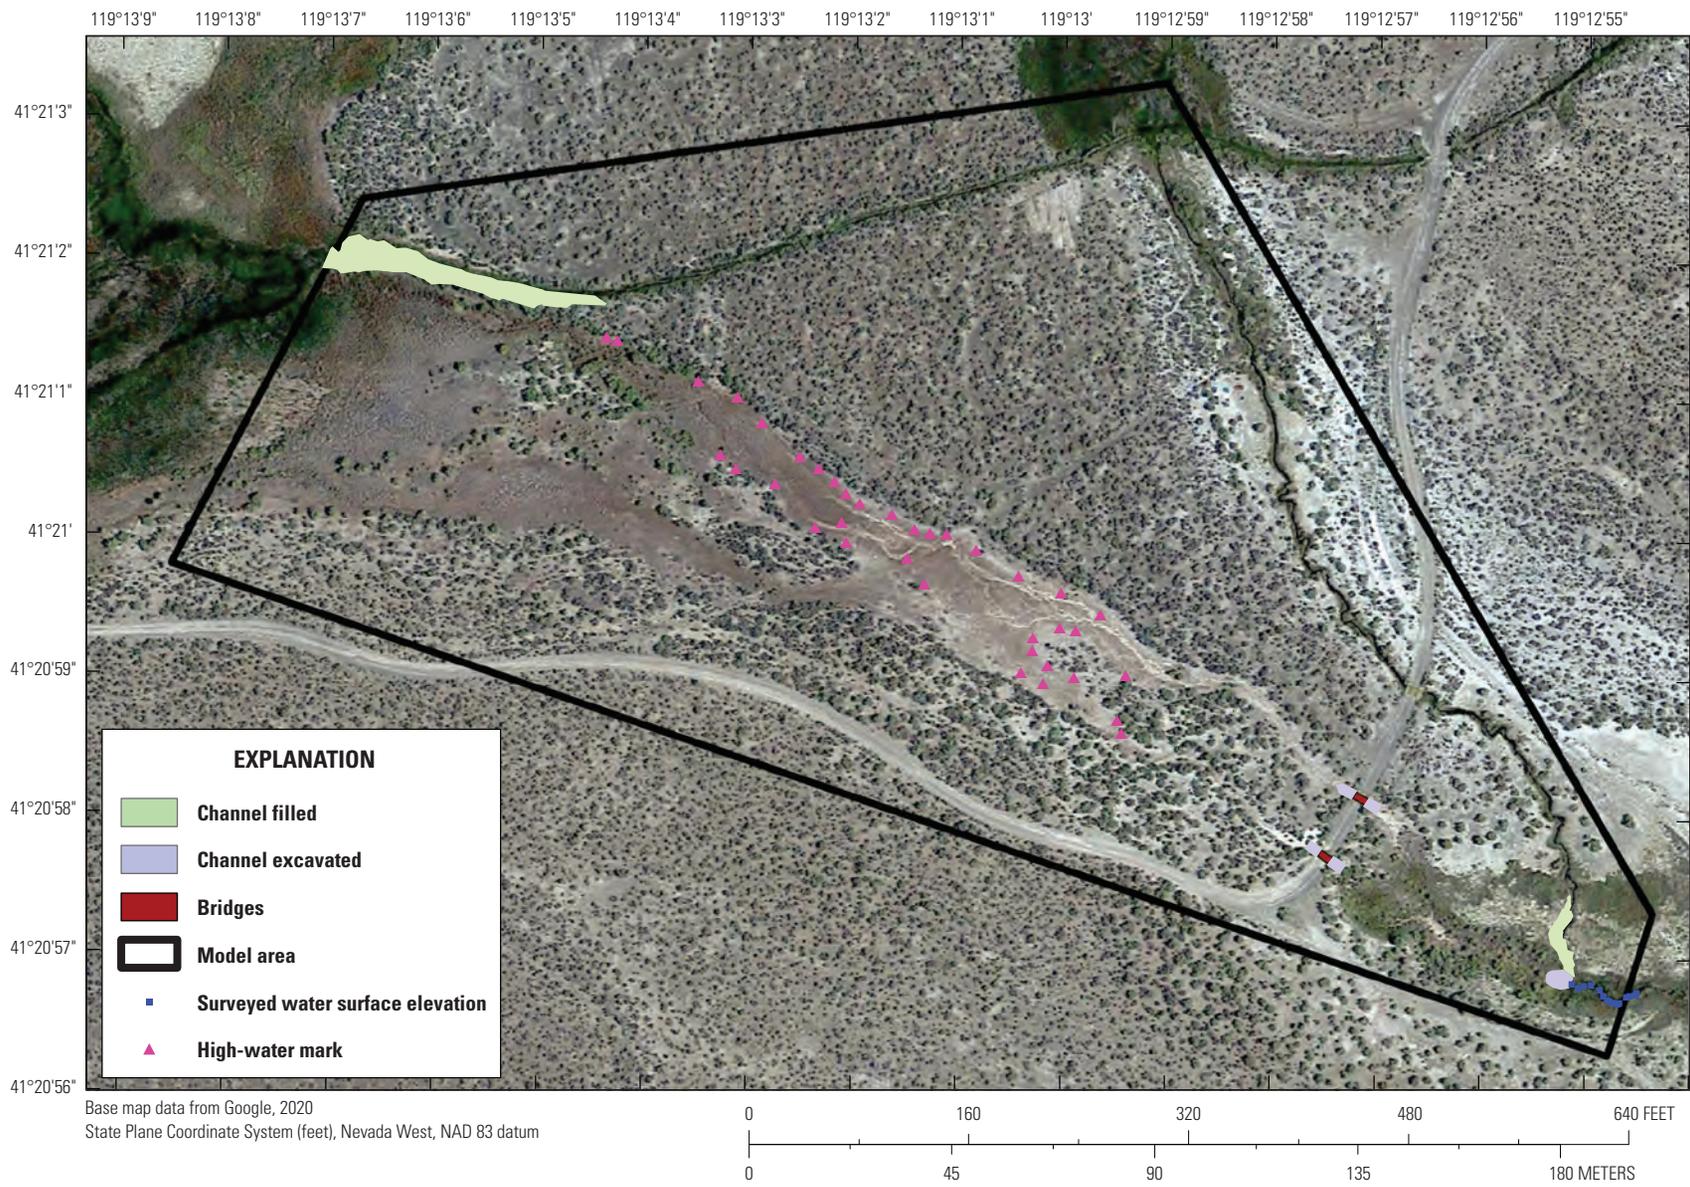
Figure 6. Model area, Soldier Meadows, Black Rock Desert–High Rock Canyon Emigrant Trails National Conservation Area, Nevada.

drop would act as a knickpoint, possibly leading to habitat fragmentation and new channel incision. A 20-ft section of elevation was graded to smooth the transition from dewatered to watered natural channel. Because the streamflow was modeled to never reach the bottom of the bridge decks, the bridges were conceptualized as concrete box culverts with natural channel bottoms in the model. All the locations of topographic adjustments are shown in figure 6.

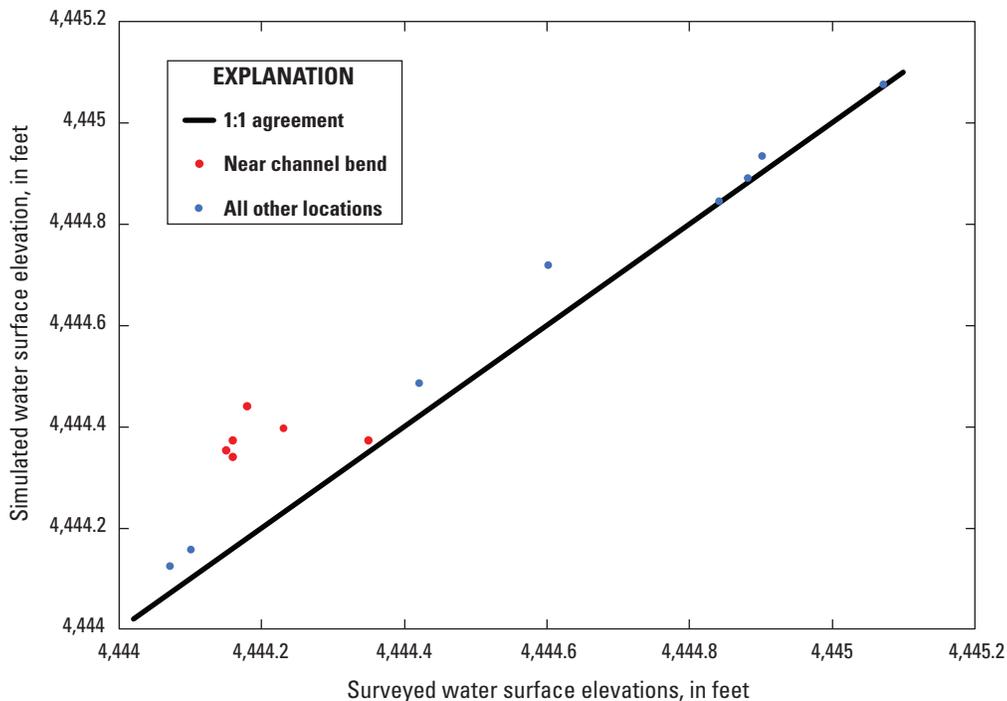
**Figure 7.** Simulated versus surveyed water surface elevations, Soldier Meadows, Black Rock Desert–High Rock Canyon Emigrant Trails National Conservation Area, Nevada.

The calibrated model simulated surveyed surface water elevations by an average of 0.10 ft too high (fig. 7), indicating roughness coefficients might be too large, whereas simulated mean velocity was 0.17 feet per second (ft/s) too large, indicating roughness coefficients might be too small. Examining the simulated versus surveyed water surface elevations, the largest differences were located near the center of the natural channel reach used for calibration, near a channel bend, where five simulated water surface elevations were on average 0.18 ft too high (fig. 7). Moreover, there are numerous locations of undercut banks in the study area where the TIN may be incorrect. The undercut banks in this section of the natural channel may be the cause of the larger model calibration error in water surface elevations. Both upstream and downstream of this section of the natural channel, the difference between simulated and measured water surface elevations was only 0.01 ft and 0.05 ft, respectively, indicating good calibration elsewhere in the natural channel.

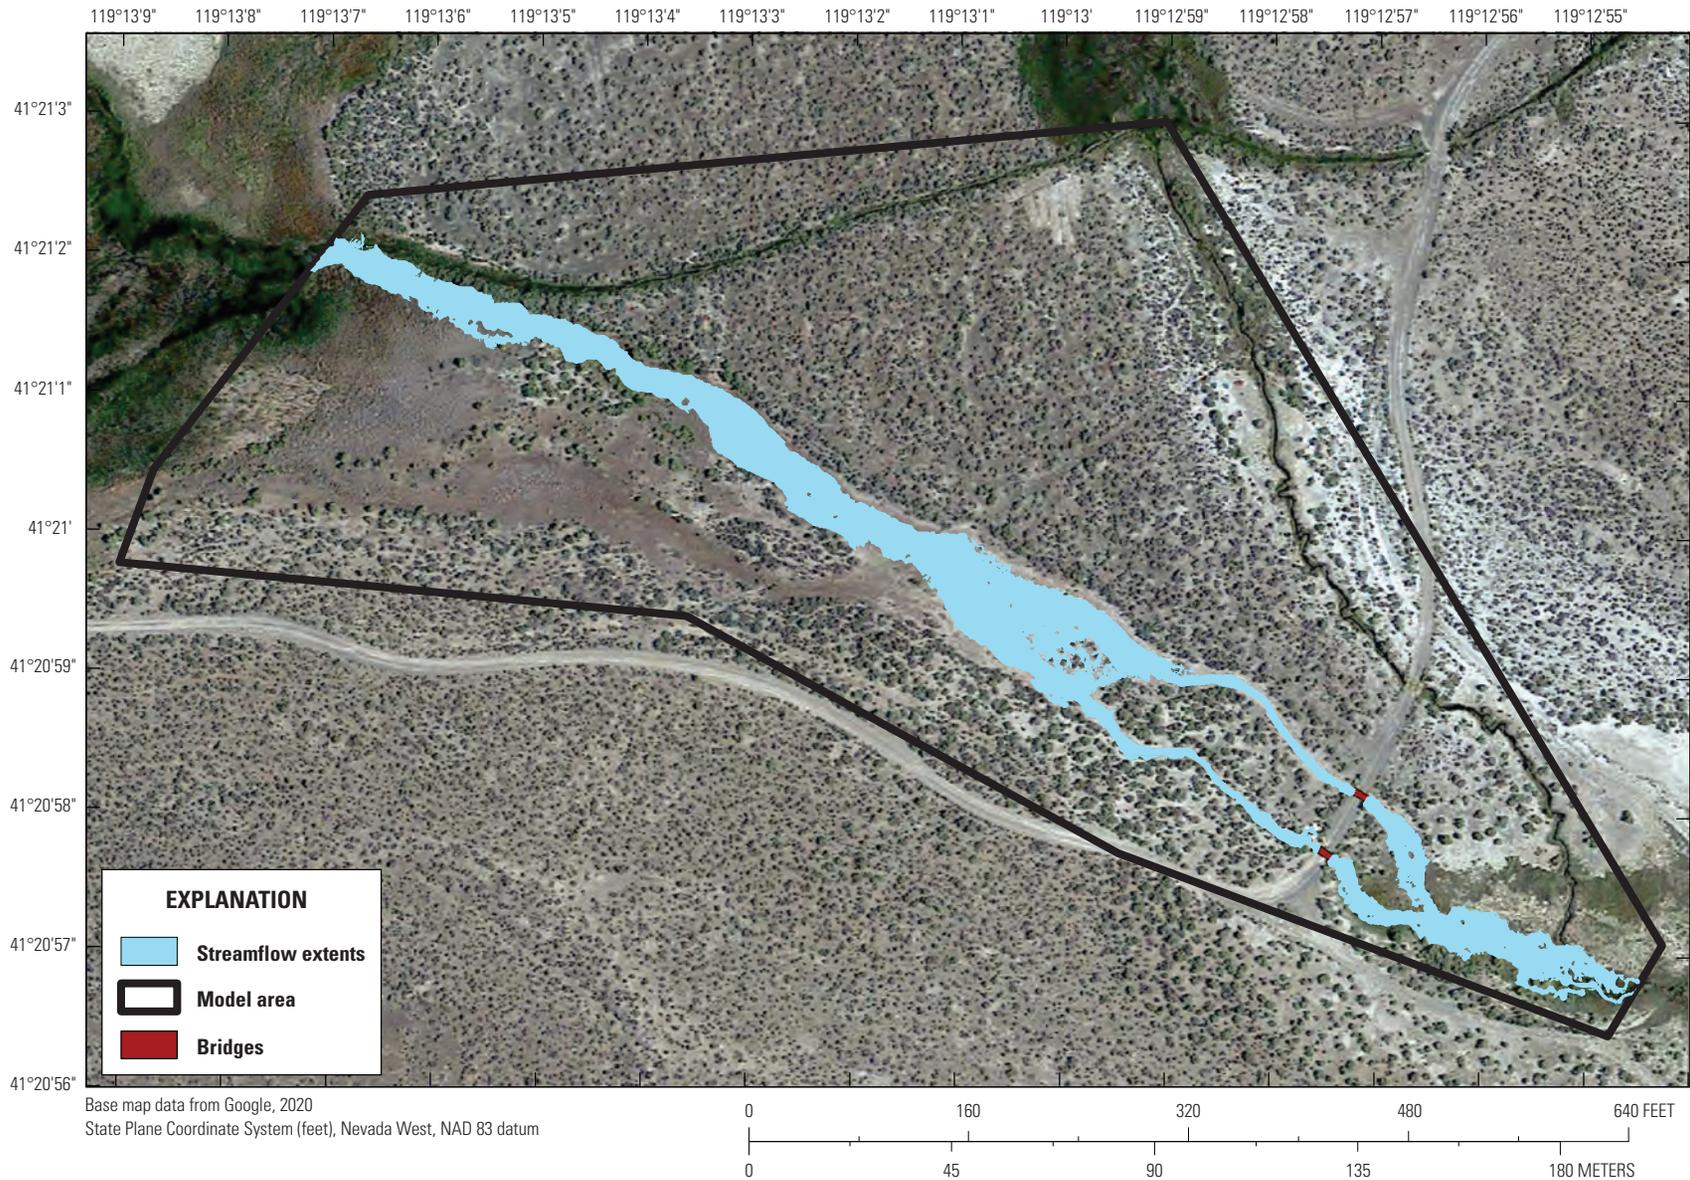
Figure 8. Simulated streamflow extents, Soldier Meadows, Black Rock Desert–High Rock Canyon Emigrant Trails National Conservation Area, Nevada.

Model results indicate that if irrigation ditch 1 above the incised channel were filled in, streamflow would return to the dewatered natural channel (fig. 8). Streamflow would continue southeast and spread into a wider section, where

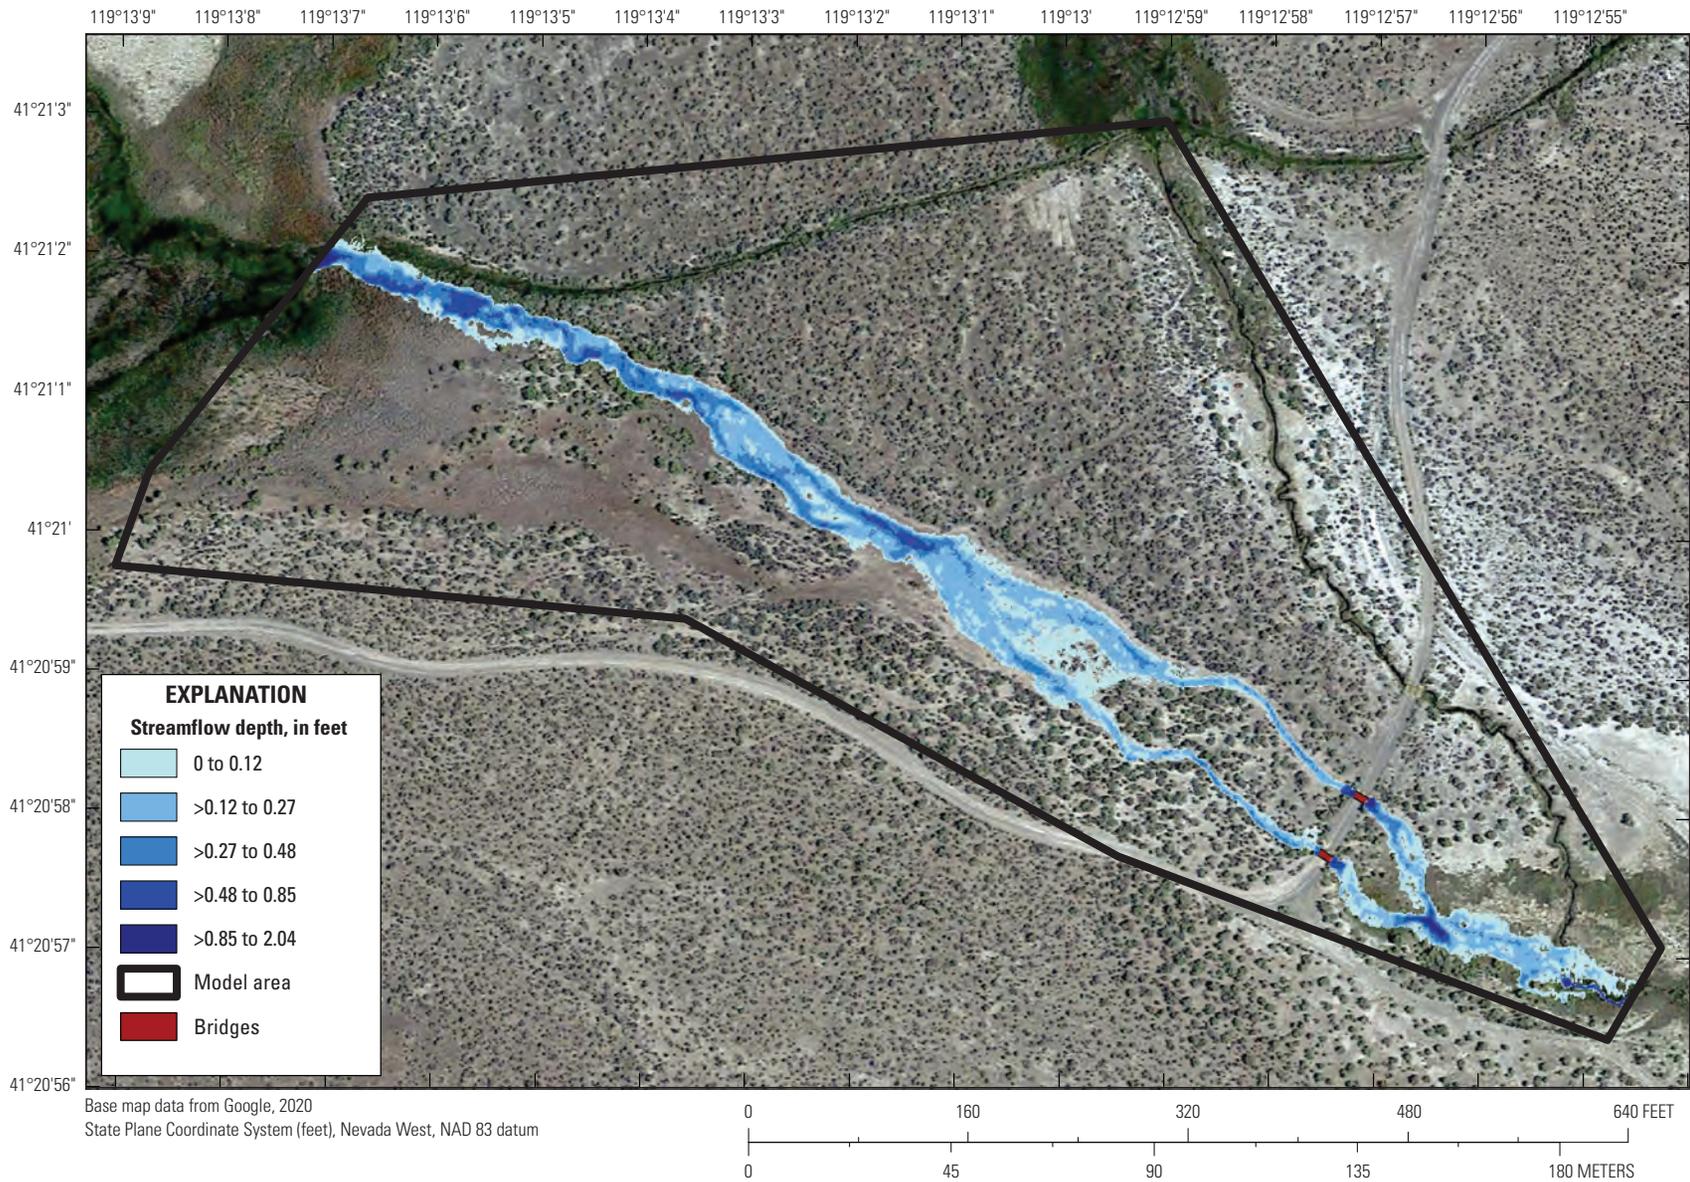
**Figure 9.** Simulated total streamflow channel depths, Soldier Meadows, Black Rock Desert–High Rock Canyon Emigrant Trails National Conservation Area, Nevada.

the streamflow depth would be about 0.15 ft and streamflow velocities would be about 0.25 ft/s (figs. 9 and 10). Farther southeast, streamflow in the natural channel would split into two narrower channels, where the depth would be about 0.30 ft and velocities would be about 1 ft/s. The two narrow channels would go under the two bridges before rejoining, just upstream of the incised channel, where the depth would be about 0.20 ft and velocities would be about 0.75 ft/s. Past the incised channel near the downstream end of the model area, the vast majority of the streamflow would continue into the current natural channel, although a small amount is predicted to split from the natural channel to the north and flow into a wide, shallow area of about 0.10 ft deep. Compared to the current conditions, simulated streamflow in the natural channel would be generally shallower, wider, and slower, but with locations of deeper and swifter streamflow.

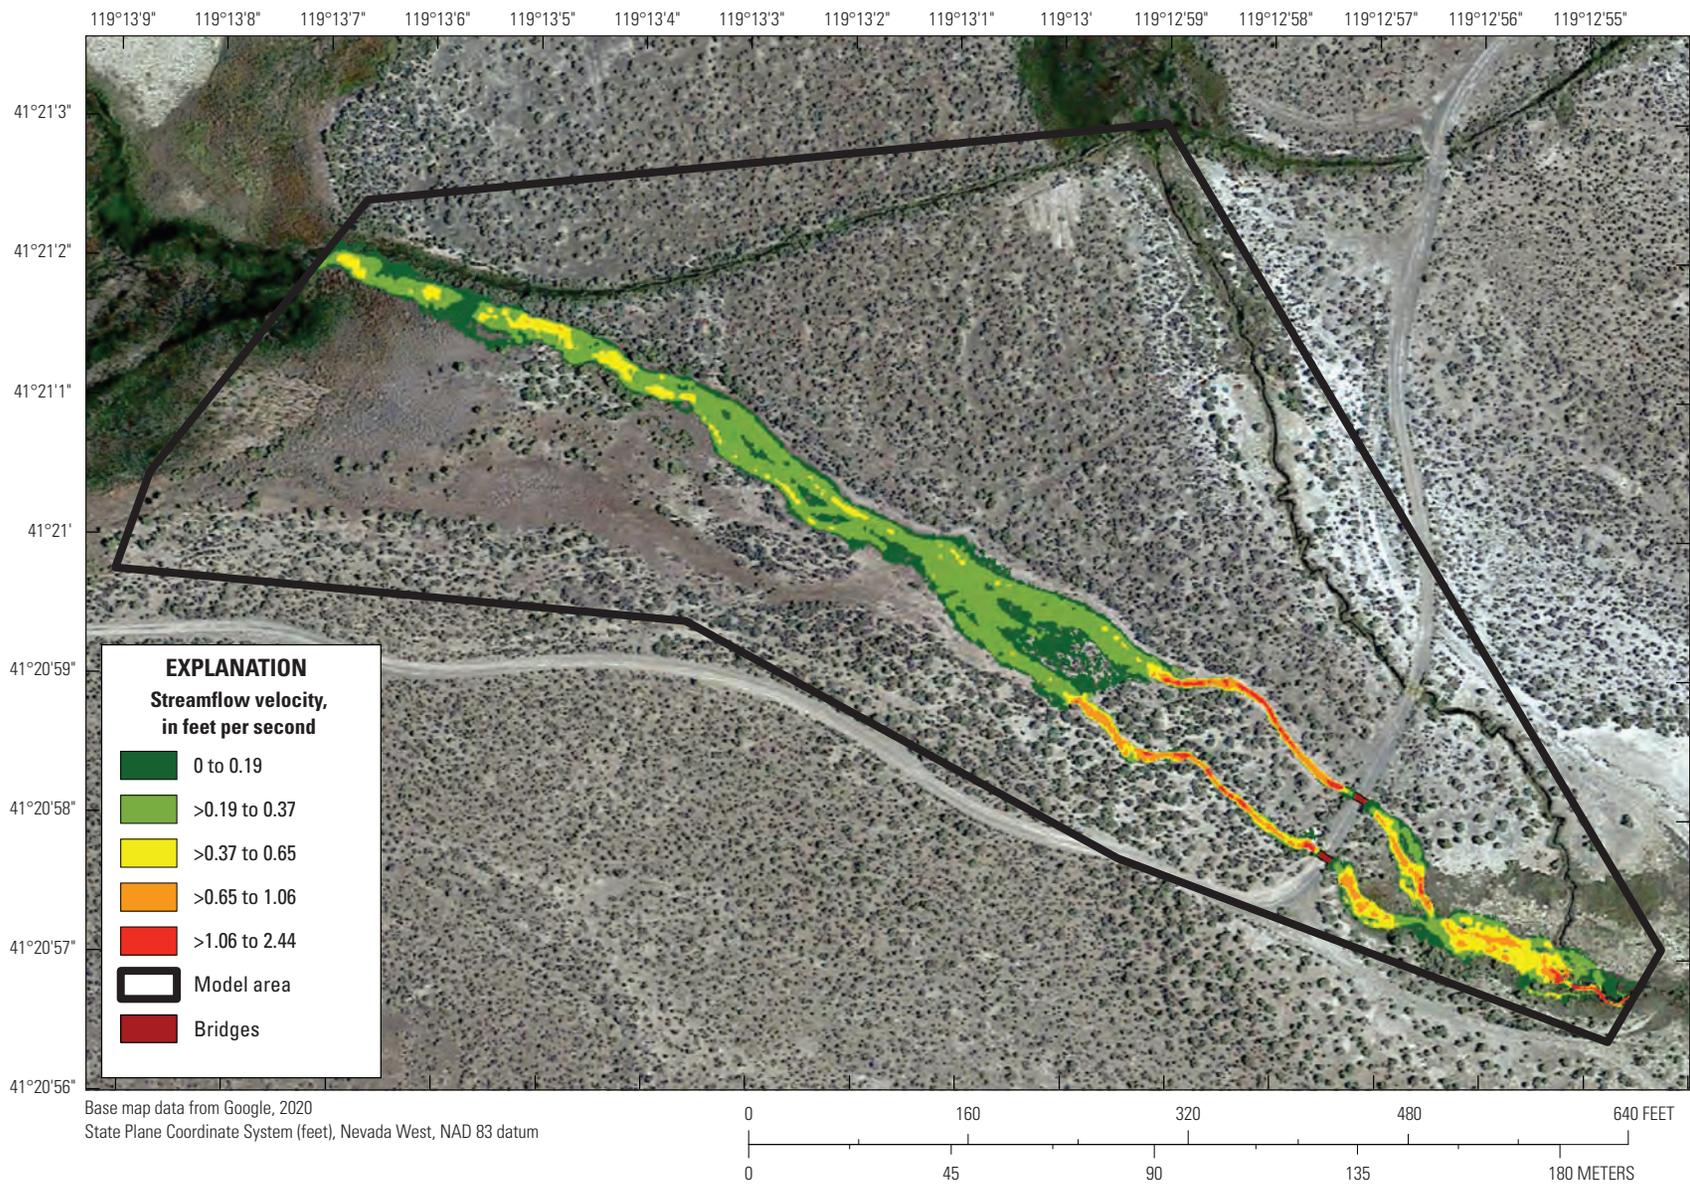
**Figure 10.** Simulated streamflow velocity, Soldier Meadows, Black Rock Desert–High Rock Canyon Emigrant Trails National Conservation Area, Nevada.

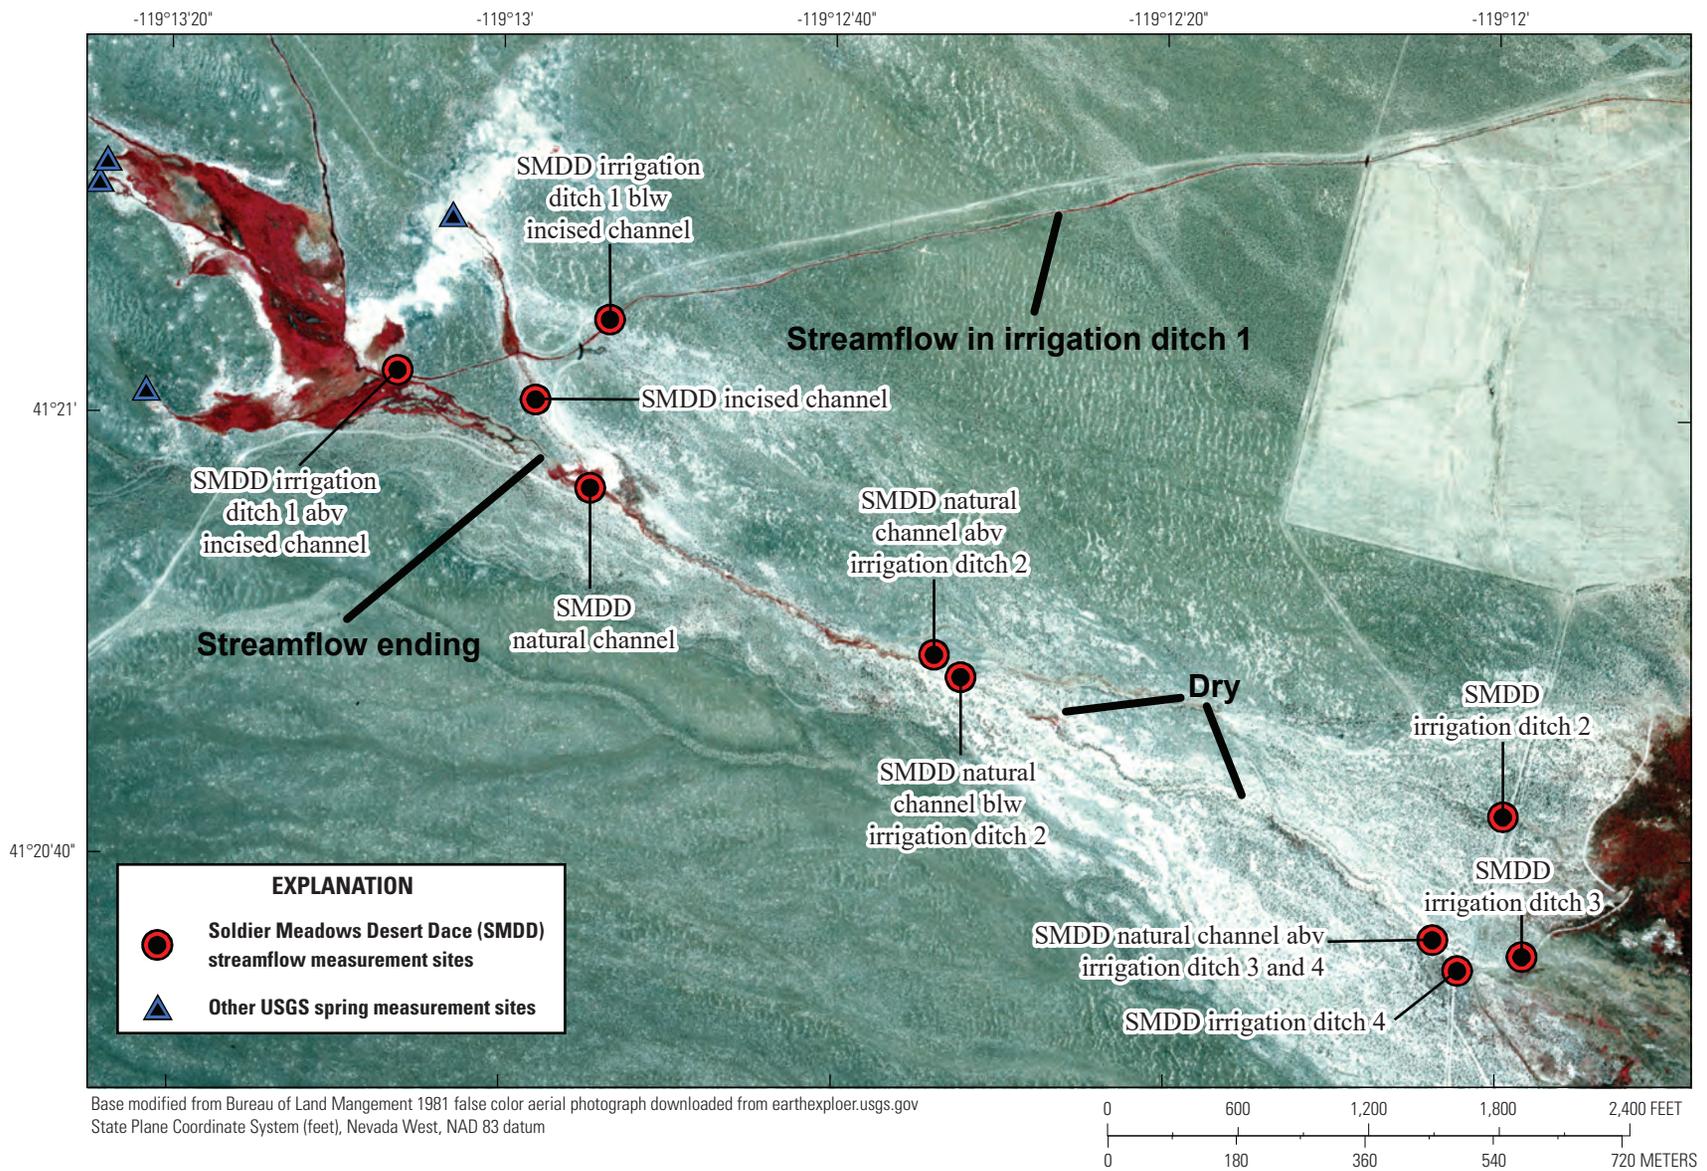
**Figure 11.** Color infrared aerial photograph of study area in 1981, Soldier Meadows, Black Rock Desert–High Rock Canyon Emigrant Trails National Conservation Area, Nevada.

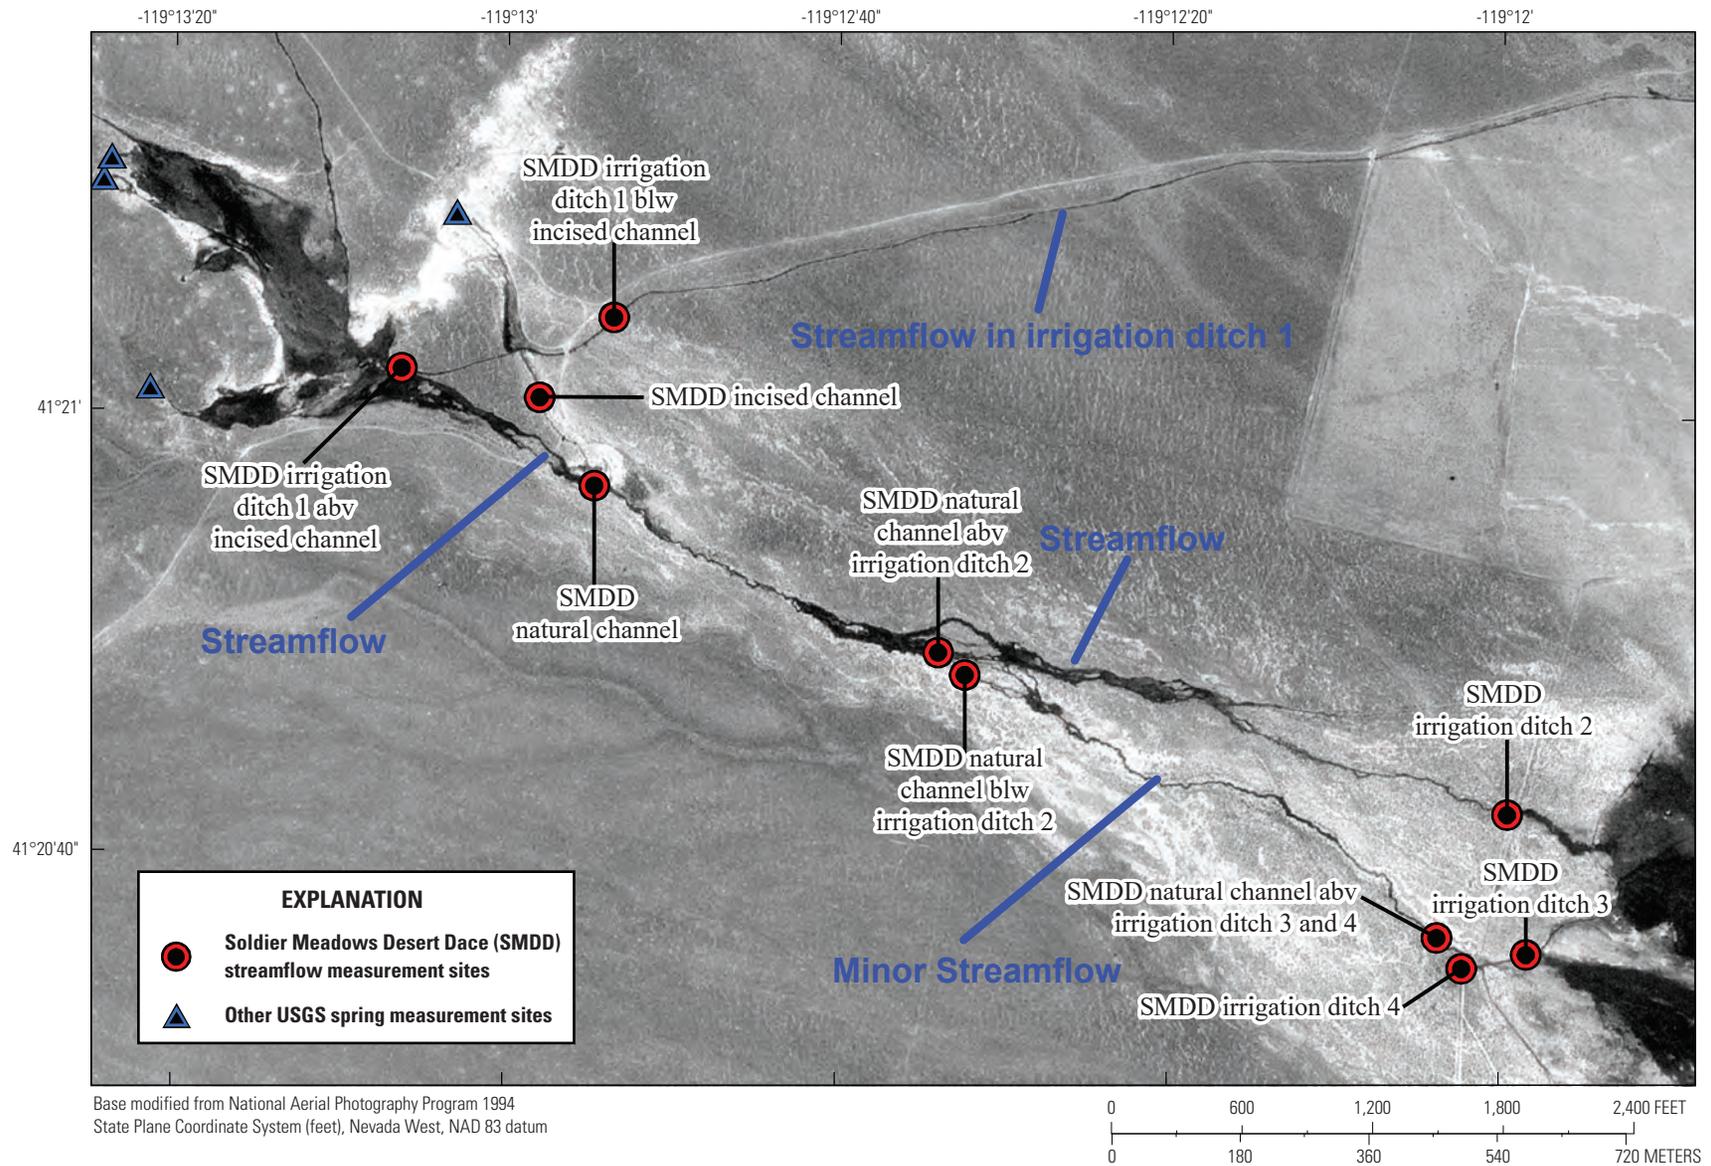
**Figure 12.** Aerial photograph of study area in 1994, Soldier Meadows, Black Rock Desert–High Rock Canyon Emigrant Trails National Conservation Area, Nevada.

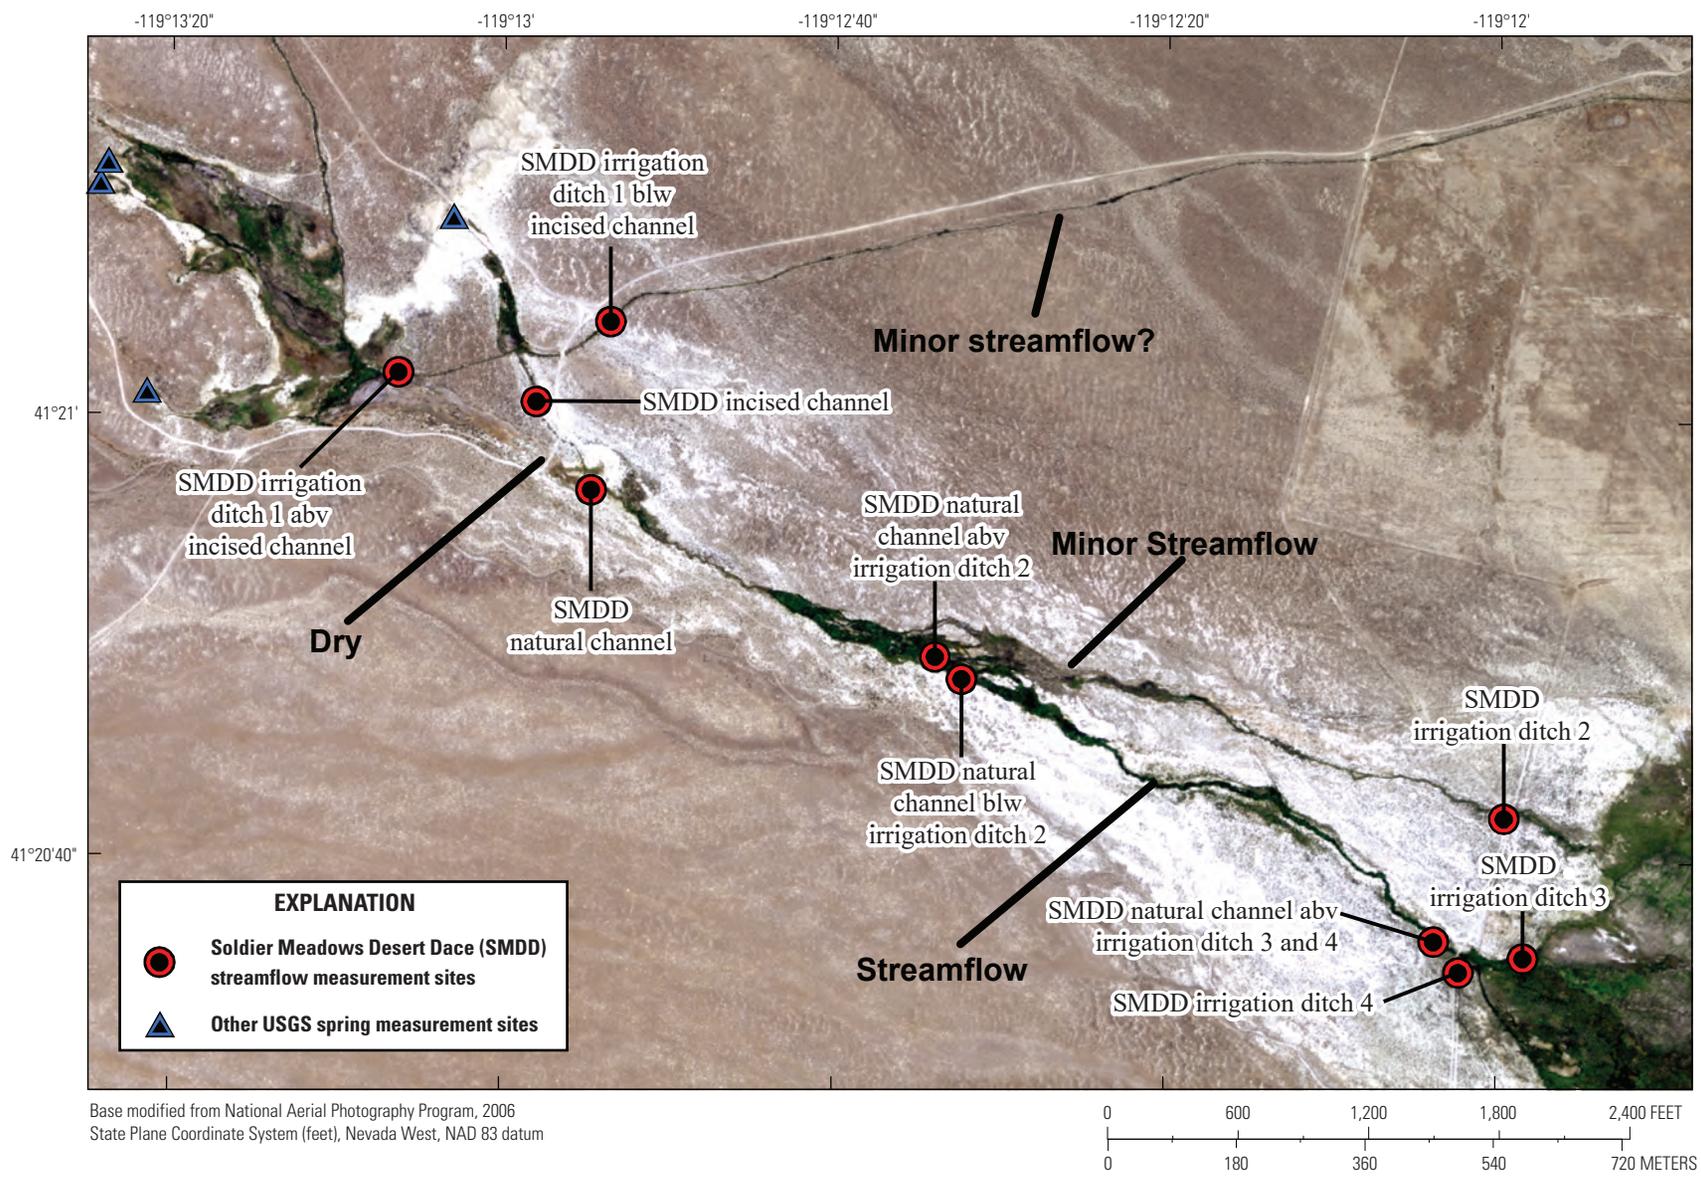
Figure 13. Aerial photograph of study area in 2006, Soldier Meadows, Black Rock Desert–High Rock Canyon Emigrant Trails National Conservation Area, Nevada.
