# Workflow for Using Unmanned Aircraft Systems and Traditional Geospatial Data to Delineate Agricultural Drainage Tiles at Edge-of-Field Sites

Scientific Investigations Report 2021–5013

By J. Jeremy Webber and Tanja N. Williamson

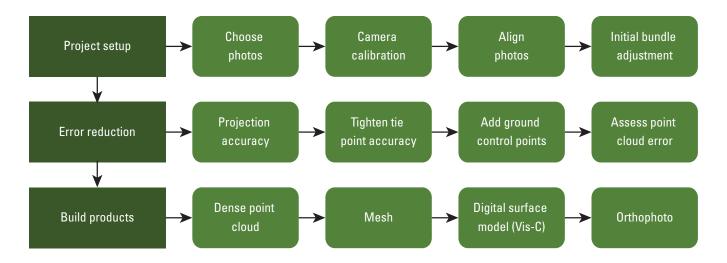
Figure 2. Structure-from-motion workflow with details of photogrammetry process.

Structure-from-motion photogrammetry is the process of taking multiple images and stitching them into a single uniform-scale image, an orthophoto, through the matching of individual pixels (Westoby and others, 2012). After returning from the field, extraneous images from take-off and landing sequences were removed because field of view changes rapidly between these successive images. Blurry images, which can occur when a gust of wind blows during image capture or when the aircraft turns to fly another transect, were also removed. Each set of images was then processed in Agisoft Metashape 1.5.2 (formerly known as Photoscan) following a set workflow (fig. 2) that was developed in coordination with the USGS National UAS Program Office and incorporates the workflow of Matthews and others (2016). Photos were aligned with a matching-point limit of 60,000, retaining all initial tie points, without adaptive fitting, and using default optimization parameters. Reconstruction uncertainty was gradually reduced to a goal of 10 pixels (15 for TIR) and optimized with default parameters. Projection accuracy was gradually reduced to a goal of 2 to 3 pixels (4 to 6 for

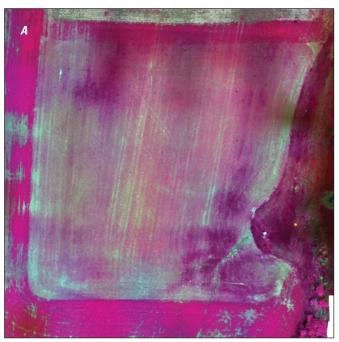
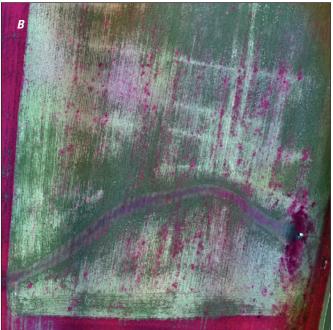
**Figure 3.** Multispectral imagery showing, *A*, field with cover crop and, *B*, field without cover crop. Infrared imagery is useful in illustrating plant health, soil water content, and identifying possible tile drains.

the presence of chlorophyll, thus rendering areas of healthy vegetation as shades of red to pink. These spectra are key to identifying tile drainage in areas with inconsistent vegetative color because where bare ground is not identifiable, plant health can indicate differences in soil-water content and drainage.

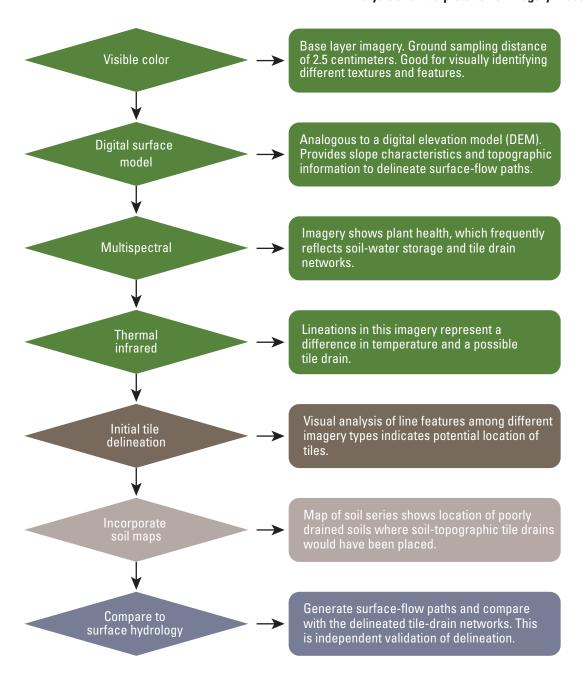
Figure 4. Edge-of-field site data-analysis workflow highlighting products and process for tile delineation.

The EOF site data-analysis workflow (fig. 4) was developed to help guide data processing and to enable the tile-drain interpretation process. For some EOF sites, all imagery products were useful, whereas for other sites, only a subset of the imagery products were helpful in interpretation.

After the DSM and orthophotos were processed, the combination was used for visible interpretation of the location of tile drains (fig. 4). Vis-C orthophotos were displayed at a 35 percent transparency and overlaid upon a hillshaded DSM to enhance the ability to discern surface-flow paths from other surficial features. Soils data (U.S. Department of Agriculture — Natural Resources Conservation Service,

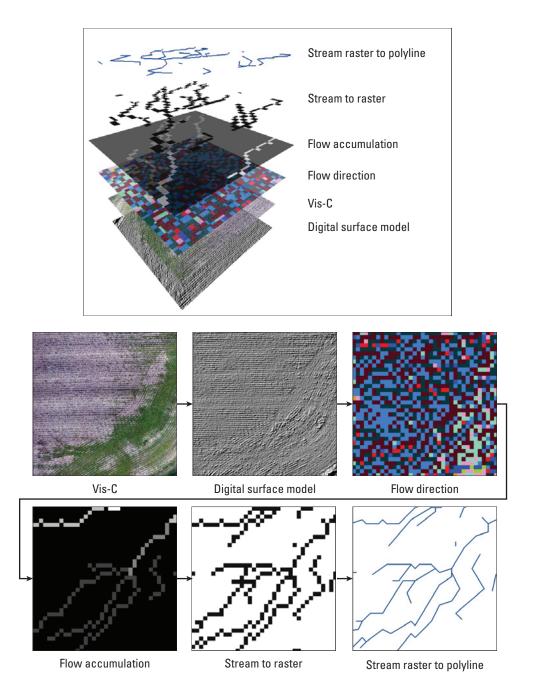
Figure 5. Surface hydrology delineation workflow in perspective and planer view.

The 2.5-cm resolution of the UAS DSM was too granular to delineate surface-water flow paths because it captured a mix of superficial features that obscured site topography, including farm-management and vegetation. Consequently, 2.5-cm DSMs were upscaled (resampled to a coarser resolution) as necessary to produce a surface-water flow network that was not interrupted by these superficial features. The resulting

DSMs were resampled from a spatial resolution of 2.5 cm to 1.53 m. Given the utility of upscaled DSMs for delineating surface-water flow paths, a second set of surface-water flow paths was delineated using lidar DEMs for individual sites to determine whether DSMs produced from UAS imagery provided additional information.

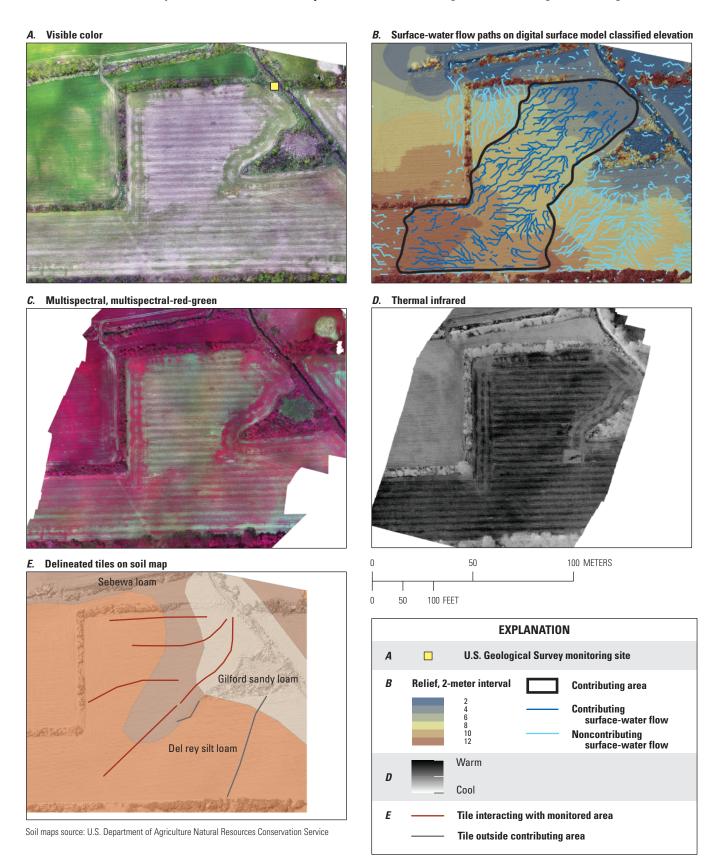
**Figure 6.** *A, C, D,* Michigan flume 2 (MI–FM2) and tile-drain 2 (MI–TL2) imagery, *B*, digital surface model derived from visible-color imagery, and, *E*, interpreted surface-water flow paths, and interpreted tile-drain locations overlain on a combination of visible-color imagery and soil series boundaries. These two monitoring sites are colocated.

The Michigan EOF site 2 (MI–FM2 [–TL2]; USGS Site ID 0414826504[3]; U.S. Geological Survey, 2021) discharges into a stream system that ultimately flows to Lake Huron (table 3; fig. 1). This site has been monitored since 2015 and after a baseline monitoring period of three years, a mixed cover crop and "other" BMPs were introduced. This mixed cover crop made it more difficult to use thermal imagery to identify the location of tile drains because the soil-water signature was inconsistent, possibly because of multiple plant types and nonuniform plant density (fig. 6). Given the plant density at this site and the presence of flowering plants over bare soil, the thermal product was minimally useful at this location. The contributing area for the MI–FM2 EOF site was originally estimated at 5.46 hectares (Institute of Water Research, 2014). After visual interpretation of the UAS imagery and associated products, the contributing area was estimated at 4.16 ha (approximately 25 percent less) because surface-water flow paths in the northwestern corner of the field drained northward. Surface flow paths delineated with the upscaled DSM were similar to those using 3-m lidar data. However, the surface-water flow path networks for this site that were derived from the upscaled DSM indicate that the tree-lined field boundaries on the northwestern and southern edges of the field create a topographic divide that helps define the contributing area in combination with field topography that divides the central part of the field from parts to the east and west.

A set of topographic-soil tiles were identified from the UAS imagery for the EOF site. Although visible tile extends beyond the area that contributes to what is monitored for surface runoff, tile density beneath this monitored area is estimated at 148.06 m/ha. Multiple types of imagery indicate a tile

drain that discharges into the swale that is outside of the contributing area; however, the site lead had already investigated, and no tile outlet was found. The uncertainty of the tile-drain extent and connectivity at this site warrant further investigation by other means or a time-series of imagery focused on a large storm while the soil is relatively exposed (Allred and others, 2020). Low-altitude Vis-C, MS, and TIR imagery collected at the Michigan site 2 are available as a USGS data release (Williamson and others, 2021a).

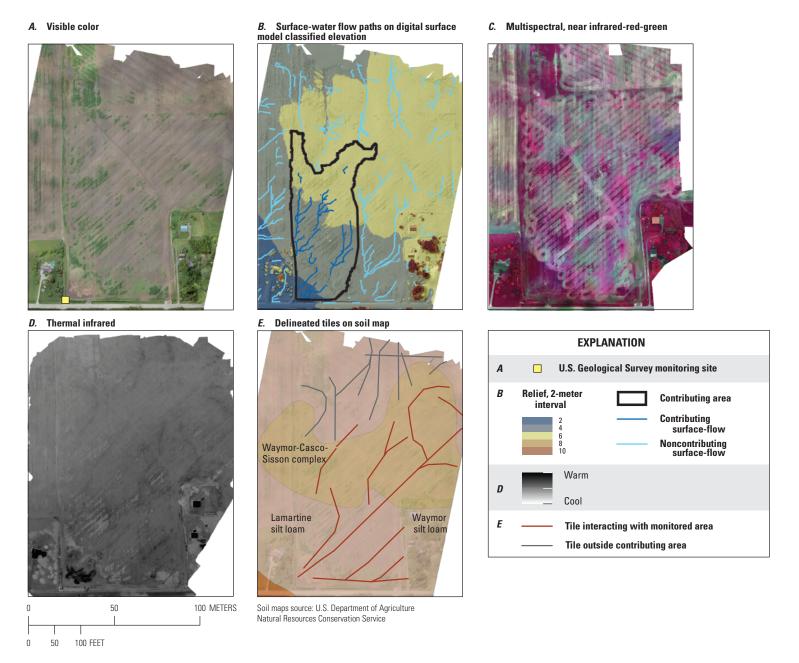
**Figure 7.** *A, C, D,* Wisconsin surface-water 3 (WI–SW3) and tile-drain 1 (WI–TL1) imagery, *B,* digital surface model derived from visible-color imagery, and interpreted surface-water flow paths, and, *E,* interpreted tile-drain locations overlain on a combination of visible-color imagery and soil series boundaries. These two monitoring sites are colocated.

Monitoring at Wisconsin surface-water site 3 (WI-SW3 [-TL1]; USGS Site ID 441520088045001[2]; U.S. Geological Survey, 2021) began in 2014, with introduction of the BMPs of conservation tillage and cover crop in 2016. This site has rolling topography, with 8 m of relief between the highest point of the drainage divide and the gaged outlet; this is the most relief among the EOF sites surveyed (fig. 7). The UASderived tile-drain network closely matched a sketch that was provided by the landowner, validating this UAS methodology. Flow networks were generated using a UAS DSM that was upscaled to 1.53-m spatial resolution from the original 2.5-cm resolution. The UAS survey confirmed that the area underlain by the monitored tile (WI-TL1) is more than twice the area contributing surface water to WI-SW3 (table 4). Tile density beneath the monitored surface-contributing area is estimated at 167.20 m/ha. Low-altitude Vis-C, MS, and TIR imagery collected at the Wisconsin surface-water site 3 are available as a USGS data release (Williamson and others, 2021b).

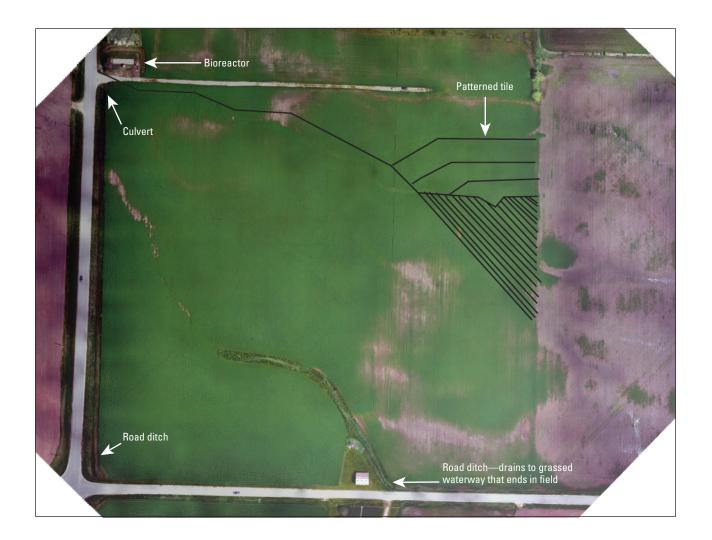
Figure 9. Wisconsin bioreactor site features including bioreactor location, culvert, and road ditches.

section (1/4 square mile; 65 hectares) shown in (fig. 9). The newly installed tile system drains the northeast quarter of this AOI and drains west to the bioreactor.

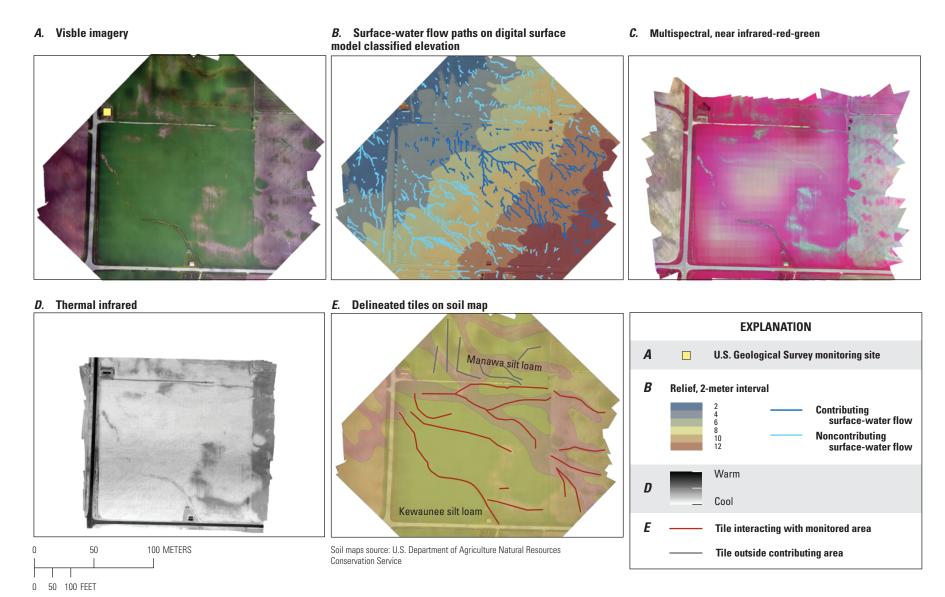
**Figure 10.** *A, C, D,* Wisconsin bioreactor imagery, *B,* digital surface model derived from visible-color imagery, and, *E,* interpreted surface-water flow paths, and interpreted tile-drain locations overlain on a combination of visible-color imagery and soil series boundaries.

Although the same workflow was completed for this site, the density and generally consistent appearance of the cover crop prevented delineation of any patterned-tile networks from the UAS imagery. Bare soil was rarely exposed at this site, so the dense cover crop was interpreted to reflect surface topography. Based on a combination of plant health, as evidenced from multiple types of imagery, with the location of a grassed waterway, topographic-soil tile drains were delineated, and the appropriateness of these tile-drain locations were interpreted using surface-water flow path networks combined with the soil map.

- 2. The contributing area for the field extends beyond the field boundary to the east. Consequently, the newly installed tile-drain system is likely draining soil water from the adjacent field. To supplement the UAS imagery, the 2018 Door County lidar DEM, with a resolution of 1 m (Wisconsin View, 2019), was also used to delineate surface-water flow paths. However, this lidar ends at the county line to the south of the image, so it also failed to capture the entire drainage network.
