Streambank Erosion and Related Geomorphic Change in Tuolumne Meadows, Yosemite National Park, California

Scientific Investigations Report 2021–5025

U.S. Department of the Interior
U.S. Geological Survey

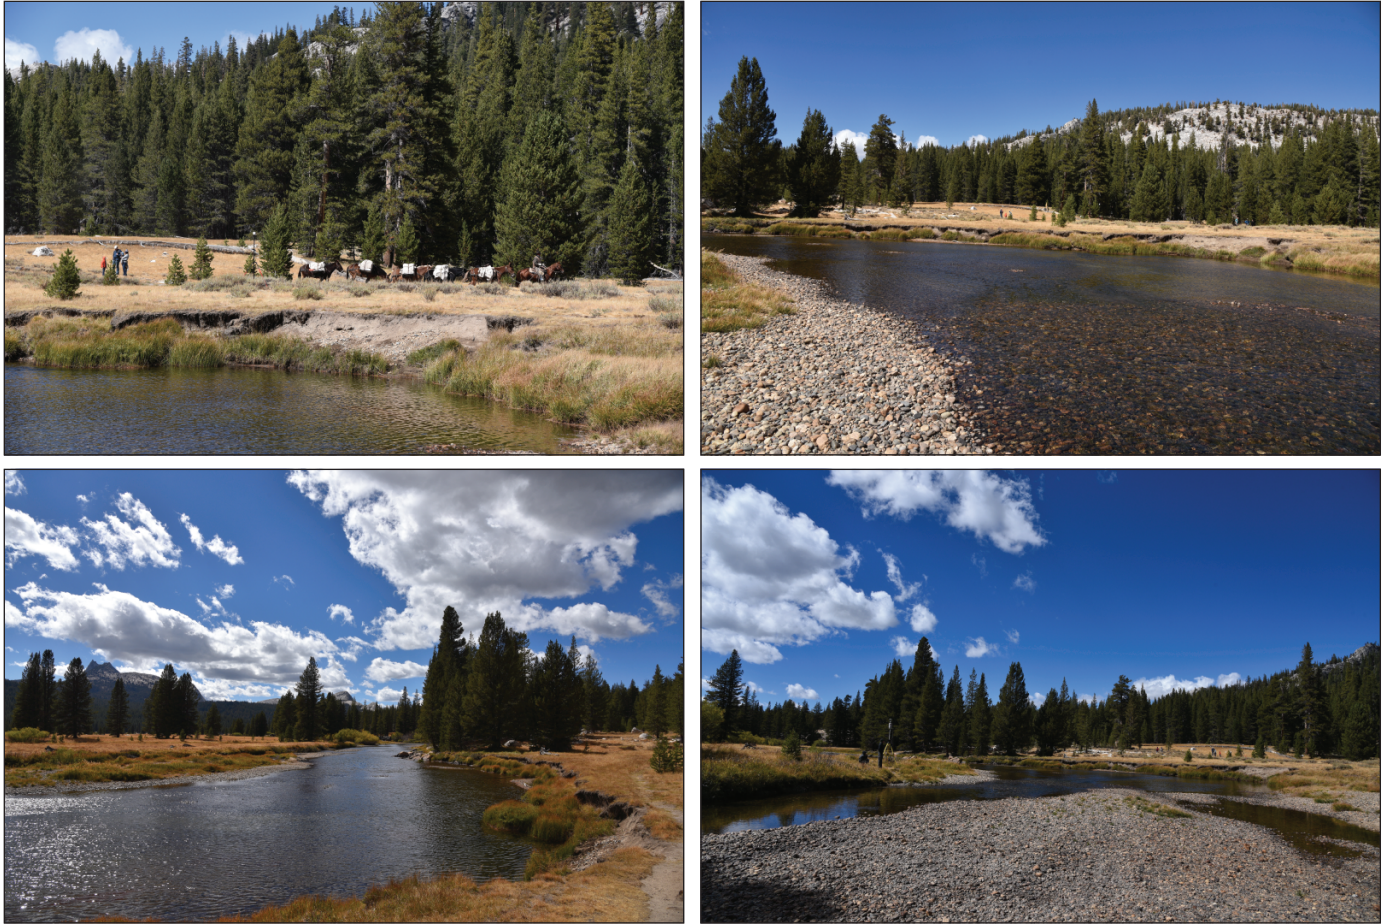
Figure 11. U.S. Geological Survey photographs of erosion zone 1, taken in 2016.

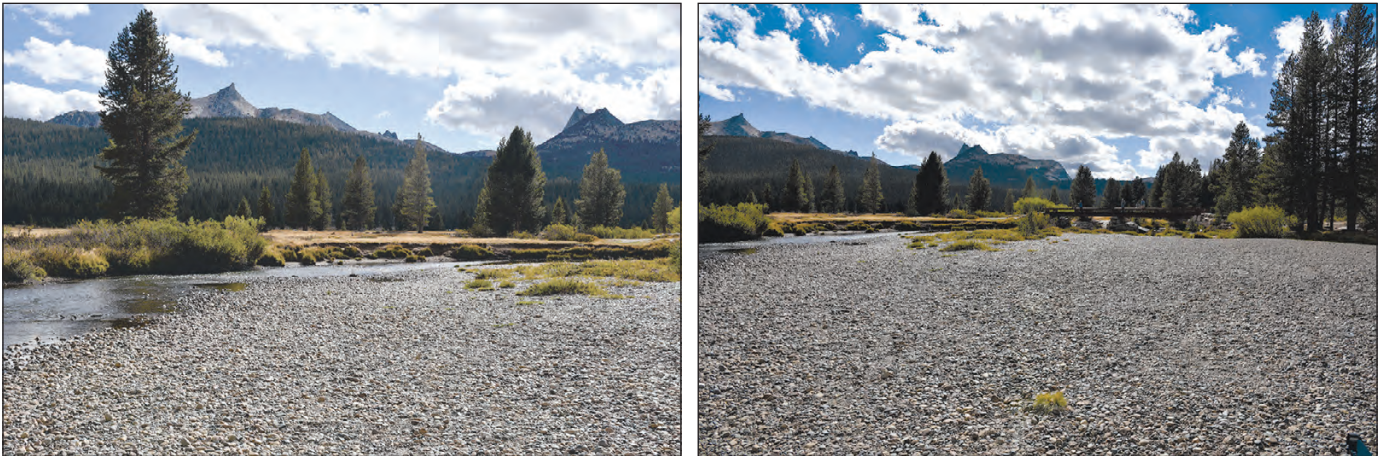
Erosion zone 3 is immediately upstream of the Soda Springs footbridge (fig. 2) on the south side of the river. It is opposite of a large point bar (fig. 14). The streambank is eroding a grass-covered meadow surface and underlying fluvial deposits (figs. 15 and 16). The streambank in this area retreated an average of 1.1 m between 2006 and 2016 (table 5). The streambank position did not retreat a measurable distance

Figure 16. U.S. Geological Survey photographs of erosion zone 3, taken in 2016.

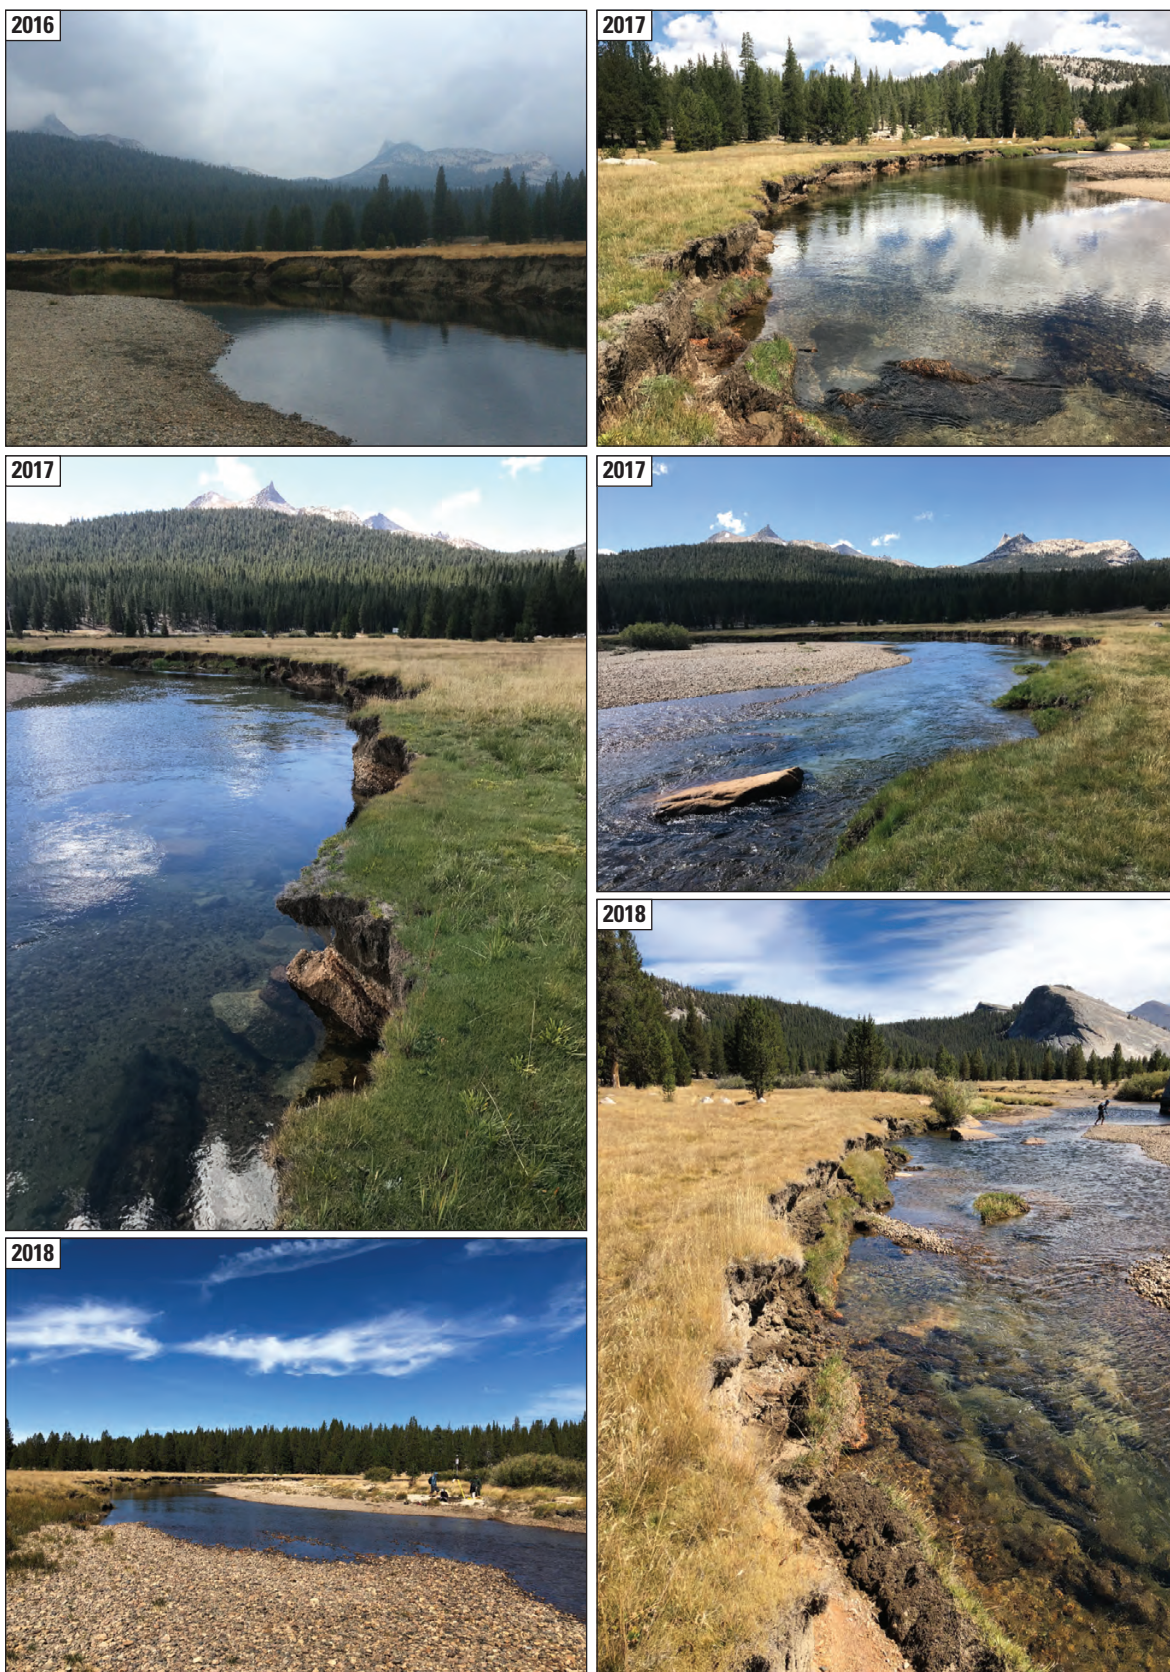
Figure 19. U.S. Geological Survey photographs of erosion zone 4, taken during 2016–2018.

The most common process by which streambanks erode in Tuolumne Meadows is undermining and failure of blocks of sediment (for example figs. 19, 28, 43, and 46). The short meadow vegetation that grows on top of the main valley surface adjacent to eroding streambanks appear to have shallow roots confined to the upper fine grained and organic-rich soil. This may indicate that erosion below roots leads to undermining and mass wasting of channel material via cantilever failure (Micheli and Kirchner, 2002a). This may cause the common overhanging nature of eroding channels, though vertical variation in material properties of the sediment along the soil profile may also be a factor in causing overhanging features in layered sedimentary material (for example DeLong and others, 2014). These overhanging blocks are gradually removed by subsequent floods.

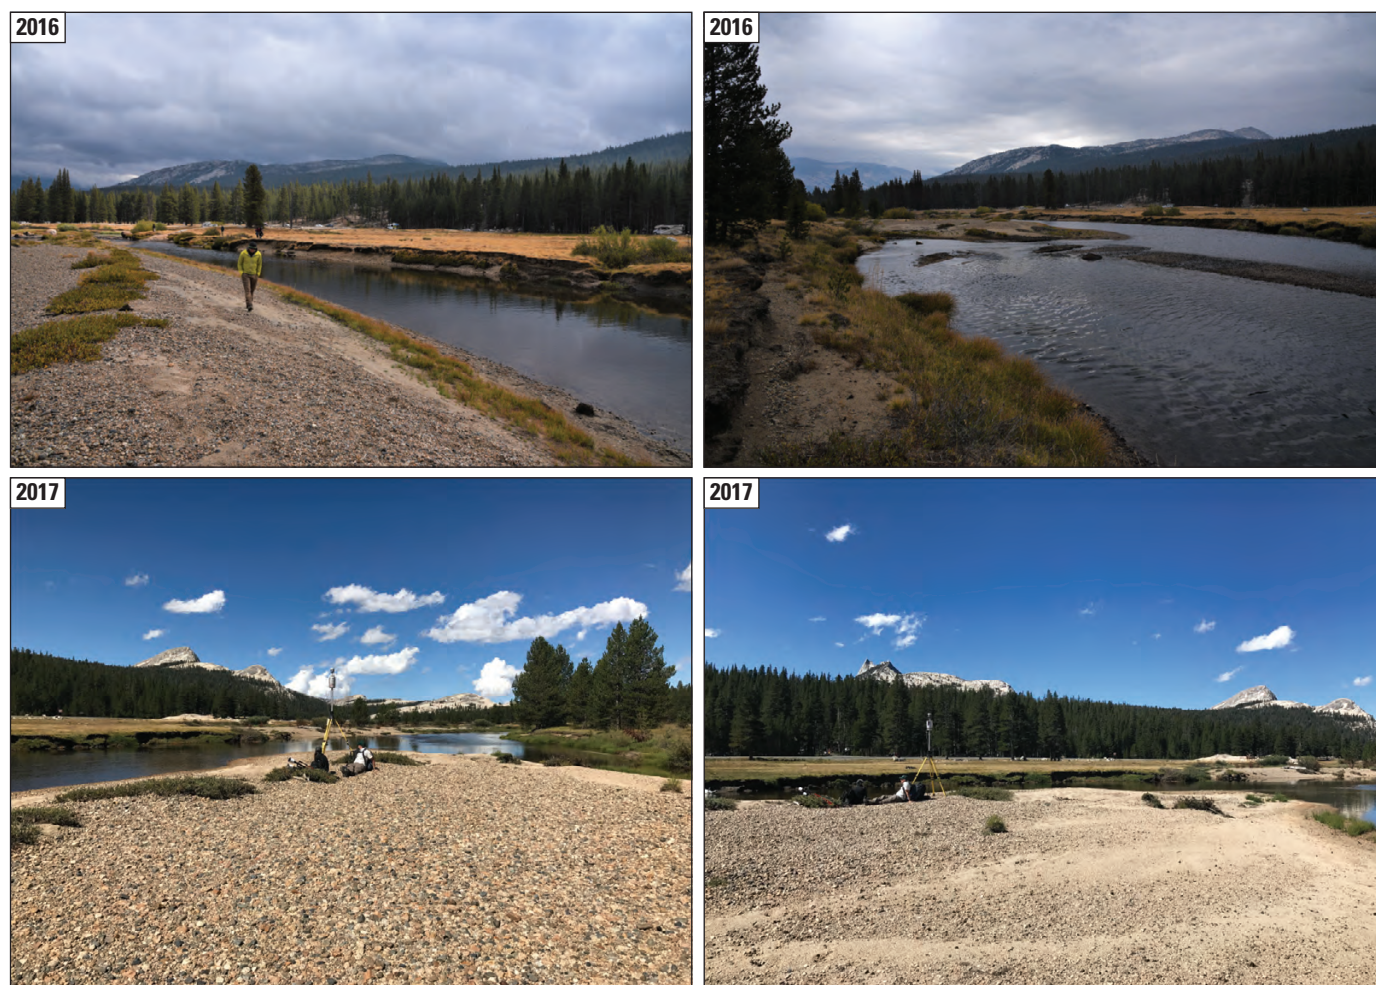
Erosion zone 5 is along a relatively straight section of the Tuolumne River. The eroding streambank is just less than 100 m long and is across from a large point/channel bar (fig. 20). The streambank is eroding a flat grass-covered surface with soil and fluvial sediments underlying it (figs. 21 and 22). The depositional bar hosts some willows. Between 2006 and 2016, the streambank retreated an average of about 1.1 m, causing between about 137 and 153 m³ of erosion (table 7). During this time, the bar accumulated about 86 m³ of sediment.

Figure 22. U.S. Geological Survey photographs of erosion zone 5, taken during 2016–2017.

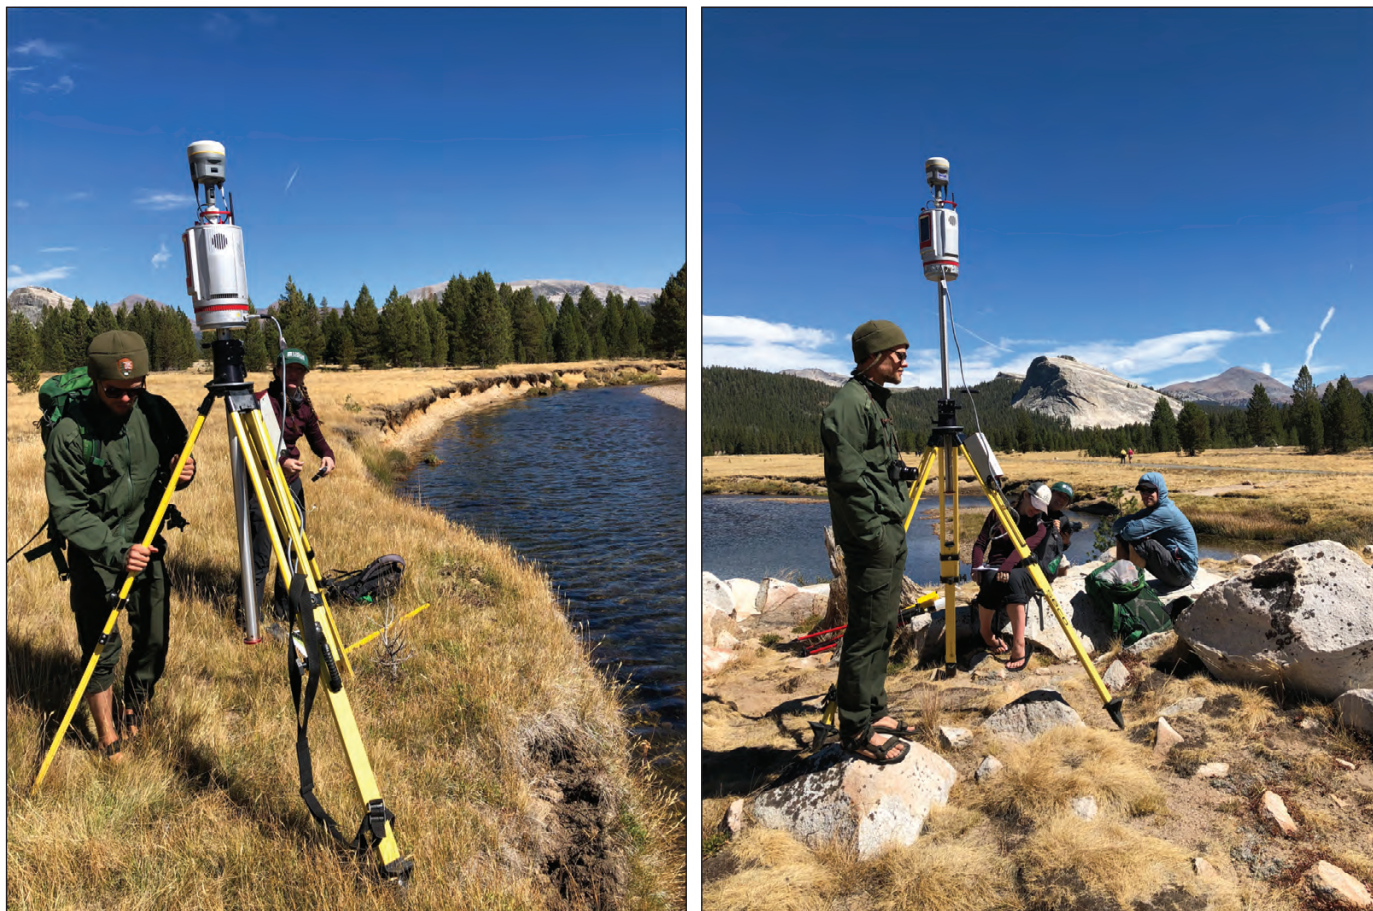
Erosion zone 6 is along a gentle bend of the Tuolumne River (fig. 23). The unvegetated point bar across from the active streambank is relatively narrow and creates a narrow channel at its upstream end. The unvegetated bar is connected to a very large vegetated bar that hosts short vegetation and occasional willows (fig. 24). The streambank is eroding grass-covered fluvial sediment and soil. The streambank retreated an average of about 0.53 m from 2006 to 2016, about 0.63 m

Figure 25. U.S. Geological Survey photographs of erosion zone 6, taken in 2018.

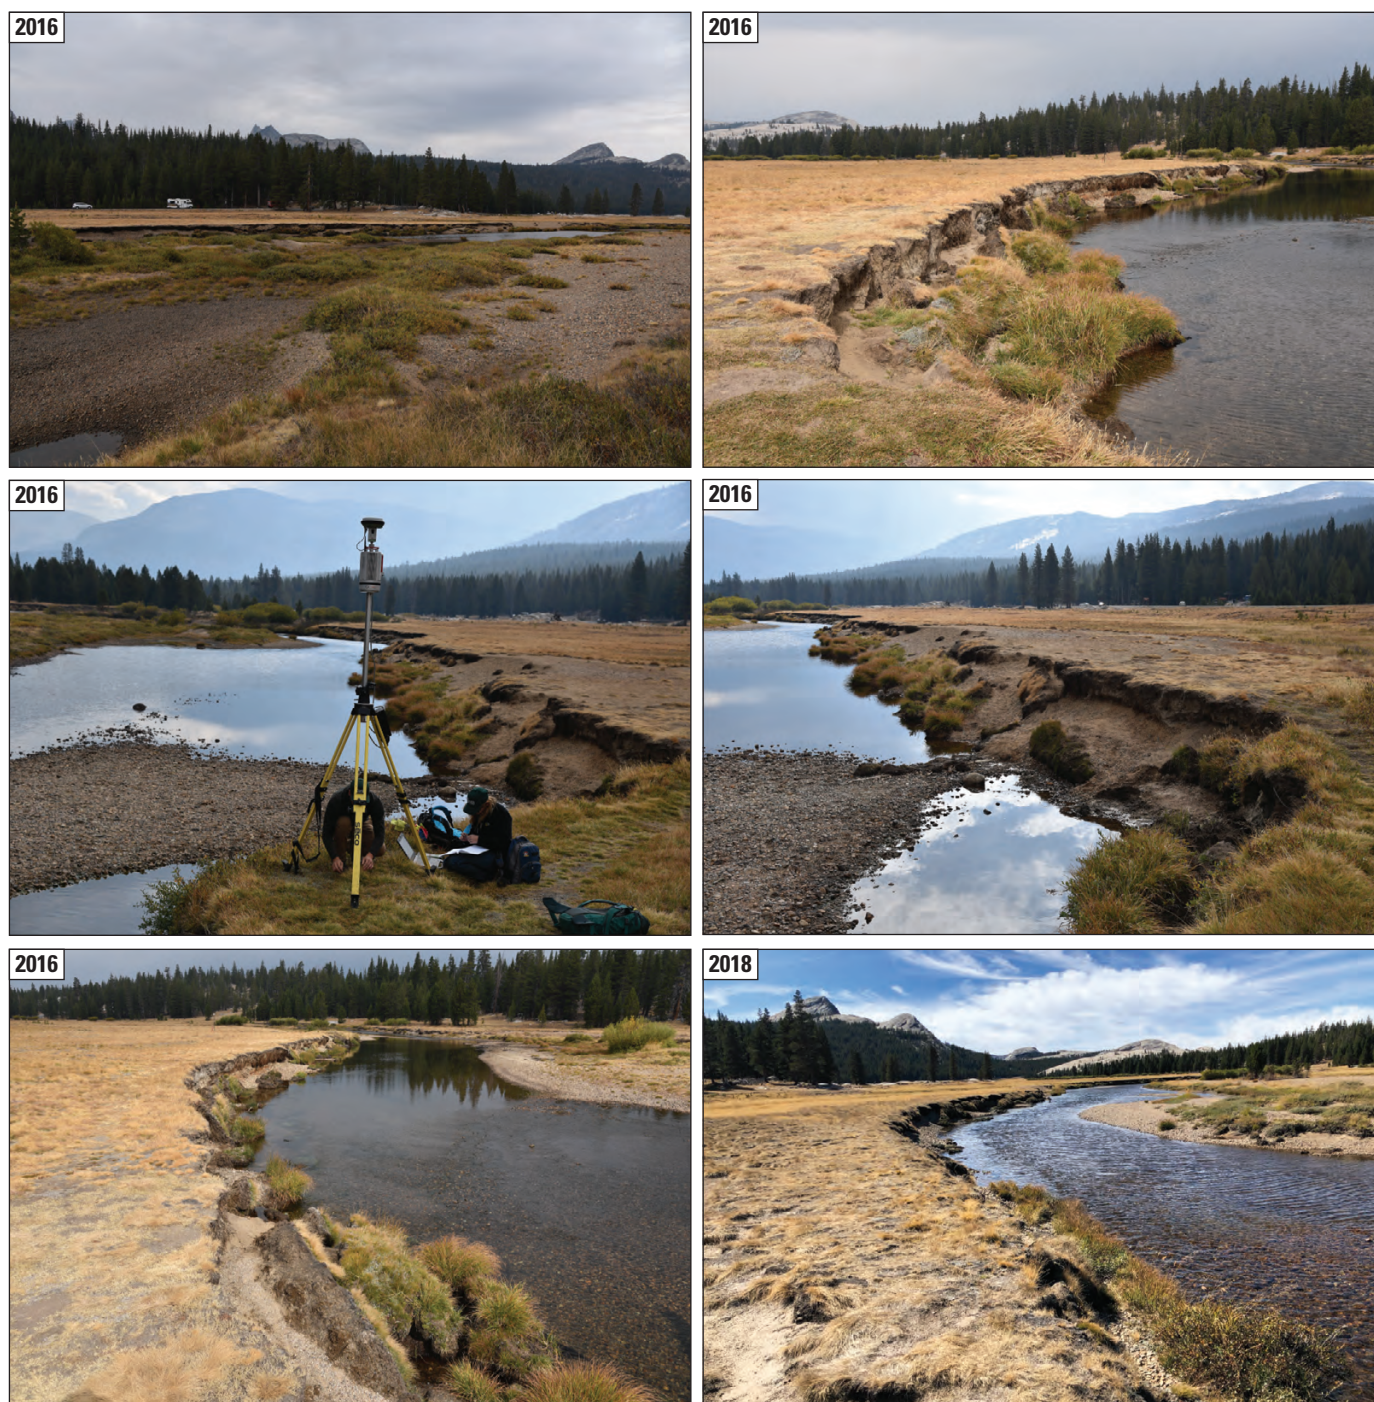
Figure 28. U.S. Geological Survey photographs of erosion zone 7, taken during 2016–2018.

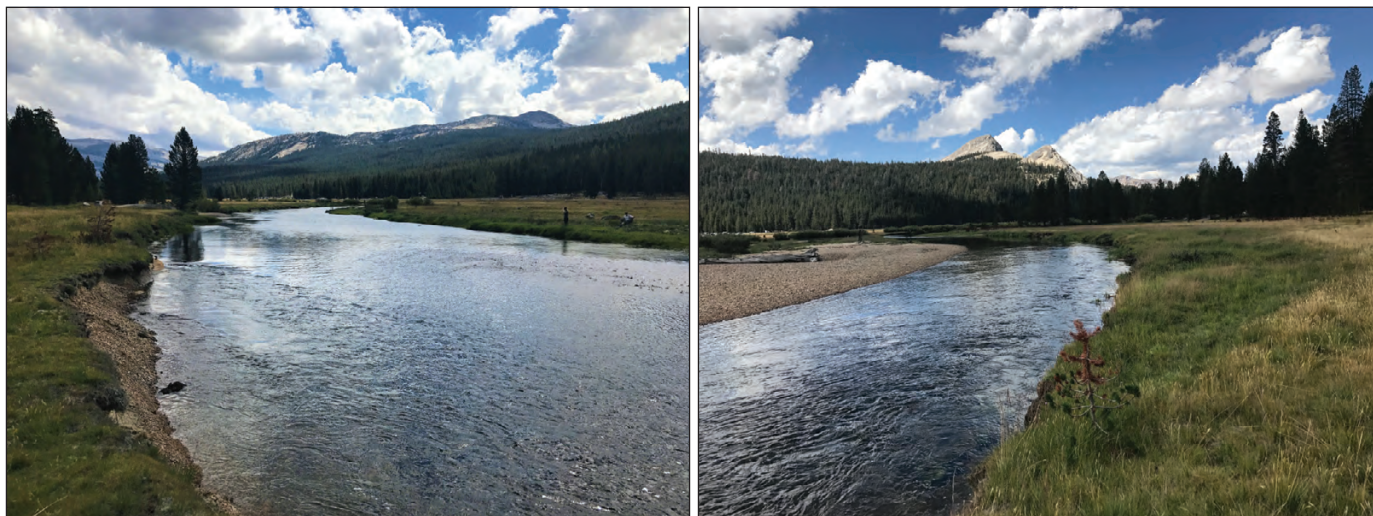
Erosion zone 9 encompasses a long, gently sweeping bend of the Tuolumne River where about 200 m of eroding streambank is opposite of a large depositional point bar (fig. 32). The streambank is eroding grass-covered soil and fluvial sediment and is approaching a slope where pine trees are growing (figs. 33 and 34). From 2006 to 2016 between 109 and 117 m³ of sediment was eroded from the streambank as it retreated an average of 0.38 m (table 11). During this time, the point bar eroded about 60 m³ of sediment. From 2016 to 2018, about 260 m³ of sediment was deposited on the point bar, mostly during the 2017 flood, and streambank erosion removed between about 26 and 330 m³

Figure 34. U.S. Geological Survey photographs of erosion zone 9, taken in 2016.

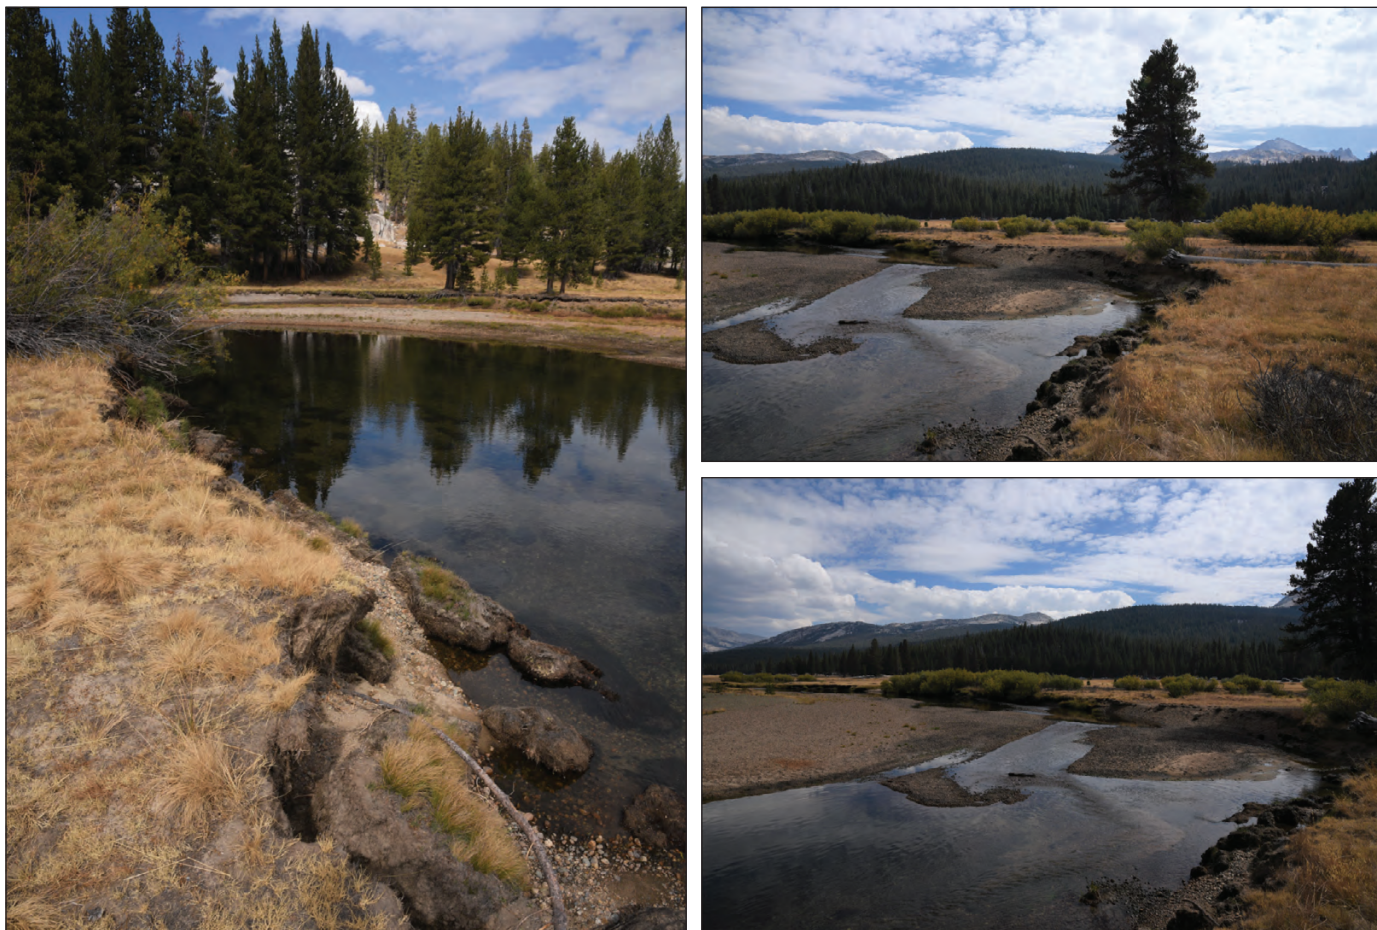
Erosion zone 10 is at a sharp bend just upstream of an even sharper bend in the Tuolumne River (fig. 35). The streambank is eroding a grass and willow-covered surface that is underlain by soil and fluvial sediment (figs. 36 and 37). The eroding streambank is opposite of a large point bar and just upstream of a channel bar that may be a remnant of a point bar that was cutoff as the channel changed position sometime prior to 2006. This remnant bar is likely the old point bar across from a steep, active-looking streambank that did not erode during the study period, therefore it is not included as an erosion zone.

Figure 37. U.S. Geological Survey photographs of erosion zone 10, taken in 2016.

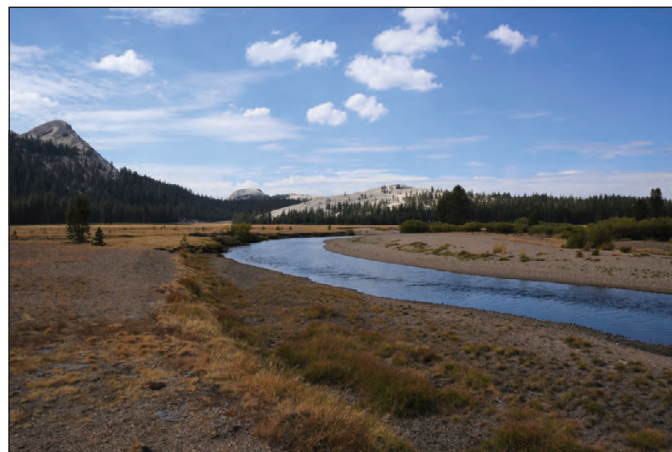
Erosion zone 11 is along a gradual bend of the Tuolumne River. It is across from and a bit downstream of a large point bar and just upstream of a large channel bar (fig. 38). The streambank is eroding a grass-covered surface underlain by soil and fluvial sediment along a length of about 35 m (figs. 39 and 40). The streambank retreated an average of 0.40 m from 2006 to 2016, eroding between about 12 and 48 m³ of sediment from the

Figure 40. U.S. Geological Survey photograph of erosion zone 11, taken in 2016.

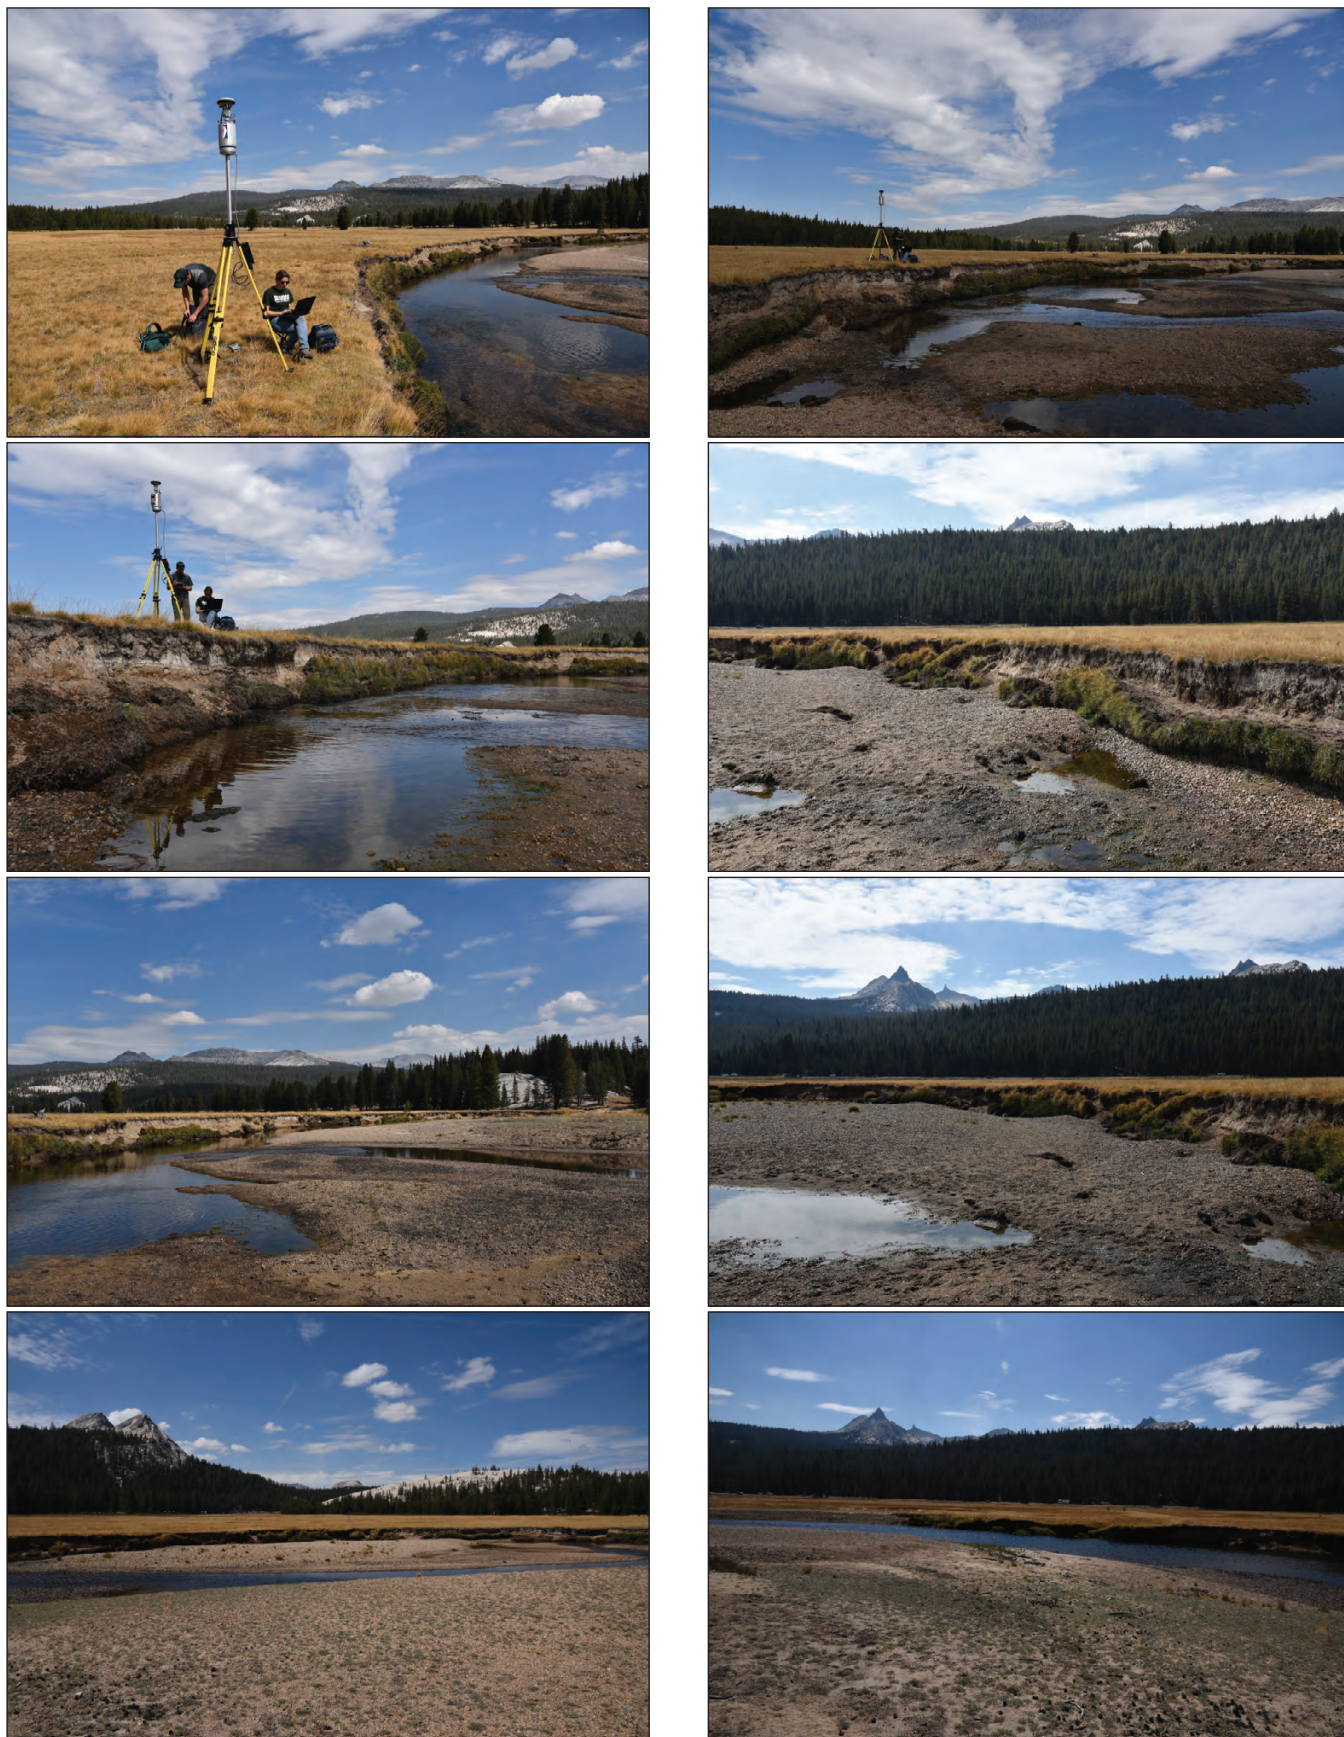
Figure 43. U.S. Geological Survey photographs of erosion zone 12, taken in 2016.

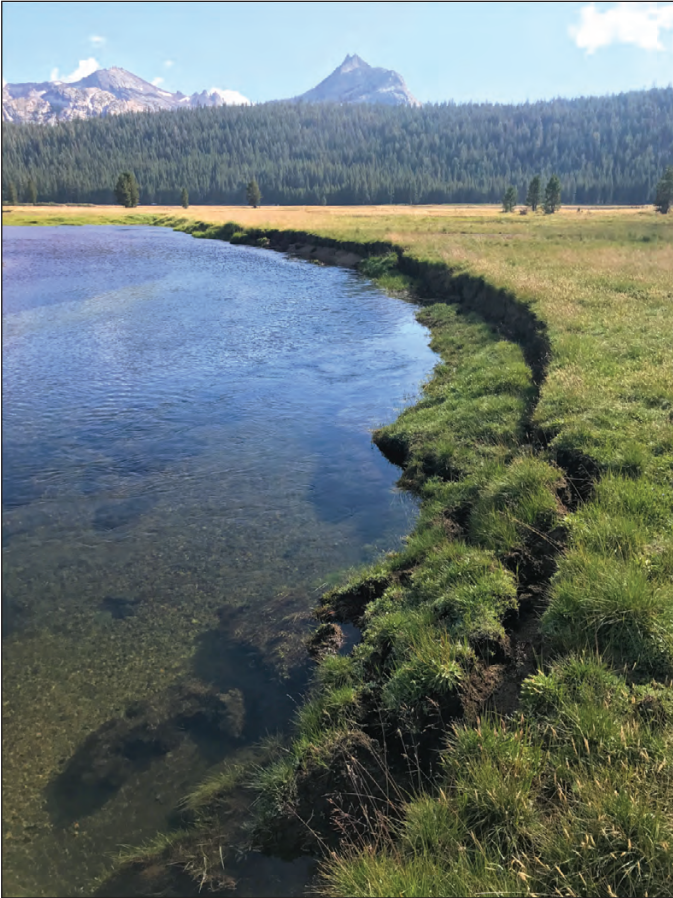
Erosion zones 13–15 were not surveyed in 2016. Erosion zone 13 is at a gentle bend in the Tuolumne River. It is opposite of a large point bar (fig. 44). The streambank is eroding a grass-covered surface underlain by soil and fluvial sediment (figs. 45 and 46). Over a length of about 111 m, the streambank retreated an average of 3.4 m from 2006 to 2017 (table 15), though much of the material was stored as large slump blocks (fig. 46). Erosion removed between about 193 and 491 m³ of sediment, though the higher number is clearly an overestimate because of the slump block material that was not completely removed. From 2017

Figure 46. U.S. Geological Survey photographs of erosion zone 13, taken in 2017.

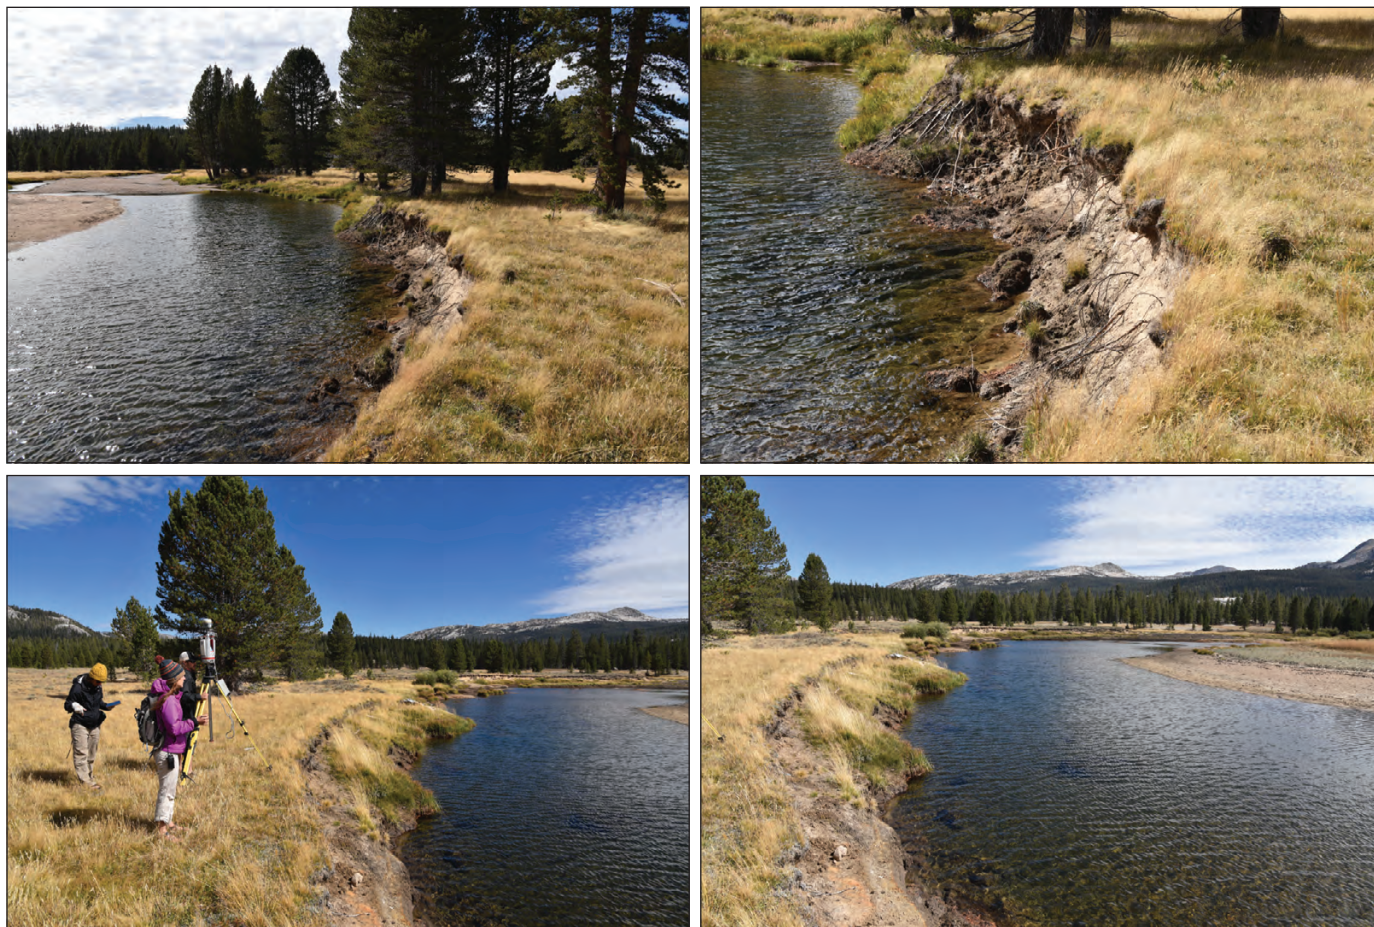
from nearby pine trees (figs. 48 and 49). From 2006 to 2017 the streambank retreated an average of about 0.08 m causing between about 3 and 15 m³ of erosion. In 2018 the streambank retreated another about 0.21 m, causing another about 6–8 m³ of erosion (table 16). Between 2006 and 2018, sediment deposition on the point bar far exceeded erosion on the streambank, about 324 m³ of sediment was deposited on this large point bar. Though not included in this erosion zone analysis, the next channel/point bar downstream was also highly depositional during this time period and contributed substantially to the full channel area deposition.

Figure 49. U.S. Geological Survey photographs of erosion zone 14, taken in 2018.

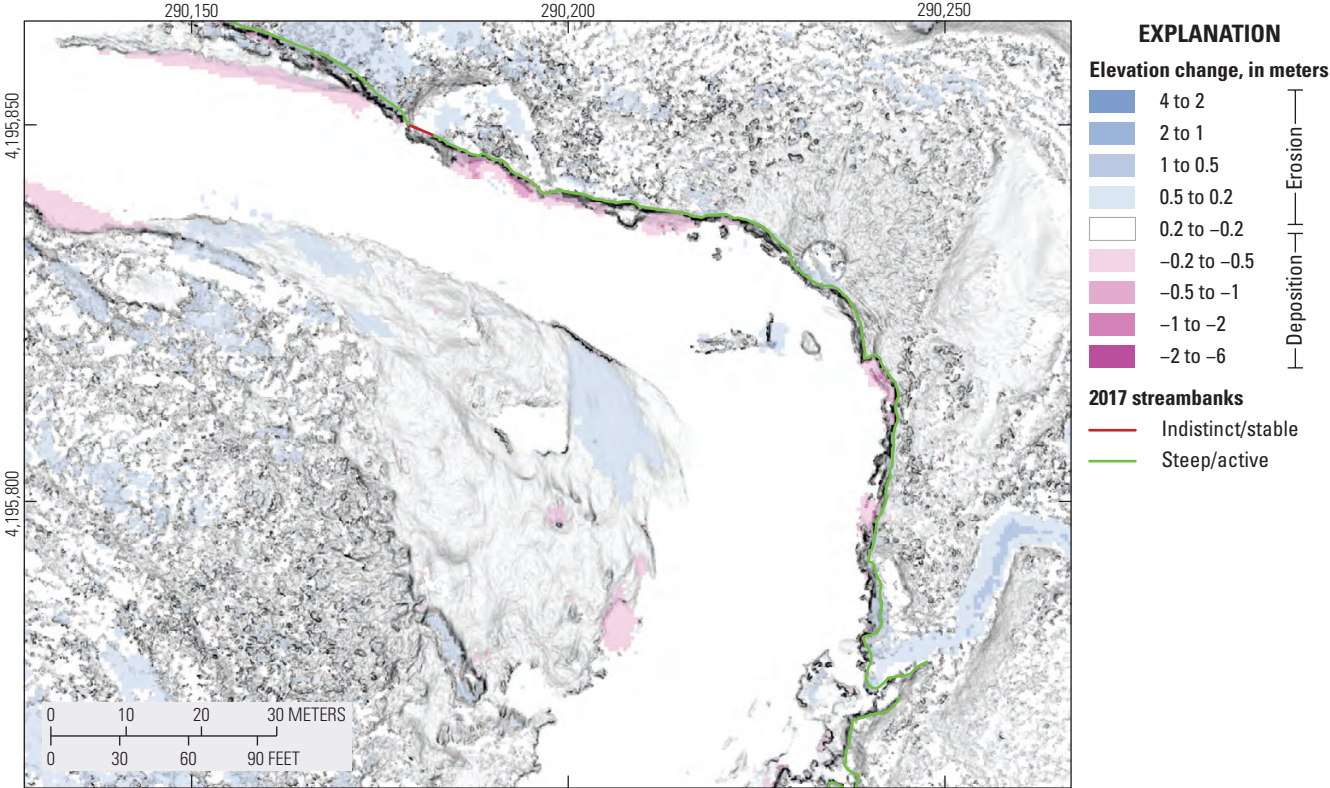
B. Landscape change from 2006–17 on 2017 TLS slopeshade

Erosion zone 15 sits at the last bend in the Tuolumne River before it exits Tuolumne Meadows (figs. 50). The streambank is eroding a surface covered by grass and short vegetation. The vegetation cover was all less than 1 m tall when surveyed but has more diversity in structure than vegetation above eroding streambanks elsewhere in the Meadows, much of it very thick and grassy (figs. 51 and 52). The surface has more microtopography than most other areas of erosion; this may indicate some heterogeneity of the underlying soil and sediment. A pine-covered slope is just over 30 m from the streambank (fig. 52). A large, unvegetated point bar is opposite of the eroding streambank and some channel bars are in the stream channel between the

Limited erosion occurred in this zone. From 2006 to 2017 44 m of streambank retreated an average of about 0.12 m. From 2017 to 2018 the streambank retreated about 0.05 m over a length of 20 m. From 2006 to 2018 the DoD analysis indicated that about 252 m³ of sediment was eroded. Most of this appears to have been eroded from the channel bars and edge of the point bar. The DoD from 2006 to 2017 does not indicate this erosion, indicating much of it occurred below the 2017 water level and was only exposed in the lower water conditions in 2018. The 2006 ALSM is challenging to interpret in this area and may not be reliable, even a few anomalous laser data returns in shallow water in the 2006 data could complicate this analysis. The streambank eroded between about 9 and 59 m³ of sediment from 2006 to 2018.

Figure 50. Lidar-derived maps showing classification of stream banks at erosion zone 15. *A*, 2006 airborne laser swath mapping (ALSM) bare-earth slopeshade with mapped streambanks. *B*, 2017 terrestrial laser scanning (TLS) bare-earth slopeshade. *C*, 2018 TLS bare-earth slopeshade. Colors indicate geomorphic change and lines are mapped streambanks.

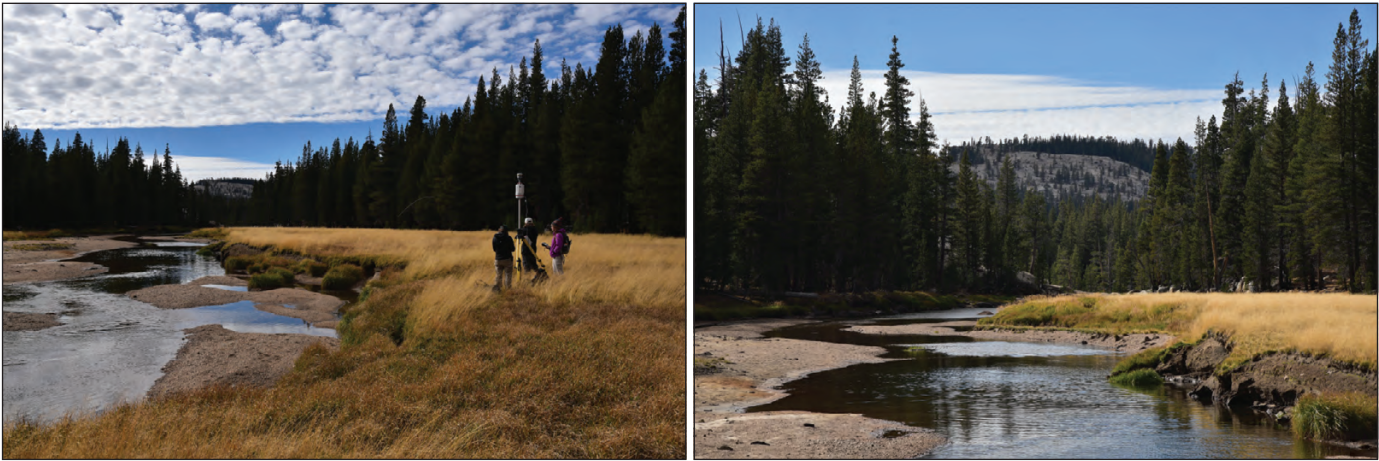
Figure 52. U.S. Geological Survey photographs of erosion zone 15, taken in 2018.

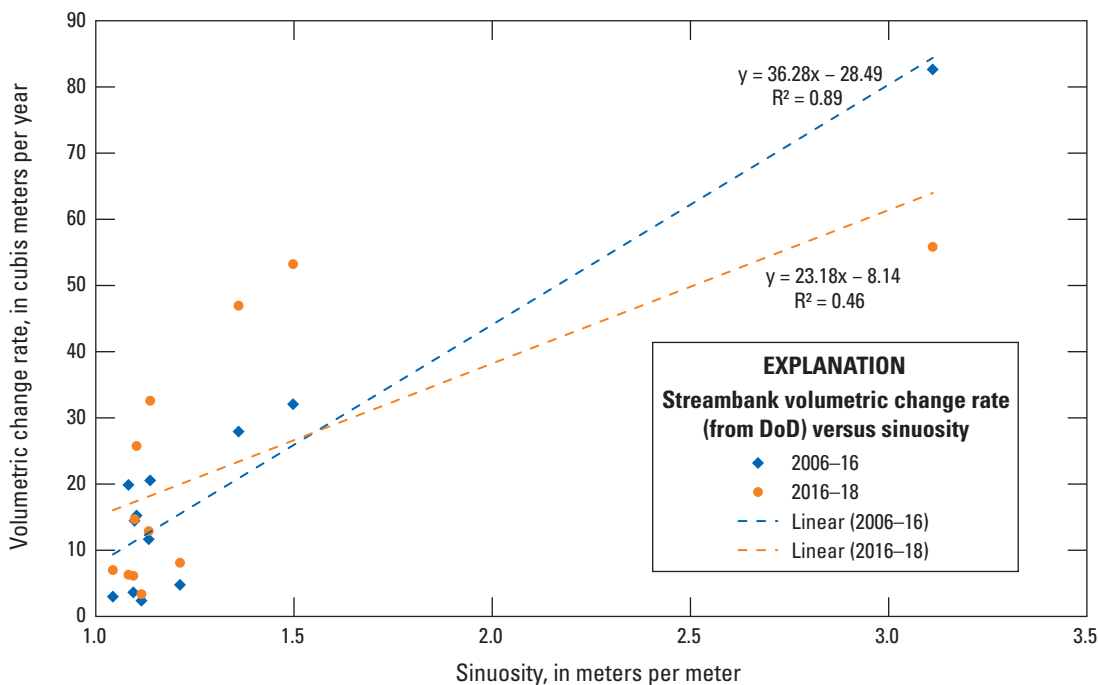
Figure 53. Graph of streambank volumetric change rate versus sinuosity along the Tuolumne River channel measured at eroding streambanks. Volumetric change rate is in cubic meters per year as calculated from a subtraction of digital elevation models (DEMs) to create a DEM of difference (DoD). Only low-water conditions data from 2006, 2016, and 2018 are displayed.

When the relationship between rates of erosion and sinuosity were investigated (figs. 53–55), a weak dependence of erosion rate on sinuosity emerged. This relationship was more easily observed as a function of volumetric change than streambank retreat rate. The reason for this is not clear, though the volumetric change rate may be better at capturing processes such as the removal of a transient slump block and other material near the streambank than the streambank retreat rate. The very local flow patterns, nature of streambank material properties, and vegetation cover may provide strong influence on streambank erosion, these factors are not captured by the sinuosity metric alone. This may be an indication that site-specific assessments are needed to improve understanding or guide mitigation efforts.

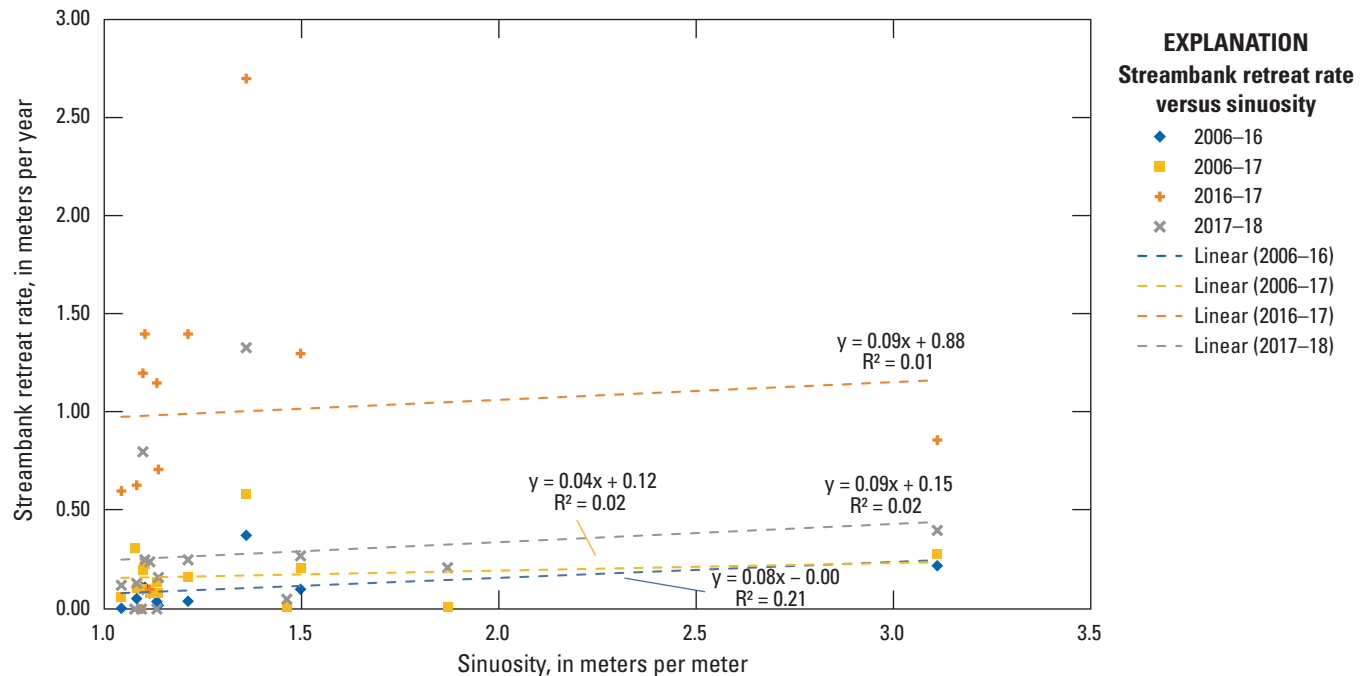
Figure 54. Graph of streambank retreat rate versus sinuosity along the Tuolumne River channel measured at migrating streambanks. Streambank retreat rate in meters per year as calculated from mapping of streambank positions from lidar data. Distances represent the average retreat along the length of eroding streambank, including some areas of no position change between areas of substantial change.

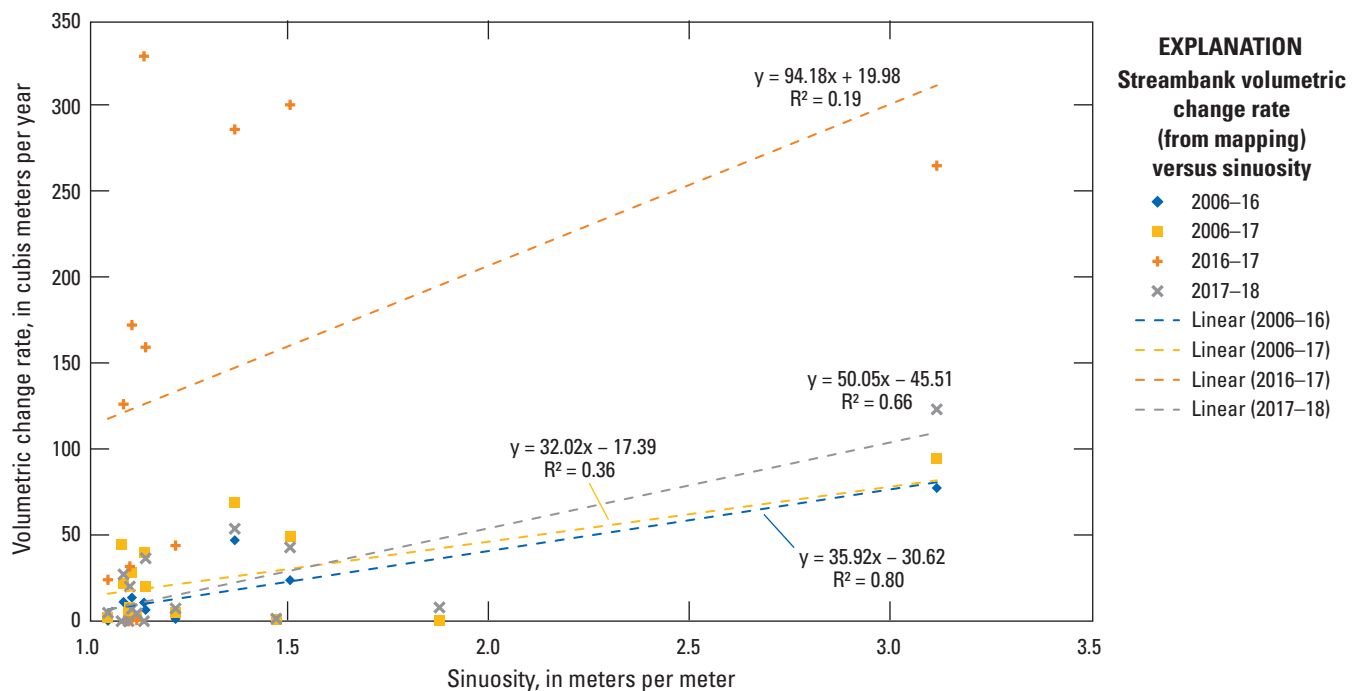
Figure 55. Graph of streambank volumetric change rate (from mapping) versus sinuosity along the Tuolumne River channel. Volumetric change rate is in cubic meters per year as calculated from volume generated from mapping of streambank position from lidar data and using the local streambank height in 2018 during low-water conditions. This assumes all material is removed as streambanks retreat which may not be the case each year as evidenced by the slower removal of collapsed streambank blocks, but likely over time collapsed material is removed as streambanks retreat.
