Streambank Erosion and Related Geomorphic Change in Tuolumne Meadows, Yosemite National Park, California

Scientific Investigations Report 2021–5025

U.S. Department of the Interior
U.S. Geological Survey

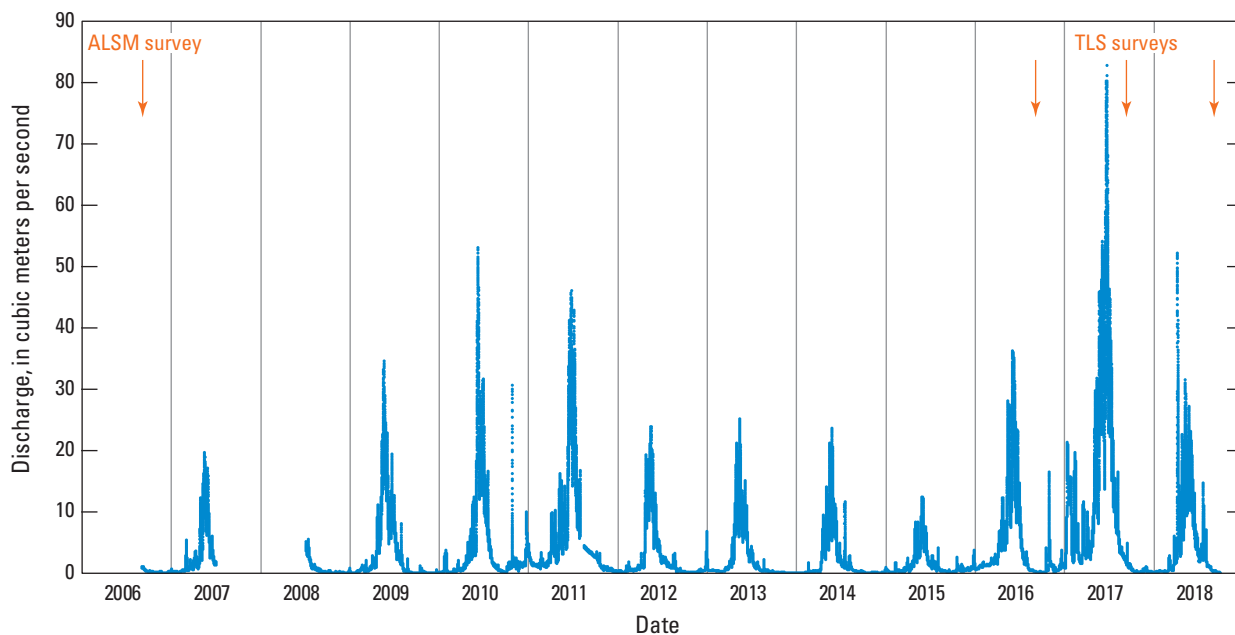
Figure 56. Graph of stream discharge along the Tuolumne River upstream of Tuolumne Meadows at gage “TUM” from 2006 to 2018. Gage is located just upstream of the study area near the California Highway 120 (Tioga Road) bridge over the Tuolumne River. The approximate times of lidar surveys are also indicated with arrows. There are no data for late 2007 and early 2008, but regional records indicate it was an unremarkable period hydrologically. Streamflow data are available at: https://irma.nps.gov/AQWebPortal/Data/Location/Summary/Location/SIEN_YOSE_TUOLTIRO/Interval/Latest.

The temporal variability in erosion rates may be controlled by the magnitude of floods. Floods in the Tuolumne River are largely a product of melting snowpack, occurring regularly in May and (or) June each year (fig. 56). Rain, such as the storms that occurred in October 2010 and April 2018, can also generate runoff. Rain-caused floods tend to have an event hydrograph with a steeper rising limb and more rapid discharge recession than seasonal snowmelt, which is often characterized by diurnal fluctuations superposed on rising streamflow trends over days to weeks followed by recession over days to weeks. Streamflow data indicate that the 2017 peak flow event had the highest

discharge during study years at about 82.75 m³/sec. This led to the most pronounced landscape change, and there is no evidence that comparable landscape change occurred between 2006 and 2017. During the study period, the next-highest measured floods peaked at 53.14 m³/s during snowmelt in June 2010; 52.18 m³/s in a rain-induced runoff event in April 2018; and 46.08 m³/s in snowmelt runoff in June 2011. All other years had substantially lower peak discharge, almost certainly including the missing data from late 2008 through early 2009, during which no remarkable floods were recorded at the next gage downstream: (https://nwis.waterdata.usgs.gov/ca/nwis/peak?site_no=11274790&agency_cd=USGS&format=html, accessed April 24, 2020).

Although the 2018 rain-caused flood may have caused landscape change, the snowmelt floods in 2010 and 2011 had high peak flows and longer durations. Because snowmelt floods vary diurnally, they are compared here in terms of number of days with peak flows greater than 30 m³/s, and number of nights with flows that are greater than 20 m³/s. The 2017 floods had peak flows greater than 30 m³/s on 48 days (including a single day in September owing to rainfall) and nighttime minimum flows greater than 20 m³/s for 46 days, whereas the 2010 floods had peak flows greater than 30 m³/s on 9 days and nighttime minimum flows greater than 20 m³/s for 7 days, and the 2011 floods had peak flows greater than 30 m³/s on 25 days and nighttime minimum flows greater than 20 m³/s for 22 days. Because the landscape change from 2017 was more substantial than that from 2006–2016 in many locations, the magnitude, duration or some combination of those in 2017 may have exceeded an important threshold

for causing landscape change. The fairly minimal landscape change that occurred in 2018 resulted from a peak snowmelt flow of 31.52 m³/s with just a single day with peak flow greater than 30 m³/s and zero nights with minimum flows greater than 20 m³/s for 46 days, and the rain-caused flood in April that had a peak discharge of 52.18 m³/s and (non-diurnally varying) flow greater than 20 m³/s for about 1 day and 21 hours. The relative geomorphic importance of the runoff caused by rain in April versus the snowmelt from April through June is not known, though it is reasonable to characterize the 2018 snowmelt runoff as unremarkable compared to other years.
