Strandlines from Large Floods on the Colorado River in Grand Canyon National Park, Arizona

Scientific Investigations Report 2021–5048

By Thomas A. Sabol, Ronald E. Griffiths, David J. Topping, Erich R. Mueller, Robert B. Tusso, and Joseph E. Hazel, Jr.

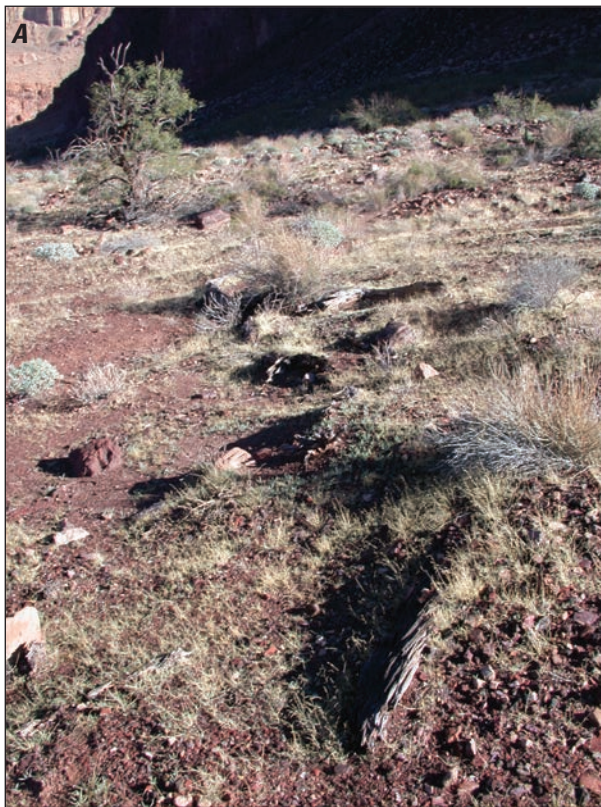
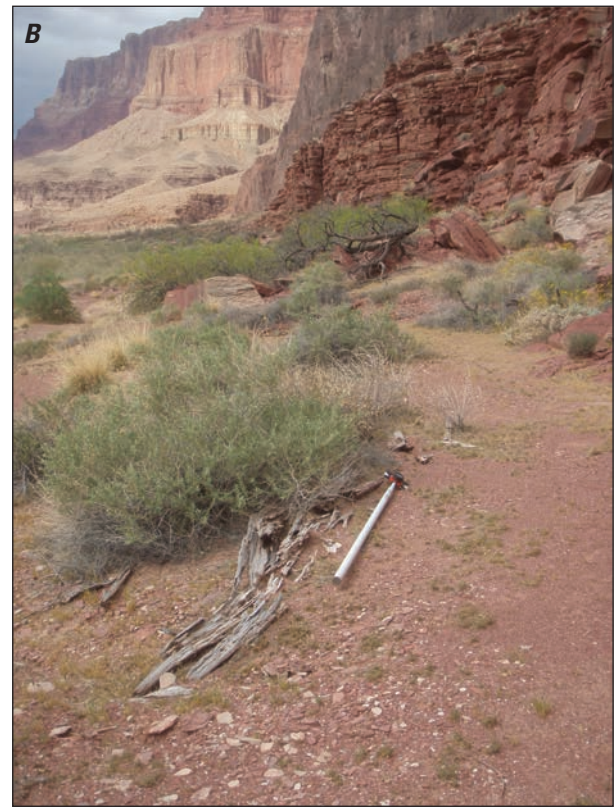
Figure 6. Photographs showing weathering of driftwood that was likely emplaced by (A) the 210,000 cubic feet per second (ft³/s) flood of 1884, and (B) the 170,000 ft³/s flood of 1921. The degree of driftwood deterioration shown in these photographs is common for 1884 and 1921 peak-stage indicators. As shown in (A), driftwood in the likely 1884 strandline is commonly partially buried in fan sediments. Photographs were taken on the left bank of the Colorado River looking upstream near (A) river mile 66.3 and (B) river mile 66.6, in the Palisades area.

indicators associated with the 1884 flood accounted for only 7.6 percent of all peak-stage indicators in the primary strandlines (table 1; Sabol and others, 2021). Driftwood and debris deposited in this strandline are typically partially buried in fan sediments and display a high degree of deterioration and disintegration (fig. 6A). Thus, the

weathering of these deposits over the last ~130 years is the likely cause for the relative sparsity of peak-stage indicators from this event. Although western settlers were beginning to inhabit the Colorado River basin upstream from Grand

Canyon by 1884, we found no trash in the likely 1884 strandline. The interpreted 1884 strandline was typically 3–5 feet higher in elevation than the likely 1921 strandline, depending on local river width.

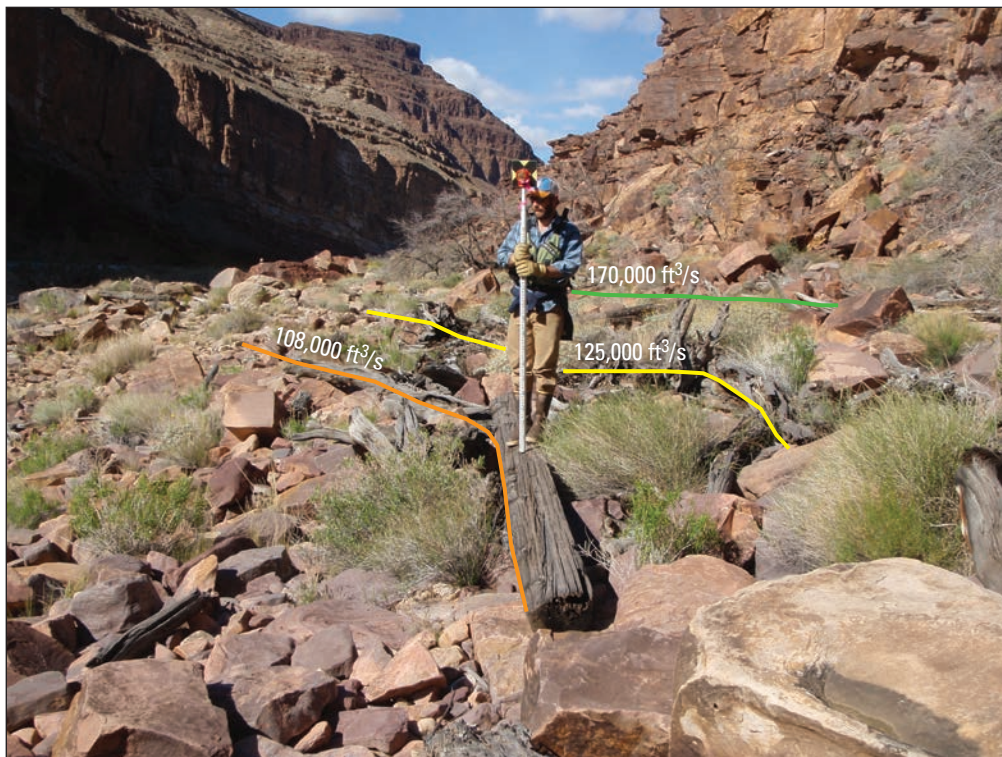
Figure 7. Photograph showing the likely strandlines from 1958, 1957, and 1921. This photograph was taken on the left bank of the Colorado River looking upstream between river miles 76.0 and 76.3. Surveyor is standing on a large structural 12 by 12 inch beam that was likely emplaced by the 1958 flood (highlighted by the orange line). Driftwood strandlines from the likely 1957 (yellow line) and 1921 (green line) floods are at progressively higher elevations to the surveyor's left (to the right in the photograph). Peak flood discharge is given in cubic feet per second (ft³/s).

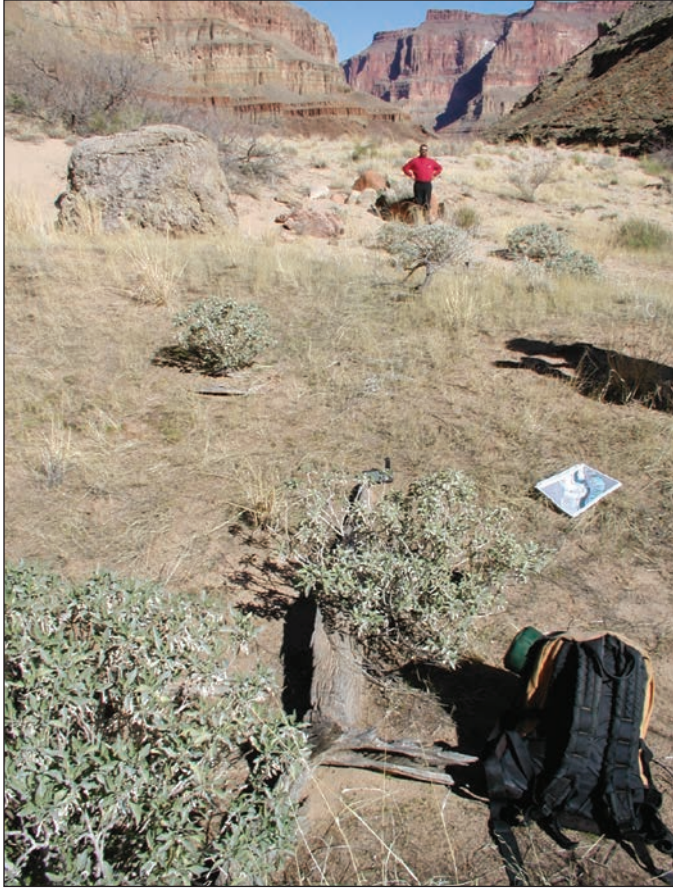
Figure 1.1. Photograph looking northeast from point 1 along the likely 1884 strandline. The driftwood at point 1 is in the foreground, left of the pack and in front of the global positioning system unit. Photograph taken on January 31, 2008.

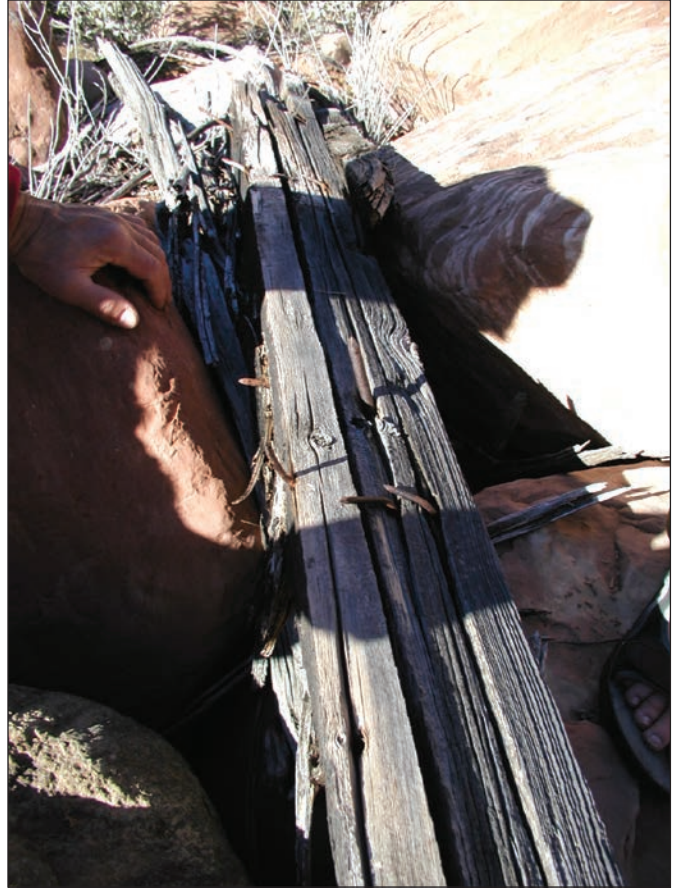
Figure 1.2. Photograph showing milled lumber with round-head nails in the likely 1957 strandline at point 10. Photograph taken on January 31, 2008.

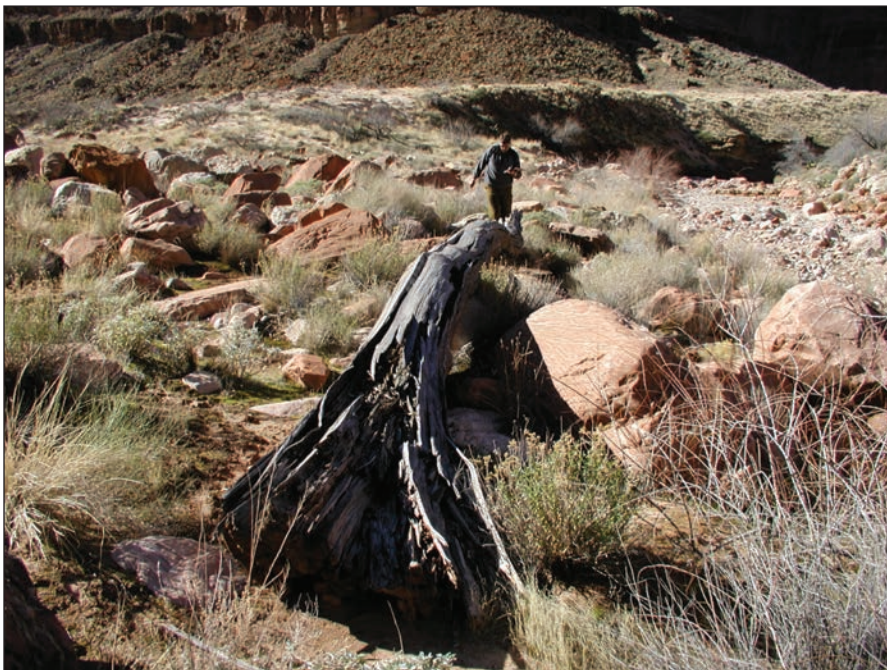
Figure 1.3. Photograph looking west along a large driftwood log in the likely 1958 strandline at point 12. Photograph taken on January 31, 2008.

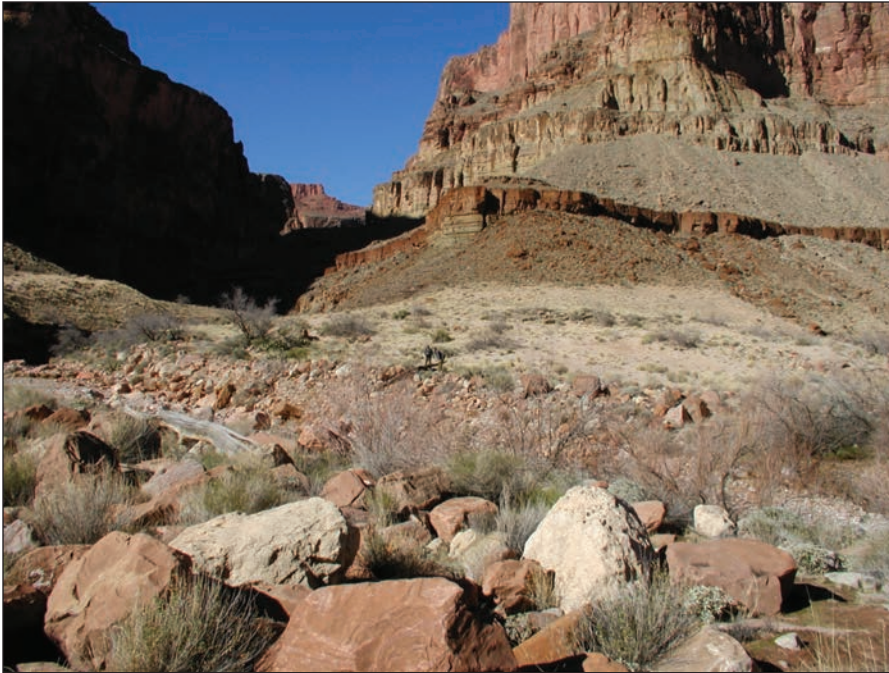
Figure 1.4. Photograph looking northwest across Fossil Creek to driftwood in the likely 1957 strandline at point 14. Two people are standing next to this log for scale. The large driftwood log is the likely 1958 strandline at point 12 (fig. 1.3) in left foreground. Photograph taken on January 31, 2008.

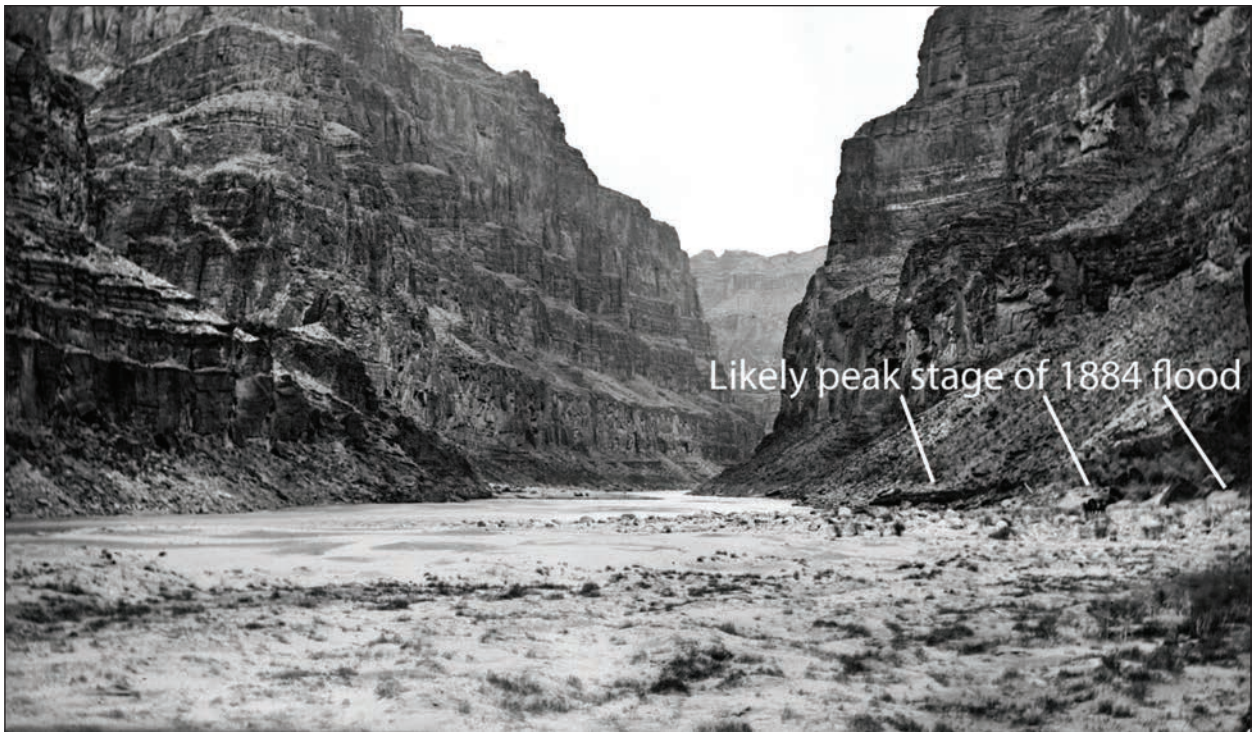
Figure 1.5. Photograph looking upstream from the mouth of Mohawk Canyon on February 26, 1890, six years after the 1884 flood (Robert Brewster Stanton, image number 57-RS-613, courtesy of The National Archives). We interpreted the indicated likely peak stage of the 1884 flood on the basis of the upward limit of “fresh” sand deposits in this photograph. This elevation was traced in the field downstream to the partially buried driftwood log at point 19 and across Mohawk Creek to the location of the buried driftwood railroad tie at point 21.

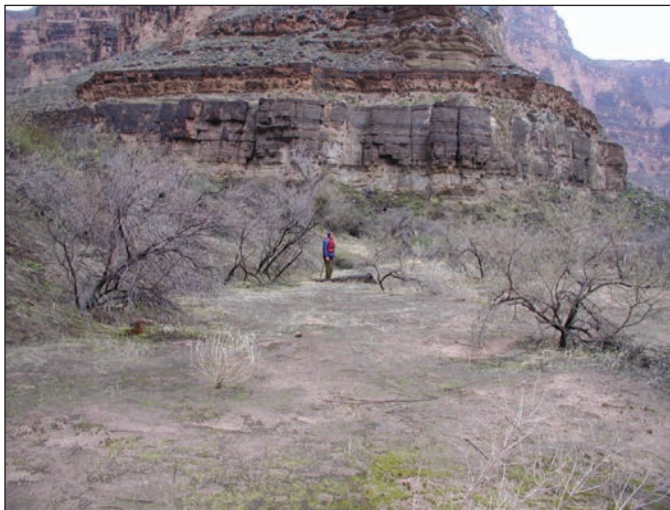
Figure 1.6. Photograph looking west showing a partially buried driftwood log in the likely 1884 strandline at point 19. The elevation of this log is similar to the elevation of the likely peak stage of the 1884 strandline indicated in figure 1.5. Photograph taken on February 3, 2008.

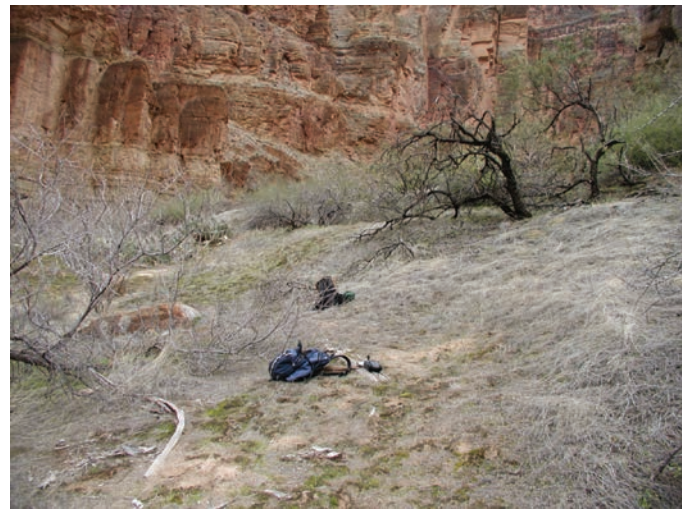
Figure 1.7. Photograph looking east showing a buried driftwood railroad tie in the likely 1884 strandline at point 21. The top of the tie is flush with the ground surface. A global positioning system unit is on the tie. The other driftwood and woody debris in the lower left was deposited at a similar elevation to the railroad tie. Photograph taken on February 2, 2008.

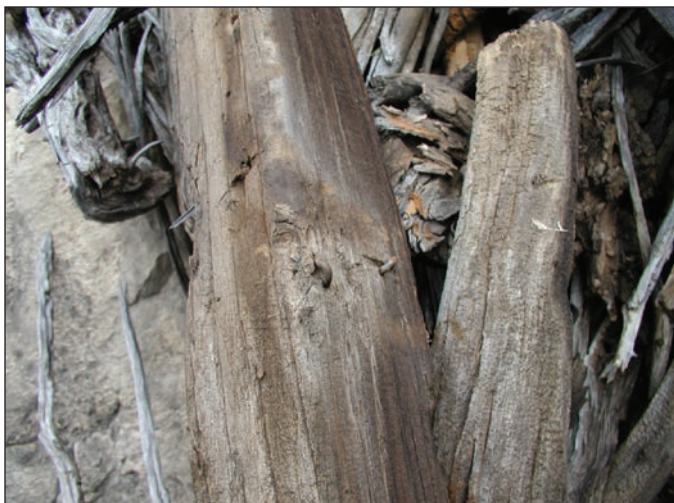
Figure 1.8. Photograph showing U-staples in milled-lumber driftwood in the likely 1957 strandline at point 24. Photograph taken on February 2, 2008.

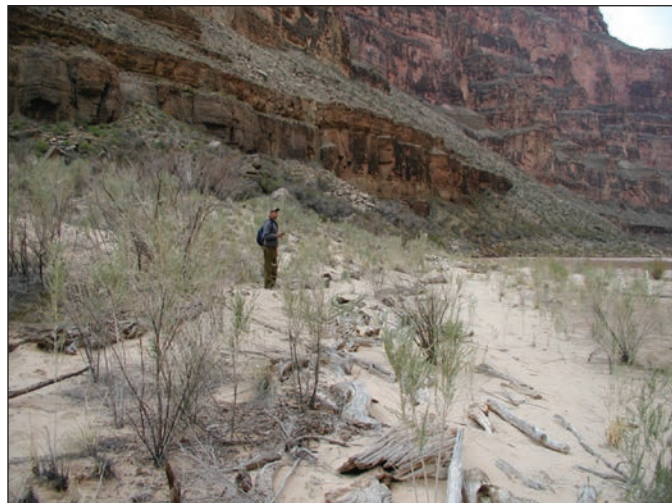
Figure 1.9. Photograph looking southwest along the likely 1996 strandline near point 36 showing the likely 1996 and 1983 double strandline. A U.S. Geological Survey scientist is standing on the likely 1983 strandline near point 48. Photograph taken on February 2, 2008.

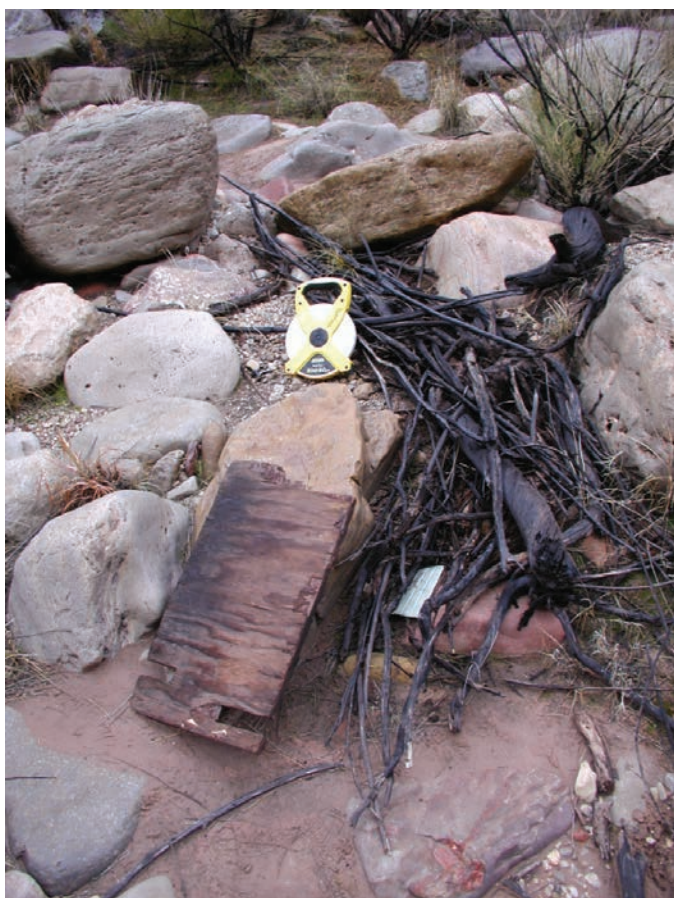
Figure 1.10. Photograph showing tamarisk driftwood and trash drift consisting of plywood and plastic in the likely 1996 strandline at point 45. Photograph taken on February 3, 2008.

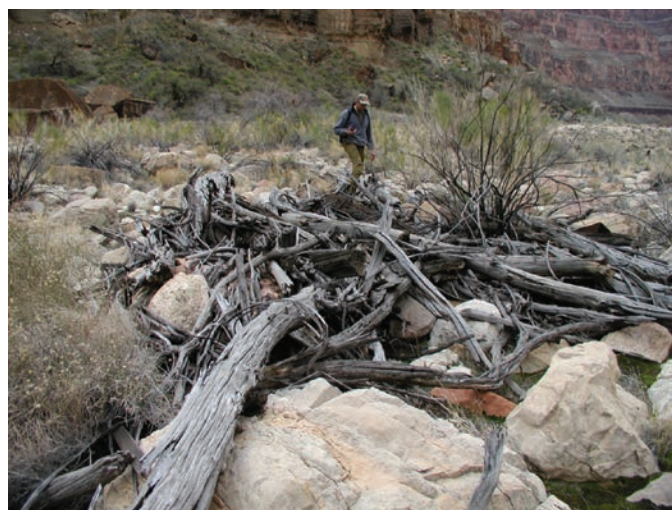
Figure 1.11. Photograph looking west at "Railroad tie mountain" showing the likely 1957 strandline at point 58. Photograph taken on February 3, 2008.

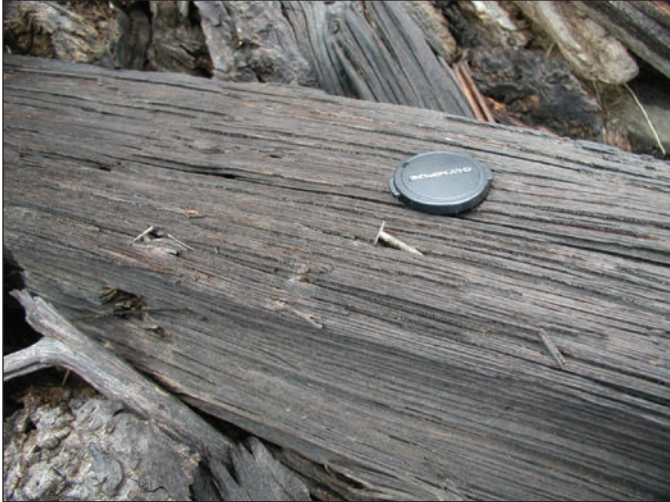
Figure 1.12. Photograph showing galvanized nails in a railroad tie at “Railroad Tie Mountain” from the likely 1957 strandline at point 58. Photograph taken on February 3, 2008.

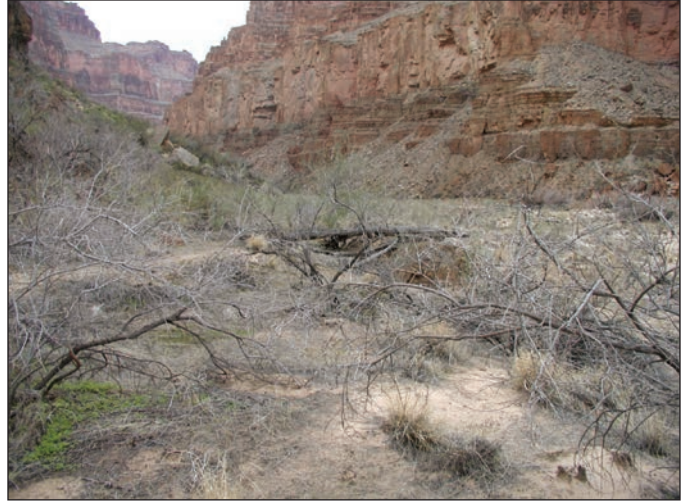
Figure 1.13. Photograph looking west showing a driftwood log on a rock in the likely 1884 strandline at point 62. Photograph taken on February 2, 2008.

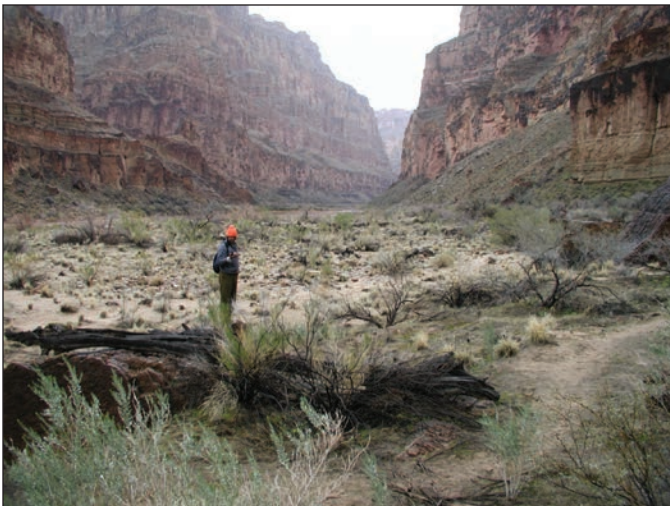
Figure 1.14. Photograph looking east showing a driftwood log on a rock in the likely 1884 strandline at point 62 in the foreground and lower driftwood deposits in the likely 1921 and 1957 strandlines in background. Photograph taken on February 3, 2008.

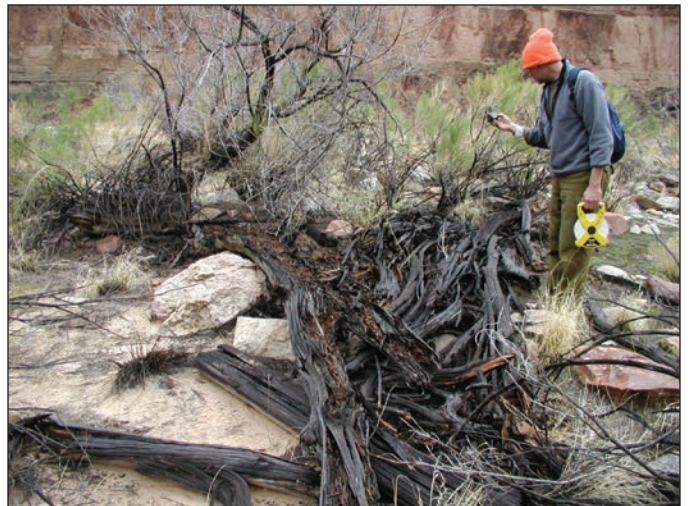
Figure 1.15. Photograph showing a pile of driftwood logs, which includes one railroad tie wedged on the upstream side of the rocks in the likely 1957 strandline at point 63. Photograph taken on February 3, 2008.

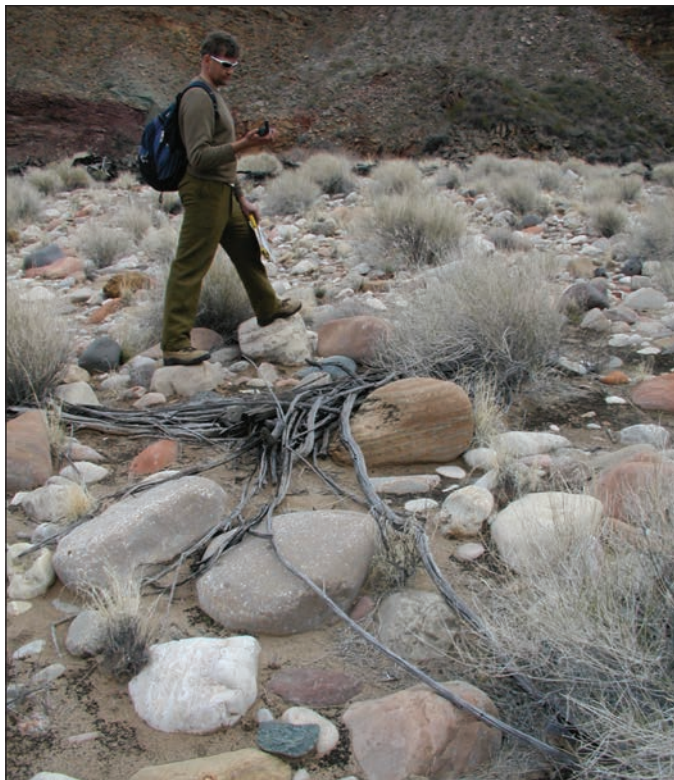
Figure 1.16. Photograph showing a tamarisk driftwood “clump” in the likely 1983 strandline at point 90. Photograph taken on February 4, 2008.

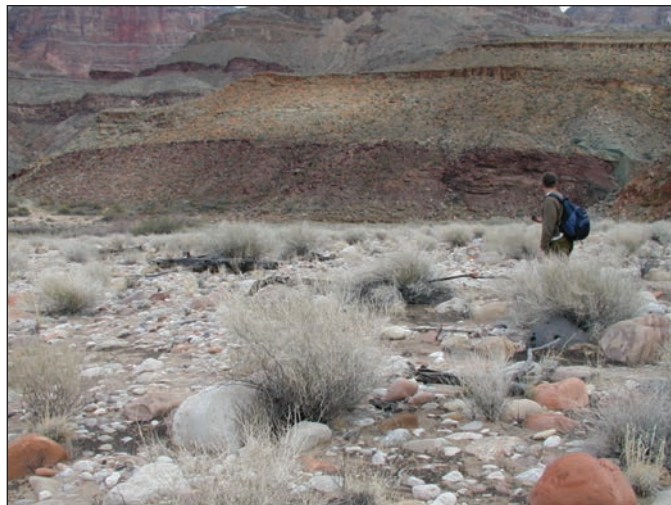
Figure 1.17. Photograph looking east showing the likely 1983 strandline from point 92. Photograph taken on February 4, 2008.

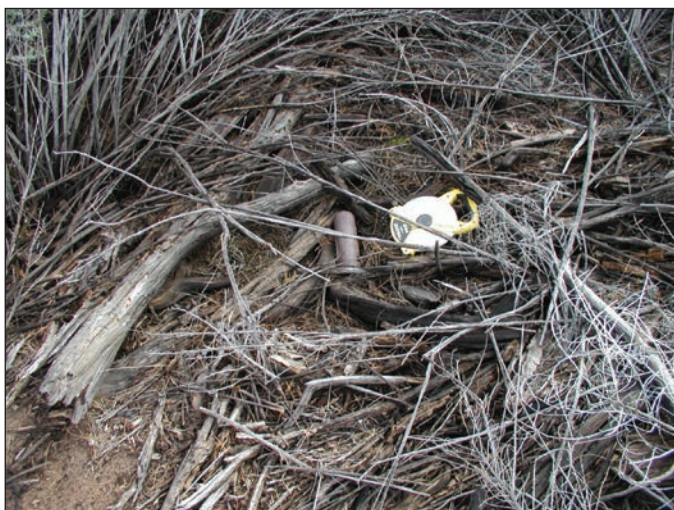
Figure 1.18. Photograph showing a propane bottle drift deposited within a tamarisk-rich driftwood pile in the likely 1983 strandline at point 97. Photograph taken on February 4, 2008.

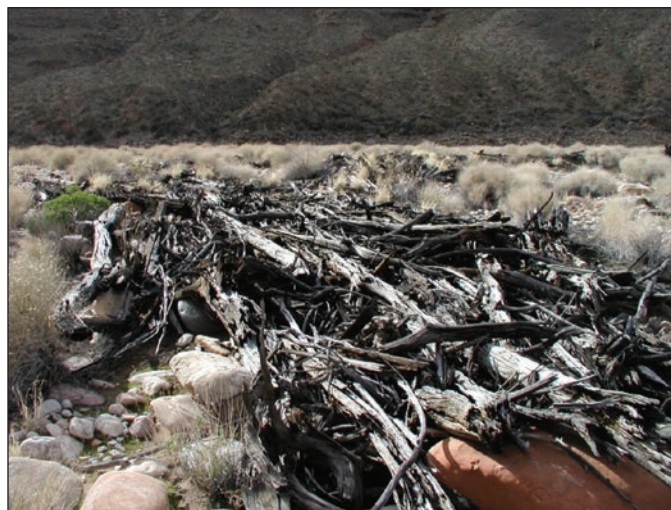
Figure 1.19. Photograph looking west from point 99 showing a large pile of driftwood logs in the likely 1958 strandline. Pieces of milled lumber and railroad ties are present within this pile. Photograph taken on February 4, 2008.

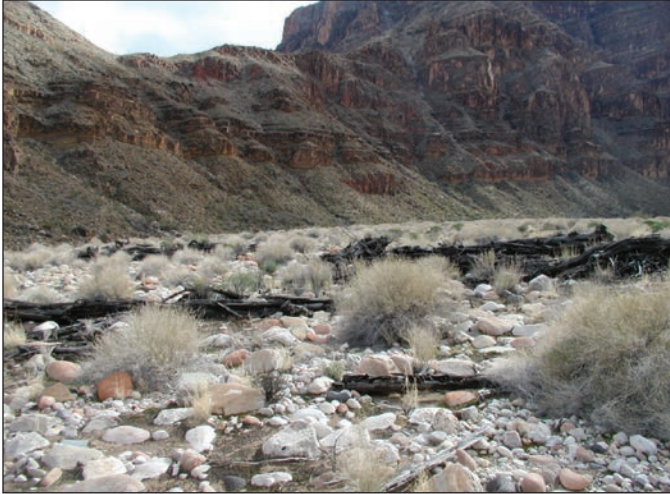
Figure 1.20. Photograph looking south from point 100 showing driftwood logs in the likely 1957 strandline. This part of the likely 1957 strandline slopes downward into the east secondary channel of the Colorado River around this island. Photograph taken on February 4, 2008.

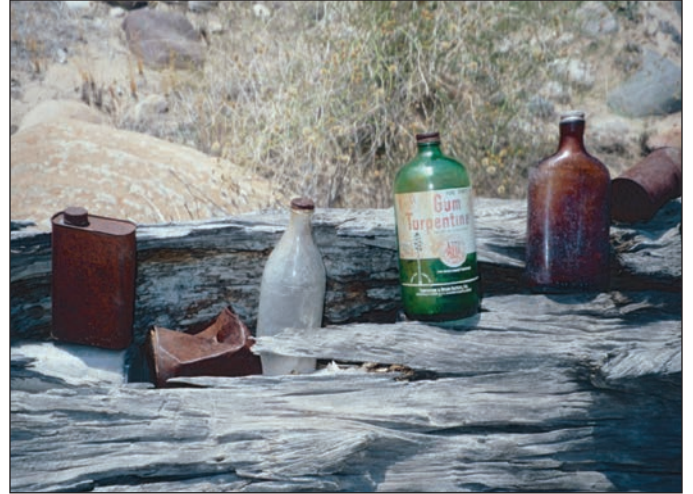
Figure 1.21. Photograph showing cans and bottles in the hollow driftwood log at point 103. Although this driftwood log was likely deposited during the 1958 flood, the bottles were likely collected and moved by boaters from other parts of the 1958 strandline and the nearby 1957 strandline. The green “gum turpentine” bottle has 1939 copyright on bottle label, other bottles have 1946 and 1947 dates on heels. The green turpentine bottle was gone when this log was revisited in 2008. Photograph taken on March 18, 2003.

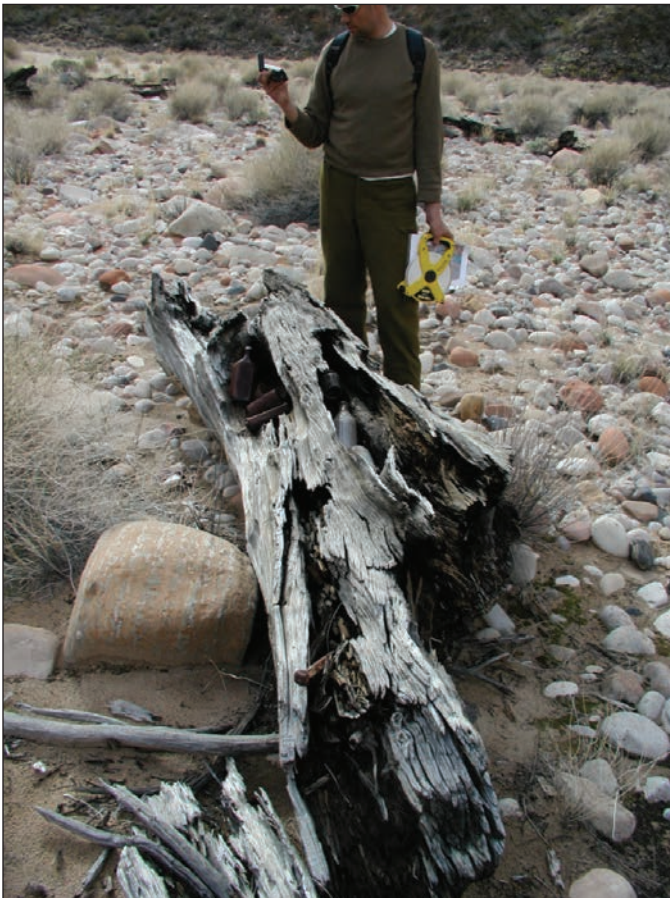
Figure 1.22. Photograph looking west along the hollow driftwood log shown in figure 1.21. Some cans and bottles are still present. Note rusty spike in log in foreground. Photograph taken on February 4, 2008.

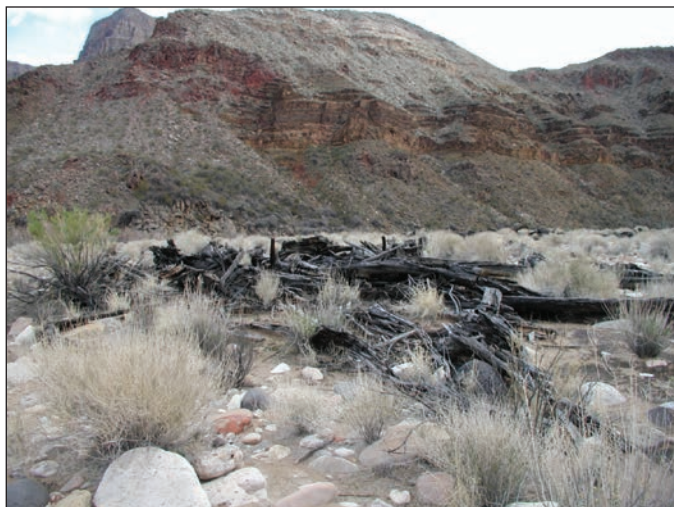
Figure 1.23. Photograph looking east showing a large driftwood pile in the likely 1958 strandline north of point 104; point 104 is just out of field of view on right side of photograph. This pile contains milled lumber and railroad ties. Photograph taken on February 4, 2008.

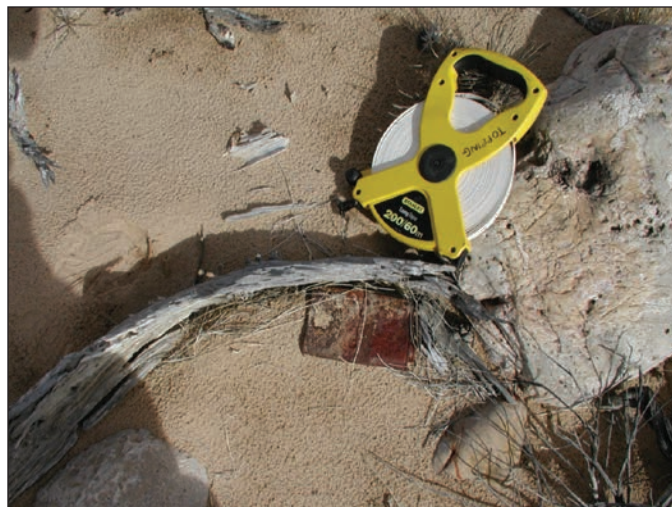
Figure 1.24. Photograph showing driftwood and can with a bullet hole in the likely 1958 strandline at point 107. Photograph taken on February 4, 2008.

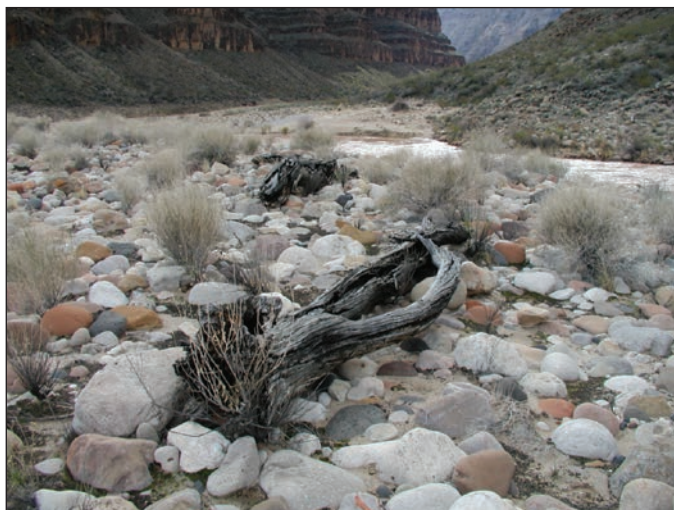
Figure 1.25. Photograph looking southwest from point 109 showing driftwood logs in the western end of the likely 1958 strandline. Photograph taken on February 4, 2008.

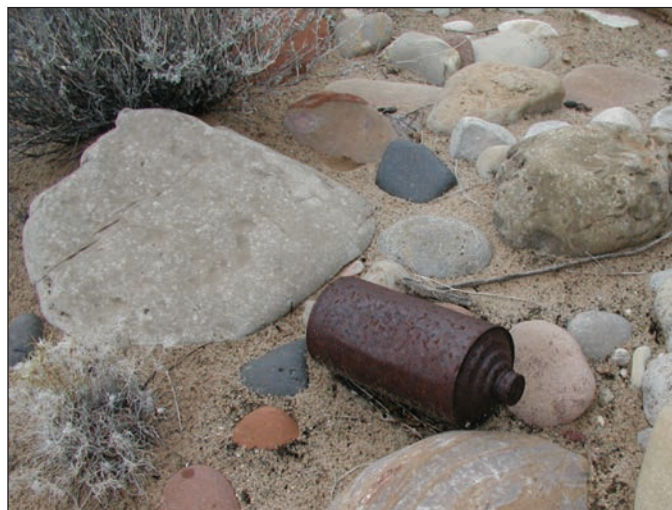
Figure 1.26. Photograph showing a can drift at point 112 in the likely 1957 strandline. Photograph taken on February 4, 2008.

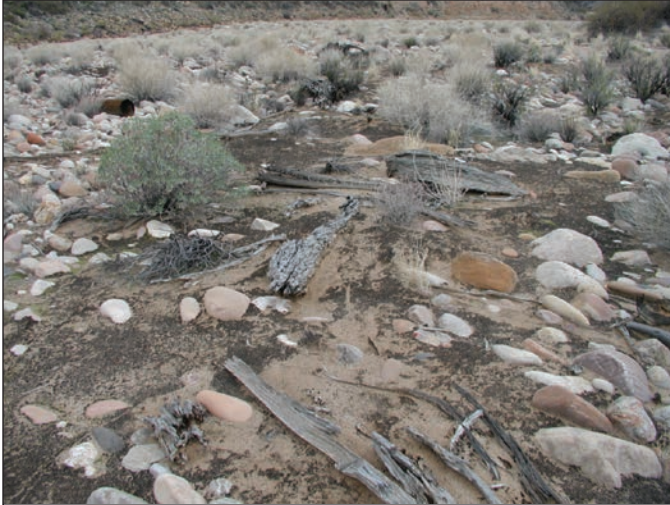
Figure 1.27. Photograph looking southwest near point 112 showing a partially buried driftwood in the likely 1957 strandline. Note the metal can drift in upper left. Photograph taken on February 4, 2008.

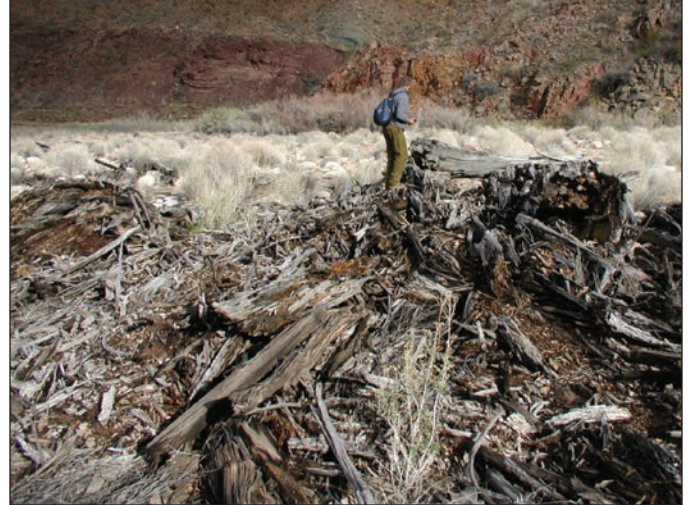
Figure 1.28. Photograph looking east from point 120 showing the eastern part of the "largest driftwood log pile" on the island. This pile is in the likely 1957 strandline and contains numerous milled lumber and railroad ties. Photograph taken on February 4, 2008.

120	2/4/2008	1957	35.96460	-113.31667	Southern edge of largest driftwood pile on island; driftwood log pile contains numerous milled lumber and railroad ties (fig. 1.28); pile deposited on upstream margin of flat sandy bench containing partially buried, highly decayed likely older driftwood (fig. 1.29); 1940s-1950s Owens-Illinois “Duraglas” glass bottle present in pile (fig. 1.30)
121	2/4/2008	1957	35.96462	-113.31653	Southeastern edge of largest driftwood log pile on island
122	2/4/2008	1957	35.96450	-113.31643	Western edge of driftwood log pile to the southeast of the aforementioned “largest driftwood pile”
123	2/4/2008	1957	35.96444	-113.31631	Driftwood logs
124	2/4/2008	1957	35.96430	-113.31623	Driftwood logs at eastern end of likely 1957 strandline
125	2/4/2008	1921	35.96396	-113.31688	15 m-long highly decayed partially buried driftwood log (fig. 1.31)
126	2/4/2008	1921	35.96388	-113.31664	Highly decayed partially buried driftwood log

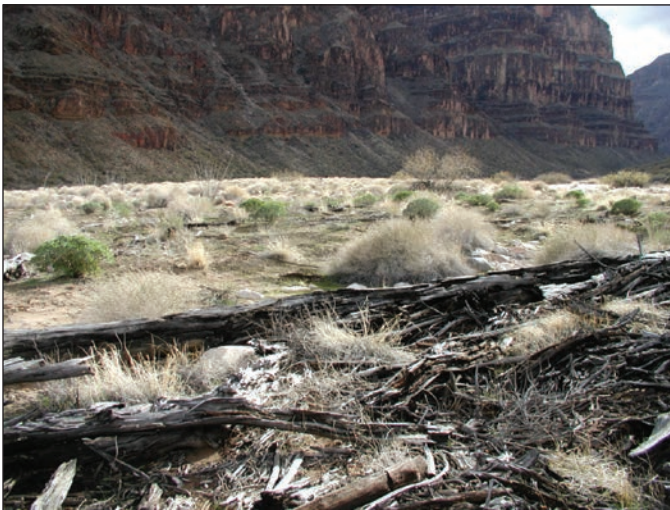
Figure 1.29. Photograph looking south from point 120 showing a sandy bench downstream from the likely 1957 strandline. The top of this sandy bench is at the same elevation as the top of the "largest driftwood log pile" on island in the likely 1957 strandline at point 120. This bench contains the partially buried, highly decayed, and likely older driftwood logs depicted in figures 1.31 and 1.32. Photograph taken on February 4, 2008.

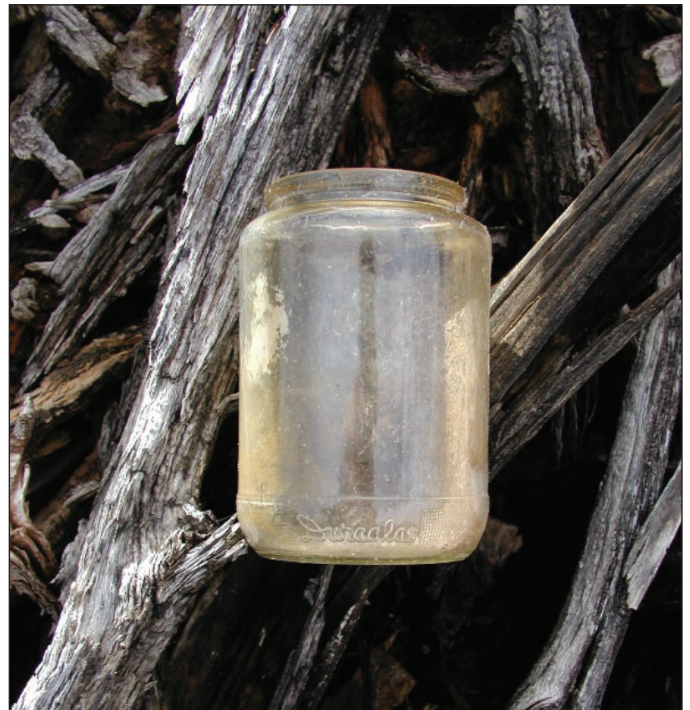
Figure 1.30. Photograph showing an Owens-Illinois glass bottle with the script "Duraglas" in driftwood logs near point 120 in the likely 1957 strandline. The script "Duraglas" on the side of the bottle near its base indicates that the bottle was produced between 1940 and 1963 (Toulouse, 1971). Photograph taken on February 4, 2008.

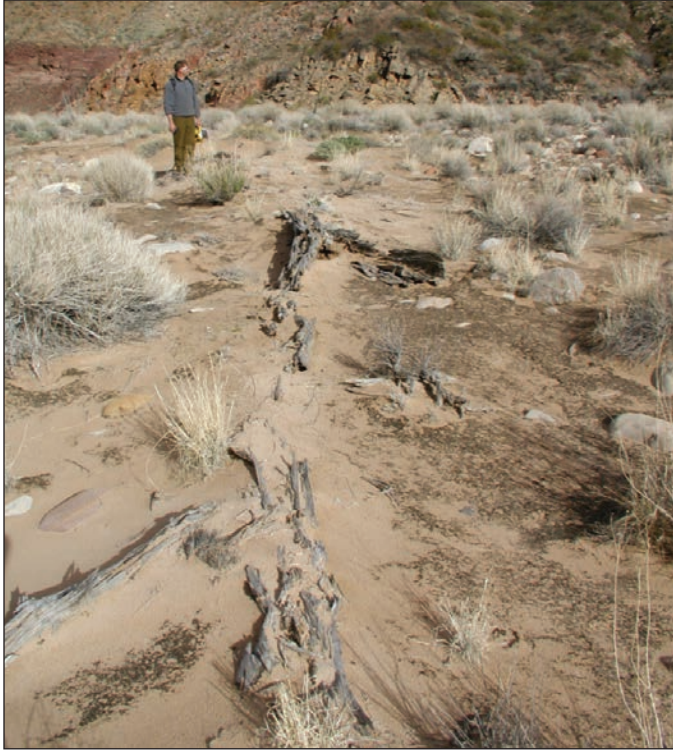
Figure 1.31. Photograph showing a 15-meter-long, partially buried, and highly decayed driftwood log in the likely 1921 strandline at point 125. Photograph taken on February 4, 2008.

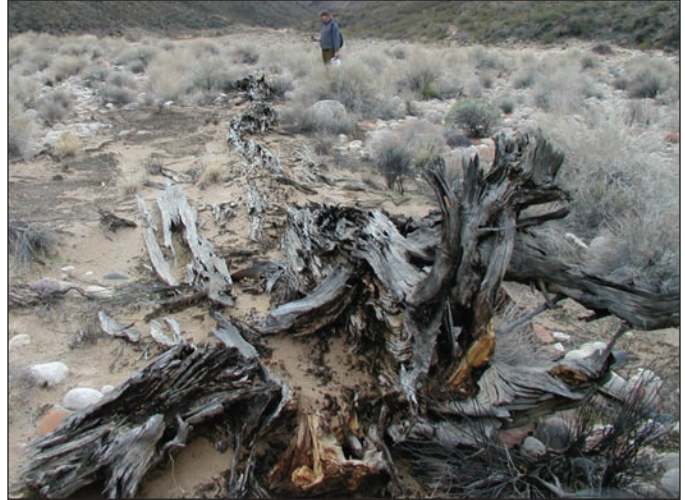
Figure 1.32. Photograph showing a 15-meter-long, partially buried, and highly decayed driftwood log in the likely 1921 strandline at point 127. Photograph taken on February 4, 2008.

127	2/4/2008	1921	35.96337	-113.31678	15 m-long partially buried, highly decayed driftwood log (fig. 1.32)
128	2/4/2008	1921	35.96332	-113.31658	Small, 1-m-long driftwood log
129	2/4/2008	1957	35.96300	-113.31661	Group of 4 driftwood logs at south end of island
130	2/4/2008	1957	35.96468	-113.31658	Driftwood logs including partially buried Anchor-Hocking L-876 3-1/8 ounce. ink-well bottle with cork top —cork top connected via metal wire to cloth applicator (figs. 1.33, 1.34); plywood driftwood present in strandline near this bottle

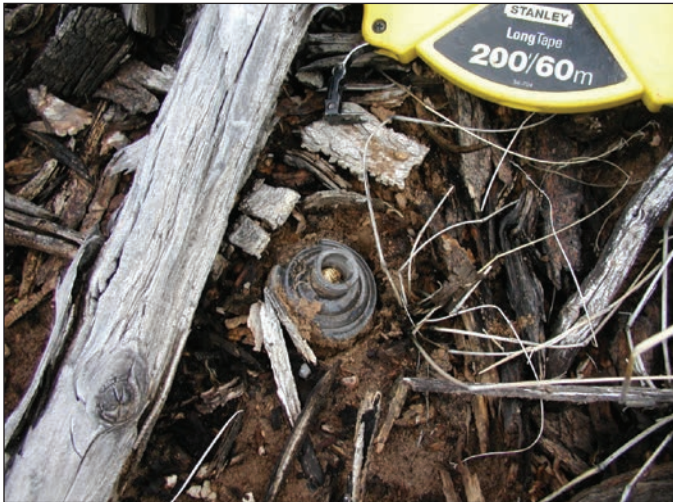
Figure 1.33. Photograph showing driftwood logs and a partially buried Anchor-Hocking L-876 3-1/8 ounce ink-well bottle with a cork top in the likely 1957 strandline at point 130. Photograph taken on February 4, 2008.

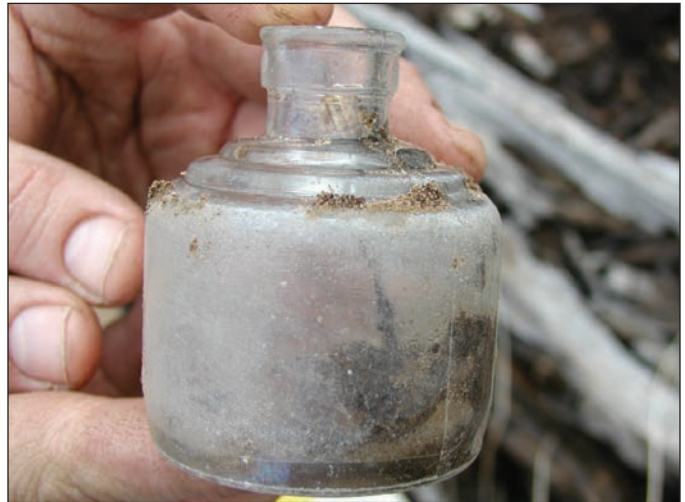
Figure 1.34. Photograph showing a side view of the Anchor-Hocking L-876 3-1/8 ounce ink-well bottle in figure 1.33. The cork top attached via a metal wire to a cloth applicator visible inside the bottle. The heel of the bottle has a number 3 to the left of the Anchor-Hocking symbol and the number 5 to the right of this symbol. Photograph taken on February 4, 2008.
