# Historical Floods and Geomorphic Change in the Lower Little Colorado River during the Late 19th to Early 21st Centuries

Scientific Investigations Report 2021–5049

U.S. Department of the Interior  
U.S. Geological Survey

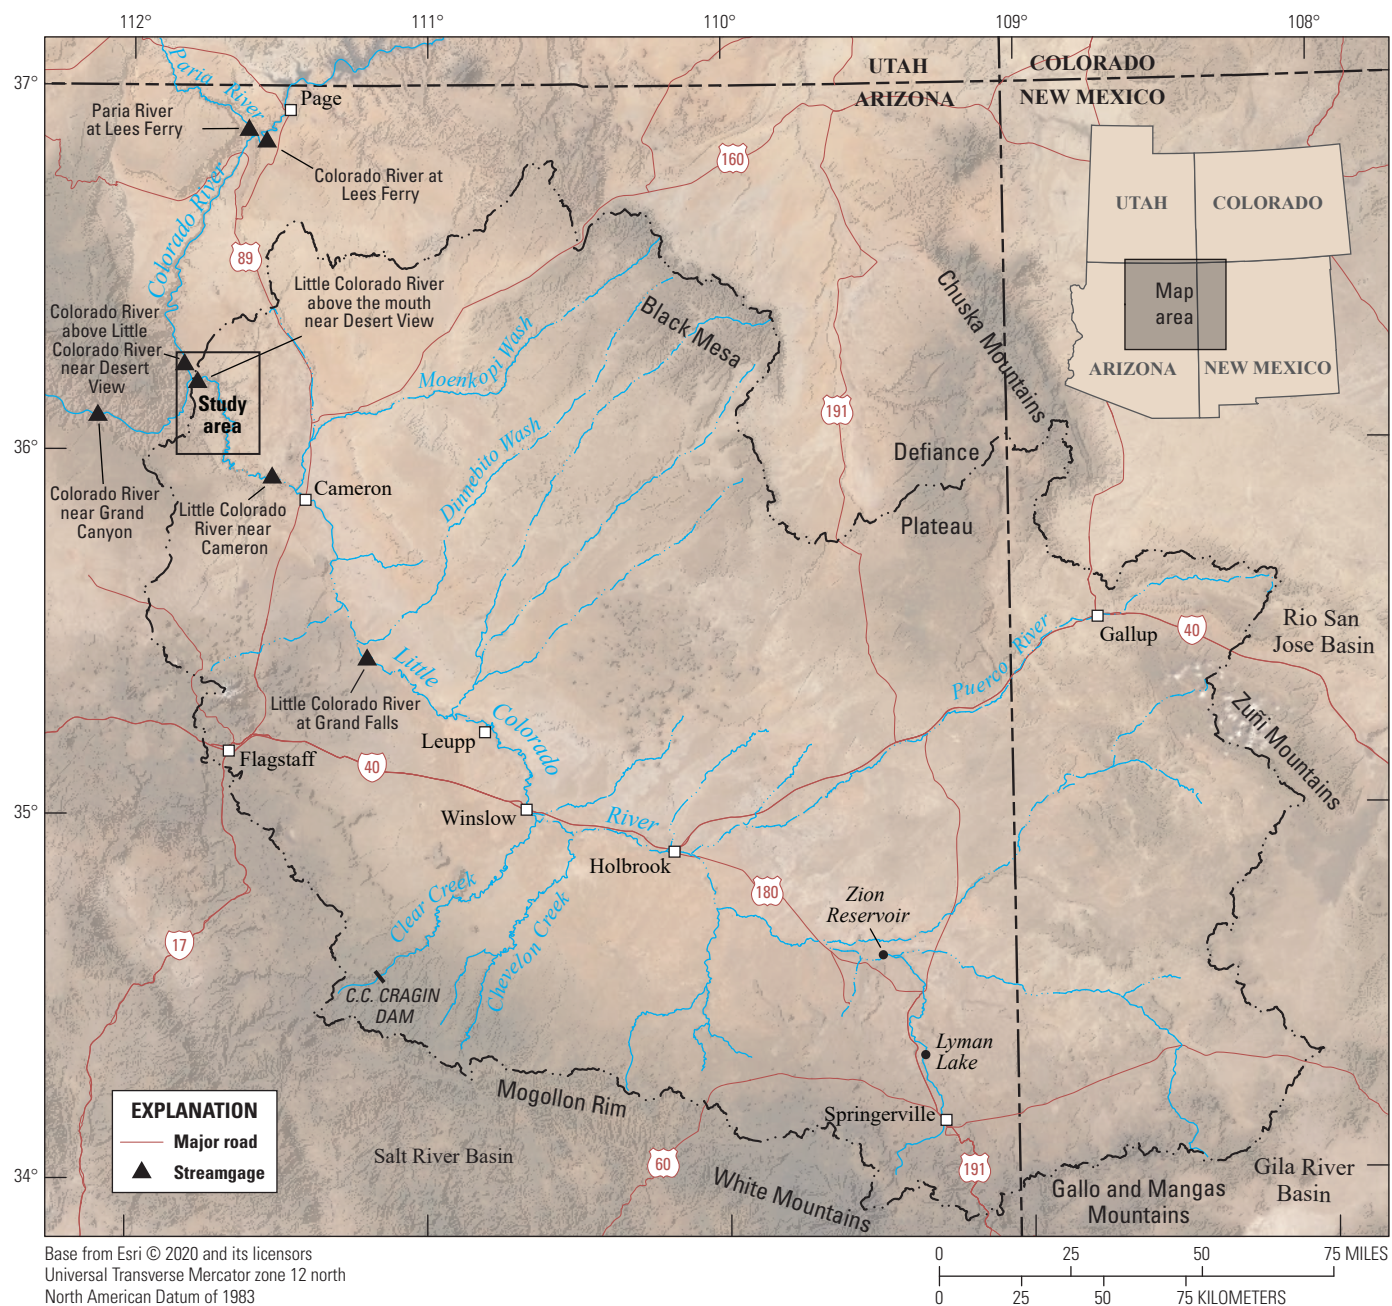
**Figure 1.** Map of the Little Colorado River Basin in Arizona showing the locations of U.S. Geological Survey (USGS) streamgages, tributaries, and other features. Streamgages (and USGS identification numbers) used in this study are Little Colorado River at Grand Falls (09401000), Little Colorado River near Cameron (09402000), Little Colorado River above the mouth near Desert View (09402300), Colorado River at Lees Ferry (09380000), Paria River at Lees Ferry (09382000), Colorado River above Little Colorado River near Desert View (09383100), and Colorado River near Grand Canyon (09402500).

The Little Colorado River originates in the White Mountains of Arizona and flows 565 km through northeastern Arizona (fig. 1) (Block, 2014). Its drainage basin of 70,000 square kilometers ( $\text{km}^2$ ) includes the northeastern slope of the Mogollon Rim escarpment and most of the Black Mesa highland area on the Navajo Nation (Hereford, 1984).

The Little Colorado River is perennial from its headwaters for 60 km to Lyman Lake, the basin's largest reservoir (fig. 1). The river is heavily regulated by Lyman Lake, and flows seasonally 40 km to Zion Reservoir. The Little Colorado River is then ephemeral from Zion Reservoir to the mouth of Chevelon Creek, near Winslow, Ariz. Spring discharge from Chevelon Creek and Clear Creek adds a small amount of base flow and creates a perennial reach for only a few kilometers. Farther downstream, the river again becomes ephemeral, with alternating sections of sand- and gravel-bedded channel and bedrock-floored channel that extend approximately 90 km to Grand Falls. This ephemeral sand- and gravel-bedded and bedrock-floored channel extends another 60 km to Cameron, Ariz. Moenkopi Wash, an important tributary to the Little Colorado River, enters about 4 km downstream from Cameron. Approximately 13 km downstream from Cameron, the Little Colorado River enters a bedrock gorge that extends approximately 78 km to its confluence with the Colorado River. The Little Colorado River remains ephemeral in the gorge until reaching the Blue Spring complex (fig. 2), which creates perennial base flow approximately 21 km upstream from the Colorado River.

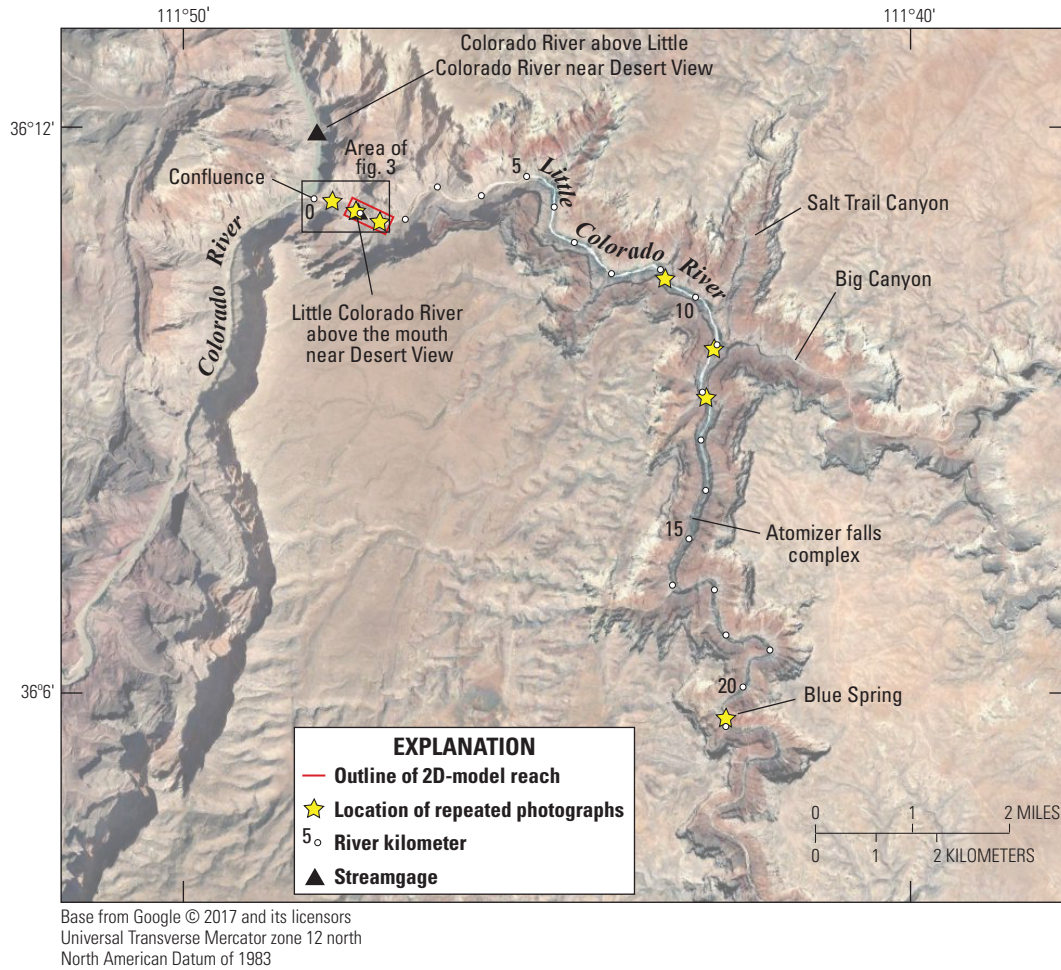
**Figure 2.** Study-area map of the lower Little Colorado River showing locations of streamgages, topographic features, model reach, and repeated photographs (yellow stars). 2D, two dimensional.

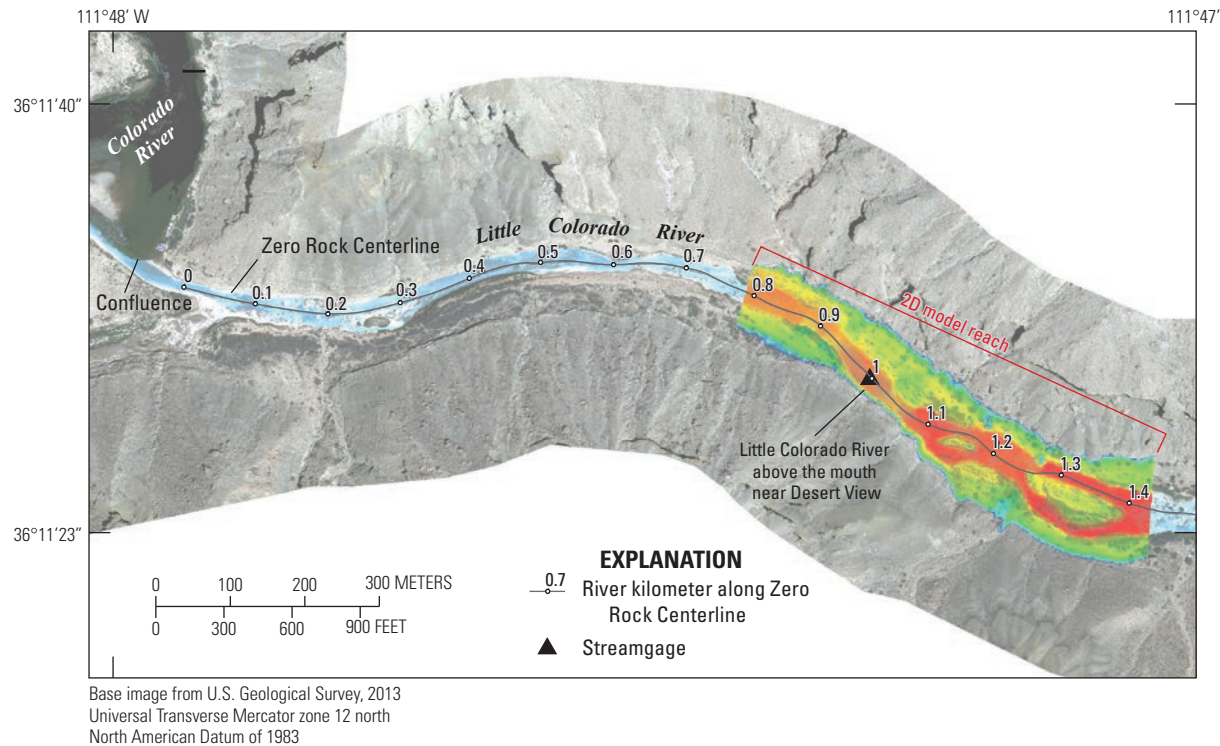
**Figure 3.** Aerial image taken in 2013 of the model reach in the lower Little Colorado River. The Zero Rock Centerline is shown with distances in tenths of a kilometer upstream from the "Zero Rock." The Little Colorado River above the mouth near Desert View, Arizona, streamgage is labeled near the middle of the model reach, and an example output from a two-dimensional (2D) flow-model run indicates the extent of the model reach; the streamflow simulated in this run was 3,400 cubic meters per second. Warm and cool colors show greater and shallower water depths, respectively.

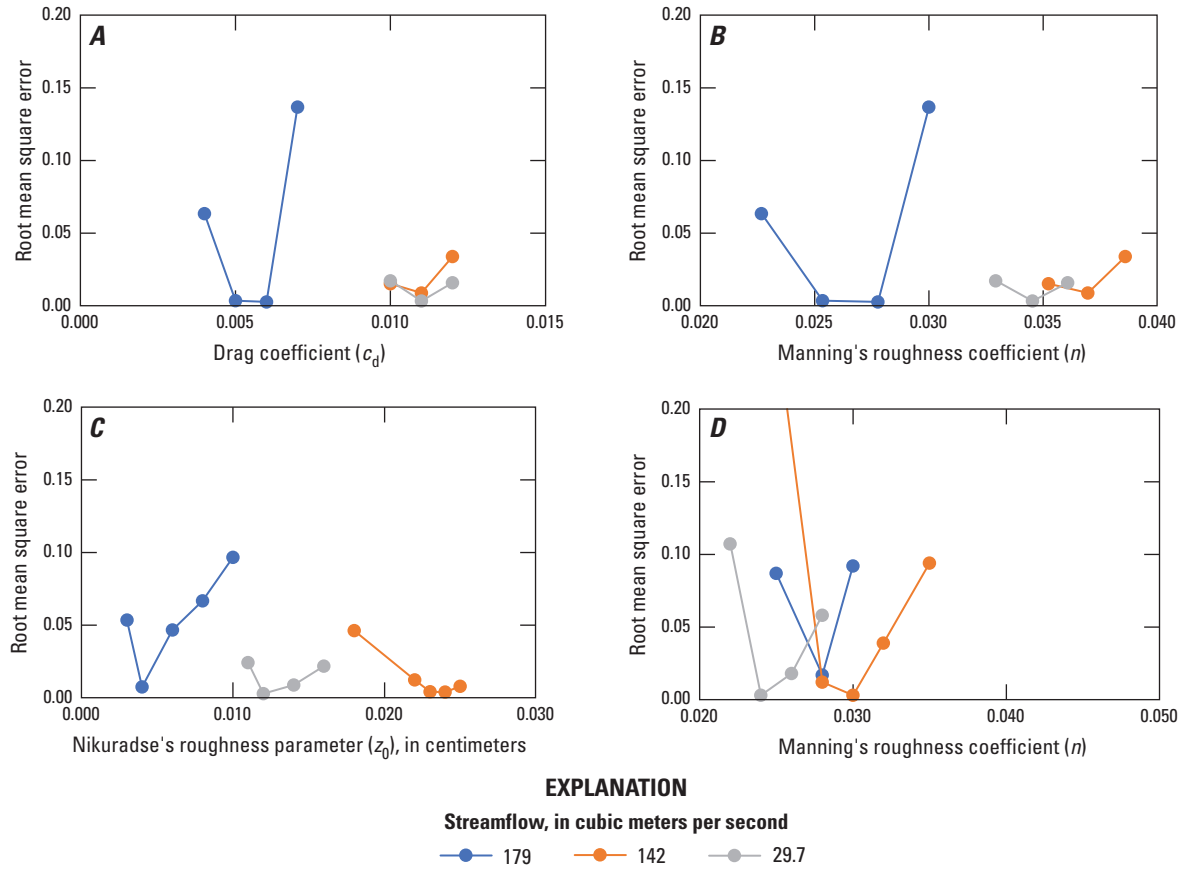
**Figure 4.** Plots showing model-roughness-calibration results calculated by using the FaSTMECH (A, B, C) and STORM (D) solvers for three floods with known water-surface profiles (peak flows of 179, 142, and 29.7 cubic meters per second). In all four calculations, the roughness coefficient with the lowest root mean square error was the best-fit roughness for that simulated flow.

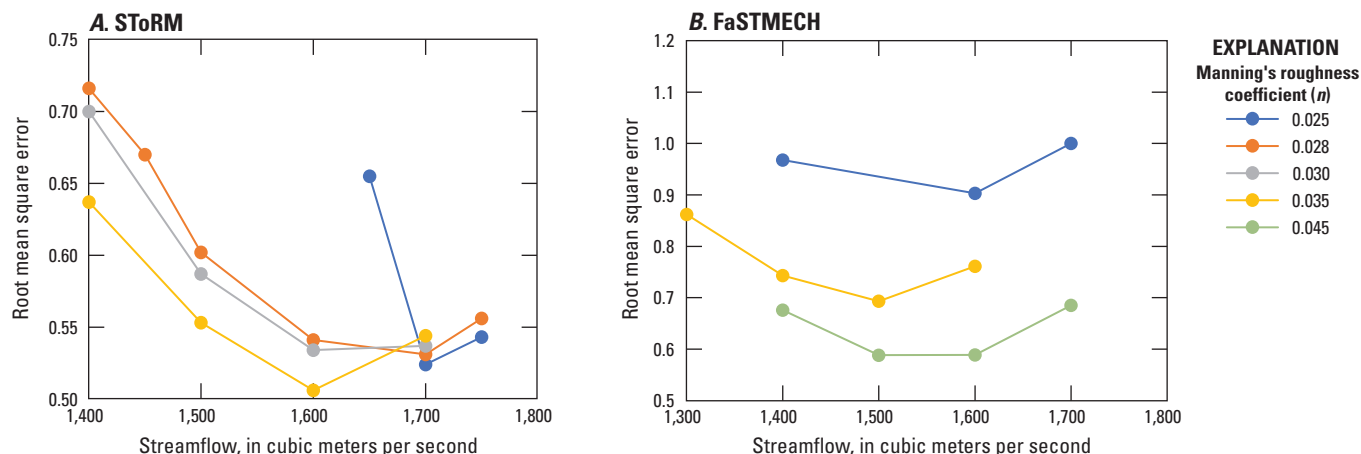
**Figure 5.** Plots showing the root mean square error for STORM (A) and FaSTMECH (B) model runs for one simulated high-water mark (HWM) set D used to determine best-fit streamflow. The simulated streamflow that best fits the HWMs has the minimum root mean square error.

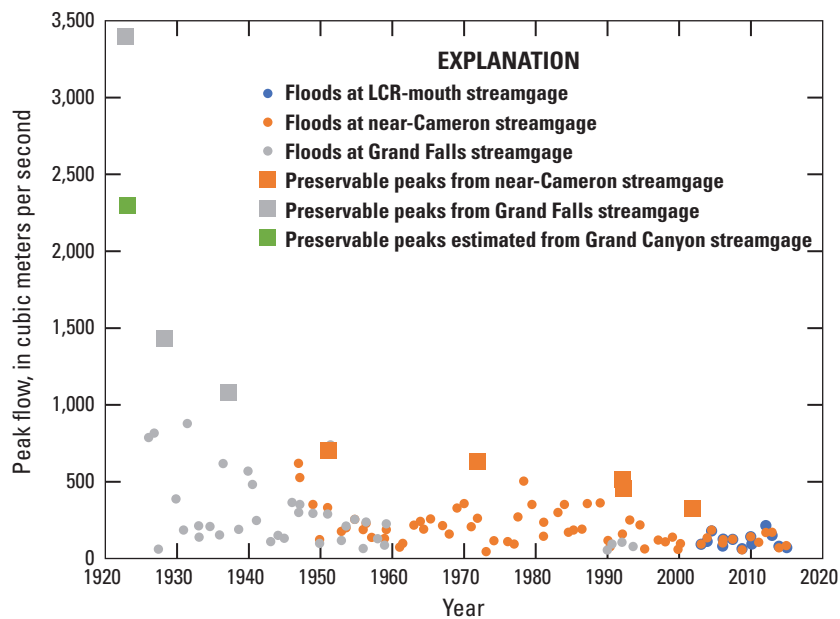
**Figure 6.** Plot showing the peak-flow record of the lower Little Colorado River constructed from the gaging records at the LCR-mouth streamgage, the near-Cameron streamgage, and the Grand Falls streamgage, and estimated by using a streamflow-routing model from the Grand Canyon streamgage for 1923–2017. The sequence of peak flows with progressively decreasing streamflow—preservable peaks—is denoted by the large squares. Note that floods larger than approximately 400 cubic meters per second ( $\text{m}^3/\text{s}$ ) become rare after 1952, and floods larger than approximately  $200 \text{ m}^3/\text{s}$  become extremely rare after the early 1990s. LCR, Little Colorado River.

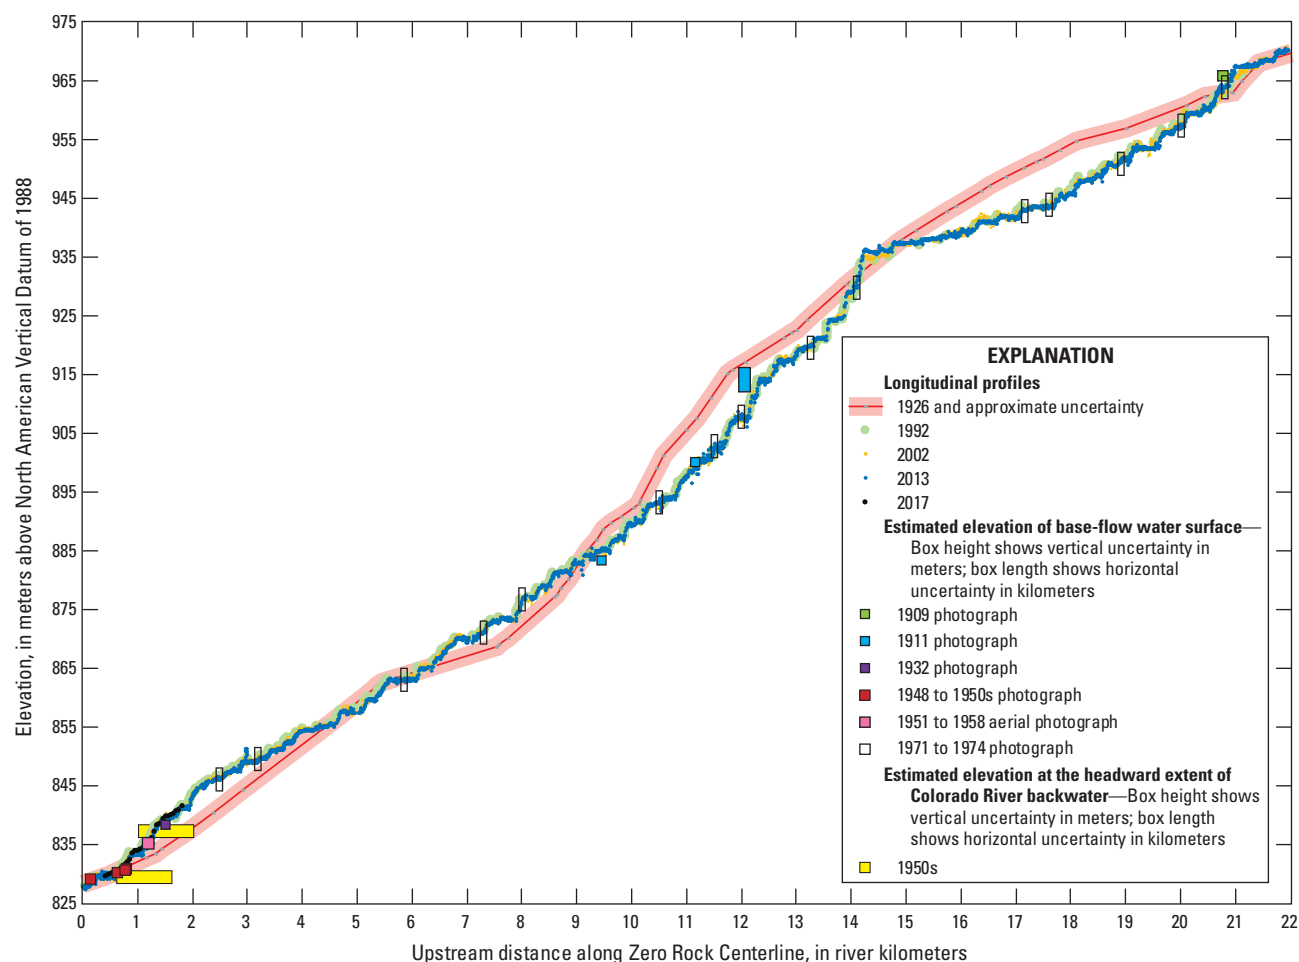
**Figure 7.** Longitudinal profiles of the lower Little Colorado River from 1926, 1992, 2002, 2013, and 2017. Estimated elevations of the base-flow water surface in 1909, 1911, 1932, 1948–1950s, and 1971–1974 historical photographs, estimated elevations of the base-flow water surface in 1951–1958 aerial photographs, and estimated elevations of the headward extents of Colorado River backwater pools in the 1950s are shown as squares whose sizes represent the approximate uncertainty in elevation and location. The  $\pm 1$ -meter magnitudes of the uncertainties in the elevations reconstructed from the backwater observations near river kilometers (Rkms) 1.1 and 1.5 were determined, in part, so that these water-surface elevations were consistent with those estimated from 1950s photographs at Rkms 0.64 and 0.78 and from a 1932 photograph at Rkm 1.5. Multiple boulders in the 1932 photograph are visible in the same locations and orientations in our 2019 photograph, thus indicating that no substantial post-1932 scour and fill occurred at Rkm 1.5 and showing the post-1932 water-surface elevation upstream from Rkm 1.5 to be no lower than it was in the 1932 photograph.

13.2, 14.1, 17.1, 17.6, 18.9, and 20.0. The largest and most extensive amount of historical aggradation occurred between Rkm 9 and 11.5; this reach aggraded between 1911 and 1926 before incising between 1926 and 2002 (fig. 7). At Rkm 9.45, a 1911 photograph shows a water-surface elevation about 2 m lower than in 2013 (fig. 16), which is, in turn, about 4 m lower than in 1926 (fig. 7). A 1911 photograph at Rkm 11.15, just upstream from Big Canyon, shows a water-surface elevation about 1 m higher than in 2013 (fig. 17), but about 6 m lower than in 1926 (fig. 13). After the rapid 1911–1926 aggradation between Rkms 9 and 11.5, the reach between Rkms 9 and 13 was incised by approximately 2 to 10 m between 1926 and the 1950s, and thereafter remained stable (fig. 7).

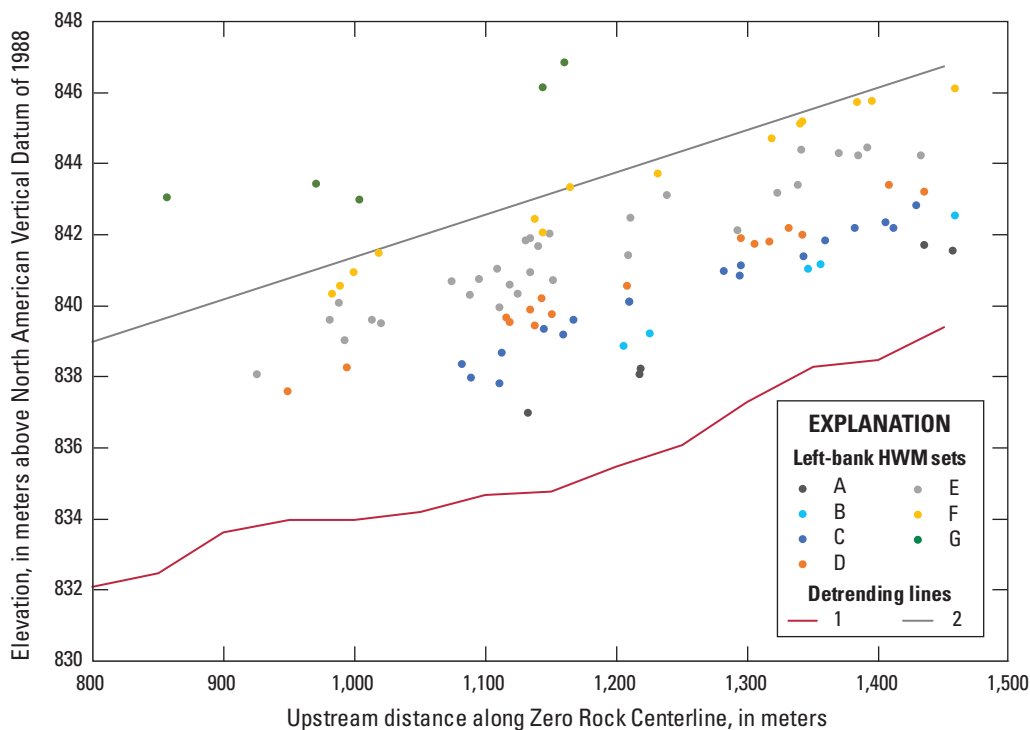
**Figure 8.** Plot of high-water-mark (HWM) elevations on the left bank of the Little Colorado River versus distance along the Zero Rock Centerline and differentiated into sets (A–G) along detrending lines 1 and 2.

were subdivided into separate sets based on their relative positions in figure 8. By this process, we assigned the HWMs above sets A and B to four different and relatively distinct sets on the more gently sloping right bank (C through F). We assigned the HWMs above sets A and B on the complicated ledge- and overhang-dominated left bank to the same four sets (C through F) plus one additional set (G).

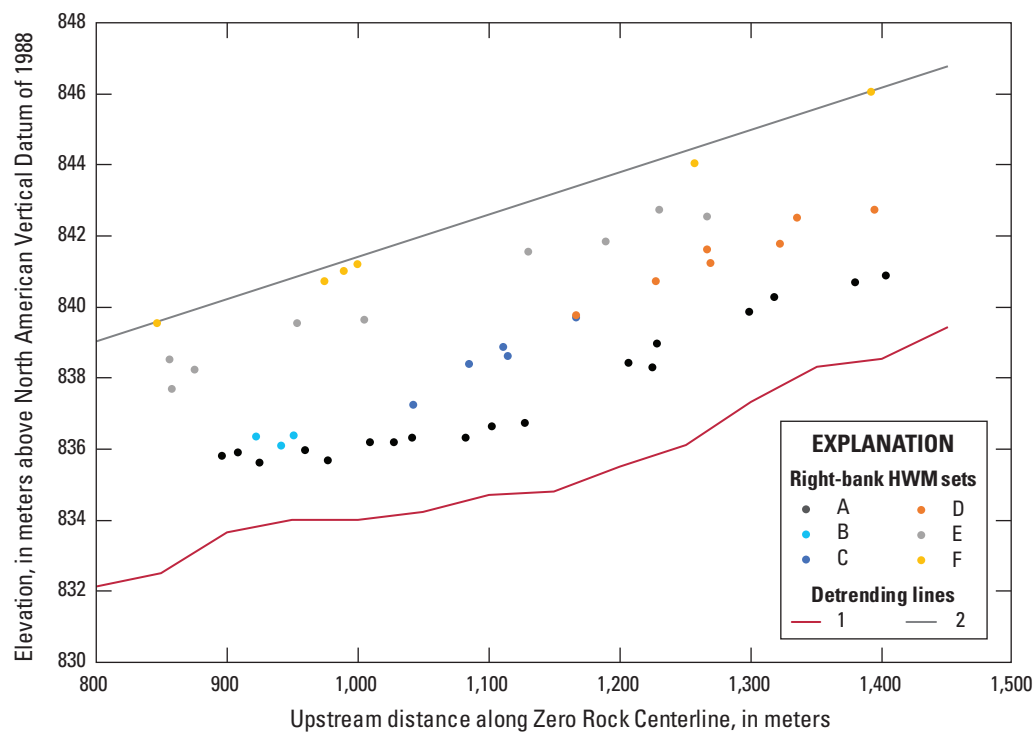
**Figure 9.** Plot of high-water-mark (HWM) elevations on the right bank of the Little Colorado River versus distance along the Zero Rock Centerline and differentiated into sets (A–G) along detrending lines 1 and 2.

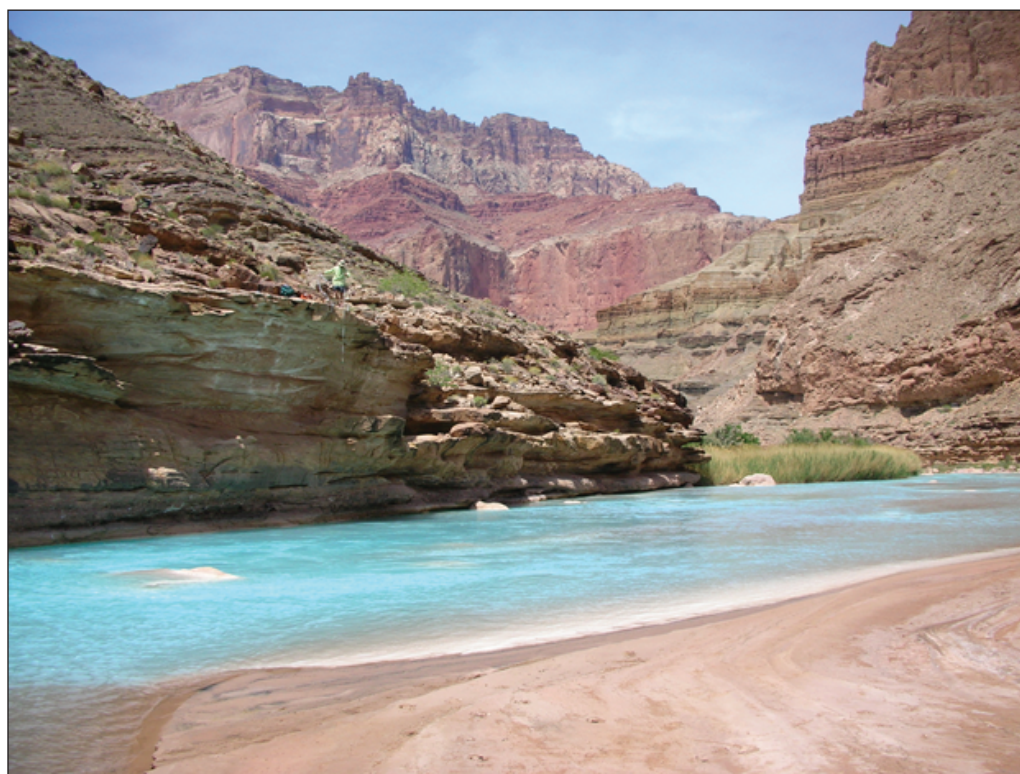
**Figure 10.** Photograph taken downstream from the complex geometry of ledges of Cambrian-age Tapeats Sandstone of Tonto Group on the left bank of the Little Colorado River near the LCR-mouth streamgauge in the reach surveyed in June 2017. Photograph taken from sandbar on right side of base-flow channel. A U.S. Geological Survey hydrologist is standing at the gaging-station downward-looking-radar stage sensor. The complex ledge geometry extends upstream approximately 120 meters from the view in this photograph in a section that includes large sloping ledges where water-surface elevations increase disproportionately during floods. The more gently sloping right bank, with fewer ledges, is to the right of the view in this photograph. LCR, Little Colorado River.

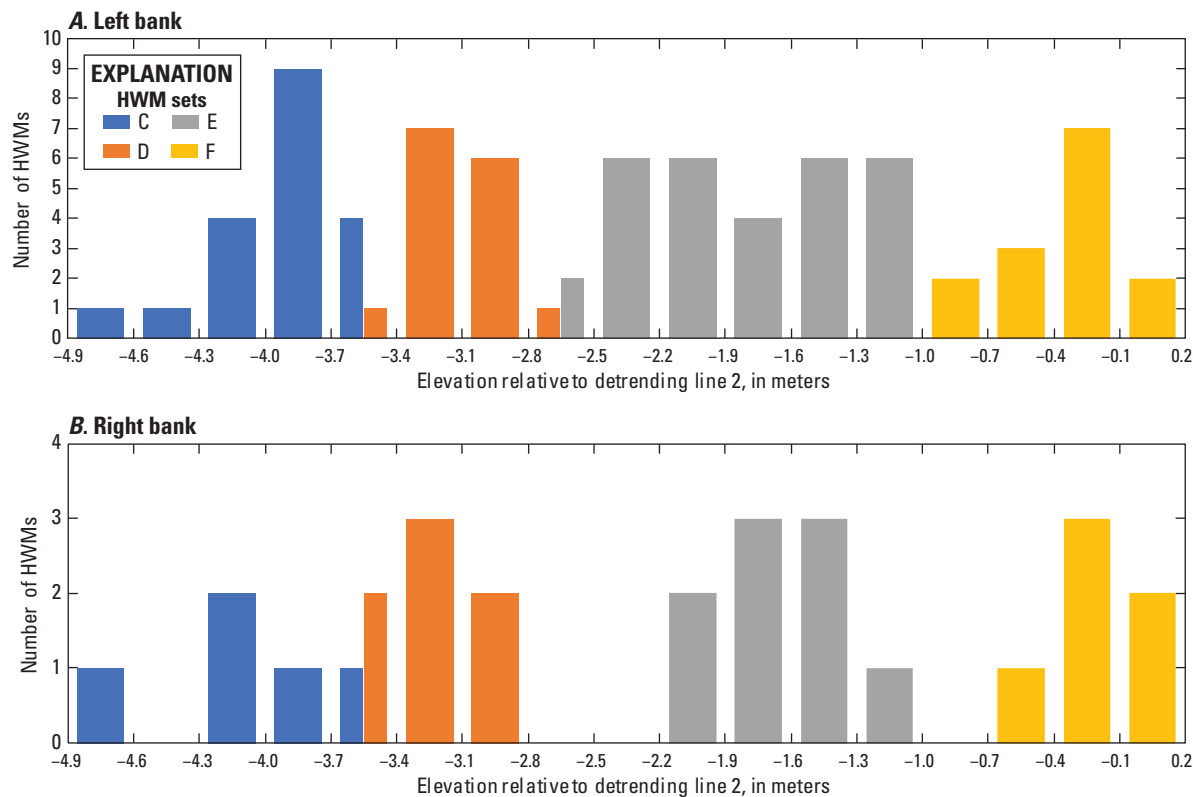
**Figure 11.** Histograms of high-water marks (HWMs) binned by elevation relative to detrending line 2 (figs. 8 and 9) for left (A) and right (B) banks of the Little Colorado River. Positive relative elevation (0.2 on the right end of the graph) indicates that the HWM is above detrending line 2. Bin size is 0.3 meter, and the numbers on the x-axis are the lower and upper bounds of each bin. Interpreted HWM sets C through F are distinguished by color; HWM set G is excluded because its HWMs are present only on the left bank and all points in set G are more than 1.5 meters above detrending line 2.

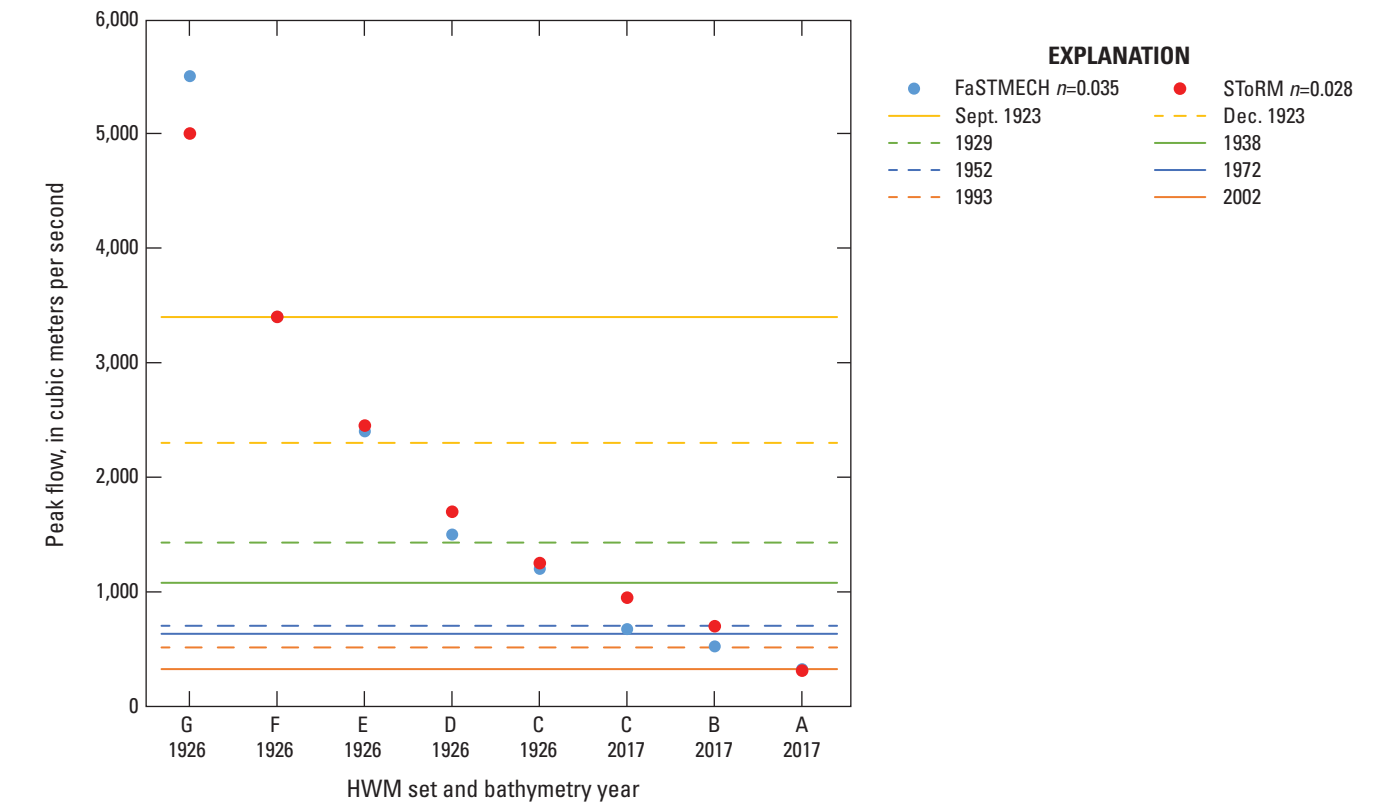
**Figure 12.** Plot showing the best-fit FaSTMECH- and STORM-predicted streamflows for the seven high-water-mark (HWM) sets compared with the peak flows associated with the preservable peak flows reconstructed from the gaging records. The best-fit streamflows predicted by FaSTMECH and STORM are indicated by the circles. The peak flows of the gaged historical floods associated with the preservable peak flows are shown as horizontal lines. The elevations of the channel bed were much lower in the 1926 bathymetry than in the 2017 bathymetry, as described in the “Methods” section. *n*, Manning’s roughness coefficient.

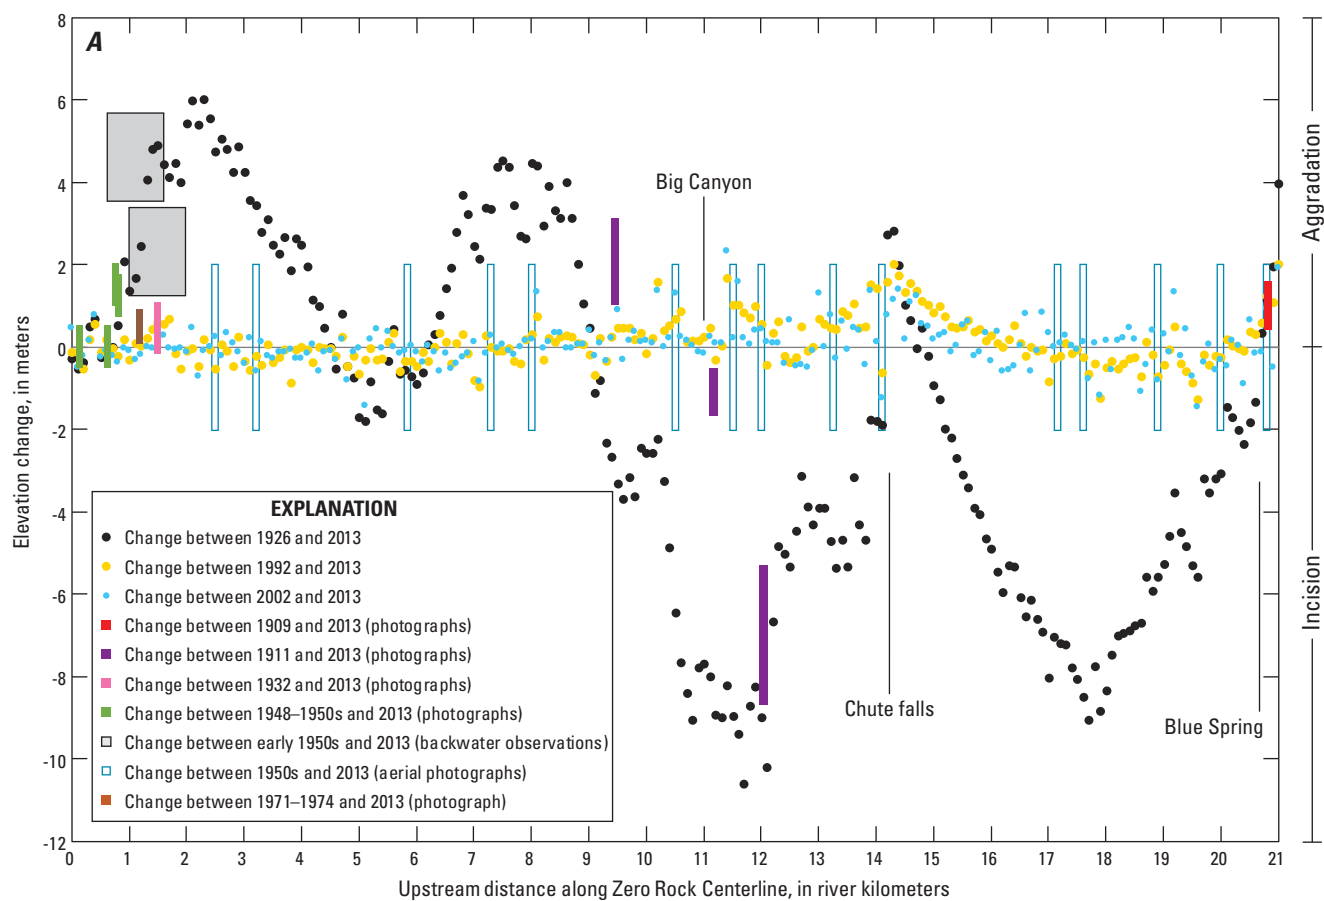
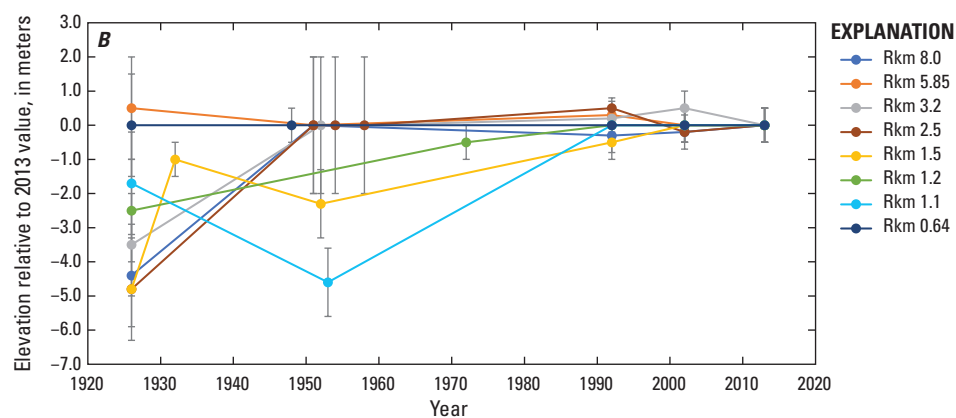
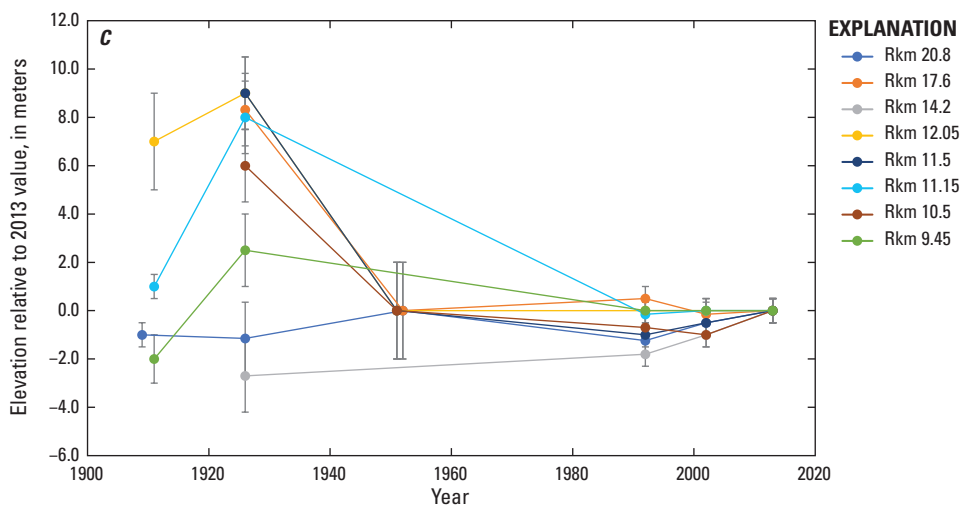
**Figure 13 (page 25).** Plots of changes in the base-flow longitudinal profile and water-surface elevations for the lower Little Colorado River. *A*, Changes in the base-flow longitudinal profile of the lower Little Colorado River relative to 2013. The height of boxes marking data points indicates the approximate vertical uncertainty in meters of elevation. The length of boxes marking data points indicate the approximate horizontal uncertainty in river kilometers (Rkm). Positive values of change indicate aggradation, and negative values of change indicate incision. *B*, Time series of elevation relative to the elevation in 2013 of the base-flow water-surface elevation at the locations of repeated photographs, backwater observations, and mid-channel rocks indicating only minimal post-1951 change between Rkm 0 and 9. Negative values indicate elevations that were lower in the specified year than the elevation in 2013. *C*, Time series of elevation relative to the elevation in 2013 of the base-flow water-surface elevation at the locations of repeated photographs and locations of mid-channel rocks indicating only minimal post-1951 change between Rkms 9 and 22. Positive values indicate elevations that were higher in the specified year than the elevation in 2013.

The reach from the confluence at Rkm 0 to Rkm 9 has aggraded substantially since 1926. This observed aggradation occurred mostly between 1926 and the 1950s and to a lesser degree between the early 1950s and 1992. The reach has remained essentially unchanged between 1992 and 2017 (fig. 13). The elevation of the confluence of the Colorado and

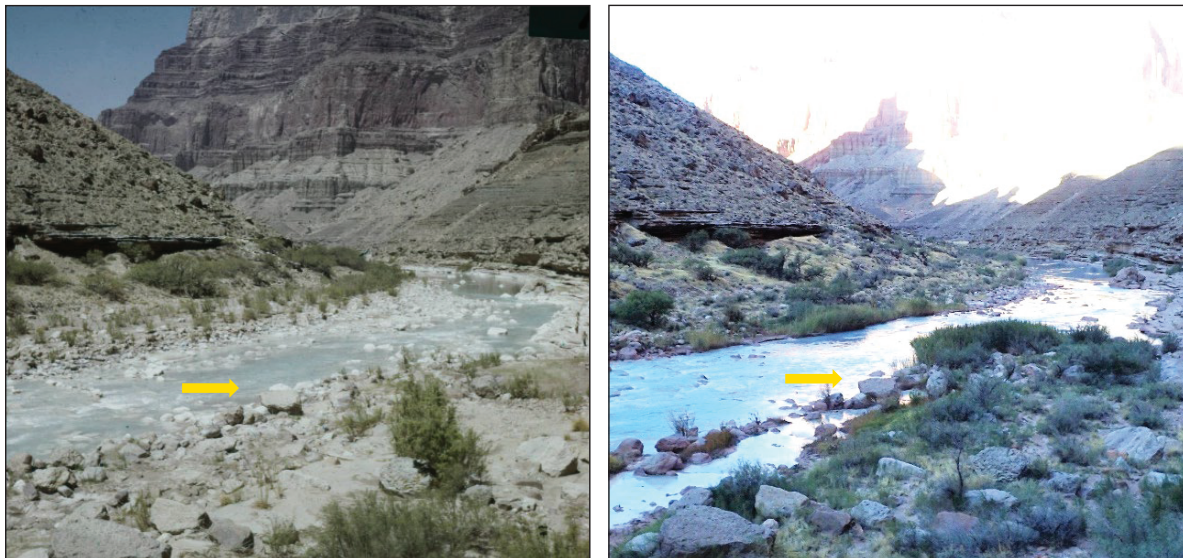
**Figure 14.** Repeated photographs from the 1950s and 2019 of the Little Colorado River at river kilometer (Rkm) 0.78; view is upstream. The 1950s photograph (left) is part of the Katie Lee collection and is matched in the 2019 photograph by Joel Unema (right). Arrows mark the top of the same rock in both photographs. Hand-level measurements in 2019 show that the base-flow water surface was  $1.5 \pm 0.5$  meters (m) higher in 2019 than in the 1950s, indicating approximately 1.5 m of bed aggradation and (or) travertine-dam growth near Rkm 0.78 between the 1950s and 2019.

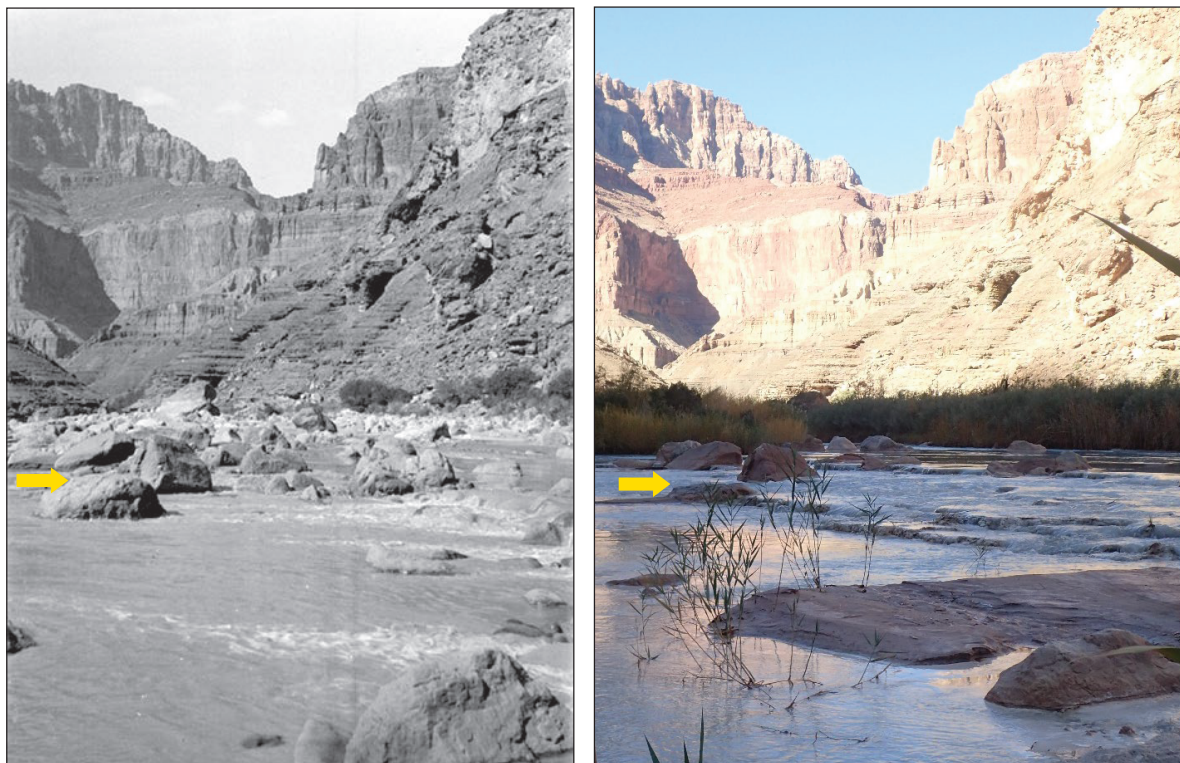
**Figure 15.** Repeated photographs from 1932 and 2019 of the Little Colorado River at river kilometer (Rkm) 1.5; view is downstream. The 1932 photograph was taken by Barbara and Edwin McKee (left) and is matched in the 2019 photograph by Joel Unema (right). Arrows mark the top of the same rock in both photographs. Hand-level measurements in 2019 show that the base-flow water surface was  $1.0 \pm 0.5$  meter (m) higher in 2019 than in 1932, indicating approximately 1 m of travertine-dam aggradation at Rkm 1.5 between 1932 and 2019.

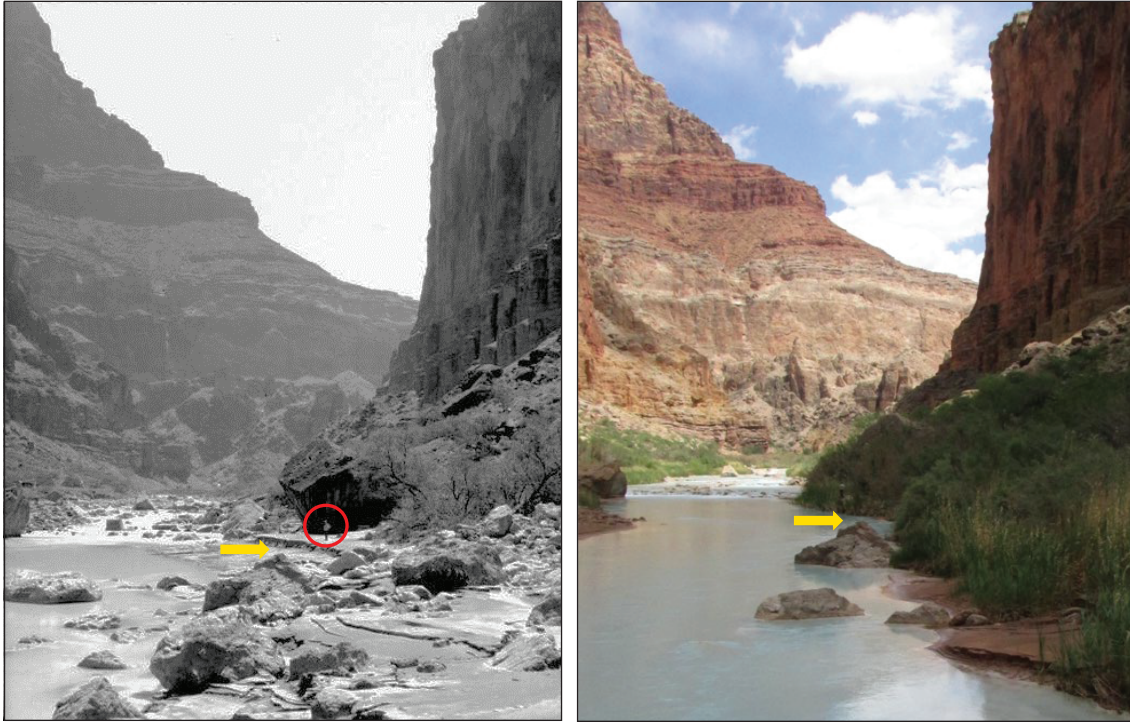
**Figure 16.** Repeated photographs from 1911 and 2013 of the Little Colorado River below Salt Trail Canyon at river kilometer (Rkm) 9.45; view is upstream. The 1911 photograph was taken by Emery Kolb (left) and the 2013 photograph by Michael Pillow (right). Arrows mark the top of the same rock in both photographs. The base-flow water surface was estimated to be  $2\pm 1$  meters (m) higher in 2013 than in 1911; this estimation used the person of about 1.7 m height (circled) for scale because this site was not measured in 2019. Thus, about 2 m of bed aggradation and (or) travertine-dam growth occurred near Rkm 9.45 between 1911 and 2013.

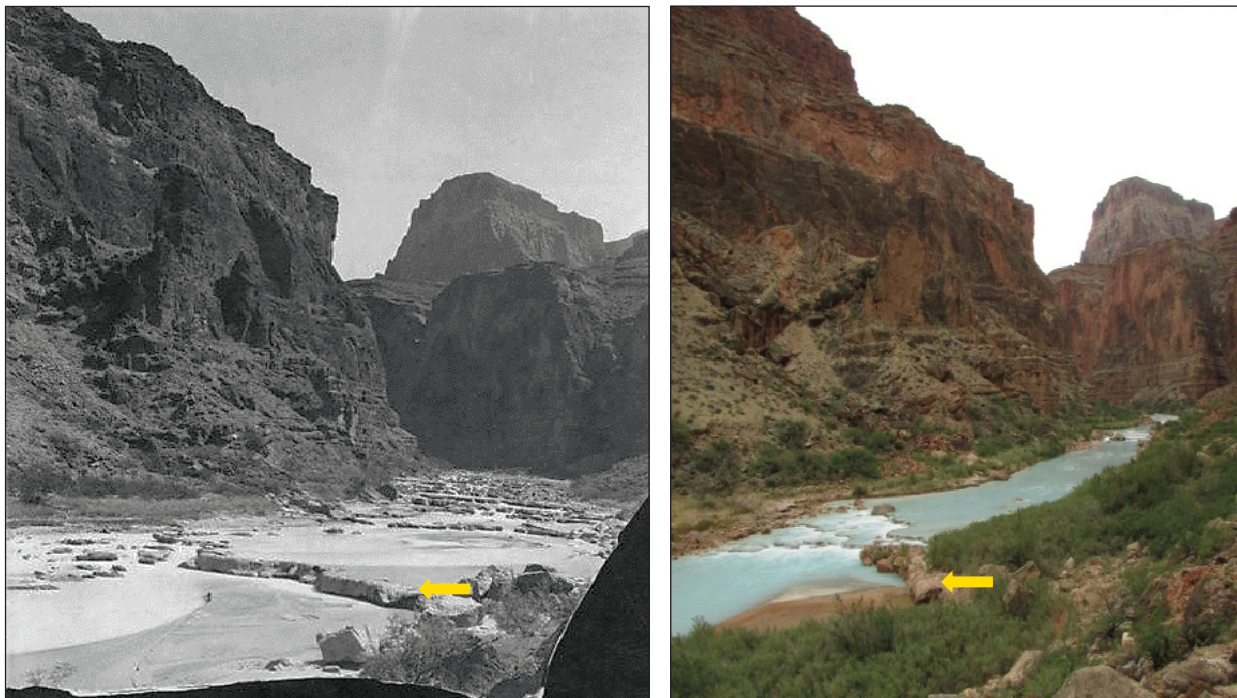
**Figure 17.** Repeated photographs from 1911 and 2013 of the Little Colorado River upstream from Big Canyon at river kilometer (Rkm) 11.15; view is upstream. The 1911 photograph was taken by Emery Kolb (left) and the 2013 photograph by Michael Pillow (right) was taken from a slightly different vantage point. Hand-level measurements in 2019 show that the water surface was  $1.0\pm 0.5$  meter (m) lower in 2013 than in 1911, indicating that about 1 m of travertine-dam incision occurred near Rkm 11.15 between 1911 and 2013. The breached travertine dam (marked by arrows) that was active in 1911 is evident in the foreground of the 2013 photograph.

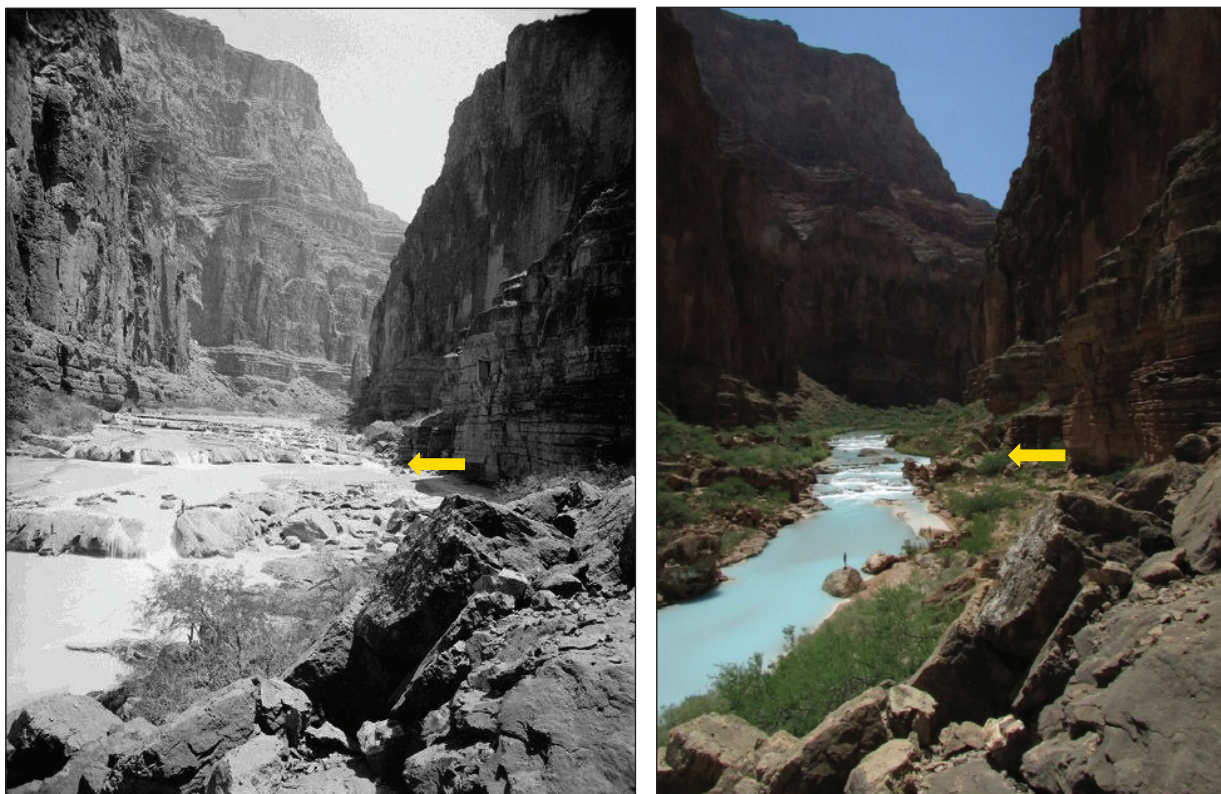
**Figure 18.** Repeated photographs from 1911 and 2013 of the Little Colorado River upstream from Big Canyon at river kilometer (Rkm) 12.05; view is upstream. The 1911 photograph was taken by Emery Kolb (left) and the 2013 photograph by Michael Pillow (right). Arrows mark the crest elevation of the same travertine dam in both photographs. Hand-level measurements in 2019 show that the base-flow water surface elevation was  $7 \pm 2$  meters (m) lower in 2013 than in 1911, indicating that about 7 m of travertine-dam incision occurred near Rkm 12.05 between 1911 and 2013.

2013 counterpart of the 1911 photograph (fig. 18). We could not find any observations or photographs of this reach taken during the period 1926 through 1951, so the exact dates and rates of dam failure and channel incision remain unknown.

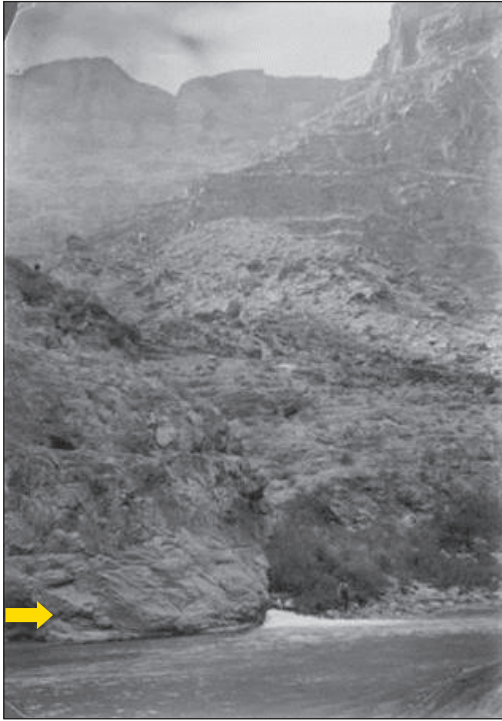
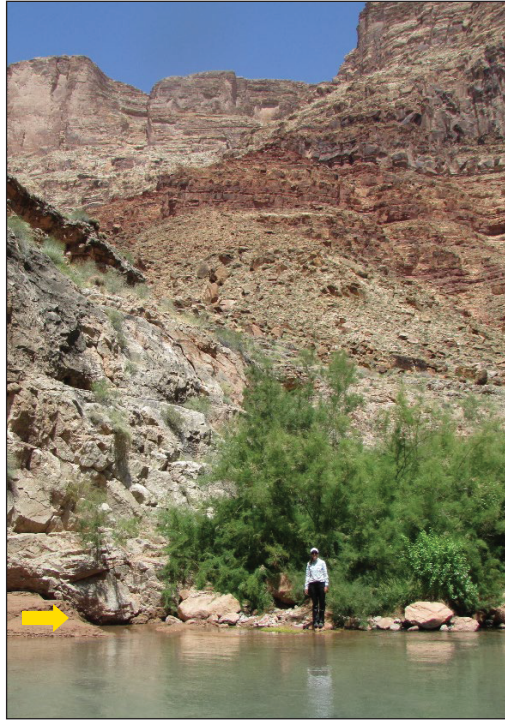
**Figure 19.** Repeated photographs from 1909 and 2013 of Blue Spring on the left bank of the Little Colorado River at river kilometer (Rkm) 20.8. The 1909 photograph was taken by Emery Kolb (left) and the 2013 photograph by Michael Pillow (right). Arrows mark the rock ledge visible in both photographs. The base-flow water surface was estimated to be  $1 \pm 0.5$  meter (m) higher in 2013 than in 1909; this estimation used a 1.7-m-tall person for scale because this site was not measured in 2013. These comparisons showed that about 1 m of bed aggradation or travertine-dam growth occurred near Rkm 20.8 between 1909 and 2013.
