Prepared in cooperation with the Northeast Ohio Regional Sewer District

# Circulation, Mixing, and Transport in Nearshore Lake Erie in the Vicinity of Villa Angela Beach and Euclid Creek, Cleveland, Ohio, June 10–12, 2019, and August 19–21, 2019

Scientific Investigations Report 2021–5122

By Justin A. Boldt and P. Ryan Jackson

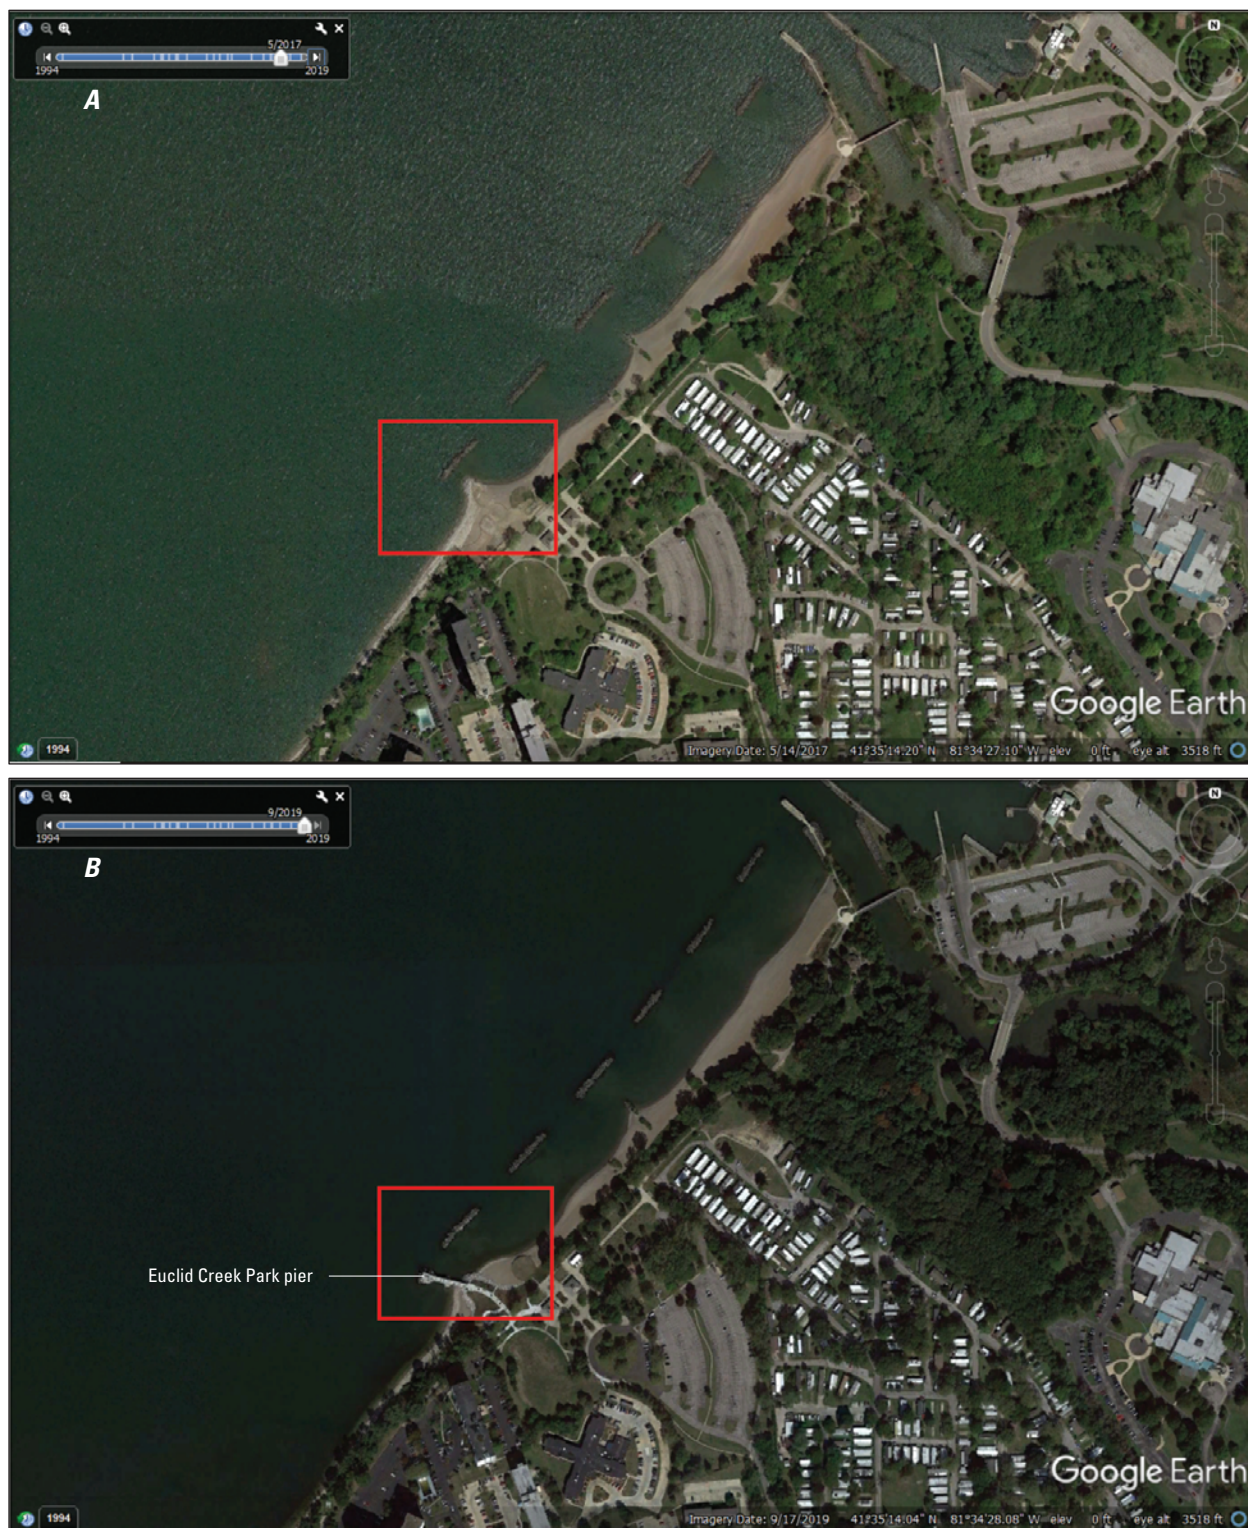
**Figure 1.** Coastal Lake Erie in the vicinity of Villa Angela Beach and Euclid Creek, Cleveland, Ohio, April 2017. *A*, Overview of the study area and Euclid Creek drainage basin. *B*, Survey domain with designated survey lines and combined sewer overflow permitted discharge points. *C*, Inset of acoustic Doppler velocity meter (ADVM) locations and measurement profiling extent.

Villa Angela Beach, near Cleveland, Ohio, is surrounded by six CSO discharge points, three on the lakefront (206, 207, 208) and three on Euclid Creek (239, 209, 210; 210 not shown) upstream from the mouth (fig. 1B). Two additional CSO discharge points (242, 002) are at the Easterly WWTP to the southwest of Villa Angela Beach (fig. 1B). All of these discharge points are managed by the NEORSD. To aid in the interpretation of the synoptic data presented in this report,

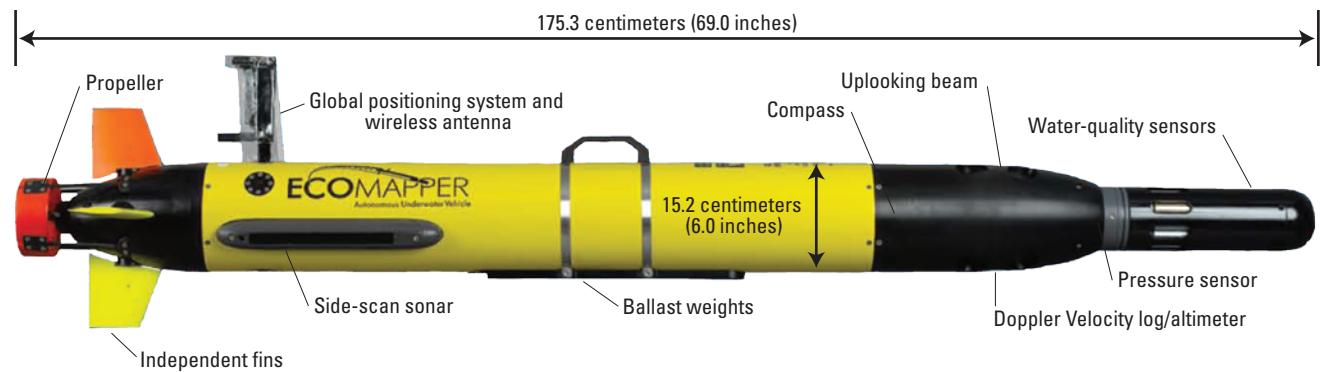
Figure 3. Schematic of the autonomous underwater vehicle.

The AUV used in the 2019 surveys is 69.0 inches in length, 6.0 inches in diameter, weighs approximately 65 pounds in air (fig. 3), and is built by YSI, Inc. (EcoMapper AUV, IVER2 base vehicle). The AUV consists of a carbon-fiber hull with aluminum nose and tail sections. The nose of the AUV houses a 6600 V2-4 YSI sonde bulkhead with four optical ports and temperature/conductivity and pH ports. A pressure sensor also is integrated into the sonde bulkhead for measurement of the sample depth. Aft of the sensor suite on the nose of the vehicle is the Doppler velocimetry log (DVL) instrument. The DVL is a 10-beam system for underwater navigation (bottom tracking) and includes vertical beams (uplooking and downlooking) for altitude and

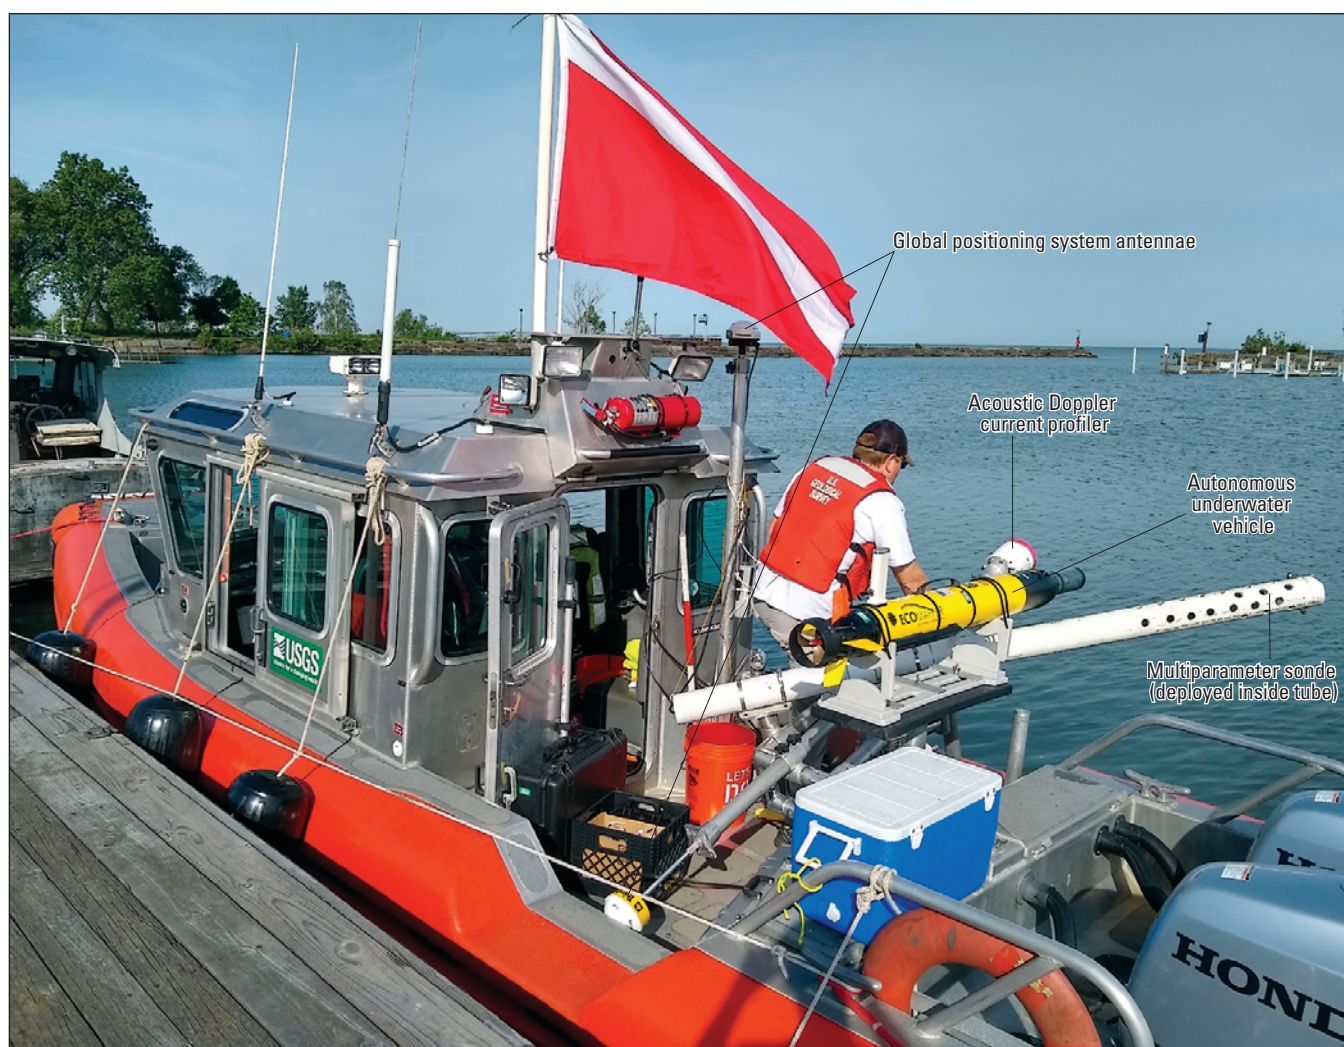
**Figure 4.** Manned boat and onboard equipment used in the coastal Lake Erie surveys in the vicinity of Villa Angela Beach and Euclid Creek, Cleveland, Ohio. Photograph by Justin Boldt, U.S. Geological Survey.

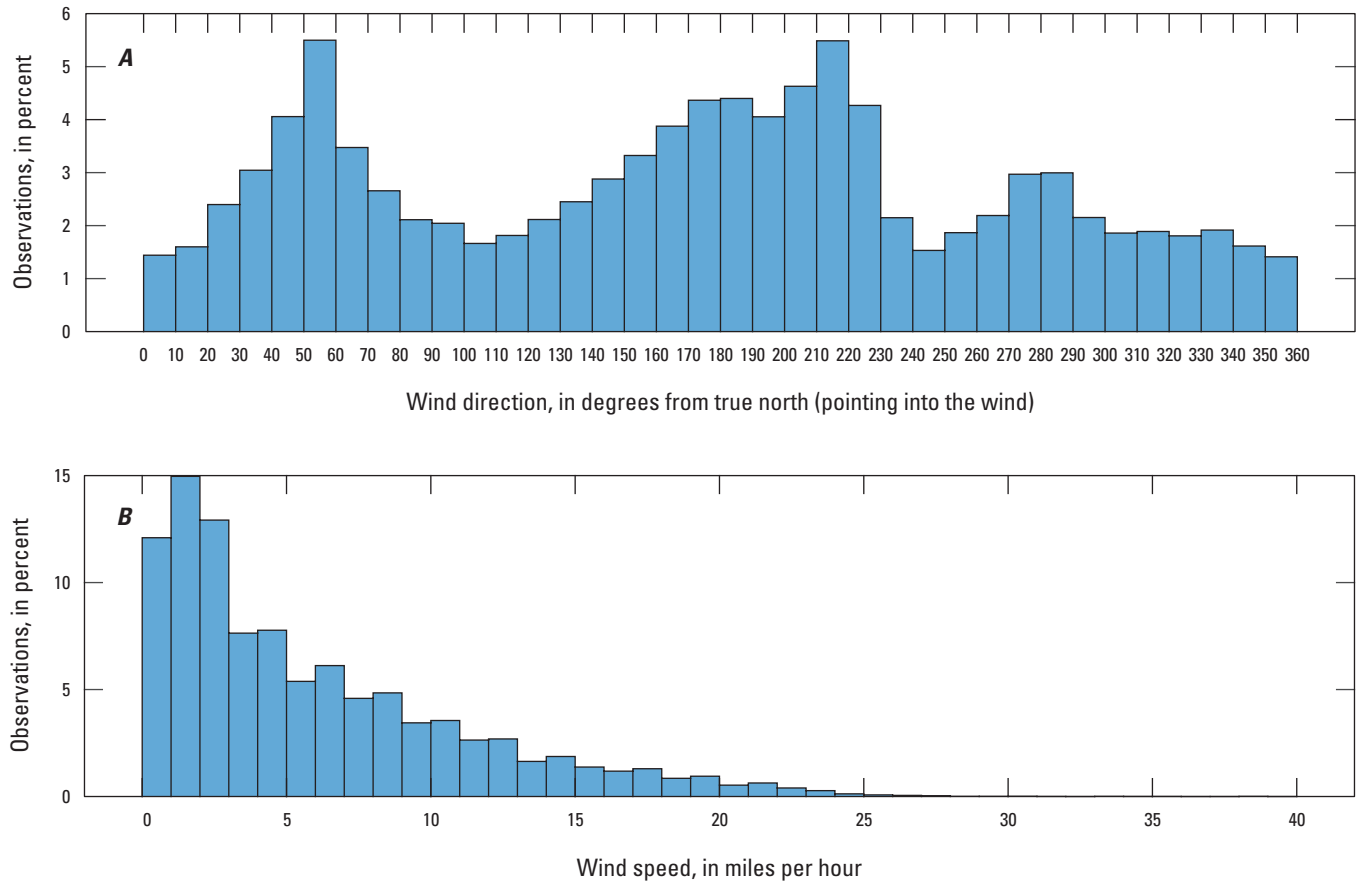
**Figure 5.** A, Wind-direction and B, wind-speed characteristics observed at the Lakefront Nature Preserve, Cleveland, Ohio, for the period June 1–September 30, 2019 (based on 6-minute interval data obtained from the National Oceanic and Atmospheric Administration station CND01; [https://www.ndbc.noaa.gov/station\\_page.php?station=cnd01](https://www.ndbc.noaa.gov/station_page.php?station=cnd01)).

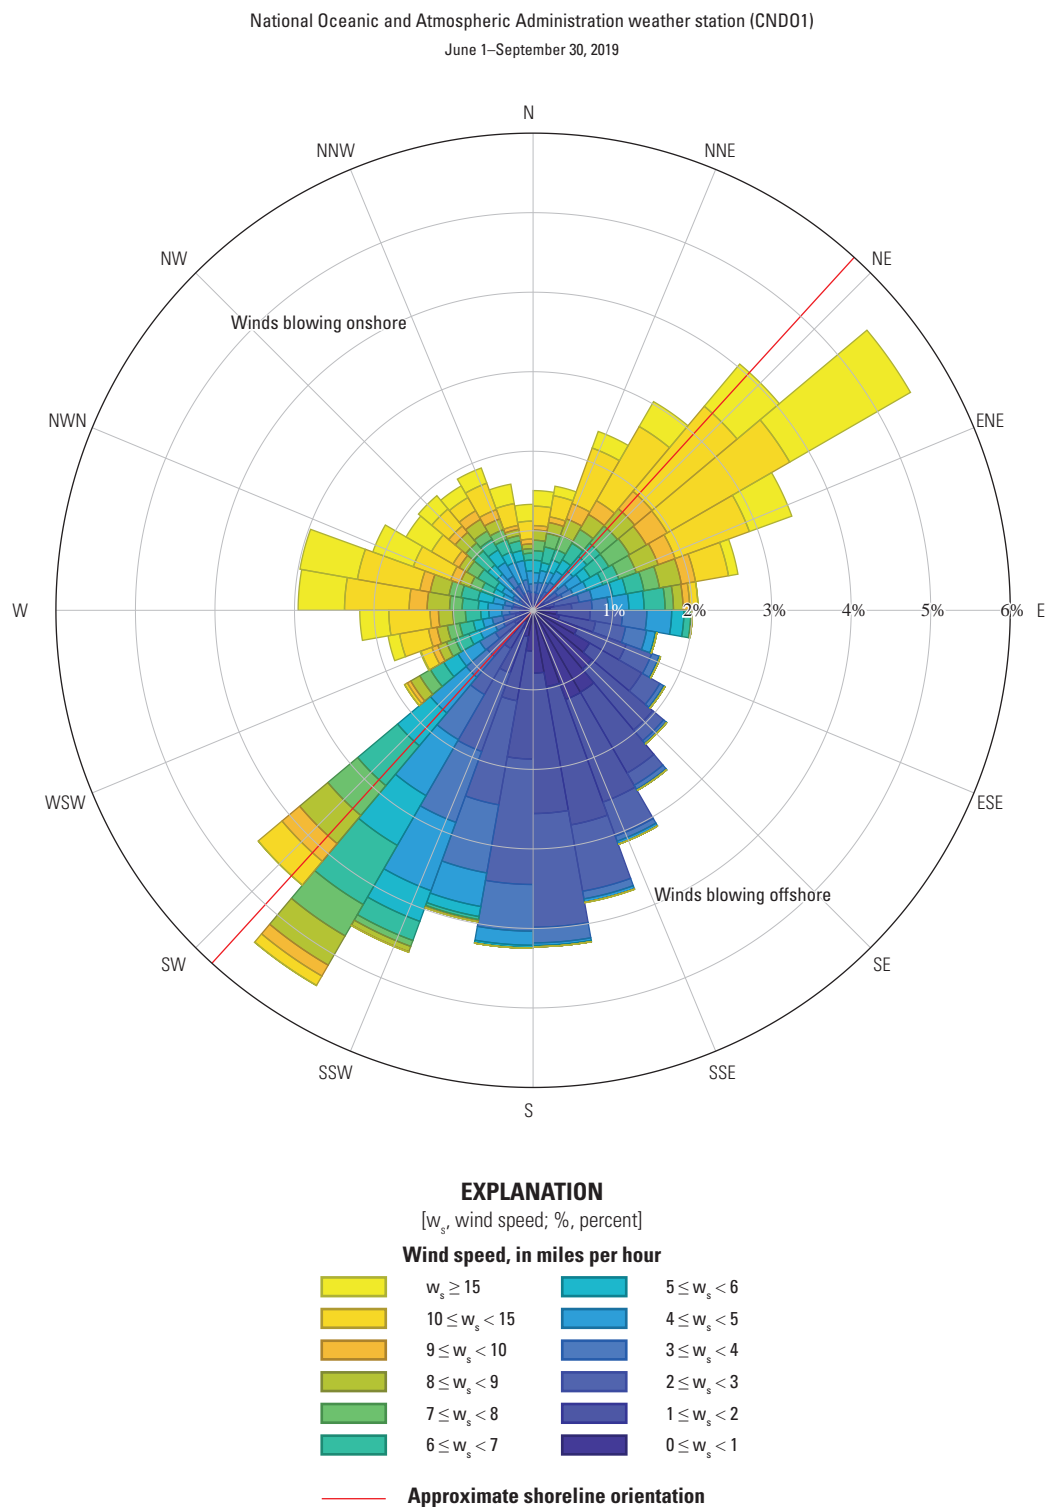
**Figure 6.** Wind-rose diagram of the wind-direction and wind-speed characteristics observed at the Lakefront Nature Preserve, Cleveland, Ohio, for the period June 1–September 30, 2019 (based on 6-minute interval data obtained from the National Oceanic and Atmospheric Administration station CND01; [https://www.ndbc.noaa.gov/station\\_page.php?station=cnd01](https://www.ndbc.noaa.gov/station_page.php?station=cnd01)).

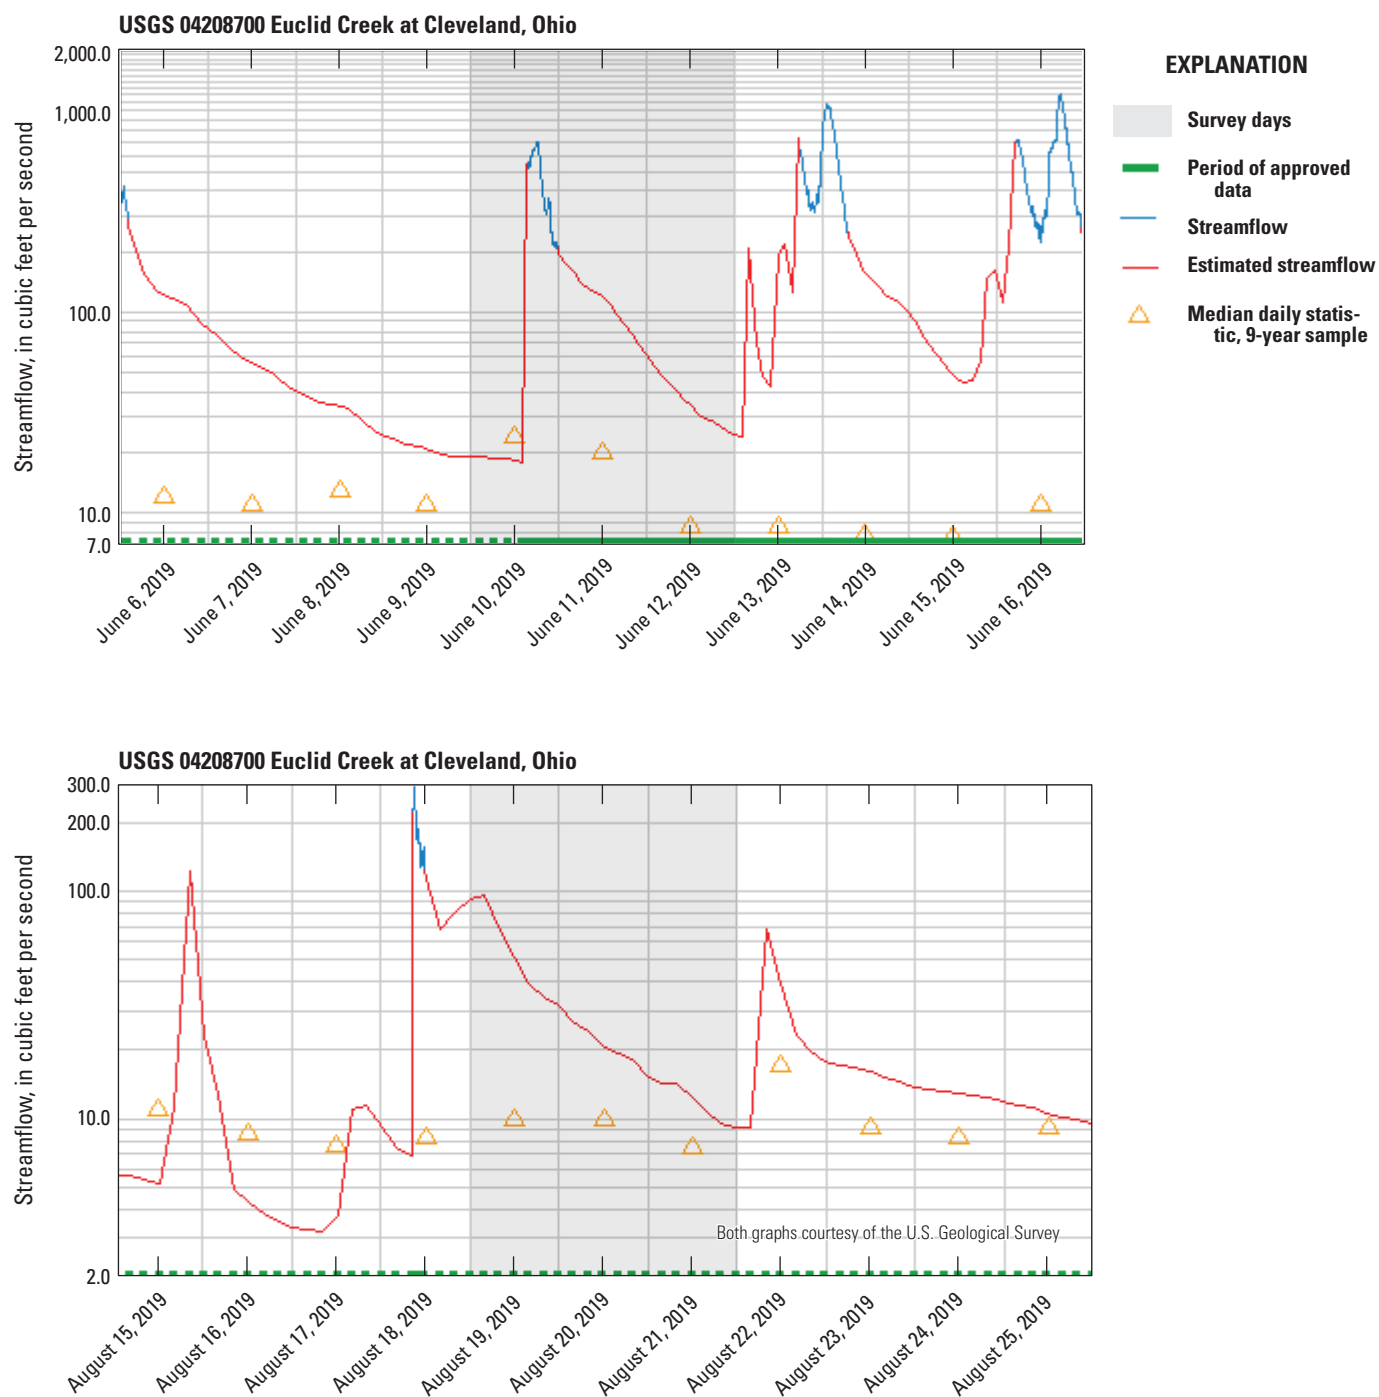
**Figure 9.** Hydrographs of streamflow for A, June 6–16, 2019 (an 11-day period centered on survey 1), and B, August 15–25, 2019 (an 11-day period centered on survey 2), recorded by the U.S. Geological Survey streamgage on Euclid Creek near Villa Angela Beach, Cleveland, Ohio (station number 04208700; U.S. Geological Survey, 2020).

Euclid Creek is a flashy stream, which means it responds quickly (a rapid increase in streamflow and return to normal) to precipitation events. In general, the runoff from a precipitation event may cause the streamflow in Euclid Creek to rapidly increase over several hours and decrease back to normal over a couple days; however, there is variation in these timeframes depending on the characteristics (such as intensity and duration) of each precipitation event. Euclid Creek ranged in flow from 18 to 700 cubic feet per second ( $\text{ft}^3/\text{s}$ ) at USGS streamgage 04208700 (U.S. Geological Survey, 2020) during these surveys. The first day of survey 1 (June 10, 2019) started at normal (base) flow conditions (about  $20 \text{ ft}^3/\text{s}$ ), but the precipitation event during the afternoon (1.14 inches of rain in 7 hours) caused a rapid increase in streamflow (over about 4 hours) to about  $700 \text{ ft}^3/\text{s}$  (fig. 9A). The surveys on June 11 (daily average flow of  $113 \text{ ft}^3/\text{s}$ ) and June 12 (daily average flow of  $36 \text{ ft}^3/\text{s}$ ) were on the receding limb of the hydrograph (as the streamflow was decreasing back to normal; U.S. Geological Survey, 2020). The August 2019 surveys were all on the receding limb of a much smaller hydrograph (fig. 9B). There was a precipitation event (0.62 inches total) the night before the first day of survey 2 (August 19, 2019) that caused the streamflow to increase from about  $7 \text{ ft}^3/\text{s}$  to  $300 \text{ ft}^3/\text{s}$ . The daily average flows on August 19–21, 2019, were  $56 \text{ ft}^3/\text{s}$ ,  $21 \text{ ft}^3/\text{s}$ , and  $12 \text{ ft}^3/\text{s}$ , respectively.

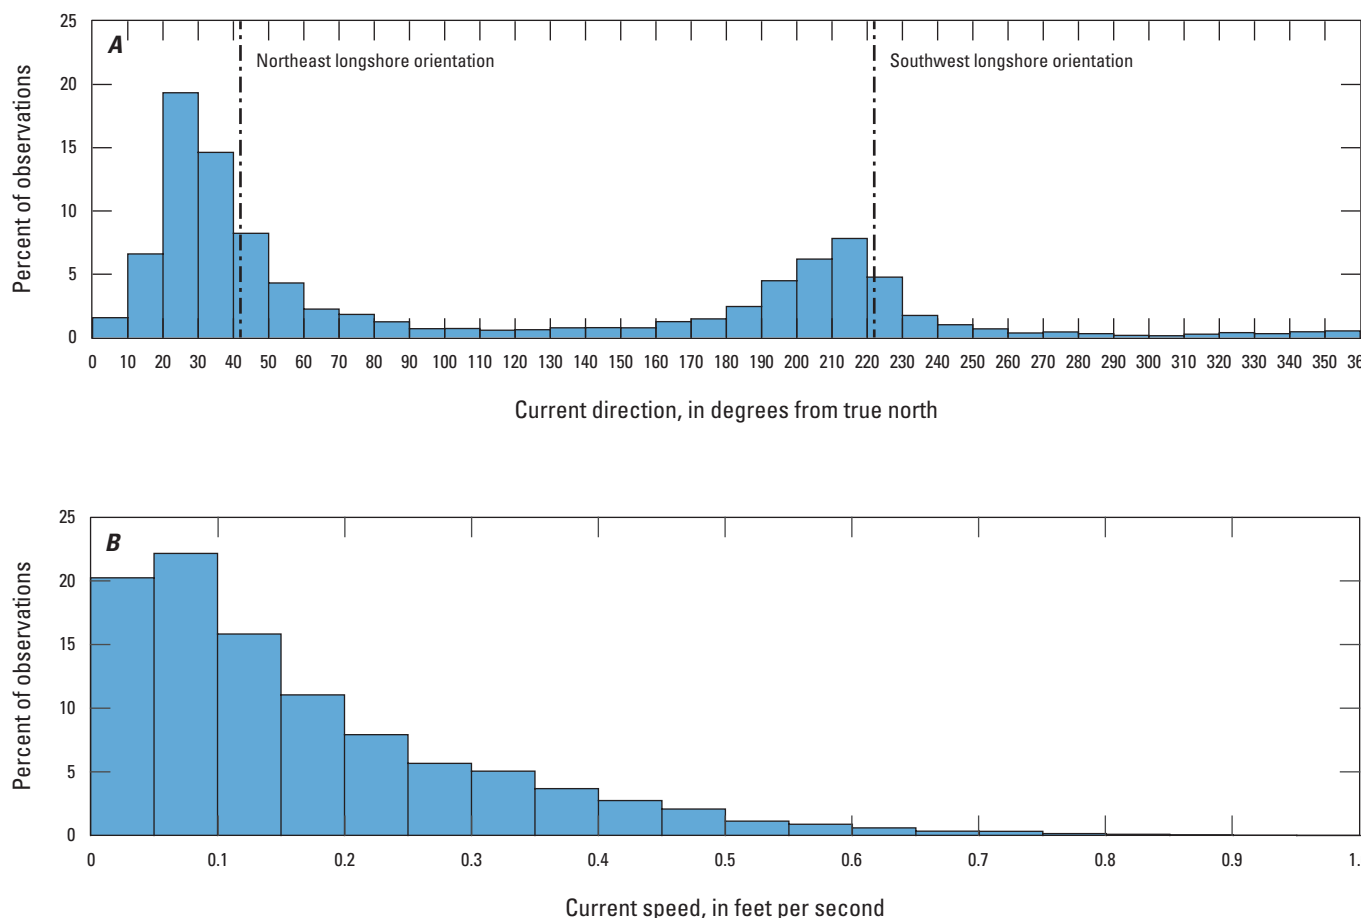
**Figure 10.** Characteristics of nearshore currents measured by the acoustic Doppler velocity meter (ADVM 1) mounted to the northwest side of the southwest caisson in front of the Wildwood Marina near Villa Angela Beach, Cleveland, Ohio. Currents were measured lakeside of the caisson from June 12 to August 28, 2019, at a height above bottom of approximately 8 feet.

Overall, by dividing these data into two groups based on the longshore current component, the data from ADVM 1 indicate that currents with a longshore component to the northeast occurred 64.6 percent of the time and currents with a longshore component to the southwest occurred 35.4 percent of the time (table 4). This is nearly the same percentage split as was observed in the summer 2012 data (69.5 percent northeast and 30.5 percent southwest; Jackson, 2013). The data from ADVM 2 indicate that currents with a longshore component to the northeast occurred 66.0 percent of the time, and currents with a longshore component to the southwest occurred 34.0 percent of the time (table 4).

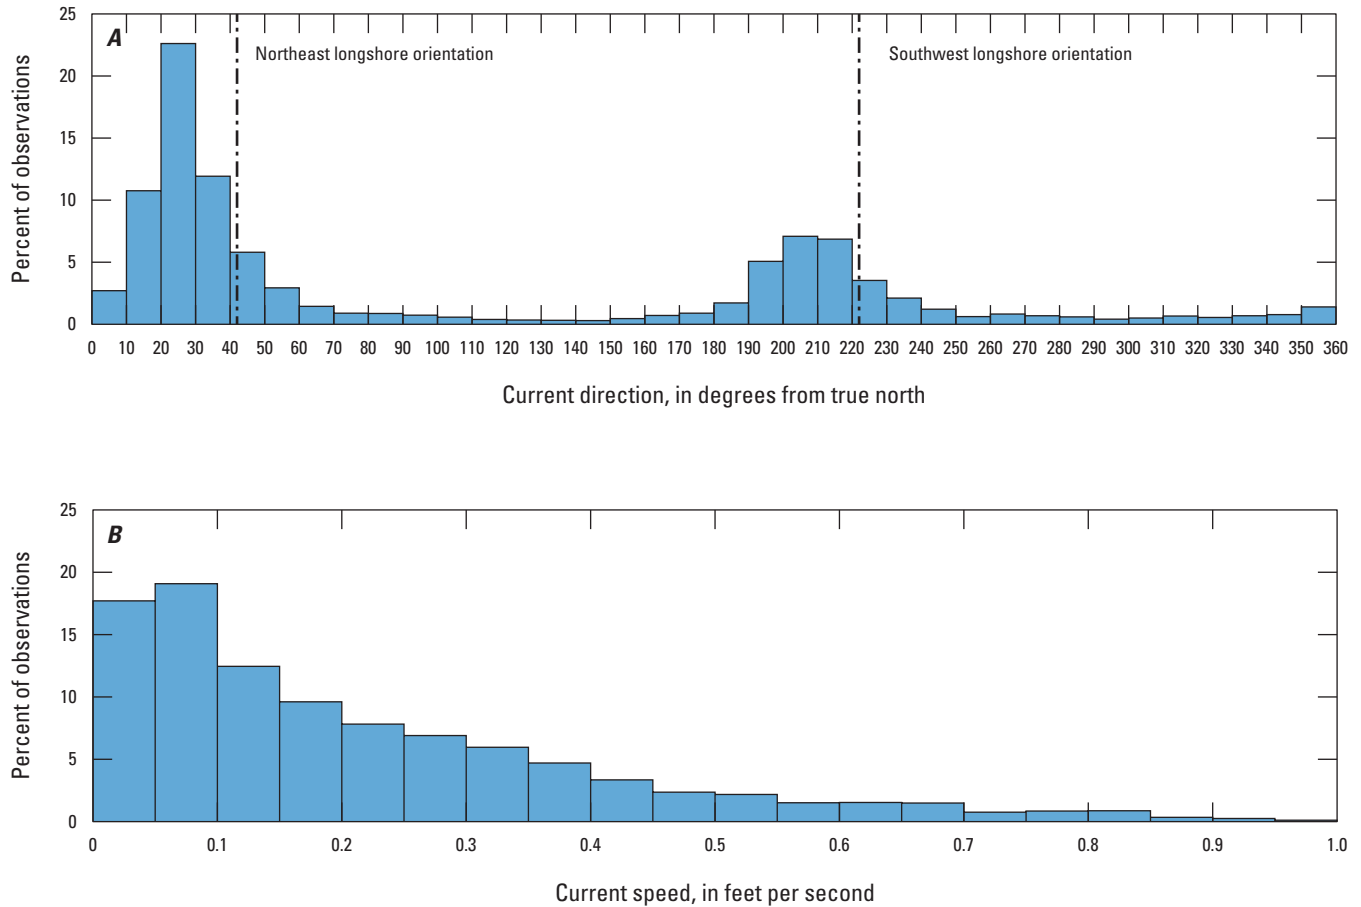
**Figure 11.** Characteristics of nearshore currents measured by the acoustic Doppler velocity meter (ADVM 2) mounted to the southeast side of the northeast caisson in front of the Wildwood Marina near Villa Angela Beach, Cleveland, Ohio. Currents were measured shoreside of the caisson from June 8 to July 23, 2019, at a height above bottom of approximately 8 feet.

Although the early summer months (June and July) indicate a similar trend in current direction (dominant in the northeast longshore current component direction for ADVM 1 and ADVM 2), a departure from this pattern was observed in August for ADVM 1 (table 6 and fig. 13A). In August, the longshore current component split became much more equal and was even slightly more dominant in the southwest direction (55.5 percent). The summer 2012 data indicated that longshore currents to the northeast occurred more often in early summer (June), and although the frequency decreased slightly throughout the summer, the longshore currents remained dominant in the northeast longshore current component direction from June through September (table 4 and fig. 7 in Jackson, 2013). Therefore, based on the data from ADVM 1, longshore currents in similar directions (to the southwest) to those associated with the observed recirculation patterns off Villa Angela Beach occurred much more often in August 2019 (55.5 percent of the time) than in June and July 2019 (27.0 and 22.7 percent of the time, respectively). Based on the two summers of data where there was a subanalysis by month (2012 and 2019), it seems likely that longshore currents in similar directions (to the southwest) to those associated with the observed recirculation patterns off Villa Angela Beach in the summer 2012 study (Jackson, 2013) occurred more often in the latter half of summer. However, because the overall dataset is small (only two summers), it is not known with great certainty whether the observed trends are characteristic of typical conditions. Additional data collection in more summer periods (June through September) would be beneficial.

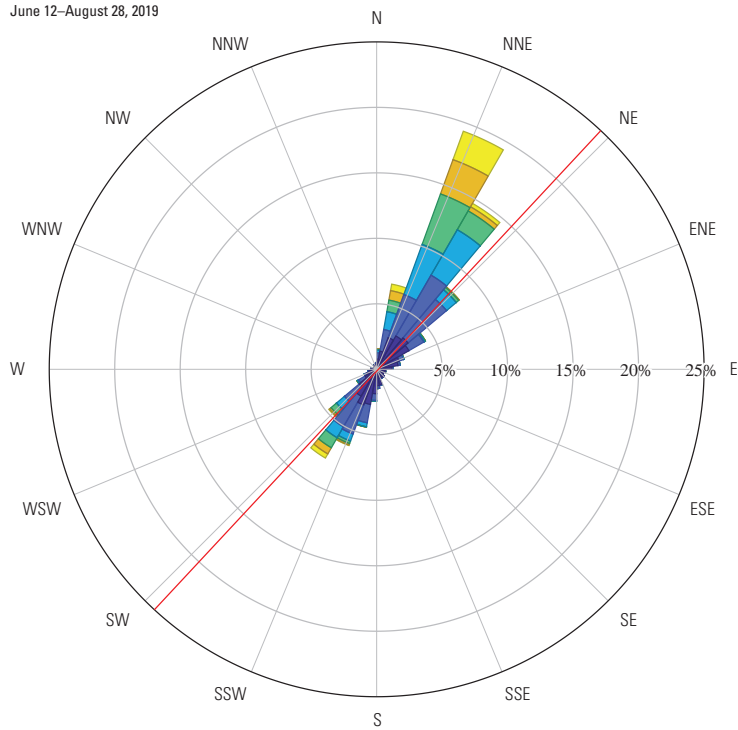
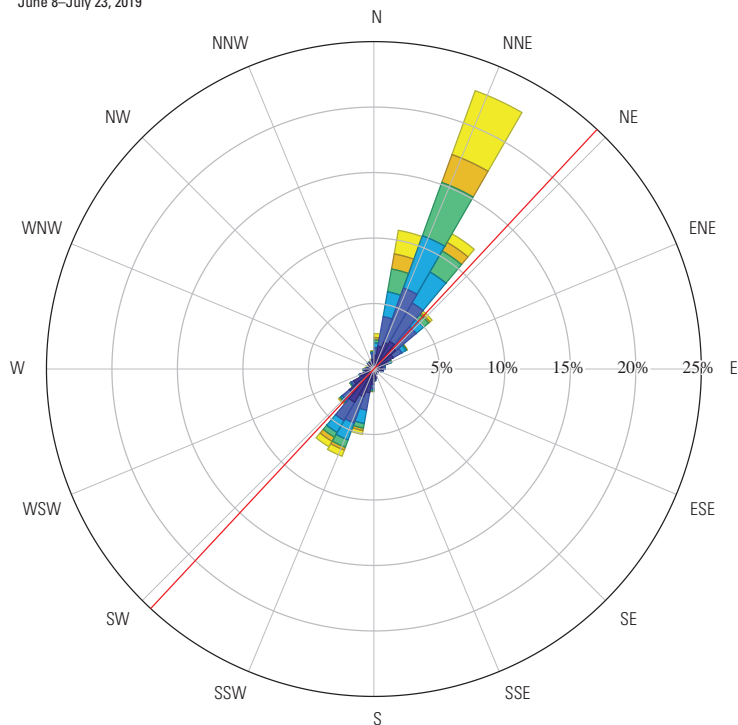
**Figure 12.** Current-rose diagrams of the current direction and current speed characteristics measured by *A*, the acoustic Doppler velocity meter (ADVM 1) mounted to the northwest side of the southwest caisson in front of the Wildwood Marina near Villa Angela Beach, Cleveland, Ohio, for the period June 12–August 28, 2019, and *B*, the acoustic Doppler velocity meter (ADVM 2) mounted to the southeast side of the northeast caisson in front of the Wildwood Marina near Villa Angela Beach, Cleveland, Ohio, for the period June 8–July 23, 2019.

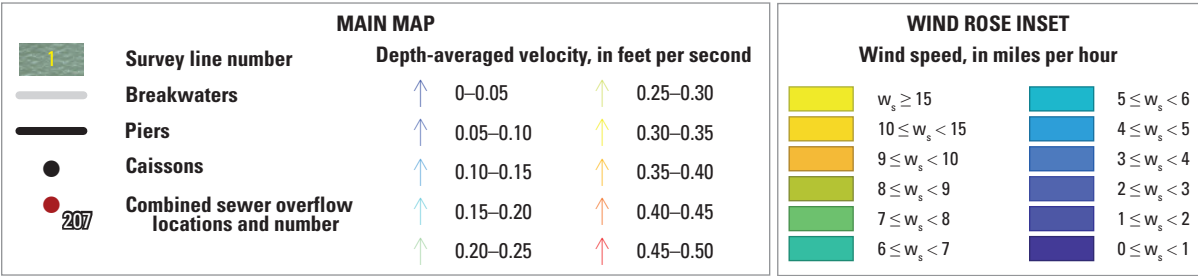
**Figure 16.** Depth-averaged currents in coastal Lake Erie in the vicinity of Villa Angela Beach and Euclid Creek, Cleveland, Ohio, afternoon of June 10, 2019.

survey, were shifting to the west as the weather system moved through (fig. 7). By the time the ADCP survey was repeated in the afternoon, the longshore currents were strongly to the northeast (fig. 16). Note that the afternoon survey started at line 18 and proceeded until line 13 and then moved to line 1 and ended at line 10. If viewed in that order, an upward trend in velocity magnitude can be observed (fig. 16). Because of time constraints and safety reasons (the waves were getting too large for the boat), some lines near the end of the survey were selectively skipped while still covering the full extent of the survey area around Villa Angela Beach, but nevertheless, the overall characteristics of the longshore currents are evident. It is not entirely obvious how an approximately 90-degree shift in the wind could cause the longshore currents to reverse direction or if the response of the longshore currents to the wind happens that quickly. Between the start of the survey (fig. 15) and the end of the survey (fig. 16), the longshore currents changed direction over a period of 5.5 hours. The mode 3 longitudinal seiche for Lake Erie has a period of

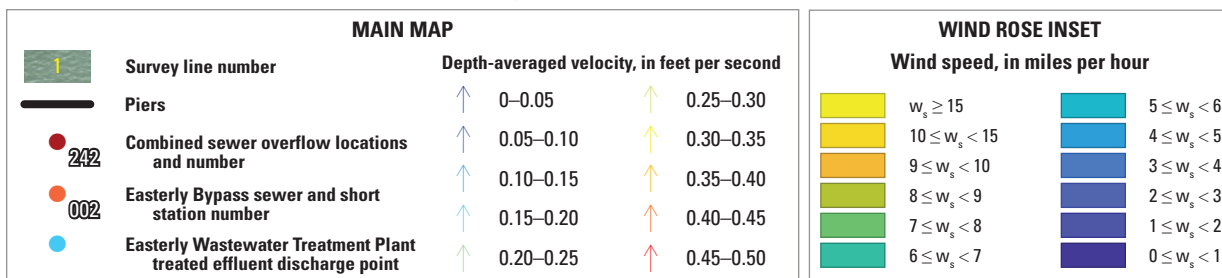
**Figure 17.** Depth-averaged currents in coastal Lake Erie in the vicinity of the Easterly Wastewater Treatment Plant, Cleveland, Ohio, June 11, 2019.

On June 11, 2019, longshore currents were to the northeast throughout the survey; however, they were stronger at the start of the survey in the morning than at the end of the survey in the afternoon (fig. 17). There are several notable observations. First, the highest velocities (red arrows) occurred in a small area near the Easterly WWTP treated effluent discharge point. Given that the seawall is flat, local flow disturbance is unlikely, so it would seem most probable that the high velocities were caused by the effluent discharge. It seems that the same discharge point was in operation (note the dark color protruding out into the lake) on the date the

aerial photograph was taken (aerial imagery date: April 26, 2017; not the same day as the survey). Second, the Easterly WWTP structure seems to shield the nearshore area to the northeast of the WWTP and creates a recirculation zone there. This setup—a strong longshore current creating a recirculation zone on the leeward side of a structure protruding from the shoreline—was also observed in the summer 2012 surveys (fig. 9 in Jackson, 2013). Because of how the study area was split into two separate areas (lines 1–18 near Villa Angela Beach and lines 23–45 near the Easterly WWTP) which were surveyed on different days, it is not clear if the recirculation zone observed on June 11 extends all the way to Villa Angela Beach, but it seems to be lessening toward the northeastern extent of the survey (line 23). Roughly fitting a line to the

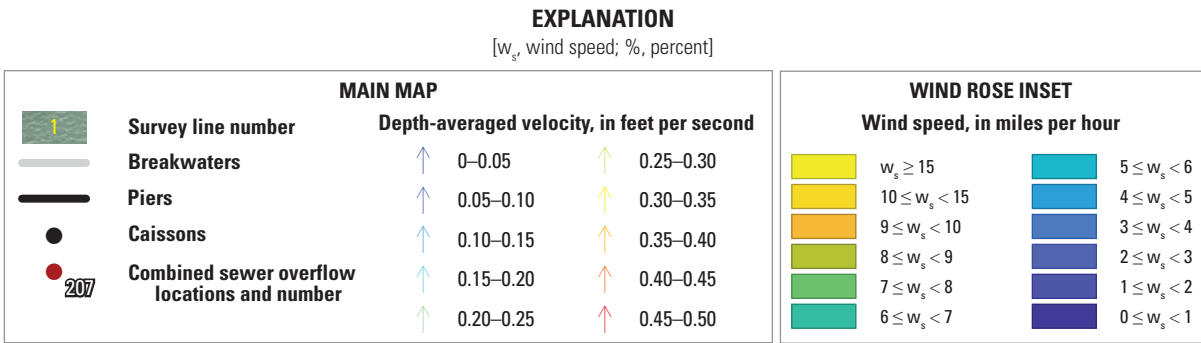
**Figure 18.** Depth-averaged currents in coastal Lake Erie in the vicinity of Villa Angela Beach and Euclid Creek, Cleveland, Ohio, morning of June 12, 2019.

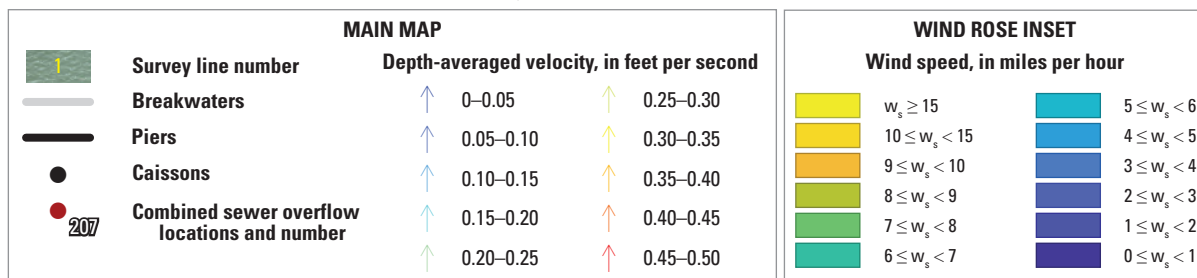
**Figure 19.** Depth-averaged currents in coastal Lake Erie in the vicinity of Villa Angela Beach and Euclid Creek, Cleveland, Ohio, afternoon of June 12, 2019.

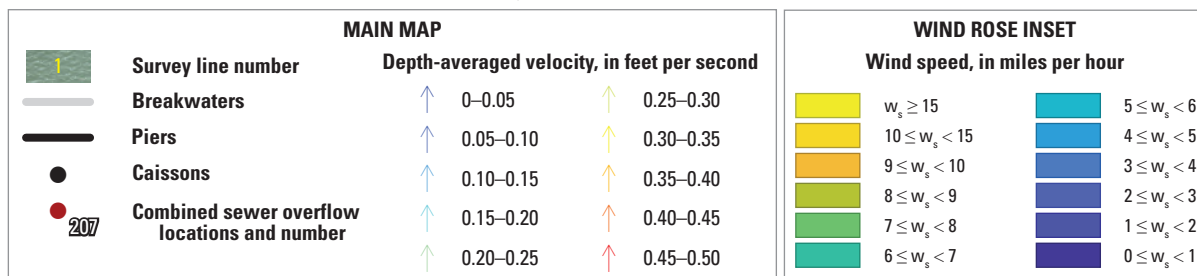
**Figure 21.** Depth-averaged currents in coastal Lake Erie in the vicinity of Villa Angela Beach and Euclid Creek, Cleveland, Ohio, afternoon of August 19, 2019.

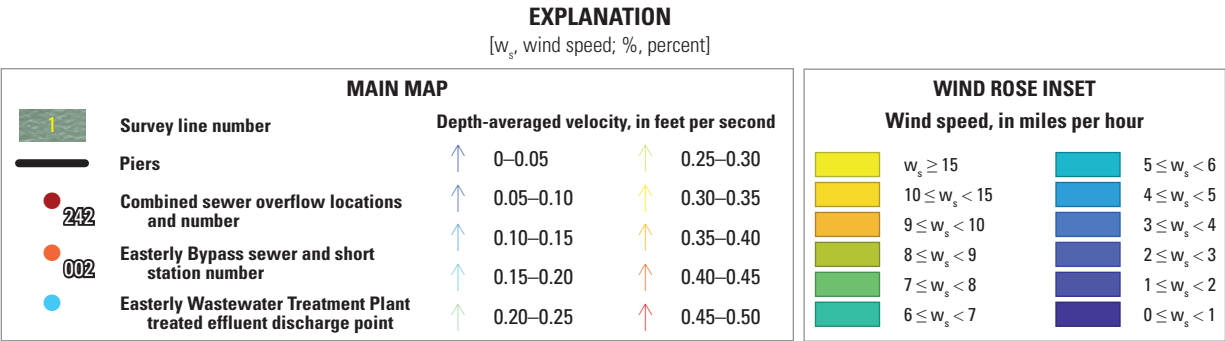
**Figure 26.** Depth-averaged currents in coastal Lake Erie in the vicinity of the Easterly Wastewater Treatment Plant, Cleveland, Ohio, afternoon of August 21, 2019.

and marina may also be important. In the time remaining on August 21, three lines were measured near the Easterly WWTP (fig. 26) to determine whether the longshore currents were the same there as they were near Villa Angela Beach that morning. It was observed that the longshore currents also were to the northeast but somewhat weaker than they had been during the morning surveys.

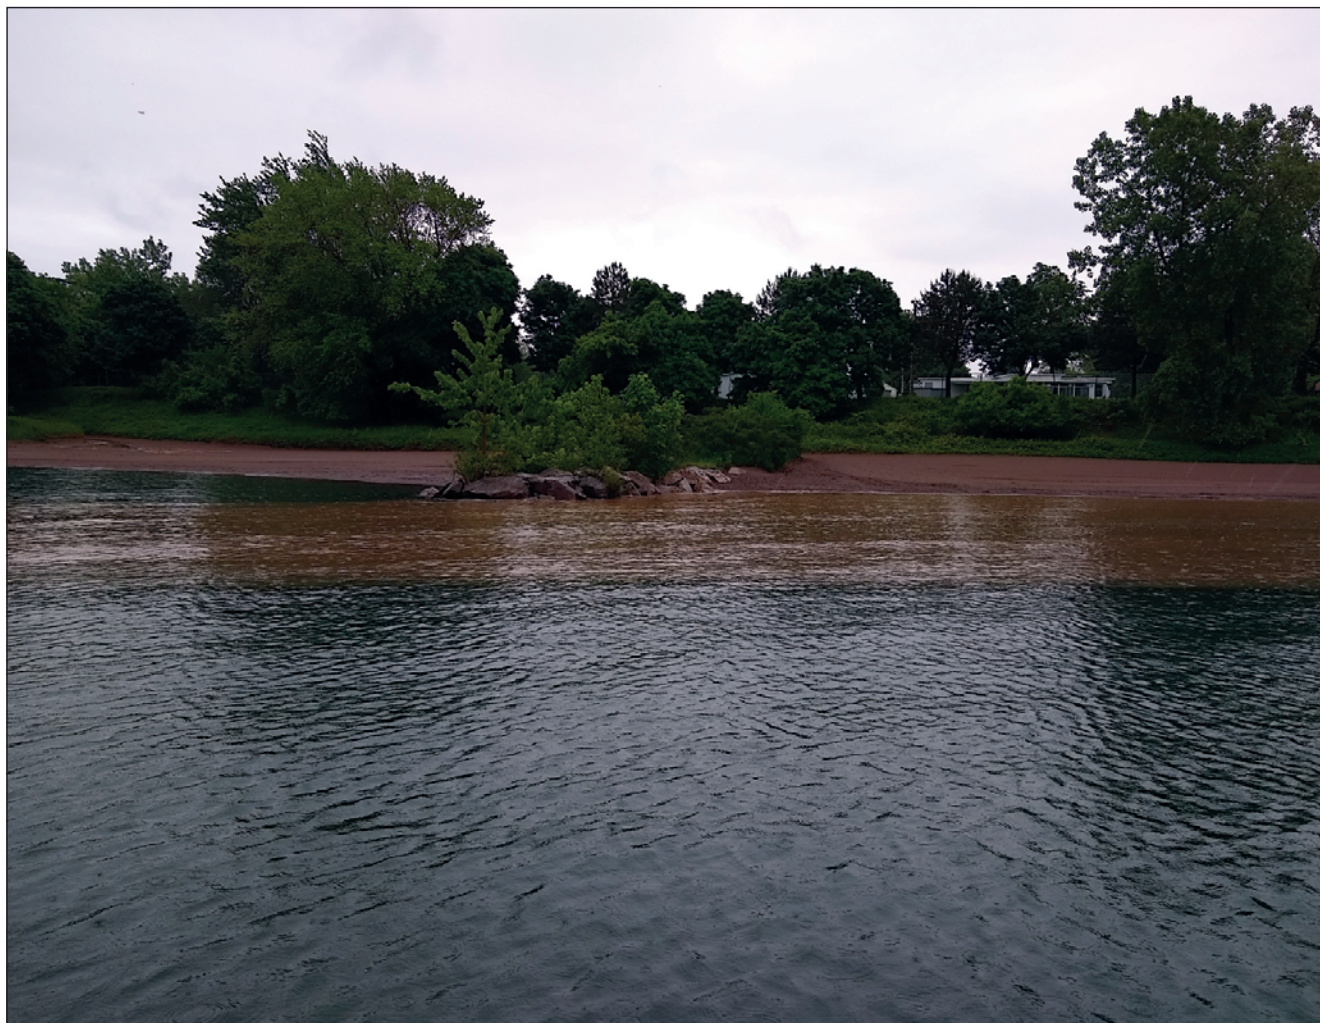
**Figure 1-1.** Discolored water inside the breakwaters along Villa Angela Beach on June 10, 2019, at 13:48 Eastern Daylight Time. Photograph by Justin Boldt, U.S. Geological Survey.

Villa Angela Beach inside the breakwaters near line 9 (purple color in [fig. 27](#)). This was also visually observed during the survey as a discoloration in the water (brownish-looking water; see [figs. 1-1](#) and [1-2](#) in appendix 1). The location of the anomaly is near a persistent anomaly observed in the 2011 USGS survey which noted a cold, dense, low pH, low dissolved oxygen anomaly between the second western-most breakwater and the beach (Jackson, 2013), but there was no anomaly in specific conductance. No anomaly was detected in the same location in the 2012 survey. This was the only day of the summer 2019 surveys that the anomaly was detected.

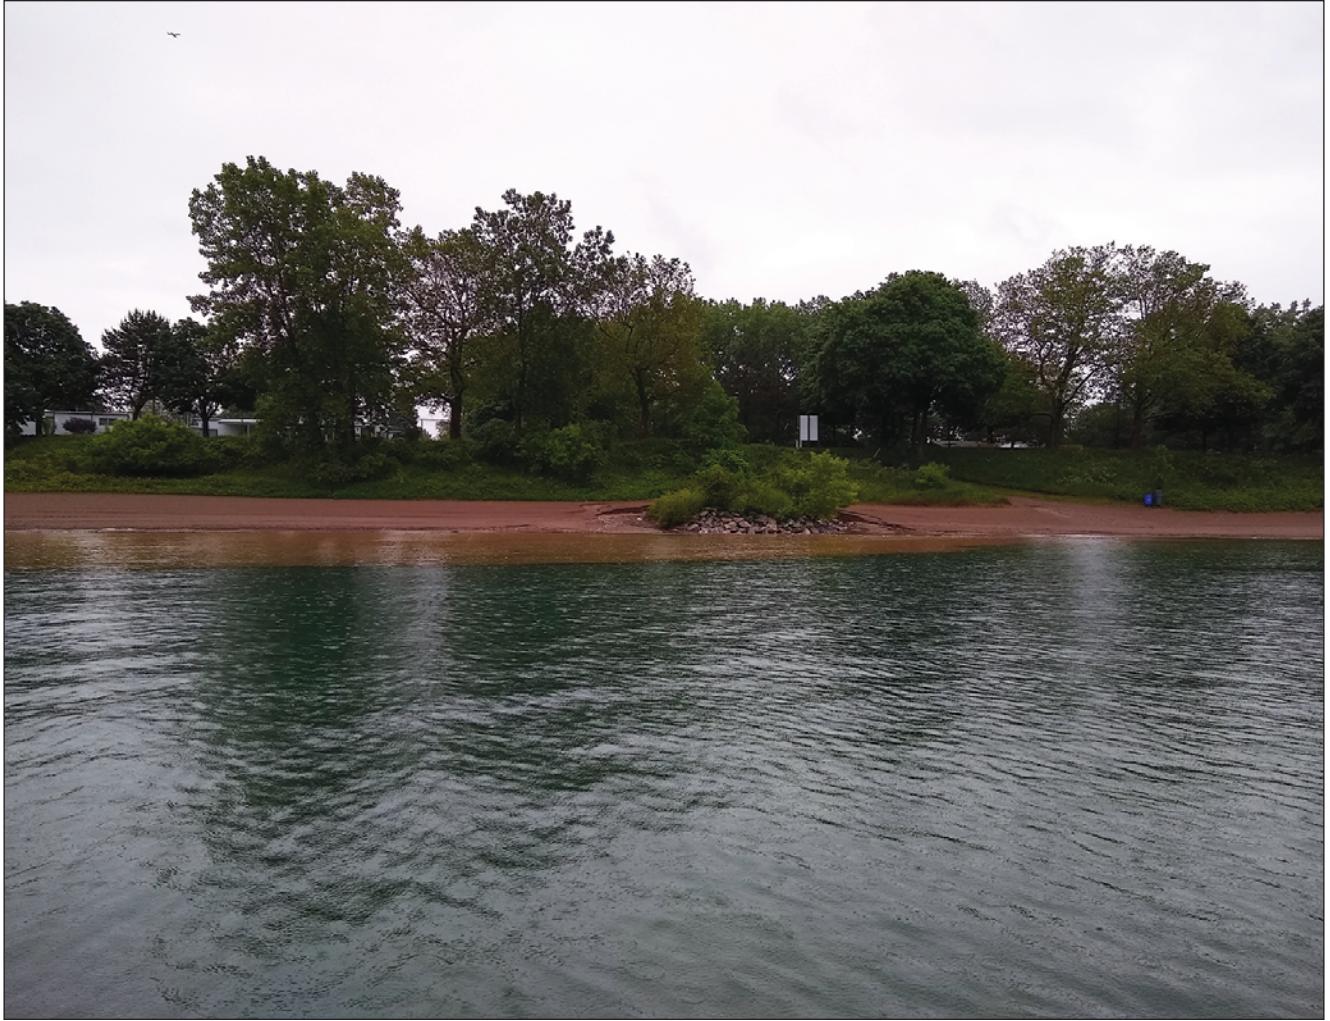
**Figure 1-2.** Discolored water inside the breakwaters along Villa Angela Beach on June 10, 2019, at 13:48 Eastern Daylight Time. Photograph by Justin Boldt, U.S. Geological Survey.

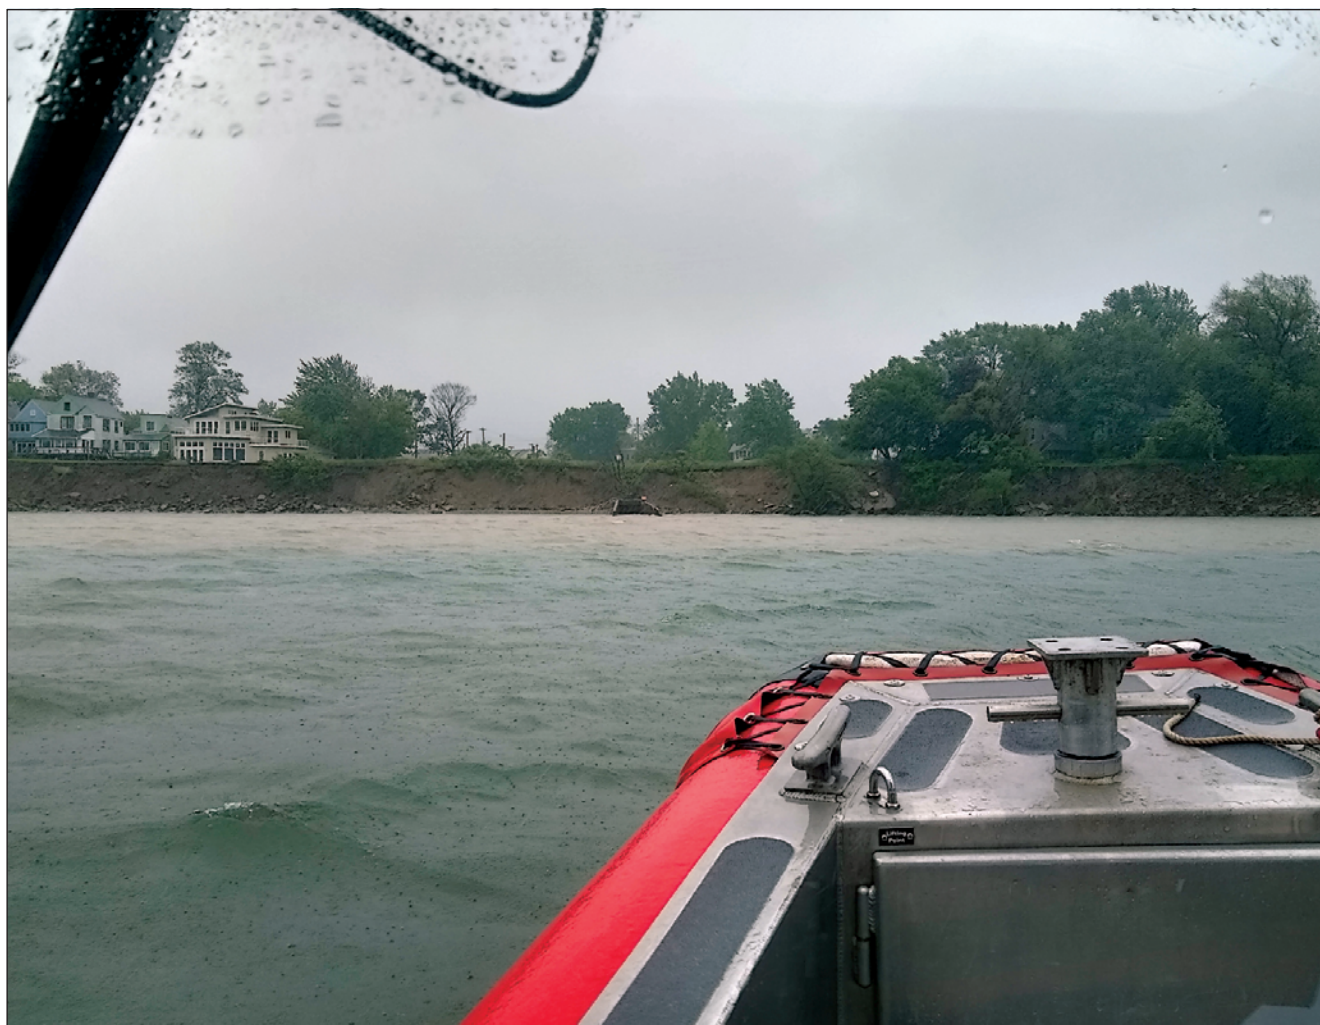
**Figure 1-3.** Discolored water around combined sewer overflow location 207 on June 10, 2019, at 15:01 Eastern Daylight Time. Photograph by Justin Boldt, U.S. Geological Survey.
