Prepared in cooperation with the Northeast Ohio Regional Sewer District

# Circulation, Mixing, and Transport in Nearshore Lake Erie in the Vicinity of Villa Angela Beach and Euclid Creek, Cleveland, Ohio, June 10–12, 2019, and August 19–21, 2019

Scientific Investigations Report 2021–5122

By Justin A. Boldt and P. Ryan Jackson

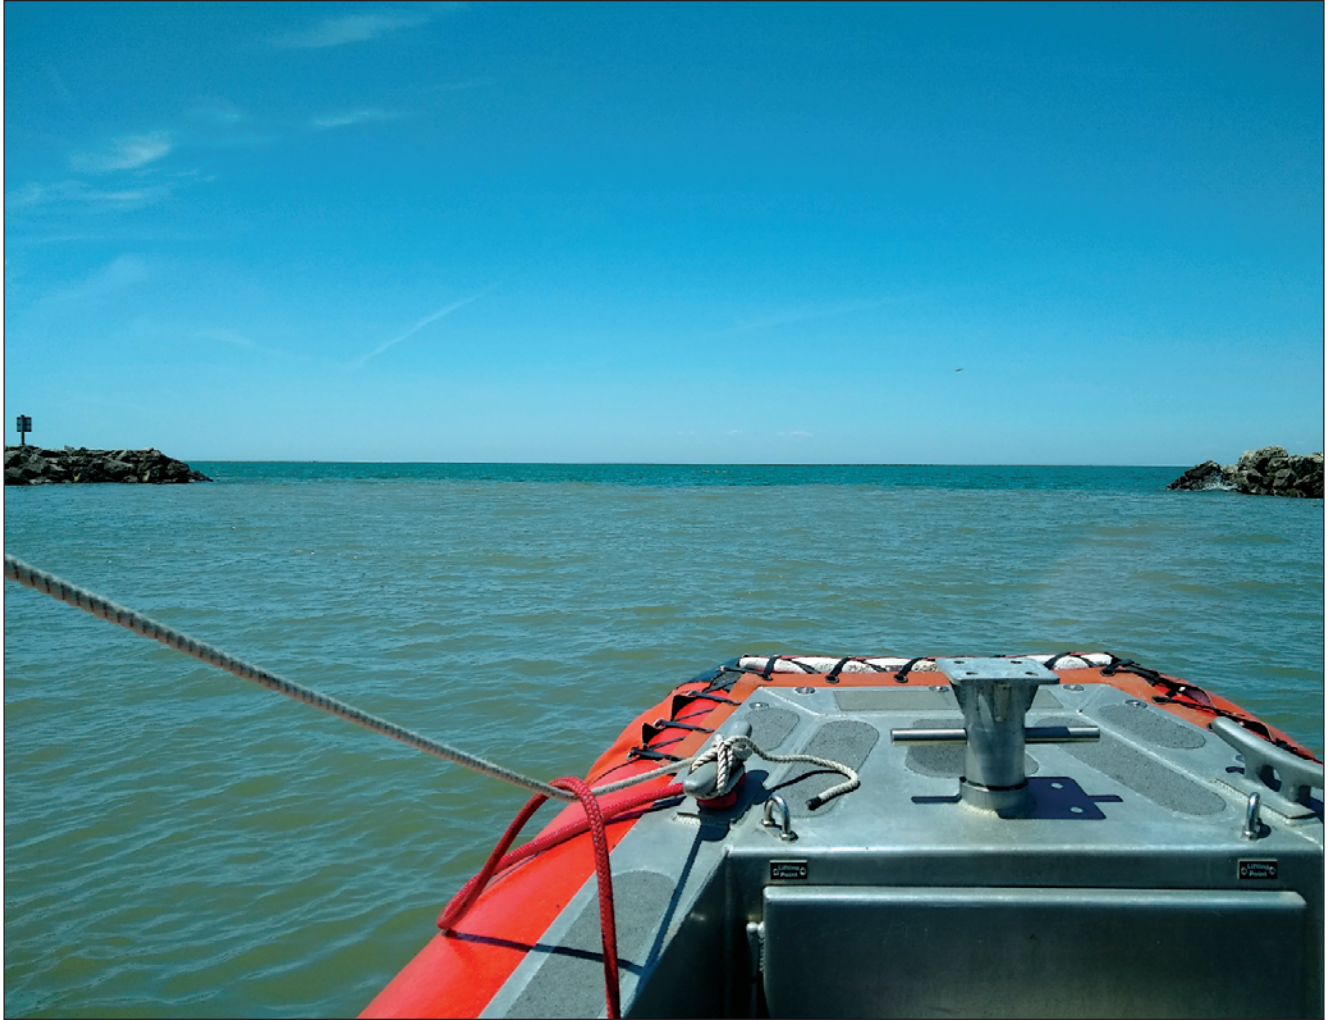
**Figure 1-4.** Discolored water inside the lagoon at the Easterly Wastewater Treatment Plant on June 11, 2019, at 14:07 Eastern Daylight Time. Photograph by Justin Boldt, U.S. Geological Survey.

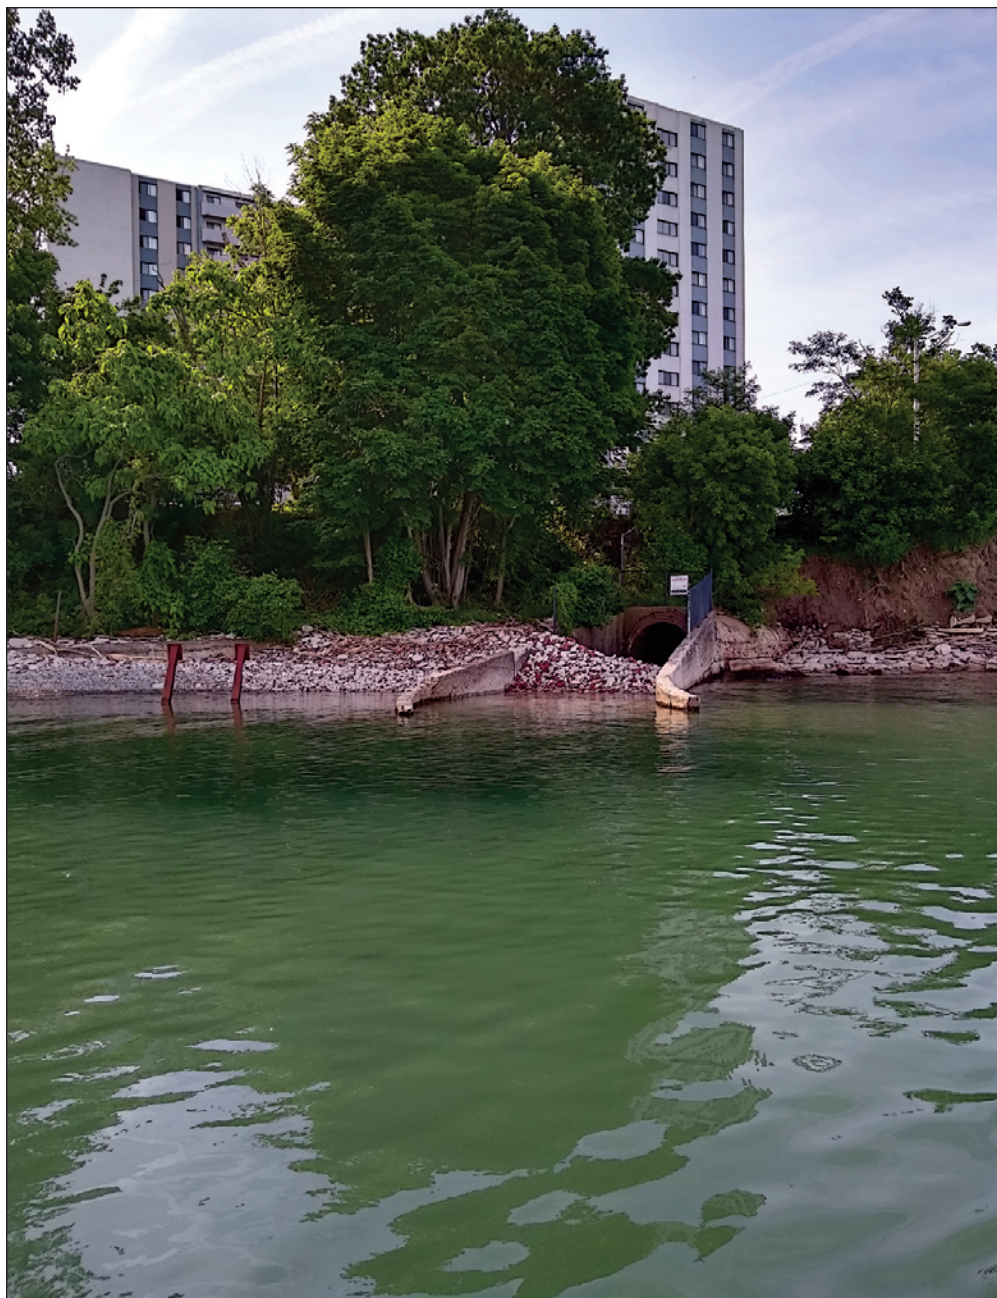
**Figure 1-5.** Discolored water around combined sewer overflow location 206 on June 12, 2019, at 09:46 Eastern Daylight Time. Photograph by Justin Boldt, U.S. Geological Survey.

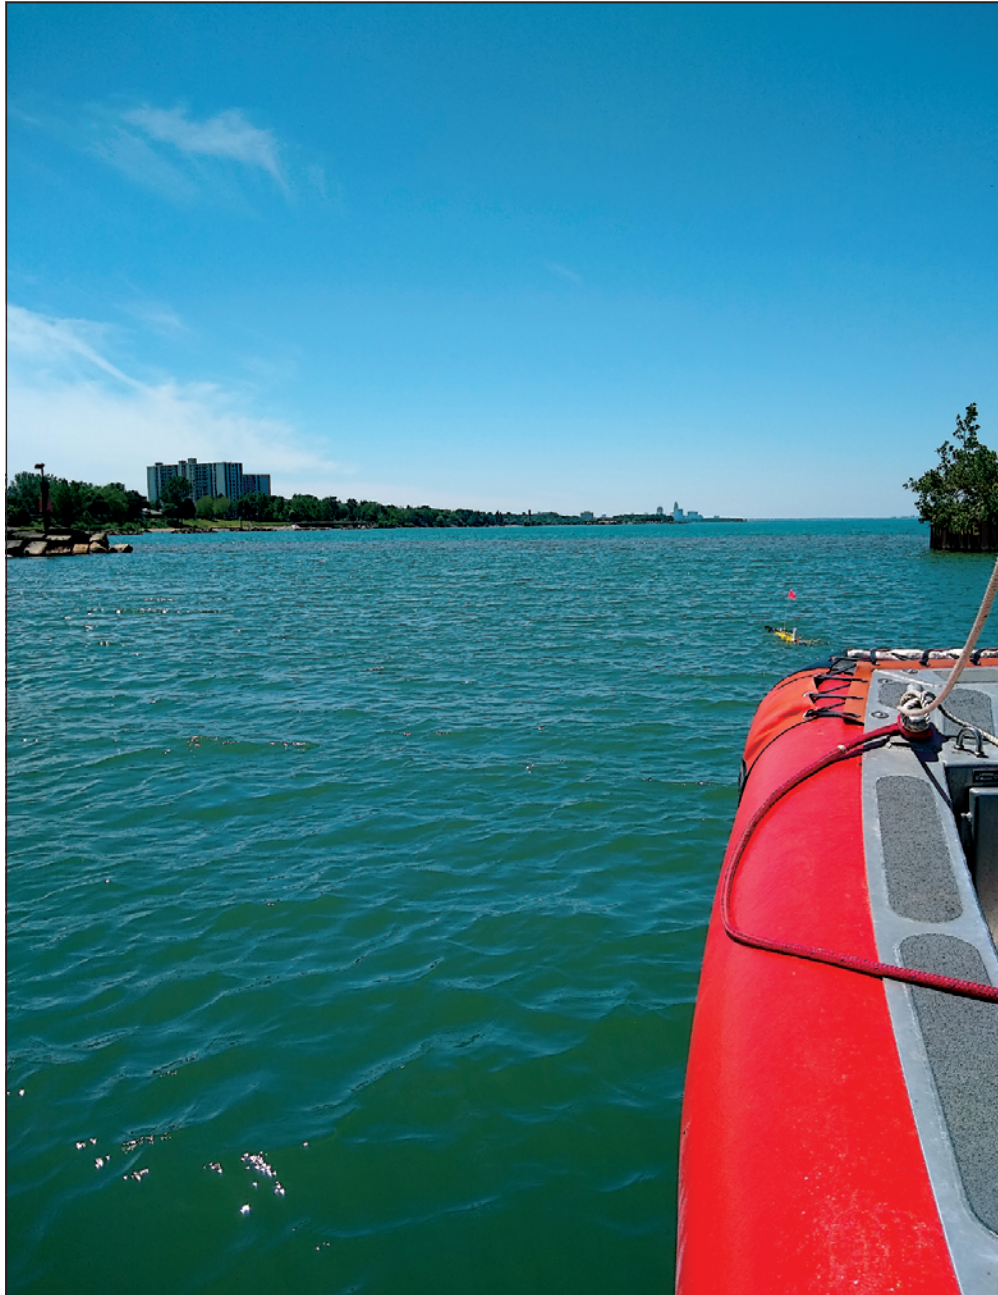
**Figure 1-6.** Discolored water near the mouth of Euclid Creek on June 12, 2019, at 12:48 Eastern Daylight Time. Photograph by Justin Boldt, U.S. Geological Survey.

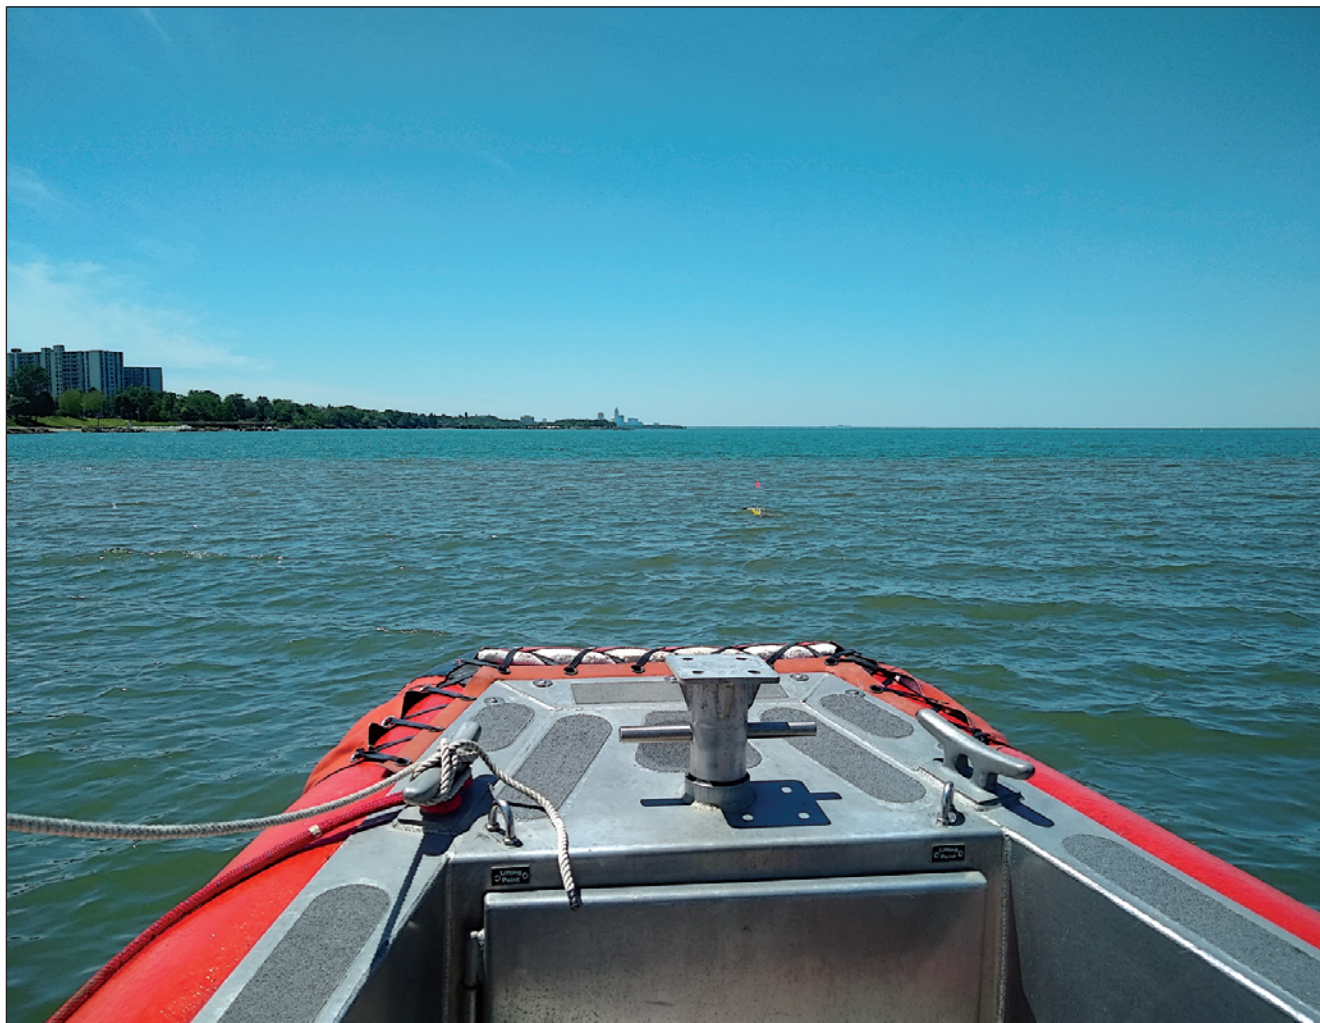
**Figure 1-7.** Discolored water near the mouth of Euclid Creek on June 12, 2019, at 12:49 Eastern Daylight Time. Photograph by Justin Boldt, U.S. Geological Survey.

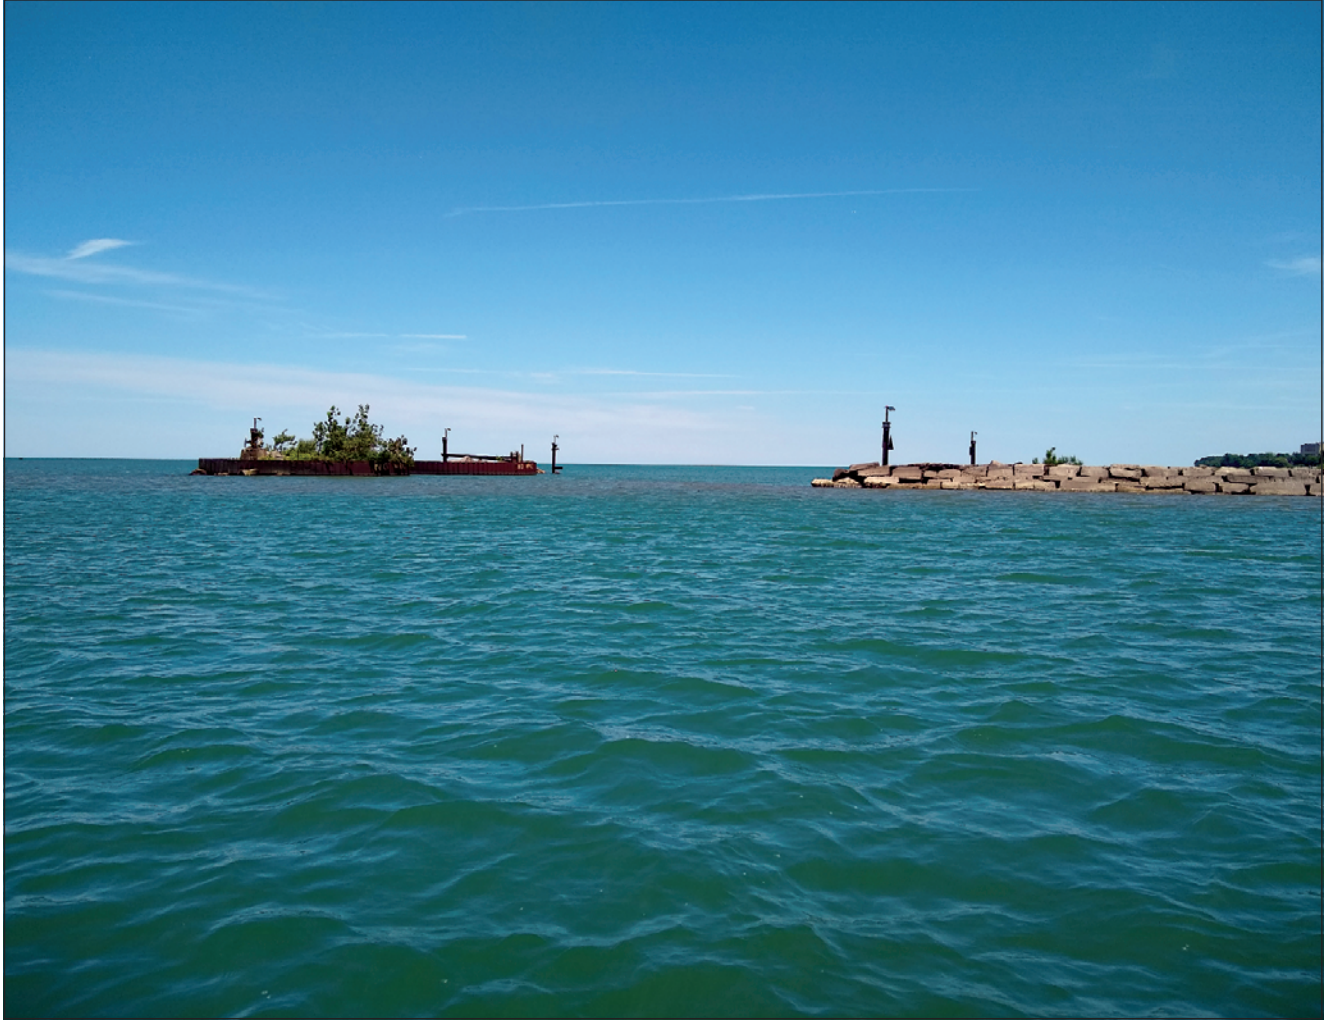
**Figure 1-8.** Discolored water near the mouth of Euclid Creek on June 12, 2019, at 13:07 Eastern Daylight Time. Photograph by Justin Boldt, U.S. Geological Survey.
