# Implementing a Rapid Deployment Bridge Scour Monitoring System in Colorado, 2019

Scientific Investigations Report 2022–5023

By Mark F. Henneberg and Rodney J. Richards

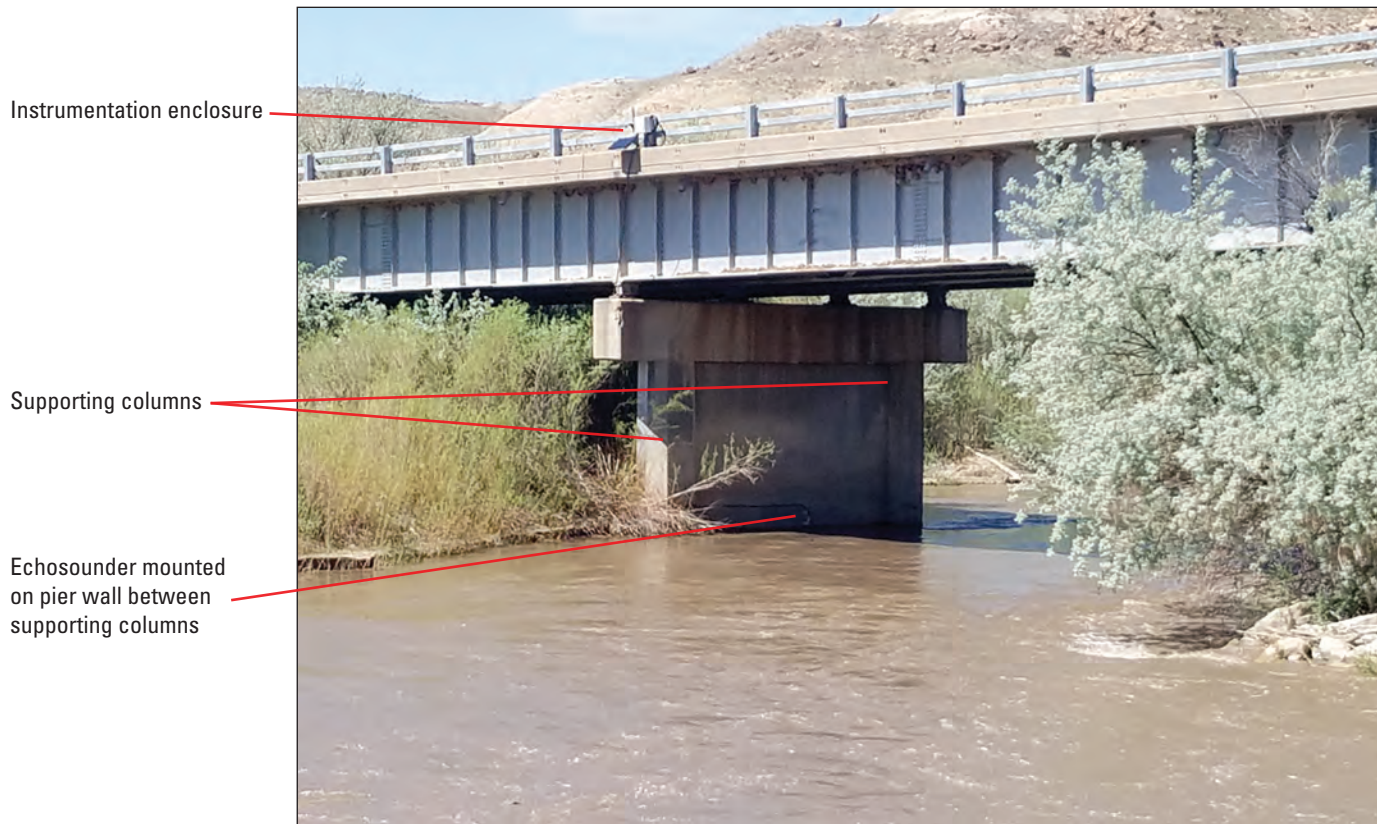
**Figure 8.** Photograph of the depth sensor, mounting plate, and instrumentation enclosure at Colorado Department of Transportation bridge P-01-G.

Installation was completed during low flow using prefabricated enclosures and mounts, which minimized onsite fabrication and installation times. The mounting plate, depth sensor mount, and depth sensor were installed on the right side of the

pier wall, approximately 20 ft downstream from the nose. This pier is constructed of two main columns supported by a pile cap, founded on driven piles, with a concrete wall between the columns (CDOT, 2015b). The depth sensor was mounted at an elevation of 4,613.89 ft, as determined by optical levels and RTK-GNSS methods following the procedures described in Kenney (2010) and Rydlund and Densmore (2012). The mounted elevation keeps the depth sensor out of water until

streamflows reach approximately 3,500 ft<sup>3</sup>/s to reduce fouling and debris accumulation during low-flow conditions. The depth sensor was oriented vertically so that the acoustic footprint would measure the streambed elevation under the pier wall between the two supporting columns. Sounding with a wading rod indicated this was the deepest location around the pier and was likely the most susceptible to scour based on the angle of attack (fig. 8). The depth sensor cabling was run up the pier wall, to the instrument enclosure mounted on the bridge guide rail. Installation of all on-pier hardware required use of a boat-mounted work platform to access the pier. Installation of the instrumentation and enclosure on the guide rail took approximately 3 hours with two personnel (fig. 8).
