U.S. Geological Survey Response to Hurricane Maria Flooding in Puerto Rico and Characterization of Peak Streamflows Observed September 20–22, 2017

By Julieta Gómez-Fragoso, Mark Smith, and Marilyn Santiago

Scientific Investigations Report 2022–5040
Version 1.1 (July 2022)

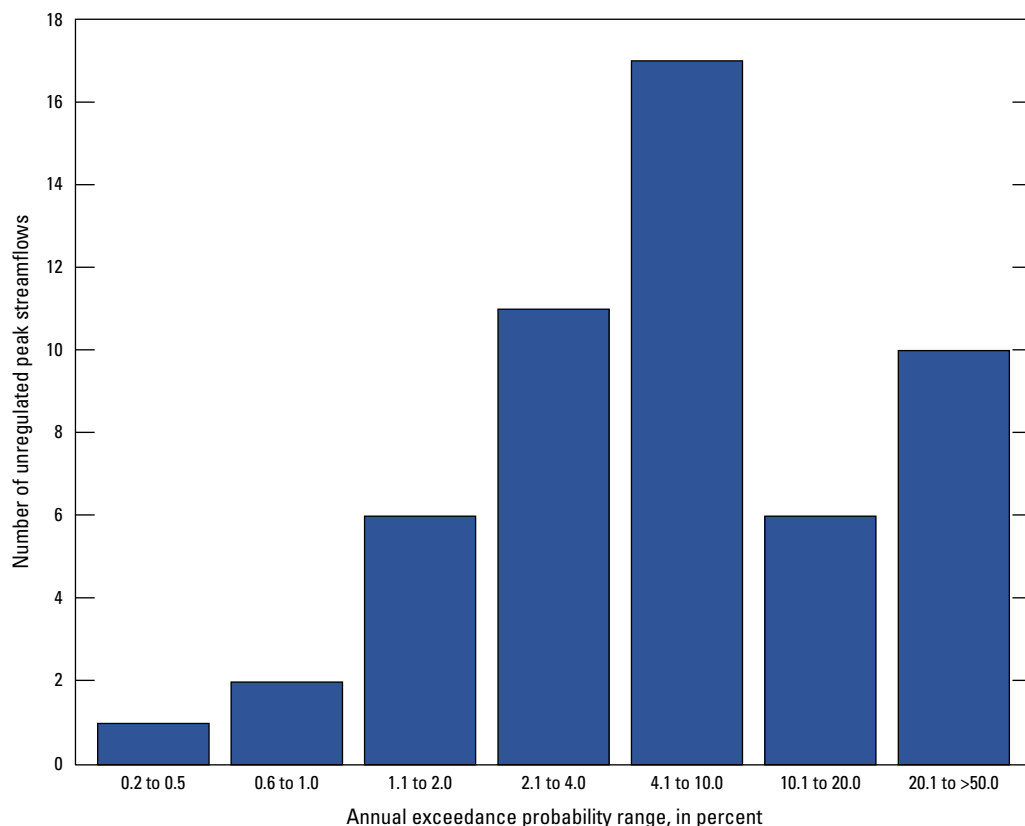
Figure 9. Number of unregulated peak streamflows in Puerto Rico within indicated annual exceedance probability ranges, flooding of September 20–22, 2017.

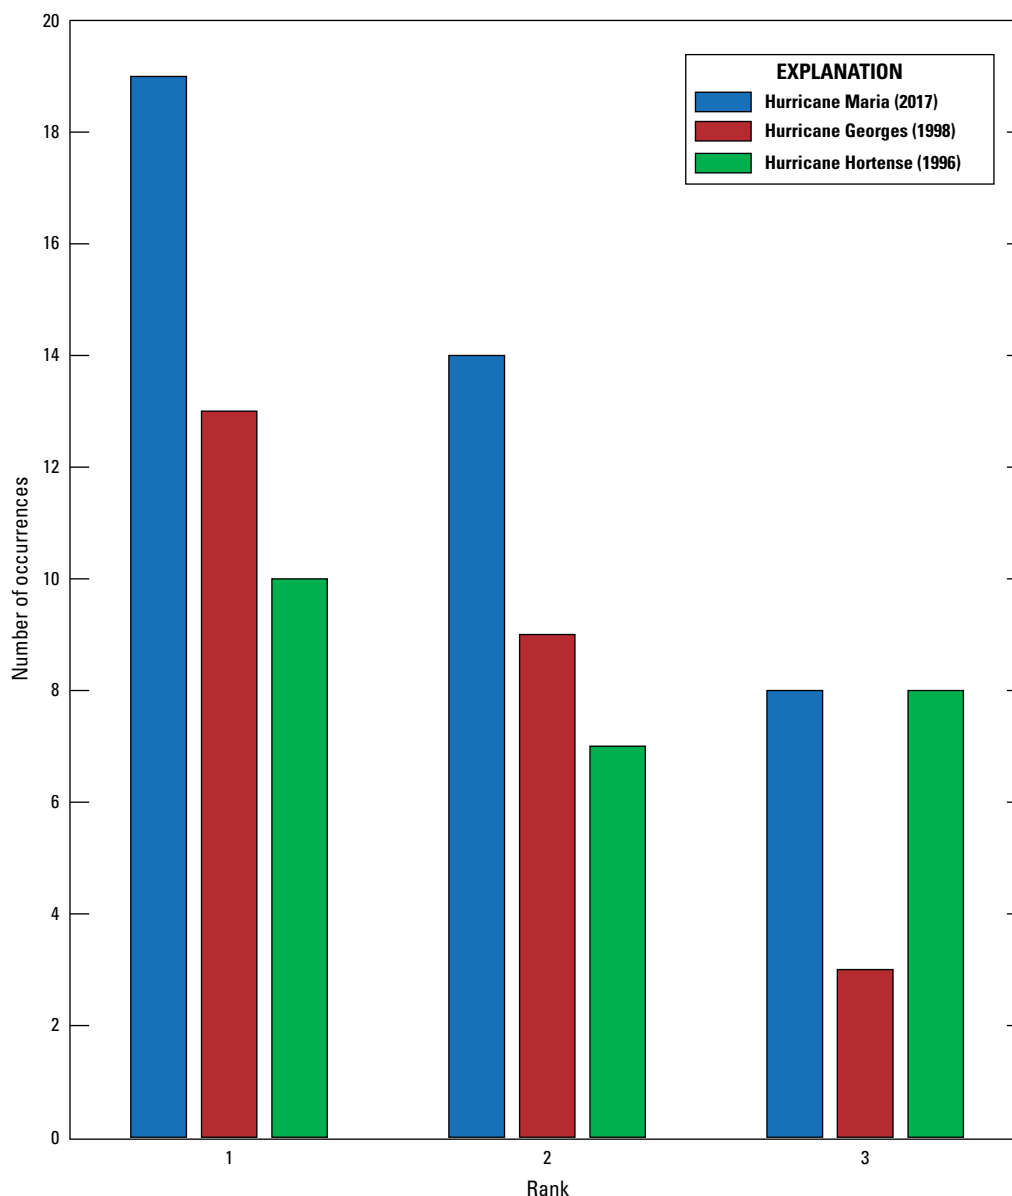
Figure 10. Comparison by rank of the three largest historical flood events in Puerto Rico, based on historical U.S. Geological Survey peak streamflow data from sites with a period of record of at least 20 years.

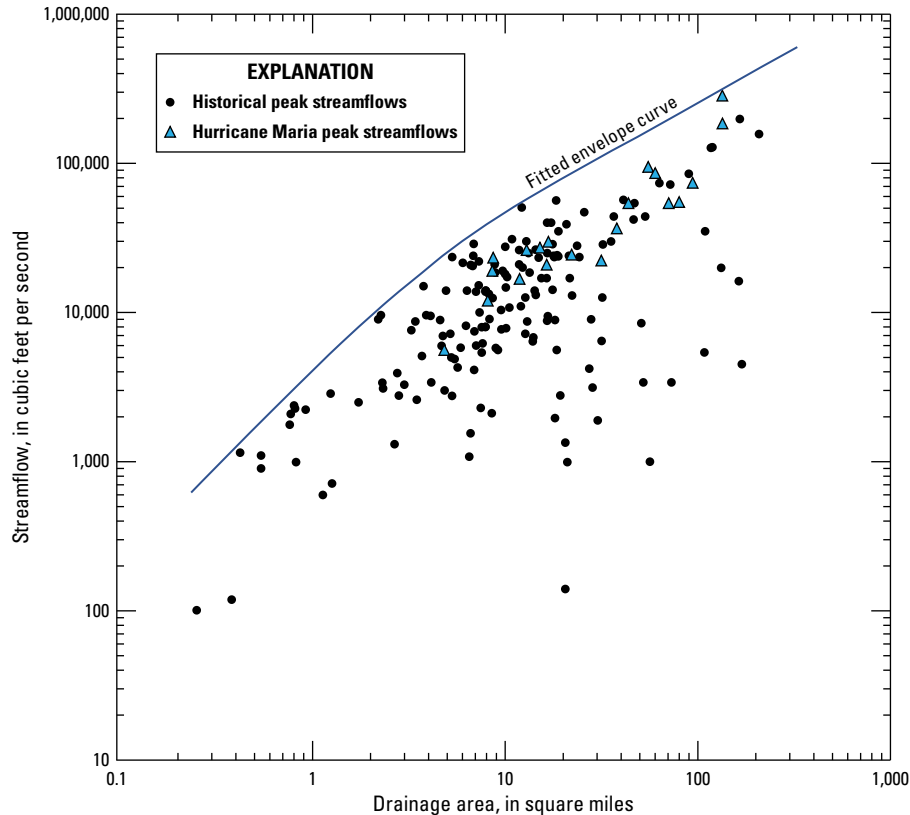
Figure 11. Drainage area versus peak streamflow for the largest period-of-record peak streamflows for 181 unregulated sites in Puerto Rico having one or more years of published peak streamflows. The fitted envelope curve defines the approximate upper limit of peak streamflows as a function of drainage area.

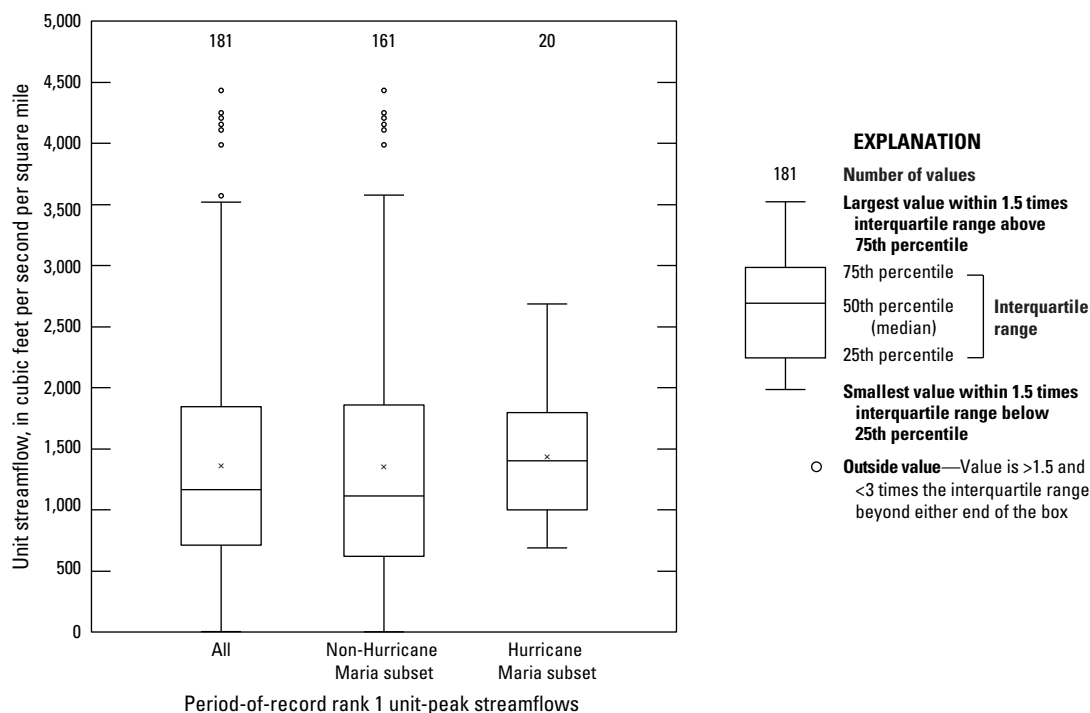
Figure 12. Boxplots showing distributions for all period-of-record rank 1 unit-peak streamflows, non-Hurricane Maria period-of-record rank 1 unit-peak streamflows, and Hurricane Maria period-of-record rank 1 unit-peak streamflows in Puerto Rico.

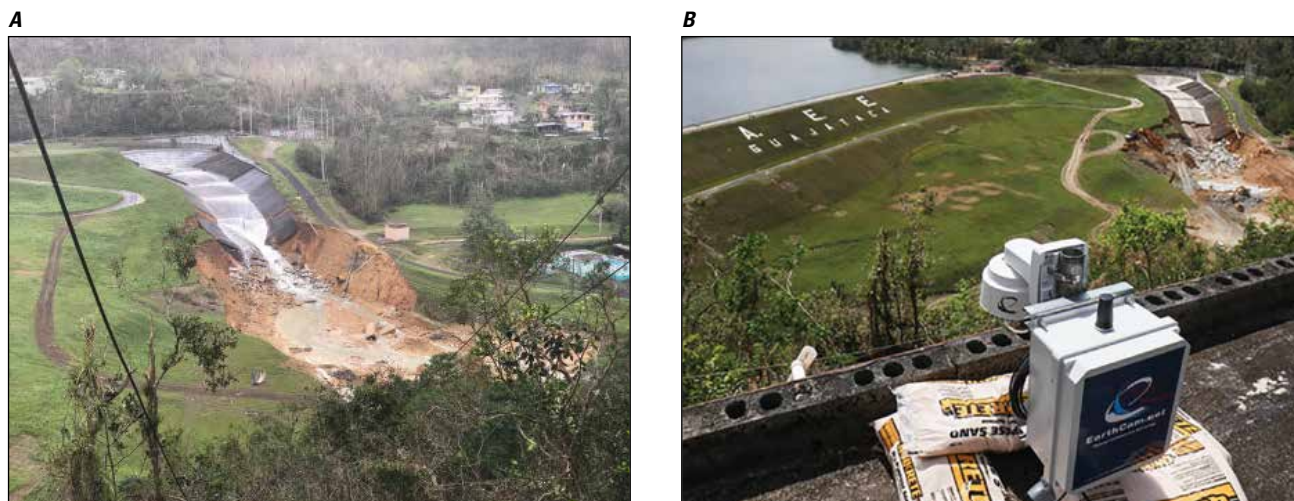
Figure 13. Photographs showing, A, the area affected by the flood of September 20, 2017 (photograph date, October 4, 2017) and, B, the high-resolution camera installed on a neighbor's rooftop near Lago Guajataca Dam for monitoring the extent of the erosion (photograph date, October 18, 2017). Photographs by John Parks, U.S. Geological Survey.

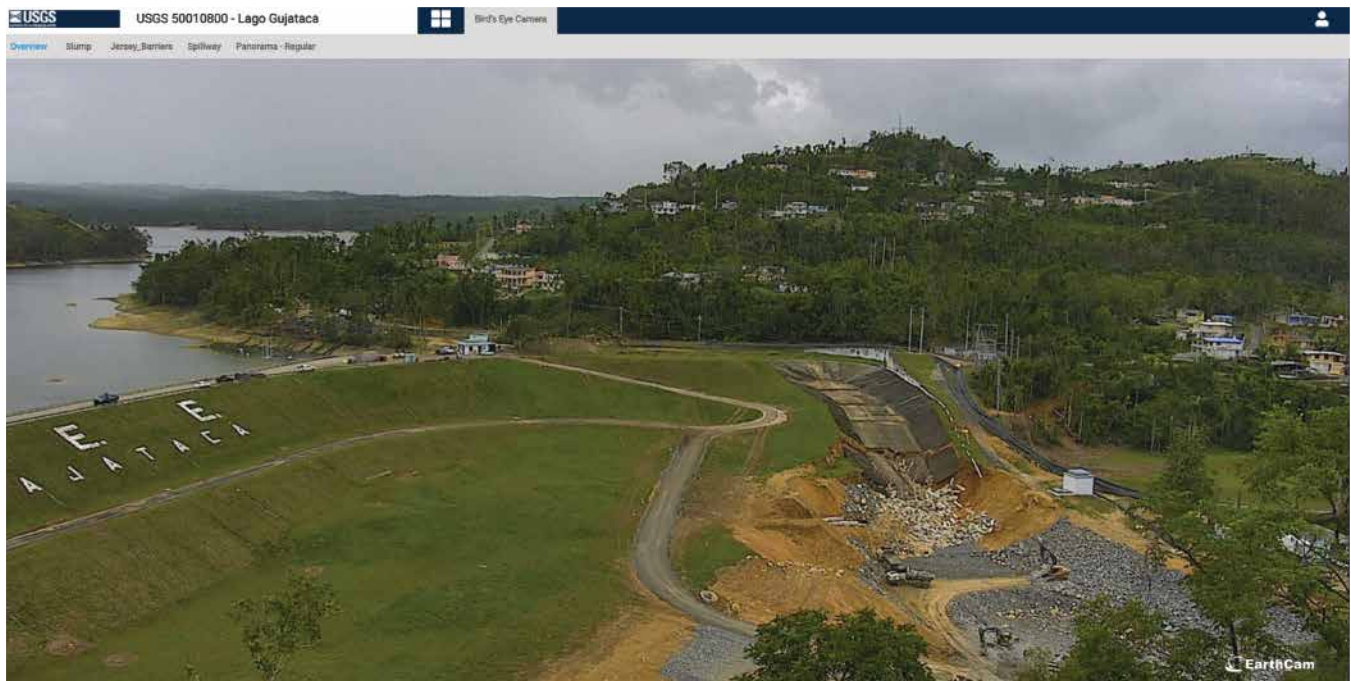
Figure 14. Screenshot of the National Water Information System web interface (NWISWeb, U.S. Geological Survey [USGS], 2021a) showing an image captured with the high-resolution camera installed for monitoring the extent of erosion occurring at the spillway of Lago Guajataca Dam. Image by John Parks, U.S. Geological Survey.

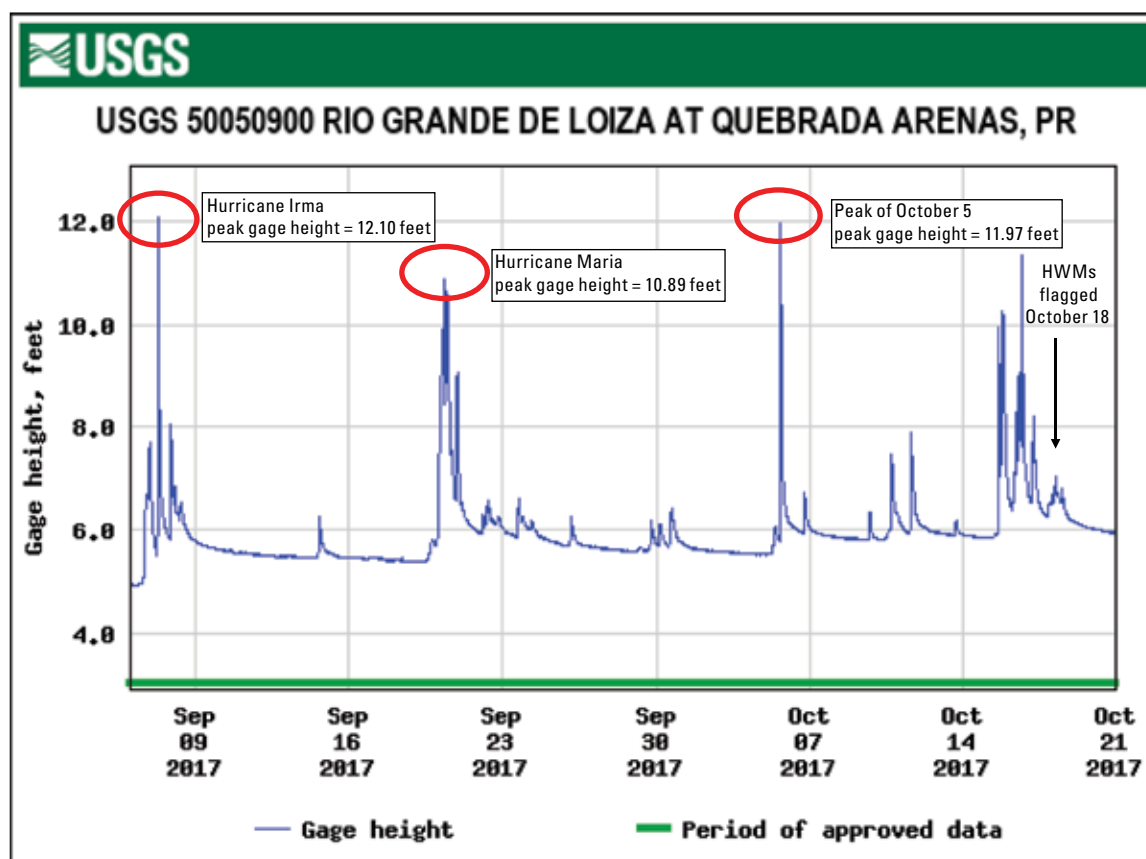
Figure 2.1. Gage-height record and event peaks for station 50050900 Río Grande de Loíza at Quebrada Arenas, Puerto Rico from September 6, 2017, to October 20, 2017. HWM, high water mark.

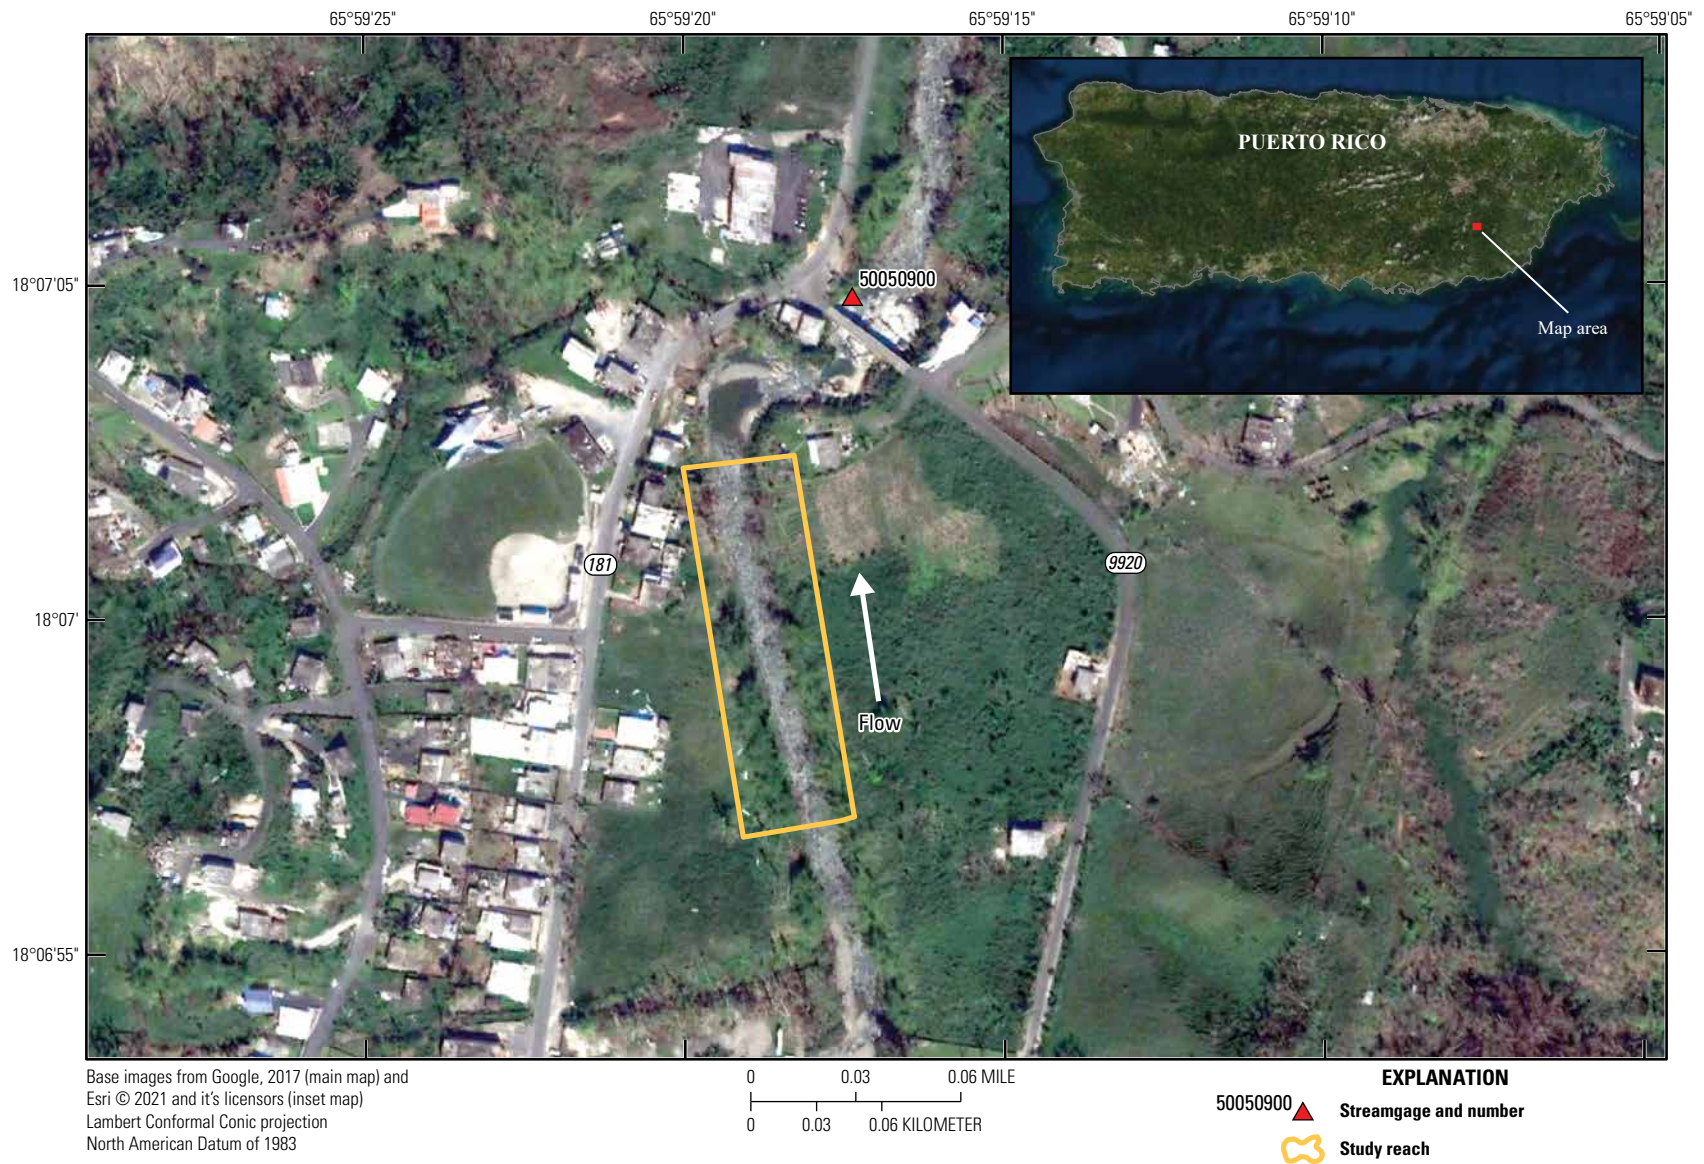
Figure 2.2. Location of study reach for slope-area measurement at station 50050900 Río Grande de Loíza at Quebrada Arenas.

USGS personnel determined that 19 HWMs recovered October 18, 2017, characterized the peak streamflow of October 5, 2017. Because of continued heavy rains, observed HWMs were sparse and generally poor in quality. (Figure 2.1 shows the series of smaller floods that occurred between October 6 and 18.) USGS personnel returned in November 2017 to survey HWMs flagged in October, select and survey channel cross sections, and collect additional data needed for slope-area indirect measurement. The team surveyed five cross sections in a 500-ft reach upstream from the gage (installed on the bridge at Route PR-9920, intersecting with Route PR-181, fig. 2.2). Figures 2.2 and 2.3 show the measurement reach location and channel conditions at the time of the field survey.

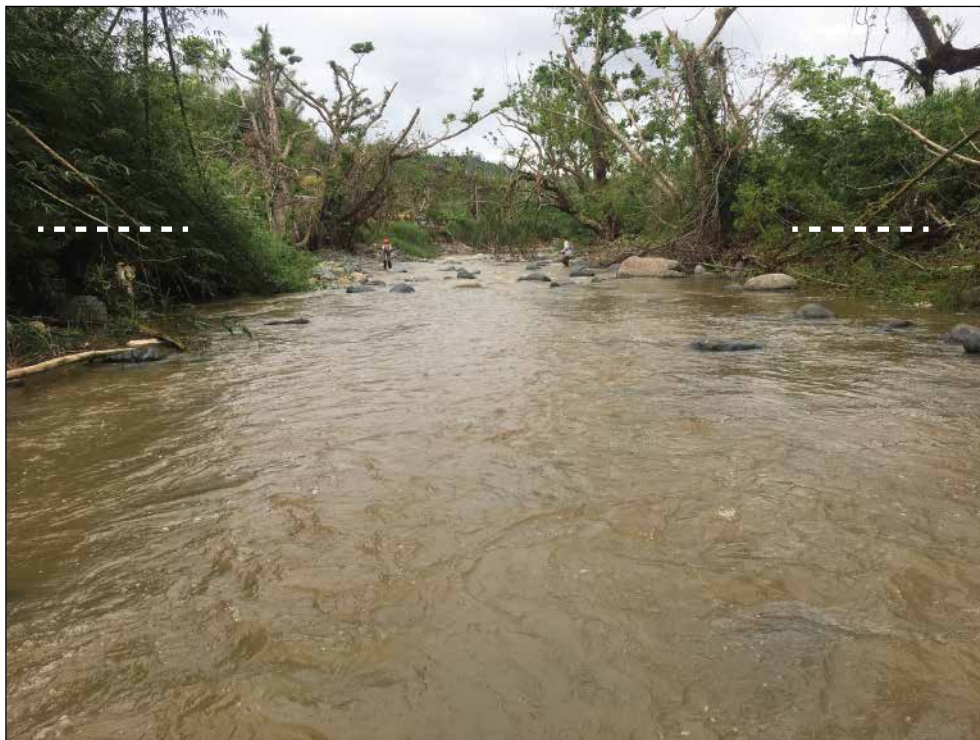
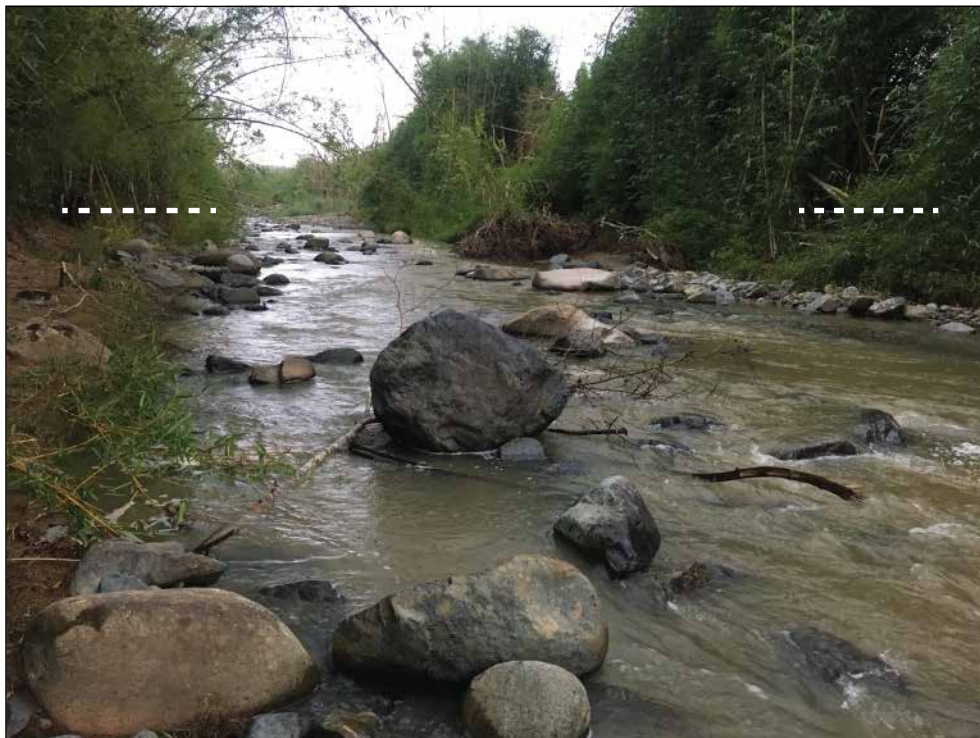
Figure 2.3. Conditions along study reach for station 50050900 Río Grande de Loíza at Quebrada Arenas, November 7, 2017. *A*, View downstream from upper end of reach; *B*, view upstream from lower middle of reach. White dashed lines denote approximate level of observed high-water marks. Photographs by Michael Kohn, U.S. Geological Survey.

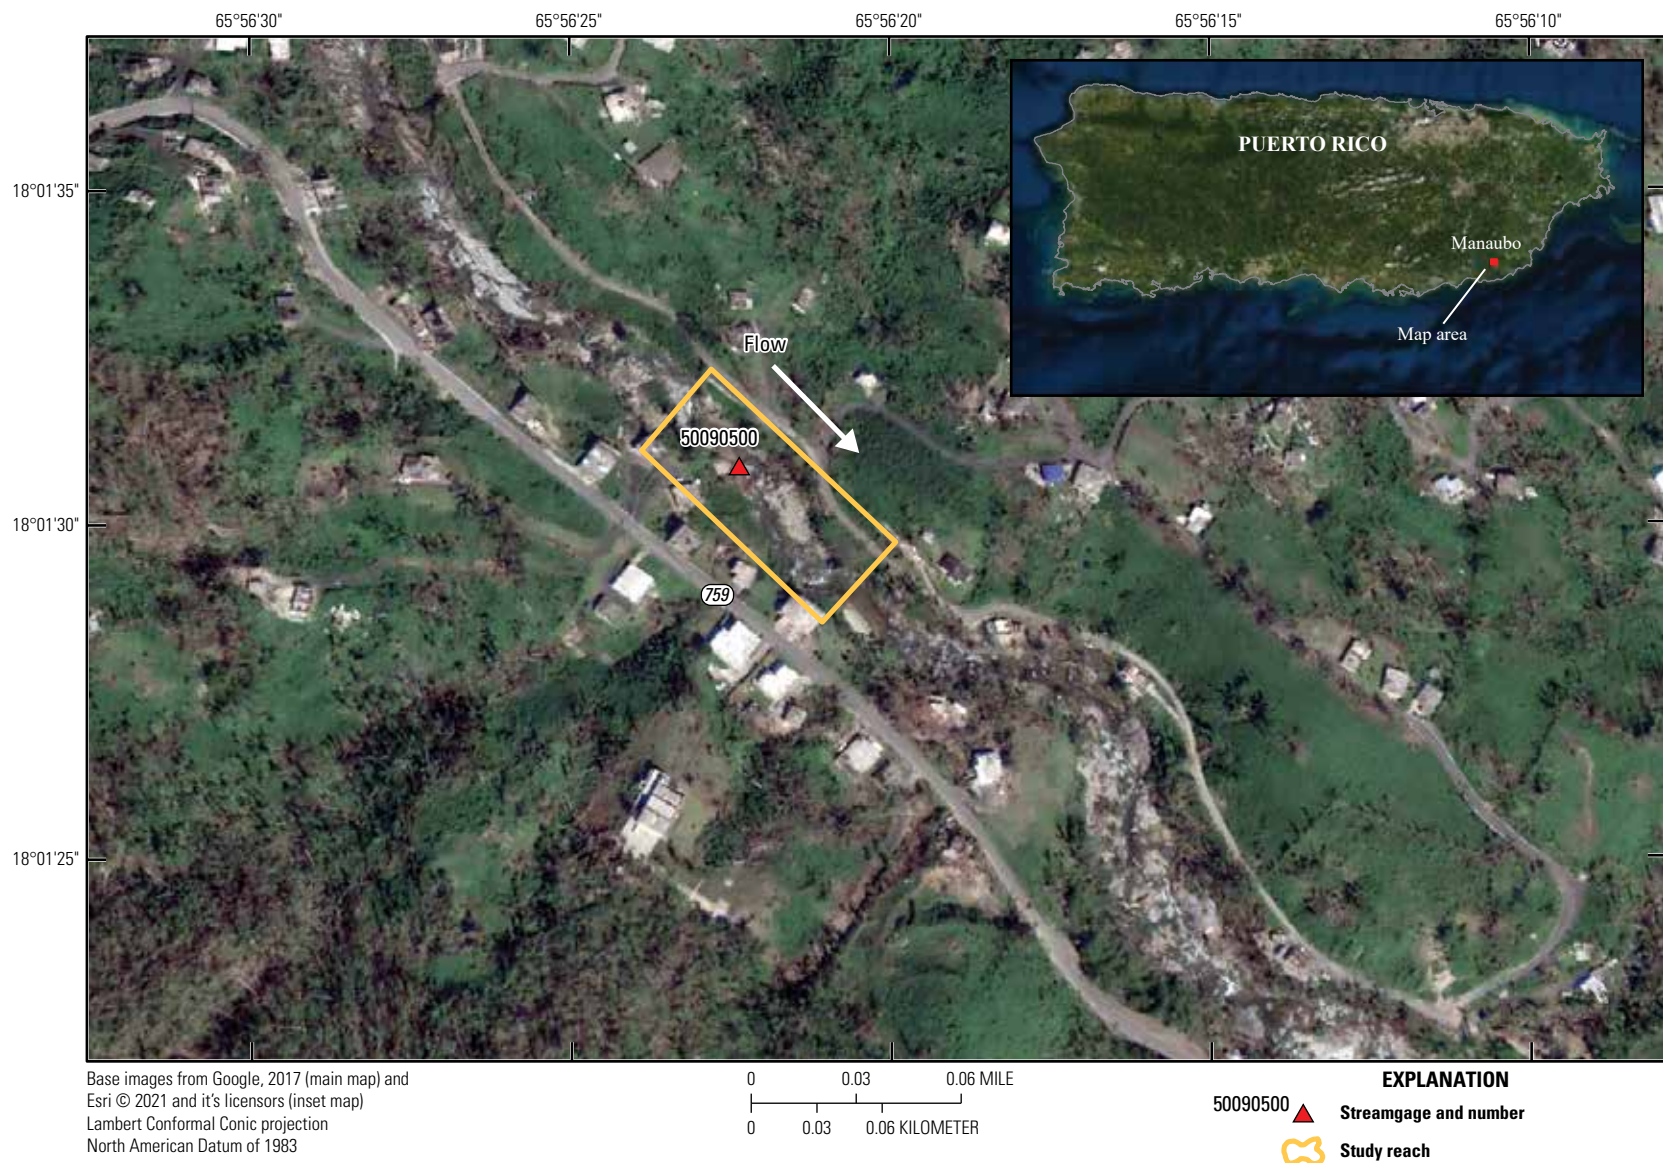
Figure 2.4. Location of study reach for slope-area measurement at station 50090500 Río Maunabo at Lizas.

The Río Maunabo at Lizas streamgage is situated in the Río Maunabo Watershed (index number 15, [fig. 6B](#)) near Route PR-759 at Lizas, 3 mi northwest of Maunabo ([fig. 2.4](#)); the contributing drainage area is 5.30 mi². The site is less than 4 mi from the southeast coast and is characteristic of coastal streams in the humid valleys of the east coast (geographic region 2, [figs. 2 and 6A](#)). Mean annual rainfall in this coastal area ranges from 50.00 to 79.99 in.; 48-hour rainfall for September 19–20, 2017, ranged from 10.00 to 14.99 in. ([figs. 4 and 5](#)).

USGS personnel returned in November 2017 to survey flagged HWMs, select and survey channel cross sections, and collect additional data needed for slope-area measurement. The team surveyed five cross sections in a 340-ft reach that begins about 80 ft upstream from the streamgage and extends about 260 ft downstream from the streamgage. [Figures 2.4 and 2.6](#) show the extent of the measurement reach and channel conditions at the time of the field survey.

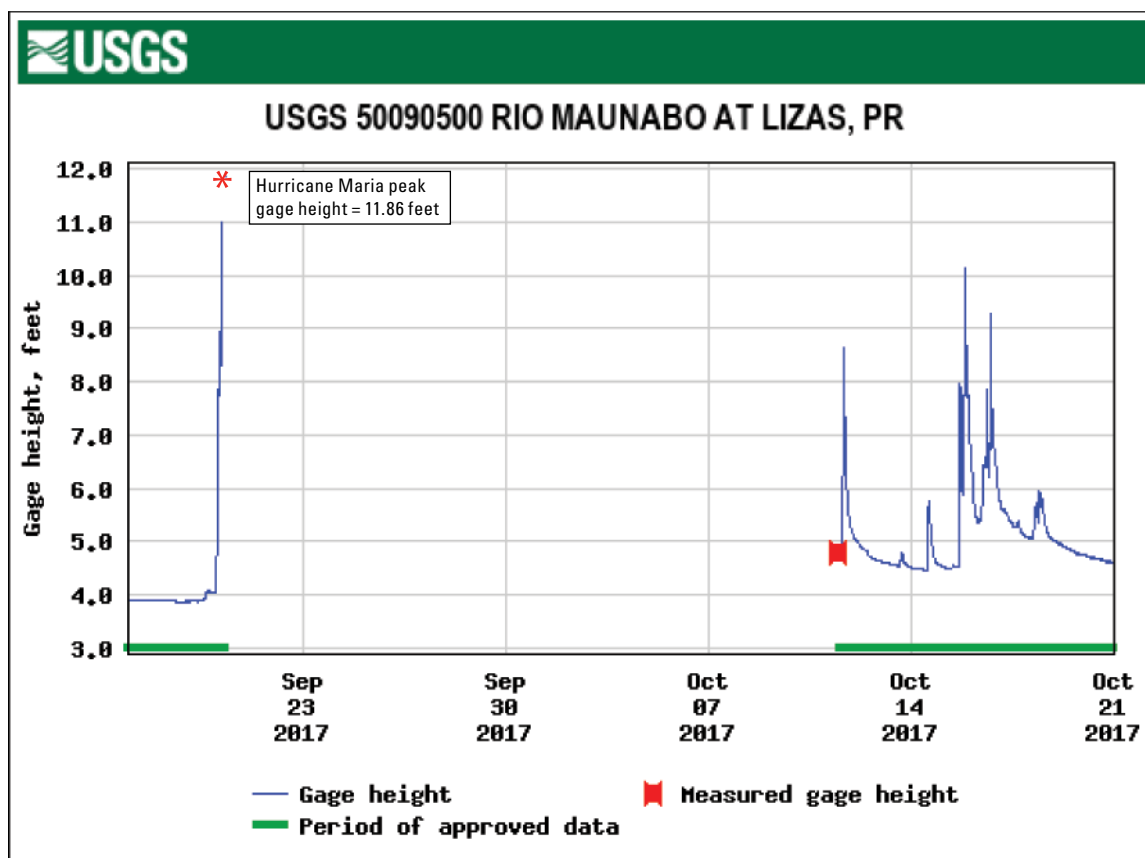
Figure 2.5. Gage-height record and event peaks for station 50090500 Río Maunabo at Lizas during the period from September 17, 2017, to October 21, 2017. The Hurricane Maria peak streamflow on September 20, 2017, was determined to be the highest peak streamflow during the period.

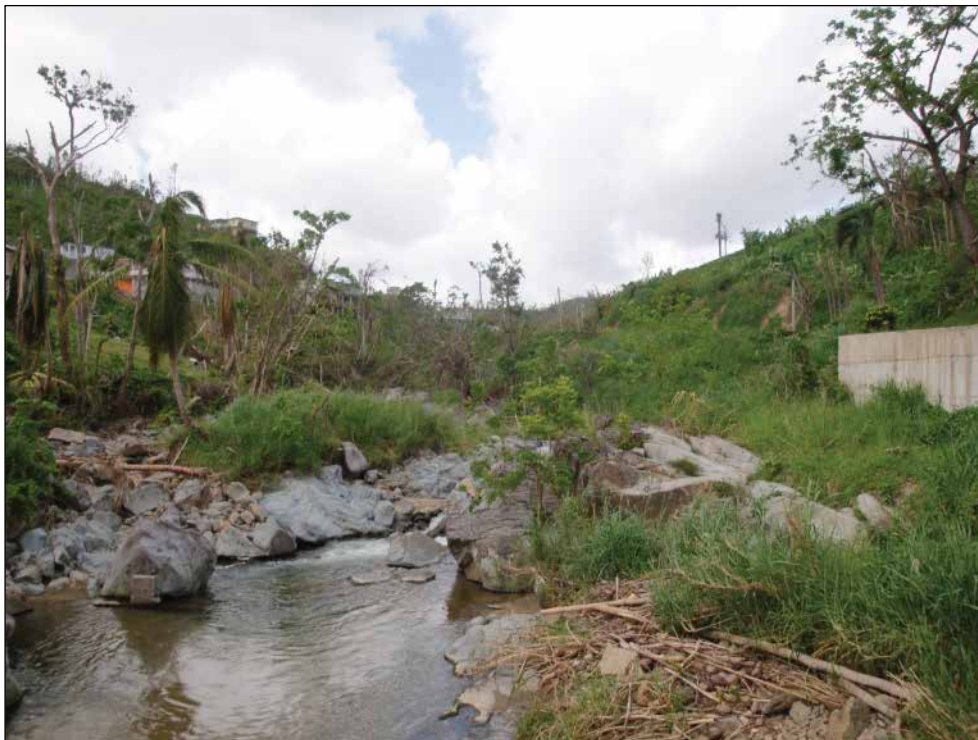
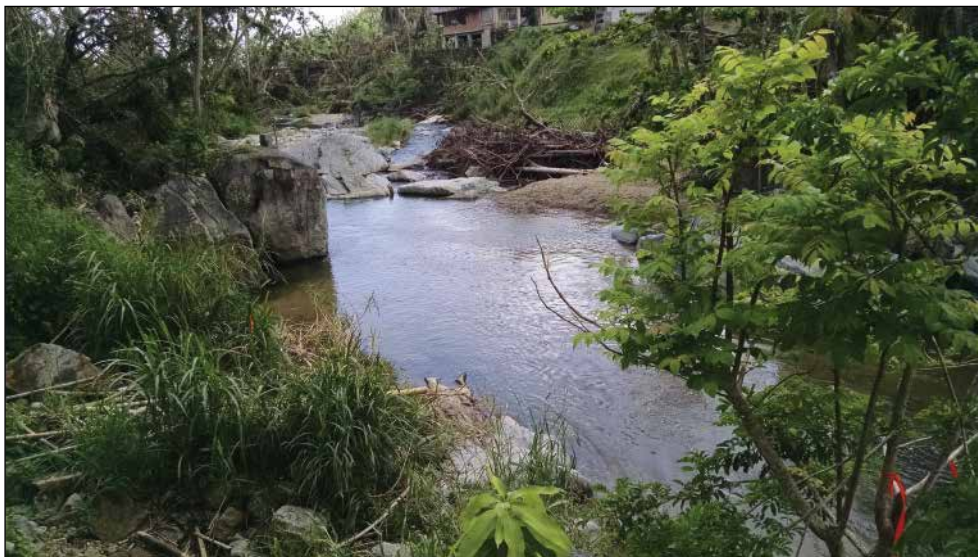
Figure 2.6. Conditions along study reach for station 50090500 Río Maunabo at Lizas, November 9, 2017. *A*, View upstream from streamgage; *B*, view downstream from upstream end of reach. Flood high-water marks are not visible in the photographs. Photographs by Jonathan Lageman, U.S. Geological Survey.

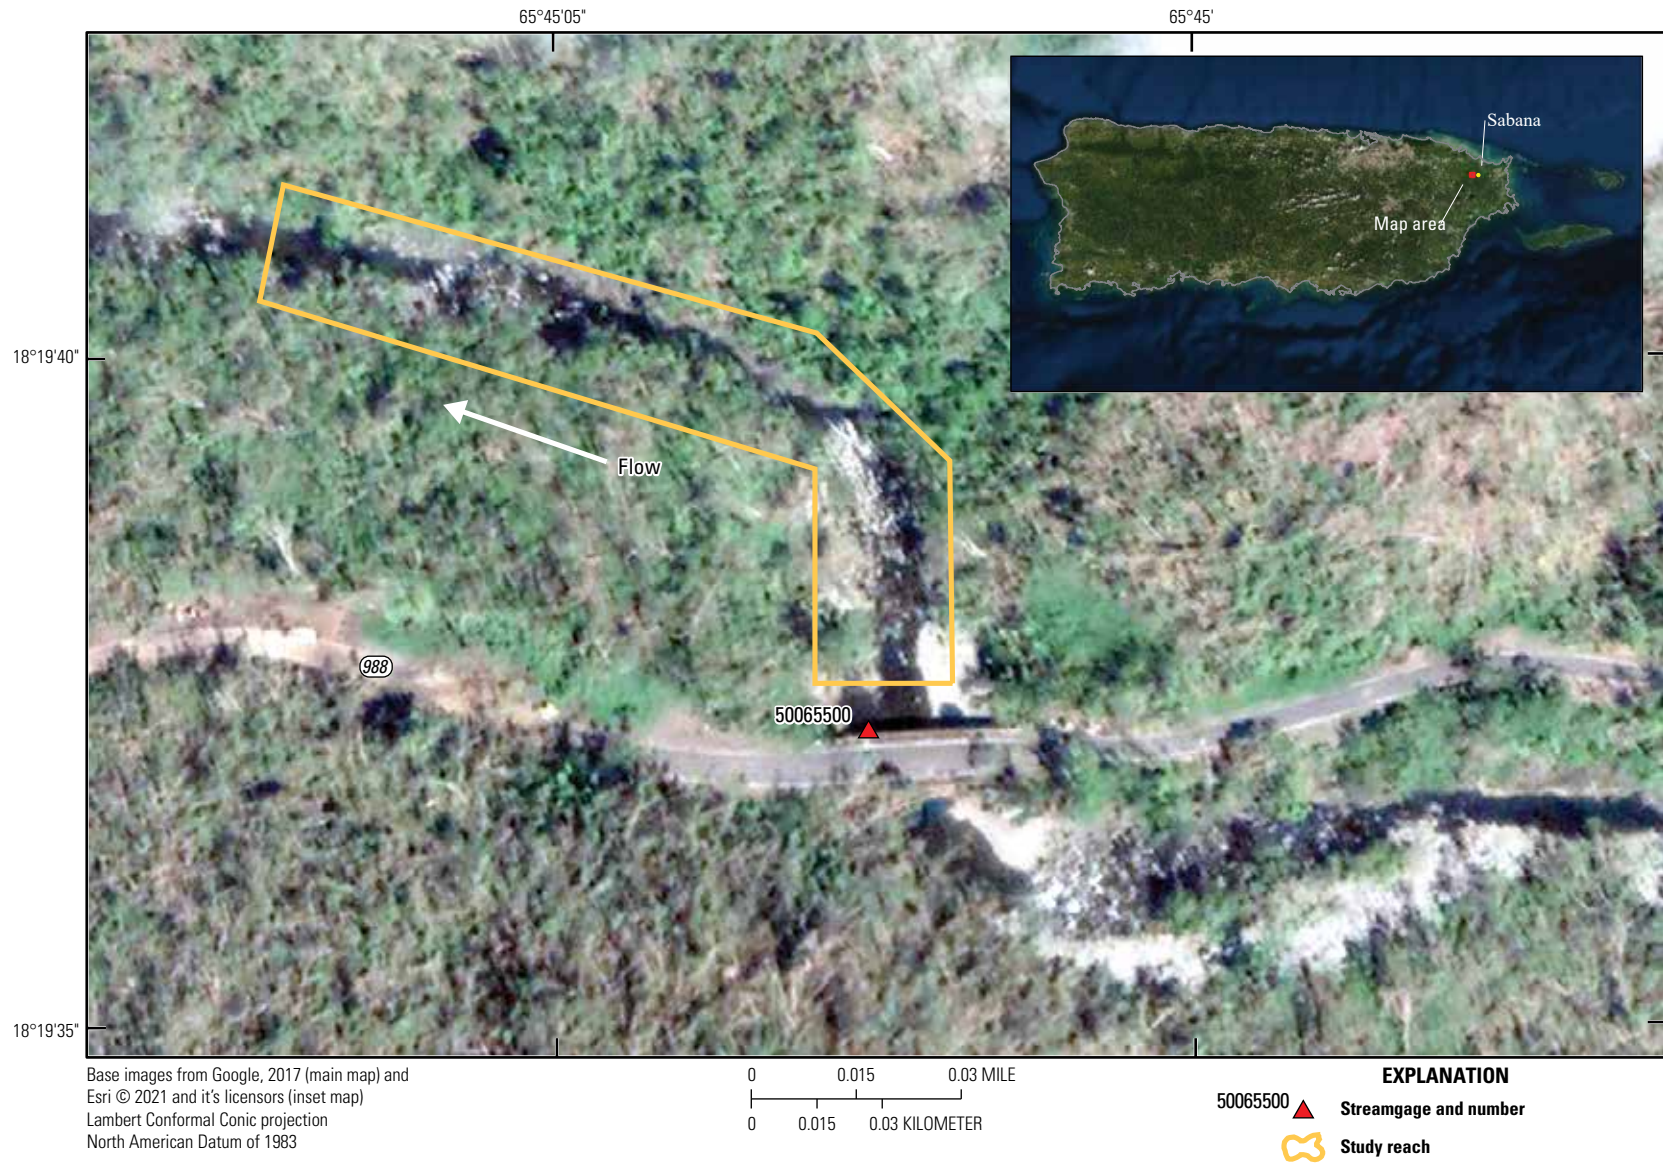
Figure 2.7. Location of study reach for slope-area measurement at station 50065500 Río Mameyes near Sabana.

The Río Mameyes near Sabana streamgage, installed on the bridge at Route PR-988, is situated near the mouth of the Río Mameyes, 1.4 mi west of the Town of Sabana ([fig. 2.7](#)) contributing drainage area is 6.77 mi². The streamgage was operated from 1967 to 1973, then reactivated and operated continuously from June 1983 until September 2017. The streamgage was damaged during the Hurricane Maria flooding of September 20, 2017, and failed to record a peak gage height; the streamgage remained inoperable until USGS personnel completed repairs on October 24, 2017.

downstream from the streamgage. Figures 2.7, 2.8, and 2.9 show the measurement reach extent and channel conditions at the time field surveys were conducted.

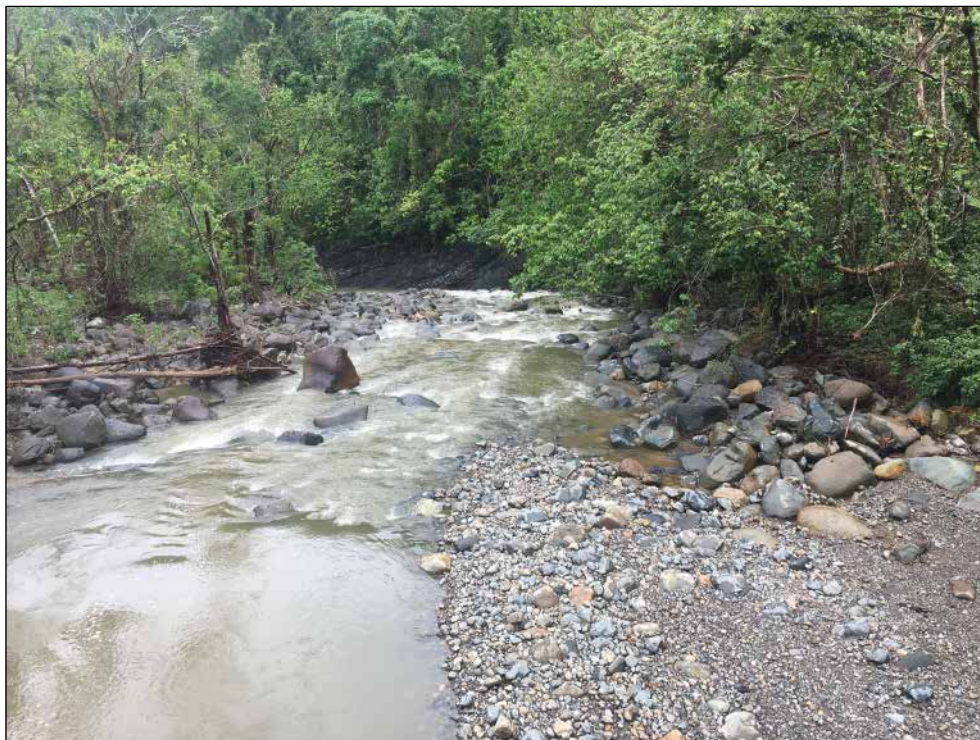
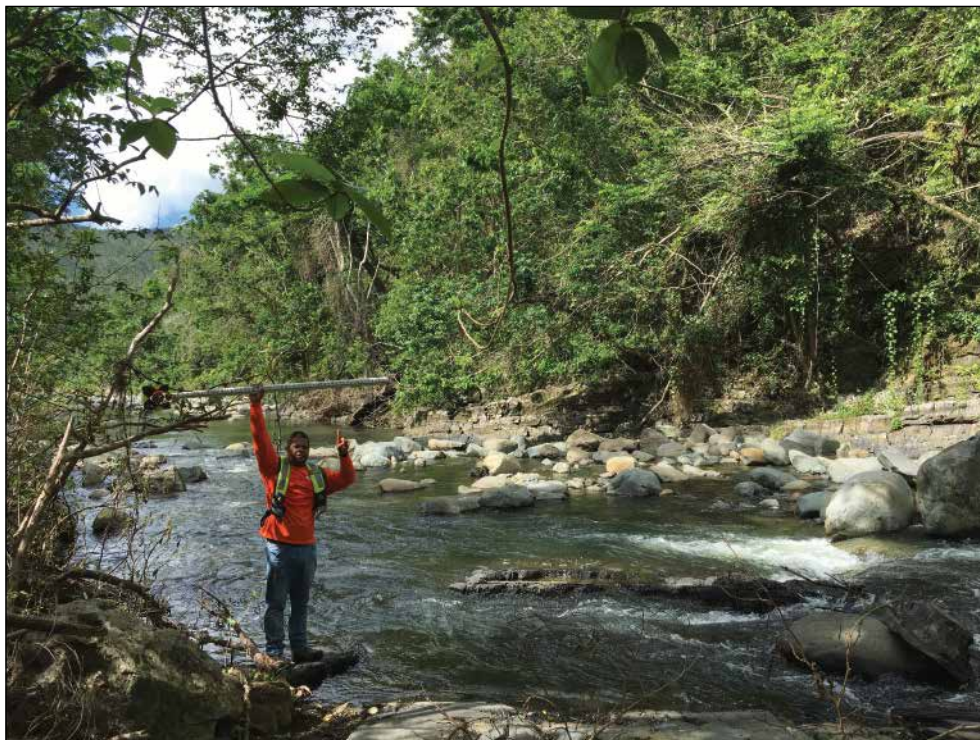
Figure 2.8. Conditions along study reach for station 50065500 Río Mameyes near Sabana. *A*, View downstream from the bridge at Route PR-988, November 11, 2017; *B*, view downstream from upstream end of reach, November 27, 2017; rod held at approximate high-water-mark level for the peak streamflow of October 15, 2017. Photographs by Michael Kohn and Julieta Gómez-Fragoso, U.S. Geological Survey.

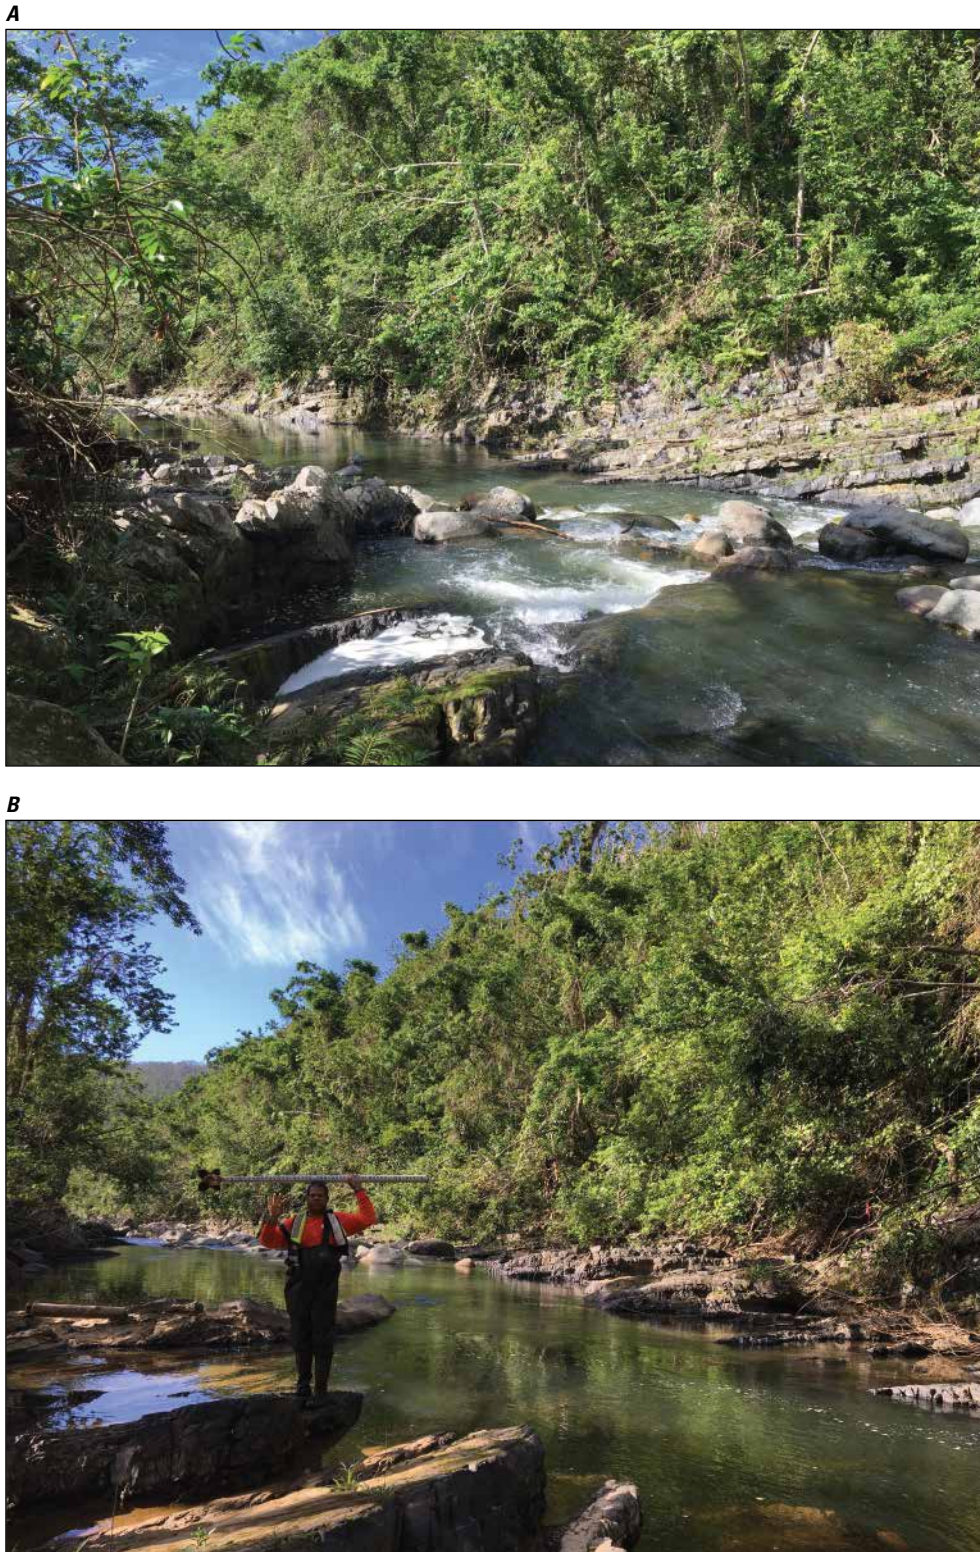
Figure 2.9. Conditions along study reach for station 50065500 Río Mameyes near Sabana, November 27, 2017. *A*, View downstream at middle part of study reach; *B*, view downstream at lower part of study reach; rod held at approximate high-water-mark level for the peak streamflow of October 15, 2017. Photographs by Julieta Gómez-Fragoso, U.S. Geological Survey.

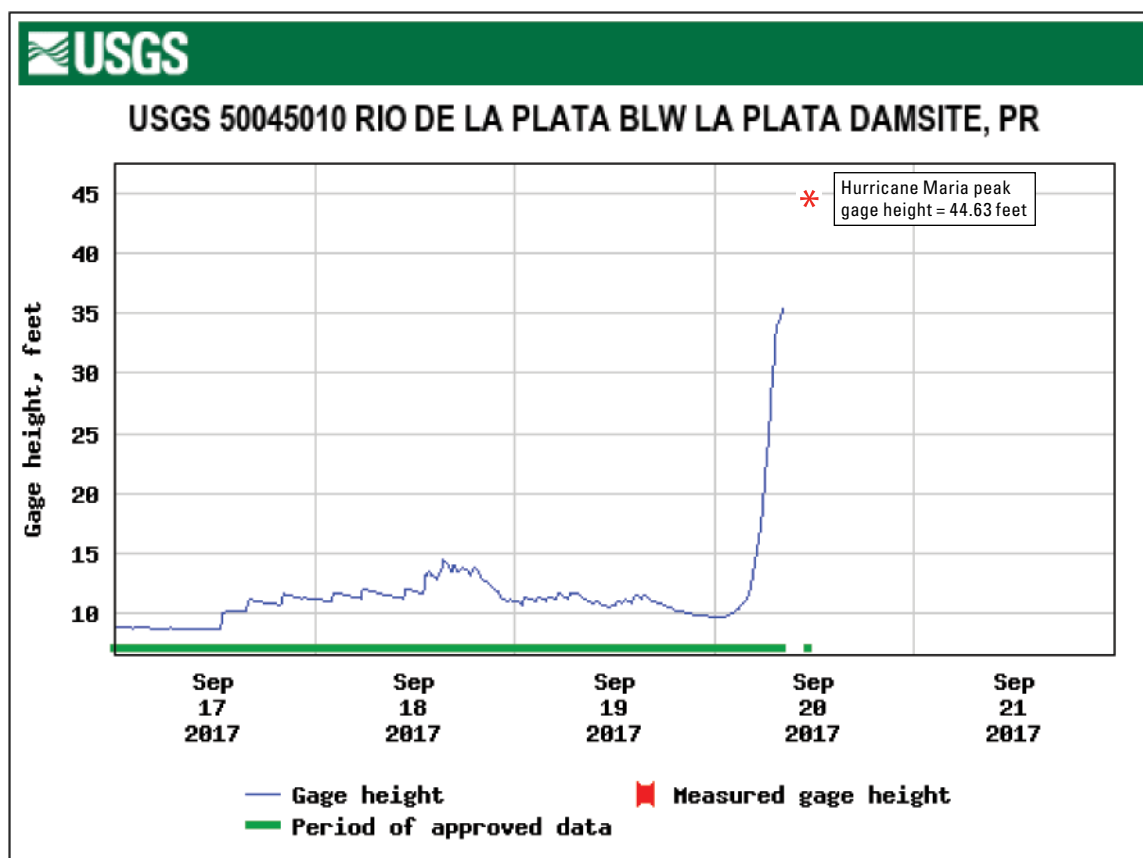
Figure 2.11. Gage-height record for station 50045010 Río de la Plata below La Plata Damsite during the period September 17–21, 2017.

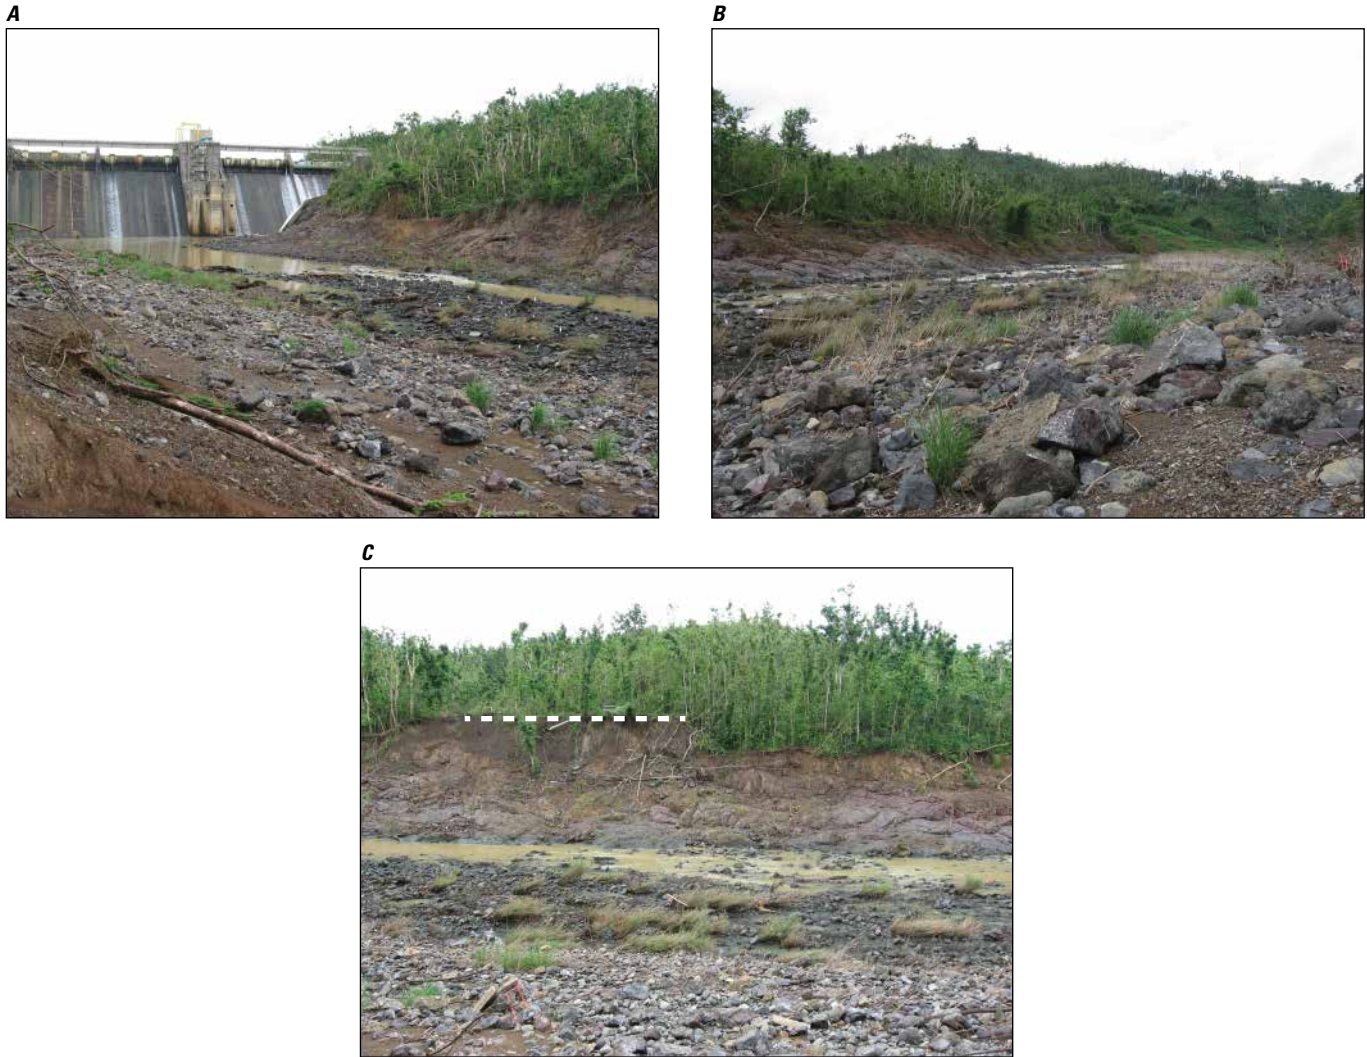
Figure 2.12. Conditions near upstream end of study reach for station 50045010 Río de la Plata below La Plata Damsite, November 18, 2017. *A*, View upstream near streamgage; *B*, view downstream near streamgage; *C*, view right to left at channel. White dashed line indicates approximate high-water mark level. Photographs by Mark Smith, U.S. Geological Survey.
