U.S. Geological Survey Response to Hurricane Maria Flooding in Puerto Rico and Characterization of Peak Streamflows Observed September 20–22, 2017

By Julieta Gómez-Fragoso, Mark Smith, and Marilyn Santiago

Scientific Investigations Report 2022–5040
Version 1.1 (July 2022)

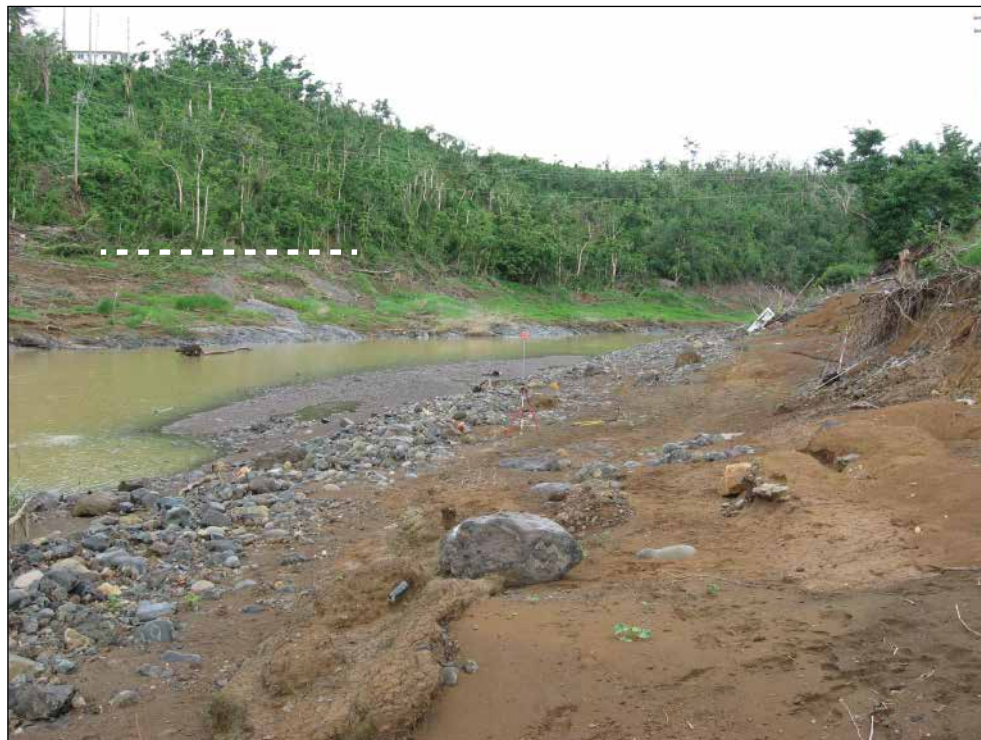
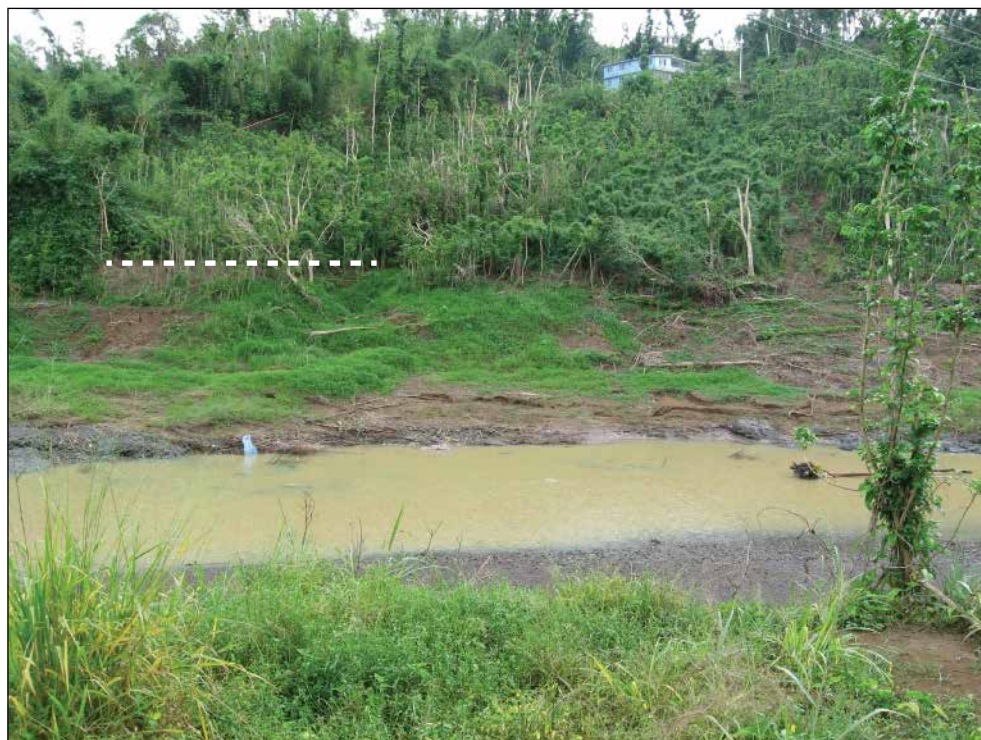
Figure 2.13. Conditions along middle part of study reach for station 50045010 Río de la Plata below La Plata Damsite, November 18, 2017. *A*, View downstream, *B*, view right to left at channel. White dashed lines indicate approximate high-water mark level. Photographs by Mark Smith, U.S. Geological Survey.

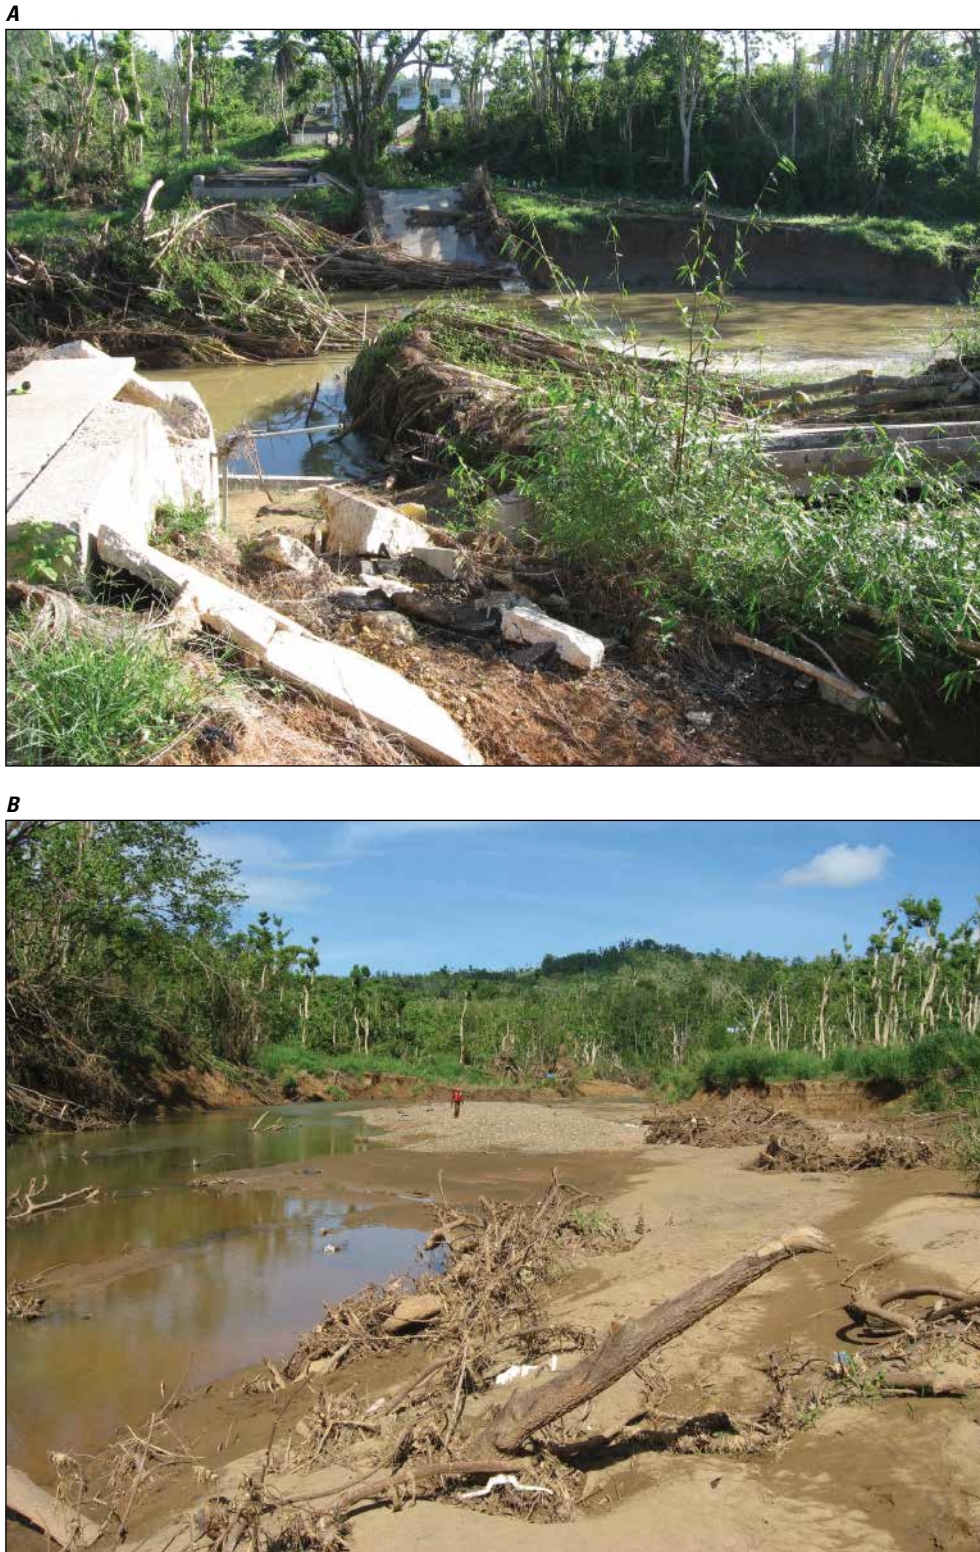
Figure 2.14. Conditions along study reach for station 50147800 Río Culebrinas at Highway 404 near Moca, November 14, 2017: *A*, View right to left of destroyed Highway 404 bridge where streamgage was located; *B*, view downstream from upstream end of study reach (600 feet downstream from streamgage). Photographs by Mark Smith, U.S. Geological Survey.

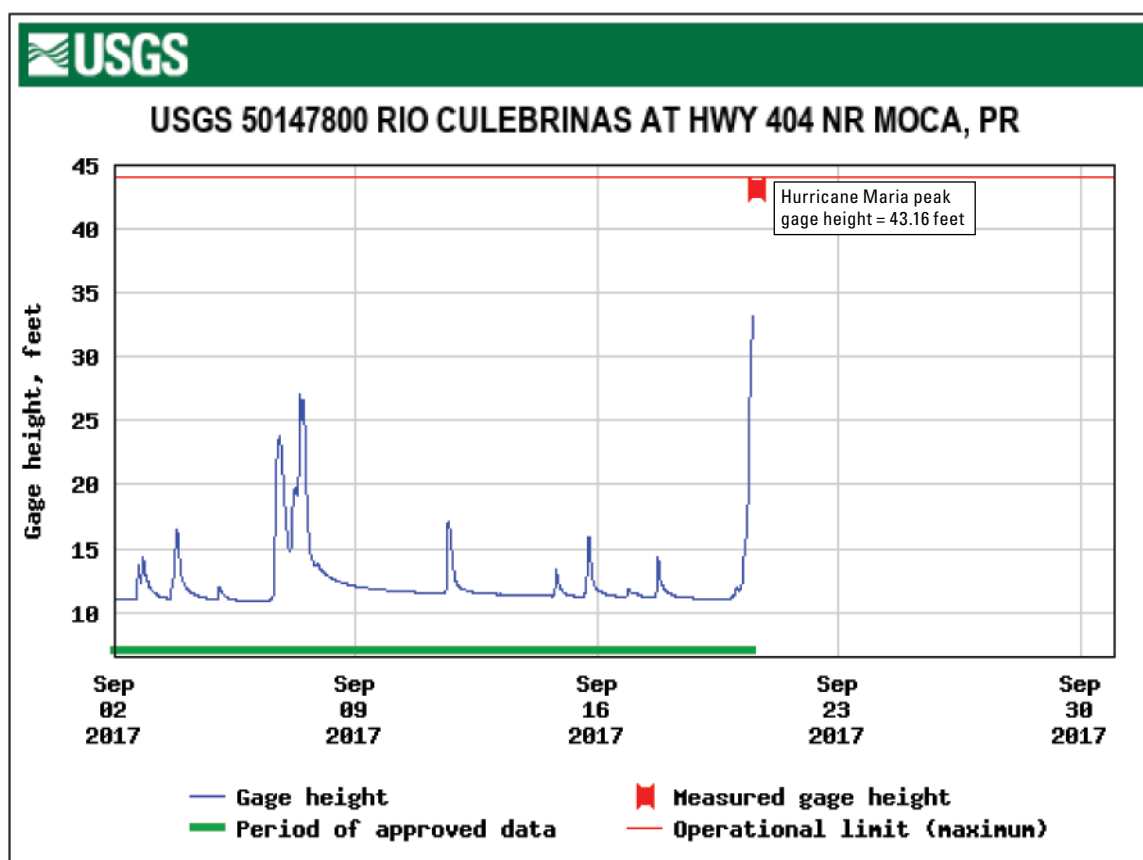
Figure 2.15. Gage-height record and event peaks for station 50147800 Río Culebrinas at Highway 404 near Moca during the period September 2–30, 2017.

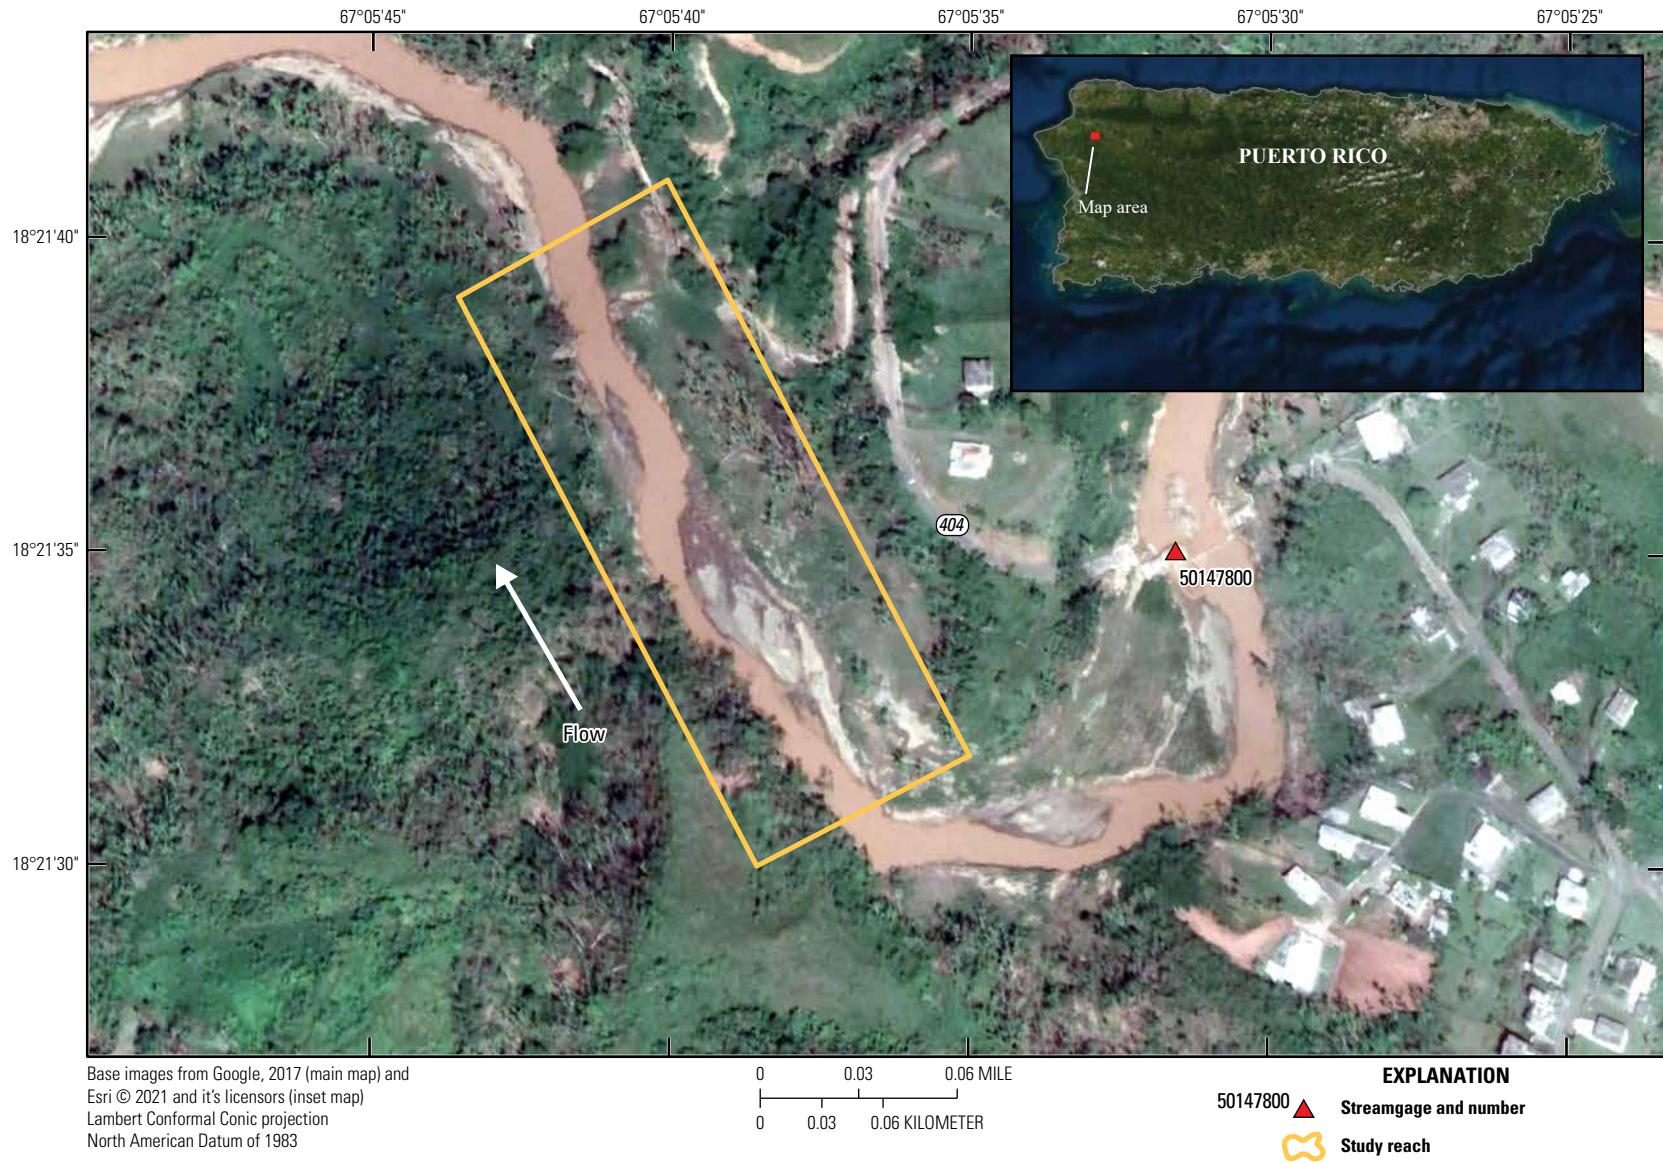
Figure 2.16. Location of study reach for slope-area measurement at station 50147800 Río Culebrinas at Highway 404 near Moca.

reach extends from about 600 to 1,600 ft downstream from the streamgage (fig. 2.16). HWMs recovered near the streamgage indicated that peak gage height for the flood event was 43.16 ft (gage datum), 9.98 ft higher than the last gage height recorded by the streamgage. Comparison of gage height and streamflow records with downstream station 50148890 Río Culebrinas at Margarita damsite near Aguada confirmed that the peak streamflow of September 20, 2017, was the highest for the period through October 23, the date USGS personnel flagged HWMs for the indirect measurement.

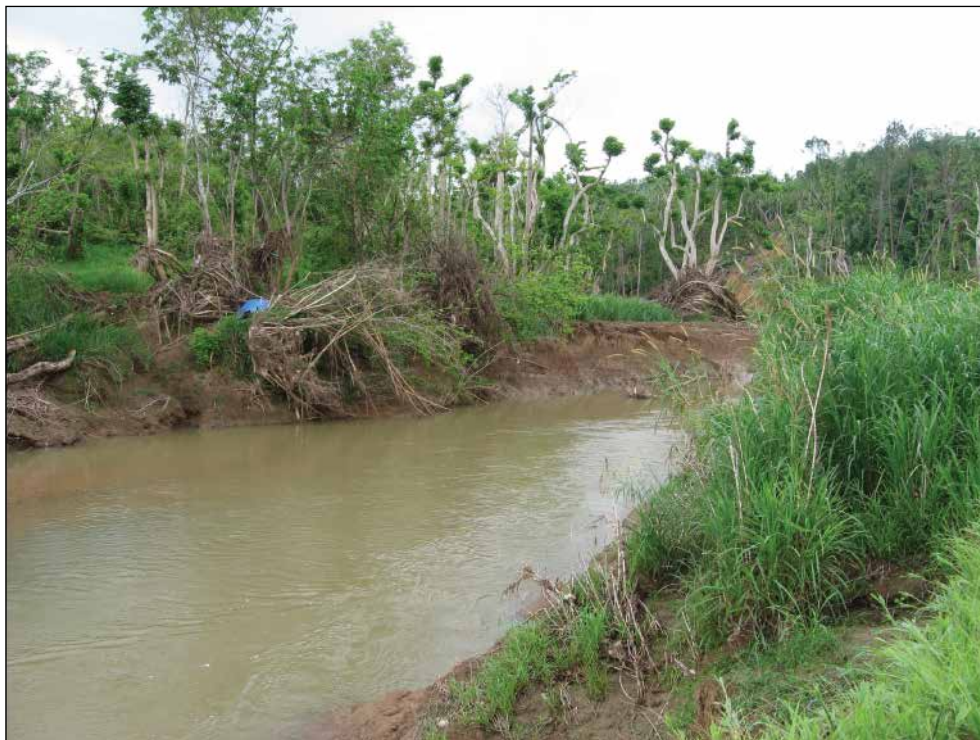
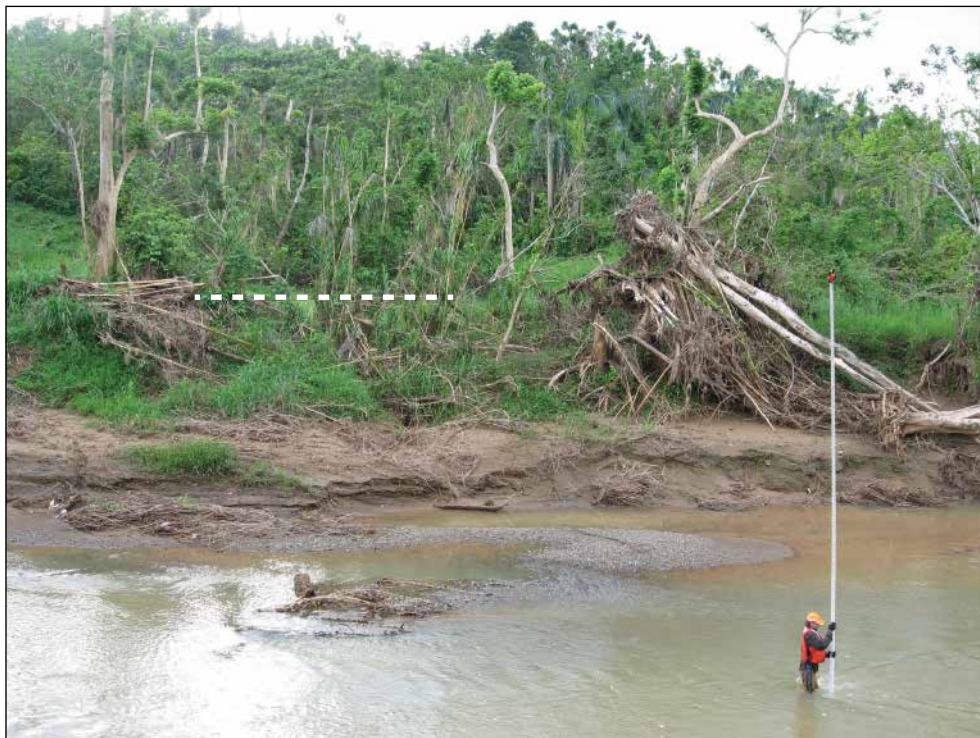
Figure 2.17. Conditions along study reach for station 50147800 Río Culebrinas at Highway 404 near Moca, November 14, 2017. *A*, View downstream at lower end of the study reach; *B*, view right to left at channel in lower part of the study reach. White dashed line indicates approximate high-water mark level. Photographs by Mark Smith, U.S. Geological Survey.

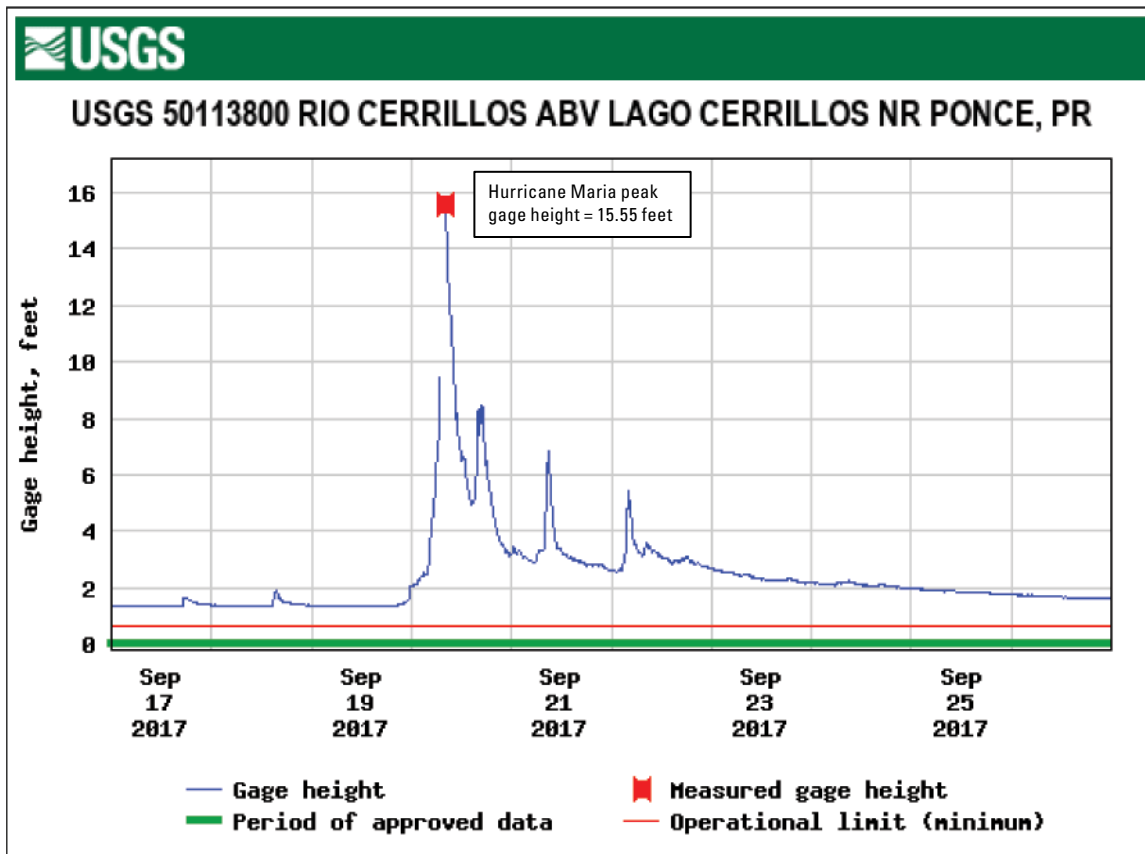
Figure 2.18. Gage-height record and event peaks for station 50113800 Río Cerrillos above Lago Cerrillos near Ponce during the period September 17–26, 2017.

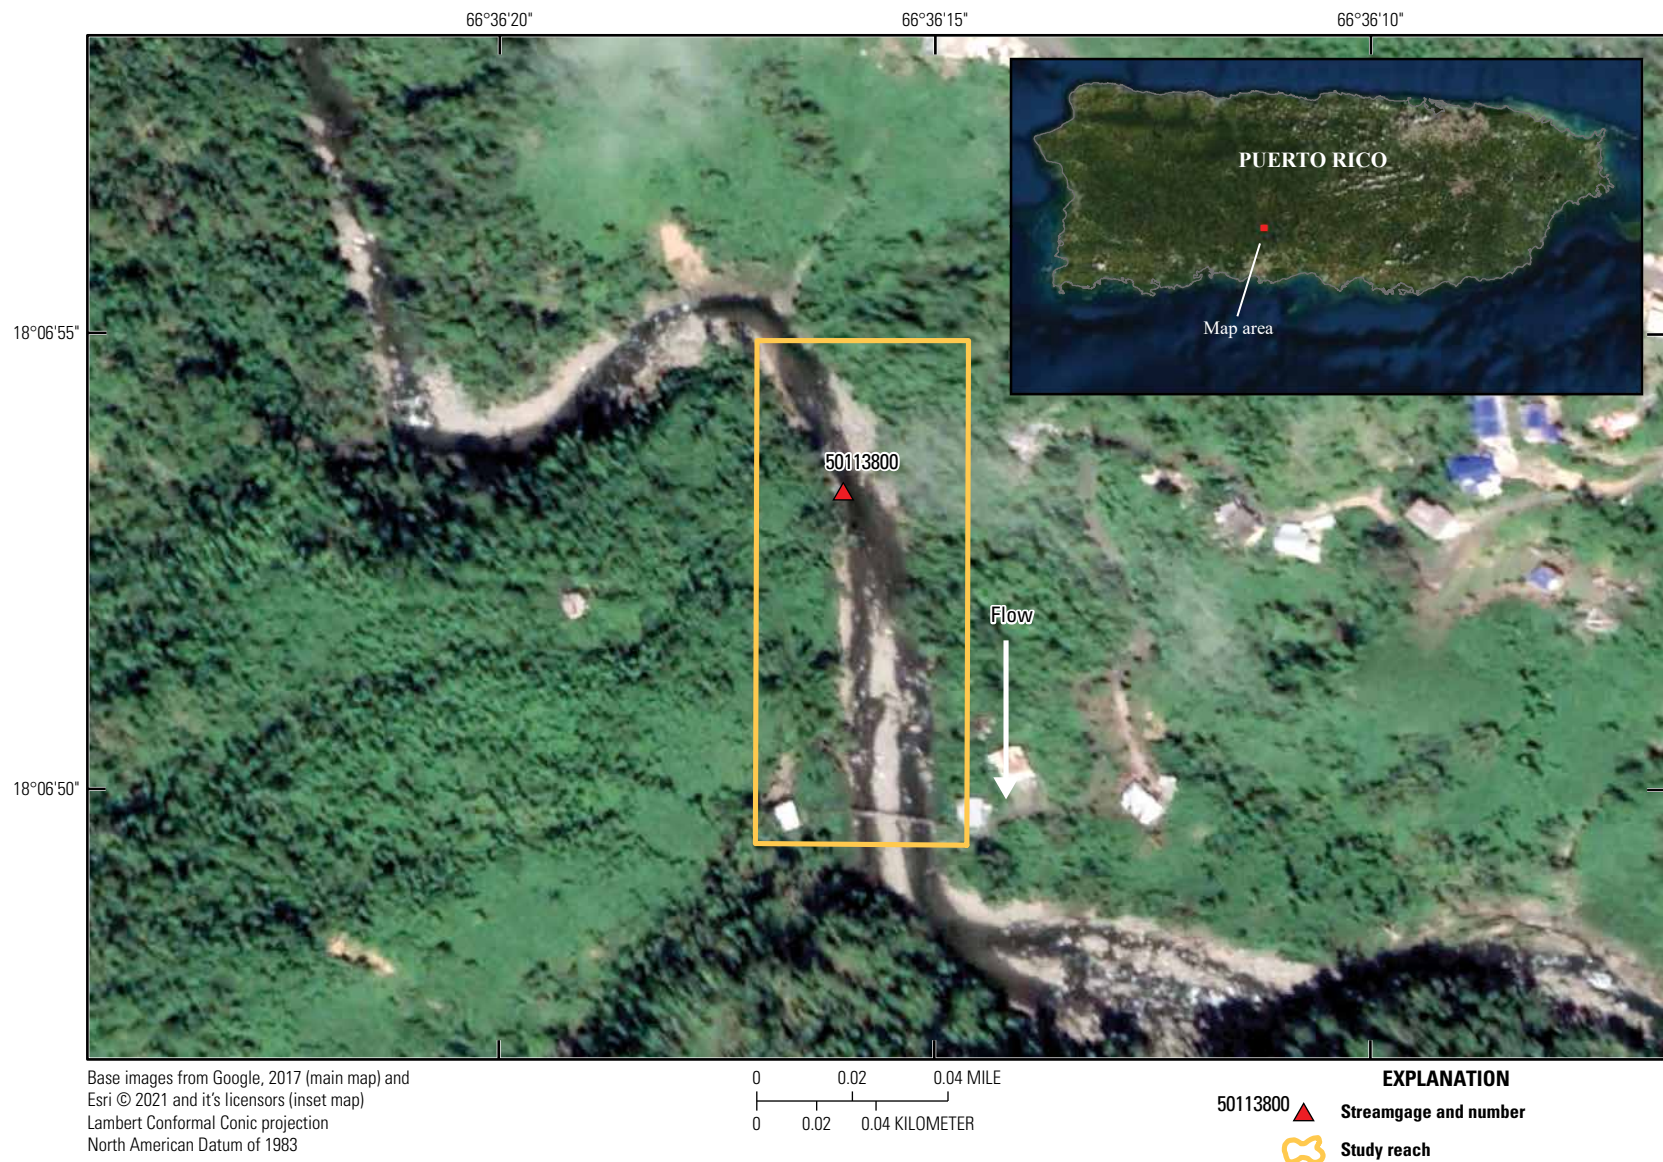
Figure 2.19. Location of study reach for slope-area measurement at station 50113800 Río Cerrillos above Lago Cerrillos near Ponce.

A USGS surveying team visited the site November 16, 2017, to survey flagged HWMs, select and survey channel cross sections, and collect additional data needed for slope-area measurement. The team surveyed five cross sections along a 550-ft reach (slightly shorter than that delineated by the HWMs), that extended from 150 ft upstream to 400 ft downstream from the streamgage. Figures 2.19 and 2.20 show the measurement reach location and channel conditions at the time field surveys were conducted.

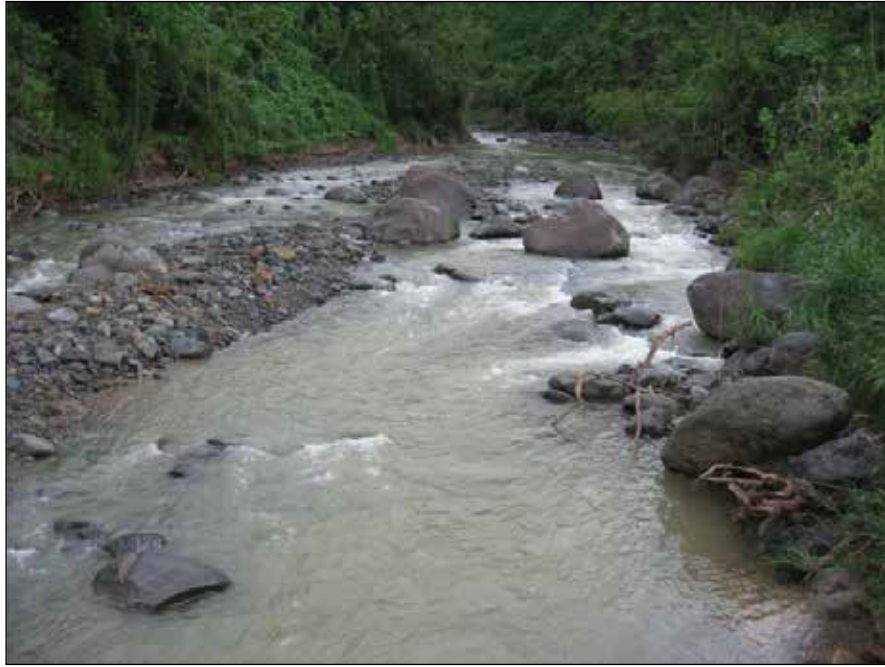
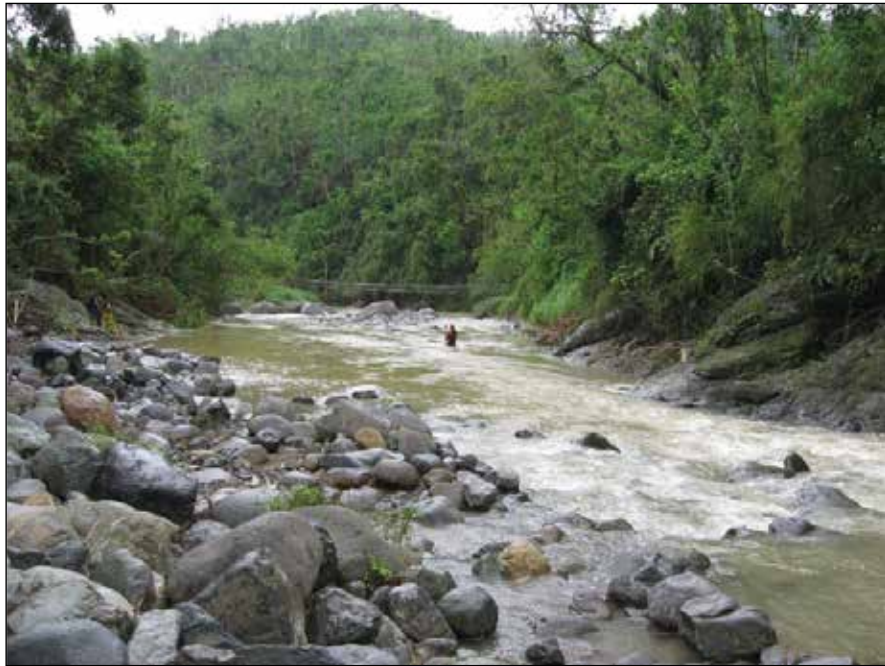
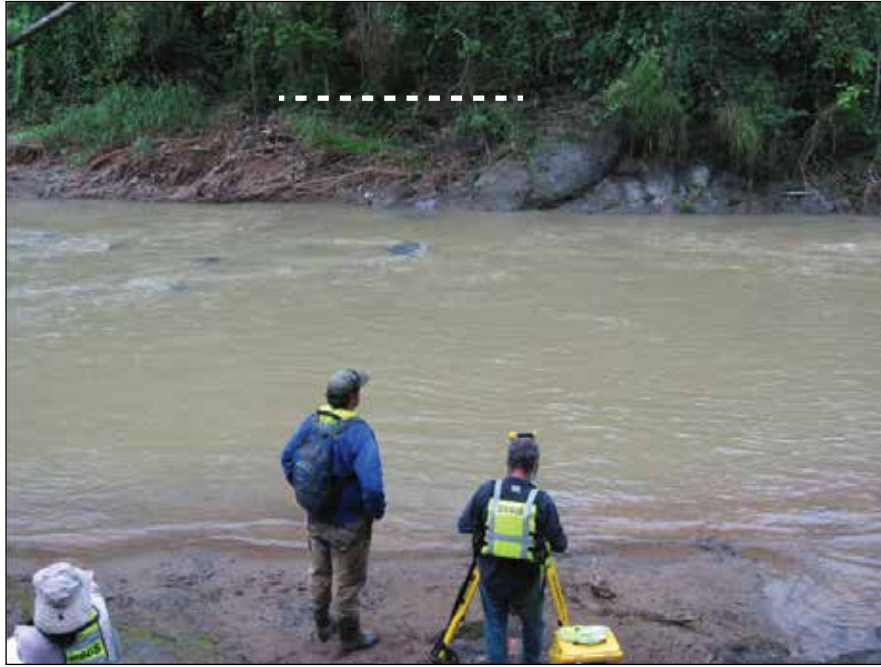
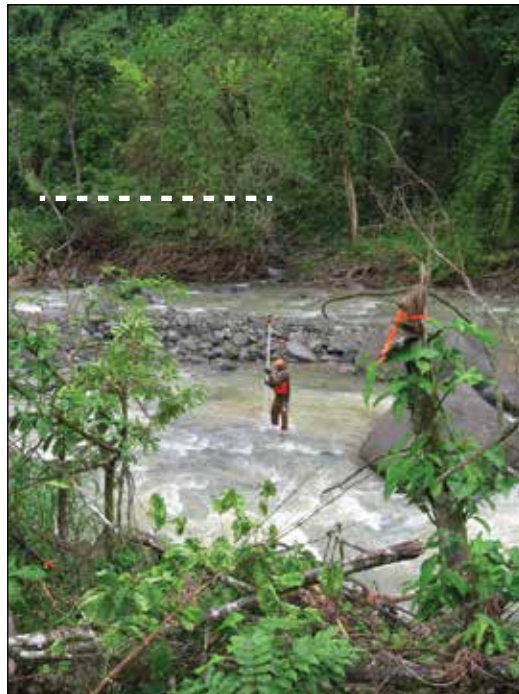
Figure 2.20. Conditions along study reach for station 50113800 Río Cerrillos above Lago Cerrillos near Ponce, November 16, 2017. *A*, View of study reach, looking upstream from footbridge at downstream end of reach; *B*, view of entire study reach, looking downstream from left bank (footbridge visible in the distance), *C*, view, left to right, at channel cross section in upper part of study reach, near the streamgage; *D*, view, left to right, at channel cross section in lower part of study reach. White dashed lines indicate approximate high-water mark level. Photographs by Mark Smith, U.S. Geological Survey.

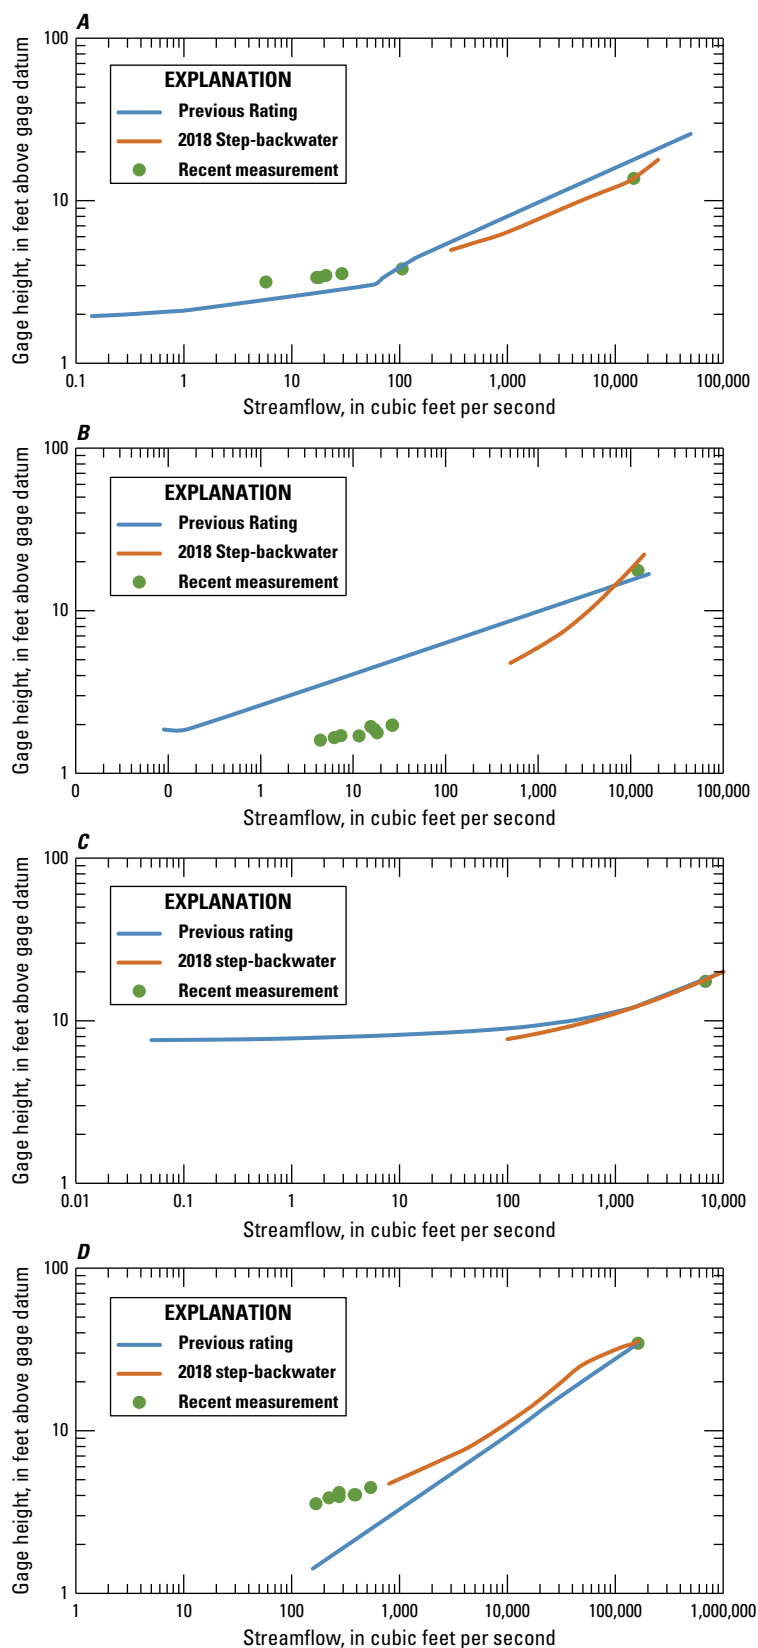
Figure 3.1. Stage-streamflow relation for stations for, *A*, 50025155 Río Saliente at Coabey, *B*, 50044810 Río Guadiana near Guadiana, *C*, 50067000 Río Sabana at Sabana, and *D*, 50144000 Río Grande de Añasco near San Sebastián, determined from 2018 step-backwater analyses, along with most recent streamflow measurements. Previous stage-streamflow relation is shown for comparison.

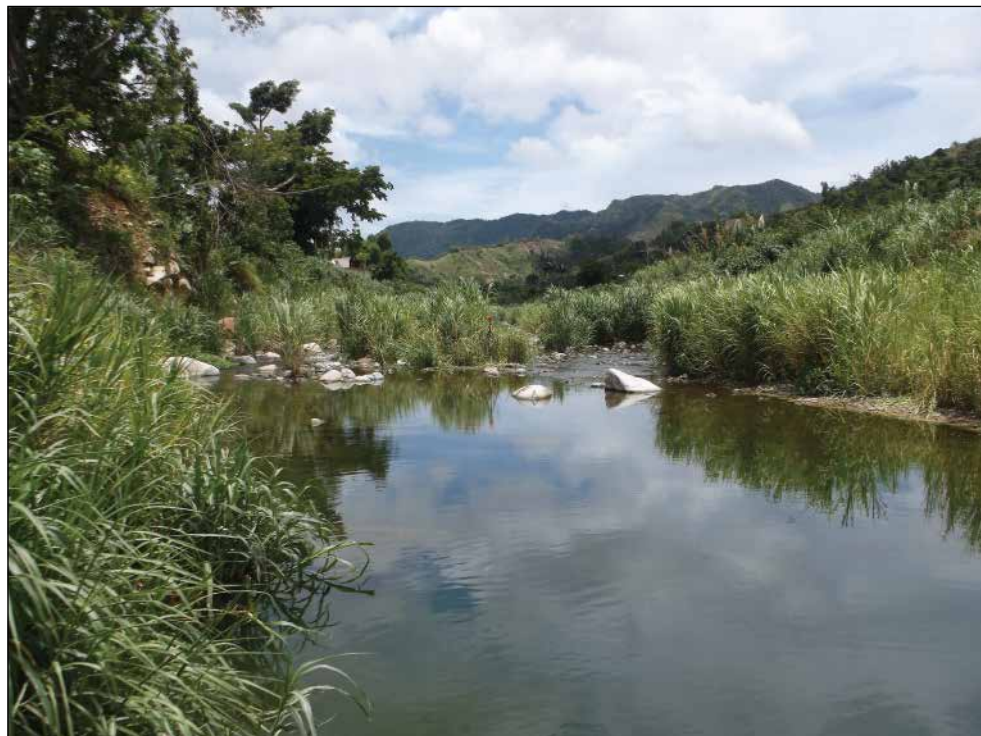
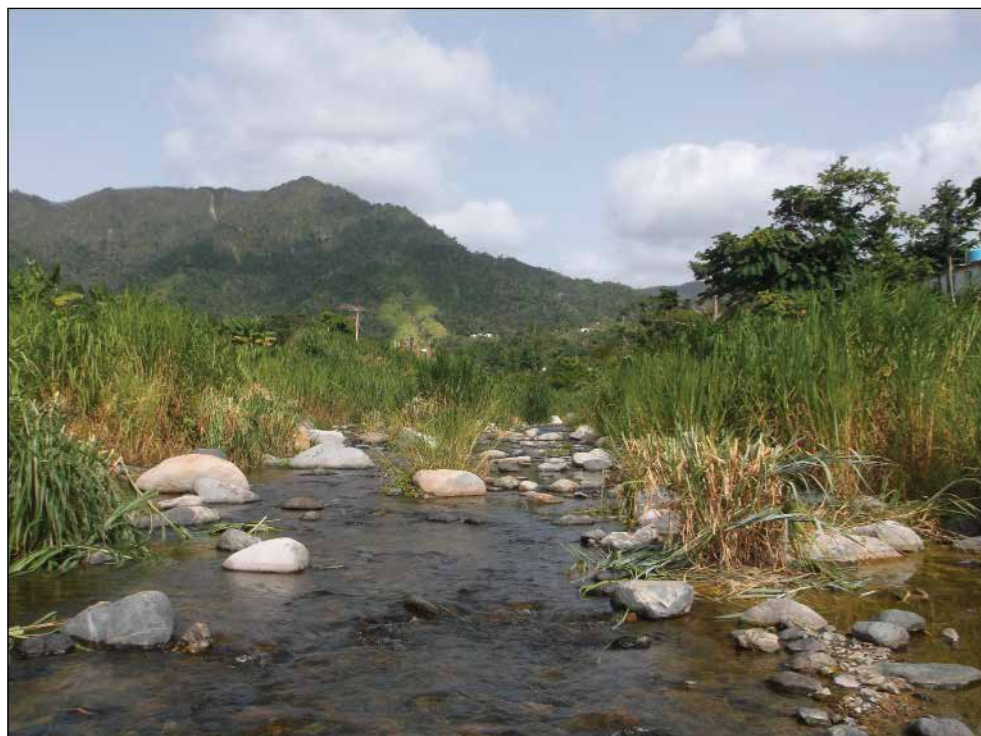
Figure 3.3. Study reach for station 50025155 Río Saliente at Coabey (July 2018). *A*, View downstream from the cross section furthest upstream; *B*, view upstream from the cross section furthest downstream. Photographs by Julieta Gómez-Fragoso, U.S. Geological Survey.

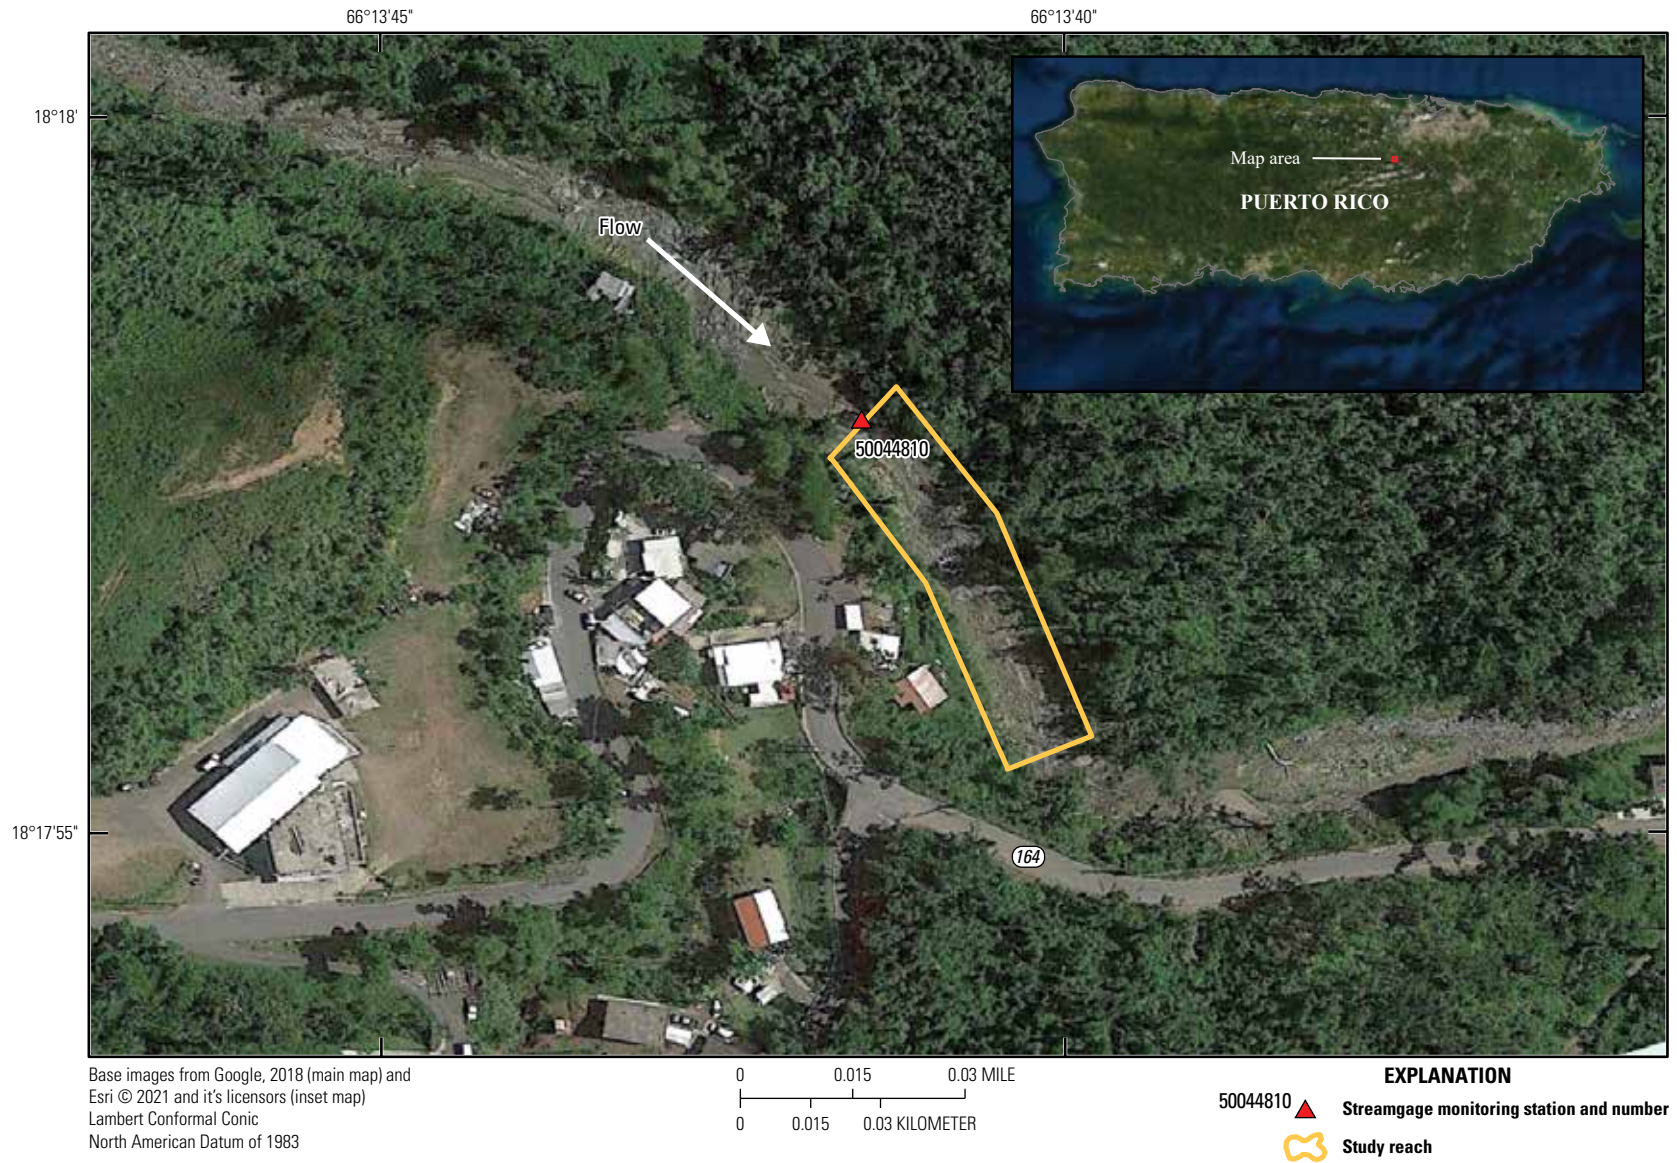
Figure 3.4. Location of study reach used for the step-backwater study at station 50044810 Río Guadiana near Guadiana.

The Río Guadiana near Guadiana streamgage is located 1.10 mi east of the town of Naranjito (fig. 2) in the humid northern foothills (geographic region 7; fig. 7A), and stage-streamflow data have been recorded at the site since 2001. The drainage area at the streamgage encompasses about 8.11 mi², and it is part of Río de la Plata watershed (figs. 3 and 7B). A 10-cross-section model was used for the SBA at the streamgage. The study reach extends downstream from the streamgage about 308 ft and is generally straight, except for a minor bend to the right about 80 ft downstream from the streamgage (fig. 3.4).

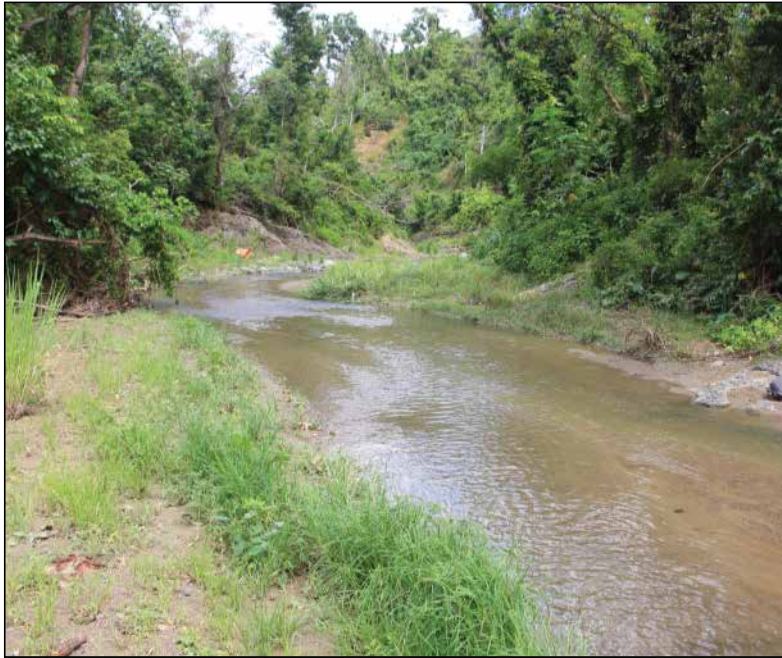
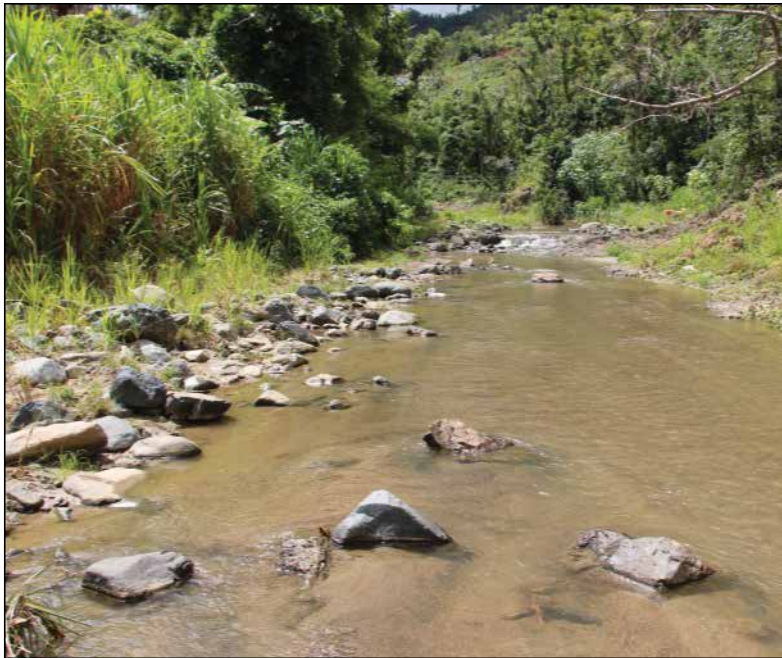
Figure 3.5. Study reach for station 50044810 Río Guadiana near Guadiana (May 2018). *A*, View downstream from the cross section furthest upstream; *B*, view upstream from the cross section furthest downstream. Photographs by Bruce Gungle, U.S. Geological Survey.

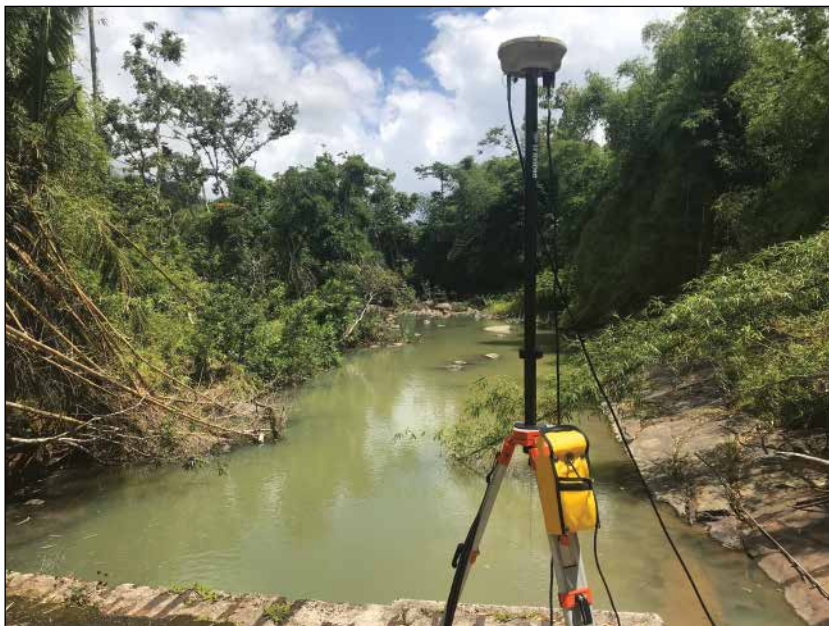
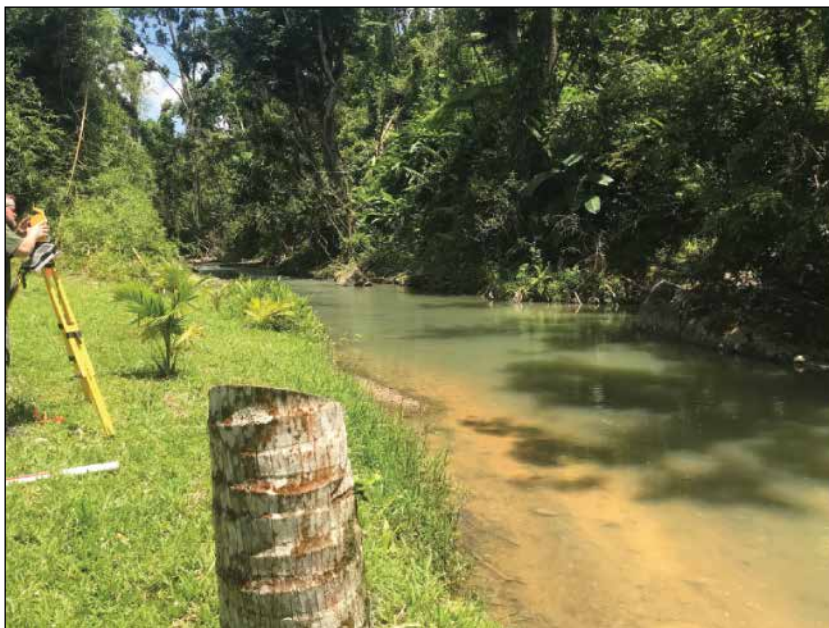
Figure 3.7. Study reach for station 50067000 Río Sabana at Sabana (May 2018). *A*, View downstream from the cross section furthest upstream; *B*, view upstream from the cross section furthest downstream. White dashed line indicates approximate high-water mark level. Photographs by Karl Winters, U.S. Geological Survey.

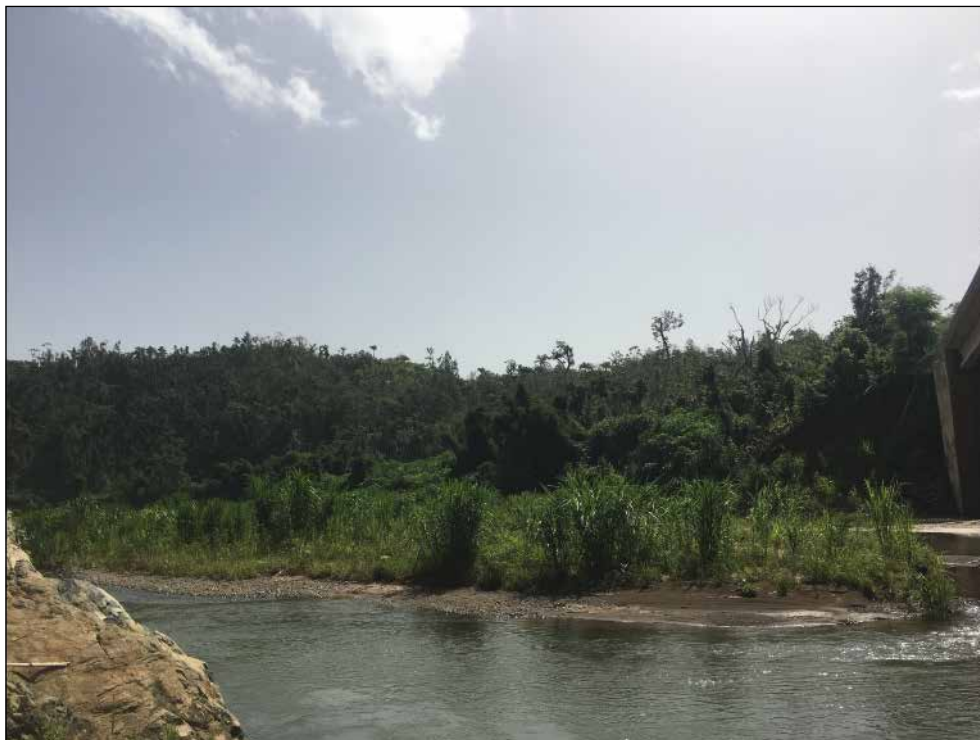
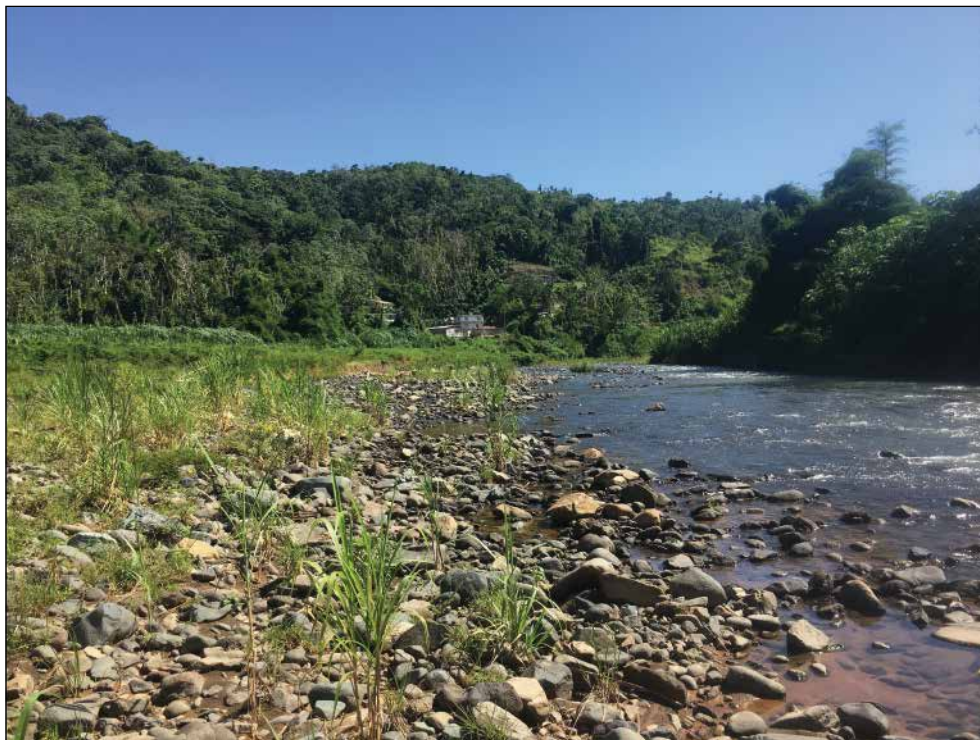
Figure 3.9. Study reach for station 50144000 Río Grande de Añasco near San Sebastián (June 2018). *A*, View downstream from the cross section furthest upstream; *B*, view upstream from the cross section furthest downstream. Photographs by Julieta Gómez-Fragoso, U.S. Geological Survey.
