U.S. Geological Survey Response to Hurricane Maria Flooding in Puerto Rico and Characterization of Peak Streamflows Observed September 20–22, 2017

By Julieta Gómez-Fragoso, Mark Smith, and Marilyn Santiago

Scientific Investigations Report 2022–5040
Version 1.1 (July 2022)

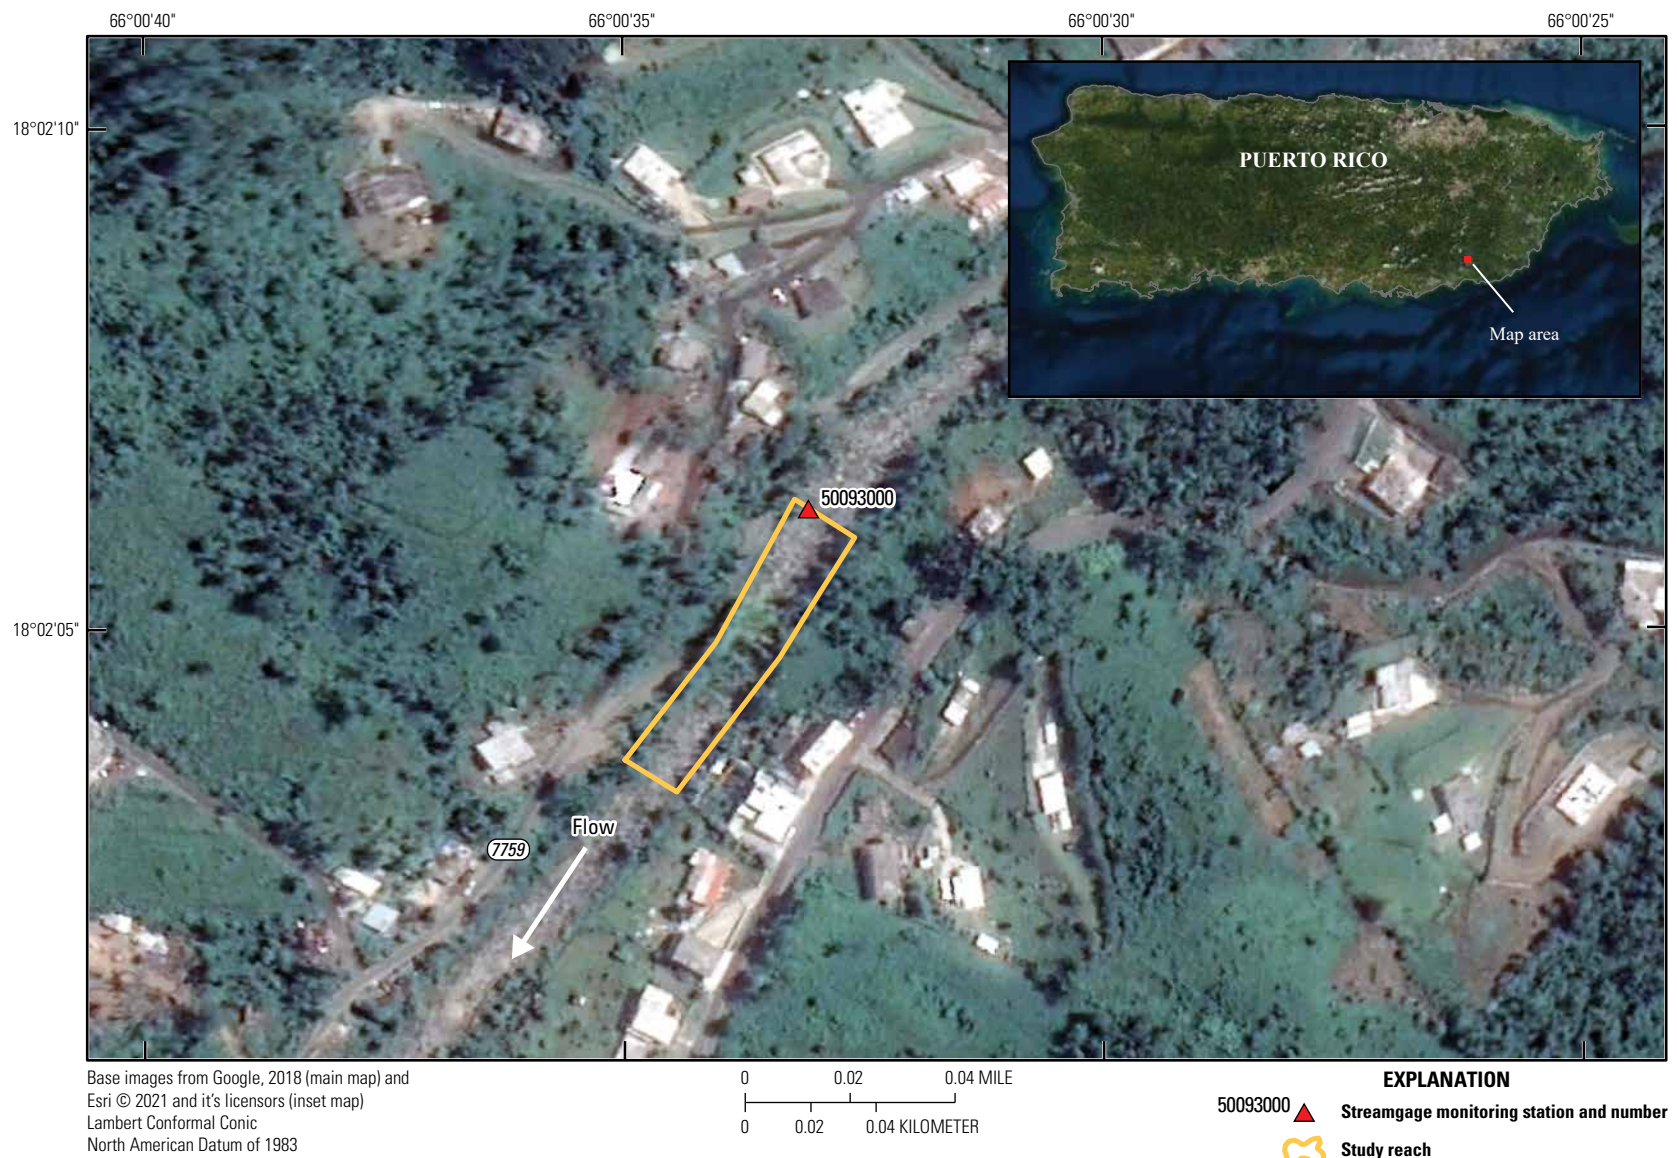
Figure 4.1. Location map of study reach at which continuous slope area sensors were installed near station 50093000 Río Marín near Patillas.

USGS field crews surveyed cross sections on May 21, 2018, at each of the four selected CSA locations, identified from upstream to downstream as CSA1, CSA2, CSA3, and CSA4. Channel geometry generally is uniform and trapezoidal in shape, and the channel bends to the right slightly between cross sections CSA2 and CSA3. Cross section CSA1 was surveyed at the streamgage and characterizes the geometry of the streamgage pool. The right bank consists of vertical bedrock and a retaining wall that extends up to the edge of a roadway at the level of the floodplain. The left floodplain is characterized by steep hillsides, some rock outcrops, and a few residential dwellings. Vegetation on the right bank consisted of grasses, seedlings, and sparse trees and bamboo near Route PR-7759 ([fig. 4.1](#)). Vegetation on the left bank was denser, consisting of grasses, shrubs, 25-ft tall trees, and thick stands of bamboo ([fig. 4.2](#)). Manning's *n*-values were assigned using the Cowan method (Cowan, 1956) during the field survey of May 19–22, 2018; field-assigned values were modified in the office based on shape-ratio tests (Davidian, 1984) to better represent the channel conditions for the range of streamflows observed from May to September 2018. A composite Manning's *n*-value of 0.069 was used for the cross section at CSA1, and a composite *n*-value of 0.054 was used for cross sections CSA2–CSA4.

A single PT was installed at each cross section near the bank of the lower main-channel section ([fig. 4.3](#)). Ideally, PTs would be installed on both sides of the channel to characterize cross-channel variability of the water-surface level; however, the budget scope for the pilot study initially provided for only one PT per cross section. As more data are collected and results are verified, additional PTs may be installed to assess cross-channel variations in water-surface level and how they might affect streamflow computations. Each PT is protected by a galvanized pipe attached to bedrock or large boulders and located 1 ft or more above the cross-section thalweg to ensure all PTs are submerged during high streamflows. Atmospheric-pressure corrections are applied to recorded gage-height values based on periodic readings made with a barometer stored in the streamgage shelter. All PTs are set to collect and record data at 5-minute intervals and the barometer is set to collect data at 15-minute intervals; USGS personnel visit the site routinely when high streamflow events occur, or at least every 6 months. Maintenance of the PTs includes verifying that all PT sensor clocks are synchronized, removing accumulated dust and sediment from the pipe enclosures, and downloading recorded data.

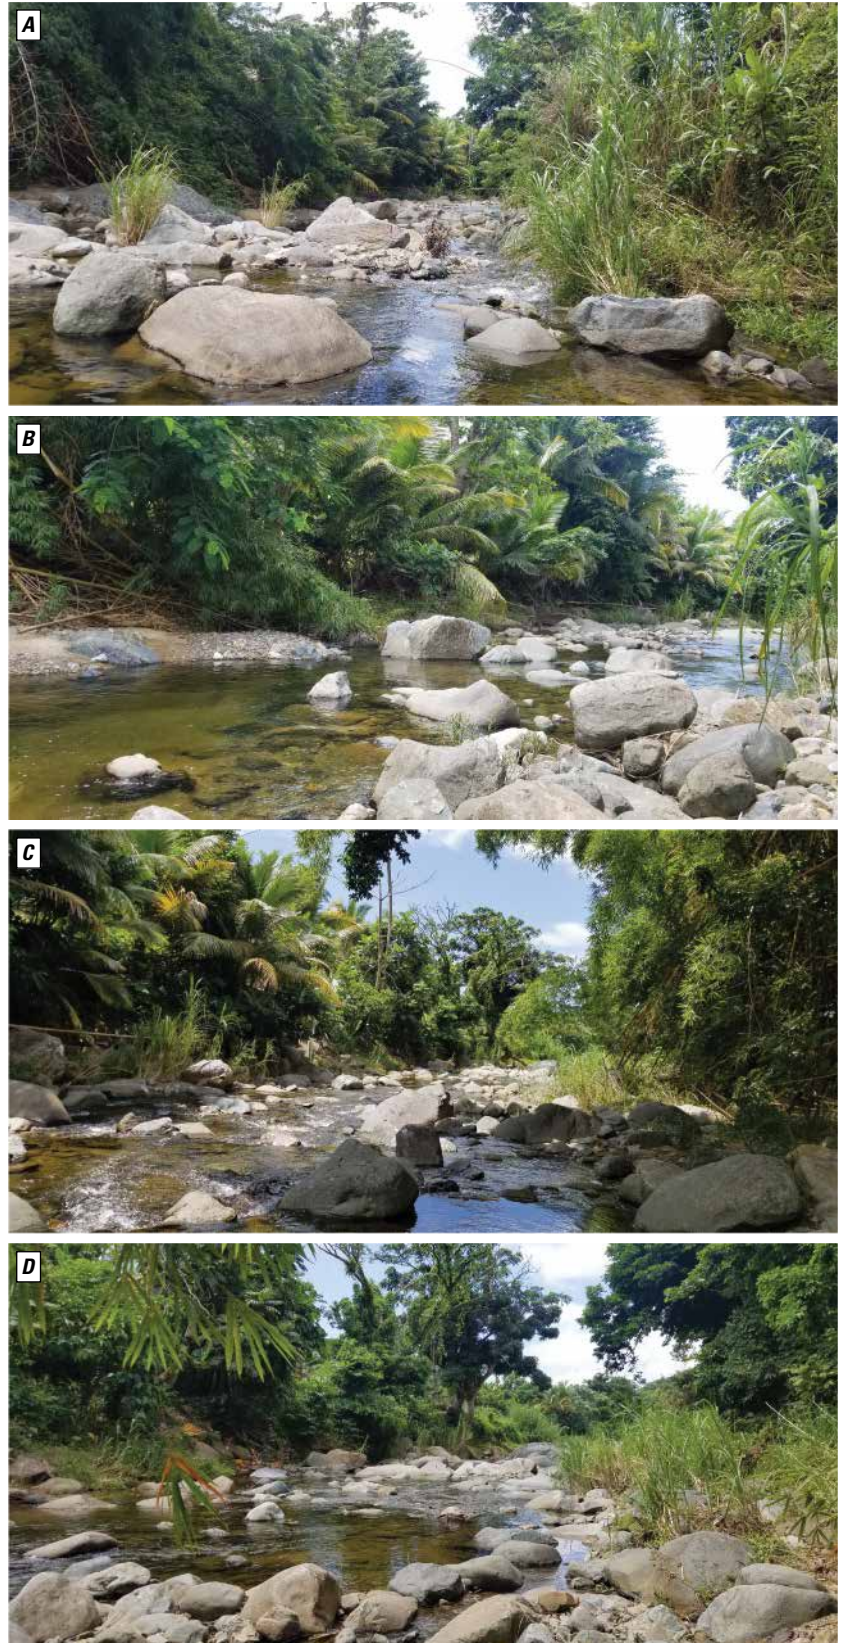
Figure 4.2. Views of study reach at continuous slope area (CSA) locations. *A*, CSA1, looking downstream; *B*, CSA2, looking downstream to the left bank; *C*, CSA3, looking downstream; and, *D*, CSA4, looking downstream at station 50093000 Río Marín near Patillas. Date of photographs is May 22, 2018. Photographs by Manuel Rosario, U.S. Geological Survey.

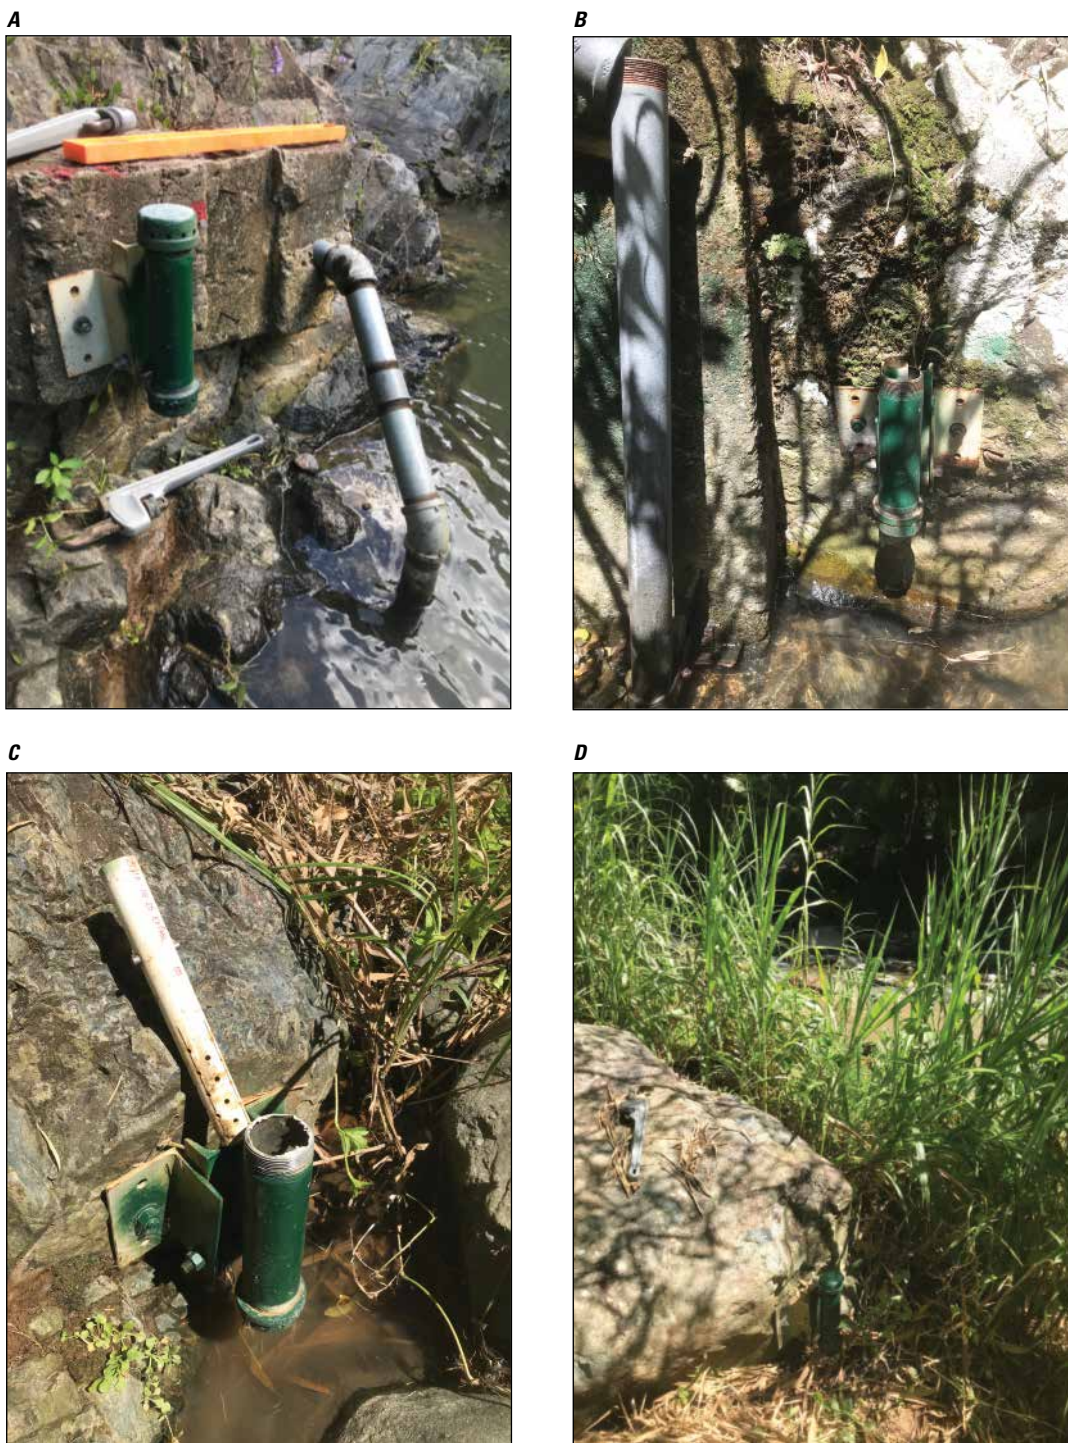
Figure 4.3. Pressure transducers installed at *A*, CSA1, *B*, CSA2, *C*, CSA3, and *D*, CSA4 at station 50093000 Río Marín near Patillas. Date of photographs is October 21, 2020. Photographs by Manuel Rosario, U.S. Geological Survey.

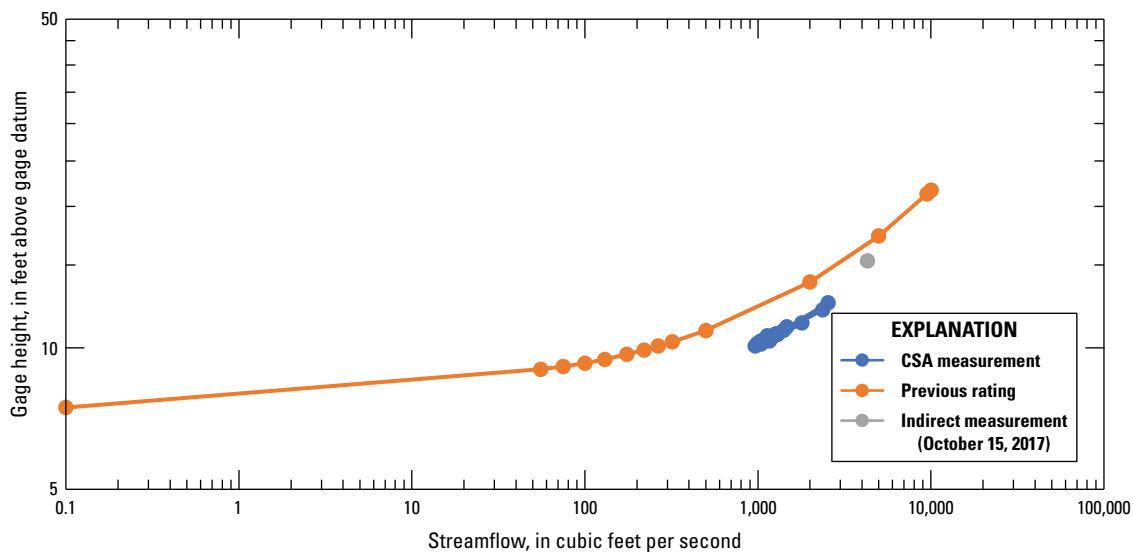
Figure 4.4. Continuous slope area (CSA) measurements for the 2018 water year, station 50093000 Río Marín near Patillas.

CSA methods were implemented in 2018 at USGS streamgages 50044810 Río Guadiana near Guadiana and 50093000 Río Marín near Patillas. At the time of this report, no CSA analyses of peak streamflows were available for streamgage 50044810 Río Guadiana near Guadiana. CSA analyses were conducted for 18 peak streamflows observed at streamgage 50093000 Río Marín near Patillas, for use in the development of a new stage-streamflow relation. All events occurred in the 2018 water year, and computed peak streamflows varied from 963 cubic feet per second (ft^3/s) (elevation of 10.10 ft above gage datum) to 2,250 ft^3/s (elevation of 12.47 ft above gage datum). The computations were rated as poor (uncertainty of ± 25 percent or greater) because of large uncertainties associated with the measurements (for example, no observed HWMs for verification of sensor readings and substantial scatter of 2-section computations versus the accepted, 4-section computation of peak streamflow). Appendix 4 documents the implementation of CSA methods at both pilot sites and provides a detailed discussion of peak-streamflow computations for CSA measurements made at streamgage 50093000 Río Marín near Patillas.
