Using Global Fiducials Library High-Resolution Imagery, Commercial Satellite Imagery, Landsat and Sentinel Satellite Imagery, and Aerial Photography to Monitor Change at East Timbalier Island, Louisiana, 1953–2021

By Gary B. Fisher, E. Terrence Slonecker, Shawn J. Dilles, Bruce F. Molnia, and
Kim M. Angeli

Scientific Investigations Report 2022–5107
Version 1.1, May 2023

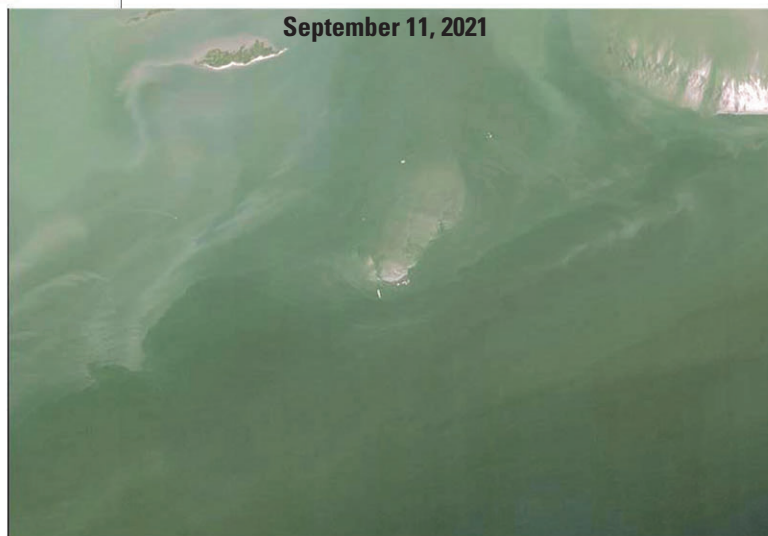
September 11, 2021

Front cover. Top left: Historical aerial photograph of East Timbalier Island, Louisiana, from March 26, 1953. Bottom right: WorldView-2 satellite image of East Timbalier Island, Louisiana, from September 11, 2021, showing the remnants of the Island.

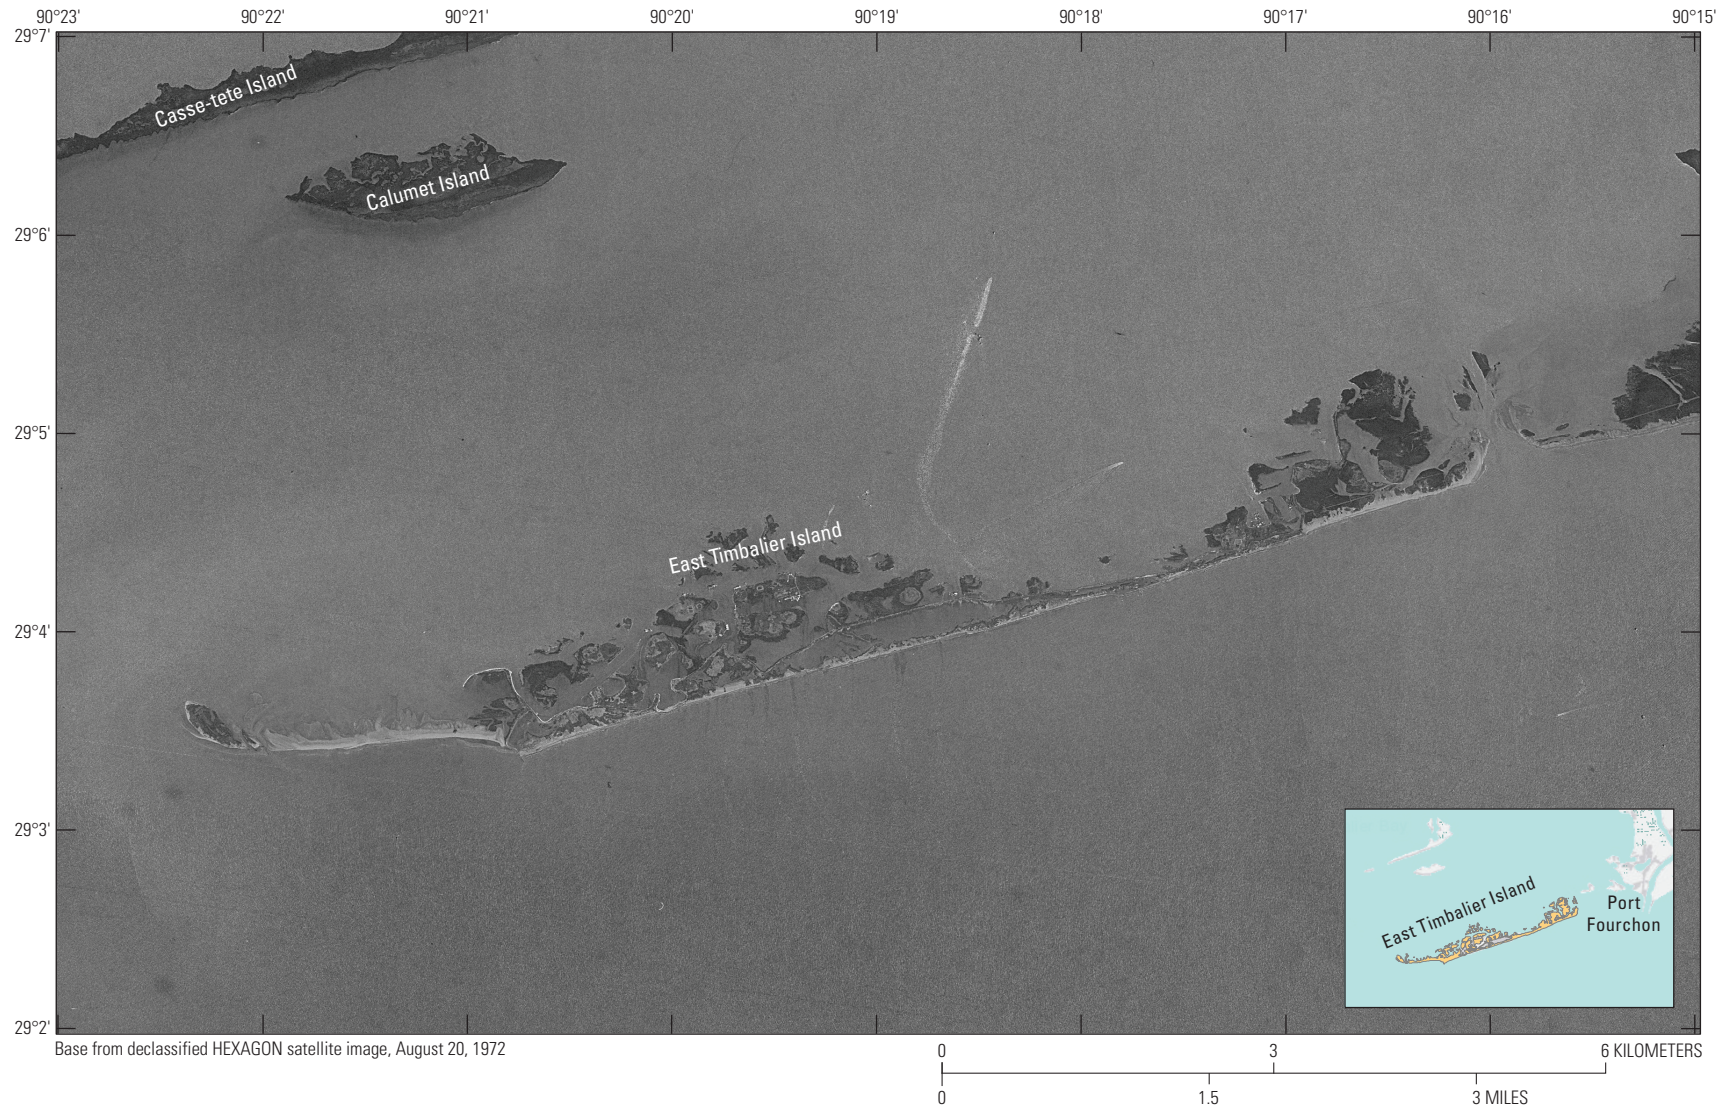
Figure 1.4. Declassified HEXAGON satellite image of East Timbalier Island, Louisiana, August 20, 1972.

The earliest pipelines, which crossed the Island, can be seen in the 1950s imagery. The images show two lines following the length of the Island westward from Belle Pass. [Appendix 1](#) contains imagery for all high-resolution images referenced in this report for 1953–2021. The 1950s imagery also shows several canals dug on the east side of the Island near Raccoon Pass ([figs. 1.1, 1.2](#)), as well as several canals and straightened shorelines on the west-central part of the Island where the main processing plant is located. In 1965, the canal dug into the western end of Belle Pass, east of Raccoon Pass inlet, quickly eroded and became a parallel inlet on the east side of Raccoon Pass ([fig. 1.3](#)). By 1972, the two inlets had merged into a single, 17-m-wide inlet that separated East Timbalier Island from the Belle Pass barrier spit ([fig. 1.4](#)).

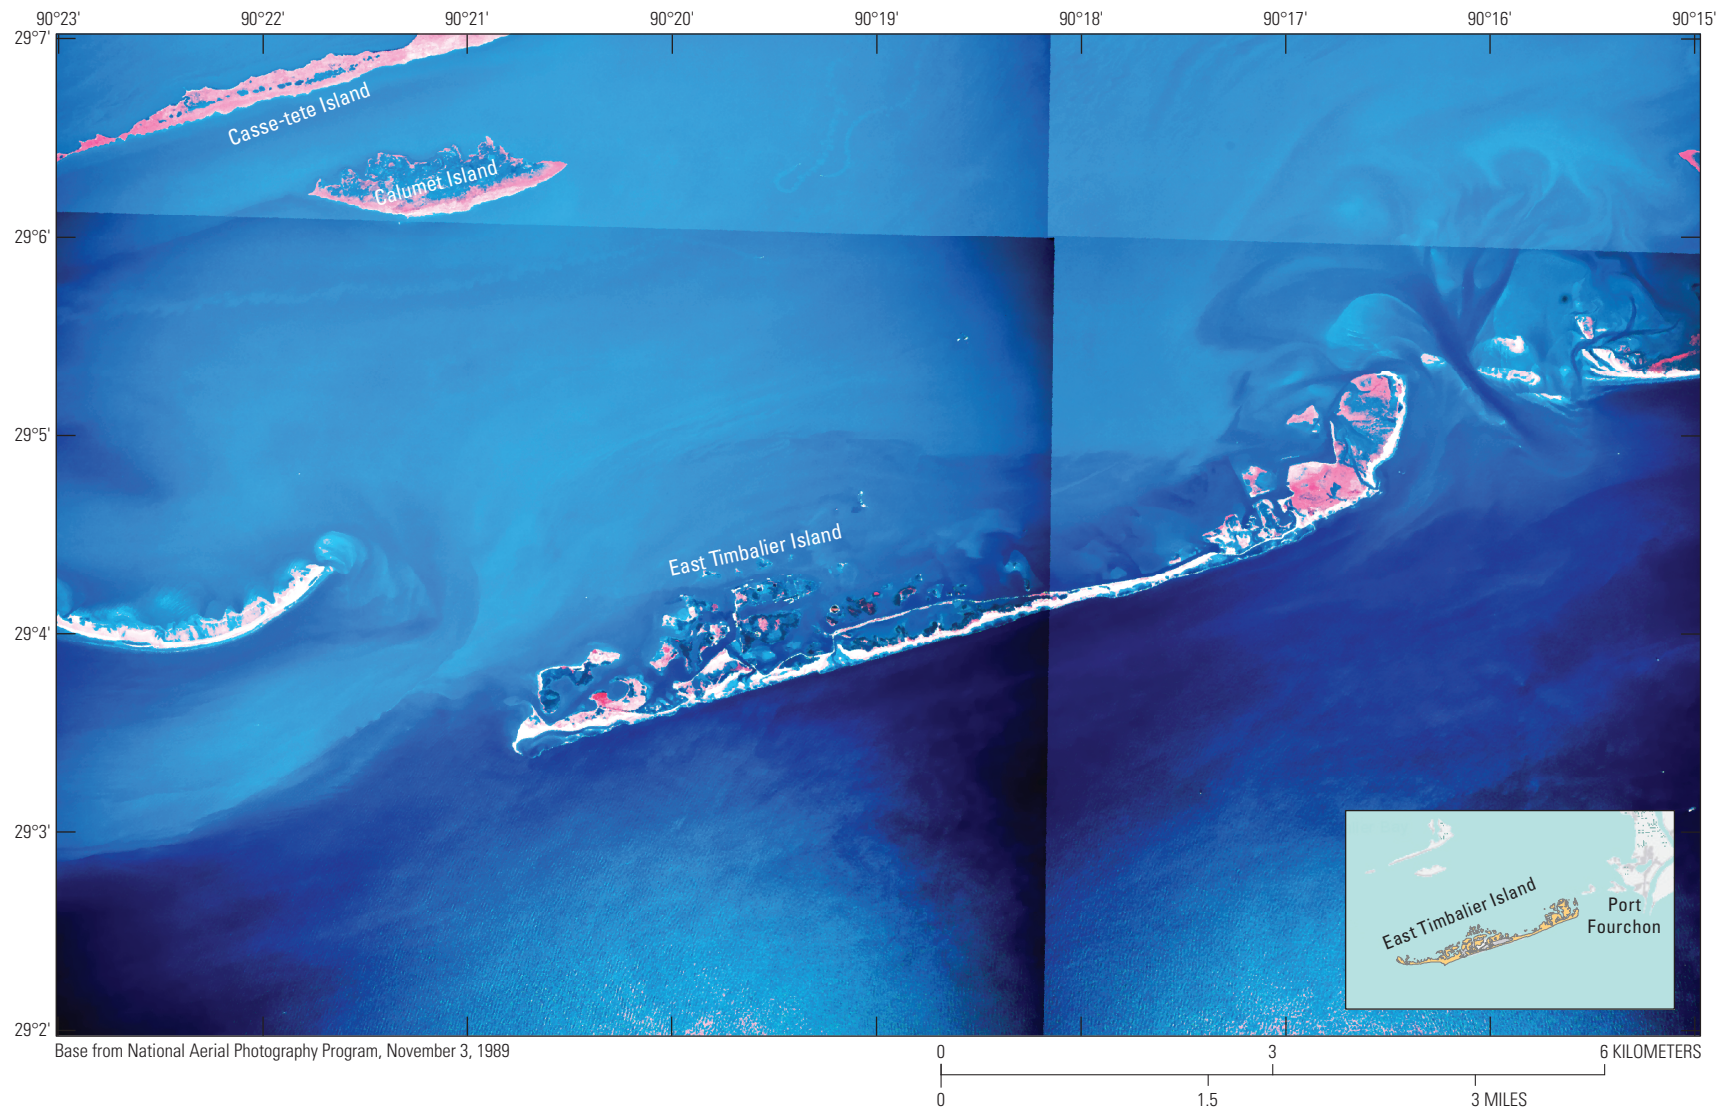
Figure 1.8. National Aerial Photography Program aerial photograph of East Timbalier Island, Louisiana, November 3, 1989.

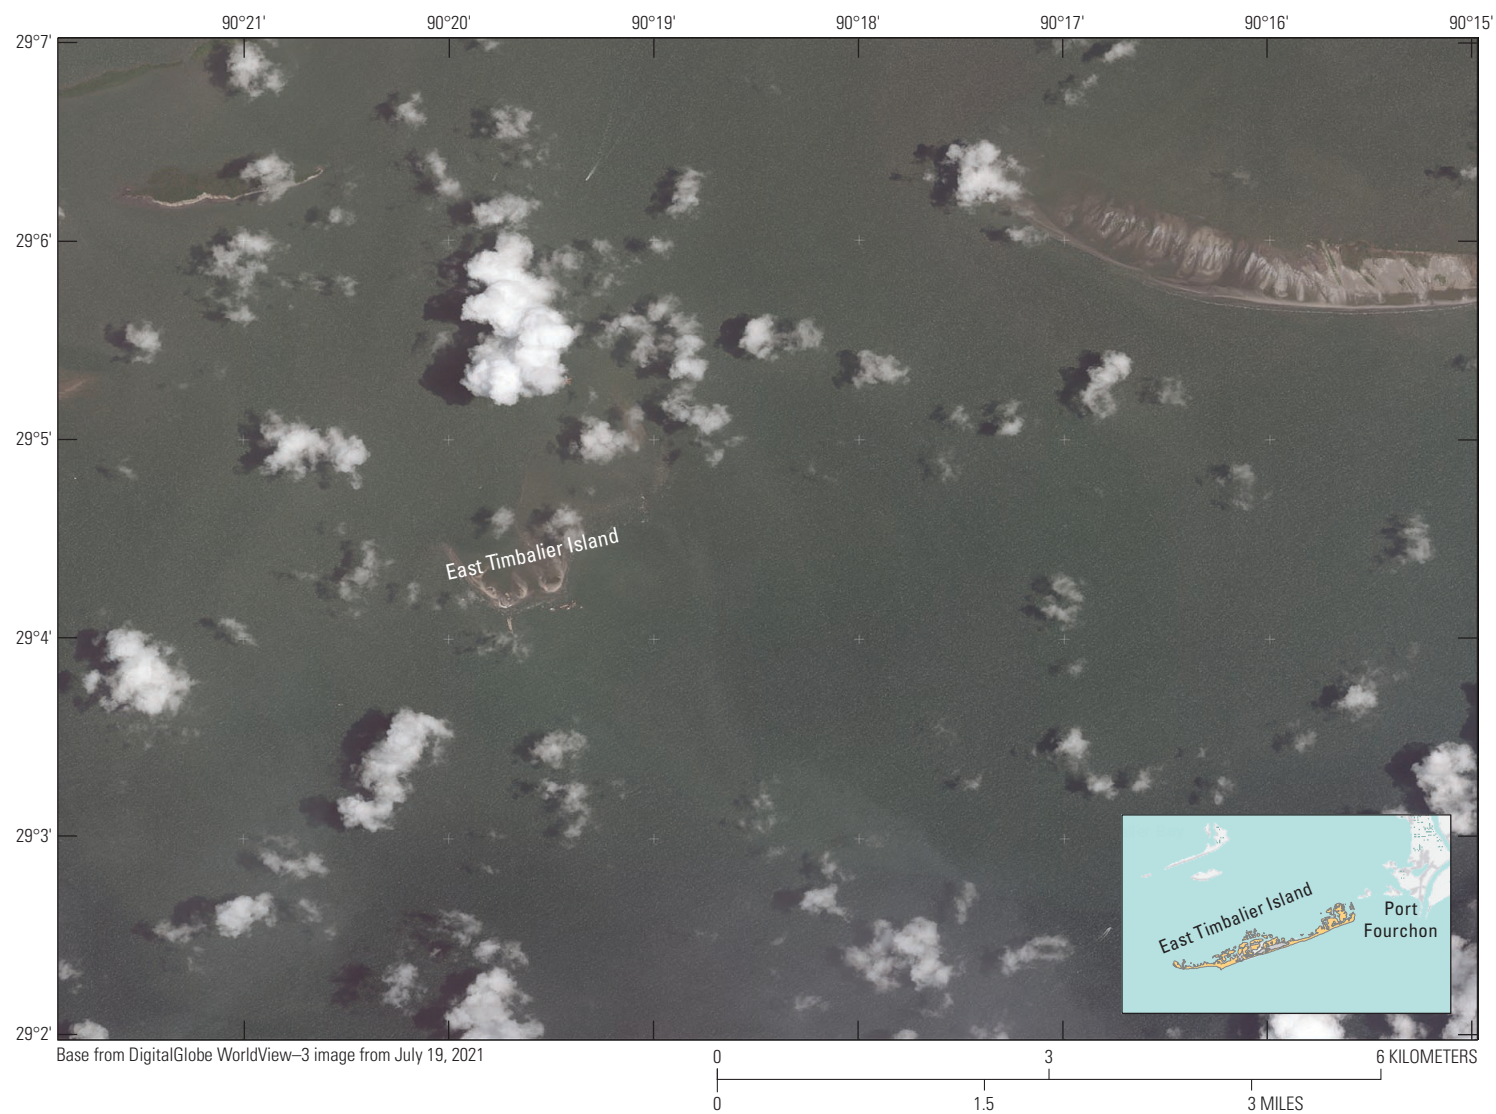
Figure 1.25. DigitalGlobe WorldView-3 image of the site of East Timbalier Island, Louisiana, July 19, 2021.
