Historical Changes to Channel Planform and Bed Elevations Downstream from Dams Along Fall Creek and Middle Fork Willamette River, Oregon, 1926–2016

Scientific Investigations Report 2023–5048

U.S. Department of the Interior
U.S. Geological Survey

By Mackenzie K. Keith, J. Rose Wallick, Gabriel W. Gordon, and
Heather D. Bervid

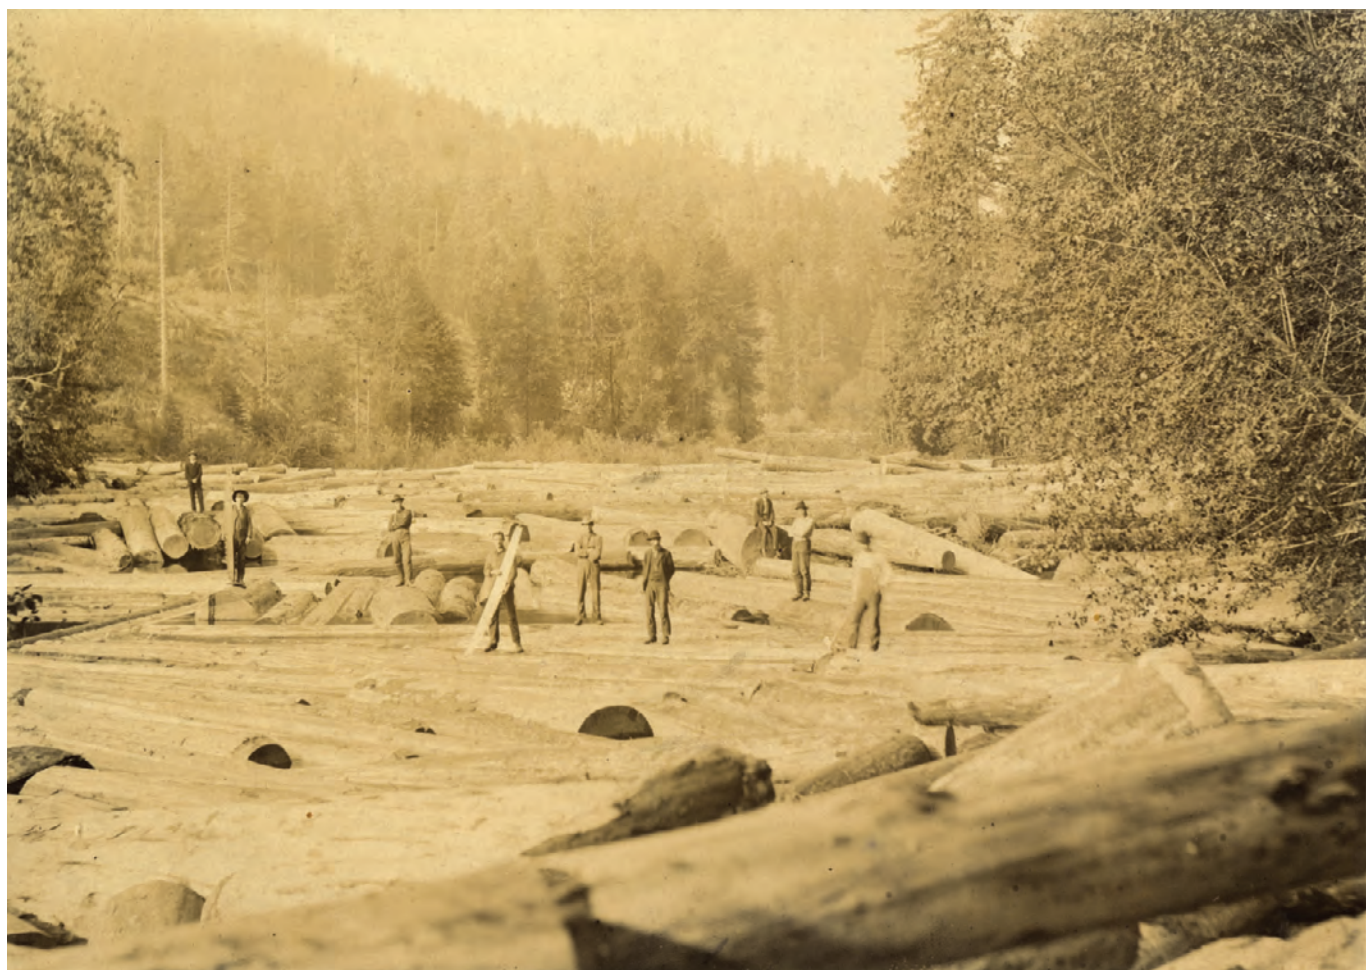
Figure 2. Log drive along Fall Creek, Oregon. Photograph taken about 1900 (date unknown) and provided by and used with permission from the Lane County History Museum.

facilitated by log drives and splash dams on the river channels (Miller, 2010; figs. 2–4). Instream gravel extraction, removal of large wood, various navigational improvements, and other activities also affected the river corridors of the Willamette River Basin (for example, Sedell and Froggatt, 1984; Benner and Sedell, 1997). One of the most substantial and persistent alterations to river morphology was perhaps the construction and operation of flood-control dams in the mid-20th century (Wallick and others, 2007). From 1941 to 1969, the USACE constructed 13 dams in the Willamette River Basin as part of the WVS, 3 of which are in the study area (fig. 1). Operation of these large, multipurpose dams has interrupted natural streamflow and sediment transport regimes along several major river corridors of the Willamette River Basin, including the Middle Fork Willamette River and Fall Creek (Wallick and others, 2013; O'Connor and others, 2014; Gregory and others, 2019). As part of the WVS, revetments were also constructed to stabilize streambanks throughout the major rivers of the Willamette River Basin (for example, Gregory and others, 2002b; Gregory and others, 2007; Wallick and others, 2007).

Other human alterations to the river channel, such as splash dams and log drives (*figs. 2–4*; Miller, 2010), tree clearing, and commercial gravel extraction may have also contributed to bed-level lowering before the implementation of large flood-control projects (dams and revetment), as has been suggested for other gravel-bed rivers in the Willamette River Basin (Klingeman, 1973; Sedell and Froggatt, 1984). Although the Dexter, Dougren, and Clearwater reaches were mainly vertically stable with local areas of lowering between 1926 and 2015, the entire Jasper reach was vertically stable. The only area with potential aggradation was the downstream end of the Dougren reach where water-surface elevations increased locally by as much as 1.7 m, which corresponds with the confluence of Fall Creek and the growth in mid-channel bars in this area (*fig. 13*). These patterns of vertical stability largely relate to geological controls and the distribution of bedrock versus alluvium observed in the present-day channel, which indicates the sensitivity of a particular reach to incision following reductions in bed-material supply that occurred after dam construction in the mid-20th century. Only short (less than 2-km) segments showed potential aggradation

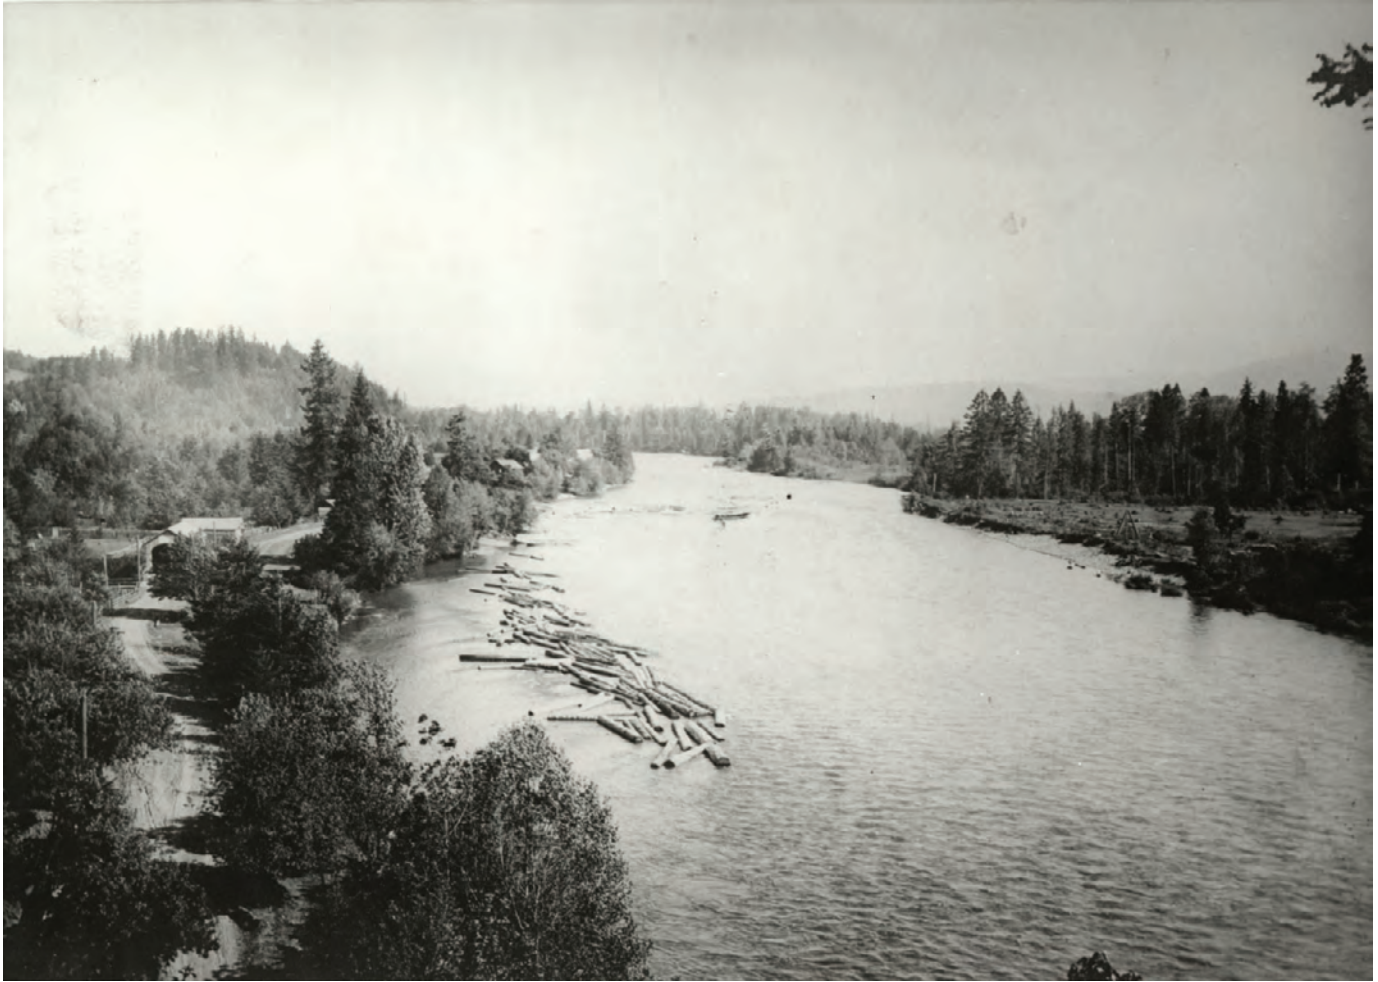
Figure 3. Logs floating to a sawmill along the Middle Fork Willamette River at Jasper, Oregon. Photograph taken in 1905 from area near Jasper Bridge looking upstream and provided by and used with permission from the Lane County History Museum.

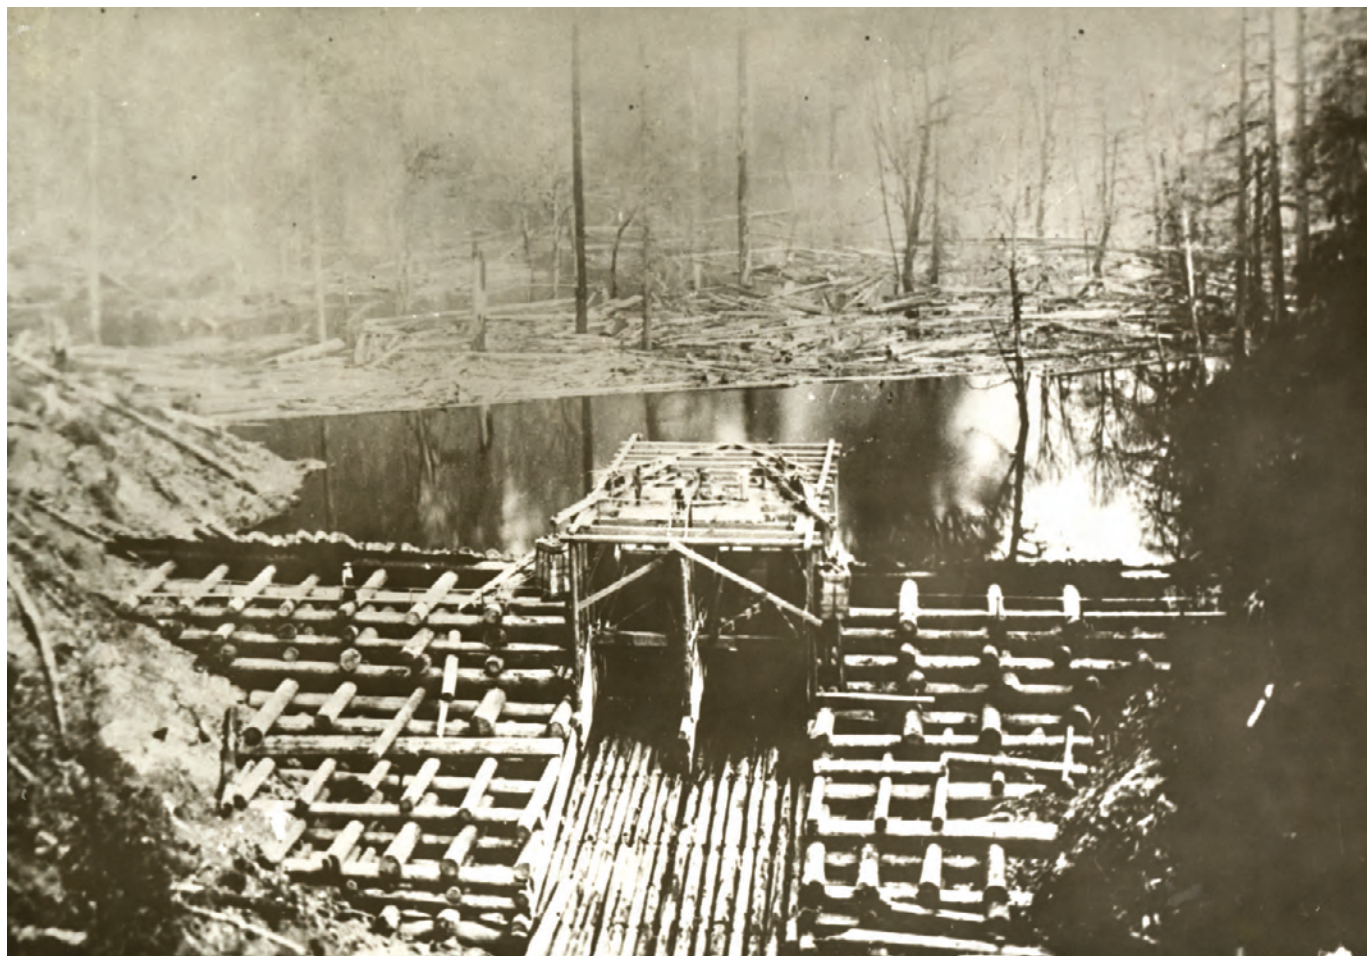
Figure 4. Splash dam along Fall Creek, Oregon. Photograph taken about 1900 (date unknown) and provided by and used with permission from the Lane County History Museum.

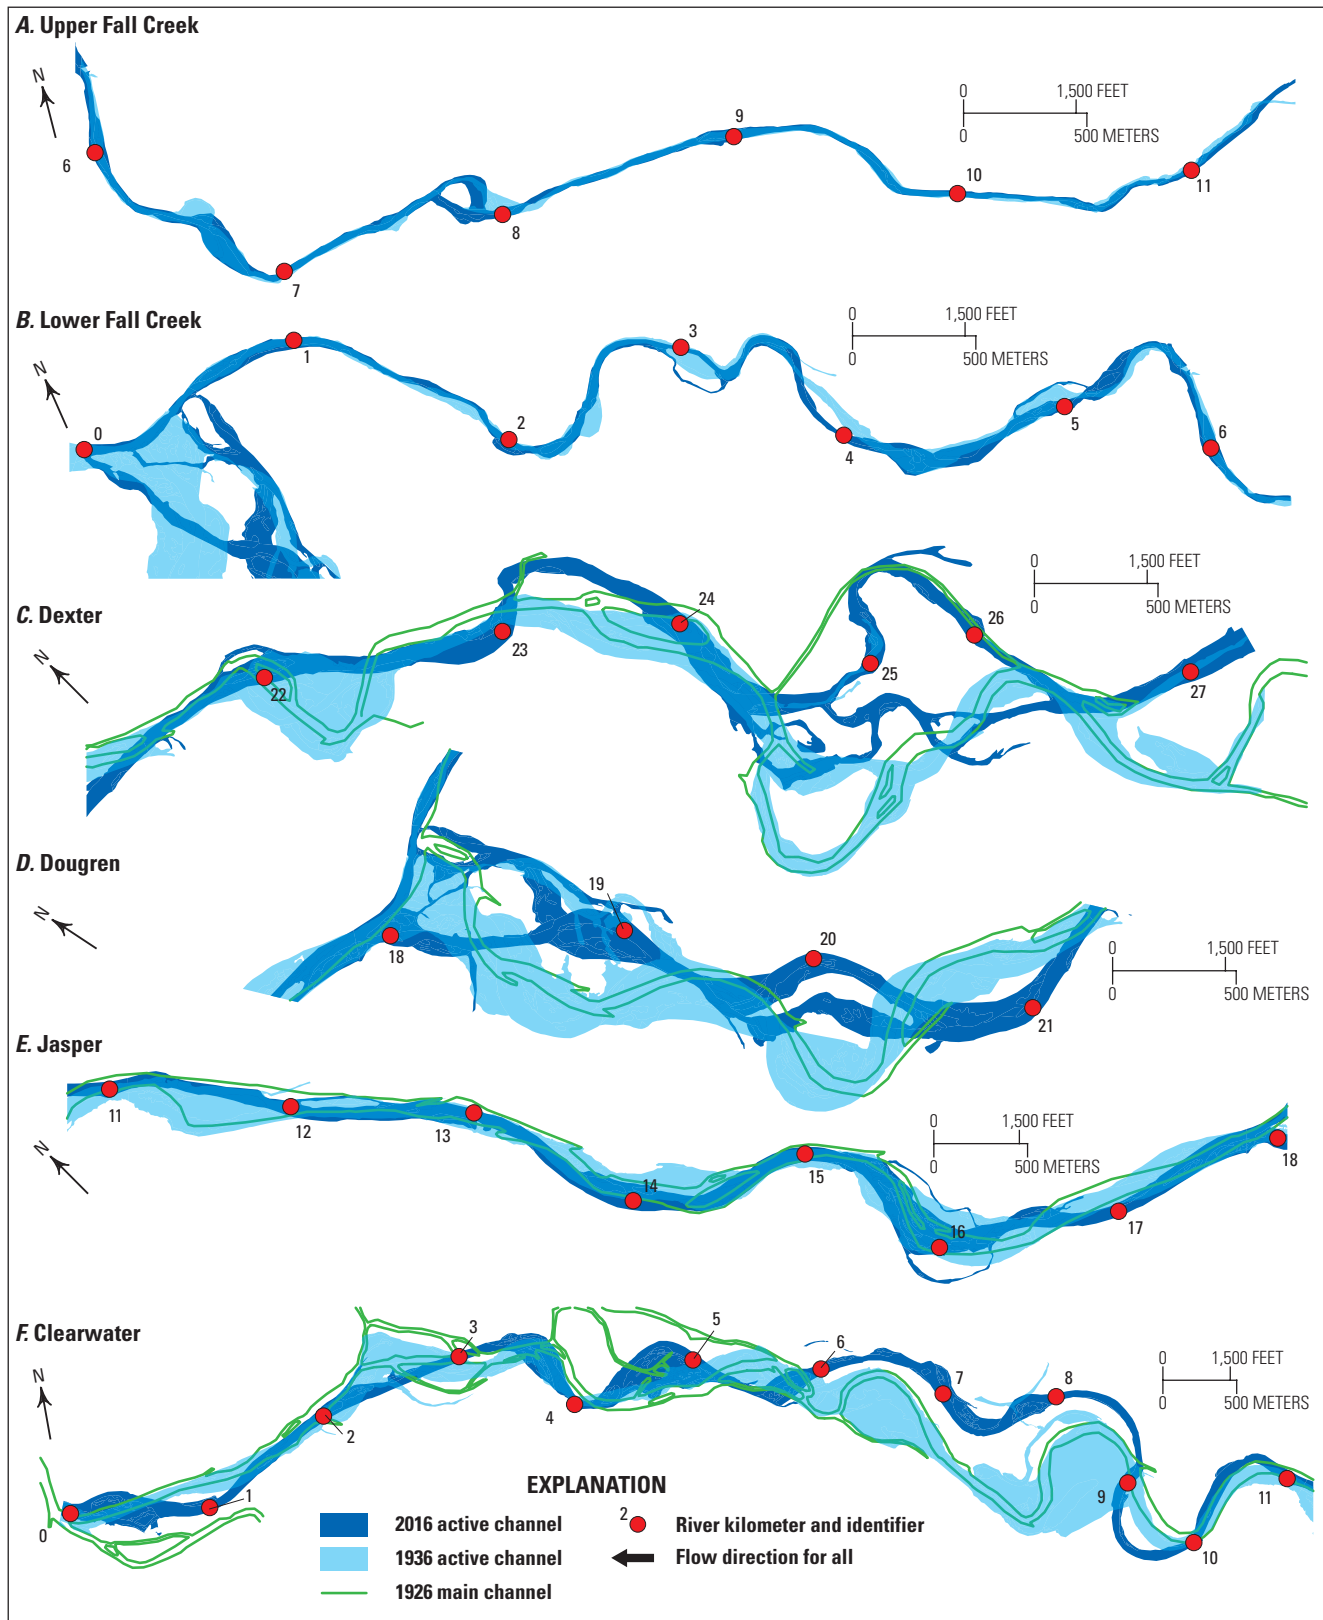
Figure 6. Planform of reaches in the study for Fall Creek and the Middle Fork Willamette River, Oregon. The 1926 outline represents the wetted channel boundary, whereas the 1936 and 2016 channel footprints depict the active channel boundary encompassing the main wetted channel, gravel bars, and secondary water features for the (A) Upper Fall Creek, (B) Lower Fall Creek, (C) Dexter, (D) Dougren, (E) Jasper, and (F) Clearwater reaches.

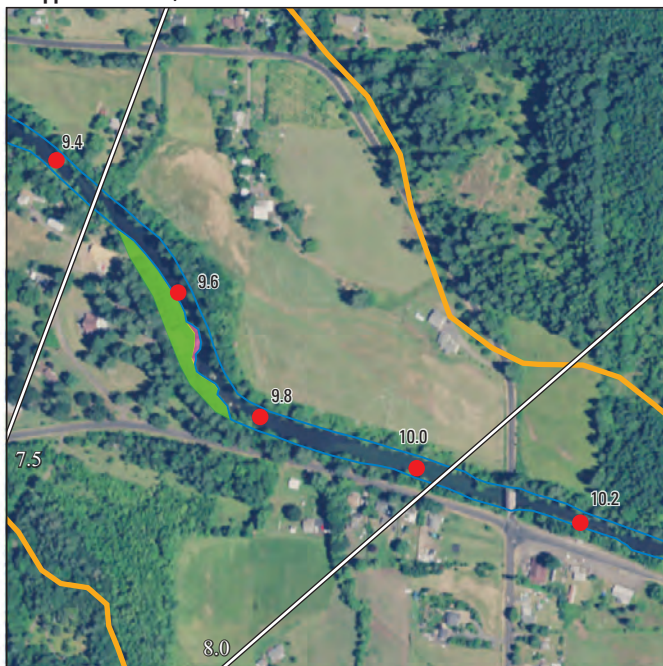
Figure 9. Repeat geomorphic mapping from aerial photographs for the Upper Fall Creek reach (river kilometers [rkm] 11.5–5.6, showing segment rkm 10.2–9.4) and the Lower Fall Creek reach (rkm 5.6–0.0; showing segment rkm 5.6–4.8), Oregon, 1936 (A and C) and 2016 (B and D). Repeat geomorphic mapping data are available from Keith and Gordon (2019).

Fall Creek was historically, and is presently, a narrow (table 1), semi-alluvial river with intermittent gravel bars (fig. 9). In 1936, the Upper Fall Creek reach had fewer total gravel bars and lowest total bar area (vegetated and unvegetated) than other reaches in the study area (61,400 m²; table 4; figs. 8, 9A). By 2016, nearly all the unvegetated bars in the Upper Fall Creek reach (fig. 9B) had either been eroded

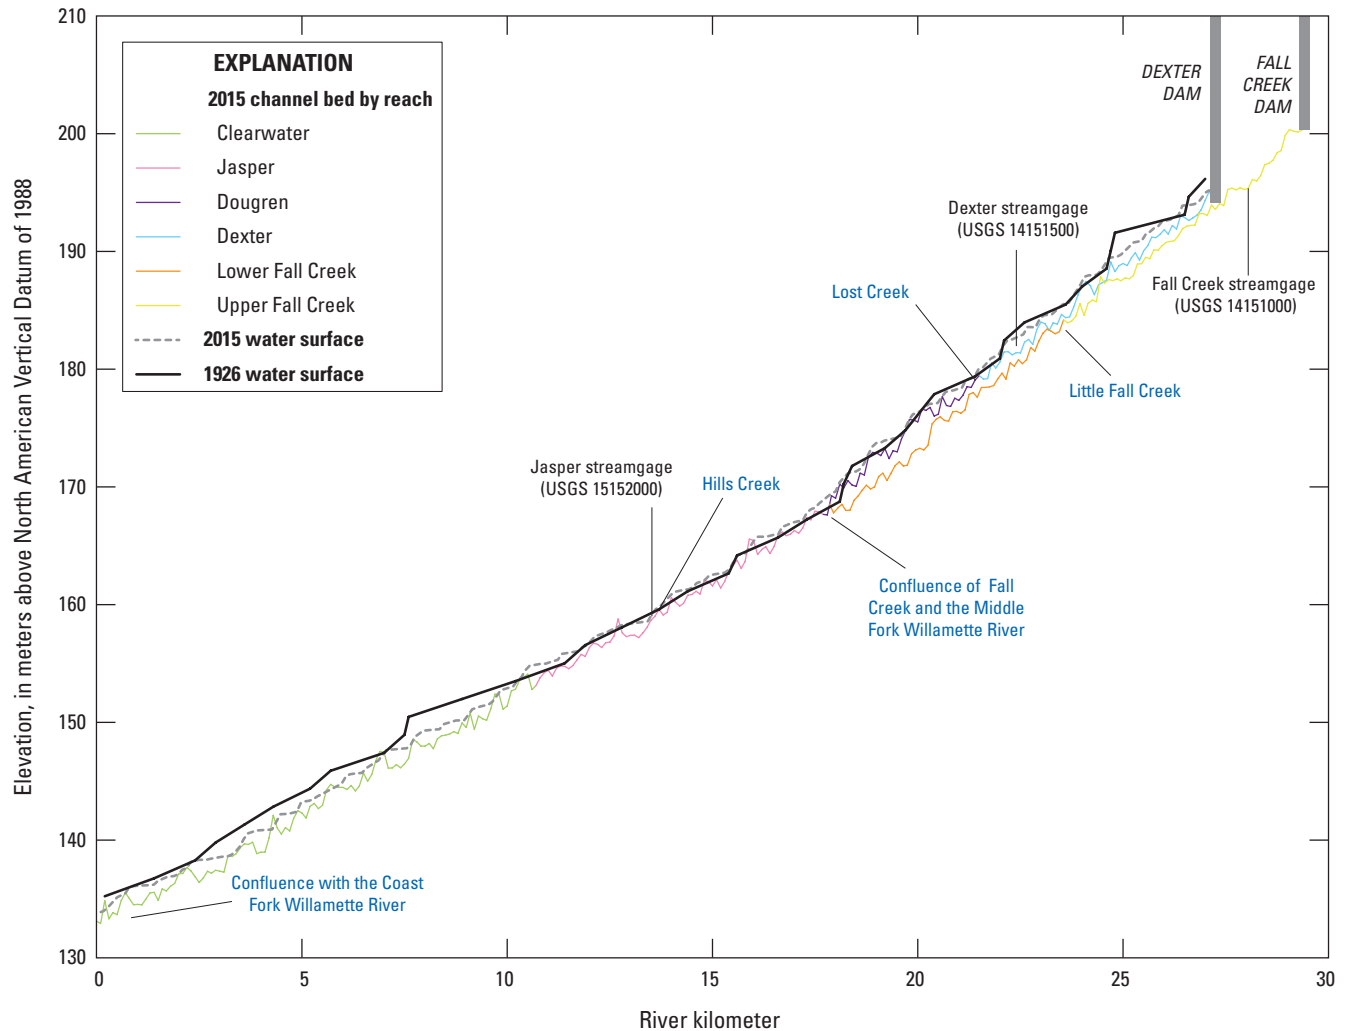
Figure 13. Recent longitudinal profiles for Fall Creek and the Middle Fork Willamette River, Oregon, from 2015 bathymetric lidar channel-bed and water-surface elevations (Quantum Spatial, 2016). Historical longitudinal profile for the Middle Fork Willamette River, Oregon, from 1926 water-surface elevation (U.S. Geological Survey, 1927).

Comparison of longitudinal water-surface profiles of the Middle Fork Willamette River extending from Dexter Dam to the confluence with the Coast Fork Willamette River (fig. 13) derived from 1926 plan and profile maps (USGS, 1927) and 2015 bathymetric lidar (water-surface and channel-bed elevations; Quantum Spatial, 2016) showed that the water-surface profile along much of the 27-km channel segment has remained largely similar over the 90-year period between surveys. Observed changes in water-surface elevation were used to indicate bed elevation changes, particularly when evaluating profiles over distances greater than 1 km. The magnitude and spatial extent of divergences between historical and recent profile elevations were the smallest along the Jasper reach, where water-surface profiles were largely similar although slightly greater (0.05–0.84 m higher) in 2015 than in 1926 at comparable locations. Areas with the most apparent lowering of water-surface elevations from 1926 to 2015 were along localized segments of the Dexter, Dougren, and Clearwater reaches. By reach, the locations with greatest decrease in water-surface elevation were rkm 24.8 in the Dexter reach (1.9 m lower), rkm 20.4 in the Dougren reach (0.7 m), and rkm 7.6 in the Clearwater reach (2.3 m; fig. 13). This lowering encompassed 2–10-km-long segments of the river, coinciding with knickpoint-like features (abrupt change in slope along the profile) and areas where the channel flows along steep (greater than about 2-m) channel banks. This study did not identify channel segments (greater than about 2 km in length) with substantial increases (more than 1 m) in the profile elevations between 1926 and 2015 that would indicate any systematic aggradation in the study area. However, at the downstream end of the Dougren reach, there was one instance where the 2015 water-surface profile was higher than 1926 by as much as 1.7 m (fig. 13). The water-surface elevations in both 1926 and 2015 reflect discharge at the time of the surveys; streamflows were not monitored in 1926, so the actual error associated could be quite large, particularly as streamflows increase for the Middle Fork Willamette River as indicated by current streamflow-stage relations (see discussion of error in section, “Plan and Profile Maps from 1926”). Overall, these findings show that, whereas much of the Middle Fork Willamette River downstream from Dexter Dam was vertically stable from 1926 to 2015, some segments likely have undergone bed-level lowering and incision.
