Bathymetric and Velocimetric Surveys at Highway Bridges Crossing the Missouri and Mississippi Rivers near St. Louis, Missouri, August 3–10, 2020

Scientific Investigations Report 2023–5050
Version 1.1, June 2023

U.S. Department of the Interior
U.S. Geological Survey

By Richard J. Huizinga

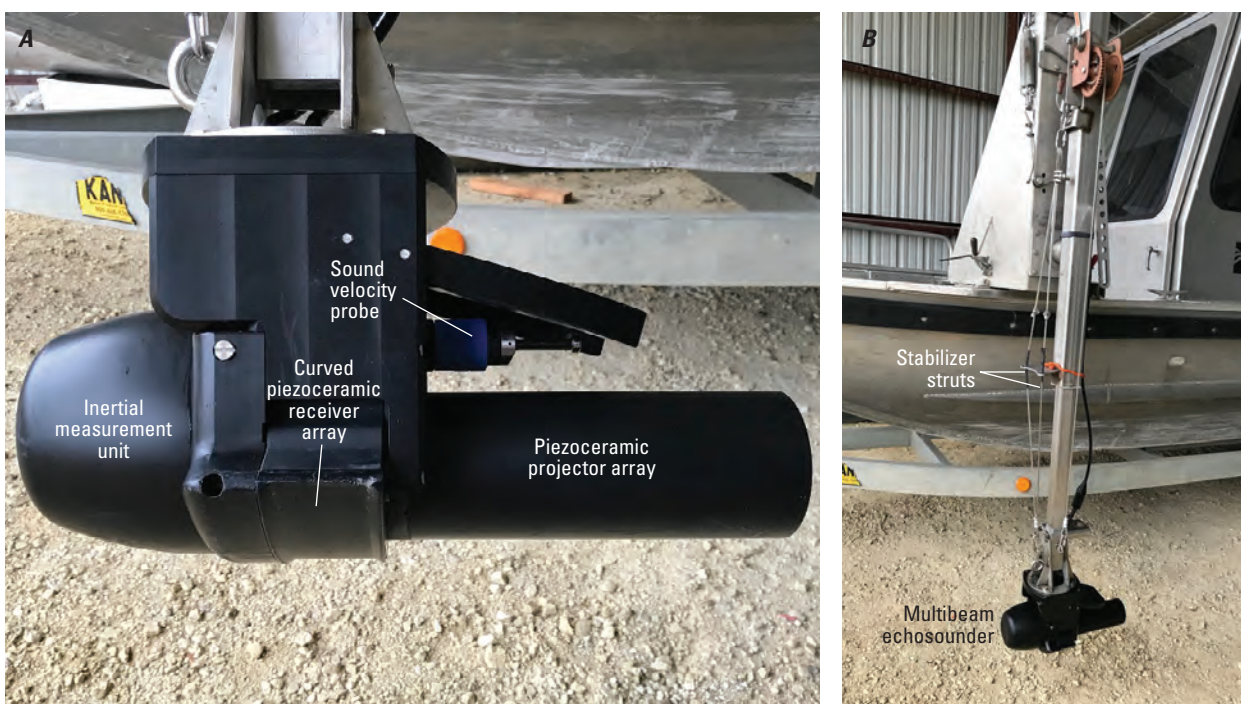
Figure 3. The multibeam echosounder. Photographs by Richard J. Huizinga, U.S. Geological Survey (USGS). A, Viewed from the side. B, Mounted on the port side of a USGS boat.

Data from the MBES and INS components were processed and integrated into a cohesive dataset for cleanup and visualization. A computer onboard the survey vessel ran the HYPACK/HYSWEEP data acquisition software (version 2020; HYPACK, Inc., 2020) that was used to prepare for and do bathymetric surveys. After completing the surveys, the acquired depth data were further processed to remove data spikes and other spurious points in the multibeam swath trace, georeferenced using the navigation and position solution data from the SBET file and visualized in HYPACK/HYSWEEP as a gridded bathymetric surface or a point cloud.

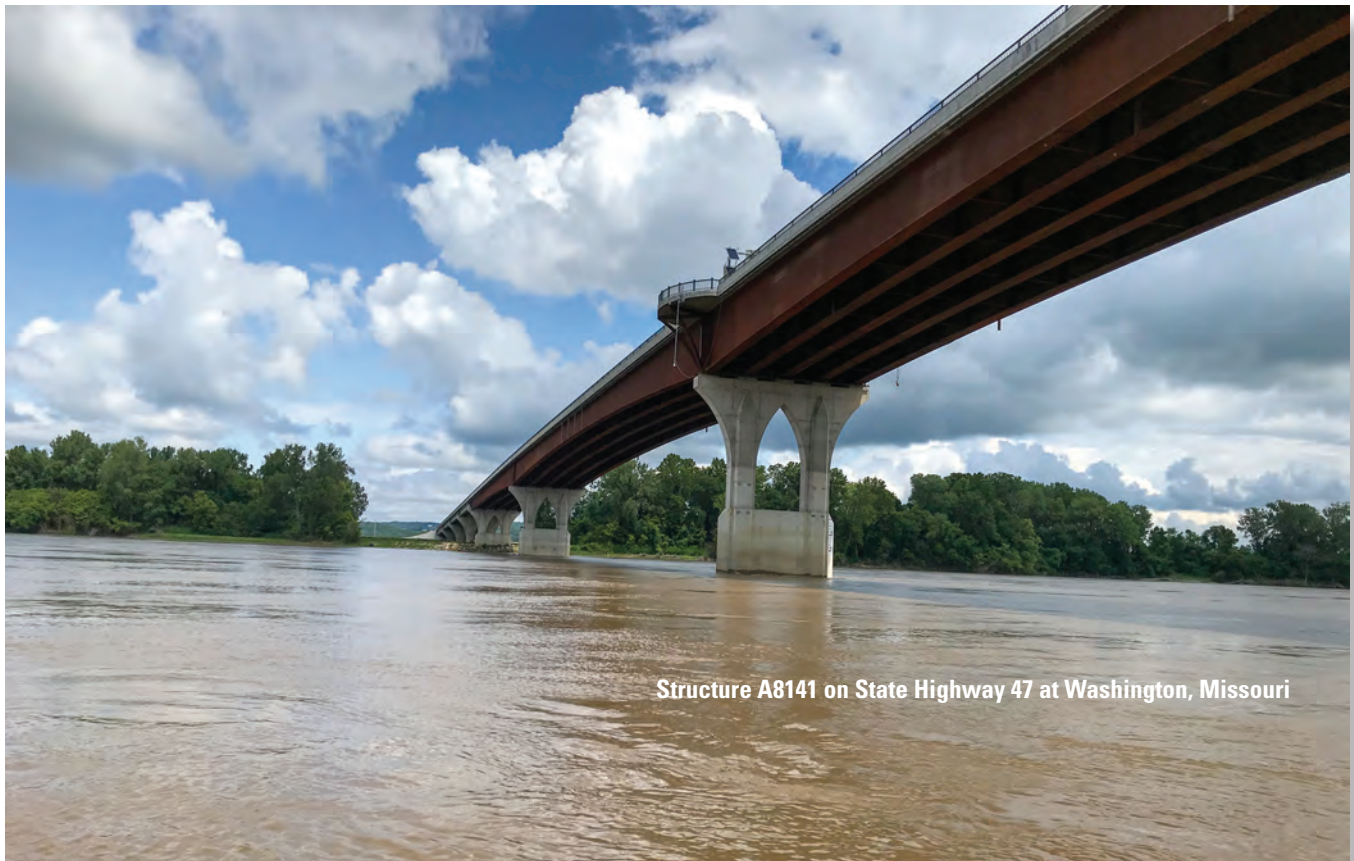
Structure A8141 on State Highway 47 at Washington, Missouri

Figure 11. Bathymetry and vertically averaged velocities of the Missouri River channel near structure A8141 on State Highway 47 at Washington, Missouri.

The vertically averaged velocity vectors indicate mostly uniform flow in the middle of the channel, where velocities range from about 4 to 9 feet per second (ft/s; fig. 11). Local lower velocities and turbulence were observed downstream from the various spur dikes on both banks (fig. 11). The wake vortices downstream from piers 6 and 7 were not pronounced and seemed to be no greater than the general nonuniformity of flow observed in the channel (fig. 11). Minor localized turbulence was present in all the sections (fig. 11).

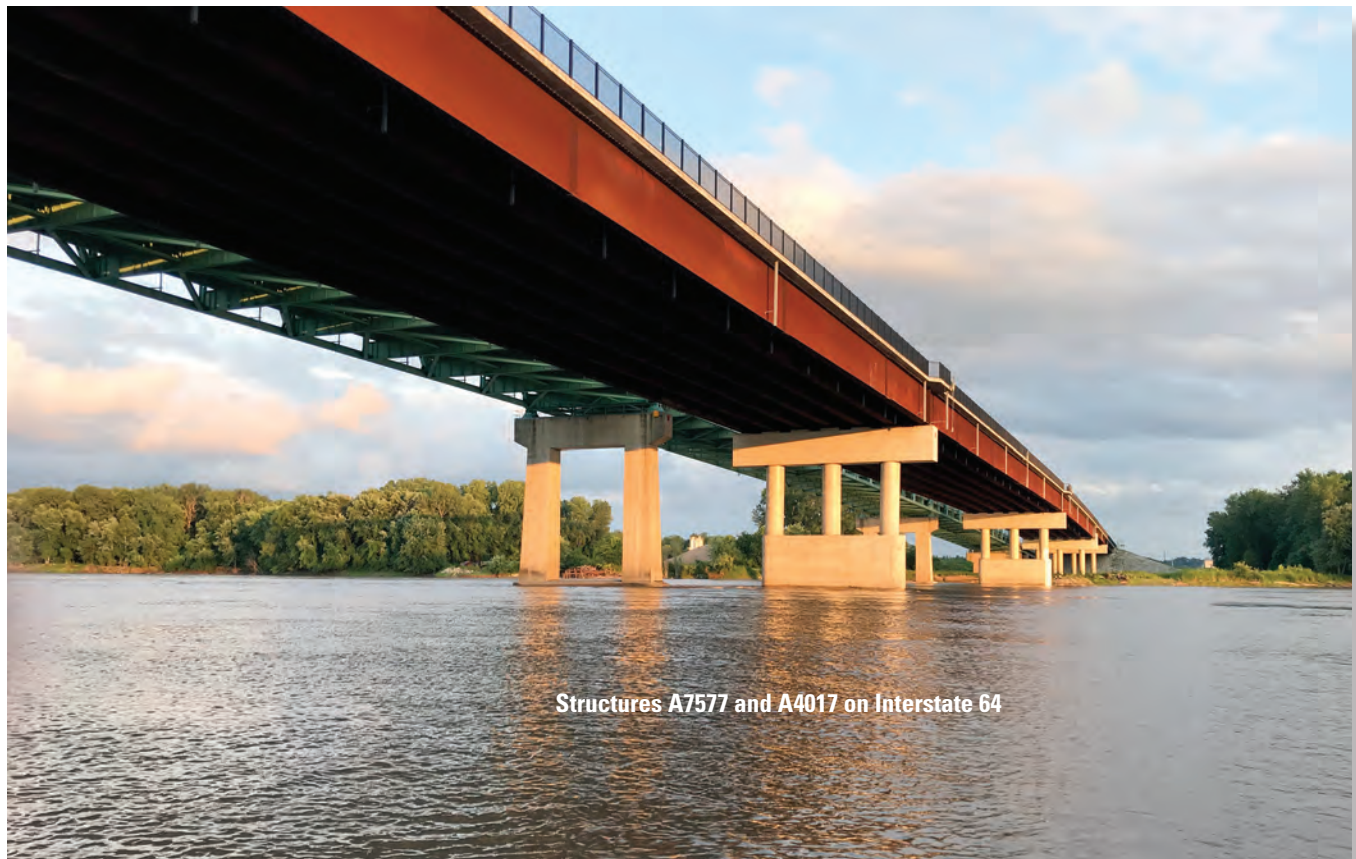
Structures A7577 and A4017 on Interstate 64

Figure 19. Bathymetry and vertically averaged velocities of the Missouri River channel near structures A7577 and A4017 on Interstate 64 near St. Louis, Missouri.

The vertically averaged velocity vectors, which ranged from about 4 to 9 ft/s, indicate mostly uniform flow in the middle of the channel (fig. 19). Local lower velocities and turbulence were observed downstream from the various spur dikes on both banks (fig. 19). The wake vortices downstream from the main channel piers and bents were not pronounced and seemed to be no greater than the general nonuniformity of flow observed in the channel (fig. 19). Minor localized turbulence was present in all the sections (fig. 19).

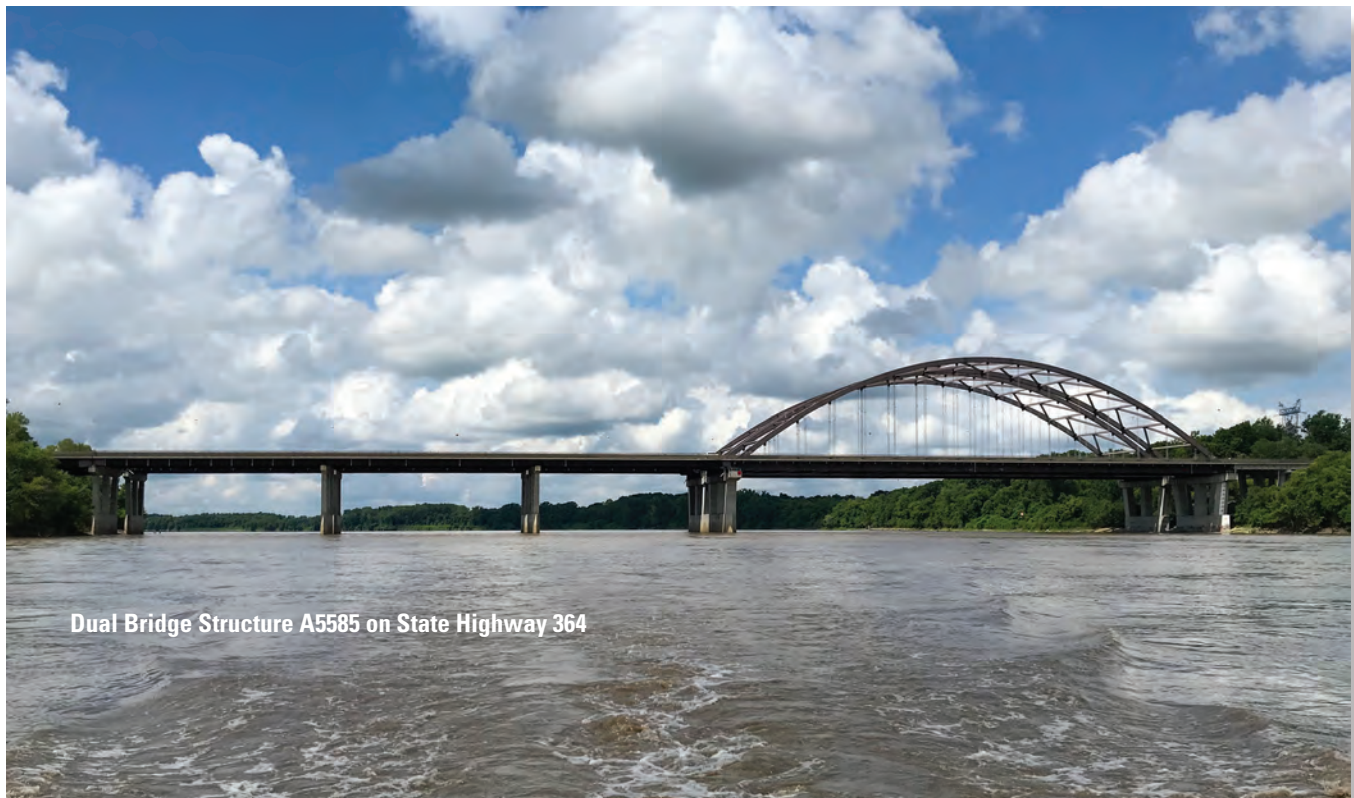
Figure 27. Bathymetry and vertically averaged velocities of the Missouri River channel near dual bridge structure A5585 on State Highway 364 near St. Louis, Missouri.

The vertically averaged velocity vectors, which range from about 4 to 9 ft/s, indicate mostly uniform flow in the middle of the channel (fig. 27). Lower velocities and

turbulence were observed on the right (south) side of the channel. The wake vortices downstream from pier 5 were slightly more substantial than at sites 22 or 23 but seemed to be no greater than the general nonuniformity of flow observed in the channel (fig. 27). Minor localized turbulence again was present in all the sections (fig. 27).

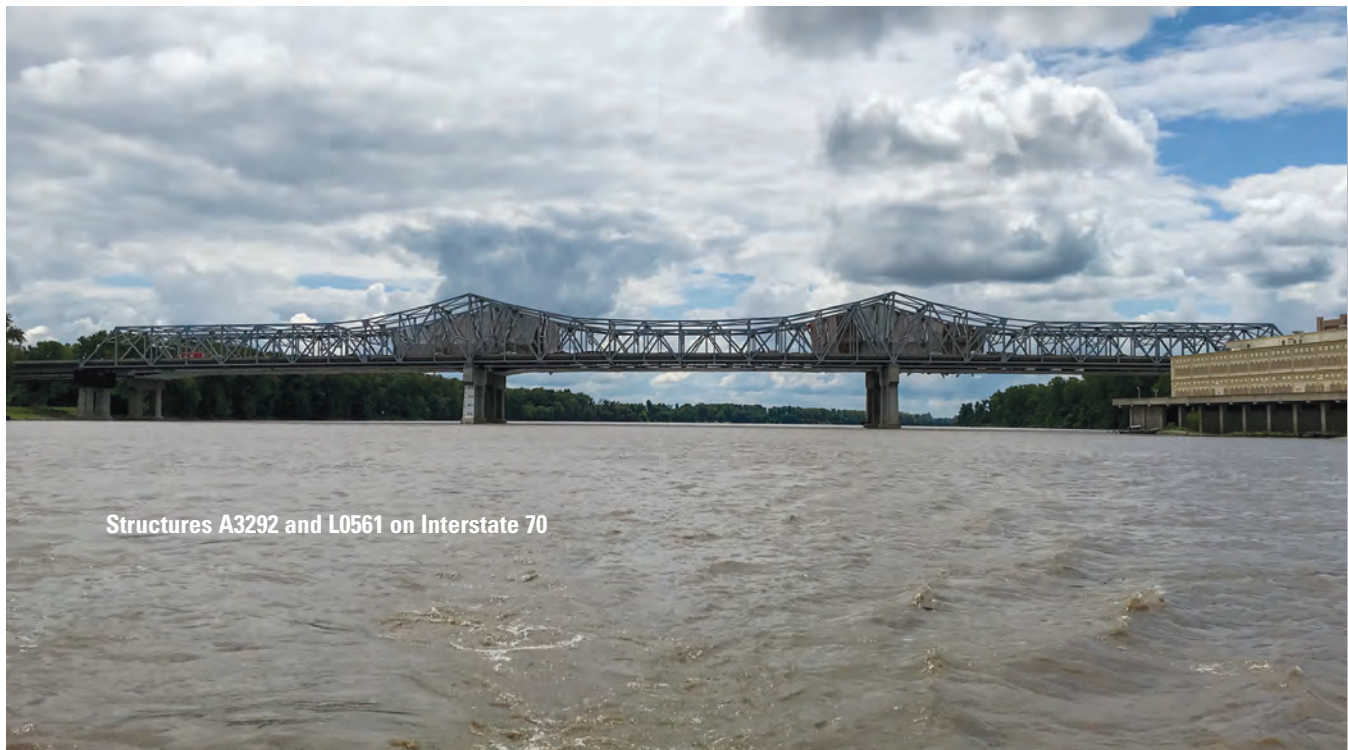
Figure 30. Key features, substructural and superstructural details, and surveyed channel bed of structure A3292 on Interstate 70 crossing the Missouri River near St. Louis, Missouri.

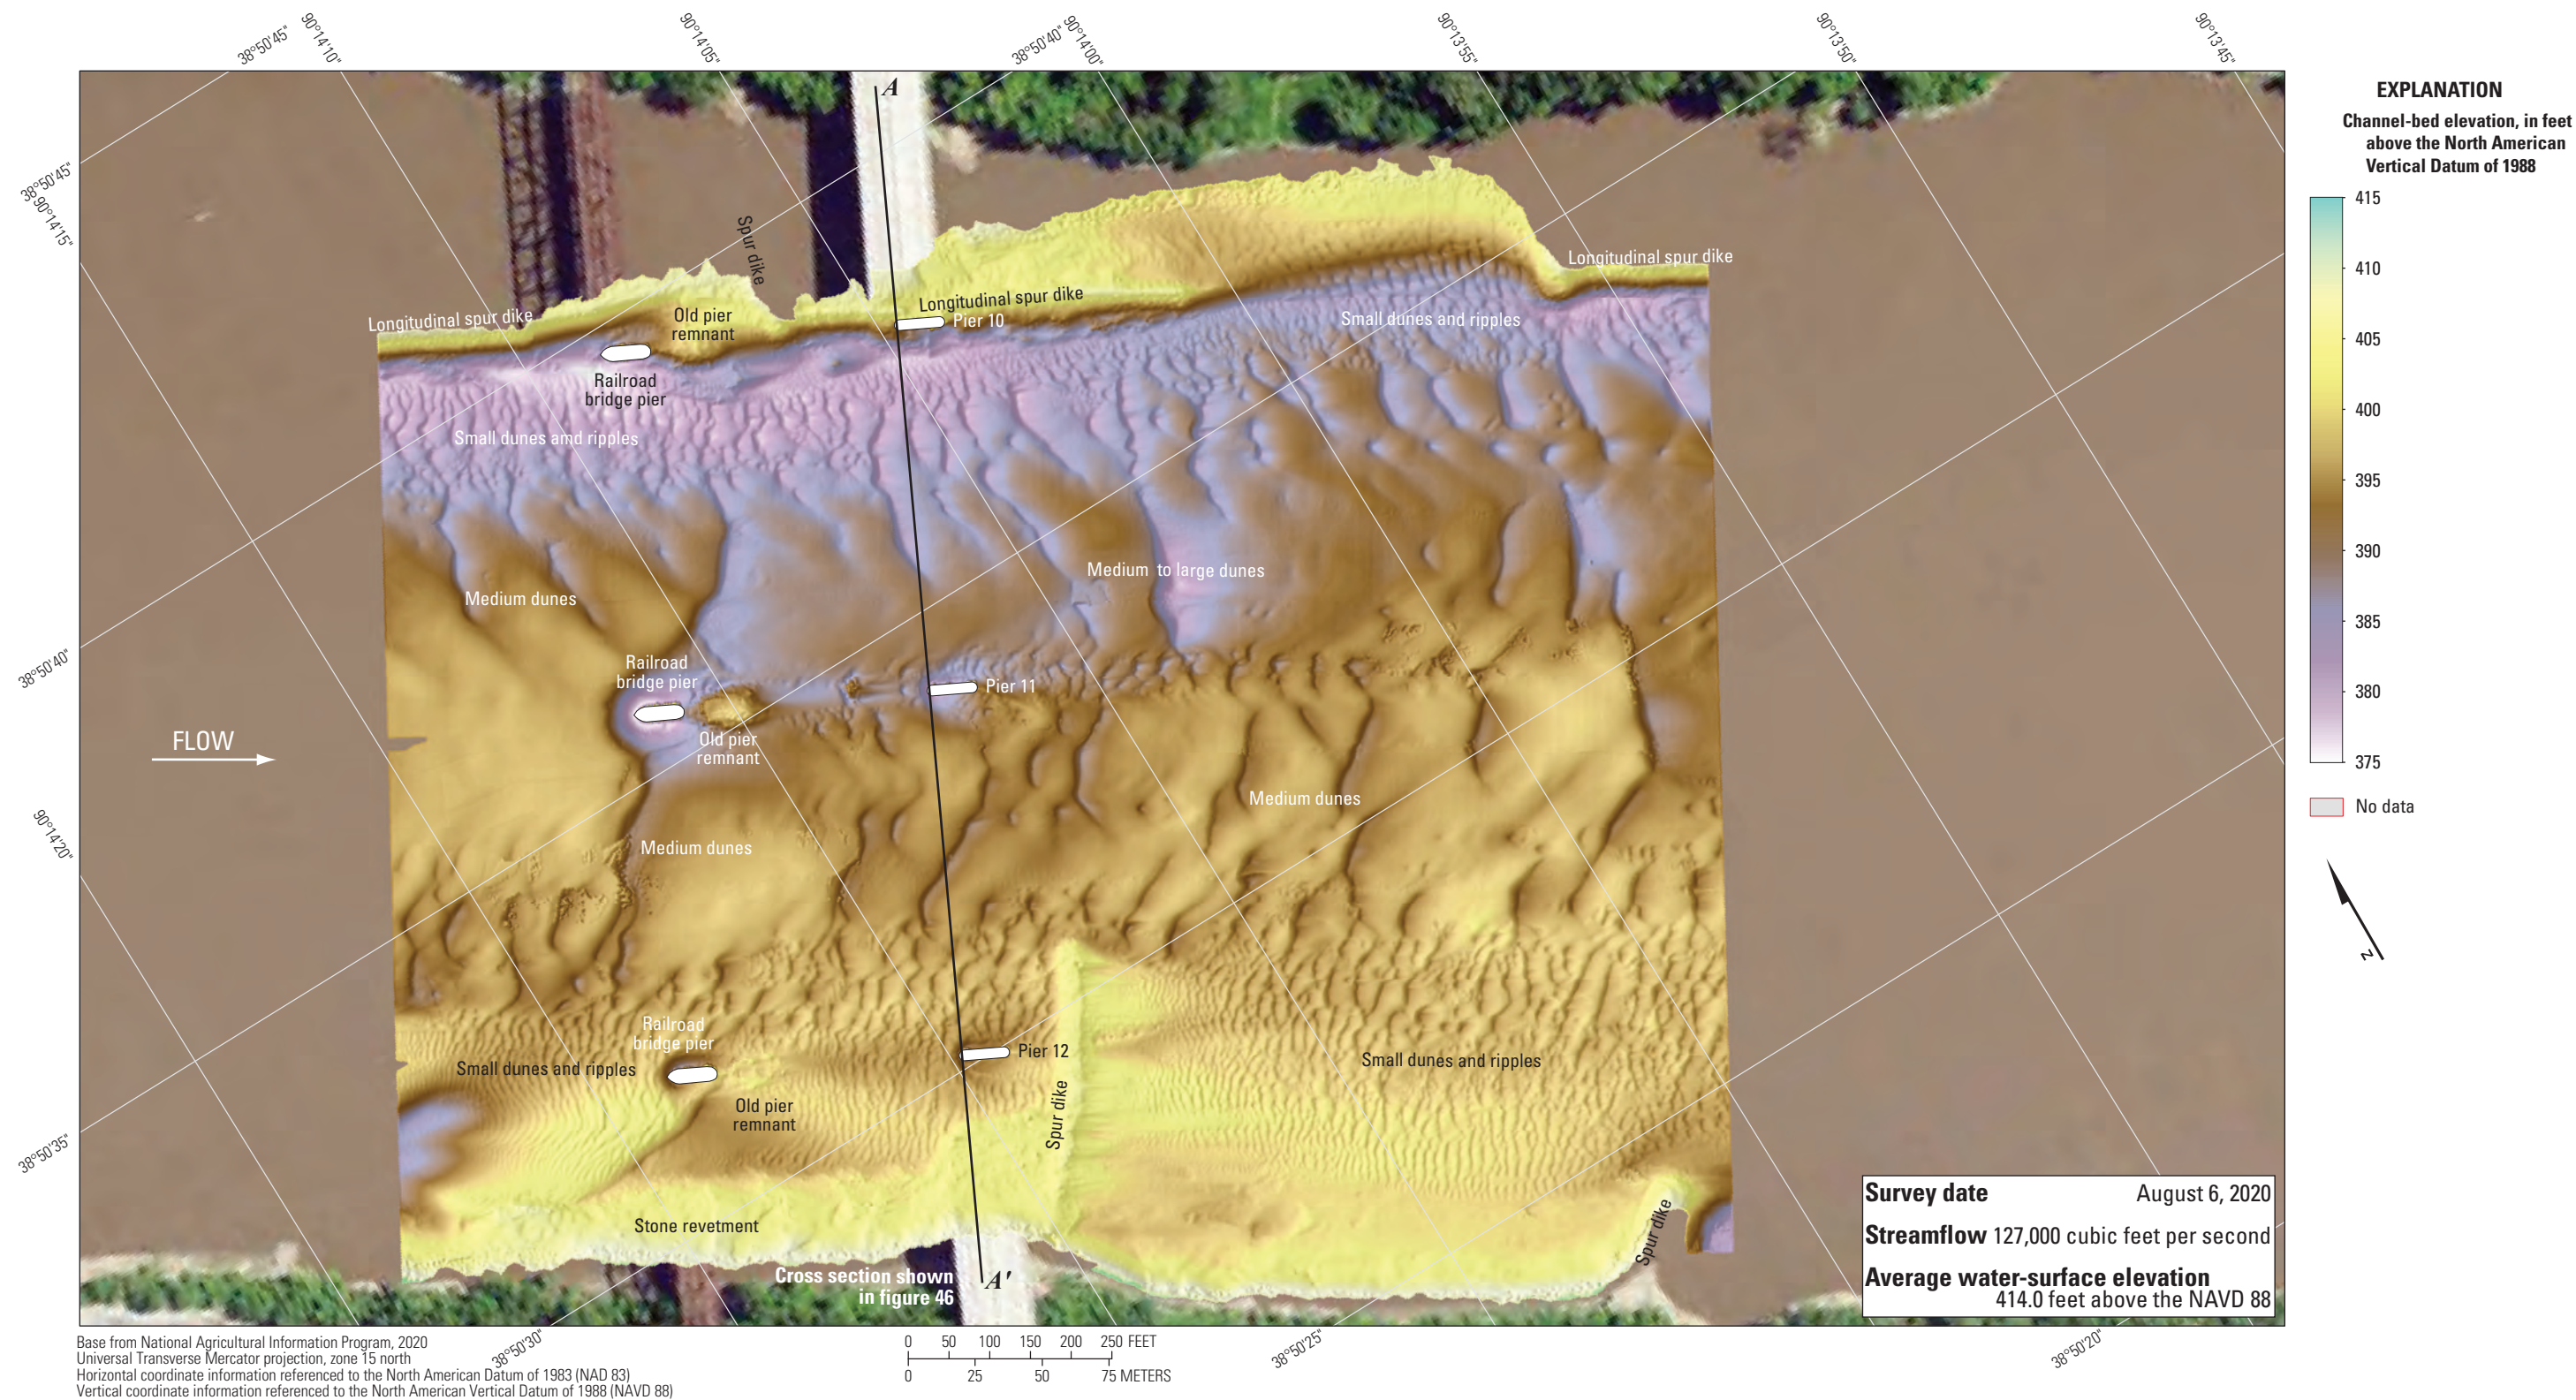
Figure 44. Bathymetric survey of the Missouri River channel near structure A3047 on U.S. Highway 67 near St. Louis, Missouri.

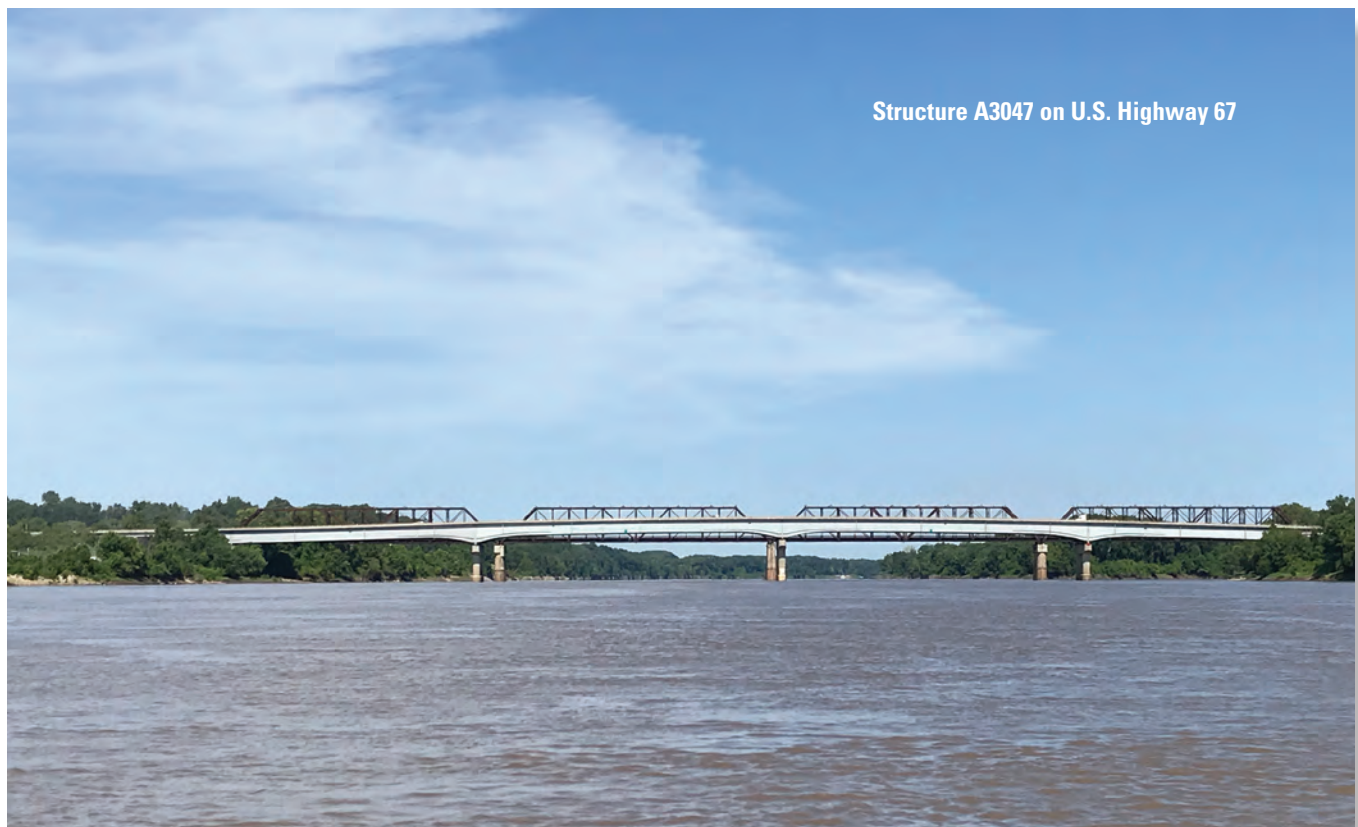
Figure 50. Bathymetry and vertically averaged velocities of the Missouri River channel near structure A3047 on U.S. Highway 67 near St. Louis, Missouri.

The vertically averaged velocity vectors, which range from about 2 to 9 ft/s, indicate mostly uniform flow throughout the channel (fig. 50). Exceptions to uniform flow include angled flows near the ends of various spur dikes along the banks and minor turbulence downstream from the piers, which are slightly skewed to approach flow (fig. 50).

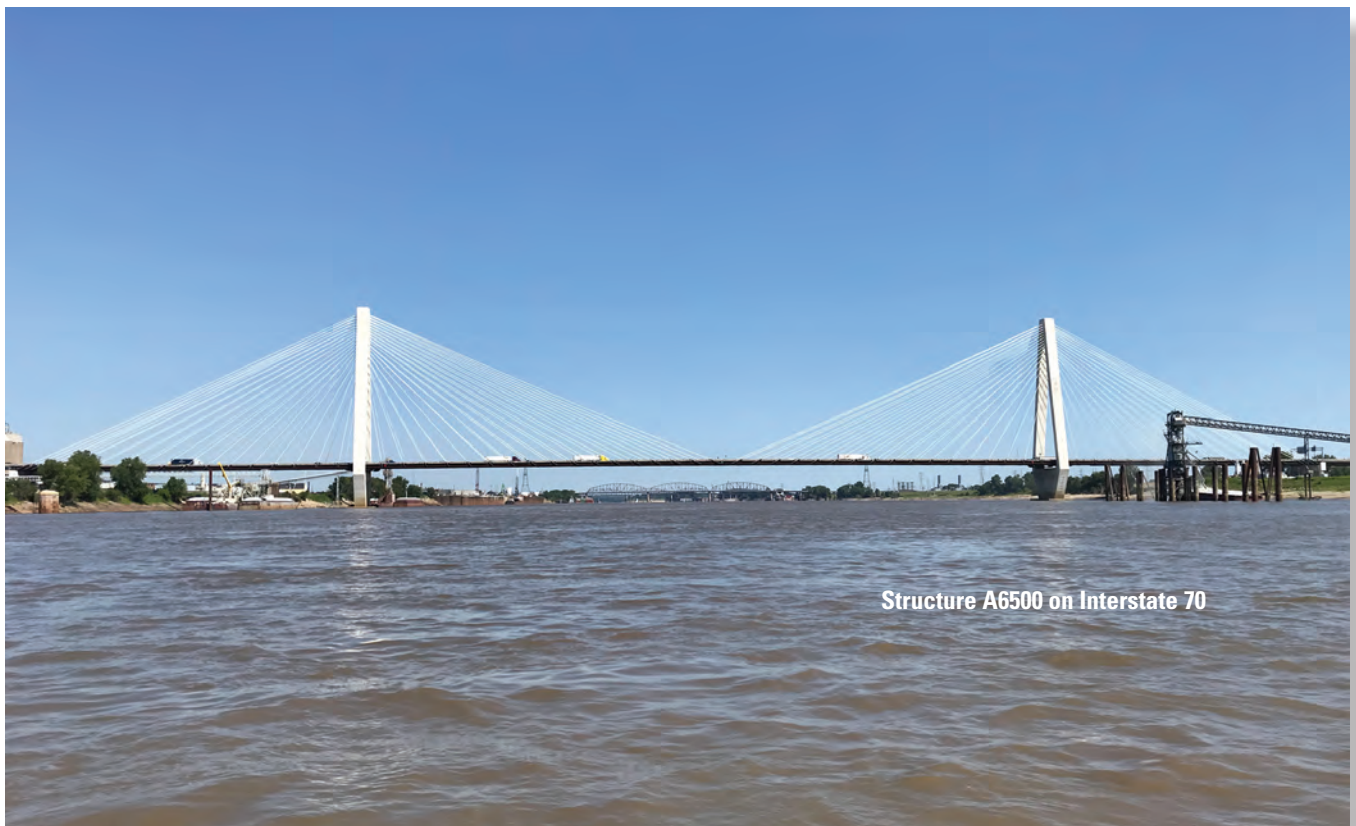
Figure 58. Key features, substructural and superstructural details, and surveyed channel bed of structure A6500 on Interstate 70 crossing the Mississippi River in St. Louis, Missouri.

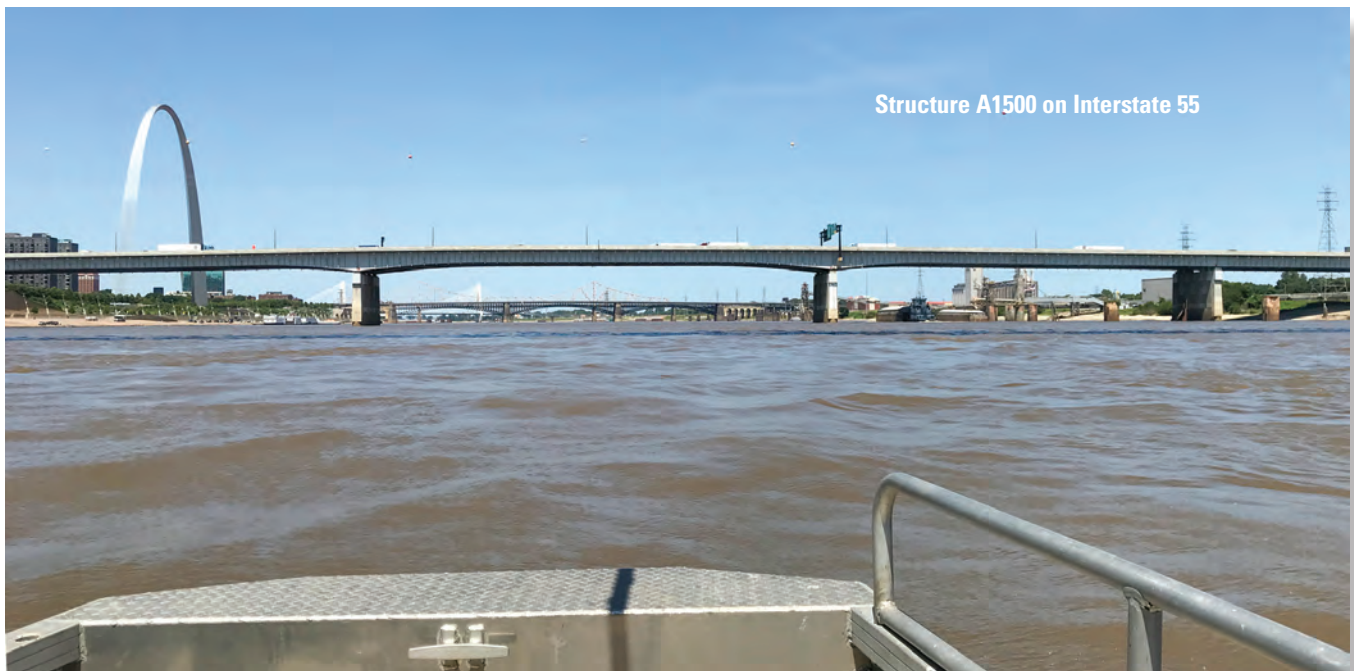
Figure 64. Key features, substructural and superstructural details, and surveyed channel bed of structure A1500 on Interstate 55 crossing the Mississippi River in St. Louis, Missouri.
