Assessment of Post-Wildfire Geomorphic Change in the North Fork Eagle Creek Stream Channel, New Mexico, 2017–21

Scientific Investigations Report 2023–5116

By Justin R. Nichols, Shaleene B. Chavarria, and Alexander P. Graziano

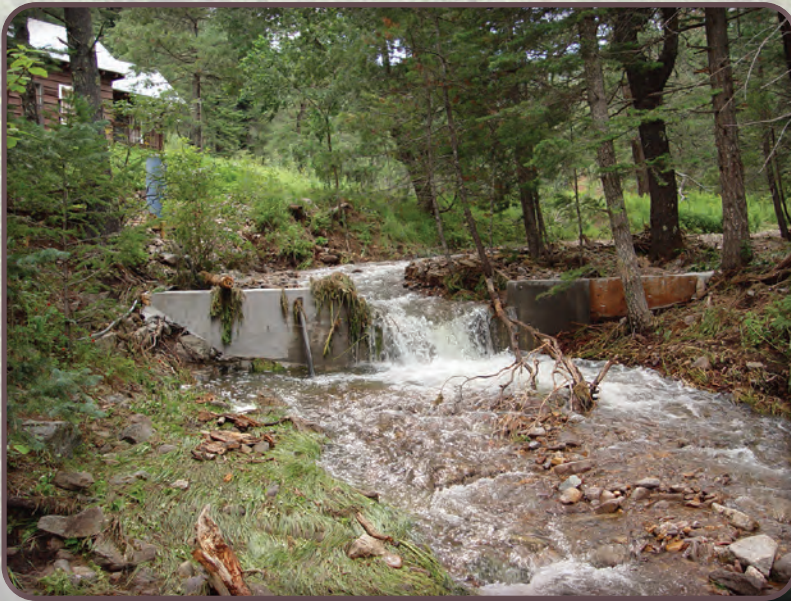
Left, North Fork Eagle Creek streamgage prior to the Little Bear Wildfire. Photograph by Anne Marie Matherne, U.S. Geological Survey (USGS).

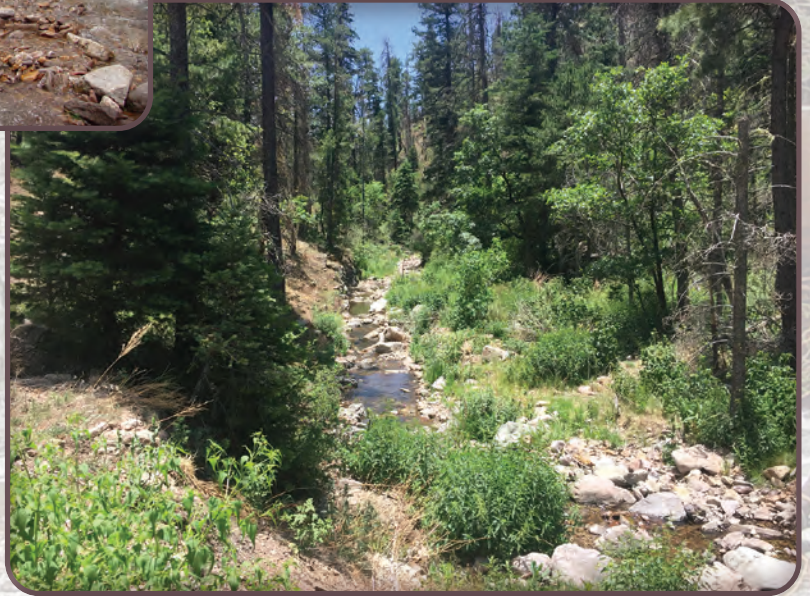
Right, North Fork Eagle Creek at the road crossing between cross-sections 2 and 3 looking downstream at a series of flowing pools, June 2018. Photograph by Alexander P. Graziano, USGS.

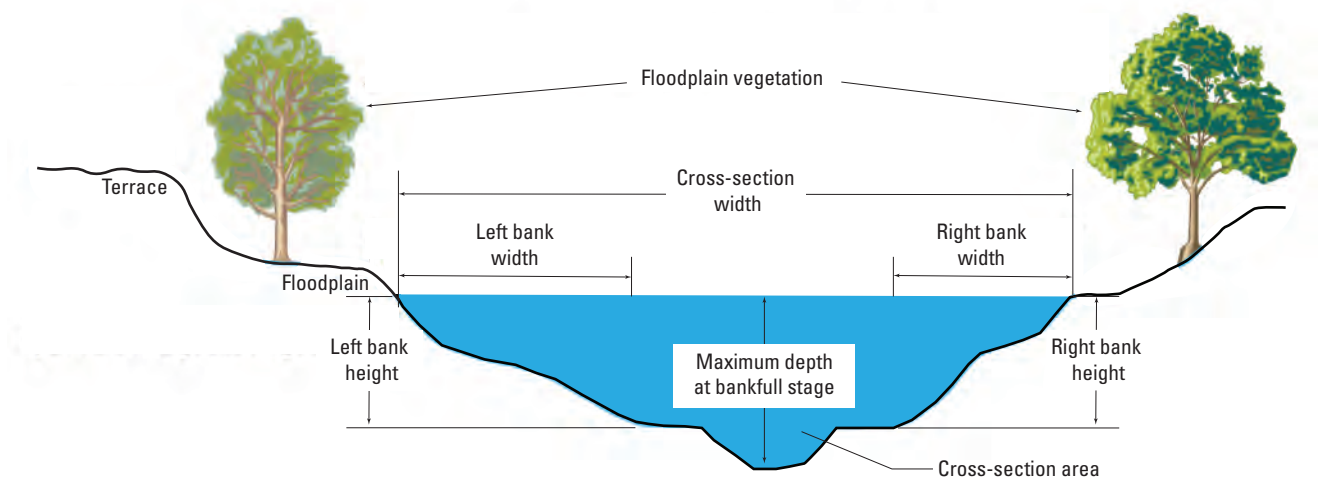
Figure 5. Conceptual diagram of a typical stream cross-section showing the measurements used to define channel characters within the North Fork Eagle Creek during the 2017–21 surveys. Modified from Parrett and Johnson (2004).

Estimates of bankfull stage were then used to calculate the following characteristics for each cross section: maximum depth at bankfull stage (in feet), cross-section width (in feet), cross-section area (in square feet), left and right bank heights looking downstream (in feet), and left and right bank slopes looking downstream (dimensionless, in feet per foot). Maximum depth at bankfull stage was defined as the depth of the thalweg at bankfull stage. Cross-section width was defined as the width of the water surface of the main channel at bankfull stage. Cross-section area was defined as the wetted area of the main channel at bankfull stage. Left and right bank heights were defined as the heights of the two banks of the main channel at bankfull stage and left and right bank slopes were defined as the bank’s height divided by its width at bankfull stage (fig. 5). Maximum depths, cross-section areas, and cross-section widths at bankfull stage were calculated in RStudio using SAC cross-section outputs (RStudio, 2022). Bank heights and slopes were calculated from interpretations of SAC cross-section outputs by defining the top of a bank as the point at which bankfull stage intersected the bank, and by defining bottom of bank as the cross-section point at the base of the corresponding bank where abrupt increases in slope began moving from the channel bed to the bank.

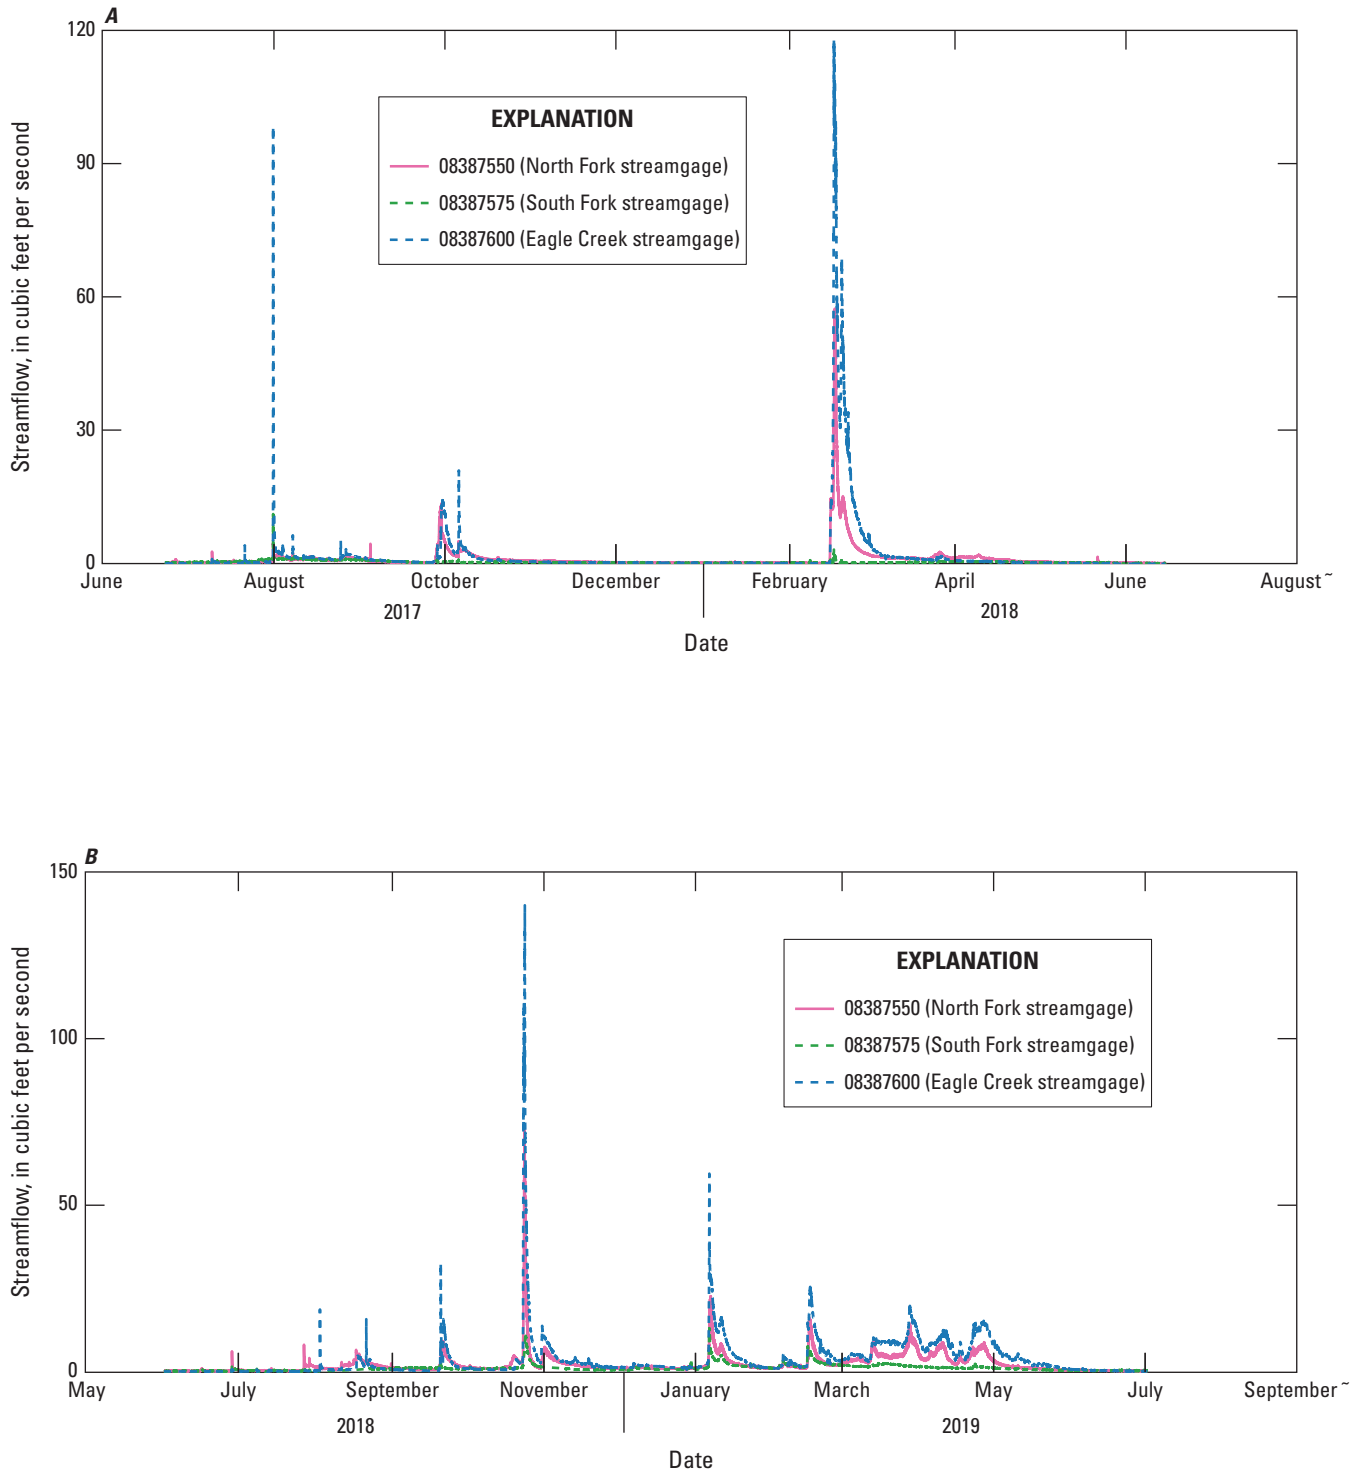
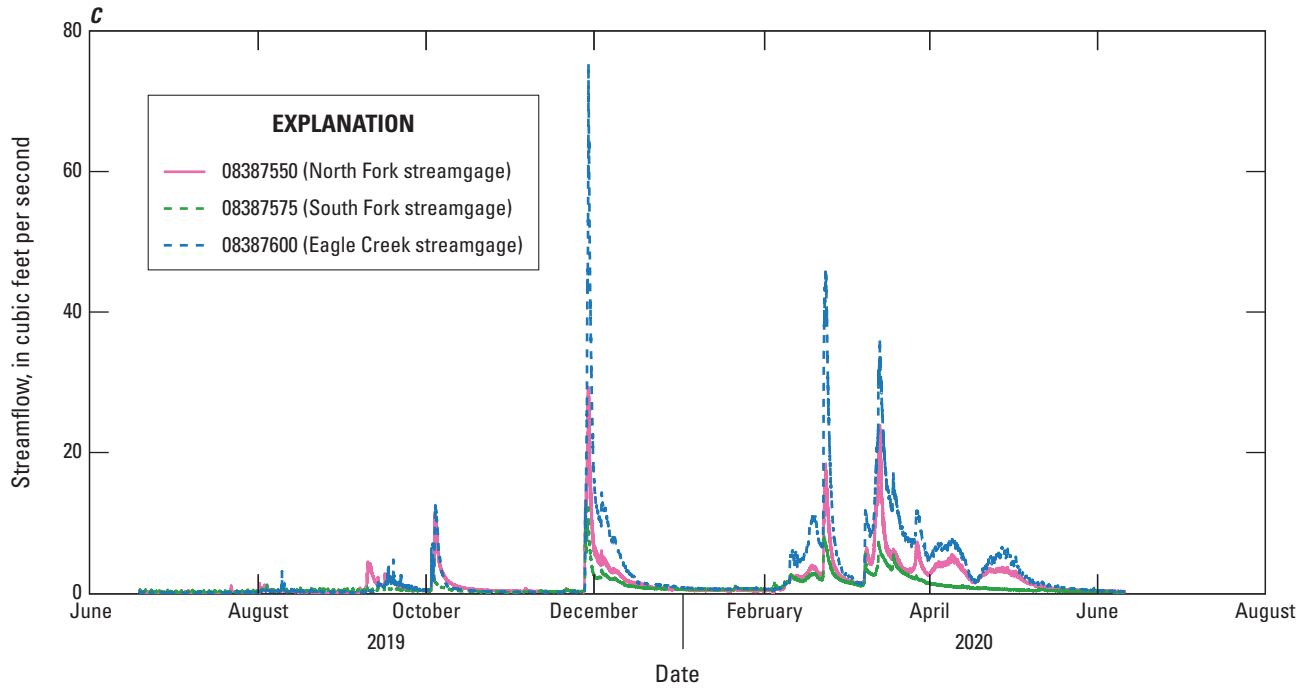
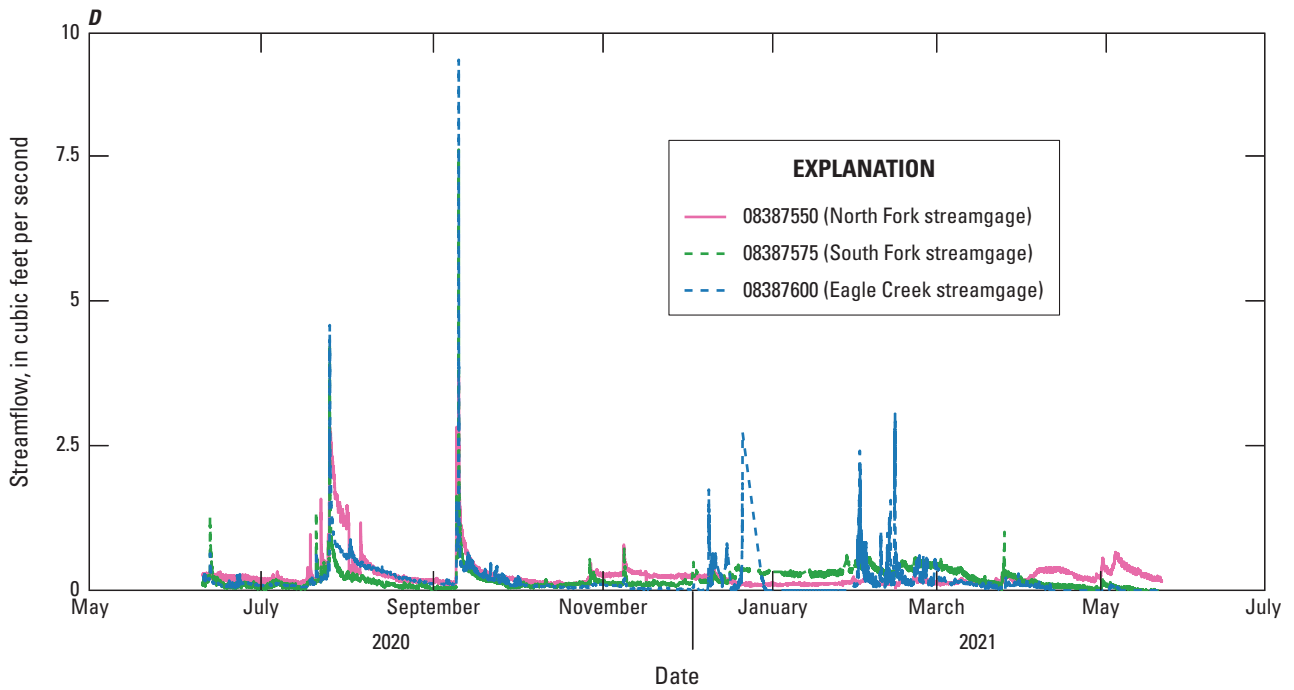
Figure 6. Instantaneous streamflow at the three U.S. Geological Survey (USGS) streamgages in the Eagle Creek Basin, south-central New Mexico, June 19, 2017, to May 20, 2021 (U.S. Geological Survey, 2022a, b, c). *A*, Period 1—June 19, 2017, to June 14, 2018; *B*, period 2—June 14, 2018, to June 20, 2019; *C*, period 3—June 20, 2019, to June 10, 2020; *D*, period 4—June 10, 2020, to May 20, 2021.

There was only one distinct high-flow event during which peak instantaneous streamflow exceeded 50 ft³/s at the Eagle Creek streamgage during the period from June 20, 2019, to June 10, 2020. The high-flow event had a peak instantaneous streamflow of 75 ft³/s, which occurred on November 29, 2019 (U.S. Geological Survey, 2022a). The high-flow event that produced the peak on November 29, 2019, was not a flashy event. Specifically, the peak on November 29, 2019, was reached about 35 hours after the start of the event (U.S. Geological Survey, 2022a). Also, streamflow during the event that produced the peak on November 29, 2019, remained greater than 50 ft³/s for about 11 hours (U.S. Geological Survey, 2022a) (fig. 6C).

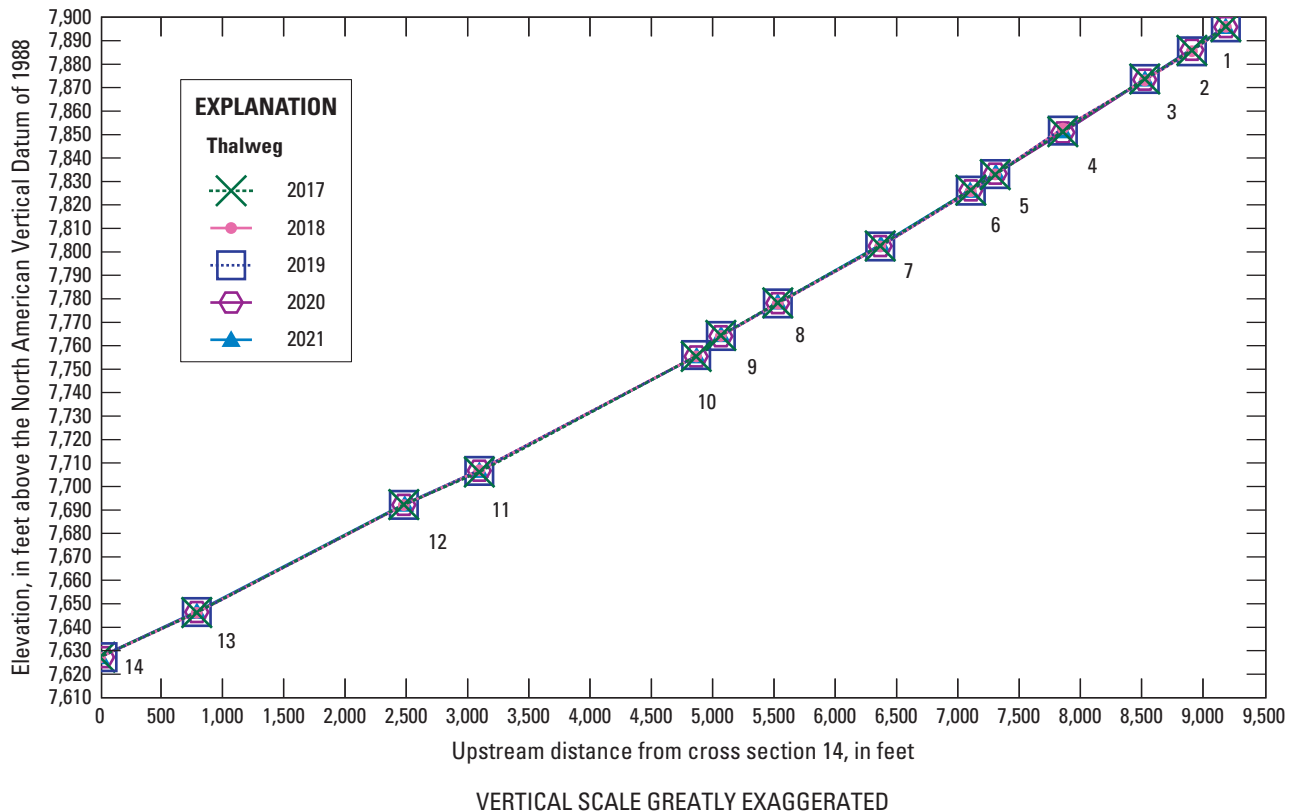
Figure 7. Channel profile from cross section 14 to cross section 1 of the study reach on North Fork Eagle Creek, Eagle Creek Basin, south-central New Mexico, 2017–21.

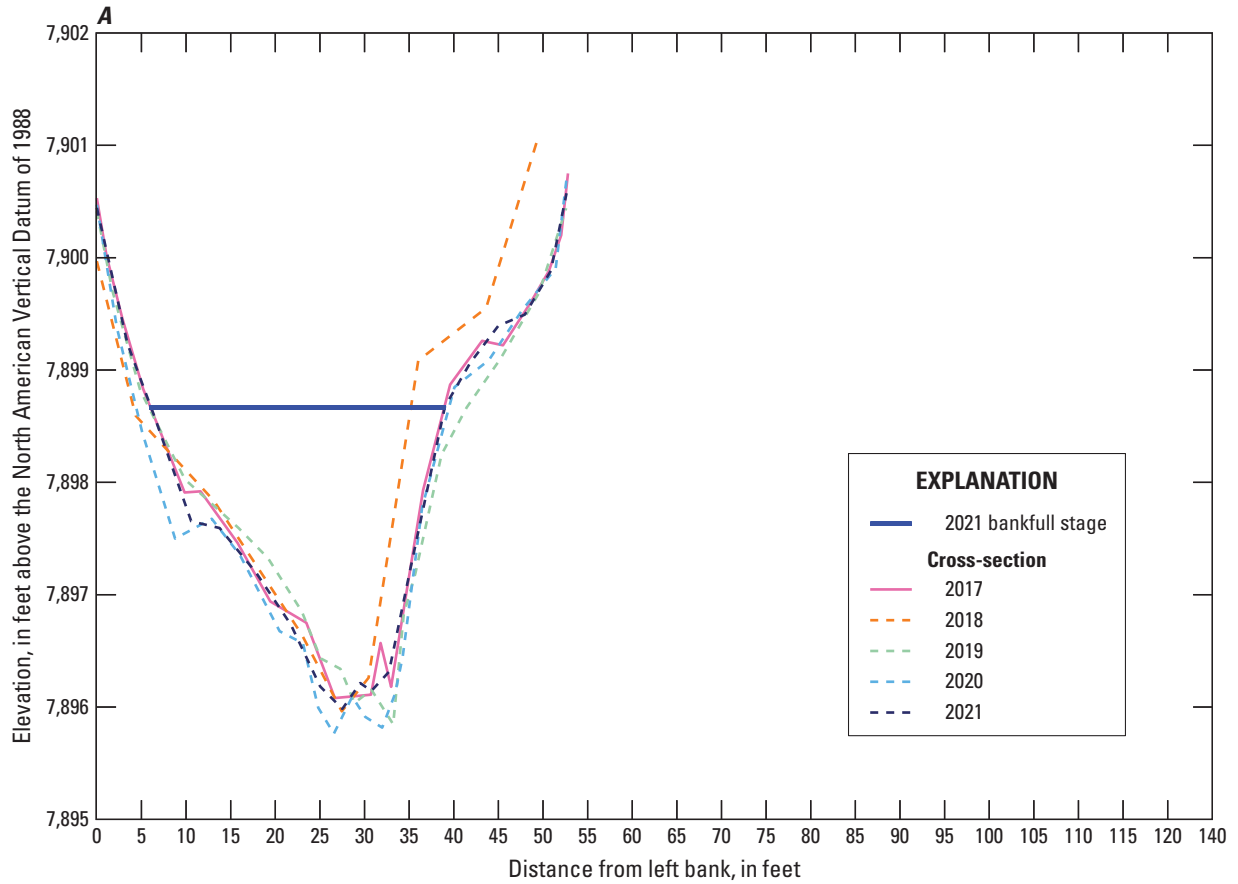
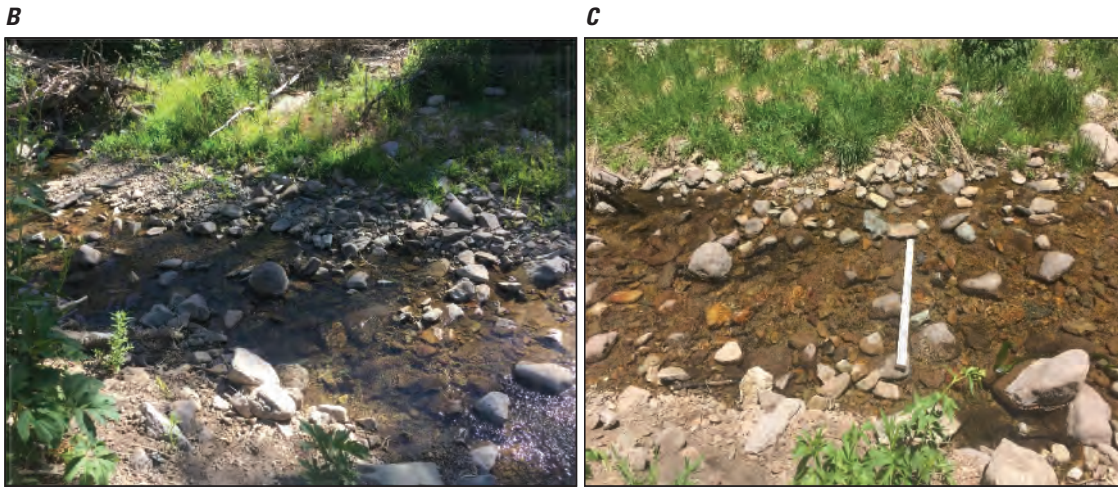
Figure 8. A, North Fork Eagle Creek, channel cross section 1, B, 2018 view looking at left bank from right bank, and C, 2020 view looking at left bank from right bank.

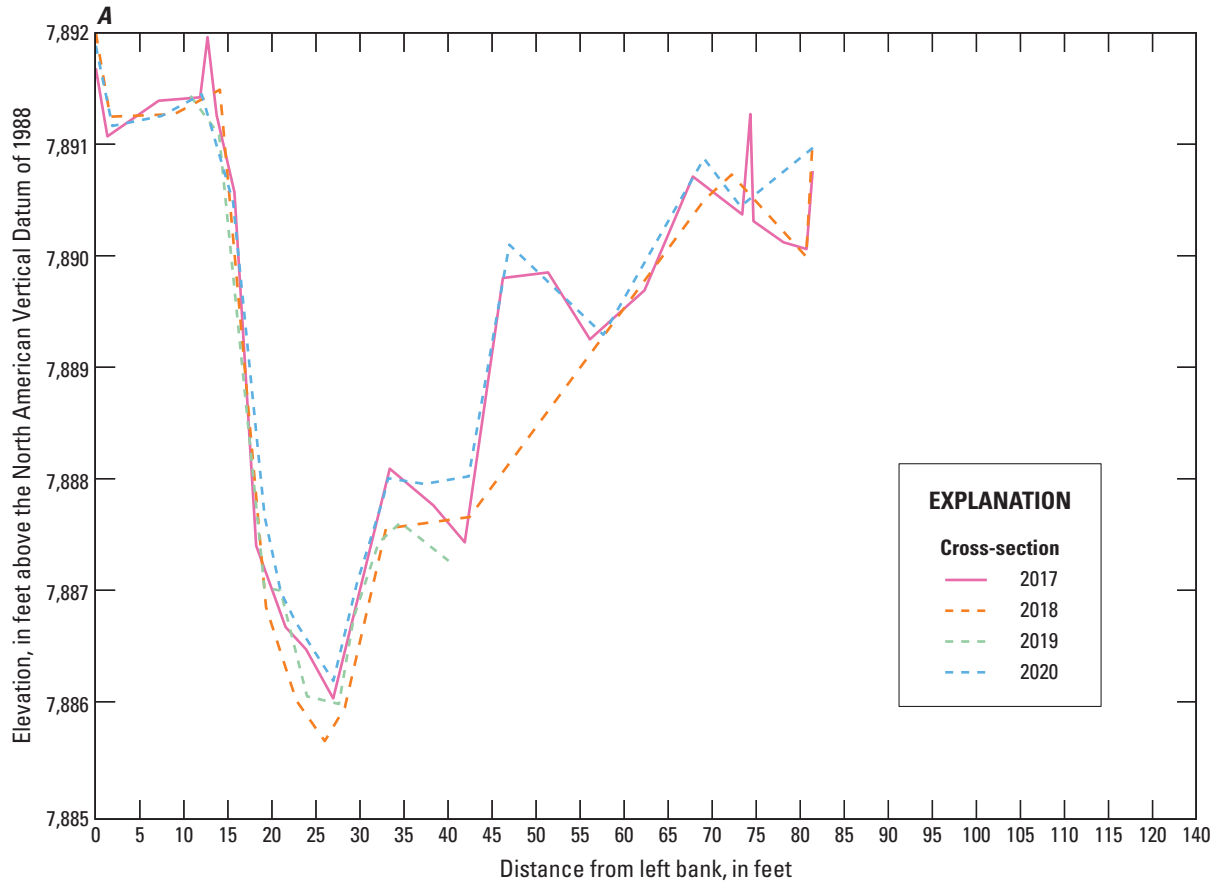
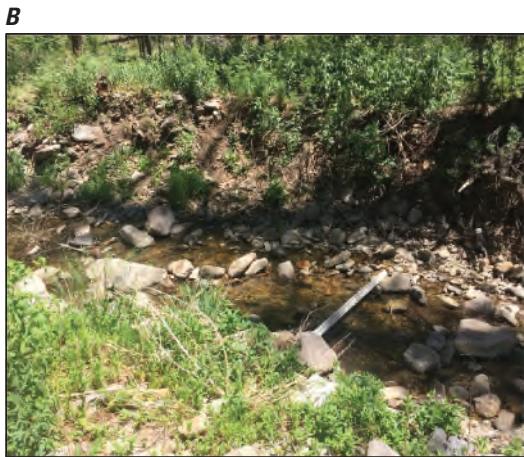
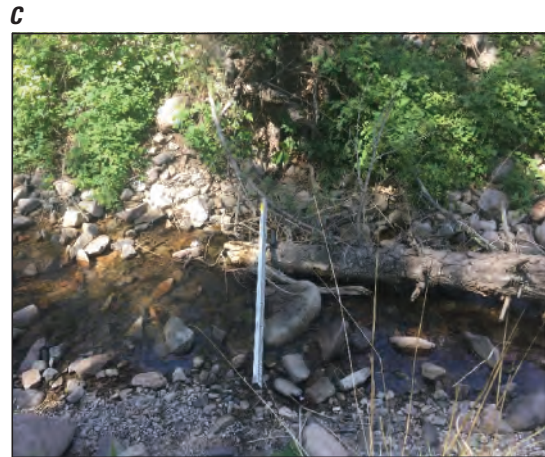
Figure 9. A, North Fork Eagle Creek, channel cross section 2, B, 2018 view looking at left bank from right bank, and C, 2020 view looking at left bank from right bank.

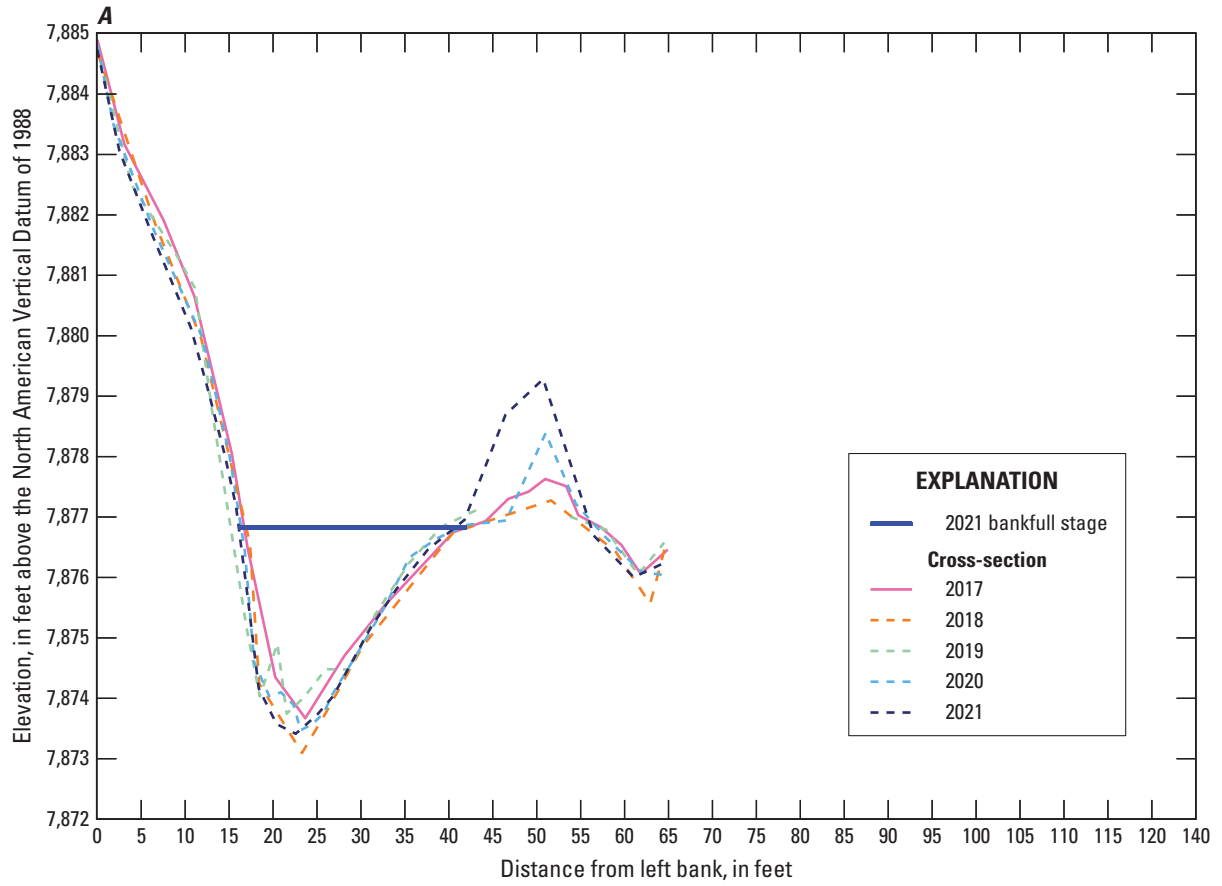
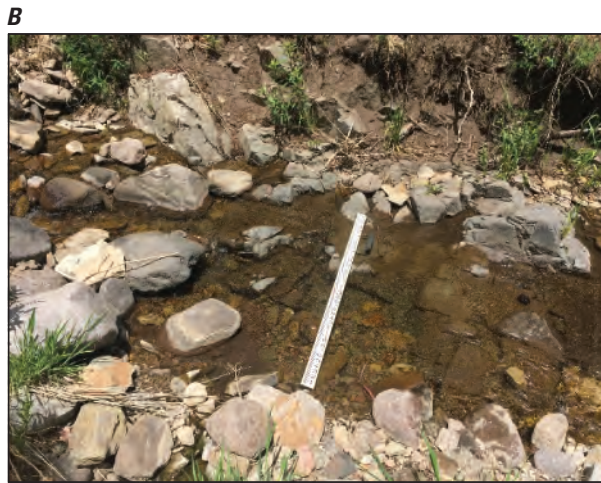
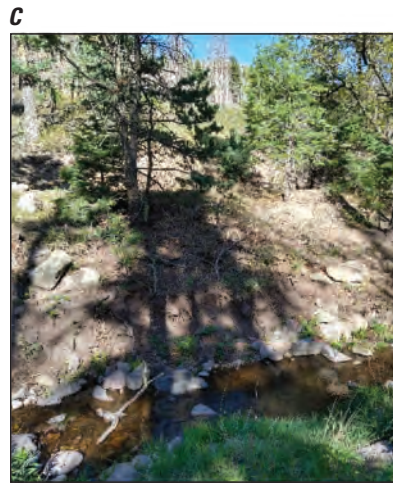
Figure 10. A, North Fork Eagle Creek, channel cross section 3, B, 2018 view looking at left bank from right bank, and C, 2021 view looking at left bank from right bank.

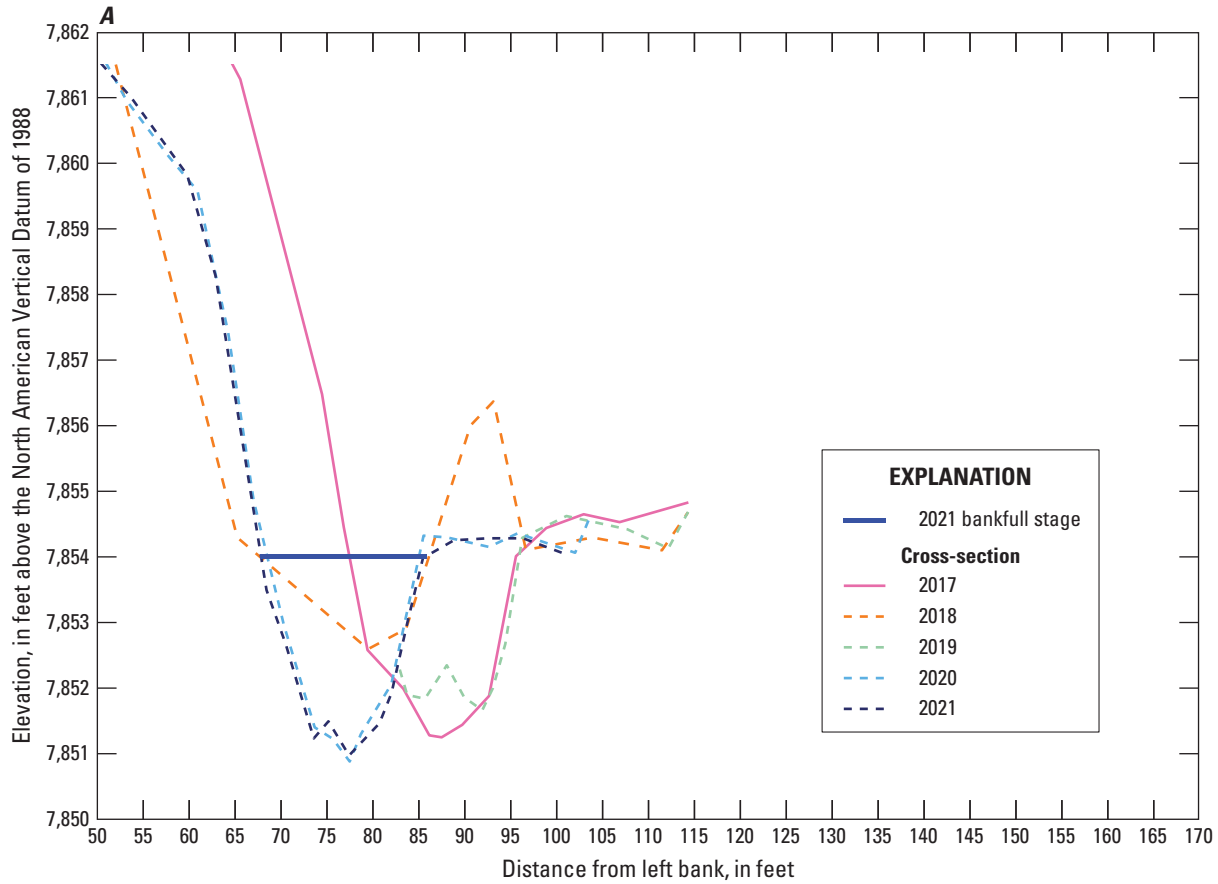
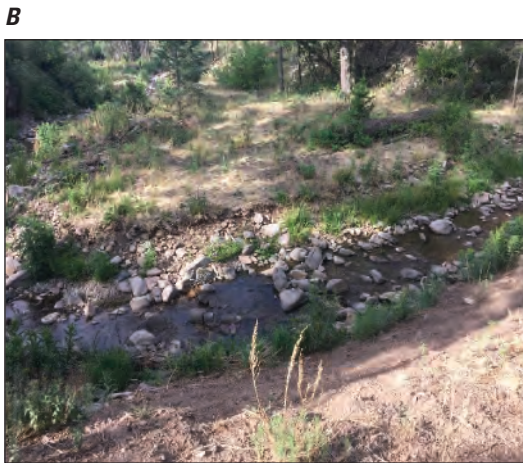
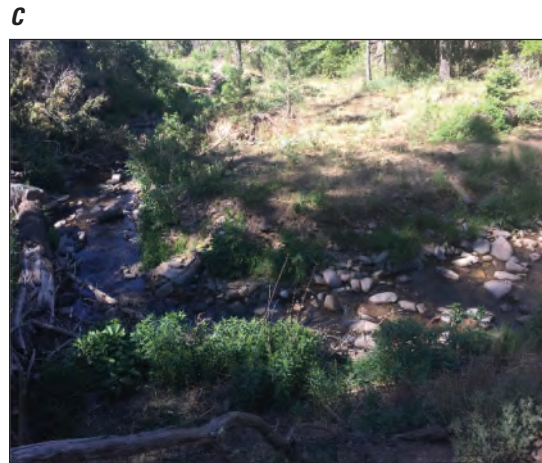
processes during the four periods of study (figs. 11, 14, 18, 19, 20). Specifically, cross section 4 experienced a decrease in its left bank elevation of a much as 7 ft during period 1, with a shift in thalweg position of approximately 8 ft to the left (fig. 11). However, during the 2018 survey, three of the left bank cross-section points had poor accuracy ranging from ± 0.8 to ± 3.3 ft; thus, the magnitude of change to cross section

Figure 11. A, North Fork Eagle Creek, channel cross section 4, B, 2018 view looking at right bank from left bank, and C, 2020 view looking at right bank from left bank.

4 during period 1 might not be as large as the results indicate (Graziano, 2020b). Cross section 7 experienced a substantial decrease in channel elevation 7–28 ft from the left bank during period 1 that resulted in an approximate elevation decrease of 2.5–3 ft (Graziano, 2020b) (fig. 14). Cross section 11 experienced a channel elevation increase of 0.6–0.9 ft during period

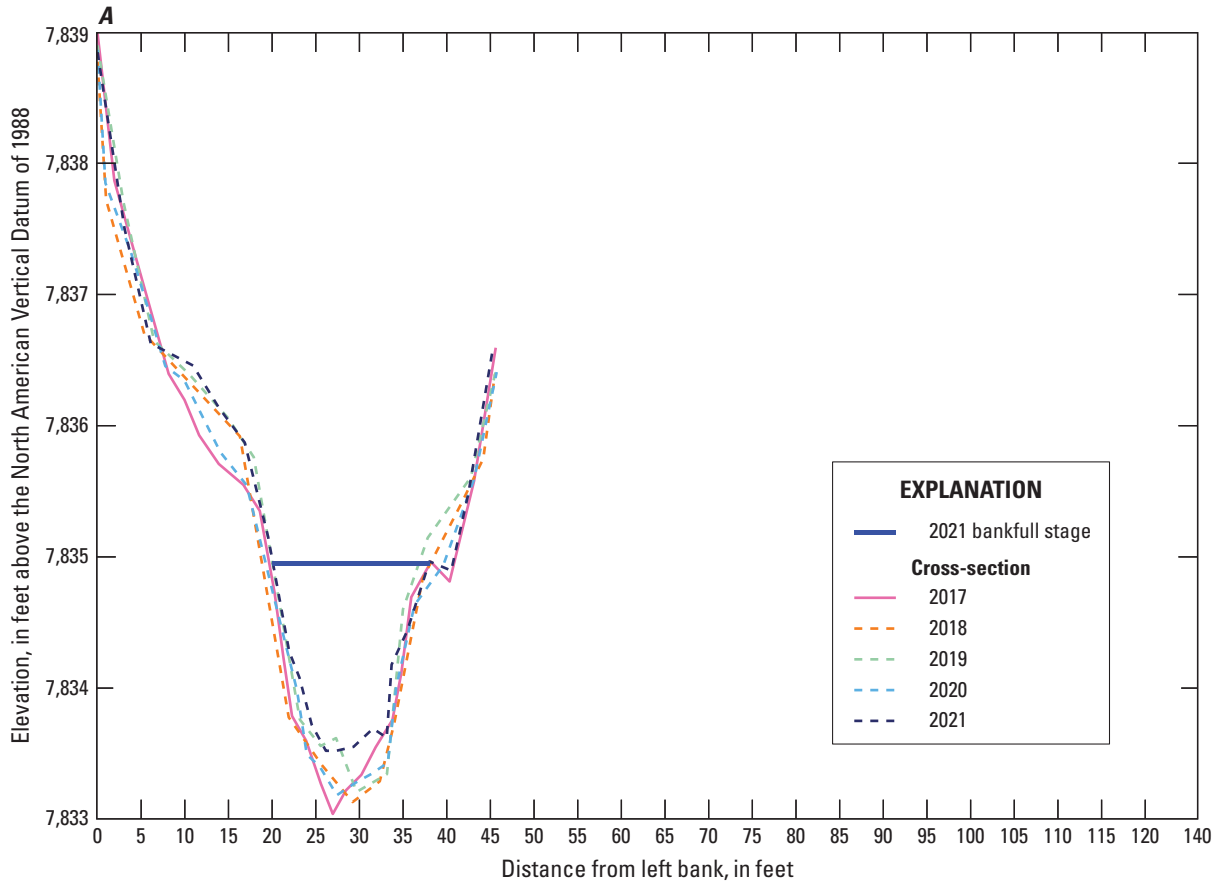
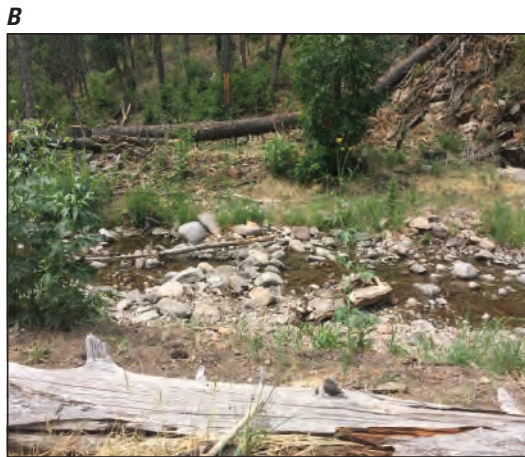
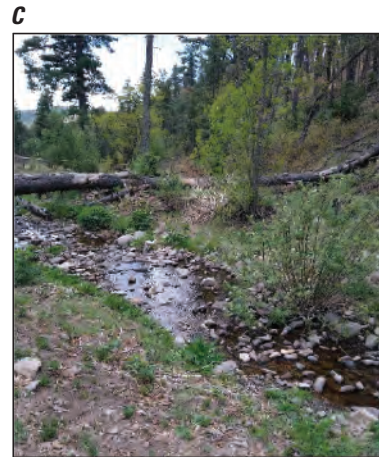
Figure 12. A, North Fork Eagle Creek, channel cross section 5, B, 2018 view looking at right bank from left bank, and C, 2021 view looking at right bank from left bank.

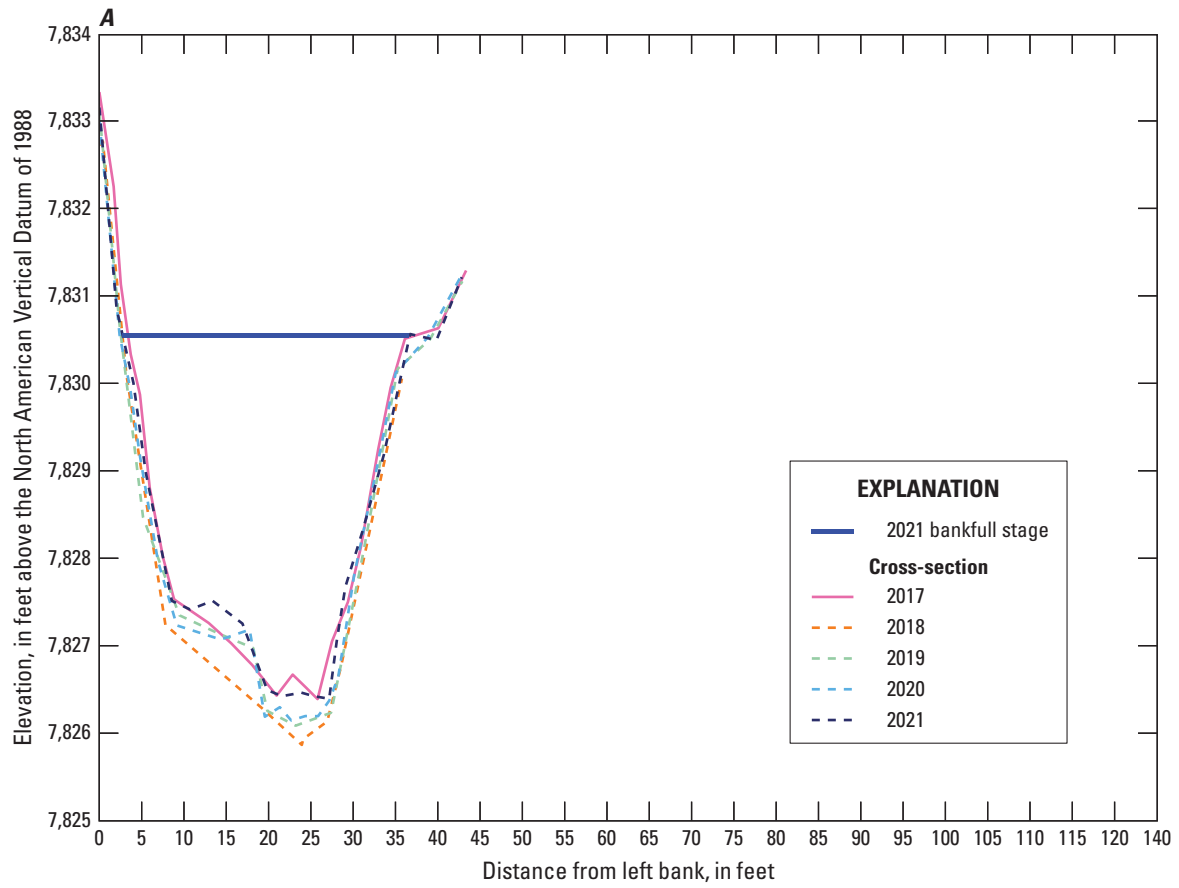
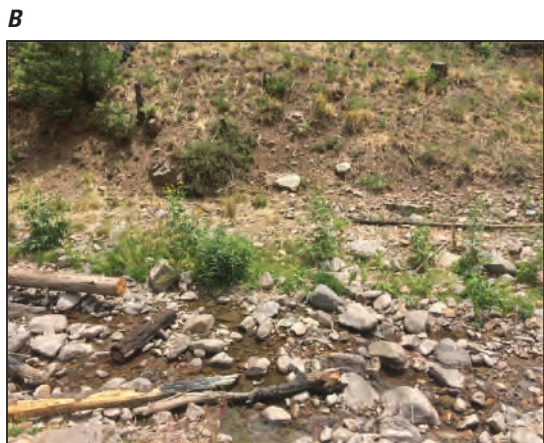
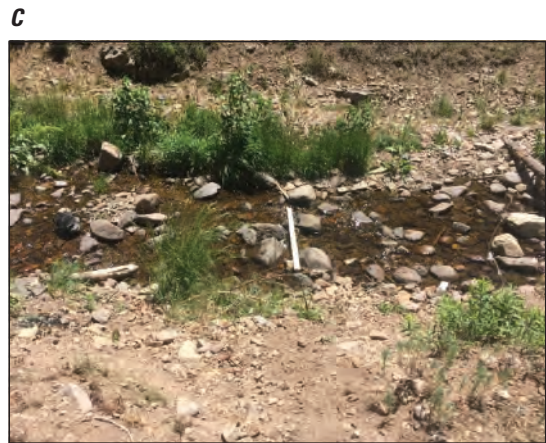
Figure 13. A, North Fork Eagle Creek, channel cross section 6, B, 2018 view looking at left bank from right bank, and C, 2020 view looking at left bank from right bank.

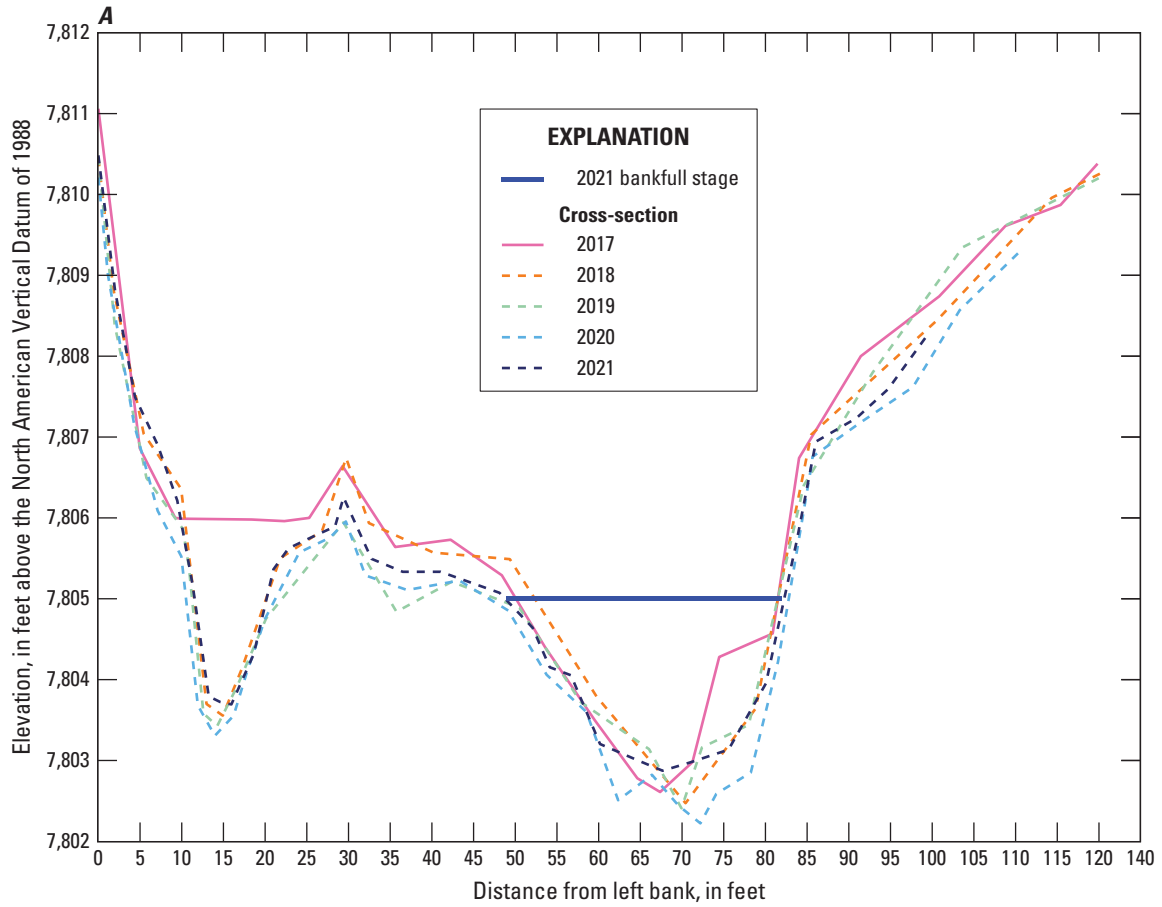
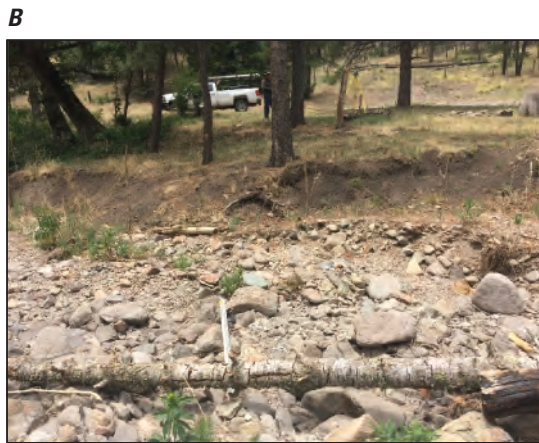
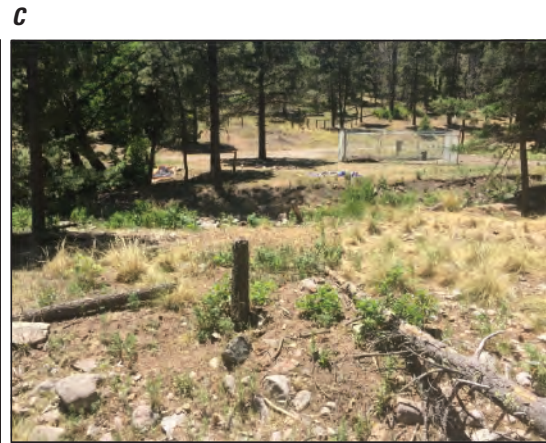
Figure 14. A, North Fork Eagle Creek, channel cross section 7, B, 2018 view looking at right bank from thalweg, and C, 2020 view looking at right bank from left bank.

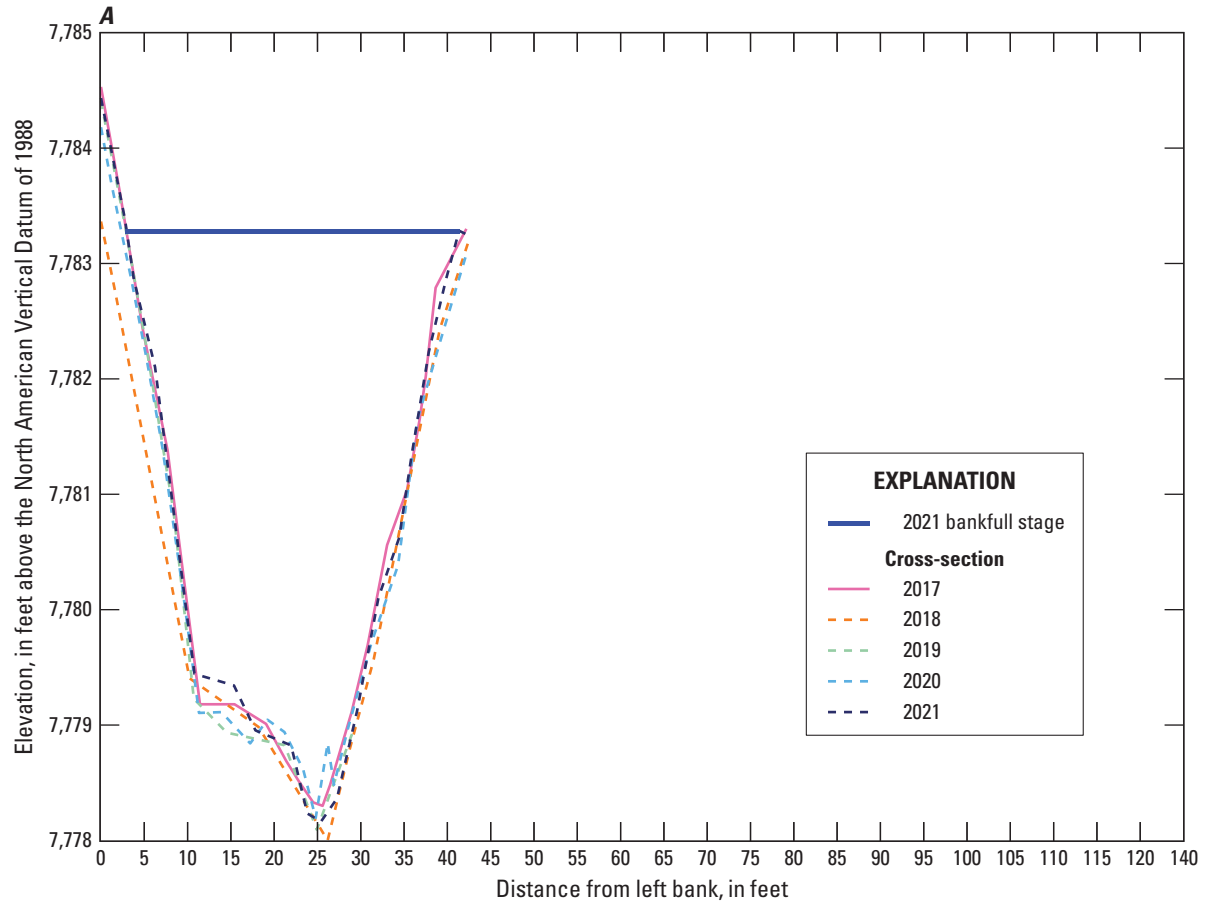
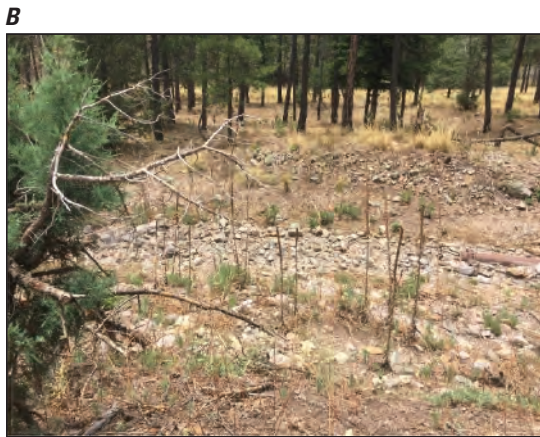
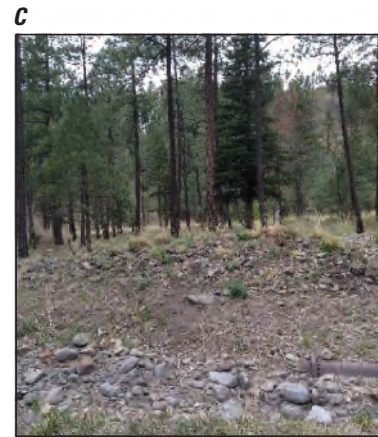
Figure 15. A, North Fork Eagle Creek, channel cross section 8, B, 2018 view looking at right bank from left bank, and C, 2021 view looking at right bank from left bank.

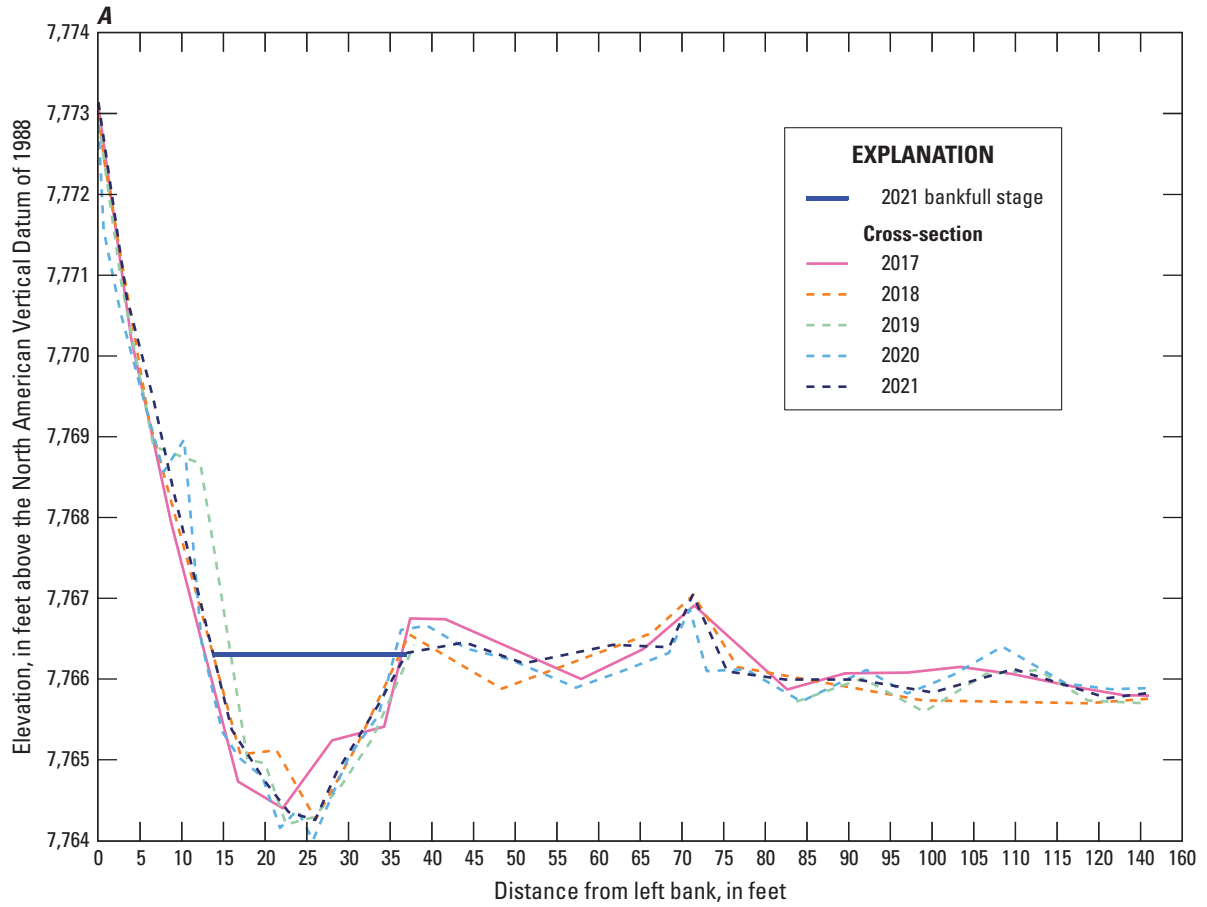
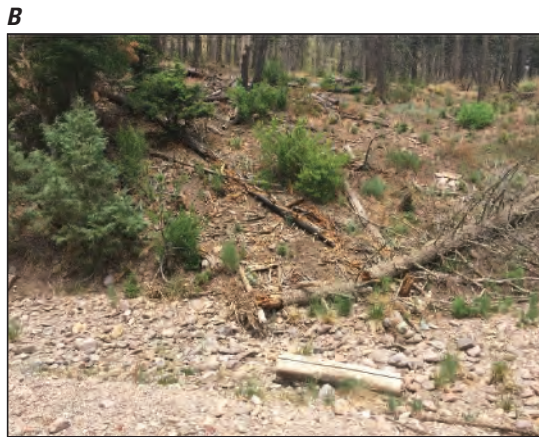
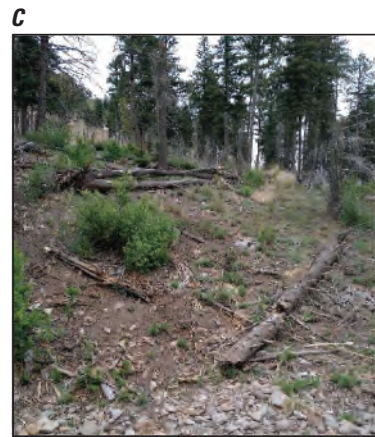
Figure 16. A, North Fork Eagle Creek, channel cross section 9, B, 2018 view looking at left bank from right bank, and C, 2021 view looking at left bank from right bank.
