Assessment of Post-Wildfire Geomorphic Change in the North Fork Eagle Creek Stream Channel, New Mexico, 2017–21

Scientific Investigations Report 2023–5116

By Justin R. Nichols, Shaleene B. Chavarria, and Alexander P. Graziano

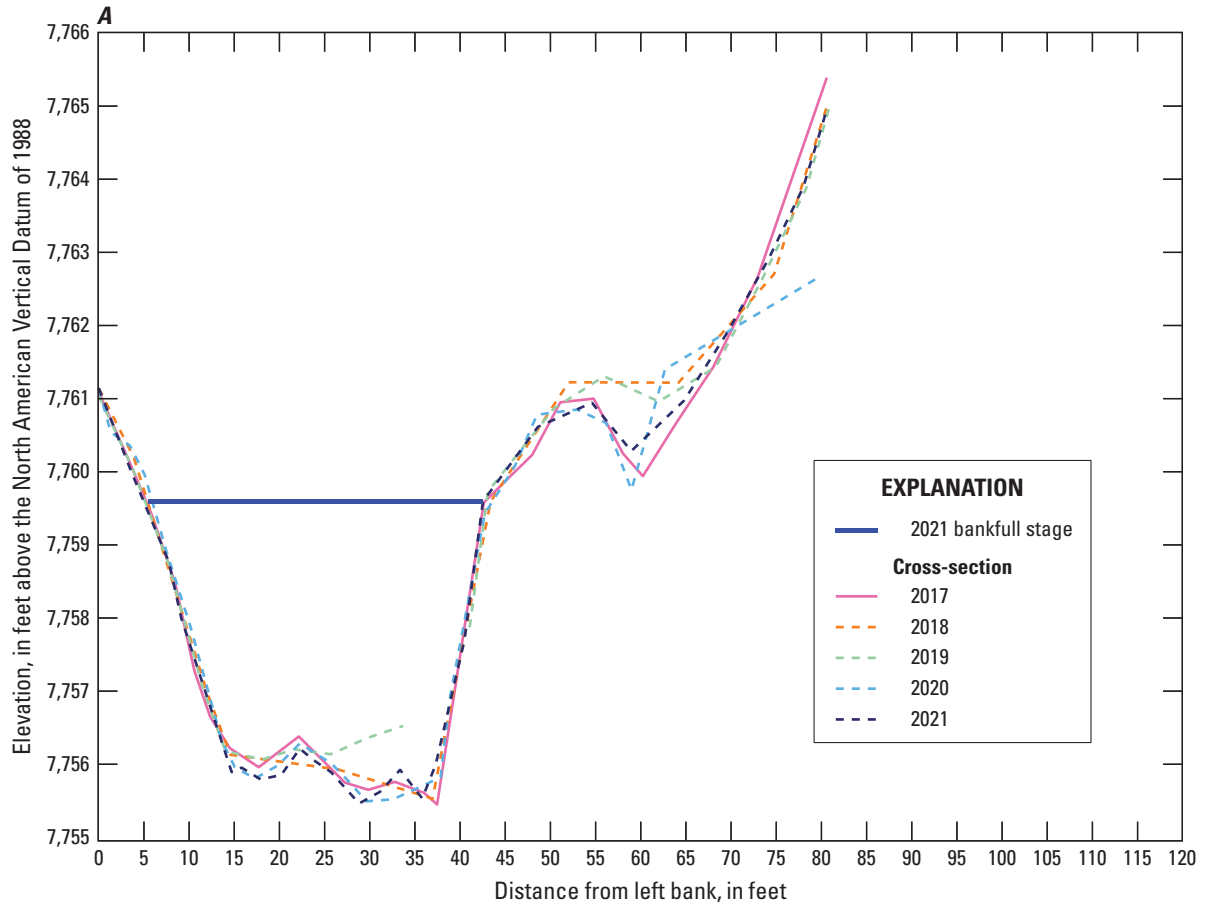
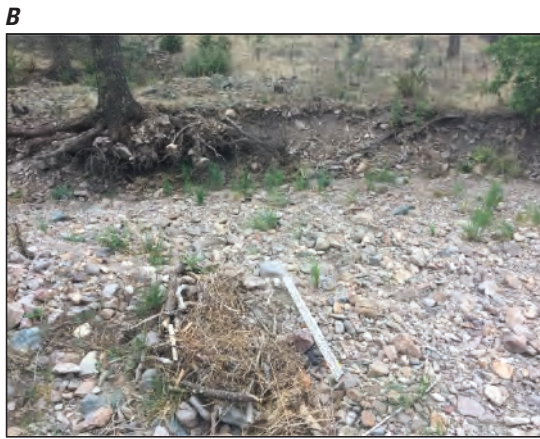
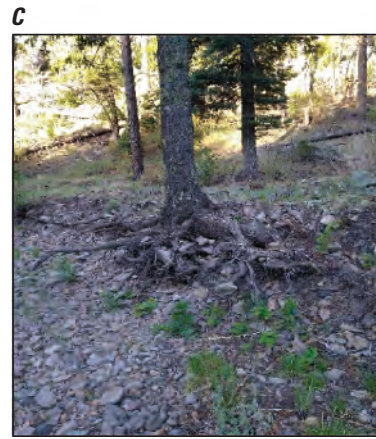
Figure 17. A, North Fork Eagle Creek, channel cross section 10, B, 2018 view looking at right bank from left bank, and C, 2021 view looking at right bank from thalweg.

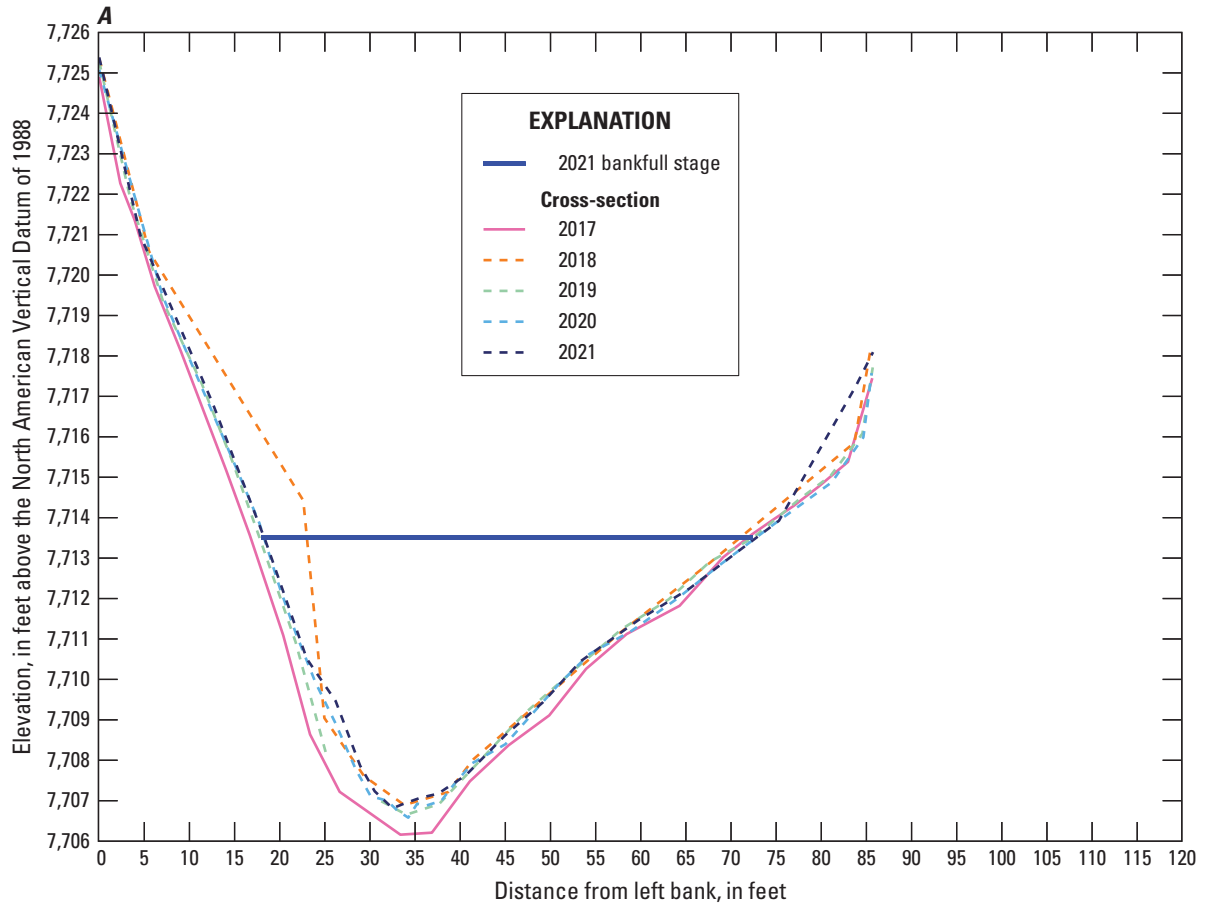
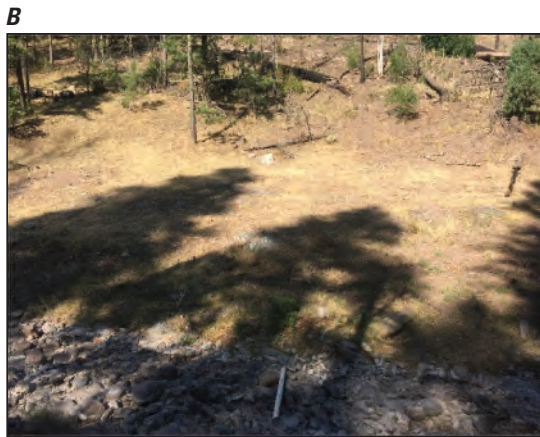
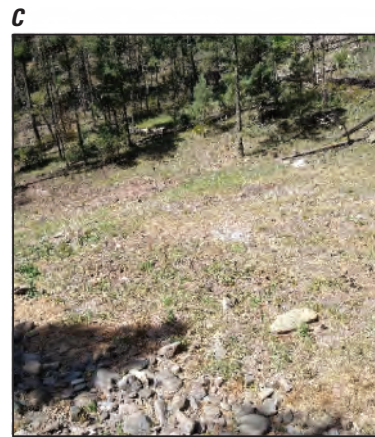
1, excluding the single high elevation point measured in 2018, with the largest change occurring in the thalweg of the cross section (fig. 18). Lastly, cross sections 12 and 13 both experienced a gradual increase in channel elevations from 2017 to 2021 that ranged from 0.5 to 1.0 ft, occurring predominately on the left bank of both cross sections (fig. 19, 20).

Figure 18. A, North Fork Eagle Creek, channel cross section 11, B, 2018 view looking at right bank from left bank, and C, 2021 view looking at right bank from left bank.

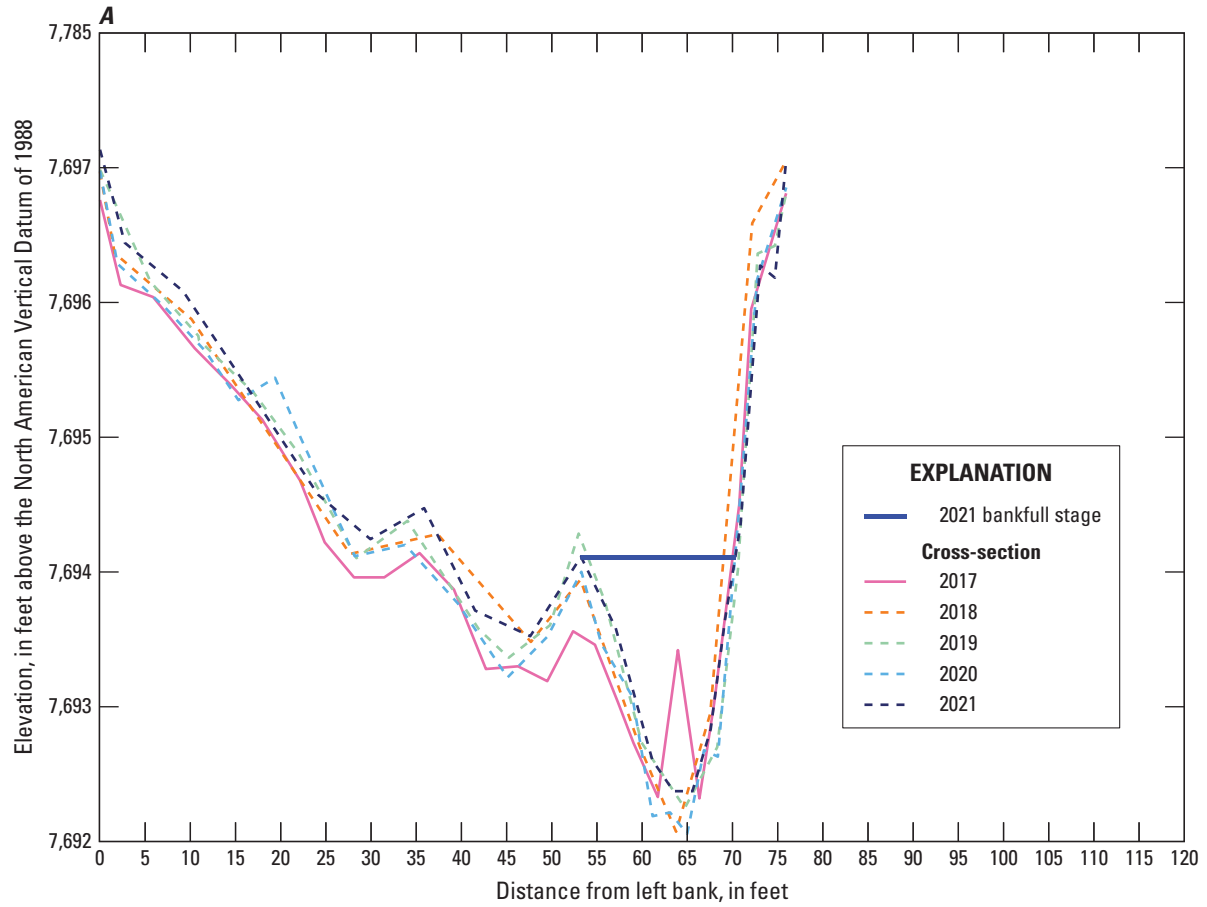
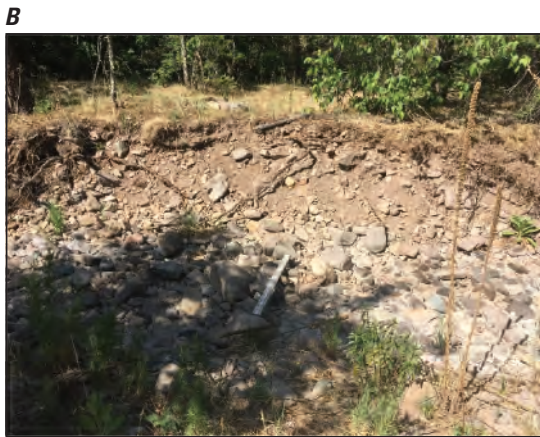
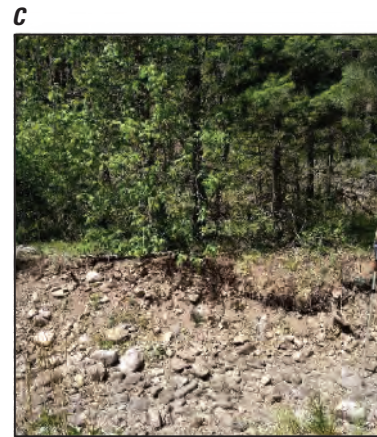
Figure 19. A, North Fork Eagle Creek, channel cross section 12, B, 2018 view looking at right bank from left bank, and C, 2021 view looking at right bank from left bank.

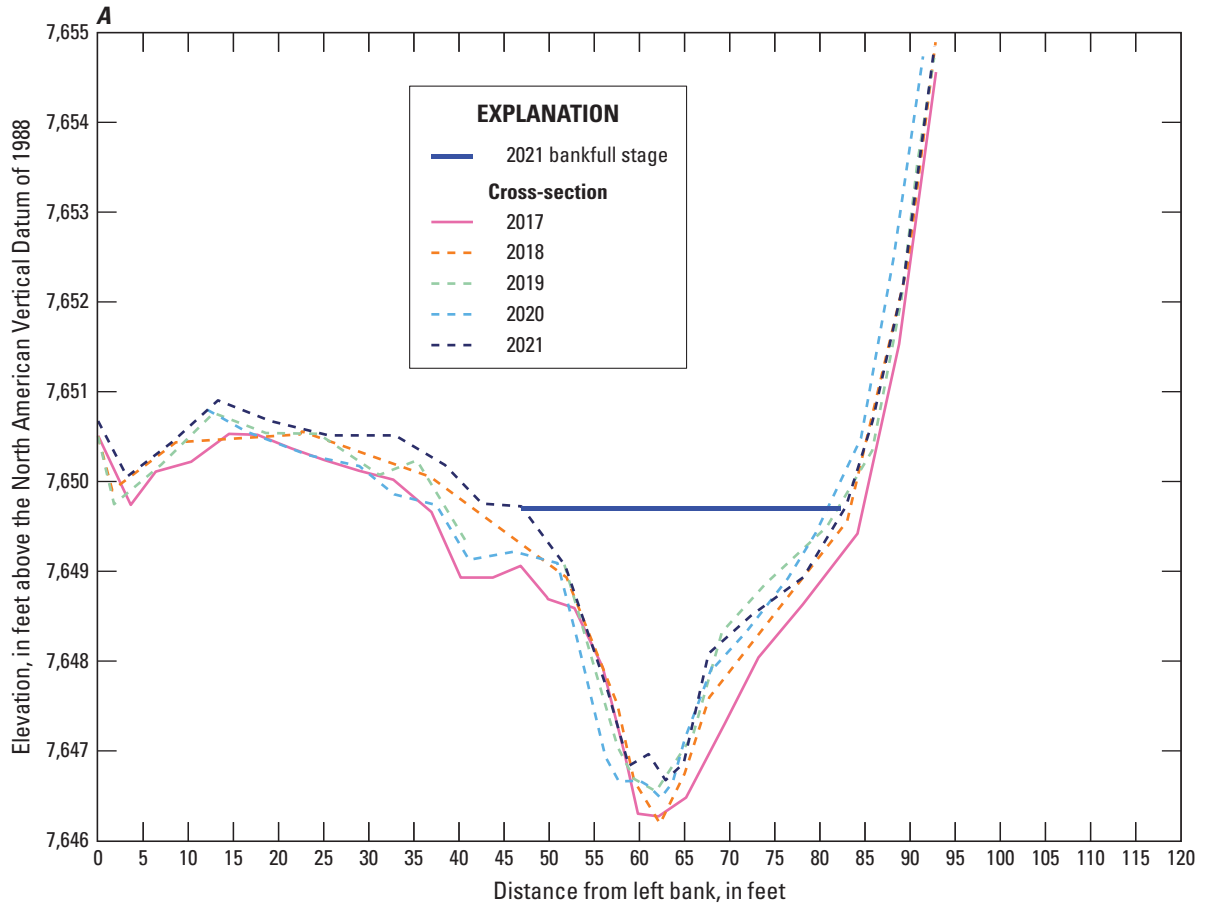
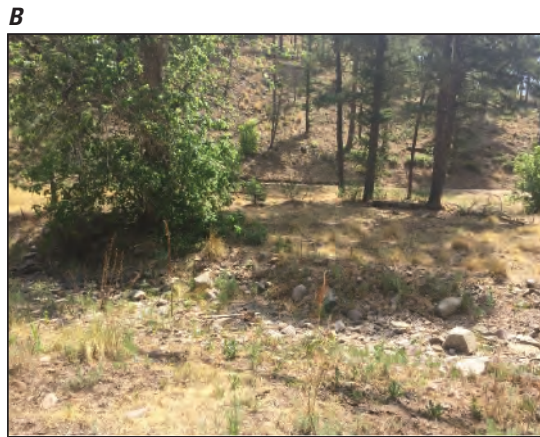
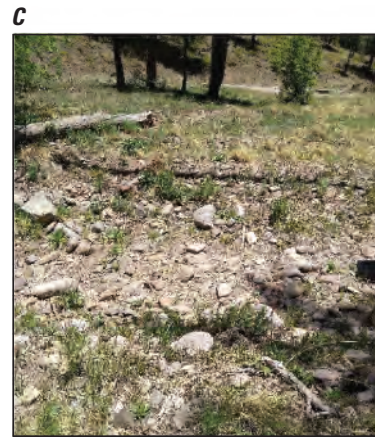
Figure 20. A, North Fork Eagle Creek, channel cross section 13, B, 2018 view looking at left bank from right bank, and C, 2021 view looking at left bank from thalweg.

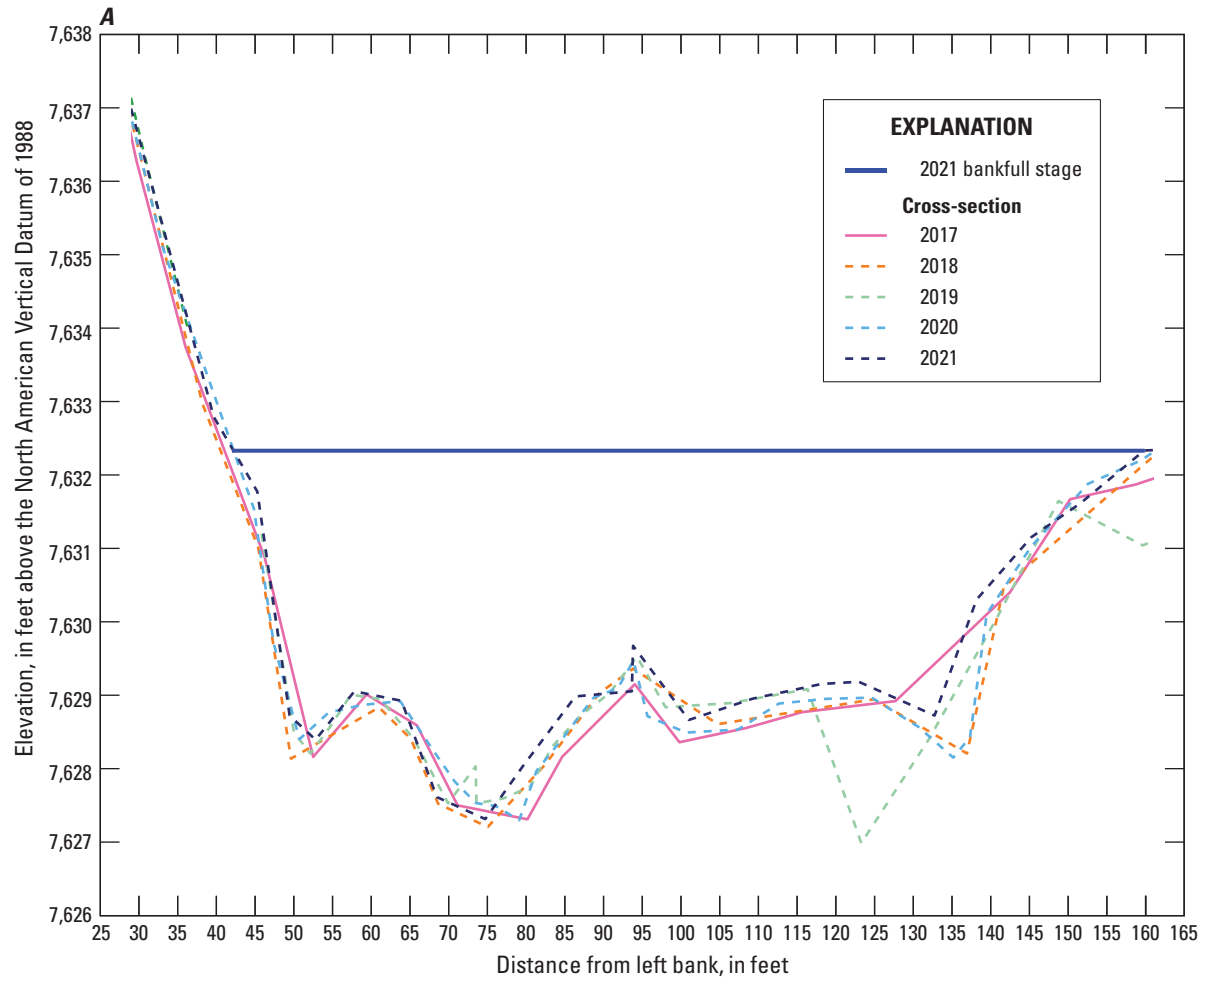
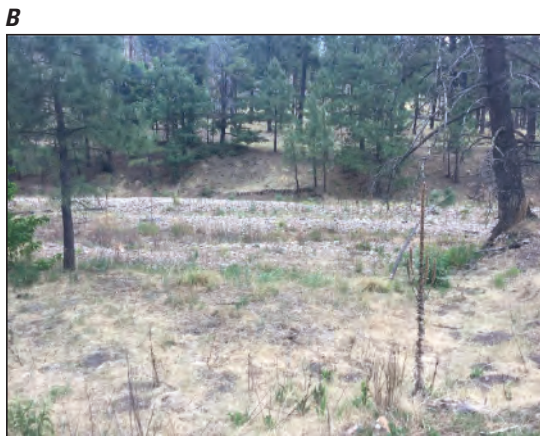
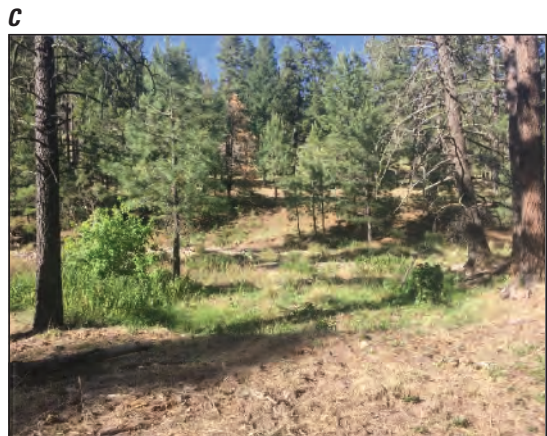
Figure 21. A, North Fork Eagle Creek, channel cross section 14, B, 2018 view looking at left bank from right bank, and C, 2020 view looking at left bank from right bank.

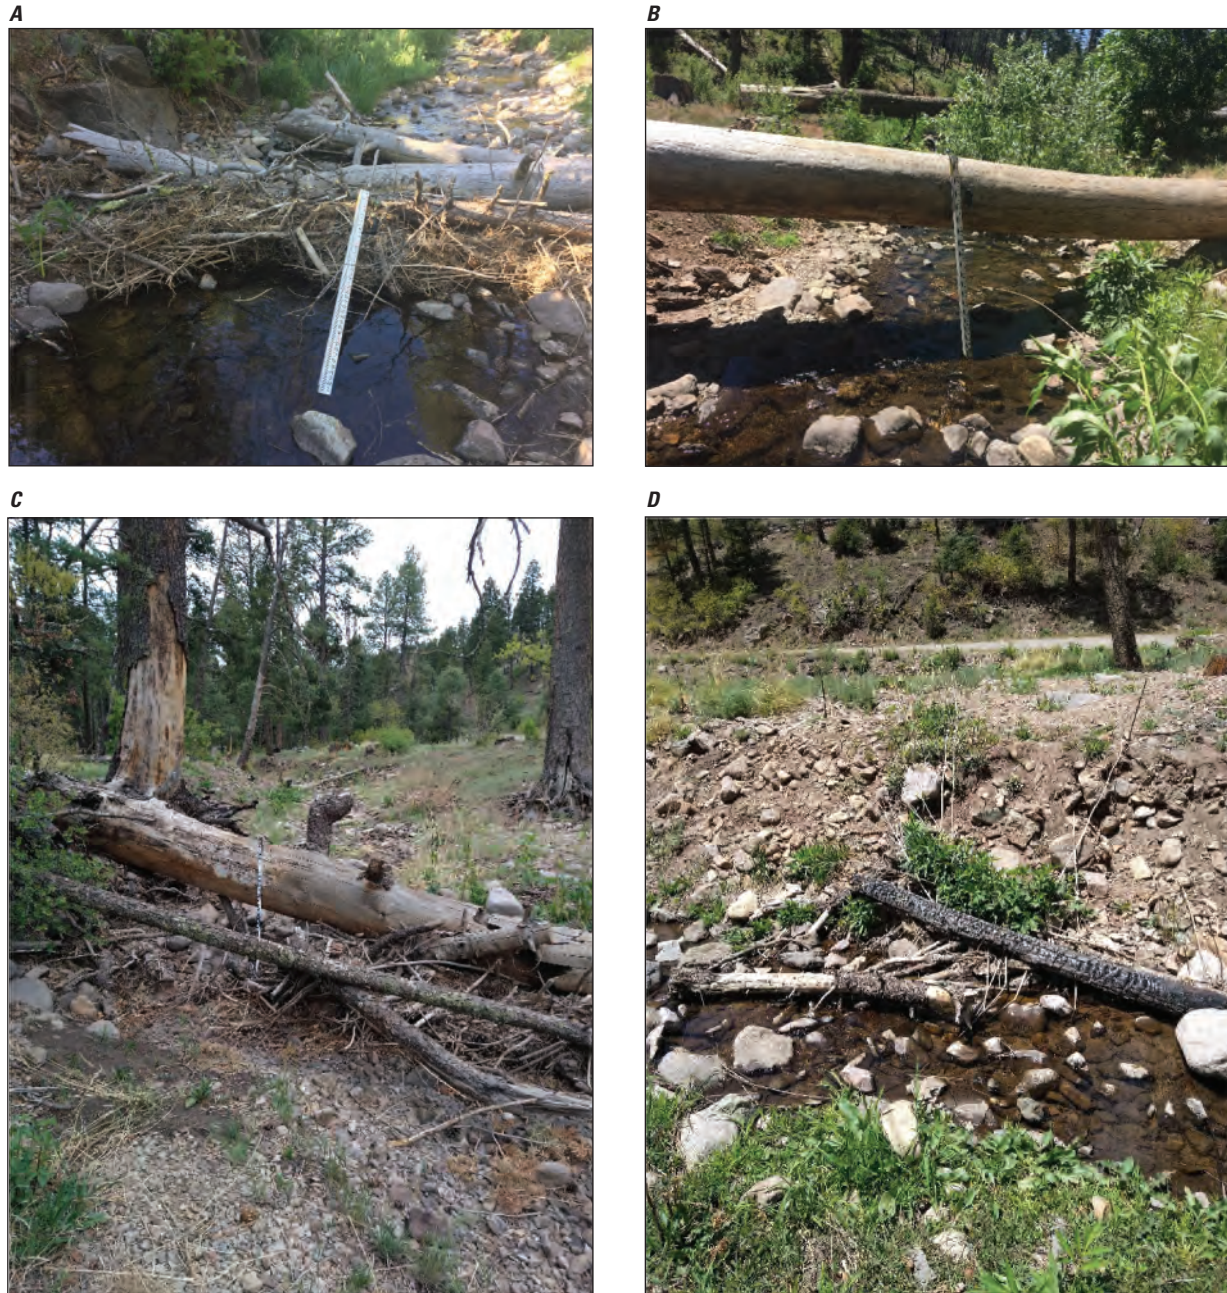
Example photographs of different woody debris accumulations identified during the 2020 and 2021 surveys are presented in figure 23. Figure 23A shows an example of an active debris jam, identified during the 2020 survey, that consists of a large log and multiple smaller woody debris accumulations blocking the stream channel, allowing for an upstream pool to form. Figure 23B shows an example of a potential debris jam identified in 2020 consisting of a large log spanning the channel without causing any jamming; this feature may deteriorate

from biodegradation into an active jam blocking streamflow in the future. Figure 23C shows an example of an active debris jam identified in 2021 that consists of a medium diameter log located in the dry subreach of the study area. Figure 23D shows an example of a debris deposit identified in 2021, consisting of medium sized logs and small pieces of woody debris resting on the side of the stream channel that were not actively blocking any streamflow under normal flow conditions.

Figure 23. Examples of woody debris accumulations identified in the study reach on North Fork Eagle Creek, Eagle Creek Basin, south-central New Mexico, between the 2020 and 2021 surveys. *A*, An active debris jam identified in 2020; *B*, a potential debris jam identified in 2020; *C*, an active debris jam identified in 2021; and *D*, a debris deposit identified in 2021. All photographs are oriented downstream. For scale, a survey rod 4.46 feet in length (with graduation at feet, tenths of feet, and hundredths of feet) was included in each photograph.

mobilize woody debris in the channel, and although some woody debris accumulations identified in 2018 may have been overlooked in 2017, the total number of woody debris accumulations in the channel increased between the two surveys (Graziano, 2020b). Between the 2018 and 2019 surveys, there were more instances of moderate flows (greater than 2 ft³/s) at the North Fork and Eagle Creek streamgages than between the 2017 and 2018 surveys and more woody debris accumulations found as a result (Graziano and Chavarria, 2022b). The increase in year-to-year woody debris accumulations would continue, with the 2020 and 2021 surveys having the highest number of woody debris accumulations identified, totaling 173 and 188, respectively. In contrast, the year with the minimum number of woody debris accumulations identified was 2017 with 58, followed by 2018 with 112, and 2019 with 164 total woody debris accumulations identified. The overall increase in woody debris accumulations may partly be due to the temporal lag between when a wildfire occurs and when damaged trees fall, allowing them to become mobilized in the stream channel (Catry and others, 2010; Angers and others, 2011). Compounding the increase in woody debris accumulations is the lack of high flow events during periods 3 and 4, which could limit the physical mechanism needed to mobilize anchored debris accumulations out of the study reach. This explanation is further validated by field photographs, which show woody debris with visible burn damage that likely originated from the Little Bear Fire burn scar (fig. 23D).

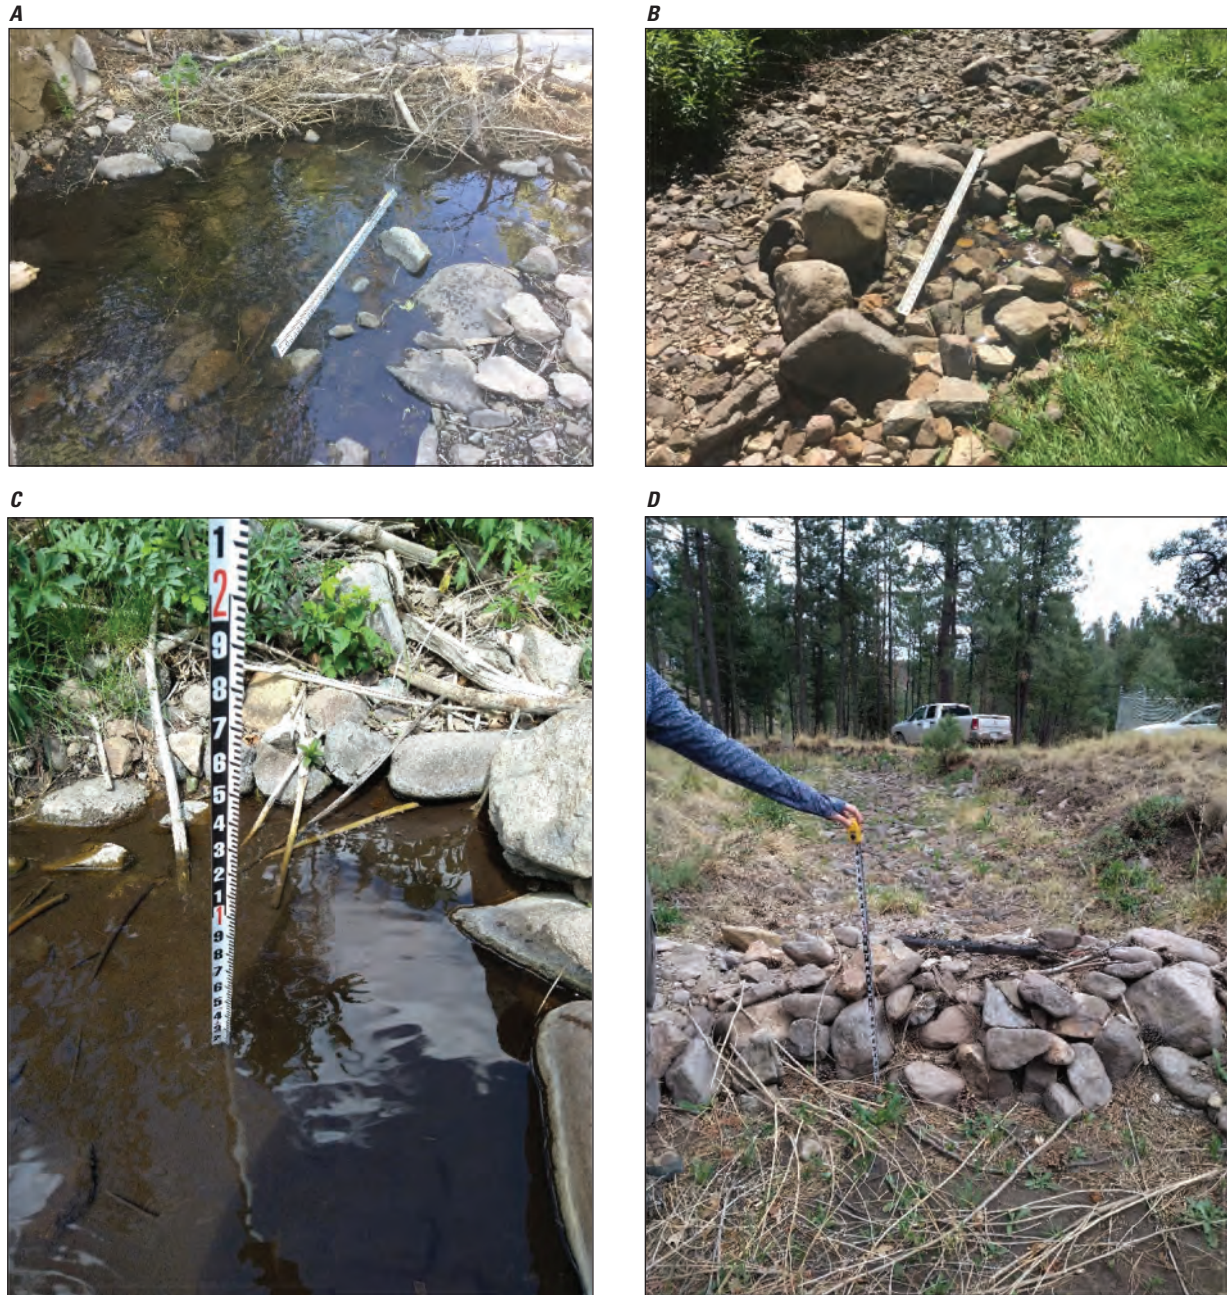
Figure 24. Examples of pools identified in the study reach on North Fork Eagle Creek, Eagle Creek Basin, south-central New Mexico, 2020 and 2021. *A*, A wet pool identified in 2020; *B*, a dry pool identified in 2020; *C*, a wet pool identified in 2021; and *D*, a dry pool identified in 2021. All photographs were taken facing downstream. For scale, a survey rod that is 4.46 feet in length (with graduation at a foot, tenths of a foot, and hundredths of a foot) or a tape measure (with graduation at a foot, tenths of a foot, and two hundredths of a foot) was included in each photograph. Figure parts *C* and *D* depict the methodology used to measure pool residual depths during both flowing and dry conditions.

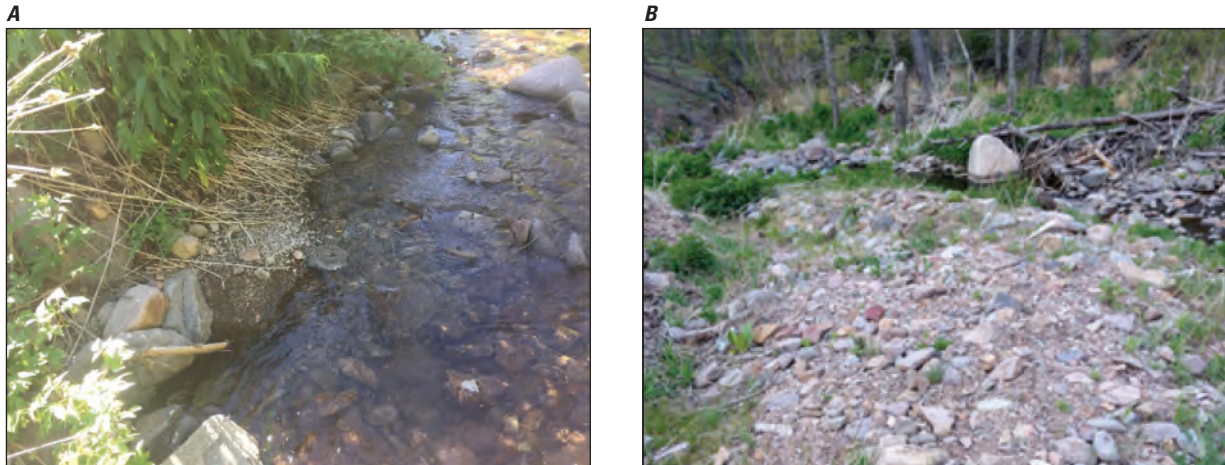
Example photographs presented in figure 25 depict characteristics of channel bifurcations and fine-sediment accumulations identified in the study reach during the 2020 and 2021 surveys. Figure 25A depicts a fine-sediment accumulation that was collocated with dense bank vegetation, which may have slowed water enough for sediment to settle during high flows. Figure 25B depicts a channel bifurcation that was about 50 ft in length along the channel reach and had no woody debris present. This bifurcation was also identified in 2020 and had dense vegetation and some woody debris consisting of large logs.

Figure 25. Examples of fine-sediment accumulations and channel bifurcations identified in the study reach on North Fork Eagle Creek, Eagle Creek Basin, south-central New Mexico, 2020 and 2021. All photographs are oriented downstream. *A*, A fine-sediment accumulation located at the base of the left bank during the 2020 survey; *B*, a channel bifurcation, which was located on the left bank of the channel and was about 50 feet long during the 2021 survey.

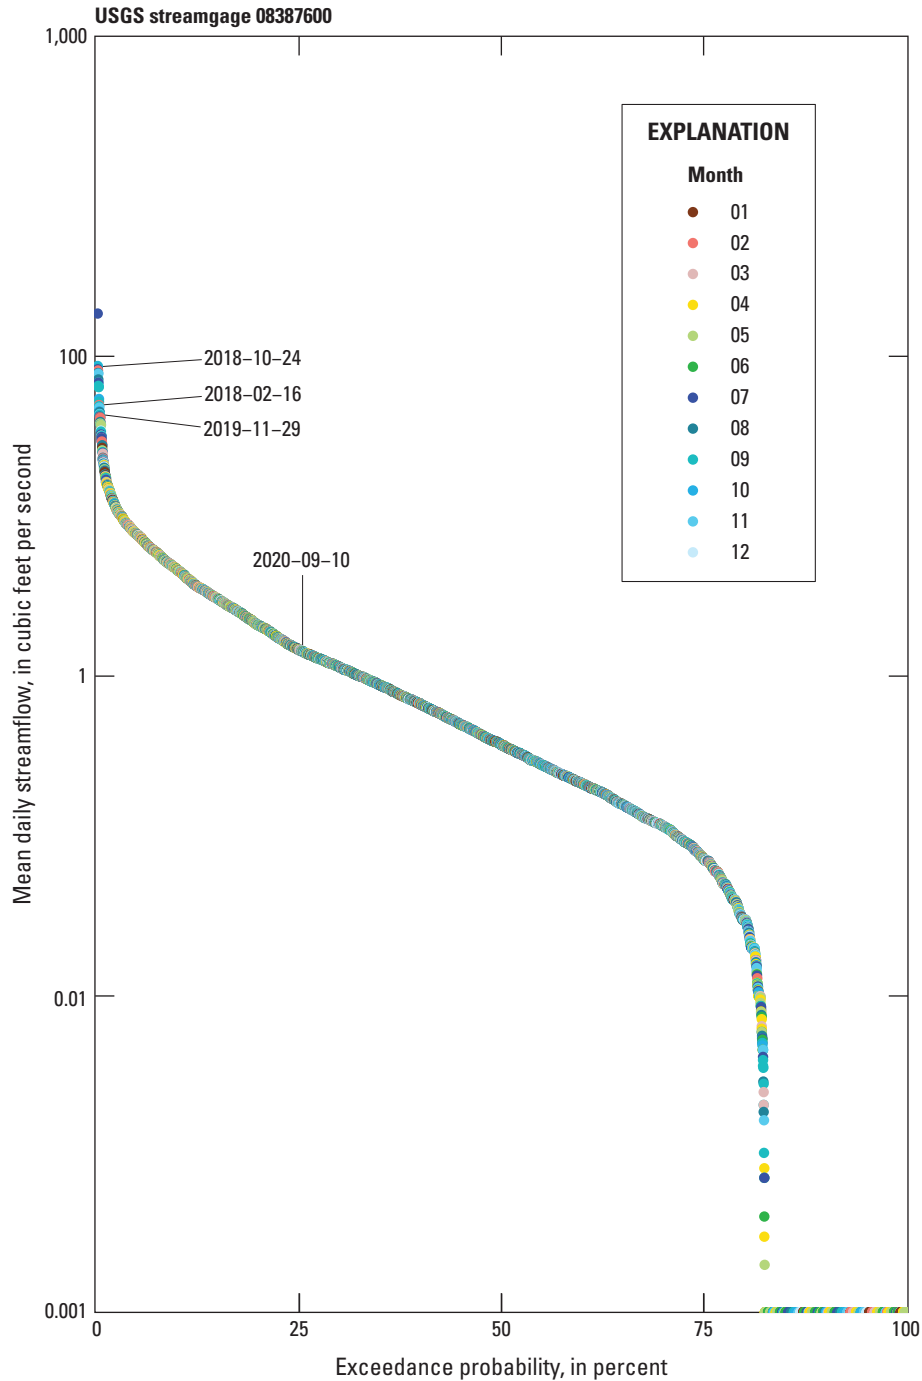
Figure 26. Mean daily streamflow flow duration curve of Eagle Creek streamgage from January 1, 1992, to May 20, 2021 (USGS site 08387600) (U.S. Geological Survey, 2022a), created using the total-period method (Dunne and Leopold, 1978). The maximum streamflow values observed between each survey period are annotated in the plot with the respective date the high streamflow event occurred. To identify seasonal patterns within the streamflow record, each daily mean streamflow value is color coded by the month in which the value was observed.
