Bathymetric and Velocimetric Surveys at Highway Bridges Crossing the Missouri River between Kansas City and St. Louis, Missouri, May 19–26, 2021

Scientific Investigations Report 2024–5021

U.S. Department of the Interior
U.S. Geological Survey

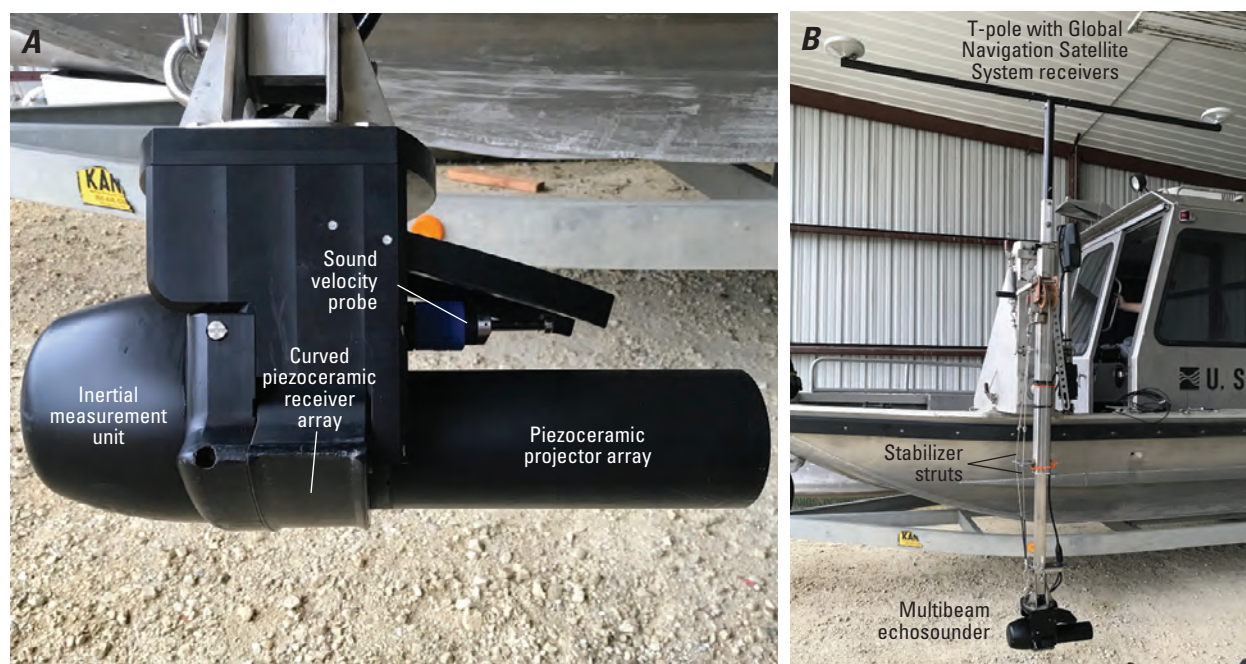
Figure 3. The multibeam echosounder. Photographs by Richard J. Huizinga, U.S. Geological Survey (USGS). *A*, Viewed from the side. *B*, Mounted on the port side of the U.S. Geological Survey boat.

An MBMS is an integration of several individual components: the multibeam echosounder (MBES), a sound-velocity probe, an inertial navigation system (INS), and a data-collection and data-processing computer. The MBES used in this study is the Norbit iWBMS_h (fig. 3), operated at a frequency of 400 kilohertz (kHz). The iWBMS_h is similar in operation to the MBES systems used in previous studies in the mid-Missouri area, except that it has a curved piezoceramic receiver array, which enables bathymetric data to be collected throughout a swath range of 210 degrees. Optimum data usually are collected in a swath of less than 160 degrees (80 degrees on each side of nadir, or straight down below the MBES); nevertheless, the swath can be electronically rotated to either side of nadir, enabling data collection along sloping banks up to a depth just below the water surface. The sound-velocity probe provides real-time measurements of the speed of sound at the MBES to accurately determine the depth readings of the MBES (Hughes Clarke and others, 1996). The

from −2.5 to −1.5 between the two patch tests (table 4). The variable angular offset for yaw observed in the 2021 surveys is believed to be the result of a combination of a loose connection on the T-pole on which the GNSS receivers were mounted (fig. 3B) and an incorrectly applied magnetic variation or grid convergence parameter in the post-processing of the survey data (Rivers and others, 2023). The measured angular offset for roll remained a constant −0.10 (table 4), which is different from previous results for this equipment configuration in other recent surveys (Huizinga, 2022a; Huizinga and others, 2023); however, the MBES had undergone calibration testing in January 2021, which is the likely source of the change. Furthermore, the roll offset of −0.10 is consistent with other data collected since the calibration testing in 2021 (Rivers and others, 2023). It was noted in the earliest work with the MBMS in Missouri (Huizinga, 2010) that a sensitivity analysis of the four offsets indicated that the ultimate position of surveyed points in three-dimensional space was least sensitive to the angular offset for yaw, whereas it was most sensitive to the angular offset for roll. Processing all the data for the bridge surveys detailed in this report with an angular offset of roll of

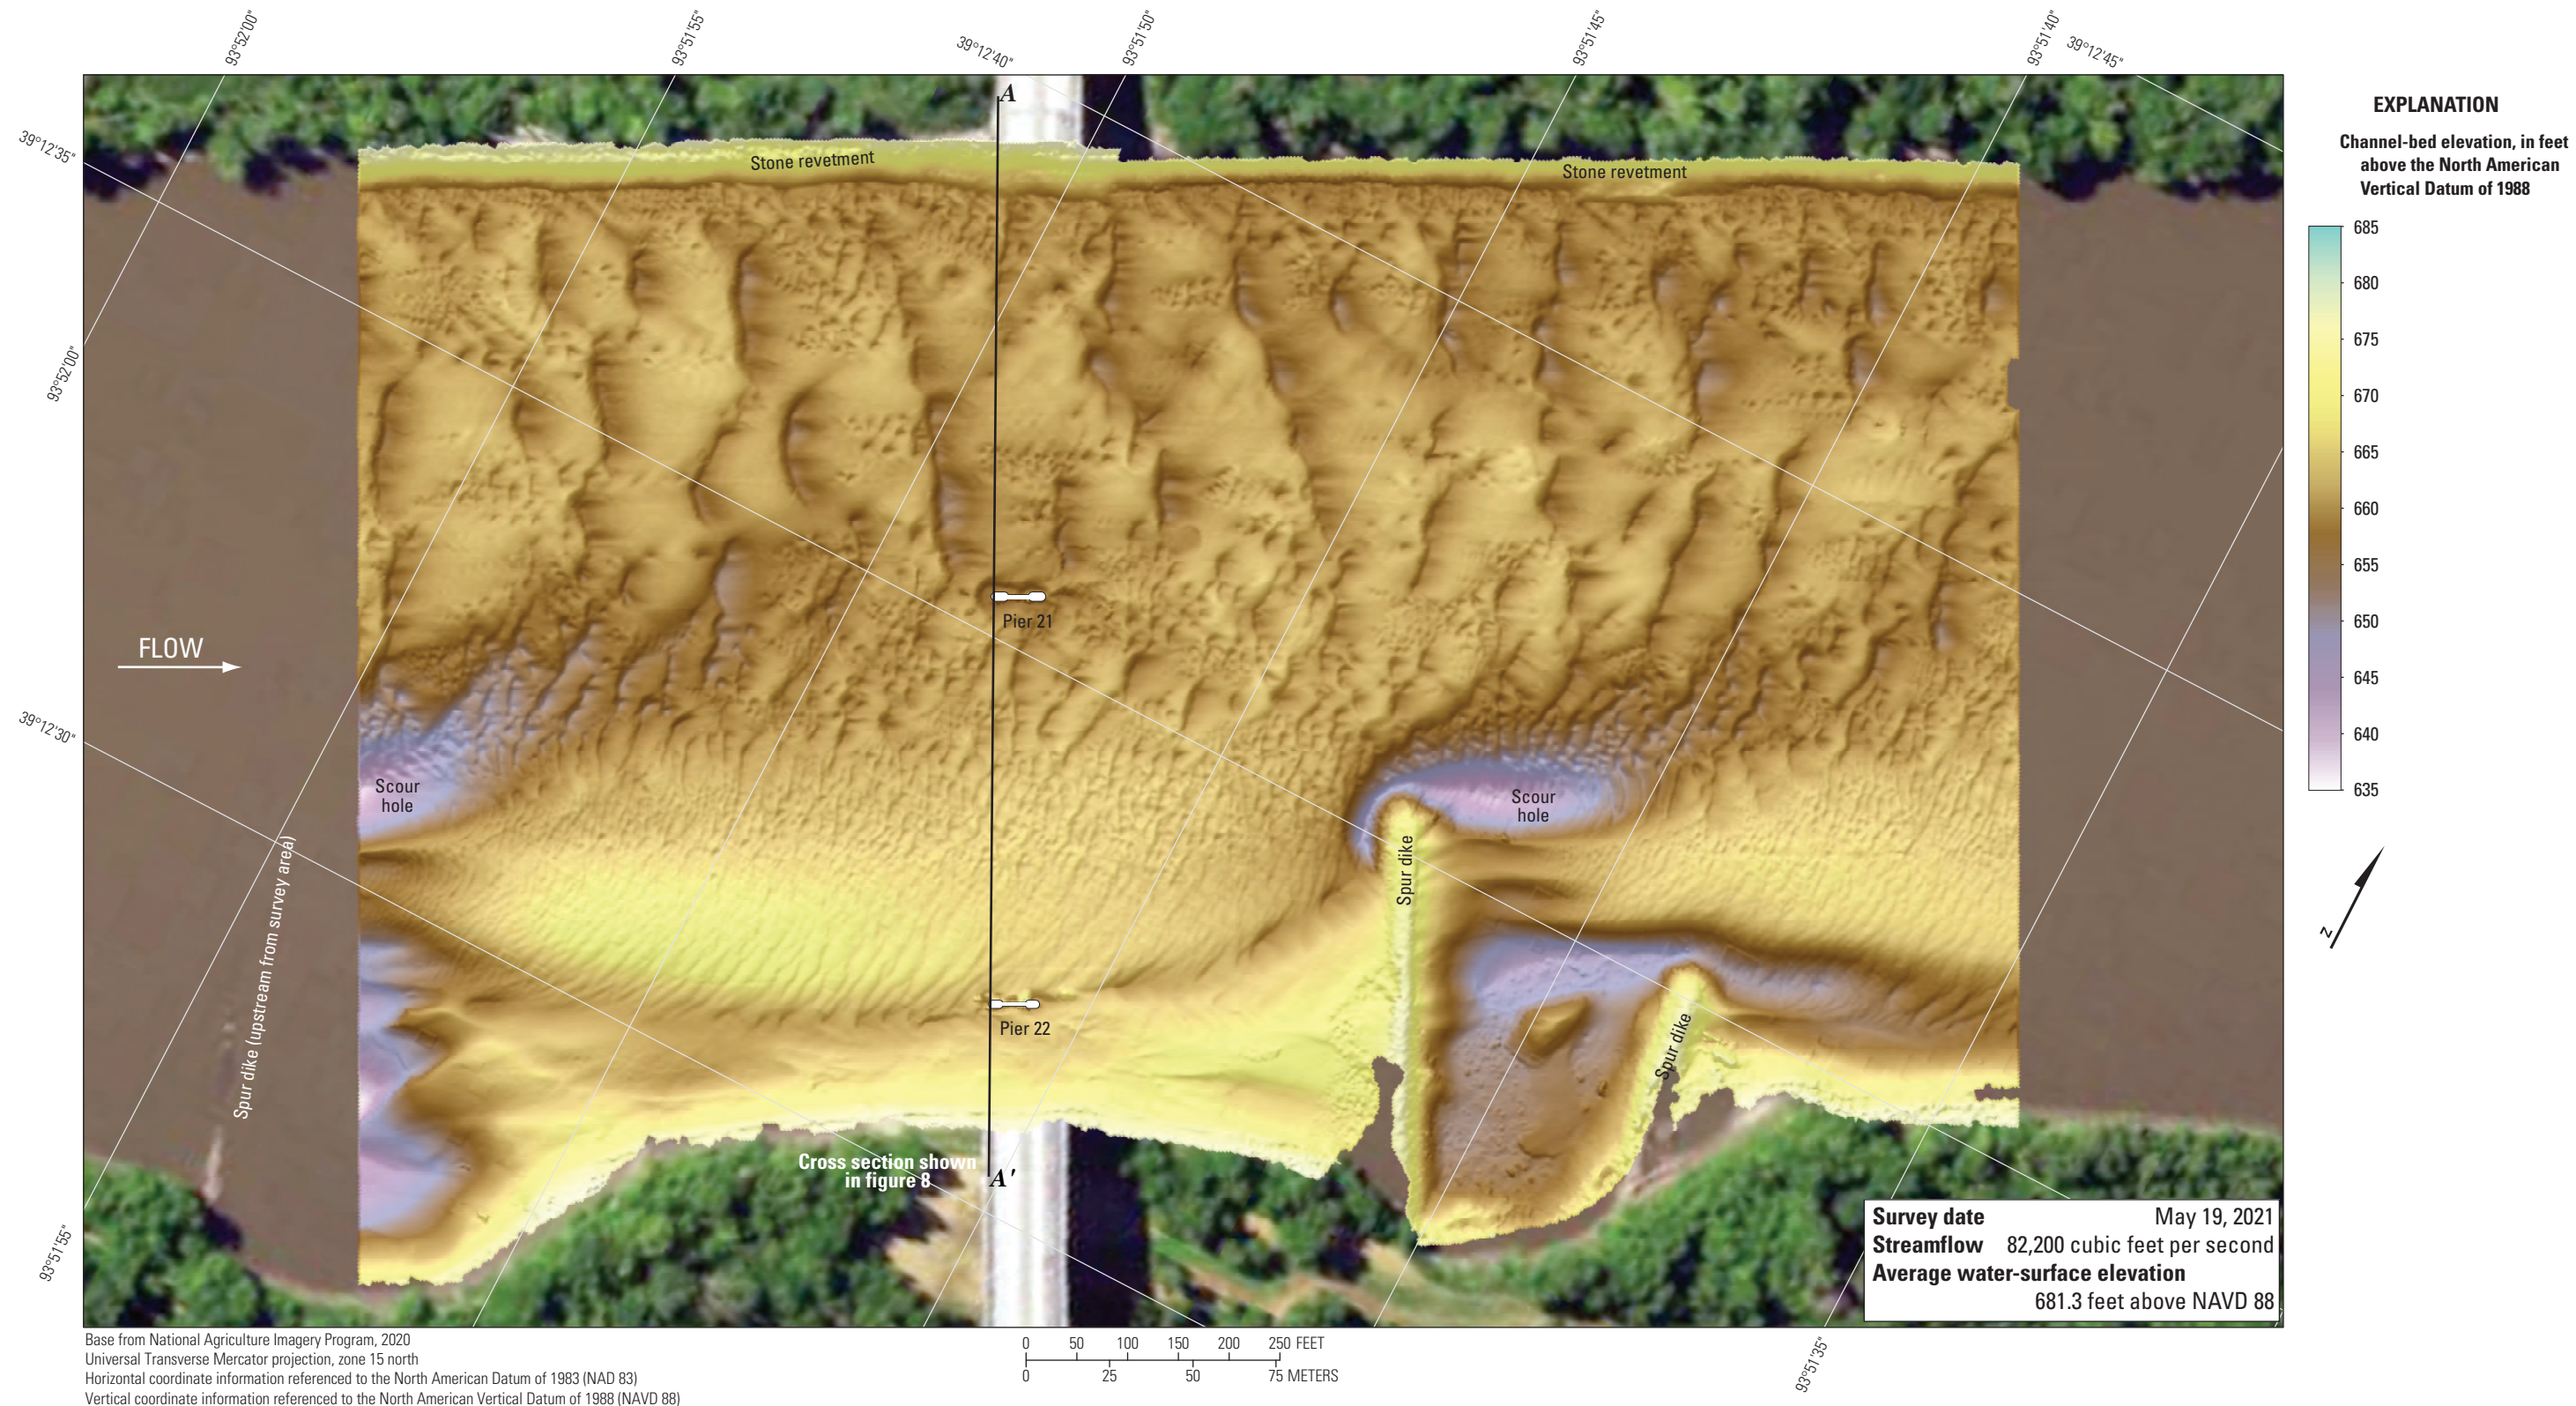
Figure 6. Bathymetric survey of the Missouri River channel near structure A5664 on State Highway 13 at Lexington, Missouri.

The minor scour holes near main channel piers 21 and 22 were difficult to discern from nearby dunes and ripples ([figs. 6](#) and [1.1](#)). Information from bridge plans indicates that piers 21 and 22 are founded on shafts drilled 28 to 50 ft into bedrock, having about 52 ft of bed material between the channel bottom and bedrock at pier 21 and about 27 ft of material at pier 22 ([fig. 8](#); difference between “Approximate minimum elevation in scour hole near pier/bent” and “Approximate elevation of bedrock near pier/bent” in [table 7](#)). The surveyed bed generally was similar to the previous multibeam surveys in 2013 and 2017, except on the left side of pier 21 ([fig. 8](#)). The scour hole near pier 21 appears to penetrate to the top of the pier footing ([figs. 6, 8, 1.1A, 1.1B](#)), which might provide some mitigation to the scour hole at this pier as the downward flow of the horseshoe vortex at the pier column face is blunted by the footing (Arneson and others, 2012).

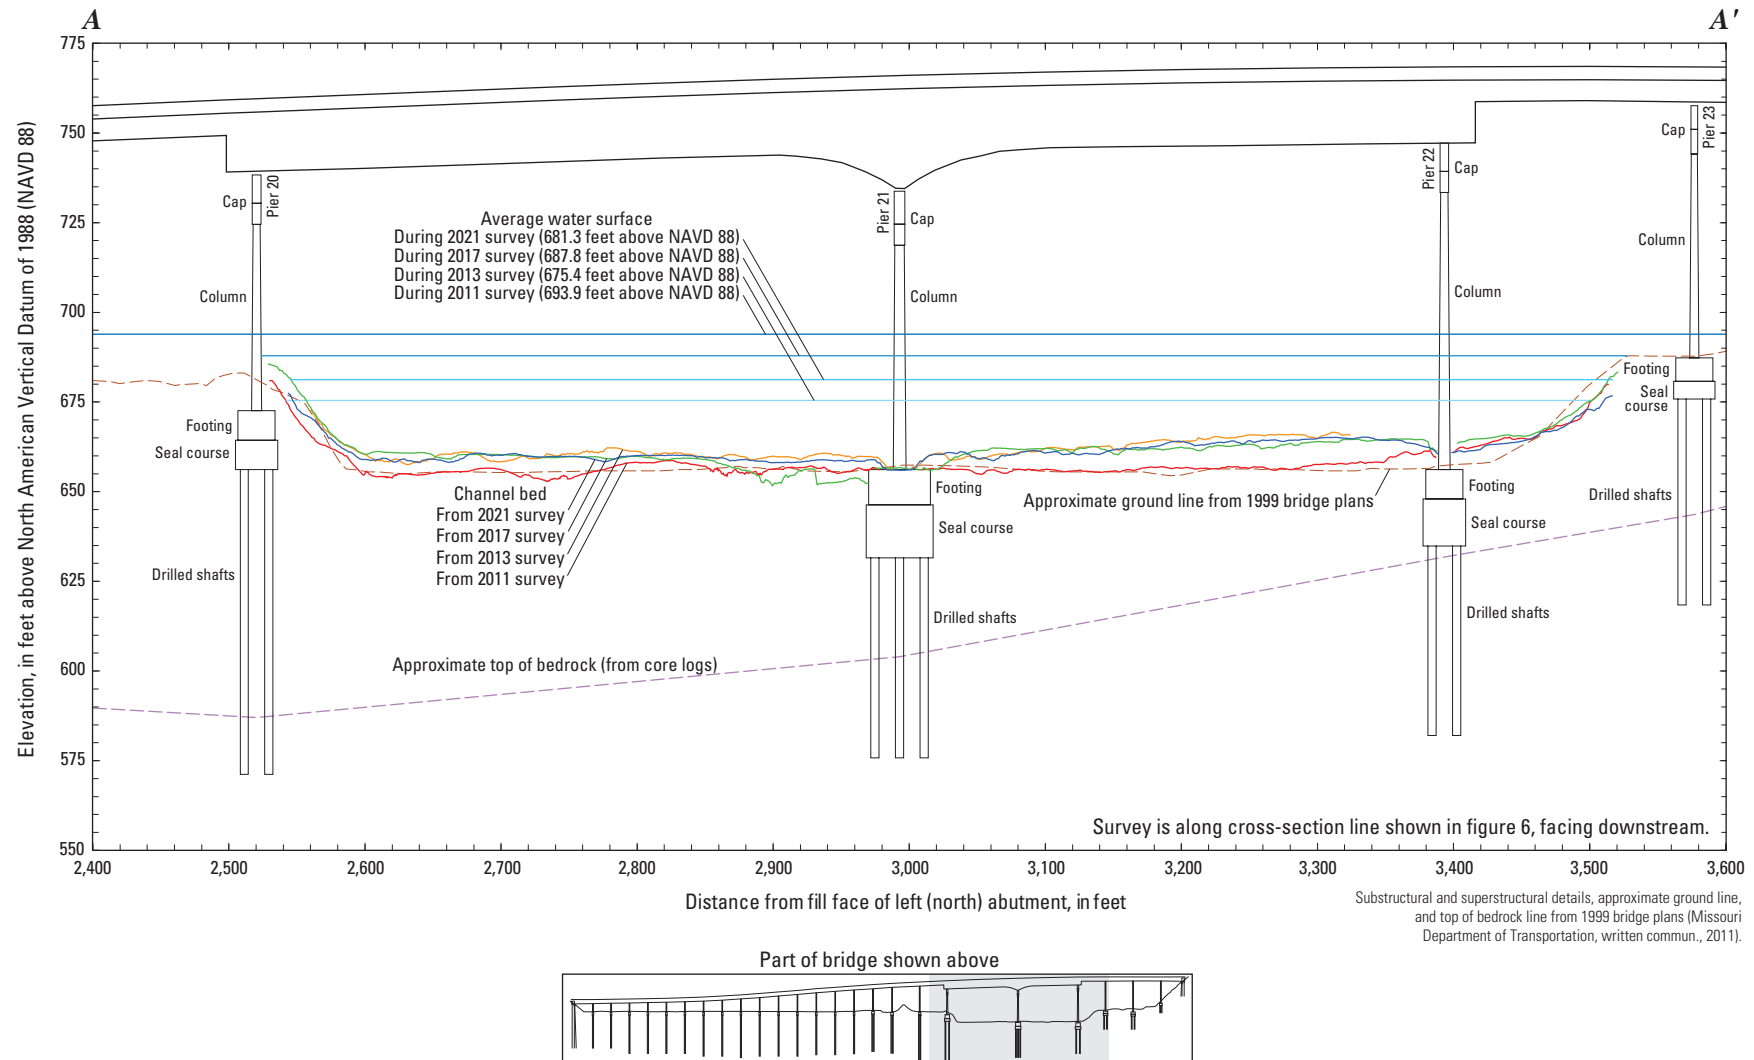
Figure 8. Key features, substructural and superstructural details, and surveyed channel bed of structure A5664 on State Highway 13 crossing the Missouri River at Lexington, Missouri.

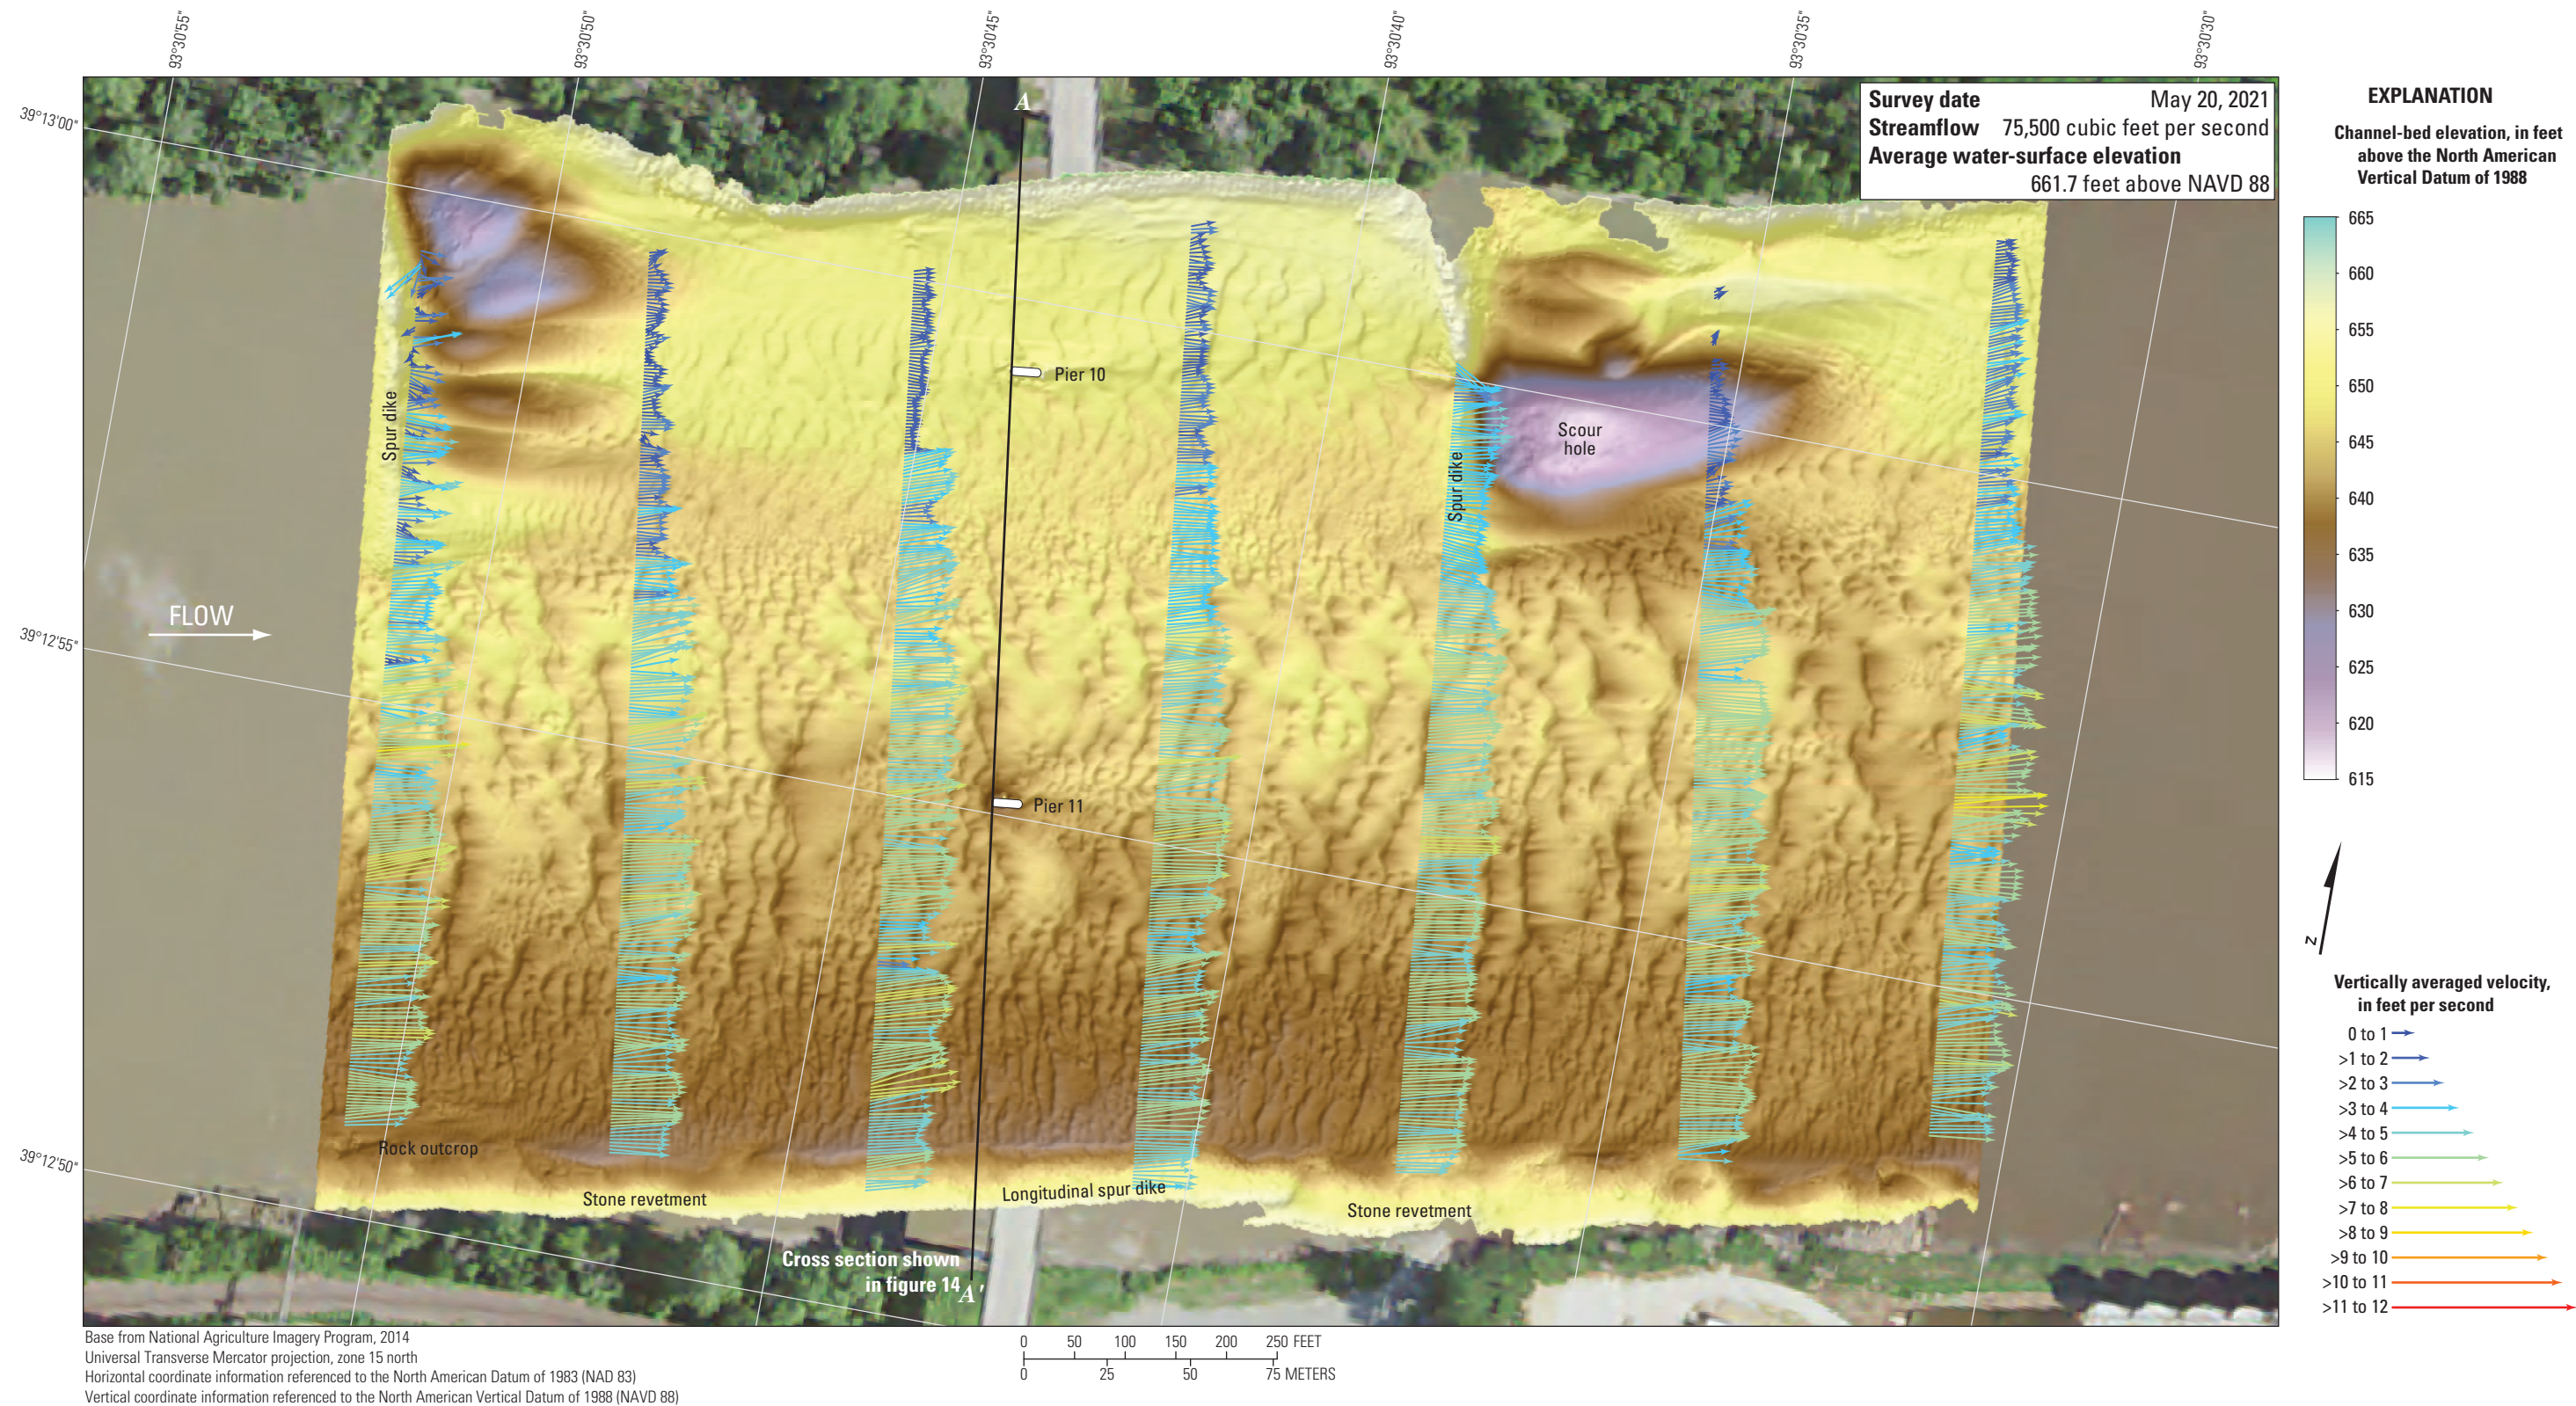
Figure 18. Bathymetry and vertically averaged velocities of the Missouri River channel near structure A5910 on U.S. Highway 24 at Waverly, Missouri.

The vertically averaged velocity vectors indicate mostly uniform flow in the middle of the channel, with velocities ranging from about 3 to 9 feet per second (ft/s; fig. 18). Local lower velocities and turbulence were observed downstream from the various spur dikes on the left (north) bank (fig. 18). The wake vortices downstream from the main channel piers were not pronounced and seemed to be no greater than the general nonuniformity of flow observed in the channel (fig. 18). Minor localized turbulence was present in all the sections (fig. 18).

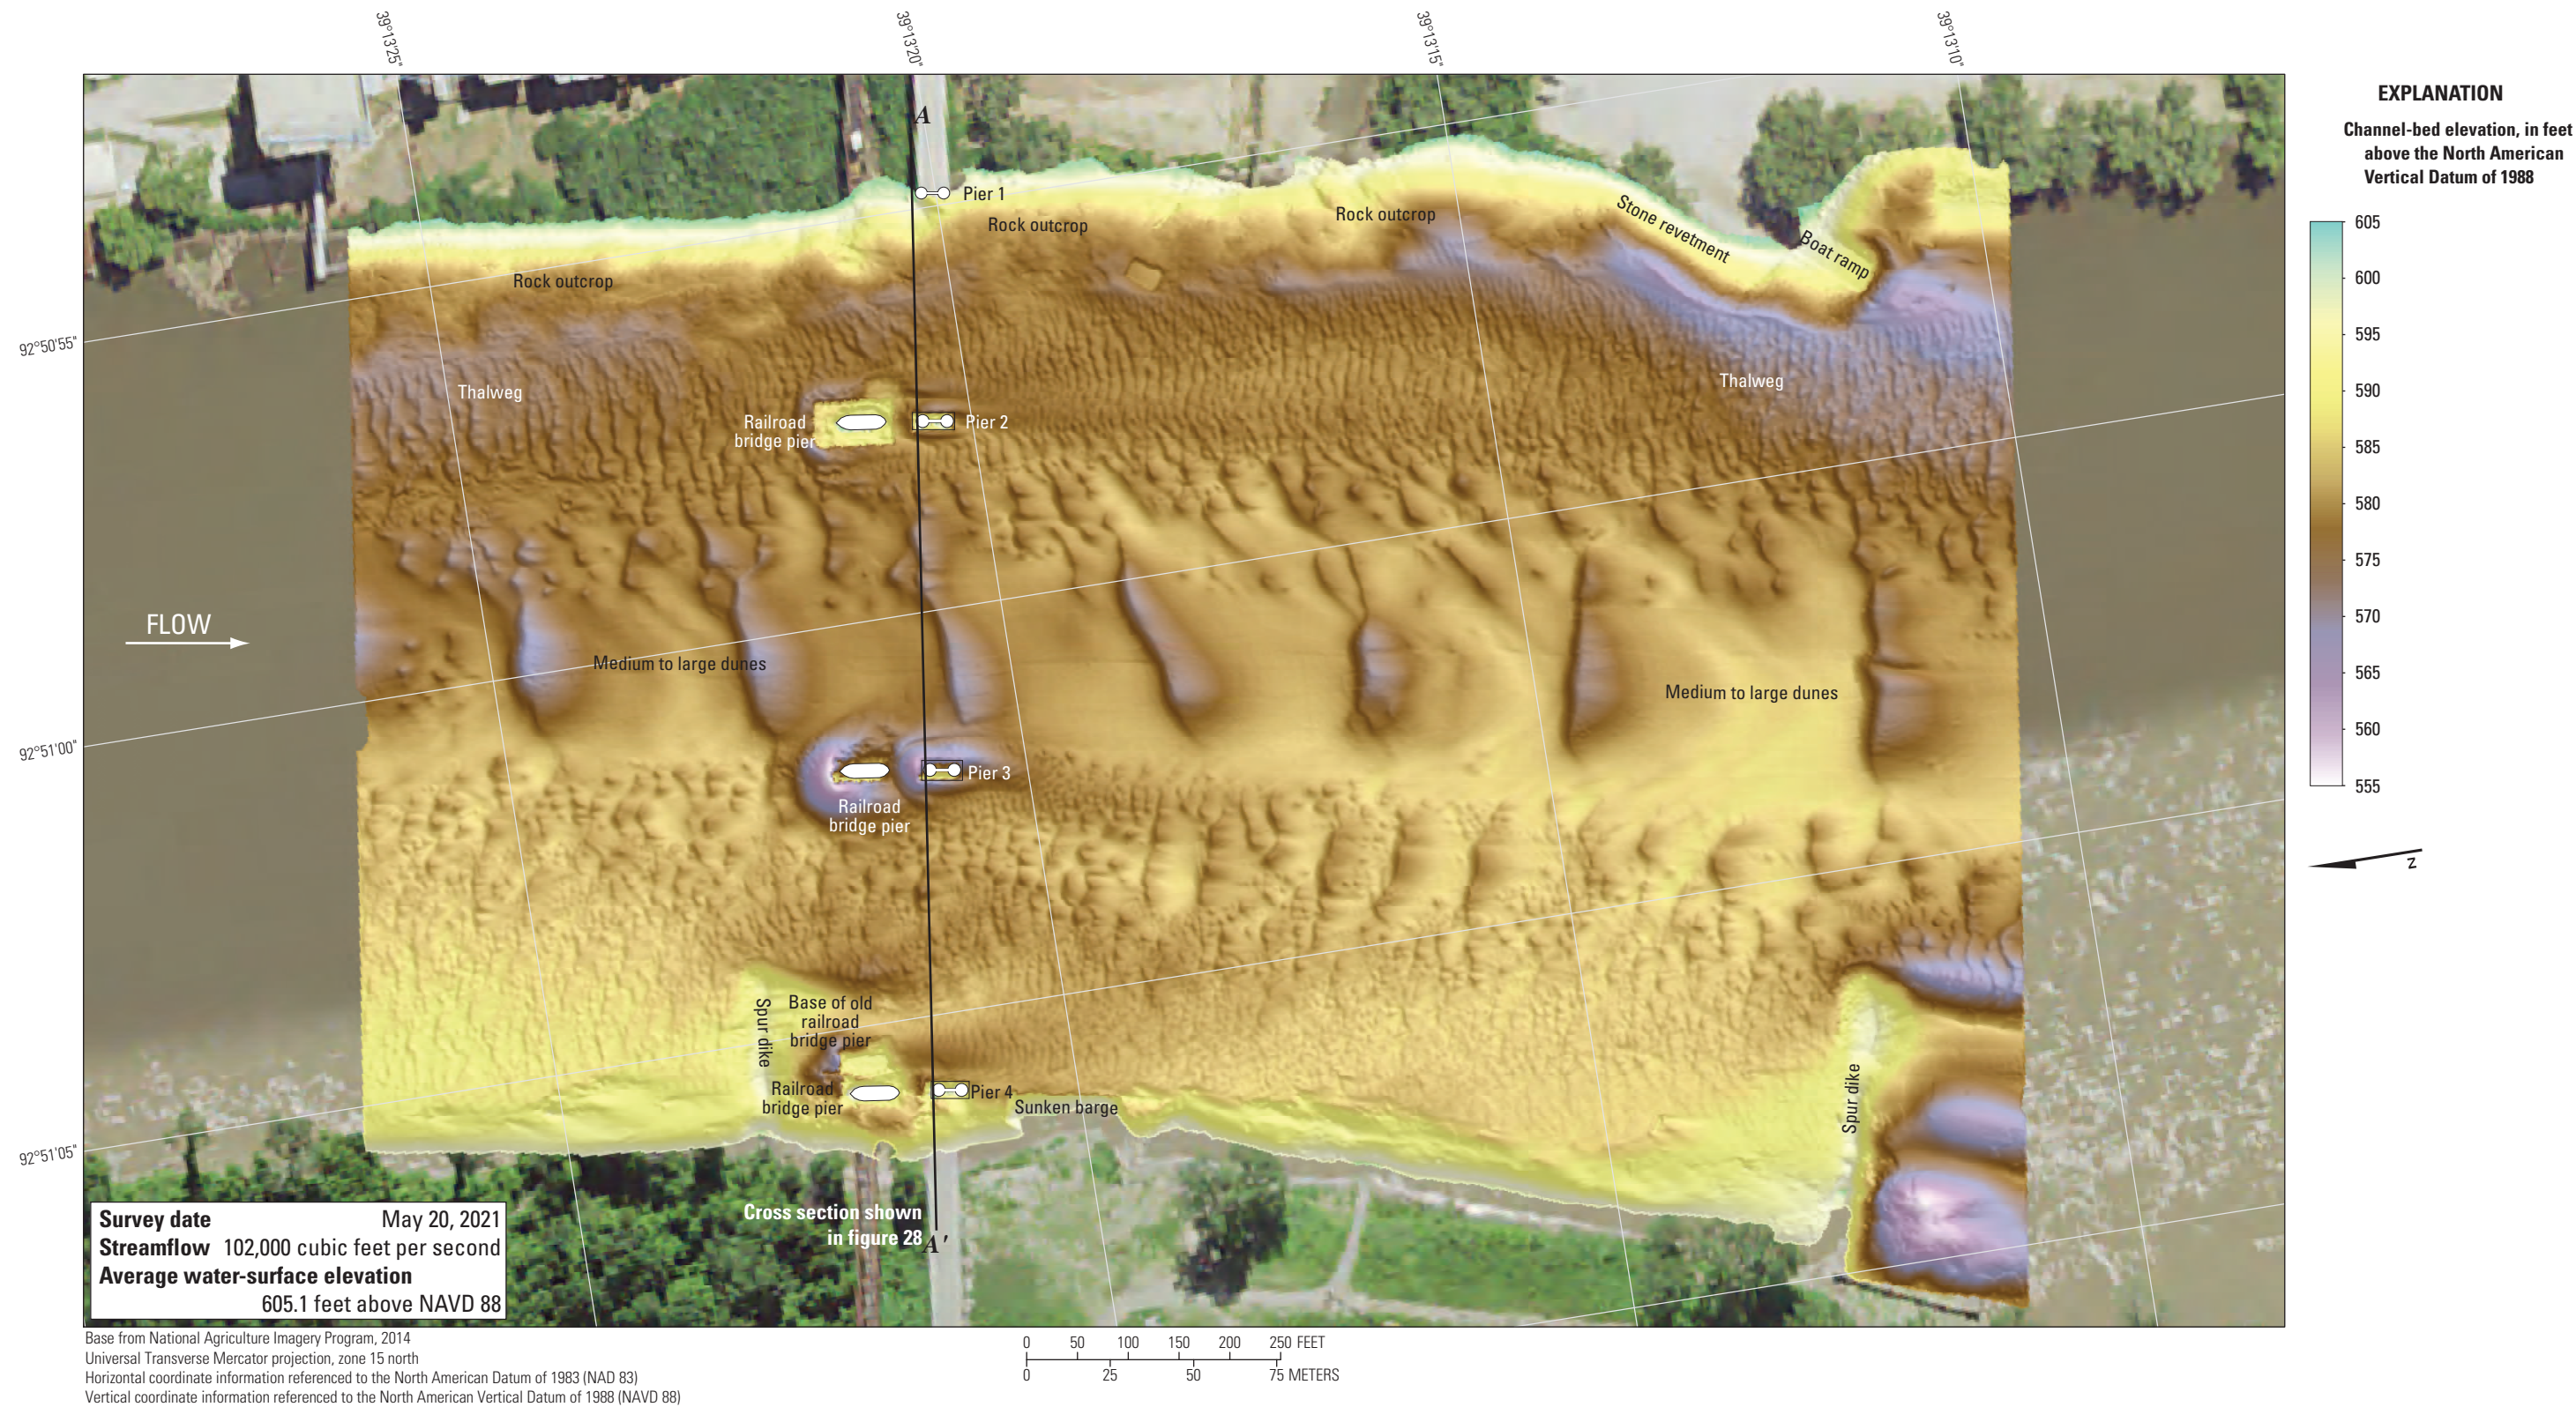
Figure 26. Bathymetric survey of the Missouri River channel near structure G0069 on State Highway 240 at Glasgow, Missouri.

A small scour hole was observed near pier 2 ([fig. 26](#)), which is founded on a footing on bedrock according to bridge plans ([fig. 28](#); [table 6](#)). The ground line from the bathymetric survey indicated that the right side of the footing seemed to be undermined in previous surveys in 2011 and 2013 but was partially buried in bed sediments in the 2017 and 2021 surveys ([figs. 28, 1.4B, 1.4C](#)). The details of the footing of pier 2 in the bridge plans for structure G0069 are not sufficient to tell if it was entrenched in the bedrock in any way, particularly if the top of the bedrock was not level, as indicated by previous surveys (Huizinga, 2014; [fig. 28](#)). In modern construction, bridge substructural elements usually are pinned or socketed to bedrock (Brown and others, 2018; American Association of State Highway Transportation Officials, 2020), but full exposure of usually buried substructural elements warrants special consideration and observation, particularly at an older bridge such as structure G0069 (built in 1922).

A substantial scour hole was observed near main channel pier 3 ([figs. 26, 1.4D, 1.4E](#)), and a smaller scour hole was observed near pier 4 ([fig. 26](#)). Near pier 3, the scour hole had a minimum channel-bed elevation of about 566 ft ([table 7](#)), which is about 12 ft below the average channel bed immediately upstream from the pier ([figs. 26, 28](#); [table 7](#)). Near pier 4, the scour hole had a minimum channel-bed elevation of about 579 ft ([figs. 26, 28](#); [table 7](#)). Information from bridge plans

indicates that piers 3 and 4 are caissons founded on bedrock, and there is about 4 ft of bed material between the bottom of the scour hole and bedrock at pier 3 and about 22 ft at pier 4 ([fig. 28](#); [table 7](#)). The scour observed near all the highway bridge piers was substantially affected by the upstream railroad bridge piers ([fig. 26](#)). The 2021 surveyed bed generally was most similar to the 2011 multibeam survey ([fig. 28](#)). The approximate top of bedrock confirmed in the previous multibeam surveys seems to have a thin layer of fluvial material near the left bank in the 2021 survey ([fig. 28](#)), with further evidence from small dunes and ripples in that area ([fig. 26](#)).

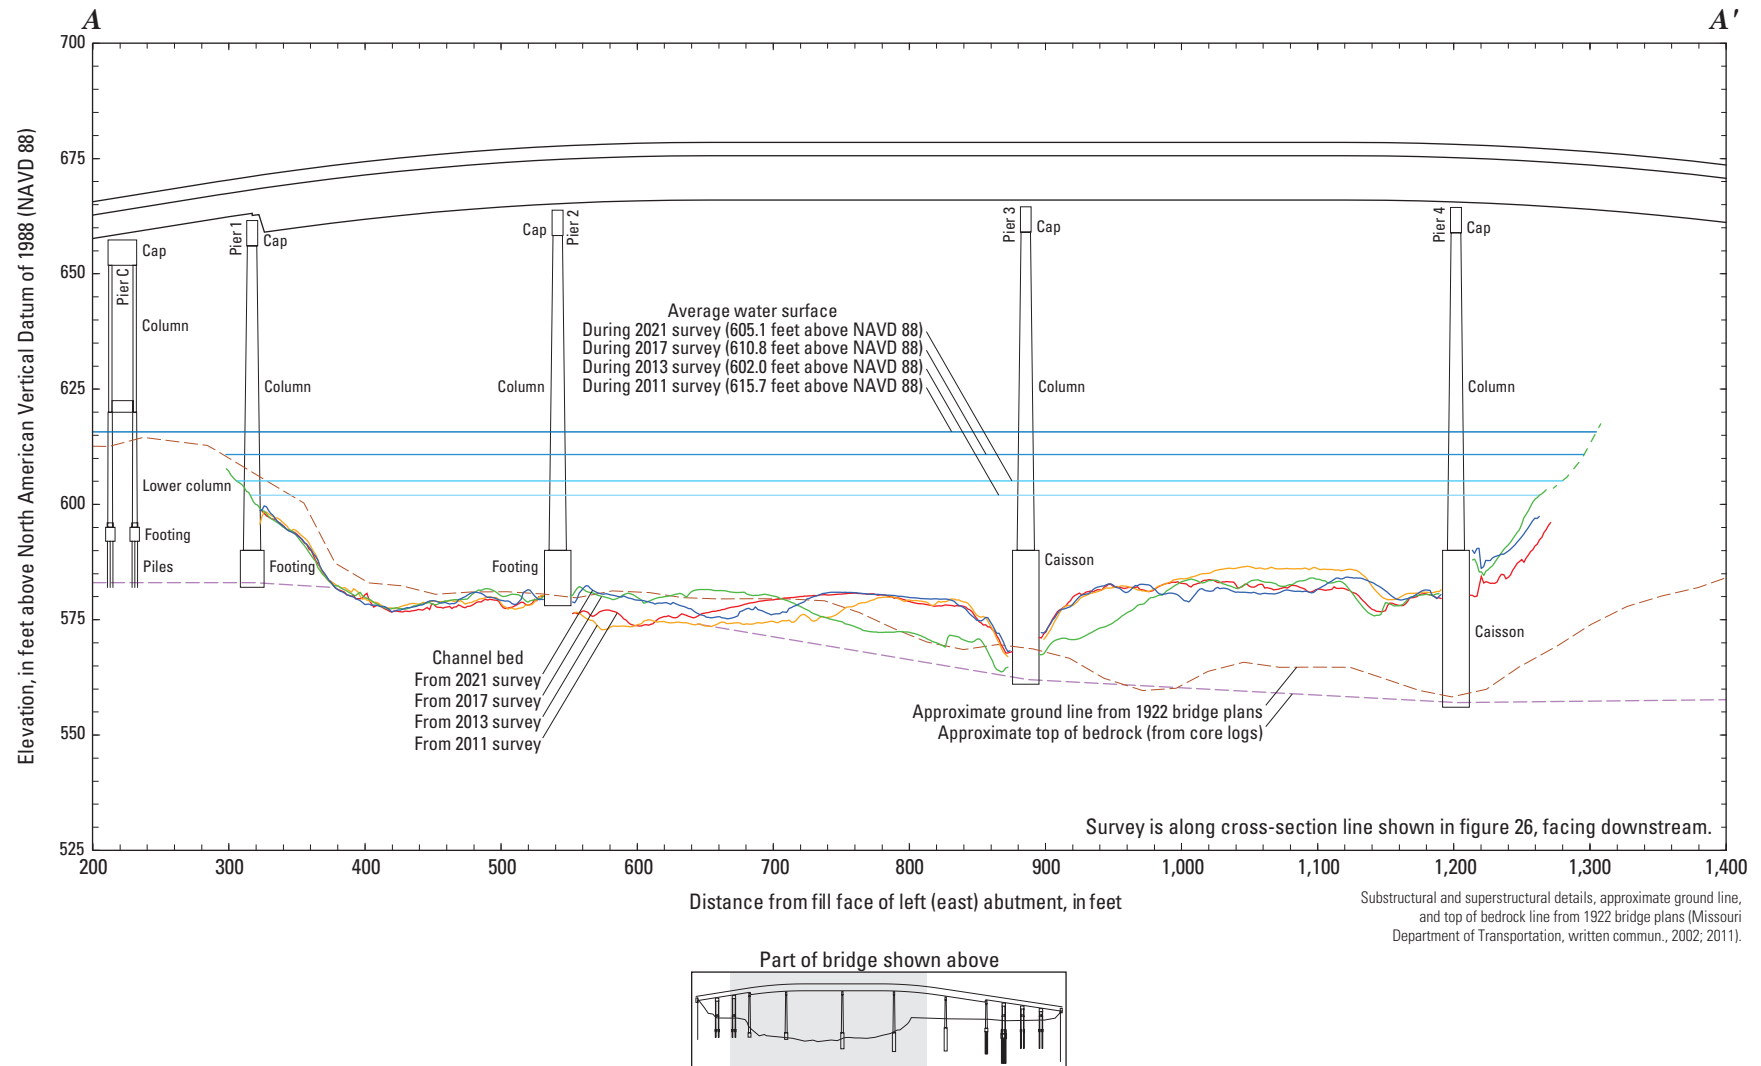
Figure 28. Key features, substructural and superstructural details, and surveyed channel bed of structure A3292 on State Highway 240 crossing the Missouri River at Glasgow, Missouri.

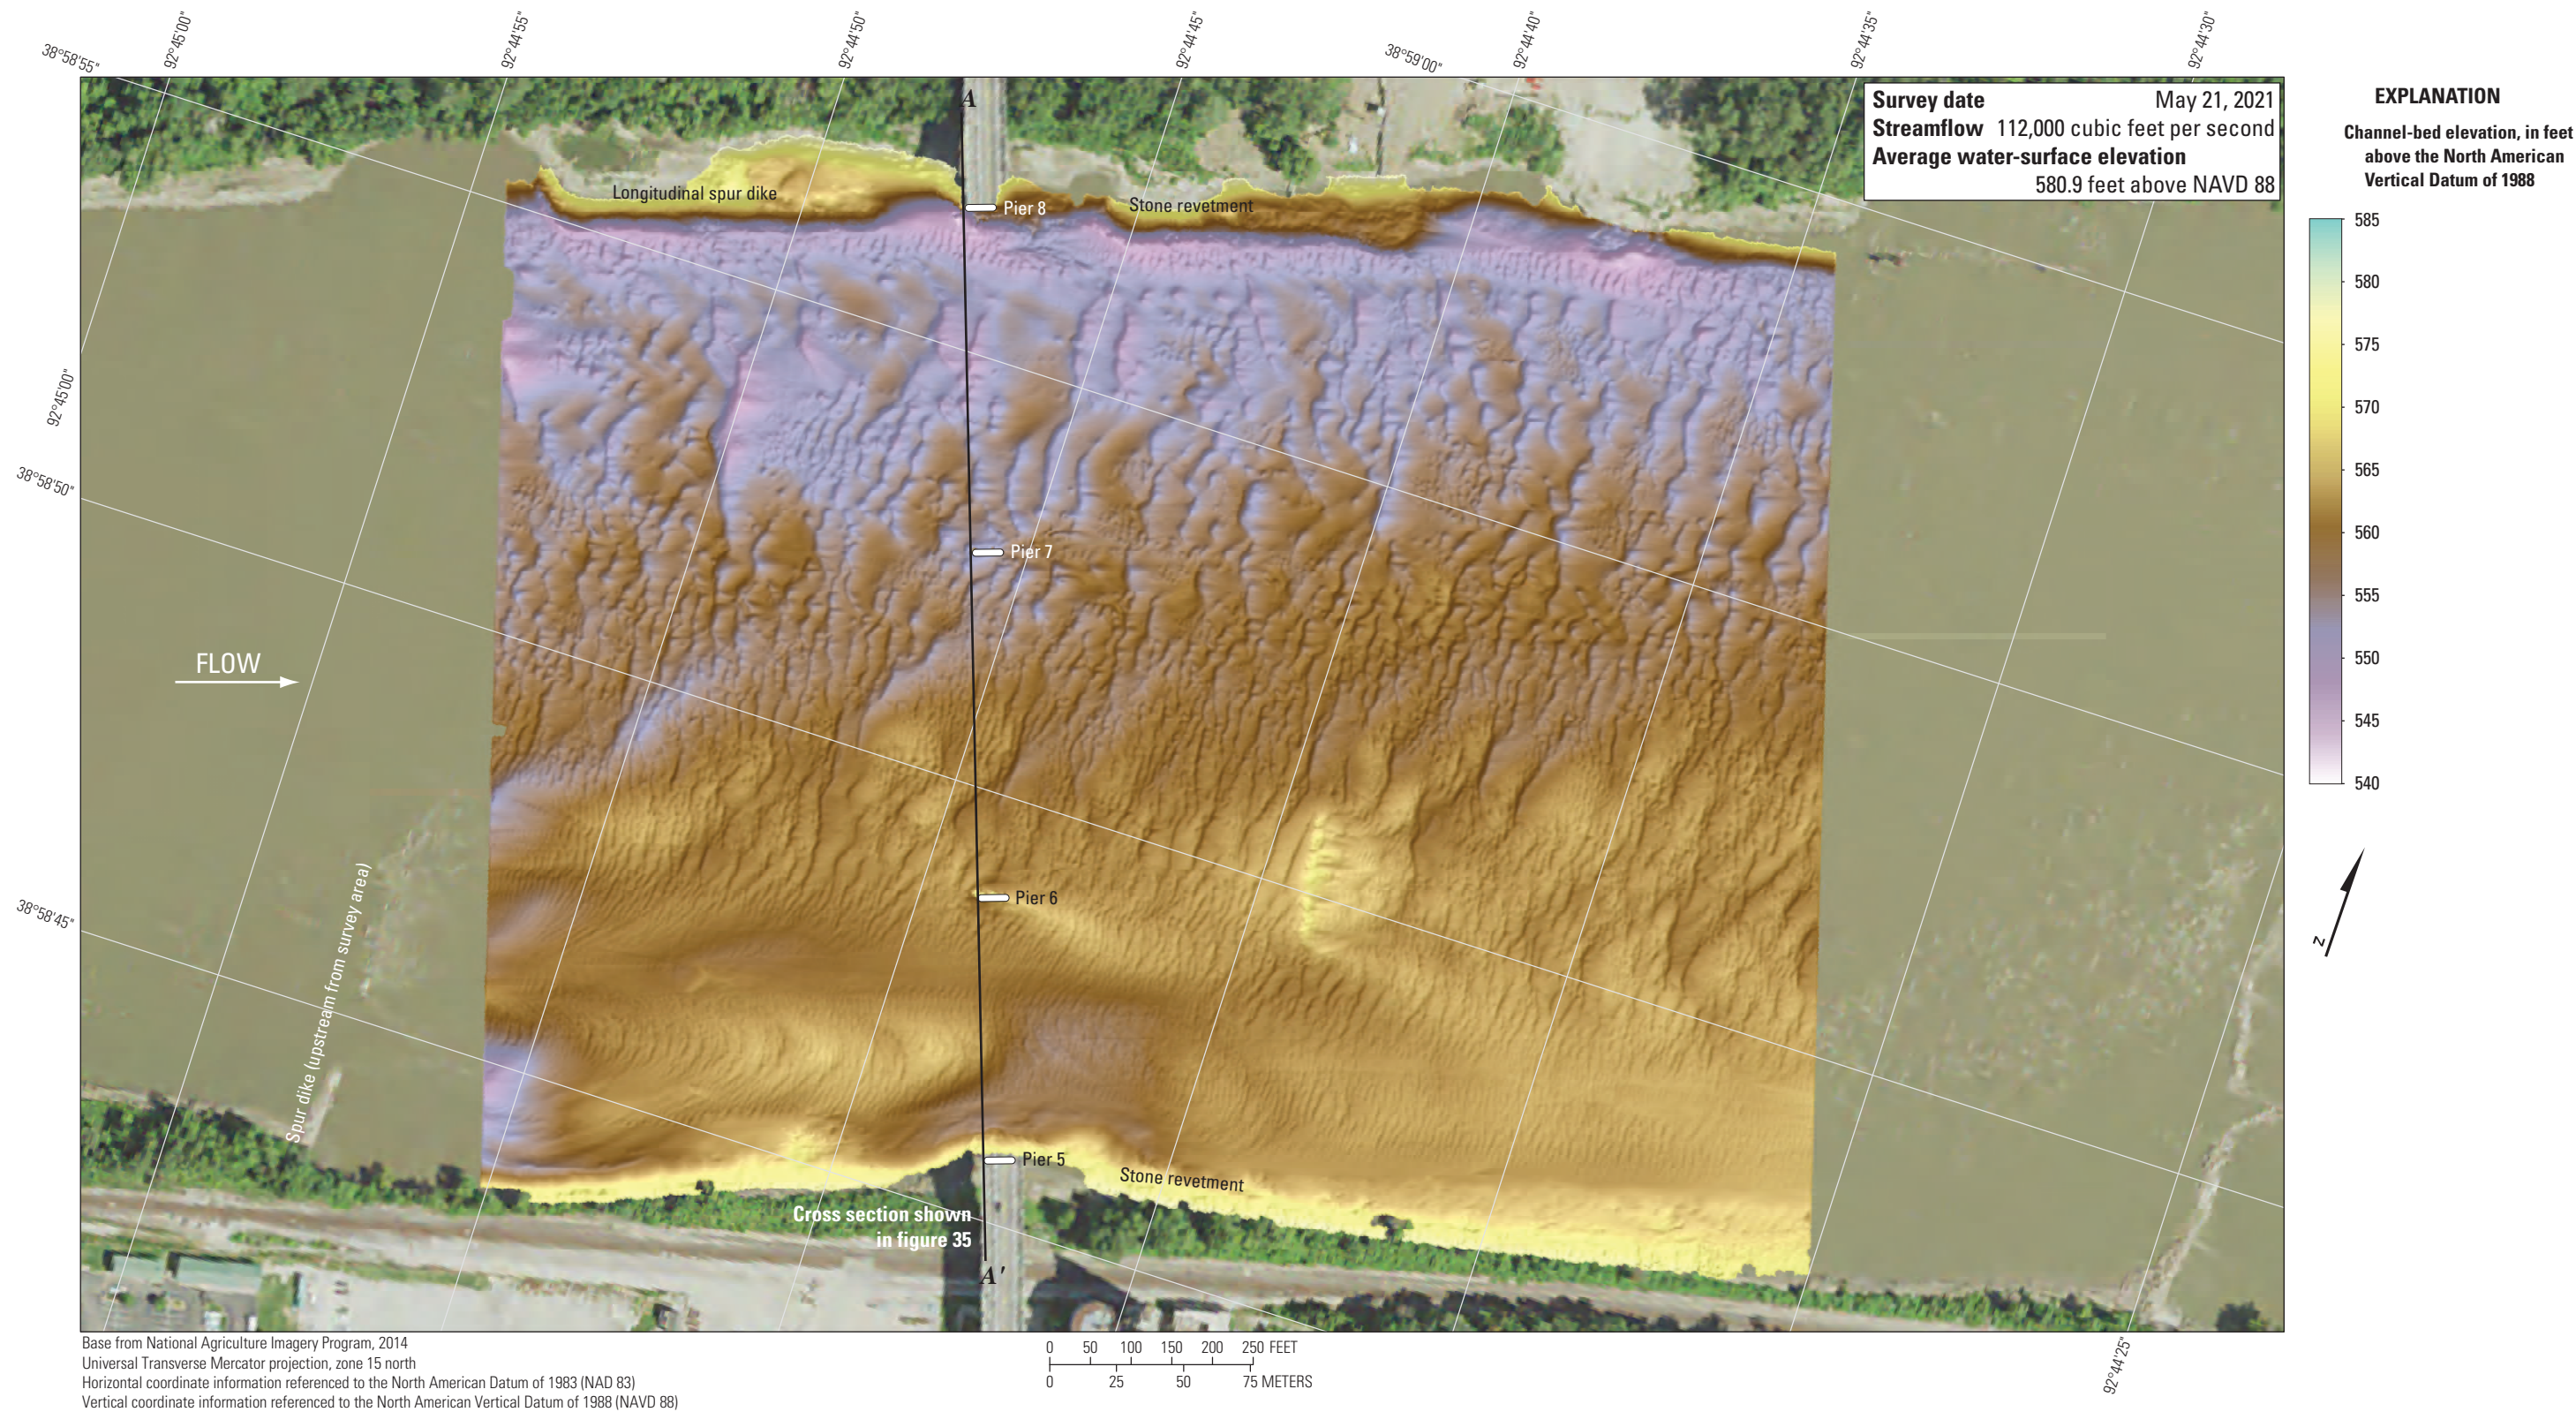
Figure 33. Bathymetric survey of the Missouri River channel near structure A4574 on State Highway 5 at Boonville, Missouri.

The minor scour holes near piers 6 and 7 were difficult to discern from nearby dunes and ripples ([figs. 33, 1.5B, 1.5C, 1.5D, 1.5E](#)). Near pier 7, the scour hole had a minimum channel-bed elevation of about 556 ft ([table 7](#)), about 23 ft above the elevation of the bottom of the pier seal course of 533.00 ft and about 43 ft above the level of bedrock near that pier ([fig. 35](#); [table 7](#)). The minor scour hole near pier 6 had a minimum channel-bed elevation of about 563 ft ([table 7](#)). Information from bridge plans indicates that pier 7 is founded on shafts drilled 39 ft into bedrock ([fig. 35](#); [table 7](#)), whereas pier 6 is founded on a footing on bedrock, having about 12 ft of bed material between the bottom of the scour hole and bedrock ([fig. 35](#); [table 7](#)). The surveyed bed was similar to the previous multibeam surveys in 2011, 2013, and 2017, with the 2021 bed oscillating between the bed in the previous surveys except between piers 7 and 8 where the bed was 5 to 7 ft lower in 2021 than in the previous surveys ([fig. 35](#)). The scour hole near pier 7 appears to penetrate to the top of the pier footing ([figs. 33 and 35](#)), which might provide some mitigation to the scour hole at this pier as the downward flow of the horse-shoe vortex at the pier column face is blunted by the footing (Arneson and others, 2012).
