Bathymetric and Velocimetric Surveys at Highway Bridges Crossing the Missouri River between Kansas City and St. Louis, Missouri, May 19–26, 2021

Scientific Investigations Report 2024–5021

U.S. Department of the Interior
U.S. Geological Survey

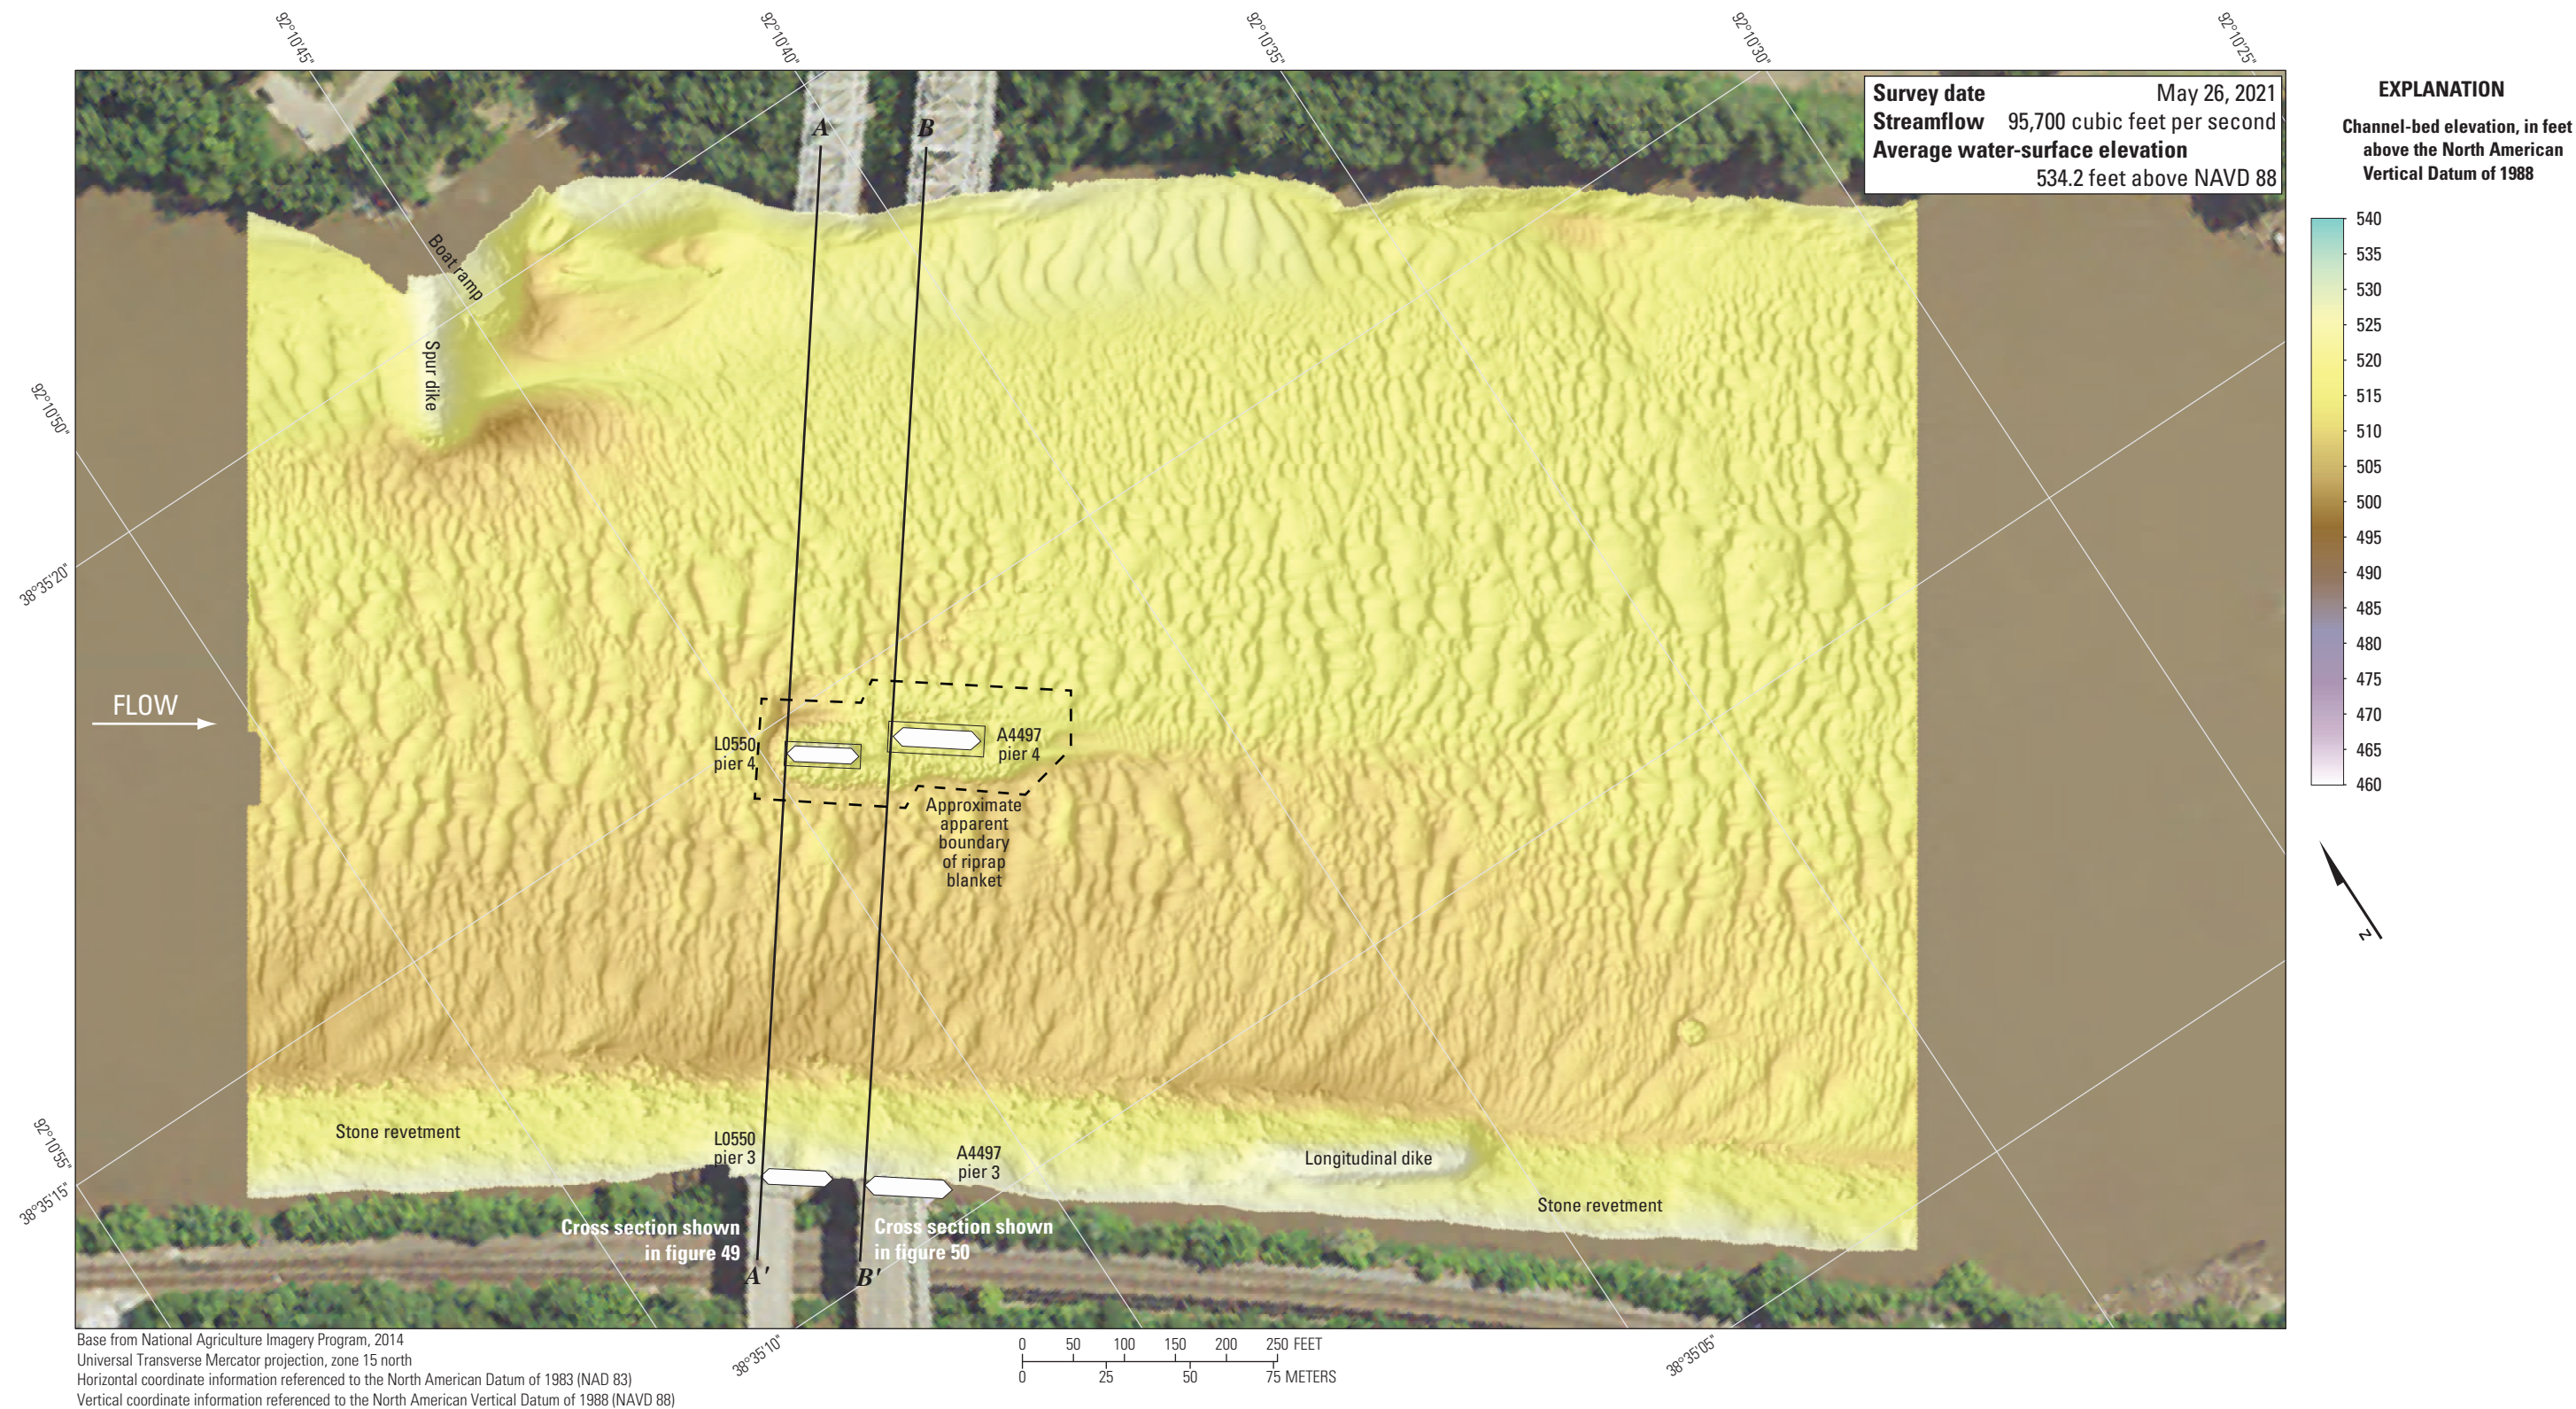
Figure 47. Bathymetric survey of the Missouri River channel near structures L0550 and A4497 on U.S. Highway 54 at Jefferson City, Missouri.
