Assessment of Effects of Channelization Mitigation Alternatives of Stoney Brook, Carlton and St. Louis Counties, Minnesota

Scientific Investigations Report 2025–5004

U.S. Department of the Interior U.S. Geological Survey

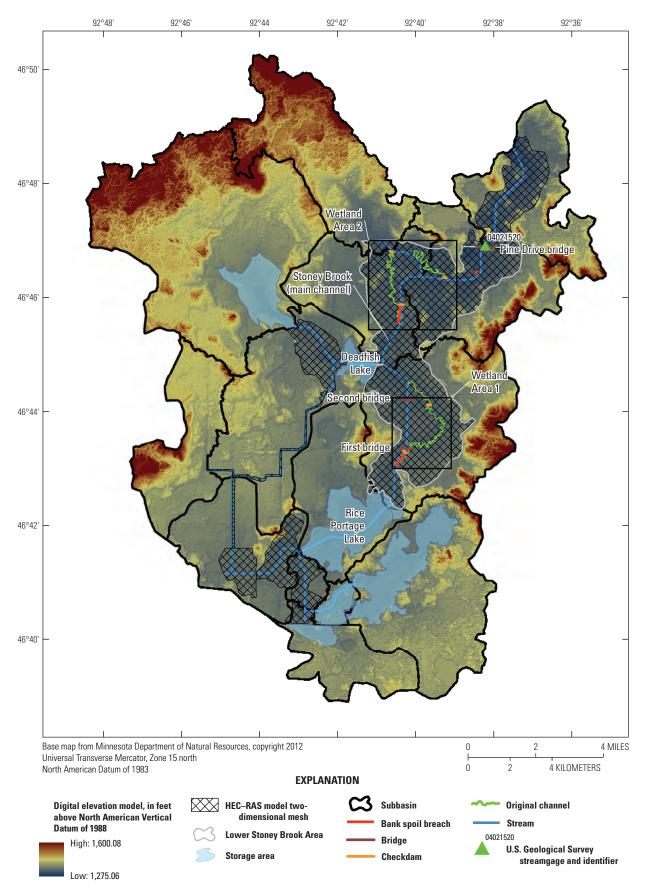
Figure 2. Digital elevation map and hydrologic and hydraulic model components for the study area. Digital elevation data from Minnesota Department of Natural Resources (2020). [HEC–RAS, Hydrologic Engineering Center—River Analysis System]

The HEC-HMS model was constructed with the Hydrologic Engineering Center–Geospatial Hydrologic Modeling System (HEC–GeoHMS) (Fleming and Doan, 2013) version 10.2, which is used within a geographic information system to build the model framework and to estimate initial model parameters. A 1-meter DEM (Minnesota Department of Natural Resources, 2020) was obtained and resampled to 3-meter resolution to reduce the jaggedness of the delineated flowlines, which can increase their total lengths. Through HEC–GeoHMS, the 3-meter DEM was used to delineate the 77.9-mi² watershed into 14 subwatersheds (fig. 2) to serve as a basic unit for parameter assignment and to segment the stream network for the hydraulic model boundary conditions.

Observed streamflow hydrographs and select stage hydrographs from the USGS station 04021520, located near the downstream boundary of the study area, were used for model calibration (fig. 2 and table 3). The previous vertical datum of 1,280 ft above mean sea level at the streamgage originated from a topographic map that did not provide the accuracy needed to convert observed stage hydrographs to WSEs for model calibration. The streamgage datum was updated in 2022 with a Level II global navigation satellite system survey (Rydlund and Densmore, 2012) to an elevation of 1,278.11 ft above the North American Vertical Datum of 1988 (U.S. Geological Survey, 2023b). The streamgage and associated datum has been at its present location since May 2009, which allowed for the conversion of stage hydrographs to WSEs from this date onward. Therefore, observed WSEs from USGS station 04021520 were used in model calibration for the June 2012 event but could not be used for the April 2008 event because it predated the current location of the streamgage and its associated datum. Lake levels at the outlet control structures were periodically measured by FDLB staff and could be converted to WSEs by using established elevations at the outlet control structures. Lake-level measurements were made during the June 2012 events that captured peak conditions and were used for model calibration. These peak conditions were not measured during the April 2008 event and only observed streamflow from the USGS station 04021520 was used to calibrate this event.

Model calibration was completed by adjusting model parameters between the hydrologic and hydraulic models (CNs, *Tc*, *R*, and Manning *n*-values) until the hydraulic computations at Pine Drive bridge (fig. 2) closely agreed with the observed hydrograph characteristics from USGS station 04021520 (figs. 3 and 4). The simulated peak flow of 471 ft³/s

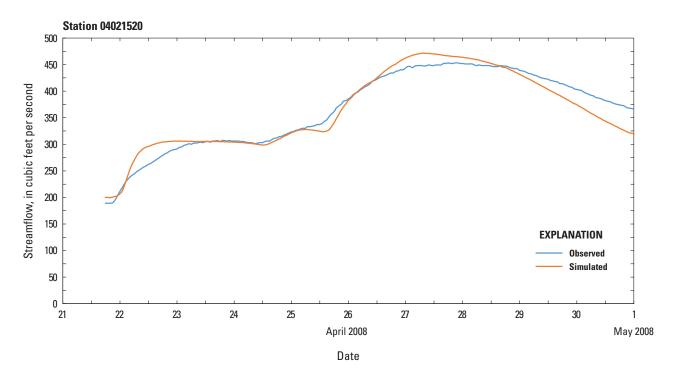
Figure 3. Simulated and observed continuous flows at U.S. Geological Survey streamgage Stoney Brook at Pine Drive near Brookston, Minnesota (station 04021520) during April 2008 calibration event. Data from U.S. Geological Survey (2023a) and Cigrand (2024).

for the April 2008 event was 18 ft³/s (about 4 percent) higher than the observed peak flow of 453 ft³/s, and the simulated peak flow of 1,380 ft³/s for the June–July 2012 event was 210 ft³/s (about 18 percent) higher than the observed peak flow of 1,170 ft³/s at the USGS station 04021520 (table 4). Peak WSEs from lake-level measurements provided additional calibration locations for the June 2012 event, and the differences from observed and simulated peak WSEs ranged from −0.27 to 0.20 ft (table 5). The June 2012 flood caused an outage at USGS station 04021520, and the streamgage did not record data for 5 days near the peak flow of the event, so there is some uncertainty with the observed peak values during this event. Nonetheless, final calibration results indicated the model simulations can replicate observed hydrographs and lake levels with acceptable accuracy (figs. 3 and 4).

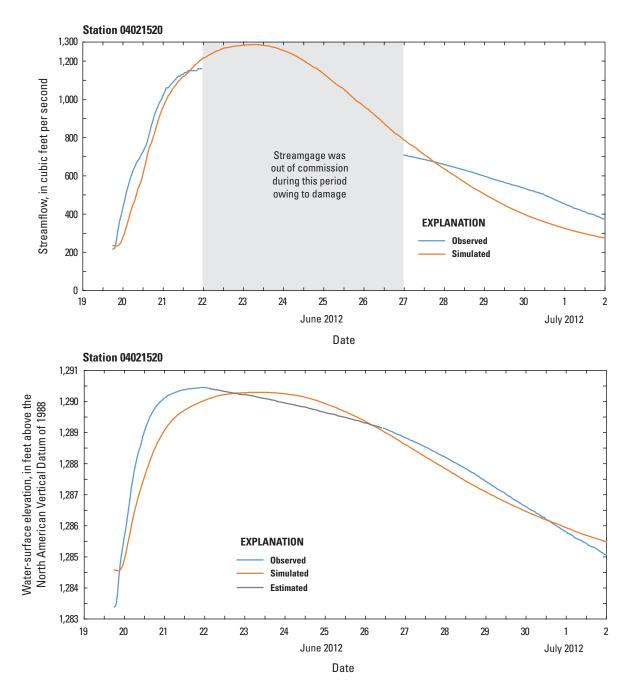
Figure 4. Simulated and observed continuous flows and water-surface elevations at U.S. Geological Survey streamgage Stoney Brook at Pine Drive near Brookston, Minnesota (station 04021520) during June 2012 calibration event. Data from U.S. Geological Survey (2023a) and Cigrand (2024).

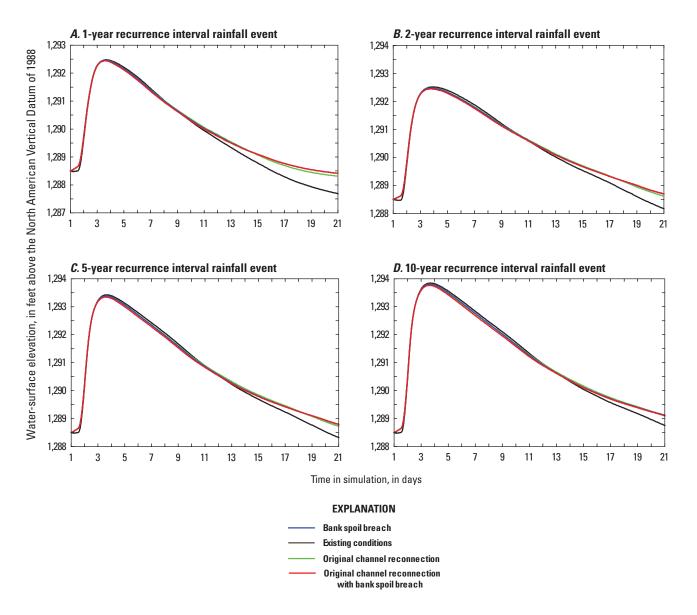
Figure 5. Water-surface elevations on Deadfish Lake for channel modification alternatives and existing conditions during 24-hour duration for 1-, 2-, 5-, and 10-year recurrence interval rainfall events. *A*, 1-year recurrence interval rainfall event. *B*, 2-year recurrence interval rainfall event. *C*, 5-year recurrence interval rainfall event. *D*, 10-year recurrence interval rainfall event. Data available in Cigrand (2024).

For each of the four frequency rainfall events (1-, 2-, 5-, and 10-year recurrence intervals), the simulated event peak WSEs and ending WSEs at Deadfish Lake and Rice Portage Lake were assessed. These are the bounding lakes to the alternative scenarios that were simulated on the Lower Stoney Brook Area (fig. 2) where substantial increases of peak WSEs could be detrimental to rice yields. The remaining lakes are located farther upstream where effects from the alternative scenarios were not substantial. The simulated results of Deadfish Lake and Rice Portage Lake had small differences of peak WSEs from the alternative scenarios and existing conditions ranging from -0.09 to 0.03 ft (figs. 5 and 6; table 7). For WSEs at the end of the 20-day simulated scenarios, both lakes had higher WSEs under the alternative scenarios, with Deadfish Lake varying from 0.34 to 0.73 ft and Rice Portage Lake varying from 0.04 to 0.13 ft (figs. 5 and 6; table 7) higher than existing conditions. These results demonstrated that the lakes would take longer to draw down with the alternative scenarios, especially water levels in Deadfish Lake that had increasingly longer drawdown periods for the lower recurrence interval rainfall events when compared to the existing conditions scenario.

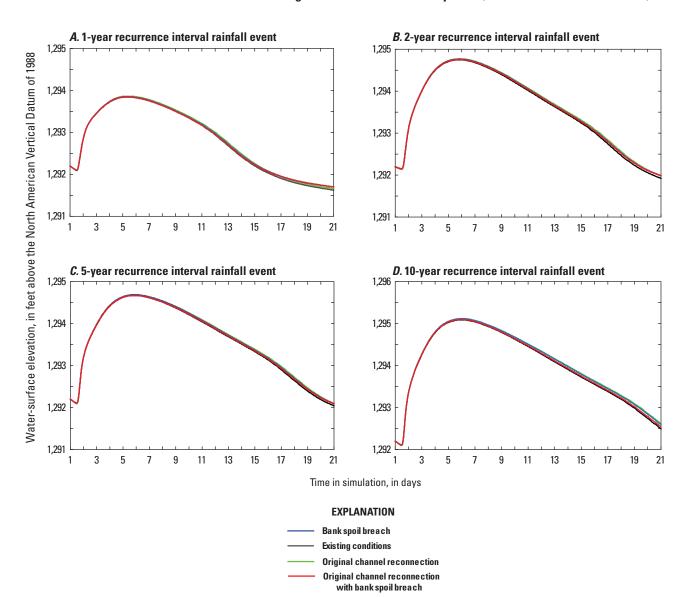
Figure 6. Water-surface elevations on Rice Portage Lake for channel modification alternatives and existing conditions during 24-hour duration for 1-, 2-, 5-, and 10-year recurrence interval rainfall events. *A*, 1-year recurrence interval rainfall event. *B*, 2-year recurrence interval rainfall event. *C*, 5-year recurrence interval rainfall event. *D*, 10-year recurrence interval rainfall event. Data available in Cigrand (2024).

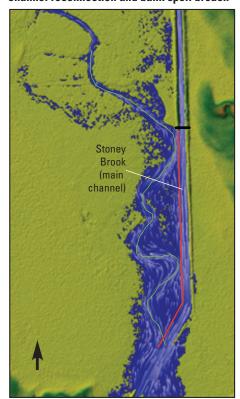
Figure 7. Simulated streamflow velocity vectors (white colored vectors in the figure) near the original channel reconnections and spoil breaches at Wetland Area 1 and Wetland Area 2 during a 1-year recurrence interval rainfall event. *A*, Upstream from Wetland Area 1 with existing conditions. *B*, Upstream from Wetland Area 1 with the original channel reconnection and spoil breach alternative. *C*, Upstream from Wetland Area 2 with existing conditions. *D*, Upstream from Wetland Area 2 with the original channel reconnection and spoil breach alternative. Visuals are from the hydraulic model available from Cigrand (2024).

For the Wetland Area 1 comparison, the channel modification alternative had a small increase in flow velocity, which is distinguished by the higher concentration of velocity vectors (white colored vectors in figure 7) in the area where flow is overtopping the bank spoil breach. In contrast, the existing conditions had an increase in flow velocity in the main channel of Stoney Brook where flow is substantially constricted within the bank spoils. No differences were noticeable in extent of inundated area at this location for the alternative and existing conditions. Wetland Area 1 could prove challenging to establish flow gradients if more flow was routed through the original channel. In Wetland Area 1 the original channel has an exceptionally low gradient (0.30 foot per mile) downstream from the first bridge (fig. 7), and the alluvial valley is not as pronounced. Alternatively, the main channel of Stoney Brook is more than 3 ft lower in elevation than the original channel immediately downstream from the first bridge and is exemplified by the higher bank spoils (fig. 7), which correlates to a greater amount of ditch excavation in this section of ditching. For the Wetland Area 2 comparison, the channel modification alternative had an increase in flow velocity and a smaller extent of inundation (less backwater) than the existing conditions in the overbank area near the checkdam. The increase in velocity and smaller extent of inundation at the flow diversion for Wetland Area 2 was an indication of less backwater and improved conveyance with the channel modification alternatives, whereas conveyance improvements were less pronounced at the Wetland Area 1 channel diversion.

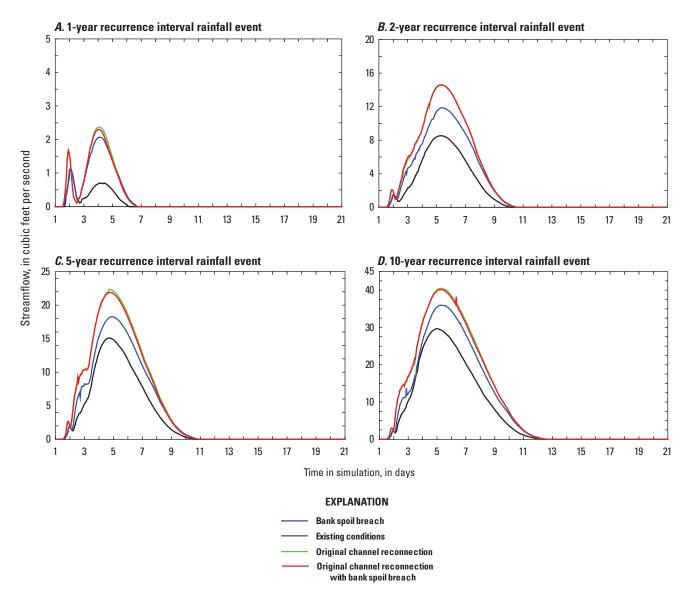
Figure 8. Wetland Area 1 flows for channel modification alternatives and existing conditions with 24-hour duration for 1-, 2-, 5-, and 10-year recurrence interval rainfall events. *A*, 1-year recurrence interval rainfall event. *B*, 2-year recurrence interval rainfall event. *C*, 5-year recurrence interval rainfall event. Data from Cigrand (2024).

Wetland Area 1 received peak flows ranging from 1.10 to 29.7 ft³/s for 1-, 2-, 5-, and 10-year recurrence intervals and hydrograph volume accumulations ranging from 2.88 to 275 acre-feet (acre-ft) for the existing conditions scenario (table 8; fig. 8). The original channel reconnection with and without the bank spoil breach alternatives had the largest increases from existing conditions with peak flows ranging from 2.37 to 40.5 ft³/s and hydrograph volume accumulations ranging from 9.10 to 415 acre-ft (fig. 8; table 8). The bank spoil breach alternative also showed increases in peak flows ranging from 2.07 to 35.9 ft³/s and 8.67 to 358 acre-ft in hydrograph volume accumulations (fig. 8; table 8) from existing conditions. Although there is not a high rate of flow going to Wetland Area 1 (especially for the lower recurrence interval rainfall events), the relative increase in flows with the channel modification alternatives could be considered substantial when compared to flows with existing conditions, and the increase in volume accumulations are more pronounced for the channel modification alternatives.

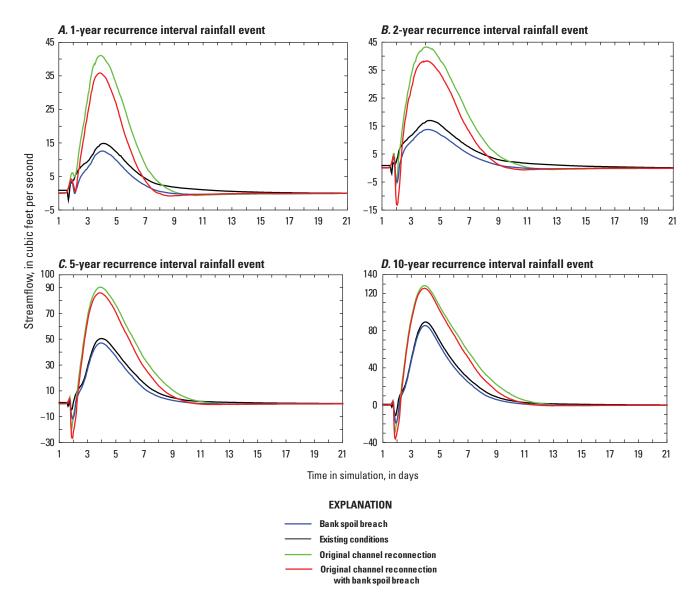
Figure 9. Wetland Area 2 flows for channel modification alternatives and existing conditions during 24-hour duration for 1-, 2-, 5-, and 10-year recurrence interval rainfall events. *A*, 1-year recurrence interval rainfall event. *B*, 2-year recurrence interval rainfall event. *C*, 5-year recurrence interval rainfall event. Data from Cigrand (2024).

Wetland Area 2 received peak flows ranging from 14.9 to 89.2 ft³/s for 1-, 2-, 5-, and 10-year recurrence intervals and hydrograph volume accumulations ranging from 124 to 646 acre-ft for the existing conditions scenario (fig. 9; table 8). The original channel reconnection alternative showed the largest increase in peak flows ranging from 41.1 to 128 ft³/s and hydrograph volume accumulations ranging from 269 to 1,070 acre-ft from existing conditions (fig. 9; table 8). The original channel reconnection with bank spoil breach alternative also resulted in increases from existing conditions with peak flows ranging from 35.9 to 125 ft³/s and 201 to 960 acre-ft in hydrograph volume accumulations (fig. 9; table 8). The bank spoil breach alternative results indicated decreases in peak flows and volume accumulations from existing conditions with peak flows ranging from 12.6 to 85.4 ft³/s and 76.9 to 559 acre-ft in hydrograph volume accumulations (fig. 9; table 8). Wetland Area 2 had substantial increases in peak flow and volume accumulations with the original channel reconnection and the original channel reconnection with bank spoil breach.

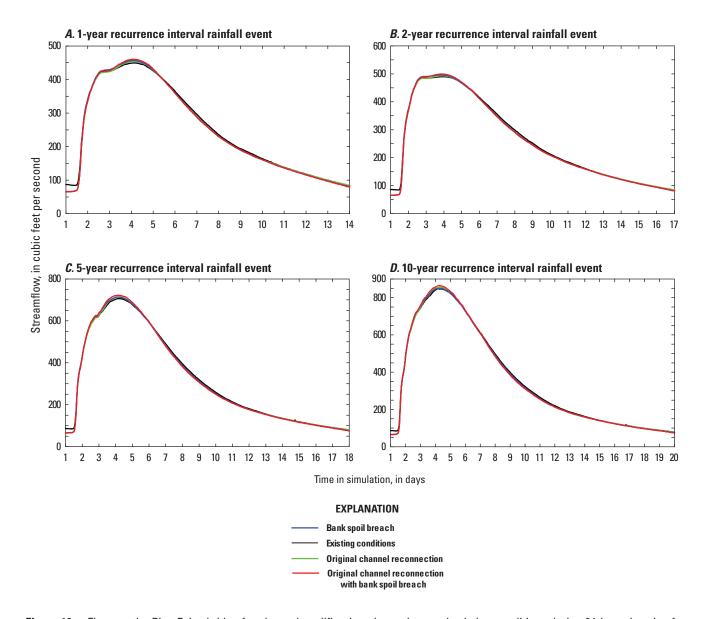
Figure 10. Flows at the Pine Drive bridge for channel modification alternatives and existing conditions during 24-hour duration for 1-, 2-, 5-, and 10-year recurrence interval rainfall events. *A*, 1-year recurrence interval rainfall event. *B*, 2-year recurrence interval rainfall event. *D*, 10-year recurrence interval rainfall event. Data from Cigrand (2024).

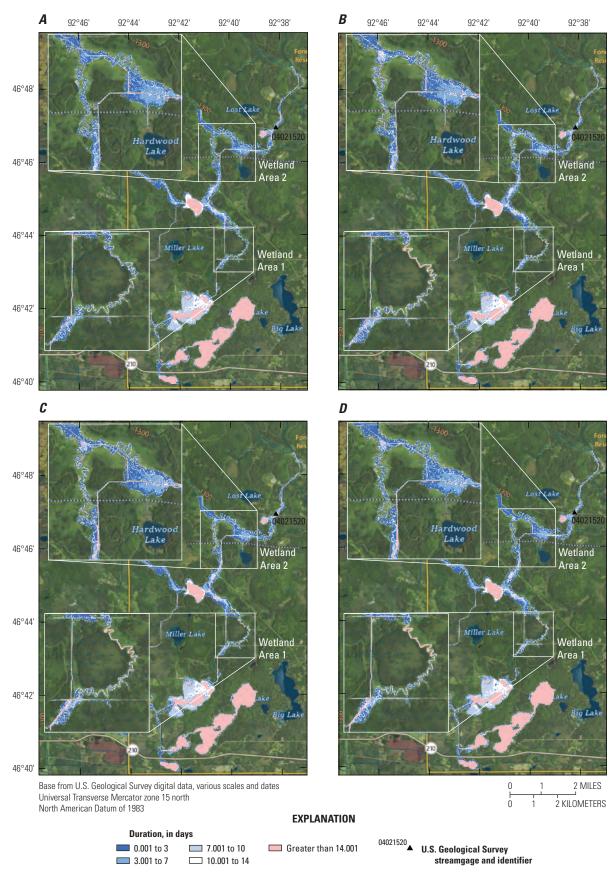
Figure 11. Duration of inundation during a 1-year recurrence interval rainfall event in the Stoney Brook watershed upstream from the U.S. Geological Survey streamgage Stoney Brook at Pine Drive near Brookston, Minnesota (station 04021520). *A*, Existing conditions. *B*, Original channel reconnection. *C*, Original channel reconnection with bank spoil breach. *D*, Bank spoil breach. Data from Cigrand (2024).

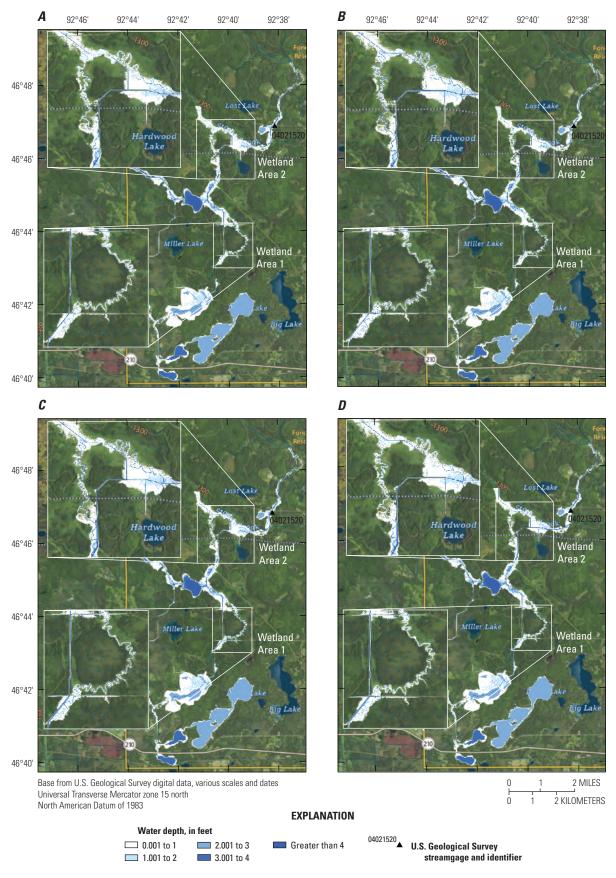
Figure 12. Depth of inundation during a 1-year recurrence interval rainfall event in the Stoney Brook watershed upstream from the U.S. Geological Survey streamgage Stoney Brook at Pine Drive near Brookston, Minnesota (station 04021520). *A*, Existing conditions. *B*, Original channel reconnection. *C*, Original channel reconnection with bank spoil breach. *D*, Bank spoil breach. Data from Cigrand (2024).

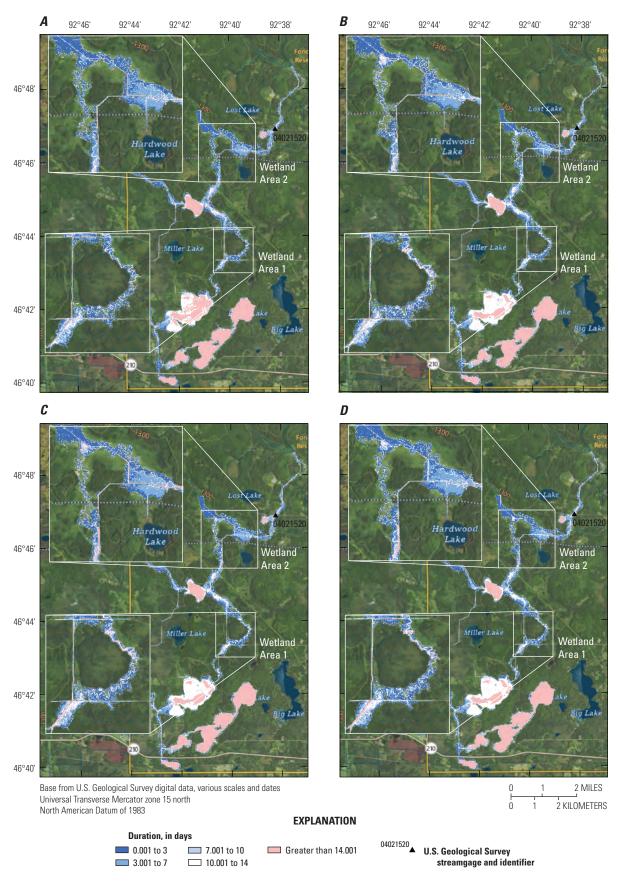
Figure 13. Duration of inundation during a 2-year recurrence interval rainfall event in the Stoney Brook watershed upstream from the U.S. Geological Survey streamgage Stoney Brook at Pine Drive near Brookston, Minnesota (station 04021520). *A*, Existing conditions. *B*, Original channel reconnection. *C*, Original channel reconnection with bank spoil breach. *D*, Bank spoil breach. Data from Cigrand (2024).

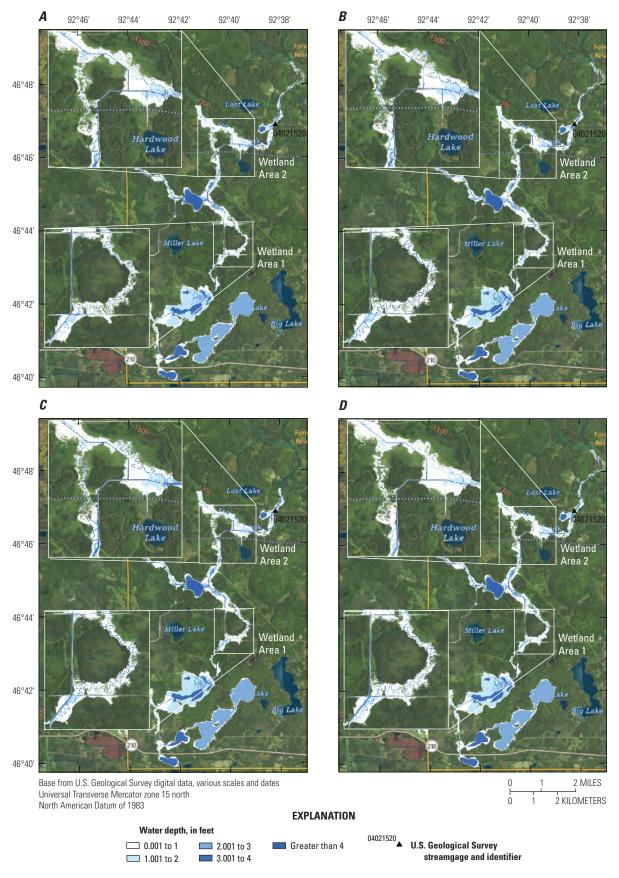
Figure 14. Depth of inundation during a 2-year recurrence interval rainfall event in the Stoney Brook watershed upstream from the U.S. Geological Survey streamgage Stoney Brook at Pine Drive near Brookston, Minnesota (station 04021520). *A*, Existing conditions. *B*, Original channel reconnection. *C*, Original channel reconnection with bank spoil breach. *D*, Bank spoil breach. Data from Cigrand (2024).

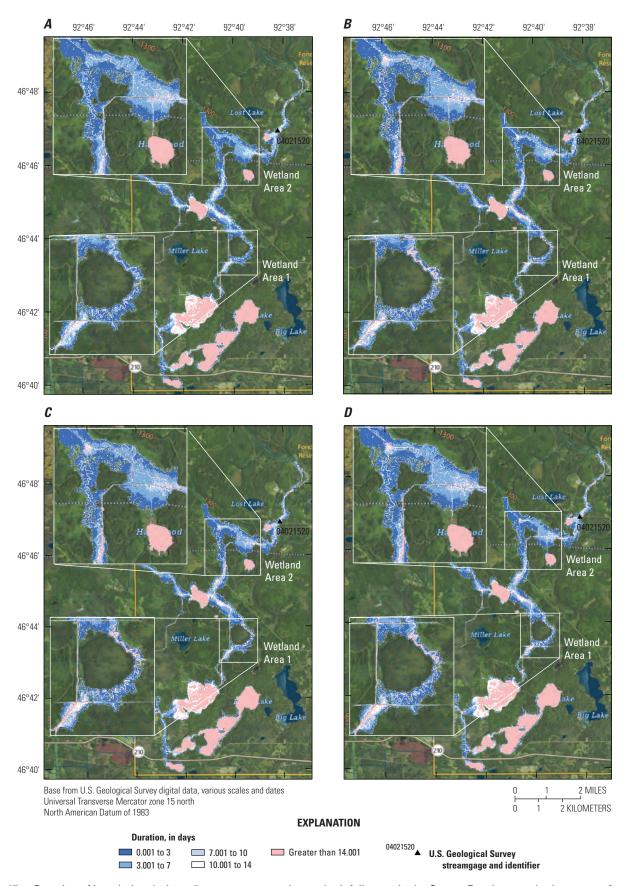
Figure 15. Duration of inundation during a 5-year recurrence interval rainfall event in the Stoney Brook watershed upstream from the U.S. Geological Survey streamgage Stoney Brook at Pine Drive near Brookston, Minnesota (station 04021520). *A*, Existing conditions. *B*, Original channel reconnection. *C*, Original channel reconnection with bank spoil breach. *D*, Bank spoil breach. Data from Cigrand (2024).

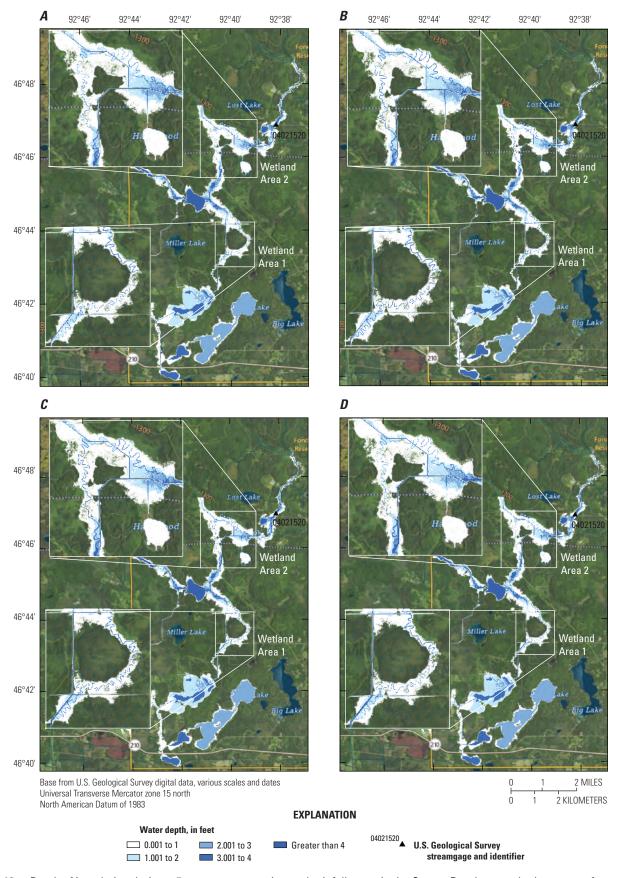
Figure 16. Depth of inundation during a 5-year recurrence interval rainfall event in the Stoney Brook watershed upstream from the U.S. Geological Survey streamgage Stoney Brook at Pine Drive near Brookston, Minnesota (station 04021520). *A*, Existing conditions. *B*, Original channel reconnection. *C*, Original channel reconnection with bank spoil breach. *D*, Bank spoil breach. Data from Cigrand (2024).

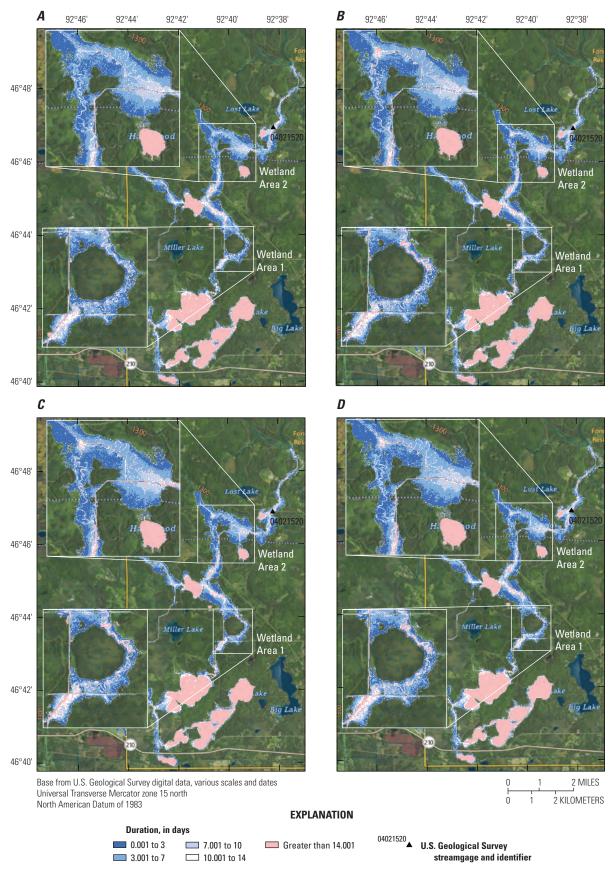
Figure 17. Duration of inundation during a 10-year recurrence interval rainfall event in the Stoney Brook watershed upstream from the U.S. Geological Survey streamgage Stoney Brook at Pine Drive near Brookston, Minnesota (station 04021520). *A*, Existing conditions. *B*, Original channel reconnection. *C*, Original channel reconnection with bank spoil breach. *D*, Bank spoil breach. Data from Cigrand (2024).

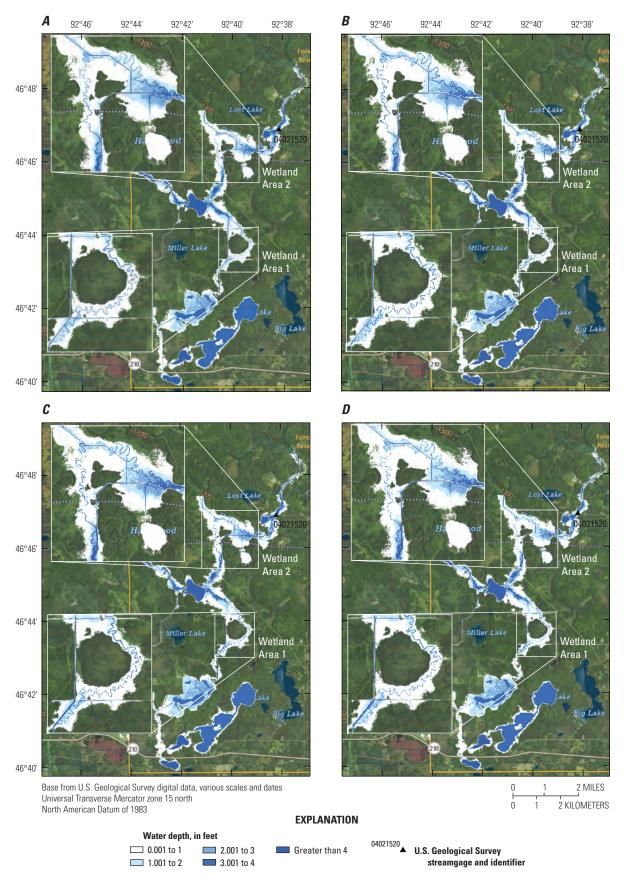
Figure 18. Depth of inundation during a 10-year recurrence interval rainfall event in the Stoney Brook watershed upstream from the U.S. Geological Survey streamgage Stoney Brook at Pine Drive near Brookston, Minnesota (station 04021520). *A*, Existing conditions. *B*, Original channel reconnection. *C*, Original channel reconnection with bank spoil breach. *D*, Bank spoil breach. Data from Cigrand (2024).
