Streamflow Extents and Hydraulic Characteristics of Meadow Valley Wash at Stuart Ranch, near Rox, Nevada

Scientific Investigations Report 2025–5069

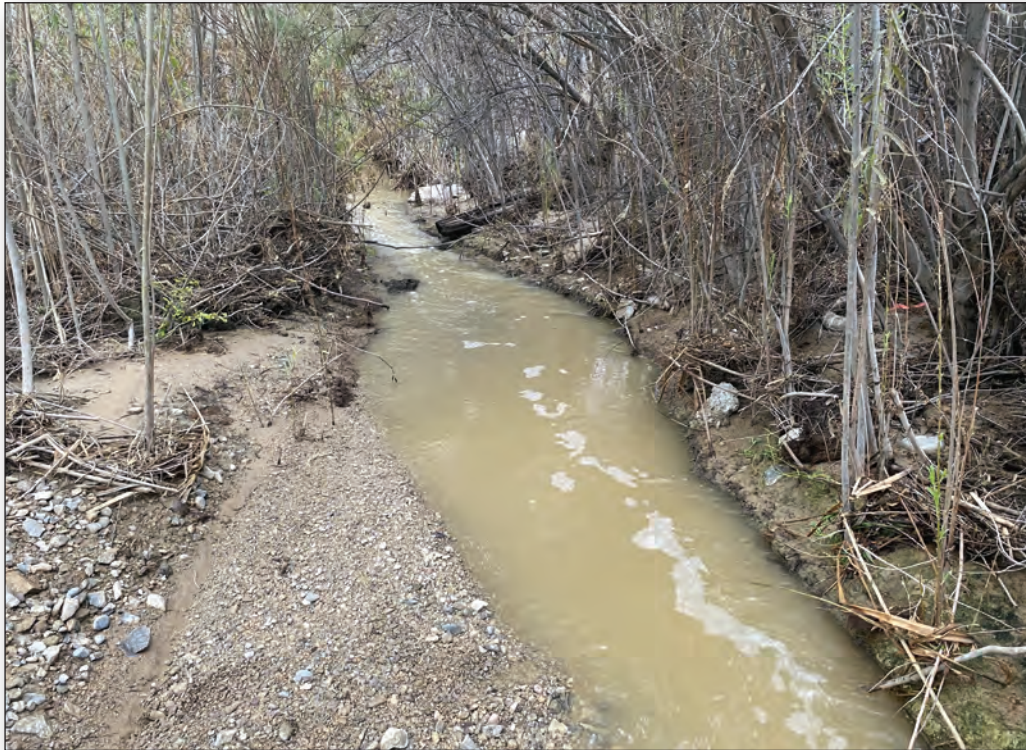
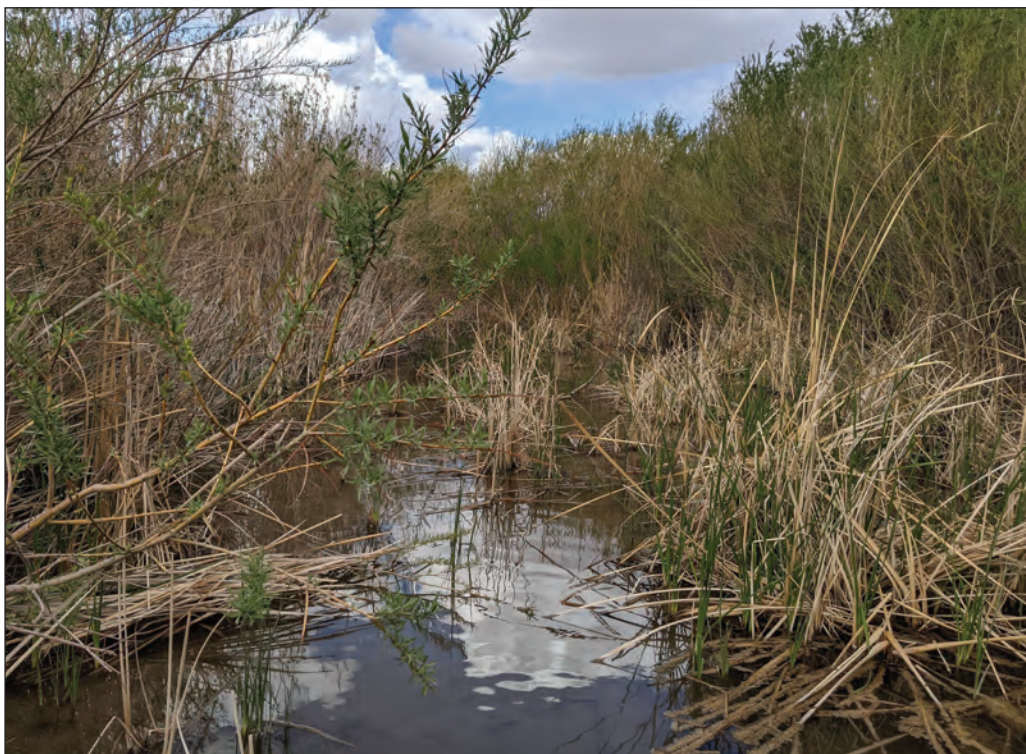
Figure 2. Base flow channel types at multiple channel locations along Meadow Valley Wash at Stuart Ranch, near Rox, Nevada. Photographs looking *A*, view downstream near the upstream end of study area, dense willows on either side of narrow channel, photograph by Megan Hederman, U.S. Geological Survey, August 12, 2022; and *B*, view upstream near the downstream end of the study area, cattails in wide slow pool, surrounded by dense willows, photograph by Hampton Childres, U.S. Geological Survey, March 23, 2021.

seepwillow (*Baccharis salicifolia*), cattails (*Typha* sp.), and Fremont's cottonwood (*Populus fremontii*; fig. 2). The perennial stream is flanked by a low floodplain vegetated with arrowweed (*Pluchea sericea*), saltbush (*Atriplex* spp.), tamarisk (*Tamarix ramosissima*), and mesquite (*Prosopis* spp.; fig. 3). On the east side of the floodplain is a nearly vertical canyon wall of Miocene ash flow tuff (fig. 3A; Schmidt, 1994). On the west side, an active railroad track and access road embankment occupies a narrow terrace between the channel and the canyon wall (fig. 3B). Approximately 1,200–3,500 ft further downstream from the streamgage, the canyon opens to an approximately 1,500 ft wide valley, and the single stream channel continues downstream, flanked on either side by several braided dry channels crisscrossing a floodplain. In the most downstream section of the reach, about 3,500–4,200 ft downstream from the streamgage, the stream expands to cover nearly the entire floodplain and flows into a cattail marsh at a slower velocity, due to several beaver dams. A higher, sparsely vegetated alluvium floodplain is on the east side of the valley and was formerly farmed (fig. 1). On the west side of the valley, the railroad track and access road embankment and a gravel road continues to the downstream end of the reach.

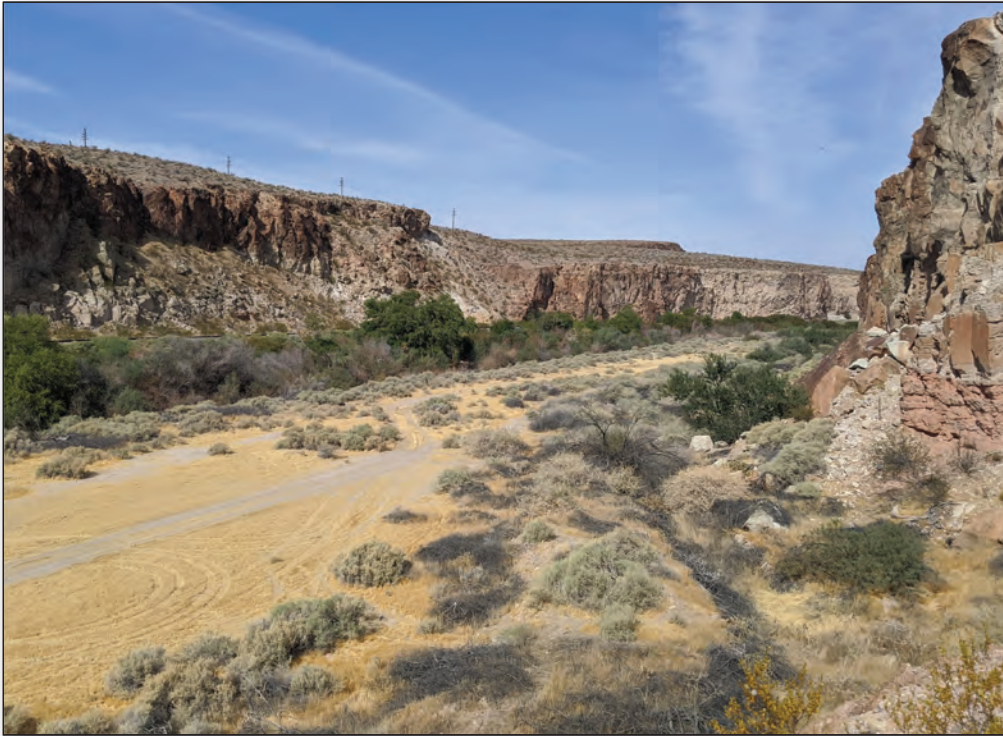
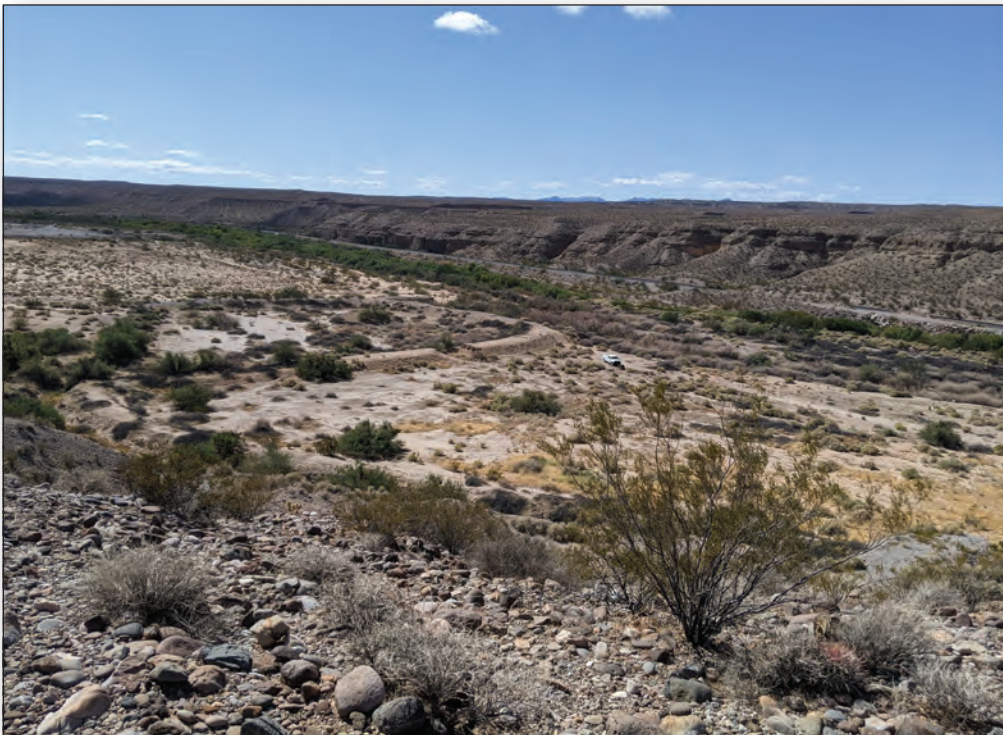
Figure 3. Floodplain along Meadow Valley Wash at Stuart Ranch, near Rox, Nevada. *A*, view looking upstream toward the northern end of the study area, with the stream riparian corridor in the background and floodplain, photograph by Christopher Morris, U.S. Geological Survey, October 8, 2020; and *B*, view looking downstream at the southern end of the study area, with the stream along the base of the canyon wall and the irrigation reservoir outlined by a nearly circular berm of earth, photograph by Hampton Childres, U.S. Geological Survey, October 12, 2021.

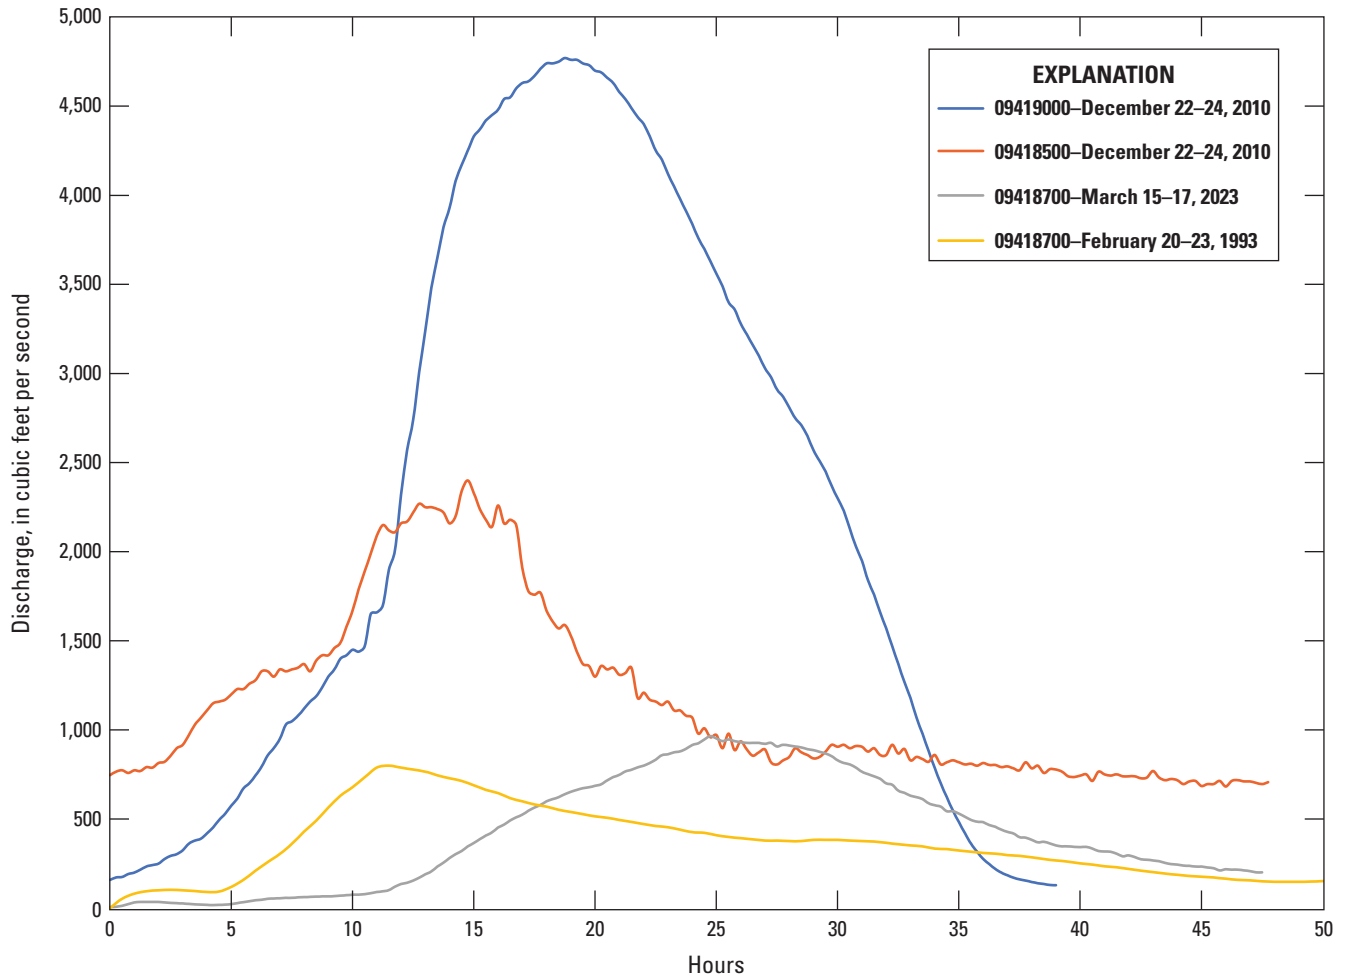
Figure 4. Observed hydrographs for selected floods, U.S. Geological Survey streamgages: (09418500), Meadow Valley Wash near Caliente, Nevada, (09418700) Meadow Valley Wash near Rox, Nevada, and (09419000) Muddy River near Glendale, Nevada. Refer to figure 1 for streamgage locations.

The flood-frequency analysis was used to estimate peak streamflow, but the unsteady hydraulic model requires a complete flood hydrograph. All floods at the Meadow Valley Wash near Rox, Nev., streamgage with a complete hydrograph were less than the 10-percent AEP streamflow, and only two floods (February 1993 and March 2023) were greater than the 20-percent AEP streamflow. The largest flood of Meadow Valley Wash with a complete flood hydrograph at any streamgage was the December 2010 flood at the upstream (Meadow Valley Wash near Caliente, Nev.—09418500; U.S. Geological Survey, 2024b) and downstream (Muddy River near Glendale, Nev.—09419000; U.S. Geological Survey, 2024c) streamgages. The Meadow Valley Wash near the Rox, Nev., streamgage was not in operation at the

time, but based on the two other streamgages, the flood was likely between a 10-percent and 2-percent AEP streamflow event at Stuart Ranch. When only the main peak of all four largest flood hydrographs were compared (February 1993 and March 2023 at Meadow Valley Wash near Rox, Nev.—09418700; Dec 2010 at Meadow Valley Wash near Caliente, Nev.—09418500; Dec 2010 at Muddy River near Glendale, Nev.—09419000), they were generally symmetrical with only minor skew and had only small variations in peak duration (fig. 4). Therefore, the estimated hydrographs were shaped based on a second-order polynomial setting the peak discharge, as estimated from the flood-frequency analysis. This estimation technique likely does a poorer job of estimating flood hydrograph shape lower on the recession; however, because the focus of this study was on the peak itself, it was deemed a reasonable approach.

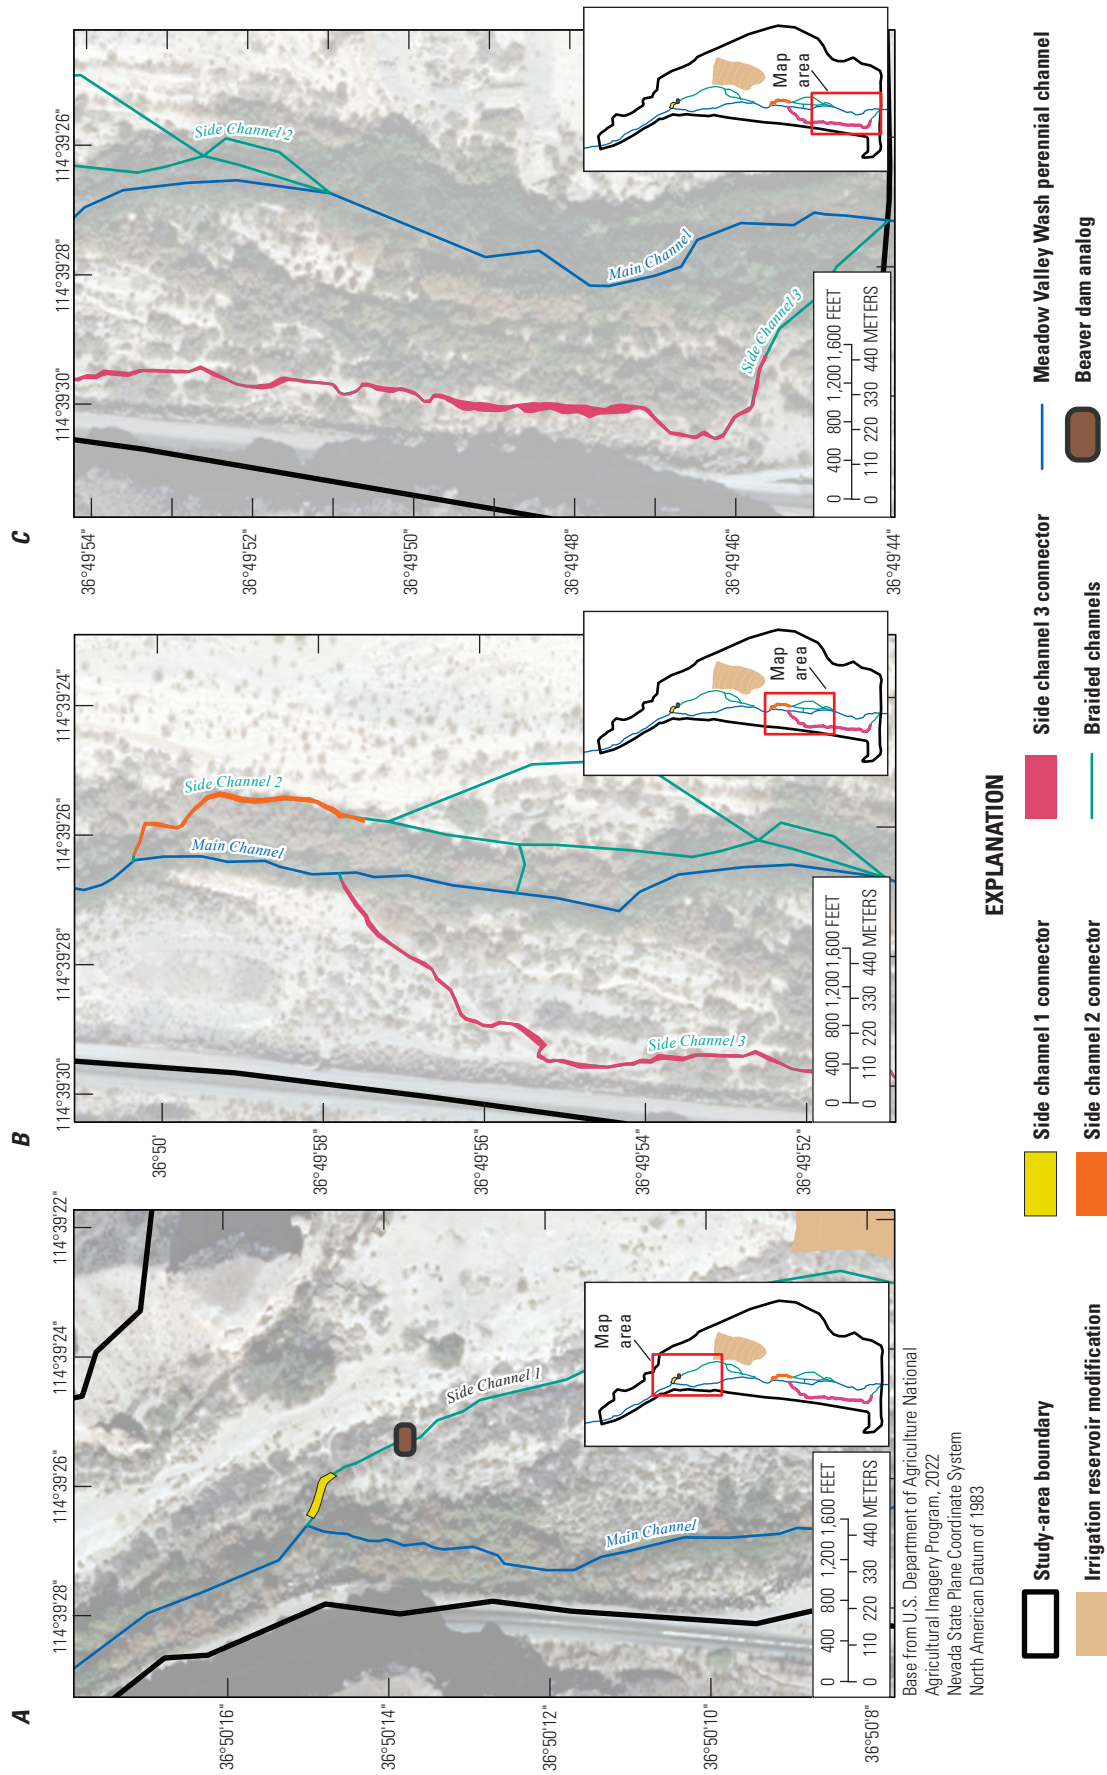
To simulate the multiple possible restoration modifications, several adjustments were made to the 2021 terrain conditions in HEC-RAS. Two different possible restoration conditions were modeled—one with minimal modifications that are referred to as the “minor restoration modifications” and one with large modifications referred to as the “major restoration modifications.” The minor restoration modifications include an excavated area approximately 1,220 ft downstream from the streamgage intended to split flow into a side channel that is east of the main channel, hereafter referred to as side channel 1 (fig. 6A). This excavated area (the side channel 1 connector) is approximately 60 ft long, 7–9 ft wide, and assigned an elevation that is the same as the bottom of the main channel. Additionally, a BDA, represented in the model as an impermeable large woody debris, was placed 100 ft downstream from the end of the excavated area to back up water and ensure some flow remains in the main channel as well (fig. 6A). The BDA was 16 ft wide and 2 ft tall. Three additional BDA near the downstream end of the reach (beginning approximately 2,600 ft downstream from the streamgage) were tested to expand flow into the side channels (side channels 2 and 3) that are apparent in higher flow conditions. However, after multiple attempts, this effort was ineffective, likely because there is not enough base flow to split the channel in these locations. Therefore, these additional BDA modifications were not included in the final minor restoration modifications, and instead, elevation of the terrain was lowered to simulate excavated areas as part of the major restoration modifications.

In addition to the adjustments included in the minor restoration modifications (BDA and side channel 1 connector), the major restoration modifications include three additional excavated areas—two side channel connectors near the downstream end of the modeled reach, and one excavated and graded area that removes the irrigation reservoir and adjacent berm structure (figs. 6B, 6C). The two side channel connectors are excavated areas to ensure flow from the main channel splits and enters the respective side channels, hereafter referred to as “side channel 2” and “side channel 3.” The excavated area to connect flow into side channel 2, east of the main channel, begins approximately 2,800 ft downstream from the streamgage, measuring approximately 350 ft long, 2–7 ft wide, and assigned an elevation that is slightly lower than the bottom of the main channel. The excavated area to connect flow into side channel 3 begins approximately 3,000 ft downstream from the streamgage, measuring approximately 1,400 ft long, 5–17 ft wide, and assigned an elevation that is slightly lower than the bottom of the main channel and surrounding terrain, with decreasing elevation moving farther downstream. The excavated area surrounding the irrigation reservoir removes the berm structure by excavating and grading the surrounding terrain. The goal is to promote better connectivity between the stream and floodplain, especially at higher flows. This excavated area begins approximately 1,900 ft downstream from the streamgage and is 350 ft east of the main channel (directly adjacent to side channel 1; fig. 6) and is approximately 770 ft long and up to 375 ft wide. This excavated area is assigned with a slightly lower elevation than the terrain that is directly upstream from the modification, with gradually decreasing elevation throughout the excavated area.
