Erosion Potential and Flood Vulnerability of Streams and Stream Crossings at Acadia National Park, Maine

Scientific Investigations Report 2026–5116

U.S. Department of the Interior
U.S. Geological Survey

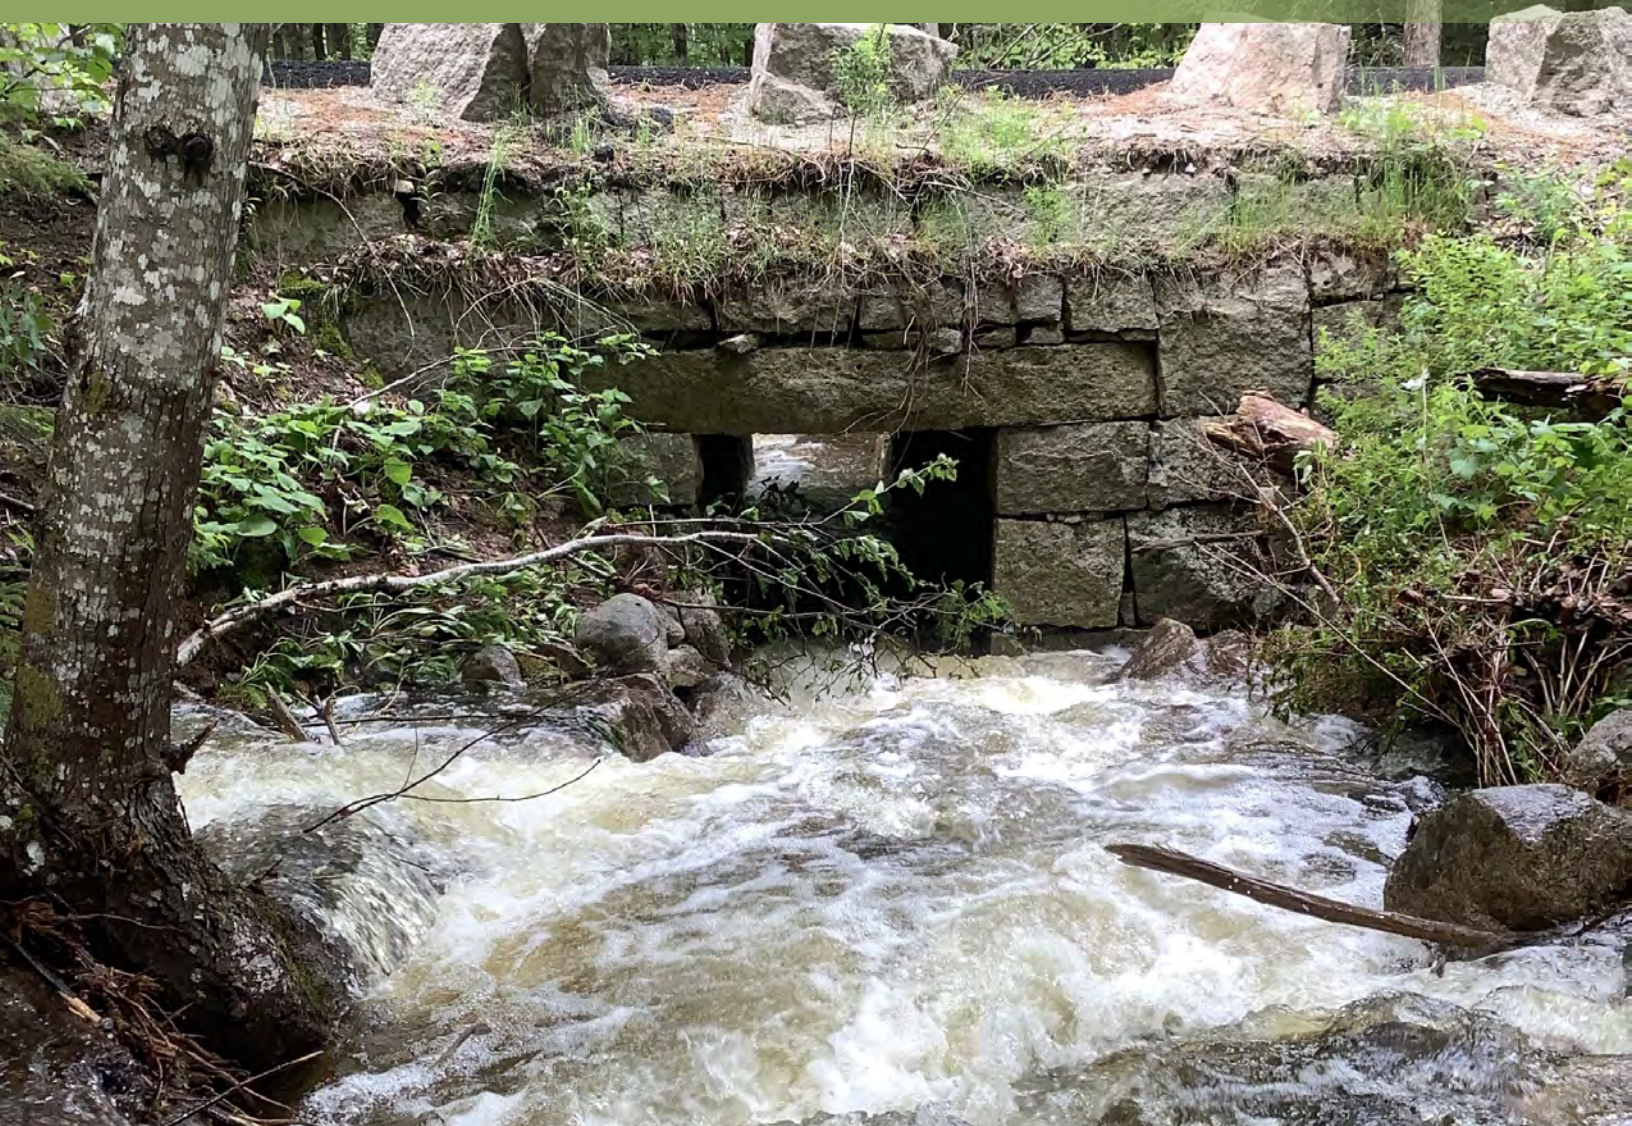
Cover: Photograph showing Browns Brook at Sargeant Drive stream crossing, Acadia National Park, on June 9, 2021. Photograph by Erica P. Doody, formerly of the National Park Service.

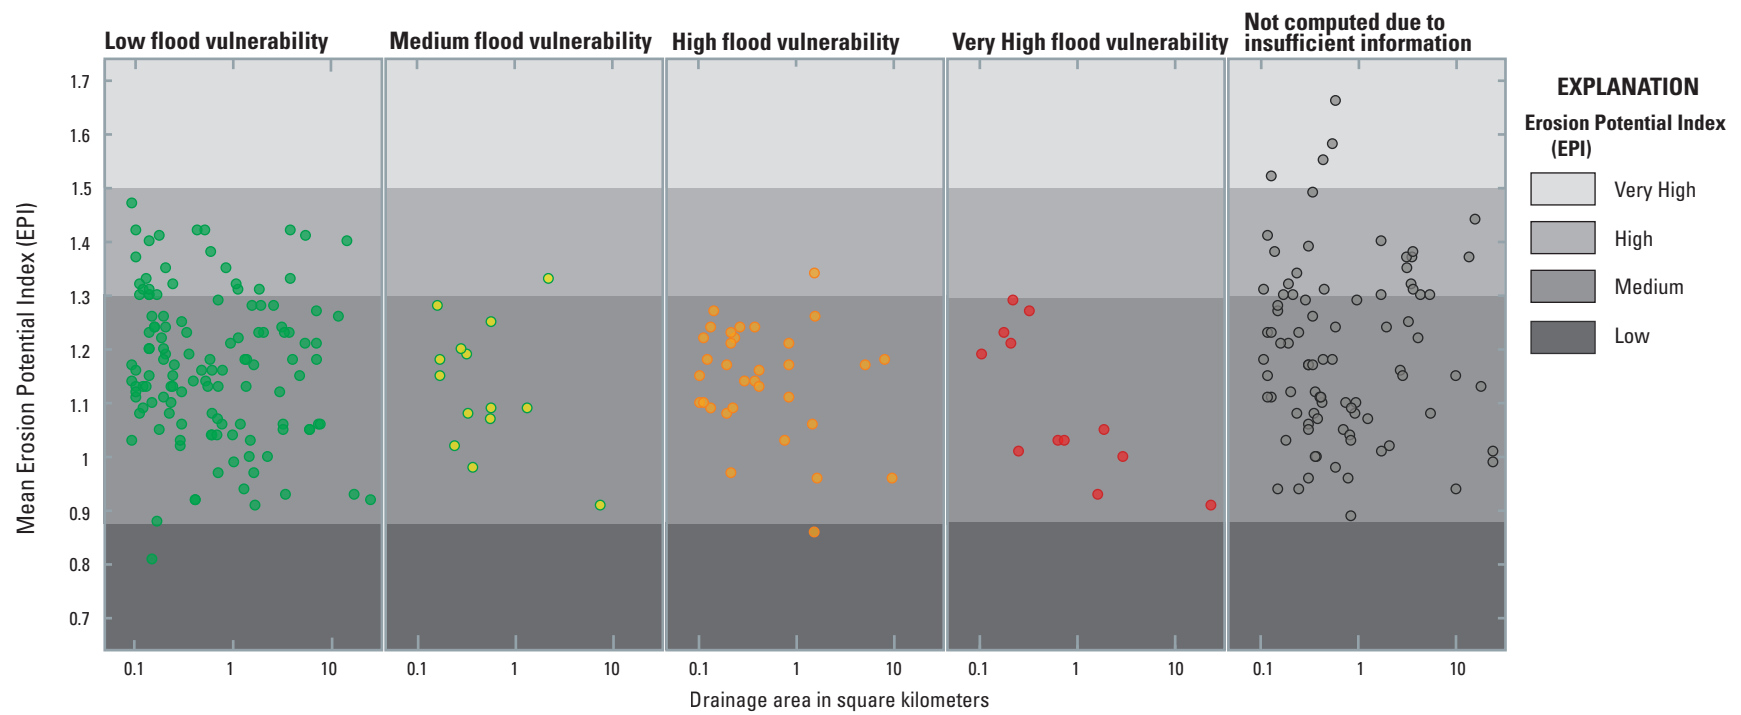
Figure 5. Plots showing the relative mean Erosion Potential Index (EPI) of stream crossings (n=271) in Acadia National Park by flood vulnerability category (Armstrong and others, 2025).
