# Thickness and Other Characteristics of Overbank Sediment Deposited During an Extreme Flood in May 1978 Along the Powder River, Montana

Scientific Investigations Report 2026–5122

By John A. Moody and Robert H. Meade

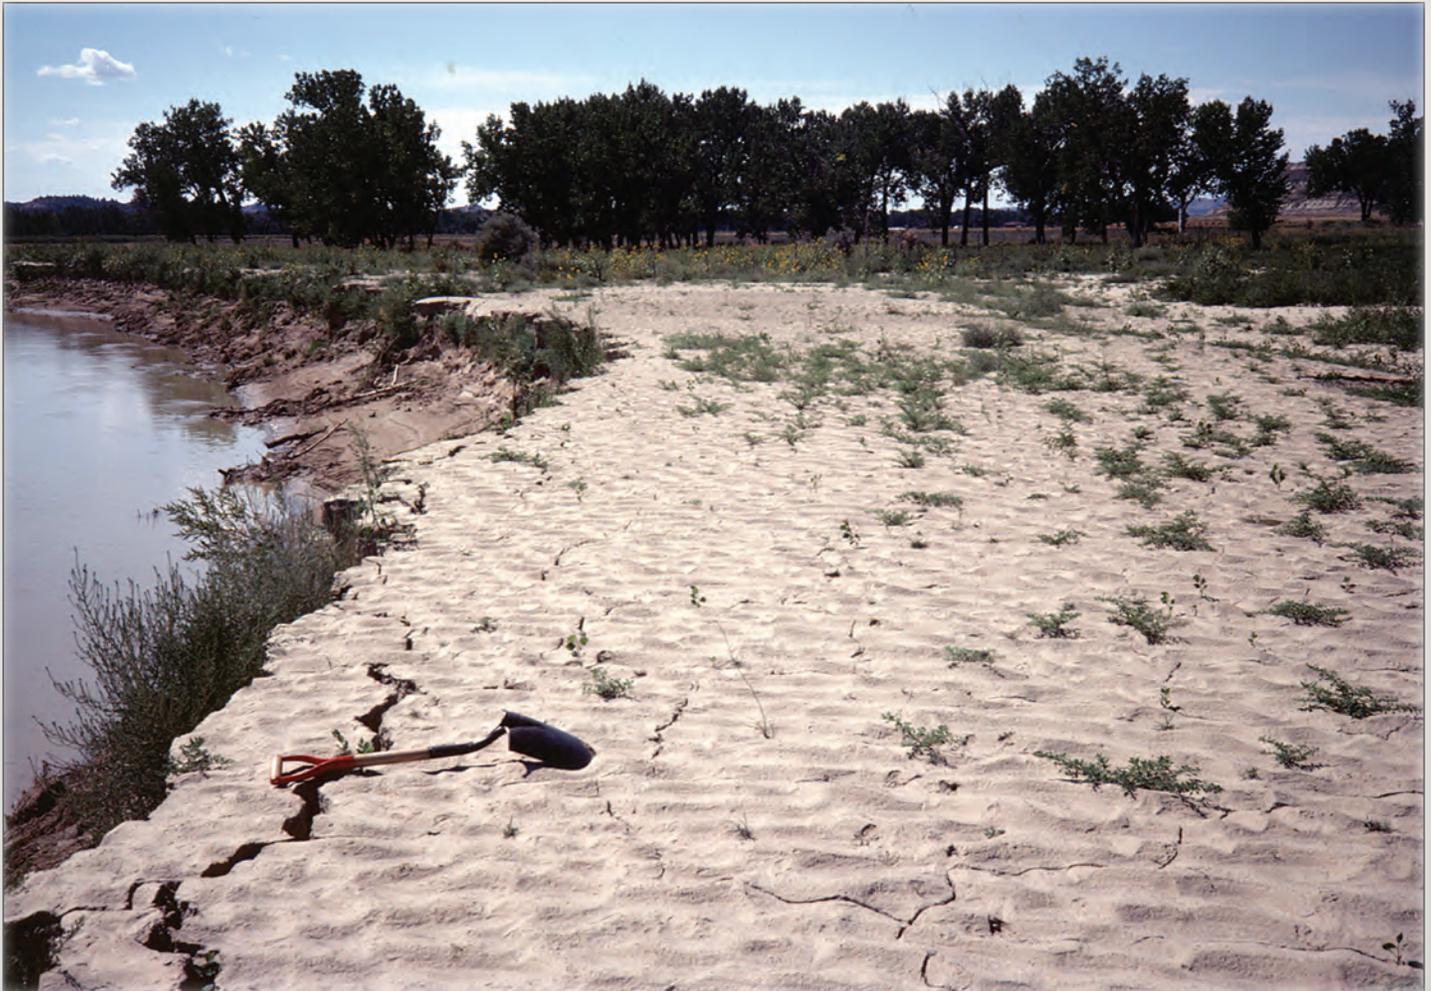
**Cover.** Photograph showing southwestward view (upriver) of sand deposited by May 1978 flood on a hectare-size area of terrace at distances 80–200 m upriver from Powder River cross section PR163. Observed thicknesses of sand in this overbank deposit ranged mostly from 10 to 45 centimeters (fig. 1.12*g* from this report). Photograph by Robert H. Meade, U.S. Geological Survey, August 30, 1978.

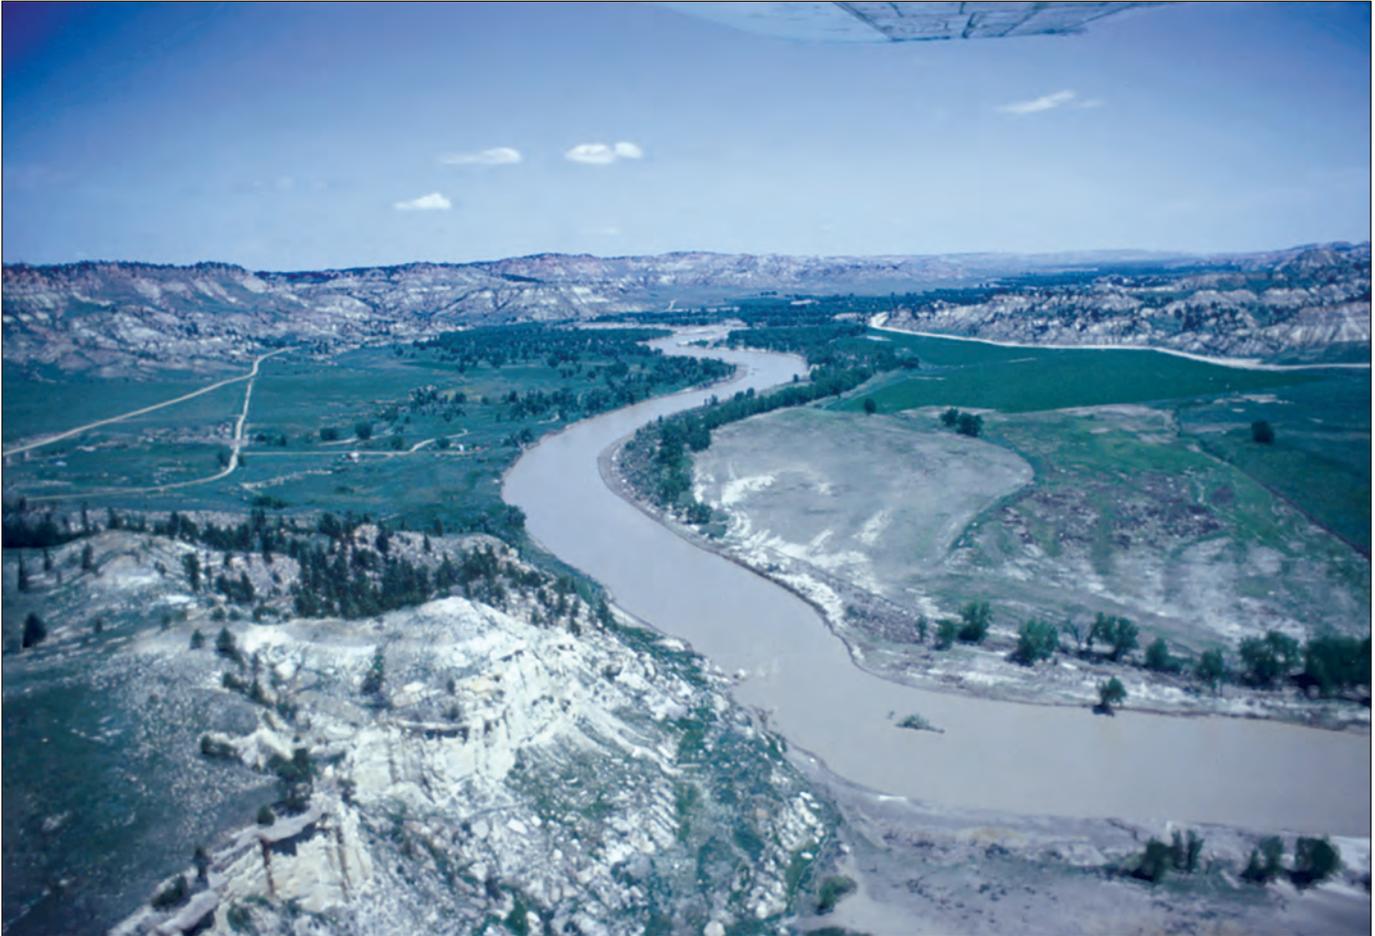
**Figure 3.** Photograph showing aerial view downriver of the expanding valley of Powder River, southeastern Montana, during the waning stage of the flood of May 1978. The Fort Union Formation (Hospital Bluff) is visible in the bottom left of the photograph and flanking either side of the valley farther downriver. New sediment, consisting of mud (primarily clay with an unknown amount of very fine silt) and sand, is seen deposited on the right bank (relative to facing downriver) of the Lightning terrace. No sediment was deposited on the left bank (relative to facing downriver), which is a Moorcroft terrace. The road on the left side of the photograph cuts across the Kaycee terrace that slopes upward to join the bluffs of the Fort Union Formation. Photograph by Robert H. Meade, U.S. Geological Survey, May 25, 1978.

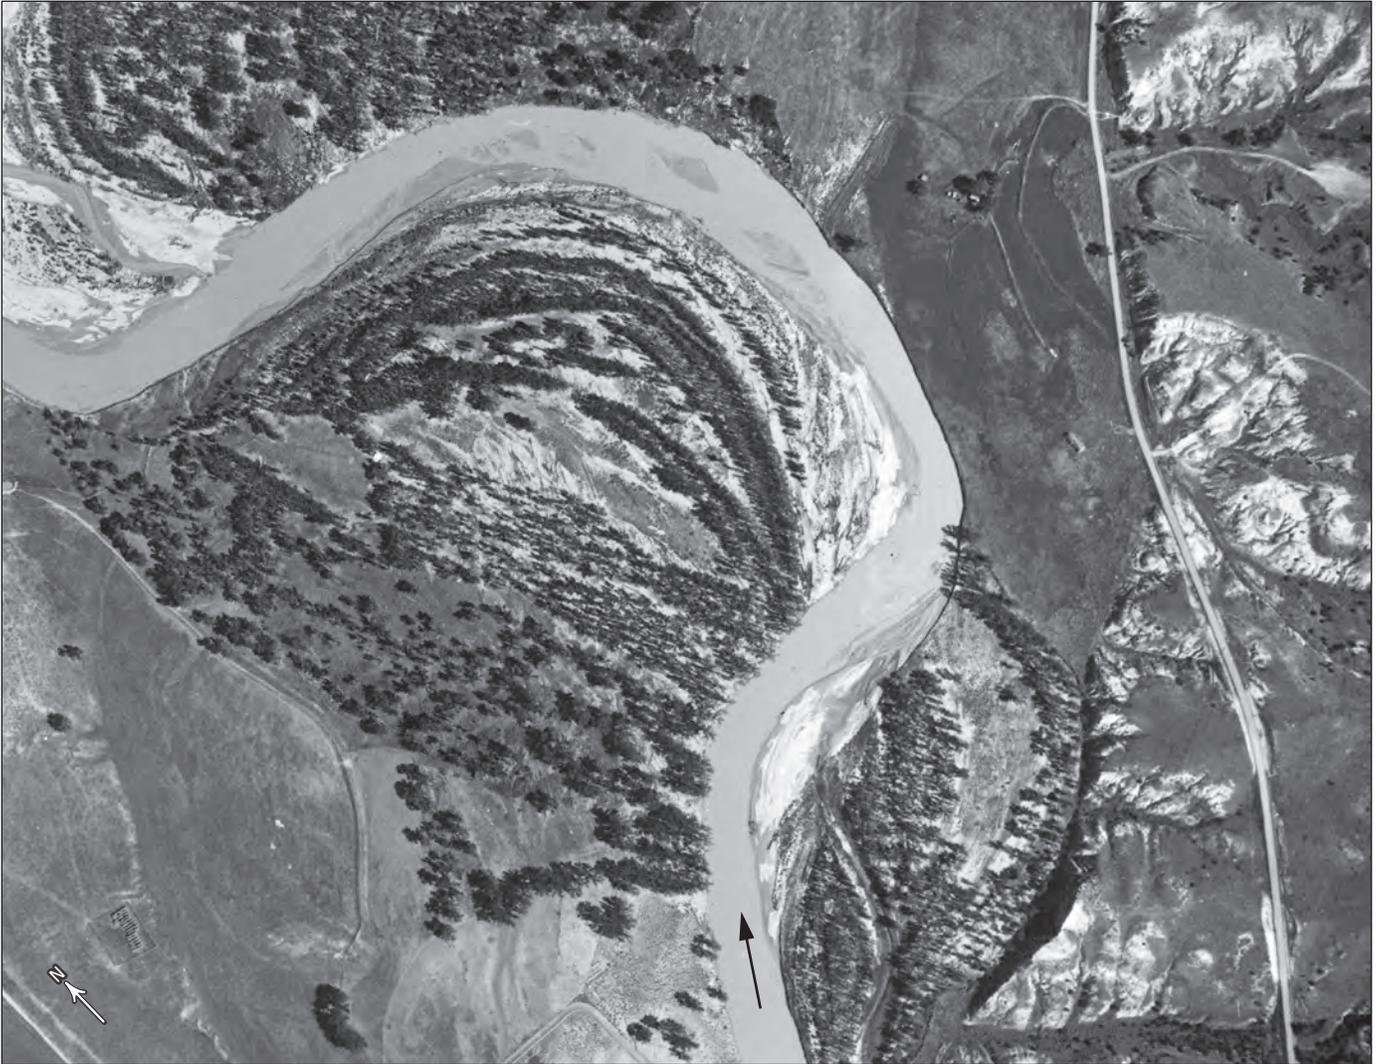
**Figure 4.** Aerial photograph showing characteristic arcuate bands of cottonwood trees and open spaces on a bend of Powder River, southeastern Montana. Open spaces have a variety of grasses and shrubs. Point bars have narrower and shorter bands of cottonwood tree seedlings, tamarisk, and sandbar willow trees. Flow in the channel is from bottom to top left, shown with arrow. Flow during the overbank stage of the 1978 flood probably was also downvalley across the neck of this bend. Aerial photograph by Bill Woodcock, Aerial Survey, Inc., Miles City, Mont., September 1978.

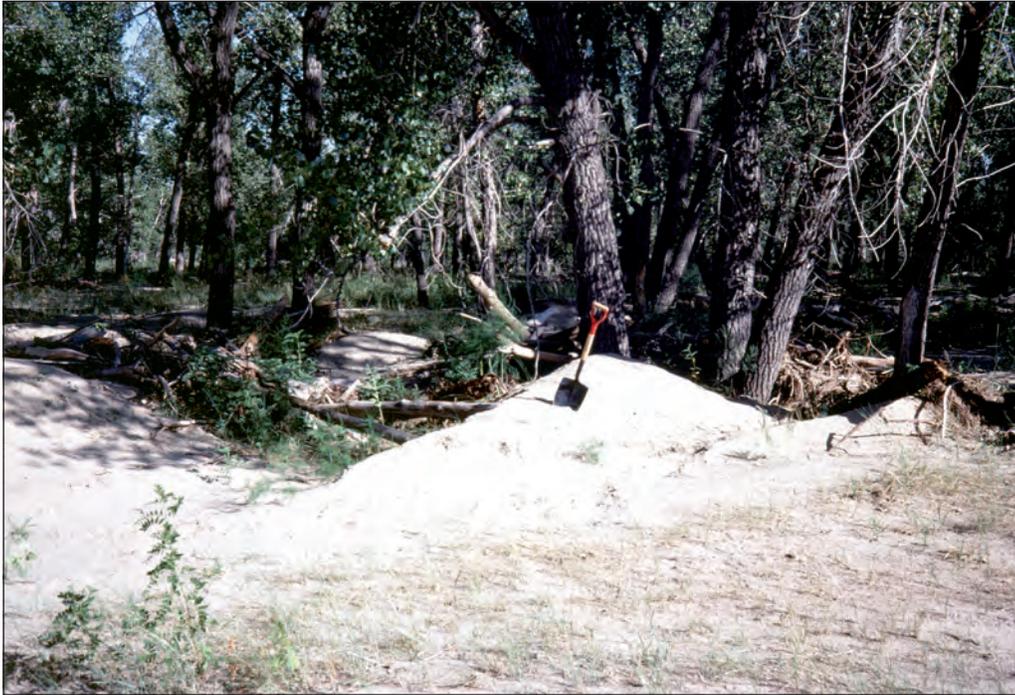
**A**

**Figure 10.** Lee dunes along Powder River looking upriver, southeastern Montana, September 1, 1978. *A*, Sediment trapped downstream from a cottonwood tree cluster along valley transect V130. Shovel length is about 1 meter (m). *B*, Multiple lee dunes looking downriver that have coalesced into semicontinuous ridges oriented along the flow direction near valley transect V156A. Person in the photograph is 1.9 m tall, and dunes are about 1 m high. Photographs taken by Robert H. Meade, U.S. Geological Survey. Refer to figure 1 for location of valley transects.

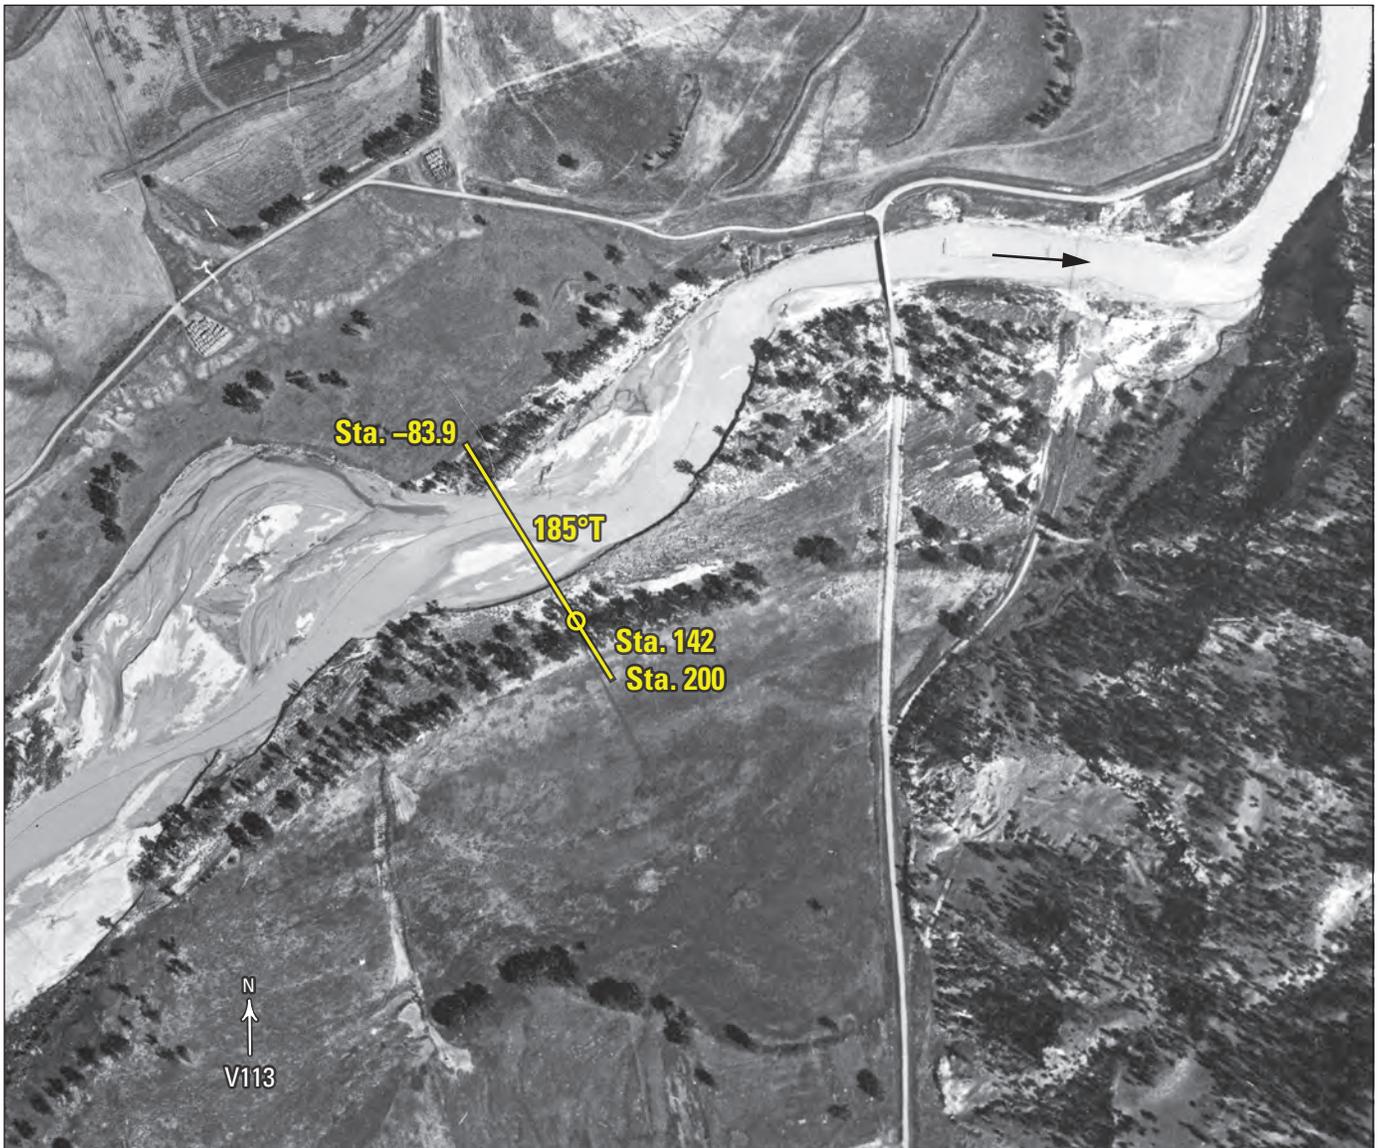
A

**Figure 1.2.** A, Aerial photograph showing valley transect V113 and channel cross section PR113 traversing cross-valley-flowing reach of Powder River at Moorhead (USGS streamgage site 06324500), southeastern Montana (refer to table 2 for Universal Transverse Mercator coordinates). Arrow indicates direction of flow in the channel. Aerial photograph by Bill Woodcock, Aerial Survey, Inc., Miles City, Mont., September 1978. Sta., station; T, true bearing. B, Transect profile showing thicknesses of sediment eroded from and deposited along cross section PR113 and valley transect V113 (which starts at station 100) during the flood of May 1978. C, Graph showing thicknesses of sediments for different particle-size classes deposited by the Powder River flood of May 1978 along valley transect V113 as a function of horizontal distance. Large thicknesses of very fine sand at cross-channel distances of 110 and 135 meters likely represent lee dunes that formed downriver from trees growing on the right-bank terrace. D, Graph showing particle-size distributions of selected samples of overbank sands deposited by the Powder River flood of May 1978 along valley transect V113. (Refer to samples listed in table 3 and footnote in table 1.2.)

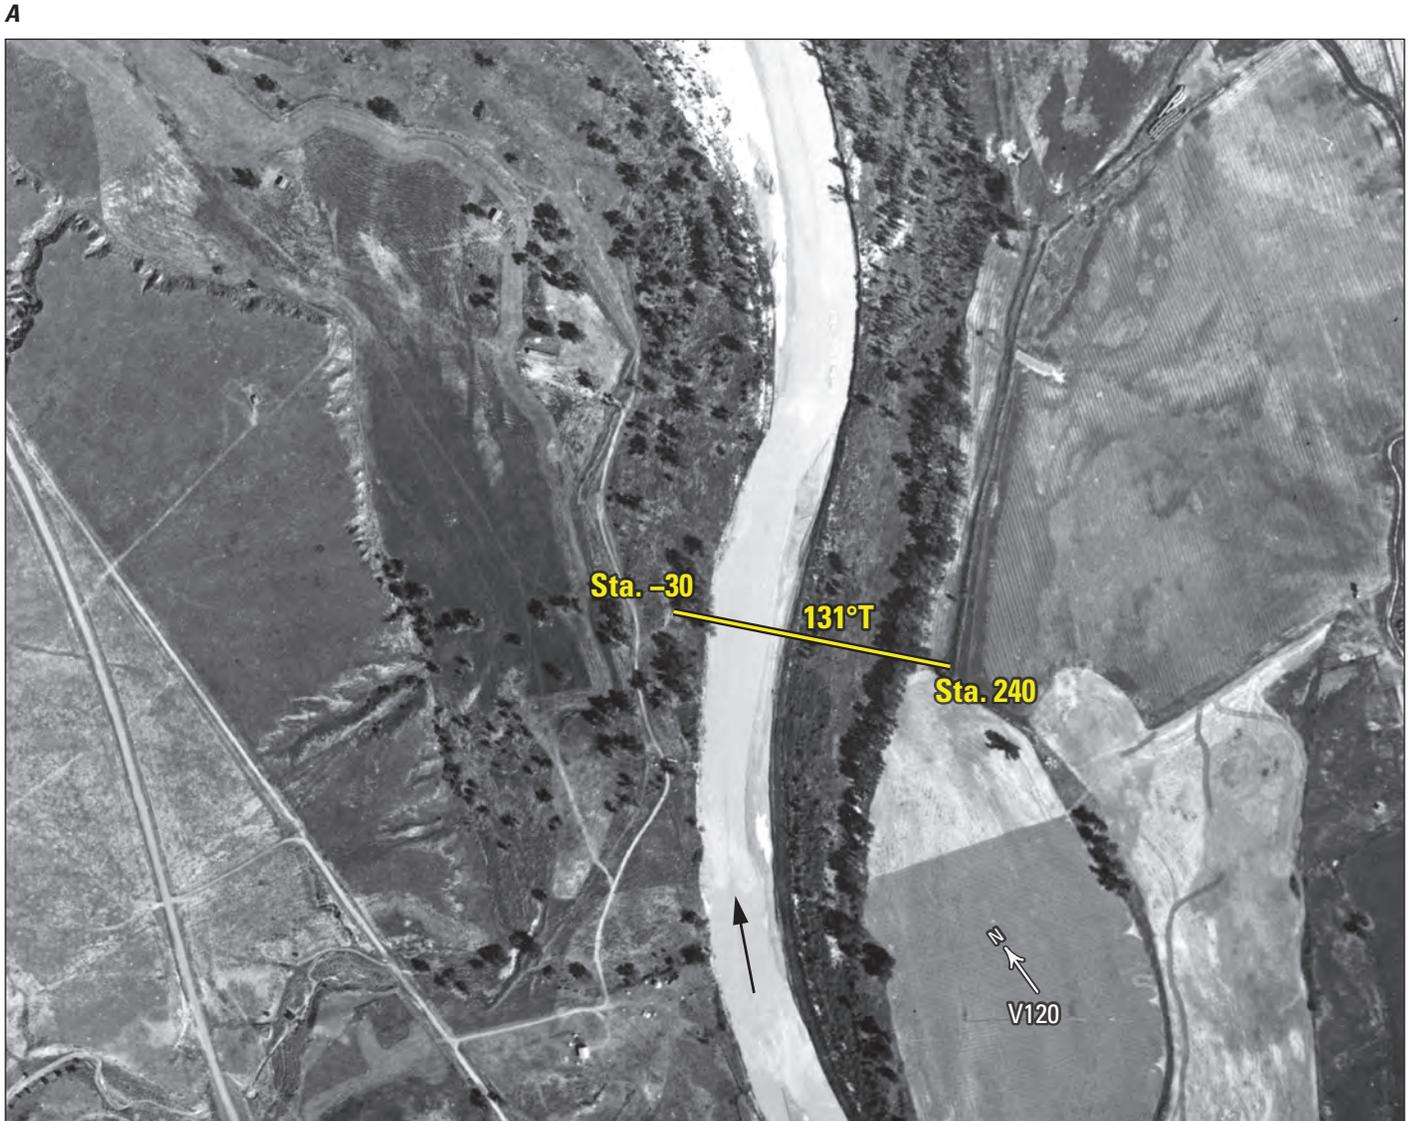
**Figure 1.3.** *A*, Aerial photograph showing segment of Powder River, southeastern Montana, showing location of valley transect V120, on which overbank sediments were deposited on the right-bank terrace by the flood of May 1978 (refer to table 2 for Universal Transverse Mercator coordinates). Arrow indicates direction of flow in the channel. Aerial photograph by Bill Woodcock, Aerial Survey, Inc., Miles City, Mont., September 1978. Sta., station; T, true bearing. *B*, Transect profile showing thicknesses of sediment eroded from and deposited in channel cross section PR120 and along valley transect V120 (which starts at station 105) during the flood of May 1978. The 1978 surface greater than station 104 was assumed equal to the surface surveyed in 2000, and the 1977 surface is equal to the 1978 surface minus the sediment thickness. *C*, Graph showing thicknesses of sediments for different particle-size classes deposited by the Powder River flood of May 1978 along valley transect V120 as a function of horizontal distance. *D*, Graph showing particle-size distribution of a typical silt deposited by the Powder River flood of May 1978 along valley transect V120. (Refer to samples listed in table 3 and footnote in table 1.3.)

Silts constitute most of the overbank sediments deposited by the flood of May 1978 along transect V120. Muds probably were deposited when backwater moved up the swale between stations 170 and 190. Very fine sands were deposited, most likely as lee dunes downriver from low-level vegetation (stations 104–180). Field notes refer to them as “sand stringers” because no obvious vegetation was present in 2000 when the surface was surveyed. Trees were noted between stations 180 and 201. Particle-size classes are listed in table 1.3 and shown in figure 1.3C.

Average sediment thickness across the Lightning terrace from stations 105 to 244 was 5 cm with a maximum of 12 cm. Complete data on thickness and lithology are listed in table 1.3. Particle-size analysis of a typical silt sample is listed in table 3 and shown in figure 1.3D.

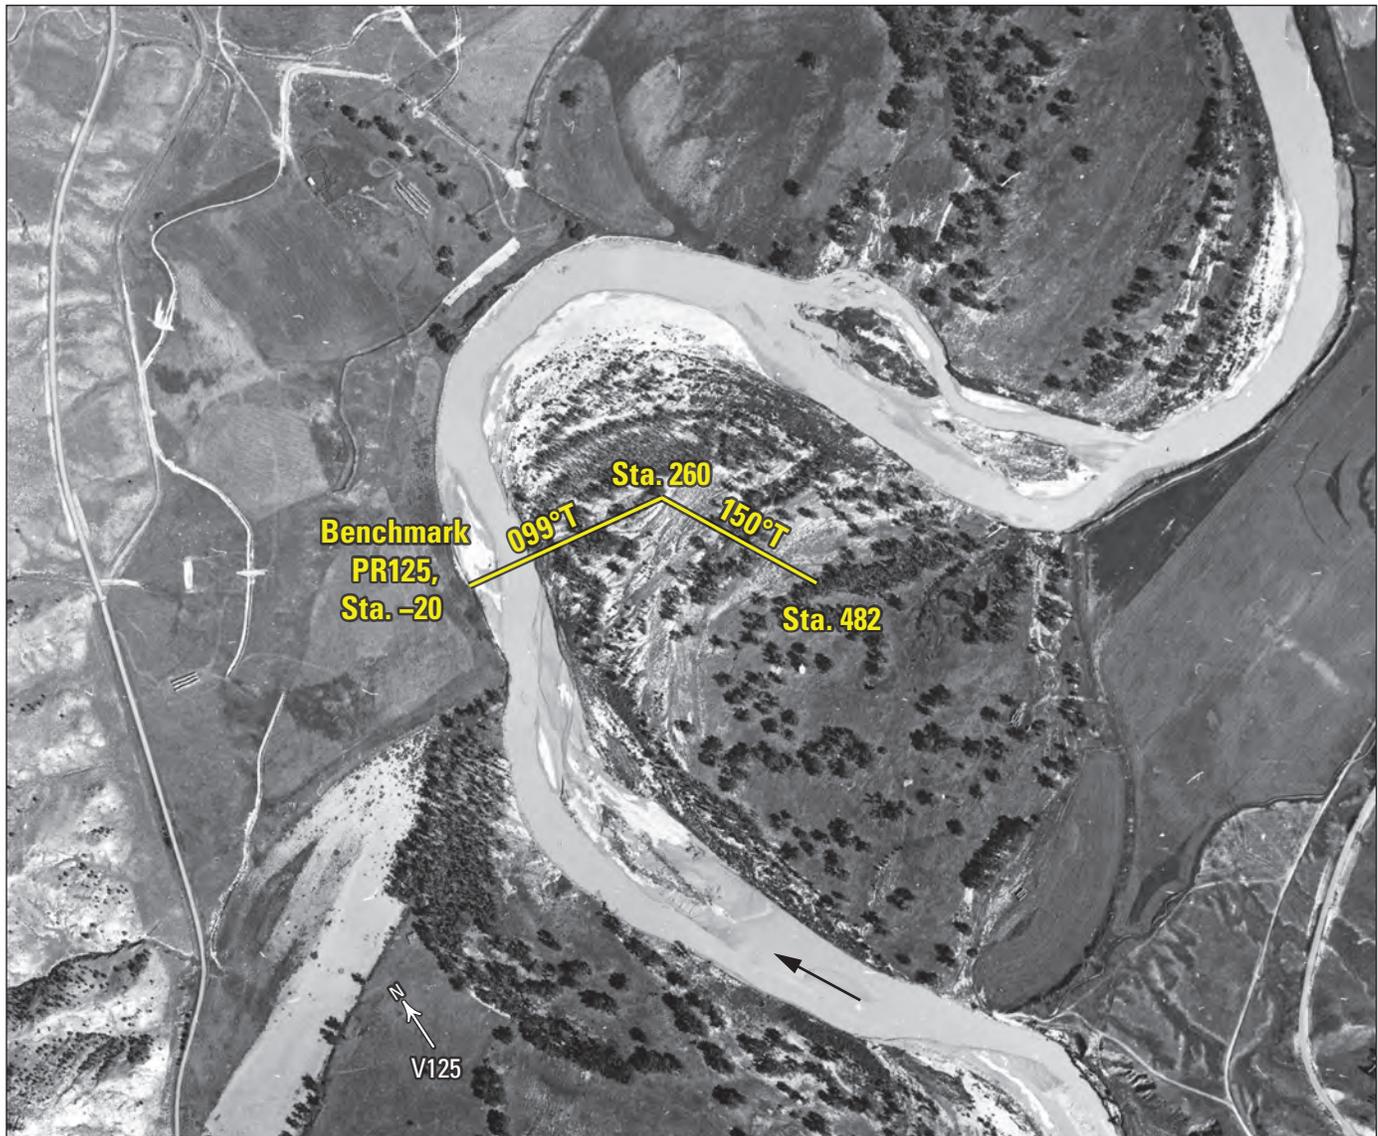
A

**Figure 1.4.** A, Aerial photograph showing reach of Powder River, southeastern Montana, location of valley transect V125 and PR125 inside the loop of a stable meander on which overbank sediments were deposited by the flood of May 1978 (refer to table 2 for Universal Transverse Mercator coordinates). Arrow indicates direction of flow in the channel. Aerial photograph by Bill Woodcock, Aerial Survey, Inc., Miles City, Mont., September 1978. Sta., station; T, true bearing. B, Transect profile showing thicknesses of sediment eroded from and deposited along cross section PR125 and valley transect V125 during the flood of May 1978. Valley transect V125 starts at station 110, and the 1978 surface eastward from station 110 was assumed equal to the surface surveyed in 2018, and the 1977 surface is equal to the 1978 surface minus the sediment thickness. C, Graph showing thicknesses of sediments for different particle-size classes deposited by the Powder River flood of May 1978 along valley transect V125 as a function of the horizontal distance. Vertical scale has been exaggerated to show details of lateral textural fining and upward coarsening. D, Graph showing particle-size distributions of selected samples of overbank sediments deposited by the Powder River flood of May 1978 along valley transect V125. (Refer to samples listed in table 3 and footnote in table 1.4.) E, Photograph showing lee dune (downvalley) deposited on low terrace of Powder River by the flood of May 1978. View is toward station 170 of valley transect V125. Photograph by Robert H. Meade, U.S. Geological Survey (USGS), September 2, 1978. F, Photograph showing excavation of lee dune (downvalley) about 10 meters upriver from station 170, along valley transect V125. Spatula indicates the pre-flood ground-level surface. Tape units are centimeters. Photograph by Robert H. Meade, USGS, September 2, 1978. Refer to figure 1 for location of valley transect.

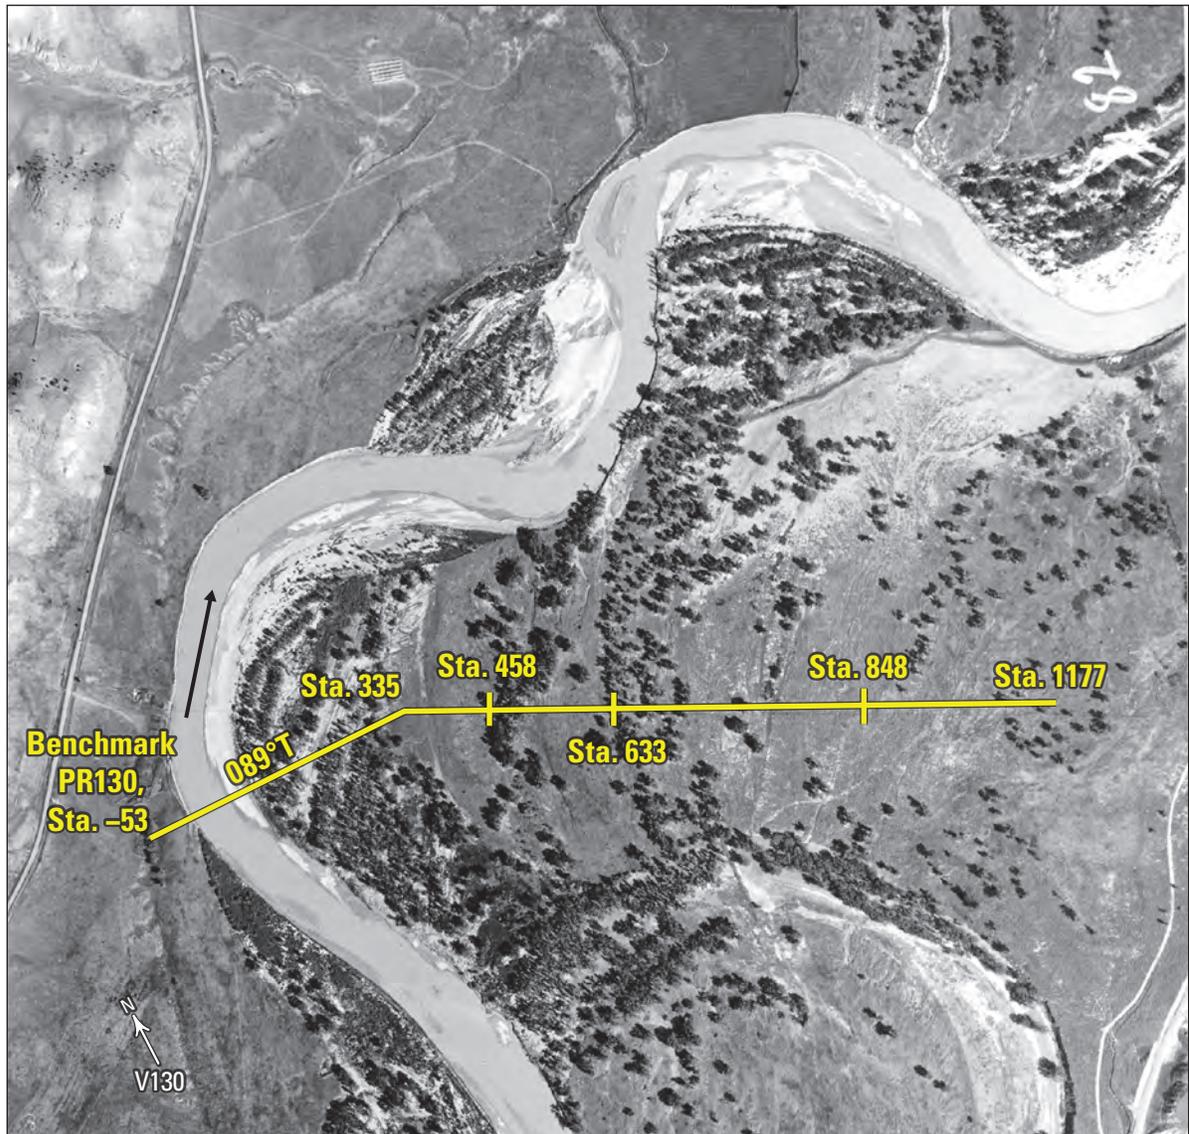
A

**Figure 1.5.** A, Photograph showing reach of Powder River, southeastern Montana, location of valley transect V130 inside a double-looped meander upon which overbank sediments were deposited by the flood of May 1978 (refer to table 2 for Universal Transverse Mercator coordinates). Arrow indicates direction of flow in the channel. Aerial photograph by Bill Woodcock, Aerial Survey, Inc., Miles City, Mont., September 1978. Sta., station; T, true bearing. B, Transect profile in two segments showing the thicknesses of eroded and deposited sediment along the cross section PR130 and valley transect V130 during the flood of May 1978. Valley transect V130 starts at station 115. The 1978 surface, greater than station 108 but less than station 335, was assumed equal to the surface surveyed in 2000, and the 1978 surface, greater than station 335, was estimated from the 7.5-minute Bloom Creek quadrangle. The 1977 surface is equal to the 1978 surface minus the sediment thickness. C, Graph showing thicknesses of sediments deposited for different particle-size classes by the Powder River flood of May 1978 along valley transect V130 as a function of the horizontal distance. Lee dunes (spikes in plot) have particle-size distributions that coarsen upward between stations 120 and 330. Thicknesses of silt shown between station 335 and 1177 are based on averaged measurements (refer to table 1.5). D, Graph showing particle-size distributions of selected samples of overbank sediments deposited by the Powder River flood of May 1978 along valley transect V130. (Refer to samples listed in table 3 for valley transect V130 and footnote in table 1.5.) E, Photograph showing south-southwest (upvalley) of lee dunes deposited by 1978 floodwaters on the downriver sides of trees near stations 210–240 of valley transect V130. Lee dunes show as thin white streaks in figure 1.5A. Photograph by Robert H. Meade, U.S. Geological Survey (USGS), September 1, 1978. F, Photograph showing south-southwest (upvalley) view of lee dune deposited by 1978 floodwaters near station 230 of valley transect V130. Length of shovel is approximately 1 meter. The interior of this lee dune shows particle-size distributions that coarsen upward (table 1.5). Photograph by Robert H. Meade, USGS, September 1, 1978.

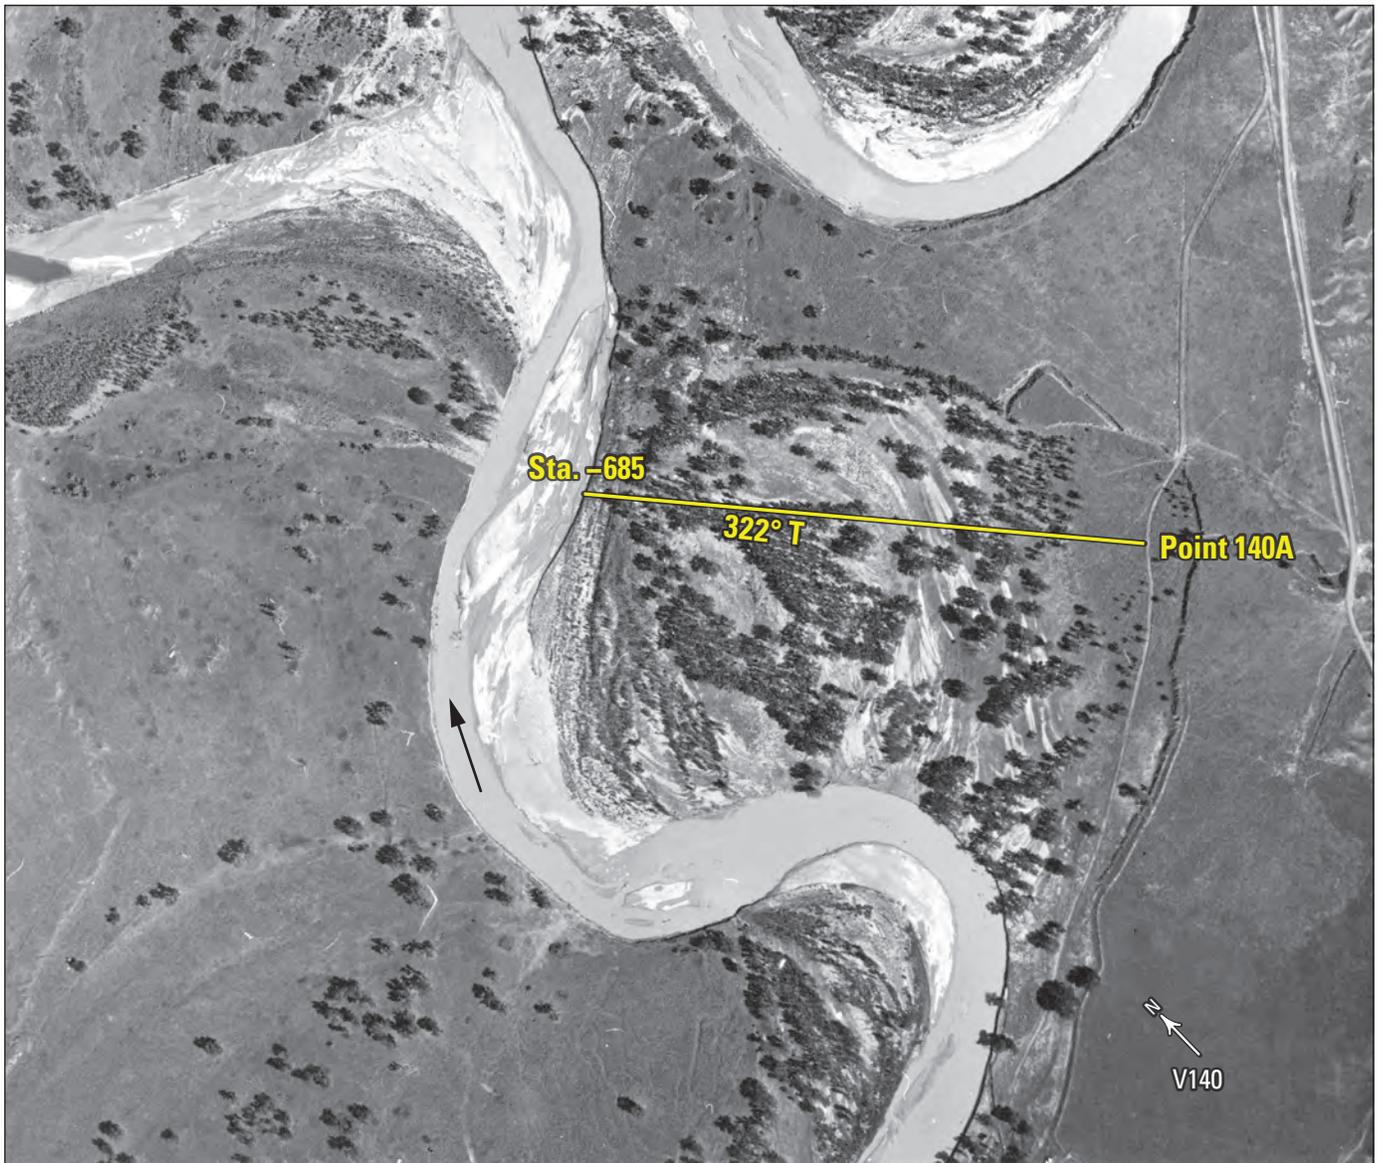
A

**Figure 1.7.** A, Aerial photograph showing reach of Powder River, southeastern Montana, location of valley transect V140 across a point bar on the right bank (refer to table 2 for Universal Transverse Mercator coordinates). Arrow indicates direction of flow in the channel. Aerial photograph by Bill Woodcock, Aerial Survey, Inc., Miles City, Mont., September 1978. Sta., station; T, true bearing. B, Transect profile showing thicknesses of sediments deposited along valley transect V140 during the flood of May 1978. The 1978 surface was assumed equal to the 2016 light detection and ranging surface, and the 1977 surface was equal to the 1978 surface minus the sediment thickness. C, Graph showing thicknesses of sediments for different particle-size classes deposited by the Powder River flood of May 1978 along valley transect V140 as a function of horizontal distance. Vertical scale has been exaggerated to show details of upward coarsening of particle sizes. D, Graph showing particle-size distributions of selected samples of overbank sediments deposited by the Powder River flood of May 1978 along valley transect V140. (Refer to samples listed in table 3 and footnote in table 1.7.)

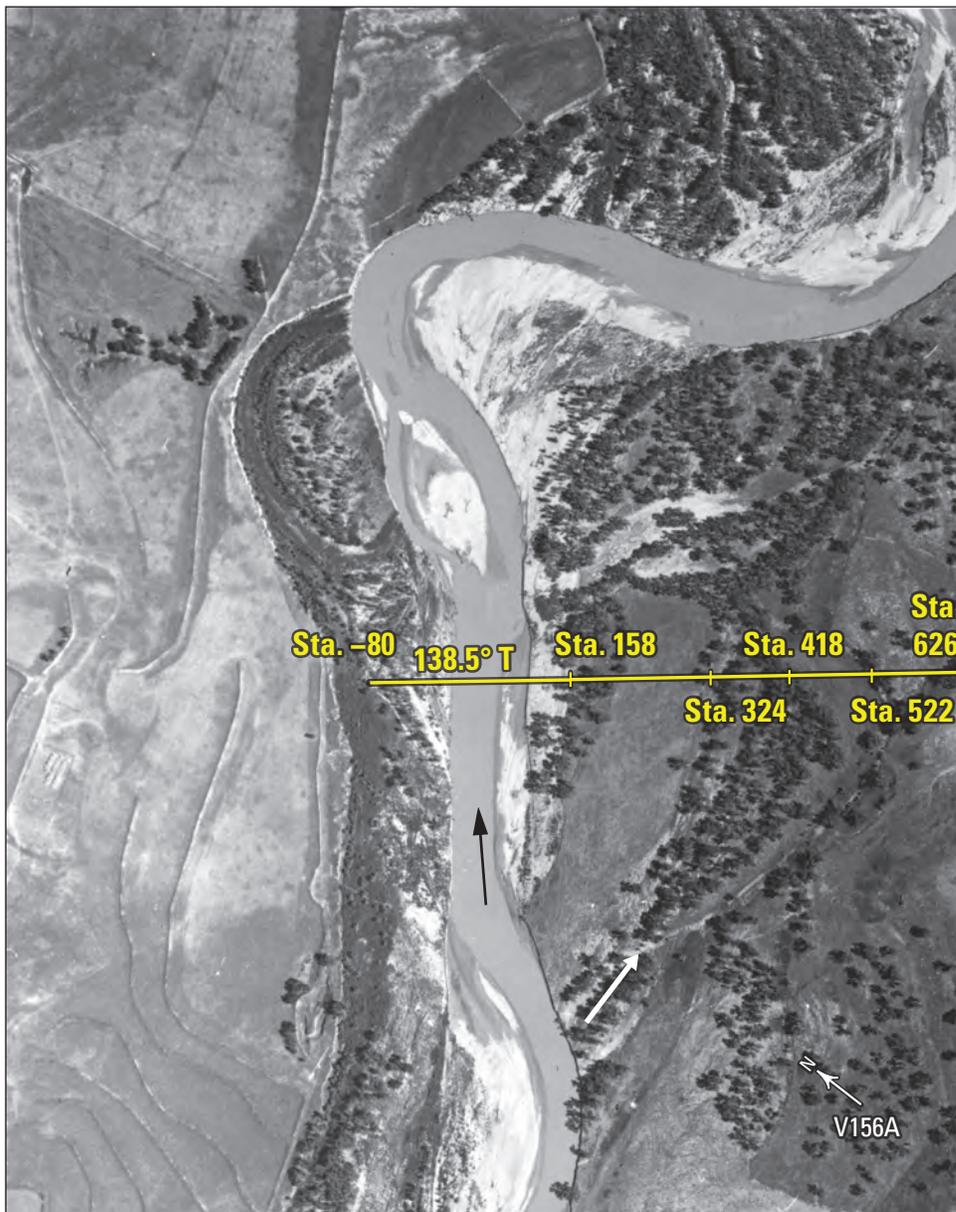
A

**Figure 1.10.** *A*, Aerial photograph showing reach of Powder River valley, southeastern Montana, in which the flood of May 1978 deposited overbank sediments on terrace levels on both sides of the Powder River. Photograph does not show the most distant 239 meters (m; stations 626–865) of the transect (refer to table 2 for Universal Transverse Mercator coordinates). Black arrow indicates direction of flow in the channel. White arrow indicates overbank flow direction. Aerial photograph by Bill Woodcock, Aerial Survey, Inc., Miles City, Mont., September 1978. Sta., station; T, true bearing. *B*, Transect profile showing thicknesses of sediment deposited along valley transect V156A during the flood of May 1978. The 1978 surface was assumed equal to the 2016 light detection and ranging surface, and the 1977 surface was equal to the 1978 surface minus the sediment thickness. *C*, Graph showing thicknesses of sediments for different particle-size classes deposited by the Powder River flood of May 1978 along valley transect V156A as a function of the horizontal distance. Vertical scale has been exaggerated to show details of the structure of lee dunes on terrace levels on both sides of the channel. *D*, Graph showing particle-size distributions of selected samples of overbank sediment deposited by the Powder River flood of May 1978 along valley transect V156A. (Refer to samples listed in table 3 and footnote in table 1.10.) *E*, Photograph showing southwestward (downvalley) view of overbank sediment deposited, mostly as lee dunes, on Lightning terrace, on left side of Powder River, about 50 m downriver from valley transect V156A. Length of shovel is approximately 1 m. Photograph by Robert H. Meade, U.S. Geological Survey (USGS), September 1, 1978. *F*, Photograph showing at same locality as in figure 1.10E, showing a trench dug through 38 centimeters (cm) of fine sand deposited above the preflood ground level in May 1978. Length of ruler at base of tree in the trench is 16 cm. Photograph by Robert H. Meade, USGS, September 1, 1978. *G*, Photograph showing wide-angle view northeastward (downriver) of new sand deposited by the May 1978 flood on right side of valley transect V156A. Photograph by Robert H. Meade, USGS, August 4, 1978.

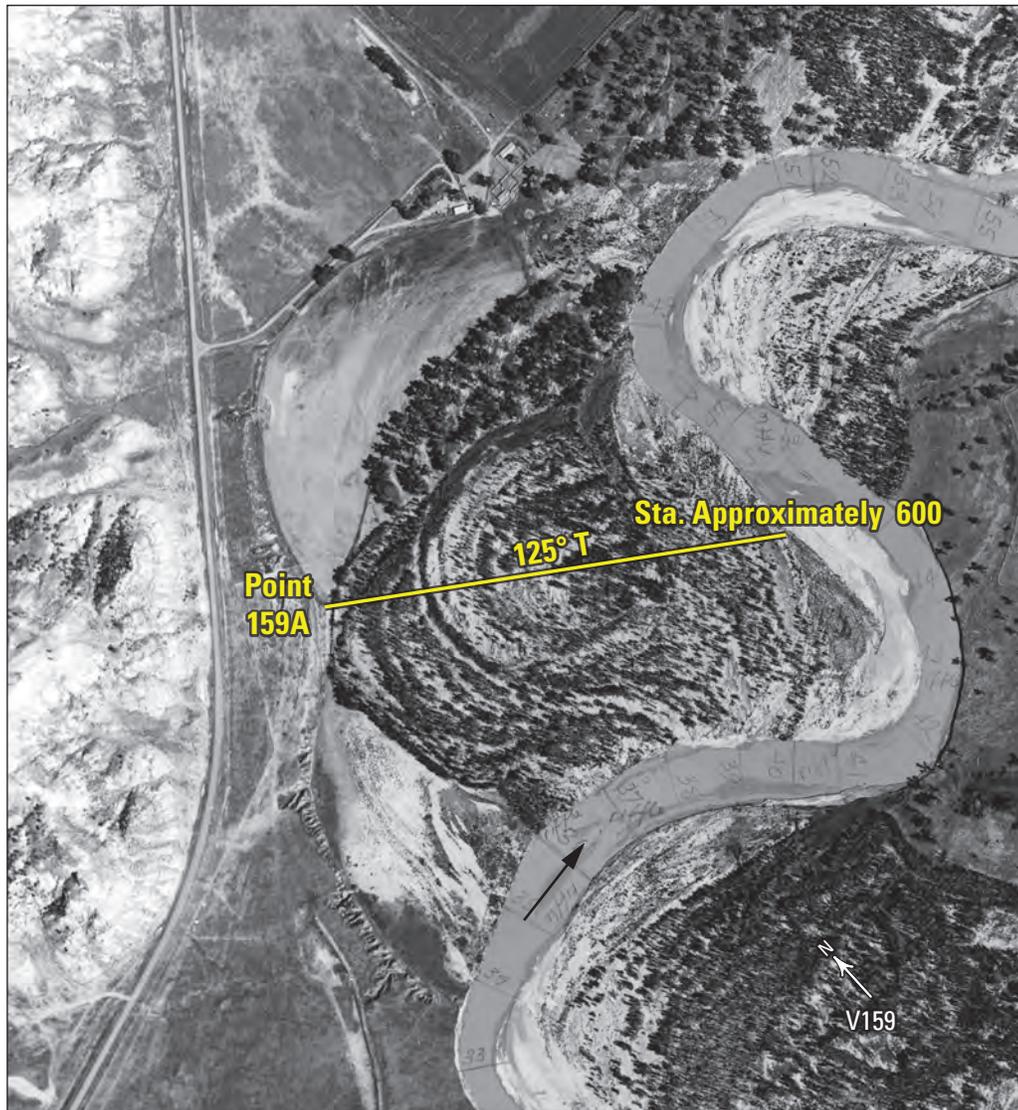
A

**Figure 1.11.** A, Aerial photograph showing reach of Powder River, southeastern Montana, location of valley transect V159, which was an axial crossing of an older meander scar on which overbank sediments were deposited during the flood of May 1978 (refer to table 2 for Universal Transverse Mercator coordinates). This photograph also shows the crescent-shaped area of sediment accumulation on an alfalfa field at a higher (Moorcroft) terrace level laying between Point 159A and the ranch houses at the end of the ranch road that branches off Moorhead Road. Arrow indicates direction of flow in the channel. Aerial photograph by Bill Woodcock, Aerial Survey, Inc., Miles City, Mont., September 1978. Sta., station; T, true bearing. B, Transect profile showing thicknesses of sediments deposited along valley transect V159 during the flood of May 1978. The 1978 surface was assumed equal to the 2016 light detection and ranging surface, and the 1977 surface was equal to the 1978 surface minus the sediment thickness. C, Graph showing thicknesses of sediments for different particle-size classes deposited by the Powder River flood of May 1978 along valley transect V159 as a function of the horizontal distance. Vertical scale has been exaggerated to show details. D, Graph showing particle-size distributions of selected samples of overbank sediment deposited by the Powder River flood of May 1978 along valley transect V159. (Refer to samples listed in table 3 and footnote in table 1.11.) E, Photograph showing northeastward view of sediment deposited by the May 1978 flood on an alfalfa field on Moorcroft terrace immediately downvalley of Point 159A of valley transect V159. Thicknesses of new flood-deposited sediment on this field were not measured directly. Photograph by Robert H. Meade, U.S. Geological Survey, October 19, 1978.

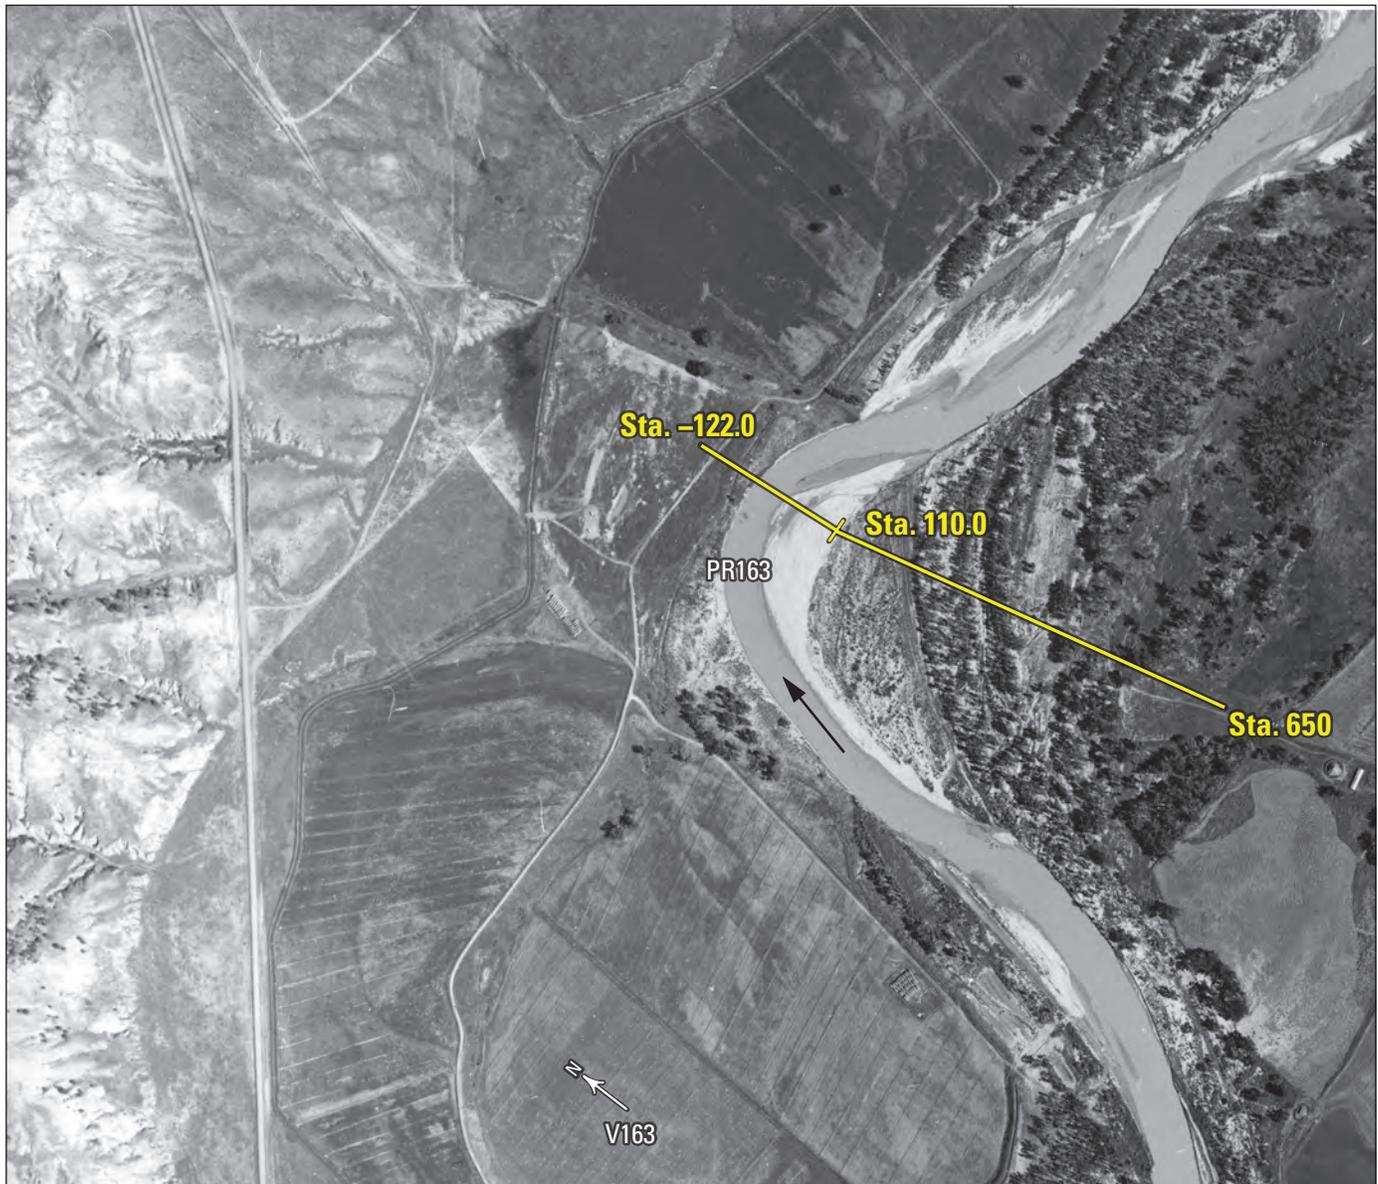
A

**Figure 1.12.** *A*, Aerial photograph showing reach of Powder River, southeastern Montana, location of valley transect V163 (refer to table 2 for Universal Transverse Mercator coordinates) on which overbank sediments were deposited during the flood of May 1978. Arrow indicates direction of flow in the channel. Aerial photograph by Bill Woodcock, Aerial Survey, Inc., Miles City, Mont., September 1978. Sta., station; T, true bearing. *B*, Transect profile showing thicknesses of sediments deposited along valley transect V163 during the flood of May 1978. The 1978 surfaces from stations 110.9 to 650 were approximated by a survey done in 1996, and the 1977 surface was equal to the 1978 surface minus the sediment thickness. *C*, Graph showing thicknesses of sediments for different particle-size classes deposited by the Powder River flood of May 1978 along valley transect V163 as a function of horizontal distance. Vertical scale exaggerated to show details of upward coarsening and lateral fining of particle sizes. *D*, Graph showing particle-size distributions of selected samples of overbank sediment deposited by the Powder River flood of May 1978 along valley transect V163. (Refer to samples listed in table 3 and footnote in table 1.12.) *E*, Graph showing change in mean particle size with distance from the channel along transect V163. *F*, Photograph showing southwestward view (upvalley) across valley transect V163 showing dunes of sand and silt. Dunes are located at lateral distances of about 100 meters (m) from station 110 of cross section PR163 and were deposited in a grove of small cottonwood trees in Powder River valley by the floodwaters of May 1978. Red rucksack marks the approximate location of transect V163. Photograph by Robert H. Meade, U.S. Geological Survey (USGS), October 16, 1978. *G*, Photograph showing southwestward view (upriver) of sand deposited by May 1978 flood on a hectare-size area of terrace at distances 80–200 m upriver from Powder River cross section PR163. Observed thicknesses of sand in this overbank deposit ranged mostly from 10 to 45 centimeters. Photograph by Robert H. Meade, USGS, August 30, 1978.
