# Thickness and Other Characteristics of Overbank Sediment Deposited During an Extreme Flood in May 1978 Along the Powder River, Montana

Scientific Investigations Report 2026–5122

By John A. Moody and Robert H. Meade

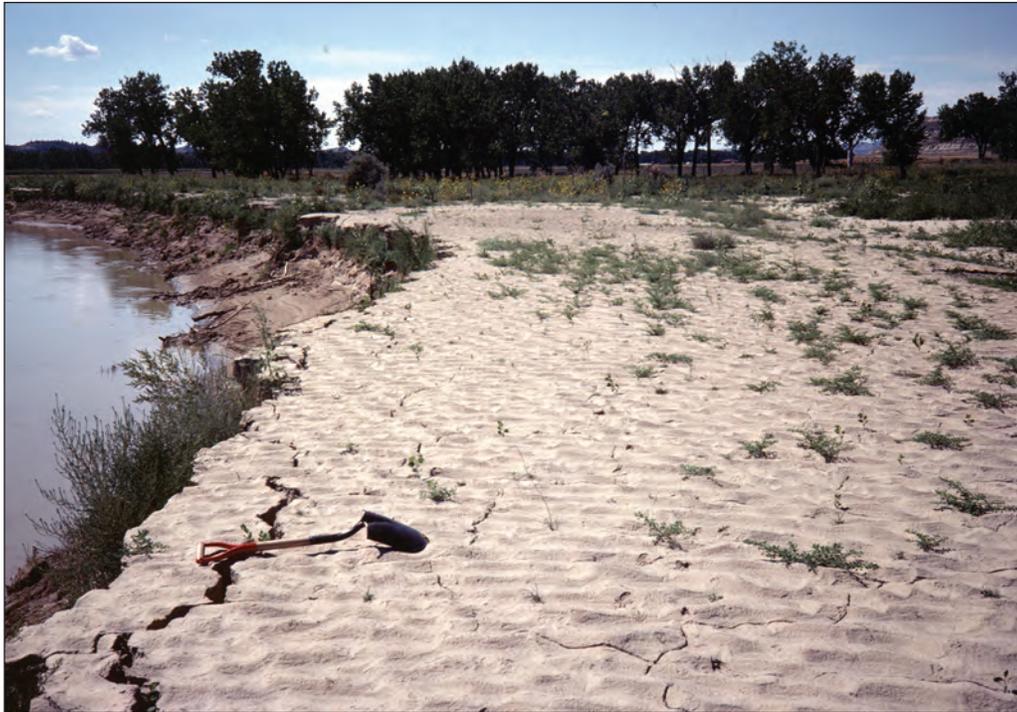
*G*

**Cover.** Photograph showing southwestward view (upriver) of sand deposited by May 1978 flood on a hectare-size area of terrace at distances 80–200 m upriver from Powder River cross section PR163. Observed thicknesses of sand in this overbank deposit ranged mostly from 10 to 45 centimeters (fig. 1.12*g* from this report). Photograph by Robert H. Meade, U.S. Geological Survey, August 30, 1978.

**Figure 1.12.** *A*, Aerial photograph showing reach of Powder River, southeastern Montana, location of valley transect V163 (refer to table 2 for Universal Transverse Mercator coordinates) on which overbank sediments were deposited during the flood of May 1978. Arrow indicates direction of flow in the channel. Aerial photograph by Bill Woodcock, Aerial Survey, Inc., Miles City, Mont., September 1978. Sta., station; T, true bearing. *B*, Transect profile showing thicknesses of sediments deposited along valley transect V163 during the flood of May 1978. The 1978 surfaces from stations 110.9 to 650 were approximated by a survey done in 1996, and the 1977 surface was equal to the 1978 surface minus the sediment thickness. *C*, Graph showing thicknesses of sediments for different particle-size classes deposited by the Powder River flood of May 1978 along valley transect V163 as a function of horizontal distance. Vertical scale exaggerated to show details of upward coarsening and lateral fining of particle sizes. *D*, Graph showing particle-size distributions of selected samples of overbank sediment deposited by the Powder River flood of May 1978 along valley transect V163. (Refer to samples listed in table 3 and footnote in table 1.12.) *E*, Graph showing change in mean particle size with distance from the channel along transect V163. *F*, Photograph showing southwestward view (upvalley) across valley transect V163 showing dunes of sand and silt. Dunes are located at lateral distances of about 100 meters (m) from station 110 of cross section PR163 and were deposited in a grove of small cottonwood trees in Powder River valley by the floodwaters of May 1978. Red rucksack marks the approximate location of transect V163. Photograph by Robert H. Meade, U.S. Geological Survey (USGS), October 16, 1978. *G*, Photograph showing southwestward view (upriver) of sand deposited by May 1978 flood on a hectare-size area of terrace at distances 80–200 m upriver from Powder River cross section PR163. Observed thicknesses of sand in this overbank deposit ranged mostly from 10 to 45 centimeters. Photograph by Robert H. Meade, USGS, August 30, 1978.

This transect is a good example of the decrease in particle size with distance from the channel (fig. 1.12C, E). This pattern has been preserved by the many sediment traps created by the stands of cottonwood trees from station 110 to about station 400 (fig. 1.12B). These traps, once filled, become the lee dunes shown as spikes in the plot of sediment thickness in figure 1.12C. Complete data on the thickness and lithology of overbank sediments deposited on transect V163 by the flood of May 1978 are listed in table 1.12. Particle sizes of selected samples are listed in table 3, graphed in figure 1.12D. Examples of the sediment are shown in figure 1.12F and G.

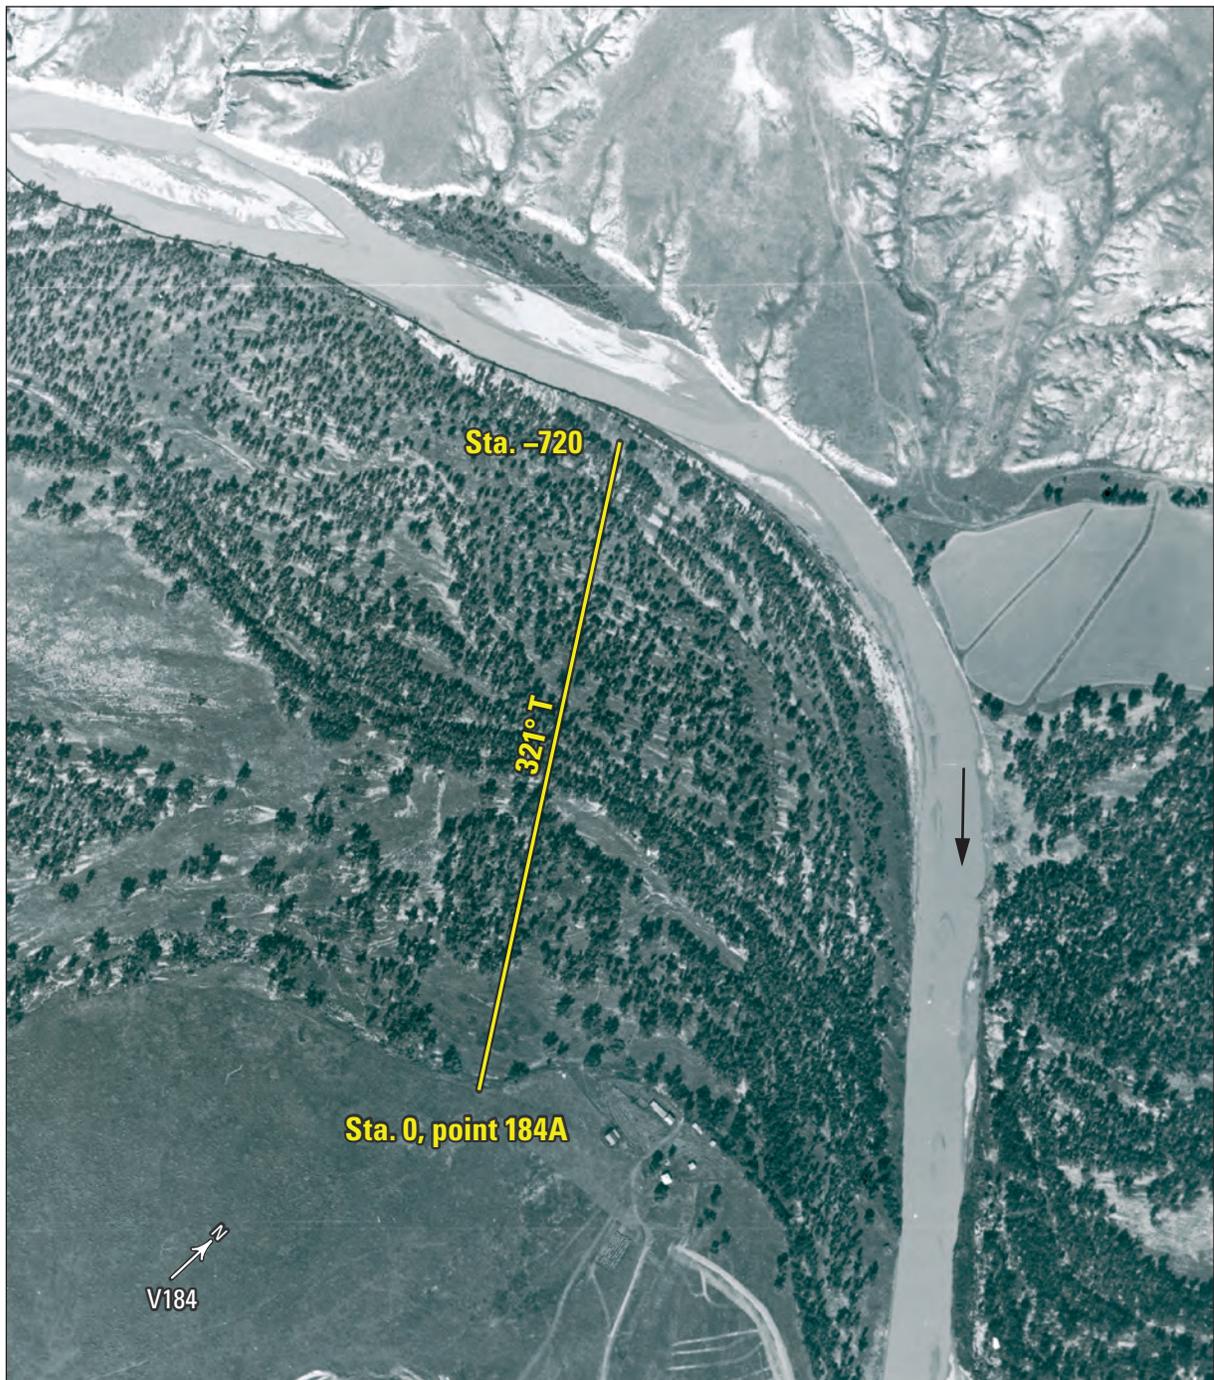
A

**Figure 1.16.** *A*, Aerial photograph showing reach of Powder River, southeastern Montana, location of valley transect V184 (refer to table 2 for Universal Transverse Mercator coordinates) on which overbank sediments were deposited during the flood of May 1978. Arrow indicates direction of flow in the channel. Aerial photograph by Bill Woodcock, Aerial Survey, Inc., Miles City, Mont., September 1978. Sta., station; T, true bearing. *B*, Transect profile showing thicknesses of sediments deposited along valley transect V184 during the flood of May 1978. The 1978 surface was assumed to be equal to the 2016 light detection and ranging surface, and the 1977 estimated surface was equal to the 1978 surface minus the sediment thickness. *C*, Graph showing thicknesses of sediments for different particle-size classes deposited by the Powder River flood of May 1978 along valley transect V184 as a function of the horizontal distance. Vertical scale has been exaggerated to show details of upward coarsening of particle sizes. *D*, Graph showing particle-size distributions of selected samples of silts deposited by the Powder River flood of May 1978 along valley transect V184. (Refer to samples listed in table 3 and footnote in table 1.16.) *E*, Photograph showing newly deposited overbank sediments atop older pre-flood sediment at station -540 of valley transect V184. Measuring tape reads 0 centimeter (cm) at the top of silt deposited by the flood of May 1978, 6 cm at the top of flood-deposited mud, and 7 cm at the pre-flood ground surface. Photograph by Robert H. Meade, U.S. Geological Survey, October 12, 1978.

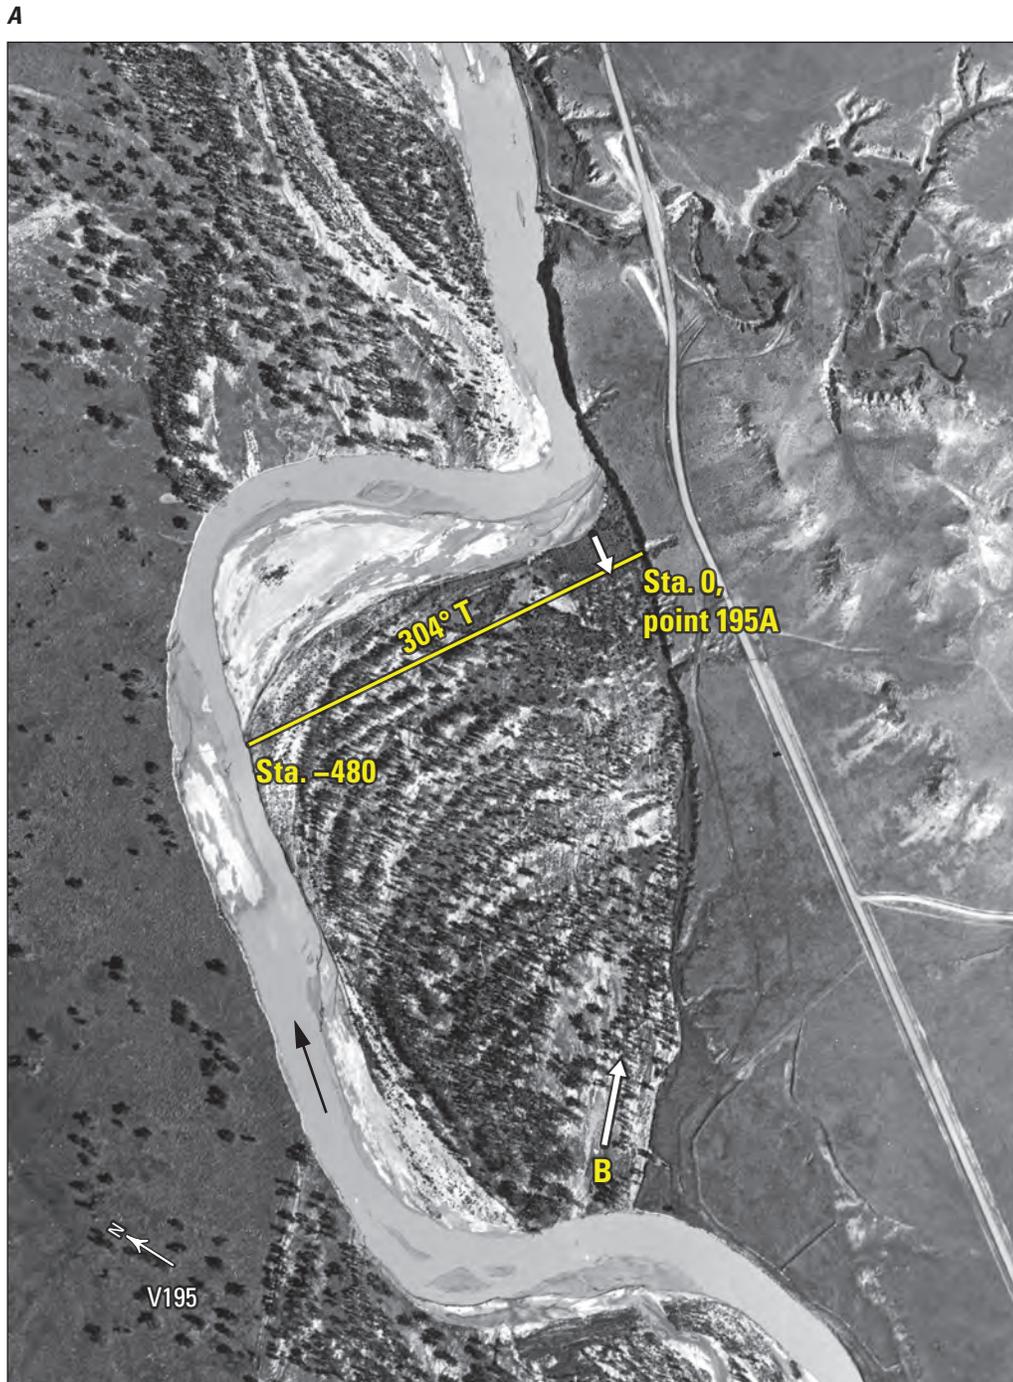
**Figure 1.18.** A, Aerial photograph showing reach of Powder River, southeastern Montana, location of valley transect V195 (refer to table 2 for Universal Transverse Mercator coordinates). The white arrow near station zero indicates the possible direction of backwater flow during the early stage of the flood, and the white arrow near B indicates the possible direction of flow near the peak stage of the flood. Black arrow indicates direction of flow in the channel. Aerial photograph by Bill Woodcock, Aerial Survey, Inc., Miles City, Mont., September 1978. Sta., station; T, true bearing. B, Transect profile showing thicknesses of sediments deposited along valley transect V195 during the flood of May 1978. The 1978 surface was assumed to be the same as the 2016 light detection and ranging surface, and the 1977 surface was estimated by subtracting the sediment thickness from the 1978 surface. C, Graph showing thicknesses of sediments for different particle-size classes deposited by the Powder River flood of May 1978 along valley transect V195 as a function of the horizontal distance. Vertical scale has been exaggerated to show details of upward coarsening of particle sizes. D, Graph showing particle-size distributions of selected samples of overbank sediment deposited by the Powder River flood of May 1978 along valley transect V195. (Refer to samples listed in table 3 and footnote in table 1.18.)

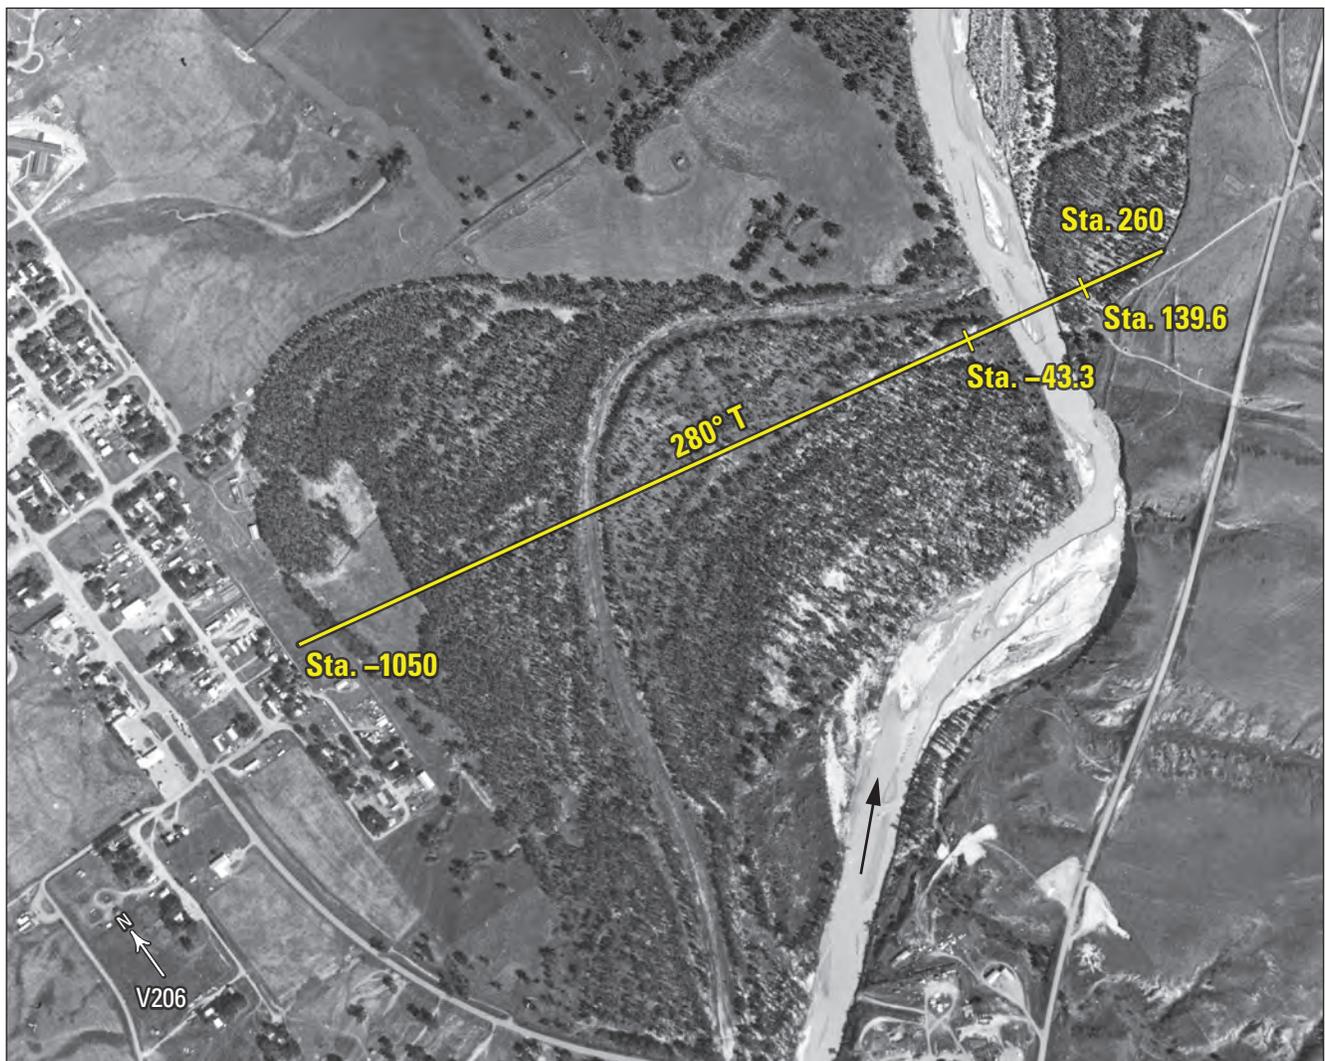
**Figure 1.20.** *A*, Aerial photograph showing reach of Powder River near Broadus, southeastern Montana, location of valley transect V206 (refer to table 2 for Universal Transverse Mercator coordinates) on which overbank sediments were deposited during the flood of May 1978. Arrow indicates direction of flow in the channel. Aerial photograph by Bill Woodcock, Aerial Survey, Inc., Miles City, Mont., September 1978. Sta., station; T, true bearing. *B*, Transect profile showing the thicknesses of sediments deposited along valley transect V206 during the flood of May 1978. Stations 1–100 were resurveyed in 1977 and 1978. Remaining stations in 1978 were either surveyed in 1984, 1991, 2014, or extracted from the Broadus 7.5-minute quadrangle. The 1977 surface was equal to the 1978 surface minus the sediment thickness. *C*, Graph showing thicknesses of sediments for different particle-size classes deposited by the Powder River flood of May 1978 along valley transect V206 as a function of the horizontal distance. Vertical scale has been exaggerated to show details of lateral fining and upward coarsening of particle sizes. *D*, Graph showing particle-size distributions of selected samples of overbank sediment deposited by the Powder River flood of May 1978 along valley transect V206. (Refer to samples listed in table 3 and footnote in table 1.20.)
