# **Bathymetric and Velocimetric Surveys at Highway Bridges Crossing the Missouri River near Kansas City, Missouri, August 8–9, 2023**

By Richard J. Huizinga and Benjamin C. Rivers

Scientific Investigations Report 2026–5124

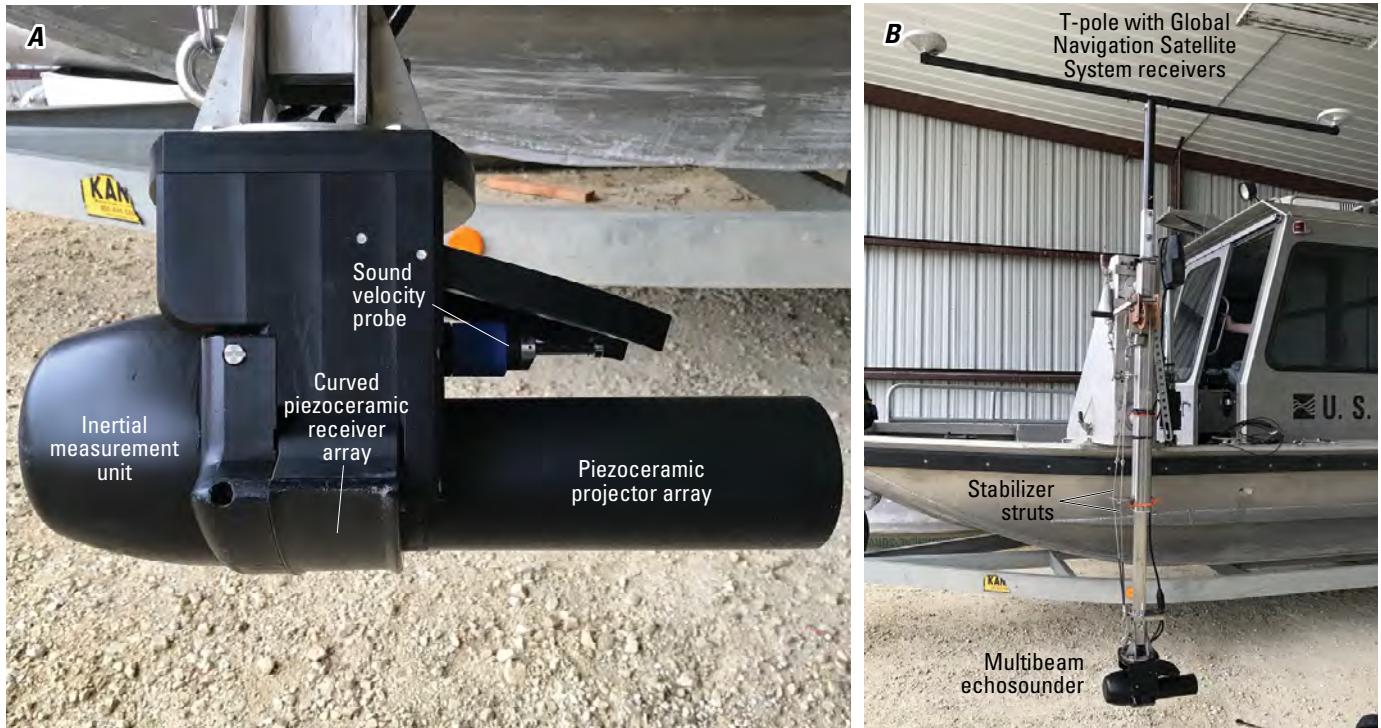
**Figure 3.** Photographs showing the multibeam echosounder (photographs by Richard J. Huizinga, U.S. Geological Survey). *A*, viewed from the side; *B*, viewed as mounted on the port side of the U.S. Geological Survey boat.

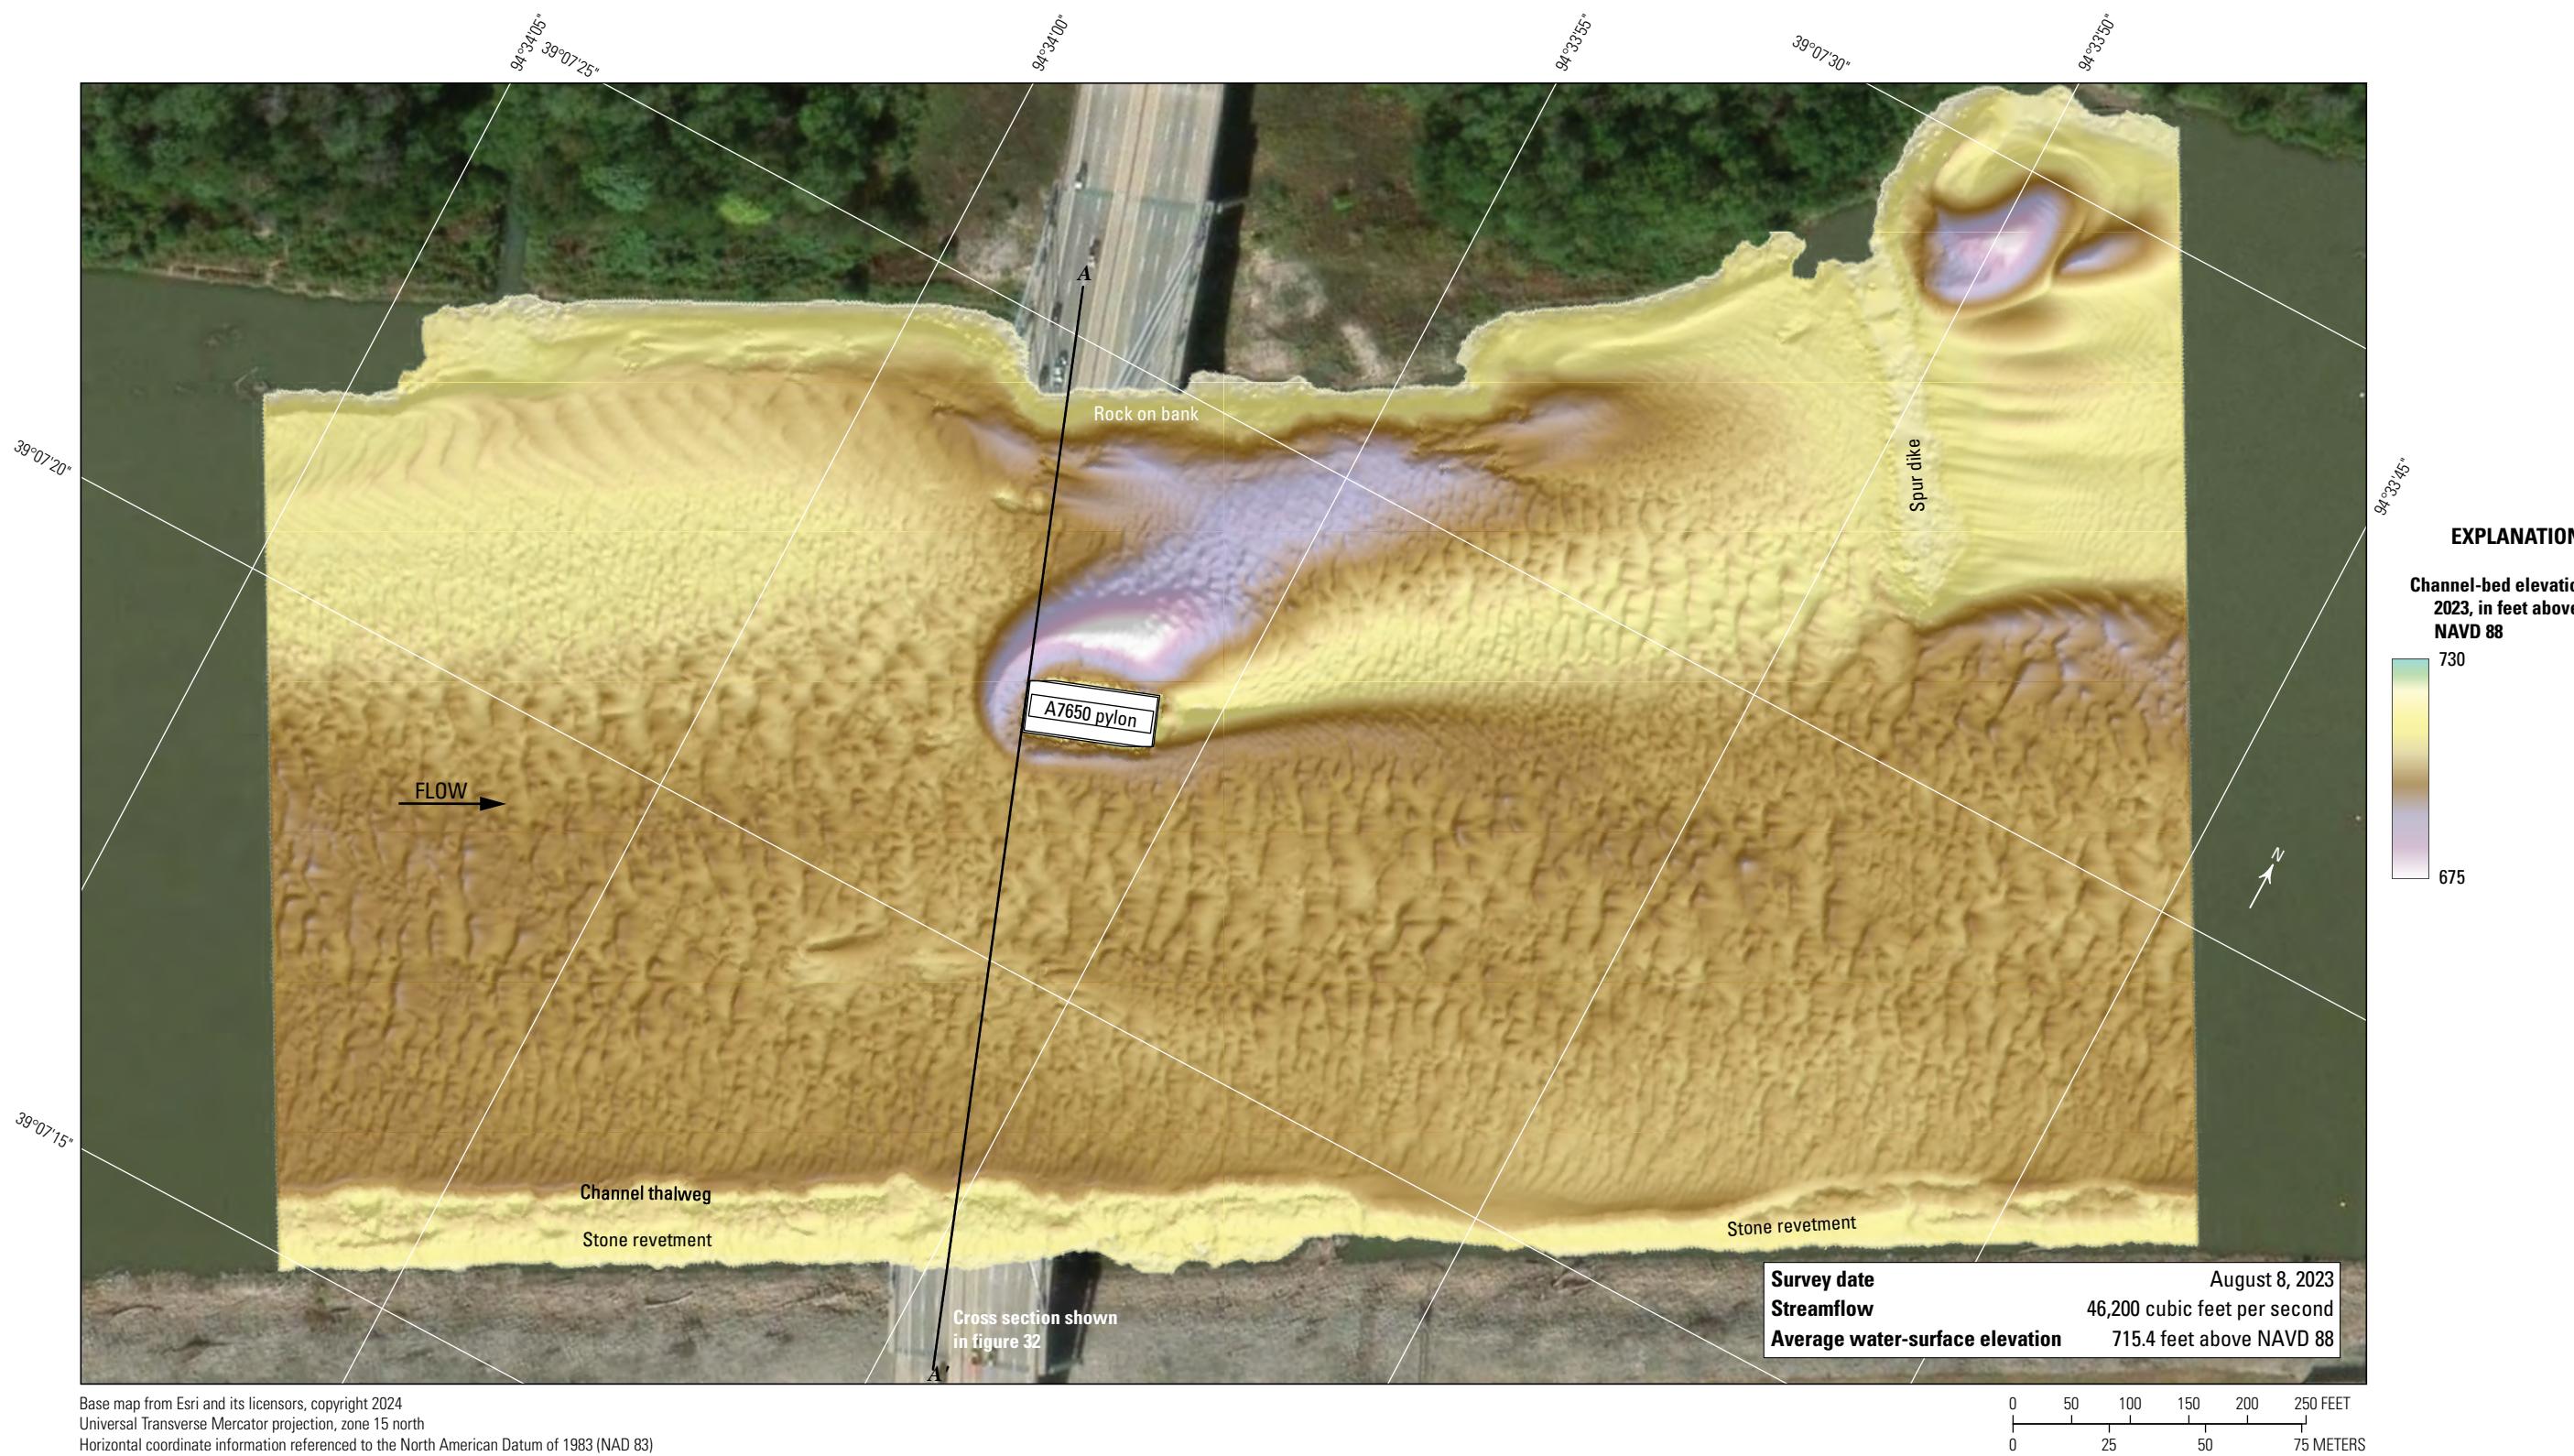
Figure 30. Map showing bathymetric survey of the Missouri River channel near structure A7650 on Interstate 35 in Kansas City, Missouri. [NAVD 88, North American Vertical Datum of 1988]

The survey area was about 1,640 ft long and averaged about 875 ft wide, extending from bank to bank across the main channel ([fig. 30](#)). The upstream end of the survey area was about 700 ft upstream from the centerline of structure A7650 at the main channel pylon ([fig. 30](#)). The channel-bed elevations in 2023 ranged from about 694 to 707 ft in height for most of the surveyed area (5 to 95 percentile range of the bathymetric data; [table 5](#); [fig. 31](#)), except near the pylon and downstream from the spur dikes on the downstream left (north) bank ([fig. 30](#); [table 5](#)). The channel is generally deeper on the right (south) side of the reach, and there is not a well-defined thalweg ([fig. 30](#)). The channel is filled with small dunes and ripples throughout the reach ([fig. 30](#)). As in previous surveys (Huizinga, 2012, 2016, 2022a), a stone revetment was on the right (south) bank throughout the reach ([fig. 30](#)).

Like previous surveys at this site (Huizinga, 2012, 2016, 2022a), the main channel pylon appears surrounded by piles of rock riprap that serve as a scour countermeasure. The local minimum channel-bed elevation is about 679 ft near the downstream left (north) corner of the study area ([table 6](#); [fig. 30](#); [fig. 1.4](#)), which is the minimum channel-bed elevation in the reach at this site ([table 5](#)). Although the pylon is skewed about 15 degrees to approaching flow ([table 6](#)), with impinging flow on the right (south) side, the scour hole is deeper and longer on the leeward left (north) side, likely because of the contraction and deflection of flow from the protrusion on the left (north) bank ([fig. 30](#)). At the upstream face, the scour hole is about 14 ft below the average channel elevation upstream from the pylon ([fig. 30](#), [fig. 1.4](#); [table 6](#)). The top of the riprap around the upstream face of the pylon was at an elevation of about 697 ft, which is slightly below the elevation of the bottom of the pylon seal course of 699.50 ft ([table 6](#)); the top of the riprap along the sides of the pylon is lower than at the upstream face ([fig. 30](#) and [fig. 32](#); [fig. 1.4](#)). The minimum channel-bed elevation near the pylon was about 20 ft below the elevation of the bottom of the pylon seal course ([fig. 30](#); [table 6](#)). Information from bridge plans indicates that the pylon is founded on shafts drilled 32 ft into bedrock, with about 32 ft of bed material between the bottom of the scour hole and bedrock ([fig. 32](#); [table 6](#)).

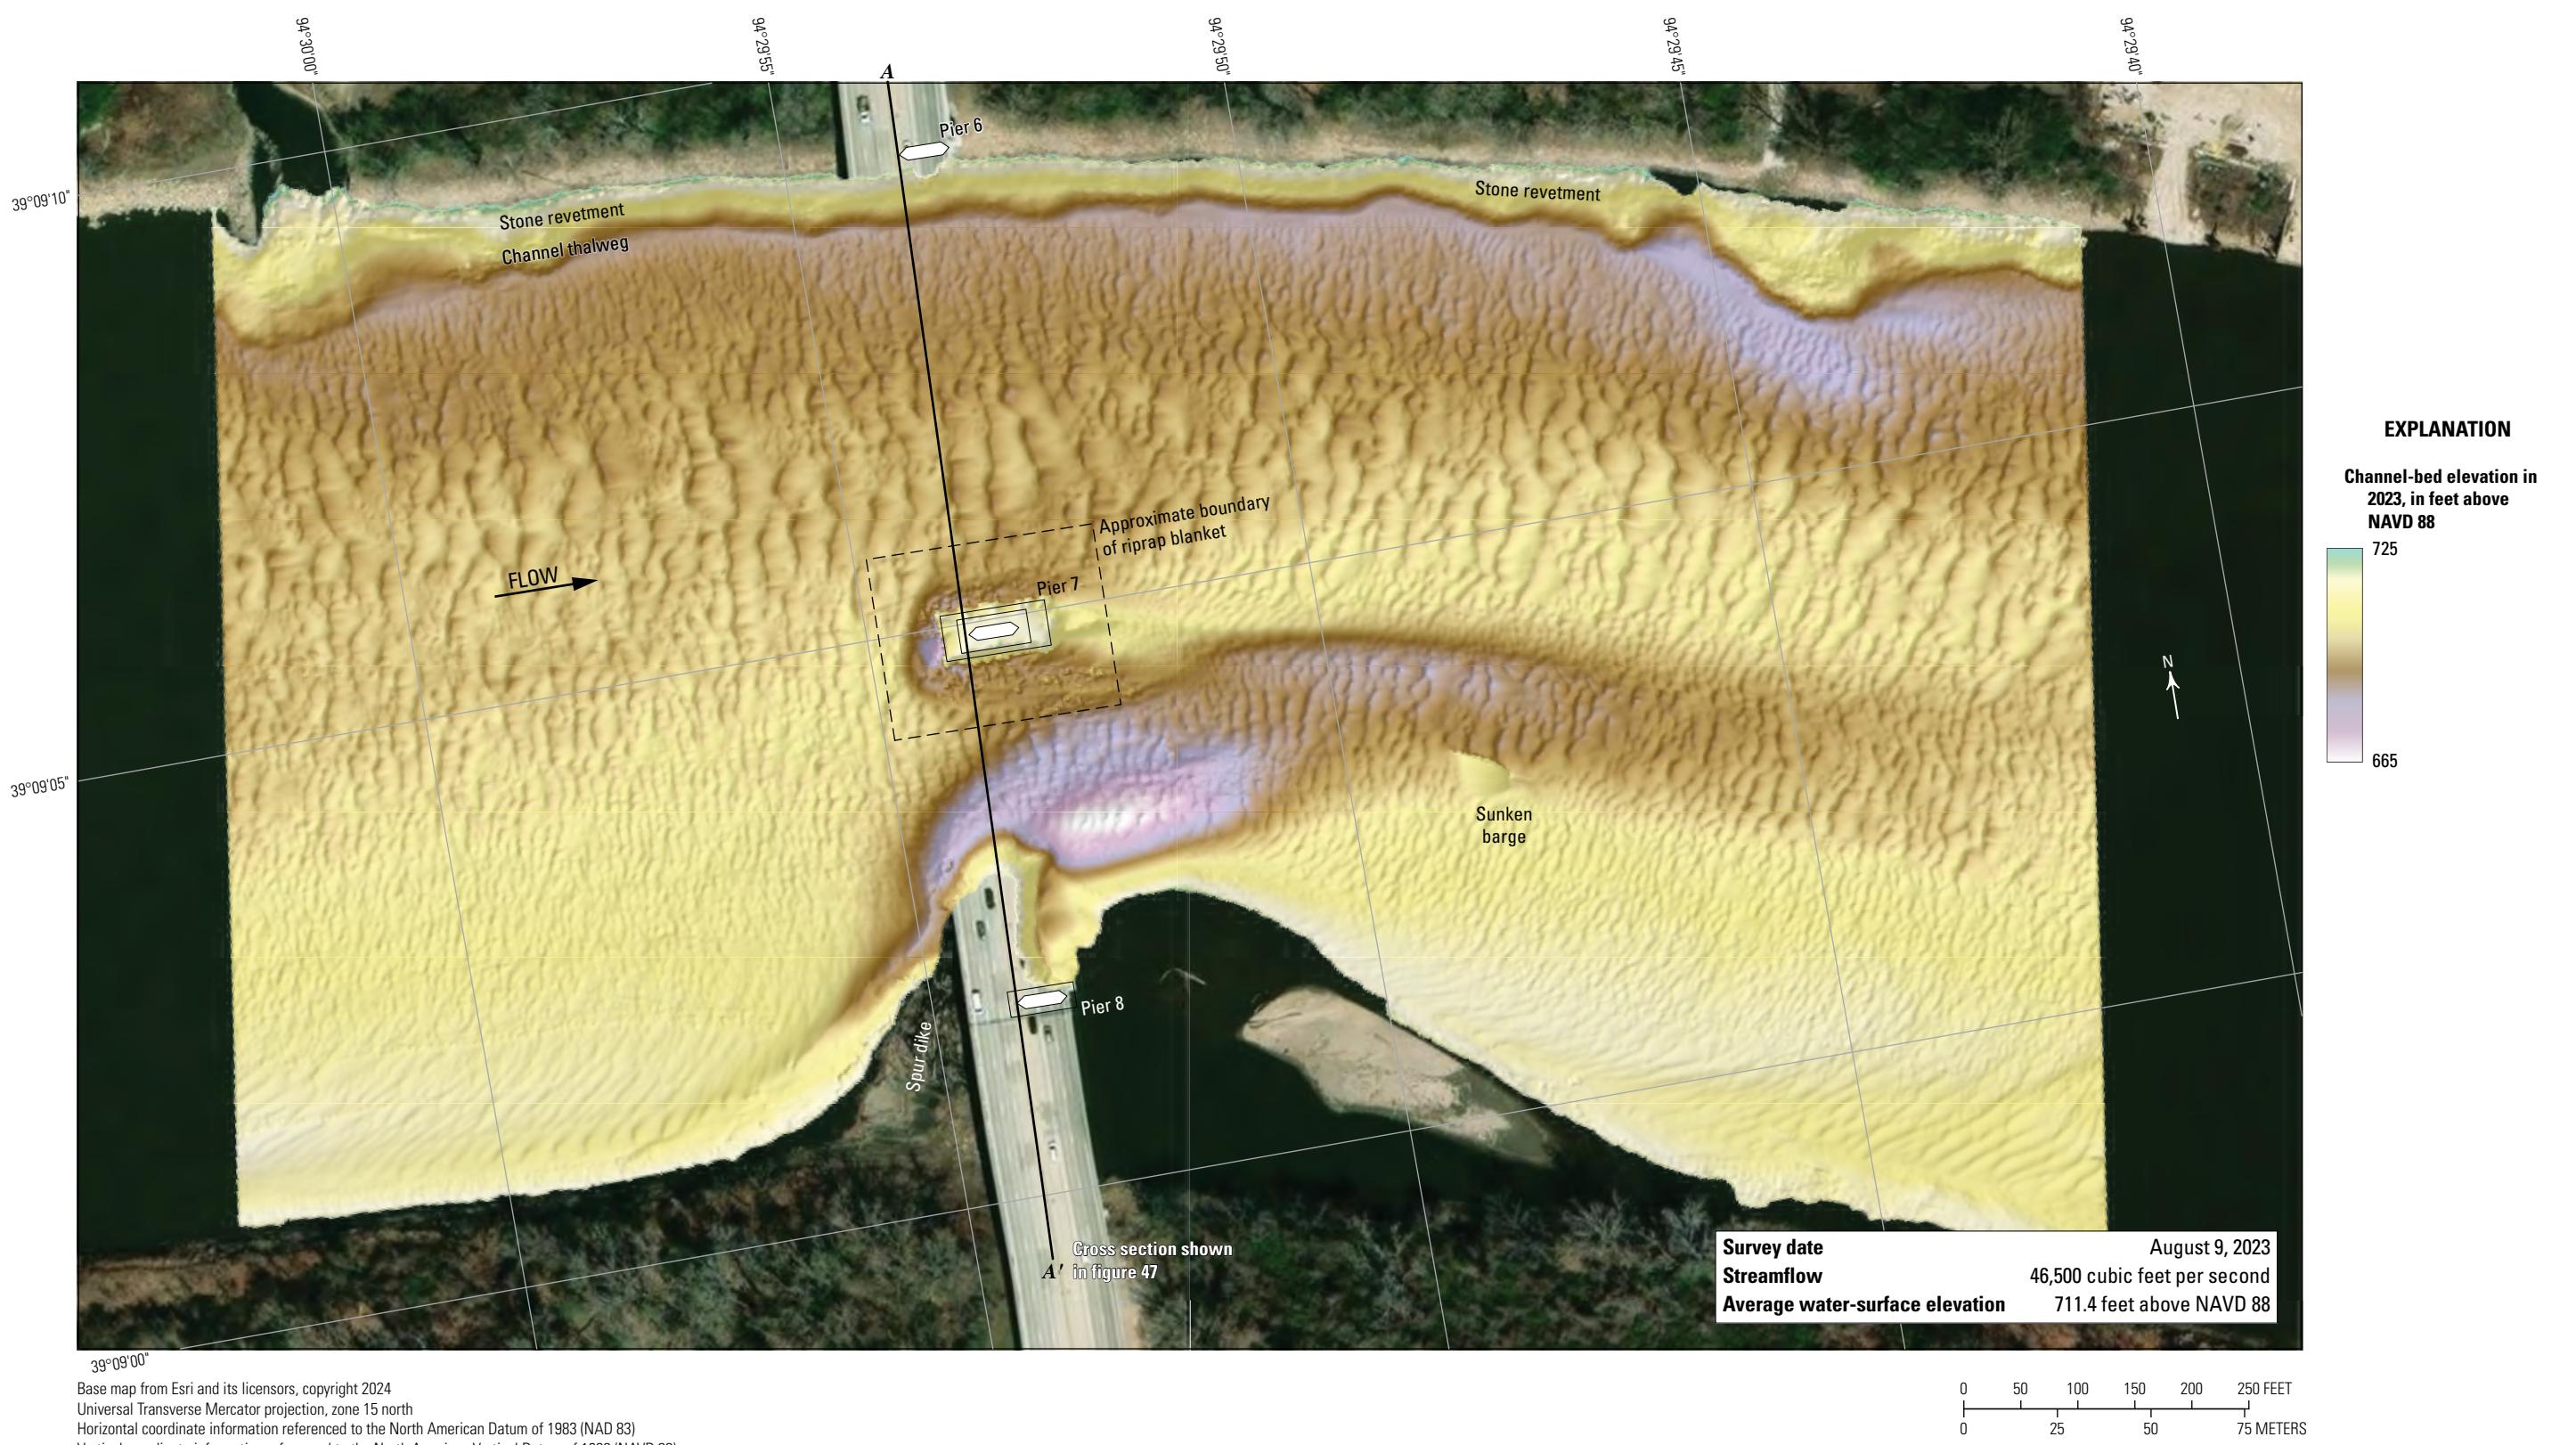
Figure 45. Map showing bathymetric survey of the Missouri River channel near structure A0767 on Interstate 435 in Kansas City, Missouri. [NAVD 88, North American Vertical Datum of 1988]

The survey area was about 1,640 ft long and about 930 ft wide, extending across the active channel from the left (north) bank to the right (south) bank in the main channel ([fig. 45](#)). The upstream end of the survey area was about 660 ft upstream from the centerline of structure A0767 at pier 7 ([fig. 45](#)). Piers 7 and 8 were in the water; however, as in previous surveys (Huizinga, 2010, 2012, 2016, 2020a), pier 8 was immediately downstream from a spur dike and the upstream side of the pier was surrounded by a persistent and substantial debris raft. Furthermore, a persistent sand bar was also downstream from pier 8, as in previous surveys (Huizinga, 2010, 2012, 2016, 2020a), which limited accessibility to that part of the survey area ([fig. 45](#)). The channel-bed elevations in 2023 ranged from about 689 to 704 ft for most of the surveyed area (5 to 95 percentile range of the bathymetric data; [fig. 46](#); [table 5](#)), except downstream from the end of the spur dike on the right (south) bank. A shallow but wide thalweg (about 3 to 5 ft deep and 150 ft wide) was along the left (north) bank throughout the surveyed area, and small dunes and ripples were detected throughout the channel ([fig. 45](#)). As in previous surveys (Huizinga, 2010, 2012, 2016, 2020a), stone revetment and bedrock outcrops were on the left (north) bank throughout the reach ([fig. 45](#)).

The scour hole historically observed at pier 7 was not present in the 2023 survey ([figs. 45, 47](#)). The most recent previous study (Huizinga, 2022a) details how MoDOT installed scour countermeasures in the form of a riprap blanket around pier 7 in 2020, and that blanket is partly evident in the current (2023) survey ([fig. 45](#); [fig. 1.6](#)). A gap in the blanket at the nose of the expanded seal course constructed as part of the countermeasures had a minimum elevation of 682 ft, which is 7 ft below the bottom of the original seal course at that pier ([table 6](#)); however, the elevation of the bottom of the modified seal course was not specified in the plans for the countermeasures (Travis Stump, Missouri Department of Transportation, written commun., 2020), but was implied to be below 675 ft. The upstream end of pier 8 was embedded in the rock spur dike and could not be surveyed because of the persistent, substantial debris raft ([fig. 45](#)). The top of the footing on the downstream end of the pier was partially visible ([fig. 45](#)), but the minimum channel elevation adjacent to the pier footing was about 697 ft, which was about 8 ft higher than the bottom of the seal course elevation of 689.26 ft ([table 6](#)). Information from bridge plans indicates that piers 7 and 8 are founded on shafts drilled 20 ft into bedrock, with about 22 ft of bed material between the bottom of the scour hole

and bedrock at pier 7 and about 49 ft of material between the bottom of the scour hole and bedrock at pier 8 ([fig. 47](#); [table 6](#)). A substantial scour hole was downstream from the end of the spur dike, which contained the minimum channel elevation in the surveyed area of 677 ft ([fig. 45](#); [table 5](#)); however, this hole was more than 50 ft away from pier 8, and substantial alluvial material was between the hole and the pier.
