Final Research Report

## **Assessing and Understanding Trail Degradation: Results from Big South Fork National River and Recreational Area**

**February, 2006**

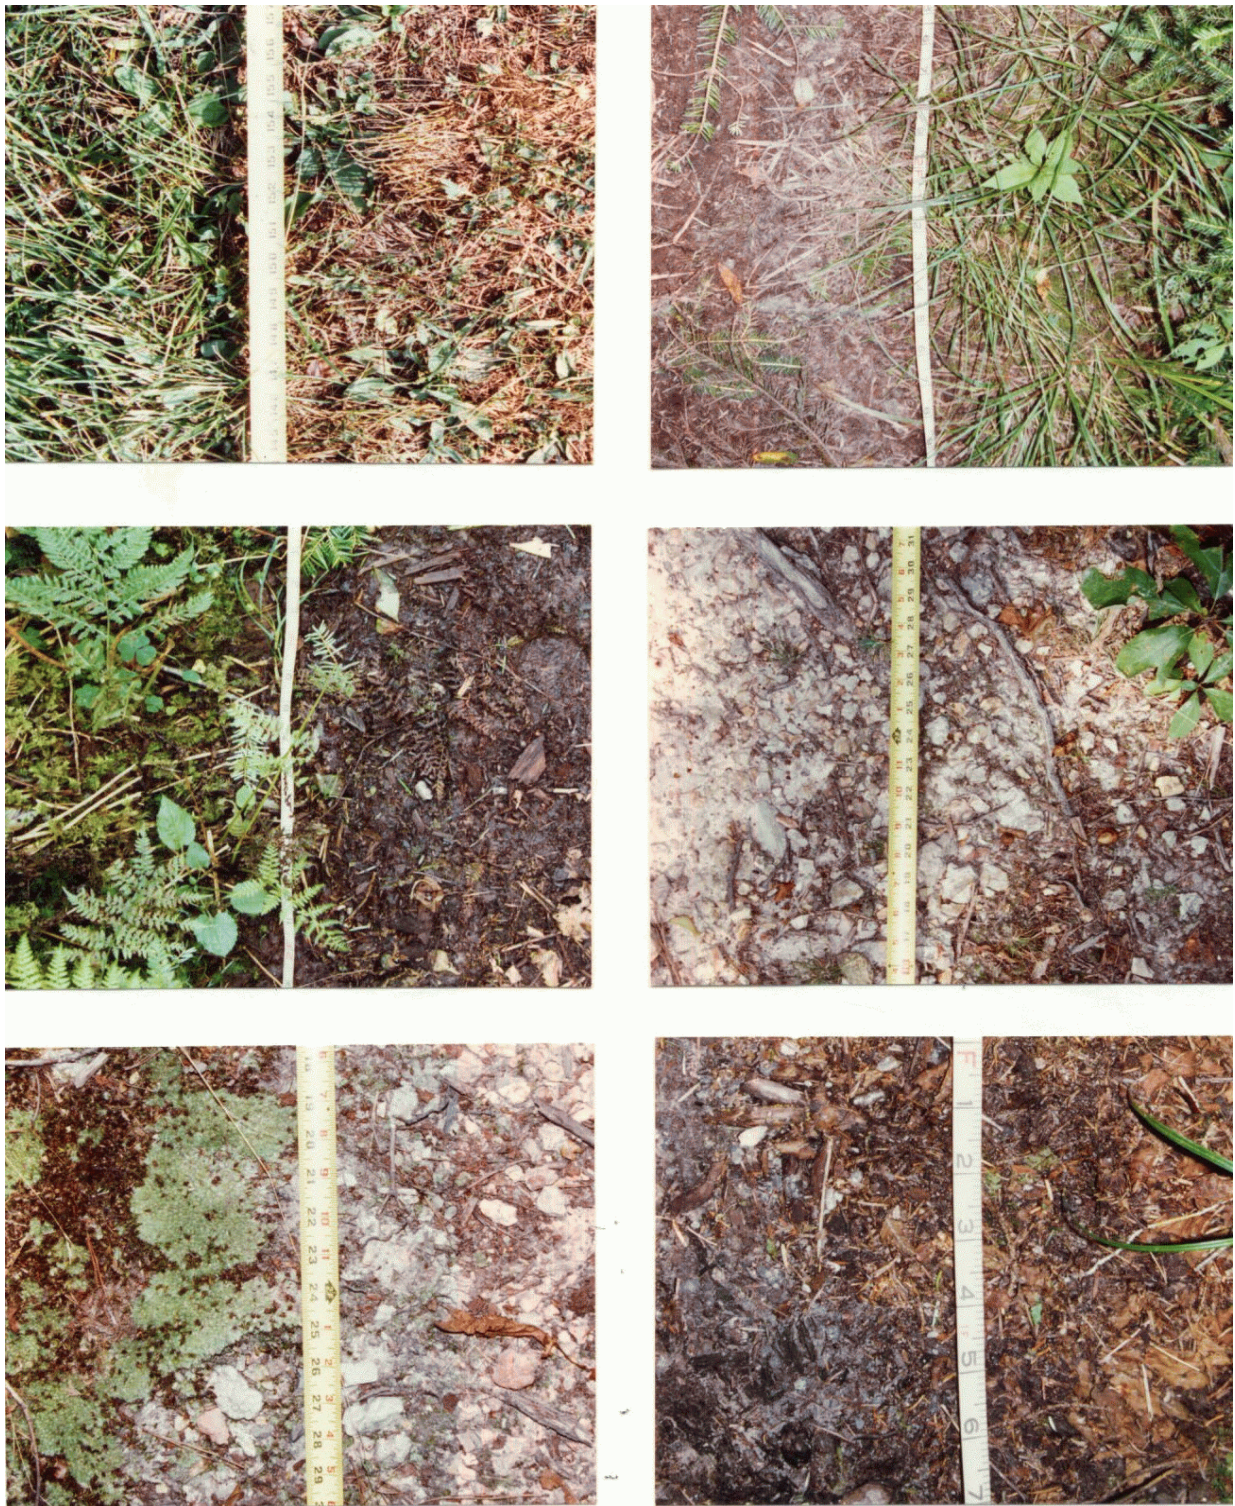
**Figure 1.** Photographs illustrating different types of boundary determinations. Trail tread boundaries are defined as the most pronounced outer boundary of visually obvious human disturbance created by trail use (not trail maintenance like vegetation clearing). These boundaries are defined as pronounced changes in ground vegetation height (trampled vs. untrampled), cover, composition, or, when vegetation cover is reduced or absent, as pronounced changes in organic litter (intact vs. pulverized). The objective is to define the trail tread that receives the majority (>80%) of traffic, selecting the most visually obvious boundary that can be most consistently identified by you and future trail surveyors.
