CHANNEL EROSION SURVEYS ALONG PROPOSED TAPS ROUTE, ALASKA, JULY 1971

CHANNEL EROSION SURVEYS ALONG PROPOSED
TAPS ROUTE, ALASKA, JULY 1971

By
Joseph M. Childers

BASIC-DATA REPORT

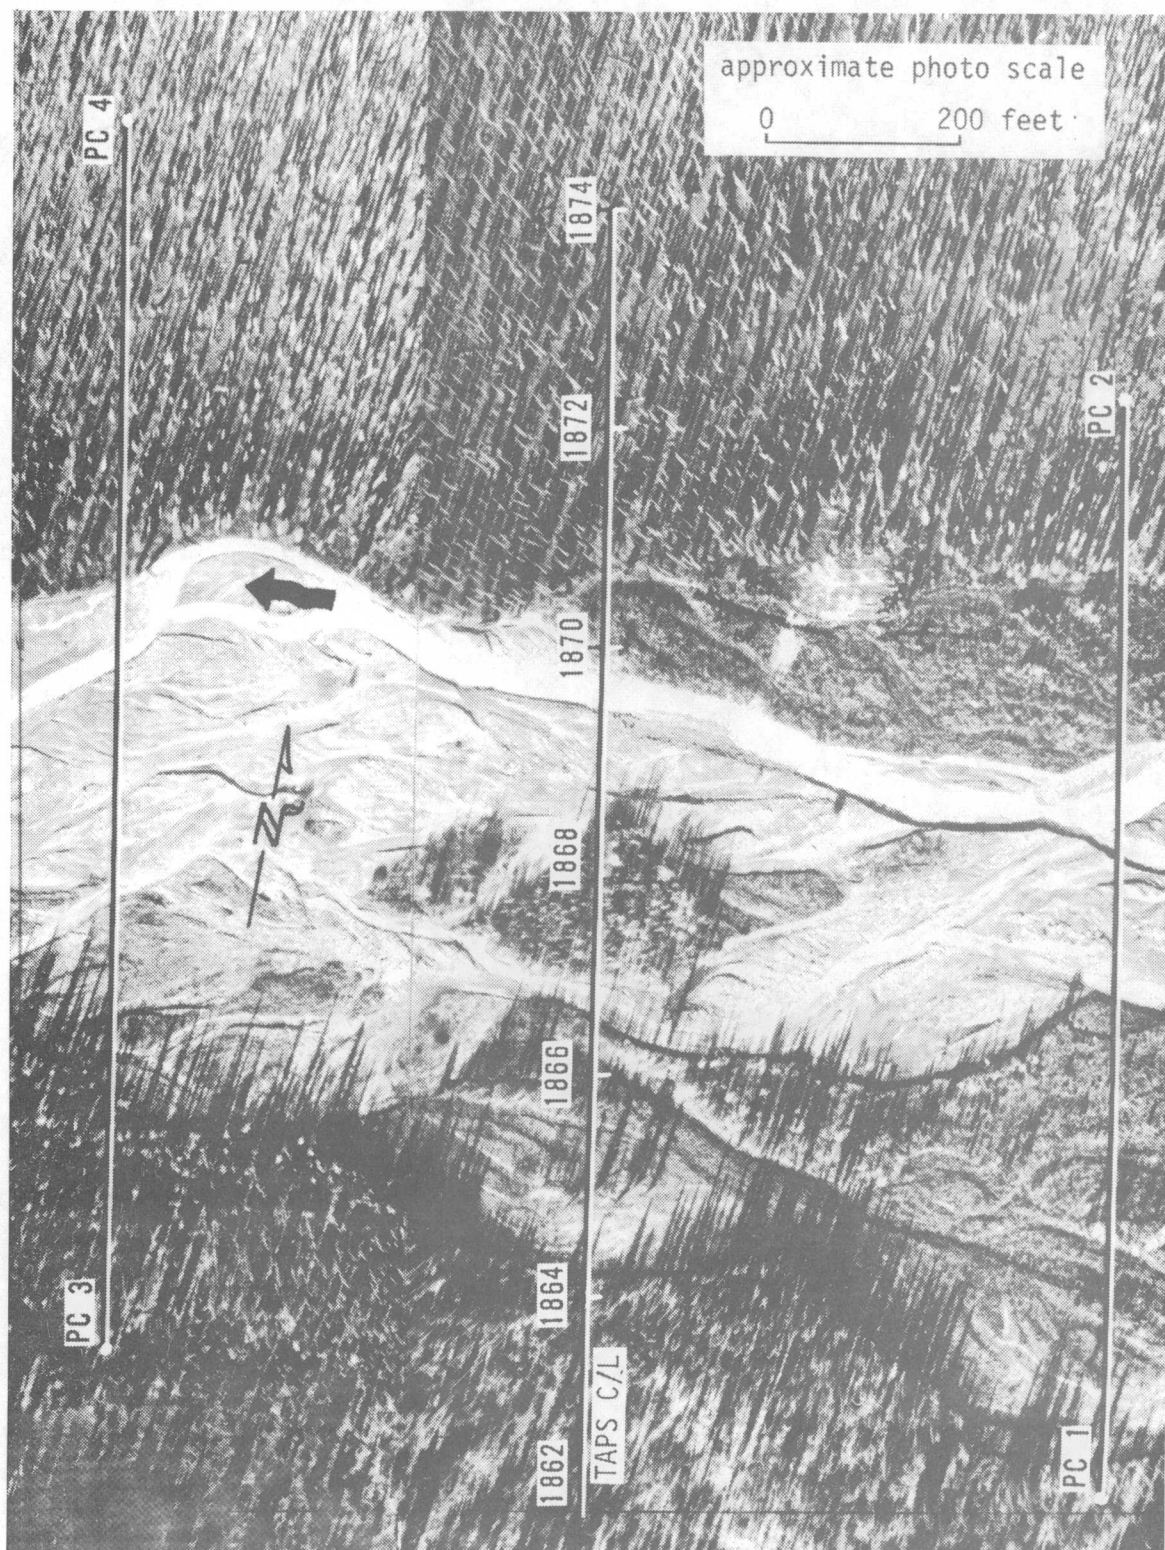
Figure 10.--Aerial photograph - Snowden Creek near Dietrich Camp.

Channel conditions.--Three cross sections were surveyed to define ground elevations in the proposed crossing reach (see aerial photograph (fig. 10) for cross-section locations). The cross sections (fig. 11) and the aerial photograph show the maximum evident floodflow channel to vary greatly through the reach increasing in total width from about 220 feet at the upstream section to about 370 feet at TAPS centerline and 550 feet at the downstream section. Maximum channel depths are about 4 feet.

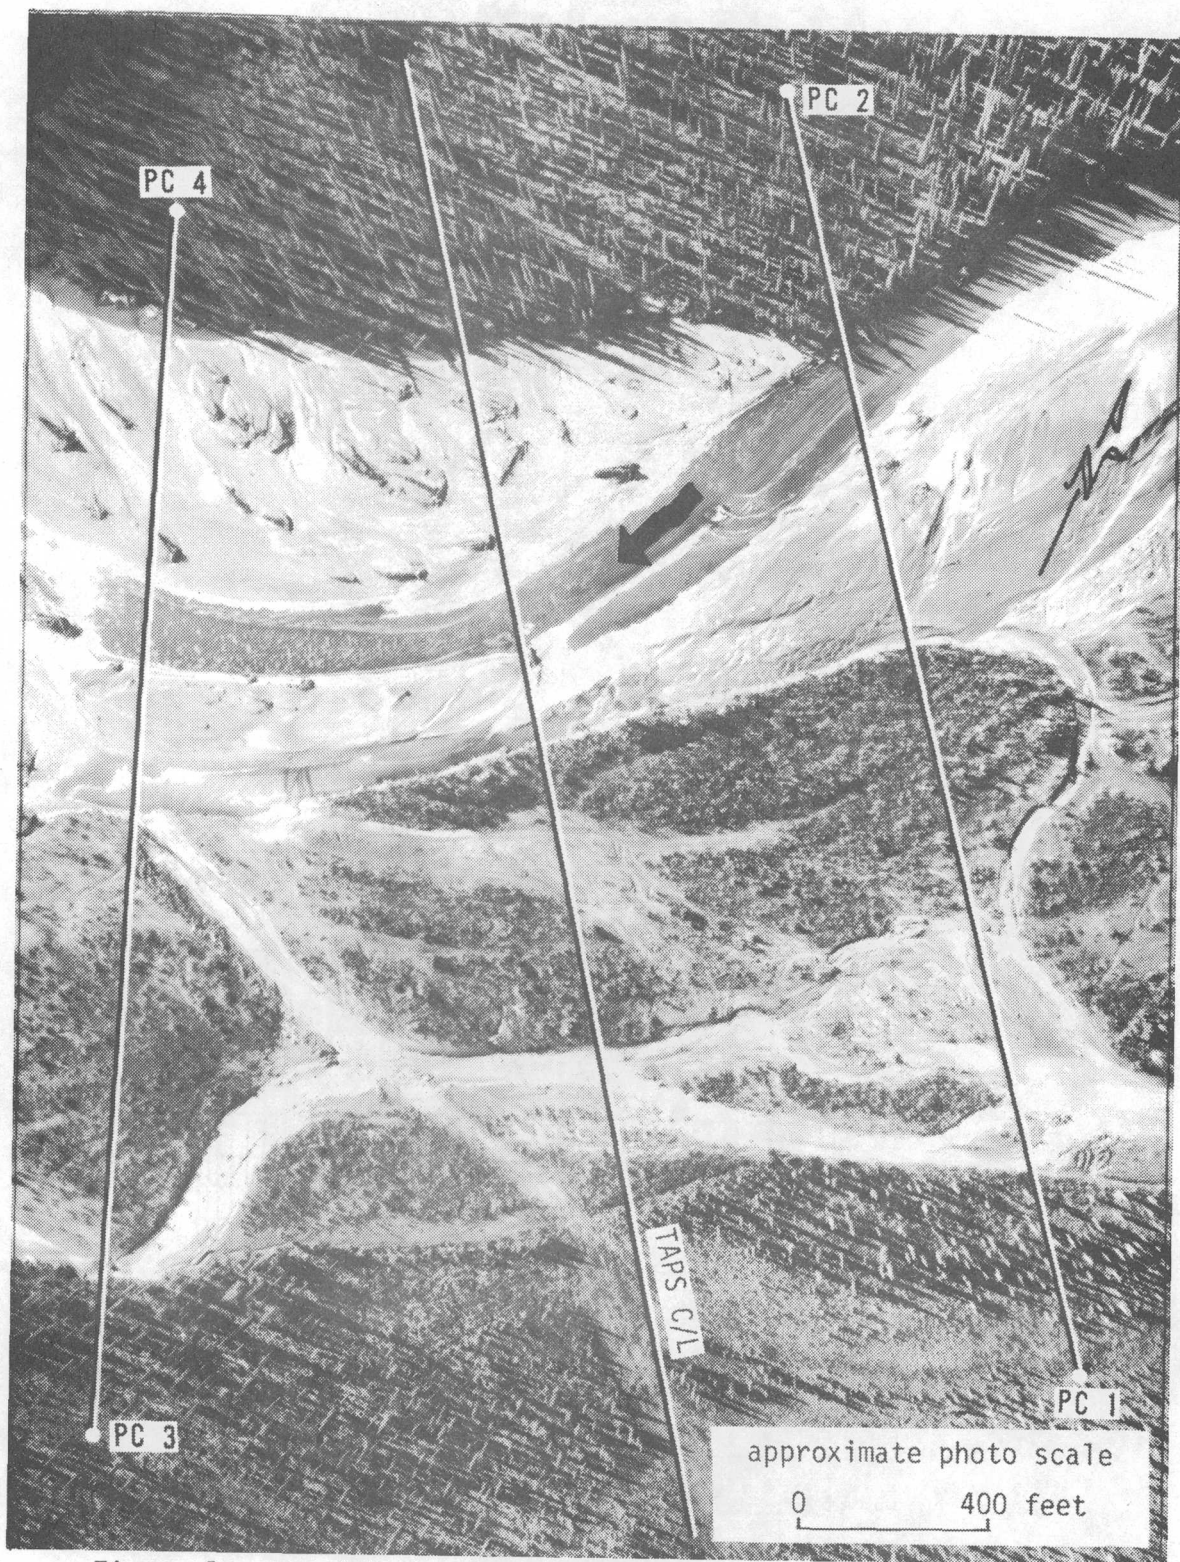
Figure 15.--Aerial photograph - Dietrich River at Bettles River.

Channel conditions.--Three cross sections (fig. 14) were surveyed to define ground elevations in the proposed crossing reach (see aerial photograph (fig. 15) for locations). The cross sections show the maximum evident floodflow channel to be about 750-800 feet wide with the main channel increasing in width from about 270 feet at the upstream cross section to about 450 feet at the downstream section and maximum depths about 8 or 9 feet.

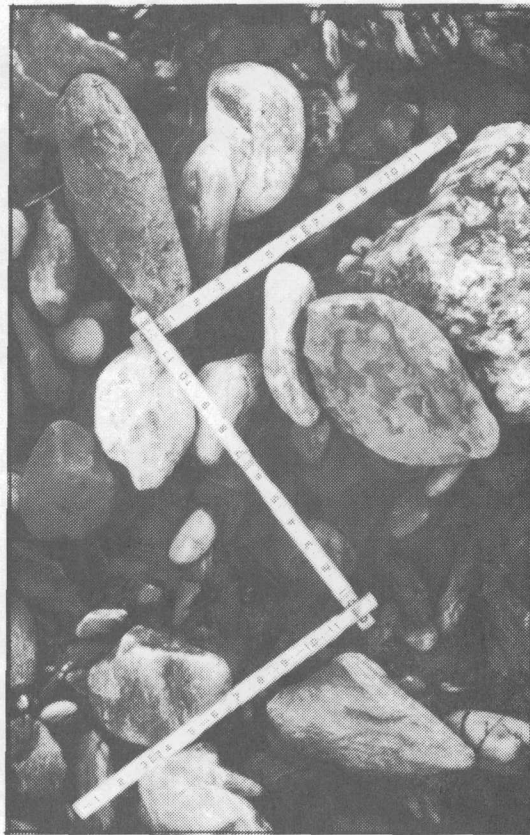
Figure 16.--Streambed material - Dietrich River at Bettles River.

Bed material in the channel varies from silt on the willow-covered flood plains to large cobbles on riffles and upstream sides of point bars. A size distribution for bed material at TAPS centerline and considered reasonably characteristic for floodflow in the main channel is shown in figure 16. A size distribution for flood-plain soil about 1 foot below the surface overlying gravel at the upstream cross section on the willow-covered flood plain is shown in figure 17 and is considered reasonably characteristic of the soil on the flood plains.

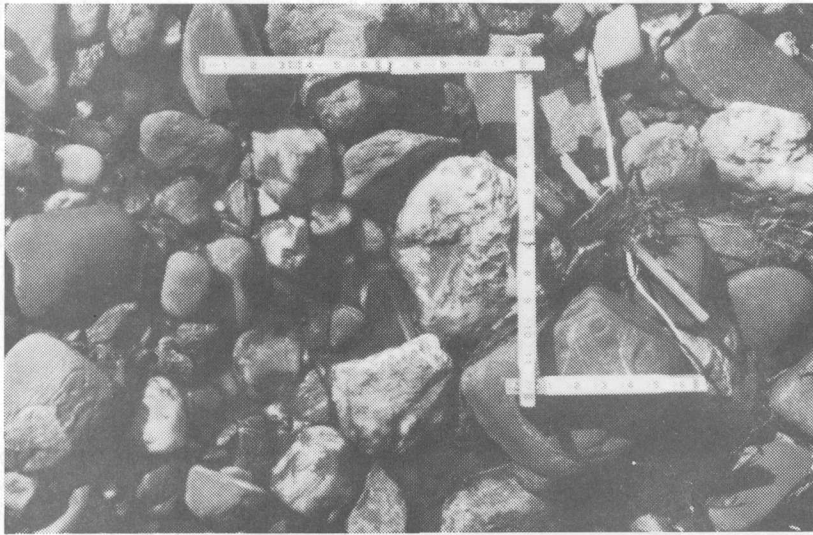
Figure 32.--Streambed material - Middle Fork Koyukuk River near Wiseman.

Bed material in the channel varies from silt on the willow-covered flood plains to boulders on riffles. A size distribution for bed material at the gaging station .25 mile upstream (fig. 32) is considered characteristic for floodflow in the main channel bed. A size distribution for flood-plain soil 2.0 feet below the surface at PC 4 (fig. 33) is considered characteristic of the spruce-covered terraces that form the banks at the crossing. Gravel and cobbles were found below 2.0 feet.

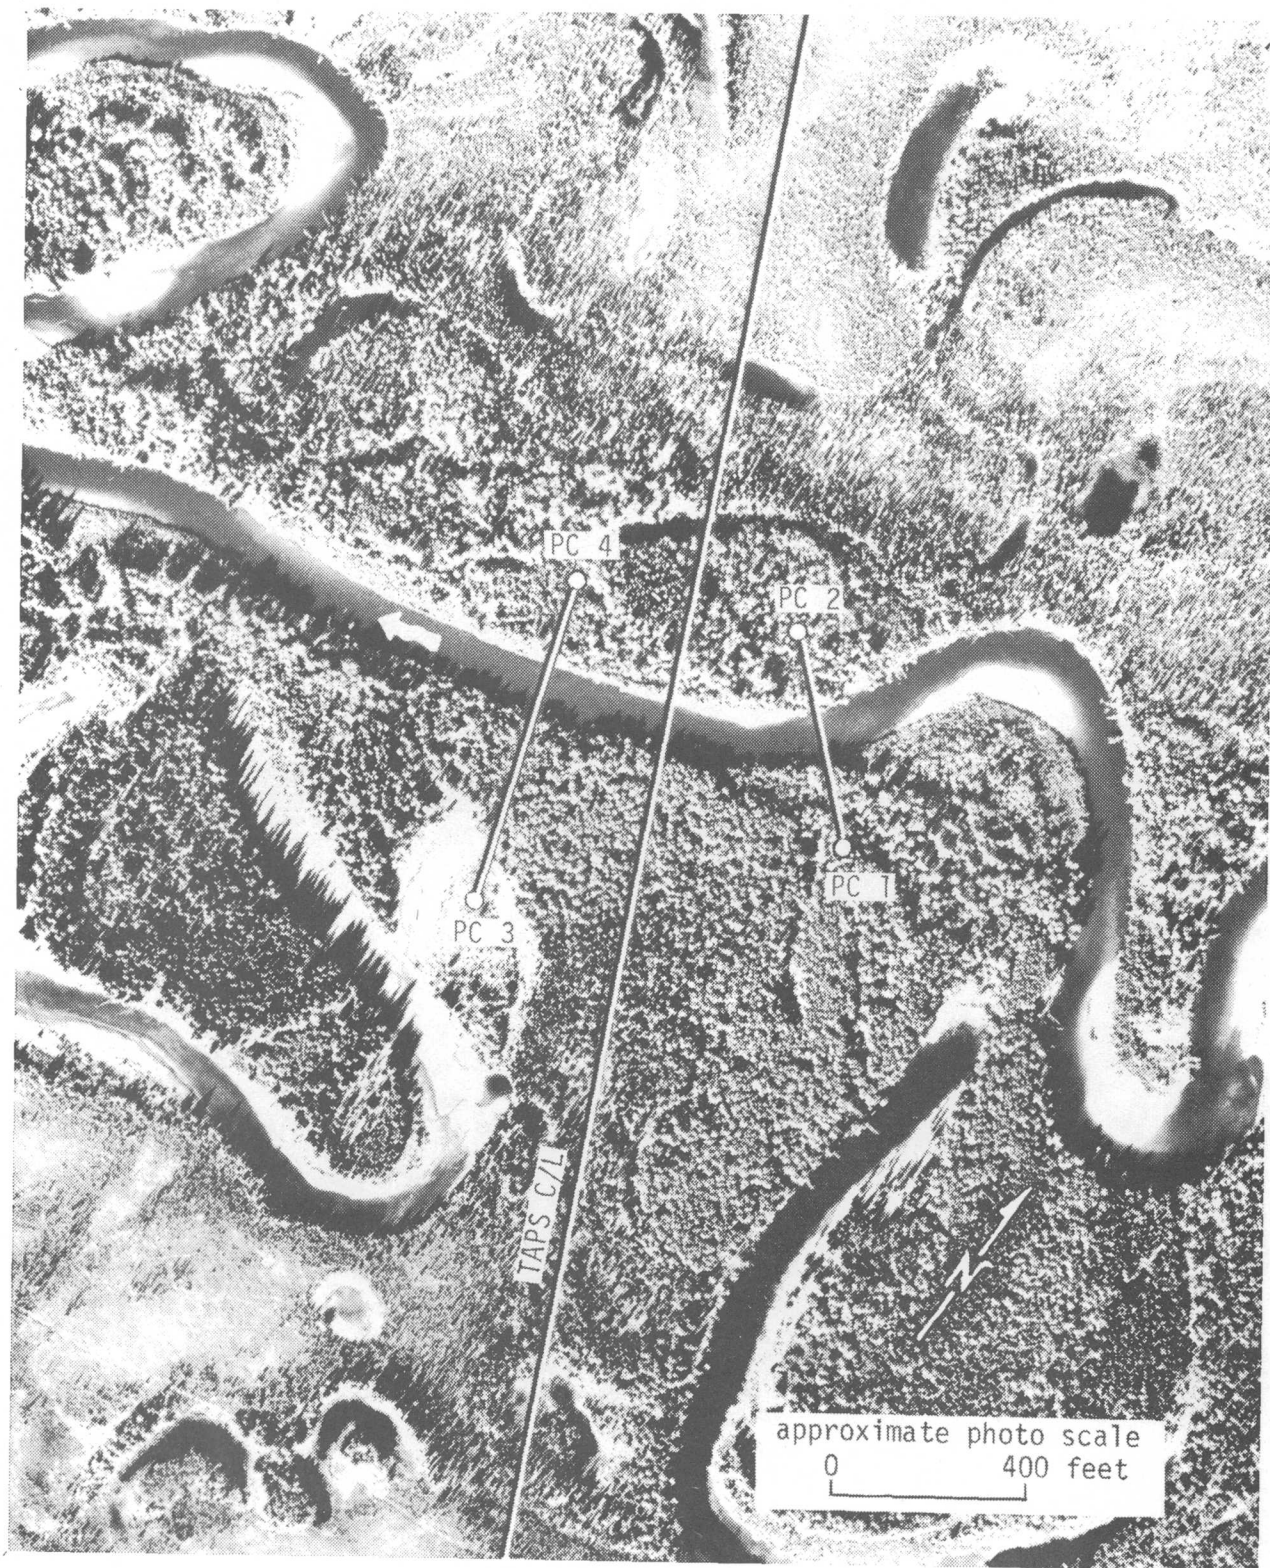
Figure 54.--Aerial photograph - Chatanika River near Olmes.

Channel conditions.--Three cross sections (fig. 53) were surveyed to define ground elevations in the proposed crossing reach (see aerial photograph (fig. 54) for locations). The cross sections show the maximum evident flood overflow on the flood plains beyond the survey bounds, with the main channel about 100 feet wide and maximum depth of 15 feet. The right bank upstream from the crossing is steep and leaning trees indicate recent erosion. Undercutting of the vegetation mat at the site can be seen in figure 55.

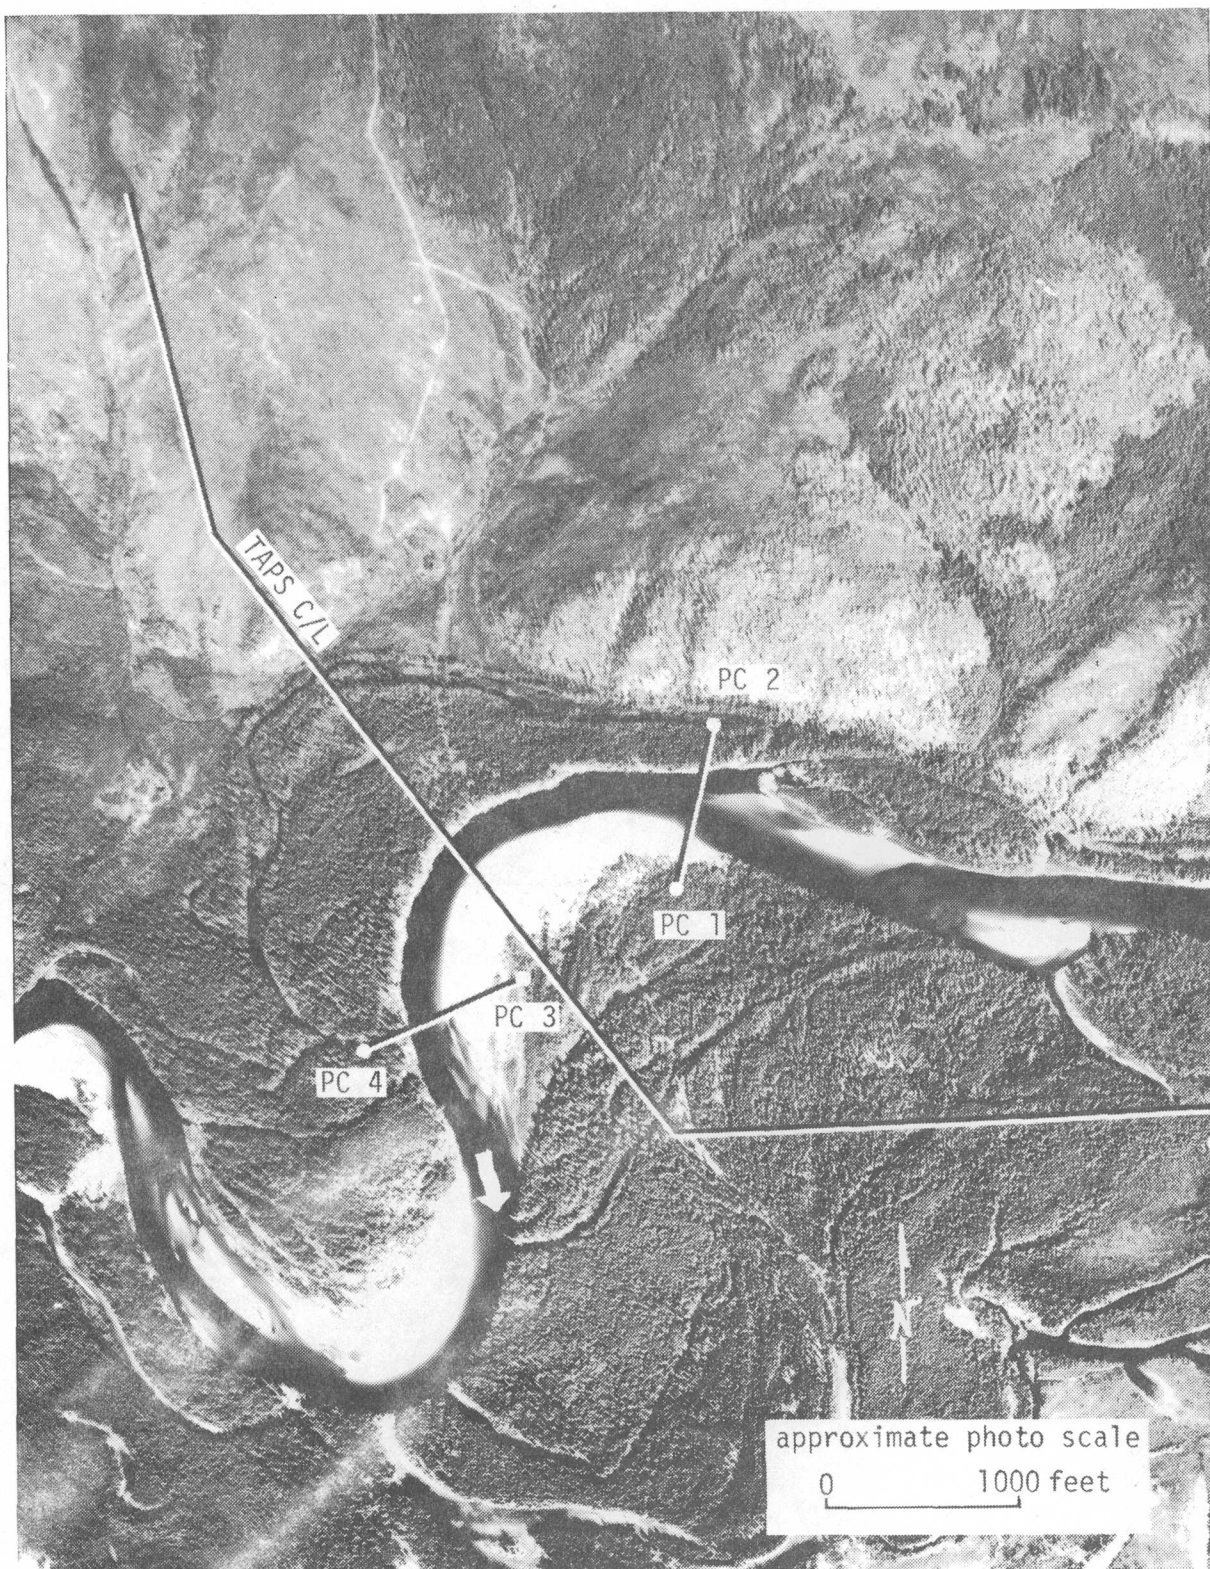
Figure 59.--Aerial photograph - Salcha River near Salchaket.

Channel conditions.--Three cross sections (fig. 58) were surveyed to define ground elevations in the proposed crossing reach (see aerial photograph (fig. 59) for locations). Maximum evident floodmarks were observed over the flood plains throughout the reach. Inadvertently the high-water marks were not surveyed. The right bank is steep, with leaning trees and slumping vegetal mat, at the proposed crossing. Numerous overflow channels cross the tree-covered flood plains. The bankfull channel is about 600-1,000 feet wide with maximum depth about 18 feet. At a site approximately 1.5 miles downstream, the maximum evident flood surface was about 3-4 feet above bankfull.

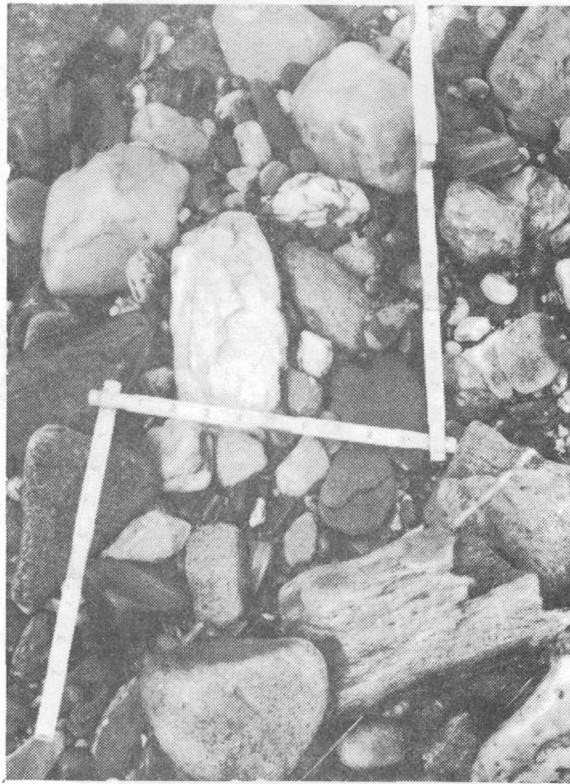
Figure 60.--Streambed material - Salcha River near Salchaket.

A size distribution for bed material on the upstream side of the point bar at the crossing is shown in figure 60. A size distribution for bed material on the downstream side of the bar near PC 3 is shown in figure 61. A size distribution for flood-plain soil 1.5 feet beneath the surface overlying gravel about 100 feet back from the bank near PC 2 is shown in figure 62.
