EARTHQUAKE DAMAGE TO SCHOOLS

U.S. Department of Commerce
National Oceanic and Atmospheric Administration
National Geophysical Data Center
Boulder, Colorado 80303, USA

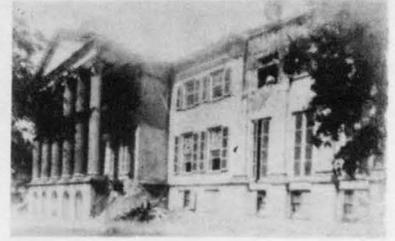
Earthquake of April 18, 1906, San Francisco, California, USA.

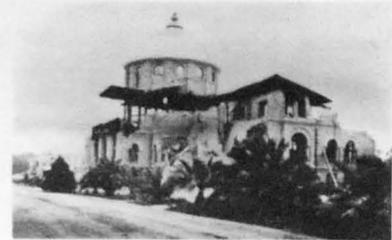
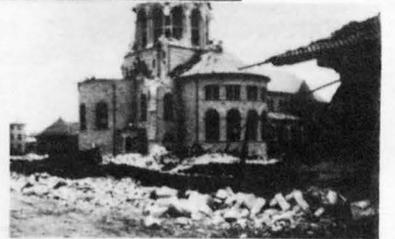
Earthquake of June 27, 1925, Helena, Montana, USA.

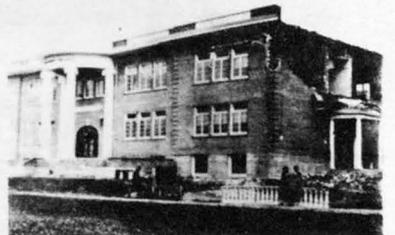
Earthquake of March 10, 1933, Long Beach, California, USA.

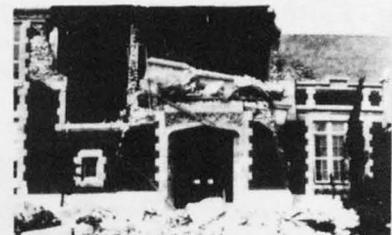
7 Walls crumbled at Alexander Hamilton Jr. High School on State Street. Photo Credit: W.L. Huber.

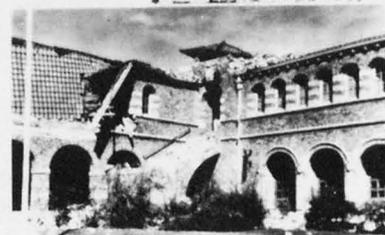
8 The photo shows the west wing of Helena High School that collapsed in the October 31 earthquake. The collapsed part of the school had reinforced concrete frame, floors, and roof, and the tile floors were faced with brick. The greatest amount of damage to a single structure was incurred by this building although it had just been completed only two months prior to the earthquake at a cost of approximately \$500,000. Photo Credit: NOAA/NGDC.

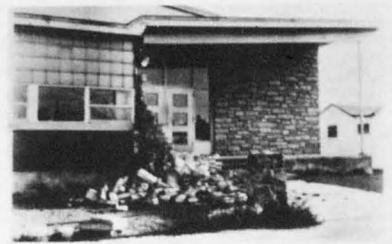
Earthquake of March 27, 1964, Prince William Sound, Alaska, USA. Location: Prince William Sound, southern Alaska; Affected Area: 1,813,000 km²; Damage: \$538 million. The earthquake was one of the most violent ever recorded. In addition to the Government Hill School which was destroyed, the Denali School incurred considerable structural damage. The entire second floor of West High School classroom wing was a total loss. Chugiak and Eagle River elementary schools incurred some damage. Despite widespread destruction, ten of Anchorage's 20 schools reopened on April 6, ten days after the earthquake.

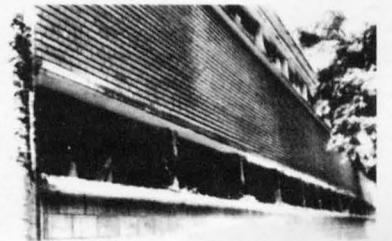
Earthquake of October 3, 1974, Lima, Peru.

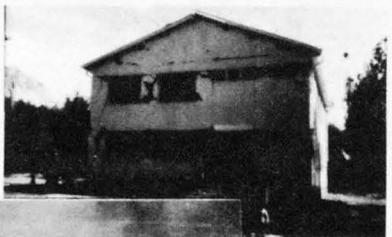
Earthquake of April 9, 1976, Esmeraldas, Ecuador.

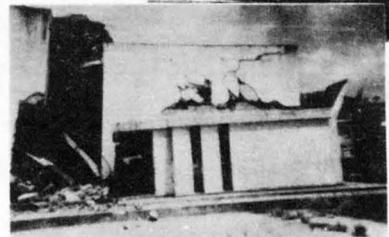
Earthquake of July 27, 1976 Tangshan, People's Republic of China. Location: Northeastern China; Damage: \$5,600 million. The death toll (240,000) was one of largest in recorded history from an earthquake. In addition, around 800,000 were injured. Extensive damage occurred over a wide area.

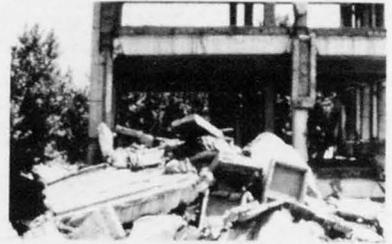
16 Collapse of a classroom and laboratory building at the College Mining Institute. The school was closed when the earthquake occurred, but more than 2,000 students were killed in their dormitories. Photo Credit: Stanford University (J.M. Gere).

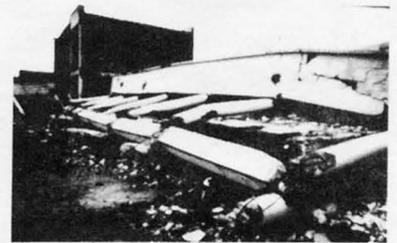
18 This modern school building collapsed at El Asnam. This school is one of 85 that collapsed during the earthquake. The earthquake occurred after school hours, and so no loss of life was sustained at this school. Photo Credit: Stanford University (H.C. Shah).

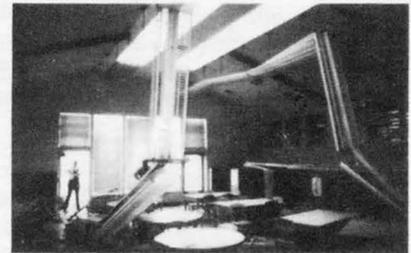
19 Failure of pendant light fixtures in the Dawson Elementary School library would have caused many injuries if the library had been occupied. The light fixtures were hung end to end. Photo Credit: Earthquake Engineering Research Institute.
