# **EARTHQUAKE DAMAGE TO TRANSPORTATION SYSTEMS**

**U.S. Department of Commerce  
National Oceanic and Atmospheric Administration  
National Geophysical Data Center  
Boulder, Colorado 80303, USA**

# Earthquake Damage to Transportation Systems

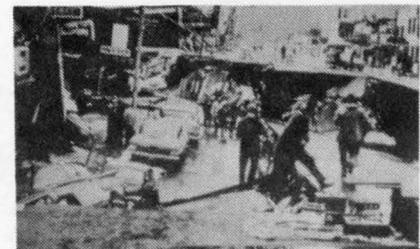
## 4-[DAMAGE CAUSED BY GROUND FAILURE]

This view of Fourth Avenue in downtown Anchorage shows the damage to the street and buildings resulting from the landslide. There was 3.3 m of subsidence and 4.2 m of horizontal movement. Two and one-half blocks of shops, bars, and stores slowly settled until their entrances were below street level. The landslide was induced by a combination of loss of strength in sensitive (quick) clay layers and liquefaction of sand and silt lenses. Photograph credit: Earthquake Engineering Research Institute.

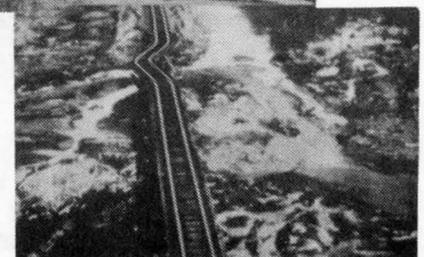
## 5-[DAMAGE CAUSED BY GROUND FAILURE]

This aerial view shows the effects of compression by movement of unconsolidated stream bank material on the railroad. Longitudinal compression dislodged the wooded railroad bridge superstructure from the substructure. Two and one-half years and \$22 million were required to repair the damage to the railway system. Photograph Credit: University of Colorado.

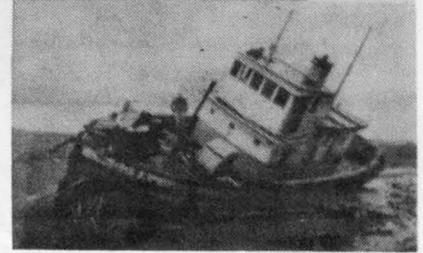
#### 8-[TSUNAMI DAMAGE]

This photo shows a beached fishing boat in the Seward area. The tsunami waves severely damaged many boats and washed them into the lagoon north of Seward and onto the tidal flats at the head of Resurrection Bay. Dock and harbor facilities were destroyed. A section of the waterfront about 1,060 m long, including the docks and the small boat harbor, slid into Resurrection Bay. Photograph credit: University of Colorado.

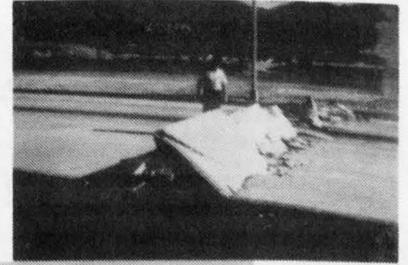
#### 11-[DAMAGE CAUSED BY FAULTING]

This photograph shows freeway compression of about 67.5 cm that occurred south of the Interchanges of Routes 5 and 210. Structural damage to highways and bridges centered in an area north of San Fernando. This area included the Route 5/210 Interchange and the Route 5/14 Interchange which are about 1.7 km apart along Route 5 and about 10 km from the earthquake epicenter. Photograph credit: NOAA/NGDC.

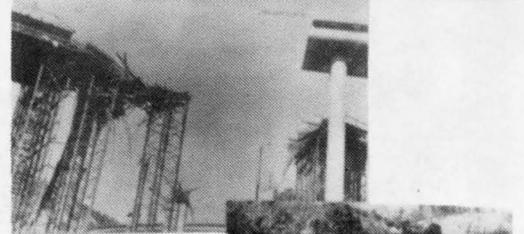
#### 12-[DAMAGE CAUSED BY VIBRATION]

Among the most spectacular damage was the collapse of freeway overpasses such as the one shown here that was under construction at the time of the earthquake. At the Route 5/210 interchange (Foothill Boulevard and Golden State Freeway,) three highway overpasses totally collapsed and two required rebuilding. Two men were killed at this location when one of the overpasses collapsed smashing their truck. Photograph credit: J.R. Evans.

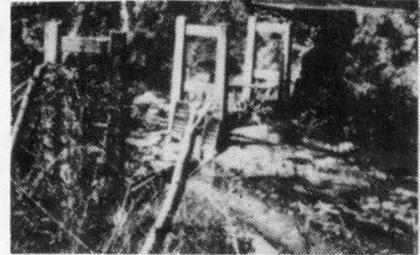
#### 13-[DAMAGE CAUSED BY FAULTING]

The picture is looking north along railroad tracks that were twisted and offset 107 cm by the Motagua fault, which is perpendicular to the tracks. This is one of numerous localities along the main railroad line between the coastal port of Puerto Barrios and Guatemala City disrupted by the faulting. Photograph credit: U.S. Geological Survey.

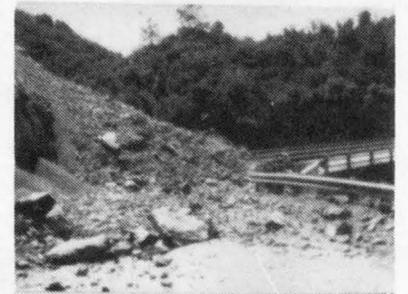
#### 15-[DAMAGE CAUSED BY GROUND FAILURE]

A landslide blocked the highway and bridge on Dunne Avenue at the east side of Cochrane Bridge. The bridge on East Dunne Avenue over Anderson Reservoir (about 7.2 km east of Morgan Hill) was closed to traffic due to a rock slide and major structural damage. Photograph credit: U.S. Geological Survey.

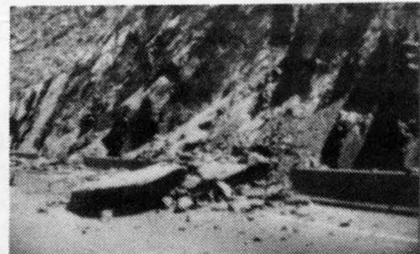
#### 16-[DAMAGE CAUSED BY GROUND FAILURE]

A rockfall and debris slide has partially blocked the highway. Photograph credit: Bay Area Regional Earthquake Preparedness Project.

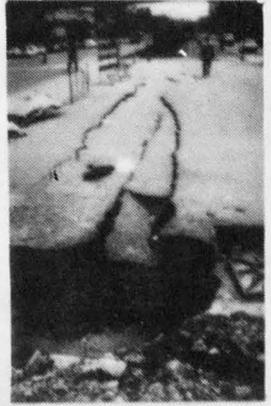
**17-[DAMAGE CAUSED BY GROUND FAILURE]**

Vibration caused failure of the subsoils and subsidence which resulted in the collapse of streets. This type of damage was particularly prevalent in Mexico City since much of the city is located on unconsolidated lake-bed sediments. These soft sedimentary clay deposits amplified the seismic waves and resulted in ground failure. Photograph credit: Munchener Ruck, Munich Re.

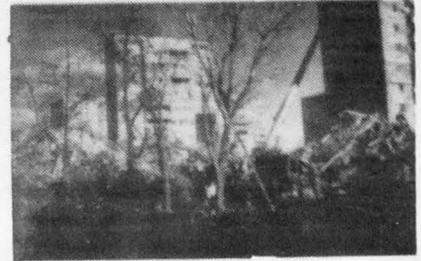
**18-[DAMAGE CAUSED BY VIBRATION]**

The ground shaking resulted in the partial or total collapse of buildings in Leninakan and filled the streets with debris making them impassible. The heavy equipment needed to lift off heavy sections of buildings to free survivors had difficulty getting to the sites. Photograph credit: U.S. Geological Survey (C.J. Langer).
