FLOODS IN THE GUAYANILLA-YAUCO AREA, PUERTO RICO.
1969.

UNITED STATES
DEPARTMENT OF THE INTERIOR
GEOLOGICAL SURVEY

FLOODS IN THE GUAYANILLA-YAUCO AREA,

Open-file Report

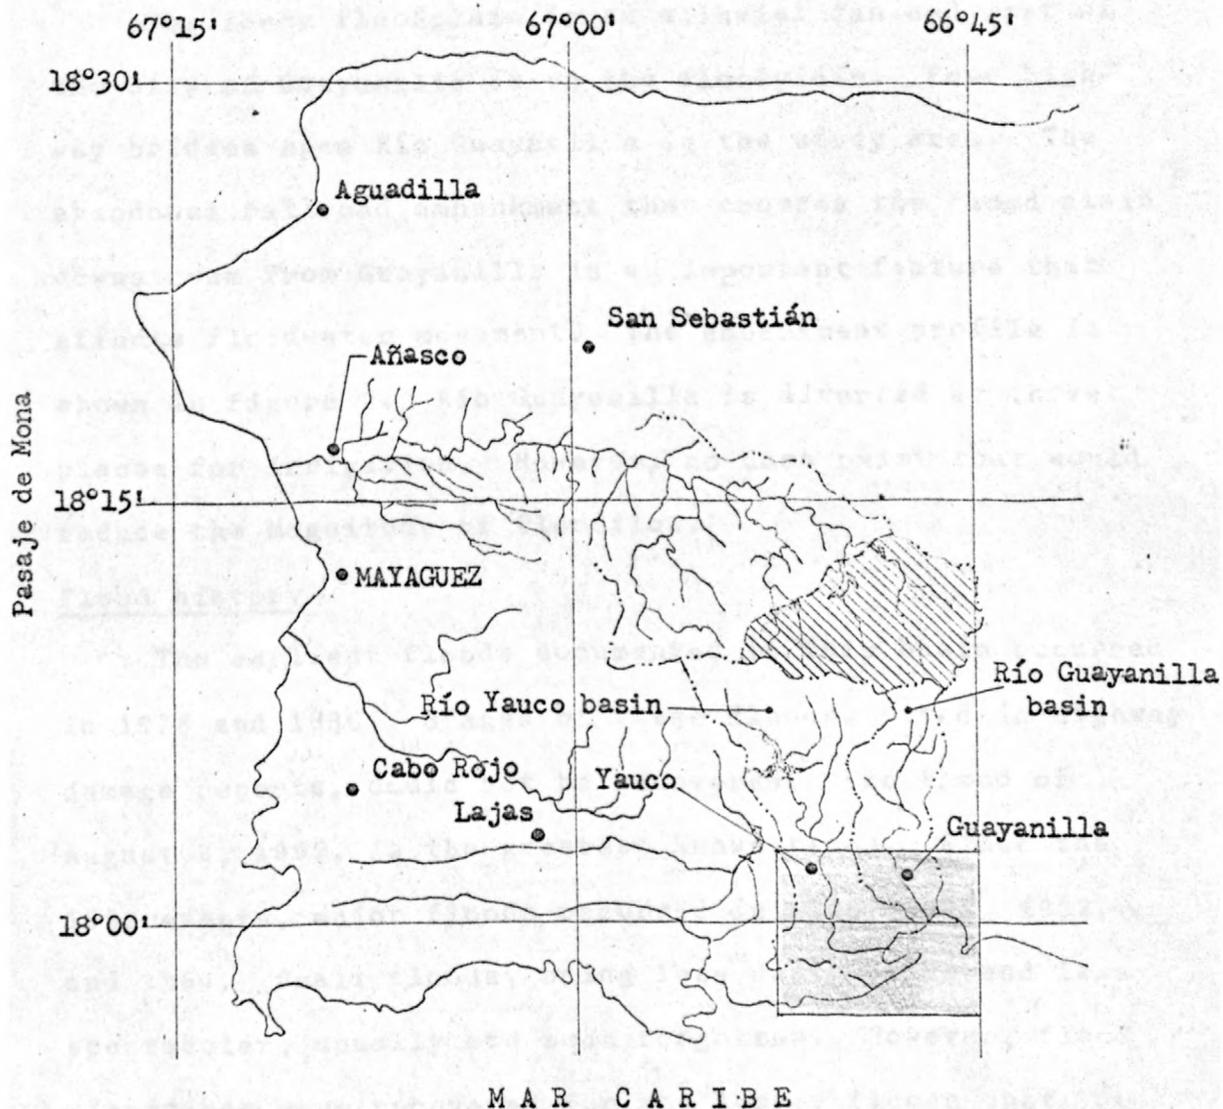
Figure 1. Location of Río Guayanilla and Río Yauco drainage basins.

The Río Guayanilla basin is the easterly basin of the study area shown in the location sketch, figure 1. It has a drainage area of 18.5 square miles at the U.S. Geological Survey gaging station 2.4 kilometers north of Guayanilla, and 20.8 square miles at the upstream Highway PR-2 bridge (of three Highway PR-2 bridges across Río Guayanilla). The total drainage area of the basin is about 31 square miles.

The Río Yauco basin is the westerly basin shown in the location sketch, figure 1. The drainage area of the basin at Escuela Arturo Lluberas, 1.3 kilometers northwest of Central San Francisco, is 45.5 square miles. The total drainage area of the basin is about 48 square miles. These areas include that part of the basin upstream from Antonio Lucchetti Dam.

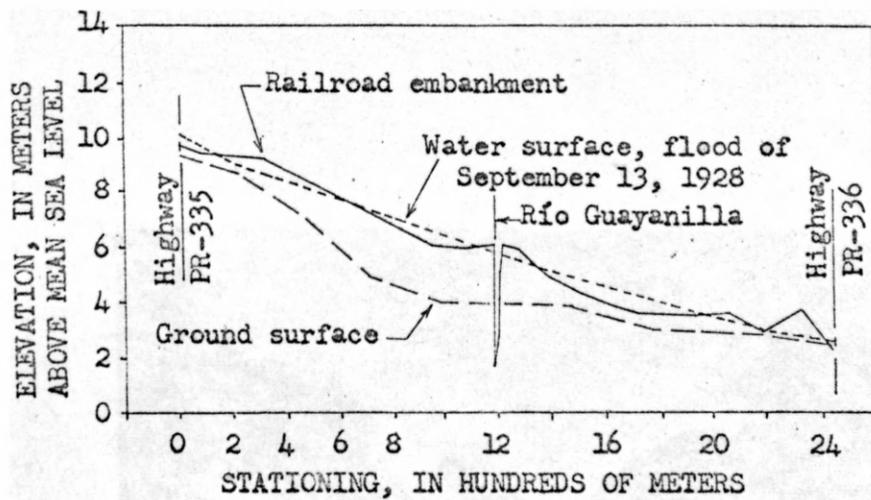
Figure 2.--Profile of abandoned railroad embankment between Highways PR-335 and PR-336.

The lower floodplain is an alluvial fan and most of the city of Guayanilla is on the floodplain. Four highway bridges span Río Guayanilla in the study area. The abandoned railroad embankment that crosses the flood plain downstream from Guayanilla is an important feature that affects floodwater movement. The embankment profile is shown in figure 2. Río Guayanilla is diverted at three places for irrigation. However, no dams exist that would reduce the magnitude of floodflow.

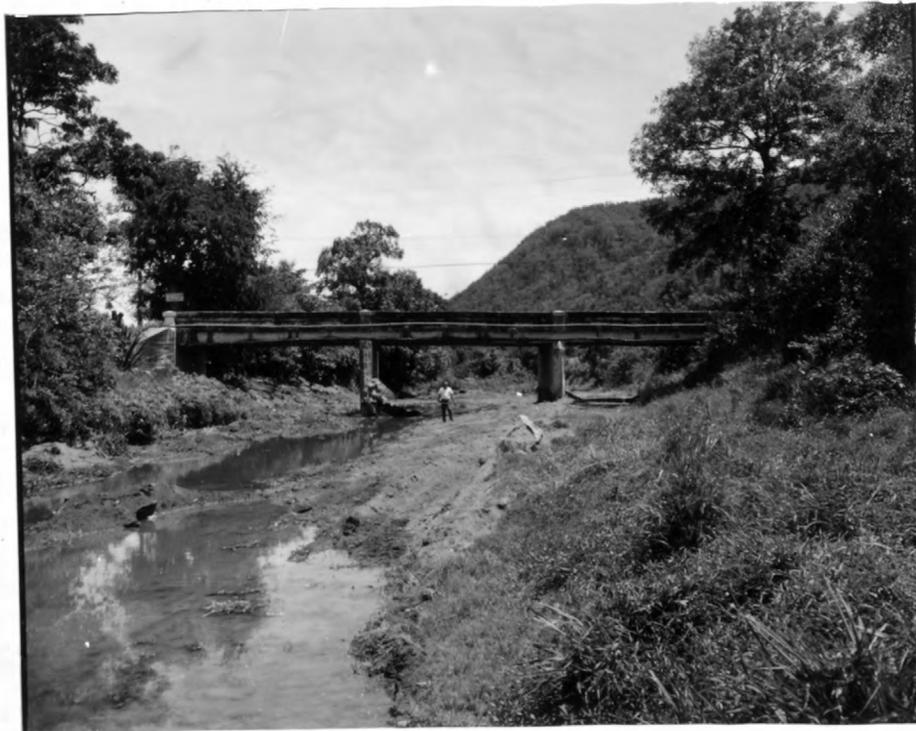
Figure 3.--Upstream Highway PR-2 bridge spanning Rio Guayanilla. The 1954 flood reached the low beam of this bridge. The top of the bridge railing is about the same elevation as the crest of the 1899 flood.

The earliest floods documented in this basin occurred in 1876 and 1886. Stages of these floods, cited in highway damage reports, could not be recovered. The flood of August 8, 1899, is the greatest known flood. Since the 1899 events, major floods occurred in 1926, 1928, 1932, and 1954. Small floods, being less destructive and less spectacular, usually are soon forgotten. However, flood elevations were recovered for the lesser floods that occurred in 1955, 1958, 1960, 1963, and 1966. A tabulation of flood stages and estimated discharges at the upstream Highway PR-2 bridge is given below. The bridge is shown in figure 3.

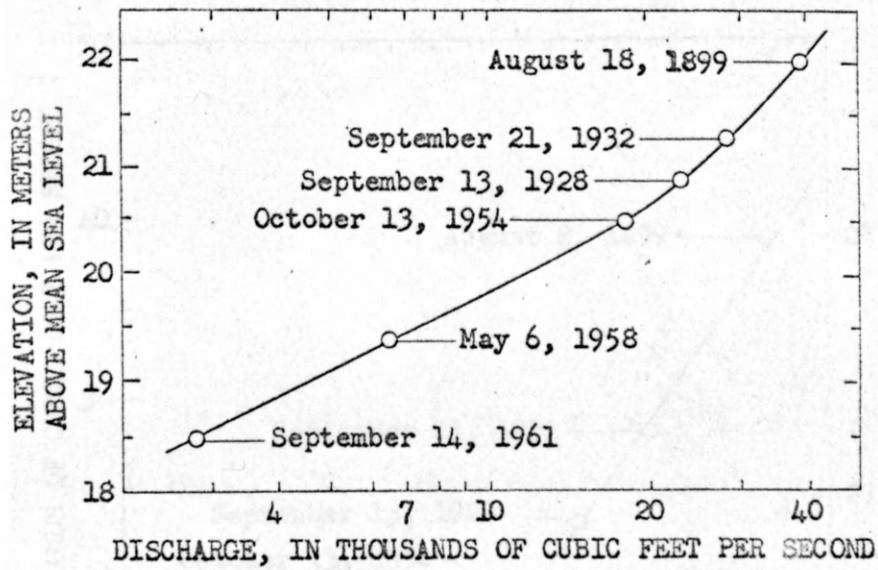
Figure 4.--Flood stage-discharge relation of Río Guayanilla at upstream Highway PR-2 bridge.

The 1926 flood stage was not established at the upstream Highway PR-2 bridge. Flood elevations farther downstream indicate the magnitude of the flood was slightly less than that of the 1928 flood. Stage and corresponding discharge at this site permit the development of the stage-discharge relation shown in figure 4.

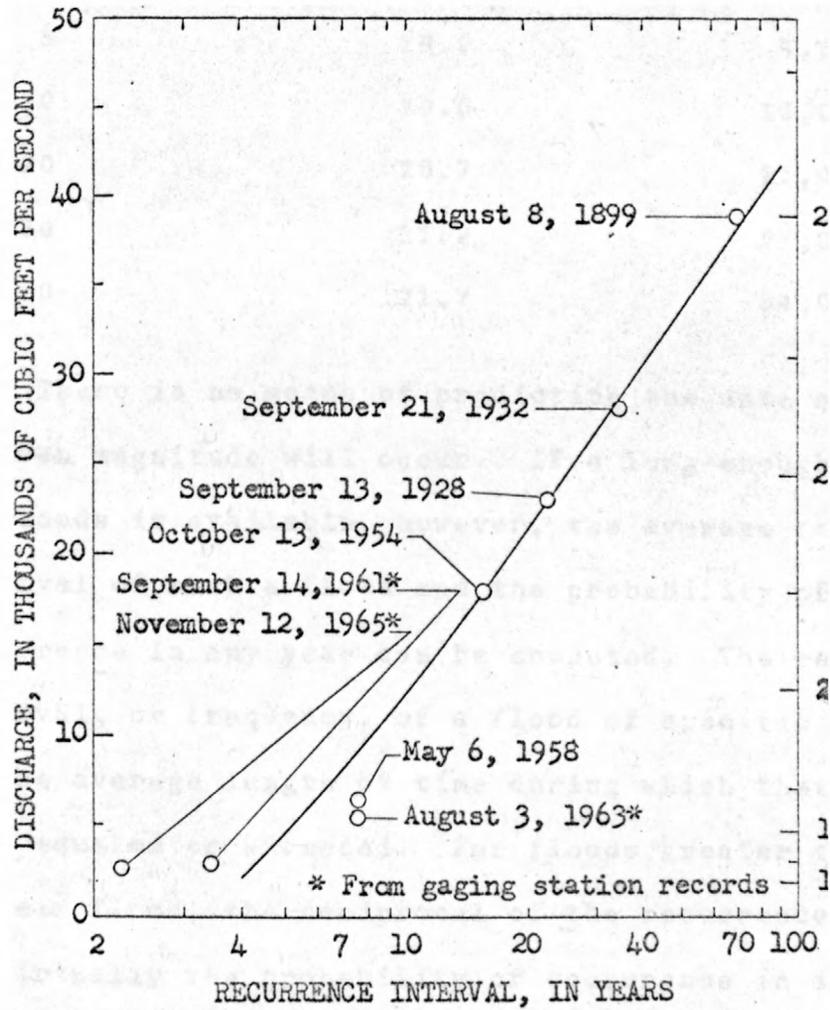
Figure 5.--Flood-frequency relation of Río Guayanil at upstream Highway PR-2 bridge.

Historical floodmark elevations were used in conjunction with discharge records collected at the Río Guayanilla near Guayanilla gaging station, unadjusted for the intervening 2.3 square miles of drainage area, to establish a flood-frequency relation at the upstream Highway PR-2 bridge. The general relation of recurrence interval to river stage and discharge is shown in figure 5. Stage and discharge for selected recurrence intervals are tabulated below.

<u>Recurrence interval, in years</u>	<u>Elevation above mean sea level, in meters</u>	<u>Peak discharge, in cubic feet per second</u>
5	19.0	4,500
10	20.0	13,000
20	20.7	21,000
30	21.2	27,000
50	21.7	34,000

At the upstream bridge on Highway PR-2, a flood elevation of 20.0 meters has an indicated 10-year recurrence interval. However, the 20.0 meter elevation was exceeded 3 times during the 7-year period 1926-32. It

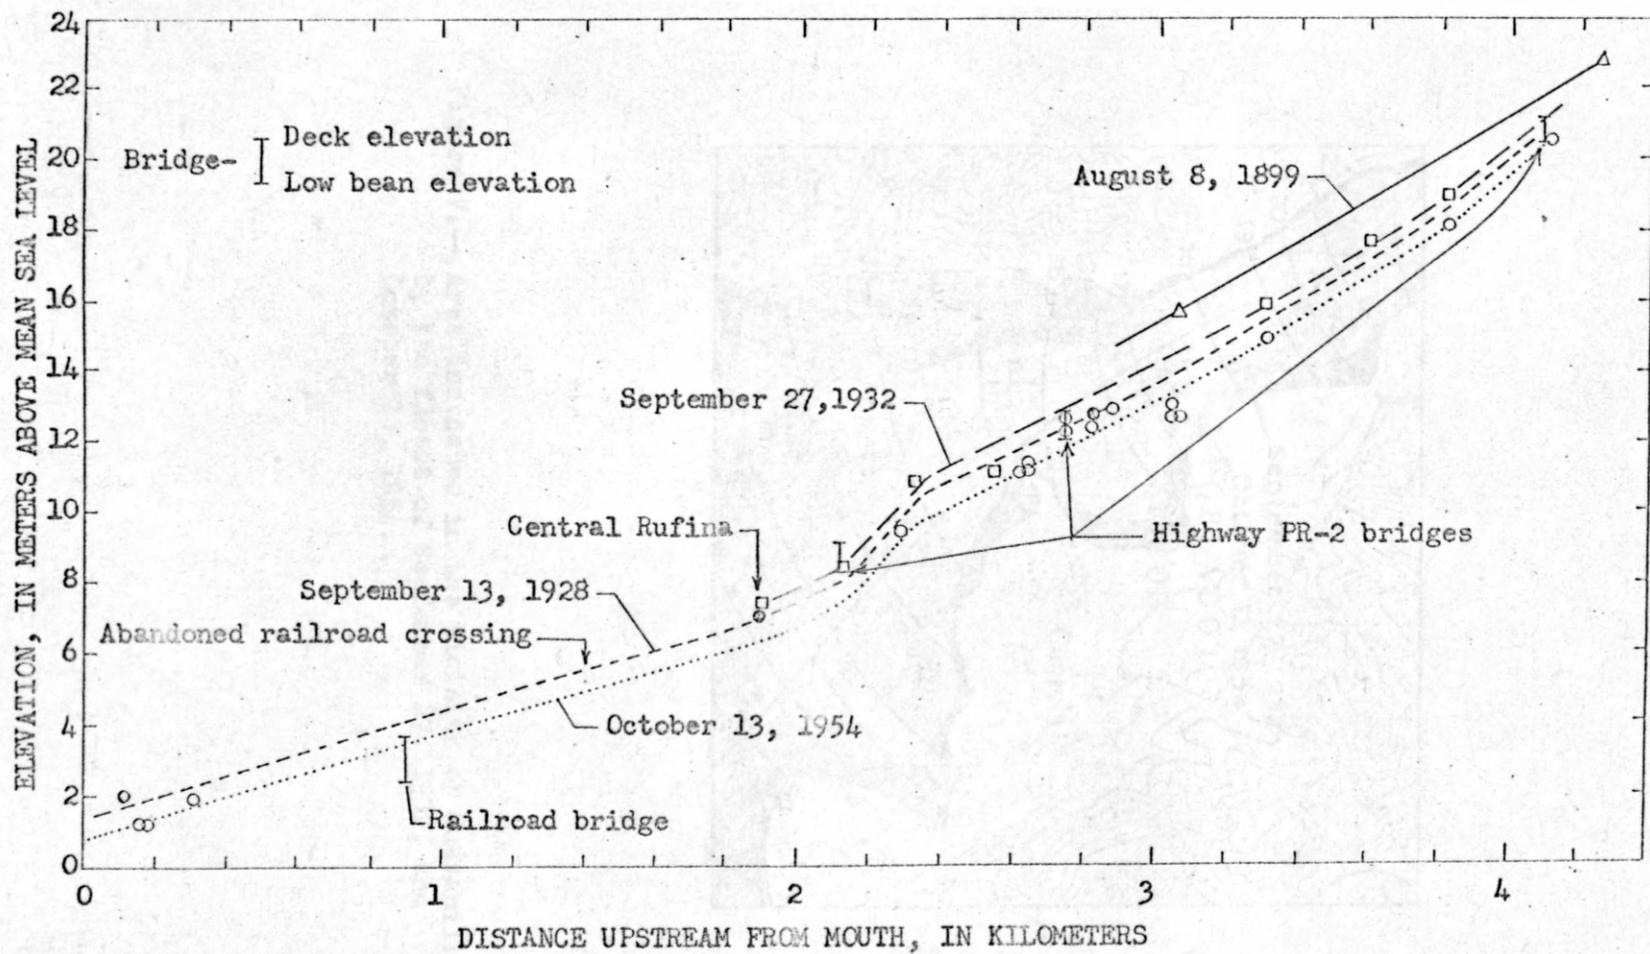
Figure 6.—Flood profiles, Río Guayanilla.

Flood elevations referenced to the arbitrary base line shown on the topographic map are shown in figure 6. The 1932 and 1954 flood profiles are well defined above an elevation of 8 meters. The 1928 flood profile is poorly defined and has been drawn on the basis of the shape of the other flood profiles. The 1928 and 1954 profiles are estimated in the reach from 0.4 to 1.8 kilometers above the stream mouth.

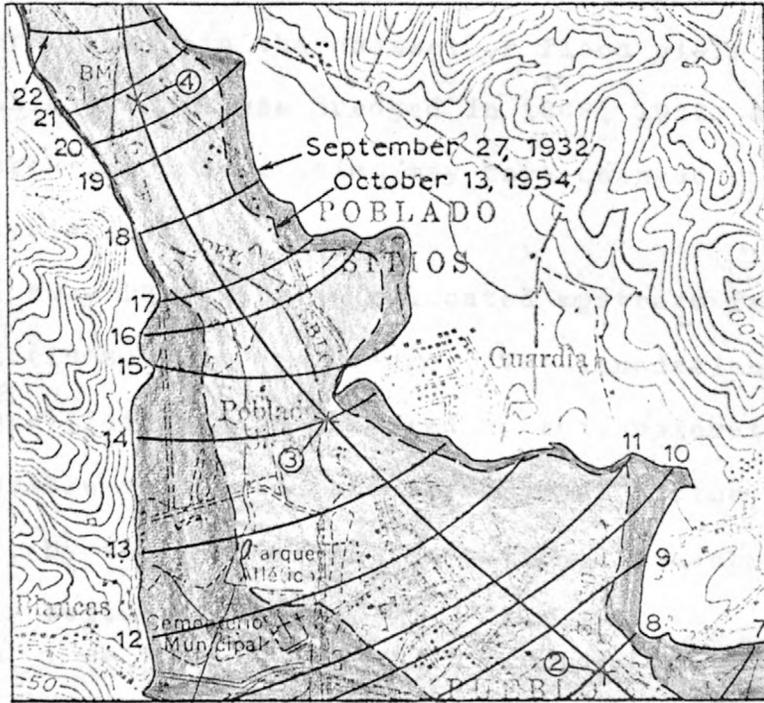
Figure 7.— Area inundated in the vicinity of Guayanilla by the floods of September 27, 1932, and October 13, 1954.

The area inundated by the 1928 flood has been delineated on the large topographic map. The area inundated by the 1932 and 1954 floods at Guayanilla is shown in figure 7. The 1928 flood was selected to be shown on the large map because it is known to have intermingled with Río Yauco and to have been consistent with the Río Yauco inundation area of 1928. The inundated area in the vicinity of El Faro and along Río Macaná is undefined and has been estimated. The effect of the abandoned railroad embankment upon the height of the water could not be defined from the available floodmarks.

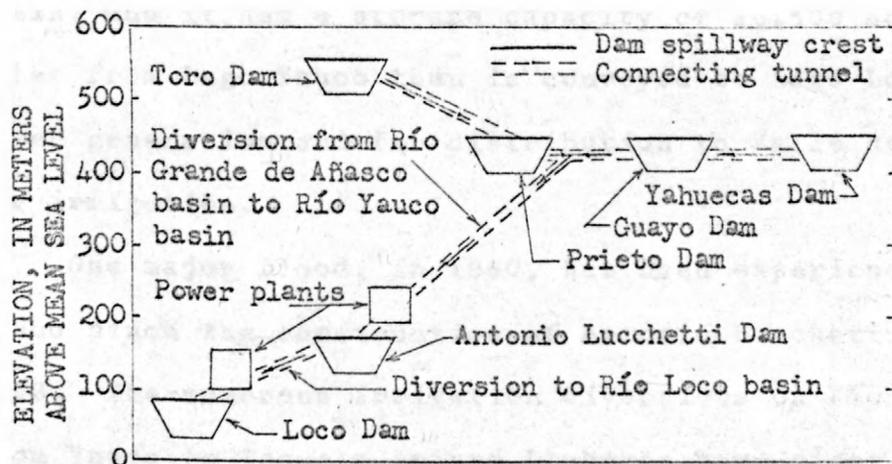
Figure 8.—Schematic diagram of streamflow diverted into and out of Río Yauco basin.

Reservoirs partly regulate streamflow within this basin. A schematic diagram of the interconnected reservoir system is shown in figure 8. Lagos Yahuecas, Guayo, Toro,

and Prieto, the four reservoirs in the headwaters of Río Grande de Añasco, have a combined storage capacity of about 20,000 acre-feet. These reservoirs, constructed during 1955 and 1956, divert flow from 39 square miles of the Río Grande de Añasco basin to Lago Yauco (above Antonio Lucchetti Dam) on Río Yauco. Lago Yauco also collects flow from 17.3 square miles of the Río Yauco basin, and it has a storage capacity of 16,500 acre-feet. Water from Lago Yauco then is conveyed to Lago Loco for power generation and for distribution to Valle de Lajas for irrigation.

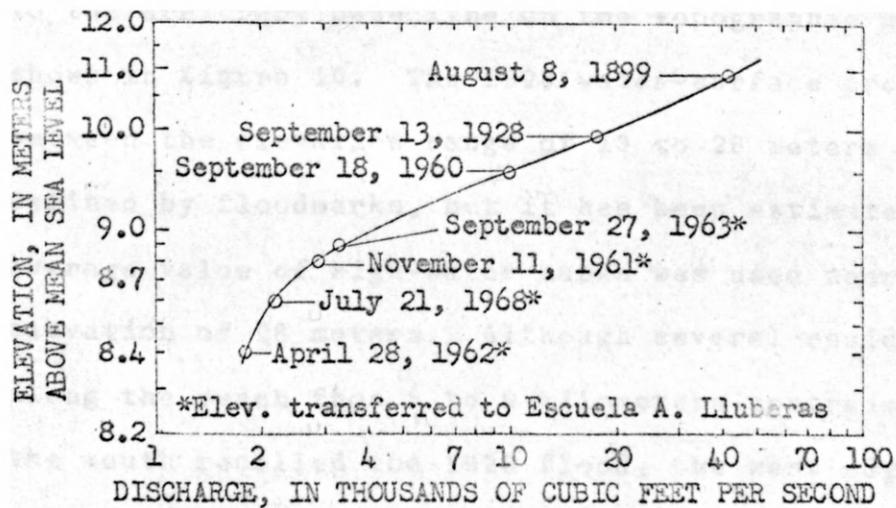
Figure 9.--Flood stage-discharge relation of Río Yauco at Escuela Arturo Lluberas.

Flood stage and discharge define the relation shown in figure 9.

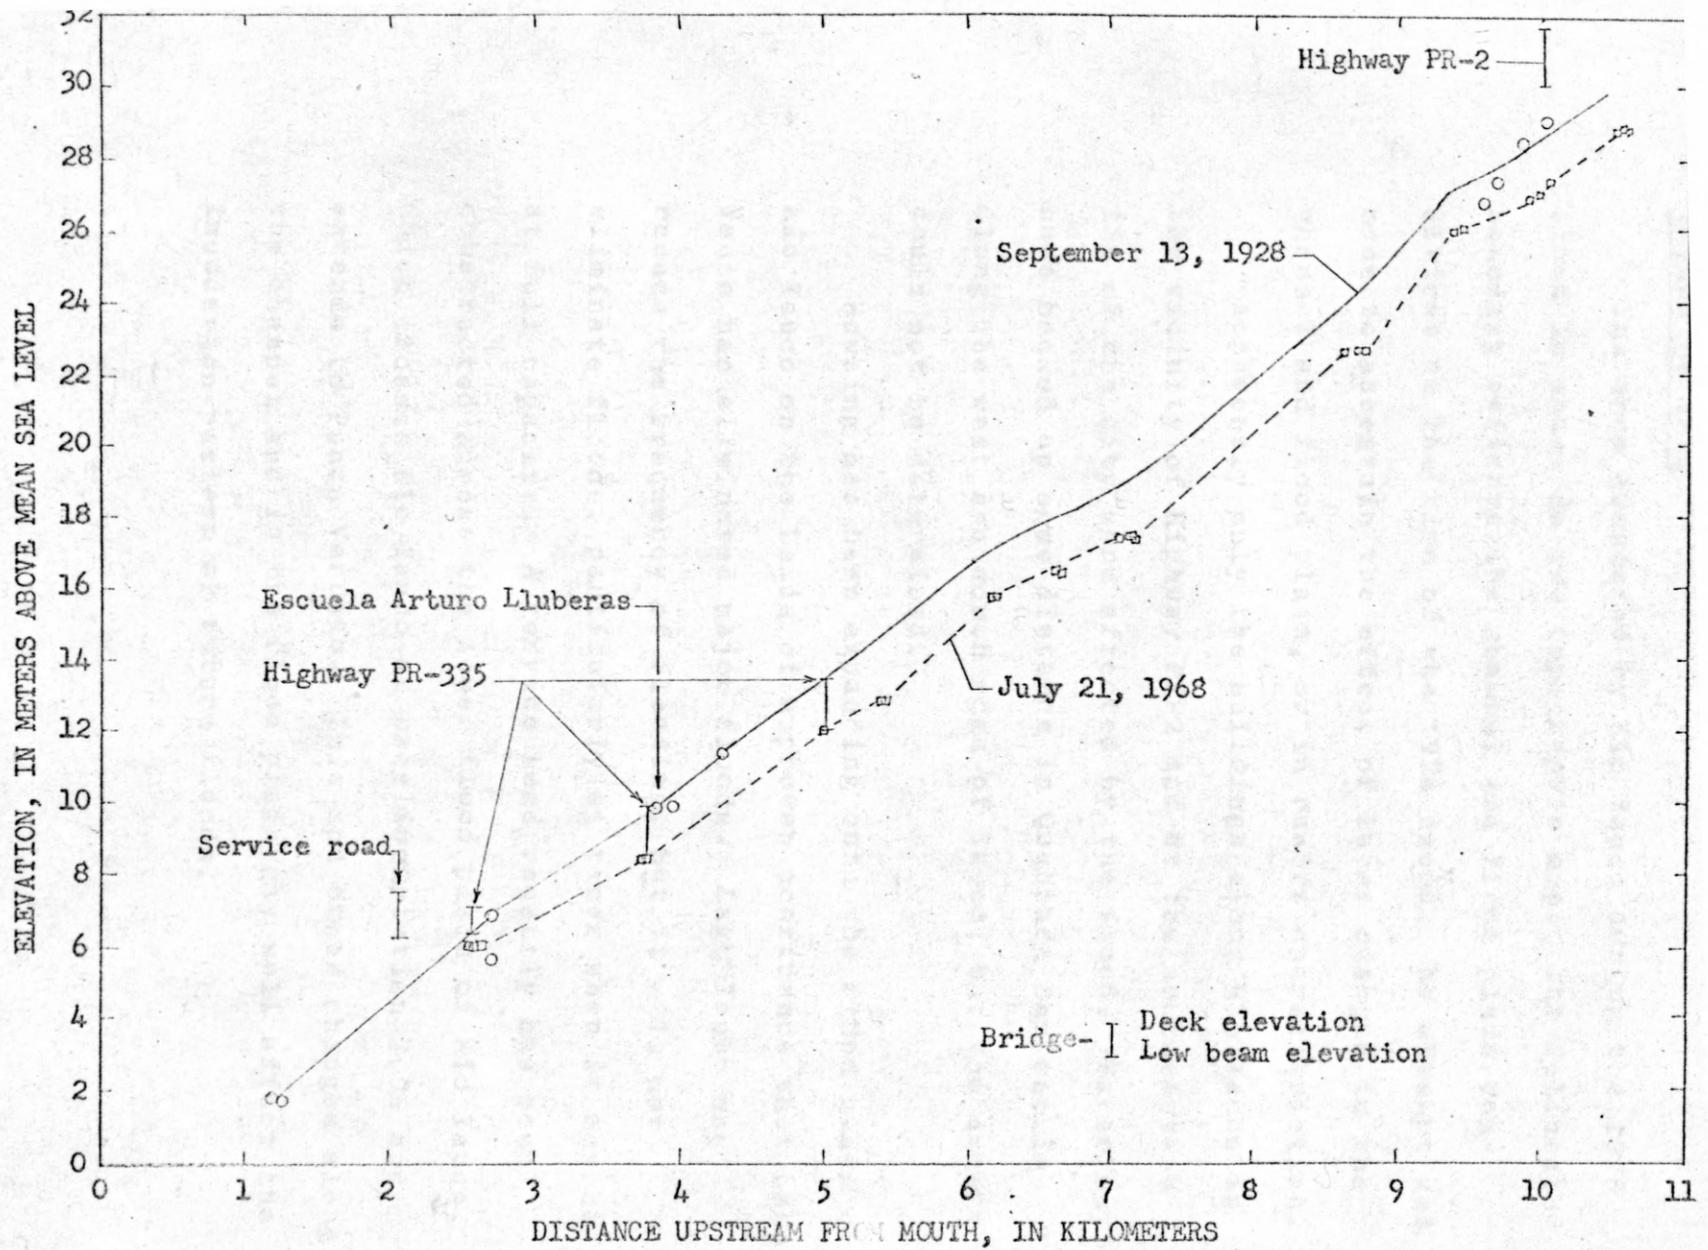
Figure 10.--Flood profiles, Río Yaure.

The 1928 and 1968 flood elevations, referenced to the arbitrary base line on the topographic map, are shown in figure 10. The 1928 water-surface profile between the elevation range of 13 to 26 meters is not defined by floodmarks, but it has been estimated. An average value of high-water marks was used near the elevation of 28 meters. Although several residents along the reach from 5 to 9 kilometers upstream from the mouth recalled the 1928 flood, the west edge of the valley has been changed, mainly by road construction, and old landmarks have been erased. One resident recalled that the flood reached Escuela Segunda Unidad de Barinas, but could point out no definite elevation of the flood. The profile has a probable accuracy of ± 0.5 meter at elevations above 12 meters.

The flood of July 21, 1968, was not a major event, but its profile provides a basis for estimating the 1928 flood profile. Río Yauco is confined at low discharge by small levees downstream from about kilometer 2.5. The 1968 profile below this point is not applicable for comparison with the 1928 flood and is not shown.
