STRATIGRAPHY OF AN ARCHEOLOGICAL SITE,
// OCMULGEE FLOOD PLAIN, MACON, GEORGIA

✓ U. S. GEOLOGICAL SURVEY, *Water Resources Division*,
WATER-RESOURCES INVESTIGATIONS 54-73

By O. J. Cosner

November 1973

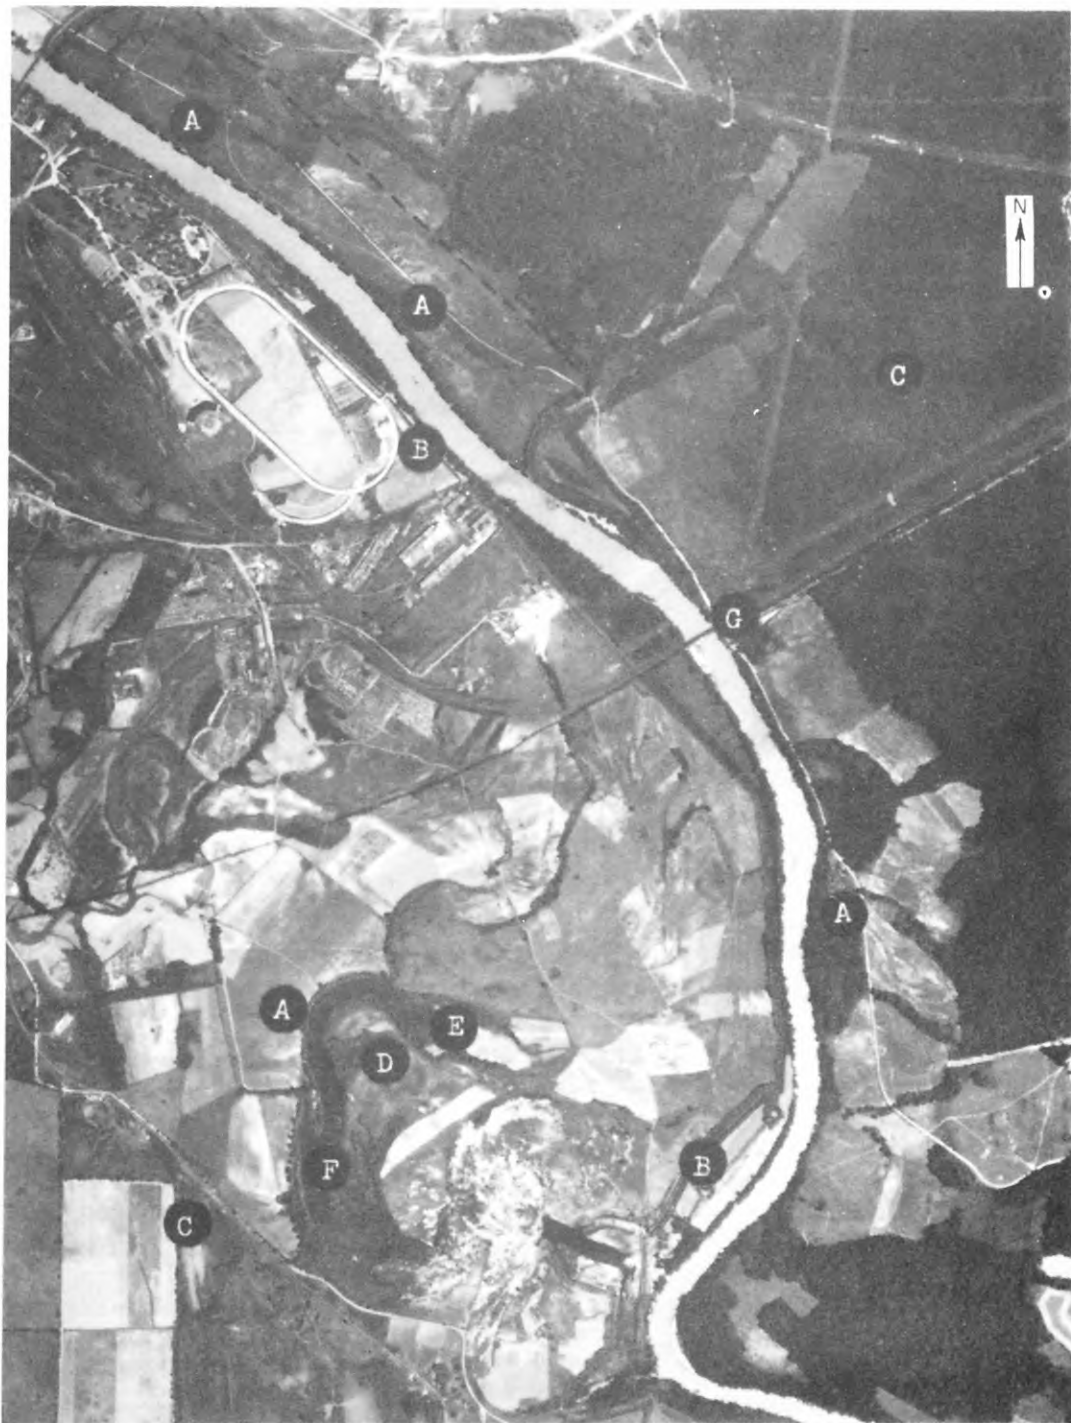
Figure 2A.—Aerial view of Ocmulgee River and flood plain showing test area and various land forms of the flood plain.

The later deposits of Qmfps and the deposits of Qmsss have also been influenced by the construction of levees on the right bank, by dredging of the channel, and by bridge construction (See figure 2A.).

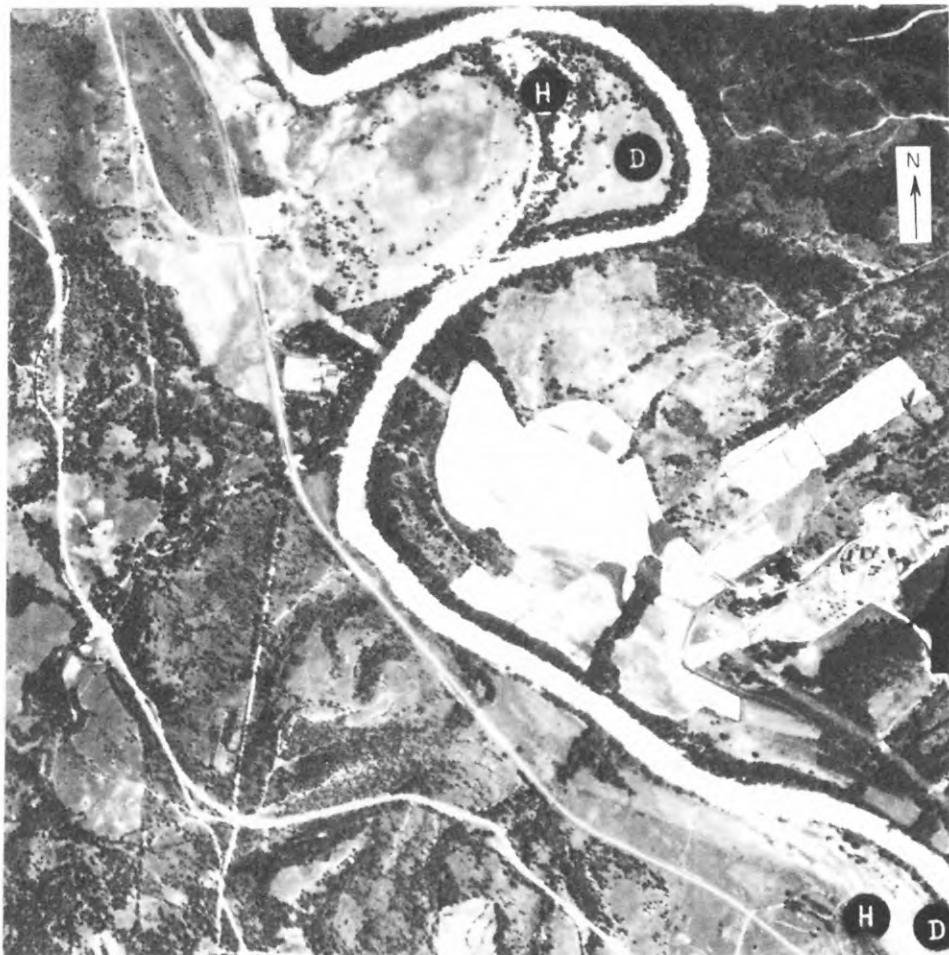
Figure 2B:—Aerial view of Ocmulgee River and flood plain 1 mile upstream from test area showing point bars and chute cutoffs.

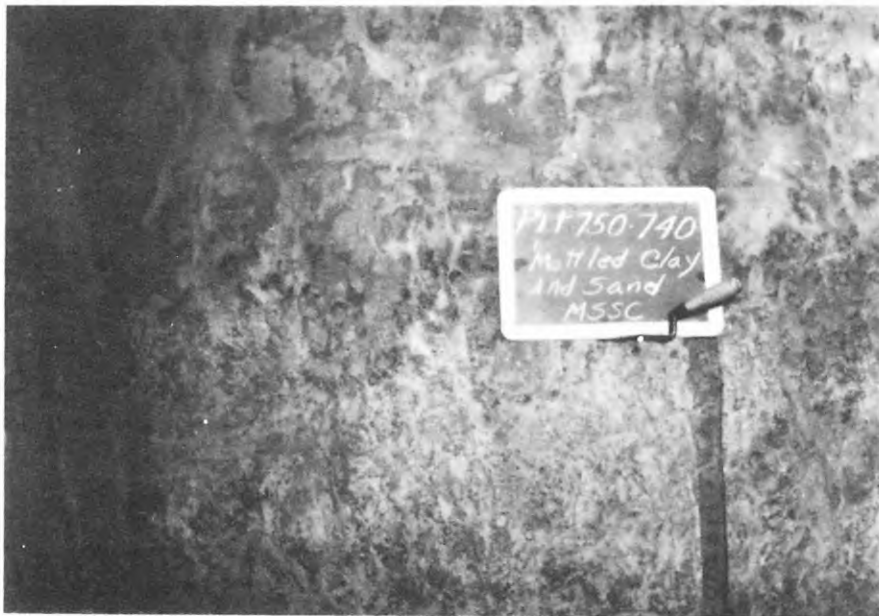
Figure 7.--Mottled silty sandy clay (Qmssc) in pit 750-740. The mottling is various shades of yellow and brown. Material above the board is sand referred to by the archeologists as the hard brown sand. That below the board is sandy clay.

During the early part of the investigation it was the author's opinion that the Qis appeared to grade downward into the Qmssc. However, in some areas a foot or more of firm mottled sand was present, similar to the Qmssc in its mottling, but having the texture of the Qis. The contact between the Qmssc and the Qis was placed at the top of the mottling. Later, more exposures of this contact were available and in some of these a distinct division was apparent between the gray sand of the Qis and the mottled sand below. The mottled sand is referred to as hard brown sand by the archeologists, but is included in the Qmssc in this report (See figure 7.).

The whole of the Qmssc member is mottled (fig. 7), with the exception of the bar-like sands shown in figures 8 and 9. The member contains a few 1/2-inch iron-manganese concretions.

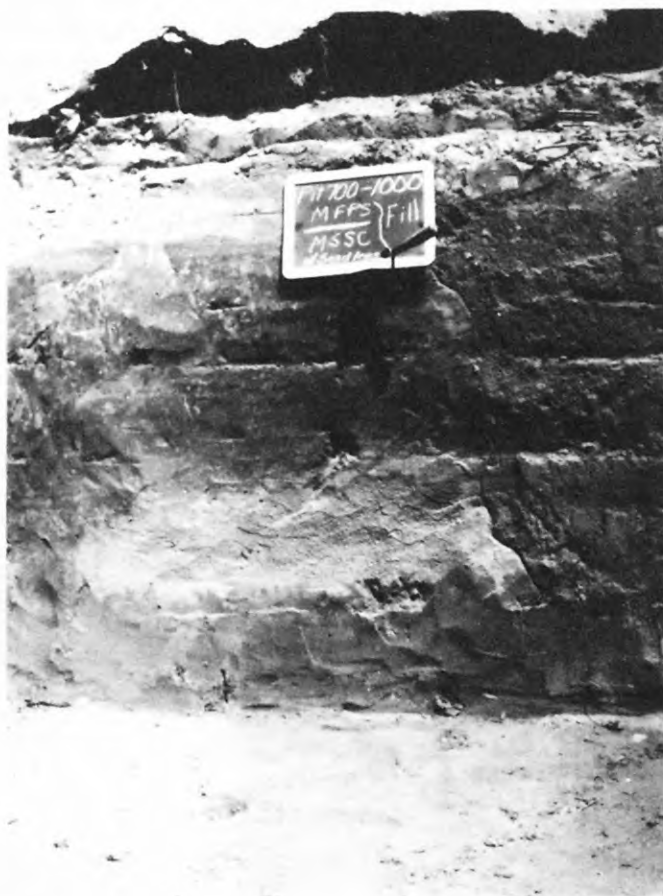
Figure 9.--Dredging fill plastered against modern flood-plain sediments (Qmfps) and mottled silty sandy clay (Qmssc). Contact is near vertical irregular line marked on face of pit. Contact between Qmfps and Qmssc is near horizontal and is located by line on board.

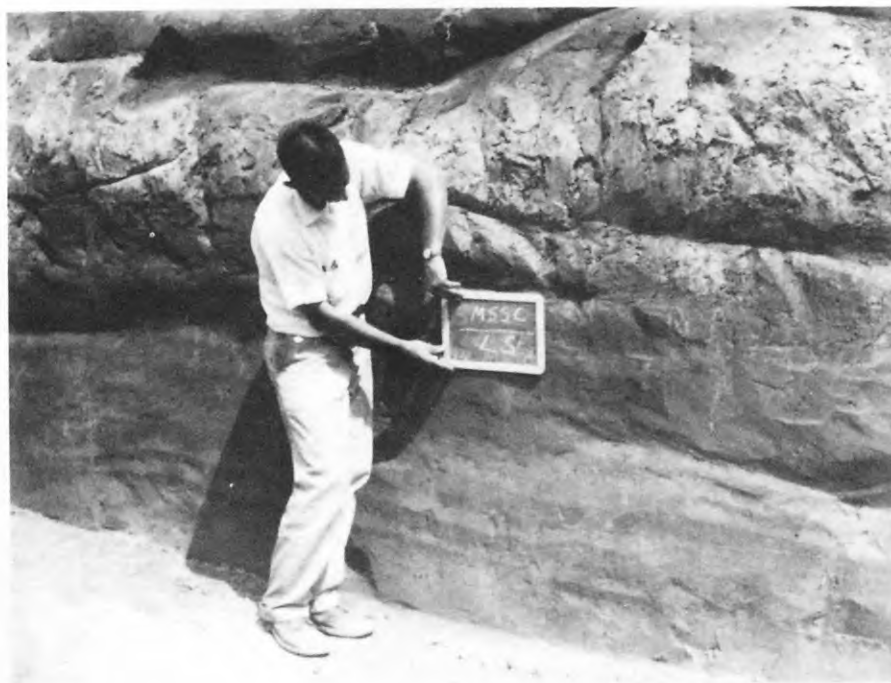
Figure 10.--Contact of mottled silty clay (Qmssc) and lower sand (Qls) in southwest wall of trench 3225 at station 475.

These deposits also exhibit thin, 0.01 to 0.05 foot, very irregular stained bands (figs. 8 and 10) that are secondary features, probably caused by the movement of ground water.

Stained zones in the sand deposits.--The bar-like sand deposits of the Qis, the Qmssc (fig. 8), and the Qls (fig. 10) show similar types of staining that appear to be a coating on the individual sand grains. Relatively wide, even bands of 0.2 to 0.5 foot of stained sand occur in all three deposits. These probably formed when the material was at the surface and represent a slight accumulation of humic, or clayey material.

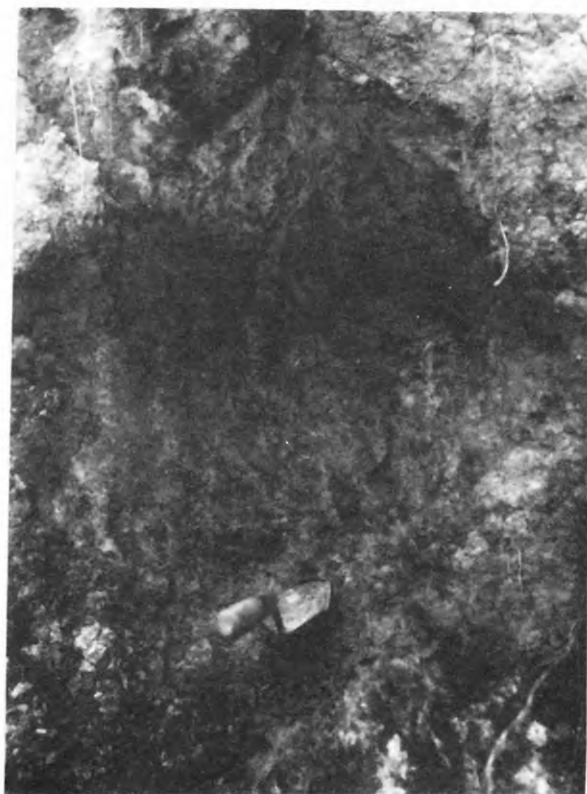
Figure 11.--Mottled clay cut at Burns Brick Company clay pit. Clay is similar to mottled silty sandy clay (Qmssc).

On the right bank, about 5 miles downstream from the test site at Burns Brick Co. clay pit, mottling is associated with vegetal material and concretions (See figure 11.). Many small black to very dark reddish brown iron-manganese concretions were present in the clay. The material surrounding them grades from dark reddish brown near the concretion through brownish yellow to yellow in the main mass of the clay. The concretions appeared to have formed in place and were not originally deposited with the clay.
