SCOUR AT SELECTED BRIDGE SITES IN ALASKA

U. S. Geological Survey

Water-Resources Investigations 32-75

Prepared in cooperation with the
Alaska Department of Highways
and the
Federal Highway Administration

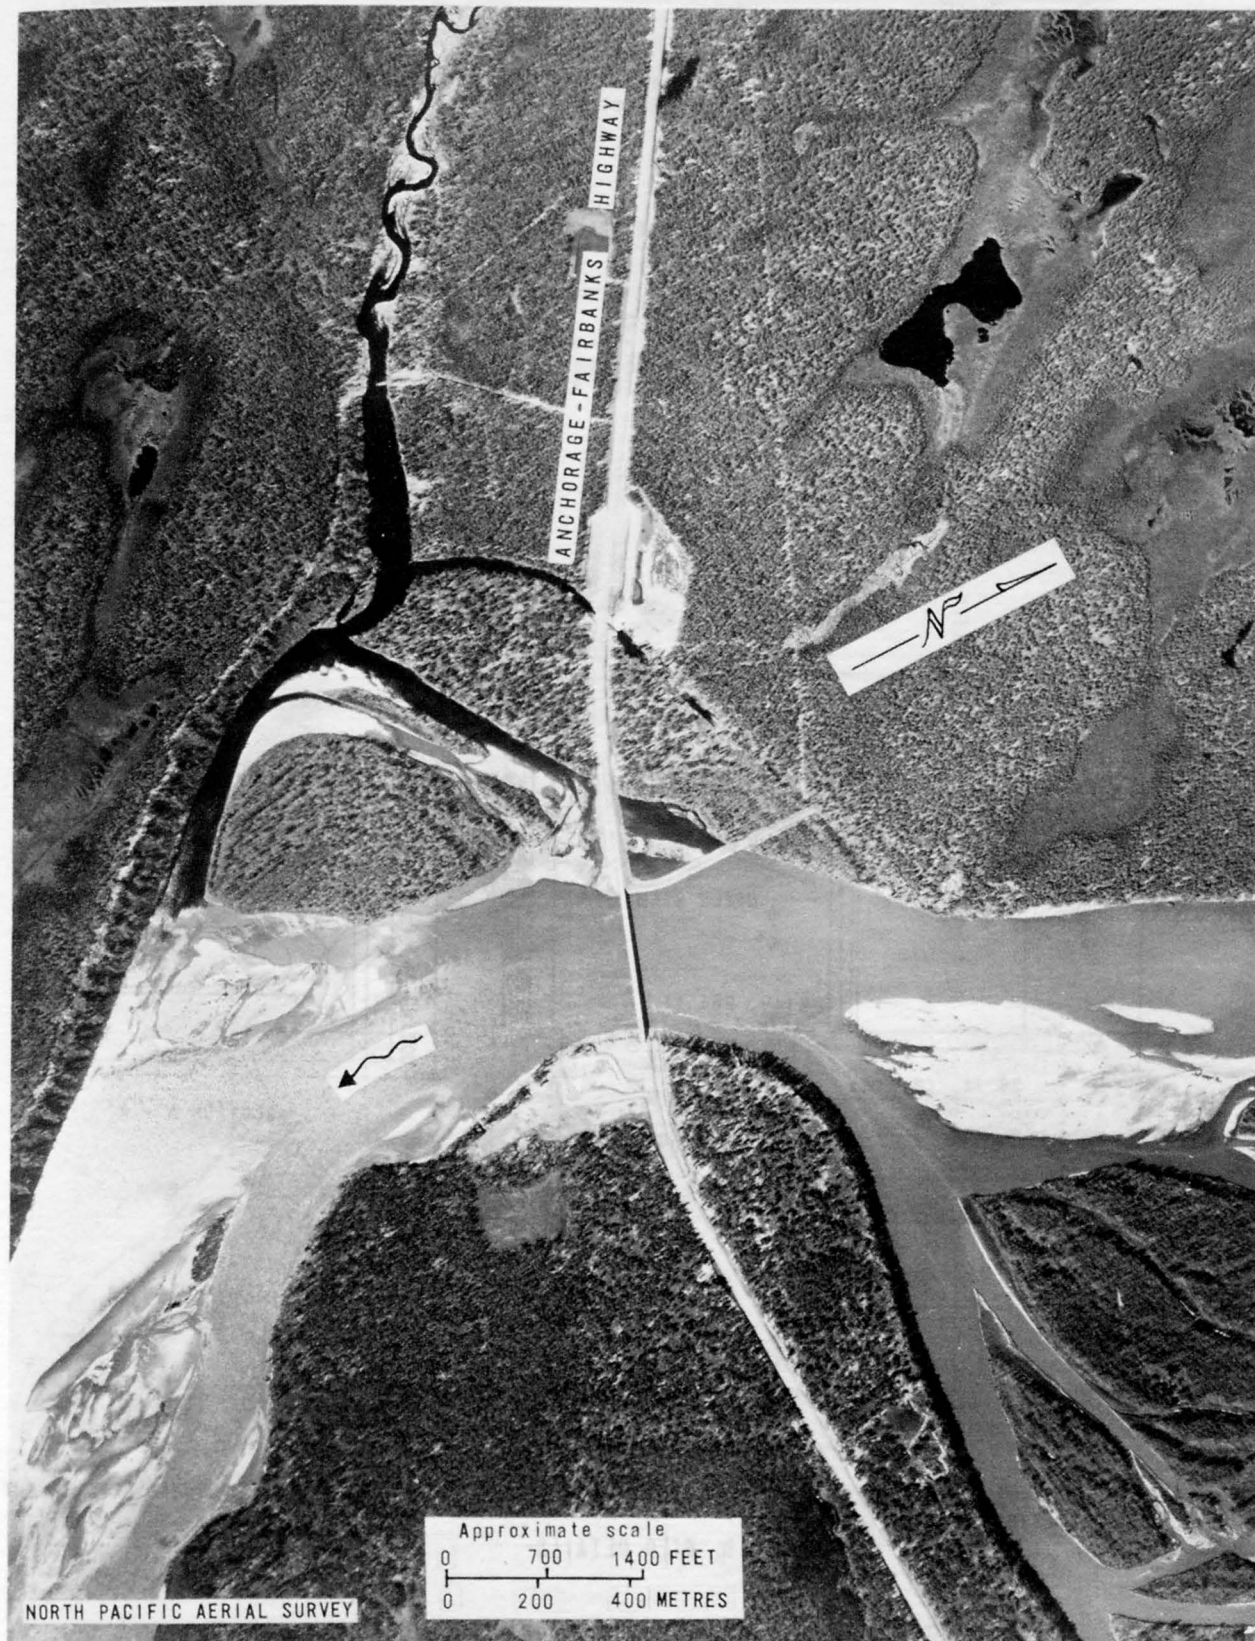
Figure 4.-- Aerial view of Susitna River near Sunshine, bridge 254, May 21, 1968.

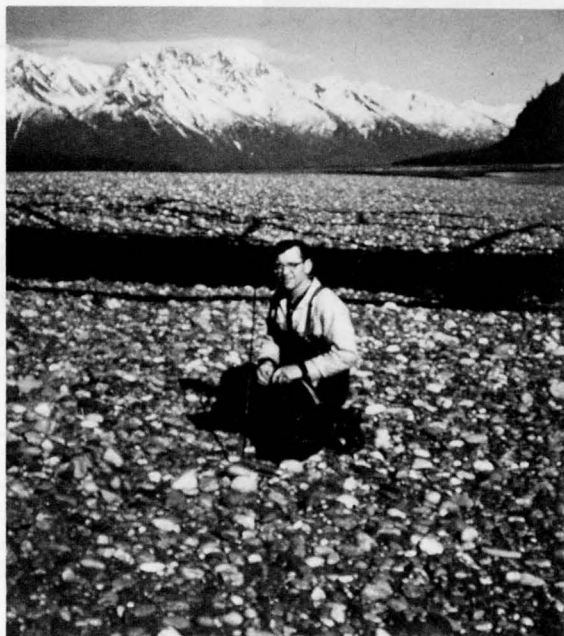
Figure 26.-- View upstream of bed material in vicinity of pier 5, bridge 539, on April 13, 1965.

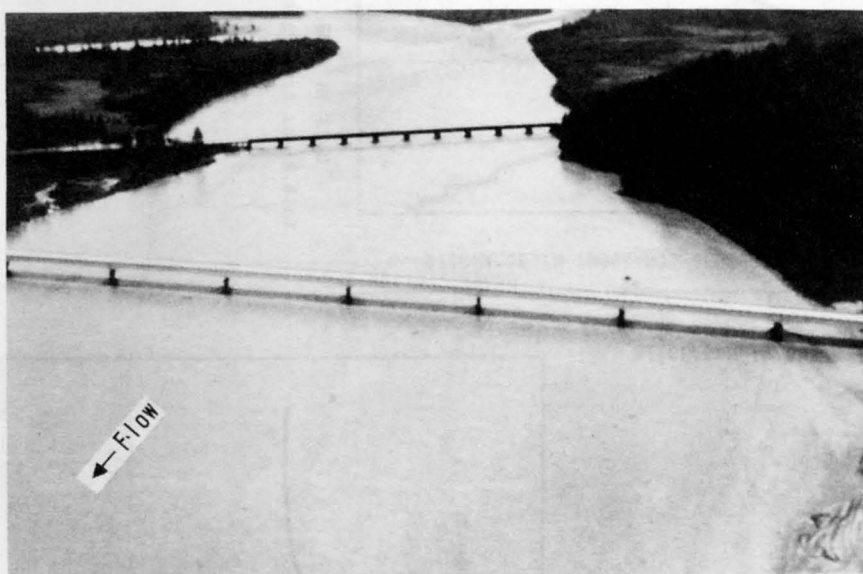
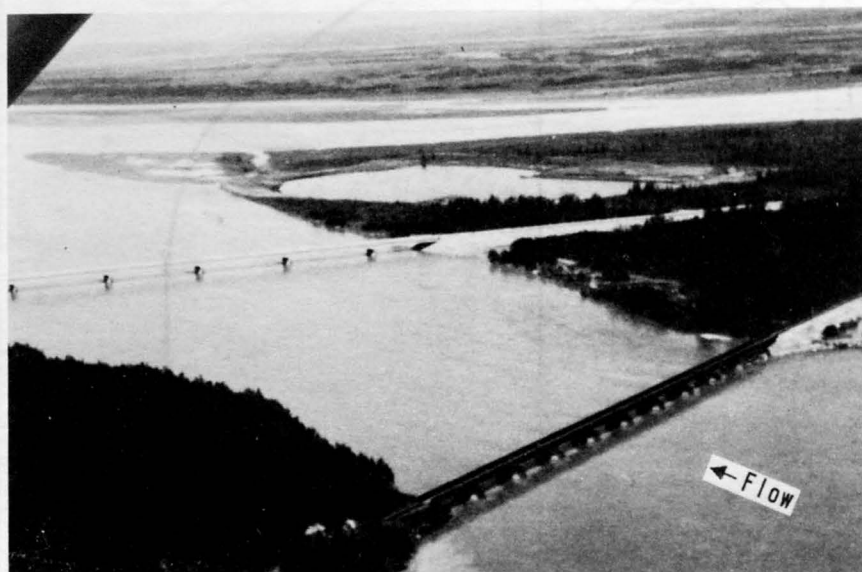
Figure 35a.-- View upstream.

Figure 35b.-- View downstream.

Figure 35.-- Knik River near Eklutna at bridge 1121 on July 10, 1965.

The fourth pier from the left bank was instrumented with a single transducer at the nose of the pier. Depth to the streambed below the transducer was recorded by fathometer. Figures 35 and 36 show the bridge and the instrumented pier.

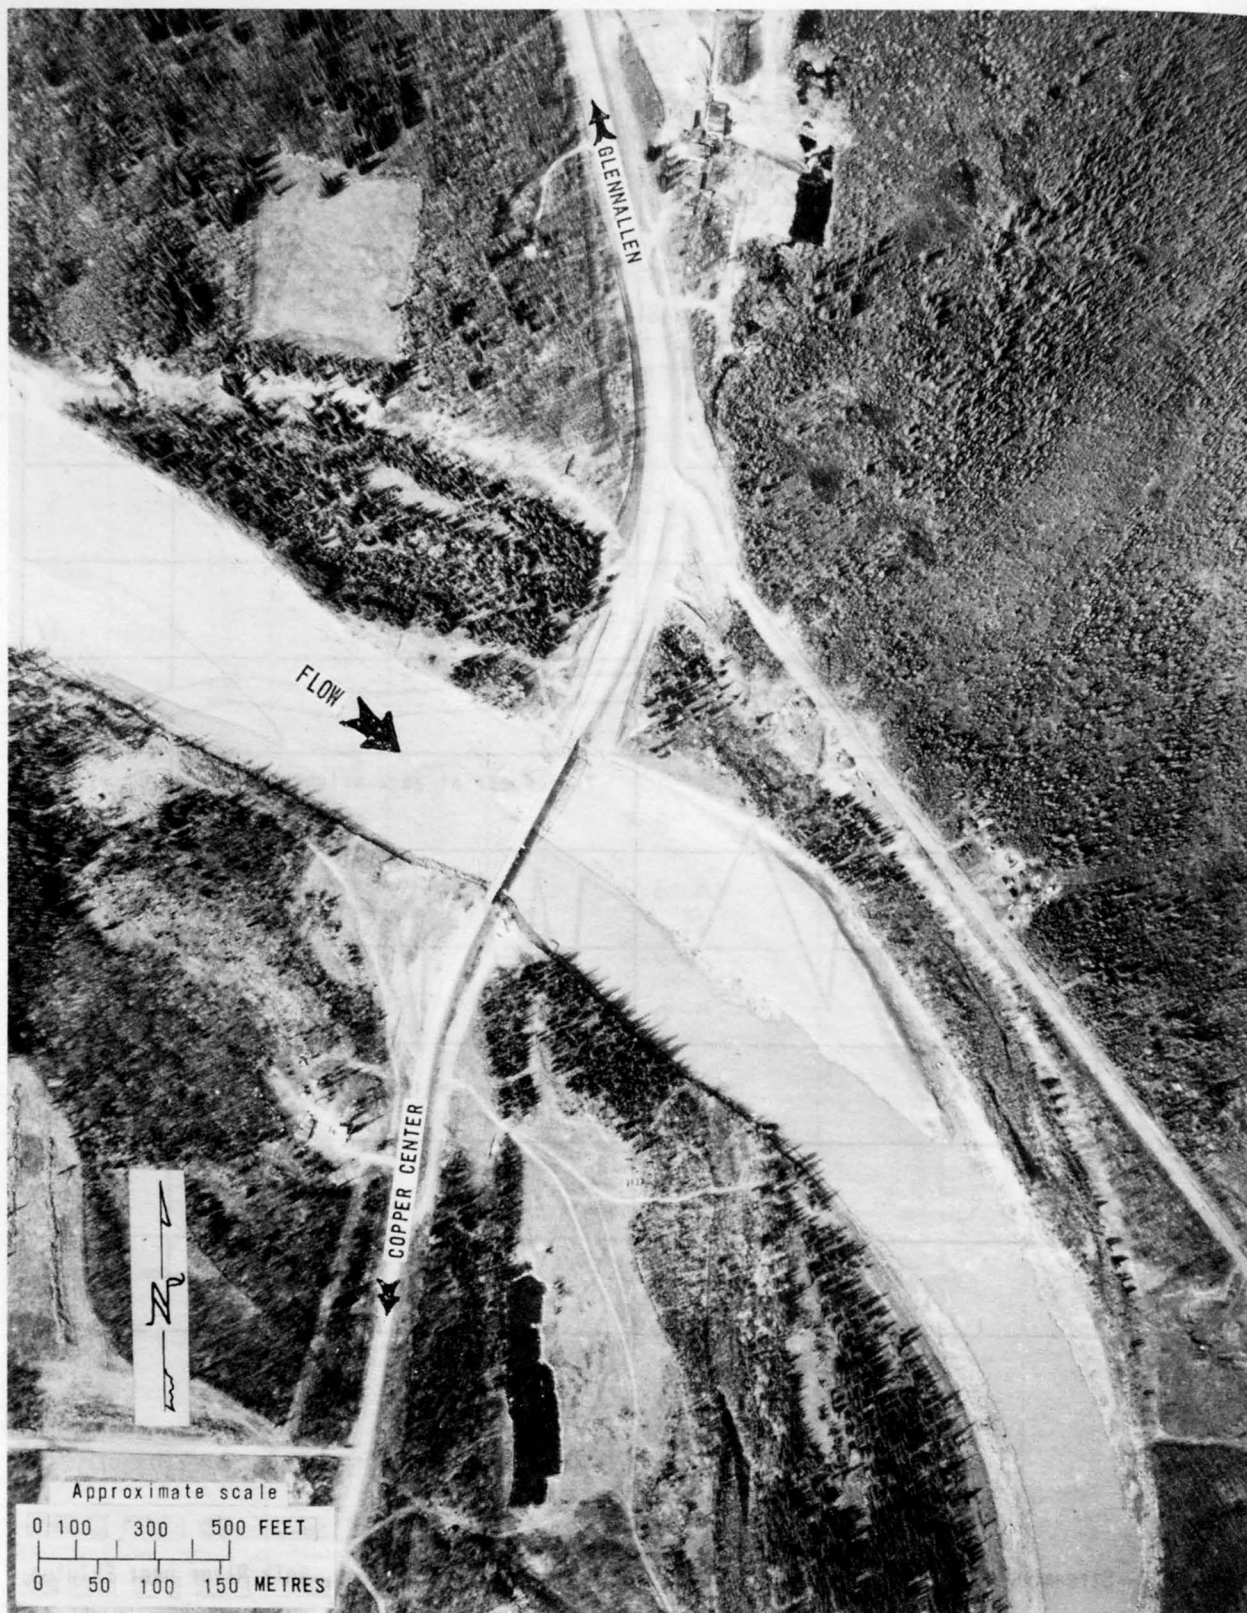
Figure 43--Aerial view of Tazlina River near Glennallen, bridge 573, May 25, 1972.

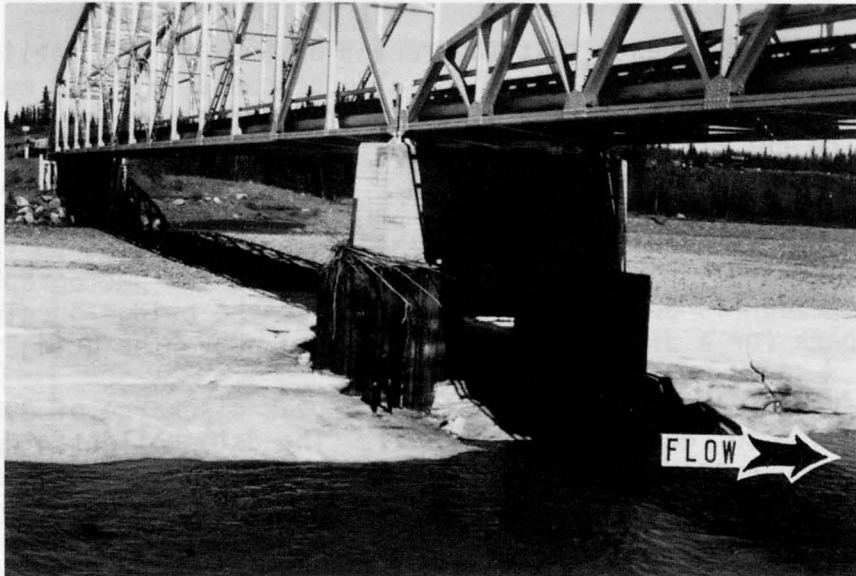
Figure 44--Bridge 573 over the Tazlina River at low flow, April 22, 1969

The Tazlina River flows from a large glacier-fed lake about 26 mi (42 km) west of the study site. The variations in discharge in the Tazlina River are subdued by the lake. Almost annually one of several glacier-dammed lakes above the lake breaks out to produce floodflows in the river. Post and Mayo (1971) discuss these lake breakouts in their report on glacier-dammed lakes. Stream-gaging records have been maintained at the bridge since 1951. Recorded annual peak flows range from a low of 15,300 ft³/s (433.3 m³/s) in 1956 to a high of 60,700 ft³/s (1,719 m³/s) in 1962. The mean annual and 50-year recurrence-interval floods are about 25,000 and 78,000 ft³/s (708 and 2,210 m³/s), respectively. The drainage area is approximately 2,670 mi² (6,910 km²).

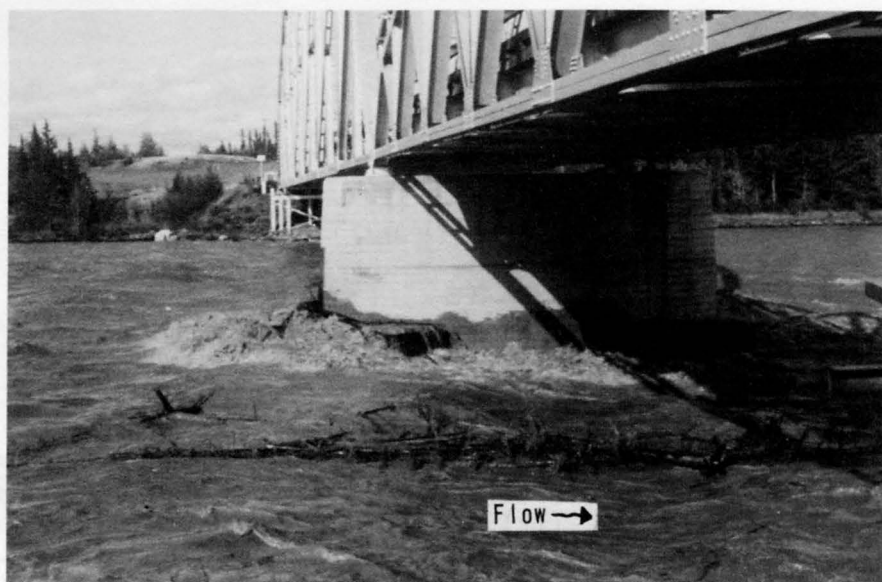
Figure 48.--Views of the surface effects of turbulence created by the pier during high flow, on September 4, 1971, Tazlina River near Glennallen.

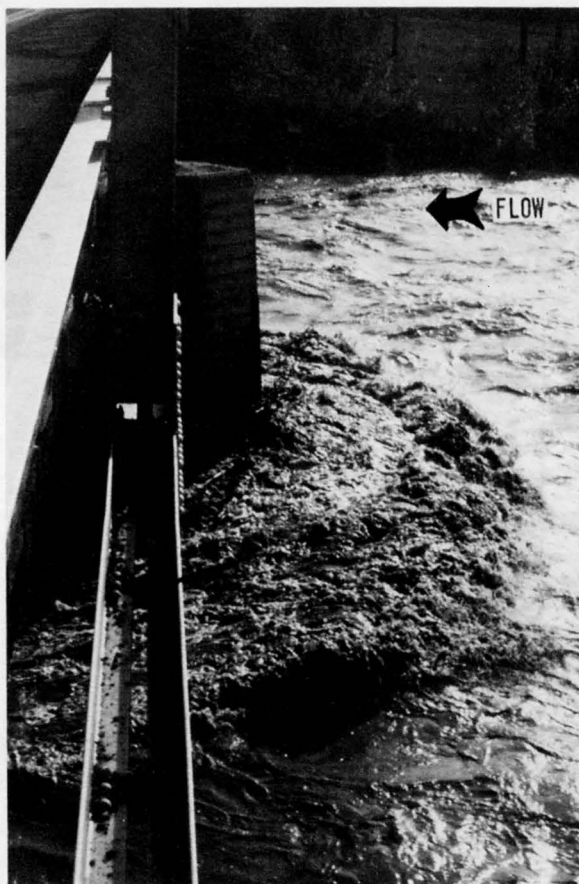
Figure 49.-- View from bridge showing the extent of the bow or nose wave created by the pier near peak flow of $39,700 \text{ ft}^3/\text{s}$ ($1124 \text{ m}^3/\text{s}$) on September 4, 1971, Tazlina River near Glennallen.

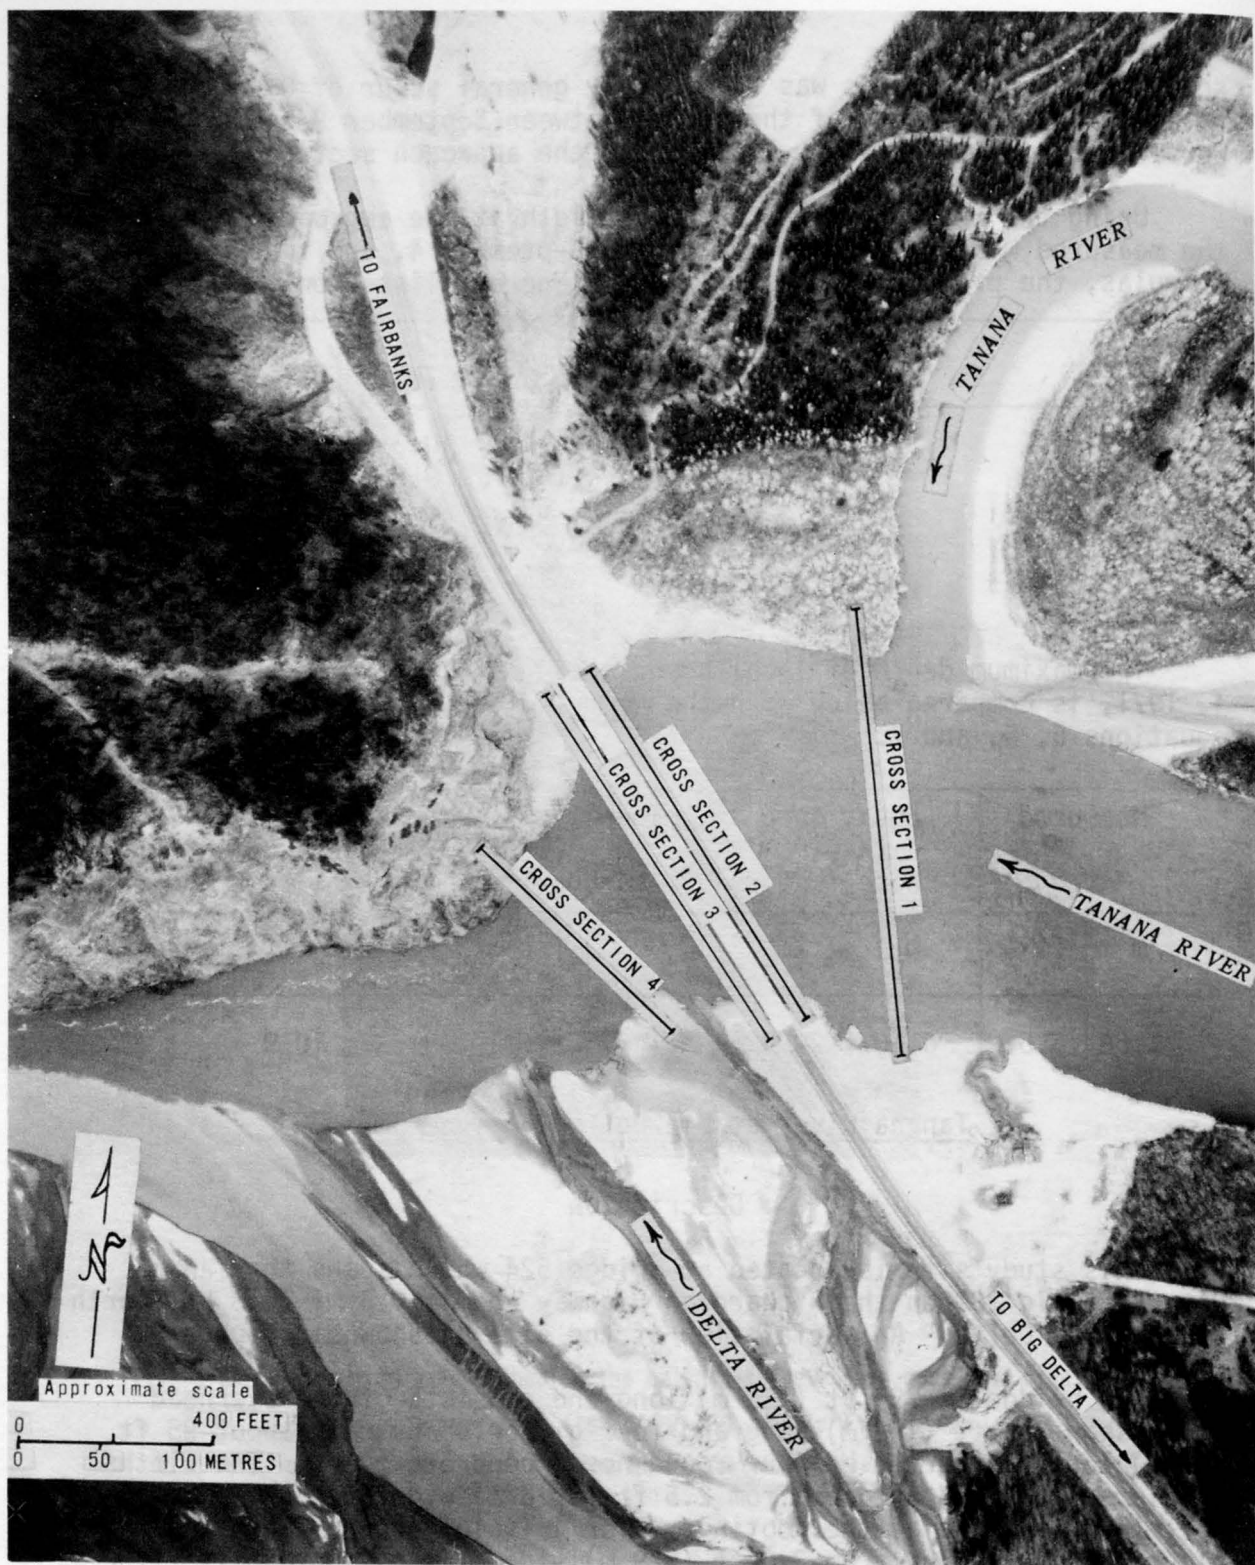
Figure 50.-- Aerial view of Tanana River at Big Delta bridge 524 on May 26, 1971.

This study site is located at bridge 524 which spans the Tanana River at mile 281 on the Richardson Highway and is 0.5 mi (0.8 km) northwest of Big Delta. An aerial view of the site is shown in figure 50.

Measurements have been made on the four cross sections shown on the photograph in figure 50.

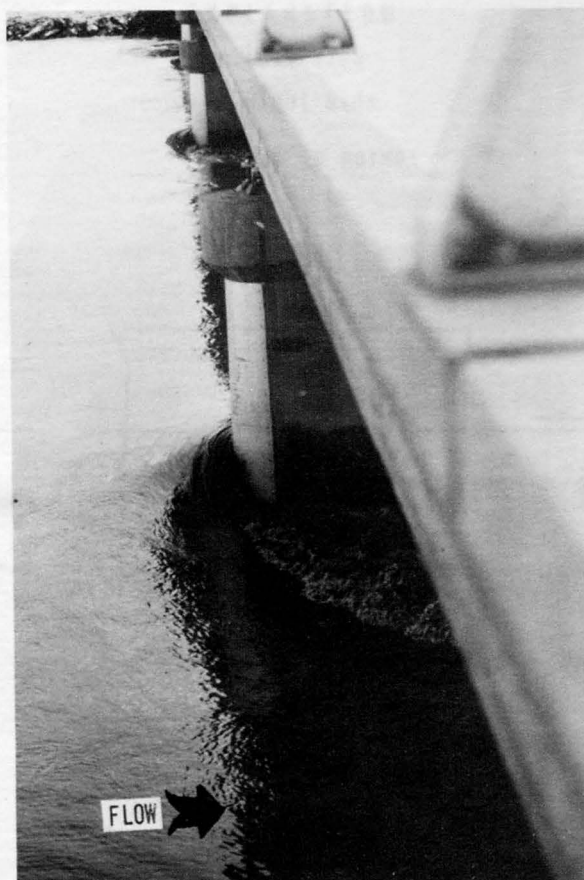
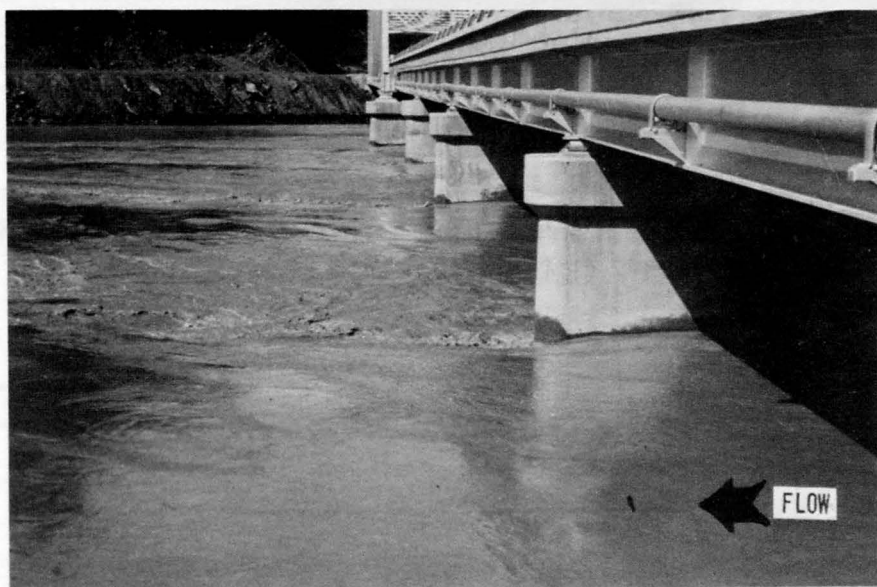
Figure 56.-- Water surface at Tanana River at Big Delta on July 16, 1971.
 A. Upstream side of bridge looking toward left bank.
 B. Downstream side of bridge looking toward right bank.

The piers, being skewed to the flow, affected the flow pattern at the bridge as illustrated in figure 56. Water on the left side of the piers had a placid appearance, whereas the water surface on the right side was extremely turbulent. Turbulence was also created by debris which had collected on the piers (fig. 57). At an average angle of attack of 37° the projected widths of piers 1-3 and of pier 4 are about 22 ft (6.7 m) and 28 ft (8.5 m), respectively.

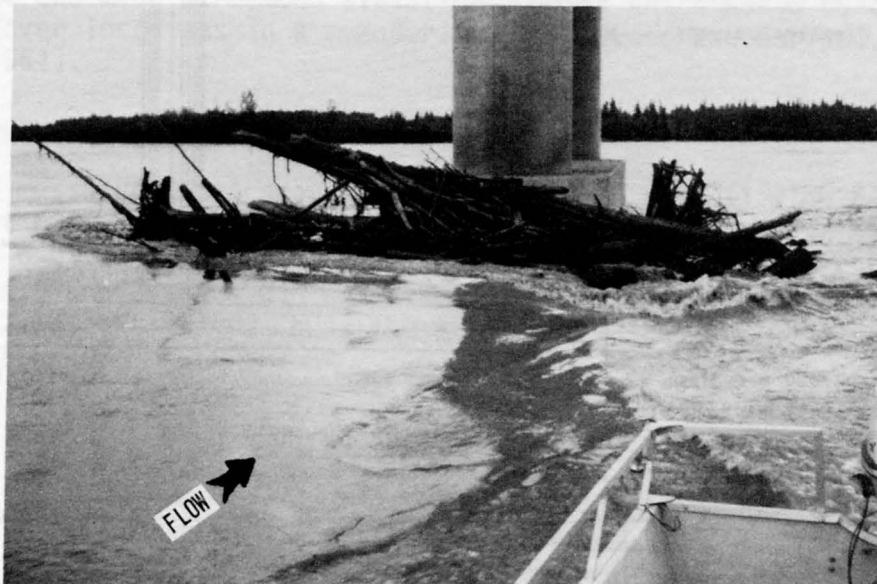
Figure 62--Looking downstream at pier with debris on pier nose, Tanana River at Nenana on July 28, 1967. $Q=123,000 \text{ ft}^3/\text{s}$ ($3483 \text{ m}^3/\text{s}$)

On July 28 and 30, 1967, longitudinal profiles of the streambed beside the pier were obtained using the boat and fathometer. Debris on the pier nose prevented the boat from getting closer than about 10 ft (3 m) from the pier. The pier and water surface, during high flow on July 28, are shown in figure 62.

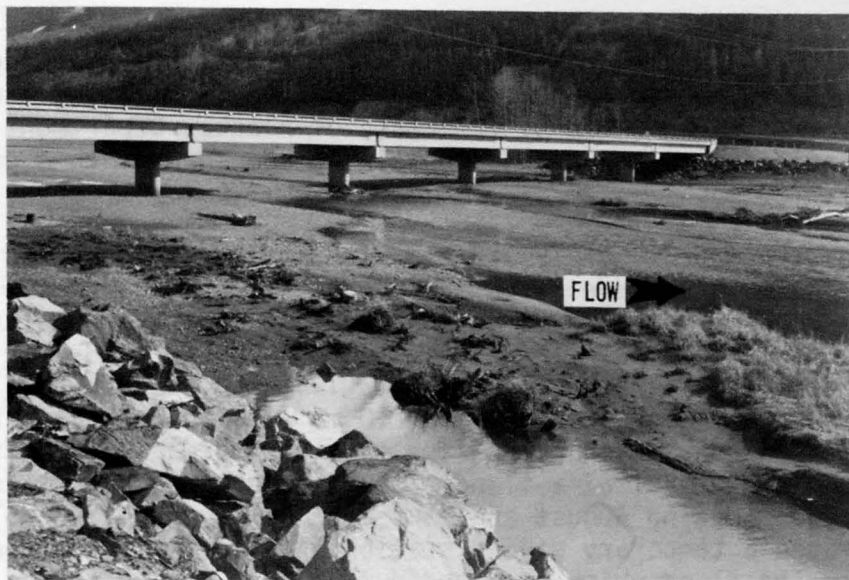
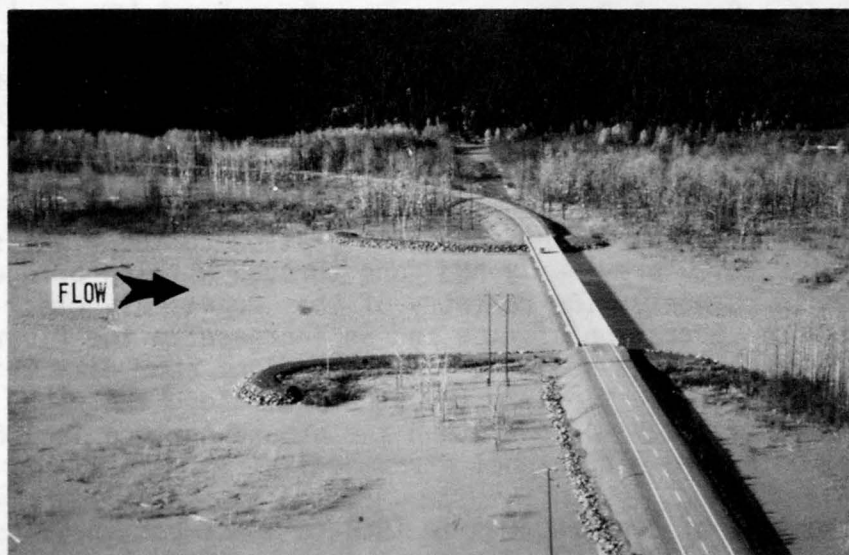
Figure 65.-- Bridge 605 over Snow River

A. View upstream from right bank during low flow on May 13, 1969.

The bridge is of girder design consisting of seven spans supported by six round-nosed pedestal-type piers 3.2 ft (0.98 m) wide and spaced 92 ft (28 m) apart, center to center. The total length of the bridge is 648 ft (197.5 m). Two spur dikes, each 300 ft (91 m) long, force the flow of the river to pass through the opening parallel to the pier alignment. Figure 65 shows the bridge at both low and high flows.

For most of the channel width the depth was too shallow to obtain a useable fathometer record of the streambed. As shown in figure 65B, the streambed form in the shallow areas probably consisted of standing waves.

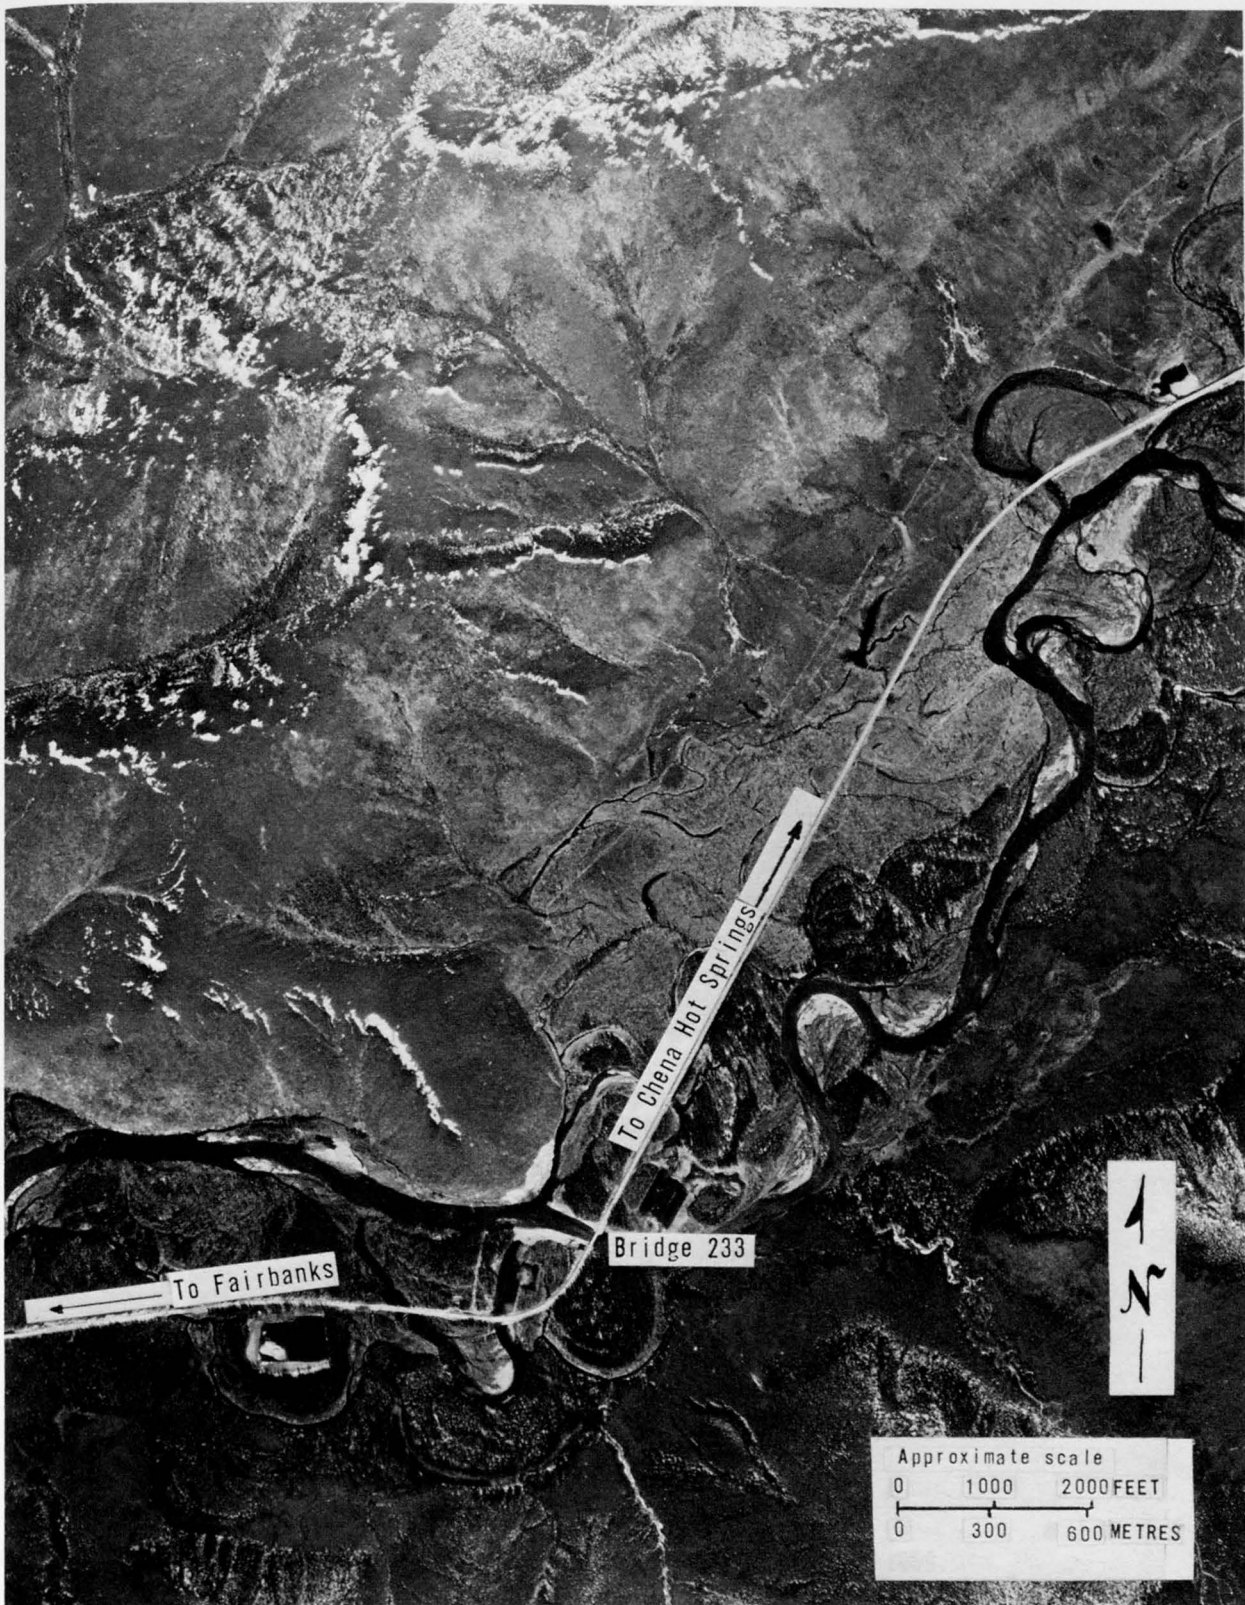
Figure 69. -- Aerial view of Chena River near Two Rivers at bridge 233 on May 23, 1972.

This study site is located at bridge 233 which spans the Chena River 41 mi (66 km) east of Fairbanks at mile 42 on the Chena Hot Springs Road. An aerial view of the site is shown in figure 69.

The Chena River in the vicinity of the study site is a meandering nonglacial stream and the bridge crosses a straight reach of the channel (fig. 69). Streambed particle size ranges from gravel to cobbles.

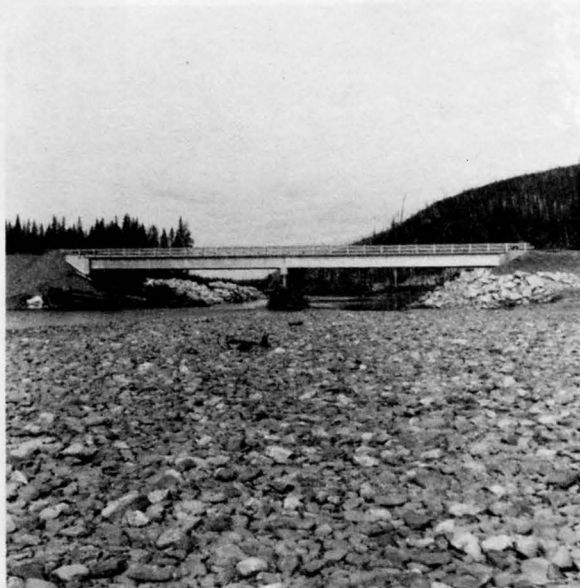
Figure 70.-- Downstream view of bridge 233 during low flow on June 5, 1969, at Chena River near Two Rivers.

The bridge is 160 ft (48.8 m) long and is supported at midspan by a 1-ft (0.30-m)-wide pointed-nosed pier with a slight positive rake. A large pile of debris had collected on the pier nose at the time of study and is visible in the downstream view of the bridge at low flow in figure 70 and during high flow in figure 71.

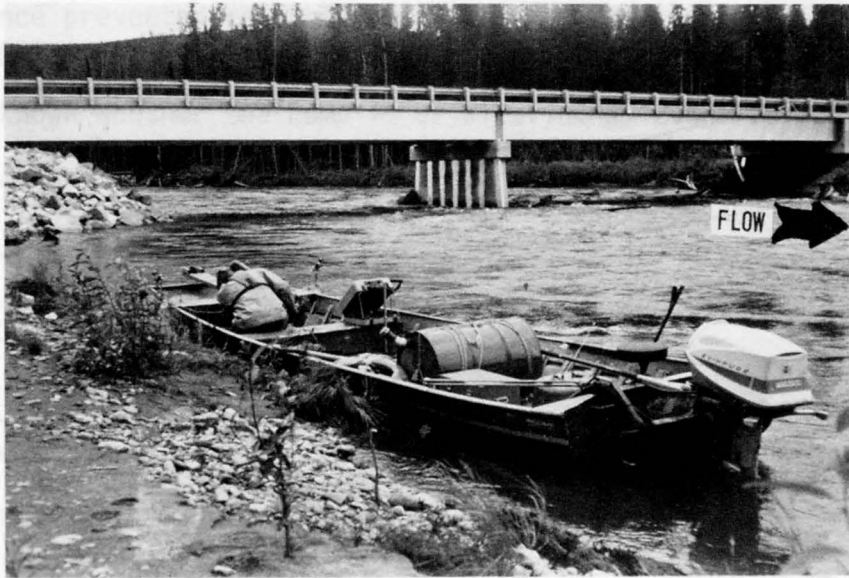
Figure 71.-- Bridge 233 during high flow, August 6, 1969.

Unfortunately, on August 6, 1969, water-surface elevations were not obtained. An estimate of water-surface elevation at the bridge was made from the photograph in figure 71 from which the water surface at the
