# FLOOD OF JULY 21, 1975 IN MERCER COUNTY, NEW JERSEY

U.S. GEOLOGICAL SURVEY

Water-Resources Investigations 51-75

Prepared in cooperation with  
NEW JERSEY DEPARTMENT OF ENVIRONMENTAL  
PROTECTION, DIVISION OF WATER RESOURCES

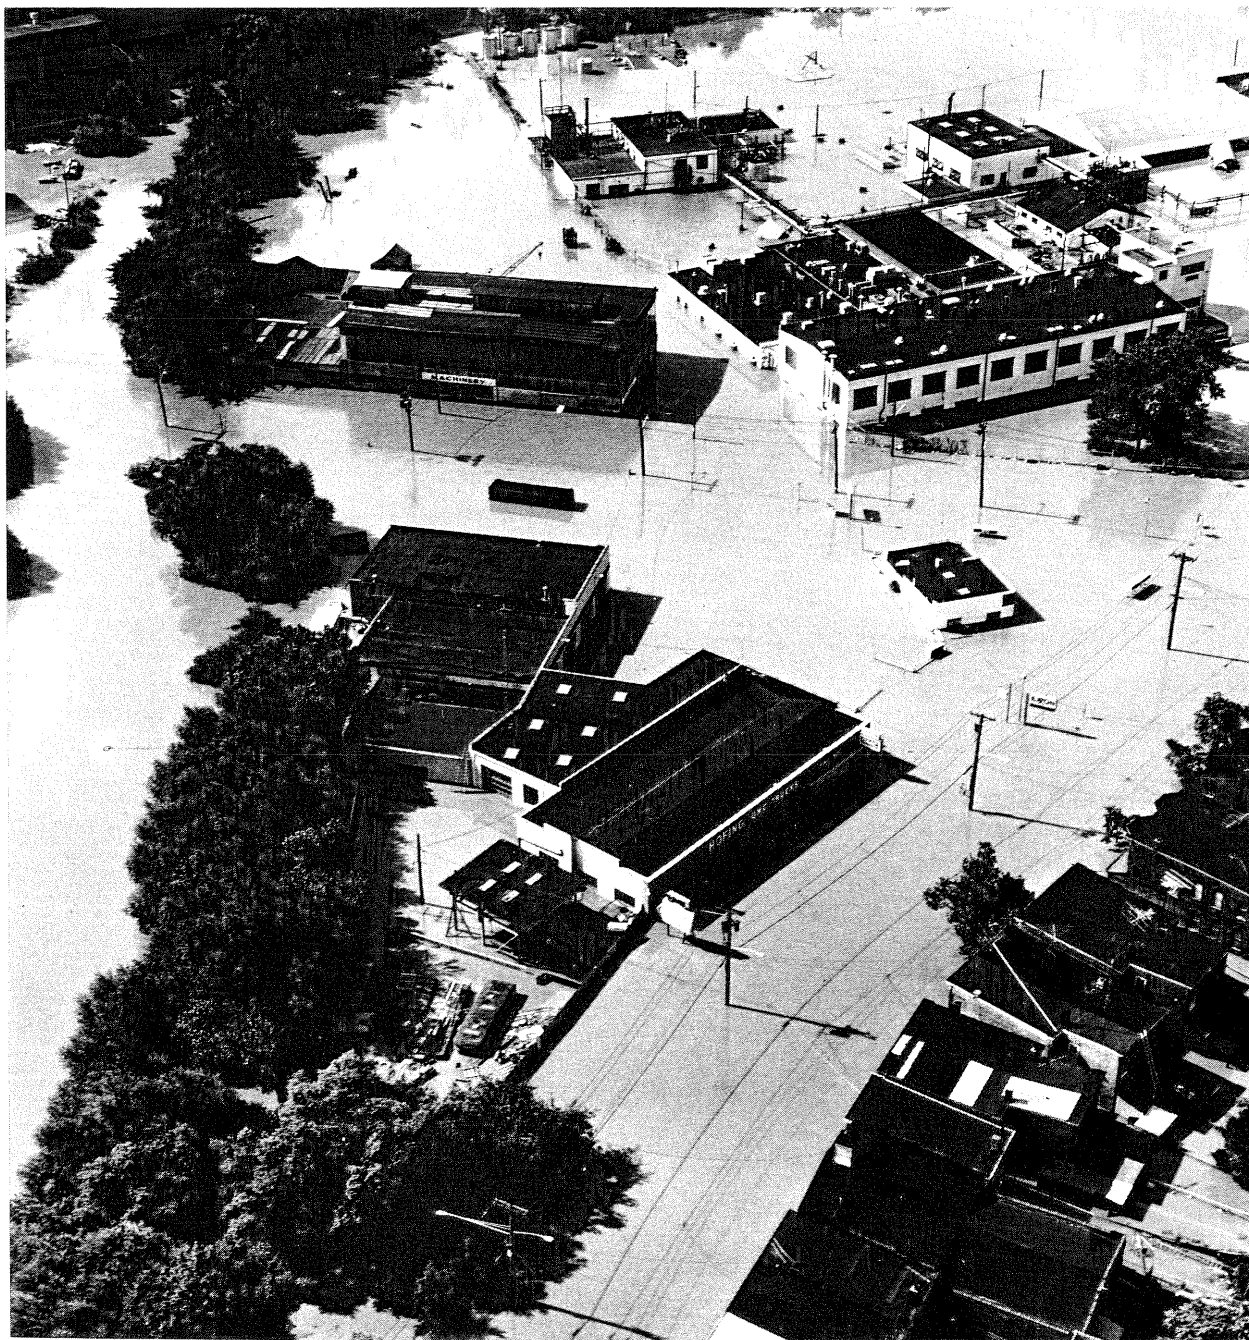
Figure 4.--Industrial and residential flooding along Assunpink Creek in Trenton, July 21, 1975. Mulberry Street is in the foreground. Nottingham Way, P.E. Albert and Sons machinery plant and Thiokol Corp. plant are in the background. Trenton Times photograph by Warren Kruse.

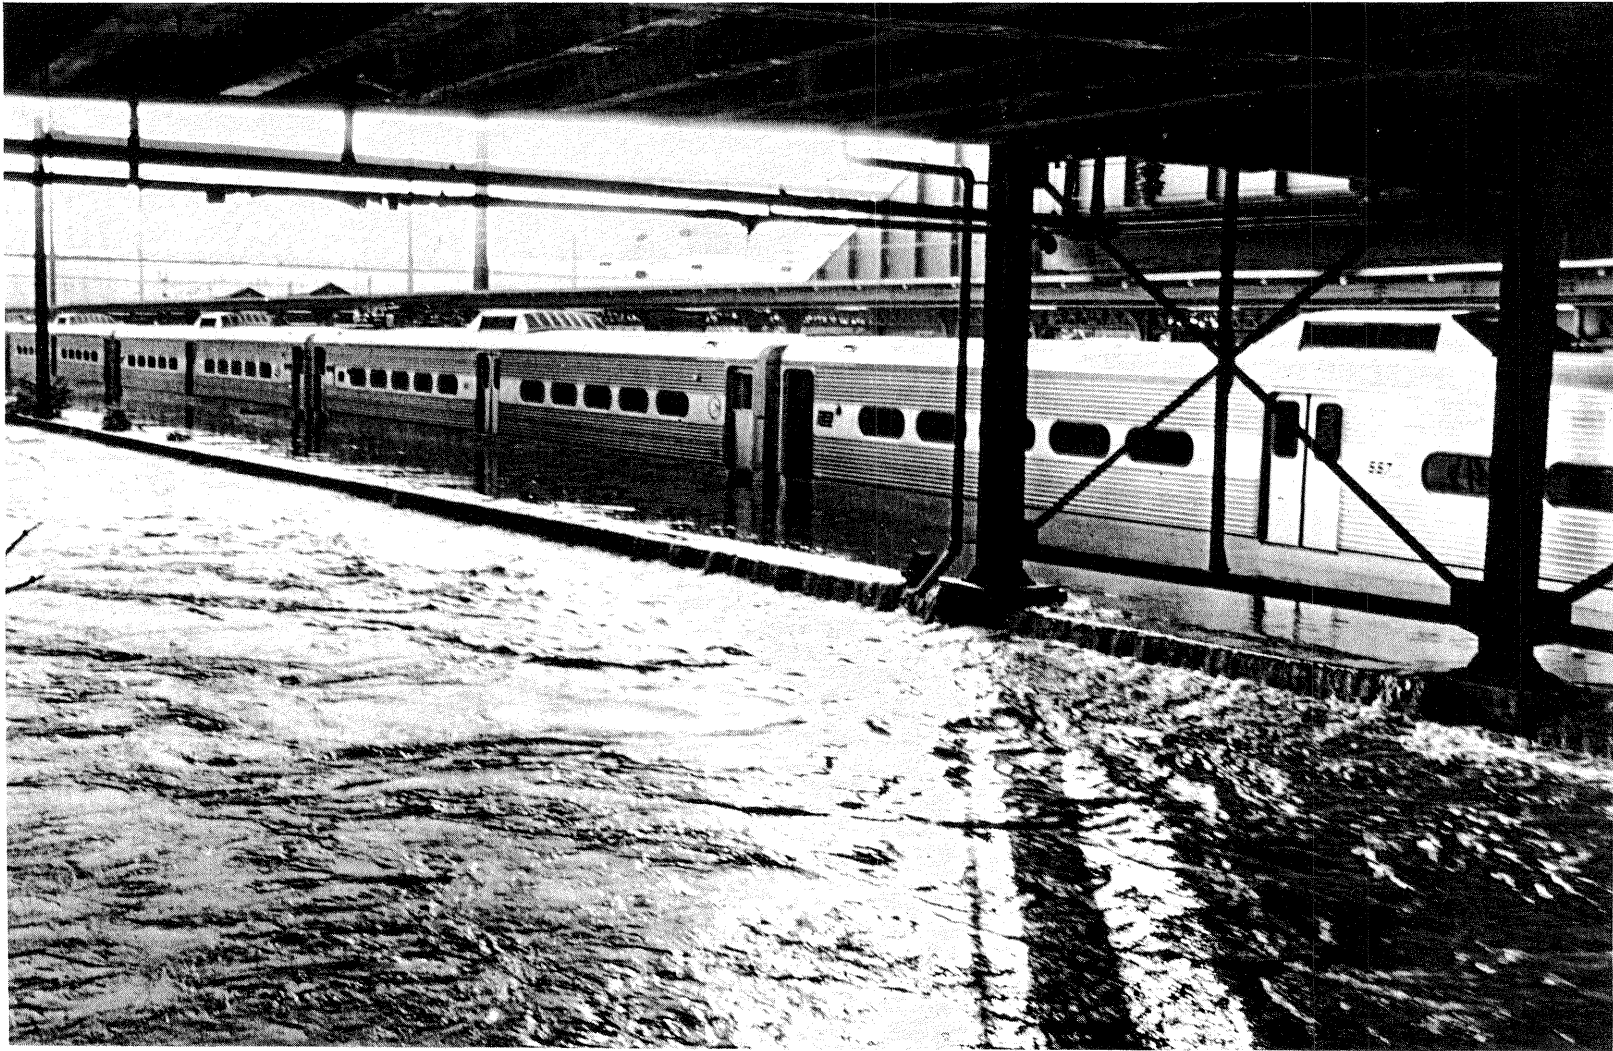
Figure 8.--Flooding along Assunpink Creek under the upper passenger concourse of the Penn Central Clinton Avenue railroad station, July 21, 1975. Trenton Times photograph by Martin D'Arcy.

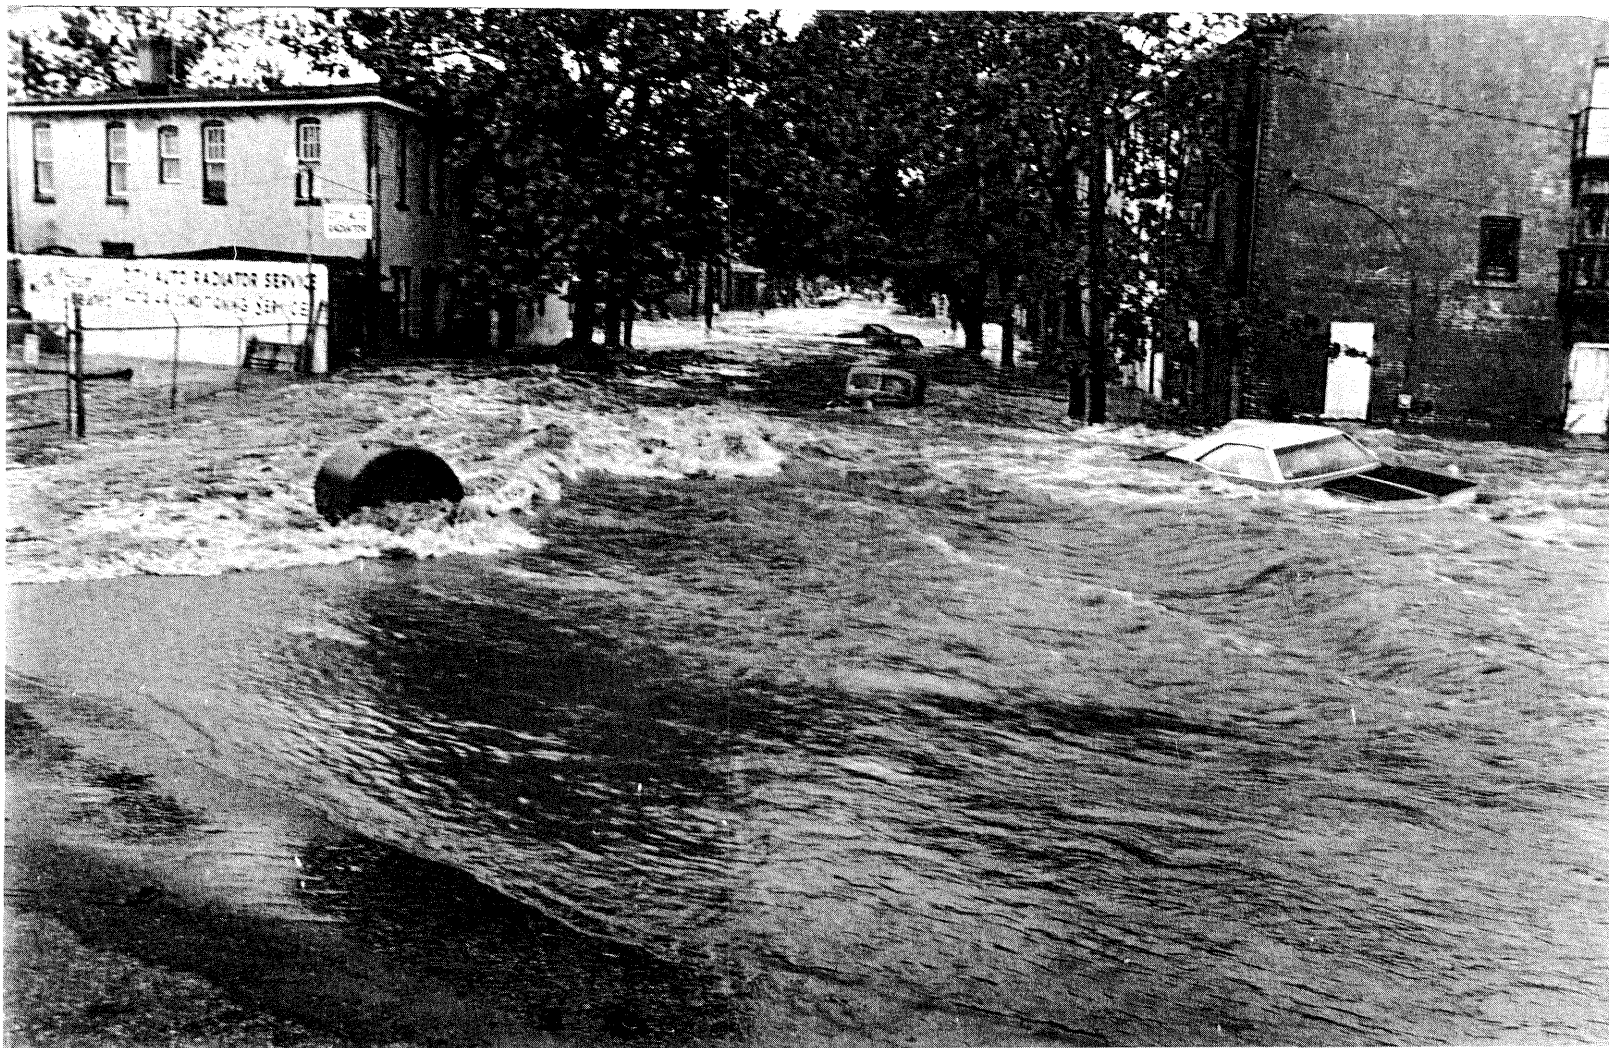
Figure 9.--Assunpink Creek floodwaters rushing off of main-line Penn Central railroad tracks onto Ferry Street near Lamberton Street in Trenton, looking southwest, July 21, 1975. Trenton Times photograph by Martin D'Arcy.

The Assunpink Creek, with a drainage area of 91.4 square miles ( $236.7 \text{ km}^2$ ) originates in Monmouth County, New Jersey and enters the Delaware River at Trenton in Mercer County, New Jersey. The largest portion of the watershed lies in Mercer County. The Assunpink Creek flows through one of the most highly urbanized areas of New Jersey. Assunpink Creek near Clarksville (site no. 1) had a peak discharge of  $1,050 \text{ ft}^3/\text{s}$  ( $29.7 \text{ m}^3/\text{s}$ ) from 34.3 square miles ( $88.8 \text{ km}^2$ ) which was 70 percent of the maximum flow observed in 1971. Flooding was devastating in the vicinity of Trenton where industrial, commercial, and residential development along the Assunpink Creek is extensive (fig. 4). Assunpink Creek at Trenton (site no. 6) reached a peak flow of  $5,450 \text{ ft}^3/\text{s}$  ( $154 \text{ m}^3/\text{s}$ ) from 89.4 square miles ( $231.5 \text{ km}^2$ ), which was 39 percent greater than the previous maximum in 51 years of record. The peak stage was 1.15 feet ( $0.350 \text{ m}$ ) higher than the 1971 peak and 3.87 feet ( $1.180 \text{ m}$ ) higher than the 1938 peak. Assunpink Creek floodwaters overflowed onto the main-line Penn Central railroad tracks in the vicinity of North Olden Avenue in Trenton and inundated the Clinton Avenue station, stopping railroad service between New York City and Philadelphia (figs. 5-8). At Trenton (site no. 6), the Assunpink Creek overflow on the Penn Central railroad tracks reached a peak of  $1,340 \text{ ft}^3/\text{s}$  ( $37.9 \text{ m}^3/\text{s}$ ). This accounts for about 25 percent of the total peak flow recorded at the site. Figures 7 and 8 show some of this overflow spilling over a flood-wall back into the main-channel of the Assunpink Creek in the vicinity of the Penn Central Clinton Avenue railroad station. Almost all of the overflow, however, continued to flow down the main-line Penn Central railroad tracks until it spilled onto Ferry Street between Lamberton Street and Bridge Street in South Trenton, where flood damage to commercial, industrial, and residential property was extensive (figs. 9-10).

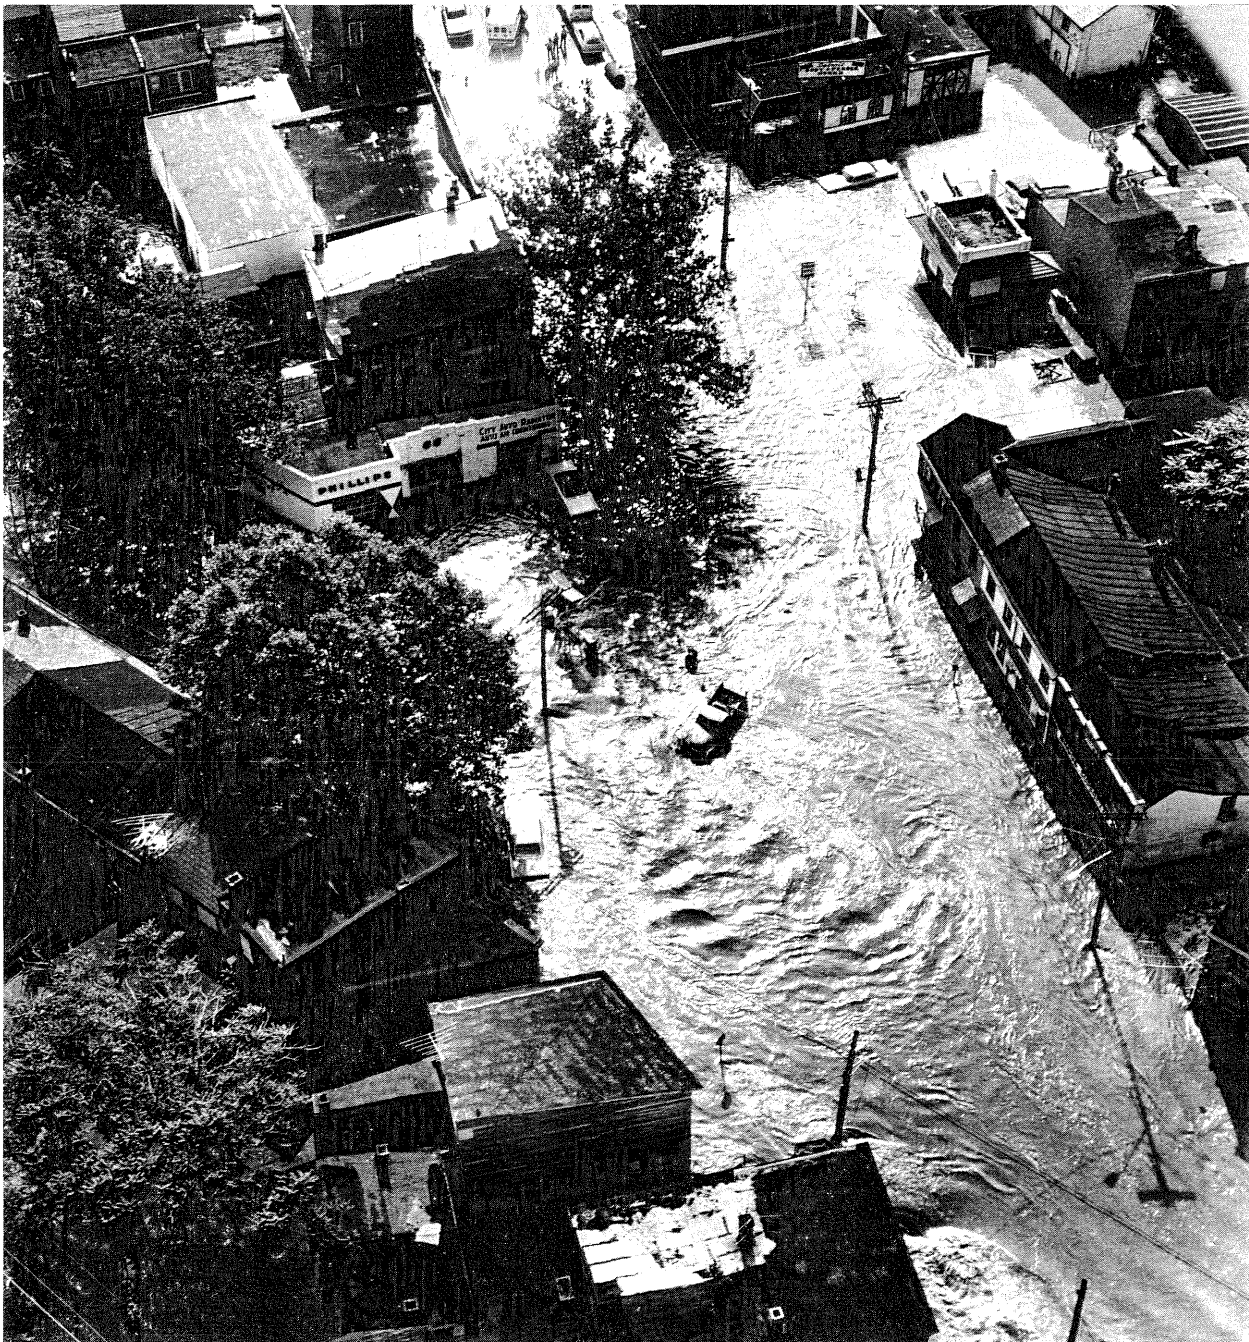
Figure 10.--Intersection of Bridge and Ferry Streets in Trenton inundated by floodwaters from Assunpink Creek which had overflowed onto the main-line Penn Central railroad tracks, July 21, 1975. View is looking east. Trenton Times photograph by Warren Kruse.

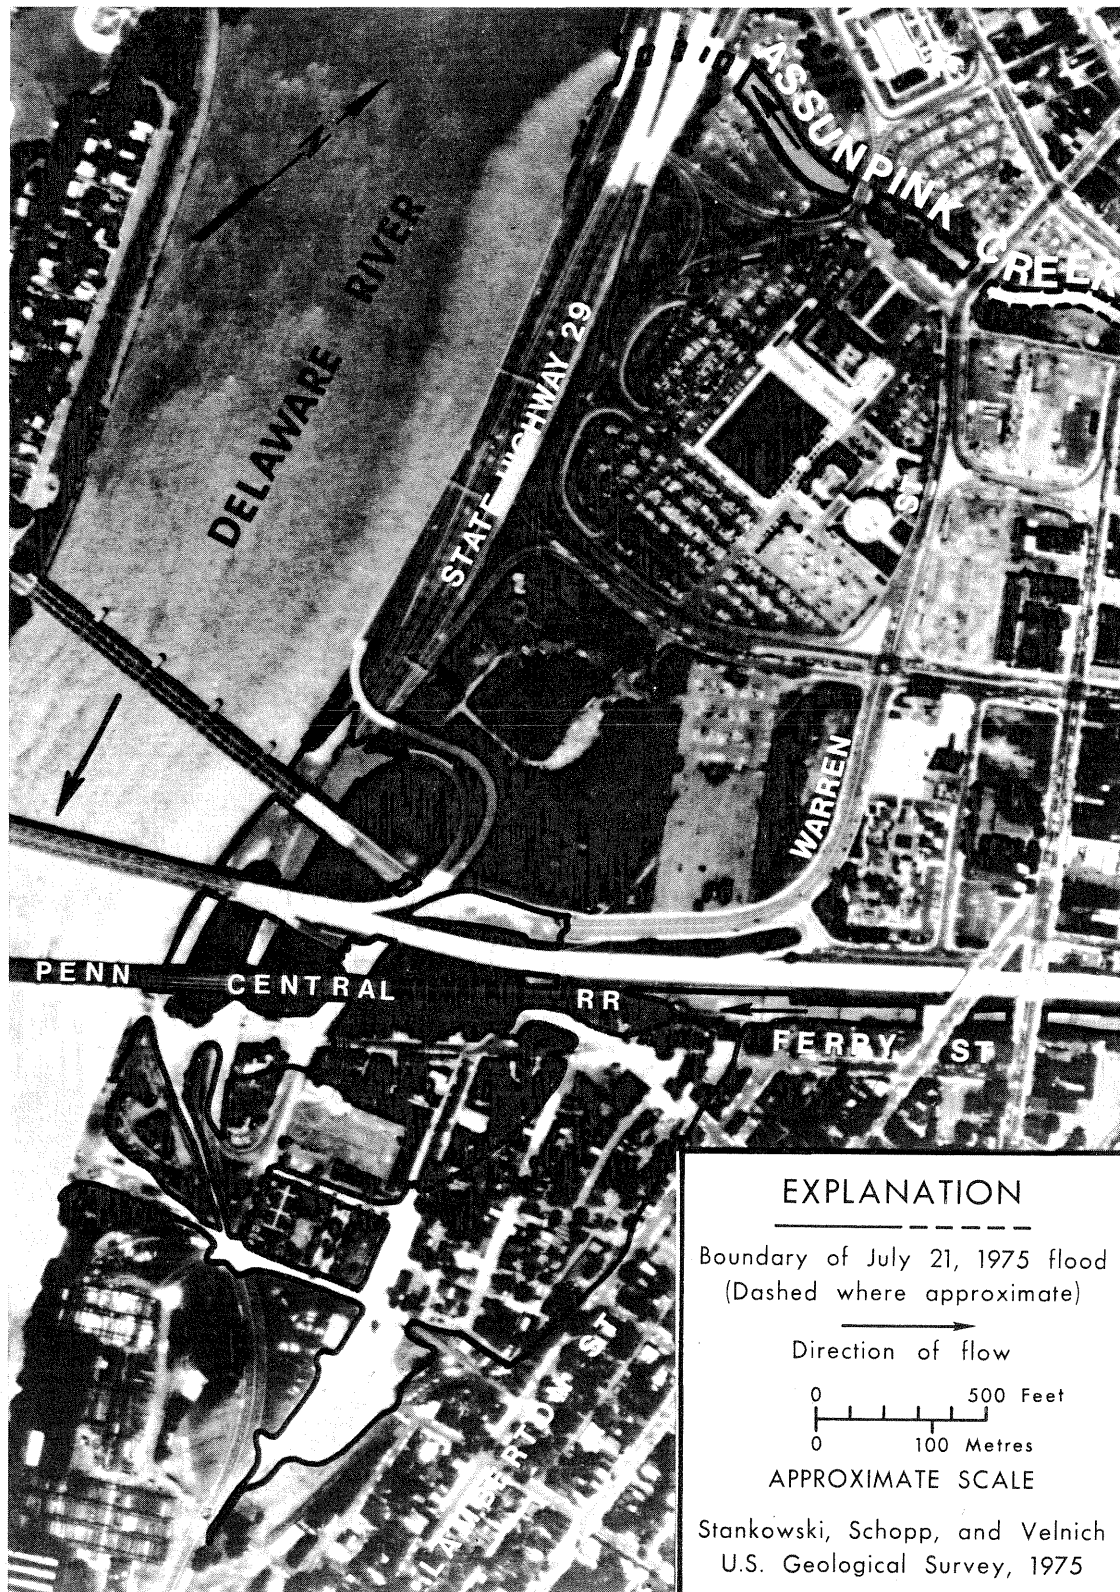
**PLATE 1**

The extent of flooding along Assunpink Creek and Pond Run, an ungaged tributary to Assunpink Creek, is shown on the photomosaic base maps on plates 2 to 18. The areas covered by the photomosaic base maps are outlined on plate 1.

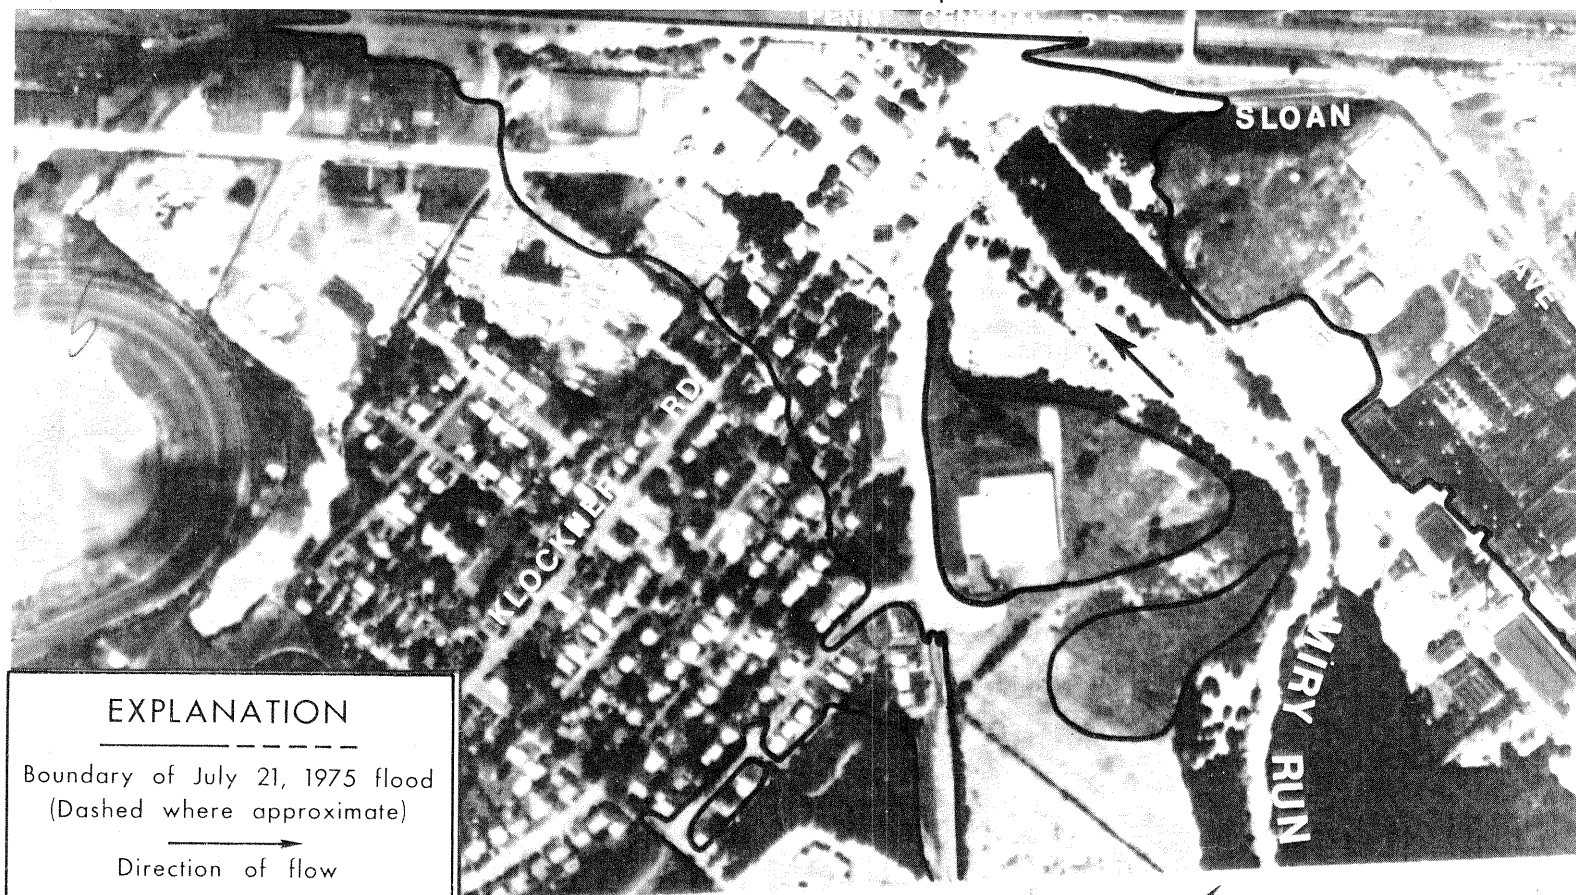
PLATE 7

# EXPLANATION

Boundary of July 21, 1975 flood  
(Dashed where approximate)
