EFFECTS OF OFF-ROAD VEHICLE USE ON THE HYDROLOGY  
AND LANDSCAPE OF ARID ENVIRONMENTS IN  
CENTRAL AND SOUTHERN CALIFORNIA

By C. T. Snyder, D. G. Frickel, R. F. Hadley, and R. F. Miller

U.S. GEOLOGICAL SURVEY

✓  
Water-Resources Investigations 76-99

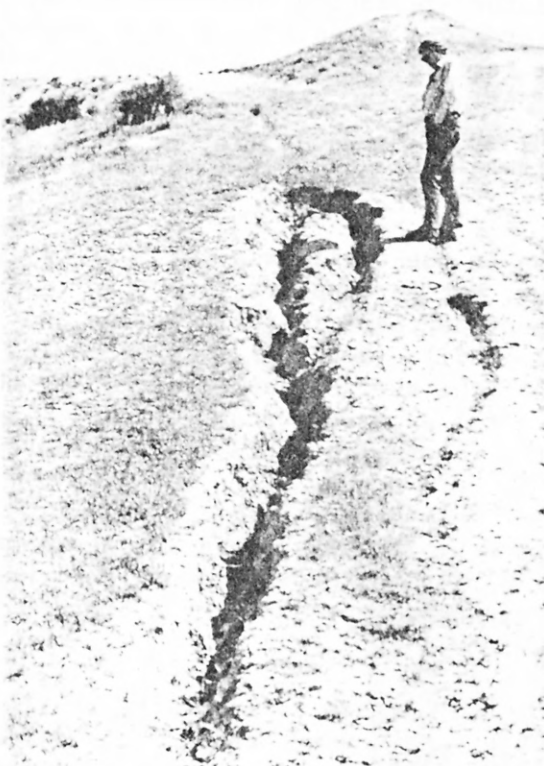
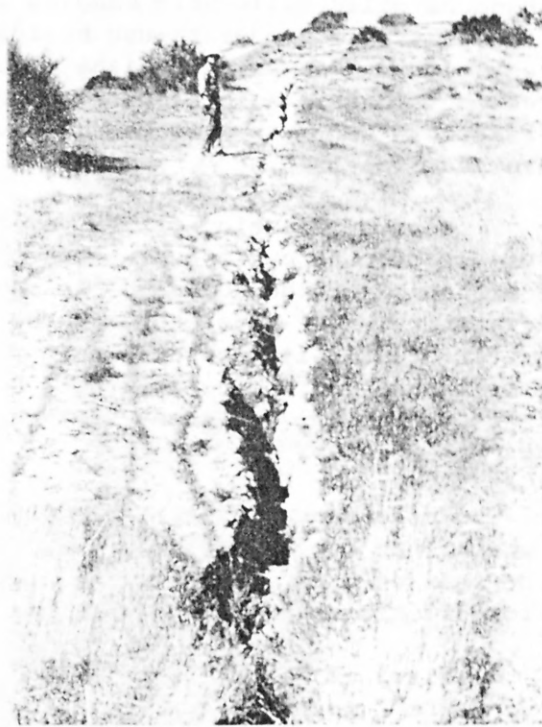
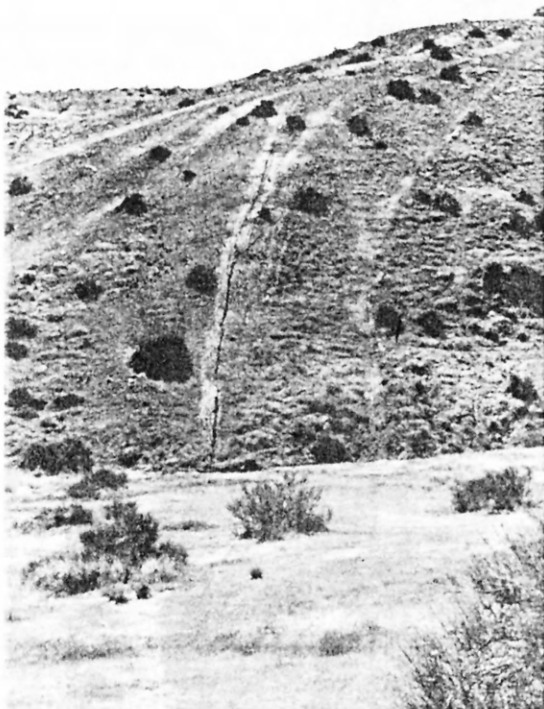
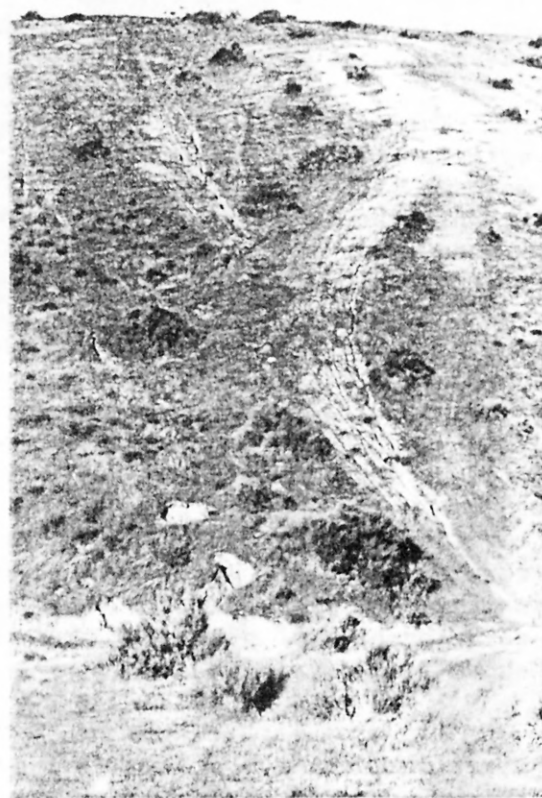
Figure 5.--Typical rilling and piping caused by trailing on the Hills.

The used area has steep hillslopes of about 65 percent. There is little remaining evidence of the plant cover that probably existed before motorcycle use, but from some isolated remnants in the vicinity of large shrubs where traffic was restricted, it appears that plant cover was once as good as in the unused basin. Motorcycle trails in the used area were completely denuded of plant cover and top soil and are deeply rilled.

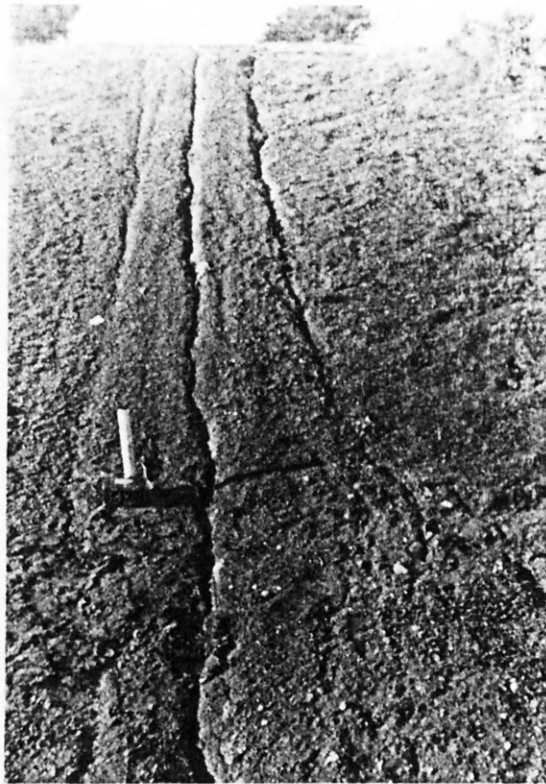
Figure 6.--Motorcycle trail and less disturbed area typical of in-trail and beside-trail sampling site with easterly exposure.

For the purpose of describing moisture-retention characteristics, the Panoche Hills soils were sampled for three use types. These were heavy-use in the trails, moderate-use beside the trails, and nonuse in basin 2. Each use type was sampled at eight sites, four near the base and four near the top of the slopes. A total of 24 sites were sampled on six different dates. Figures 6 and 7 show representative view of use and nonuse sampling sites, respectively.

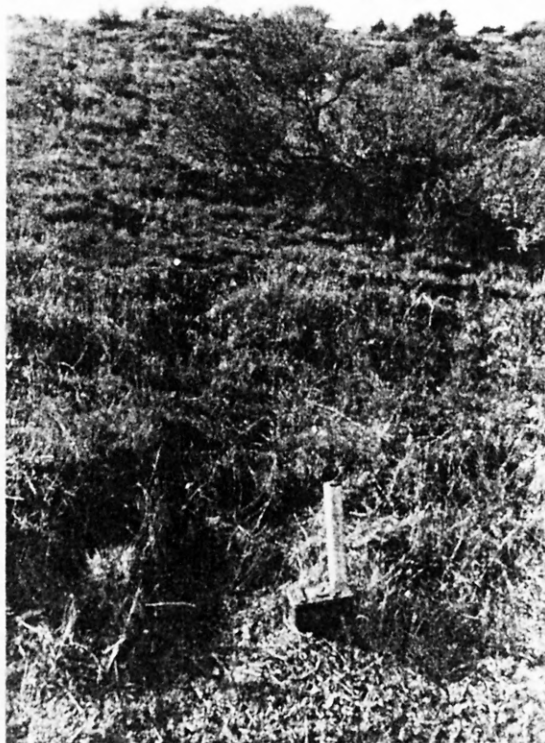
Figure 7.--General aspect of undisturbed area with easterly exposure.
